INVESTIGATION NO. 3136
THE WICHITA VALLEY RAILWAY COMPANY
REPORT IN RE ACCIDENT
AT SEYMOUR, TEX., ON
OCTOBER 15, 1947

Accident at Seymour, Tex., on October 15, 1947, caused
by failure to operate a motor-truck approaching
a railroad crossing at grade in accordance with
requirements of law.

Inv. No. 3136
 Wichita Valley Railway
 Seymour, Tex.
 October 15, 1947

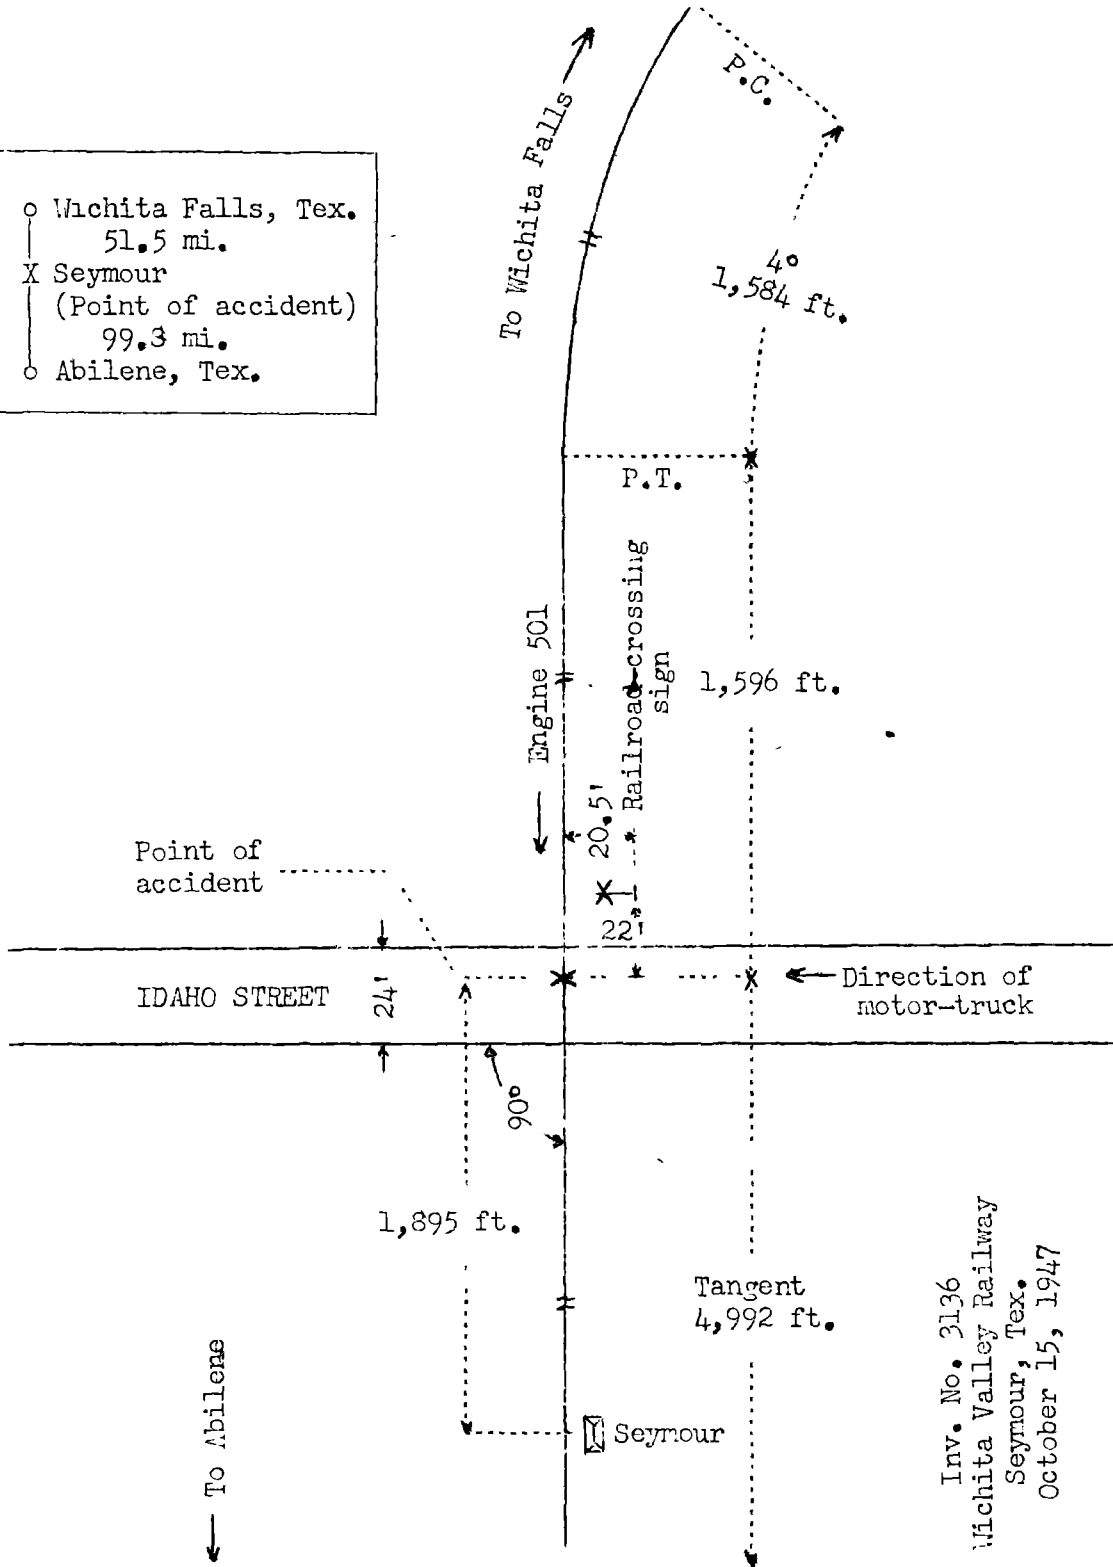
o Wichita Falls, Tex.
 51.5 mi.
 X Seymour
 (Point of accident)
 99.3 mi.
 o Abilene, Tex.
