REPORT NO. 3336

THE YOUNGSTOWN AND NORTHERN RAILROAD COMPANY

IN RE ACCIDENT

NEAR YOUNGSTOWN, OHIO, ON

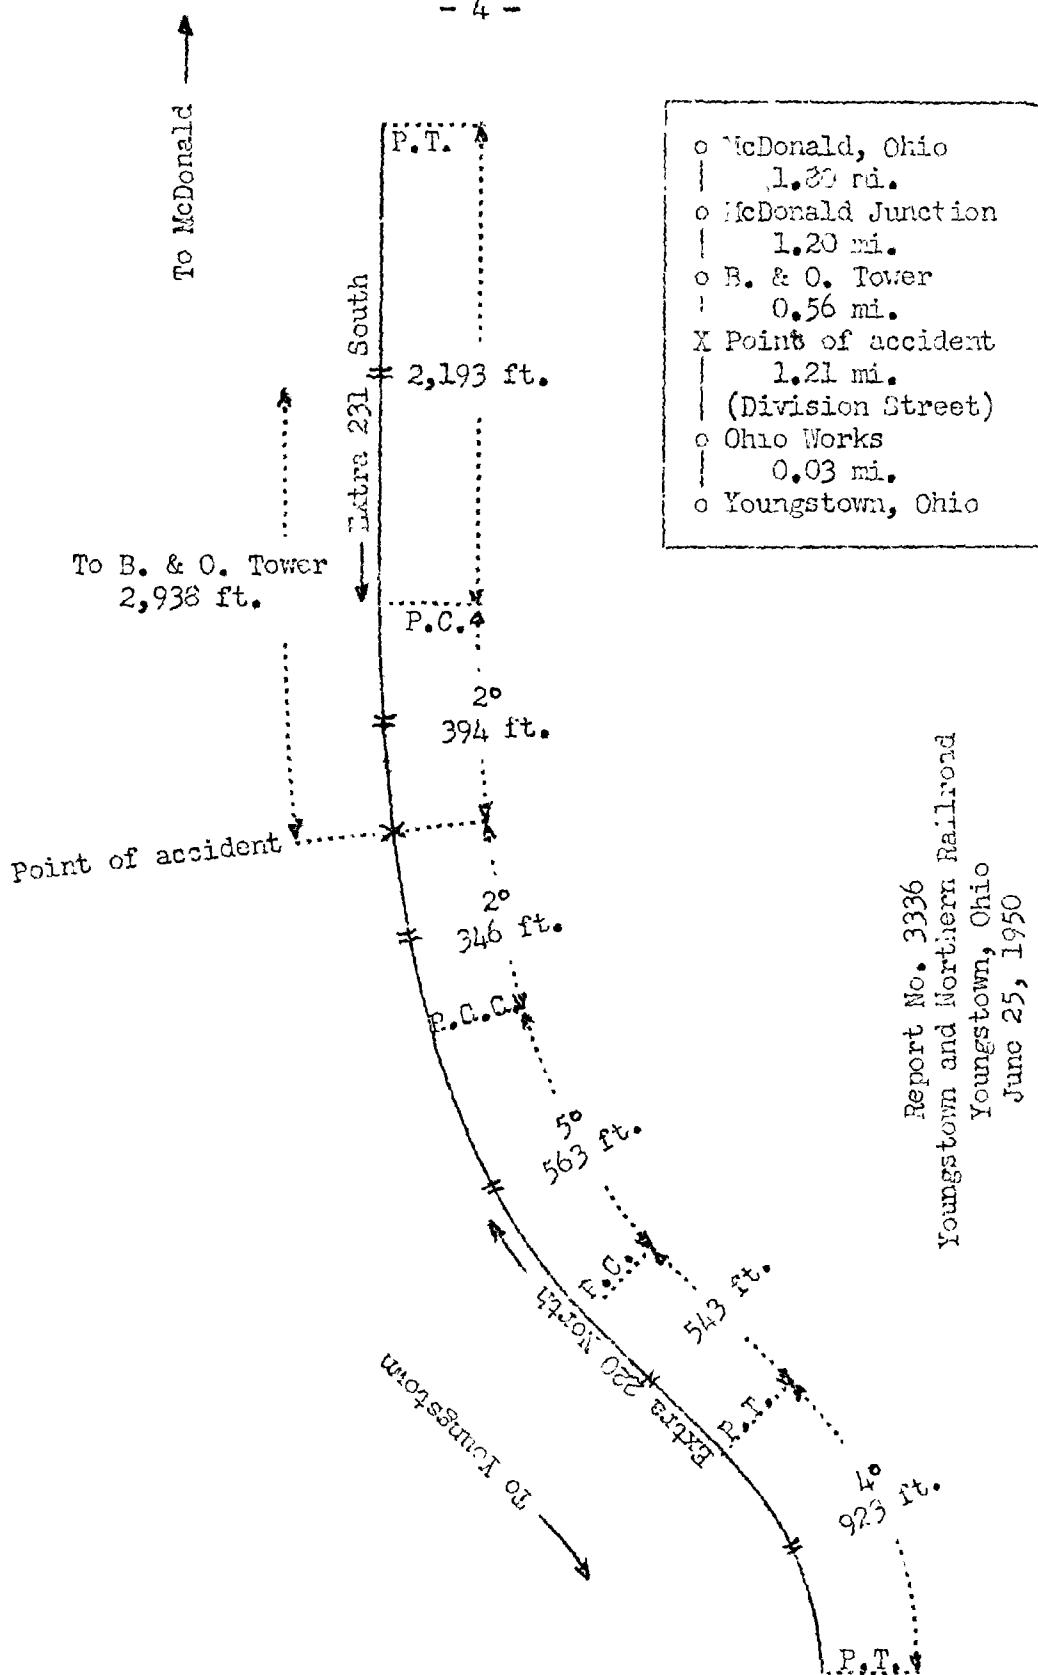
This accident occurred on the main track of the Youngstown and Northern Railroad, which extends between Youngstown and McDonald, Ohio, 4.8 miles. In the vicinity of the point of accident this is a single-track line, over which trains are operated by train orders. There is no block system in use. The accident occurred 1.24 miles north of Youngstown and 1.02 miles north of Division Street. From the south there are, in succession, a 4° curve to the left 923 feet in length, a tangent 543 feet, a 5° curve to the right 563 feet and then a 2° curve to the right 346 feet to the point of accident and 394 feet northward. From the north there are, in succession, a tangent 2,193 feet in length, and then the curve on which the accident occurred. The grade is 0.25 percent descending northward at the point of accident.
