INTERSTATE COMMERCE COMMISSION

REPORT OF THE DIRECTOR OF THE BUREAU OF SAFETY IN RE
INVESTIGATION OF AN ACCIDENT WHICH OCCURRED ON THE
BOSTON AND MAINE RAILROAD AT WOODSVILLE, N. H , ON
DECEMBER 3, 1931.

January 26, 1932

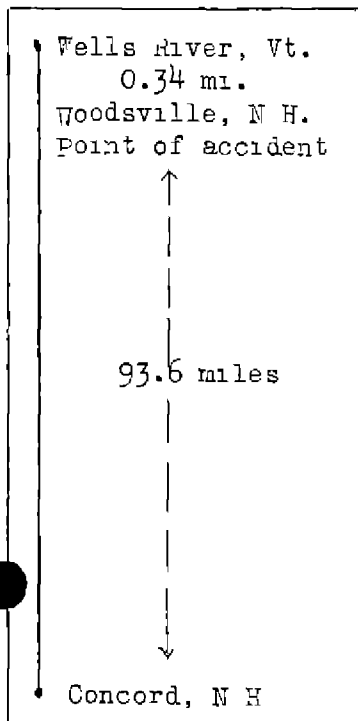
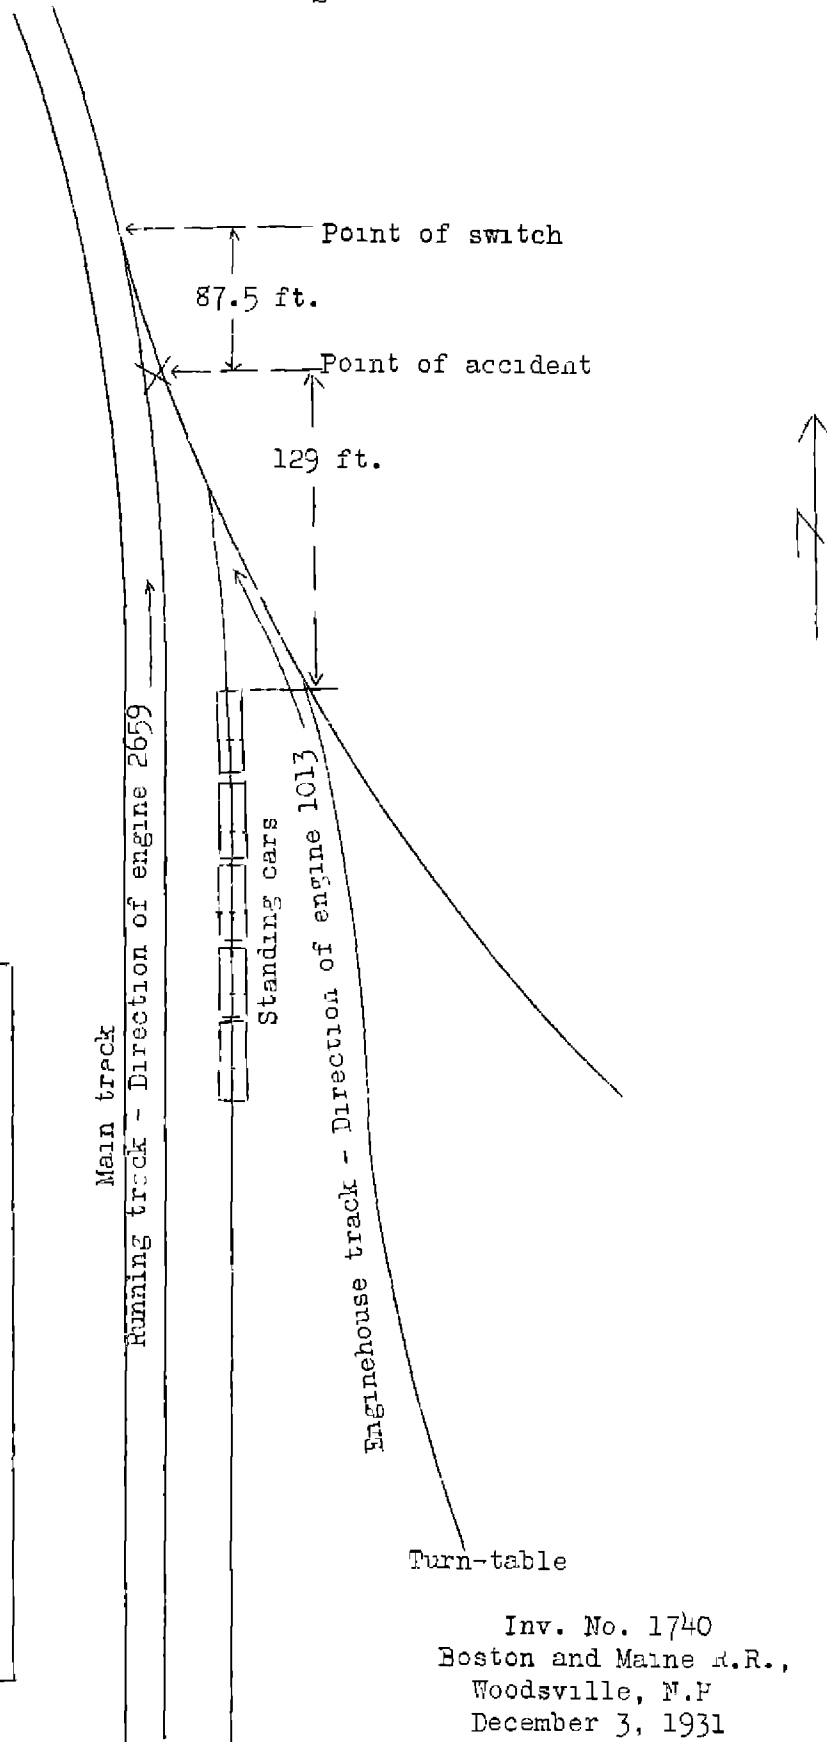
Inv. No. 1740
Boston and Maine R.R.,
Woodsville, N.H.
December 3, 1931

This accident occurred on the New Hampshire Division, within the limits of Woodsville yard, at a point where the lead track from the enginehouse joins a running track which parallels the main track on the east. This running track was formerly the northbound main track, but on November 24, 1931, it was changed to a yard track, at which time the interlocking plant at Woodsville was discontinued, and it was further provided that engine movements in and out of the enginehouse would be made through the north switch, except when going to the freight yard, located south of the engine house. The accident occurred at a point about 87.5 feet south of the switch at the junction of the lead and running tracks, or about 2,900 feet south of the passenger station. Approaching the point of accident on the running track from the south, there is a slight curve to the left approximating 1° for a distance of 560 feet to the point of accident. The grade for northbound trains on this track is 1.103 per cent ascending at the point of accident. The track extending from the engine house is on a curve to the left where it meets the lead track, and the latter track is practically straight up to its junction with the running track.

The lamp of the switch involved is approximately 6 feet 6 inches above the ties, and shows a green indication for movements on the running track and a yellow indication for movements on the lead track.

At the time of the accident five loaded coal cars were standing on a track between the running track and the enginehouse track, obscuring the view had by the engine crews

of engines approaching northbound on the engine-house track as well as on the running track, the north end of this cut of cars was 125 feet south of the approximate point of accident.
