INTERSTATE COMMERCE COMMISSION

REPORT OF THE DIRECTOR OF THE BUREAU OF SAFETY IN RE INVESTIGATION OF AN ACCIDENT WHICH OCCURRED ON THE CHICAGO, ROCK ISLAND & GULF RAILWAY, AT NORTH FORT WORTH, TEXAS, ON SEPTEMBER 12, 1930.

INV. No. 1664

Chicago, Rock Island and Gulf Railway

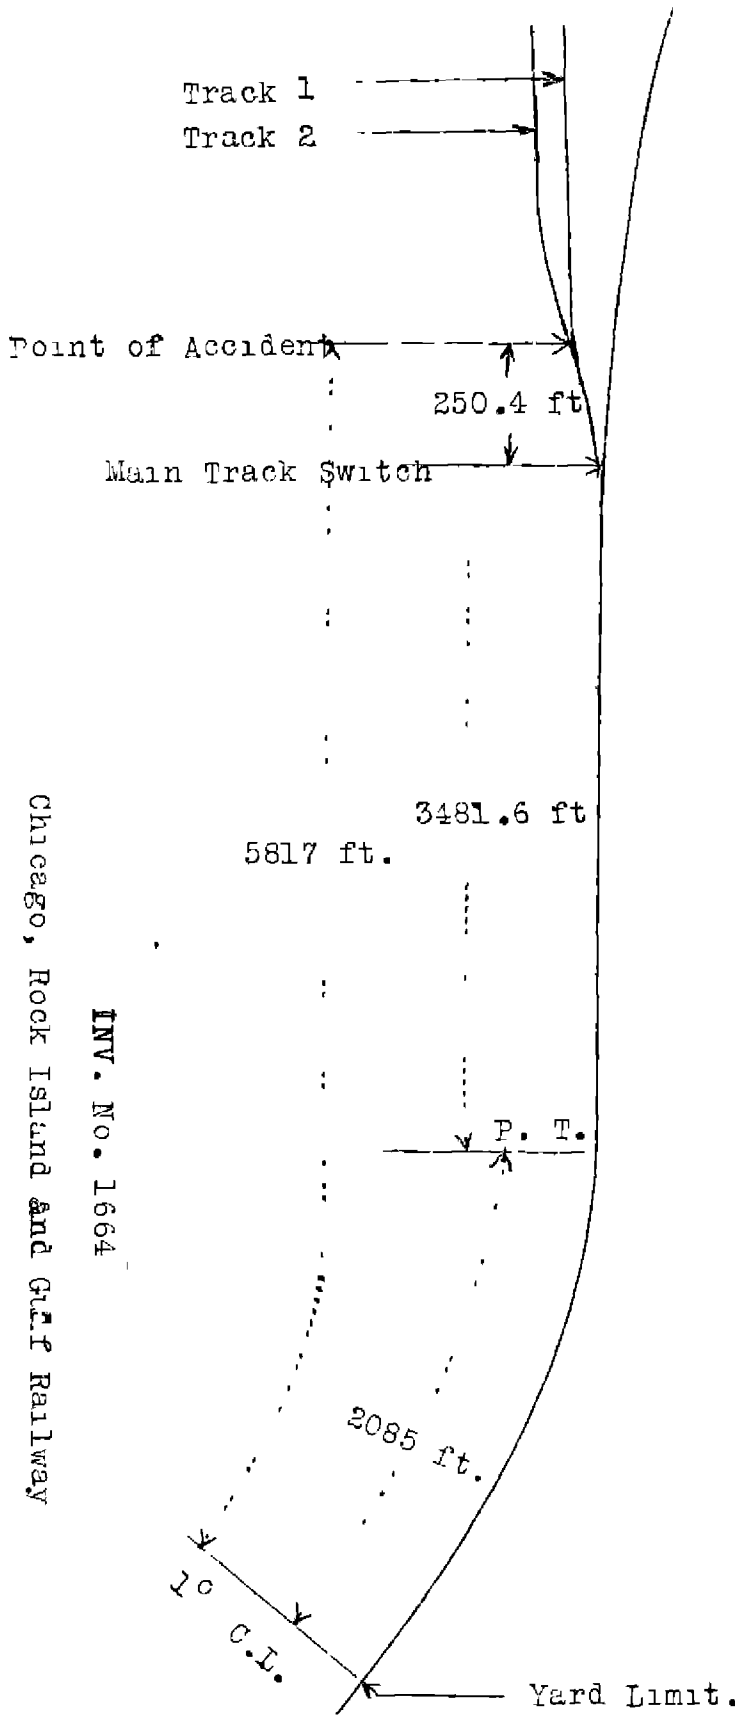
North Fort Worth, Tex.

September 12, 1930

This accident occurred on Sub-division 1 of the Second District of the Oklahoma-Southern Division, extending between Waurika Yard, Okla., and Fort Worth, Texas, a distance of 112.3 miles. In the vicinity of the point of accident this is a single-track line over which trains are operated by time-table and train orders, no block-signal system being in use. The accident occurred within yard limits, on a spur track, at a point 5,817 feet west of the east yard-limit board. The spur-track switch is a facing-point switch for westbound trains and parallels the main track on the south, the accident occurring 250.4 feet from the switch. Approaching the point of accident from the east yard-limit board, there is a 1° curve to the left 2,085 feet in length, followed by 3,481.6 feet of tangent track to the switch, this tangent extending 308 feet beyond. The grade is 1.0 per cent descending for westbound trains.

The switch stand is located $9\frac{1}{2}$ feet south of the track and is equipped with a red target 12" x 24", mounted with its center $8\frac{3}{4}$ inches below the top of the mast, the top of the mast being 7 feet 9 inches above the tie. The spur track is used for spotting oil and gasoline tank cars at the loading rack of the White Eagle Refinery and is known as track 1. There is another spur, known as track 2, which leads from track 1 at a point about 210 feet west of the main-track switch. Track 1 is 1,132 feet in length and track 2 is 967 feet in length, and the loading rack is located between the two tracks. An unobstructed
