INTERSTATE COMMERCE COMMISSION

REPORT OF THE DIRECTOR OF THE BUREAU OF SAFETY IN RE
INVESTIGATION OF AN ACCIDENT WHICH OCCURRED ON THE
CHICAGO, ROCK ISLAND & PACIFIC RAILWAY AT BECKETT,
OKLA., ON MAY 27, 1930.

Inv. 1643
Chicago, Rock Island & Pacific Ry.
Beckett, Okla.
May 27, 1930.

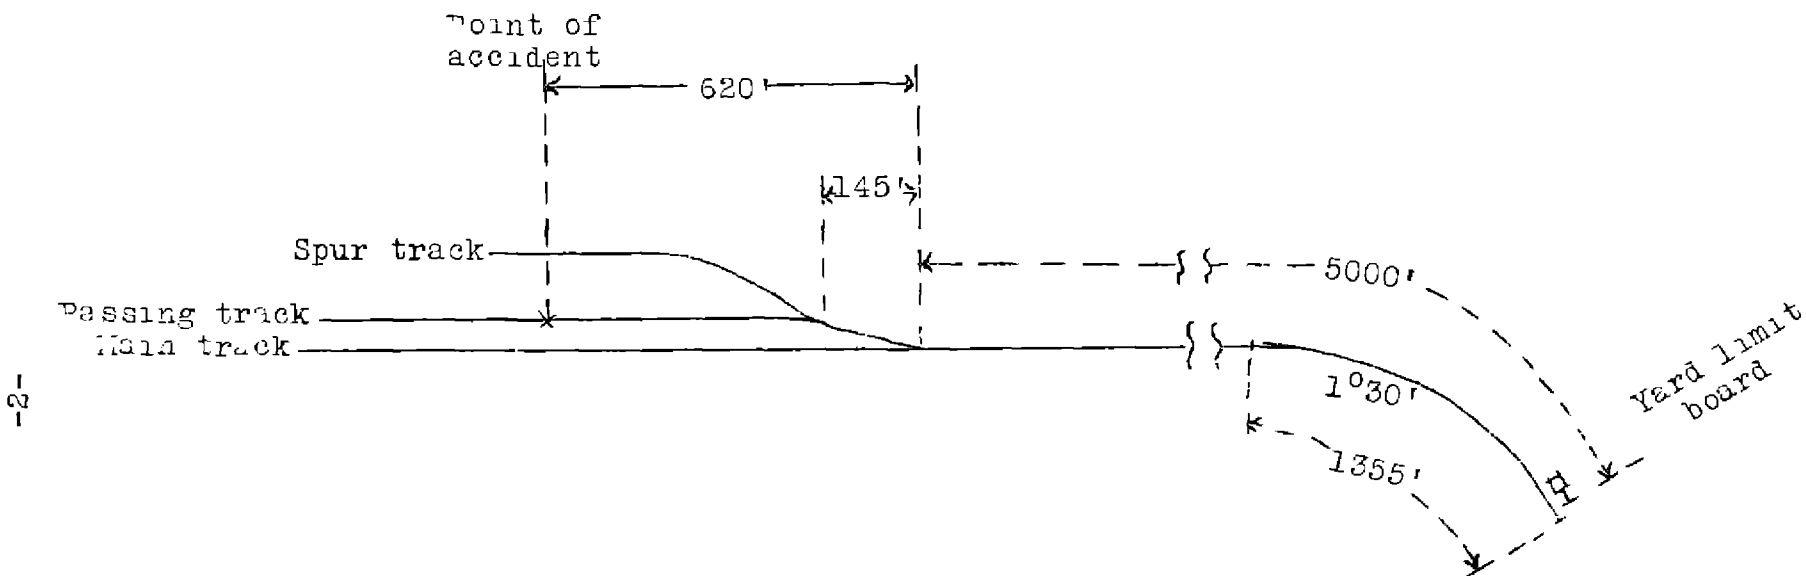
North

The switch stand of the east switch of the passing track is located on the north side of the track, at a point about 9 feet from the track center; the height of the mast is 7 feet 9 inches from the top of the tie and there is a switch lamp mounted on top of the mast, night indications being red when the switch is open and green when it is closed. At a point 145 feet west of this switch, there is another high switch stand, located on the same side of the track, at a point about 20 feet from the track; the switch at this latter point leads off the passing track to a spur track, the spur track being 639 feet in length and paralleling the main and passing tracks on the north; this latter switch stand is also equipped with a switch lamp, displaying red and green indications. An unobstructed view of the point where the accident occurred can be had from the cab of an approaching westbound engine.
