## INTERSTATE COMMERCE COMMISSION

REPORT OF THE DIRECTOR OF THE BUREAU OF SAFETY IN RE  
INVESTIGATION OF AN ACCIDENT WHICH OCCURRED ON THE  
ILLINOIS CENTRAL RAILROAD AT FREEPORT, ILL., ON  
FEBRUARY 7, 1931.

Inv. No. 1089  
Illinois Central R.R.,  
Freeport, Ill.  
February 7, 1931.

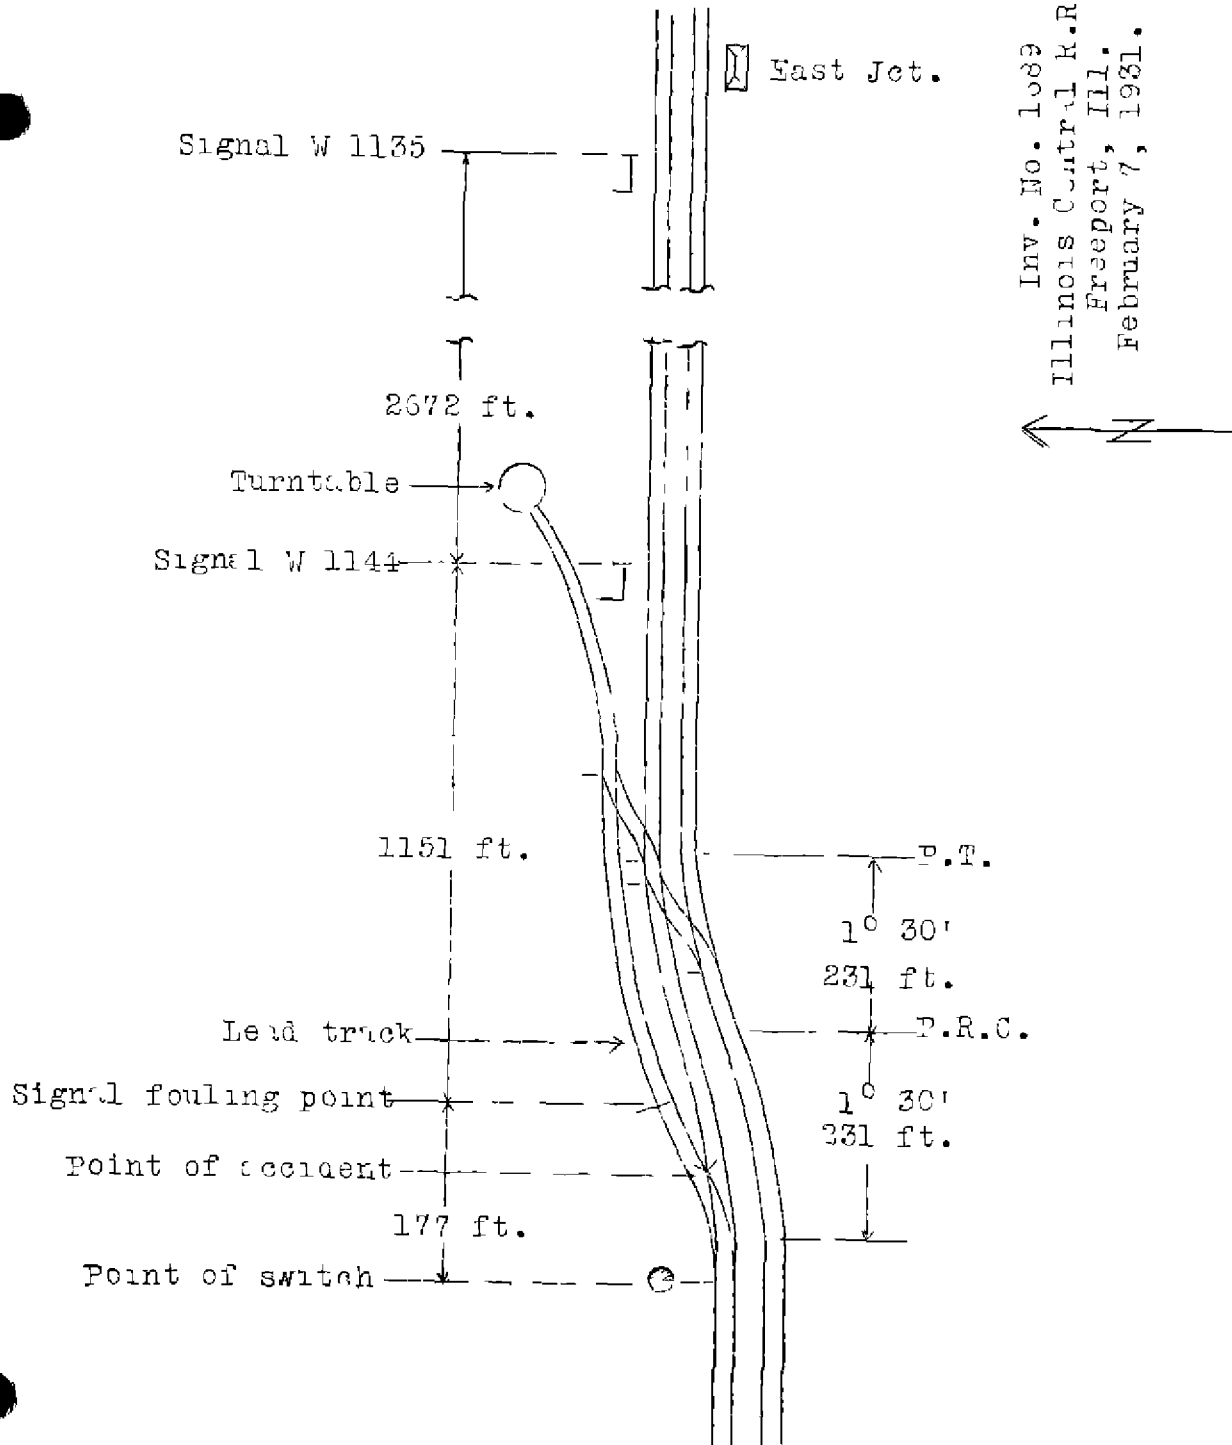
The lead track parallels the main tracks on the north. The signal fouling point on the lead track is located 177 feet east of the switch points; automatic signal W1144 is located 1,151 feet east of the signal fouling point, while signal W1135 is located 2,672 feet farther east. Night indications are red, yellow, and
