INTERSTATE COMMERCE COMMISSION

REPORT OF THE DIRECTOR OF THE BUREAU OF SAFETY IN RE
INVESTIGATION OF AN ACCIDENT WHICH OCCURRED ON THE
LOUISVILLE AND NASHVILLE RAILROAD AT TRAFFORD, ALA ,
ON JANUARY 20, 1930.

March 7, 1930.

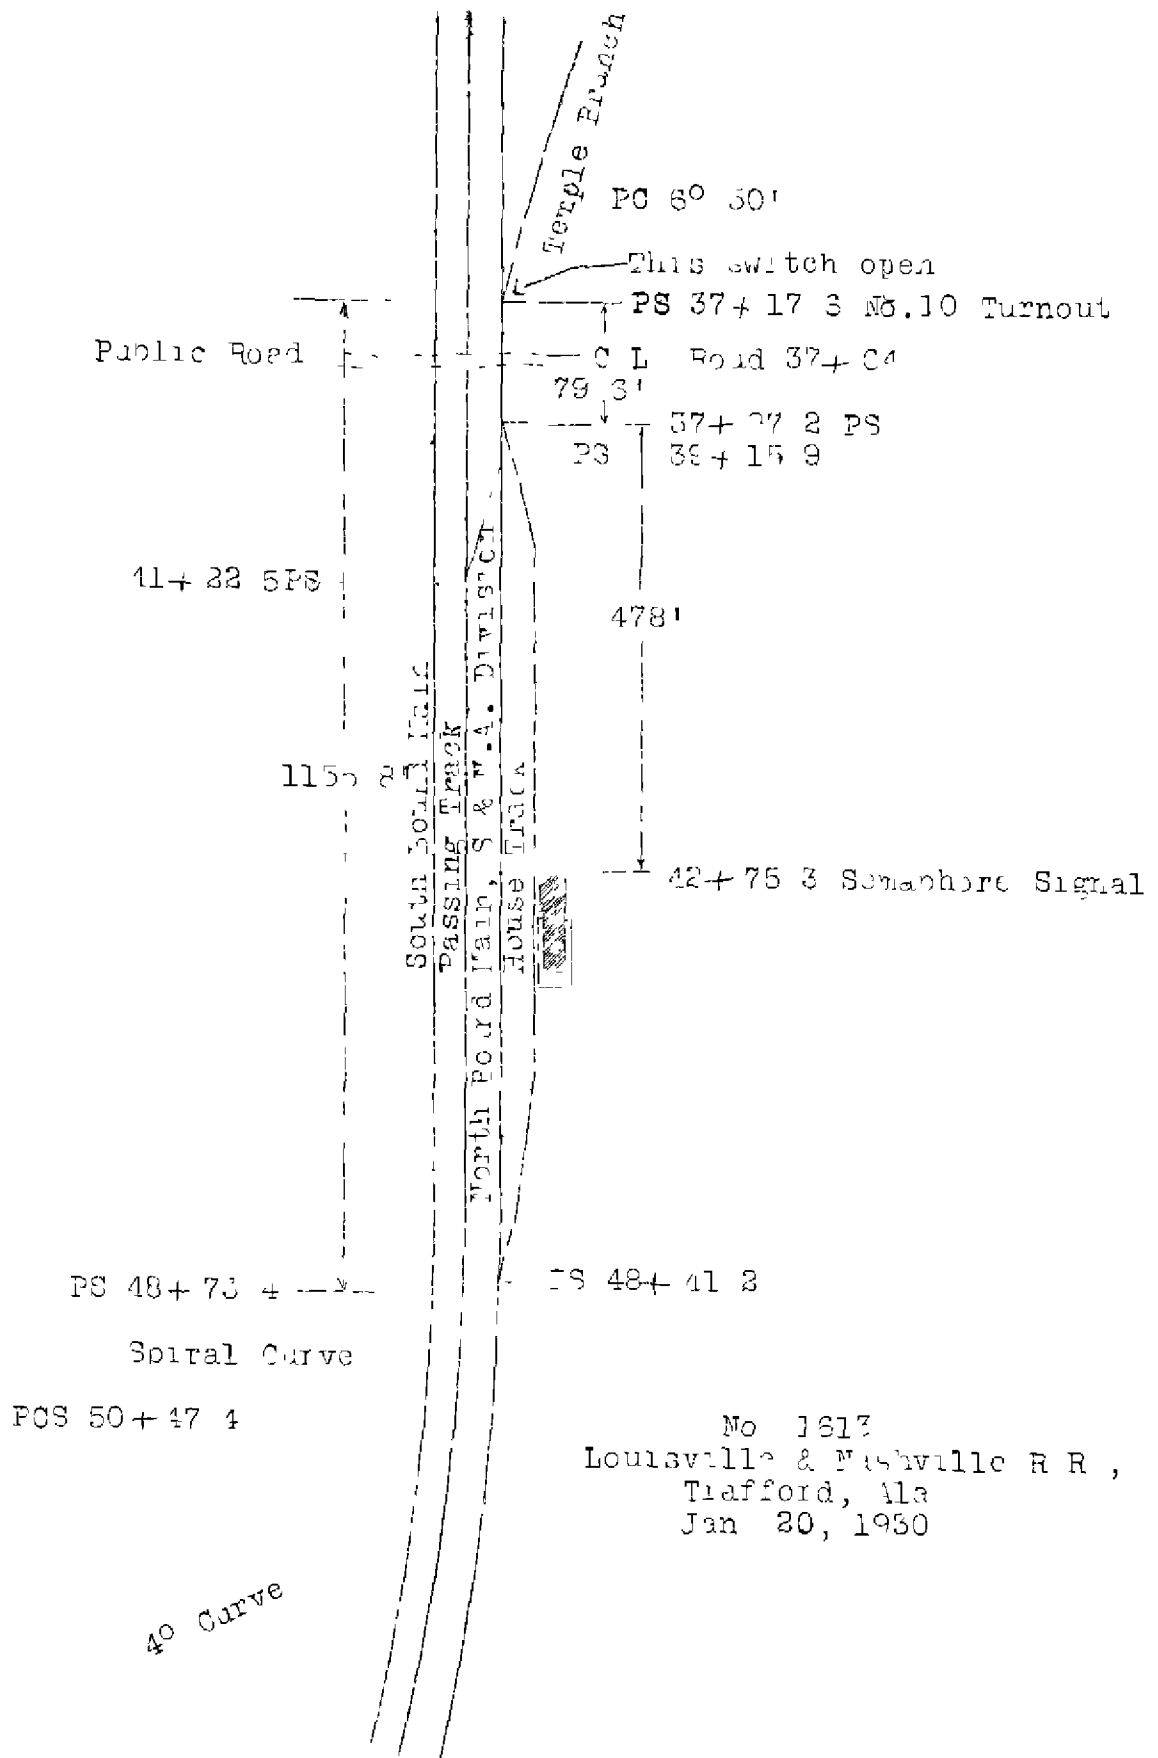
Approaching the point of accident from the south, there is a 4° curve to the left which is 789 feet in length, and then the track is tangent to the Temple branch switch, a distance of 1,153 feet, and for some distance beyond. The Temple branch is tangent from the turnout switch for ap-

proximately 89 feet, followed by a 6° 30' curve to the right on which the accident occurred. The grade is 0.43 per cent descending to the Temple branch switch, continuing to descend on the Temple branch for about 450 feet, at which point a 1.04 per cent ascent begins. The Temple branch switch is laid with a standard No. 10 turnout in the main track connection. The first curve in the branch track has an elevation of 2 inches and is maintained in good condition for a speed of about 20 miles per hour, while the main track is well maintained and in condition for high speed.
