Report No. 19-008

# Development of Load Rating Procedures for Deteriorated Steel Beam Ends

Principal Investigator  
Dr. Simos Gerasimidis  
Dr. Sergio Brena  
University of Massachusetts Amherst

1. Report No. 19-008	2. Government Accession No. n/a	3. Recipient's Catalog No. n/a	
4. Title and Subtitle Development of Load Rating Procedures for Deteriorated Steel Beam Ends: Deliverable 4: Final Report.		5. Report Date July 2019

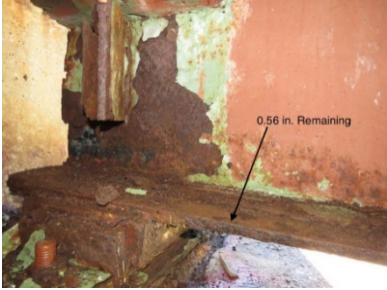
**Table 2.2: Web corrosion pattern W1.**

<p>Adopted from H-23-011-1UQ-DOT-NBI (District 3, Town of Hopkinton)</p>
<p><b>Short description:</b> W1 is a rectangular shape corrosion pattern that appears at the beam end above the bearing. The dimensions of the damaged area are <math>C_H</math> for the depth of the damaged area and <math>C_L</math> for the length. <math>B_L</math> is the bearing length and <math>B_0</math> is the length of the free end of the beam beyond the bearing. The photograph on the right shows a case of W1 for which the <math>C_H</math> is equal to the depth of the beam web <math>H_0</math>.</p>

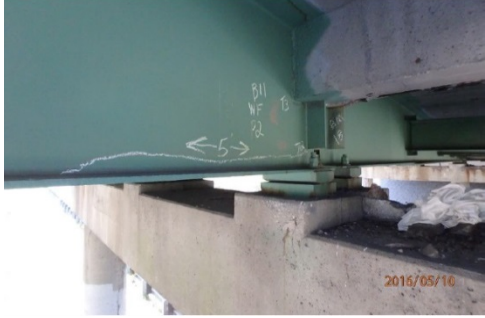
**Table 2.3: Web corrosion pattern W2.**

<p>Adopted from N-06-015-3WR-DOT-NBI (District 5, Town of New Bedford)</p>
<p><b>Short description:</b> W2 is similar to W1, with the addition of a triangular-shaped corrosion area at the end of the rectangular shape. For W2, <math>C_H</math> is the depth of the damaged area, while <math>C_{L1}</math> is the length of the rectangular part of the corrosion. <math>C_{L2}</math> is the length of the triangular damage. <math>B_L</math> is the bearing length, and <math>B_0</math> is the length of the free end of the beam beyond the bearing. The photograph on the right shows a typical case of W2.</p>

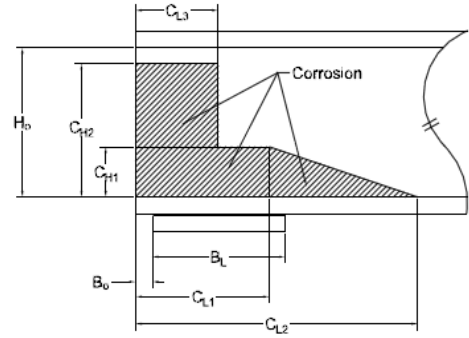
**Table 2.5: Web corrosion pattern W4.**

<p data-bbox="982 1516 1339 1564">Adapted from F-01-042-3X5-DOT-NBI (District 5, City of Fall River)</p>
<p><b>Short description:</b> W4 is a slight modification of W3 to include the complication of the shape of the bottom left rectangular shape. The depth of the corroded area is described using <math>C_{H1}</math> and <math>C_{H2}</math>. Similarly, <math>C_{L1}</math>, <math>C_{L2}</math> and <math>C_{L3}</math> are used to provide the length of the corroded area. <math>B_L</math> is the bearing length, and <math>B_0</math> is the length of the free end of the beam beyond the bearing. The photograph on the right shows a typical case of W4.</p>

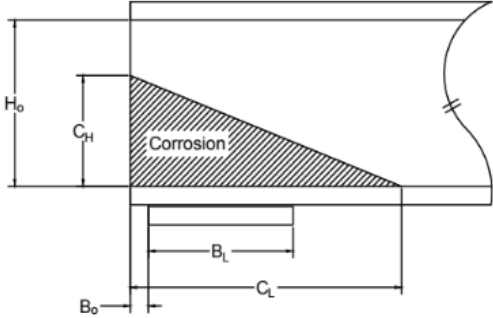
**Table 2.6: Web corrosion pattern W5.**

<p data-bbox="982 772 1339 823">Adapted from W-05-024-0T4-MUN-NBI (District 2, Town of Ware)</p> <p data-bbox="365 823 1388 947"><b>Short description:</b> W5 is a simple triangular shape corroded area described by <math>C_H</math> which is the height of the triangle, and <math>C_L</math> which is the length of the triangle. <math>B_L</math> is the bearing width, and <math>B_o</math> is the length of the free end of the beam beyond the bearing. The photograph on the right shows a typical case of W5.</p>

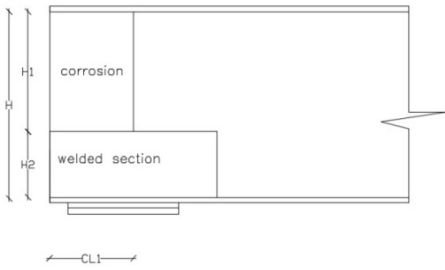
**Table 2.7: Web corrosion pattern W6.**

<p data-bbox="982 1486 1339 1537">Adapted from N-19-064-10C-DOT-NBI (District 2, City of Northampton)</p> <p data-bbox="365 1537 1388 1690"><b>Short description:</b> W6 is a rare case, but it is included here for the sake of completeness. It involves a welded plate at the bottom side of the web. The corrosion extends above the welded section as shown in the graph at the left. For this case <math>H_1</math> is the height of the corroded area, <math>C_{L1}</math> is the length of the corroded area, and <math>H_2</math> is the height of the welded plate. The photograph on the right shows a typical case of W6.</p>

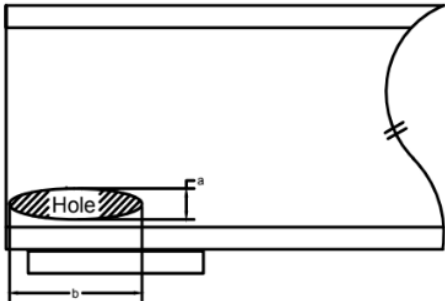
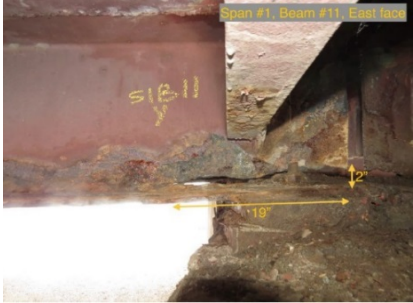
**Table 2.8: Web hole pattern M1.**

<p data-bbox="961 680 1302 724">Adapted from F-04-017-23N-DOT-634 (District 3, City of Fitchburg)</p>
<p><b>Short description:</b> M1 is a case where a hole appears at the lower part of the web and extends longitudinally over the bearing. For this case, a is the height of the hole and b is the length of the hole. The photograph on the right shows a typical case of M1.</p>

Each web corrosion pattern can be combined with each of the hole patterns, as well as with three combinations of hole patterns: M1+M2, M1+M3, and M2+M4.

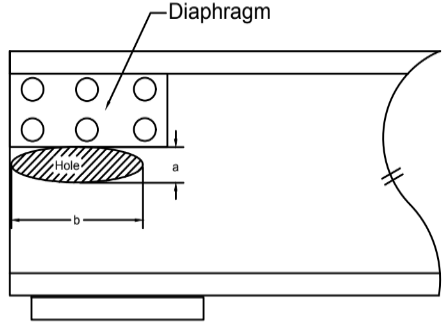
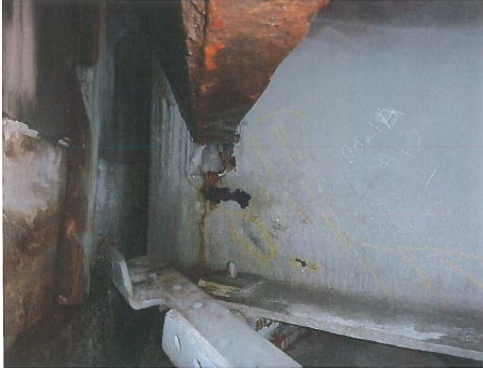
**Table 2.9: Web hole pattern M2.**

<p data-bbox="961 1417 1302 1465">Adapted from S-24-017-14K-DOT-634 (District 2, City of Springfield)</p>
<p><b>Short description:</b> M2 is a case where the beams have a diaphragm, and the hole appears just below the diaphragm. For this case, a is the height of the hole and b is the length of the hole. The photograph on the right shows a typical case of M2.</p>

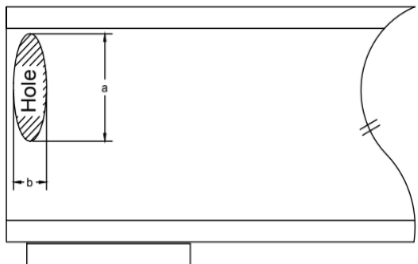
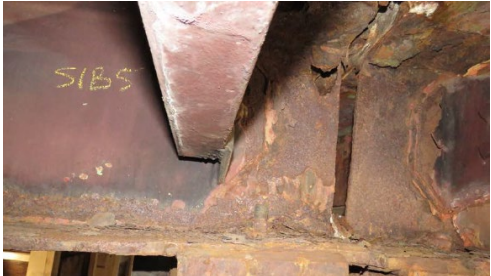
**Table 2.10: Web hole pattern M3.**

<p data-bbox="966 682 1307 730">Adapted from F-04-017-23N-DOT-634 (District 3, City of Fitchburg)</p> <p data-bbox="365 735 1372 829"><b>Short description:</b> M3 is a case where a hole appears at the top part of the beam. For this case, a is the height of the hole and b is the length of the hole. The photograph on the right shows a typical case of M3.</p>

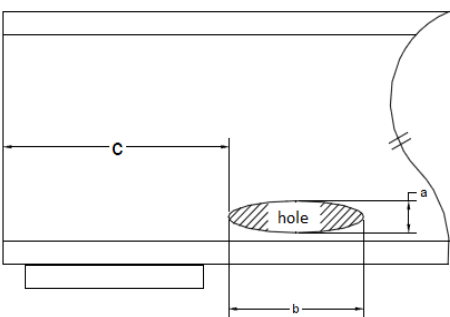
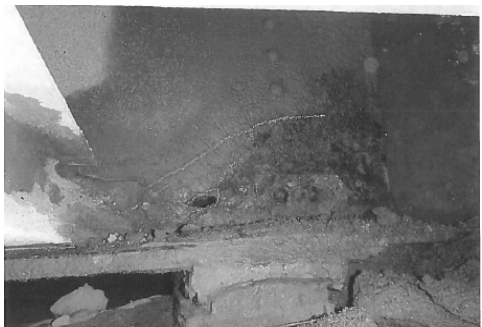
**Table 2.11: Web hole pattern M4.**

<p data-bbox="966 1375 1307 1423">Adapted from S-24-017-14K-DOT-634 (District 2, City of Springfield)</p> <p data-bbox="365 1428 1372 1554"><b>Short description:</b> M4 is a case where a hole appears away from the bearing at the lower part of the beam. For this case, a is the height of the hole, b is the length of the hole and c is the distance of the end of the hole from the end of the beam. The photograph on the right shows a typical case of M4.</p>

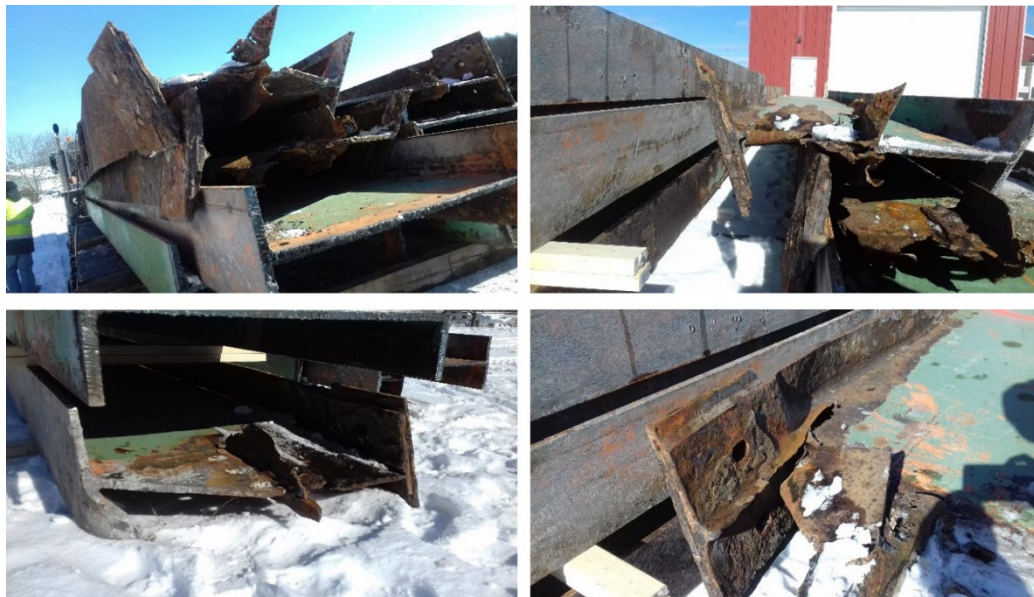
Based on the conditions of the delivered beams, the evaluation of their testable quality was performed. Of the 22 acquired beams (eight girders cut in half from the Colrain bridge and six from the Charlemont bridge), only six (numbered as Specimens 1 to 6) were considered testable and promising of results that would be representative of load-carrying capacities. The discrepancy in the number of the acquired and the testable beams was attributed to the heavy distortion of the corroded ends caused during the demolition process (Fig. 3.3).

**Figure 3.3: Distorted beams rejected for experimental testing due to condition.**

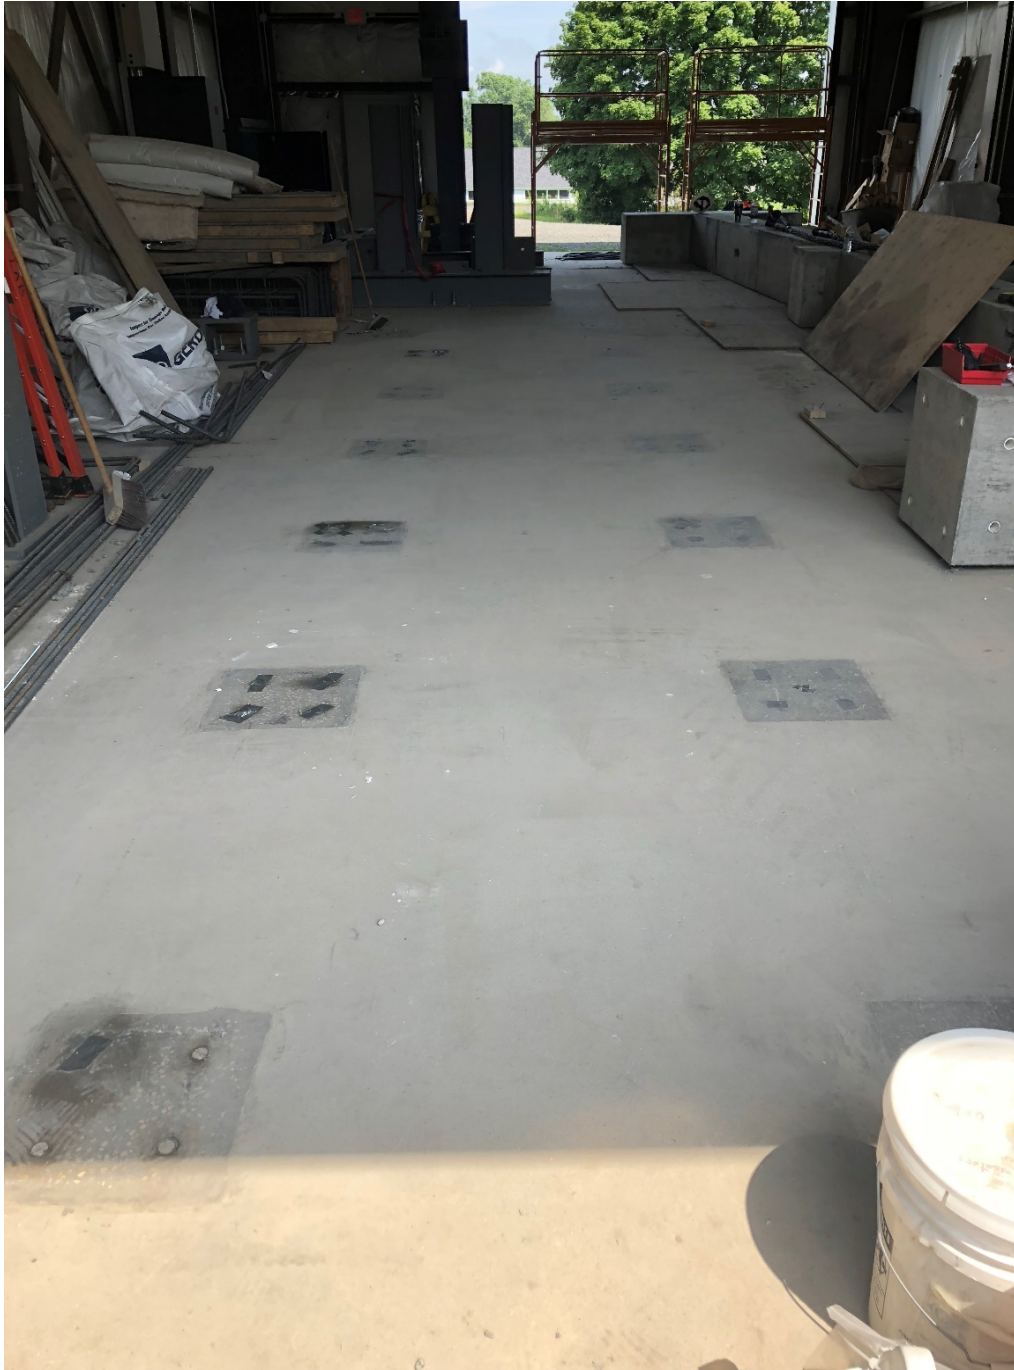
Aug. 8, 2018: The specimen for the completed experiment on concrete girders was taken off the supports and laid on the right side of the lab (Fig. 3.8). The experimental configuration

**Figure 3.8: Experimental configuration from completed test was disassembled, and anchor spots were cleaned and removed.**

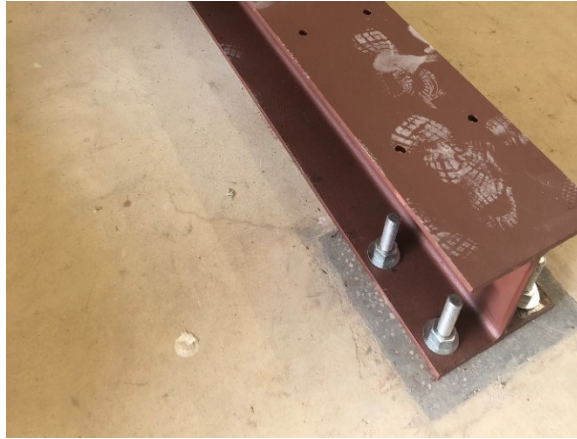
Aug. 10, 2018: Floor beams were moved into the Brack Structural Testing Laboratory. Floor beams were tied down using anchor rods and bolts (Fig.3.9).

**Figure 3.9: Floor beams tied down at strong floor anchor spots of Brack testing facilities.**

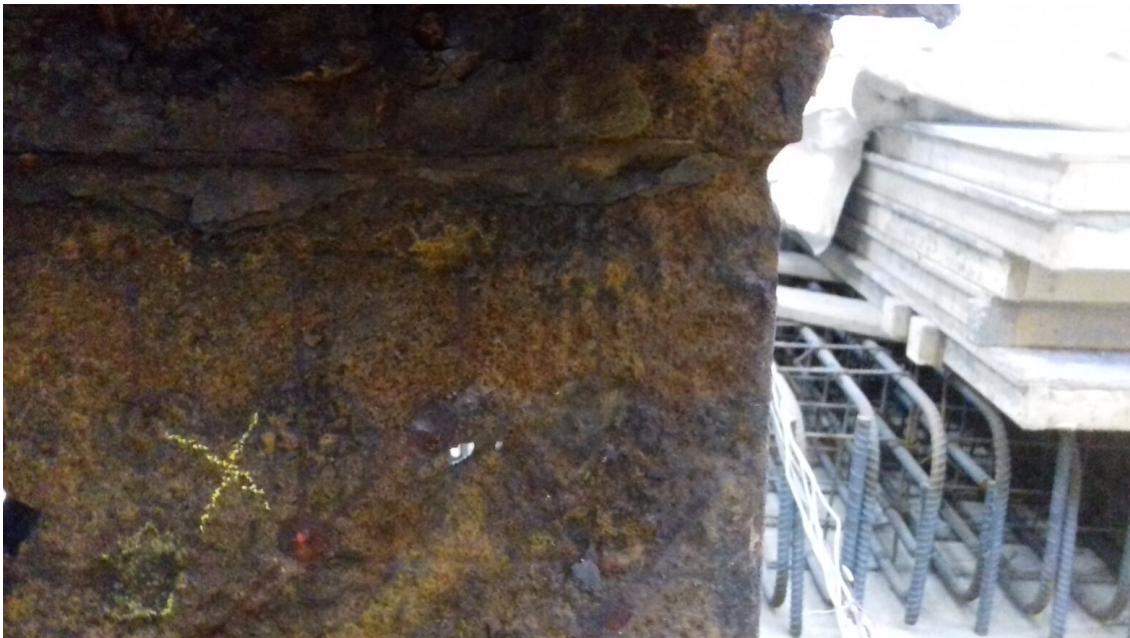
**Figure 3.22: A 1/4-in. diameter hole, located 4 in. below the steel angle sections.**

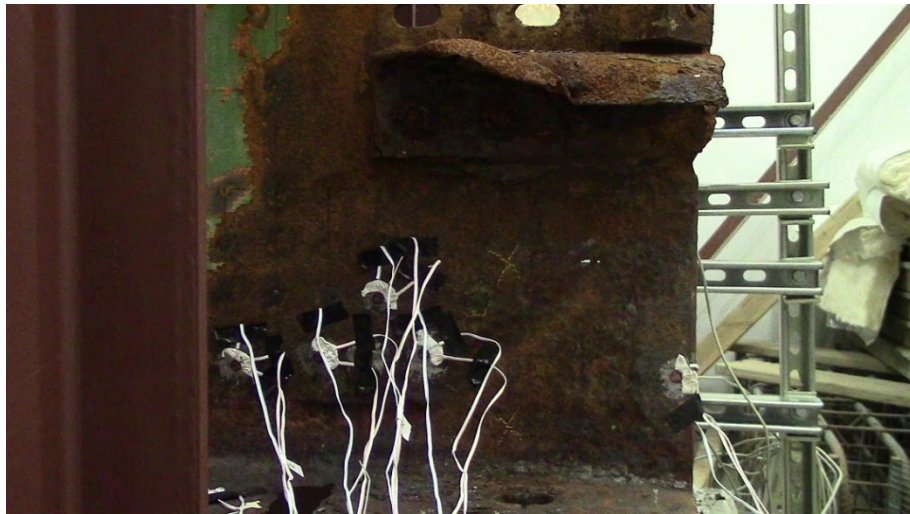
**Figure 3.26: Instrumentation configuration at the end of Specimen 2.**

The exact experimental configuration is illustrated in Fig. 3.25, and the instrumentation configuration in Fig. 3.26.

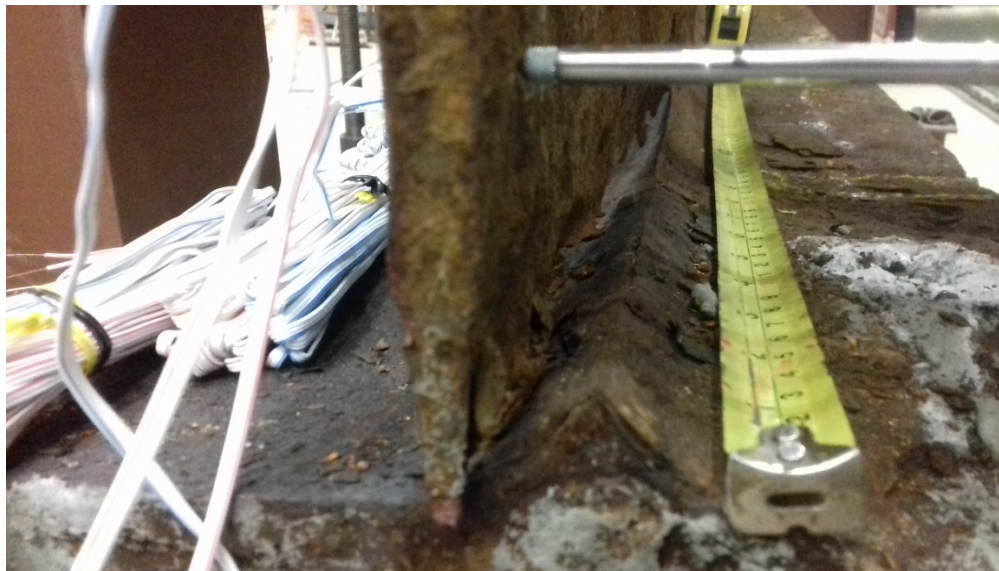
The most extensive section loss was observed in the lower half of the web (Fig. 3.29). Two holes could also be observed among the corrosion. The first one (18 in. long) was located directly above the flange (Fig. 3.20). The area with the 100% section loss extends 6 in. beyond the end of the bearing. The second hole was located below the steel section angles, similar to Specimen 1.

**Figure 3.29: Area with 100% section loss above flange.**

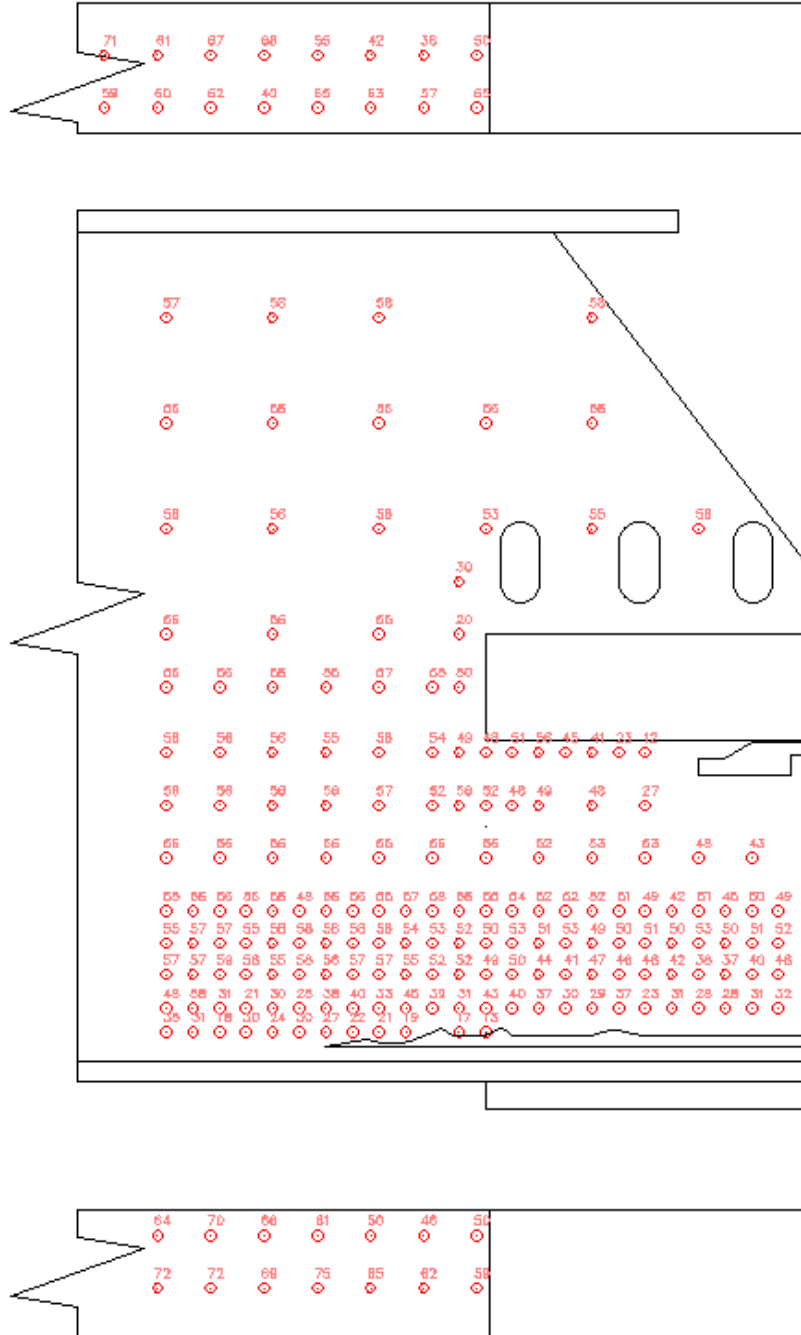
to create the thickness reduction profile along the corroded end. The data was gathered using a Pocket MIKE Compact Thickness Gauge, manufactured by GE Inspection Technologies. In total, 181 points were measured on the web and 30 points at the bottom flange (Figure 3.30). The illustrated values are  $10^{-2}$  inches. Intact thicknesses are 0.57 in. for the web and 0.805 in. for the flange.

**Figure 3.30: Web and flange thickness for Specimen 3.**

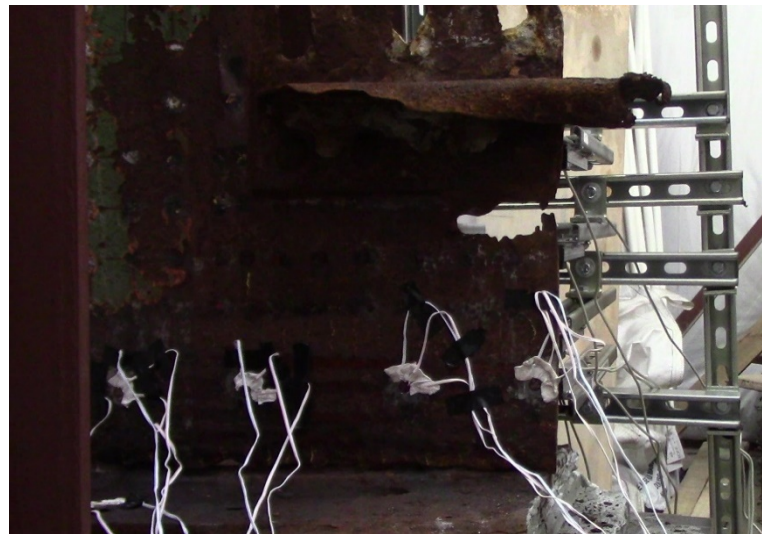
**Figure 3.32: Instrumentation configuration for Specimen 3.**

The exact experimental configuration is illustrated in Fig. 3.31, and the instrumentation configuration in Fig. 3.32.

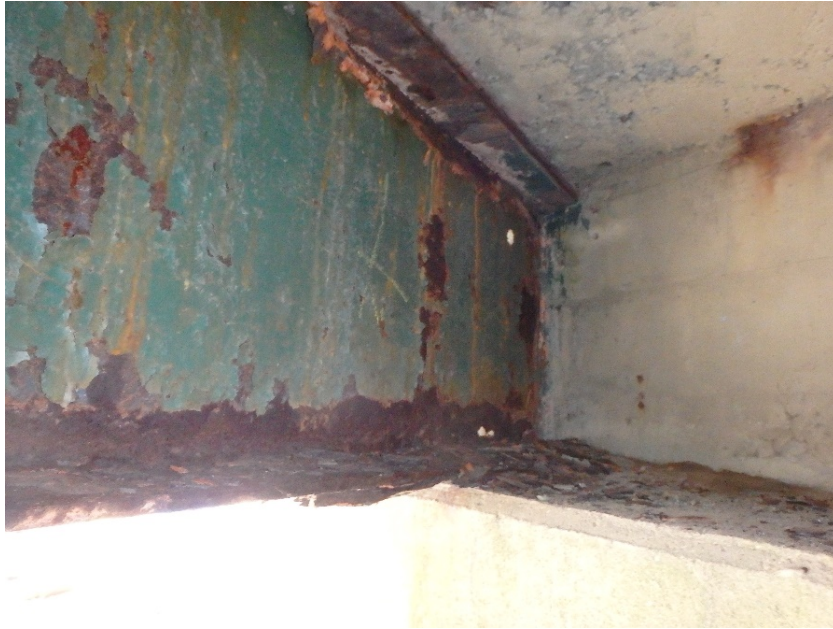
Specimen 4 was the first beam extracted from Charlemont bridge, with length equal to 271.8 inches. According to the available construction drawings, the girder was a 21WF59. However, based on the measurements performed prior to testing, the geometry of the beam section better matched the nominal dimensions of a 21WF73. While the bridge was in service, the end of the beam was fully embedded in concrete, as shown in Fig. 3.33.

**Figure 3.33: Bearing geometry of Charlemont bridge beams while in service.**

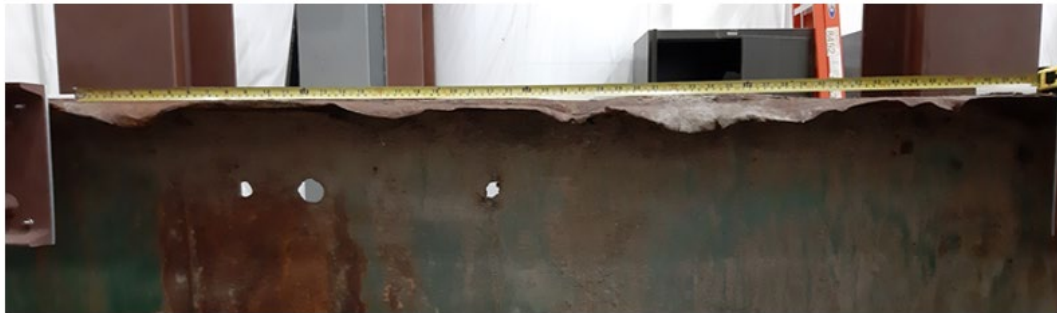
No initial web sideways deflection was observed at the bearing area. However, the specimen was heavily distorted and bent along the transverse axis of the web. The maximum deflection equaled 1.75 in. and was located 7 ft. away from the intact end. This deflection resulted in local buckling of the flange as is illustrated in Fig. 3.35. It is possible this deformation could be attributed to the demolition process.

**Figure 3.35: Top view of the specimen (a) and side view of the buckled web (b).**

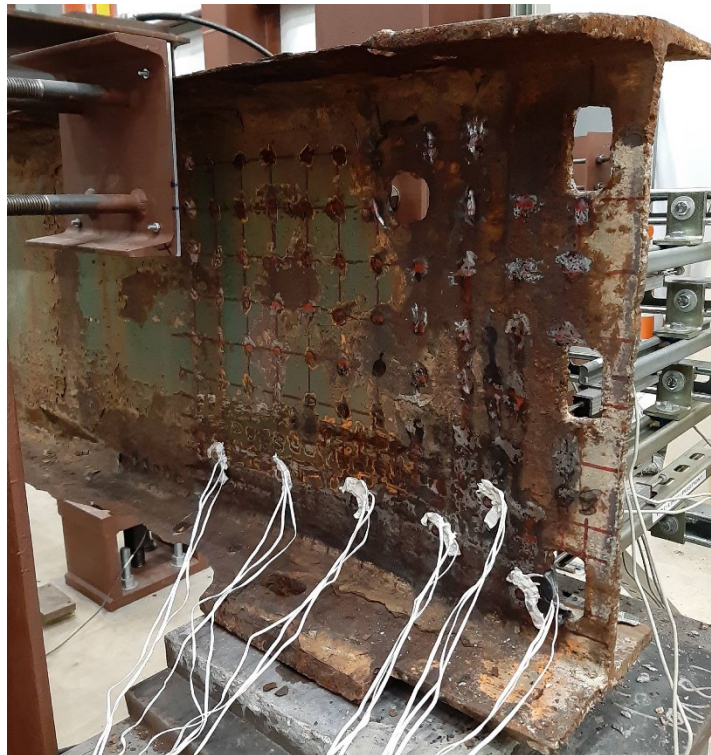
**Figure 3.38: Instrumentation configuration for Specimen 4.**

The exact experimental configuration is illustrated in Figure 3.37, and the instrumentation configuration in Figure 3.38.

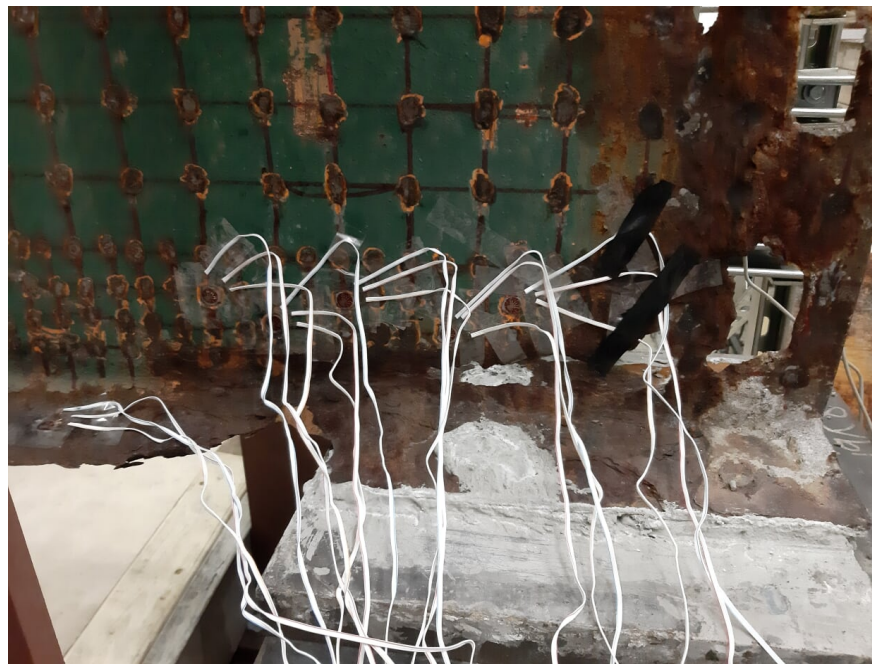
The first potentiometer column was placed close to the inner bearing edge, while the second one between the adjacent holes close to beam's end.

**Figure 3.42: Instrumentation of Specimen 5.**

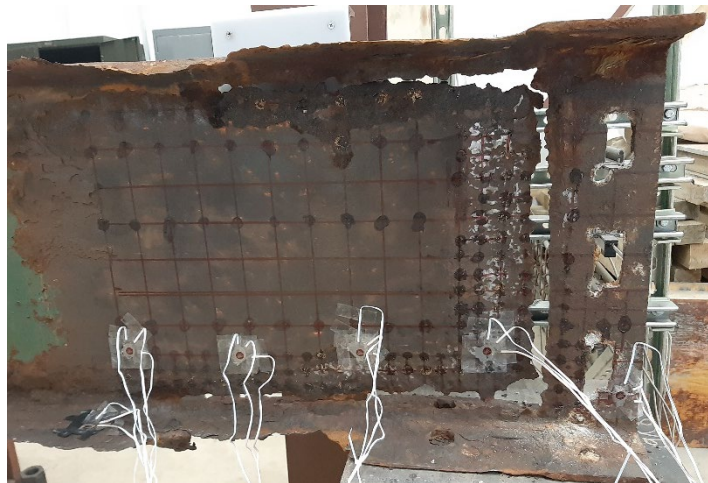
The first potentiometer column was placed at the stiff outer part of the web that used to be embedded in concrete while the Charlemont bridge was in service, while the second one was close to the inner bearing edge.

**Figure 3.46: Instrumentation configuration of Specimen 6.**

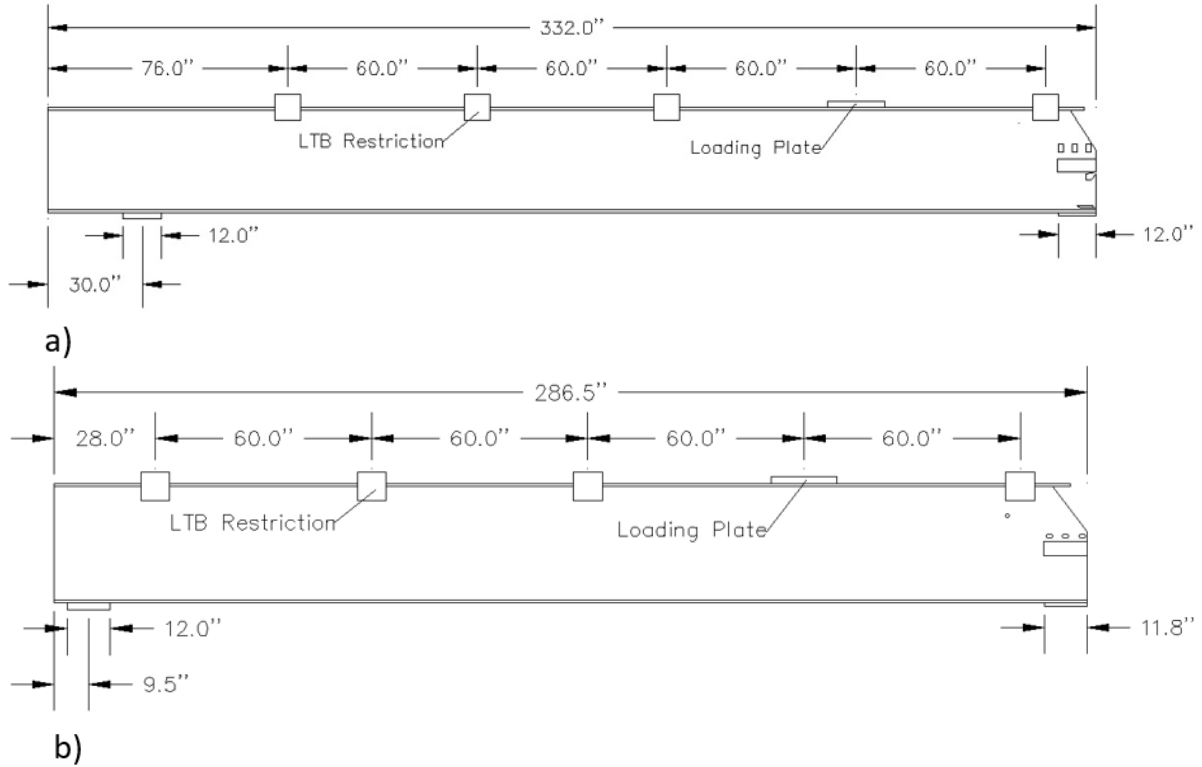
Both boundary and loading conditions simulate the exact experimental configuration. The load is applied as uniform pressure in the location of the loading plate (Fig. 4.4). The loading plate covers the full flange width, and its length equals 18 inches. The out-of-plane displacement is not allowed at the locations of the LTB restrictions. The bottom flange of the girder is resting on two steel bearing plates, which are considered fixed.

**Figure 4.4: Exact experimental configuration and dimensions for (a) Specimen 1 and (b) Specimen 2**

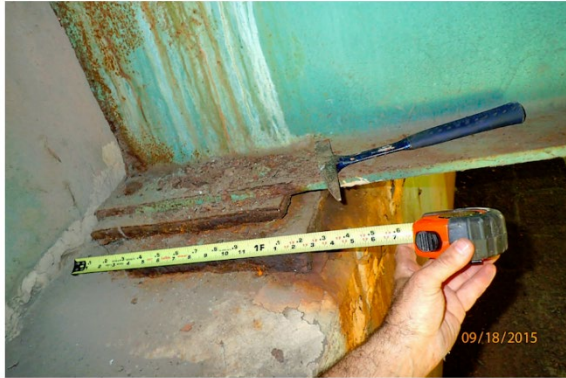
Photo 30: Typical bearing, over extended without anchor bolts.

All the preceding are based on the design of the bridges. However, the reality of the field and the work done by the inspectors documented in their inspection reports showed a different situation. Fig. 4.14 shows examples of cases where the anchor bolts were either completely missing or severely corroded or bent, as noted by inspectors. These examples are just some of the many cases of similar condition. To conclude, it was decided that the set of boundary conditions would not include the anchor bolts. This meant that the vertical constraint coming from these bolts would not be included in the model. This condition can be described as the most damaged condition.

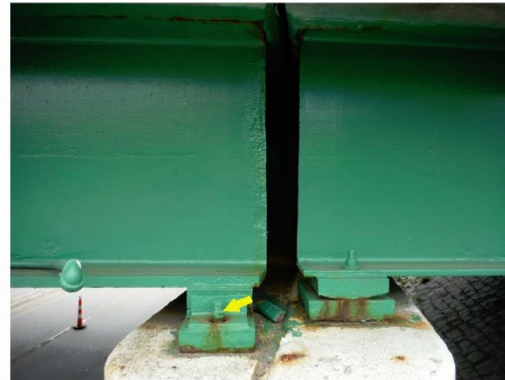
Photo 11: Heavy section loss to the anchor bolt nut of the Beam 37 bearing at Pier 2 in Span 5.

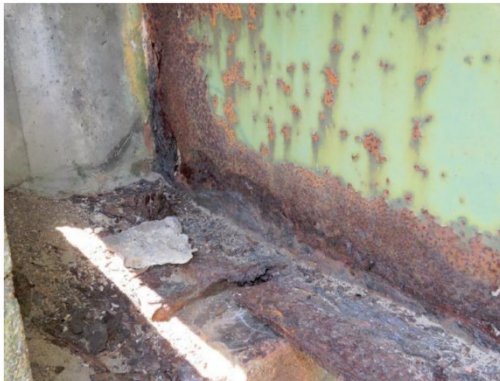
Photo 9: Beam #6 at the South end.

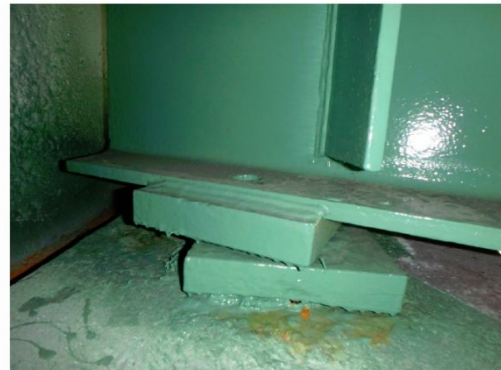
Photo 21: Span 4, Beam 31, West Abutment: Missing south anchor bolt and rotated bearing

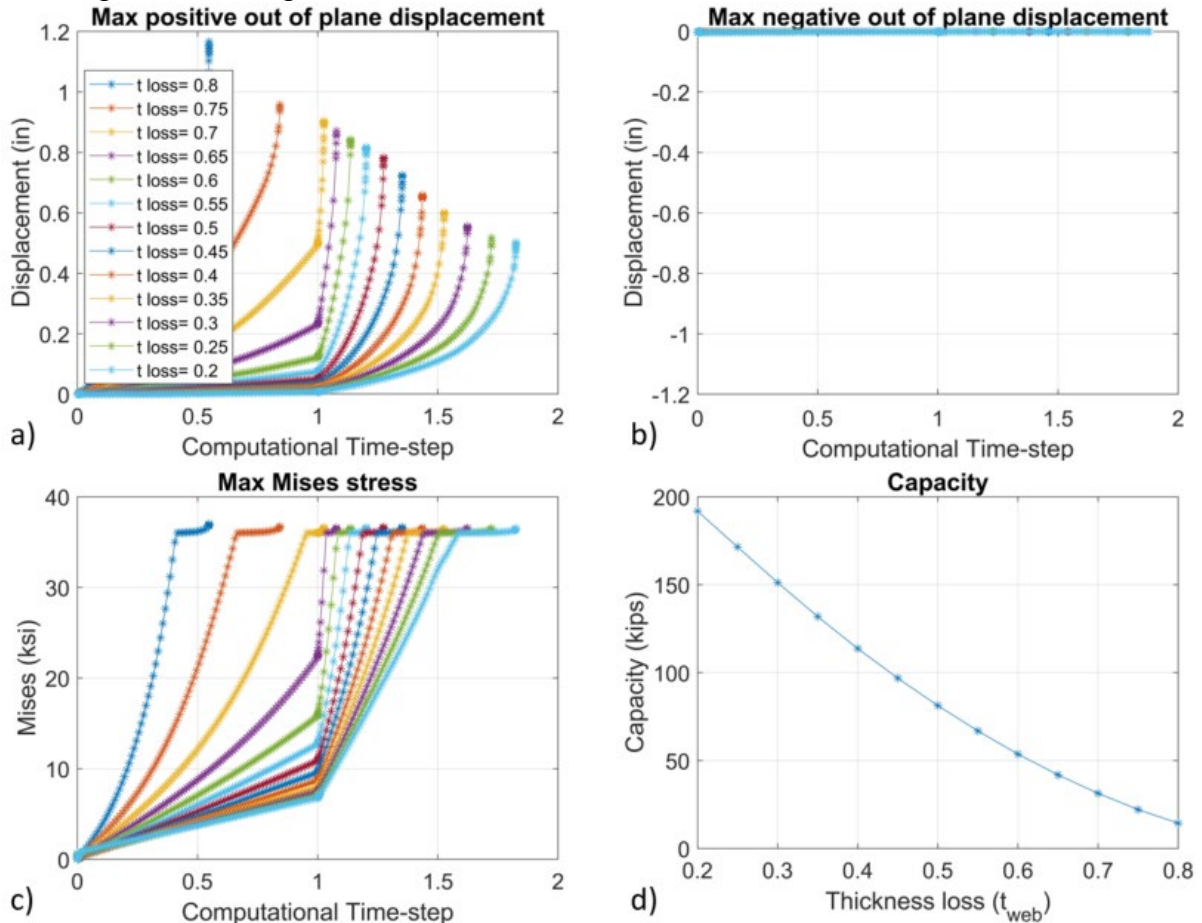
In order to ensure the smooth operation of the developed methodology as well as that every analysis was terminated due to instability phenomena, supplementary scripts that read the Abaqus output files were also developed, and in addition to bearing load, data relevant with the maximum out-of-plane displacement and Von Mises stresses were automatically extracted. An example is given in Fig. 4.17a-d, where multiple conclusions can be drawn for a 36WF150 beam with full height corrosion and section loss in the range of 20% to 80% of intact web thickness. The beams with 80% and 75% material loss are not able to undertake the full dead load, and they fail prior to the completion of Step 1. The failure mode is characterized by a buckling wave formulated along the same direction for all specimens (following the initial imported eigenmode). For cases with extensive section loss, buckling occurs shortly after the first element yields. Finally, the obtained capacities are smoothly reducing for increasing section loss.

**Figure 4.17a-d: Data extracted and plotted from every set of analyses, for a 36WF150 beam with full section loss in the range of 20% to 80% intact web thickness.**

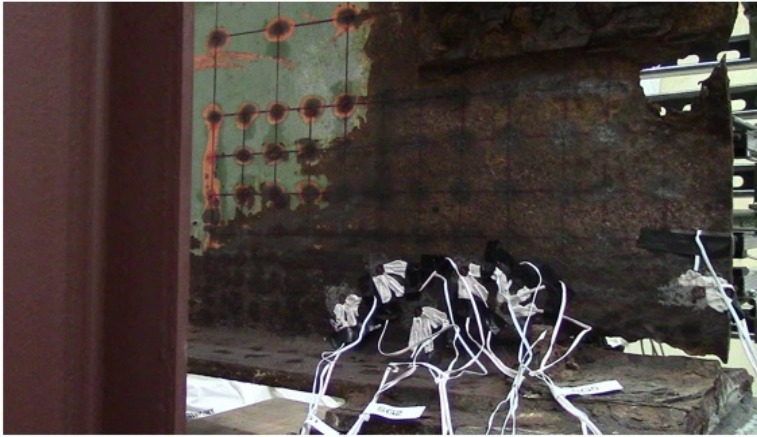
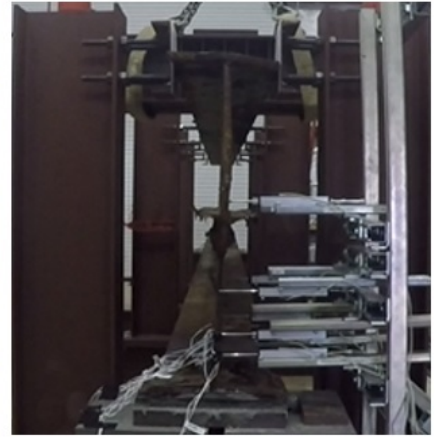
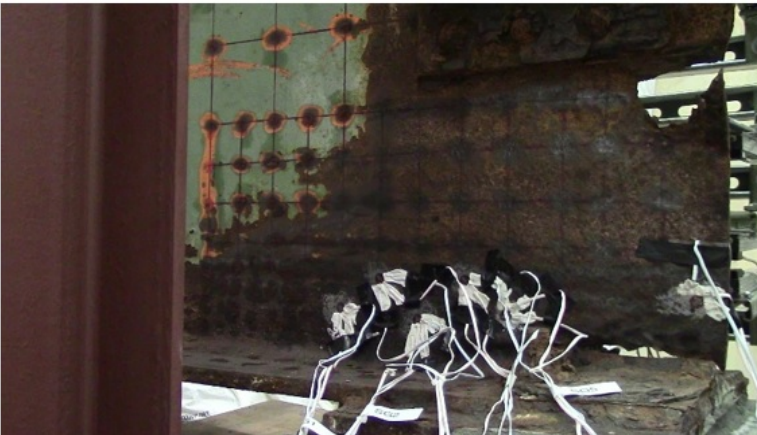
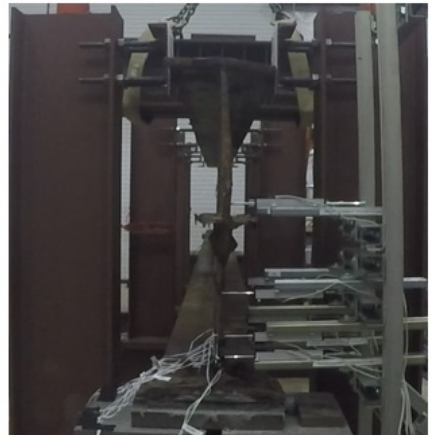
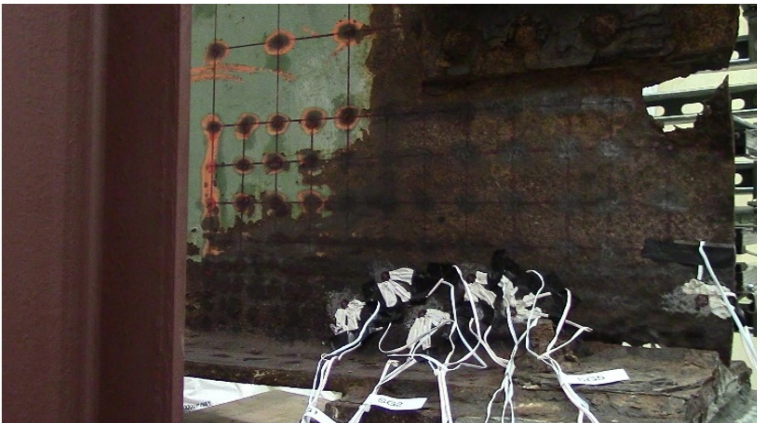
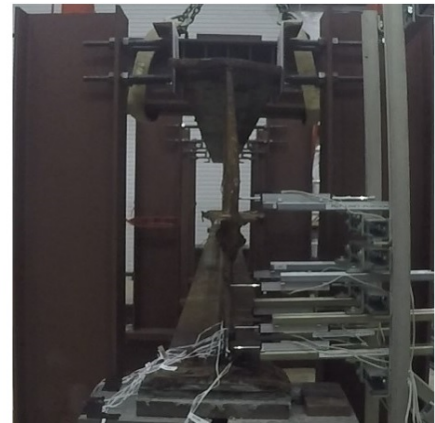
In Fig. 6.3, the deformation of the corroded end is presented, using images captured from two cameras that recorded the experimental process. The first camera recorded the plane of the web (side view of the beam), while the second camera recorded the beam profile. These pictures illustrate the girder's deformation at the initial condition before loading, followed by deformations observed at different steps of the experimental procedure (Points A to E, at Fig. 6.1a).

At Point D, due to the extensive out-of-plane displacement, the web had begun bearing at the top of the anchor protruding from the flange. The system lost stiffness, and the flange bent

significantly as the vertical displacement reached 1.4 inch. At Point E, the experiment was terminated because the top flanges reached the boundary of the lateral support.

**Figure 6.3: Side-by-side images showing side view of web and profile view of beam during experiment. Letters A-E correspond to Fig. 6.1a.**

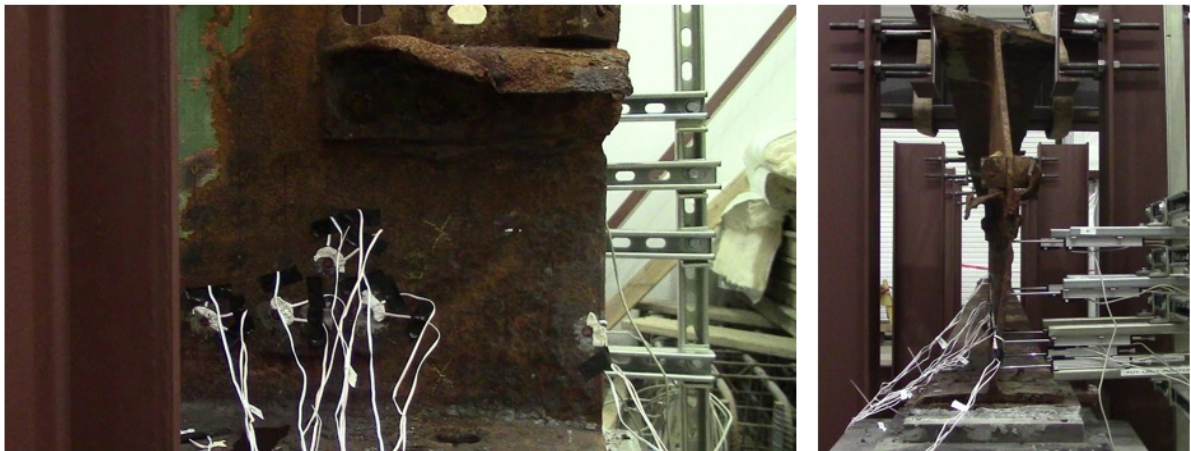
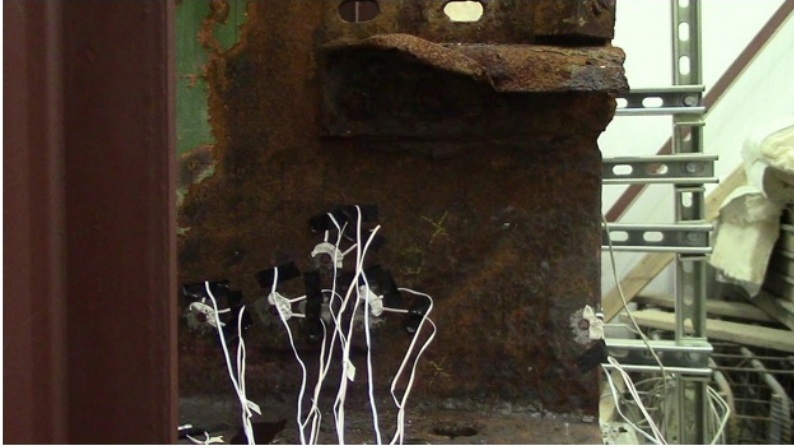
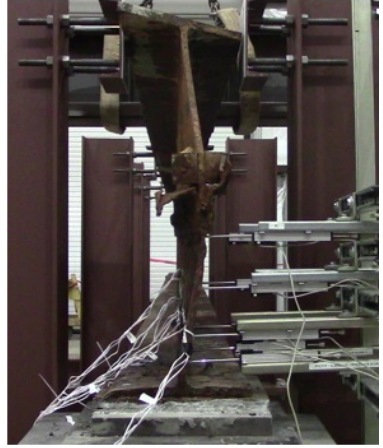
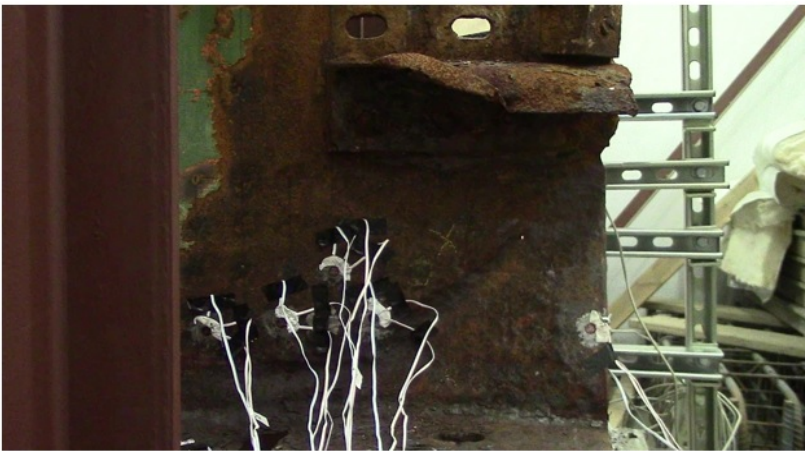
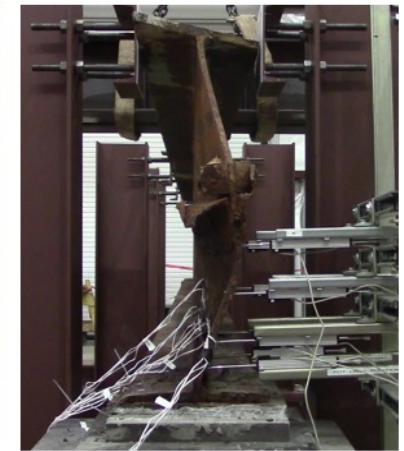
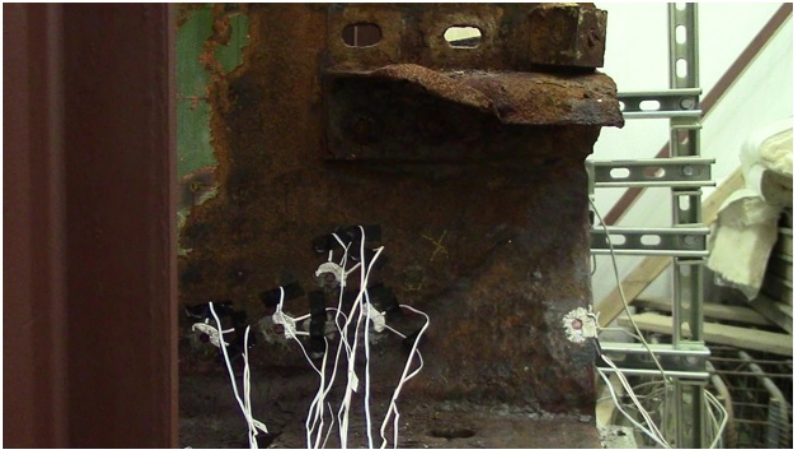
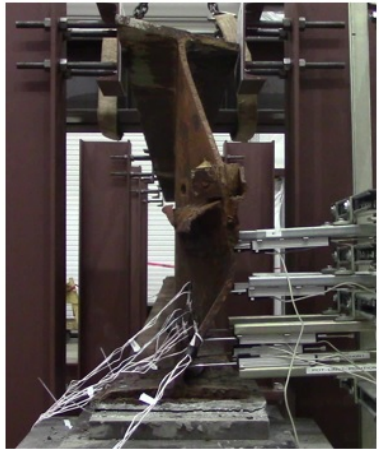
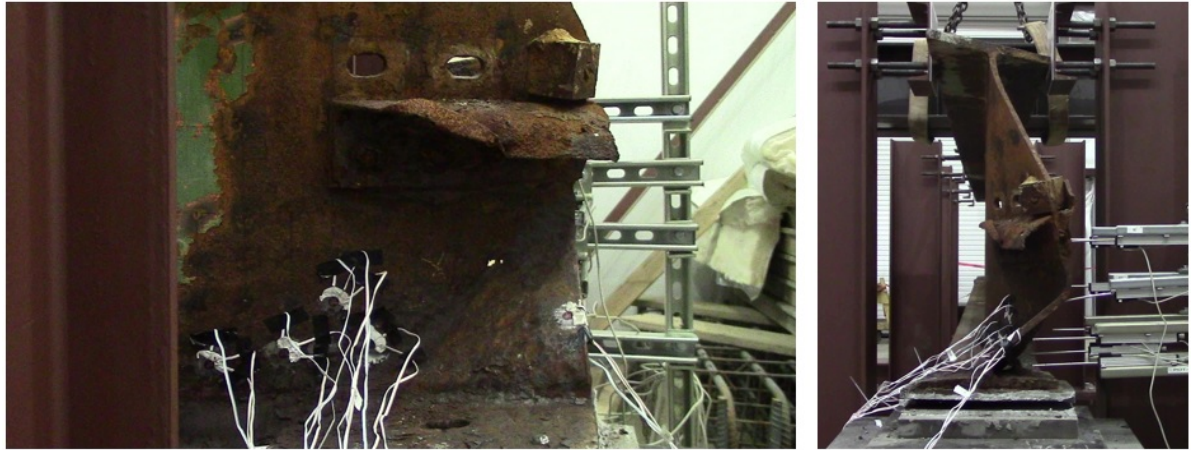
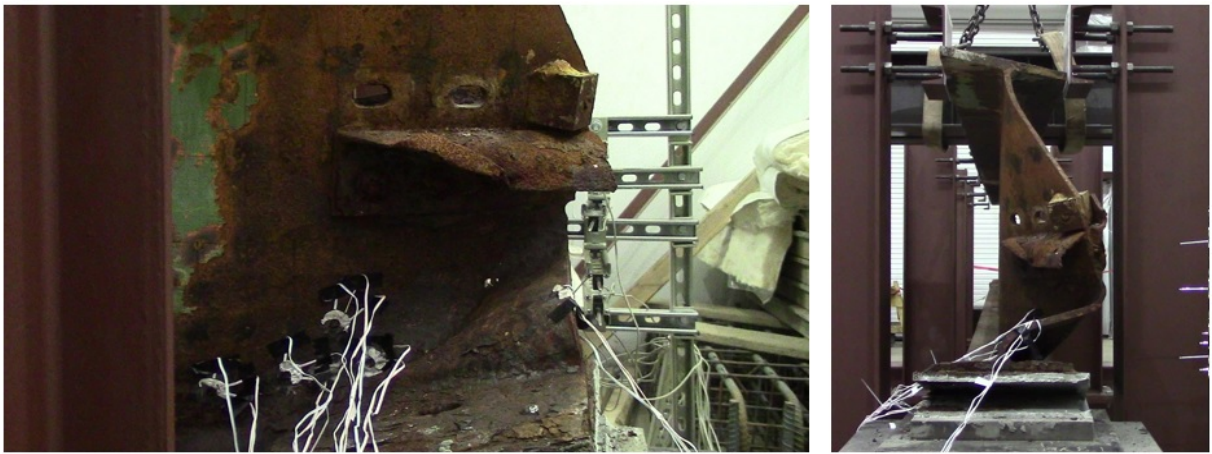
In Fig. 6.10, the deformation of the corroded end is presented, using images captured from two cameras that recorded the experimental process. The first camera recorded the plane of

the web (side view of the beam), while the second camera recorded the beam profile. These pictures illustrate the girder's deformation at the initial condition before loading, followed by deformations observed at different steps of the experimental procedure (Points A to E, at Fig. 6.8a).

Similar to the first specimen, the system gained stiffness and began retaining additional load. This behavior can be attributed to the web bearing on the top of the anchor protruding from the flange. Point D captured this geometrical configuration.

At Point D, the deformed web began bearing on the flange. The uplift reduced, and the system gained stiffness and began retaining additional load. The out-of-plane displacements continued to increase, while the vertical displacement reached an additional 0.6 inch. At Point E, the experiment was terminated because the top flange reached the boundary of the lateral support.

**Figure 6.10: Side-by-side images showing side view of web and profile view of beam during experiment. Letters A-E correspond to Figure 6.8a.**

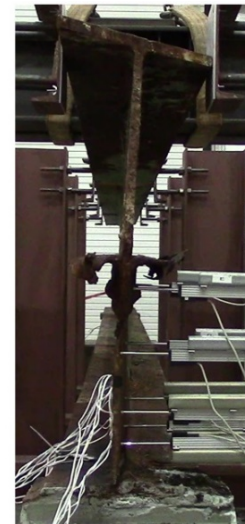
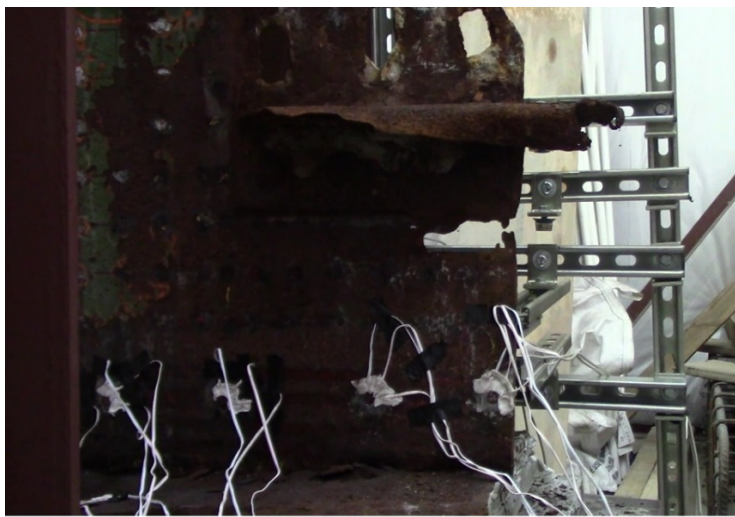
In Fig. 6.17, the deformation of the corroded end is presented, using images captured from two cameras that recorded the experimental process. The first camera recorded the plane of the web (side view of the beam), while the second camera recorded the beam profile. These pictures illustrate the girder's deformation at the initial condition before loading, followed by

deformations observed at different steps of the experimental procedure (Points A to E, at Fig. 6.15a).

From the initial condition pictures, two holes were observed in the corroded end. One small area with 100% section loss was located on the web below the steel angle section, and another at the base of the web. The bottom hole expanded 6 in. beyond the inner edge of the bearing. However, due to extensive bearing uplift, the web started bearing on the flange prior to loading.

Point C captured the failure mode and load of the specimen. From the initial condition up to Point C, the web deformation was described by a progressive sideways deflection. The bottom of the web was folding as a result of the bearing to the flange under loading.

Compared to the results of the first two specimens, this was the first time that a sudden stiffness loss was observed after peak load was reached (leading to Point D). Beyond that point, the load was reducing under a constant rate up to Point E, where unloading took place. In order to further investigate the behavior of the specimen, the research team reloaded the specimen. The girder initially had the same stiffness, following the unloading path of the plot. Close to 50 kips applied load, the stiffness began reducing. At Point F, the experiment was terminated because the top flange reached the boundary of the lateral support.

During the largest part of the loading process, the principal strain direction at SR3 was approaching zero, revealing that flange was subjected to direct tension. On the other hand, SR5 with the initiation of the loading process recorded shear deformation ( $\theta$  approaching 45 degrees), which was progressively reduced to 2 degrees at peak load, reflecting pure compression. This behavior can be attributed to the contact with the flange. However, compared to the rest of the gauges installed on the web, it experienced the most intense compressive strains. One can assume that the decomposition of these strains to membrane and bending strains would include increased bending strains due to its position. In particular, SR5 is located very close to the imaginary line around which the web folds (Fig. 6.17f).
