Report No. 19-008

# Development of Load Rating Procedures for Deteriorated Steel Beam Ends

Principal Investigator  
Dr. Simos Gerasimidis  
Dr. Sergio Brena  
University of Massachusetts Amherst

1. Report No. 19-008	2. Government Accession No. n/a	3. Recipient's Catalog No. n/a	
4. Title and Subtitle Development of Load Rating Procedures for Deteriorated Steel Beam Ends: Deliverable 4: Final Report.		5. Report Date July 2019

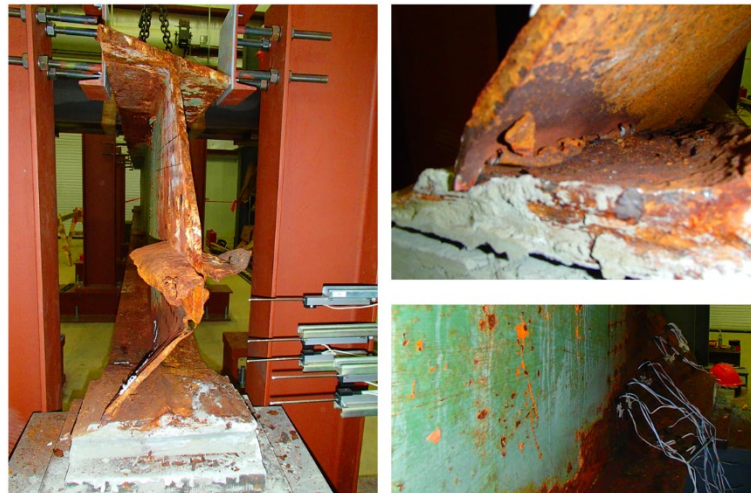
**Figure 6.19: Residual deformation after unloading Specimen 3.**

Interpreting these figures, potentiometers at the same height along the beam's length followed a similar pattern, capturing the web sliding on the flange, across the same direction. The residual displacement is presented in Fig. 6.19.

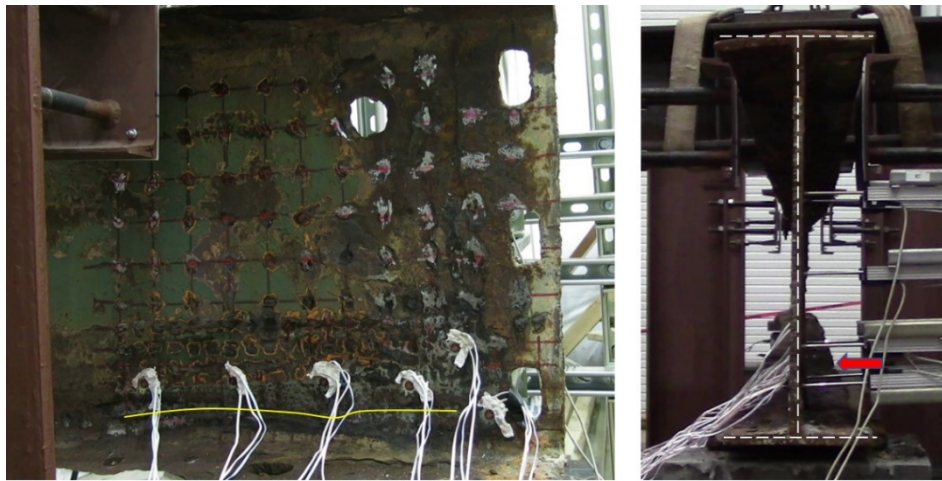
**Figure 6.24: Side-by-side images showing side view of web and profile view of beam during experiment. Letters A-B correspond to Fig. 6.22a. The yellow line denotes local buckling domain, while dashed white line denotes mid surfaces of Specimen 4.**

In Fig. 6.24, the deformation of the corroded end is presented using images captured from two cameras that recorded the experimental process. The first camera recorded the plane of the web (side view of the beam), while the second camera recorded the beam profile. These pictures illustrate the girder's deformation at the initial condition before loading, followed by deformations observed at different steps of the experimental procedure (Points A and B, Fig. 6.22a).

At Point A, the specimen has already experienced maximum vertical displacement equal to 0.86 inch. However, the initial imperfection of the beam governed the deformation profile, with lateral displacements initiated at midspan. In particular, as illustrated with the red arrow in Fig. 6.24, the bottom flange exhibited extensive in-plane translation. Between Points A and B, the applied load tended to plateau with rapidly increasing deformations. The deformation profile indicated torsional buckling. In detail, both flanges were deflecting along the longitudinal axis, mainly in the domain defined by the two LTB restrictions located closer to the studied end.

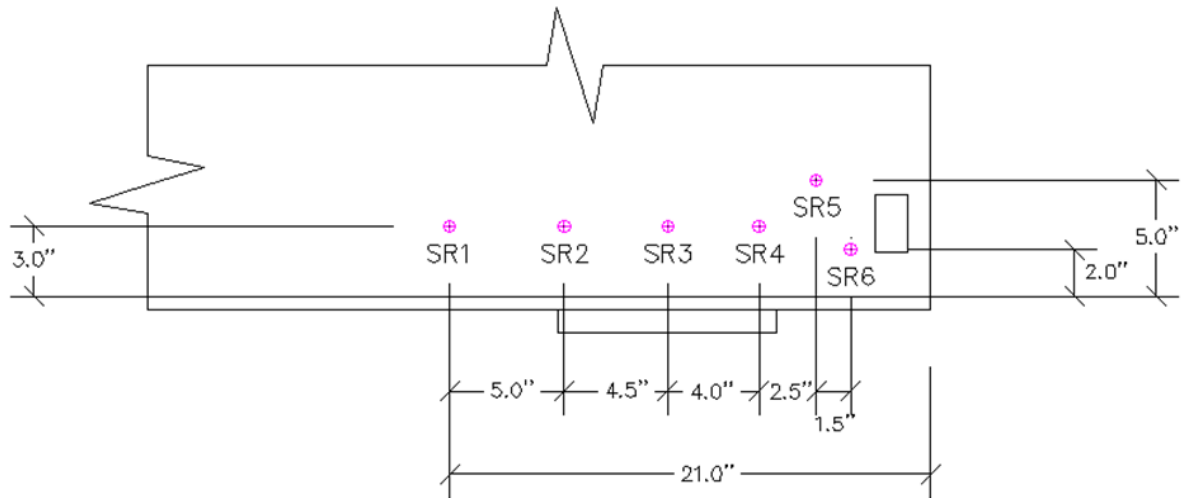
**Figure 6.28: Exact location and SR nomenclature for Specimen 4.**

The SR nomenclature and the exact configuration are illustrated in Fig. 6.28.

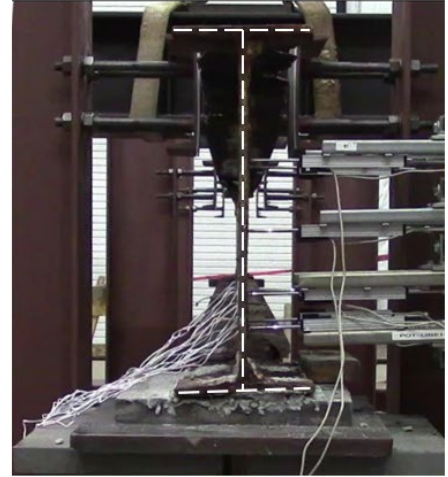
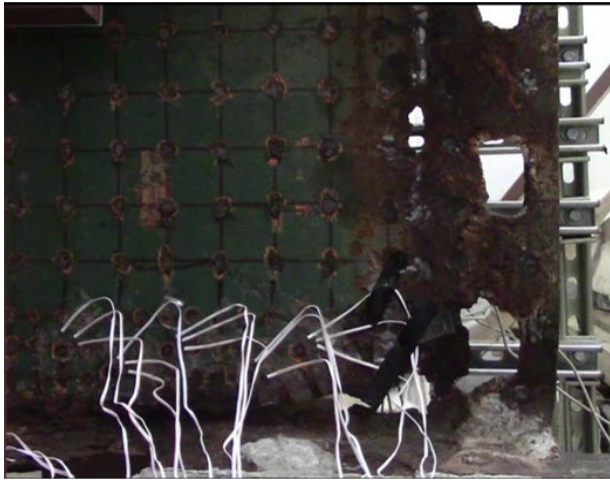
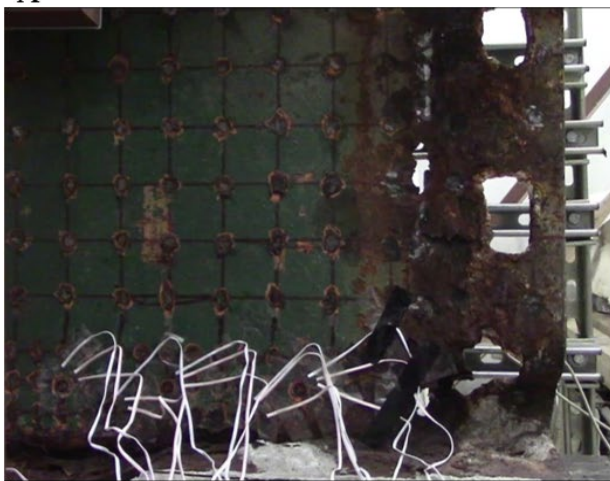
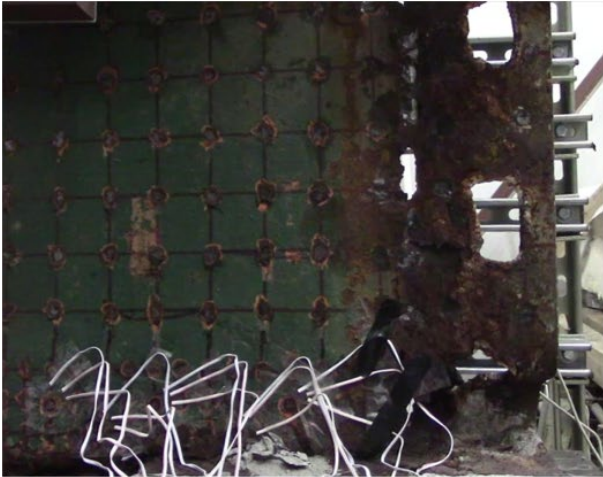
**Figure 6.31: Side-by-side images showing side view of web and profile view of beam during experiment. Letters A-D correspond to Fig. 6.29a.**

In Fig. 6.31, the deformation of the corroded end is presented, using images captured from two cameras that recorded the experimental process. The first camera recorded the plane of the web (side view of the beam), while the second camera recorded the beam profile. These pictures illustrate the girder's deformation at the initial condition before loading, followed by deformations observed at different steps of the experimental procedure (Points A to D, Fig. 6.29a). Fig. 6.32 presents the lateral displacement profiles as they were measured by the eight potentiometers for three different loads, 0.5, 0.75, and 1  $F_u$ , where  $F_u$  is the corresponding load at Point A. Two columns of instruments had been installed. The first one was placed close to the inner bearing edge, while the second one (Fig. 3.42) between the adjacent holes

The preloading conditions of the corroded end, which was mainly characterized by the combination of artificial and corrosion holes expanding along the largest part of the bottom of the web, defined the failure. In detail, at Point A (Fig. 6.29), a brittle failure was observed at the narrow material strips located at the outer web part. The buckling area was limited at the strips area, potentially due to the corrosion holes, which prevented the buckling wave propagation to the rest of the web. The web uniformly translated out of plane. This behavior can be observed both at cameras (Fig. 6.31a) as well as at potentiometer recordings. The blue line (Fig. 6.32) at peak load described a buckling wave formulated at the outer web part, while the red one an almost linear displacement profile.

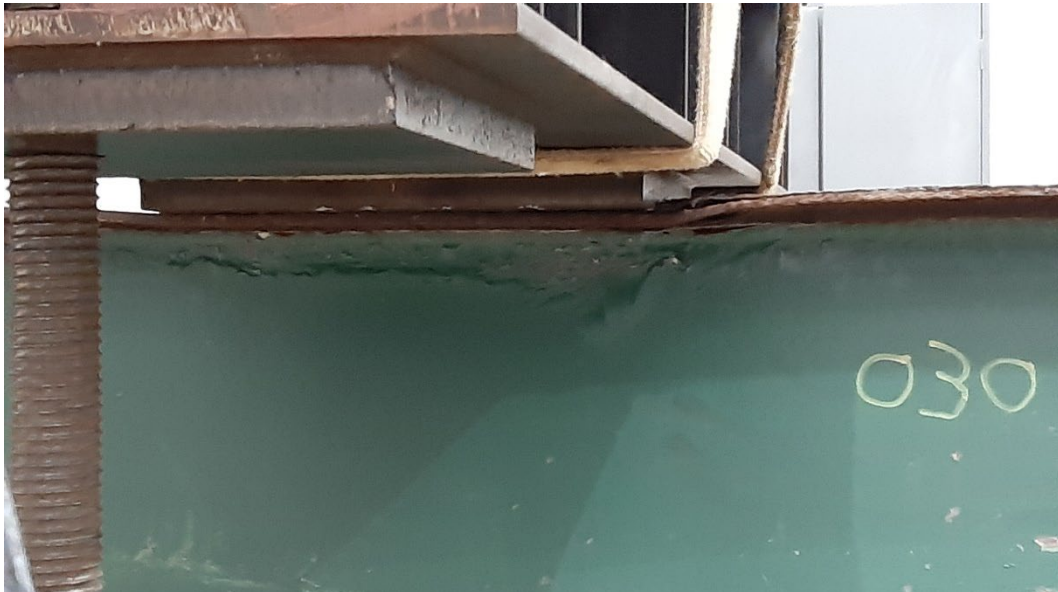
**Figure 6.34: Web crippling observed underneath area of loading.**

The residual deformation of the corroded end is presented in Fig. 6.33. Note that crippling was observed underneath the load application area, Fig. 6.34.

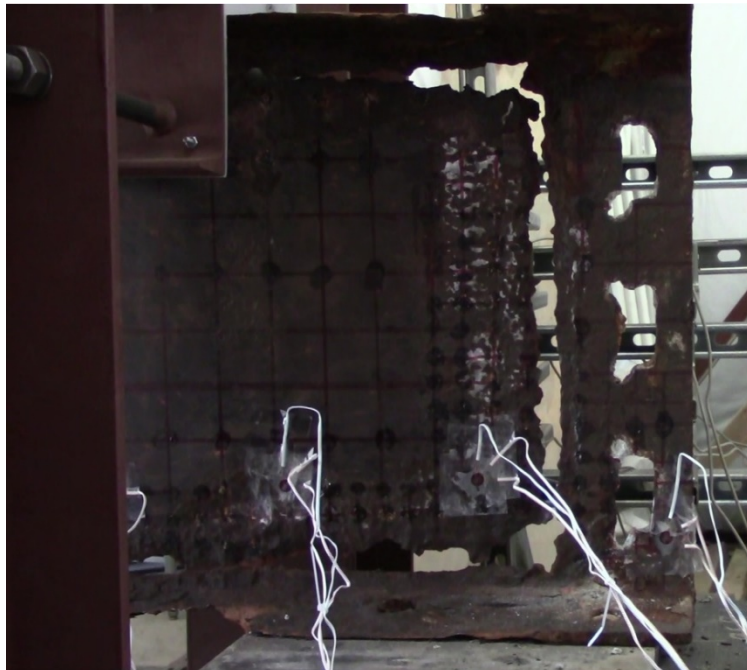
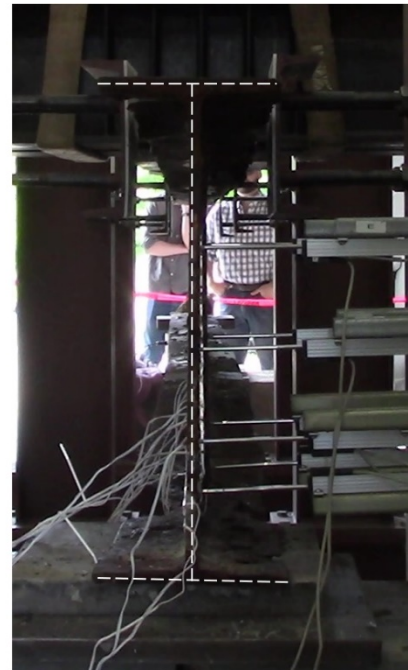
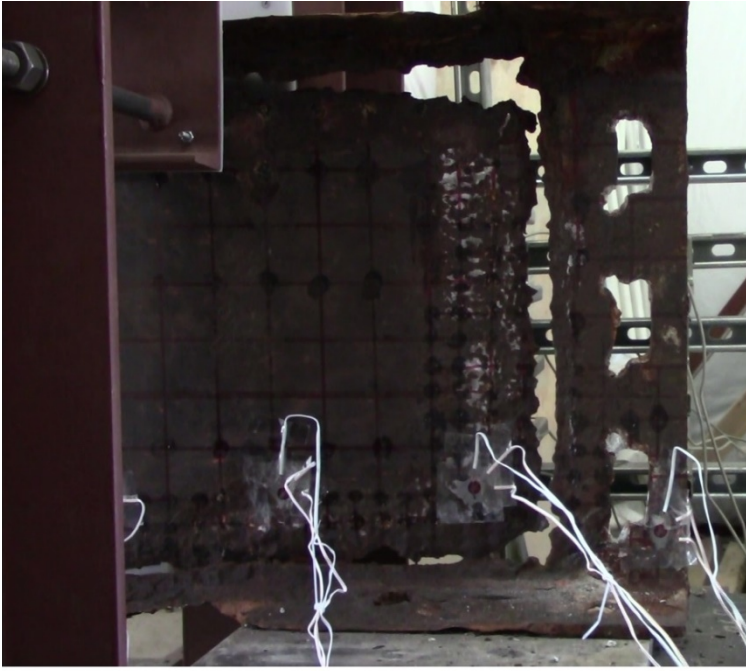
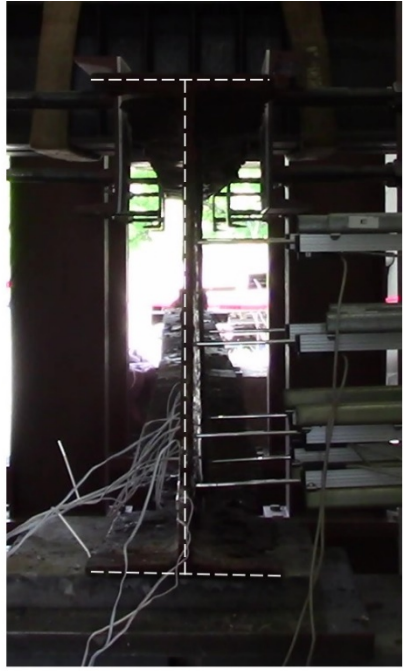
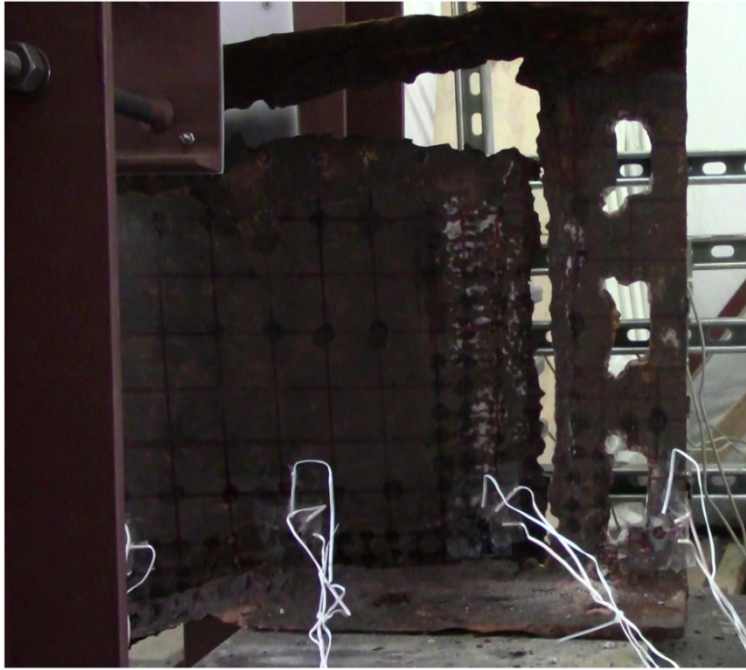
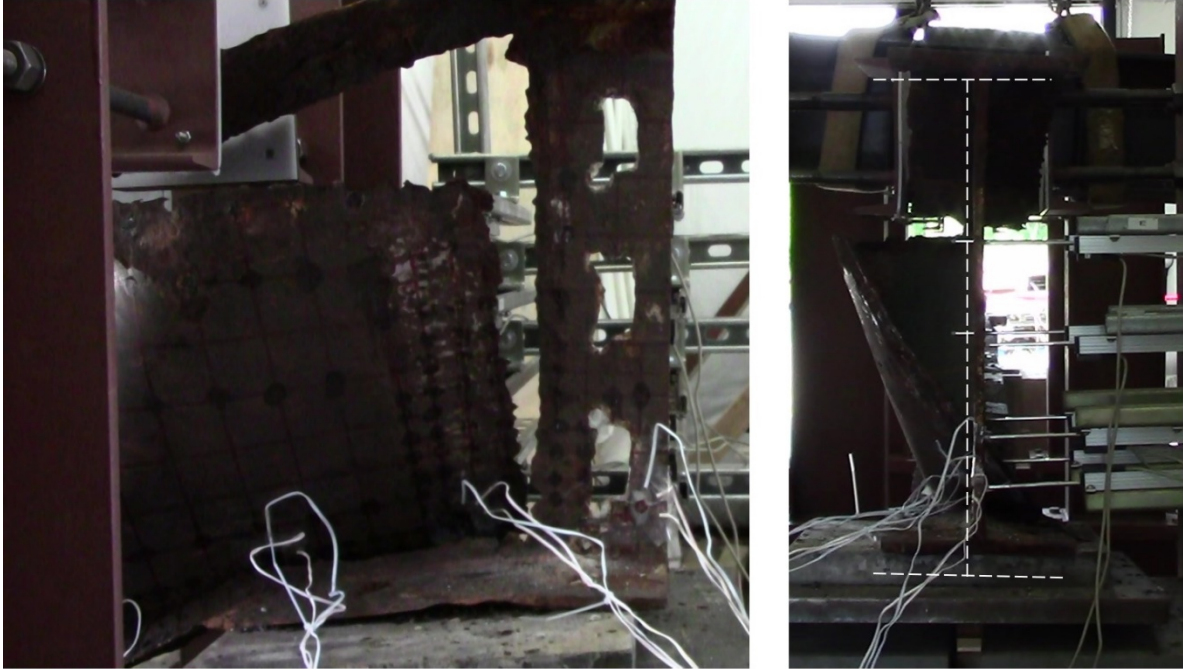
**Figure 6.39: Side-by-side images showing side view of web and profile view of beam during experiment. Letters A-C correspond to Fig. 6.37a. White dashed lines illustrate cross-section location at loading initiation.**

The failure mechanism of Specimen 6 is explained through Figs. 6.39 to 6.41. In Fig. 6.39, the deformation of the corroded end is presented, using images captured from two cameras that were recording the web plane and the cross-section view of the beam during the experimental process. Fig. 6.40 presents the lateral displacements as they were measured by the eight potentiometers for three different loads, 0.5, 0.75, and 1  $F_u$ , where  $F_u$  is the bearing failure load. Two columns of instruments were installed. The first one (blue) was placed above the outer edge of the bearing measuring the deflection of the stiff outer part of the web, while the second one above the inner edge of the bearing (red) recording the displacement of the nonsupported web. Red lines were not connected to web bounds, in order to mimic the discontinuous web profile due to holes existence. Finally, Fig. 6.42 presents the principal strain and its directions at six locations on web and flange, and the exact strain rosettes configuration is presented in Fig. 6.43.

After the loading initiation, due to the hole's extension, the web had limited contribution to the specimen's stiffness. The initial plateau observed at the load displacement curve captured mainly the flange action and was characterized by rapidly increasing deformations. This situation alternated for deflection equal to 0.6 in. (Fig 6.39a); where the unrestricted web began bearing the flange, the system gained stiffness and started retaining additional load. Principal stains development revealed that contact was initiated at the domain close to SR6, and the area below SR4 followed. The nonrestricted web continued experiencing large deformations, following the initial imperfection profile (Fig. 6.40), while the stiff part of the web (blue) was deflecting along the opposite direction. Finally, at 58.8 kips applied, the bearing on flange web buckled (Fig. 6.40b); its bottom, which was in contact with the flange, remained almost at constant position compared to 0.75  $F_u$ , while the top part translated 0.8 in. to the left (Fig. 6.40). The post-peak regime was characterized by rapidly reducing stiffness and extensive uplift (Fig. 6.37).

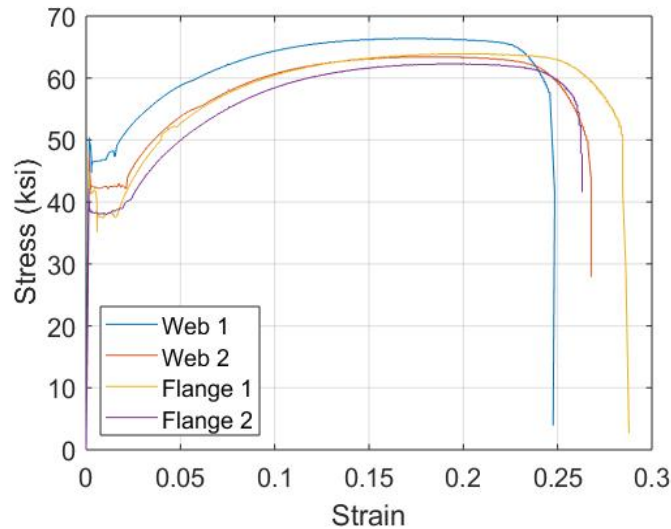
Results obtained by the tensile test of the four coupons obtained from Specimen 1 are illustrated in Fig. 6.44. Tests revealed a discrepancy in yield and ultimate stress of the steel along the rolling and transverse direction. Variation was also observed between the web and flange coupons. However, the curves for the top and bottom flange were similar, thus the results were considered valid.

**Figure 6.44: Stress strain curves for four coupons extracted from Specimen 1. Nomenclature of specimens is according to Figure 3.47.**

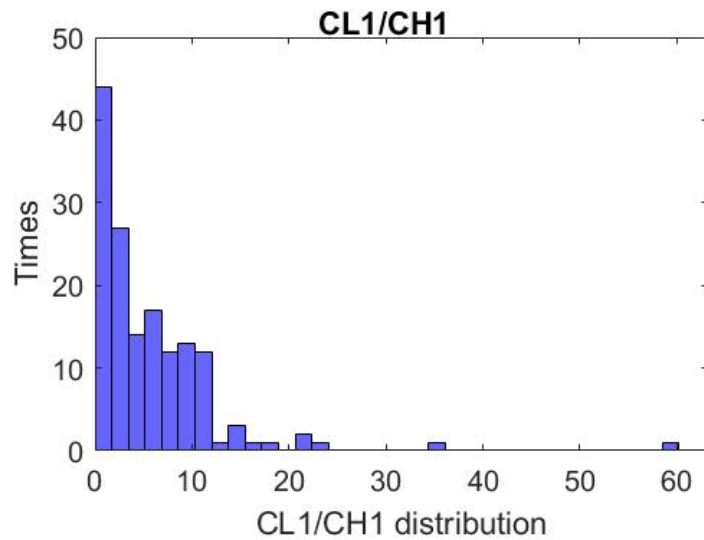
Fig. 12.4 shows the ratio of  $CL_1/CH_1$  which indicates that in general, the length of the corroded area is greater than its height. Fig. 12.5 focuses on the range 0-15 for the same distribution.

**Figure 12.4: Ratio of corrosion length ( $CL_1$ ) to corrosion height ( $CH_1$ ) of W1 pattern for beams without diaphragm.**

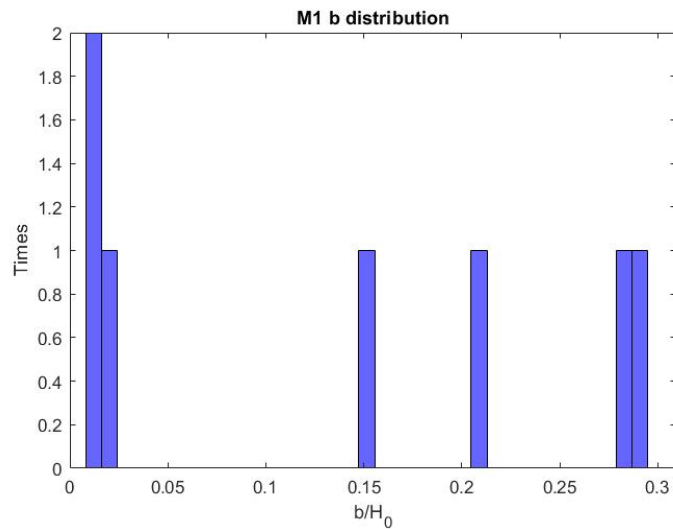
**Figure 12.20: M1 web hole's pattern length distribution of W1 web corrosion pattern for beams without diaphragm.**

Observing Figs. 12.19 and 12.20, it can be said that M1 appears in the form of pit holes (very small dimensions) or in a rectangular shape with the long side parallel to flange. Due to the small number of the available data for the holes, dimensions are not investigated for each case A, B, or C separately.

Thus, it could be said that the holes appear when the web thickness loss exceeds 40%. The distribution of the hole dimensions is shown in Figs. 12.19 and 12.20:

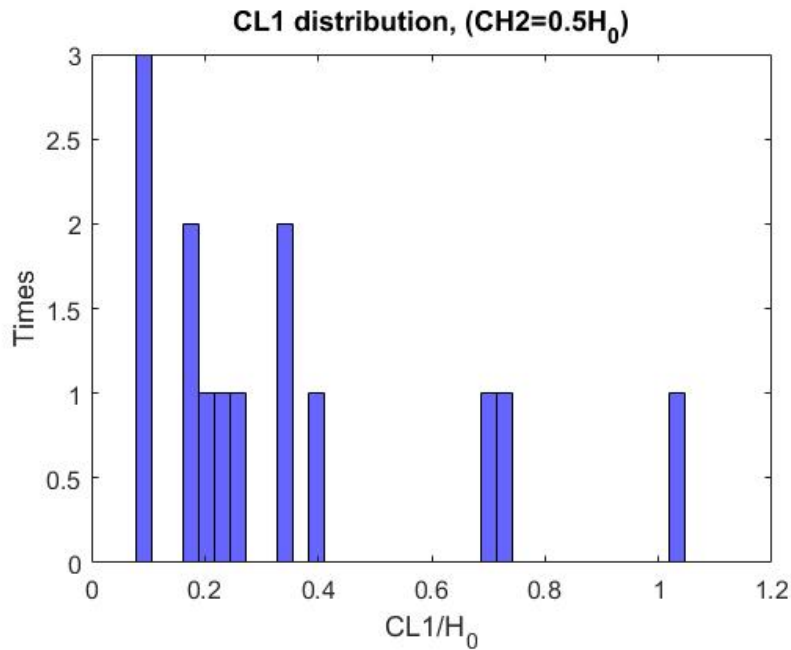
**Figure 12.49: CL1 distribution of W4 web corrosion pattern, with corrosion height up to 50% of  $H_0$  for beams without diaphragm.**

Based on Figs. 12.48–12.52:

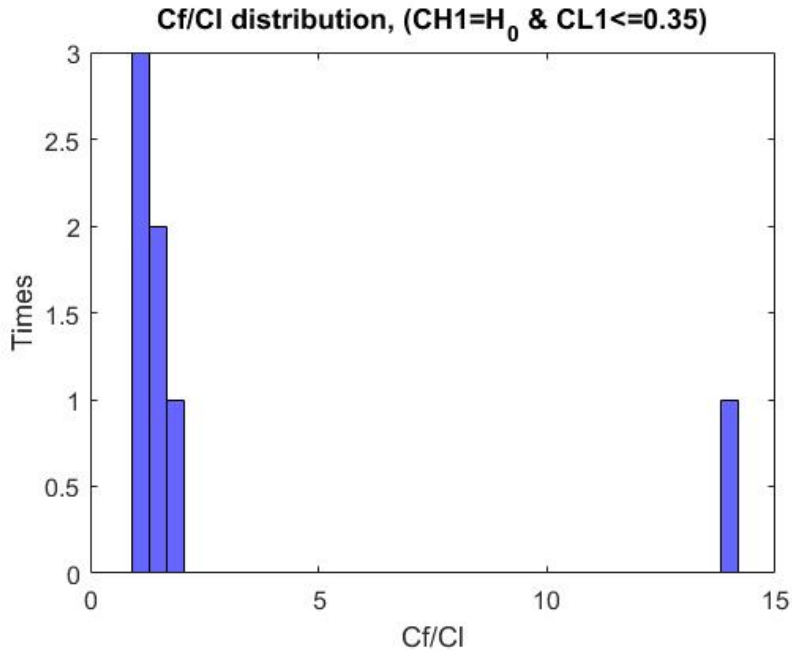
**Figure 12.79: Ratio of flange to web corrosion length distribution of W1 web corrosion pattern, with full height corrosion and up to 35% of  $H_0$  length, for beams with diaphragm.**

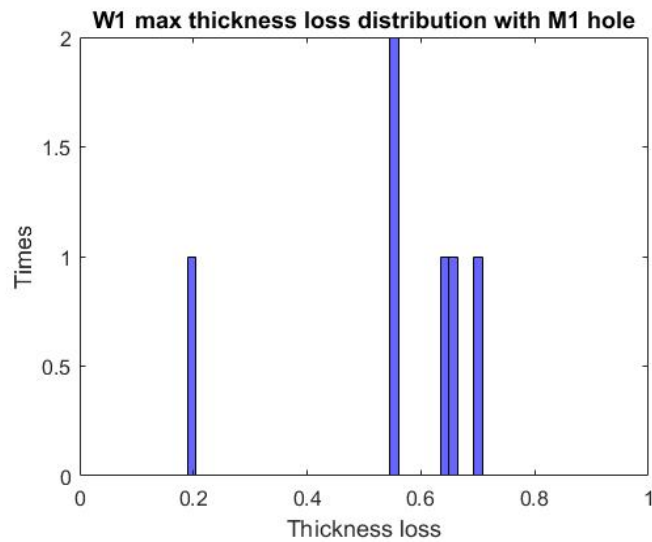
The W1 pattern is combined 11 times with the M1 hole pattern. The web thickness loss, holes dimensions, and corrosion height at these cases are given as:

**Figure 12.86: Max thickness loss distribution for W1 web corrosion patterns and M1 hole for beams with diaphragm.**

From Fig. 12.86, one can conclude that holes are equally distributed between web corrosion scenarios CASE A and CASE B. It is worth mentioning that there are two cases of long parallel to flange holes (Fig. 12.88). The two longest holes ( $1.3 H_0$  and  $1.4 H_0$ ) are the same with the greatest height (0.18 and 0.21, respectively). As a result, an extreme hole case is considered the following (projected on Case B web corrosion scenario):

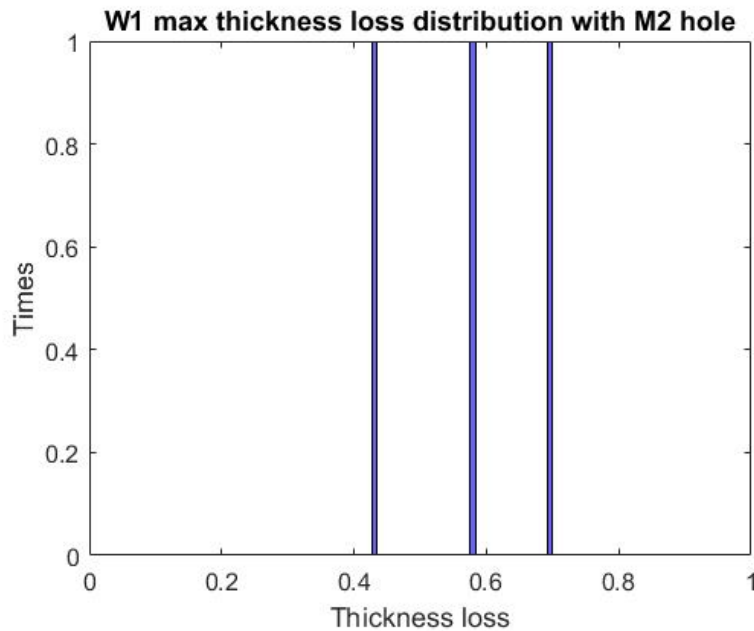
There are also four cases of M2 hole pattern. The web thickness loss, hole dimensions, and corrosion height of these cases are given as:

**Figure 12.91: Max thickness loss distribution for W1 web corrosion patterns and M2 hole for beams with diaphragm.**

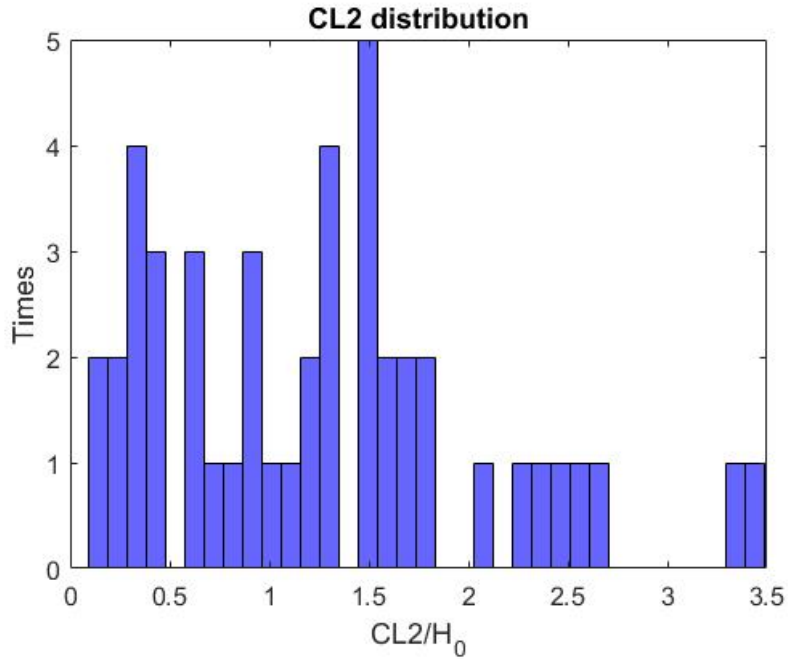
Figure 12.96: CL2 distribution of W2 pattern for beams with diaphragm.

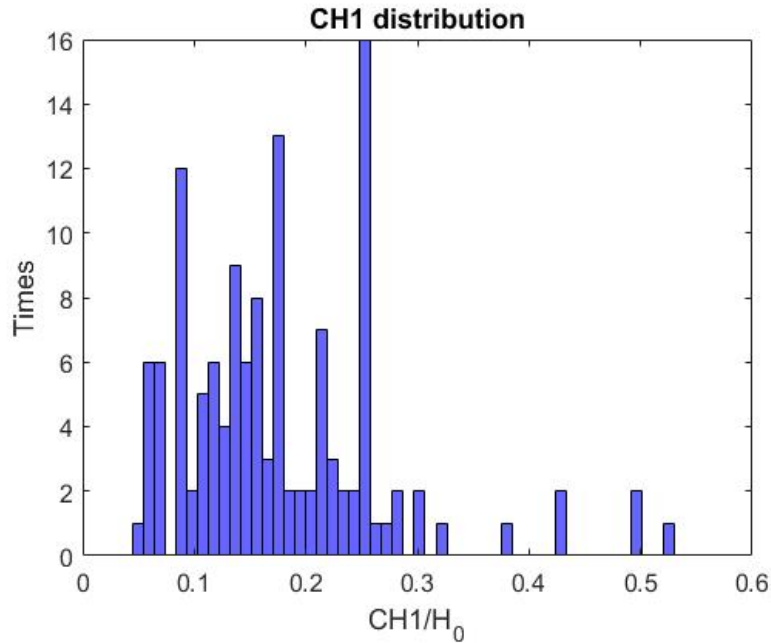
**Figure 12.106: CH1 distribution of W3 web corrosion pattern for beams with diaphragm.**

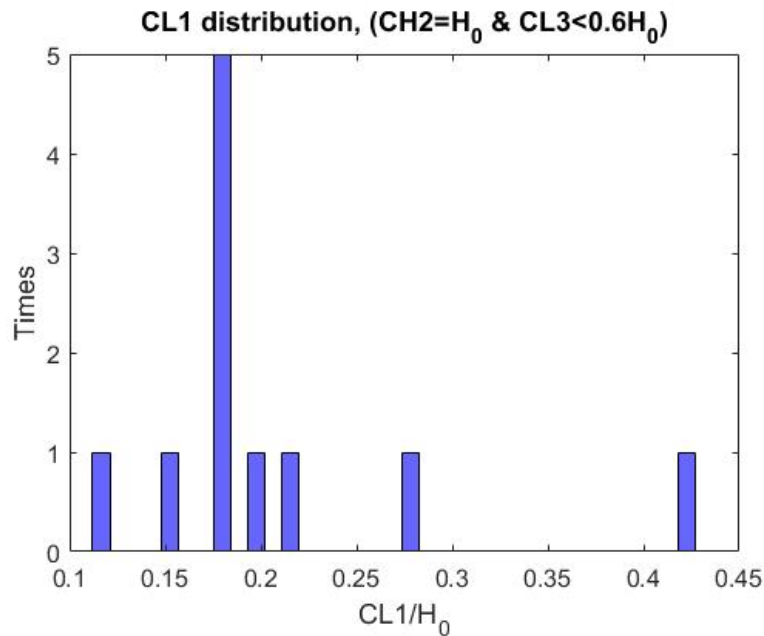
**Figure 12.118: : CL1 distribution of W3 web corrosion pattern with full height corrosion and deteriorated length up to 60% of  $H_0$  for beams with diaphragm.**

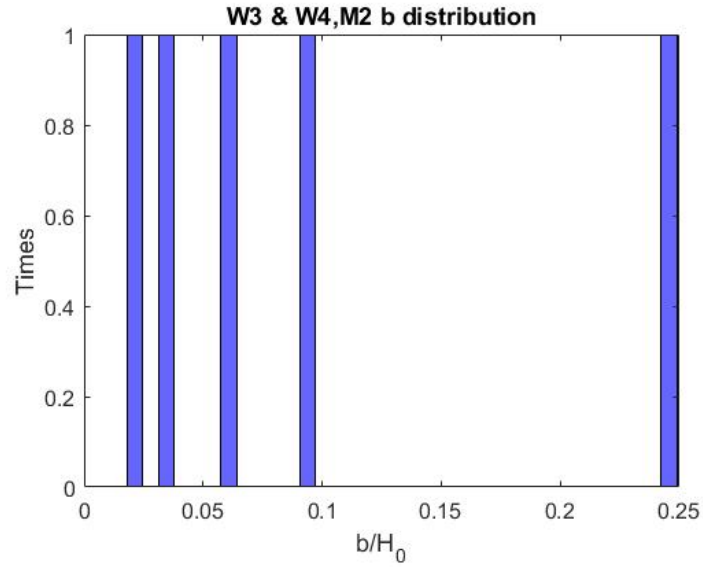
**Figure 12.167: M2 web hole's pattern length distribution of W3 and W4 web corrosion pattern for beams with diaphragm.**

The worst-case scenario is:  $a=0.1$ ,  $b=0.25$ .

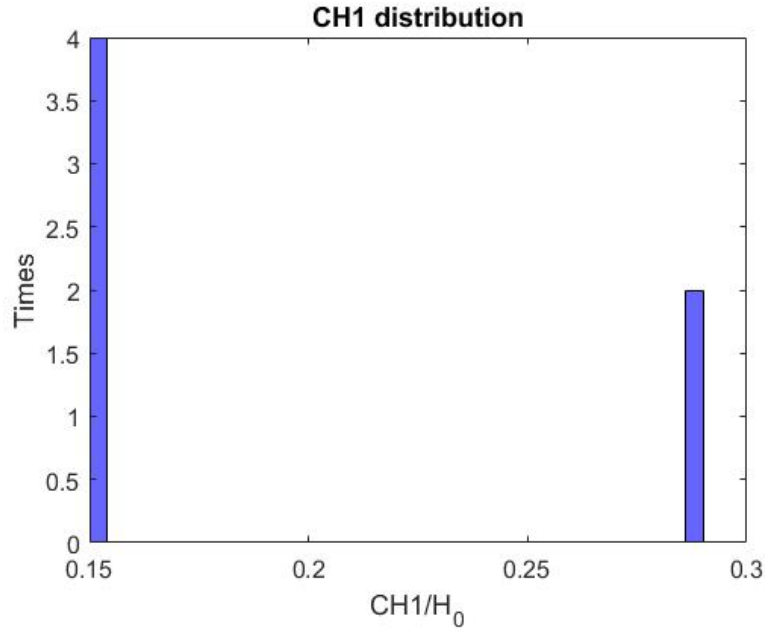
Figure 12.169: CH1 distribution of W5 web corrosion pattern for beams with diaphragm.
