**MARYLAND DEPARTMENT OF TRANSPORTATION
STATE HIGHWAY ADMINISTRATION**

RESEARCH REPORT

**OPTIMIZING FIELD DATA COLLECTION & DEVELOPING
ADVANCED GPR PROCESSING MODULES**

FINAL REPORT

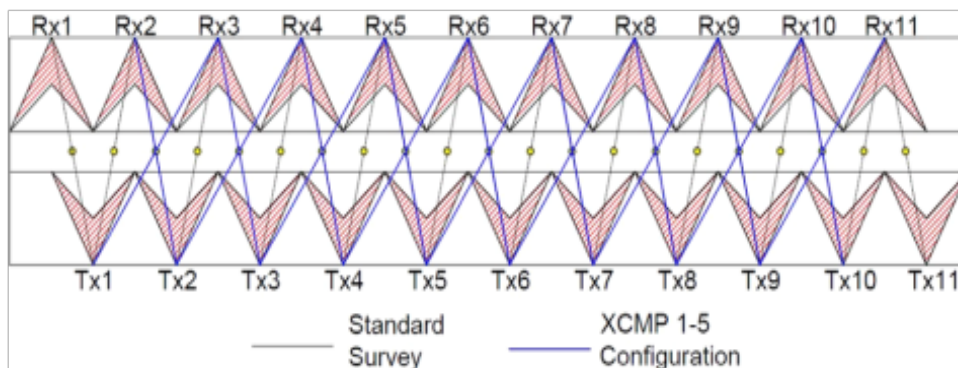
Figure 5. DX 1821 Antenna Array Layout and CXMP configurations (Zhao et.al., 2016).

A study by Zhao et. el., (2016) used extended CMP (XCMP) with SF-GPR to detect the dielectric properties and asphalt layer thickness. The configurations were based on the transmitting and receiving antennas that share the same midpoint (Table 3). The 3D-GPR antenna DX1821 (Figure 5) has a pattern, gain, and impedance nearly constant over a wide frequency range. The governing equations are based on geometry of configuration and they are not necessarily stable, meaning that a small perturbation in the inputs could have a huge influence on the outputs. Therefore, Whittaker-Shannon interpolation was applied to convert the data from frequency domain to time domain and increase the time domain sampling rate. Alternative XCMP patterns were used to identify which setup provides the most accurate GPR interpretation results in relation to measured asphalt layer thickness from design and cores. The study indicated that specific XCMP patterns provided accurate asphalt layer thickness detection within 0.2 inches (5 mm) accuracy which meets construction tolerance.

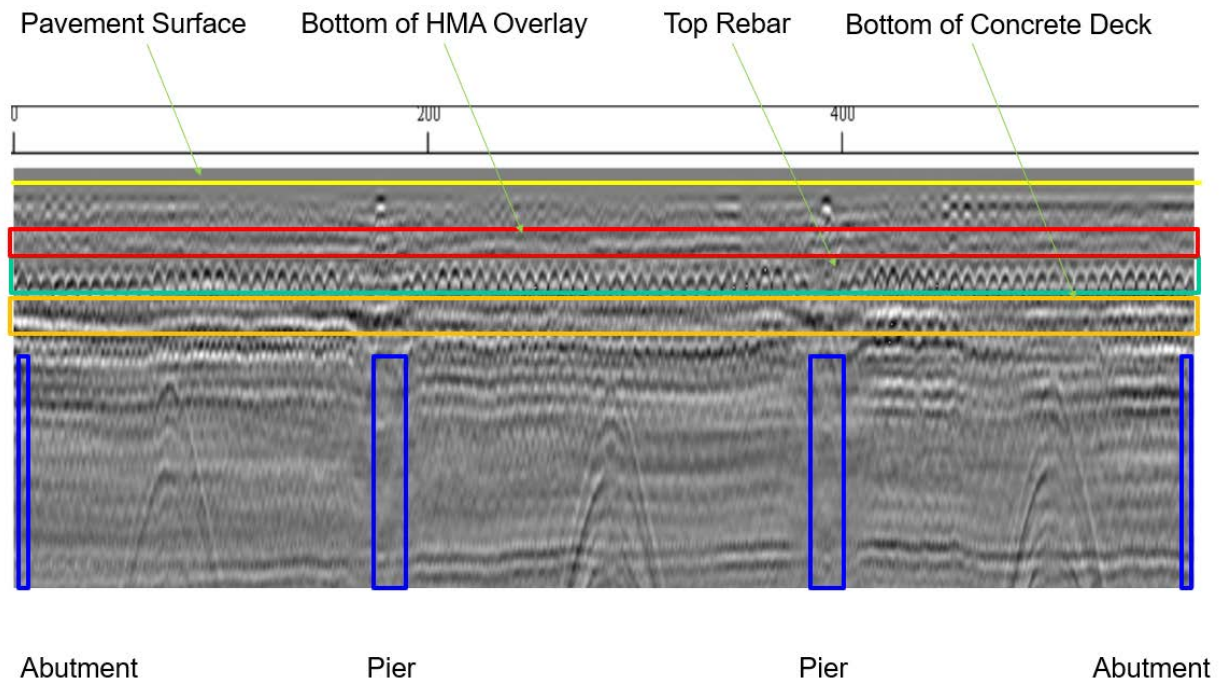
Figure 6. Example Profile View (B-scan) of three-span bridge deck.

In this task the research team in coordination with Starodub reviewed the revised SF-GPR analysis pipeline which incorporates the new data modules: (i) thickness and condition of the HMA overlay and (ii) delamination potential. Figure 6 is an example of a profile radagram of a three-span bridge. The extent of areas of activity are color-coded. The abutments and piers are shown in blue, the overlay-concrete interface in red, the top steel in green, and the bottom steel in orange. Each data element is generated using several GPR interpretation algorithms involving dimensional filters, detection and fusion algorithms. The revised SF-GPR analysis pipeline is presented in Figure 7. Details of its components were included in the Phase II report (Goulias 2016) based on the initial SF-GPR analysis pipeline. The final summary report for each bridge deck, by span, and for all spans is shown in Figure 8. The summary report includes two types of data elements: (a) bridge deck information data, and, (b) bridge deck condition data. Appendix A presents the latest version of the data analysis modules, with details on how each bridge deck condition parameter is detected using the SF-GPR data. It specifically includes:

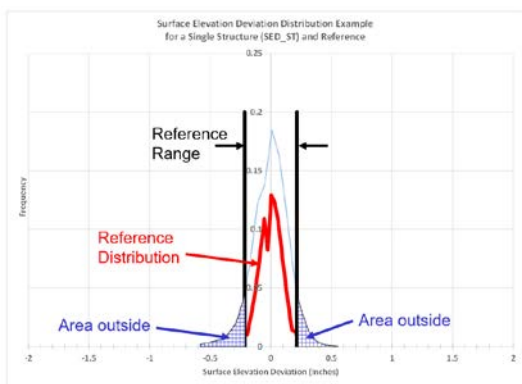
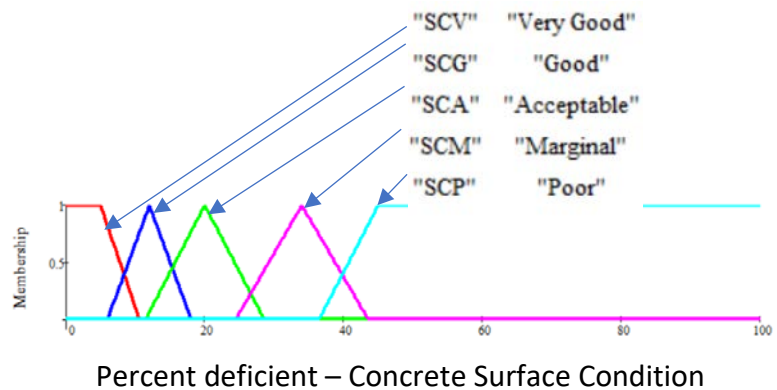
A Reference Distribution and Range for is established for each data element (see figure). It represents the best condition of a new deck as close to the condition free of defects and deterioration. For a given set of measurement, the percent area that falls outside the reference is estimated. The larger the area, the greater

the potential for deterioration. Membership functions are defined to represent the increasing change from the reference captured in the percent deficient. For the data element shown in the figure above, there are five fuzzy sets that represent “very good”, “good”, “acceptable”, “marginal”, and “poor” ratings.

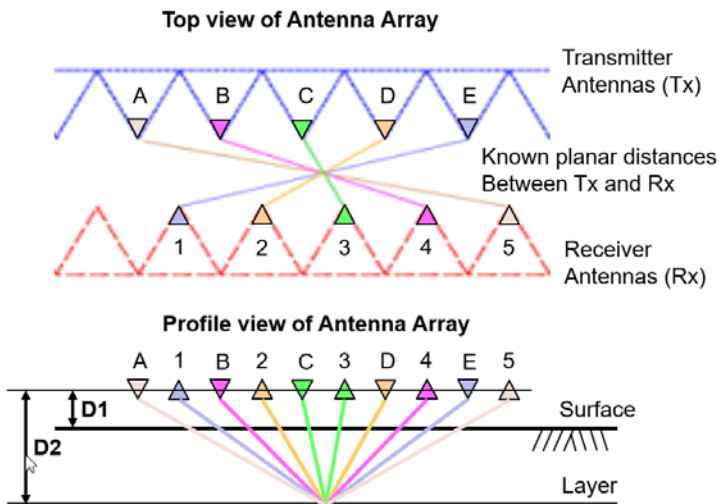
The thickness of the overlay is estimated as the vertical distance between the surface and the overlay/concrete-deck interface. The estimates of thickness are calibrated using the common-mid-point (CMP) method based on geometric triangulation. The figure on the left shows five lateral offsets of five different transmitter-receiver pairs. Note that all five lines cross at a common-mid-point. The distance D2 is estimated using the five measurements, knowing the five lateral offsets. The thickness of the overlay is $D2 - D1$, where D1 is estimated using a similar triangulation.
