1. REPORT NUMBER  CA20-3296	2. GOVERNMENT ASSOCIATION NUMBER	3. RECIPIENT'S CATALOG NUMBER
4. TITLE AND SUBTITLE Locations for Future Intercity Passenger Rail Maintenance or Layover Facilities in CA		5. REPORT DATE  01/06/2020
		6. PERFORMING ORGANIZATION CODE
7. AUTHOR  Shailesh Chandra and Mehran Rahmani		8. PERFORMING ORGANIZATION REPORT NO.
9. PERFORMING ORGANIZATION NAME AND ADDRESS California State University, Long Beach 1250 Bellflower Blvd Long Beach, CA 90840		10. WORK UNIT NUMBER
		11. CONTRACT OR GRANT NUMBER  65A0717
12. SPONSORING AGENCY AND ADDRESS California Department of Transportation Division of Research, Innovation and System Information 1727 30th Street Sacramento, CA 95816		13. TYPE OF REPORT AND PERIOD COVERED Final Report 12/1/2018 - 11/30/2019
		14. SPONSORING AGENCY CODE
15. SUPPLEMENTARY NOTES

Maintenance and layover facilities are vital in operating and maintaining passenger rail systems. This research project is interested in the decision-making criteria for locating such facilities and how those criteria impact the performance of the rail system. This research project looks at the locations and the types of most recently-built rail maintenance and layo

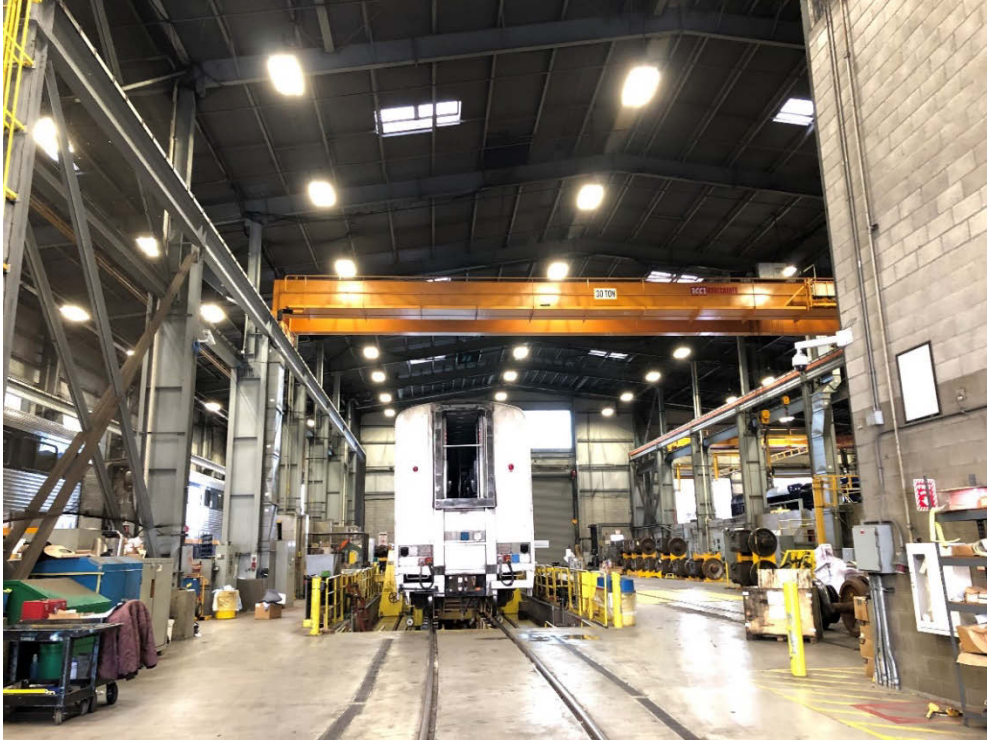
Figure 10: Building structural components, roof framings and overhead crane system

The steel portal frames are constructed of I-shape built-up steel sections. The perimeter columns of the portal frames are encased in concrete at their base. The frame and the concrete encasement are shown in Figure 9. The CMU walls are 10 feet tall on the north and south sides of the building (as shown in Figure 9). There are windows and composite sidings on the upper part of the side walls. The height of the CMU walls varies up to 20 feet in the east and west sides by the building entrances. The roof structure is comprised of steel purlins spanning between steel rafters of the steel portal frames. The roof is clad by corrugated metal sheeting. Additional steel beams are mounted on the interior columns supporting a 30-ton overhead crane system. Figure 10 presents the roof and the crane system. On the north side of the building, a raised track and a raised floor is constructed for easing locomotives' light and heavy maintenance operations. Figure 11 shows the raised steel deck flooring on steel hollow structural section (HSS) columns and the raised track supported on H-shape steel piers.

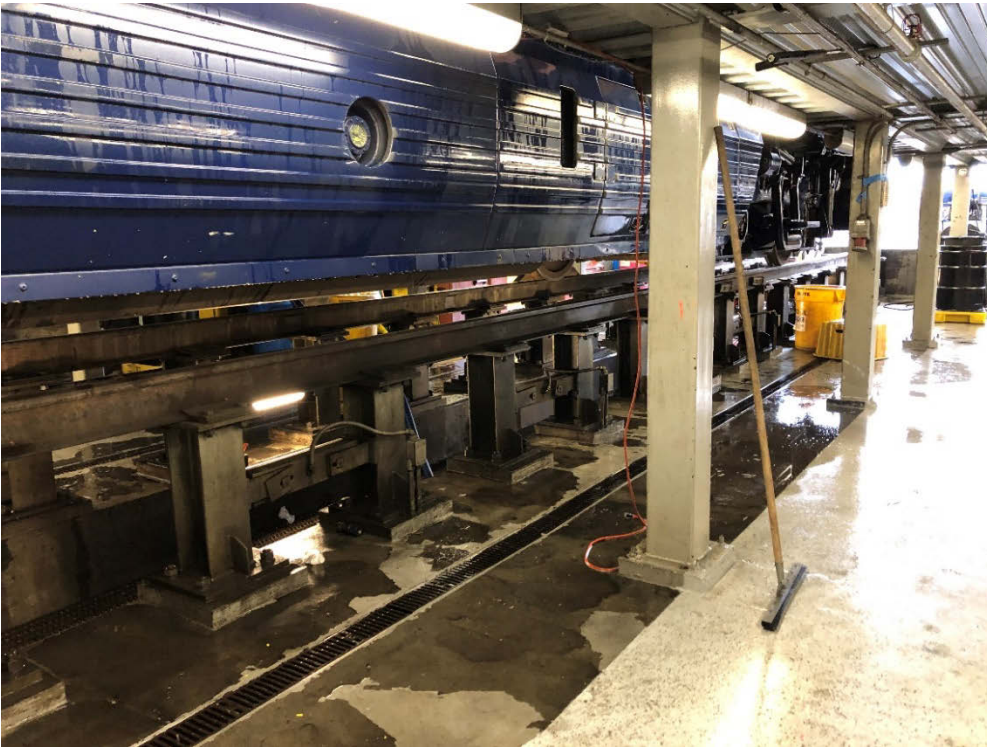
Figure 11: Raised steel deck flooring on steel HSS columns and the raised track supported on H-shape steel piers

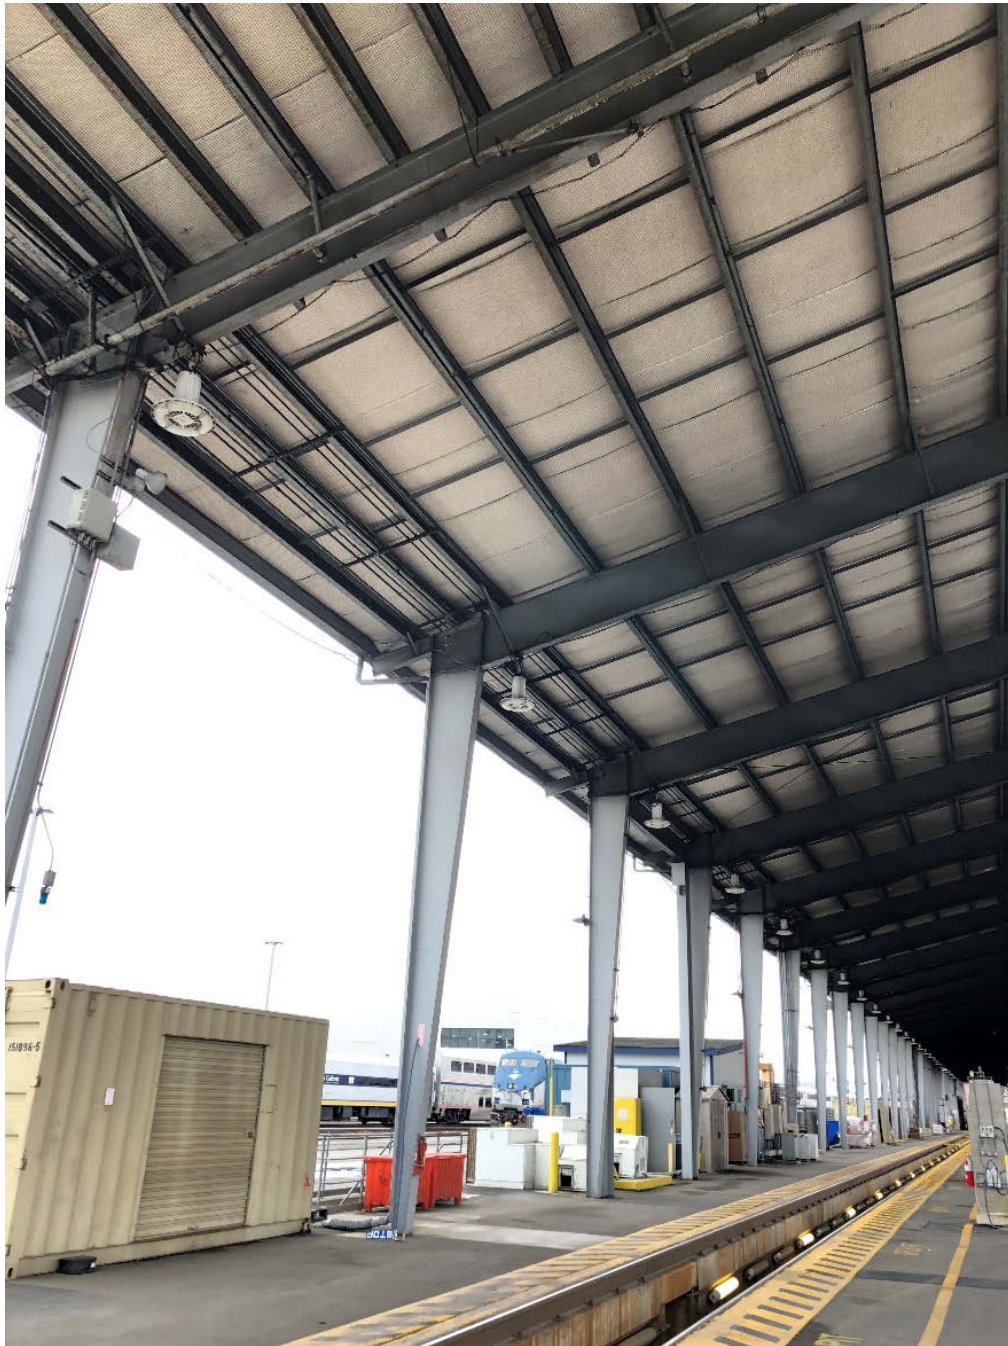
*Figure 12: Structural components of the outdoor light facility: Steel portal frame and roof system and maintenance pit*

The building's structural drawings were not available for review. The constructed foundation system, among those recommended in the geotechnical report, is not known. However, it is likely that the buildings' foundation is continuous strip footings under the CMU walls and driven piles and pile caps under the steel columns. The building's ground floor is a concrete slab-on-ground. The outdoor facility consists of similar structural framing and roof system with no walls and no overhead crane system. Figure 12 shows the steel portal frame and maintenance pit for the light outdoor facility.

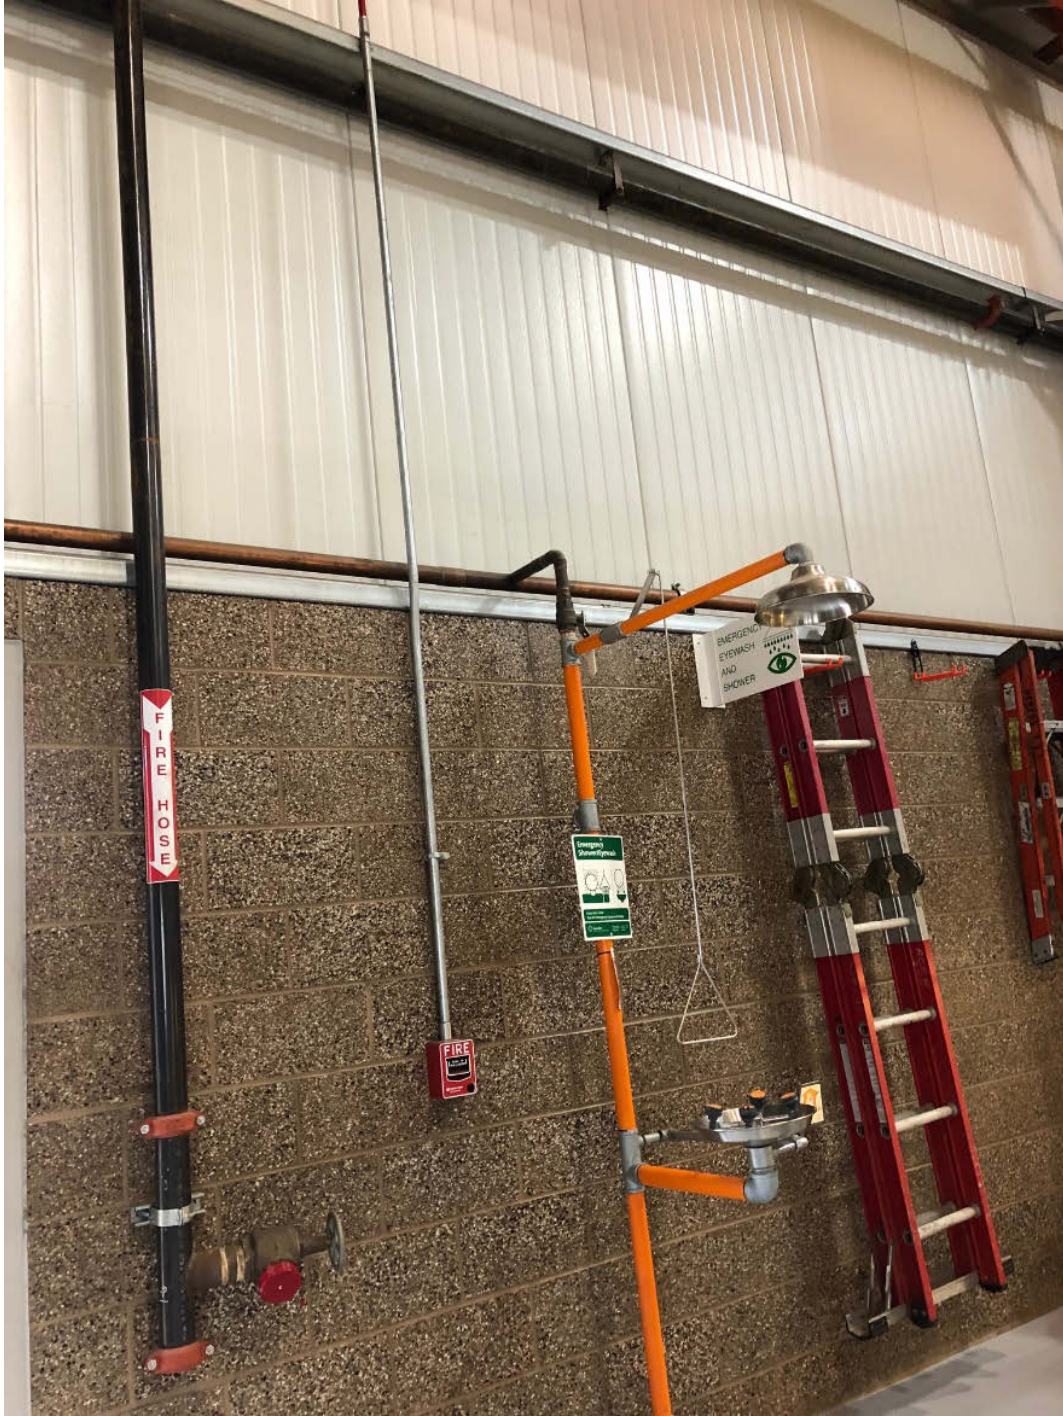
Figure 18: Building components: perimeter CMU walls and composite sidings

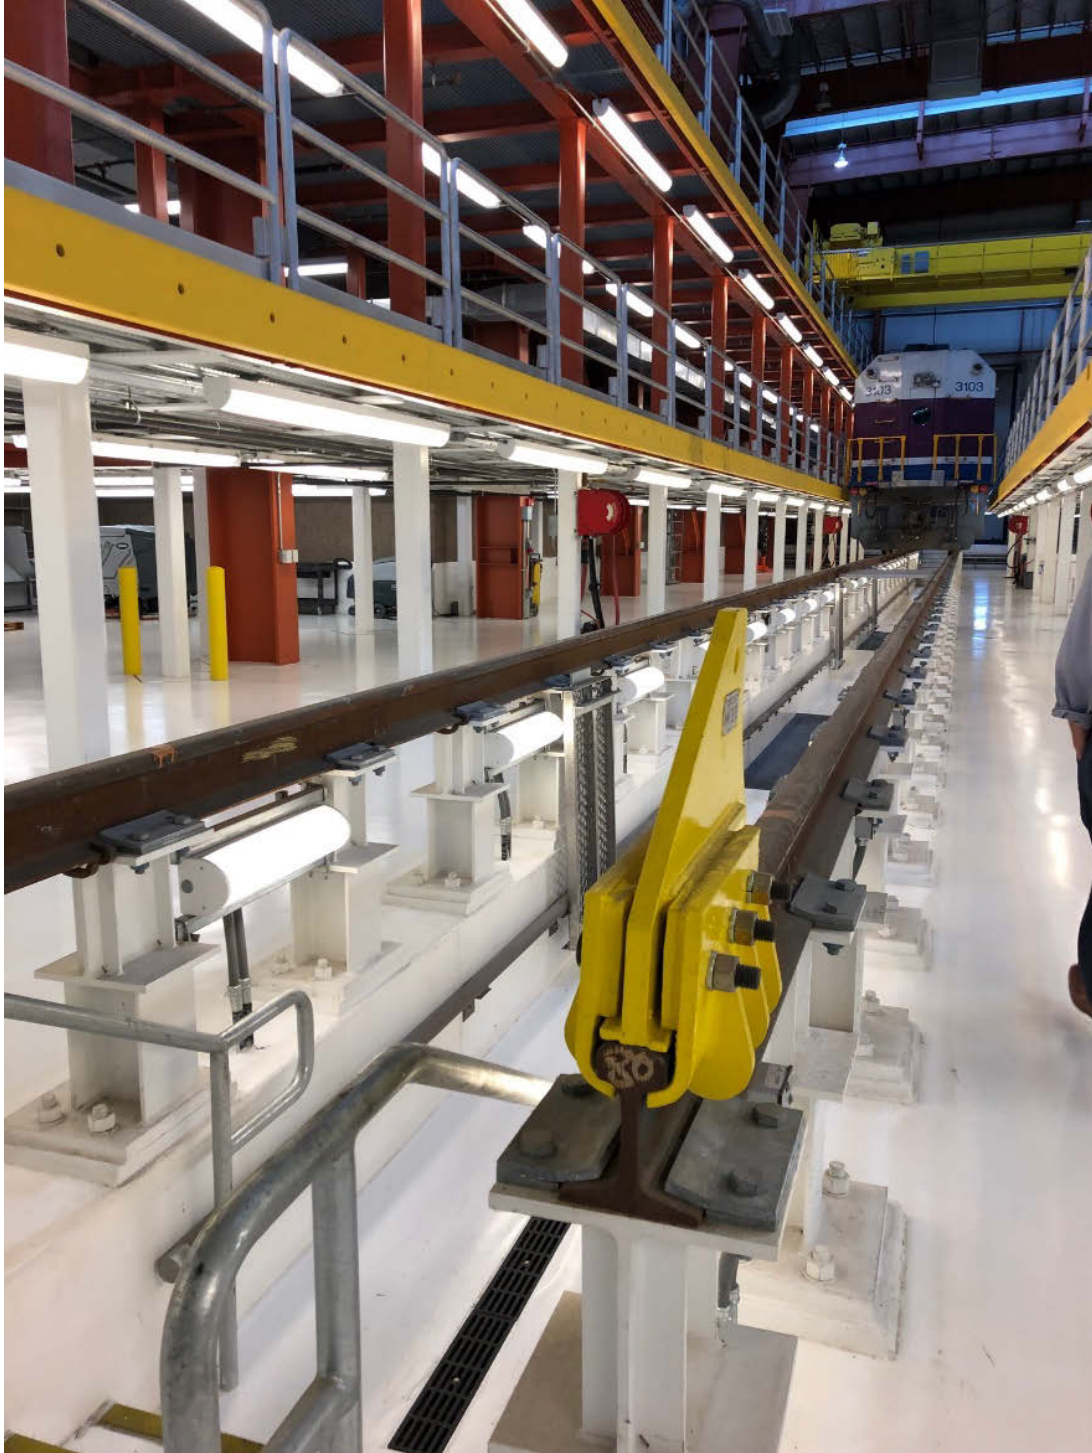
*Figure 19: Raised steel deck flooring seated on steel HSS columns and the raised track supported on H-shape steel piers*

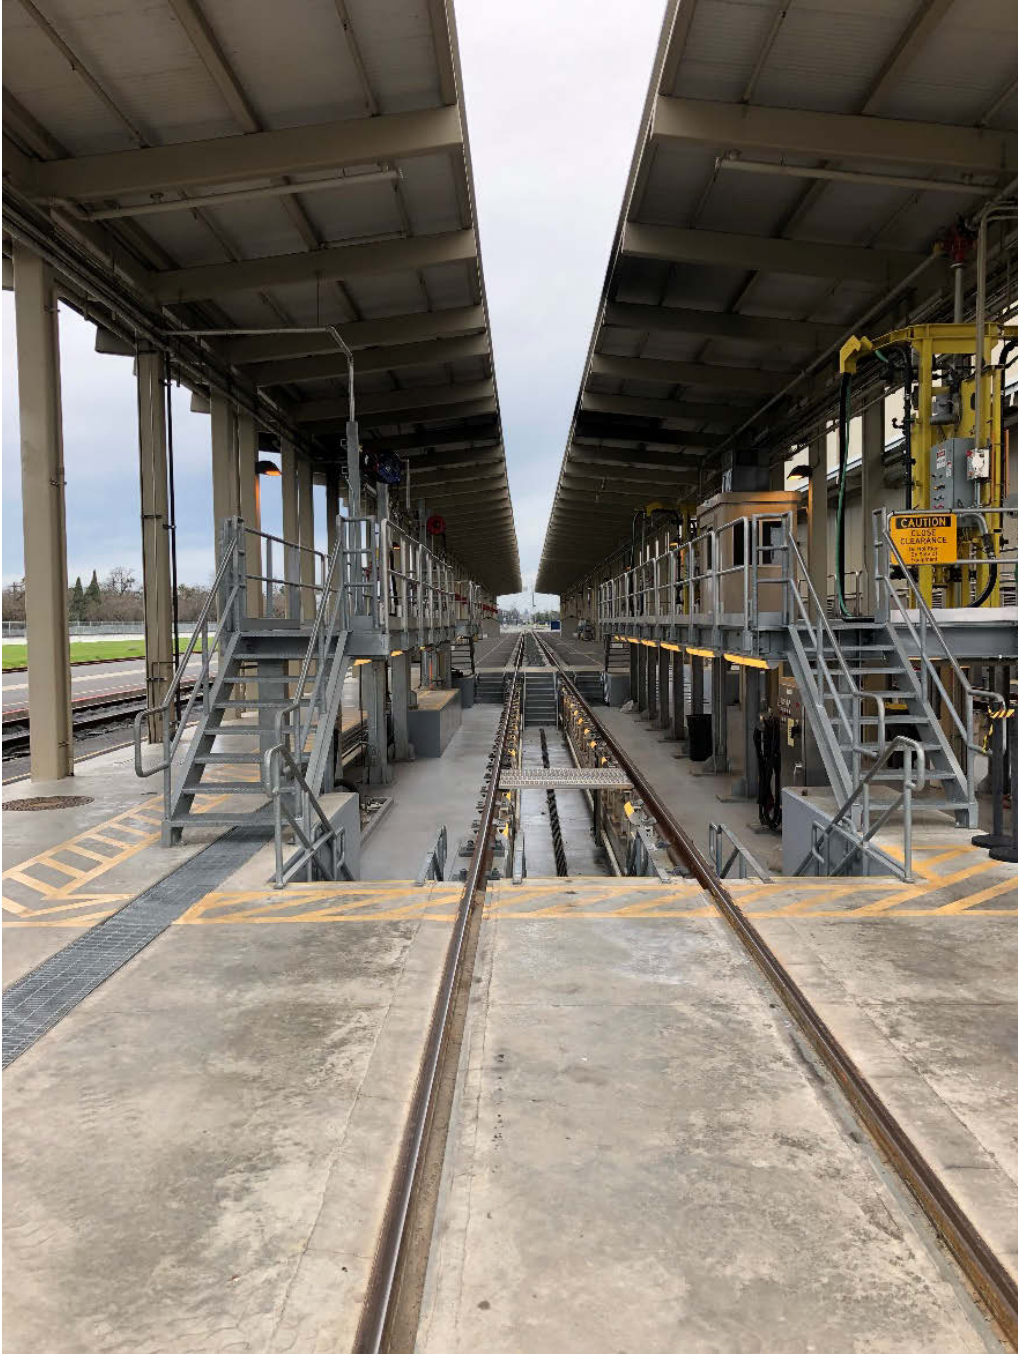
Figure 20: Steel structural framing and maintenance pit for the outdoor facility structure

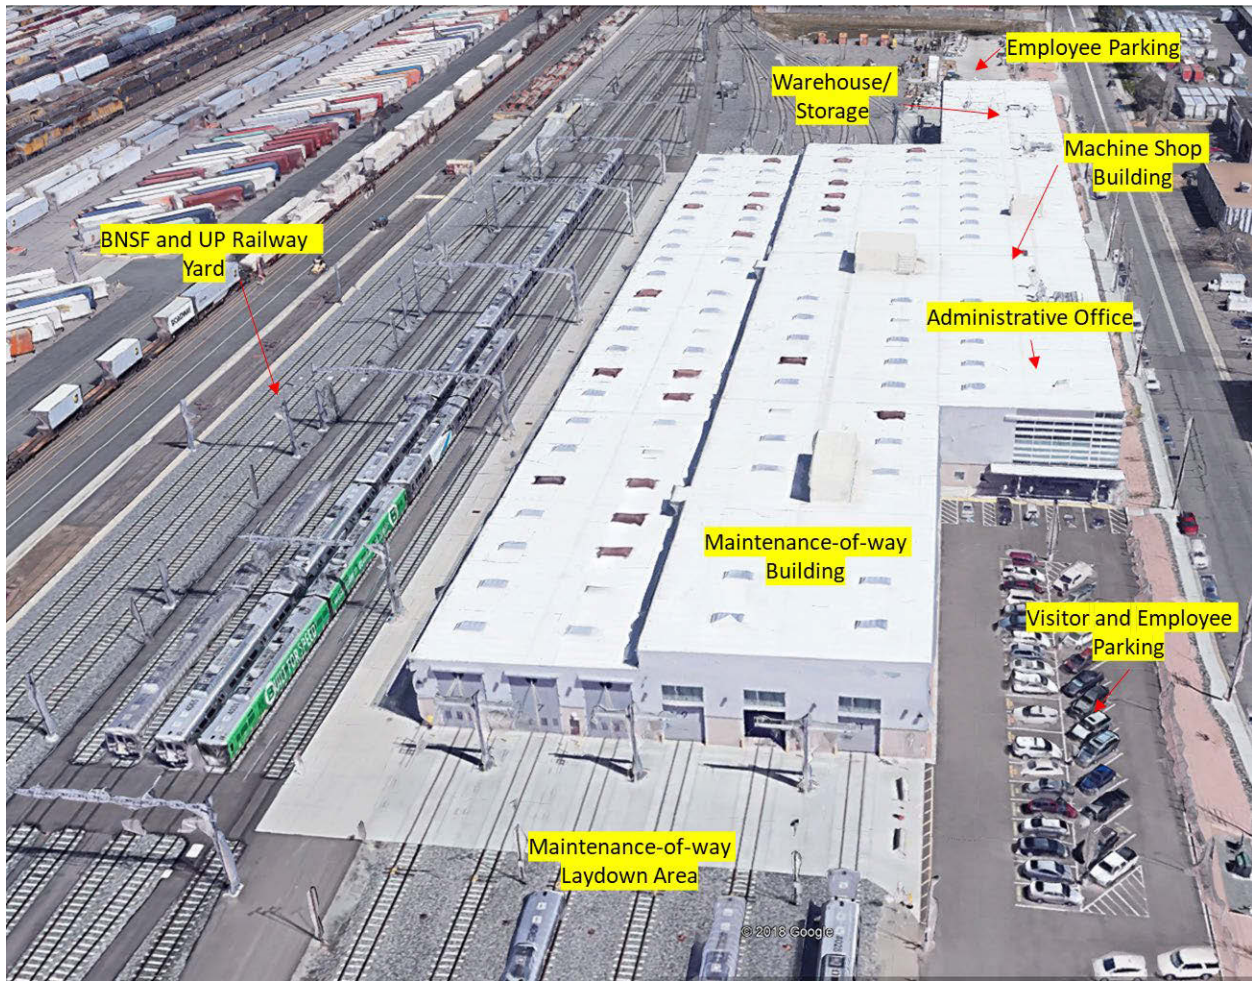
Figure 23: Bird's Eye view of the RTD Commuter Rail Maintenance Facility (by Google Earth) from the South Side

The location of the CRMF is very strategic and close to the BNSF and UP railroad freight lines (see Figure 23). Denver Transit Partners (DTP) acquired electric multiple-unit (EMU) cars for the commuter rail and are being maintained at the facility. Various facility components as shown in Figure 23 are interconnected. The facility is currently servicing 66 cars and can service up to 80 electric rail cars. The facility is spread over an area of 230,000-square-foot and is equipped with state-of-the-art training and conference rooms, staff break room and lockers. The facility buildings at Denver CRMF has LEED<sup>22</sup> Gold Certification.

Various building components in the layout of Figure 23 is summarized below:

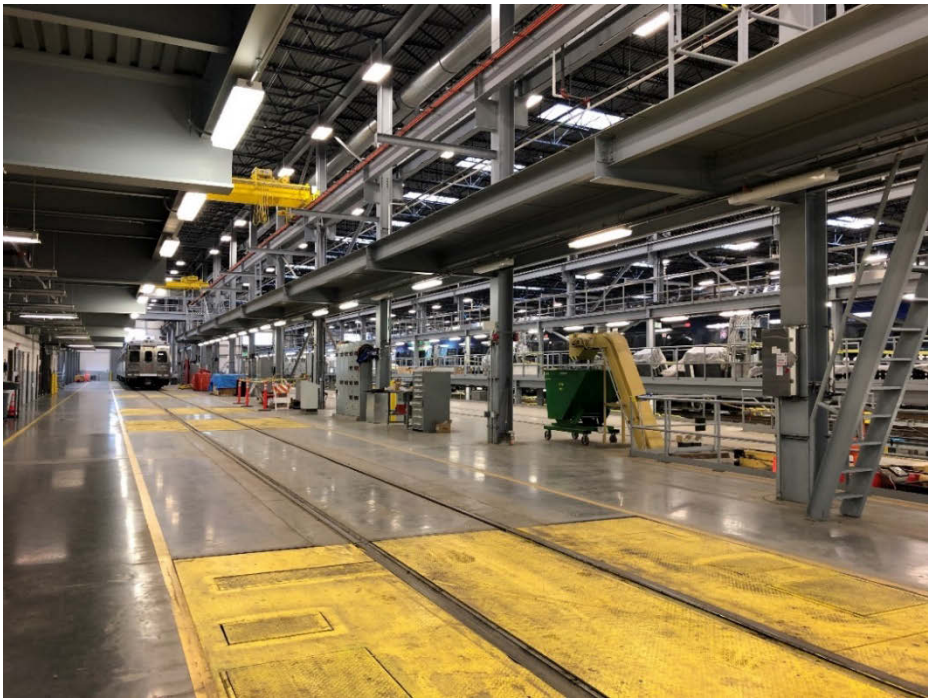
*Figure 27: Building's structural components: steel columns and beams and cantilevered mezzanine levels*

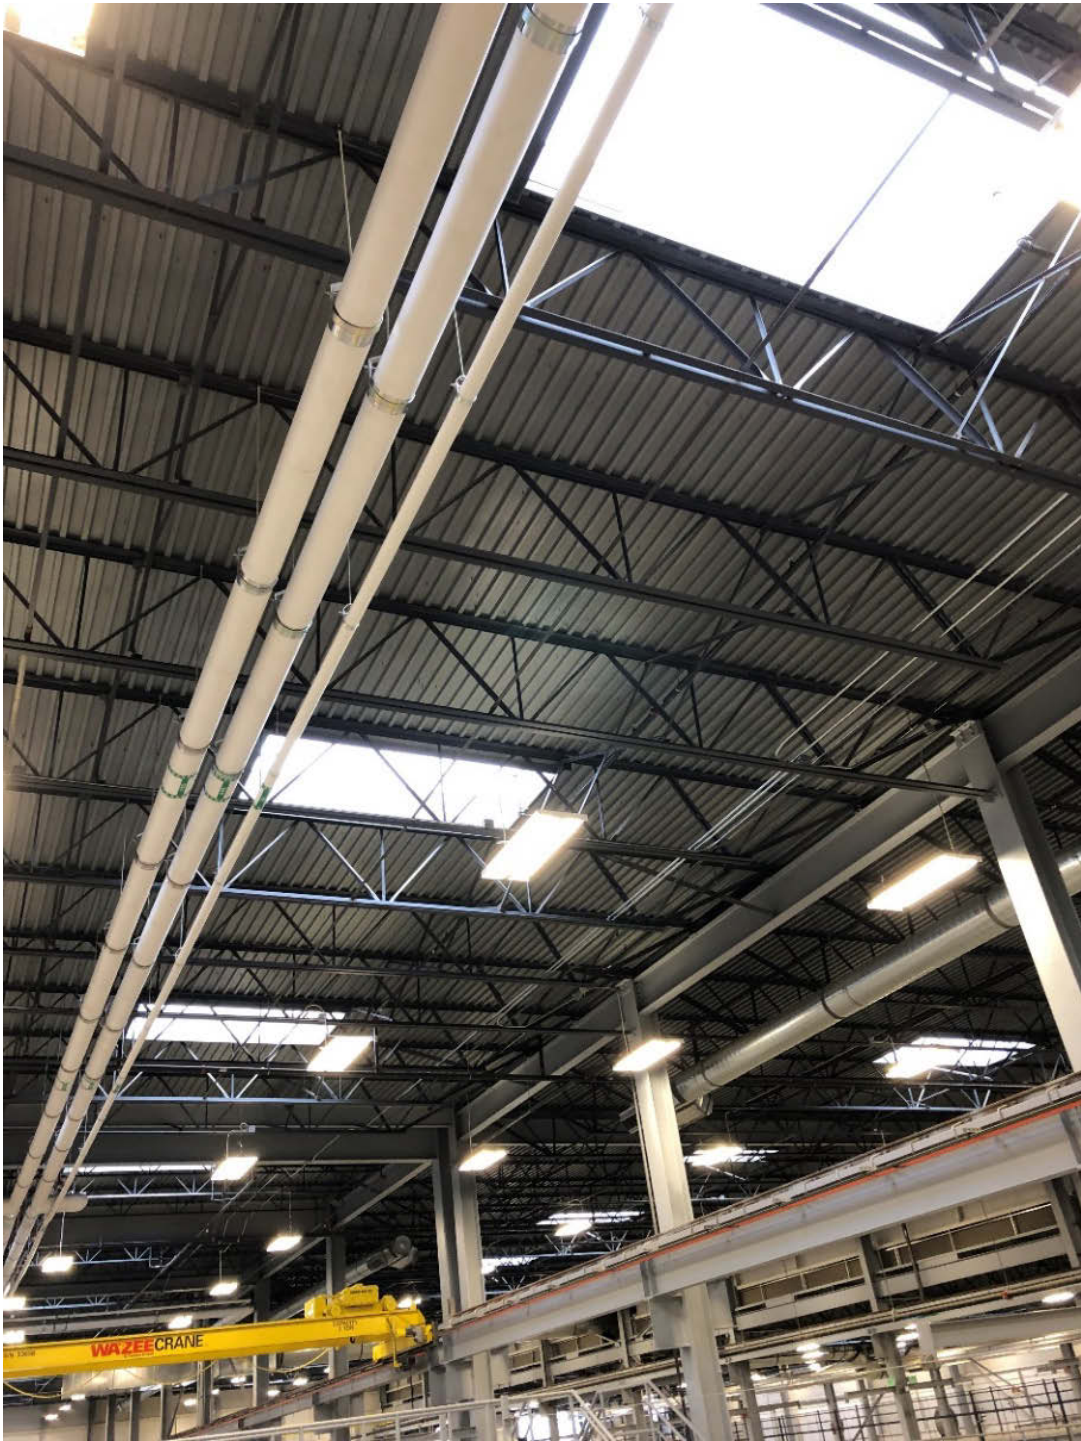
*Figure 28: Building's structural components: Steel columns and girders and roof truss-joists spanning east-west*

The building's steel frames are constructed of both built-up sections and wide-flange steel sections. The columns are laterally supported by steel bracing at some bays (see Figure 26). The roof system comprises steel truss joists spanning east-west between the steel girders. The roof is clad by corrugated metal sheeting and skylights. The building's structural drawings and geotechnical report were not available for review. However, it is likely that the buildings' foundation comprises continuous strip footings under the CMU walls and isolated pad footings under the steel columns (i.e., shallow foundation system). The building's ground floor is a concrete slab-on-ground. The building has received a Gold LEED certificate for energy efficiency. The building enclosure comprises reflective windows for insulating heat and cold. Also, the building's heating system is embedded into ground floor's slab. Sensor-activated lights and several skylights throughout the building are deployed for reducing the energy consumption. Figure 35 shows the facility's doors. Aluminum roll-up doors are used for regular maintenance tracks whereas double-fold steel doors are used for powered tracks. Figures 36 to 29 show specific facility features.

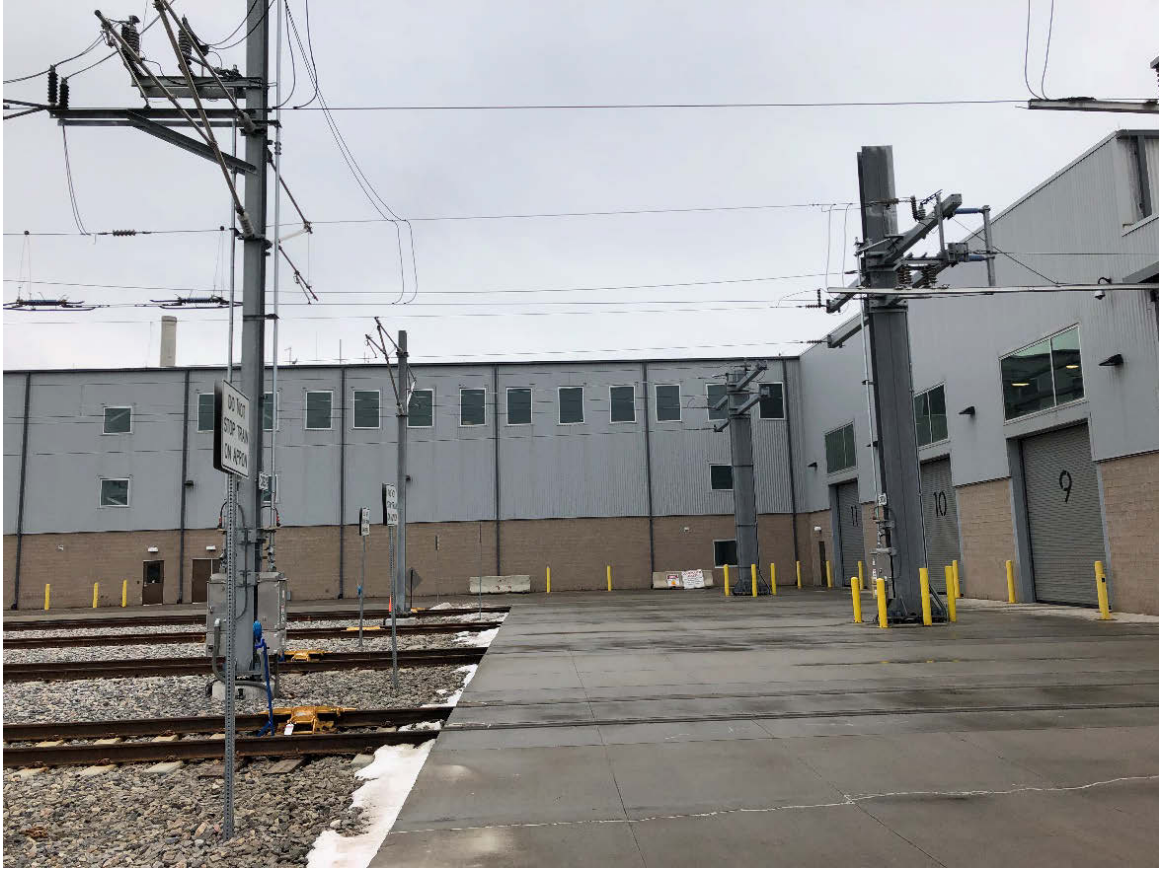
*Figure 29: The building enclosure comprising CMU walls and corrugated metal sidings*

The CRMF facility includes a main building structure and an outdoor car-wash structure. Figure 24 shows the property location on a vicinity map and Figure 23 shows a bird's-eye-view of the two structures. The main building includes an indoor maintenance facility, admin offices, small shop rooms, and the material storage warehouse. The facility building has an overall footprint of approximately 600 feet by 260 feet. The building has a rectangular shape with the eastern wing shifted about 200 feet toward north (see Figure 25). The eastern wing of the building includes a three-story structure which houses the shop rooms (e.g., weld shop, machine shop, battery shop, air brake shop, etc.) on the ground level and office spaces on the second and the third floor. Figure 26 presents the three-story structure at the east wing of the building. The maintenance work is performed on the central and western area of the facility including three regular and three powered tracks, respectively. In addition, there are six outdoor *staging* tracks along the west side of the building laid north-south. Construction of the facility structures started in 2012, and the facility operation started in 2014. The facility structure consists of a single-story warehouse-type structure comprising steel columns, steel girders and truss joist spanning east-west. To increase use of air space and for easing the maintenance work, there are multiple mezzanine levels throughout the main structure. Figure 27 and 28 show the structural components and the mezzanine levels. The mezzanines are constructed on cantilevered composite beams with concrete slabs on metal decks. In addition, for efficiency, the mezzanine levels provide additional areas for storing parts and for bench-testing of defective components. The facility includes 230,000 sq. ft of indoor area. The building is enclosed by 10-foot tall reinforced Concrete Masonry Unit (CMU) walls and corrugated metal sidings at the upper part.

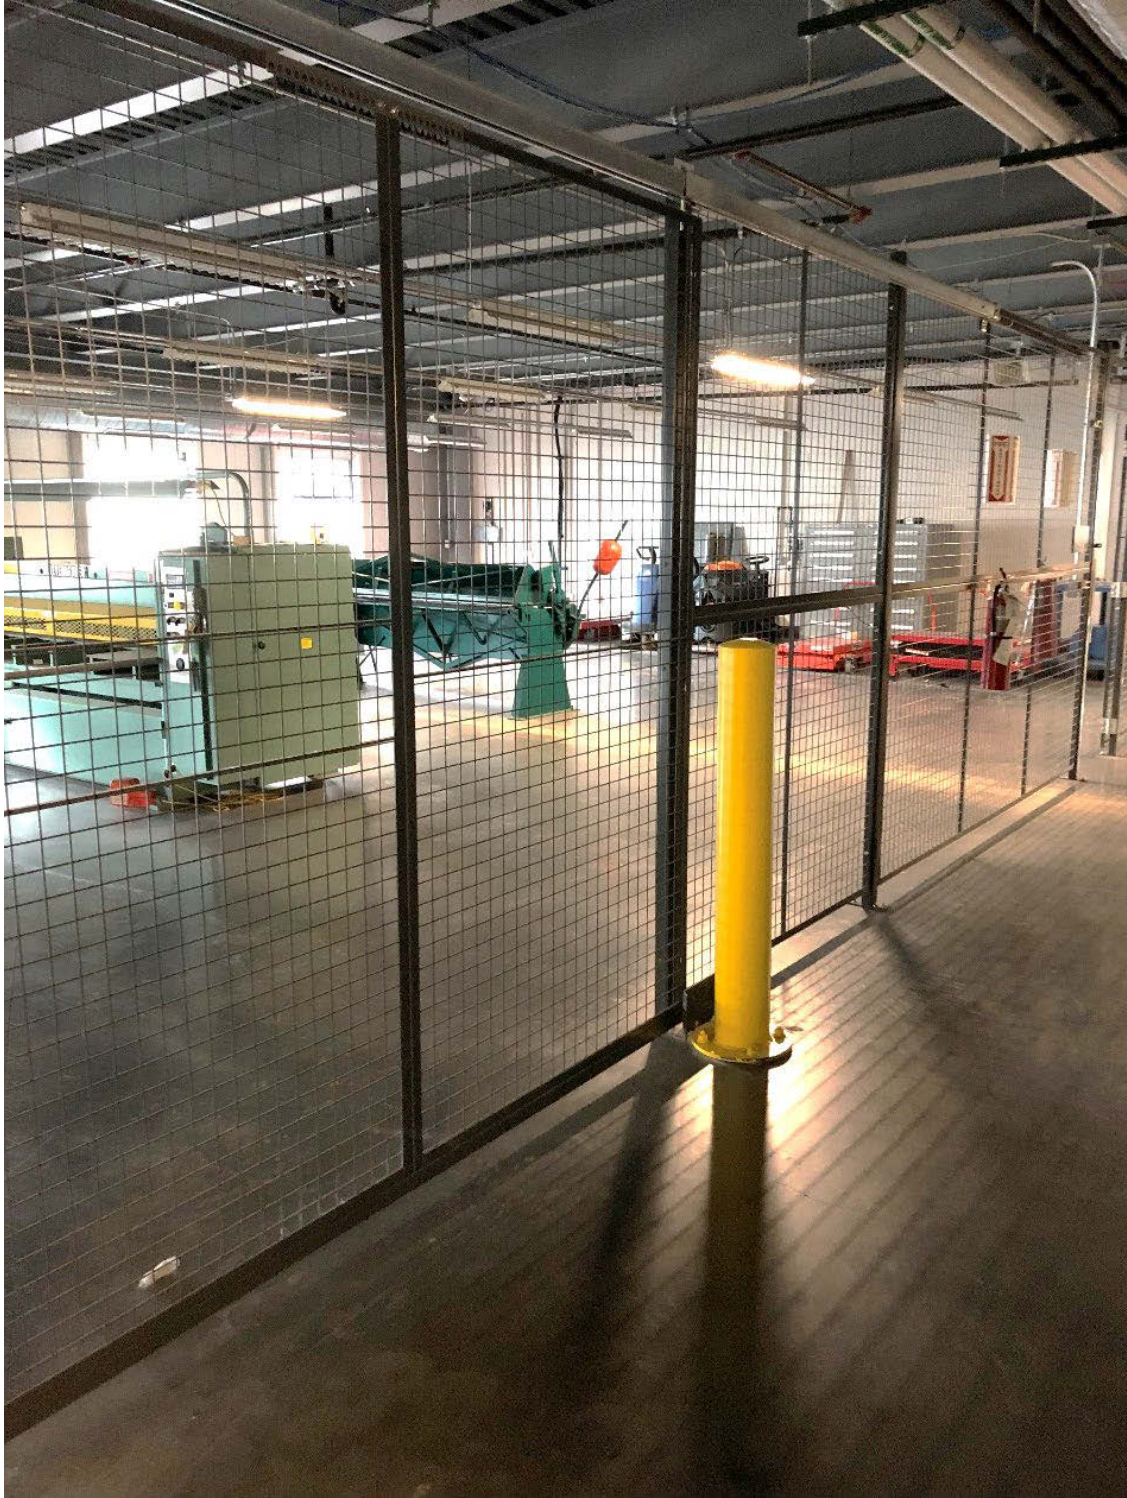
*Figure 30: Machine shop and the second-floor structural system – Eastern wing of the building*

On the east wing, the three-story structure comprises steel columns, steel girders and concrete slabs on metal deck. Figures 30 and 31 show the elevated slab system at the machine shop. Additional overhead cranes have been deployed in each shop room to facilitate materials handling in the shops. Figure 31 shows the battery shop including an overhead crane where the crane rails are mounted on steel seats. It can be seen in Figure 32 that the steel beams in the battery shop, unlike the machine shop, are protected by fireproof coating for increasing the *fire rating*. Also, CMU wall in the battery shop partitions the room from the machine shop for potential containment of fire in the battery shop. Figure 33 presents a single-level mezzanine next to facility tracks. The facility includes four 3-ton and one 15-ton overhead cranes. The former is used for smaller components handling (e.g., HVAC units) and the latter is used for lifting cars' trucks. Figure 34 shows a two-level mezzanine floor for easing access next to a maintenance pit. The materials storage warehouse is located at the north-east area of the facility (see Figure 25).

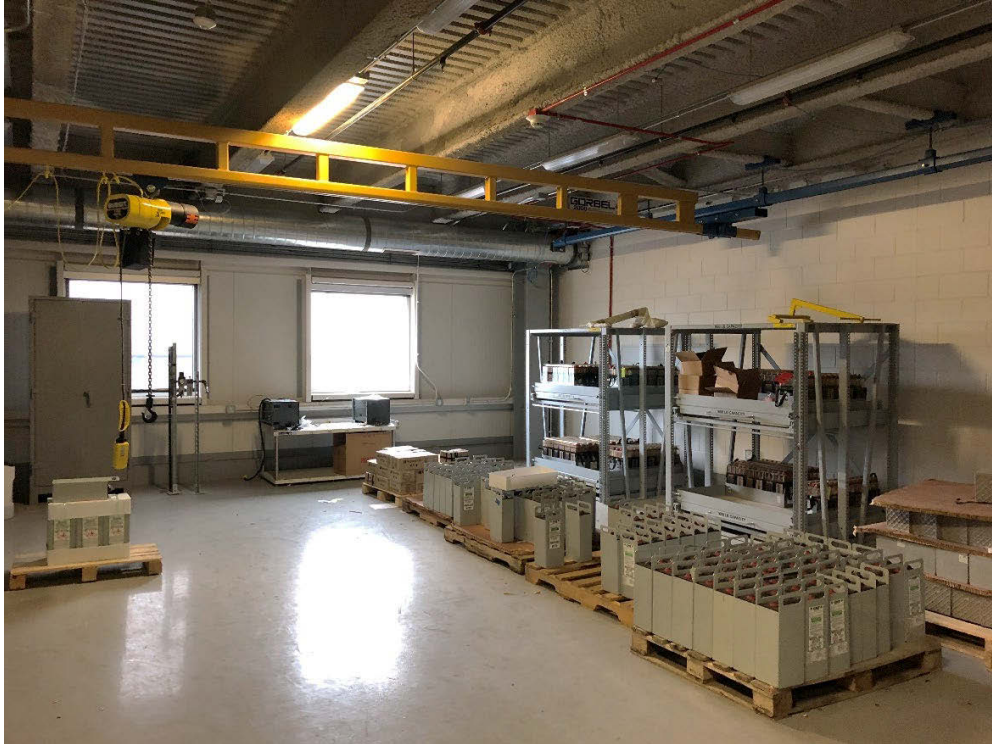
*Figure 32: Small capacity overhead cranes installed in the shop rooms*

**(Figure 32 shows example of battery shop. Concrete masonry block walls used to separate the battery shop from other areas. The steel beams are protected using fireproof coating)**

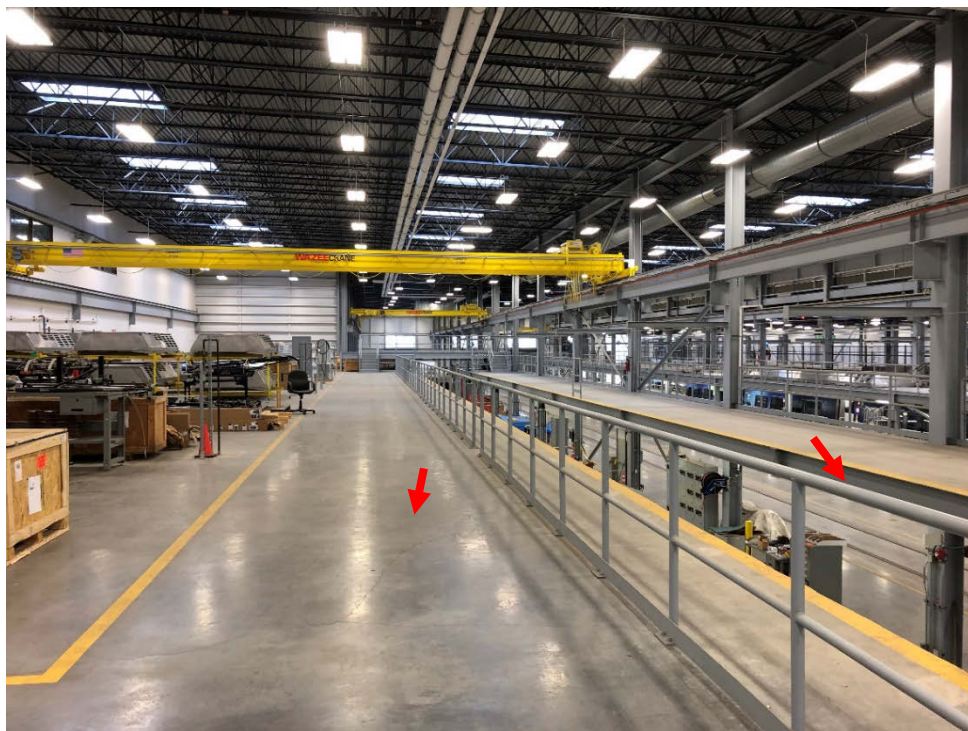
*Figure 33: Single-level mezzanine area with two 3-ton overhead cranes*

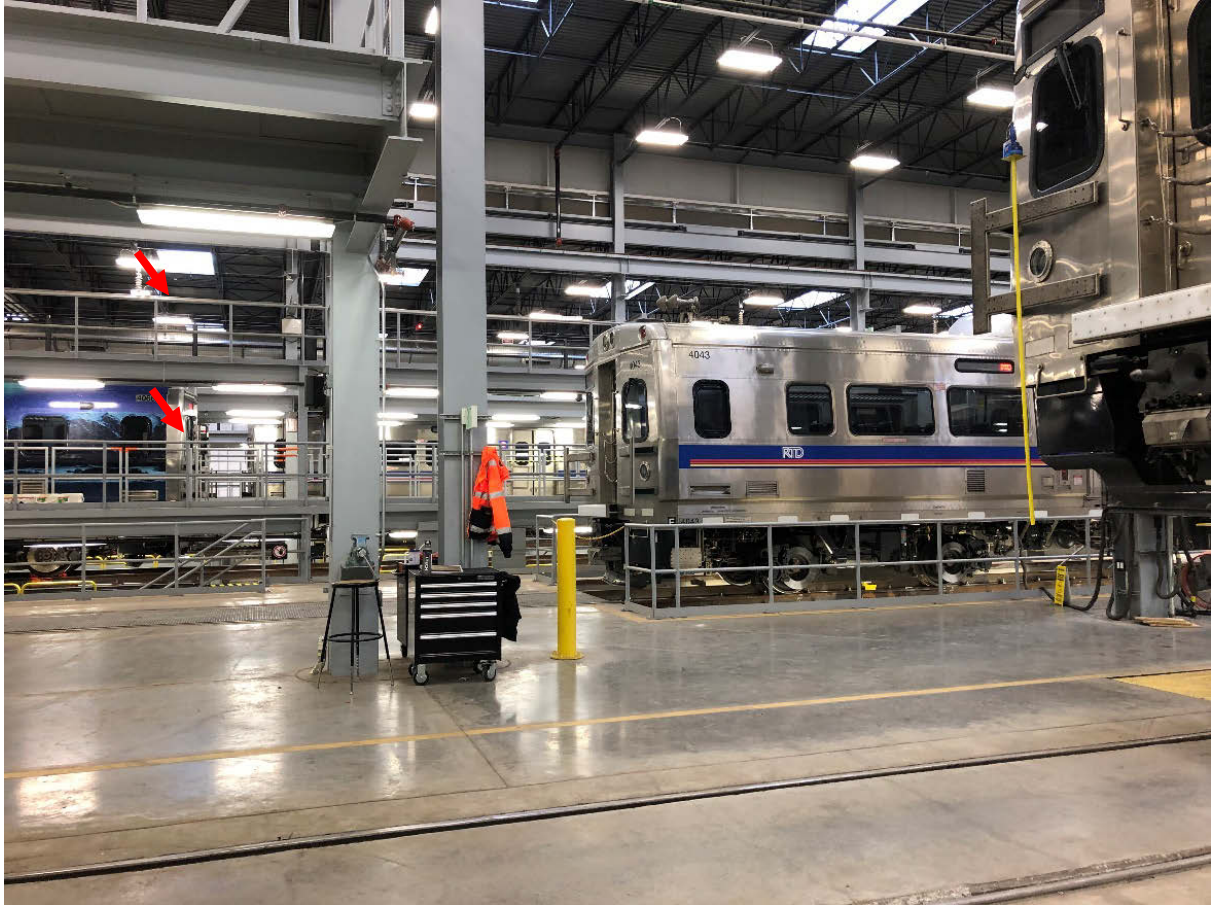
*Figure 34: Two-level mezzanine floors next to a drop pit for easing access during maintenance and increasing efficiency*

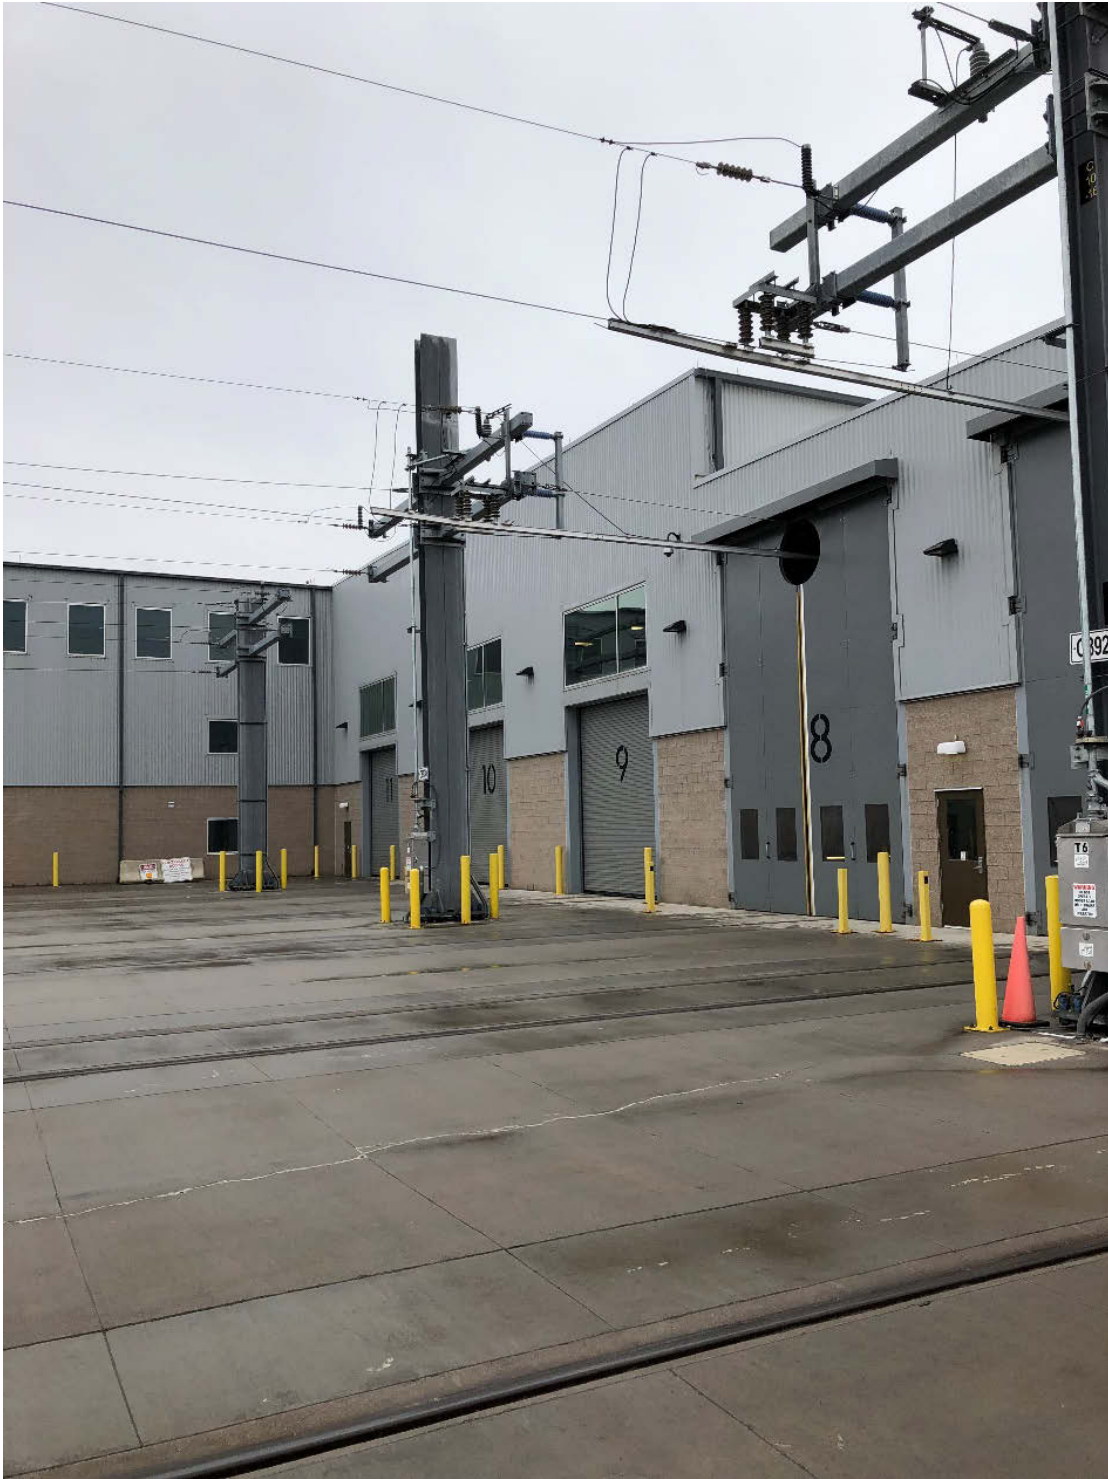
*Figure 35: The facility's doors – Roll-up aluminum doors for regular tracks and tall double-fold steel doors for powered tracks*

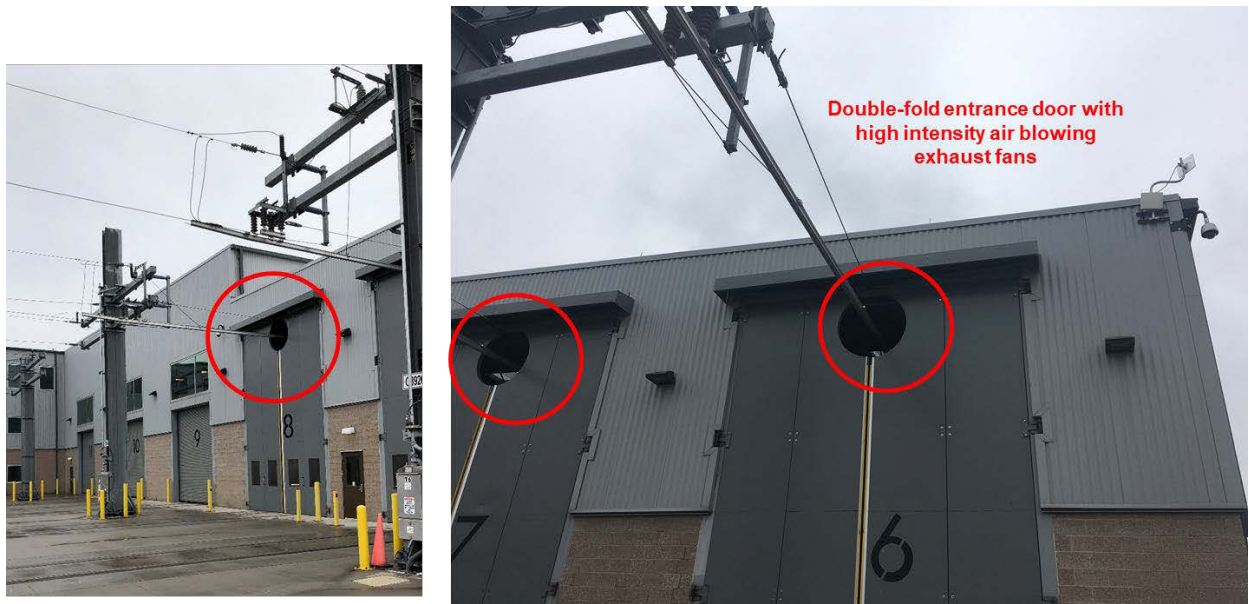
Figure 38: Double-fold entrance door with high intensity air blowing exhaust fans

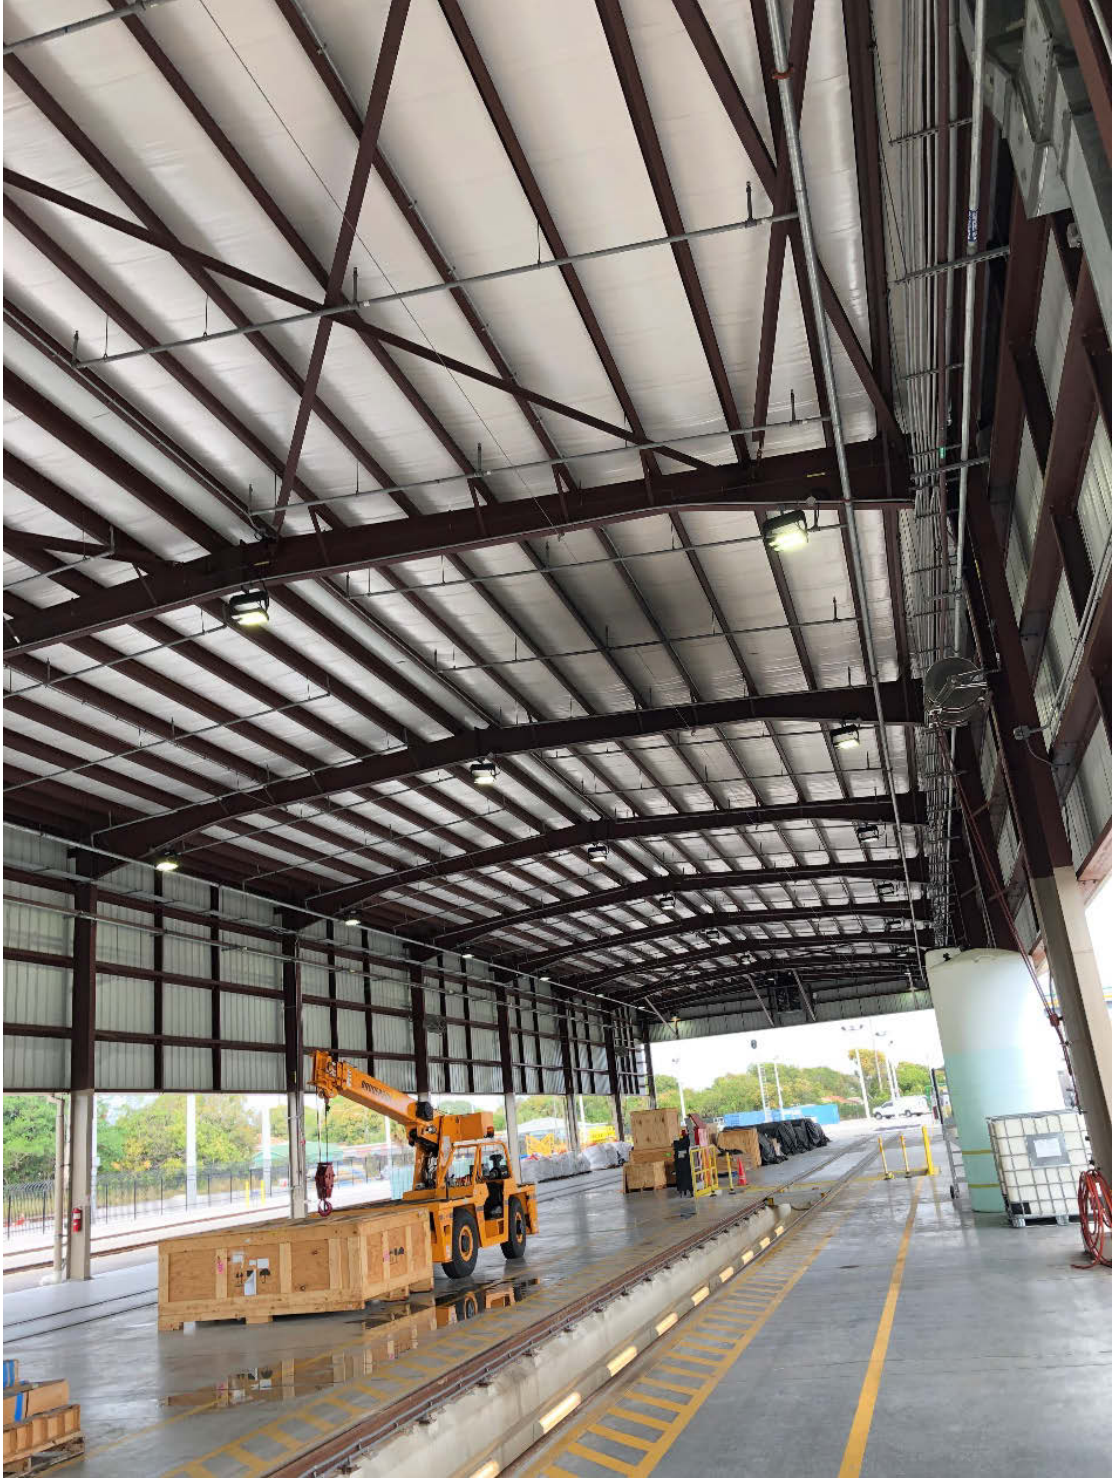
*Figure 43: Building structural components: steel portal frame and horizontal steel bracing, and open perimeter*

The steel portal frames are constructed of wide-flange steel sections. The perimeter columns of the portal frames are laterally braced by horizontal wide-flange steel sections. Figure 43 and Figure 44 show the facility building's structural system. Most of the lower half of the building perimeter is open up to 10 feet, while the upper half is clad by corrugated metal sheets attached to the columns and the horizontal steel bracings. The building enclosure including the steel framings and the metal sheets are presented in Figure 45 and Figure 46. Located in a zone with high speed gust and hurricane hazard, the open perimeter of the building helps with reducing the induced wind load on the structure through the windward and leeward faces of the building. The roof system comprises of steel purlins spanning north-south between steel rafters of the steel portal frames. The roof is clad by corrugated metal sheeting along with thermal insulator sheets. The structure does not include any overhead crane. The building's structural drawings and geotechnical report were not available for review. However, it is likely that the facility buildings' foundation is isolated pad footings on pile under the steel columns. The building's ground floor is a concrete slab-on-ground.
