1. REPORT NUMBER  CA20-3296	2. GOVERNMENT ASSOCIATION NUMBER	3. RECIPIENT'S CATALOG NUMBER
4. TITLE AND SUBTITLE Locations for Future Intercity Passenger Rail Maintenance or Layover Facilities in CA		5. REPORT DATE  01/06/2020
		6. PERFORMING ORGANIZATION CODE
7. AUTHOR  Shailesh Chandra and Mehran Rahmani		8. PERFORMING ORGANIZATION REPORT NO.
9. PERFORMING ORGANIZATION NAME AND ADDRESS California State University, Long Beach 1250 Bellflower Blvd Long Beach, CA 90840		10. WORK UNIT NUMBER
		11. CONTRACT OR GRANT NUMBER  65A0717
12. SPONSORING AGENCY AND ADDRESS California Department of Transportation Division of Research, Innovation and System Information 1727 30th Street Sacramento, CA 95816		13. TYPE OF REPORT AND PERIOD COVERED Final Report 12/1/2018 - 11/30/2019
		14. SPONSORING AGENCY CODE
15. SUPPLEMENTARY NOTES

Maintenance and layover facilities are vital in operating and maintaining passenger rail systems. This research project is interested in the decision-making criteria for locating such facilities and how those criteria impact the performance of the rail system. This research project looks at the locations and the types of most recently-built rail maintenance and layo

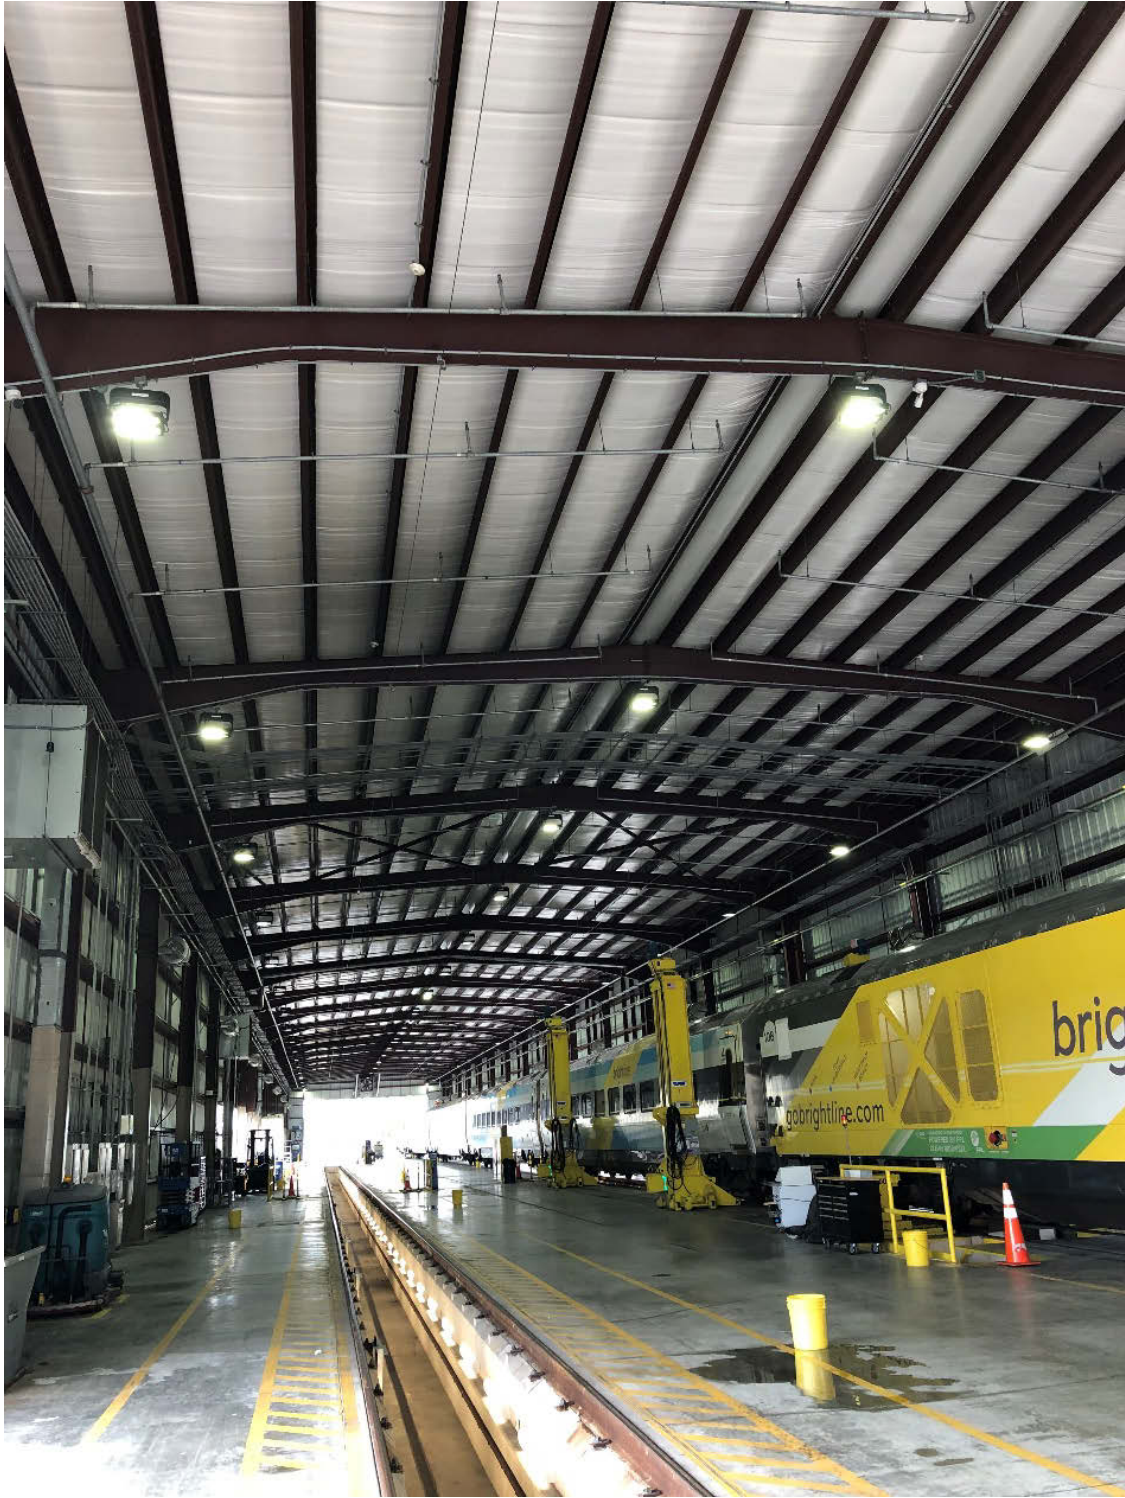
*Figure 44: Building structural components: steel portal frame, concrete slab on grade, and the maintenance pit*

The steel portal frames are constructed of wide-flange steel sections. The perimeter columns of the portal frames are laterally braced by horizontal wide-flange steel sections. Figure 43 and Figure 44 show the facility building's structural system. Most of the lower half of the building perimeter is open up to 10 feet, while the upper half is clad by corrugated metal sheets attached to the columns and the horizontal steel bracings. The building enclosure including the steel framings and the metal sheets are presented in Figure 45 and Figure 46. Located in a zone with high speed gust and hurricane hazard, the open perimeter of the building helps with reducing the induced wind load on the structure through the windward and leeward faces of the building. The roof system comprises of steel purlins spanning north-south between steel rafters of the steel portal frames. The roof is clad by corrugated metal sheeting along with thermal insulator sheets. The structure does not include any overhead crane. The building's structural drawings and geotechnical report were not available for review. However, it is likely that the facility buildings' foundation is isolated pad footings on pile under the steel columns. The building's ground floor is a concrete slab-on-ground.

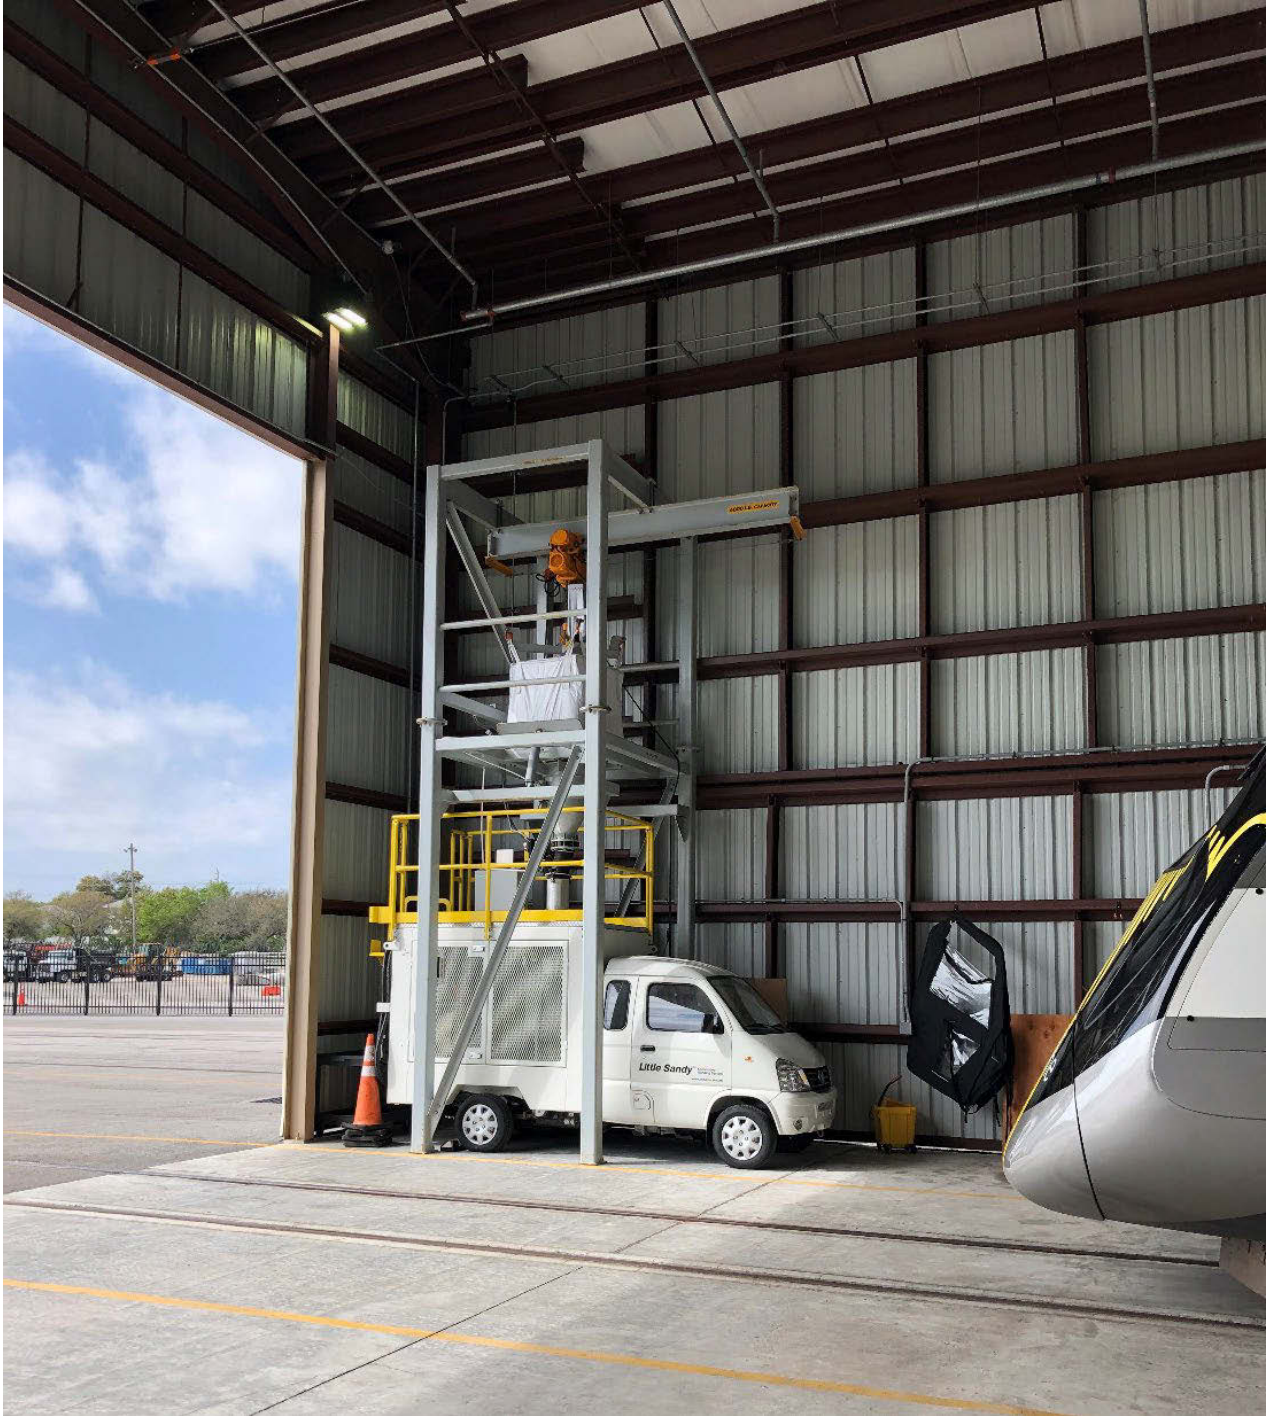
*Figure 45: Maintenance building's perimeter enclosure: horizontal steel braces and vertical studs and attached corrugated metal sheets*

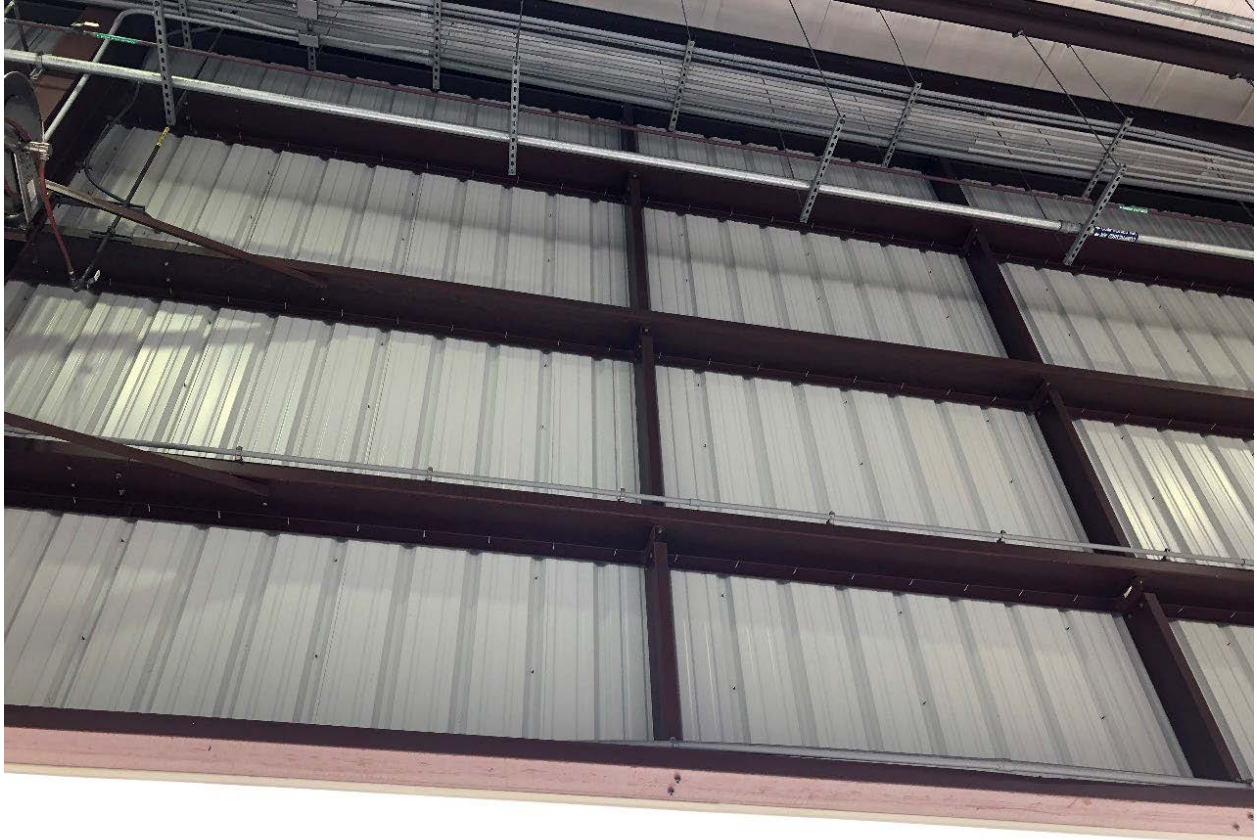
*Figure 46: A close view of the facility enclosure: The horizontal steel braces and the attached metal sheets*

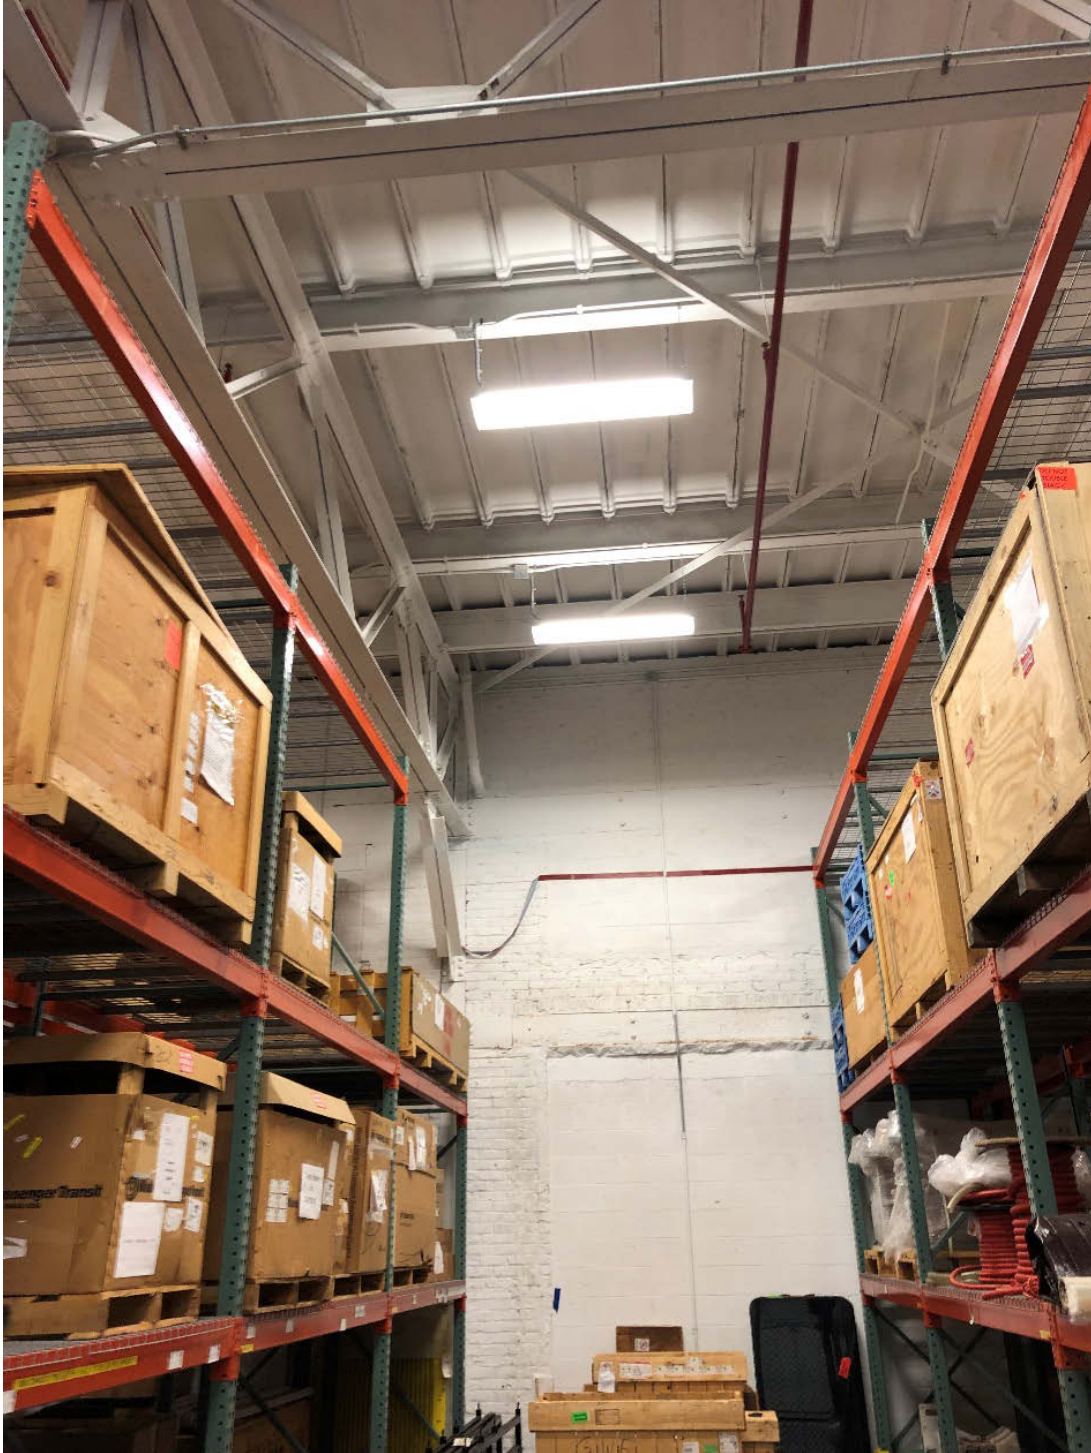
*Figure 47: Materials storage building's walls and roof system*

It is expected that the preexisting office and materials warehouse building was built in the 70's. The building comprises steel columns and, roof truss and steel beams. The building is enclosed at its perimeter by double-width unreinforced masonry brick walls. Figure 47 shows the building's walls and roof system. The building's structure has been slightly modified to accommodate current facility's need. For instance, a mezzanine level has been added at the machine shop in between the offices and the materials warehouse. Also, some of the building's openings have been covered by CMU walls. Figure 48 shows a closer view of the steel columns and the perimeter masonry walls. The roof system includes a two-way truss-joists supporting roof steel beams. The roof is clad by flat steel sheets and bituminous roofing pads. Figure 49 presents an interior view of the roof structural system.

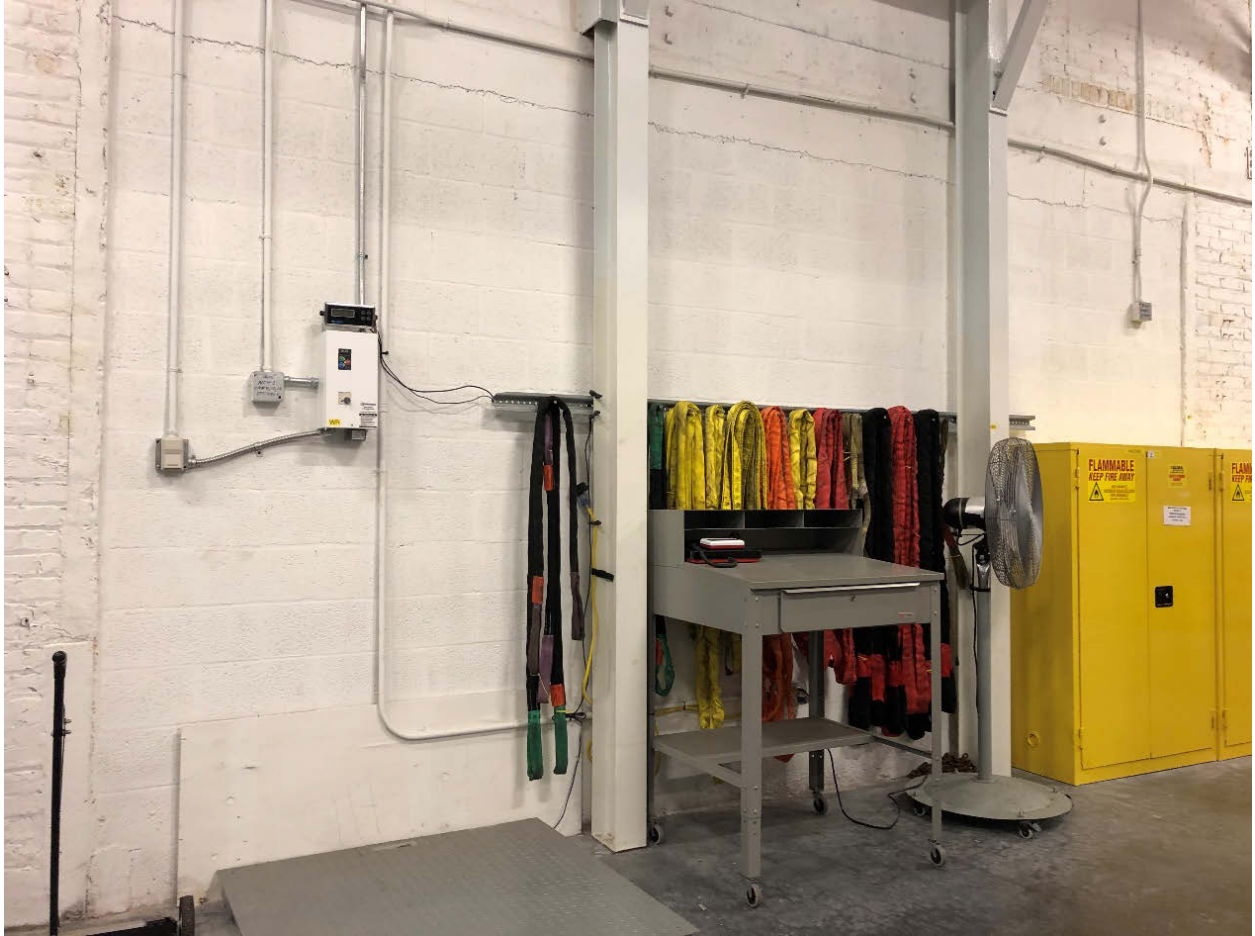
*Figure 48: Materials storage building's steel framings and the perimeter masonry walls*

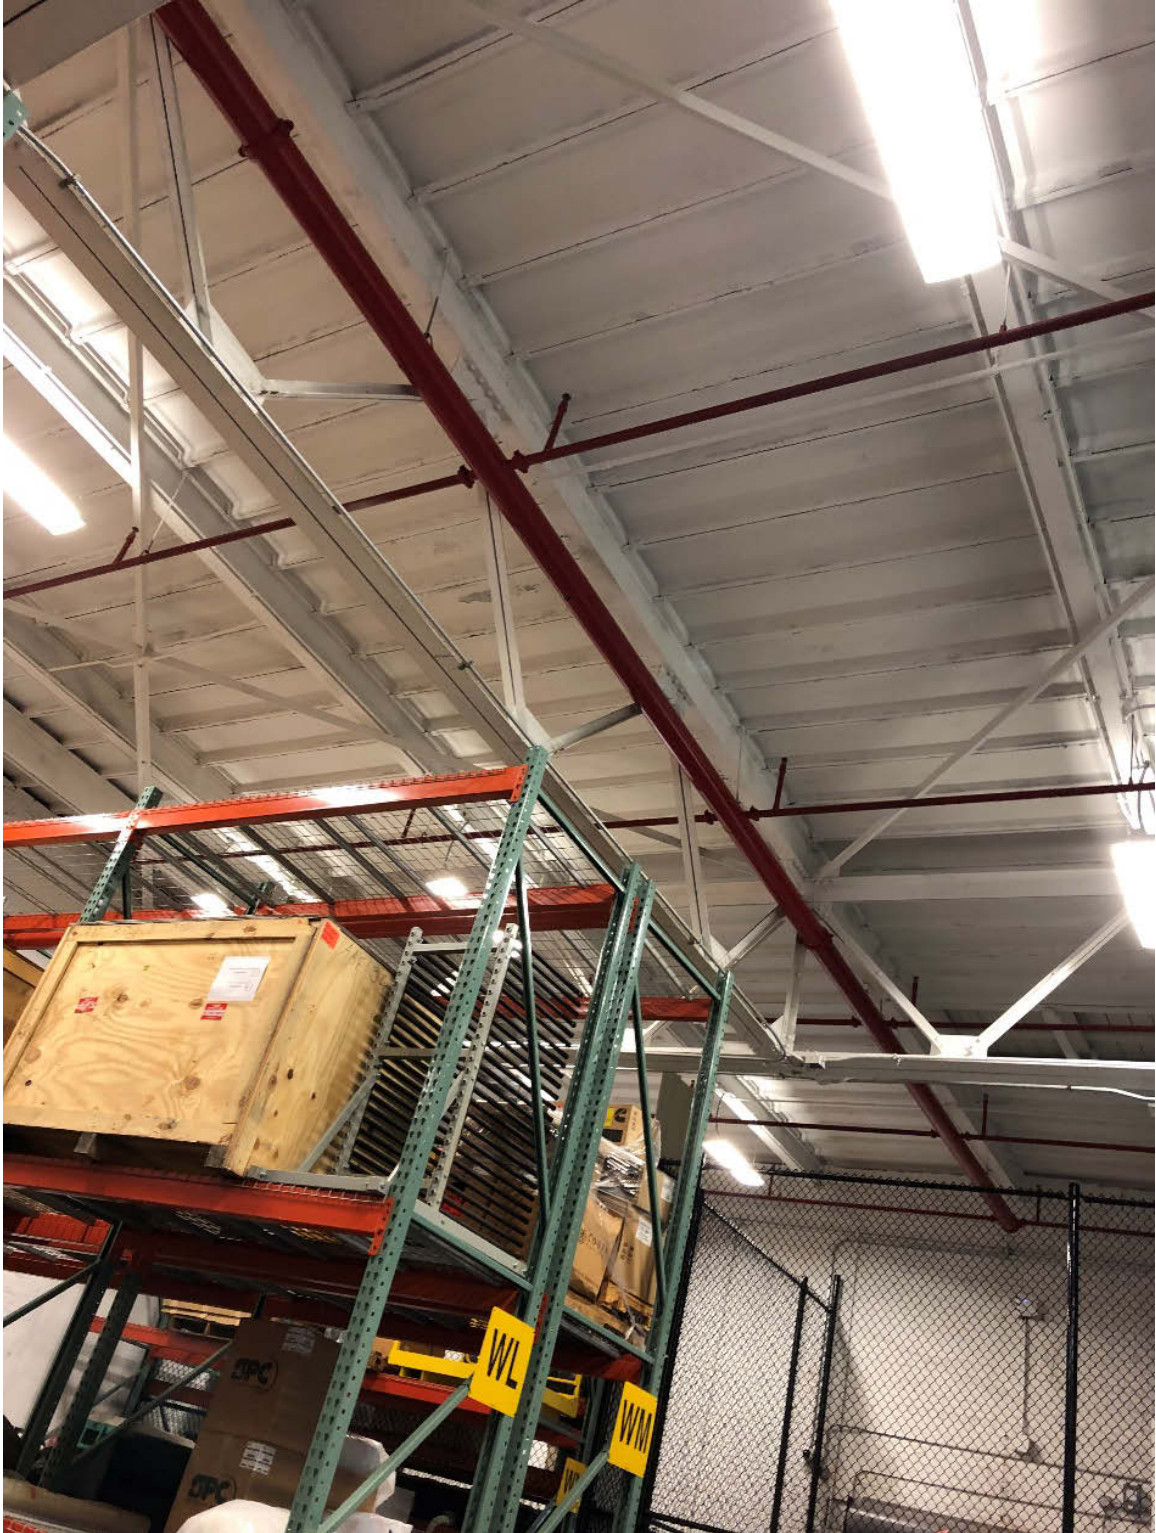
Figure 49: Two-way truss-joints supporting roof steel beams – Materials storage building

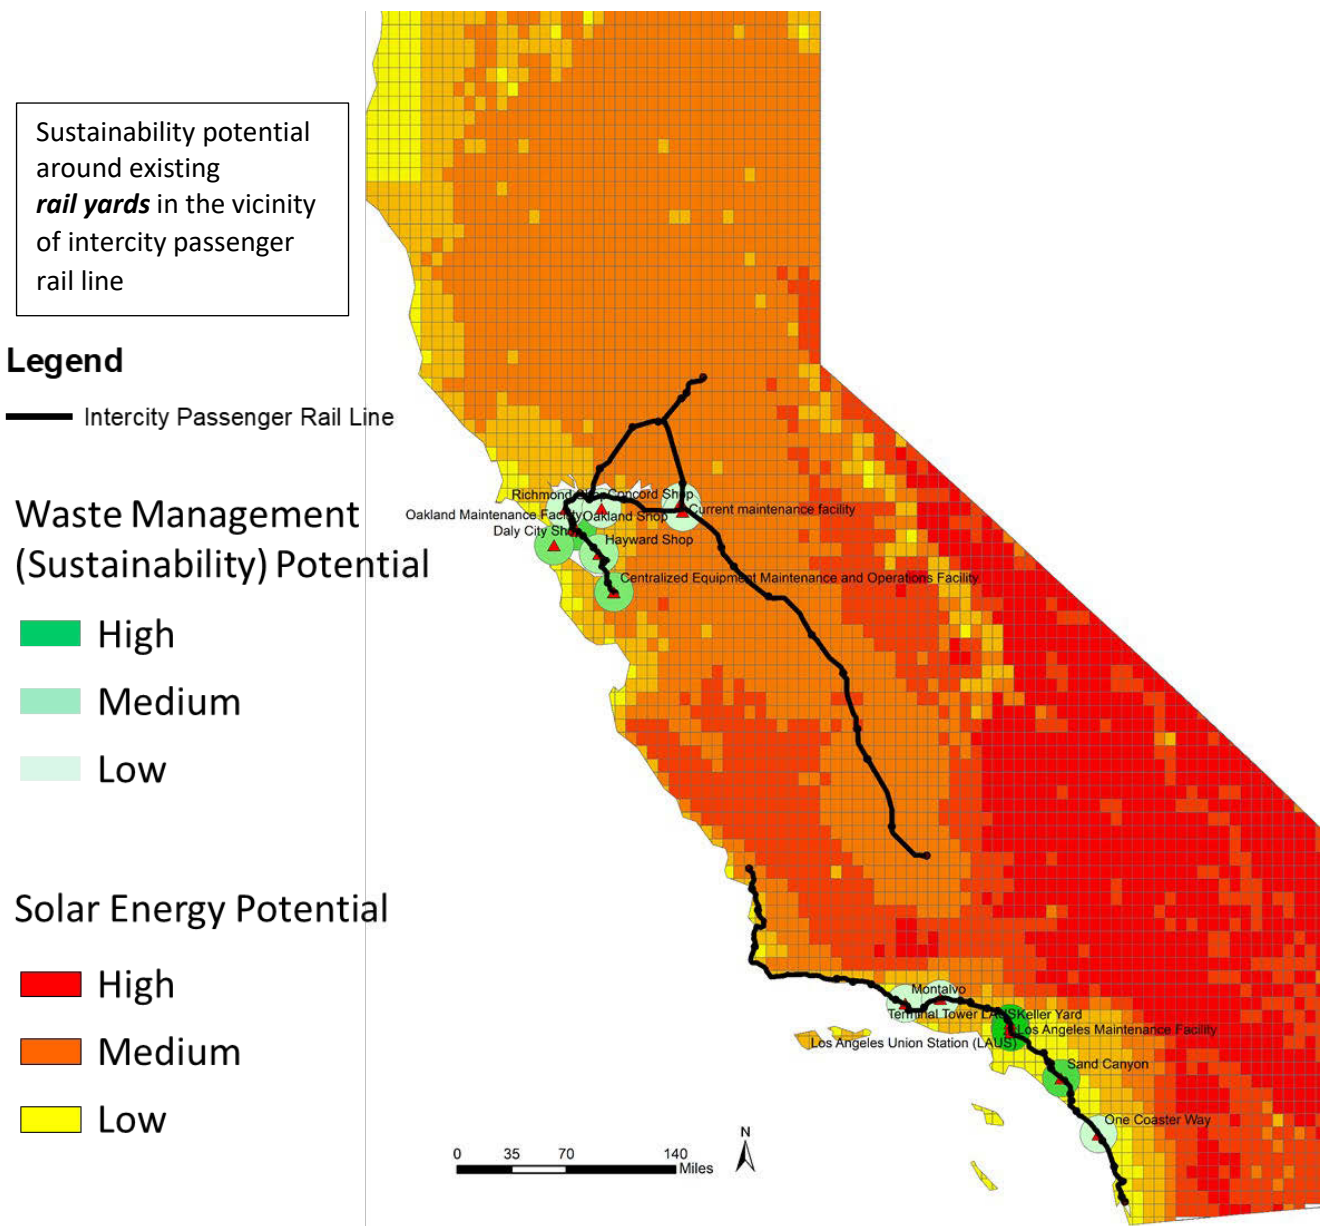
Figure 51: Sustainability potential (waste management and solar energy) surrounding existing rail yards close to rail line

It is observed that the following yards provide a more sustainable option for waste management if expanded as a future facility: Los Angeles Maintenance Facility, Keller Yard, Sand Canyon, Centralized Equipment Maintenance and Operations Facility and Daly City Shop.

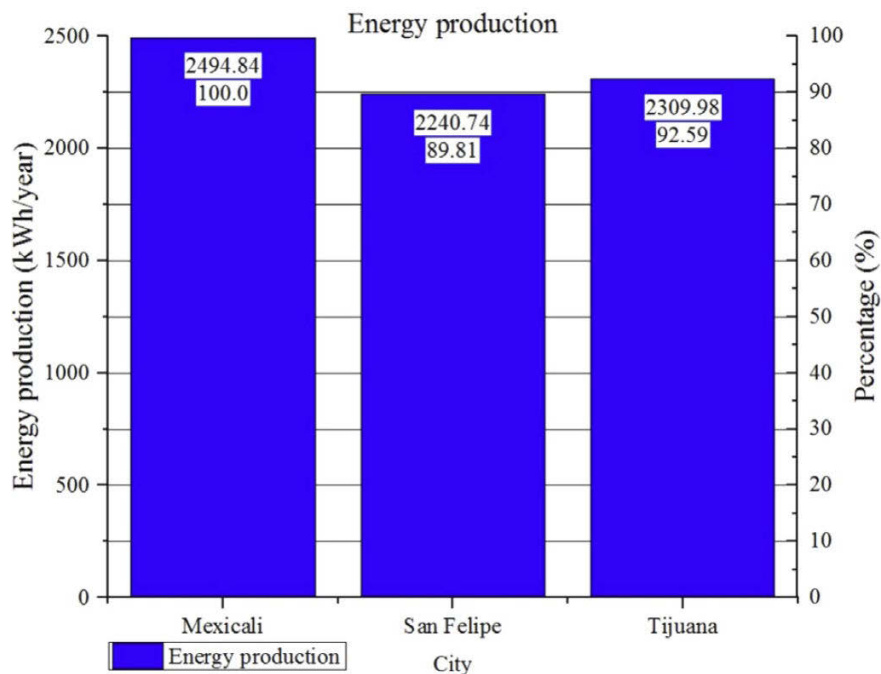
**Figure A3: Energy production per installed multicrystalline kWp**

Technology Summary – See Figure A2, above, for overview of potential energy production in Mexicali, San Felipe, and Tijuana, Mexico. The focus of this study was to analyze the photovoltaic (PV) module orientation for optimum power production and create a solar resource assessment for these three cities. This would create a template by which to identify the PV module’s optimum orientation to utilize solar energy for a cleaner power source.

Mexicali reached the shortest return on investment period: 13.02 years with an installed capacity of 4 kWp with the highest cost-benefit factor of 3.17. Solar resource was noted as the largest factor in how quickly a building in a given city would break even on their investment. Due to this factor, solar energy may be ideal for desert-like climates, which are not uncommon in California.

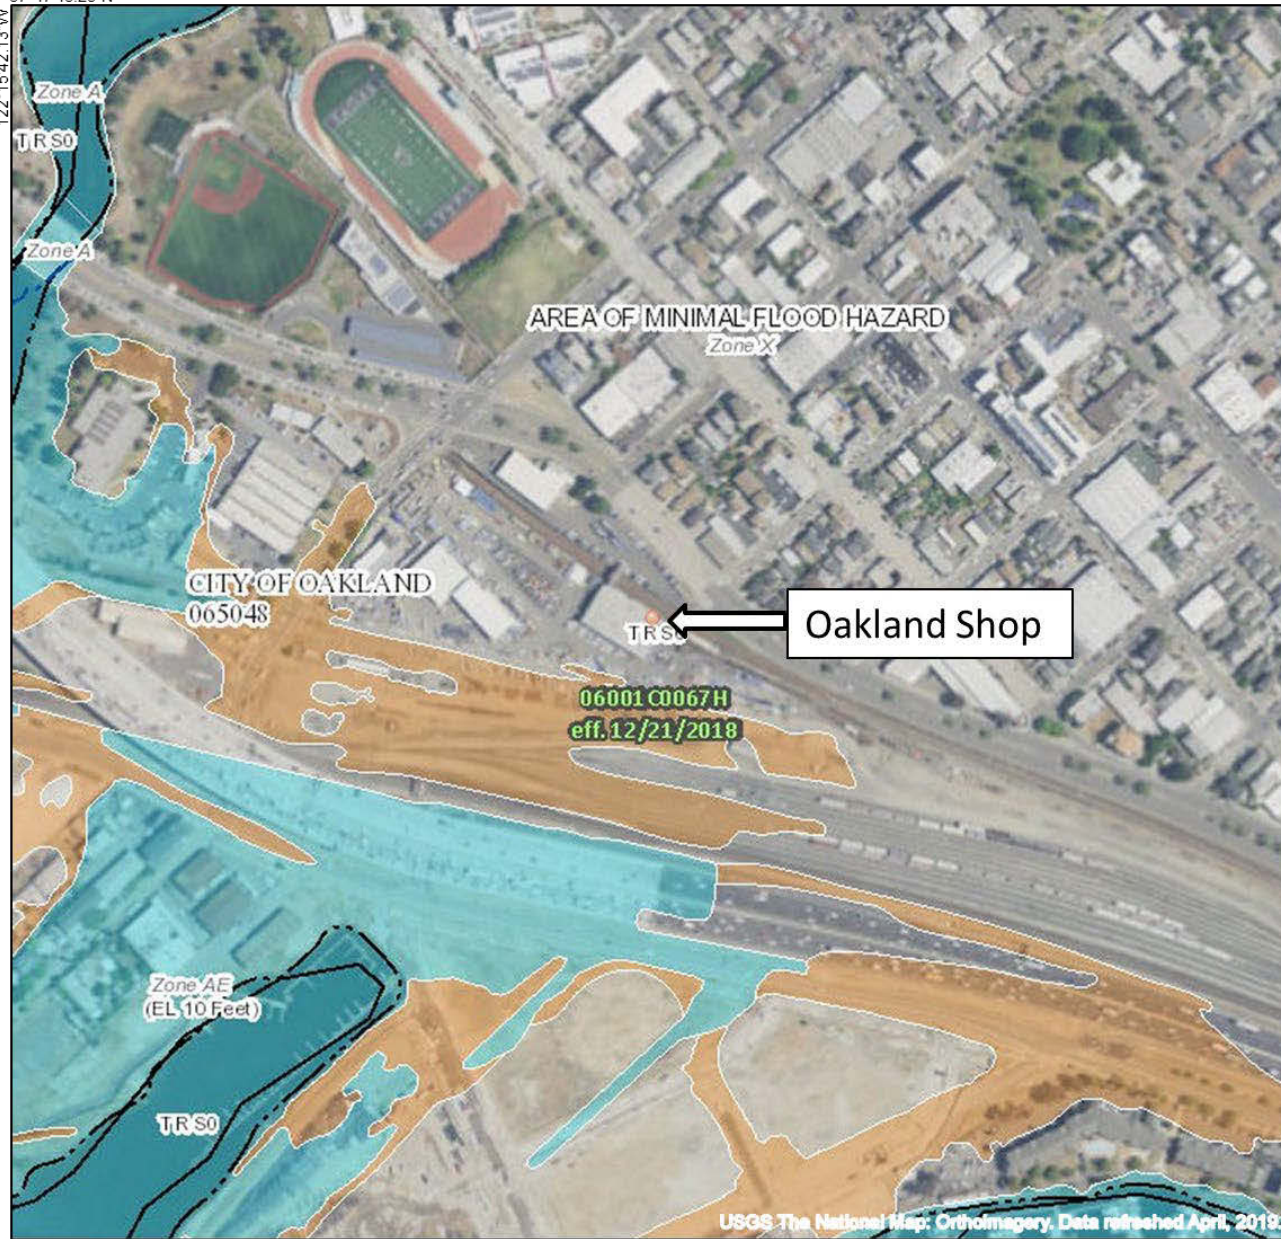
# National Flood Hazard Layer Oakland Shop

The flood hazard information is derived directly from the authoritative NFHL web services provided by FEMA. This map was exported on 10/8/2019 at 4:36:12 PM and does not reflect changes or amendments subsequent to this date and time. The NFHL and effective information may change or become superseded by new data over time.

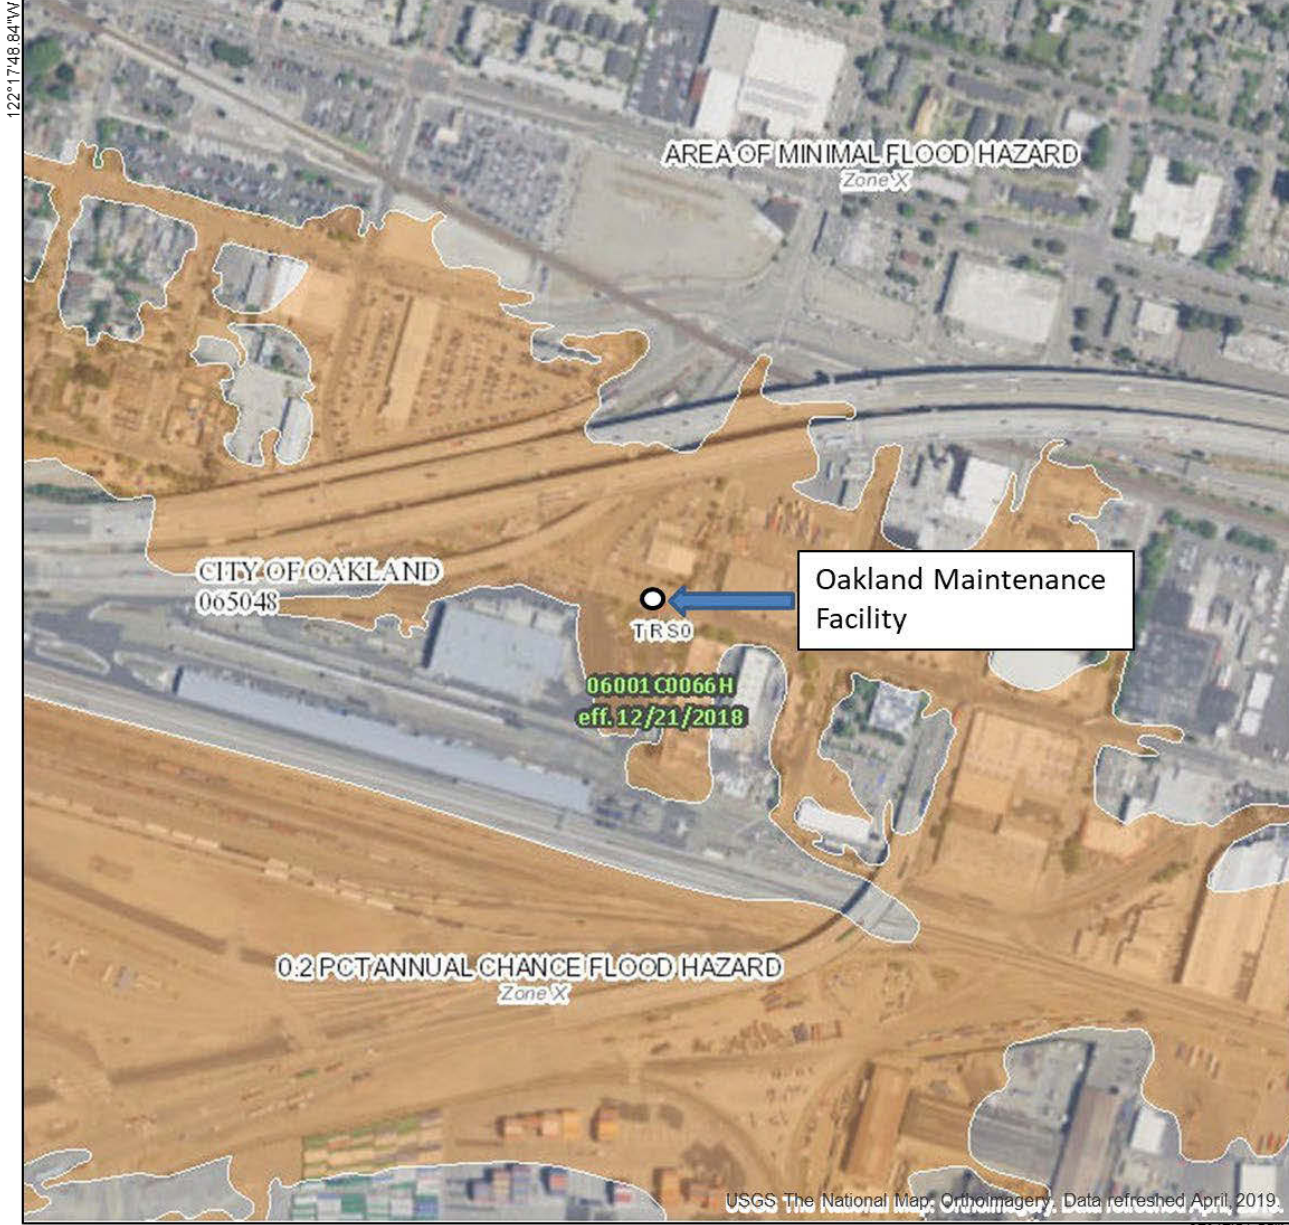
# National Flood Hazard Layer Oakland Maintenance Facility

The flood hazard information is derived directly from the authoritative NFHL web services provided by FEMA. This map was exported on **10/8/2019 at 4:43:10 PM** and does not reflect changes or amendments subsequent to this date and time. The NFHL and effective information may change or become superseded by new data over time.
