U.S. Department  
of Transportation  
**National Highway  
Traffic Safety  
Administration**

DOT HS 812 883

# **Occupant Safety in Vehicles Equipped With Automated Driving Systems, Part 2: Crash Safety Considerations For Out-of-Position Occu- pant Posture in Vehicles With Automated Driving Systems - Field Data Investigation**

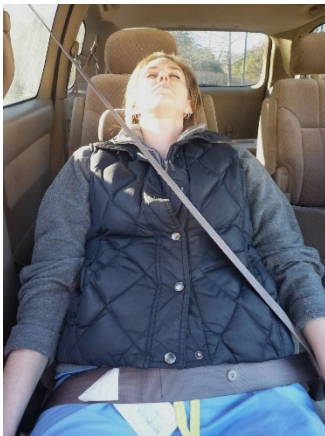
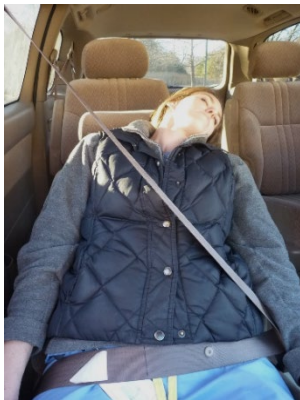
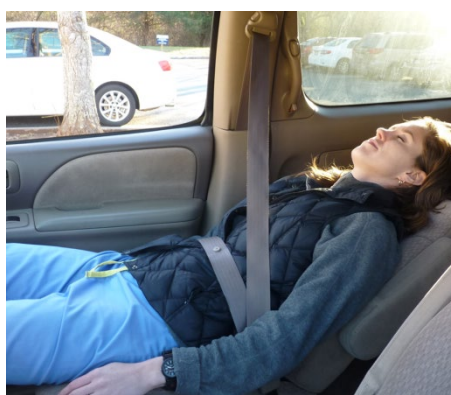
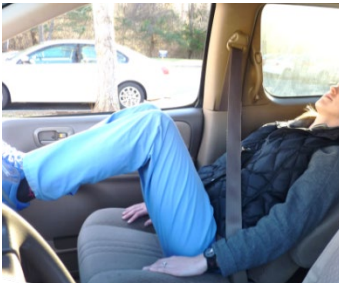
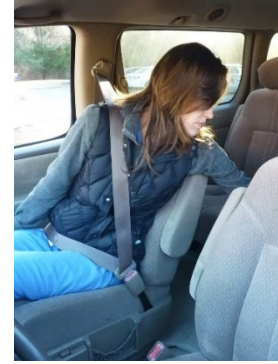
**Figure 1. OOP postures.**

Partial Recline, Midline

Partial Recline, Leaning Right, Head Behind Shoulder Belt

Partial Recline, Leaning Right, Head in Front of Shoulder Belt

Partial Recline, Leaning Left, Shoulder Belt Path Lateral of Mid Clavicle

Full Recline, Midline, Slouched, Lap Belt Over Abdomen

Full Recline, Feet on I.P.

Partial Recline, Legs Crossed  
Reading

Turning, Reaching to the Back Seat,  
Shoulder Belt Remained in Place

Four of the seven subjects sustained both C-spine and abdominal injuries, which are commonly reported for submarining occupants and suggestive that altered shoulder and lap belt fit were contributing factors. Occupants who sit in a reclined posture are more likely to submarine due to a posteriorly rotated pelvis that is less able to capture and to load the lap belt (Figure 1) (Thorbole, 2015).

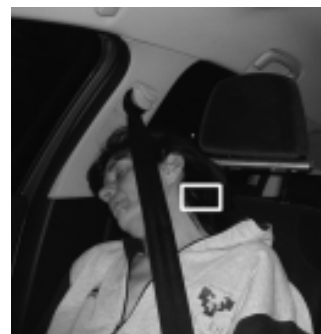
**Figure 3. Lateral sleeping posture. Source Lopez-Valdes et al. (2011).**

In addition to injuries caused by being in a poor position relative to the belt restraints, occupants who ride reclined could be in a hazardous position relative to deploying air bags. Lopez-Valdes et al. (2011) found that several volunteers who participated in a sleeping right front passenger study slept with their head and upper torso resting against the B-pillar and possibly in the path of deploying side air bags (Figure 3). Appendix A, Sleeping Postures, provides additional images of volunteers sleeping in the right front passenger seat.

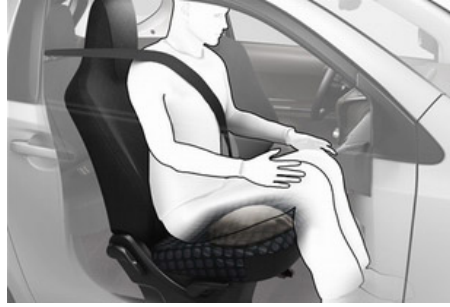
**Figure 5. Seat cushion air bag. Source IIHS**

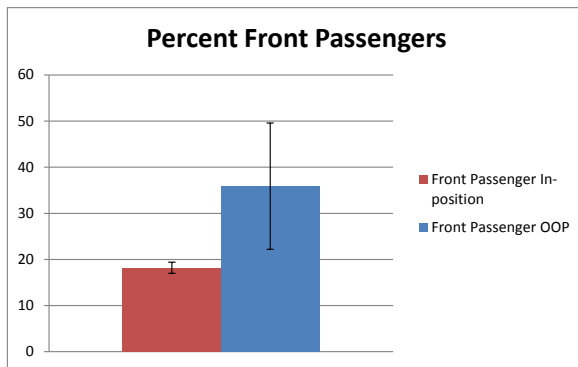
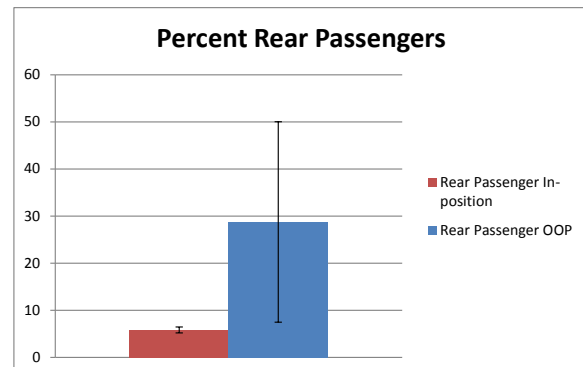
**Figure 9. Seating position.**

OOP occupants were more likely to be younger (Figure 8), right front or rear passengers (Figure 9) and unbelted (Figure 11). Crash characteristics such as delta V and PDOF were similar for both groups. The only difference identified was travel speed as indicated by the posted speed limit. OOP occupant vehicles were more likely to travel at higher highway speeds of at least 89 km/h (55 mph) although this difference was not significant (p-value = 0.0796) (Figure 11). Injury severity, in terms of average MAIS and average ISS, was not significantly different for OOP occupants (Figure 12).

In terms of occupant characteristics, there were a few differences such as age, seating position, and belt use that were strongly statistically significant for in-position and OOP occupants. That OOP occupants were younger, less likely to be drivers, and less likely to be belted (Figures 8, 9, 10) is not unexpected. Drivers must be older than our 13-year-old search minimum and, usually, in-position and less able to assume various postures given their need to control the vehicle. Except for the “Lying on or across the seat” occupant (as discussed above), the average OOP occupant was less likely to be belted. It is likely that some alternative postures make belt use uncomfortable or inconvenient.

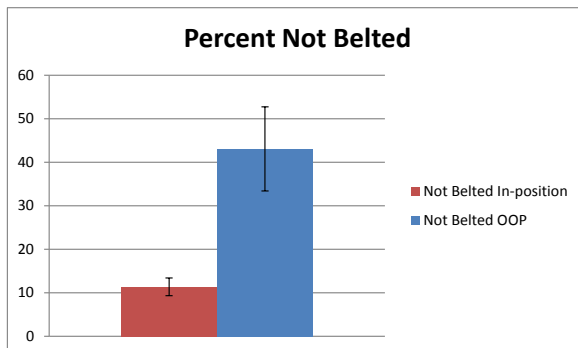
**Figure 10. Percent unbelted.**

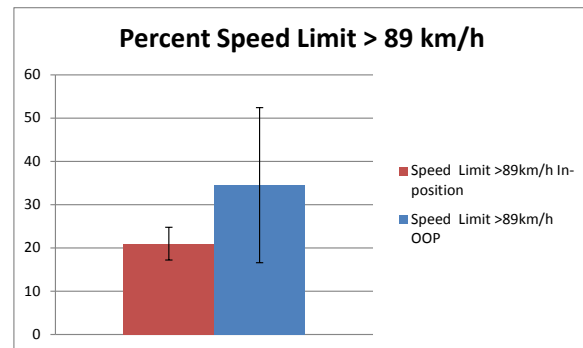
**Figure 11. Percent of cases for which the posted speed limit was at least 89 km/h.**

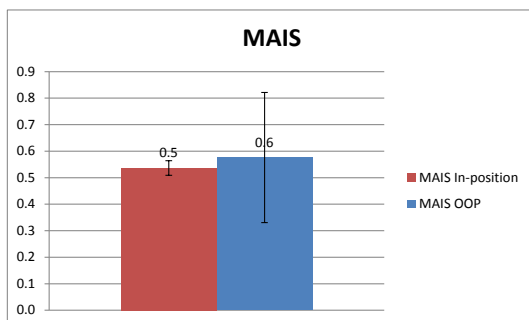
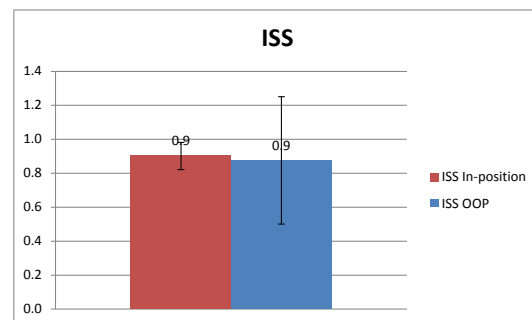
**Figure 12. Relative injury severity, all occupants.**

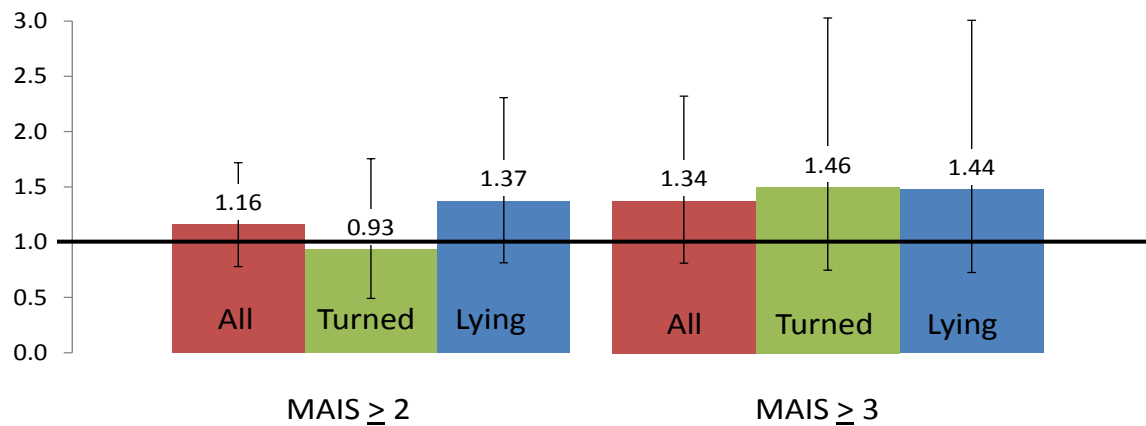
**Figure 13. Odds ratios for OOP right front passengers relative to in-position drivers for MAIS  $\geq 2$  and MAIS  $\geq 3$  with 2.5 percent and 97.5 percent confidence intervals.**

Odds ratios were estimated using the conditional logit model to account for matching, and then further adjusted for the continuous match variables, age, height, weight, and dvttotal.

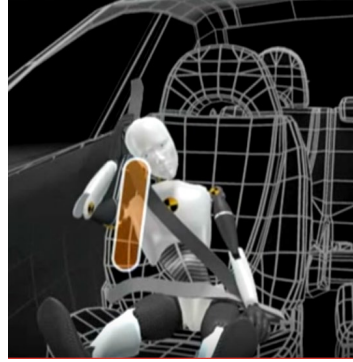
Figure A2. Occupant position seat sensor (Fukui, 2001).

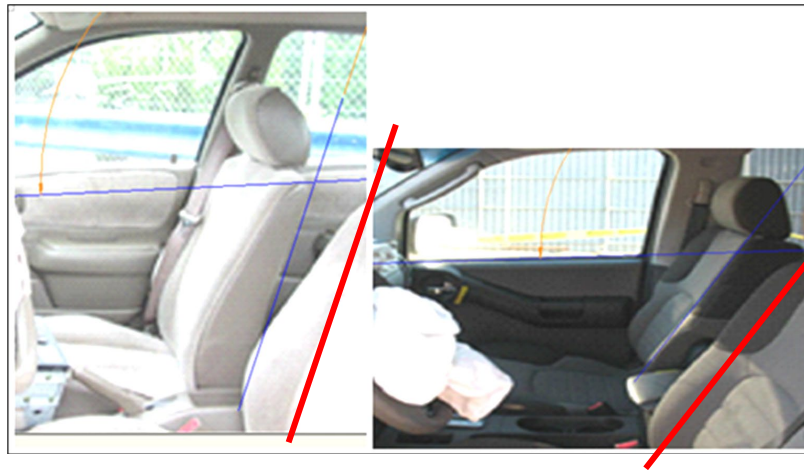
**Figure B3. Seatback recline angle estimation on the seatback rear surface (left) and the front surface (right)**

1. Line 4 was drawn on the rear border of the seatback when it was visible. In most photos, however, it was not visible and the front surface of the seatback cushion was used (Figure B3).
2. Judgement was required in drawing the line that was intended to represent the average angle of the seatback that was comprised of two or more segments with different inclinations.
3. Although we rejected case photos taken at noticeably oblique angles ( $> \sim 15$  degrees) relative to the vehicle, the position of the camera relative to the vehicle and seatback varied from case to case and this variability introduced an unknown error due to parallax.

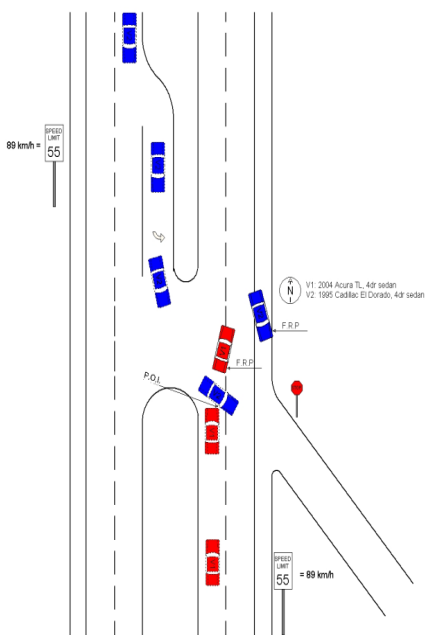
<p>The diagram illustrates the crash scene on a two-lane road. A 2004 Acura TL (V1, blue) is shown impacting a 1995 Cadillac Eldorado (V2, red) from the front. The impact point is marked with a red dot. Road markings include a dashed center line and solid edge lines. A speed limit sign of 55 km/h is visible on the left. A north arrow points towards the top right. The vehicles are labeled with their respective IDs and descriptions.</p>

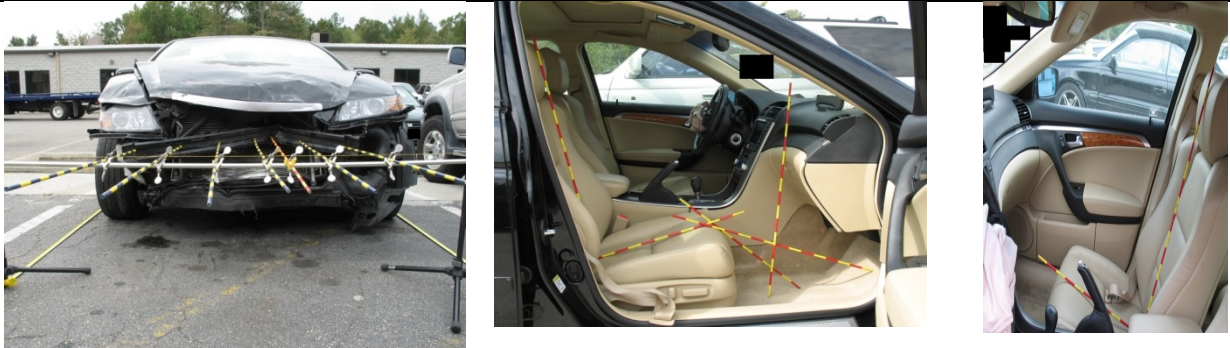
Vehicle Images

<p>The first photograph shows the exterior front view of the 2004 Acura TL, which has significant front-end damage. The second photograph shows the interior of the vehicle from the driver's side, highlighting the dashboard and front seats. The third photograph shows the interior from the passenger's side, highlighting the front seats and center console. Red and yellow dashed lines are drawn on the interior seats to indicate the location of the occupant.</p>

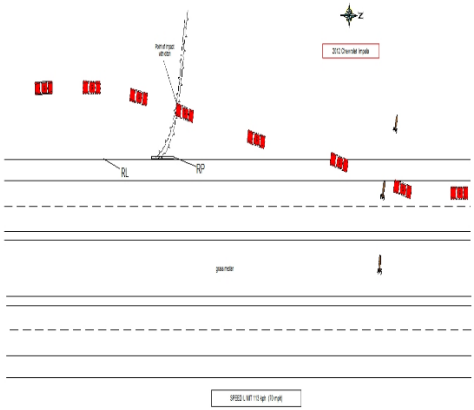
<p>The diagram illustrates the crash scene on a multi-lane highway. A vehicle's path is shown with a dashed line leading to a red 'X' marking the impact point. A north arrow is located in the upper right corner. A red box labeled '20' Channel' is positioned near the impact. A speed limit sign for 'SPEED LIMIT 15 mph' is shown at the bottom. The road features multiple lanes with dashed center lines and solid edge lines.</p>

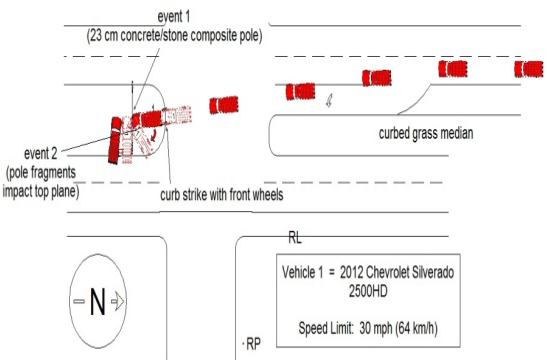
<p>event 1 (23 cm concrete/stone composite pole)</p> <p>event 2 (pole fragments impact top plane)</p> <p>curbed grass median</p> <p>curb strike with front wheels</p> <p>RL</p> <p>Vehicle 1 = 2012 Chevrolet Silverado 2500HD</p> <p>Speed Limit: 30 mph (64 km/h)</p> <p>RP</p>

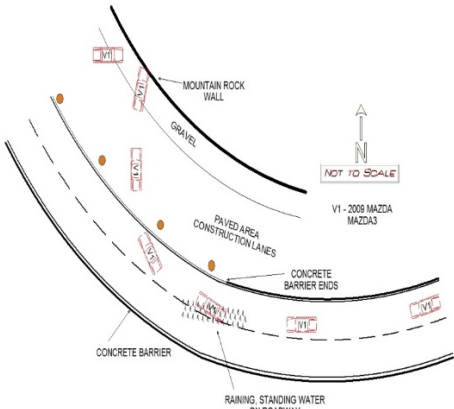
<p>The diagram illustrates the crash scene on a curved road. Key features include a mountain rock wall on the left, a gravel area, a paved area, construction lanes, and a concrete barrier. A north arrow points upwards, and a label indicates 'NOT TO SCALE'. The vehicle is labeled 'V1 - 2009 MAZDA3 MAZDA3'. The road surface is marked with 'RAINING, STANDING WATER ON ROADWAY'.</p>

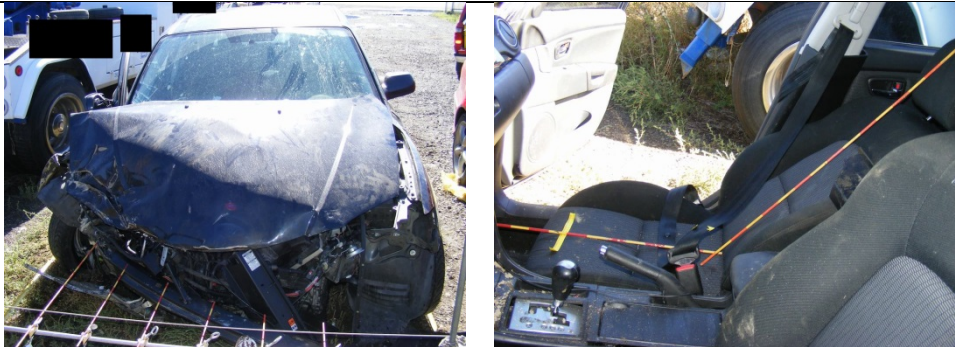
Vehicle Images

<p>The left photograph shows the front exterior of the vehicle, which is heavily damaged and crumpled. The right photograph shows the interior of the vehicle, specifically the dashboard and seat area, with a red and yellow measuring tape visible.</p>

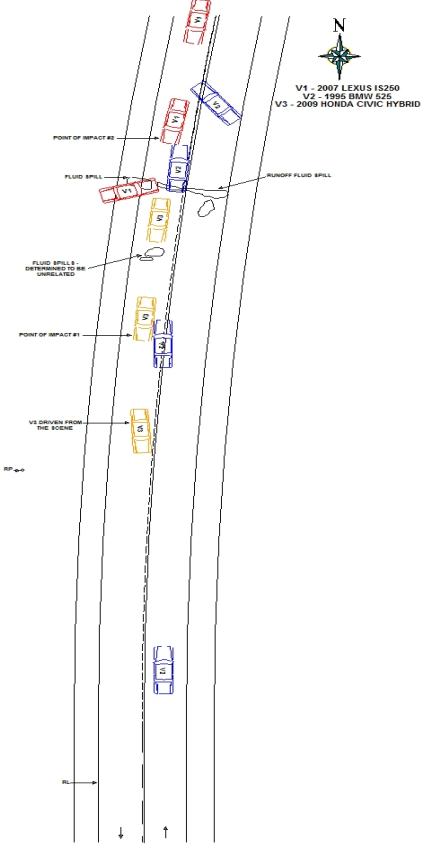
<p>V1 - 2007 LEXUS ES250 V2 - 1995 BMW 525 V3 - 2009 HONDA CIVIC HYBRID</p> <p>POINT OF IMPACT #2</p> <p>FLUID SPILL</p> <p>POINT OF IMPACT #1</p> <p>FLUID SPILLS - DETERMINED TO BE UNRELATED</p> <p>V3 DRIVEN FROM THE SCENE</p> <p>PL</p> <p>↓</p> <p>↑</p>

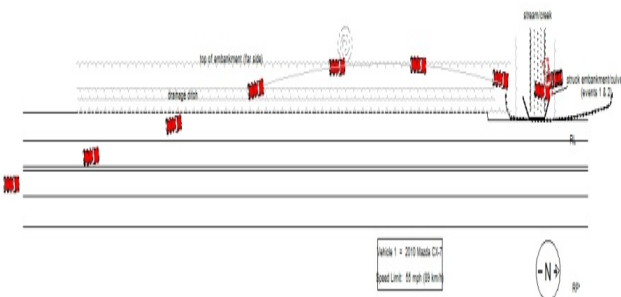
<p>The diagram illustrates the crash scene with a vehicle's path leading to an impact point on an embankment. Key features include the 'top of embankment (on axis)', 'impact point', 'vehicle 1', and 'vehicle 2'. A legend identifies 'Vehicle 1 = 2010 Mazda CX-7' and 'Speed Limit: 35 mph (56 km/h)'. A north arrow is also present.</p>

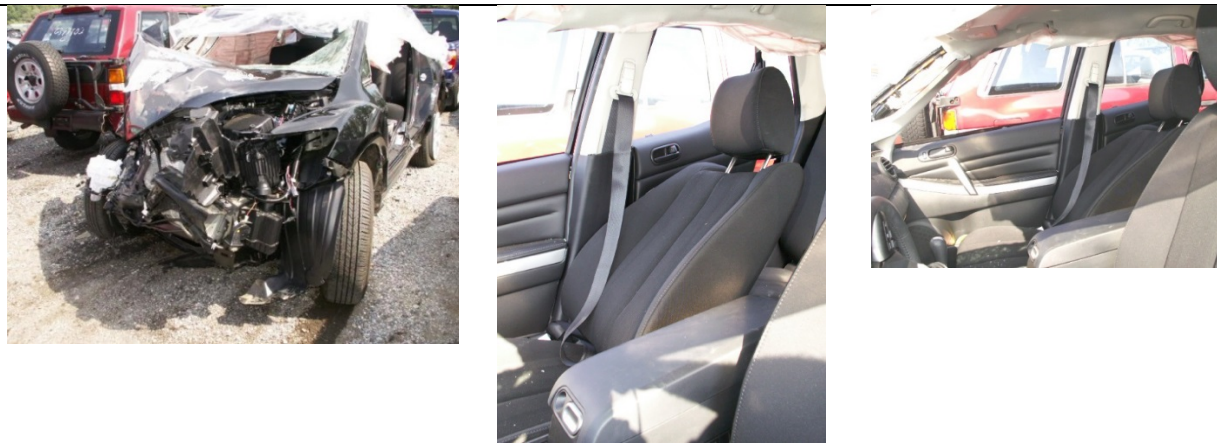
Vehicle Images

<p>The vehicle images section contains three photographs: the left image shows the exterior front-end damage of the vehicle; the middle image shows the interior passenger side with the seat and seatbelt; the right image shows the interior driver's side with the seat and seatbelt.</p>

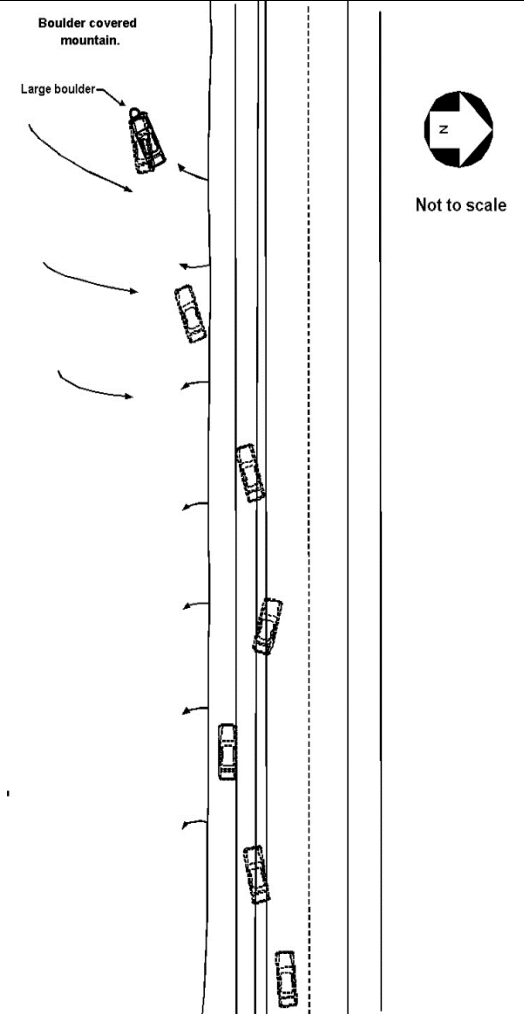
Profile #	Event#	Direct Damage Location	Field L Location	Max Crush																																																
1	1	FL corner - inward	Entire front	C2 / C3																																																
2	2	Right rear wheel	Same	NA																																																
Event	Object Contacted	Force Dir	Location	Total	Long	Lateral	Energy	Impact	Barrier	Est	Rank																																									
1	Other fixed object (spec)	0	12FDEW04	51	-51	0	124554	998	51	1	1																																									
2	Ground	90	03RBWN02	999	999	999	-9999	999	999	7	2
