# RESEARCH & DEVELOPMENT

## *Final Report*

### **Risk Assessment of Roadside Utility Structures under Vehicular Impacts**

1. Report No. <b>NCDOT 2018-24</b>	2. Government Accession No.	3. Recipient's Catalog No.	
4. Title and Subtitle <b><i>Risk Assessment of Roadside Utility Structures under Vehicular Impacts</i></b>		5. Report Date <b>February 29, 2020</b>

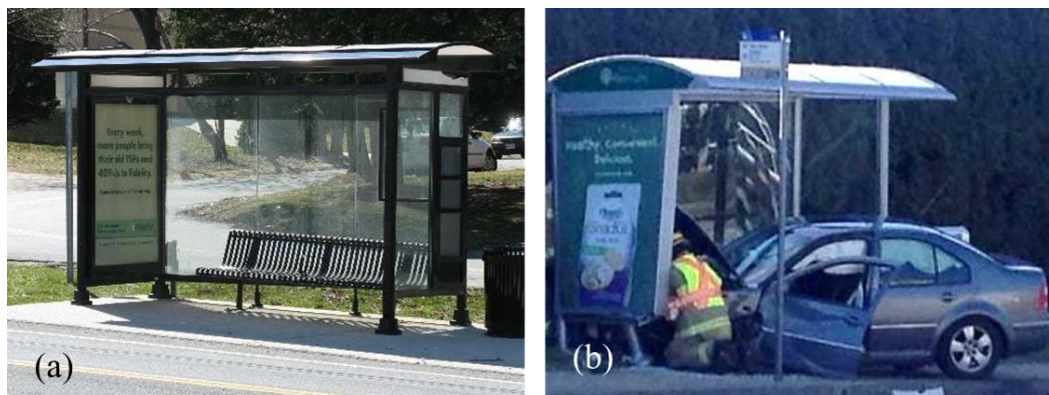
Figure 1.1(a) shows a typical bus shelter installed on the side of the road along the bus route. The bus shelter is composed of metal frames and polycarbonate coverings. When crashed by the errand vehicles, bus shelters may cause fatality or severe injuries to the occupants as well as pedestrians. Figure 1.1(b) shows a small passenger car crashing into a bus shelter, resulting in the death of the driver due to the relatively high rigidity of the bus shelter. On the other side, a severely damaged bus shelter may also cause severe injuries to the occupants due to intrusions into the occupant compartment. Furthermore, the debris of the shattered polycarbonate glasses imposes safety risks for pedestrians in the proximity of the crash location.

Figure 1.1 A typical bus shelter (a) and a bus shelter crash incident (b).

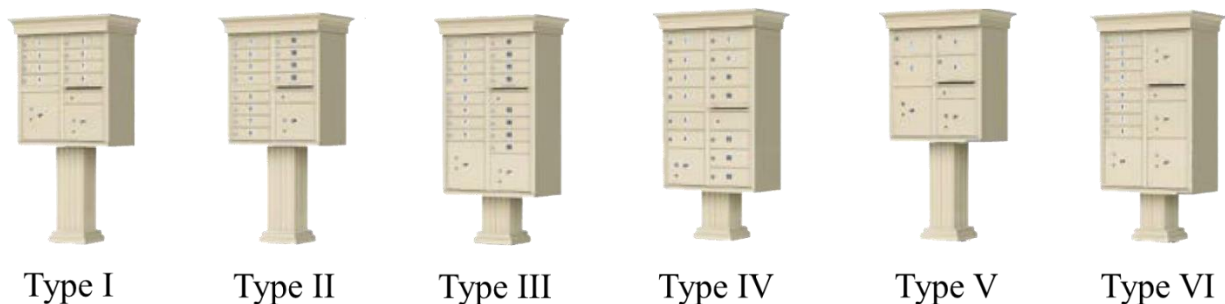
Most of today's CBUs are made by Florence Manufacturing. Table 2.1 gives the detailed specifications of the six types of current models of cluster mailboxes, as shown in Figure 2.2.

Figure 2.2 Configurations of the six types of cluster mailboxes.

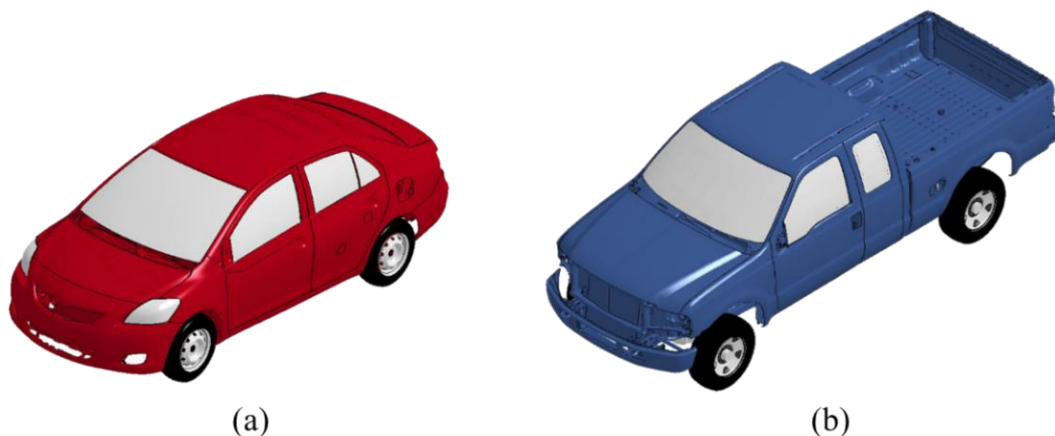
Figure 3.1 shows the FE models of the two test vehicles used in this project, a 2010 Toyota Yaris passenger car (MASH 1100C) and a 2006 Ford F250 pickup truck (MASH 2270P).

Figure 3.1 FE models of the two MASH compliant vehicles used in crash simulations.  
(a) A 2010 Toyota Yaris passenger car; and (b) a 2006 Ford F250 pickup truck.

The FE model of the 2010 Toyota Yaris had a total of 926 components that were meshed into 602,106 nodes and 582,690 elements (15,165 solid, 562,821 shell, 4,685 beam, and 19 discrete elements). Eleven different material models were used, including

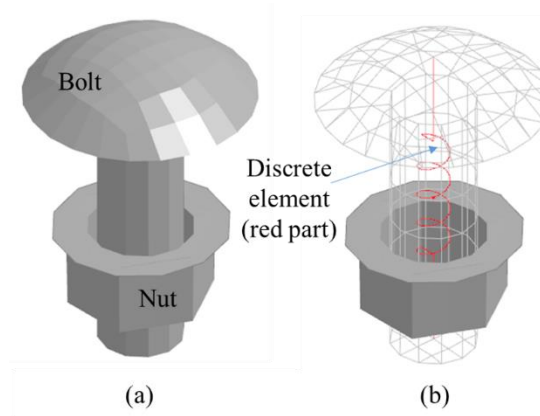
The bolt-and-nut connections were used between the pedestal top plate and the horizontal beams. Figure 3.5 illustrates the modeling scheme on how the clamping force is provided by the bolt-and-nut connection in the FE model. A discrete element was embedded inside the bolt, with its two ends sharing nodes with bolt head and the nut, respectively. A sliding contact definition was specified between the bolt and nut to allow small, translational movement. The clamping force was triggered by a prescribed elongation of the discrete element. The pedestal base plate was fixed to the ground as boundary conditions.

Figure 3.5 FE model of a bolt-and-nut connection.

(a) FE model of a bolt and nut; (b) Discrete element utilized in the bolt-and-nut model.

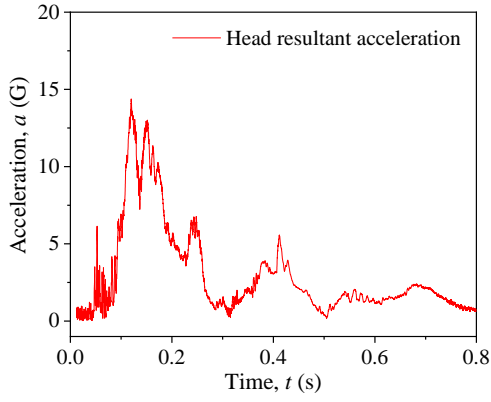
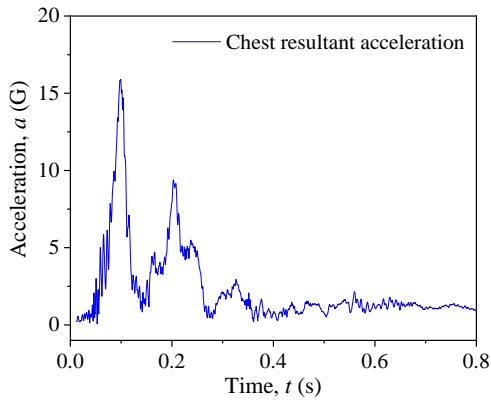
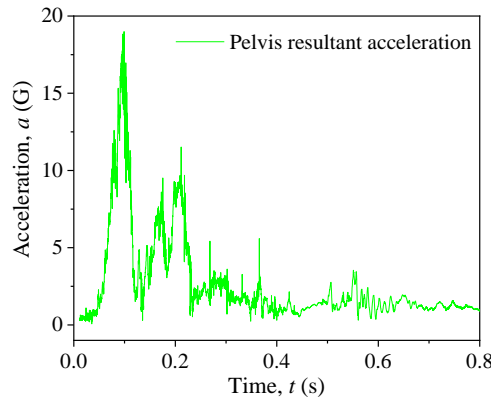
Table 4.6 Dummy responses and injury parameters for Category 1 – Case 3.

Dummy head acceleration	Head impact criteria

Head injury parameter	Value	Threshold	Pass/Fail
	HIC <sub>15</sub>	9.02	700	Pass
	$p(\text{HIC}_{15})$	0 %	31%	Pass
Dummy chest acceleration	Dummy pelvis acceleration

The simulation results of Category 1 – Case 3 showed that the connection between the pedestal and upper body of the unit being impacted first did not fail completely due to support from the other mailbox unit. Subsequently, the pedestals of the two mailbox units stuck between the front wheels and the two units were pushed forward, causing severe warpage and wrinkling on the vehicle's hood. Compared to the single-unit mailbox, the dual-unit mailbox caused larger deformation on the impacting vehicle. Nevertheless, the trajectory of the mailbox indicated no possibility of hitting the windshield of vehicle, eliminating the possibility of compartment intrusions. The vehicle's roll and pitch angles, as well as the OIVs and ORAs in both longitudinal and lateral directions, were all within the MASH allowed limits. For occupant response, the maximum head acceleration was approximately 14 G and the HIC<sub>15</sub> value was calculated to be

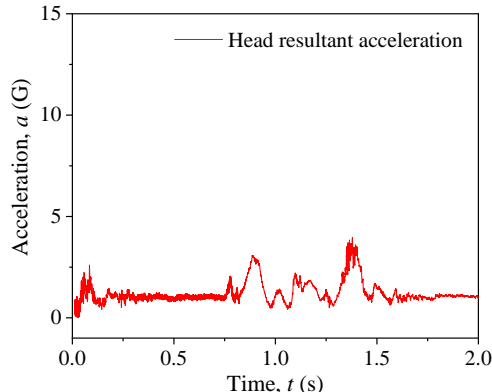
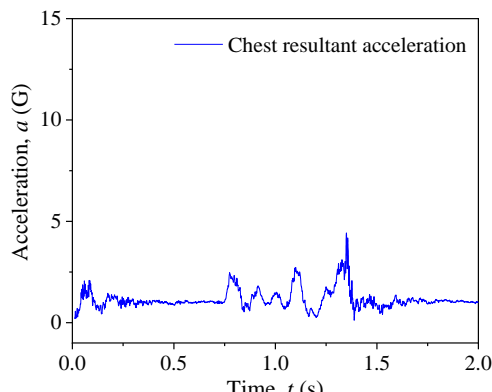
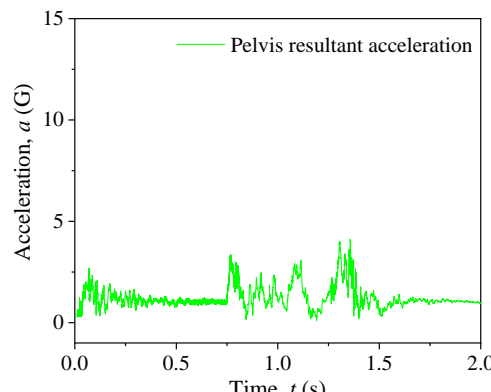
Table 4.16 Dummy responses and injury parameters for Category 1 – Case 8.

Dummy head acceleration		Head impact criteria

Head injury parameter	Value	Threshold	Pass/Fail	
	HIC <sub>15</sub>	0.30	700	Pass	
	<i>p</i> (HIC <sub>15</sub> )	0 %	31%	Pass	
Dummy chest acceleration		Dummy pelvis acceleration

The simulation results of Category 1 – Case 8 showed that when the vehicle impacted the mailbox at the mid-point after passing the curb, it barely touched the first unit and pushed the second unit to bend backwards. The two mailbox units were not detached from the ground after the impact. In this case, the mailbox will not cause any compartment intrusions. The vehicle's roll and pitch angles, as well as the OIVs and ORAs in both longitudinal and lateral directions, were all within the MASH allowed limits. For occupant response, the dummy's head did not have significant

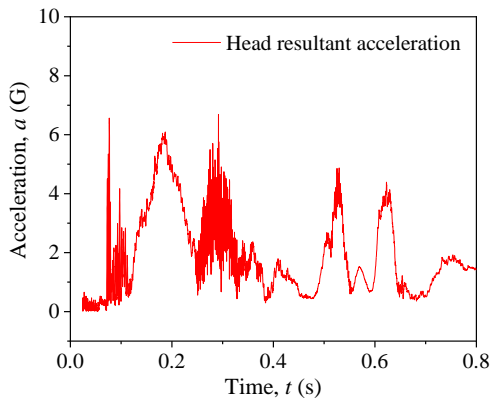
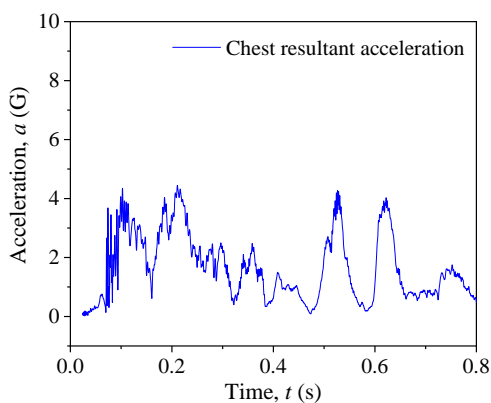
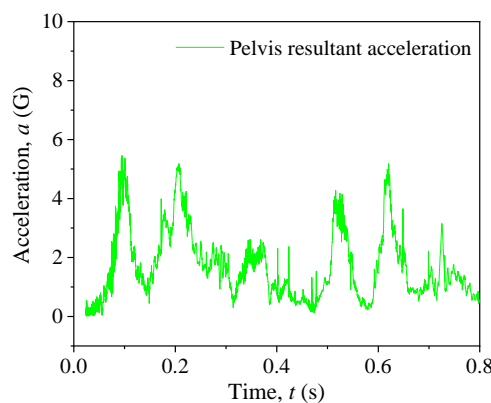
Table 4.24 Dummy responses and injury parameters for Category 2 – Case 4.

Dummy head acceleration	Head impact criteria

Head injury parameter	Value	Threshold	Pass/Fail
	HIC <sub>15</sub>	1.20	700	Pass
	$p(\text{HIC}_{15})$	0 %	31%	Pass
Dummy chest acceleration	Dummy pelvis acceleration

histories of the crash test dummy on the head, chest, and pelvis. The  $HIC_{15}$  and the probability of skull injury were also calculated for this case, as given in Table 4.24.

The simulation results of Category 2 – Case 4 showed that the connection between the pedestal and upper body of the unit being impacted first failed immediately, leaving the upper unit stuck between the vehicle’s front and the second unit, which was pushed down to the ground. The wheel rolled over the pedestal of second mailbox while the upper body being pushed by the vehicle, resulting the failure of the connection. At the end of the crash, both mailbox units were pushed forward by the test vehicle. The damage on the vehicle was a sharp V-shape dent on the hood. The trajectory of the mailbox showed that there was no possibility of hitting the windshield of vehicle, eliminating the possibility of compartment intrusions. The vehicle’s roll and pitch angles, as well as the OIVs and ORAs in both longitudinal and lateral directions, were all within the MASH allowed limits. For occupant response, the dummy’s head moved forward for a long distance due to impact pulses, but it did not touch the deployed airbag. The maximum head acceleration was approximately 6 G and the HIC<sub>15</sub> value was calculated to be 1.20, far below the threshold value of 700 and indicating no possibility of skull injury. The above analysis indicated that there was no potential occupant injury for this impact case.

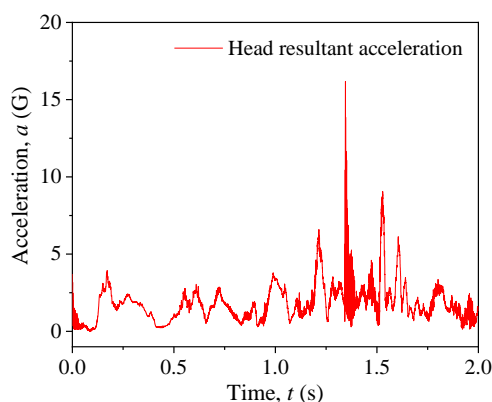
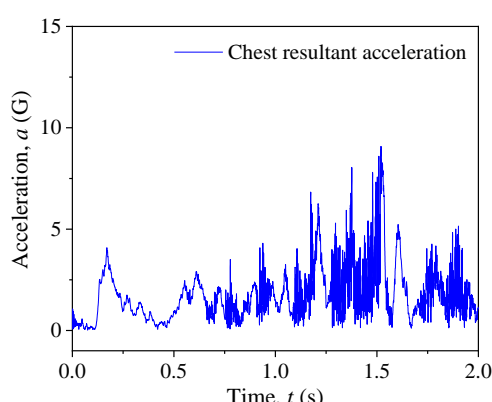
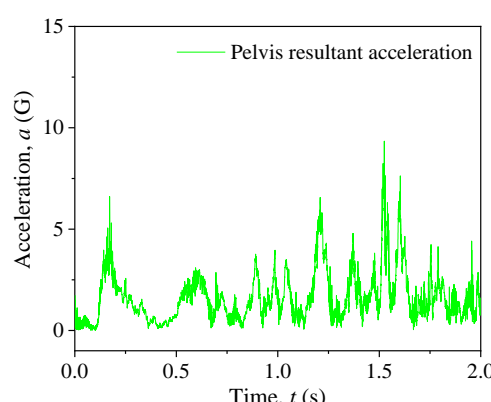
Table 4.32 Dummy responses and injury parameters for Category 2 – Case 8.

Dummy head acceleration		Head impact criteria

Head injury parameter	Value	Threshold	Pass/Fail	
	HIC <sub>15</sub>	2.55	700	Pass	
	$p(\text{HIC}_{15})$	0 %	31%	Pass	
Dummy chest acceleration		Dummy pelvis acceleration

shows the overlapping contour plot of vehicle trajectory for this case. The vehicle's roll and pitch angles, OIVs, and ORAs were calculated and summarized in Table 4.31. Table 4.32 gives the acceleration histories of the crash test dummy on the head, chest, and pelvis. The HIC<sub>15</sub> and the probability of skull injury were also calculated for this case, as given in Table 4.32.

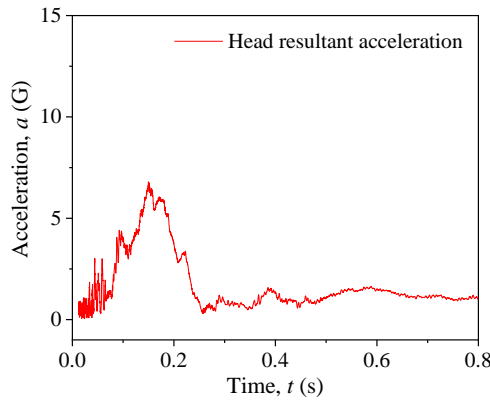
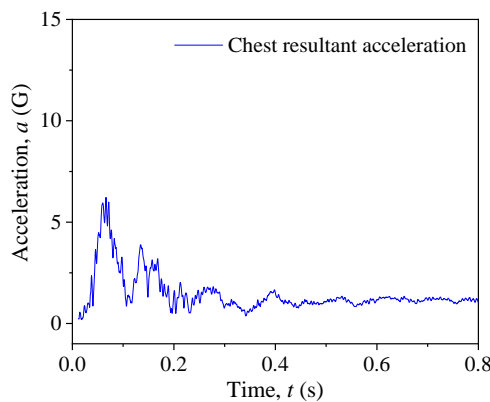
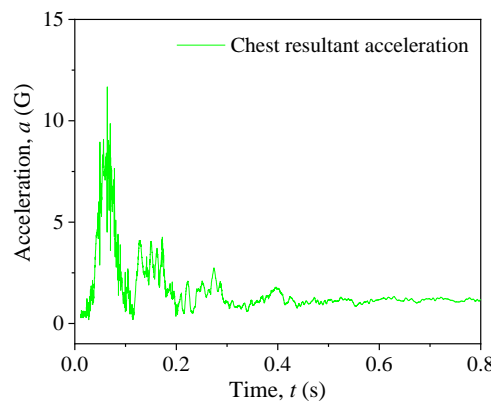
Table 4.34 Dummy responses and injury parameters for Category 3 – Case 1.

Dummy head acceleration		Head impact criteria

Head injury parameter	Value	Threshold	Pass/Fail	
	HIC <sub>15</sub>	1.52	700	Pass	
	$p(\text{HIC}_{15})$	0 %	31%	Pass	
Dummy chest acceleration		Dummy pelvis acceleration

Chest resultant acceleration

The simulation results of Category 3 – Case 1 showed that the pedestal was separated from the upper body upon impact and stuck under the chassis of the Yaris. The upper body was pushed forward by the vehicle and caused minor damage to the front bumper and hood of the vehicle. The trajectory of the mailbox showed that there was no possibility of hitting the windshield of vehicle, eliminating the possibility of compartment intrusions. The vehicle's roll and pitch angles, as well as the OIVs and ORAs in both longitudinal and lateral directions, were all within the MASH allowed limits. The dummy's head moved forward and barely touched the deployed airbag. The HIC<sub>15</sub> value was calculated to be 1.52, far below the threshold value of 700 and indicating no possibility of skull injury. The above analysis indicated that there was no potential occupant injury for this impact case.

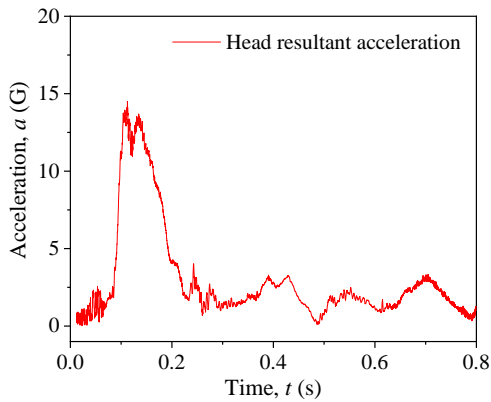
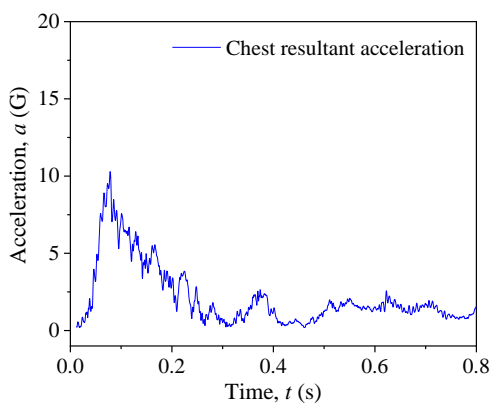
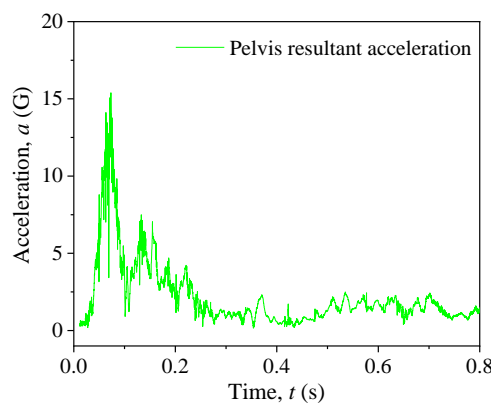
Table 4.38 Dummy responses and injury parameters for Category 3 – Case 3.

Dummy head acceleration		Head impact criteria

Head injury parameter	Value	Threshold	Pass/Fail
		HIC <sub>15</sub>	9.70	700	Pass
		$p(\text{HIC}_{15})$	0 %	31%	Pass
Dummy chest acceleration		Dummy pelvis acceleration

The simulation results of Category 3 – Case 3 showed that the pedestals of both units were separated from the upper bodies upon impacts of the vehicle. Both upper units were pushed forward by the vehicle, with the unit impacted first severely damaged. The larger mass of the Type IV mailbox caused larger damage on the vehicle's front than that for the Type I mailbox. The trajectory of the mailbox showed that there was no possibility of hitting the windshield of vehicle, eliminating the possibility of compartment intrusions. The vehicle's roll and pitch angles, as well as the OIVs and ORAs in both longitudinal and lateral directions, were all within the MASH allowed limits. During impact, the dummy's head moved forward and hit the deployed airbag. The maximum head acceleration was approximately 14 G and the HIC<sub>15</sub> value was calculated to be 9.70, far below the threshold value of 700 and indicating no possibility of skull injury. The above analysis indicated that there was no potential occupant injury for this impact case.

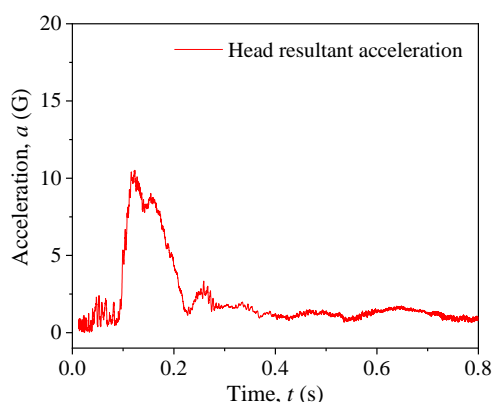
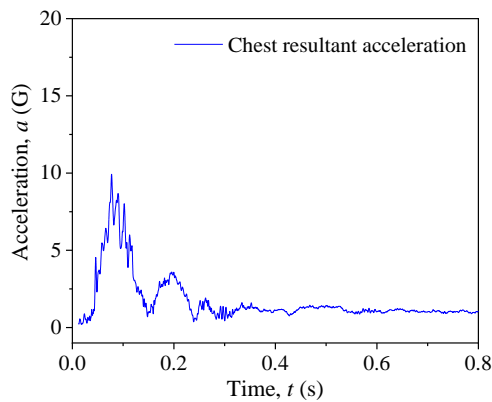
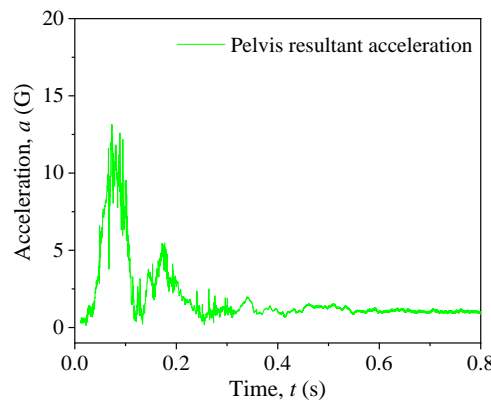
Table 4.42 Dummy responses and injury parameters for Category 3 – Case 5.

Dummy head acceleration	Head impact criteria

Head injury parameter	Value	Threshold	Pass/Fail
	$HIC_{15}$	4.63	700	Pass
	$p(HIC_{15})$	0 %	31%	Pass
Dummy chest acceleration	Dummy pelvis acceleration

The simulation results of Category 3 – Case 5 showed that the mailbox unit impacted first by the vehicle remained attached to the ground. The second mailbox unit was pushed down to the ground with the pedestal attached to the upper body. The damage of the vehicle was on the front bumper and hood. The trajectory of the mailbox showed that there was no possibility of hitting the windshield of vehicle, eliminating the possibility of compartment intrusions. The vehicle's roll and pitch angles, as well as the OIVs and ORAs in both longitudinal and lateral directions, were all within the MASH allowed limits. During impact, the dummy's head moved forward and hit

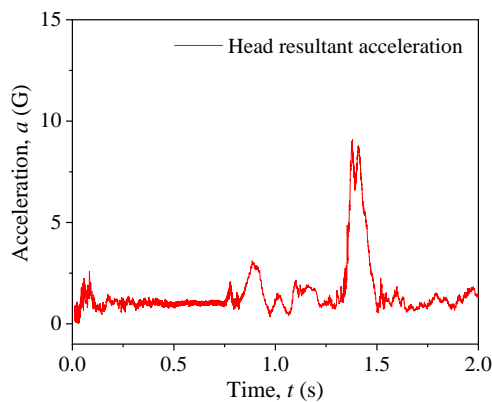
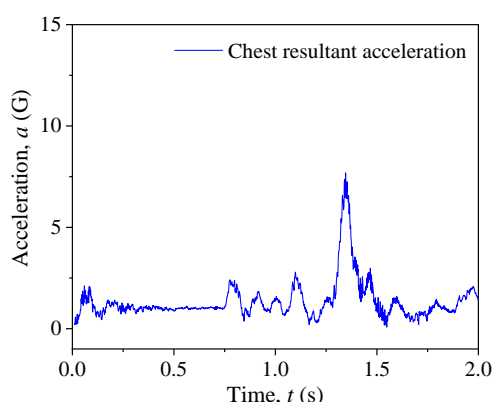
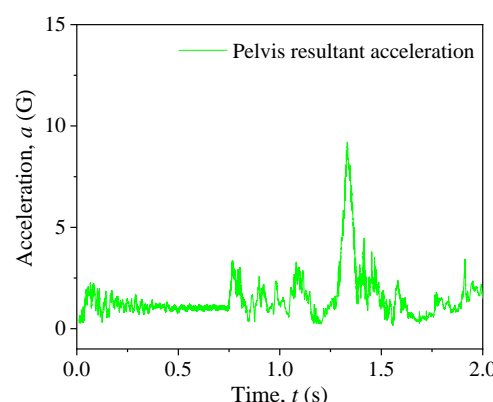
Table 4.44 Dummy responses and injury parameters for Category 3 – Case 6.

Dummy head acceleration	Head impact criteria

Head injury parameter	Value	Threshold	Pass/Fail
	HIC <sub>15</sub>	3.09	700	Pass
	$p(\text{HIC}_{15})$	0 %	31%	Pass
Dummy chest acceleration	Dummy pelvis acceleration

The simulation results of Category 3 – Case 6 showed that the upper unit was detached from the pedestal upon impact and was severely damaged on the front. The upper body was pushed by the vehicle and the damage on the vehicle was minimal. The trajectory of the mailbox showed that there was no possibility for it to hit the windshield of vehicle, eliminating the possibility of compartment intrusions. The vehicle's roll and pitch angles, as well as the OIVs and ORAs in both longitudinal and lateral directions, were all within the MASH allowed limits. During impact, the dummy's head moved forward hit the deployed airbag. The maximum head acceleration was approximately 9 G and the HIC<sub>15</sub> value was calculated to be 3.09, far below the threshold value of 700 and indicating no possibility of skull injury. The above analysis indicated that there was no potential occupant injury for this impact case.

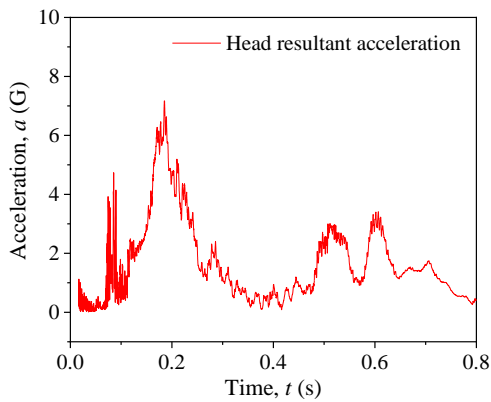
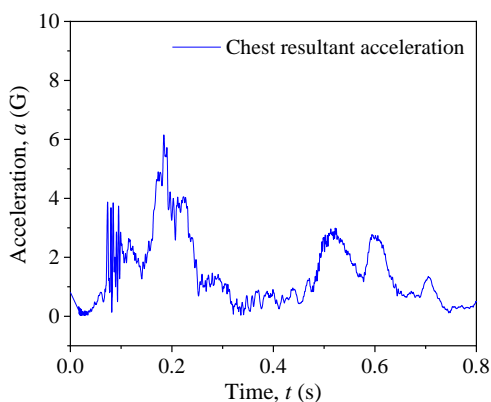
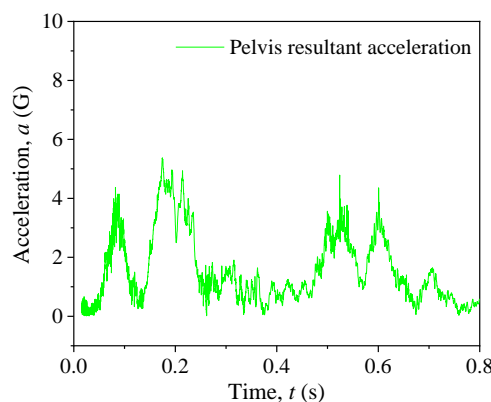
Table 4.50 Dummy responses and injury parameters for Category 4 – Case 1.

Dummy head acceleration		Head impact criteria

Head injury parameter	Value	Threshold	Pass/Fail
		HIC <sub>15</sub>	1.44	700	Pass
		<i>p</i> (HIC <sub>15</sub> )	0 %	31%	Pass
Dummy chest acceleration		Dummy pelvis acceleration

The simulation results of Category 4 – Case 1 showed that the upper unit of the mailbox was detached from the pedestal instantly upon impact and pushed forward by the vehicle in its travel direction. The damage on the vehicle was minimal, a shallow flat dent on the front. The trajectory of the mailbox showed no possibility of hitting the windshield of vehicle and thus no possibility of penetrating the occupant compartment. The vehicle's roll and pitch angles, as well as the OIVs and ORAs in both longitudinal and lateral directions, were all within the MASH allowed limits. During impact, the dummy's head moved forward but did not hit the deployed airbag. The maximum head acceleration was approximately 7 G and the HIC<sub>15</sub> value was calculated to be 1.44, far below the threshold value of 700 and indicating no possibility of skull injury. The above analysis indicated that there was no potential occupant injury for this impact case.
