FULL-SCALE SHELL IMPACT TEST OF A DOT-105 TANK CAR

On August 1, 2018, the Federal Railroad Administration (FRA) conducted a full-scale shell impact test of a DOT-105A500W (DOT-105) tank car at the Transportation Technology Center (TTC) in Pueblo, CO. The shell of the car was struck at its mid-length by a 297,000 pound ram car equipped with a 6-inch by 6-inch impactor. [Figure 1](#) shows the tank car in its pre-test position against the impact wall at TTC.

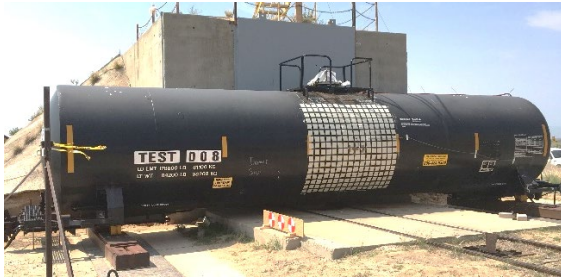
Figure 1. Pre-test Photo of DOT-105 Tank Car

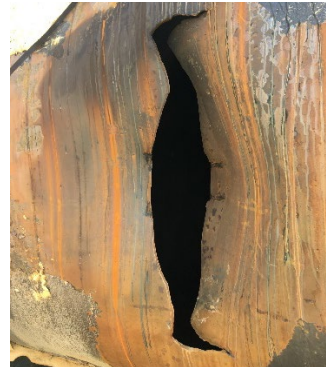
The tank was punctured after an indentation of 27 inches, at a peak force of ~840,000 pounds. Based on review of the test measurements, the impactor slowed to less than 1 mph when puncture occurred, confirming the model prediction that an impact speed of 9.7 mph only slightly exceeds the speed necessary to puncture this tank car. [Figure 2](#) shows the vertical tear in the post-test shell.

Figure 2. Post-test Photo of the Punctured Shell with Jacket Cut Out

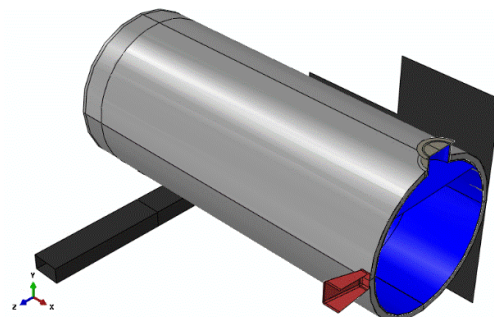
FEA was performed in conjunction with the test. A schematic of the FE model is shown in Figure 3. This model used symmetry (half-length) in order to simplify and speed-up the simulations. This model featured simplified modeling of the water and air within the tank. The water was modeled using a hydraulic cavity approach and the air was modeled as an ideal gas using a pneumatic cavity. The mass of the water was distributed through a membrane representing the interior wall of the tank and the free surface of the water. The jacket was modeled using shell elements. The tank was modeled using shell elements, except in the vicinity of the impact. The impact zone was modeled using solid elements that had elastic-plastic and ductile failure behaviors. This combination of element type and properties would allow puncture of the tank car to be modeled while minimizing the model's run-time.

Figure 3. Half-symmetric DOT-105 FE Model

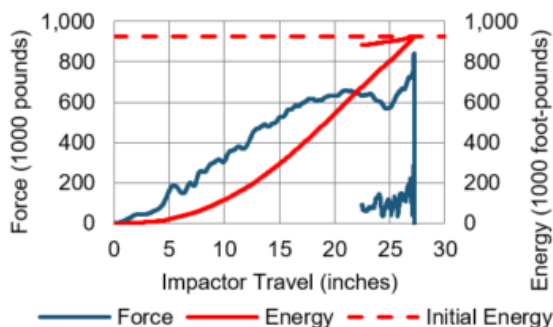
The impact occurred at 9.7 mph and resulted in puncture of the tank. The impactor had a maximum travel of approximately 27 inches after making contact with the jacket of the tank. The peak force during the impact was approximately 993,000 pounds. The force-displacement and energy-displacement results from the test are shown in Figure 4, as well as the initial kinetic energy of the ram. These results were taken from the average of the five longitudinal accelerometers mounted on the ram car. A CFC-60 filter was used on these results. From this graph, it is apparent the impactor's energy had nearly been completely dissipated at the time of puncture and that the impactor rebounded from the tank after puncture.

Figure 4. Test Force- and Energy-displacement Results at 9.7 mph

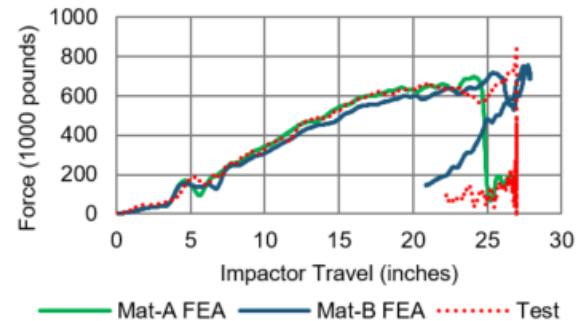
The force-displacement results from the test and from the pre-test FE model, re-run at 9.7 mph, are compared to one another in Figure 5. This model was run with two different tank shell materials: (1) *Mat-A* has a ductility that slightly exceeded the requirements of TC128B and (2) *Mat-B* has a ductility that greatly exceeds the

requirements of TC128B. These two material behaviors are derived from samples cut from previously-tested tank cars. The two pre-test FE model results bound the test results, with the test having a displacement at puncture greater than *Mat-A*, but less than the peak displacement of *Mat-B* which did not puncture at 9.7 mph.

Figure 5. Pre-test FEA and Test Force-displacement Results at 9.7 mph

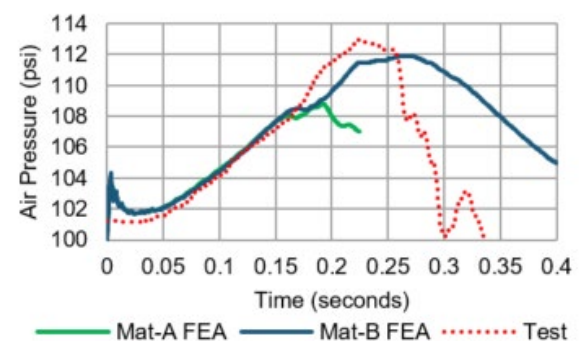
The average air pressure in the pre-test FE model is compared to the air pressure measured in the manway during the test in Figure 6. Overall, the air pressure measured in the test exhibits a similar response to the responses from the models after settling.

Figure 6. FEA and Test Average Air Pressure Results at 9.7 mph
