DOT/FAA/TC-15/61

Artificial Turf and Gopher Tortoises at Orlando Sanford International Airport

January 2016

Final Report

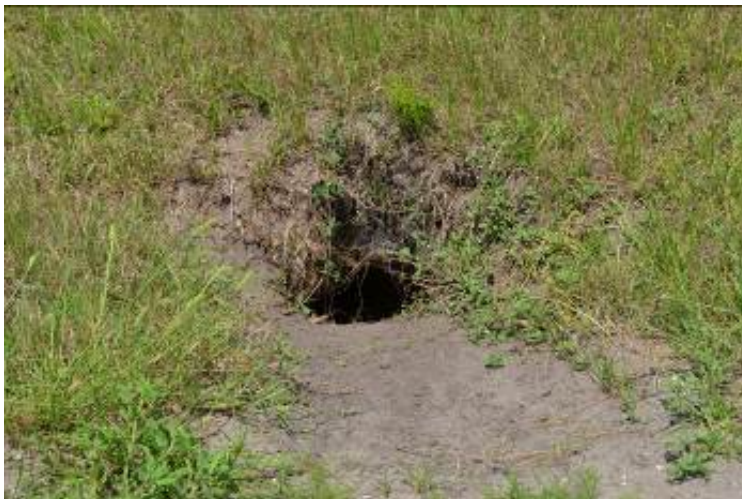
The gopher tortoise (*Gopherus polyphemus*) is a species of the *Gopherus* genus, which is native to the southeastern United States. Gopher tortoises typically grow to be up to 15 inches long and weigh from 8 to 15 pounds. Their burrows, such as the one shown in figure 2, can vary from 3 feet to 52 feet in length and up to 23 feet deep. They are most active in the warmer months but spend most of their lives in their burrows. Each tortoise can dig and use several burrows within their home range throughout the active season. The number of burrows used by an individual

Figure 2. Typical Gopher Tortoise Burrow

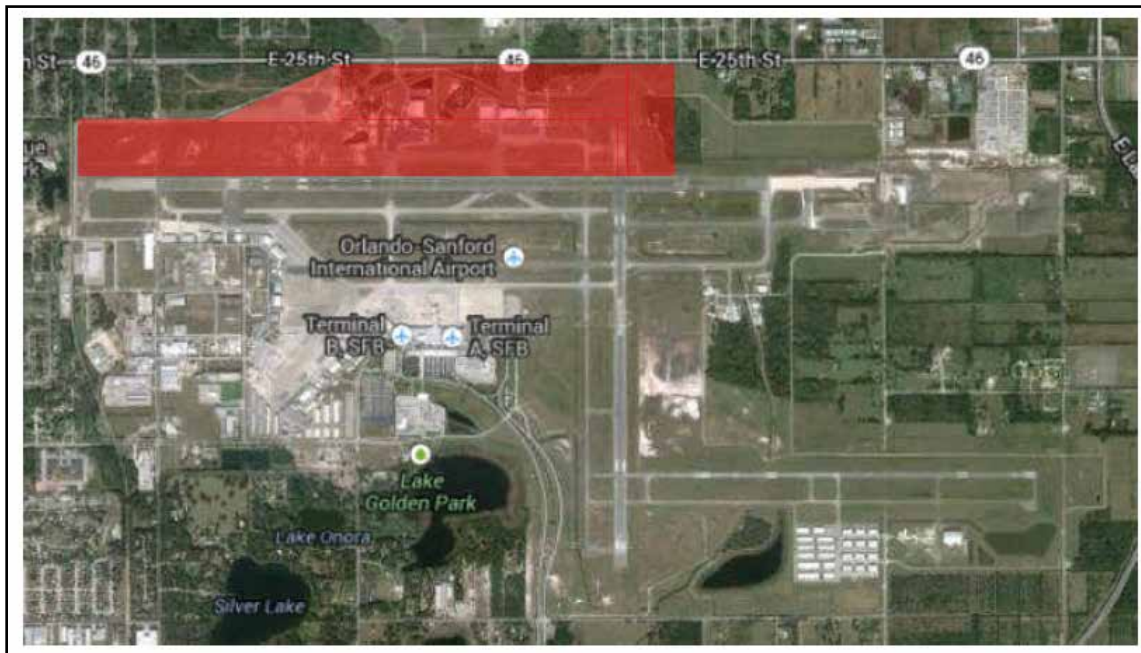
Burrow distribution was heavily concentrated in the northwest region of the airport. The predominant concentration of gopher tortoise burrows was north of RWY 9L-27R and north and west of the approach end of RWY 18. This area comprised portions of land both on and off airport property, as depicted in red in figure 3. Discussions with airport personnel indicated that although airfield gopher tortoise distribution was highest in the northwest region, gopher tortoises have been documented using other areas. [7]

Figure 3. Aerial Photograph of SFB Showing Location of Highest Gopher Tortoise Densities on and off Airport Property

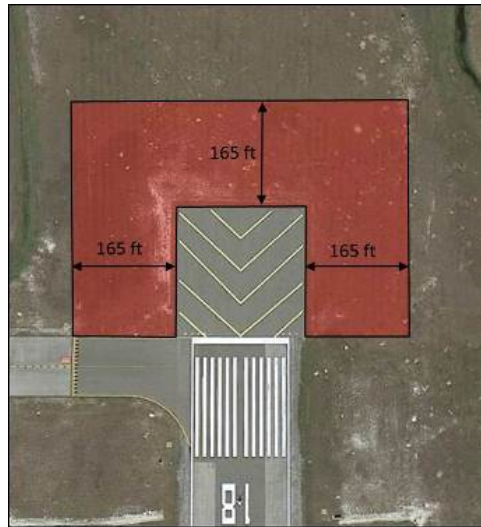
Preparing the selected site first required removing all gopher tortoises and back filling all burrows within the designated area. Initial designs defined this burrow exclusion area as the area extending 165 feet outward from the edge of the blast pad area, as shown in the red portion of figure 4. Note the white marks on the landscape; these are gopher tortoise burrows.

Figure 4. Burrow Exclusion Zone

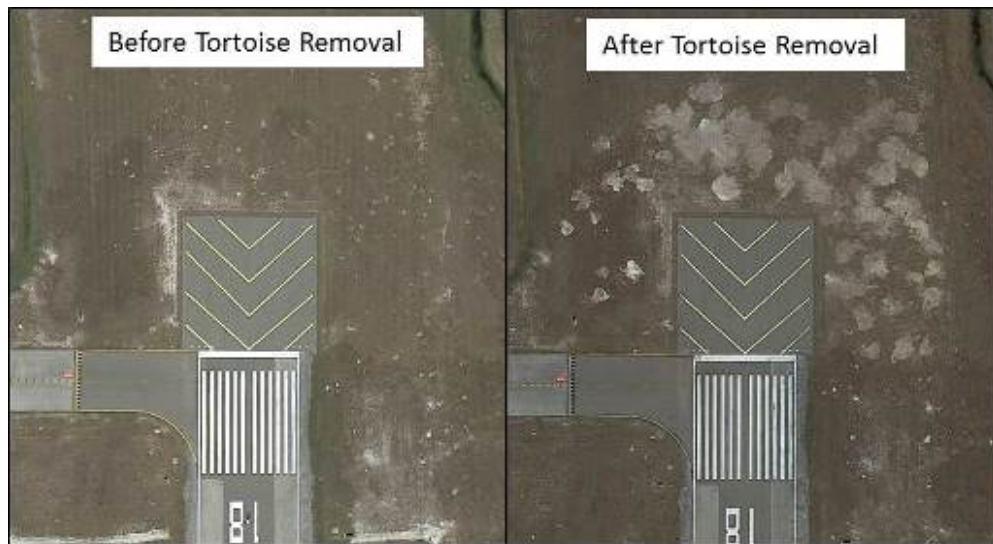
Initially, a total of 129 burrows were identified within the exclusion zone during the preconstruction process; 85 were active, 16 were inactive, 26 were abandoned, and 2 were not found at the time of removal. A total of 121 gopher tortoises were found; 75 were adults, and 46 were immature [8]. Data recorded for each burrow are included in appendix A. Each burrow's geographic coordinates and video footage of the video borescope inspections remain on file with the Airport Technology R&D Branch and is available upon request. Figure 6 depicts two Google Earth™ images of the test area location, one taken on January 22, 2013 prior to burrow excavation, and the other taken January 17, 2014 after excavation and filling.

Figure 6. Satellite Imagery Before and After Burrow Excavation

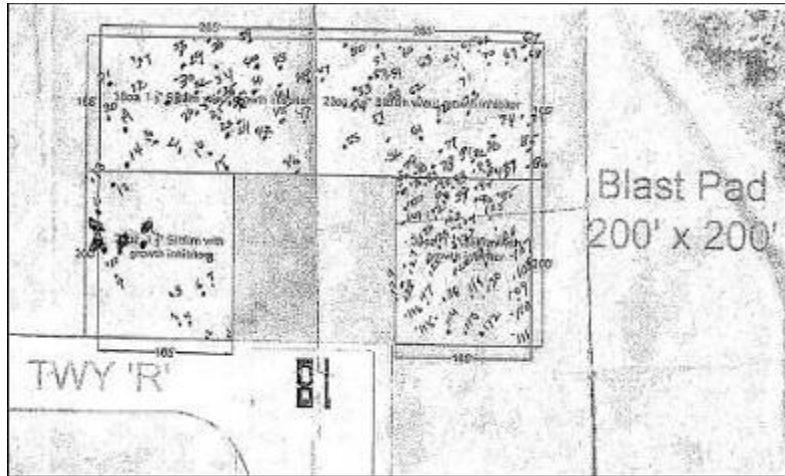
The combined length of all the burrows amounted to 1291 linear feet of underground void space in the exclusion zone, with the average individual burrow having a length 10.2 feet. Burrows were predominantly located on the southeast side of the blast pad. Each burrow location was numbered and noted on a diagram, as shown in figure 7.

Figure 7. Locations of Numbered Burrows

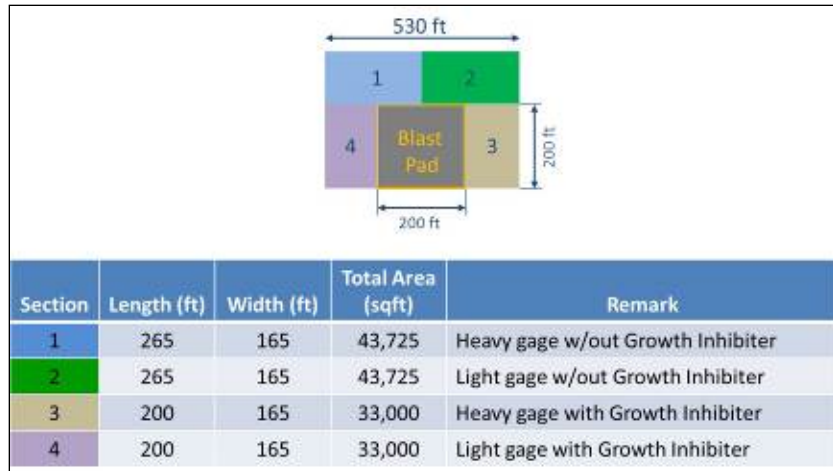
The artificial turf test section was comprised of four distinct plots of artificial turf, which included combinations of two different densities of synthetic turf fibers, i.e., less dense (22 oz) and more dense (38 oz), as well as treatment of a weed growth inhibitor additive. Figure 8 shows a side-by-side photograph of the two different turf densities. Each plot was adjacent to the blast pad pavement, as shown in figure 9.

Figure 9. Test Plot Specification Table

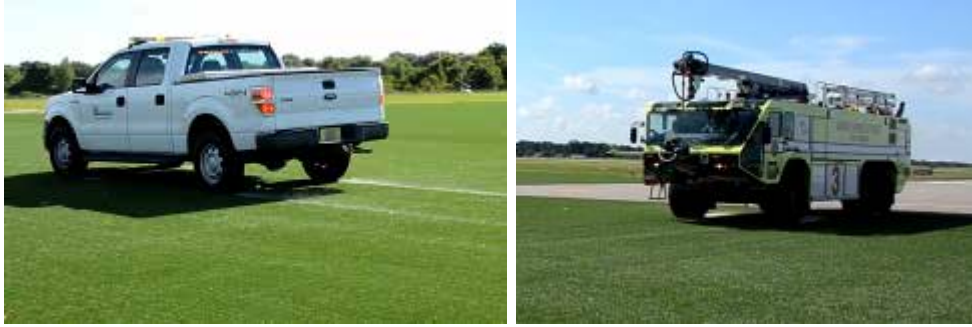
In July 2014, the FAA research team traveled to SFB for testing. To test the artificial turf's maneuverability, common types of airport vehicles were maneuvered around the artificial turf test area under normal vehicle passage conditions, e.g., normal speeds, turning, and normal braking. An Ops truck (Ford® F-150) and an ARFF vehicle (Oshkosh® Striker® 3000) were used as test vehicles. Both vehicles also performed turns and normal braking to a stop on the turf. No damage was observed during these tests. Figure 12 depicts the Ops and ARFF vehicles during the dry maneuverability tests.

Figure 12. The Ops Truck and ARFF Vehicle in Dry Maneuverability Tests

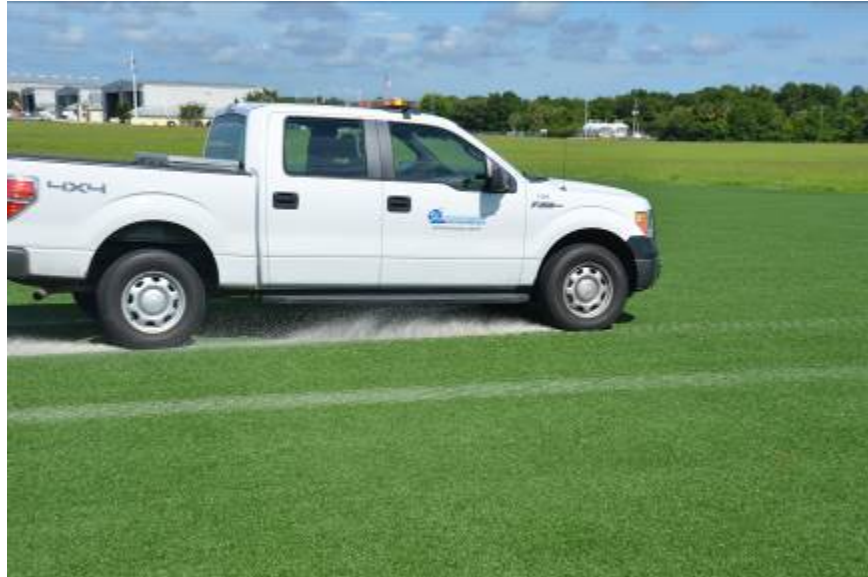
In this series of tests, the Ops truck began at the RSA boundary line (30 feet left of the runway centerline), accelerated up to a designated speed (20 mph, 30 mph, and 40 mph, respectively), and drove straight through the blast pad onto the turf. The vehicle began braking at 22 feet past the runway threshold and came to a stop prior to exiting the turf at the backside. Next, the ARFF vehicle, weighing approximately 81,700 pounds, followed the same maneuvers as the Ops truck, but at slower speeds. The designated braking area for the ARFF vehicle was 47 feet past the runway threshold. No damage was observed on the artificial turf during these tests except for two small ripples less than 1 inch in height, which surfaced in front of the ARFF vehicle during run 8. The ripples flattened as the ARFF vehicle exited the area. Additionally, as the vehicles passed over the turf during each test run, some sand infill material kicked up behind the tires, as shown in figure 13. The sand accumulated on the surface of the artificial turf in the wheel paths.

Figure 13. Sand Infill Material Displacement From Ops Truck Passage

After the dry vehicle braking runs were completed, the tire paths were swept with a push broom to push the sand infill material back into place among the base of the synthetic fiber turf blades.

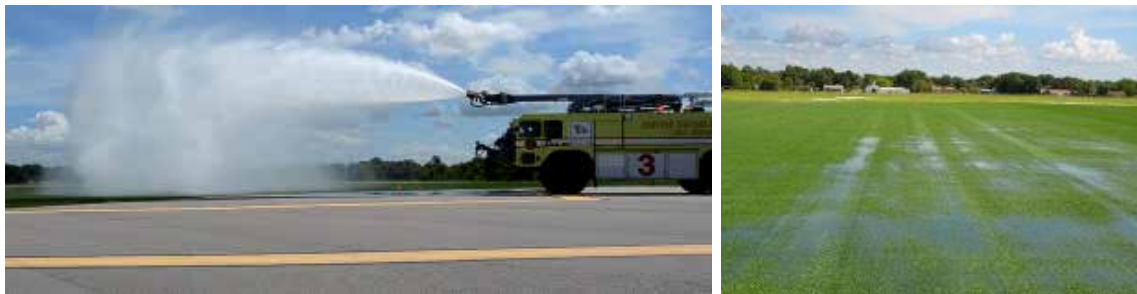
The testing area was then prepared for wet braking conditions. An ARFF vehicle used an overhead boom to apply 3000 gallons of water to the artificial turf test sections to create a flooded condition representative of a significant passing rain shower. Figure 14 shows the ARFF vehicle spraying the test area and the flooded condition immediately following.

Figure 14. Water Application to Artificial Turf Test Sections

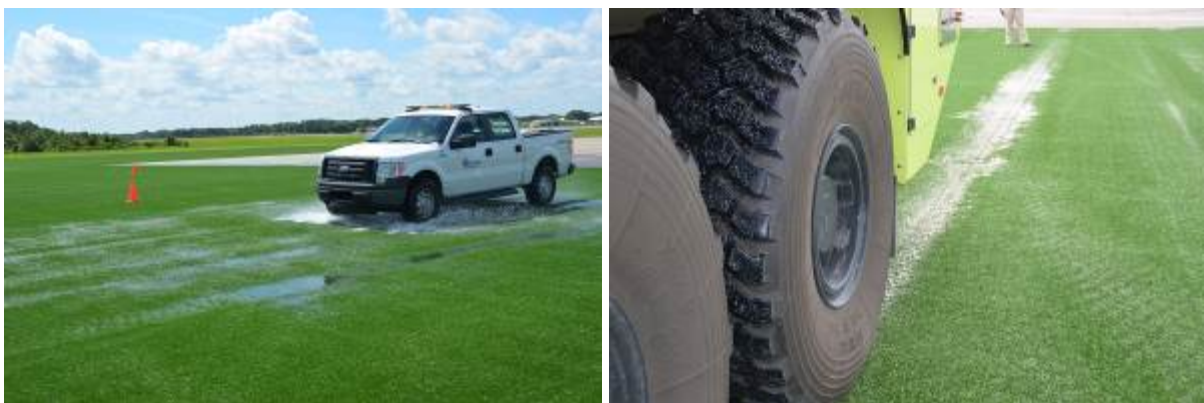
The Ops truck and the ARFF vehicle repeated the same braking tests on the wet artificial turf as described for the dry braking tests. Table 8 shows the results of the artificial turf test runs under wet conditions for the Ops truck and ARFF vehicle. In one instance, the ARFF vehicle caused small ripples in front of the tires similar to what occurred during the dry tests. During one of the faster runs, small ruts were created in the artificial turf, and significant sand infill was dislodged, as shown in figure 15.

Figure 15. The Ops Truck and ARFF Vehicle During Wet Friction Tests

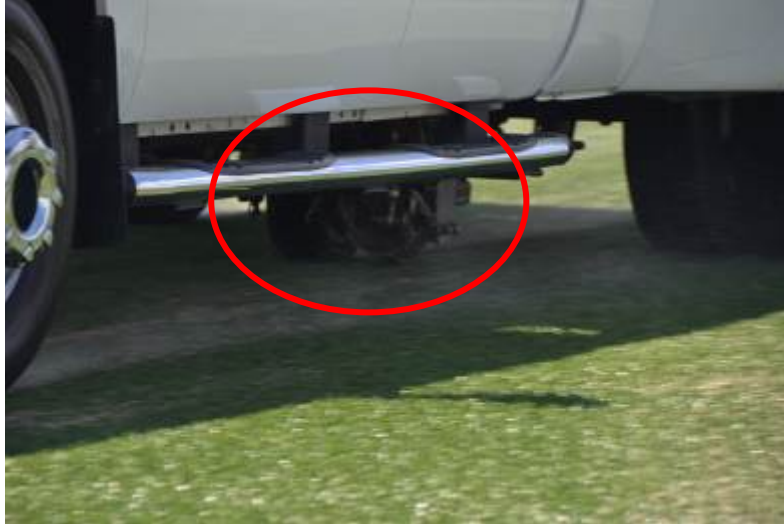
The BAT vehicle test runs were designed so the vehicle would traverse both densities of turf in a single run. The test lane configuration is shown in figure 16. Two test lanes, right and left, were established. Each test lane included acceleration zones (shaded blue in figure 16) that enabled the BAT vehicle to achieve the target entrance speeds. For the right test lane, the BAT vehicle accelerated from a stopped position at the southeast corner of the RSA boundary line and drove diagonally to the southwest corner of the turf at the RWY 18 threshold. The vehicle then stopped accelerating and maintained speed throughout the purple portion of the lane. An orange traffic cone was placed at the end of the purple zone to designate the beginning of the braking zone. Braking was conducted within the orange braking zone until the BAT vehicle came to a complete stop. Figure 17 shows the aircraft wheel chassis mounted under the truck during braking (circled in red).

Figure 17. The BAT Vehicle Aircraft Wheel Chassis During Testing

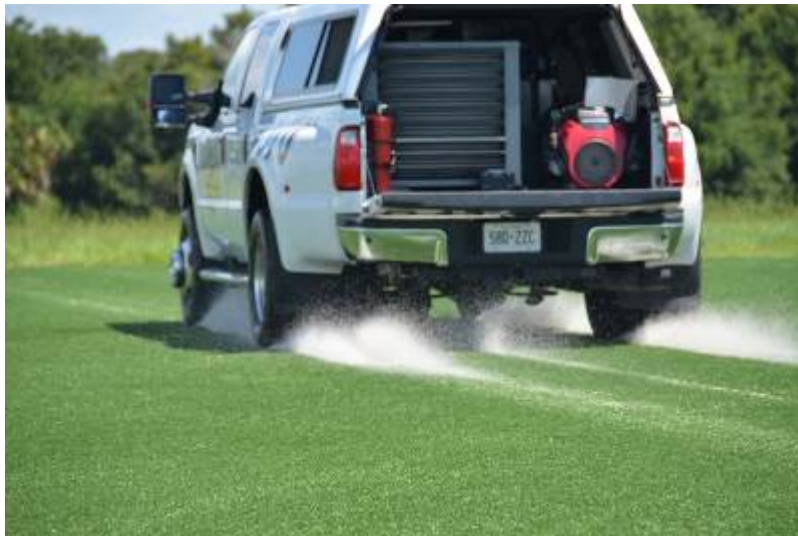
Several variables were introduced: vertical load of 1900 lb and 2600 lb, speed, with and without aircraft wheel braking, and wet and dry conditions. The nose gear tire was inflated to 185 psi. Figure 18 depicts the BAT vehicle during dry braking action and friction characteristics test, and figure 19 shows the BAT vehicle during wet braking action and friction characteristics tests. For each run, stopping distance was recorded and no damage was observed. The results are listed in table 9.

Figure 18. The BAT Vehicle During Dry Braking Action and Friction Characteristics Tests

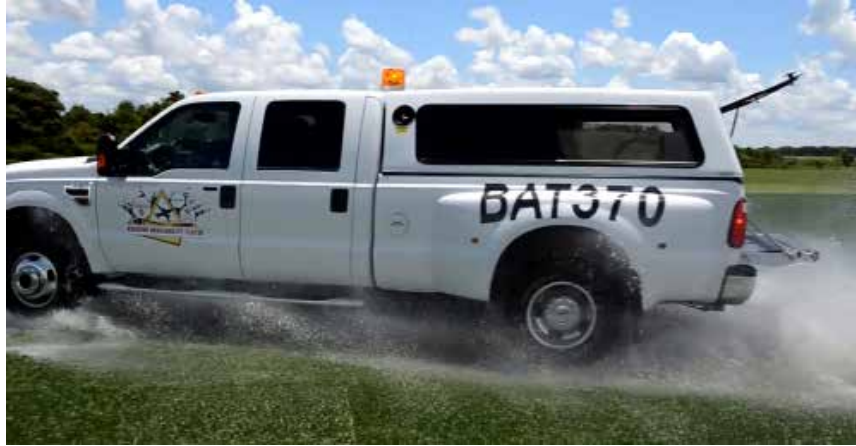
Figure 19. The BAT Vehicle During Wet Braking Action and Friction Characteristics Tests

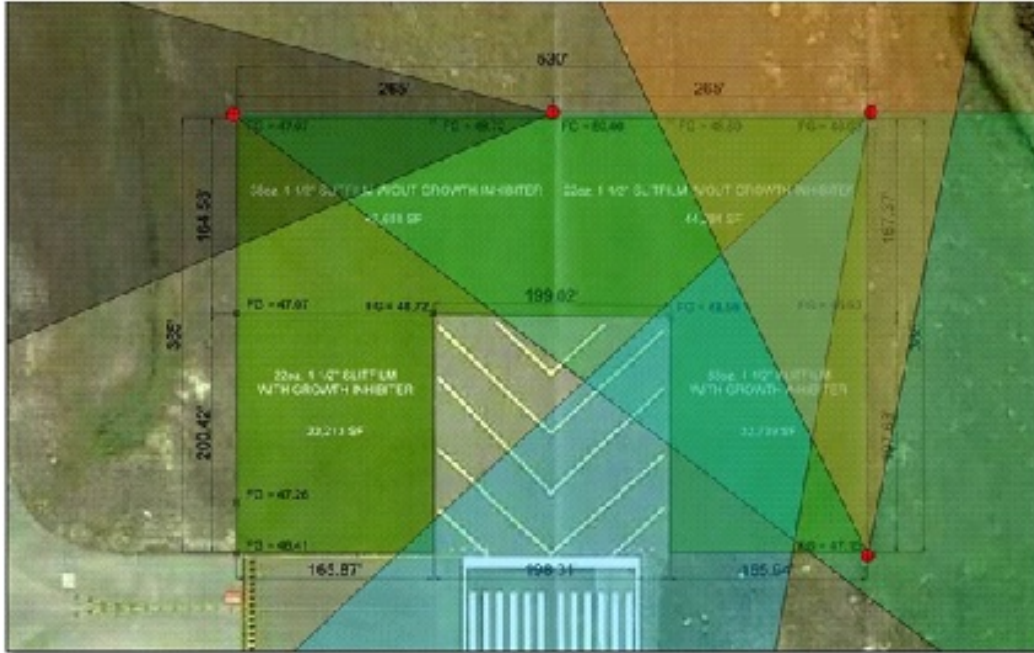
Four wildlife cameras were installed at locations along the perimeter of the artificial turf adjacent to the blast pad, which provided perspectives from the northwest, north, northeast, and southeast. Figure 20 shows the locations of each camera represented by red dots and lightly shaded overlays to show the field of view of each camera with respect to the artificial turf plots.

Figure 20. Location of Wildlife Cameras Surrounding Artificial Turf Plots

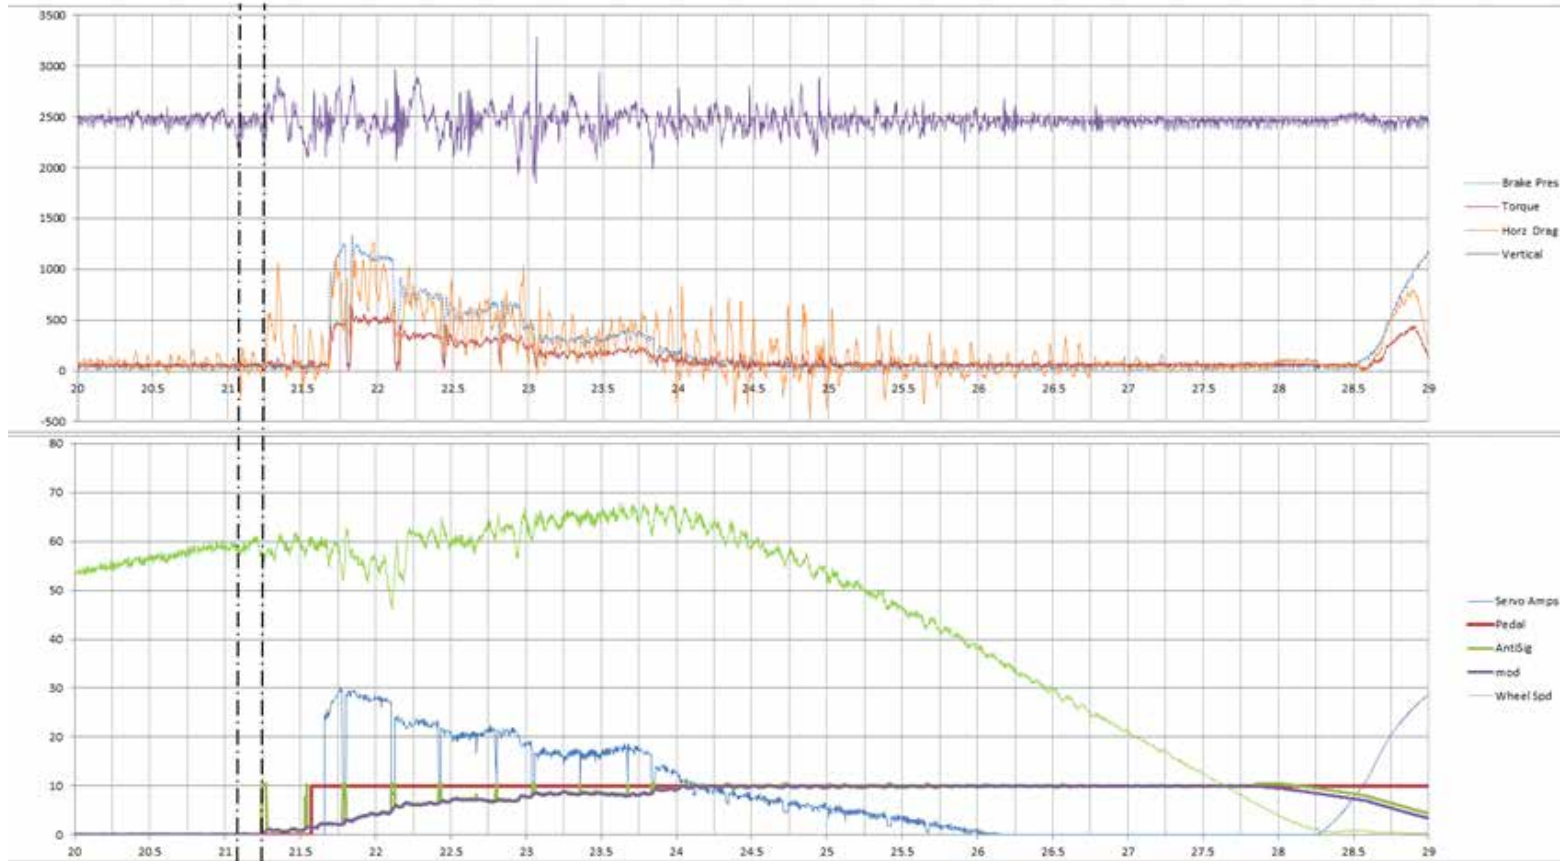
Side	left
Target Speed (fps)	73.5
Vertical load (lb)	High
Brake (Y/N)	Y
Wet/Dry	Dry

Figure C-5. Test Run 4 Data From the BAT Vehicle

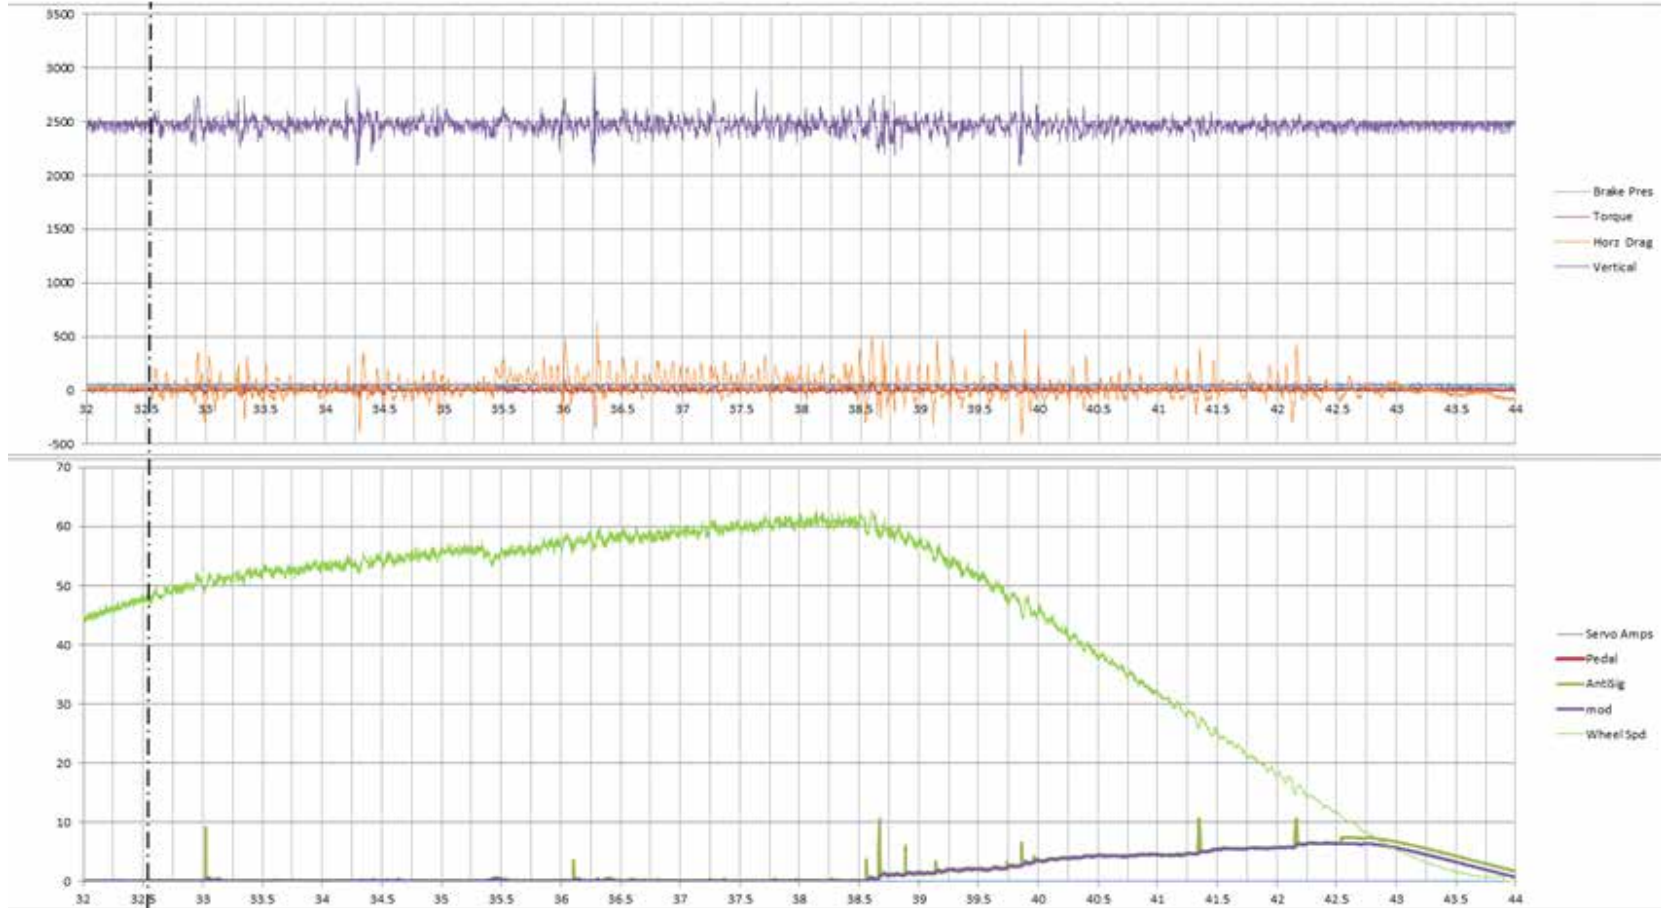
Side	right
Target Speed (fps)	44.1
Vertical load (lb)	High
Brake (Y/N)	N
Wet/Dry	Dry

Figure C-6. Test Run 5 Data From the BAT Vehicle

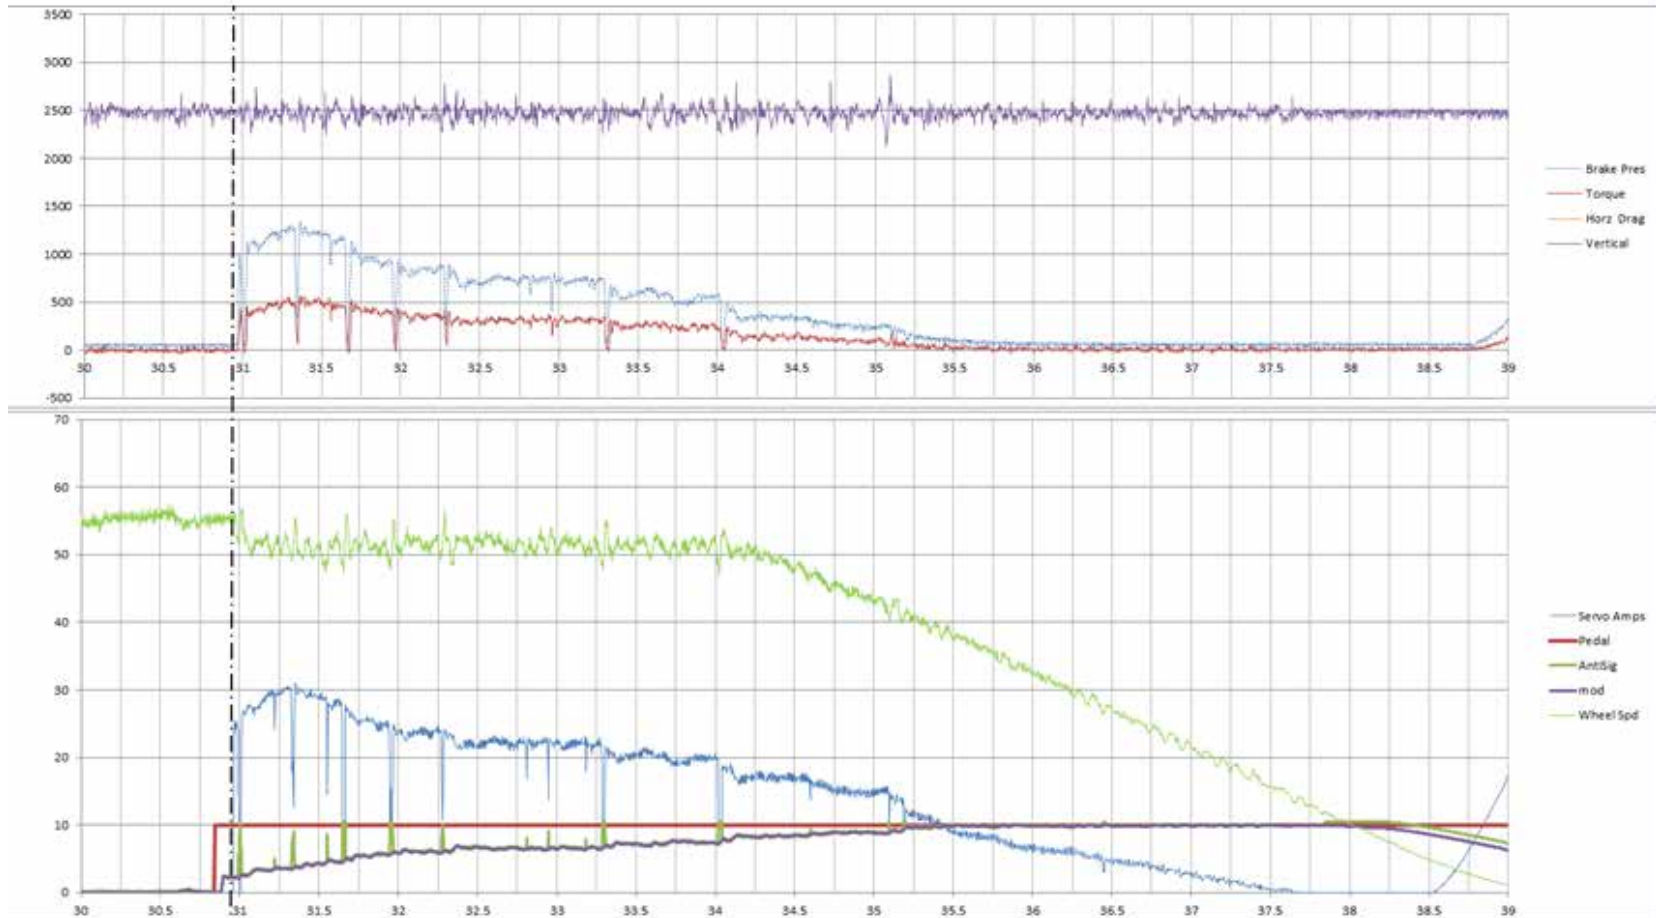
Side	right
Target Speed (fps)	44.1
Vertical load (lb)	High
Brake (Y/N)	Y
Wet/Dry	Dry

Figure C-7. Test Run 6 Data From the BAT Vehicle

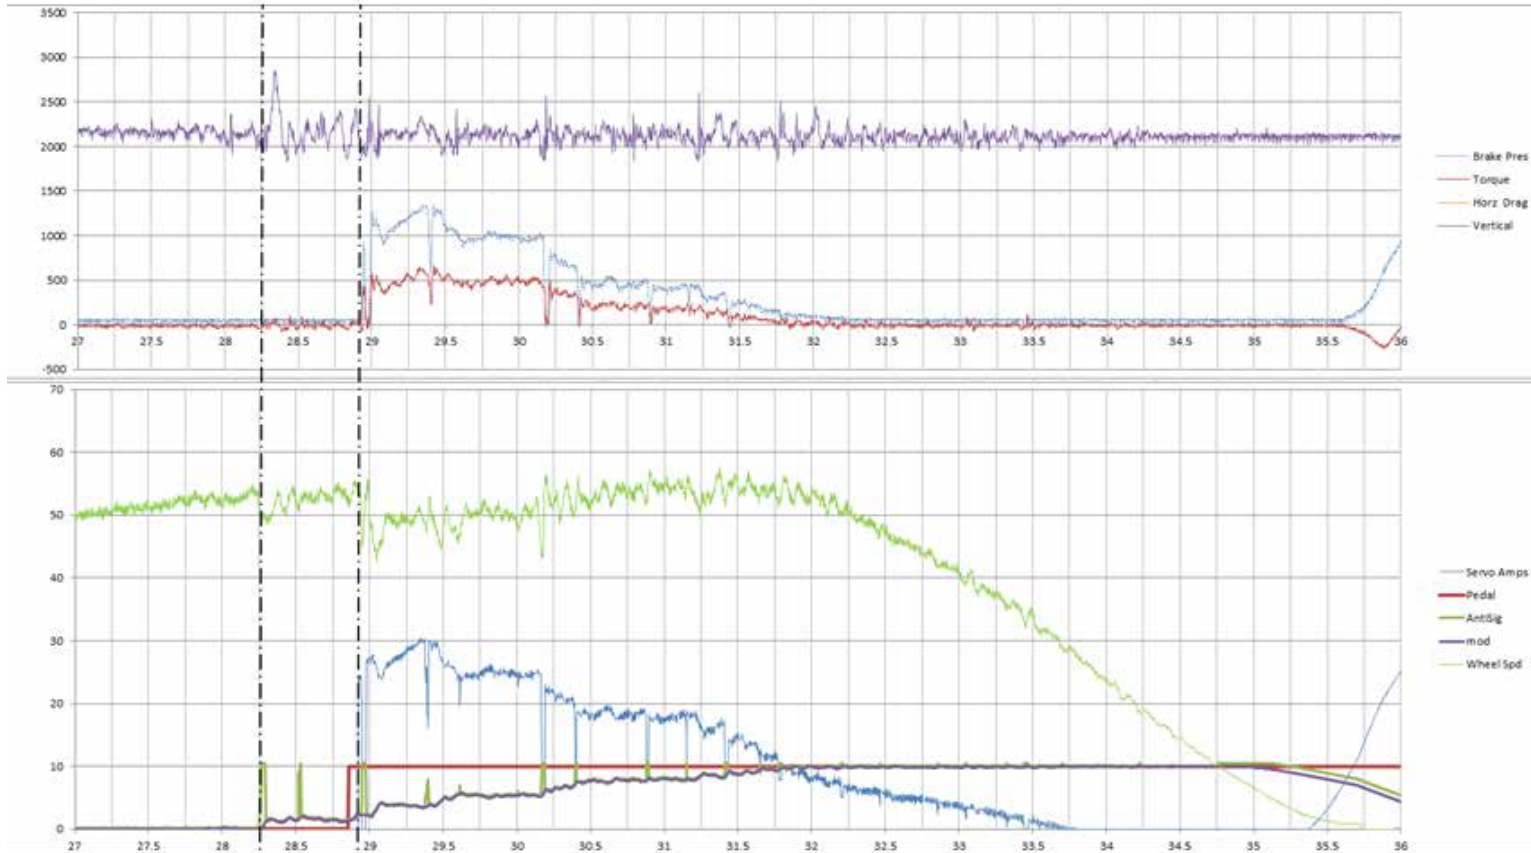
Side	left
Target Speed (fps)	44.1
Vertical load (lb)	Low
Brake (Y/N)	Y
Wet/Dry	Dry

Figure C-11. Test Run 10 Data From the BAT Vehicle

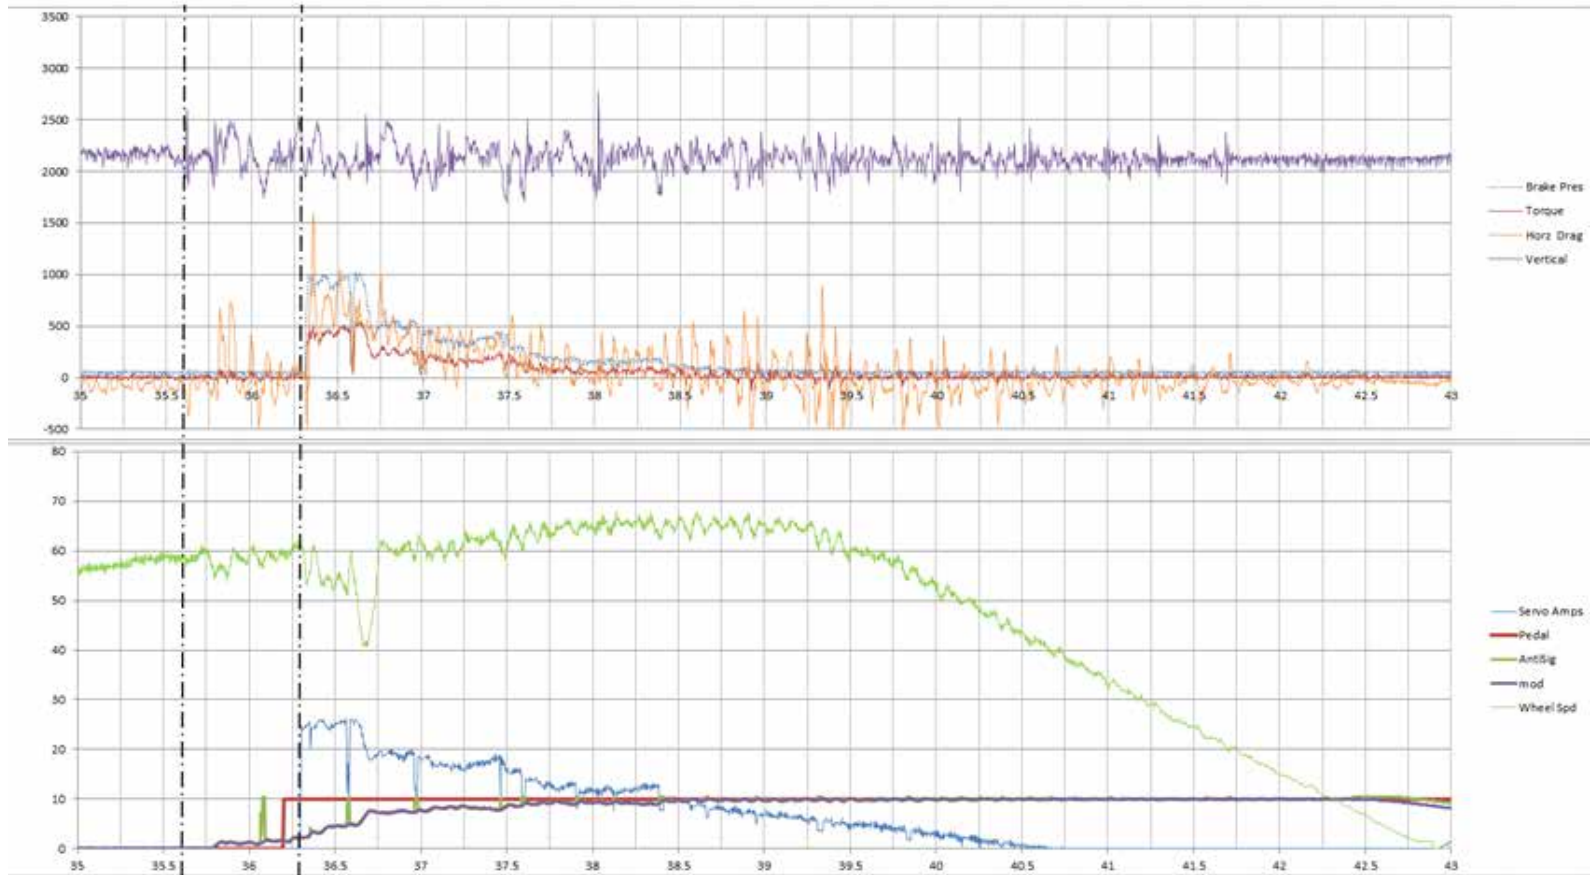
Side	left
Target Speed (fps)	73.5
Vertical load (lb)	Low
Brake (Y/N)	Y
Wet/Dry	Dry

Figure C-13. Test Run 12 Data From the BAT Vehicle

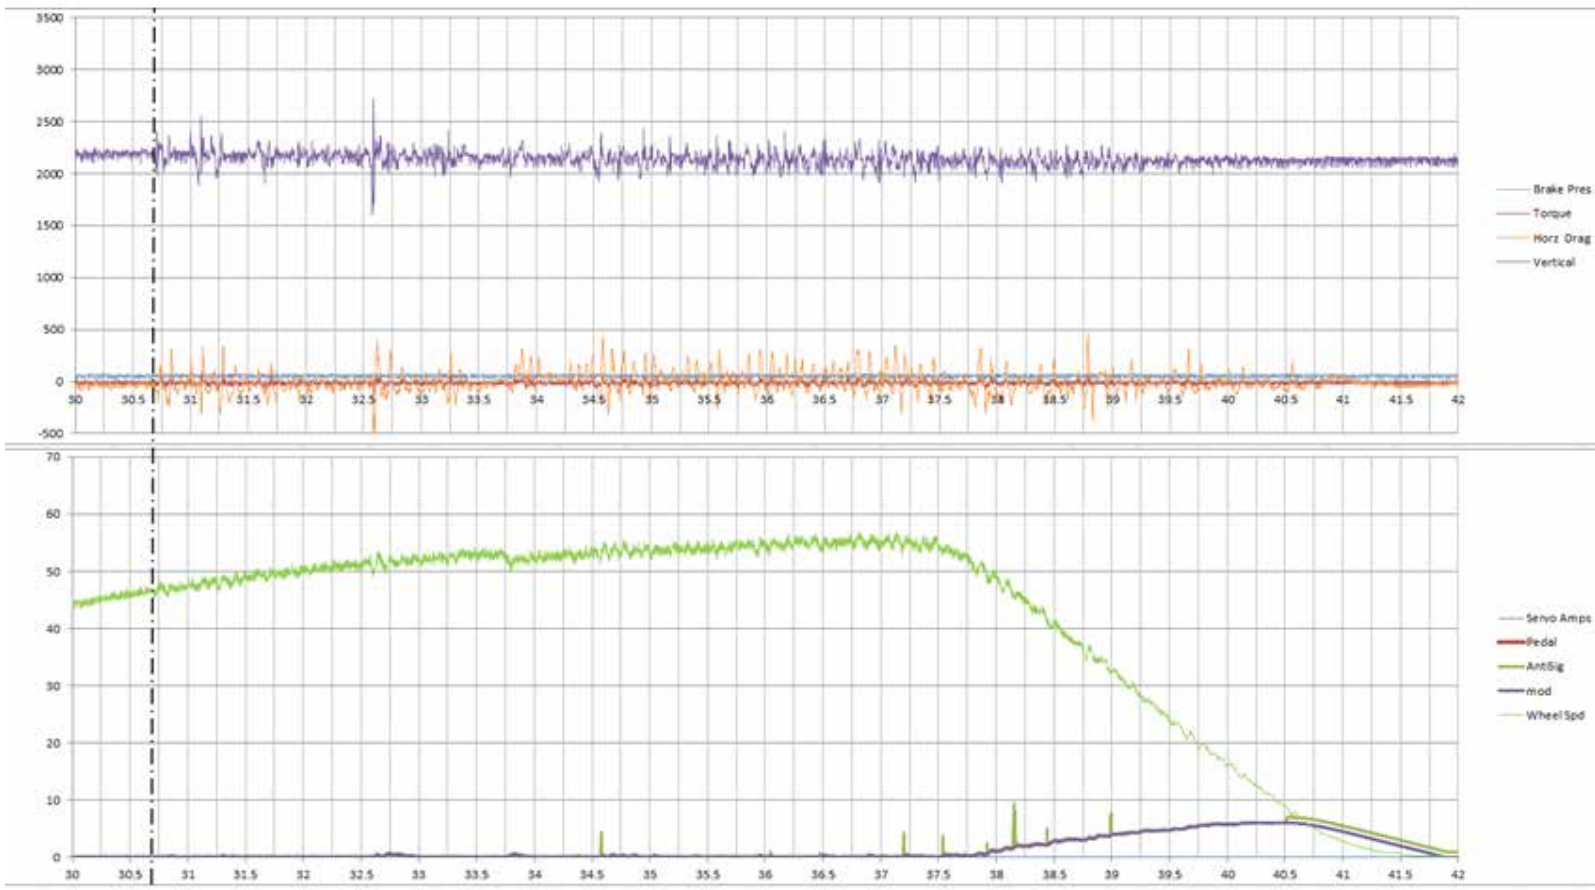
Side	right
Target Speed (fps)	44.1
Vertical load (lb)	Low
Brake (Y/N)	N
Wet/Dry	Dry

Figure C-14. Test Run 13 Data From the BAT Vehicle

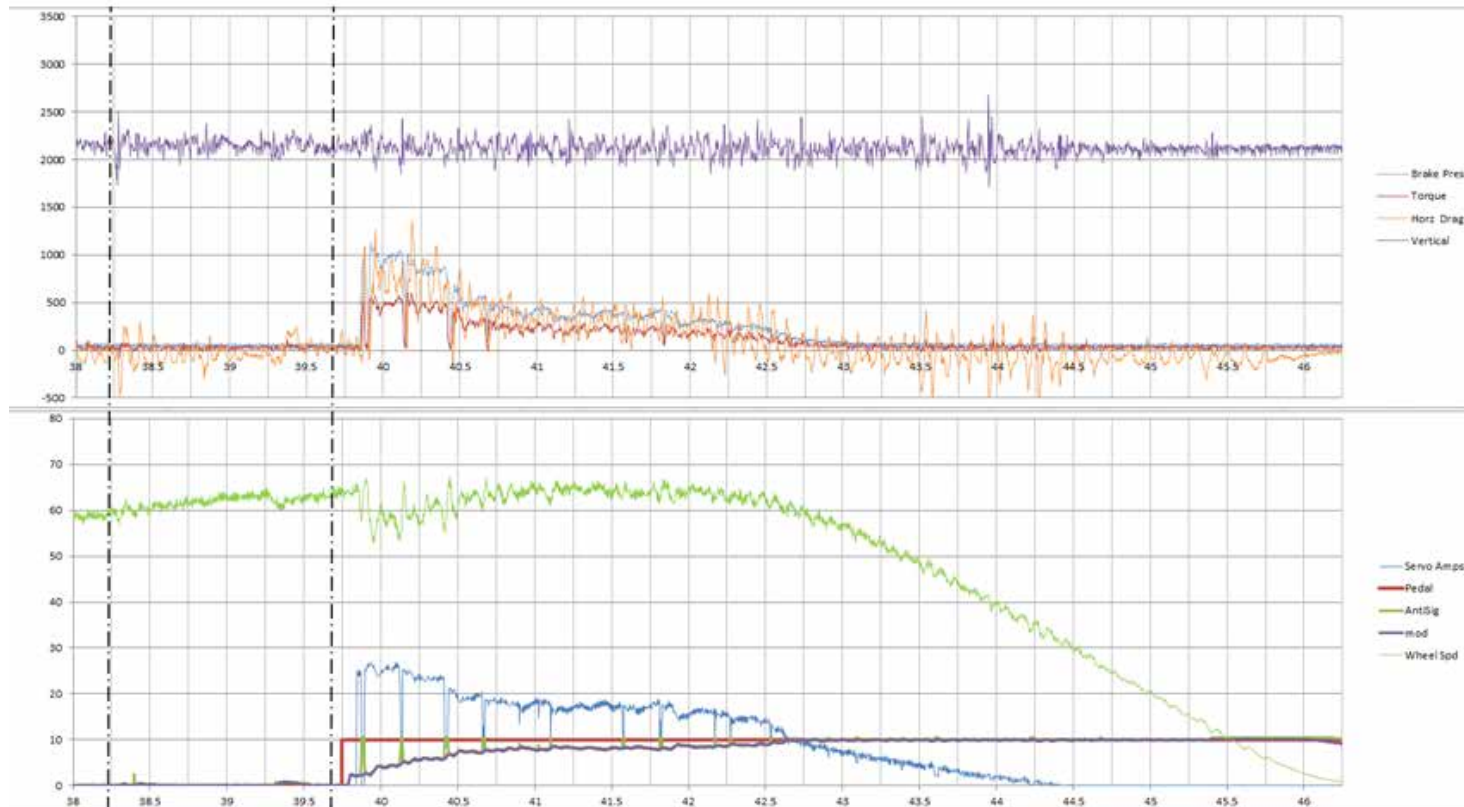
Side	right
Target Speed (fps)	73.5
Vertical load (lb)	Low
Brake (Y/N)	Y
Wet/Dry	Dry

Figure C-17. Test Run 16 Data From the BAT Vehicle
