DOT/FAA/TC-18/2

Problematic Taxiway Geometry Study Overview

January 2018

Final Report

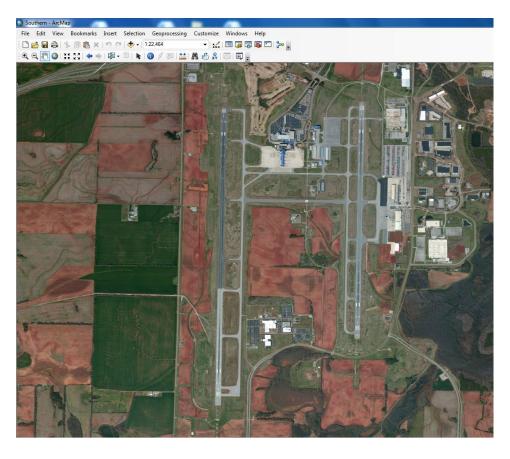
The basemap served as the foundation onto which layers of data were added. This base layer contains the World Imagery hosted by $\operatorname{Esri}^{\text{TM}}$ on $\operatorname{ArcGIS}^{\text{@}}$ Online [8], a sample image of which is shown in figure 1. World Imagery consists of satellite and aerial imagery that is continuously updated at a 0.3-meter resolution for the contiguous United States and at 1-meter resolution or better for the rest of the world.

Figure 1. Basemap Imagery

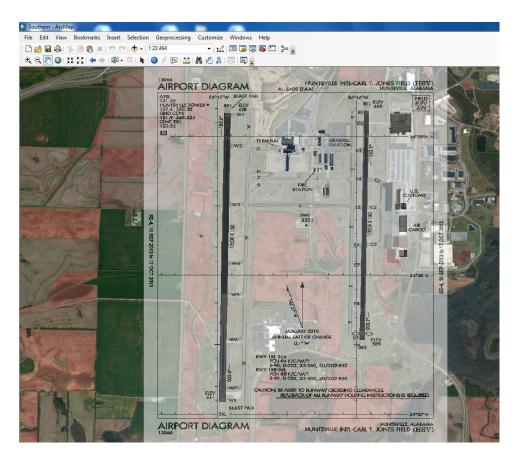
For the next layer, airport diagrams were superimposed on the basemap, as shown in figure 2. The airport diagrams were inserted as raster images and are grouped by individual state. Raster data is the way that GIS displays photographic imagery—as a matrix of cells displayed in a grid. These semitransparent, georeferenced images assist with visually identifying and confirming airport features, such as runways and taxiways, as well as current hot spot locations. To approximate the scale and alignment of the aerial imagery in figure 2, multiple control points were used to match locations on the diagrams with locations on the basemap imagery. In some instances, the airport diagrams depict recently completed airport construction projects, which are not yet reflected in the aerial imagery.

Figure 2. Airport Diagram Depiction

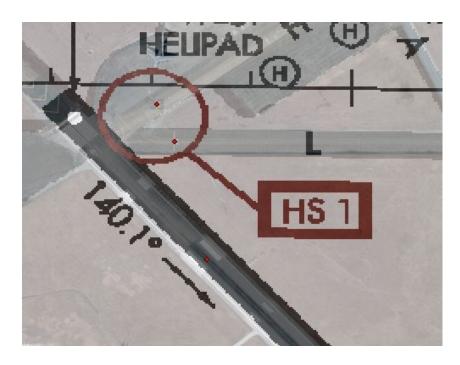
The first type of geometry location point is a hot spot. According to the FAA, areas identified as hot spots often have a history of runway incursions or surface incidents, or are areas known to require increased vigilance from air traffic control. They are designated by local Runway Safety Action Teams (RSAT). RSATs are made up of airport users that meet to discuss safety issues involving moving around the airport and airspace and make recommendations to enhance safety. Hot spots remain charted on the airport diagram until the factors that contribute to the increased risk are mitigated [7]. An example of a hot spot marking, labeled HS 1, is shown in figure 3.

Figure 3. Hot Spot Depiction on Airport Diagram

To georeference existing hot spot locations, points were created in the database and numbered according to the current airport diagram. The three-letter airport identifier was also added to each existing hot spot point (e.g., BWI-HS1).

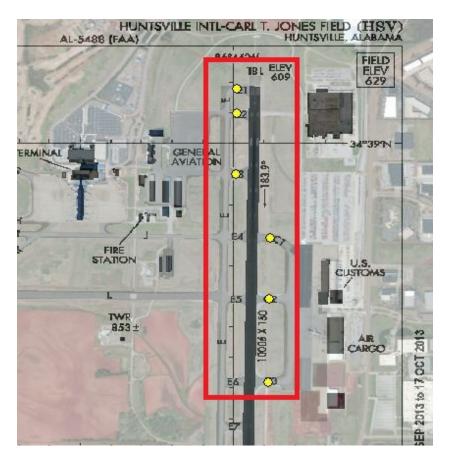
The second type of geometry location point includes all other locations that met the criteria to be considered PTG. This criterion is described in EB 75, and relates to a taxiway's "location, alignment, width, and operational use" [4]. Also referenced were the criteria detailed in the taxiway design standards provided in AC 150/5300-13A [3] and airport geometry data elements identified by the Office of Runway Safety (AJI-14) [9]. This study focused on the guidance-documented PTG, plus other PTG to obtain the 19 most common geometry elements associated with a runway/taxiway intersection, known as geocodes. The points identified as having PTG were depicted as yellow circles when viewed in the geodatabase, as shown in figure 4.

Figure 4. Problematic Taxiway Geometry Locations

PTG points were located by analyzing an airport's diagram and aerial imagery. Where applicable, PTG points were located at the intersection of the runway or taxiway centerline and a runway holding position marking. Each location identified was assigned a code consisting of the airport's three-letter identifier and a sequential number (e.g. ORD-01, ORD-02, etc.).

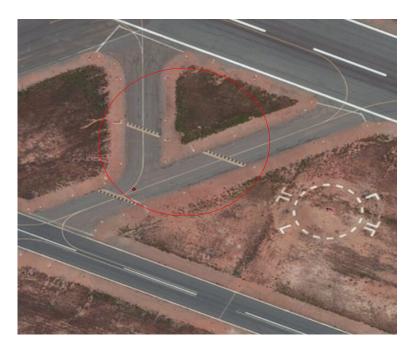
1: Y-shaped taxiways crossing a runway [3]

Multiple taxiway entrances at one runway location, such as Y-shaped connectors, present opportunities for ground navigation errors as a result of wide expanses of pavement, difficulties in reading signage, etc., which promote the potential for runway incursions and for aircraft vacating one runway to enter a wrong taxiway or a different runway [3]. An example of this is shown in figure 5. Limiting the routing options available to pilots on each runway entrance or exit may help to avoid runway confusion.

Figure 5. Y-Shaped Taxiways

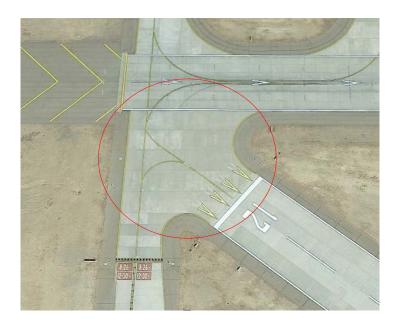
Locations that experience a high frequency of wrong runway landings or takeoffs can also be associated with other airport geometry issues, such as runway thresholds in close proximity, as shown in figure 6.

Figure 6. Runway Thresholds Susceptible to Wrong Runway Landings and Takeoffs

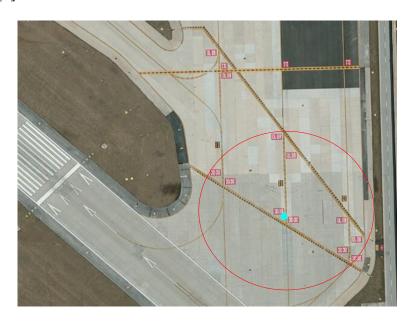
3: Wide expanses of taxi pavements entering or along a runway [4]

Wide pavements typically require nonstandard sign placement with respect to the taxiway centerline, lack of sign placement, and/or further placement of signage from the taxiway centerline than prescribed by the standard. These conditions have the capability to reduce the pilot's ability to see visual cues, especially in low-visibility conditions [4]. Wide pavements are especially critical at runway entrance points, as shown in figure 7 [4].

Figure 7. Wide Expanse of Pavement at Runway Entrance

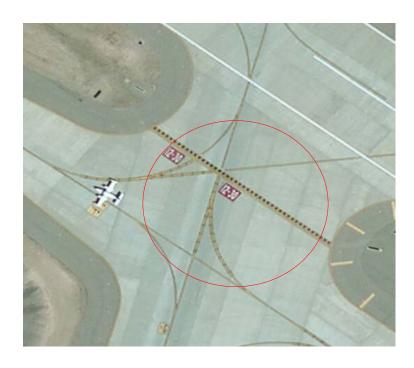
4: Convergence of numerous taxiway types entering a single runway [3]

Taxiway configurations with multiple taxiways entering a runway create large expanses of pavement that make it difficult to provide proper signage, marking, and lighting, as shown in figure 8 [3]. This configuration also violates the three-node concept of taxiway design as described in AC 150/5300-13A [3].

Figure 8. Converging Taxiway Types for a Runway

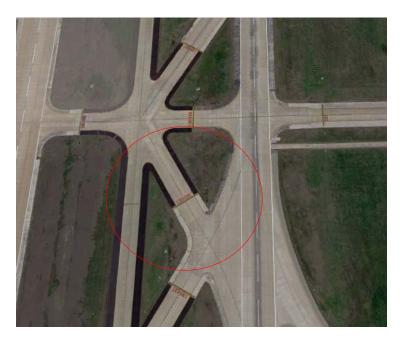
5: High-speed exit crossing a taxiway [4]

A high-speed exit that crosses or connects with another taxiway directly entering a runway can result in a runway incursion, as shown in figure 9 [4]. The main safety issues with this design are the difficulties with marking, signing, and lighting the resultant wide expanses of pavement.

Figure 9. High-Speed Exit Taxiway Crossing

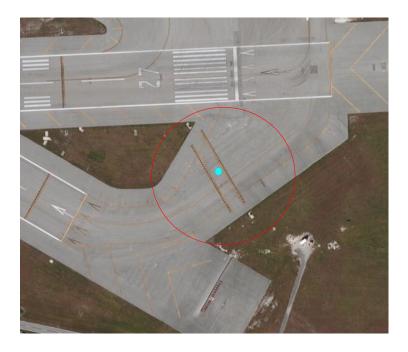
6: Two runway thresholds in close proximity [3]

Configurations where runway thresholds are too close together are not recommended, as shown in figure 10. This type of configuration can be confusing to pilots, resulting in runway incursions, as well as wrong runway takeoffs [3].

Figure 10. Runway Thresholds in Close Proximity

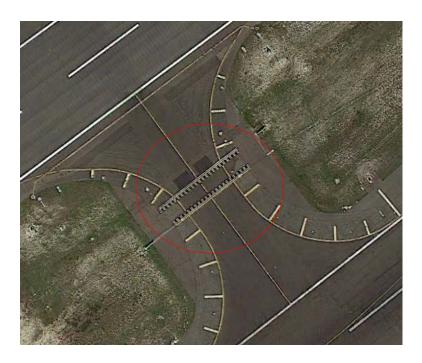
7: Short taxiways (stubs) between runways [3]

Short taxiways between intersecting runways (especially a taxiway within the runway safety area of both runways), as shown in figure 11, can cause aircraft exiting the runway to almost immediately encounter another aircraft in runway holding position. This configuration may not be expected by the pilot, resulting in a failure to hold short and lead to a runway incursion [3]. This same situation may make it impossible to hold aircraft or vehicles between the two runway holding positions.

Figure 11. Short Taxiway Between Runways

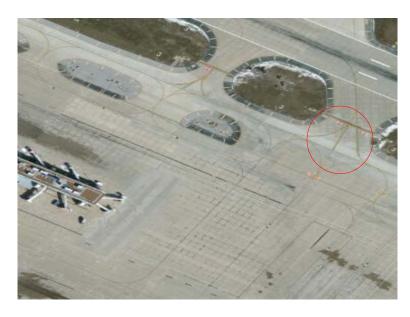
8: Direct taxiing access to runways from ramp areas [3]

Taxiways that lead directly from an apron to a runway, as shown in figure 12, are not recommended. These configurations may create the false expectation of a parallel taxiway prior to the runway (basic design standard), which could lead to confusion and runway incursions [3].

Figure 12. Direct Access to Runway From Ramp

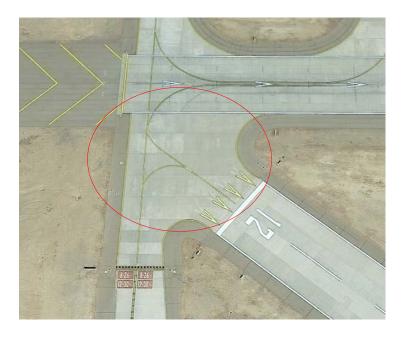
9: An aligned taxiway entering runway ends [3]

An aligned taxiway is one in which the taxiway centerline coincides with a runway centerline [3], as shown in figure 13. These typically occur in areas where the runway end was permanently relocated to a new location and a new perpendicular entrance taxiway was not provided onto the new runway. An aligned taxiway has been shown to cause runway incursions in addition to placing the taxiing aircraft in direct line with an aircraft that may be taking off or landing. The result is the inability to use the runway while the taxiway is occupied, along with the possible loss of situational awareness for the pilot [3].

Figure 13. Aligned Taxiway

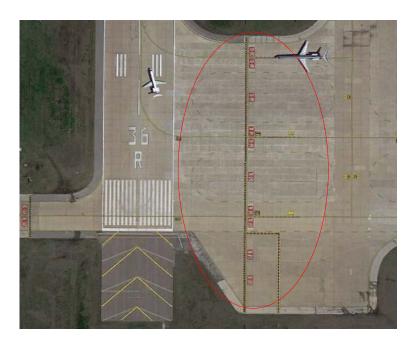
10: Nonstandard markings and/or signage placement [9]

Nonstandard markings and/or signage could include, but are not limited to, overlapping hold bars, nonstandard hold bar placement, and runway intersections with multiple hold lines. Nonstandard location or lack of placement and visibility of the markings, lighting, and signage on taxiways, as shown in figure 14, decreases the pilot's situational awareness within the area/location. [9].

Figure 14. Nonstandard Marking Placement

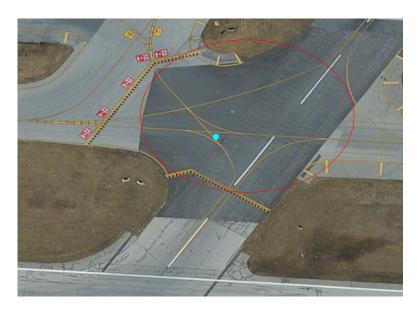
11: Greater than three-node taxiway intersection [3]

All taxiway intersections should be constructed with the three-node design principle in mind [3]. This principle reduces the number of taxiways intersecting in a single location, which allows for proper placement of airfield markings, signage, and lighting. An intersection that has greater than three nodes, as shown in figure 15, is considered problematic. This may lead to pilot confusion and, if located at or near runway entrance points, can lead to incursions [3].

Figure 15. Intersection Greater Than Three Nodes

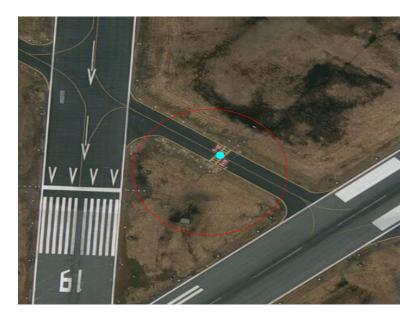
12: Taxiway connection to V-shaped runways [9]

One taxiway leading to an area with multiple runway thresholds located in close proximity to one another, as shown in figure 16, can result in hold lines in short proximity. This can result in a failure to hold short and a runway incursion [9].

Figure 16. Taxiway Connecting V-Shaped Runways

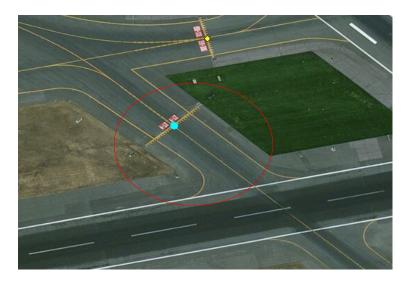
13: Taxiway intersect runway at other than a right angle [3]

Right-angled intersections are the standard design for all taxiway/runway entrance intersections [3]. Right-angled intersections provide the best visual perspective to a pilot of the entire runway (left and right) when approaching the intersection [3]. If a taxiway intersects a runway at any angle other than a right angle, as shown in figure 17, the chance of a landing/departing aircraft colliding with an errant taxiing aircraft (runway incursion) increases [3].

Figure 17. Taxiway Intersecting Runway at Other Than a Right Angle

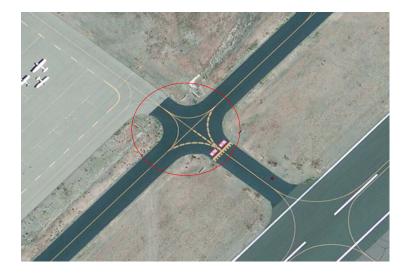
14: Short taxi distance from ramp/apron area to a runway [9]

A short taxi distance, compared to a direct ramp-to-runway configuration, between the terminal and the runway requires pilots to complete the same number of checklist items in a shorter timeframe than longer taxi routes. Therefore, during the head-down period, the pilot(s) may taxi through the runway hold line (loss of pilot's situational awareness) [9]. An example of this type of geometry is shown in figure 18.

Figure 18. Short Taxi Distance to Runway From an Apron

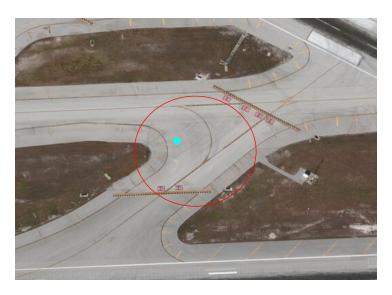
15: High-speed exits leading directly onto another runway [4]

A high-speed exit taxiway that provides a direct route from one runway across another runway is especially problematic, particularly for closely spaced runways and dual visual runways [4]. Exiting aircraft may have little to no time to position themselves before

crossing the adjacent runway's hold line. This configuration, as shown in figure 19, has resulted in runway incursions.

Figure 19. High-Speed Exit Leading Directly to Another Runway

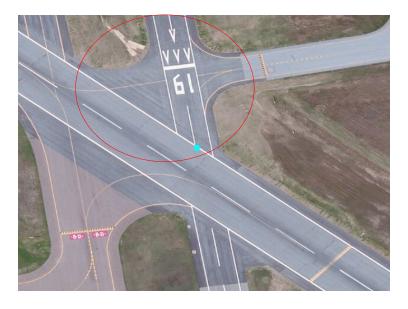
16: Taxiway coinciding with the intersection of two runways [3]

Taxiway configurations where a single taxiway enters a multiple runway intersection in a single area, as shown in figure 20, can create various difficulties. Large expanses of pavement may make it difficult to provide proper placement of signage, marking, and lighting [3]. In addition, this may be a contributing factor in wrong runway takeoffs.

Figure 20. Taxiway Coinciding With Intersection of Two Runways

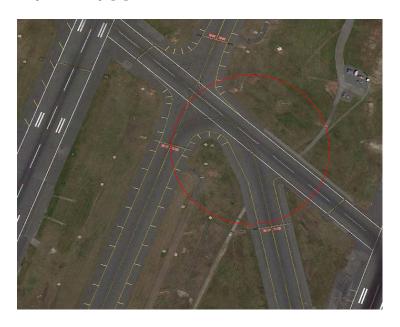
17: Use of a runway as a taxiway [3]

Runways used as taxiways, as shown in figure 20, can lead to confusion, wrong runway takeoffs, or runway incursions. A runway should always be clearly identified as a runway and only a runway [3].

Figure 21. Using a Runway as a Taxiway

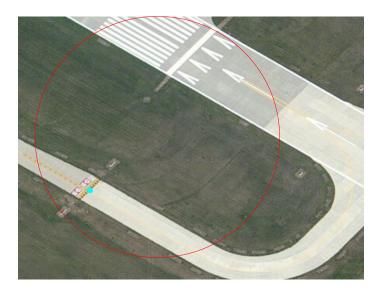
18: Displaced threshold with holding position marking on parallel taxiway [3]

This placement is unexpected by the pilot and may cause the pilot to ignore/not expect the hold position point, resulting in a possible runway incursion. An example of a problematic displaced runway threshold is shown in figure 22.

Figure 22. Displaced Threshold With Holding Position Marking on Parallel Taxiway

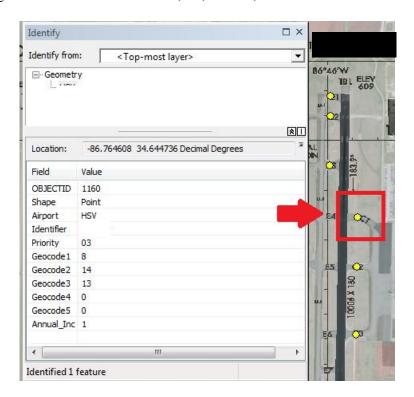
As an example, in the case of the PTG location shown in figure 23, three different geocodes were applied. These geocodes include numbers 8, 14, and 13, as shown in table 1.

Figure 23. The PTG Location Attribute Table With Associated Geocodes

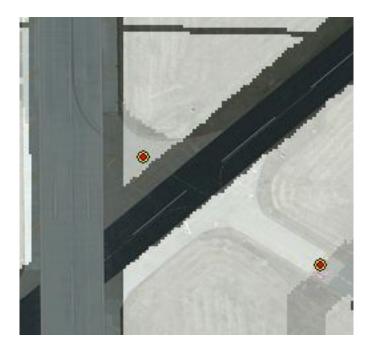
The initial geodatabase included all PD and V/PD runway incursions and surface incidents reported between October 1, 2007 and September 30, 2013 at NPIAS-towered airports. Each incident point corresponds to a runway incursion or surface incident report. An example of how runway incursions are depicted in the geodatabase is shown in figure 24.

Figure 24. Runway Incursion Depiction in Geodatabase

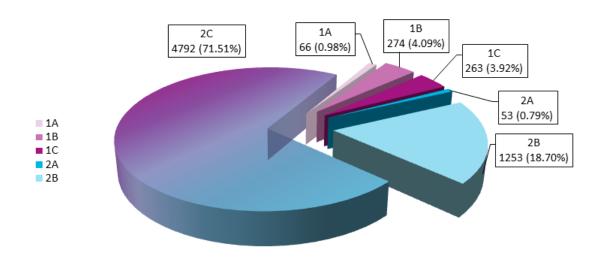
A total of 5099 r unway incursions were georeferenced along with 6701 PTG points at 516 NPIAS-towered airports. For the purpose of this analysis, surface incidents were removed. The final distribution of the PTG points, according to the six categories outlined in section 5.2, is shown in figure 33. Of the 603 hot spots included in the study, 263 hot spots fell within Category 1C with no associated incidents. Of the remaining 358 hot spot locations with associated incidents, 274 had a peak annual incident rate of 1 or 2 reported events (Category 1B) and 66 had a peak annual incident rate of 3 or more reported events (Category 1A).

The remaining 6098 PTG points that were not hot spots contained 4792 locations that had no associated incidents (Category 2C). Of the remaining non-designated hot spot PTG points, 1253 had a peak annual incident rate of either 1 or 2 reported events (Category 2B) and 53 had a peak annual incident rate of 3 or more reported events (Category 2A).

Figure 33. Geometry Location Points Category Distribution

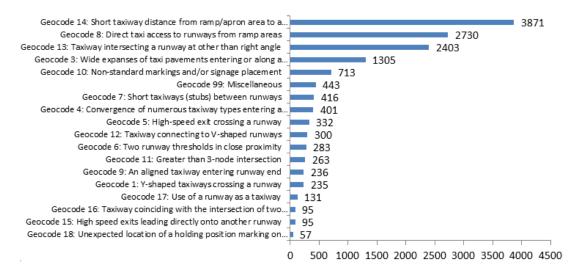
The geocodes assigned to each geometry location were analyzed to determine their relative levels of frequency in the database and their role in runway incursion frequency. Of the geocodes (section 4.3.2) assigned to the existing hot spot and other non-hot spot problematic geometry locations, several codes stand out as the most frequently occurring, as shown in figure 34. These include short taxiway distances from the ramp/apron to a runway

(3871 locations—Geocode 14), direct taxi access from the ramp/apron area to a runway (2730 locations—Geocode 8), taxiways intersecting runways at less than a right angle (2403 locations—Geocode 13), and wide expanses of taxi pavements entering or along a runway (1305—locations Geocode 3).

Figure 34. Geocode Occurrences at Inventoried Locations for all Categories

The most frequently occurring geocodes were generally associated with the highest number of PD and V/PD runway incursions in absolute terms. For example, as shown in figure 35, locations identified as having a short taxi distance from ramp/apron area to a runway or direct taxi access to runways from ramp areas experienced the highest number of runway incursions (2135 and 1508, Geocodes 14 and 8, respectively). Locations can be identified by up to five geometry types; hence, figures 34 and 35 sum to a number greater than the total number of runway incursions in the database.

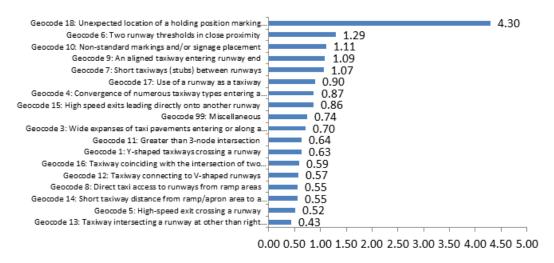
Figure 36. Runway Incursion Rate of Each Geometry Type for all Categories

To determine the relationship between the geocodes at a location to the number of PD and V/PD runway incursions occurring there, the incursion totals were divided by the number of locations exhibiting the geometric characteristics. Using this criterion, an unexpected location of a holding position marking on a parallel/entrance taxiway was associated with the highest rate of incidents (4.30 per location on average), as shown in figure 36.

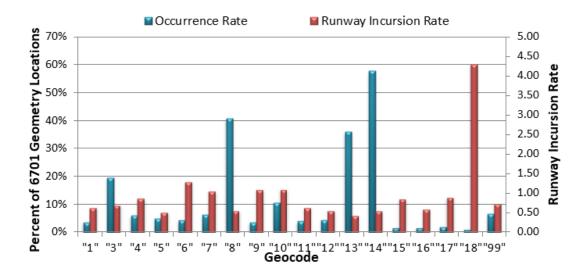
Figure 37. Geocode Occurrences Versus Runway Incursion Rate for all Categories

Figure 37 compares the geocode occurrences versus runway incursion rate. Similar to the analysis of all incursion types, despite being the most infrequently identified geometry types (identified at less than 1% of geometry locations), Geocode 18, representing locations with an unexpected location of a holding marking on a parallel or entrance taxiways, was associated with the highest rate of incursions (4.30 per location). In contrast, the data showed that although Geocode 14, representing short taxi distance from ramp/apron area to a runway, had the highest rate of occurrence at 58% of geometry locations, it had the third lowest runway incursion rate at 0.55 incursions per location, as shown in figure 38.

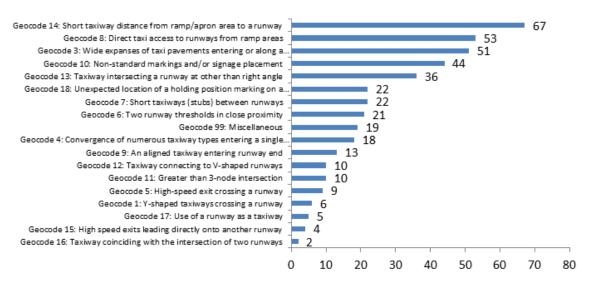
Figure 38. Geocode Occurrences at Inventoried Locations for Categories 1A and 2A

A filter was applied to examine the higher-incident areas where PD and V/PD runway incursions occurred. The locations listed as either 1A (66 existing hot spots) or 2A (53 other non-hot spot PTG locations) made up the 119 locations with the highest peak annual incident occurrence rates. The most common geocodes included the same two geocodes for the whole runway incursion analysis, Geocodes 14 and 8. The third most common geocode was wide expanses of taxi pavements entering or along a runway (Geocode 3), as shown in figure 38.

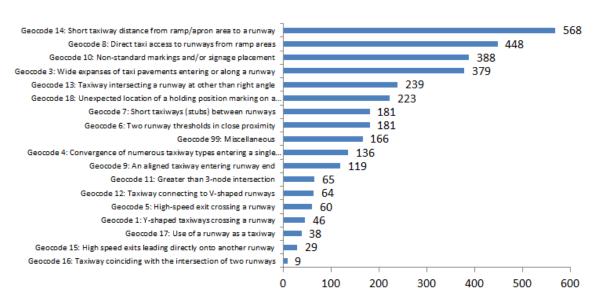
Figure 39. Runway Incursions Associated With Each Geocode for Categories 1A and 2A

Figure 39 shows the total number of runway incursions for PTG locations categorized as 1A and 2A.

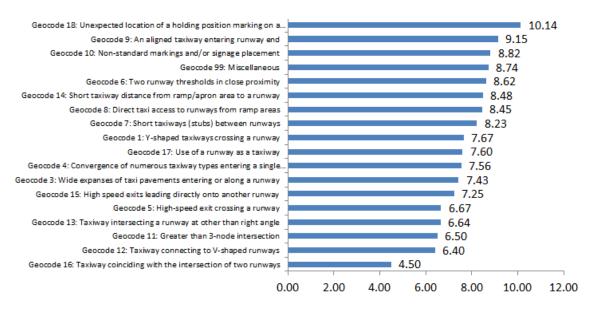
Figure 40. Runway Incursion Rate of Each Geometry Type for Categories 1A and 2A

Figures 40 and 41 show the relationship of the occurrence rate for the individual types of geocodes. Data indicated that the incident rates of geocodes at the 119 high-incident category locations differed from the overall runway incursion rates for all locations. As shown in figure 40, locations with unexpected holding position markings on a parallel/entrance taxiway, Geocode 18, had the highest incident rate (10.14 per location). The next highest incident rates were not much less: Geocode 9, aligned taxiways entering runway ends, was 9.15; and Geocode 10, nonstandard markings and/or signage placement, was 8.82. It should be noted that figure 40 is a ranking and does not indicate that the features with an associated low-incident rate are less important.

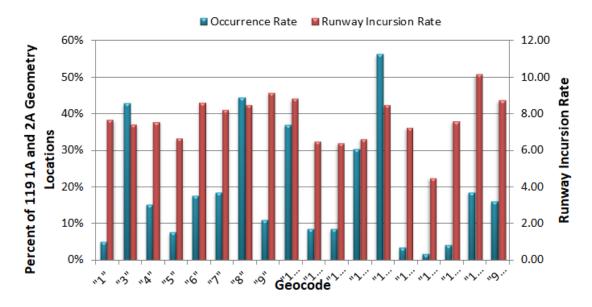
Figure 41. Geocode Occurrences Versus Runway Incursion Rate for Categories 1A and 2A

Figure 41 compares the percentages of locations labelled with each geocode to the average number of incidents (rate) associated with the codes for high-incident locations (categorized as 1A and 2A). This figure shows that some geocodes with comparatively low occurrence rates can have higher incident rates than other geocodes with a much higher occurrence rate. For example, Geocode 9 (a taxiway aligned with a runway end), was identified at only 11% of 1A and 2A locations, but 119 runway incursions were associated with this geometry type. This resulted in an average runway incursion rate of 9.15 incursions per occurrence. Geocode 14 by contrast (short taxiway distance from ramp/apron to a runway entrance), which had more runway incursions in absolute terms (568), has a lower overall average of 8.48 per occurrence since many occurrences did not result in runway incursions. Therefore, geocodes with higher runway incursion rates are more severe with respect to the probability of a runway incursion.
