U.S. Department  
of Transportation  
**Federal Railroad  
Administration**

## Revenue Service Evaluation of a Truck Component Inspection System

**REPORT DOCUMENTATION PAGE**

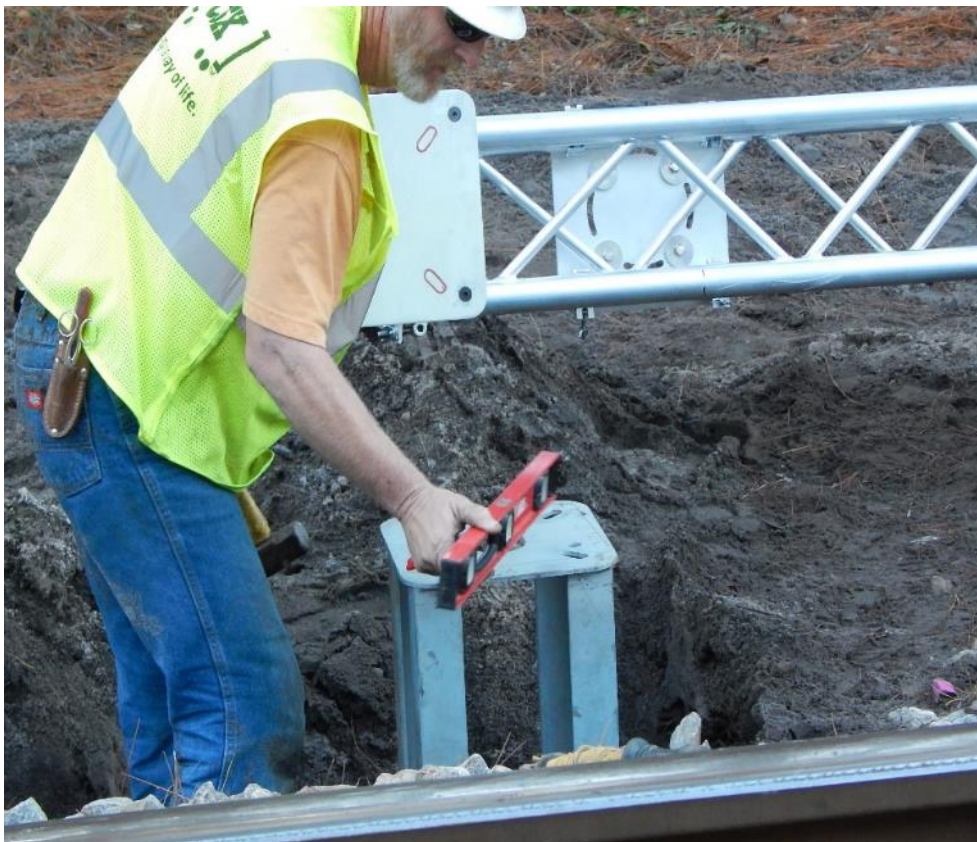
Per the KLD requirements, CSX installed pylons beside the track to provide a foundation for the equipment stanchion. The type of pylon selected did not require concrete. Instead, a hole was dug and the pylon was driven into position. [Figure 1](#) depicts installation of the pylons.

**Figure 1. Installation and Leveling of the Foundation Pylons for the Camera Stanchions**

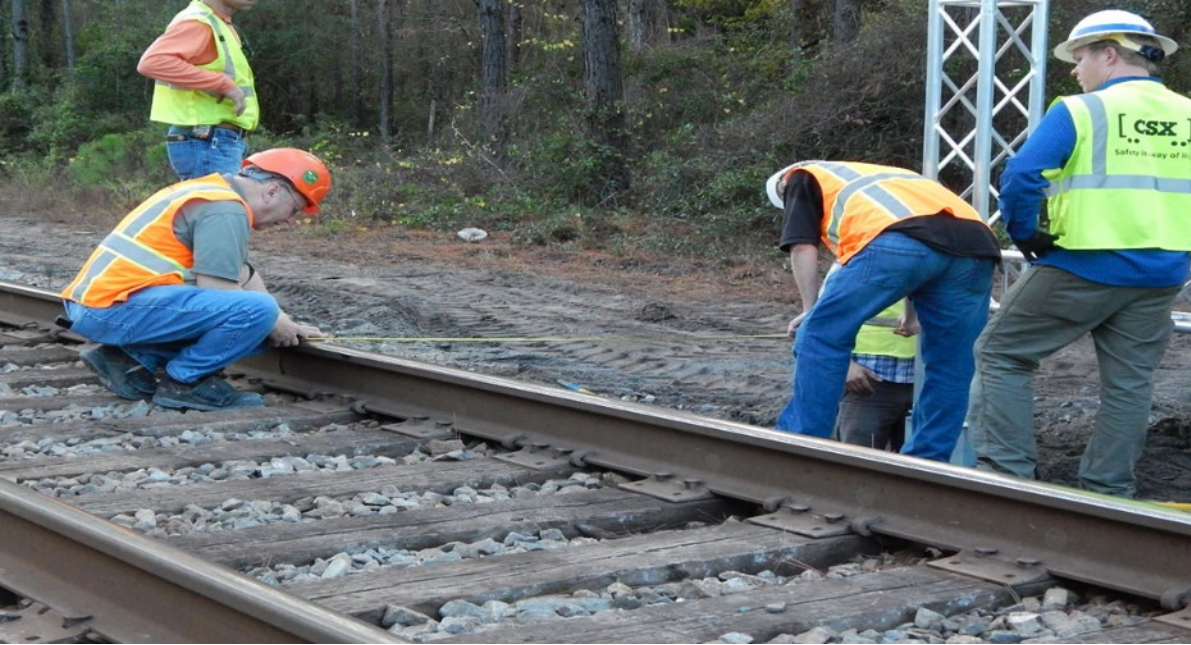
After backfill, the stanchions were positioned for installation on the pylons. Distance to the track must be known precisely so that component sizing is accurate within the images. [Figure 2](#) shows the installation team positioning the stanchions prior to bolting them down.

**Figure 2. Installation Team Positioning Stanchions**

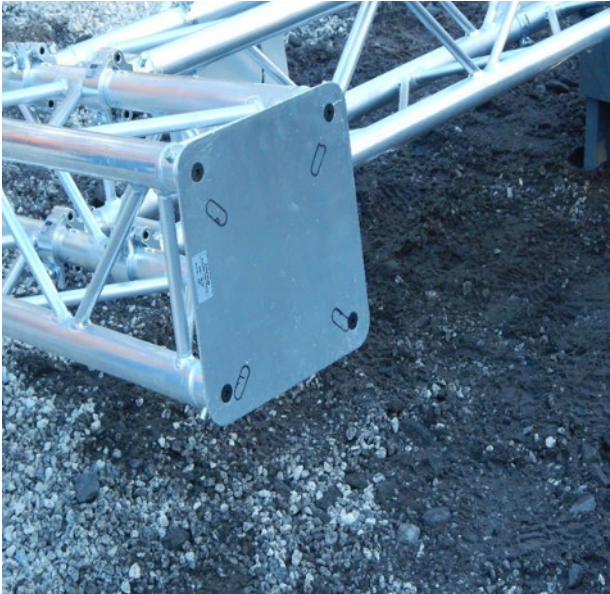
Once the stanchions were situated, the bases were marked so holes could be drilled in the required location. [Figure 3](#) shows the markings.

**Figure 3. Bases Marked and Holes Drilled to Maintain the Exact Distance from the Rail**

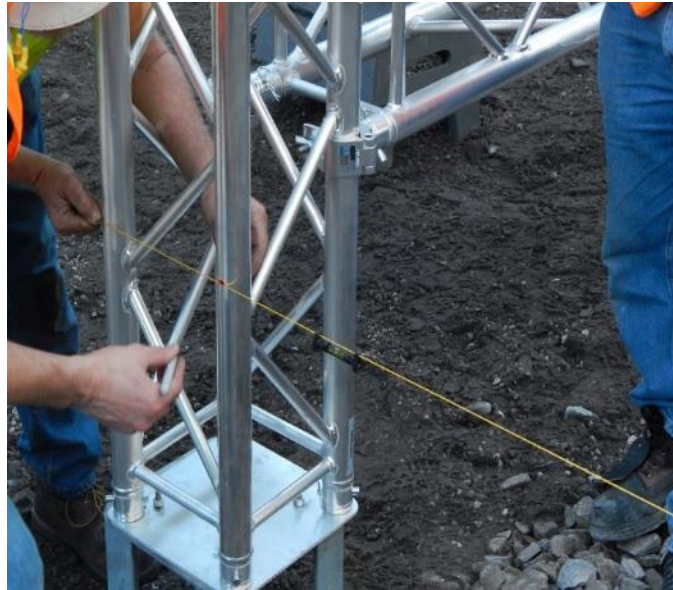
Distance from the rail head to the top cross member was determined using a string line. The stanchion was then marked for the required camera height. [Figure 4](#) shows the marking of camera height.

**Figure 4. Camera Height Set a Known Distance above the Rail**

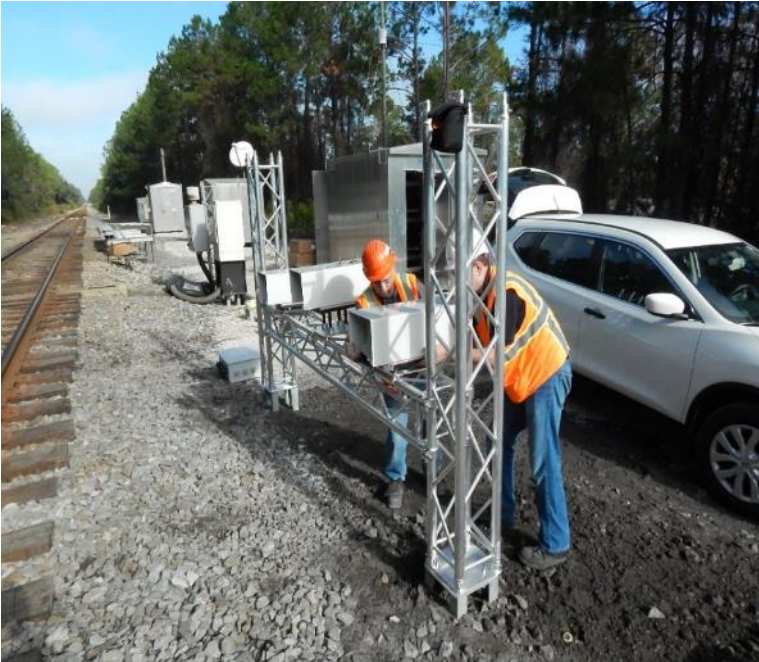
Figure 6 shows workers installing the cameras on one side of the track. The control bungalow is visible in the background.

**Figure 6. Installation of Axle-level Cameras at Hague Site**

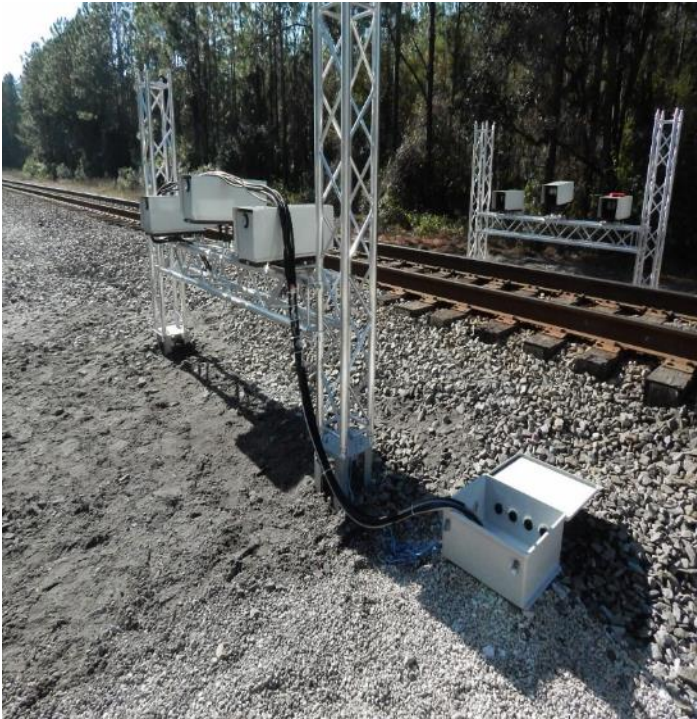
Figure 7 shows an image of the nearly completed system, with cameras mounted on both sides of the track.

**Figure 7. Nearly Completed System Showing All Cameras in Position**

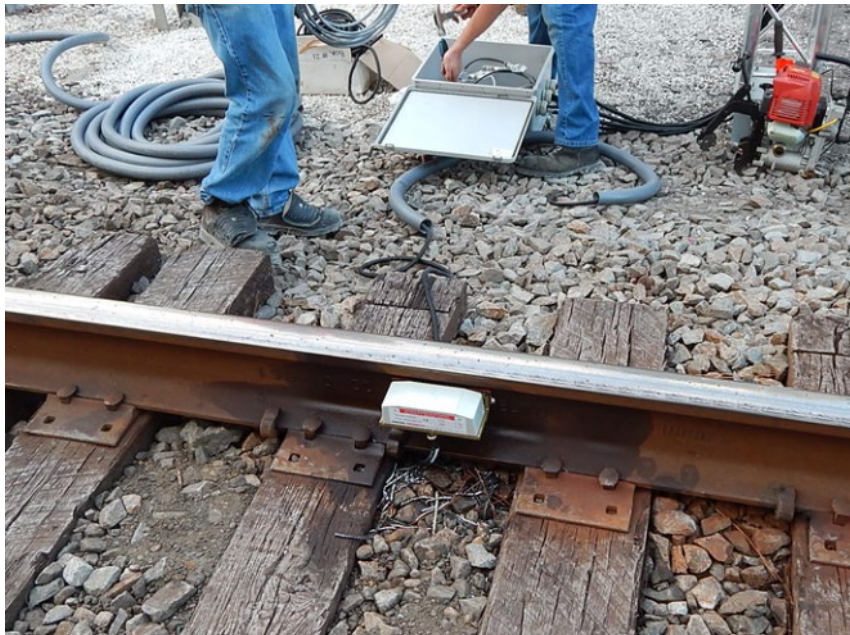
Precise triggering of the cameras is required to assure the components are centered in the camera view. Triggering is provided by wheel sensors mounted to the rail. Holes were drilled and the sensors mounted on each rail. [Figure 8](#) shows the sensors mounted to the near rail.

**Figure 8. Wheel Sensors Mounted on Each Rail for Precise Triggering of Cameras**

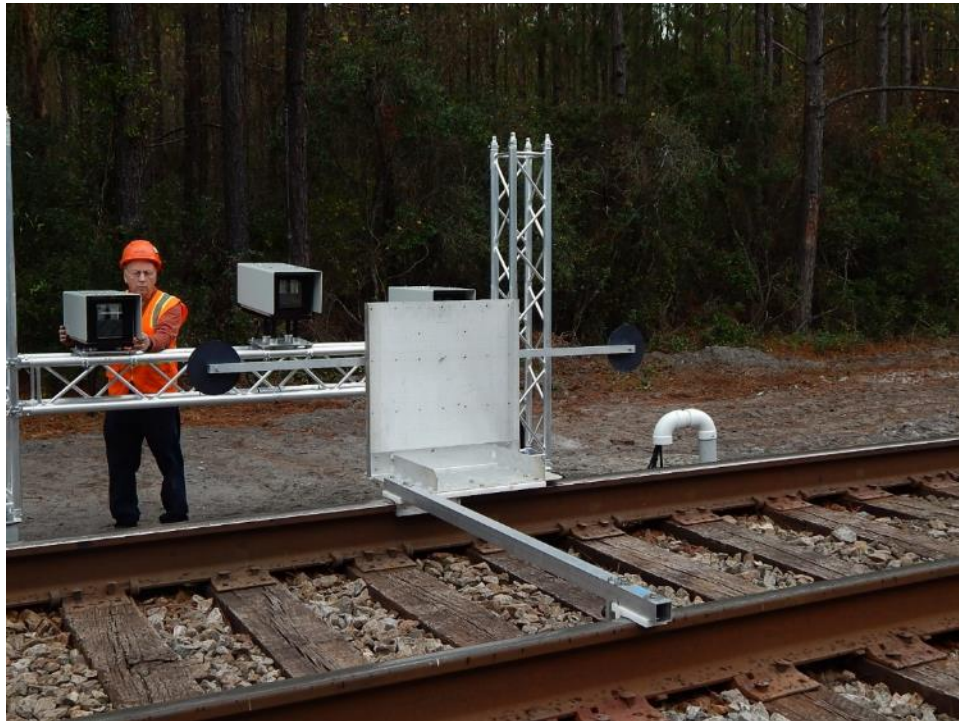
Adjustments were made until the target sizing and placement in the image was correct. [Figure 11](#) shows the workman adjusting the camera aim.

**Figure 11. Cameras Adjusted to Align the Image in the Camera Field of View**
