Re-rounding of Deflected Thermoplastic Conduit, Phase 2

Prepared for
The Ohio Department of Transportation
Office of Statewide Planning and Research

June 2021

Final Report

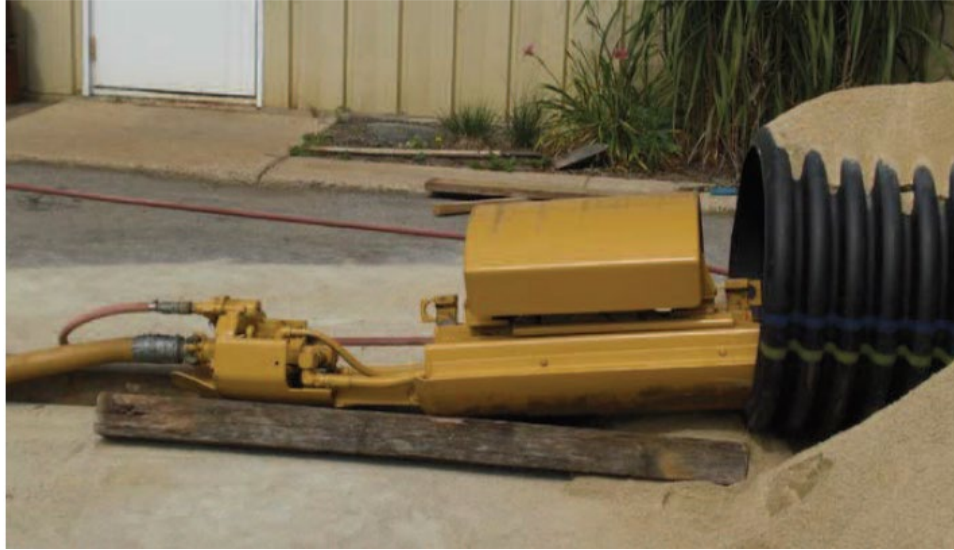
Figure 1. Pipe re-rounding device at pipe entrance [ADS, 2009].

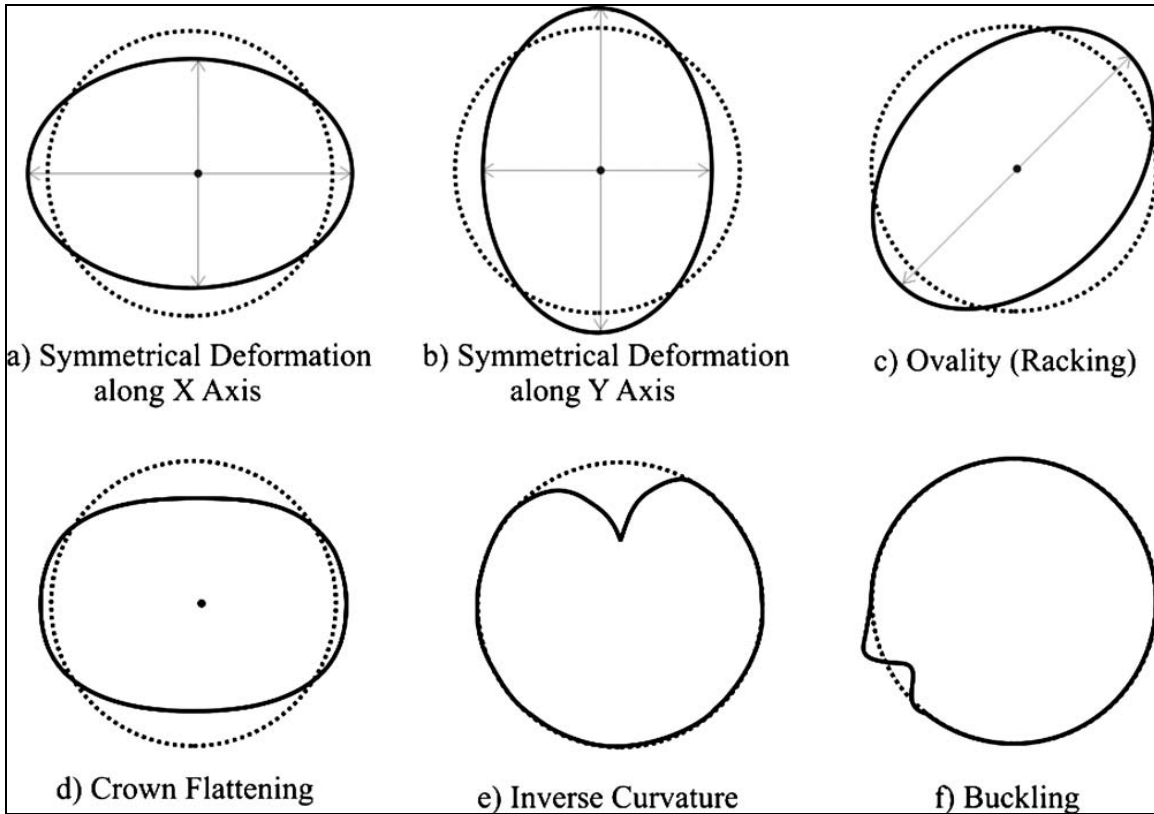
According to a study by Motahari and Abolmaali [2009], HDPE pipe deformations can be classified into six different shapes as shown in Figure 2: (a) Symmetrical deformation along the horizontal x-axis, (b) Symmetrical deformation along the vertical y-axis, (c) Ovality or racking deformation, (d) Crown flattening, (e) Inverse curvature, (f) Buckling.

Figure 2. Different types of pipe deformations [Motahari and Abolmaali, 2009].

Motahari and Abolmaali [2009] describe each type of deformation. Symmetrical deformation along the horizontal x-axis occurs when the loads are transferred to the plastic pipe from the soil fill above, causing the pipe to deform and elongate the diameter along the horizontal x-axis. On the other hand, symmetrical deformation along the vertical y-axis occurs when the soil is compacted from the sides, which applies horizontal pressure on the pipe, elongating the diameter along the y-axis. Ovality deformation takes place when the pipe diameter deforms in a diagonal direction, which is also known as racking. Crown flattening deformation depends on the load type and how the backfill soil was compacted; these factors cause the crown of the culvert to flatten and deflect downward. Inverse curvature or “snap through” occurs when the pipe deforms into a reversed shape due to loss of stability, which forces the pipe into tensile strain instead of compressive strain. The last deformation type is called buckling or “out-of-plane deformation” and occurs when the pipe undergoes large circumferential stresses, causing longitudinal and/or radial waves to appear on its surface.

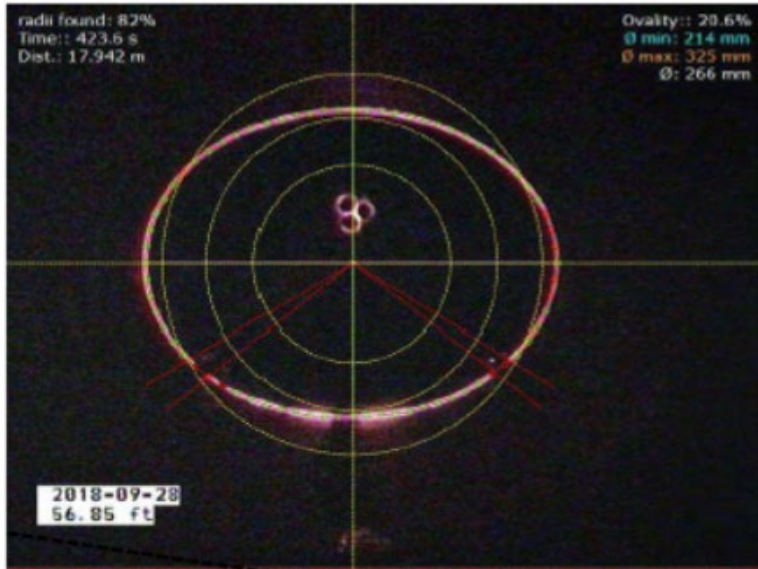
A remote video inspection and laser profile were performed by the contractor on September 28, 2018. The cross-section taken at the location of maximum vertical deflection is shown in Figure 7. The vertical deflection at this location is estimated to be in excess of 15%.

Figure 7. Maximum vertical deflection of conduit along IR 75 in Toledo.

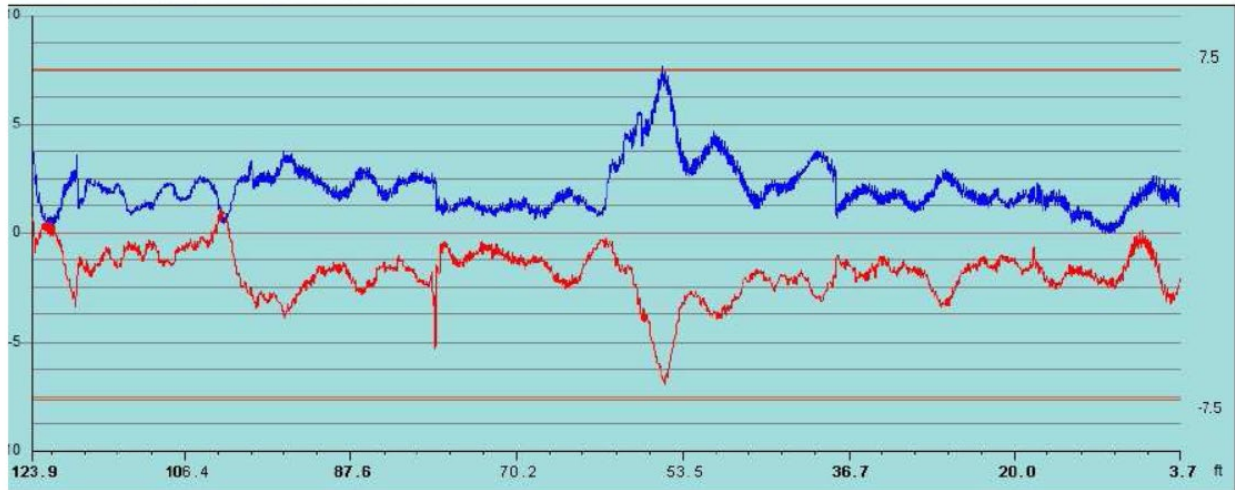
The contractor performed a post-re-rounding laser scan of the conduit on December 6, 2018. The profile plot of the re-rounded conduit is provided in Figure 9. The measurements show a maximum vertical deflection immediately after re-rounding of 7.5%.

Figure 8. Conduit profile report immediately after re-rounding, showing maximum deflection after re-rounding of 7.5%.

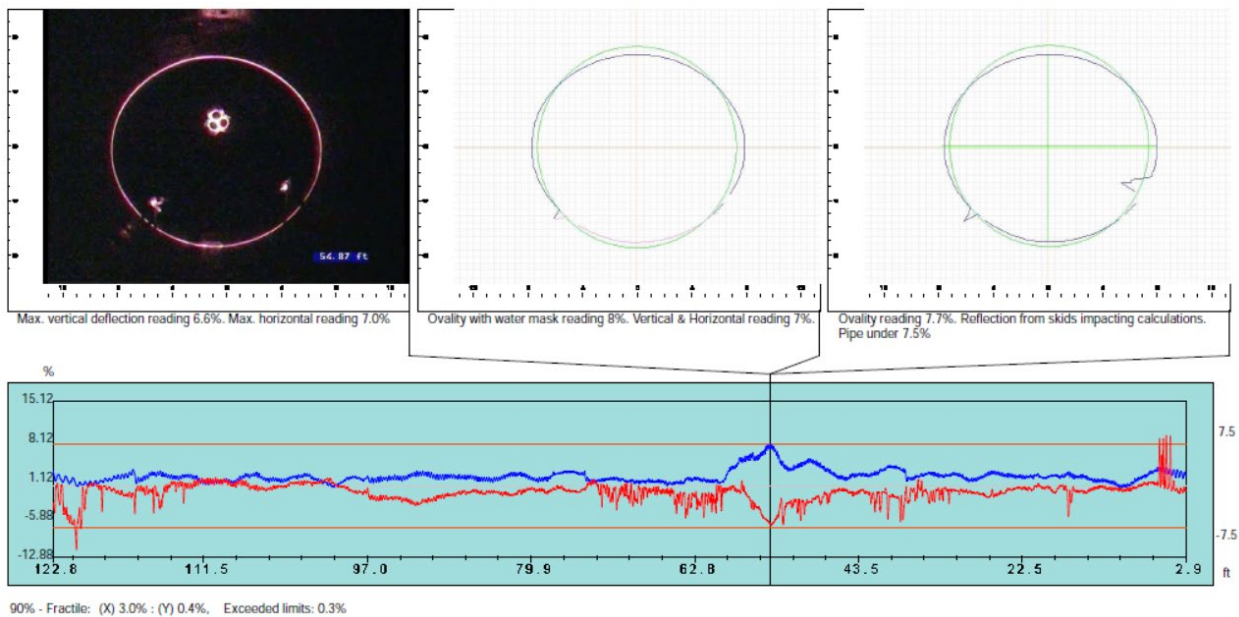
The contractor followed up with another video inspection and laser profile on May 21, 2019, approximately 6 months after the conduit was re-rounded. The results of the profilometer showed a maximum vertical deflection of 7%. The profile report for the conduit is provided in Figure 9.

Figure 9. Conduit profile report 6 months after re-rounding. The maximum deflection is 7%, as shown in the profile at top center.

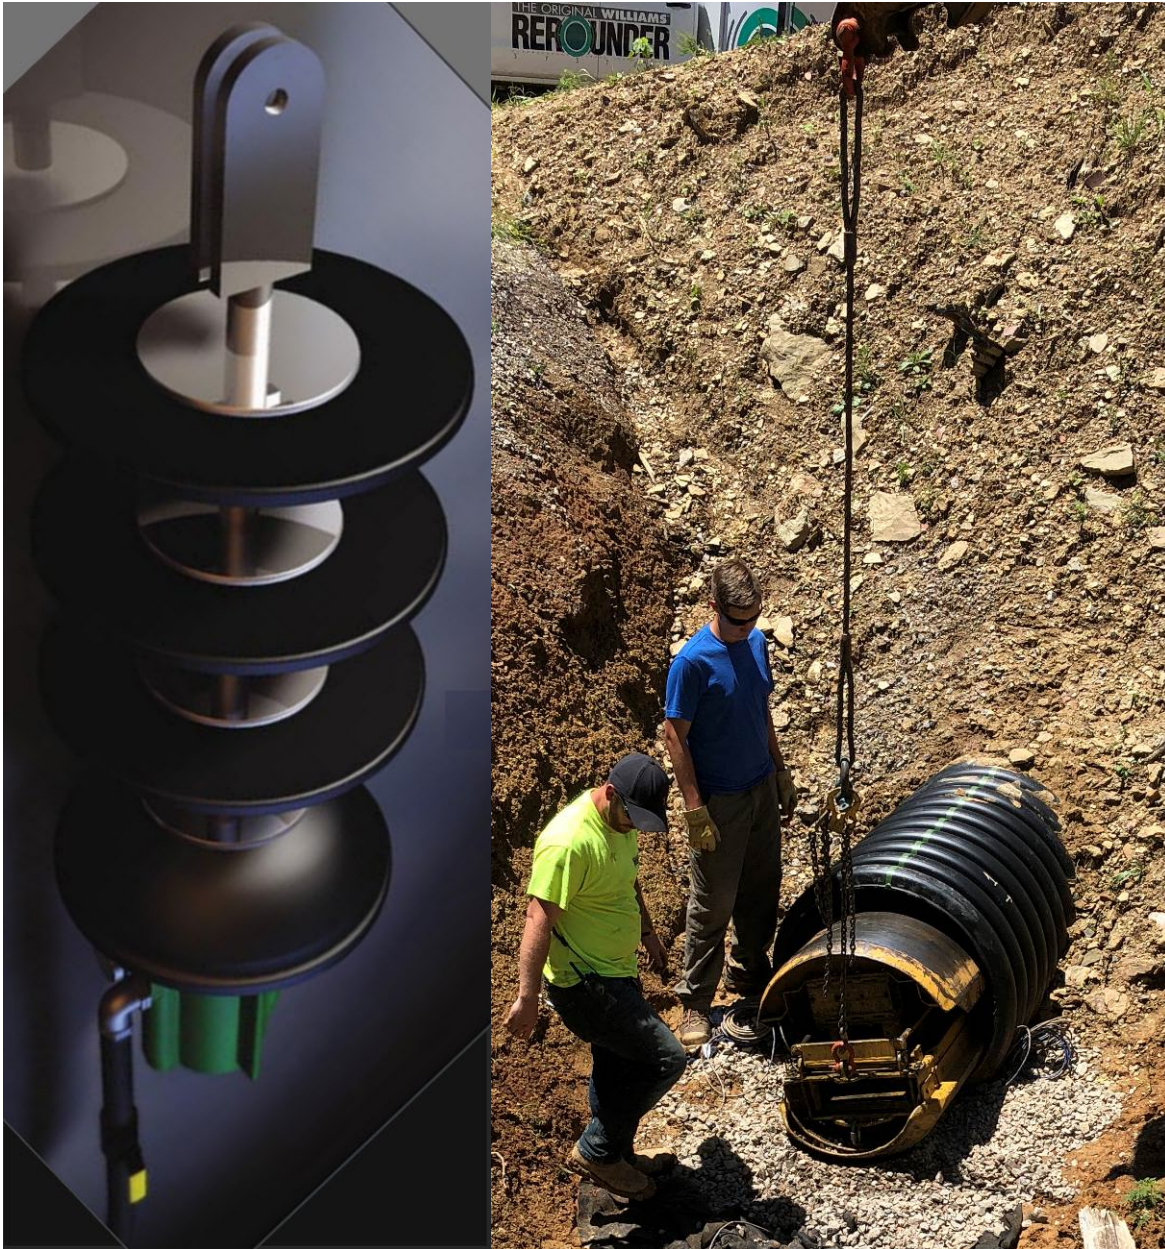
Figure 13. Re rounding devices: Hurco Re-rounder™ (left, adapted from Hurco brochure [Hurco, 2005]) and Williams re-rounding device in 36 in (0.9 m) diameter pipe (right).

There are two companies who perform re-rounding work in Ohio, Drier and Maller, Inc. of Reynoldsburg who employ technology developed by Hurco Technologies of Harrisburg SD, and Williams Testing, Inc., of Harrod OH, who use equipment they developed [Sargand et al., 2017b]. The Williams device is comprised of two semi-circular plates which are pushed against the crown and invert of the pipe while the plates are vibrated via an eccentric vibrator. The Hurco device is a series of increasing diameter mandrels placed along a rod which is pulled through the pipe while vibrating. These devices are depicted in Figure 13.

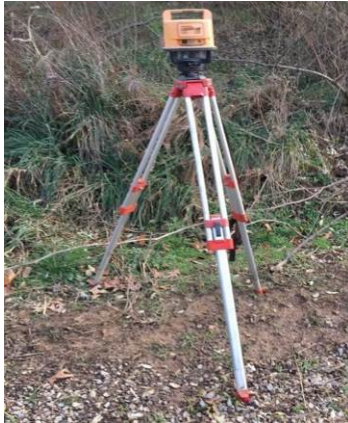
Figure 16. Spectra Physics Laserplane 220.

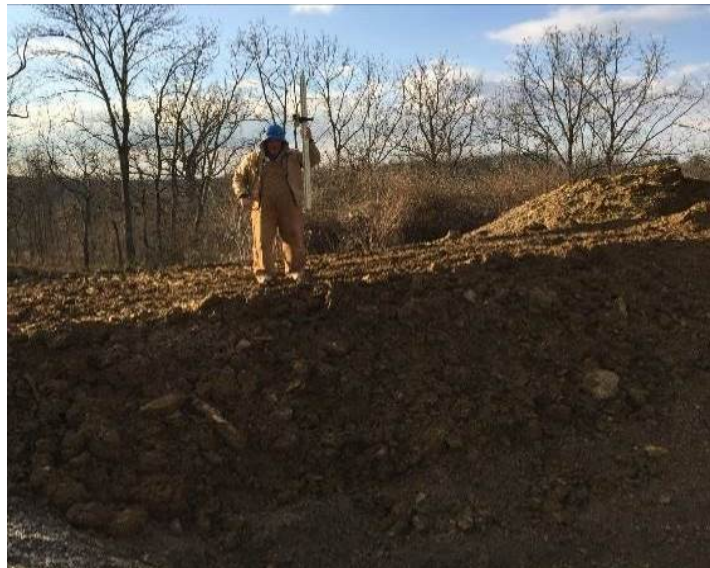
Figure 17. Rod being held during backfill height measurement by laser plane.

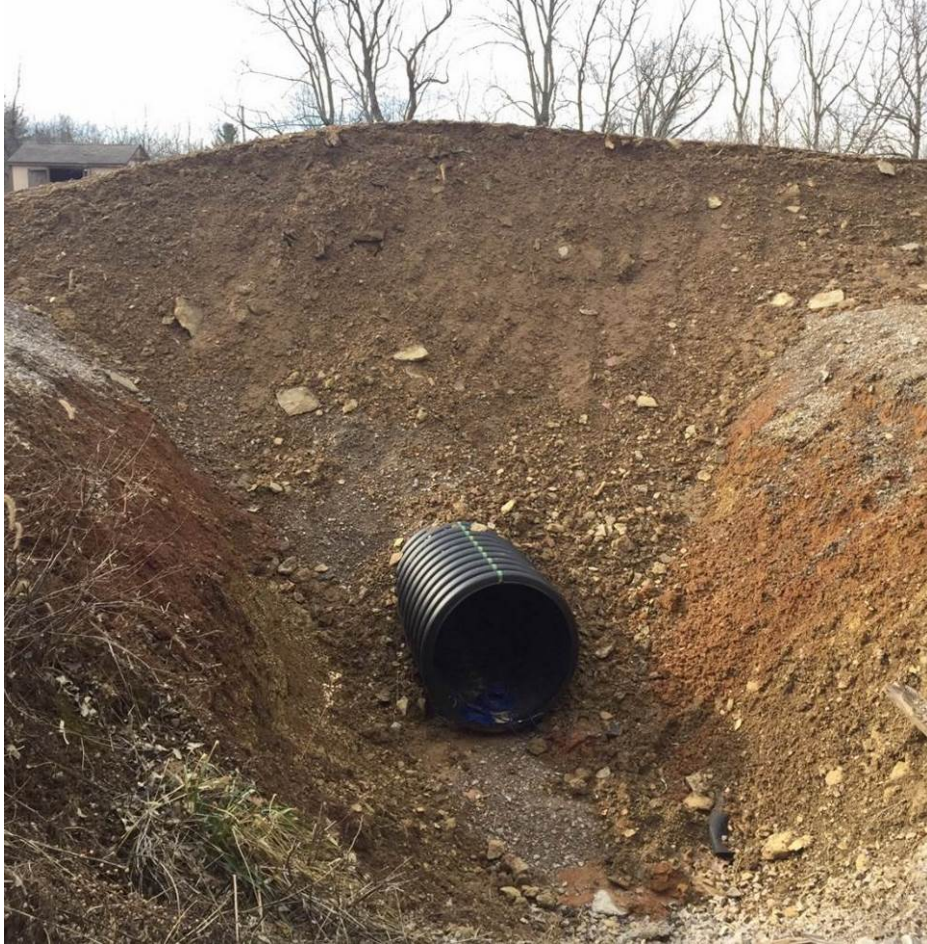
Figure 18. Completed installation.

was used to press down on the installation to force the deflection. The final installation is shown in Figure 18.

Six inches (0.15 m) of compacted ODOT Type 2 sand was prepared as a bedding (see Figure 17) for the installation of Pipe 2. The full conduit was buried in a structural backfill of the same material used for bedding, as shown in Figure 18. The same procedures for pressure cell placement, markings inside the pipe, and laser profile-meter readings after the pipe's burial for initial readings were all repeated for this second experiment.

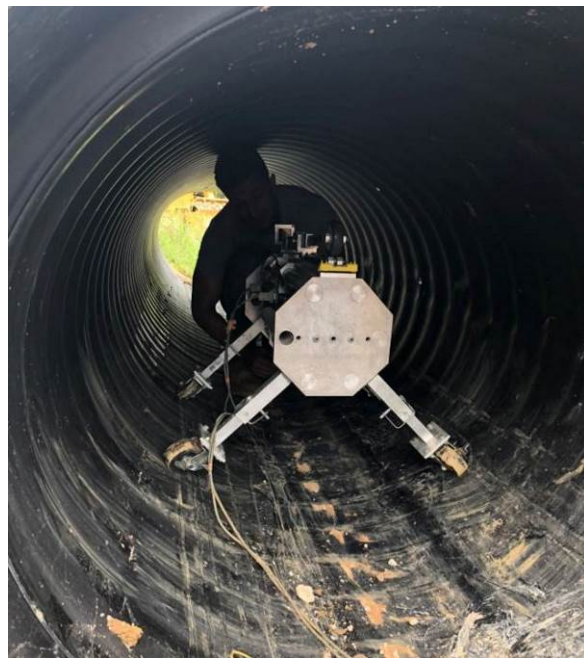
Figure 19. Laser profiler recording a cross-sectional profile.

The laser profiler, shown in Figure 19, was used to record circumferential profiles at 10 positions along the length of the pipe, shown in the diagram in Figure 20. The device rotates a full 360° and records the distance at 119 points (every 3.2°) around the pipe circumference, starting from the zenith. Immediately after backfill was complete, different deflections were observed along the pipe and initial measurements were recorded manually using a tape measure and also with the profiler. Finally, corrugation depth was measured at each of ten points in Figure 20 to investigate changes in the corrugation before and after re-rounding. This was accomplished by drilling a small hole in the smooth interior wall at the crown (all ten locations A through J) and both springlines (locations A through F), then inserting a caliper, shown in Figure 21, until the tip contacted the inside of the outer wall at the peak of a corrugation. Measurements from before and after re-rounding were compared to see if the pipe corrugation had been damaged in the re-rounding process.

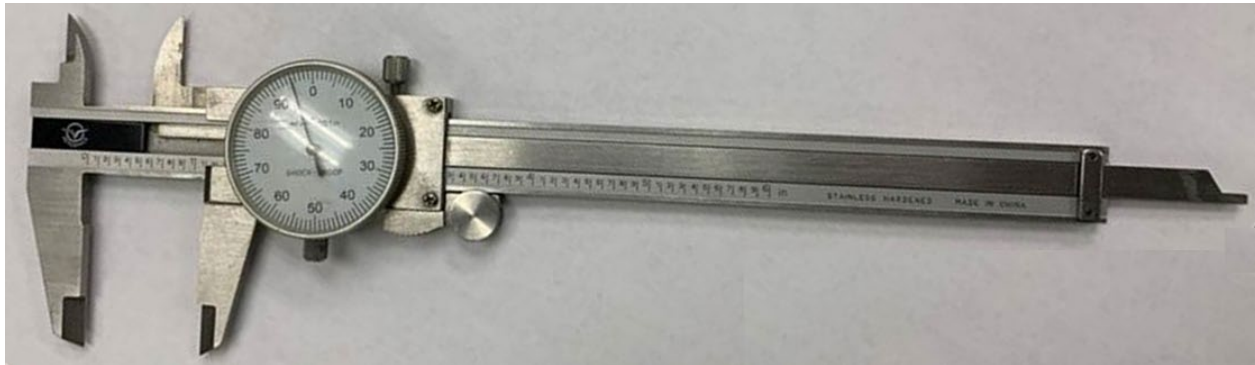
Figure 21. Calipers used to measure corrugation depth. The right end was extended into a hole until it touched the crest of the corrugation.

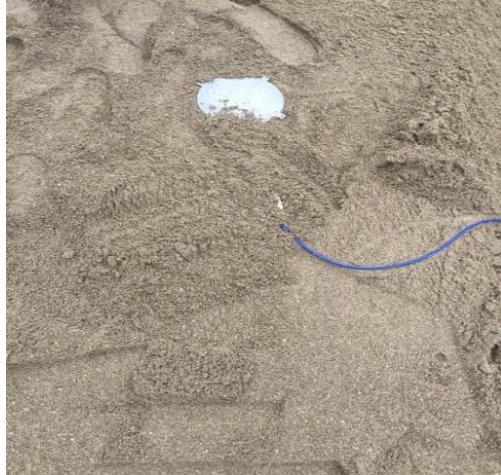
Figure 23. GEOKON pressure cell above crown of the pipe.

Three GEOKON pressure cells were around the longitudinal center of the pipe, at distances of 7 in (180 mm) from the outer surface; two at the springline on either side and one above the crown, as shown in Figure 22. The pressure cell over the crown is shown in Figure 23 at time of installation, and Figure 24 shows the pressure cell being installed. Initial pressure cell readings were taken using the GEOKON vibrating wire readout device shown in Figure 25, which read both frequency, which determines soil pressure, and the temperature of the backfill. A device to measure in-situ soil-stiffness was placed at shoulder and springline of Pipe 1, but the device moved and it could not be located after re-rounding to complete the measurements.

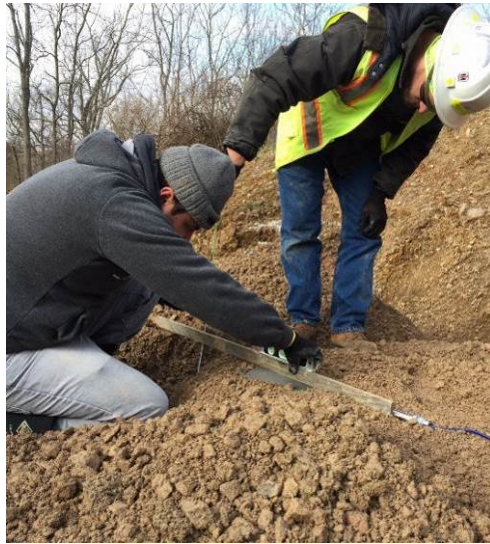
Figure 24. Positioning pressure cell above the pipe crown.

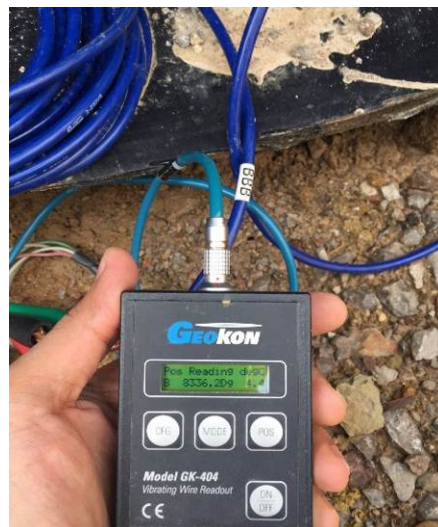
Figure 25. Geokon vibrating wire readout device.

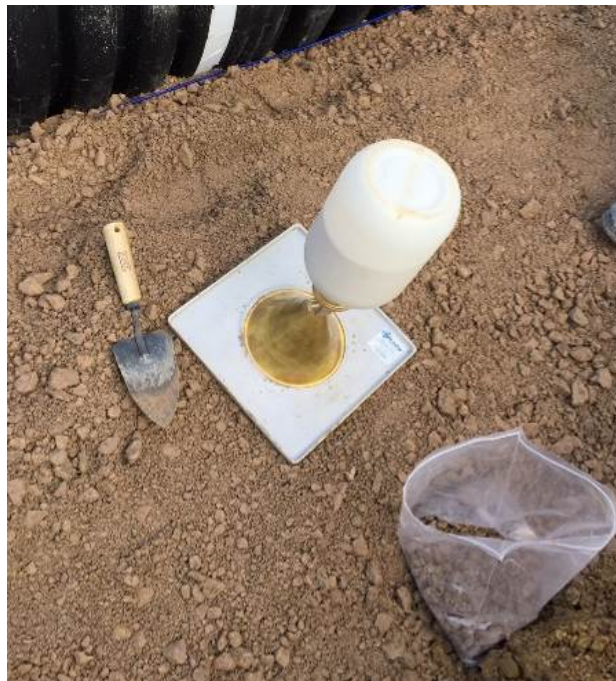
A sand cone test, shown in Figure 26, was conducted on two layers of backfill: at the level of the pipe's springline and at the completion of backfilling, in order to determine the dry weight density and degree of compaction in the backfill. After 30 days, the re-rounding was scheduled with Williams Testing, Inc, to occur 189 days after pipe installation. Measurements with the laser profiler were taken at ten locations (designated A-J in Figure 20) along the pipe after completion of cover, again immediately before re-rounding, and after each pass of the re-rounder. The re-rounder was placed at one end of the pipe, as shown in Figure 27 and connected to an air compressor to produce the high-frequency vibrations that reshape the internal surface of the pipe. A cable running through the pipe was connected to the re-rounder at one end and a winch at the other, like that shown in Figure 28. A full pass of the re-rounder through the pipe took 15 to 20 minutes. Three passes of the vibrating re-rounder were performed, and a mandrel run through the pipe to determine if deflection was sufficiently reduced to be successful. During the third pass, the device had become so hot the vendor declared it unsafe for the equipment to be used on another pass. After each pass, the cross-section of each of the ten locations A-J inside the pipe was measured with the laser profiler. Thirty days after re-rounding, the pipe was exhumed and 75 lb (45 kg) of the backfill was collected from around the pipe for a laboratory sieve analysis.

Figure 26. Sand cone test.

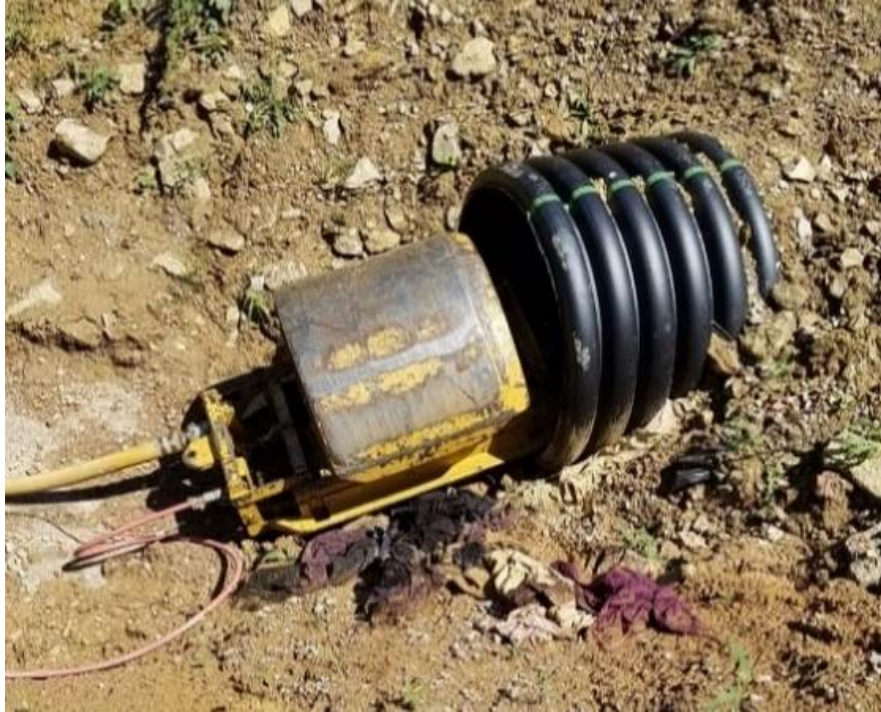
Figure 27. Re-rounder positioned at entrance to the pipe at start of re-rounding.

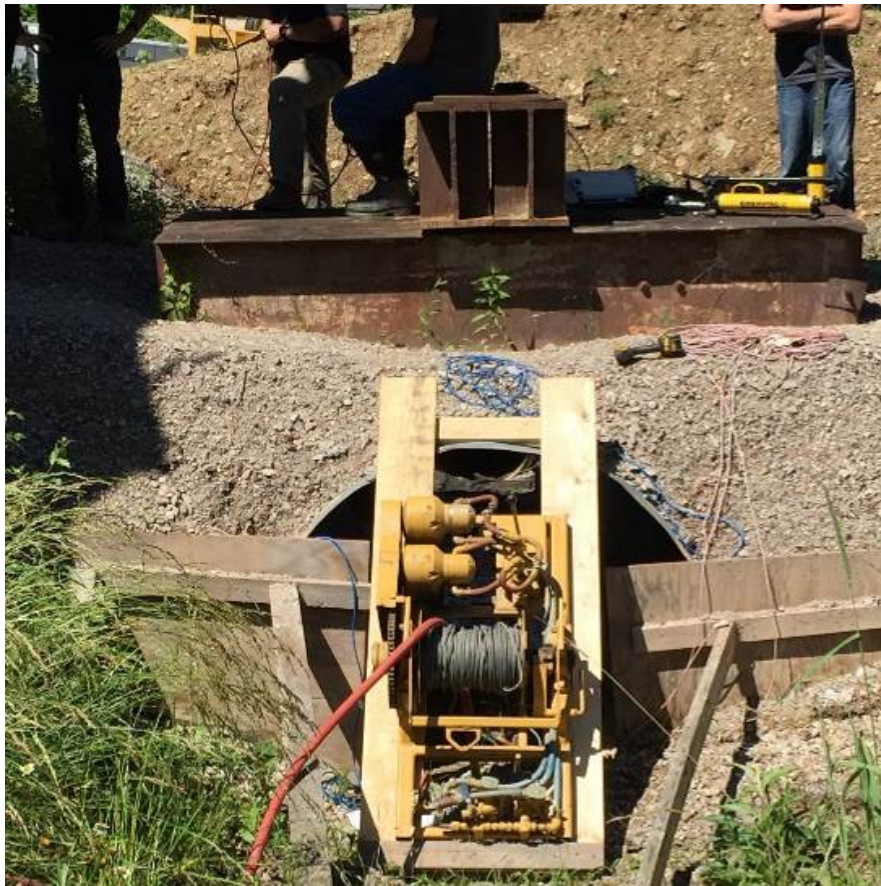
Figure 28. Winch placed at exit of the pipe to pull the re-rounder through.

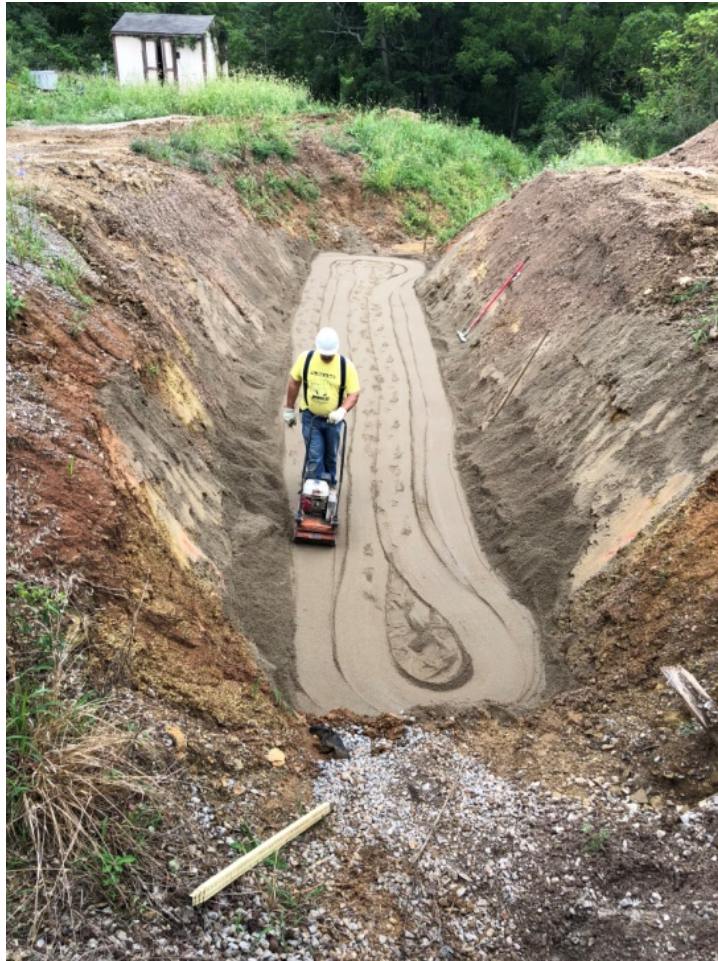
Figure 29. Compacting the 6-in (150 mm) bedding layer of ODOT Type 2 backfill sand before placing Pipe 2.

The second pipe was installed on August 2, 2018, following the same method as for Pipe 1, except the bedding and backfill were ODOT Type 2 backfill (sand). Pipe 2 itself was identical to Pipe 1, consisting of three sections of 36 in (0.9 m) diameter thermoplastic pipe with total length 40 ft (12 m) and two joints. Two passes of the re-rounder were made 88 days later on October 29, 2018, and the pipe was removed on May 20, 2019, 209 days after re-rounding. Figure 29 shows the bedding layer being compacted before placement of Pipe 2.

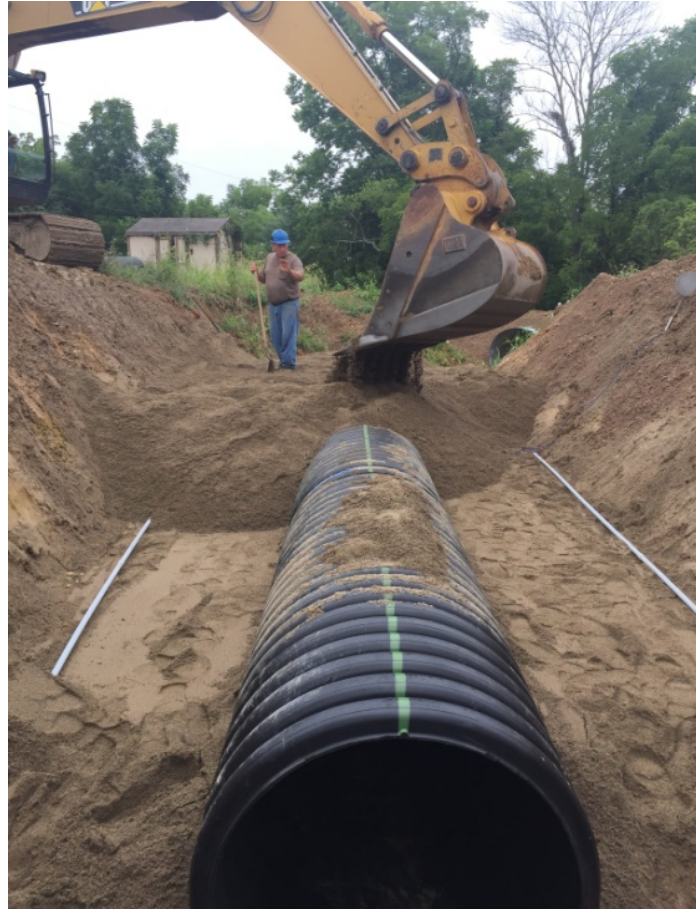
Figure 30. Placing ODOT Type 2 backfill sand around Pipe 2.

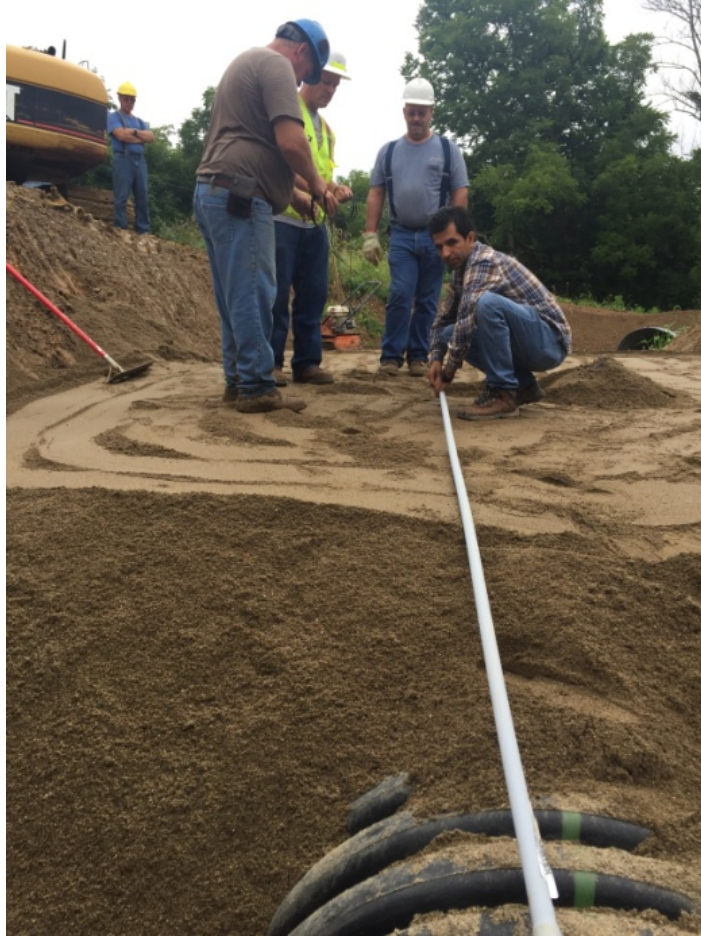
Figure 31. Positioning accelerometers above crown of Pipe 2.

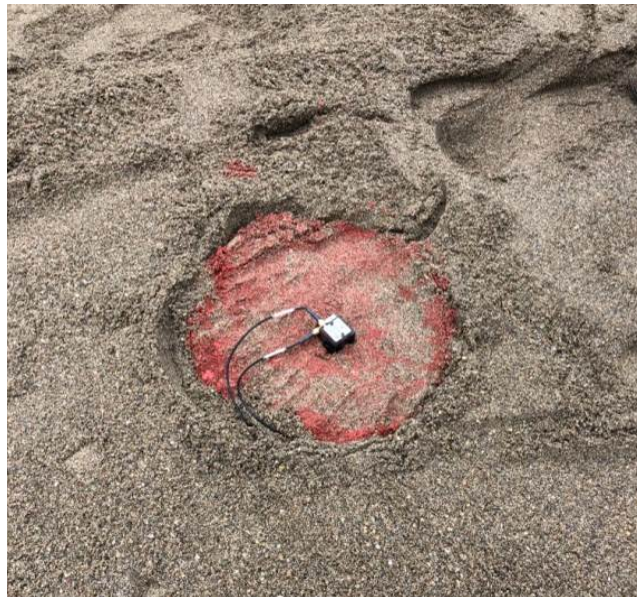
Figure 32. Upper accelerometer 18 in (460 mm) above pipe crown with red sand surrounding.

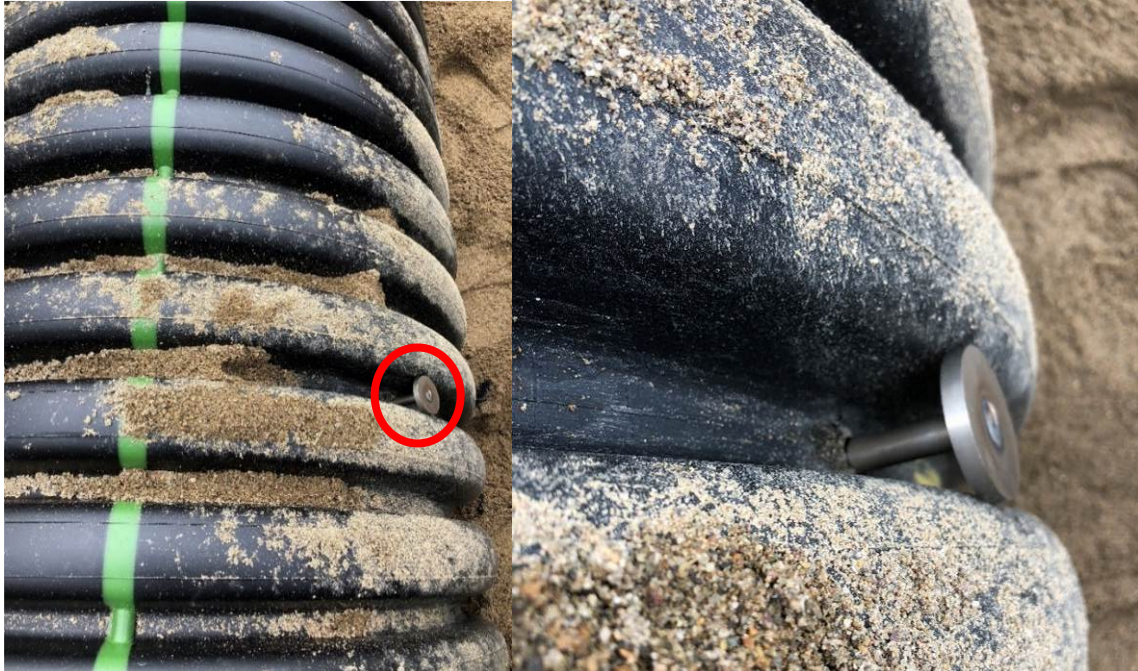
Figure 35. Left: The circled apparatus was installed at the shoulder of the pipe to measure soil resistance before and after re-rounding; Right: A closer view of the device.

Finally, the apparatus shown in Figure 35 was installed on the right shoulder of the pipe (between the crown and springline) to measure the soil stiffness before and after re-rounding. Figure 36 shows a schematic of the apparatus installed between the pipe corrugations. Figure 37 shows a hydraulic jack connected to the apparatus mentioned to read the soil resistance data.

A device shown in Figure 35 and Figure 36, was placed at the shoulder and springline of Test Pipe 2 to measure the in-situ stiffness of the structural backfill material. An identical device was installed in the haunch region of Test Pipe 3. (A similar device in Test Pipe 1 did not work successfully.) The measurements obtained before and after re-rounding are provided in Table 21.

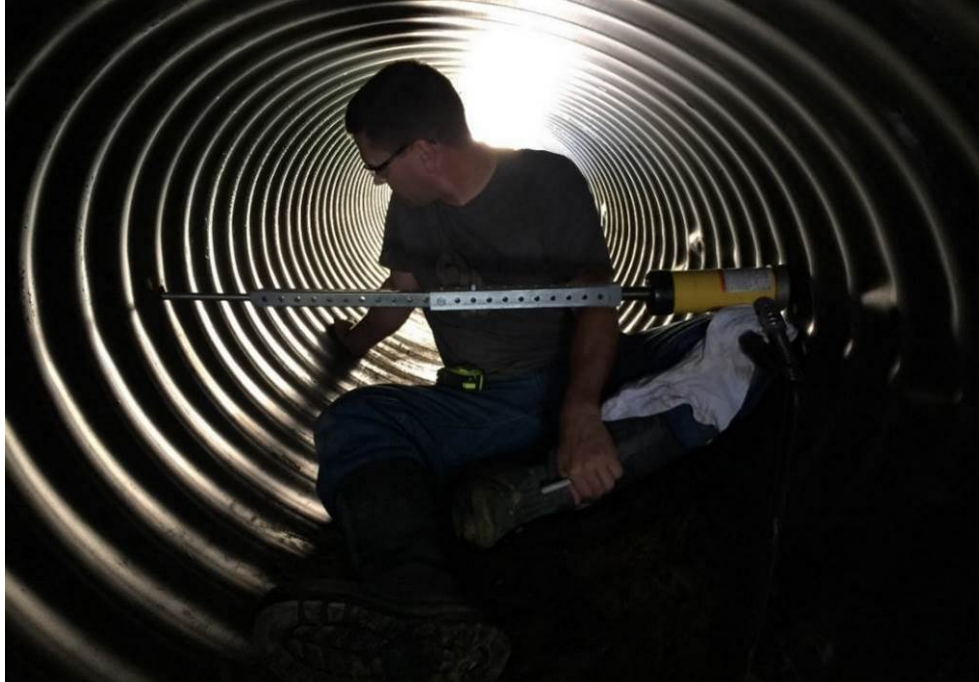
Figure 37. A hydraulic jack was used to measure soil resistance before and after re-rounding.

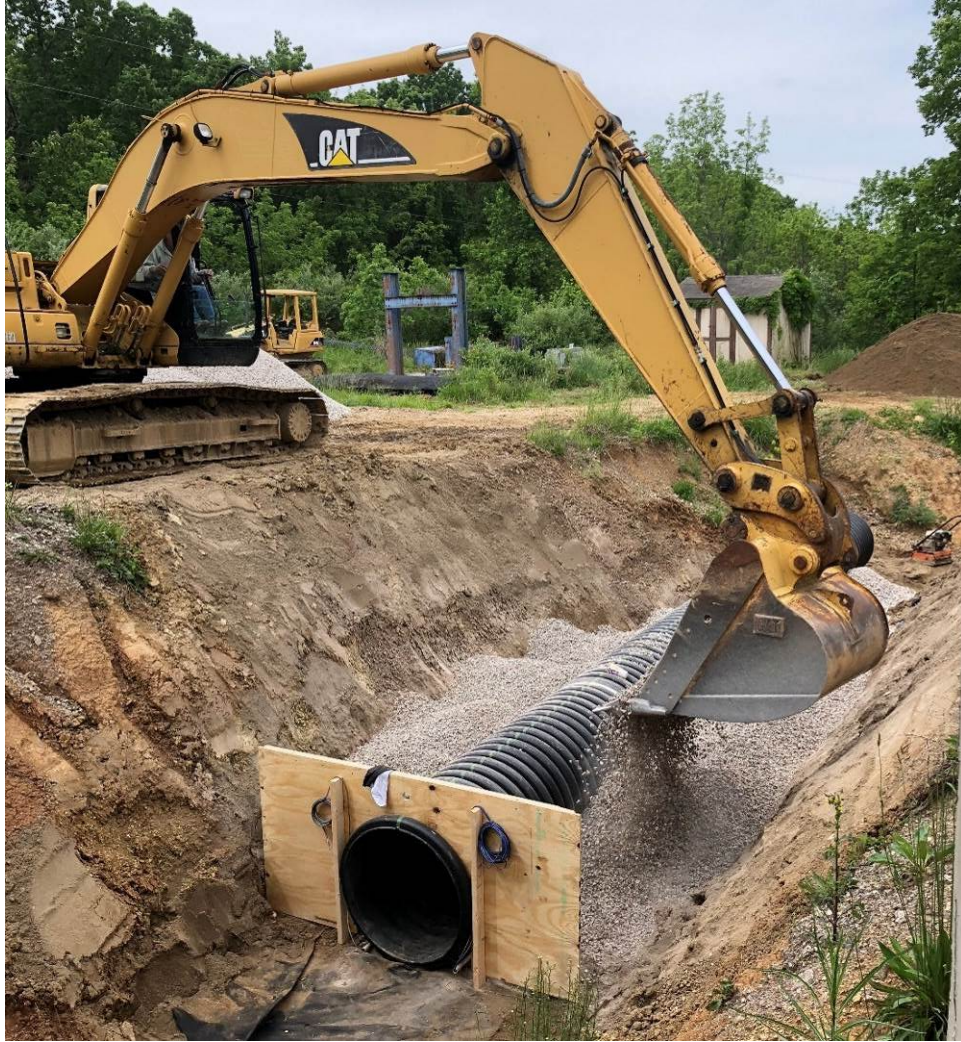
Figure 38. Placement of Structural Backfill Type 3 on Test Pipe 3.

The pipe, identically configured to Test Pipes 1 and 2, was placed on a 6 in (150 mm) bed of Structural Backfill Type 3, specifically AASHTO #57 crushed stone aggregate. The pipe was then backfilled with the same material to approximately crown height. Figure 38 shows the placement of the structural backfill. To simulate the poor construction procedures believed to produce excessive vertical deflection, compactive effort was not applied to the Structural Backfill material until the material was above the crown of the pipe. Once the aggregate level reached the crown of the pipe, a hydraulic plate compactor was used to compact the structural backfill (see Figure 39). Despite the application of significant compaction energy, the deflection in the pipe was minimal. When the pipe was damaged by the backhoe in the attempt to create sufficient deflection, this experiment was aborted so a replacement pipe could be installed.

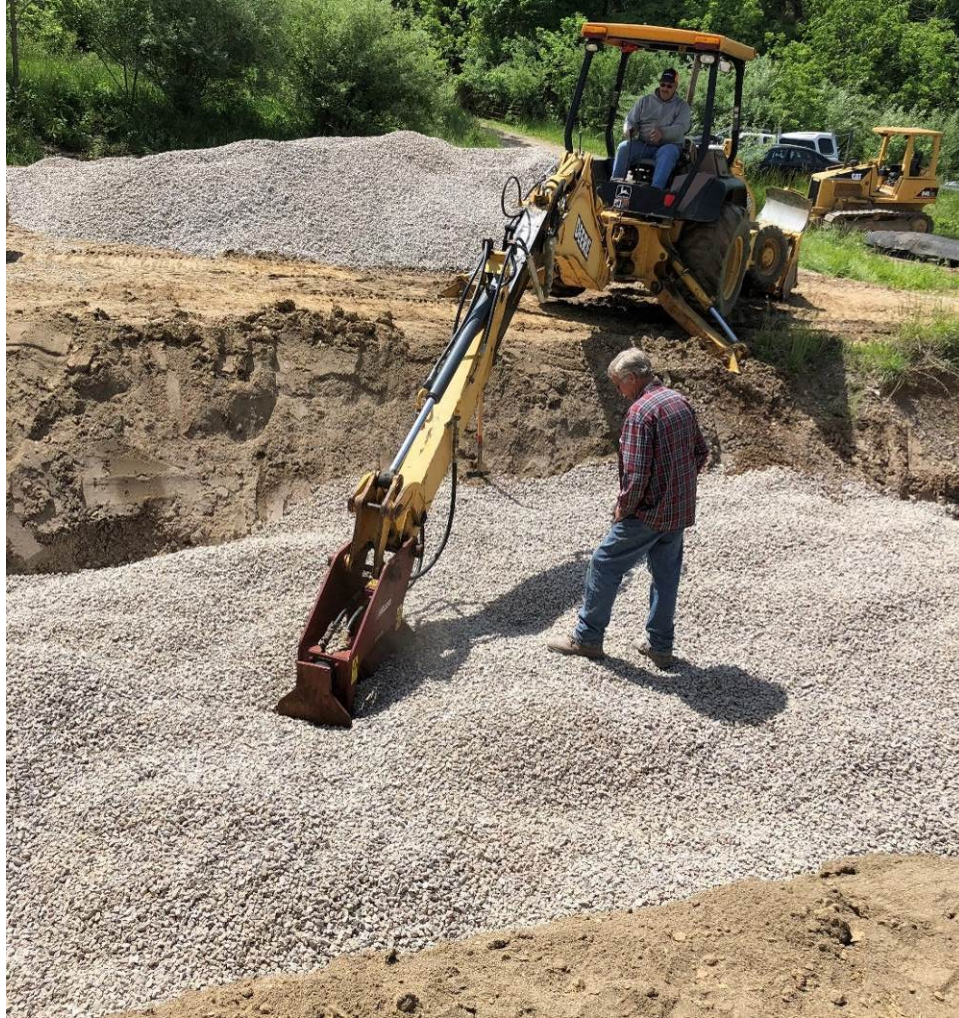
Figure 39. Compaction of the Structural Backfill Type 3 over Test Pipe 3 using a hydraulic plate compactor.

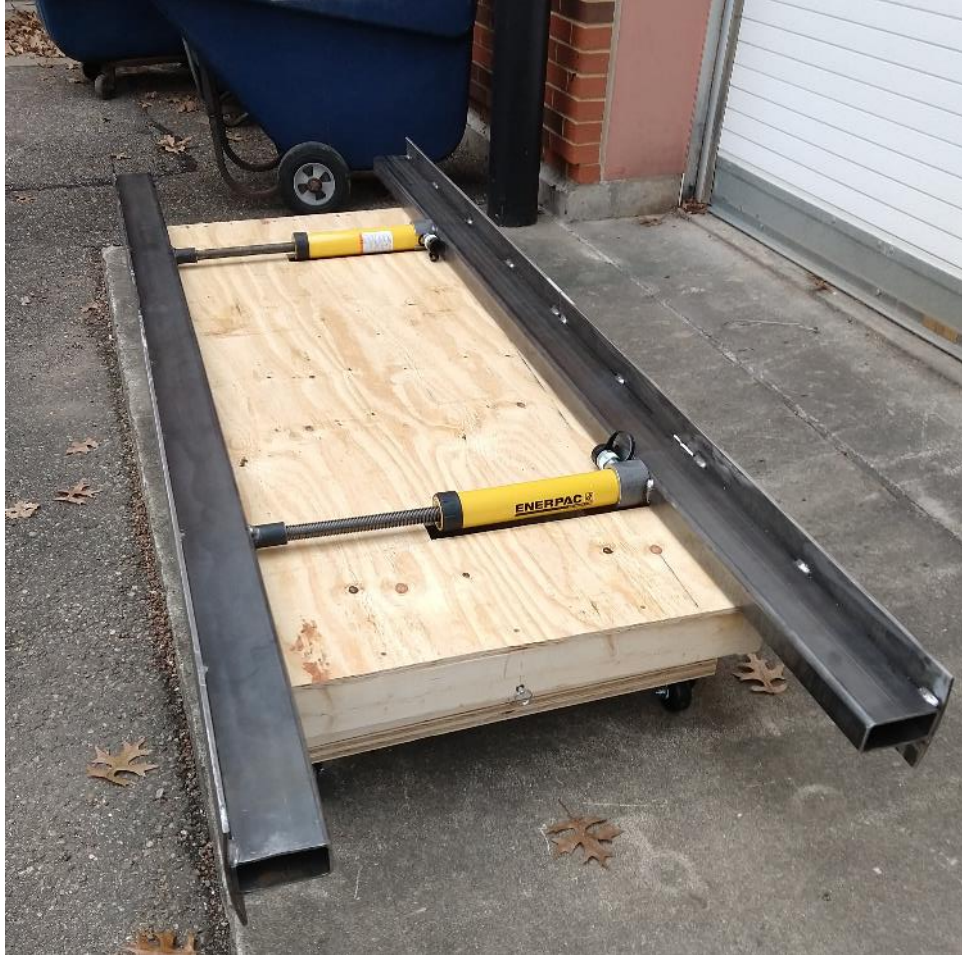
Figure 40. Pipe deflector assembled at ORITE laboratory.

The device is comprised of two 8 ft (2.4 m) long steel plates curved to match the inner curvature of the pipe with two hydraulic actuators positioned in between, and the entire apparatus placed on a cart designed to position the curved plates to contact the pipe along the horizontal diameter. The actuators then expand outward to create a horizontal displacement in the pipe. Figure 40 shows the device in the laboratory and Figure 41 shows a schematic representation of the device. Figure 42 shows the deflection device and delivery system in place within a segment of Test Pipe 3. Two of these devices were built and used to deflect a total length of 16 ft (4.9 m) of pipe.

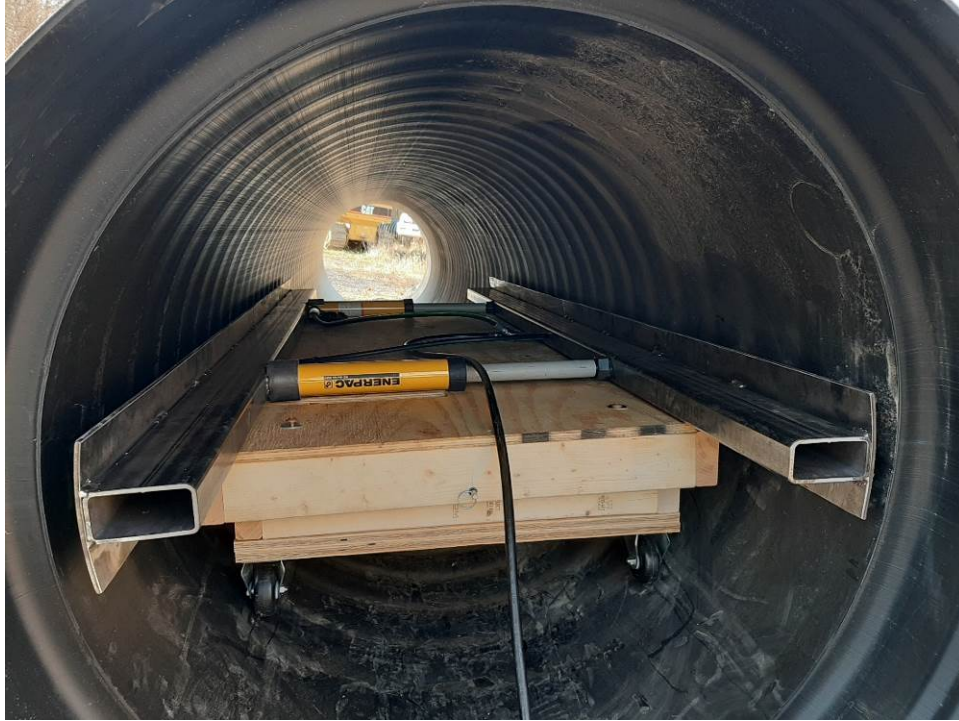
Figure 42. Actuated deflection device and delivery system deforming Pipe 3.

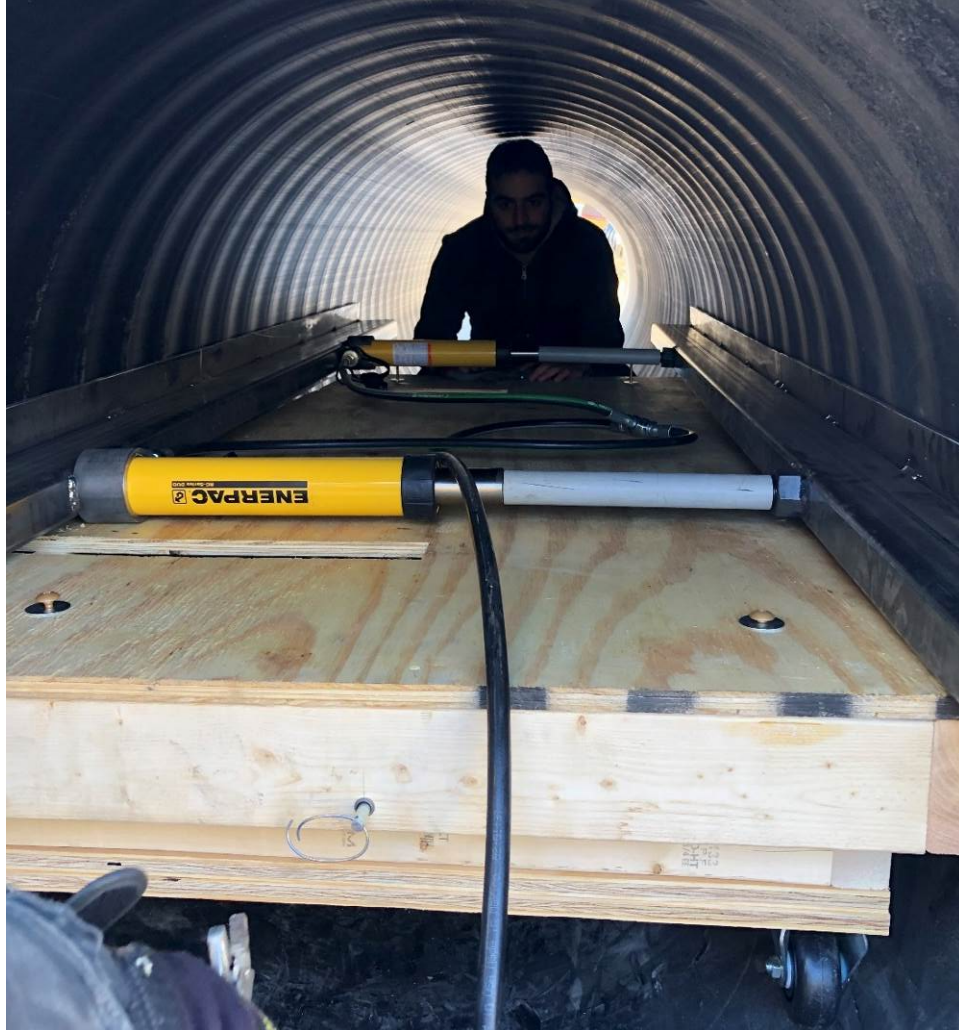
Figure 43. Actuated deflection device and delivery system showing the deformed pipe section.

A new Test Pipe 3, configured identically to those in the preceding experiments, was installed on a 6 in (150 mm) bedding of Structural Backfill Type 3. The specific material type utilized was a crushed AASHTO #57 aggregate. Two of the deflection devices were positioned inside the pipe at the approximate mid-point along the length of the pipe. The hydraulic actuators applied a horizontal force to the inside wall of the pipe until a target deflection of 10% was reached. The deformed pipe with the deflection apparatus inside is shown in Figure 43.

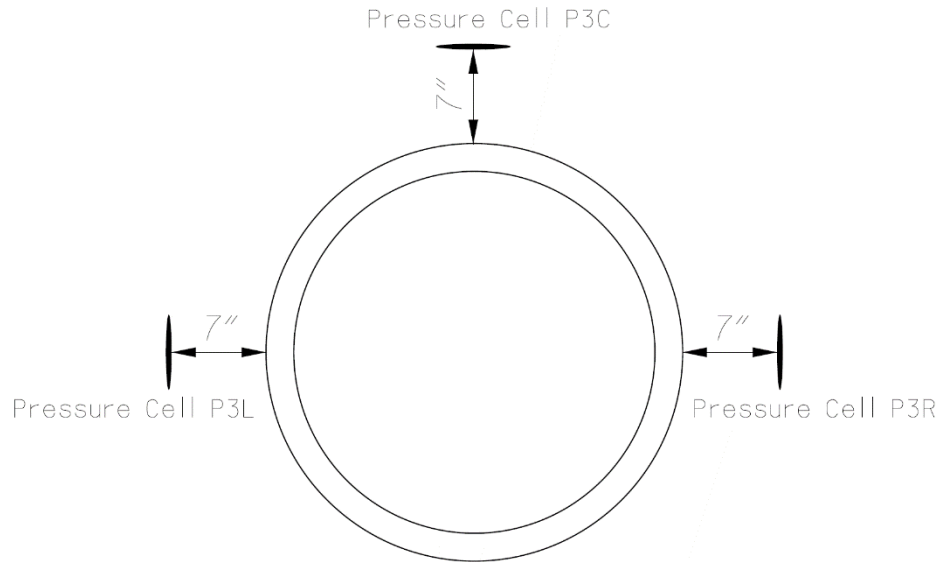
Figure 44 Pressure cell orientation, location and naming convention for Test Pipe 3. (7 in = 180 mm)

Instrumentation was installed for Test Pipe 3 included three pressure cells following the approach used on the first two test pipes. Figure 44 shows the pressure cell orientation, location, and naming convention relative to the pipe cross-section. Accelerometers were installed in a like manner as Test Pipe 2; Figure 45 shows a schematic layout of the accelerometers. The in-situ soil stiffness mechanism was installed at the haunch of the pipe, similar to Test Pipe 2. A layer of the AASHTO #57 aggregate was painted red to identify the location of the accelerometers. Similar to Test Pipe 2, the painted material was used to trace migration of the backfill material. Immediately after backfilling, the initial shape of the pipe was measured using a tape measure and pressure cell readings were obtained. The corrugation depth was measured at the crown and right springline at locations D and E only, as was the case for Pipe 2.
