Re-rounding of Deflected Thermoplastic Conduit, Phase 2

Prepared for
The Ohio Department of Transportation
Office of Statewide Planning and Research

June 2021

Final Report

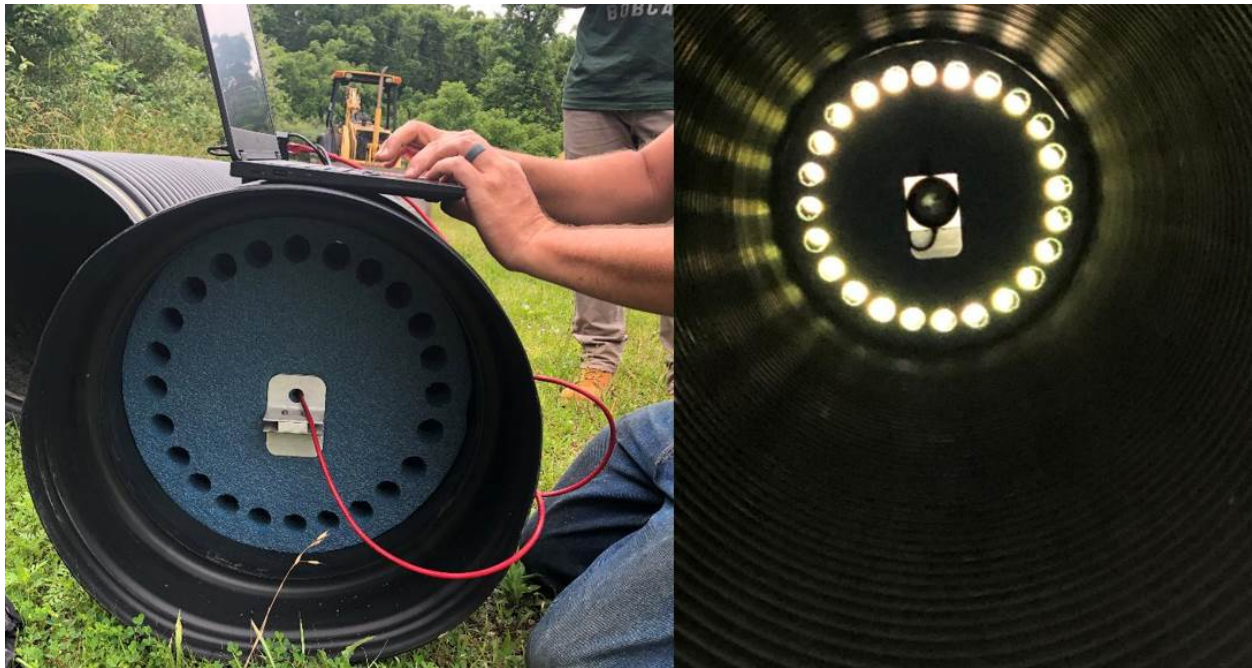
Figure 46. LiDAR pipe profiler in use. Left: Profiler placed in pipe and connected to controller laptop. Right: View of profiler from inside pipe.

A new profiler was developed by ORITE to measure pipe profiles. It is based on Light Detection And Ranging (LiDAR) (also called Laser Imaging, Detection, And Ranging) principles and uses an updated laser system centered between two plastic spacer disks. The device is shown in Figure 46. The LiDAR unit recorded between 305 and 352 radius readings at intervals of 1.02° to 1.18° ; most runs collected at least 342 readings (1.05° intervals).

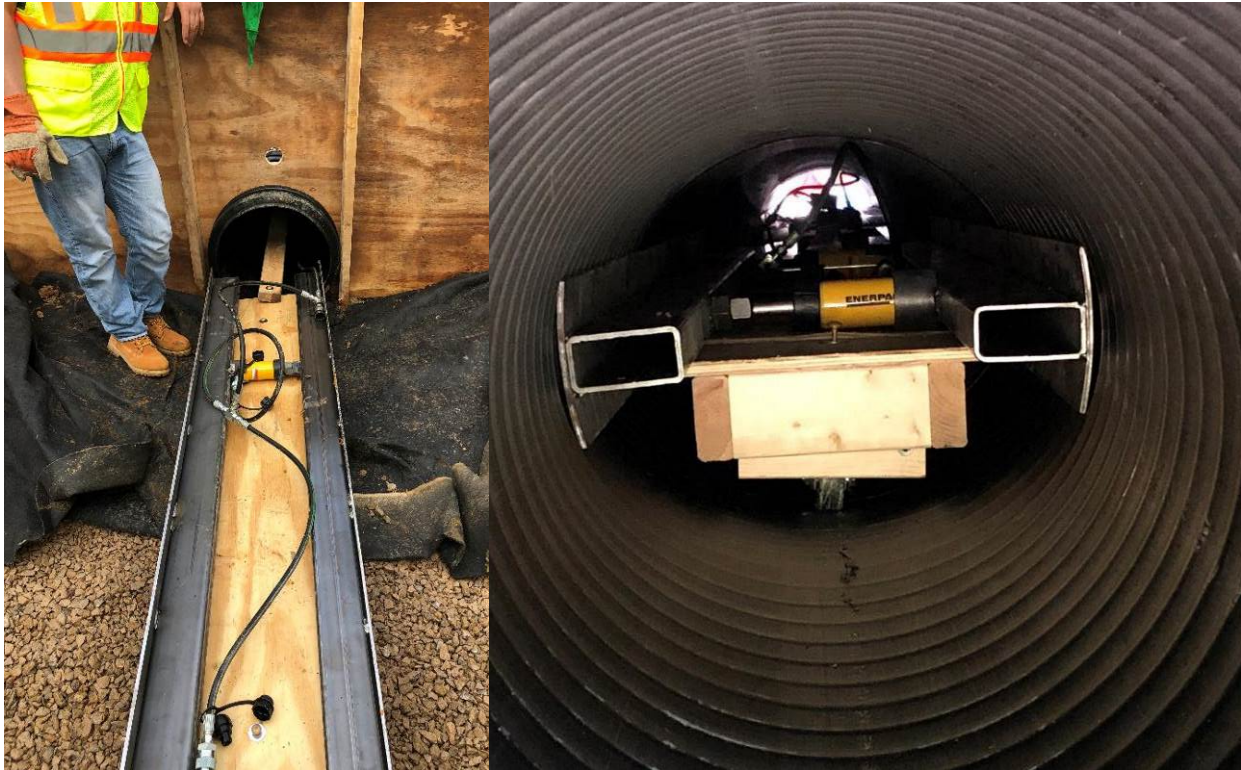
Figure 47. The pipe deflector was used to deform Test Pipe 4 during installation. Left: Deflector being inserted into pipe. Right: Deflector in operation.

the backfill was placed around the pipe, as shown in Figure 47; two deflector units were applied in the pipe at the two joints at 10 ft (3 m) from either end. Instrumentation was the same as for Test Pipe 3, except there was no soil-stiffness gauge installed. The installation of a pressure sensor and accelerometer are shown in Figure 48.

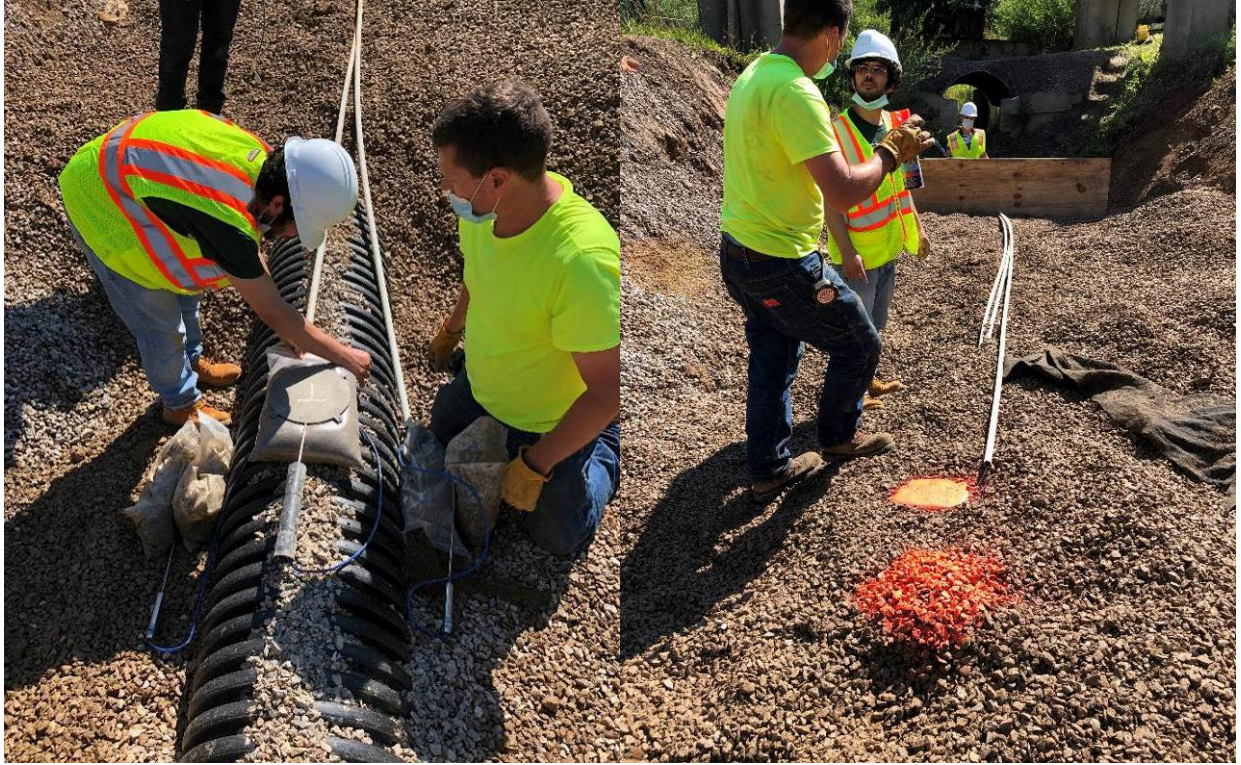
Figure 48. Installation of sensors around Test Pipe 4. Left: Pressure cell placed over crown. Right: Accelerometers and colored aggregate.

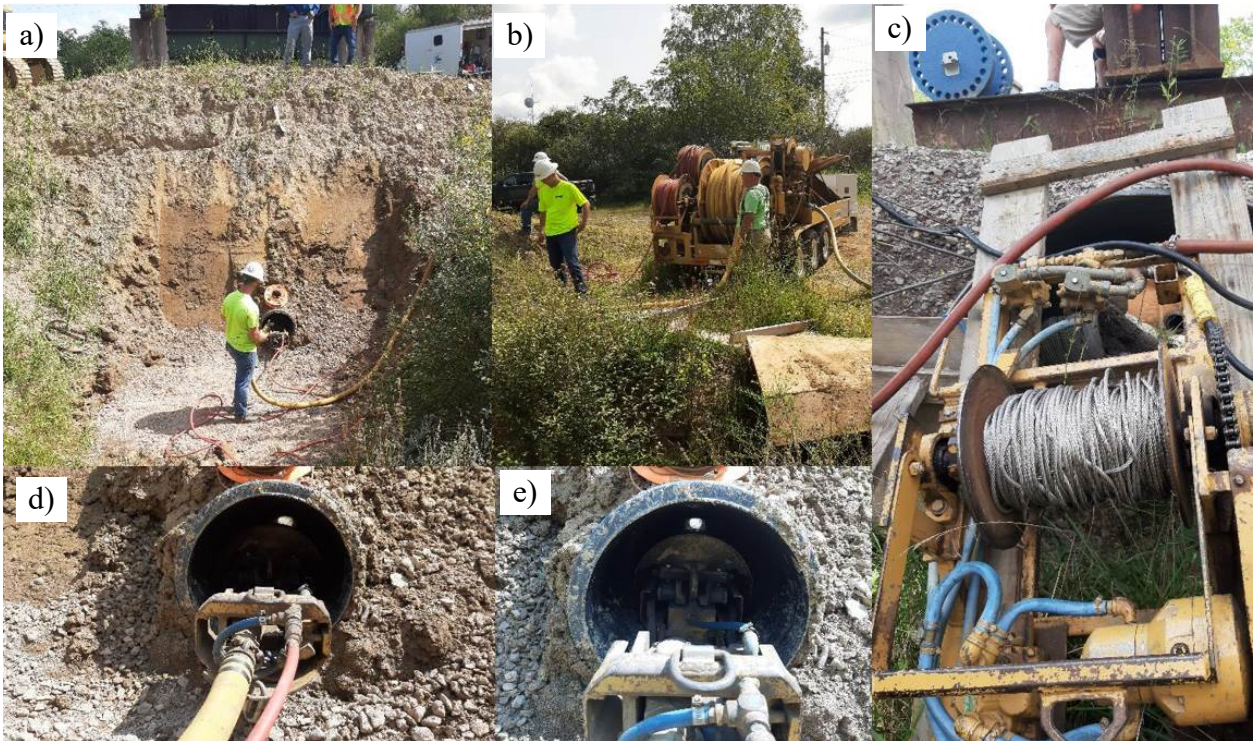
Figure 49. Views of re-rounding of Test Pipe 4: a) Re-rounder and operator at inlet of pipe; b) Reels with pneumatic and electrical cables connected to re-rounder; c) Winch at outlet to pull re-rounder through pipe; d) and e) Close-up views of re-rounder inside pipe.

Test Pipe 4 was re-rounded on September 10, 2020, 78 days after installation. Figure 49 shows views of the re-rounding operation. Only one pass of the re-rounder was required to adequately restore the pipe profile. Figure 50 shows the LiDAR profiler being used on the pipe. The final profile was collected 41 days after re-rounding, on October 21, 2020, followed by exhumation of the pipe.

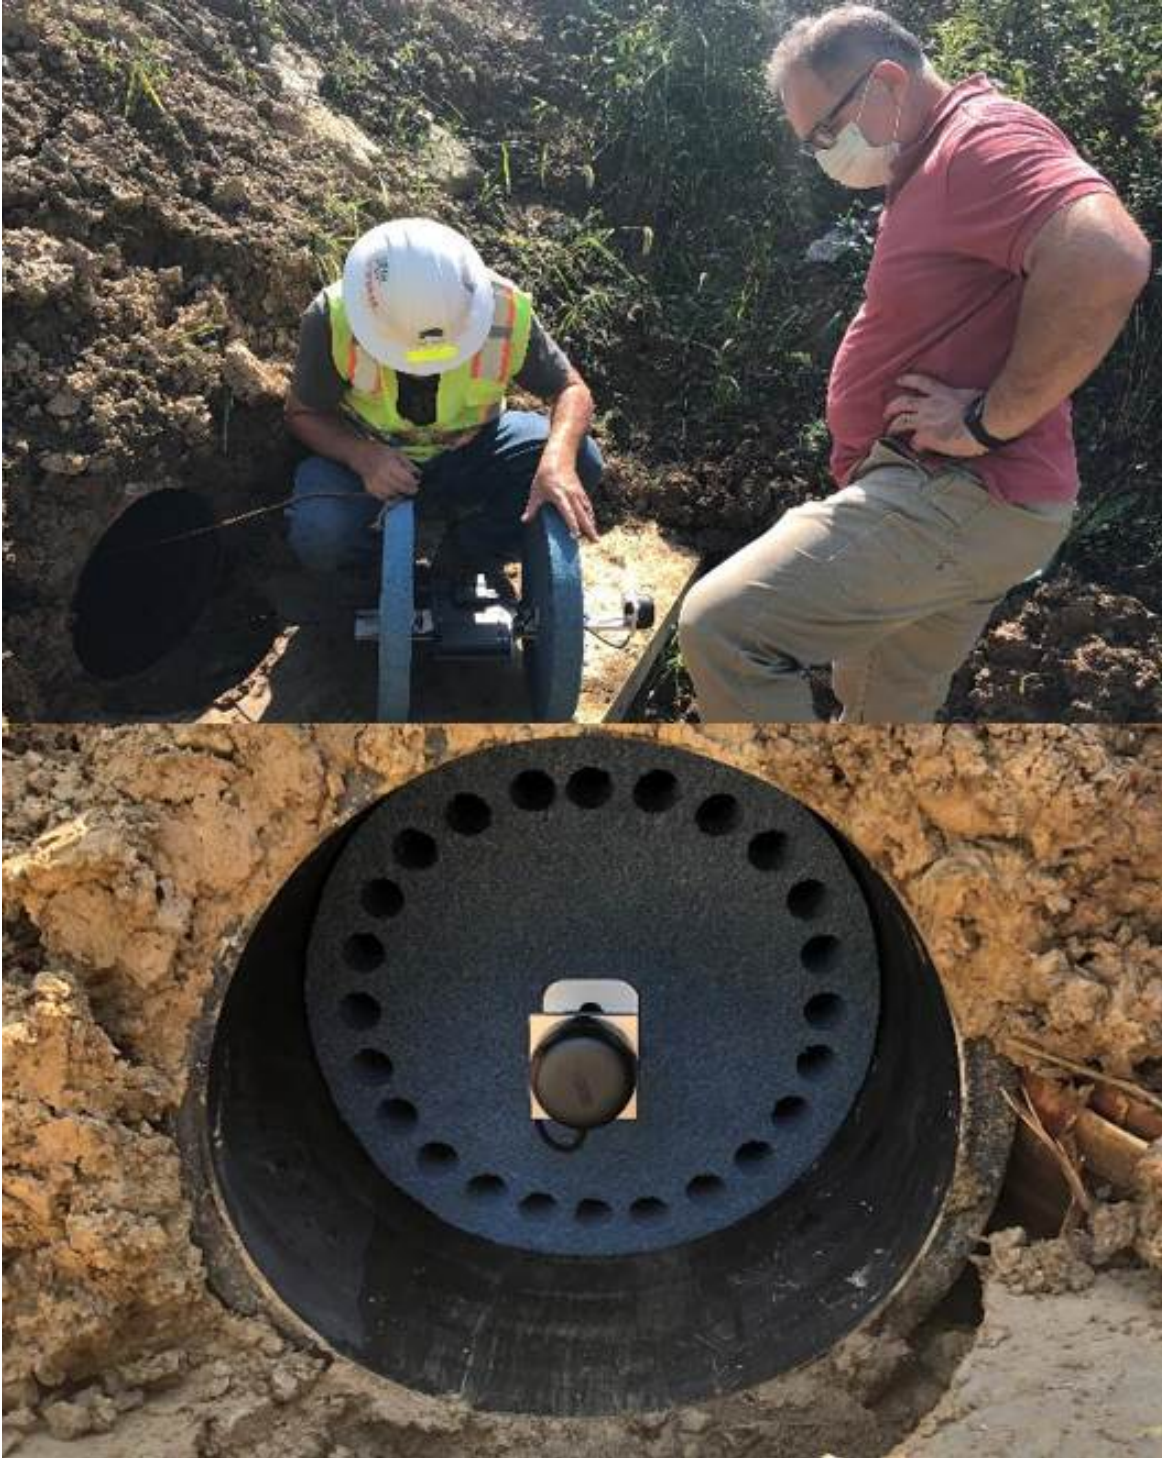
Figure 50. LiDAR profiler being used on Test Pipe 4. Top: Profiler being prepared by graduate student for insertion; Bottom: Profiler inside pipe.

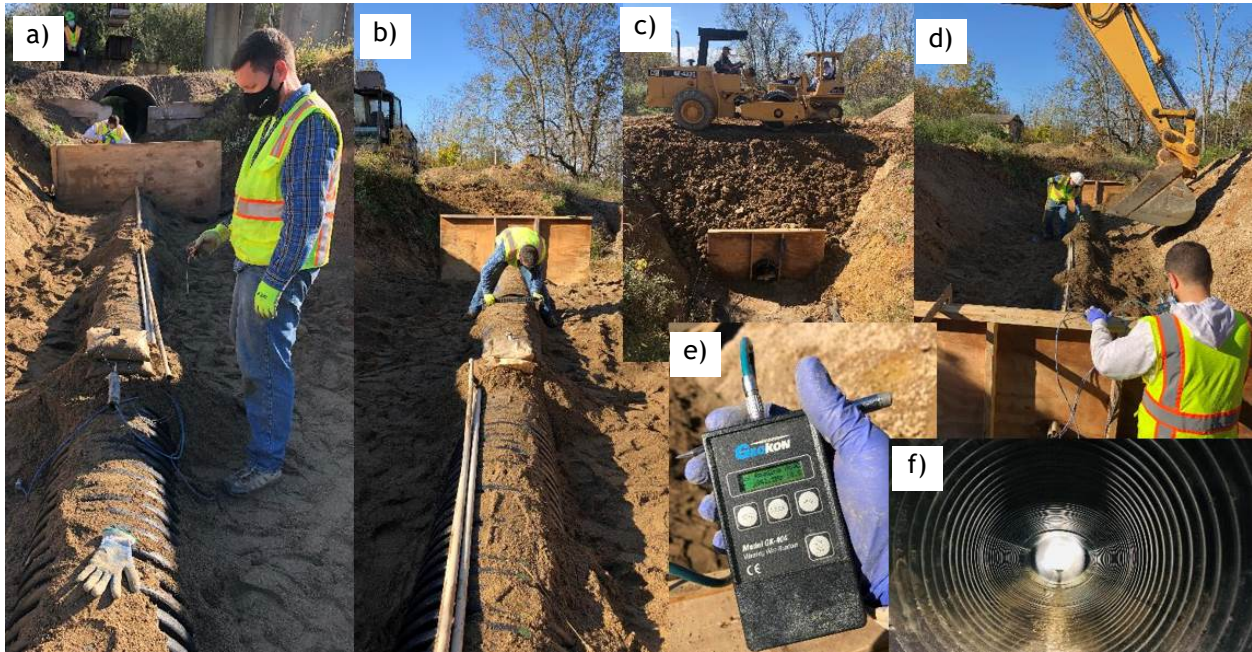
Figure 51. Views of installation of Test Pipe 5 on October 22, 2020: a) Testing accelerometer; b) Levelling backfill above crown in preparation for placing accelerometer; c) Placement of second (higher) accelerometer; e) Checking pressure cell readout; f) view inside pipe.

Test Pipe 5 was installed on October 22, 2020. The pipe is identical to Test Pipe 4 and placed in ODOT Structural Backfill Type 2 (sand), comparable to Test Pipe 2. Instrumentation was the same as for Test Pipe 4. Figure 51 shows some views of the installation of Test Pipe 5.

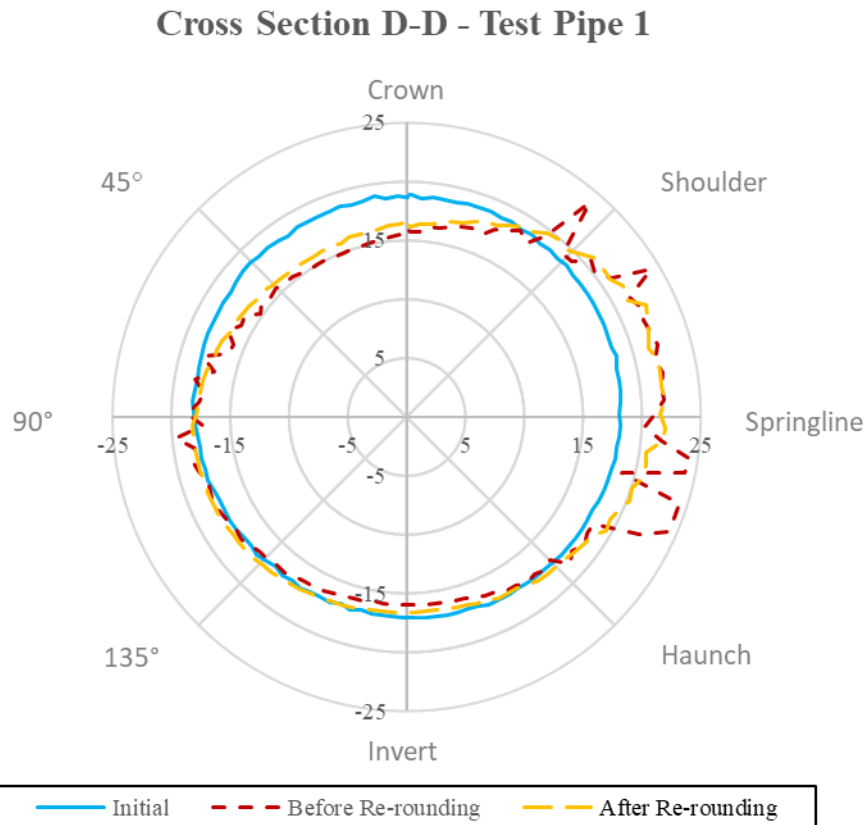
Figure 53 shows the shape of the test pipe at cross-section D-D. This cross-section is located approximately 15 ft (4.6 m) from the inlet of the pipe or 5 ft (1.5 m) from the inlet end of the second pipe section. For this cross-section, several data points obtained immediately before re-rounding were obviously erroneous data points most likely caused by moisture on the pipe surface which refracted the laser signal resulting in the erroneous readings. These points were not considered when determining the deflected pipe dimensions.

Figure 53. Deflected cross-section D-D of Test Pipe 1 (1 in = 25.4 mm).

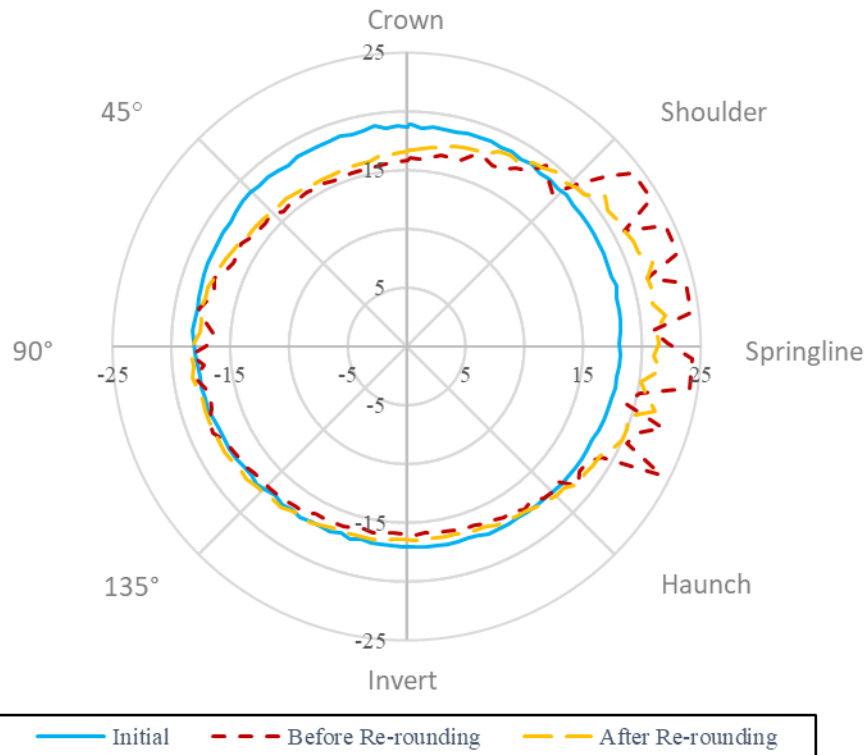
Cross Section E-E - Test Pipe 1

Figure 54 shows the shape of the test pipe at cross-section E-E. This cross-section is located approximately 20 ft (6.1 m) from the inlet of the pipe which is the mid-point of the second pipe section. For this cross-section, several data points obtained immediately before re-rounding were obviously erroneous and most likely caused by moisture on the pipe surface refracting the laser light. These points impact the horizontal dimensions. Only vertical diameter data are presented for cross-section E-E.

The vertical diameter immediately before re-rounding was 32.08 in (0.8148 m), indicating a vertical deflection immediately before re-rounding of -10.76%. After three passes of the re-rounder the vertical dimension was 33.22 in (0.8438 m), an increase of 1.14 in (29.0 mm). The vertical deflection after re-rounding was -7.61%, a net change in vertical deflection of +3.15%.

Figure 54. Deflected cross-section E-E of Test Pipe 1 (1 in = 25.4 mm).

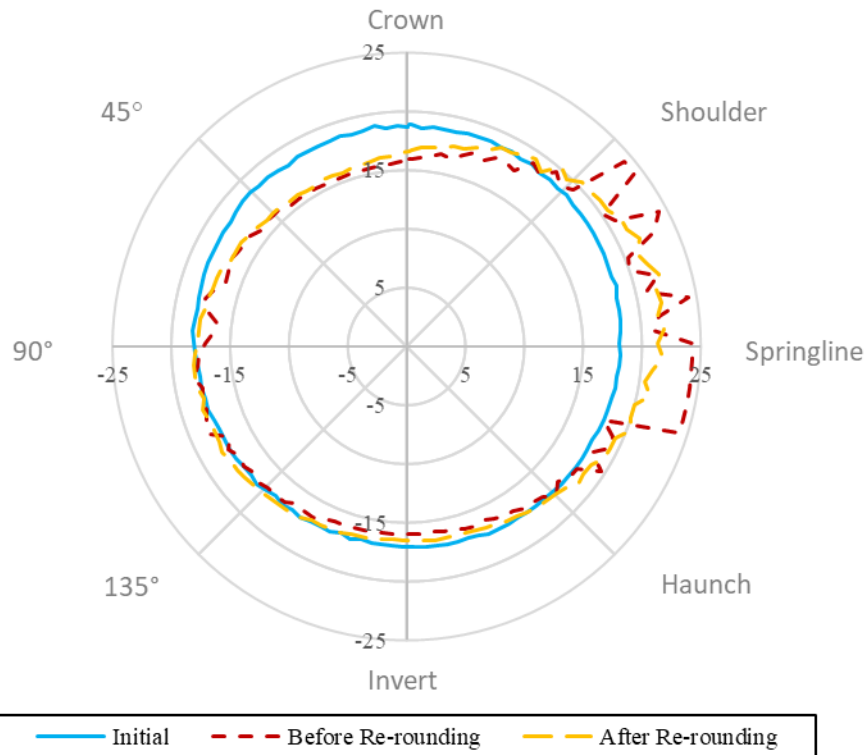
Cross Section F-F - Test Pipe 1

Figure 55 shows the shape of the test pipe at cross-section F-F. This cross-section is located approximately 25 ft (7.6 m) from the inlet of the pipe or 5 ft (1.5 m) from the outlet end of the second pipe section. For this cross-section, several data points obtained immediately before re-rounding were obviously erroneous and most likely caused by moisture on the pipe surface which refracting the laser light. These points impact the horizontal dimensions, so only the vertical diameter data are presented for cross-section F-F.

The vertical diameter immediately before re-rounding was 31.85 in (0.8090 m), a vertical deflection of -10.40%. After three passes of the re-rounder, the vertical diameter was 33.12 in (0.8412 m). The vertical deflection after re-rounding was -7.88%, a net change of +3.52%. After the third pass, the re-rounder stopped the procedure due to the unit becoming extremely hot.

Figure 55. Deflected cross-section F-F of Test Pipe 1 (1 in = 25.4 mm).

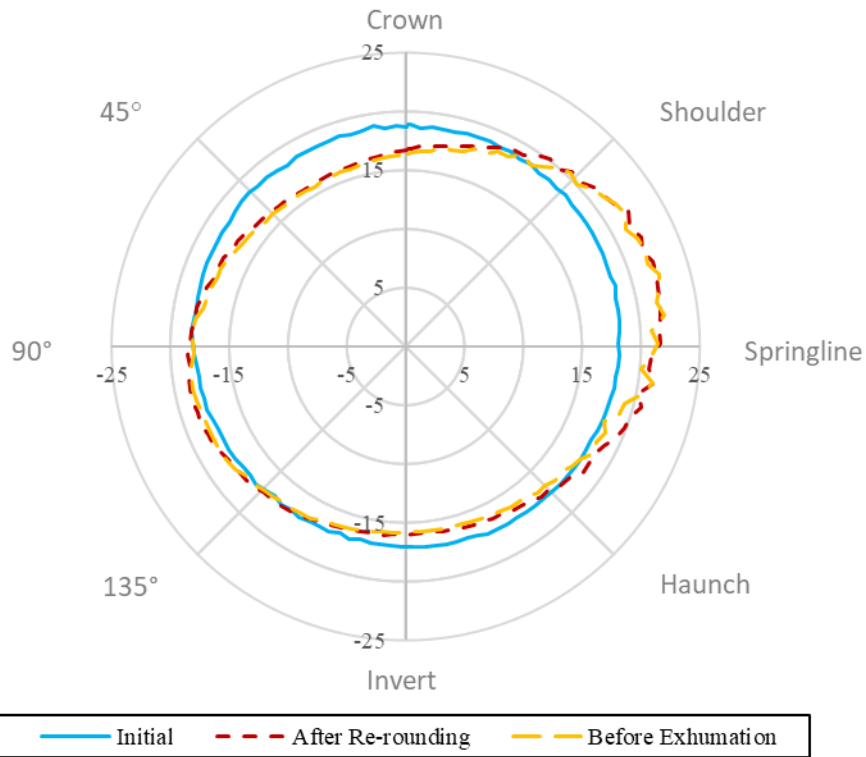
Cross Section C-C - Test Pipe 1

Test Pipe 1 was exhumed 48 days after re-rounding, after recording final measurements using the laser profilometer. Figure 56 shows the shape of the pipe immediately after re-rounding and just before removal. The shape of the pipe is essentially unchanged between re-rounding and removal.

Figure 56. Long-term cross-section C-C of Test Pipe 1 (1 in = 25.4 mm).

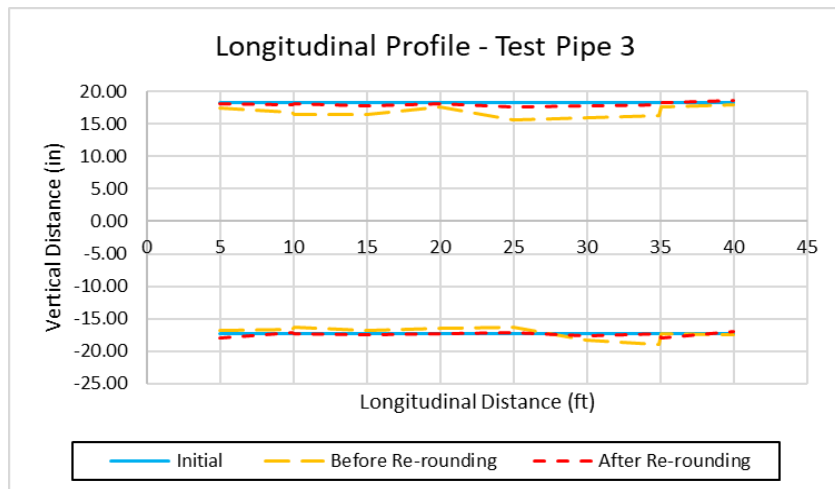
Test pipe 3 was a 36 in (0.9 m) nominal diameter HDPE pipe. The initial vertical and horizontal inside diameters were measured at 35.65 in (905.5 mm) and 34.89 in (886.2 mm), respectively. The pipe was backfilled using an open-graded aggregate meeting the requirements of ODOT Structural Backfill Type 3 which is equivalent to an AASHTO #57. Fill material was placed to a height of 10 ft (3 m) above the crown of the pipe. A plot of the longitudinal profile of the test pipe is provided in Figure 62.

Figure 62. Longitudinal profile of Test Pipe 3 (1 in = 25.4 mm).

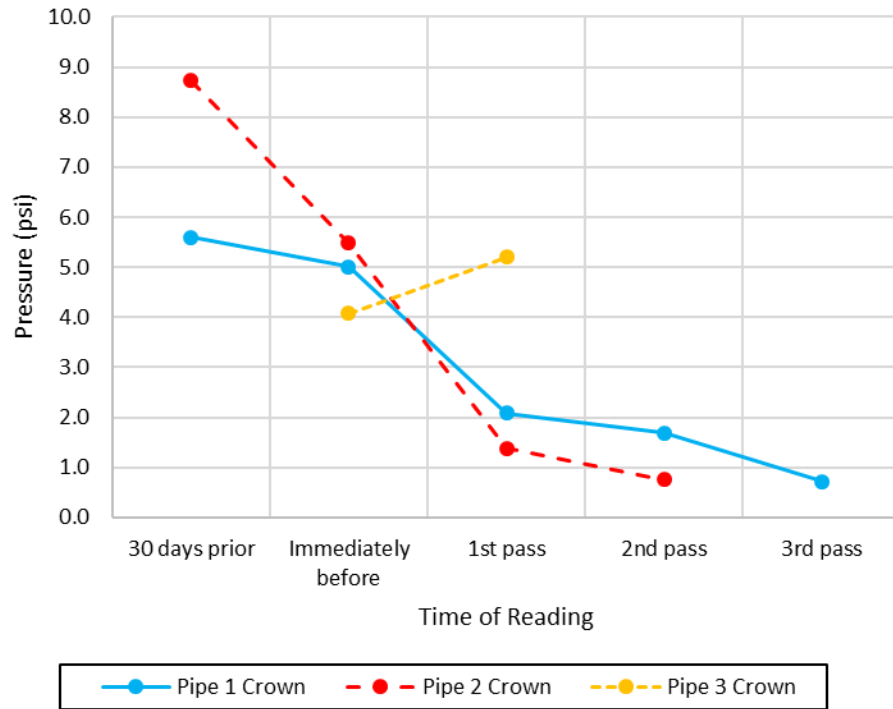
Summary of Crown Pressure Cell Readings

Both Test Pipe 1 and Test Pipe 2 show a reduction in radial pressure at each pressure cell. The change between the readings taken 30 days prior and immediately before reading is explained by the viscoelastic relaxation of the HDPE with time while under near-constant deformation. Over a 30 day period, the apparent modulus of the HDPE can decrease by as much as 60% [Pluimer, et al., 2018]. The result is positive soil arching and a reduction in the radial pressure. Additionally, the magnitude of the initial radial stress for Test Pipe 3 was significantly lower than for Test Pipes 1 and 2. Test Pipes 1 and 2 also saw a much greater reduction in radial pressures as a result of the re-rounding process.

Figure 69. Summary of crown pressure cell readings (1 psi = 6.89 kPa).
