**DOT/FAA/TC-20/21**

# **Post-Crash Fire Forensic Analysis on Aerospace Composites – Literature Review**

August 2020

Final report

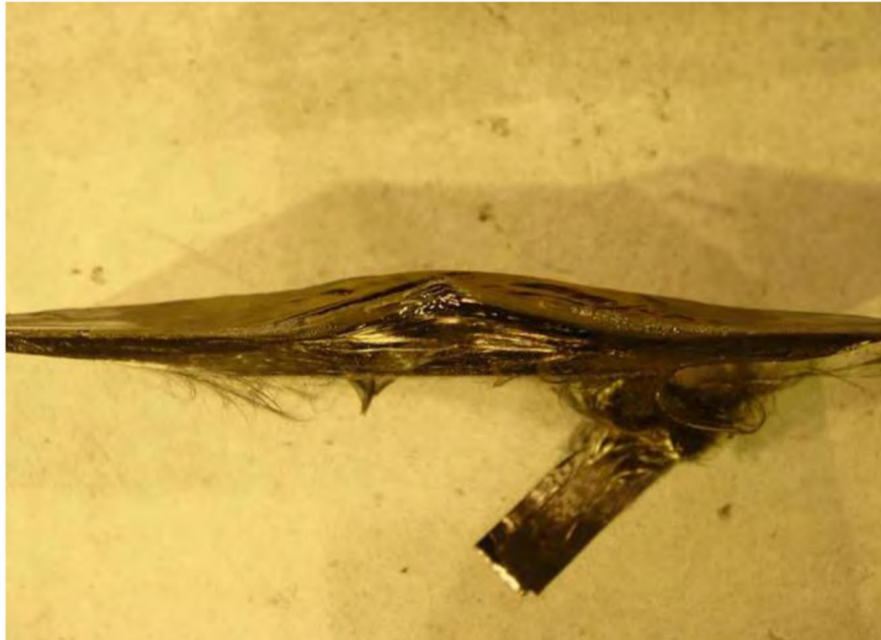
Figure 6. Side view of a buckled CFRP sample after ten minutes of fire exposure (Hode, 2012)

The FAA performed 20 tests on carbon fiber composite samples using the NextGen Fire burner mounted at a 45° angle on glass laminate aluminum reinforced epoxy (GLARE) and carbon-fiber-reinforced polymer (CFRP) (Hode, 2012). The deformed configuration of the specimens and the experimental setup are shown below (see Figure 6, Figure 7, and Figure 8). Out of the 20 samples tested, 7 buckled at 23 to 42 seconds once the test started (Hode, 2012), as shown in Figure 6 and Figure 8 (Hode, 2012). Fire-induced internal matrix pyrolysis produces internal pressurized gases that lead to void formation/cavitation and swelling. Resin bubbles were visible at the border of the damaged areas. Smoke appeared roughly 16 seconds after the beginning of the tests. A reduction in smoke typically occurred before mechanical failure. For all 20 tests, flaming continued for 1-3 minutes after extinguishing the NextGen burner. Fourteen samples exhibited smoldering, either immediately or up to 2.55 minutes after exposure. This study showed that smoking, smoldering, and flaming combustion occurred to different degrees during and after fire exposure, depending on the exposure duration. The smoldering was only induced by the heating of the carbon fibers (Hode, 2012).

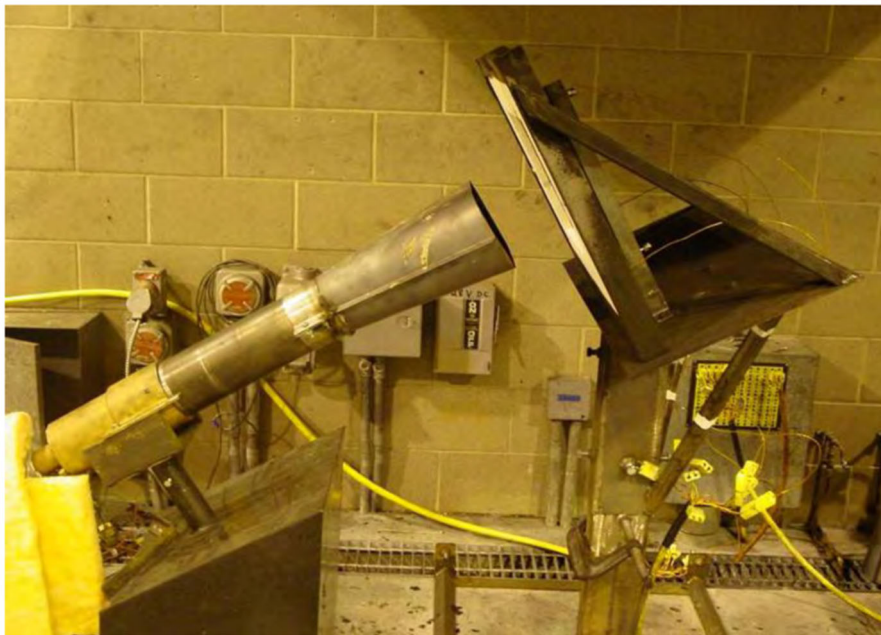
Figure 7. Kerosene-fired FAA NextGen burner and sample frame (Hode, 2012)

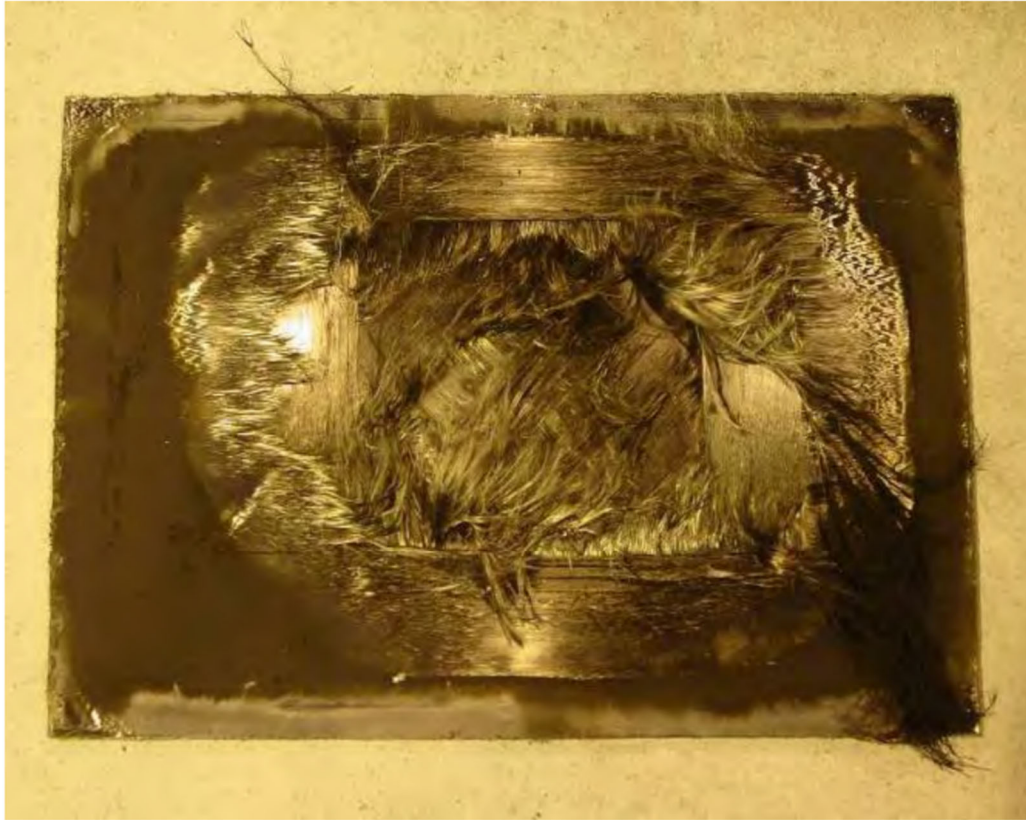
Figure 8. Front view of CFRP sample after ten minutes of fire exposure (Hode, 2012)

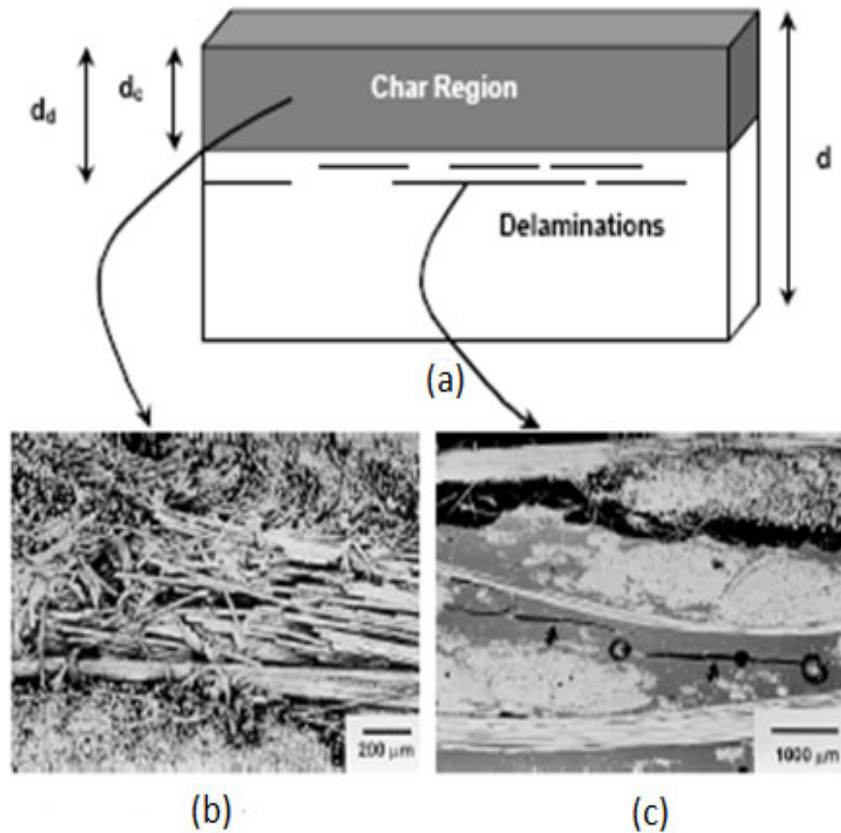
Figure 18. (a) Through-thickness fire damage, (b) char-layer, (c) delamination cracks SEM (Mouritz et al., 2001)

The fire damage induced on the small and large panels was investigated using SEM. The crack depths in the panels caused by the fire were determined using pulse-echo ultrasonics. The identified fire damage on the composite surfaces after the cone calorimeter and fuel fire testing is shown in Figure 18 (Mouritz et al., 2001). In both cases, the damage was nearly identical. Char formation started on the surface fibers in both small and large composite panels due to the combustion and thermal degradation of the polyester matrix upon ignition. Delamination occurred at the interphase between the burnt and unburnt parts of both small and large composite panels due to thermal strains produced during the burning. As the temperatures generated in the calorimeter were higher than those in the fuel fire tests, the charring, cracking, and burn-through rate for the small samples was higher than those for the large panel (Mouritz et al., 2001). The post-fire flexural stiffness and strength of the composite specimens were measured by quenching the burnt small and large panels and cooling them to room temperature. After cooling, the panels were cut into coupons with dimensions 240 mm long, 25 mm wide, and 12 mm thick. The

samples for cone calorimeter tests were thicker (13.5 mm) than those for fuel fire tests (12 mm). The burned part of the coupons was loaded to failure under bending-induced compression (Mouritz et al., 2001)

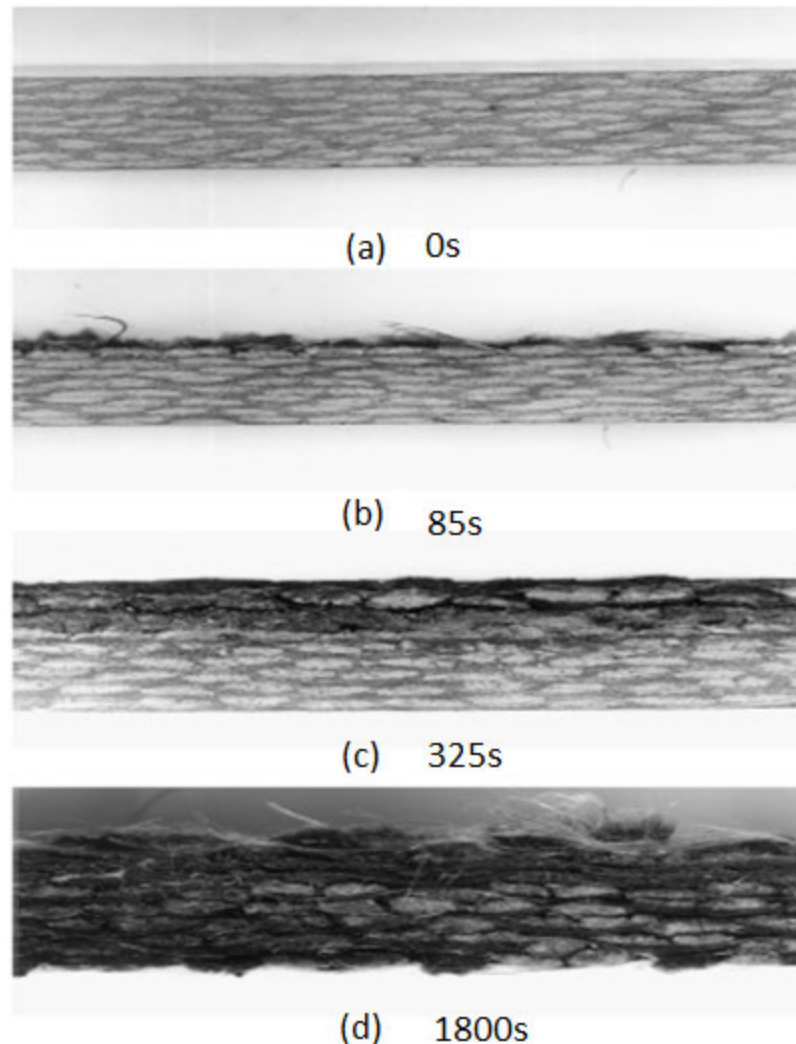
Figure 19. A cross-sectional view of an 11.5 mm thick non-coated composite after burning (Mouritz & Mathys, 2001)

The cross-section of an 11.5 mm thick non-coated composite after being exposed to a heat flux of  $50 \text{ kW/m}^2$  at four different times (0, 85, 325, and 1800 s) is shown in Figure 19 (Mouritz & Mathys, 2001). Figure 19(a) represents the pristine composite. When exposed to fire, the outer layers of the composite started to char (black layer in Figure 19(b)). The char-thickness increased with exposure time (Figure 19(c)). Although the tested composite was 11.5 mm thick, the char spread through the whole thickness (Figure 19(d)) due to the polyester matrix's total thermal decomposition and combustion. Mouritz and Mathys (Mouritz & Mathys, 2001) also stated that the degree of char formation was independent of the heat flux, as the polyester matrix exothermally decomposed, producing heat that enhanced the combustion process upon the ignition of the composite. However, the char growth depended on the post-ignition heat-exposure time and oxygen transfer-rate to the combustion front. The combustion front is defined as the

interface between the burnt and unburnt layers of the composite. The oxygen transport rate dropped as the char thickness increased (Mouritz & Mathys, 2001).
