Fouled Ballast Waiver Operations and Results

1. REPORT DATE January 2022		2. REPORT TYPE Technical Report		3. DATES COVERED June 12, 2017–January 31, 2019	
4. TITLE AND SUBTITLE Fouled Ballast Waiver Operations and Results			5a. CONTRACT NUMBER 693JJ6-18-D-000005		
			5b. GRANT NUMBER		
			5c. PROGRAM ELEMENT NUMBER

13. SUPPLEMENTARY NOTES COR: Hugh Thompson					
14. ABSTRACT Current regulations require locations of noncompliant ballast to be remediated within 30 days or to be taken out of service, regardless of track class. In 2013, the Association of American Railroads (AAR) applied for a waiver to the current regulations that proposed a track class specific approach to managing noncompliant ballast. In 2015, the Federal Railroad Administration (FRA) granted the waiver subject to certain conditions including weekly track geometry measurements. The waiver also initiated a research project to investigate the behavior of reduced performance ballast. BNSF Railway (BNSF) operated safely throughout the waiver period on 340 route miles of its Creston and St. Joseph subdivisions from June 12, 2017, to January 31, 2019. Researchers observed a significant variation in track performance a

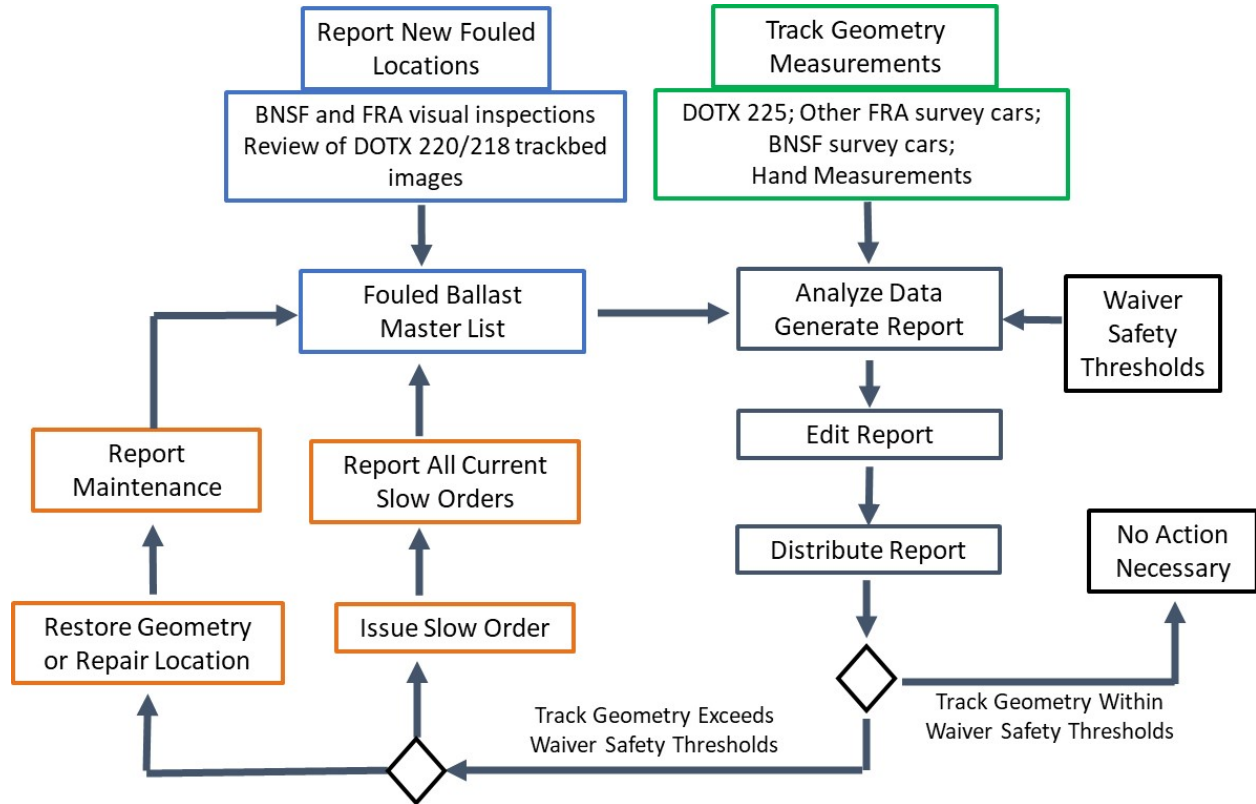
Figure 2. Fouled Ballast Waiver Weekly Compliance Procedure

The reduced performance ballast research team developed a detailed procedure to ensure compliance with the waiver conditions. The procedure ensured safe operations and collection of data to meet the objectives of the reduced performance ballast plan. The weekly compliance procedure was in effect from June 12, 2017, to January 31, 2019. Figure 2 summarizes this in the flow chart.

The following four subsections describe the four different colored regions of Figure 2.

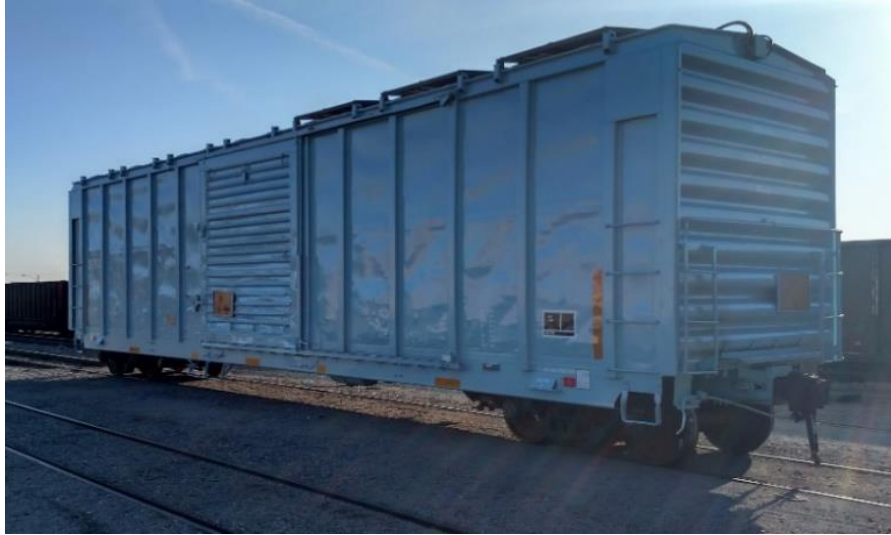
Figure 5. DOTX 225 ATGMS Vehicle

FRA provided its DOTX 225 and DOTX 226 for dedicated operation to collect track geometry data on the waiver territory. Both vehicles are refurbished freight box cars with a carbody mounted Autonomous Track Geometry Measurement System (ATGMS) for unmanned operations. [Figure 5](#) shows DOTX 225.

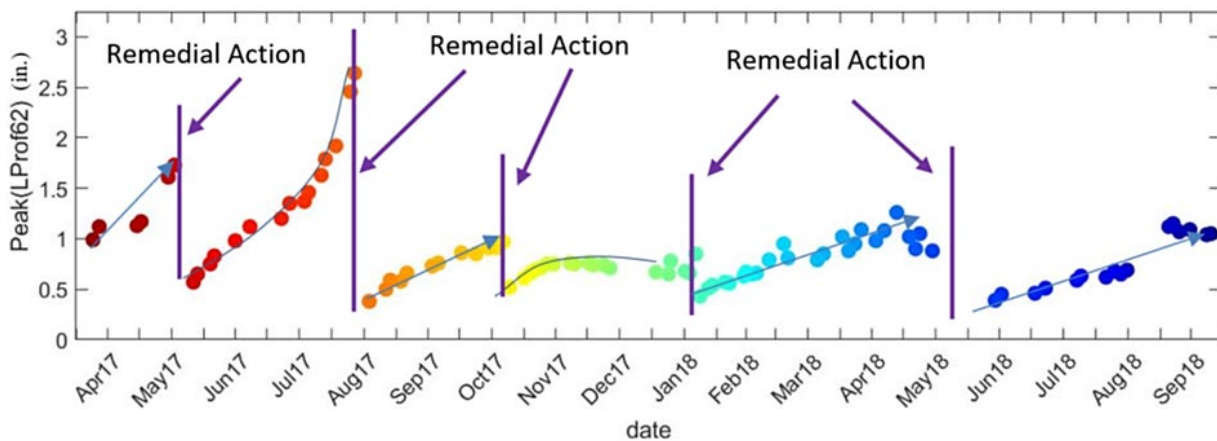
Figure 11. Example Track Geometry Peak Time History

Figure 11 shows an example of a track geometry peak time history. This graph plots the peaks in 80 recordings against the test date. The peaks are for the 62-foot mid-chord offset for profile of the left rail (LProf62).

The vertical lines in Figure 11 show the dates when remedial action was taken to improve track geometry. This example clearly shows a repeated pattern of degradation and improvement.

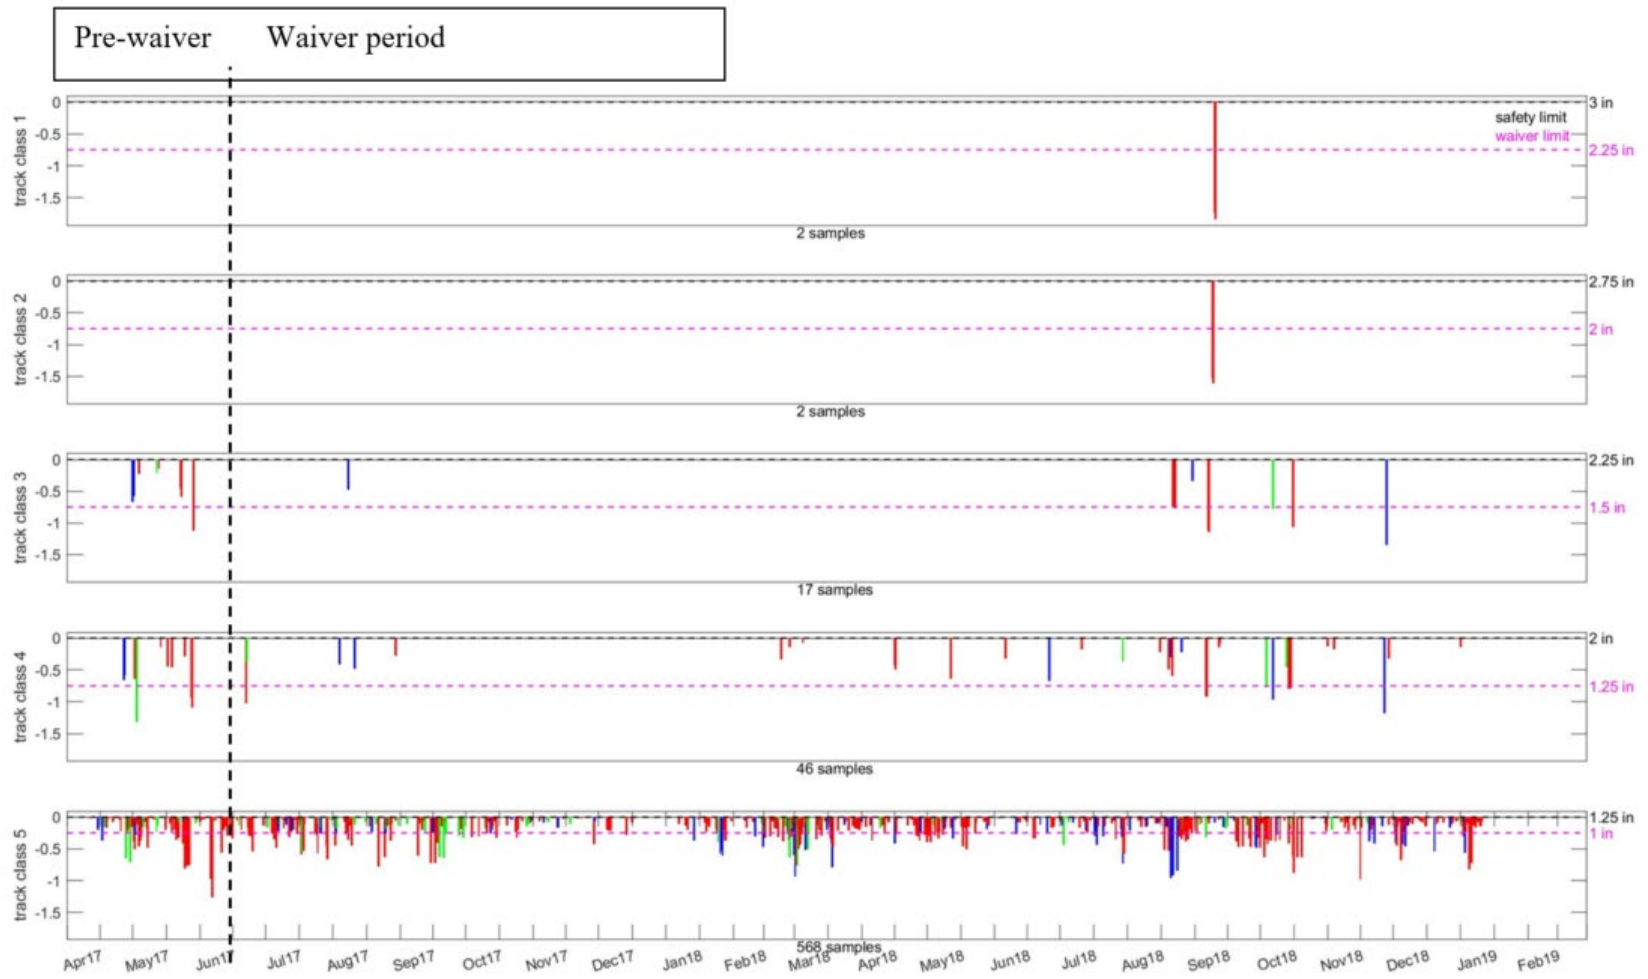
Figure 13. Degradation Results for Profile 62 During the Pre-waiver and Waiver Periods

[Figure 13](#) shows the degradation results for the mid-point offset on a 62-foot chord for the profile of the left and right rails (Profile 62). These results are for the pre-waiver period from April 2017 to June 2017 and for the waiver period from June 2017 through January 2019. [Figure 14](#) shows the degradation results for Profile 62 in the post-waiver period from January through December 2019. Similar results for the other track geometry parameters are shown in [Appendix A](#).

[Figure 13](#) and [Figure 14](#) have separate charts for track classes 1 through 5. Each chart shows instances when the relevant safety limit for the track class was crossed. Color coding is used to indicate tangent, curved, or spiral track. The units of the y-axis are inches.

Color Codes: Red – Tangent, Green – Curve, Blue – Spiral

The results in [Figure 13](#) and [Figure 14](#) are grouped by track class. The dashed horizontal lines in these figures show the safety limit and waiver thresholds for track parameter Profile 62. [Figure 13](#) and [Figure 14](#) show most of the calculated degradation results occurred on tangent track. Some results were on curves and a few were on spirals. This is consistent with the lengths of tangents and curves on the waiver territory. The results show some degradation results exceeded the additional safety margin between the waiver threshold and the track safety limit.

The degradation results found in [Figure 13](#) and [Figure 14](#), and in [Table 2](#) and [Table 3](#) are for all fouled ballast locations in the master list regardless of length. [Figure 15](#) compares the variation in degradation between lengths less than 10 feet with the variation for those equal to or greater than 10 feet. These results are for locations where the Profile 62 parameter crossed the track class 4 safety limit during the waiver period.

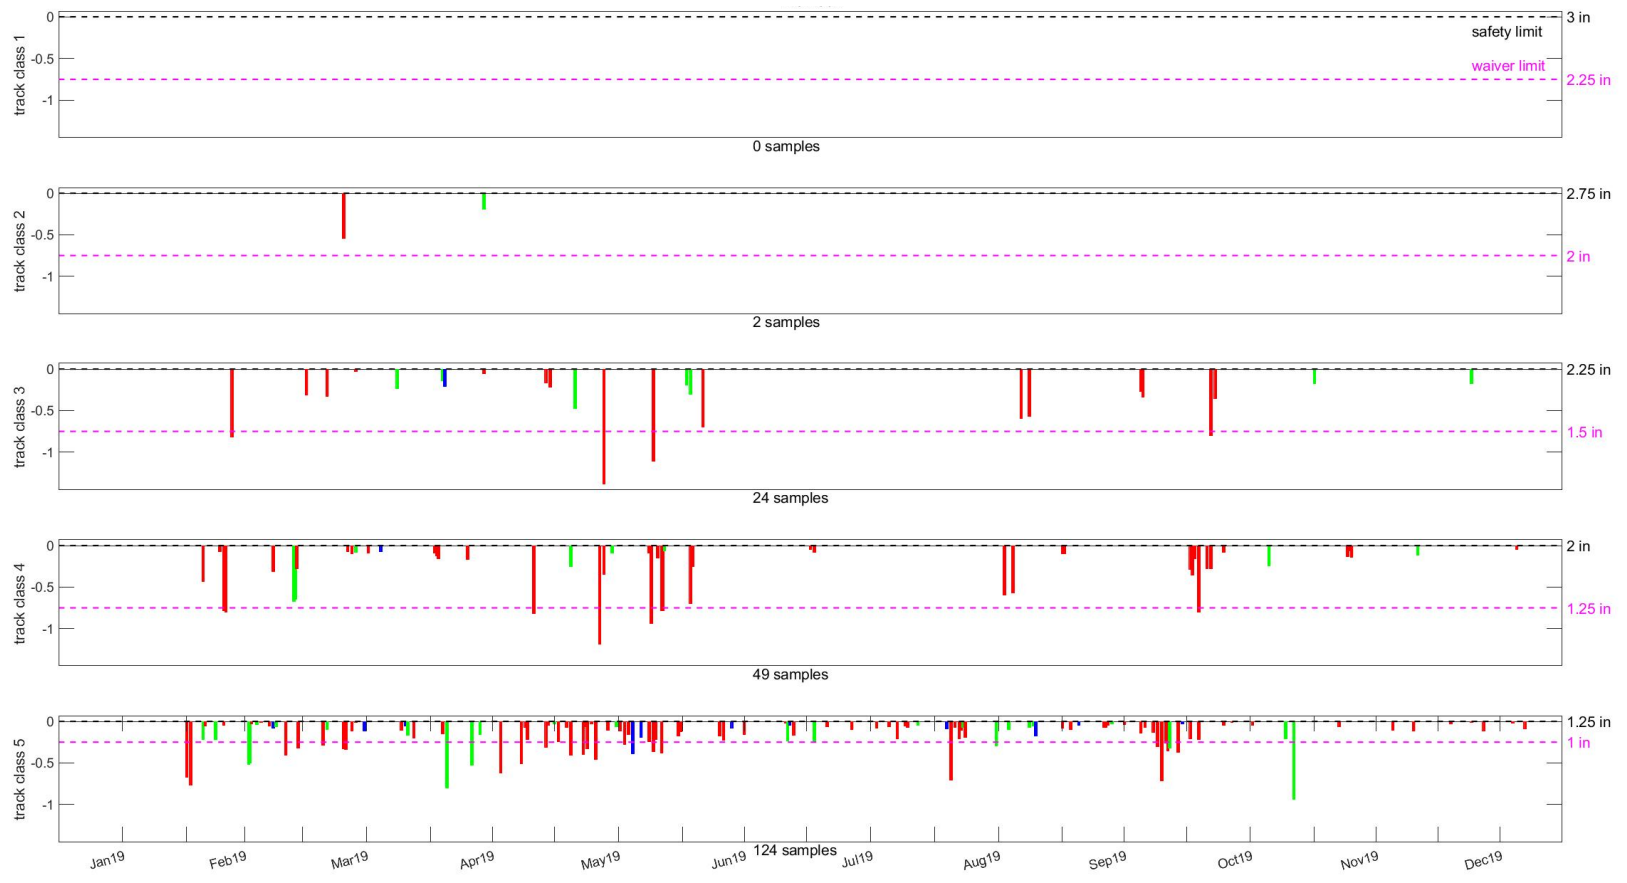
Figure 14. Degradation Results for Profile 62 During the Post-waiver Period

Color Codes: Red – Tangent, Green – Curve, Blue – Spiral

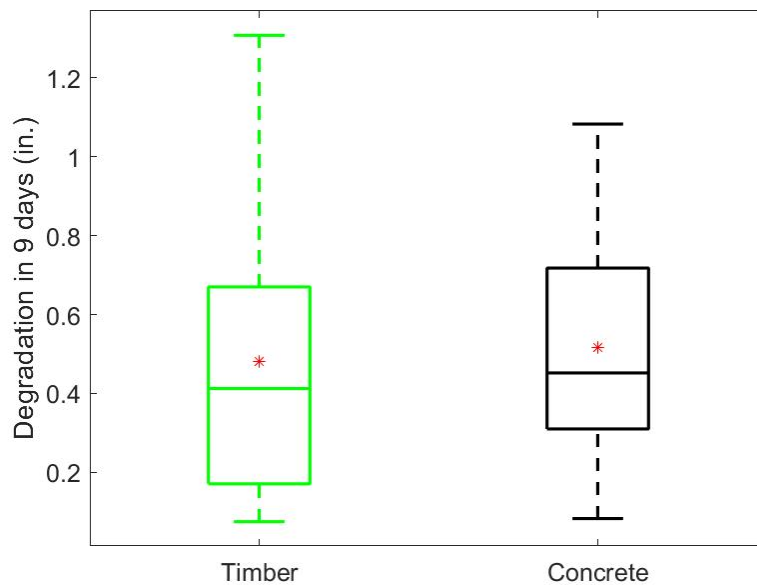
Figure 17. Profile 62 Degradation by Tie Type – Track Class 4 Safety Limit

Figure 17 compares the variation in degradation in the Profile 62 parameter between different types of tie. These results are for all lengths of fouled ballast locations crossing the track class 4 safety limit and for all time periods.

Figure 17 shows box and whisker plots for both tie types. The means are also shown for comparison with the medians. The mean degradation for timber ties (22 results) is similar to that for concrete ties (24 results). A statistical test confirmed there is no evidence that the degradation is different for these two types of tie.

The maximum degradation for the timber ties, 1.31 inches, is slightly larger than that for the concrete ties, 1.08 inches.

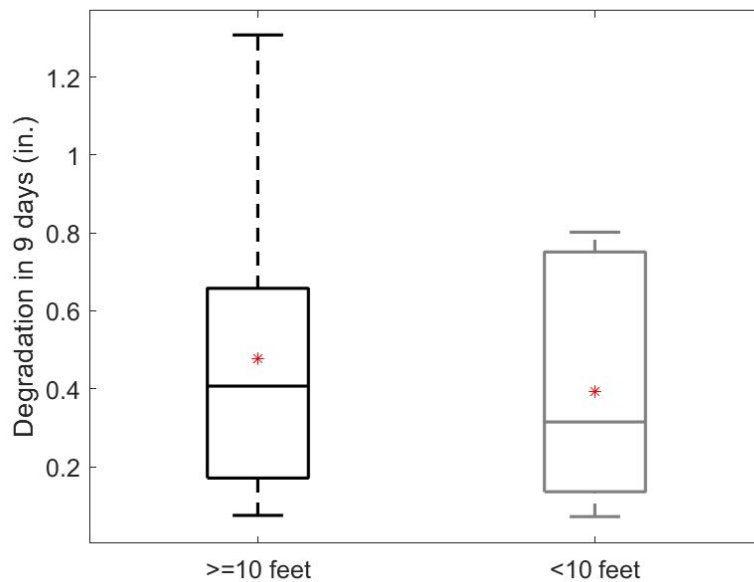
Figure 18. Profile 62 Degradation by Fouled Ballast Location Length – Track Class 4 Safety Limit – All Periods and Tie Types

Figure 18 compares the variation in degradation between lengths less than 10 feet with the variation for those equal to or greater than 10 feet. These results are for locations where the Profile 62 parameter crossed the track class 4 safety limit during the pre-waiver, waiver, and post-waiver periods. They are for both types of tie.

Figure 18 shows box and whisker plots for both categories of fouled ballast length. The means are also shown for comparison with the medians. The mean degradation for locations equal to or greater than 10 feet (54 results) is similar to that for locations less than 10 feet (15 results). A statistical test showed there is no reason to conclude the degradation is different for these two datasets.

Comparing Figure 21 with Figure 18 shows mean degradation before crossing the track class 5 safety limit is less than that before crossing the safety limit for track class 4. The variation is similar for short and long locations of fouled ballast.

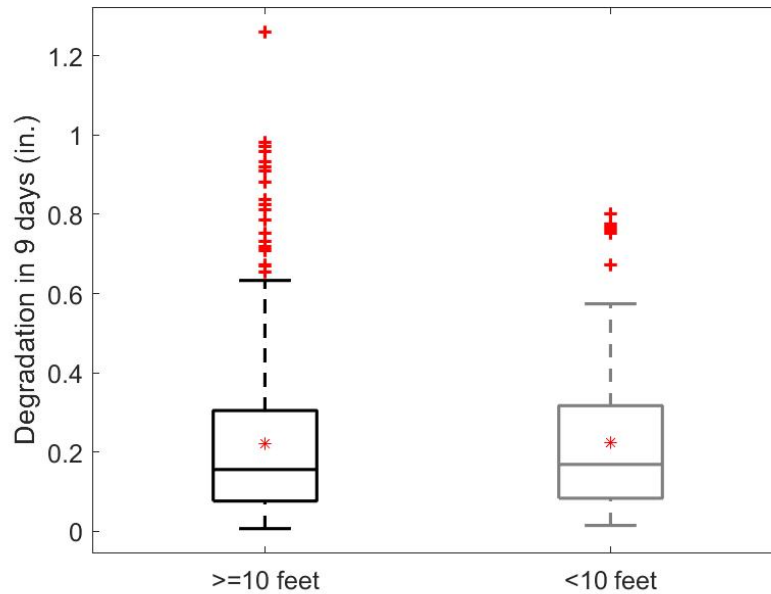
Figure 21. Profile 62 Degradation by Fouled Ballast Location Length – Track Class 5 Safety Limit – All Periods and Tie Types

Figure 21 shows results from locations where the Profile 62 parameter crossed the track class 5 safety limit. It compares the variation in degradation between lengths less than 10 feet with the variation for those equal to or greater than 10 feet. These results are for locations during the pre-waiver, waiver, and post-waiver periods, and both tie types.

Figure 21 shows box and whisker plots for both categories of fouled ballast length. The means are also shown for comparison with the medians. Data points that lie outside the fence are also shown. They indicate several locations with exceptionally high degradation. (Note that the previous box plots showed these outliers were not present in the track class 4 Profile 62 degradation results.)

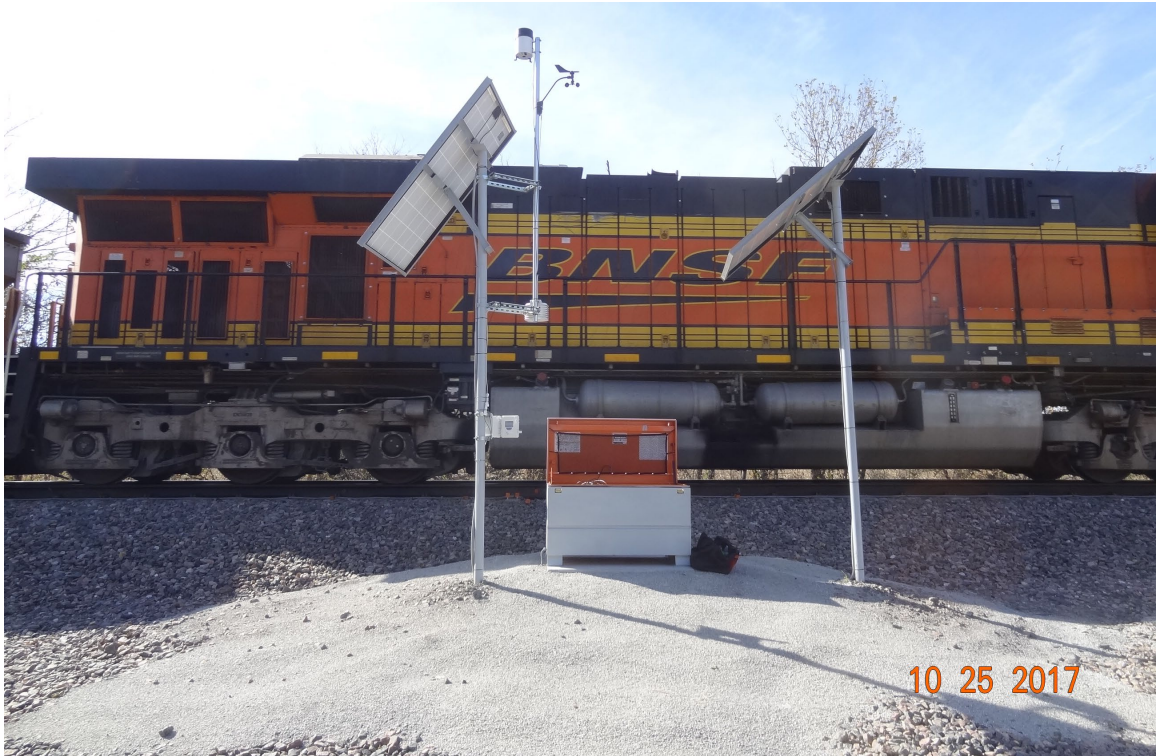
Figure 29. Typical Setup of Instrumentation Box, Solar Panels, and Weather Station

Figure 29 shows the overall instrumentation setup installed at each of the six instrumented sites. Solar panels were initially installed to provide power to the National Instruments (NI) data acquisition system. The solar panels at each site were augmented with a wind generator to maintain adequate power throughout the range of environmental conditions these sites experienced. In addition, four sites had weather stations mounted on the same pole as one of the solar panels. The weather stations measured rainfall, wind speed, and direction.

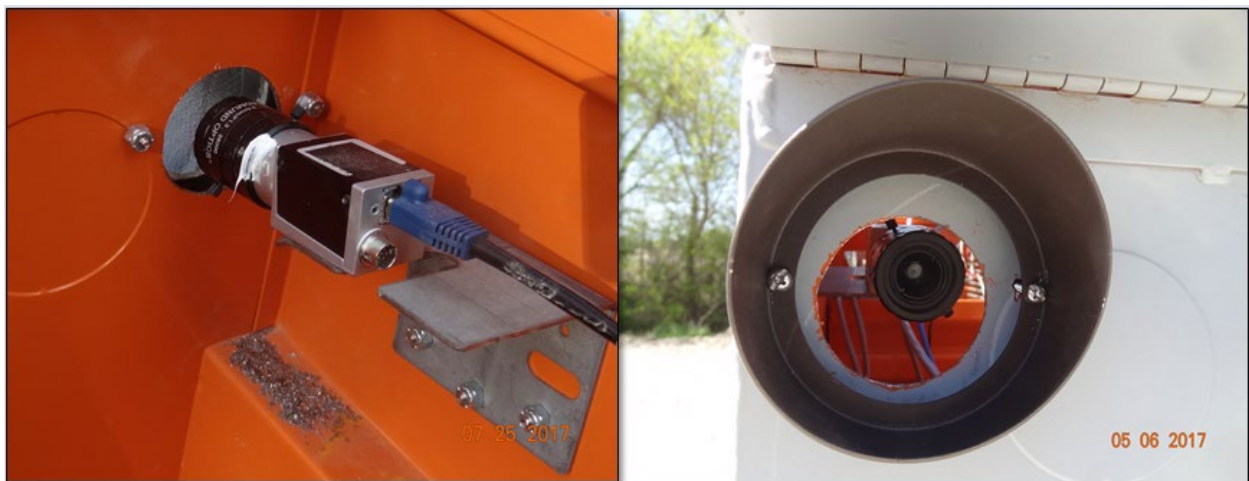
Figure 32. High Frequency Video Camera and Glass Shield

Figure 32 shows one of the two high frequency video cameras installed in each instrumentation box. The glass shield that protected each camera is shown on the right of Figure 32. The cameras recorded each train at a rate of 100 frames per second for 3 minutes. For each train, the 4 TB hard drive stored 36,000 frames. Researchers connected the cameras directly to the DAQ controller and recorded the transient and permanent displacements of the orange targets that were installed on the rail and adjacent ties. Each camera monitored two ties and the connecting rail. Each camera also monitored a ground stake that was installed in front of the two ties and responded to the ground vibrations induced by the passing train. The ground vibrations were subtracted from the measured rail and tie displacements to estimate the transient and permanent displacements of only the rail and ties.

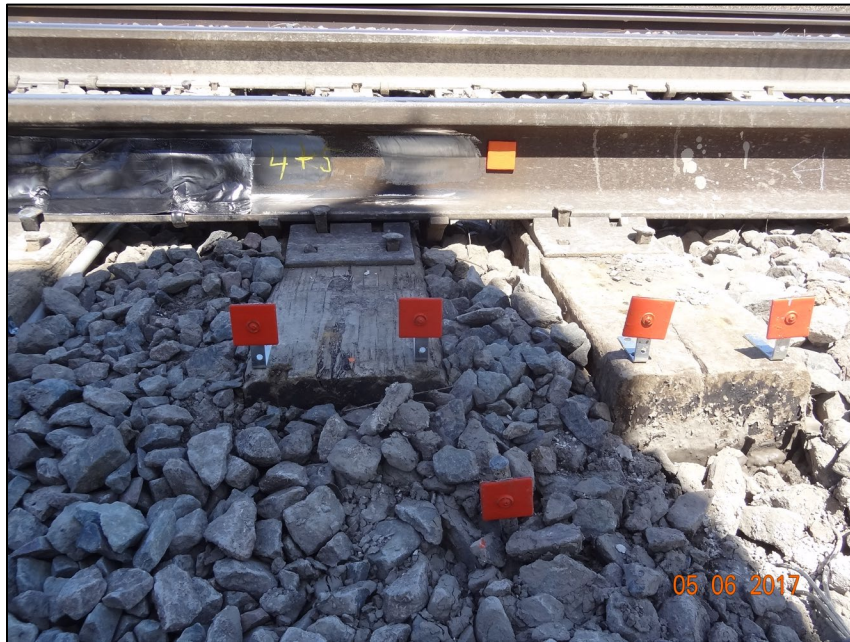
Figure 33. Targets Attached to Adjacent Cross ties, Connecting Rail and Ground Stake

Figure 33 shows the system of orange targets installed for one of the cameras. The MATLAB code obtained transient displacement time histories of the rail and tie targets for each train. The

use of these time histories estimated the tie-to-ballast gap, rail-to-tie gap, and track stiffness as a function of wheel load. The installed targets were 2-inch metal squares, which were painted orange to distinguish them from the surrounding environment.

The MATLAB code processed the transient displacement data from each camera and target assembly by calculating the relative movement per frame compared to the image of the target immediately before the train arrived. This was possible because a rail strain gauge or a tie accelerometer activated the DAQ system prior to train arrival at the first target.

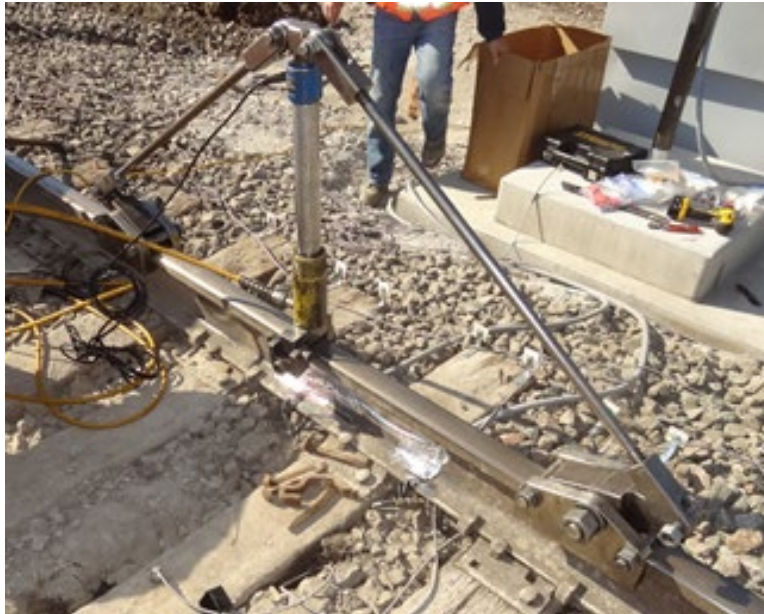
Figure 35. Strain Gauge Calibration Frame

[Figure 35](#) shows the loading fixture used to calibrate the rail strain gauges. During calibration, a load up to 40,000 lb. is applied by a hydraulic jack in the fixture to simulate the maximum wheel load and deflect the rail. The results are used to construct a load-deflection relationship that yields a calibration factor for converting the strain gauge bridge voltage to the applied load. A calculation of the separate calibration factor took place for each crib and tie strain gauge circuit.

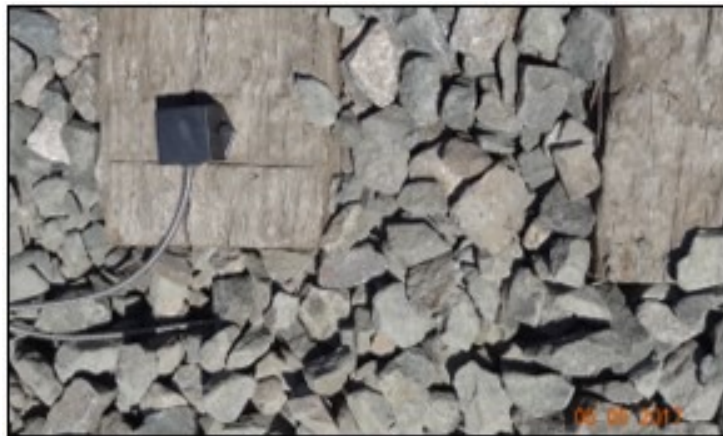
Figure 38. Accelerometer Attached to a Tie and Covered with a Plastic Box

Since they were intended for long-term monitoring, the accelerometers were weather-proofed and attached rigidly to the ties. For the PCB uniaxial accelerometers, mounting pads were soldered onto metal plates that were then screwed to the ties. Plastic boxes were used as a cover. The triaxial accelerometers were installed in water-proof boxes and conduit was used to protect any vulnerable cables.

Figure 38 shows a typical accelerometer installation.

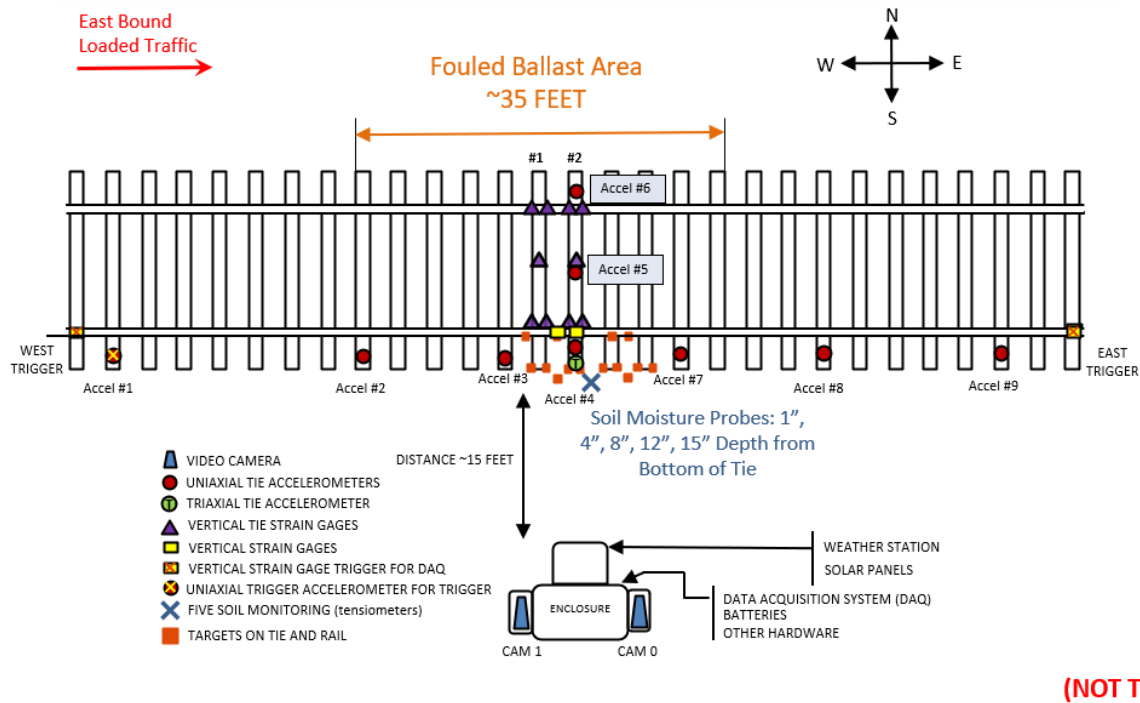
Figure B.1. Instrumentation Layout at Waldron

This appendix provides the instrumentation details at the monitoring site, featured in Figures B.1 through B.10.

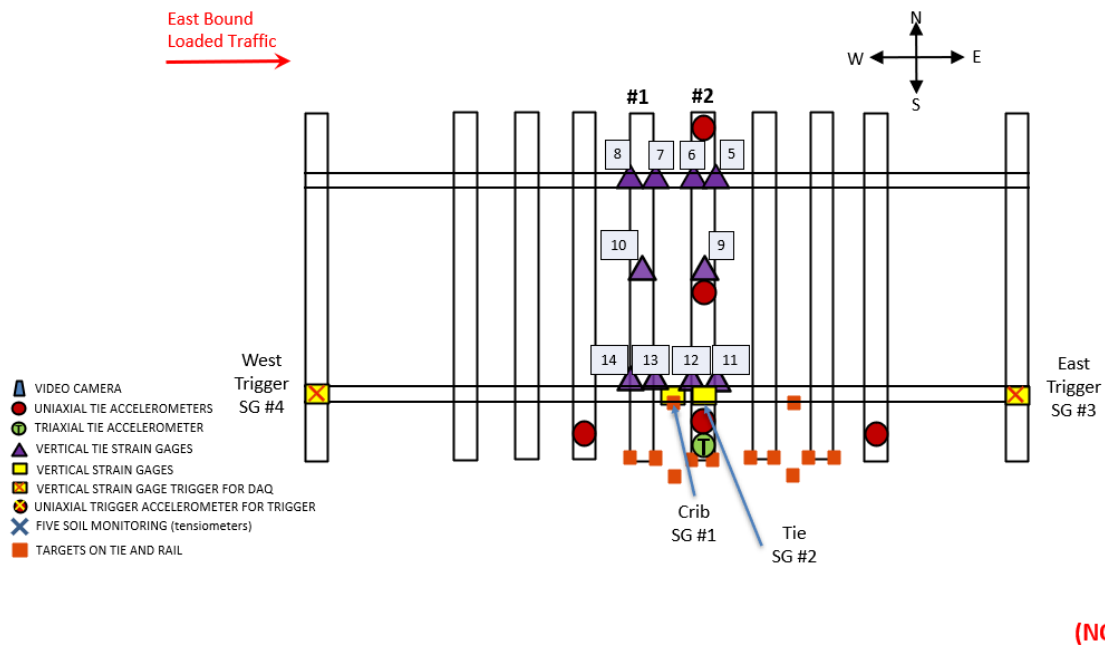
Figure B.2. Strain Gage Layout at Waldron

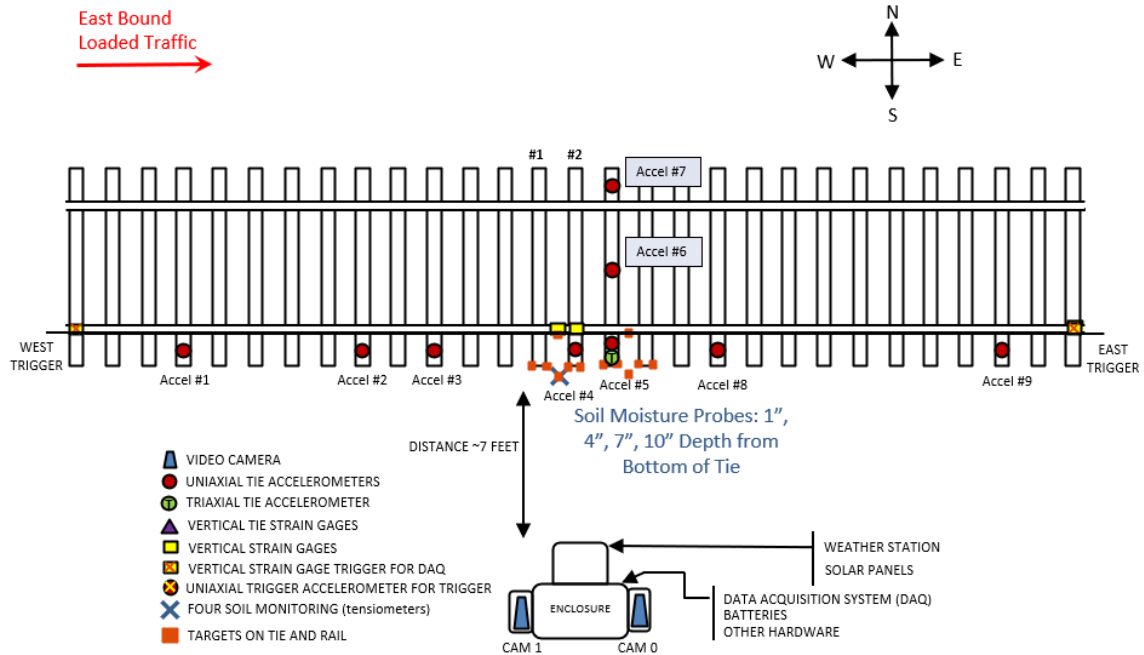
Figure B.9. Instrumentation Layout at Hickman – Control

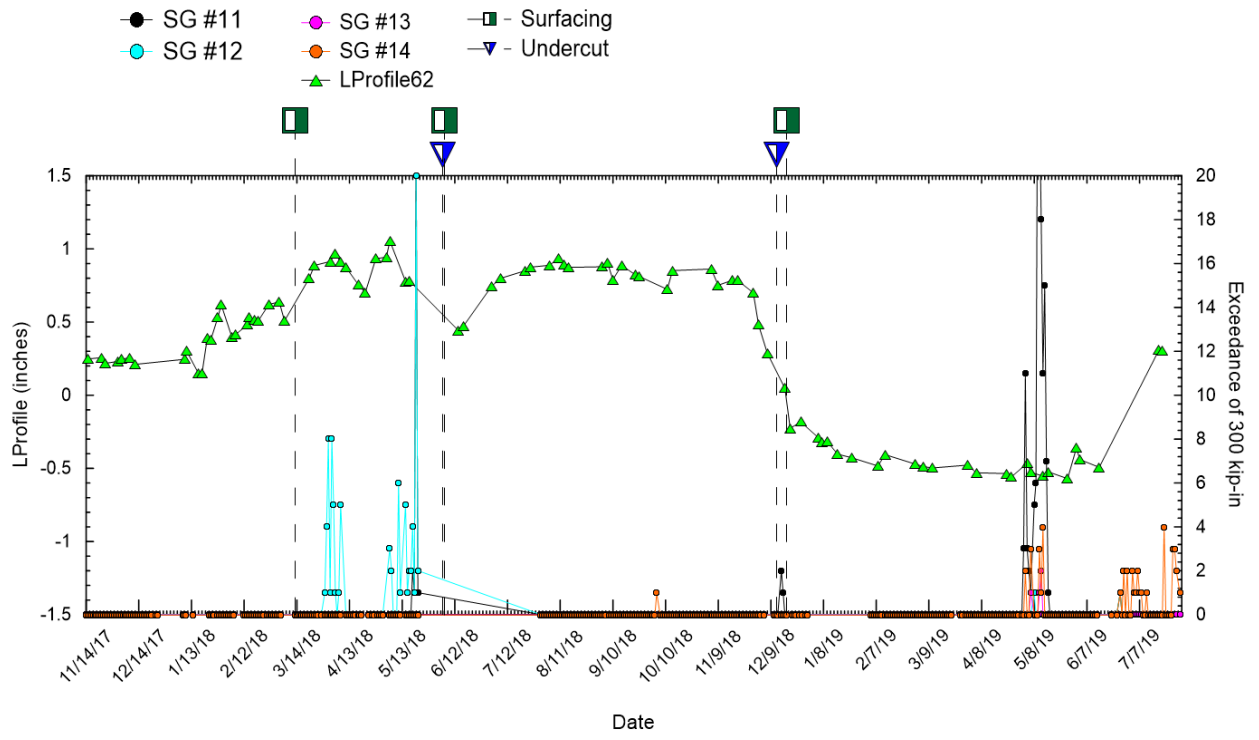
Figure C.8. Bending Moment Exceedances at Waldron

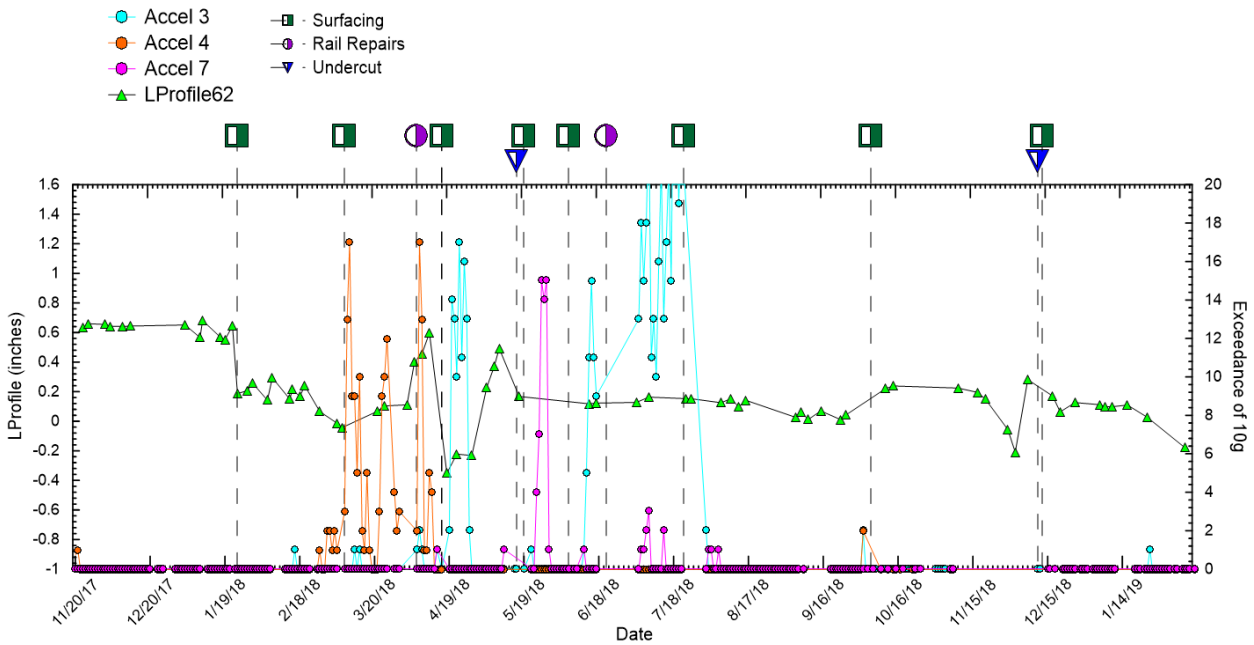
Figure C.14. Acceleration Exceedances at Parkville
