Performance of Wicking Geotextile on Mitigating Water Pumping Issue on I-44 Highway

March 2020
Final Report

Project number TR201905
MoDOT Research Report number cmr 20-003

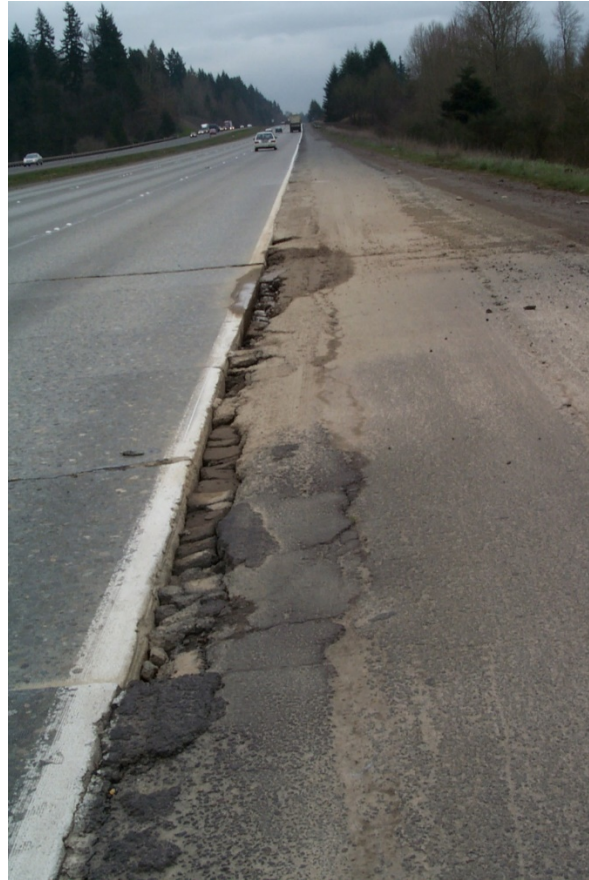
Figure 1.1 Damage caused by water pumping at the inner edge of the road shoulder

Pumping is the ejection of water and fine materials out of the pavement under pressure (i.e., traffic loads) through cracks. The water ejection, carrying fine materials, may result in progressive material deterioration and loss of support. Evidence of pumping includes surface stains and accumulated material on the road surface close to joints and cracks (please see Figure 1.1).

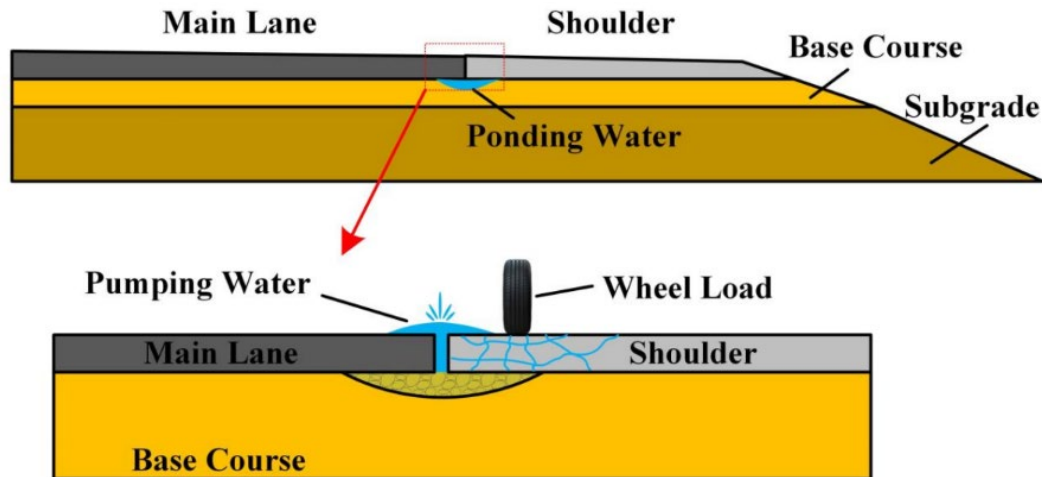
Figure 1.2 Schematics of pumping action

Pumping is an issue causing failure in both rigid and flexible pavements. This type of failure is caused by either ejection of water and fine contents through pavements joints, cracks, and edges or redistribution of materials underneath the slab. Three conditions are required for pumping to occur: (a) large deflection (heavy axle loads and/or thin slabs); (b) water in the pavement; and (c) materials that are susceptible to pumping. The schematic view of the pumping problem is shown in Figure 1.2 . Deformation under heavy wheel loads generates excess pore water pressure in a saturated base course layer. The pore water pressure is typically generated at top of a layer that contains higher fines content mainly for two reasons. First, this layer can hold more water and due to less permeability, and infiltrated water can pond on top of it. Second, due to less permeability, the loading applied is close to undrained condition. Thus, repeated traffic loads increase pore water pressure. Eventually, the excess pore water pressure is high enough to cause water flow and displace small particles in the soil layer. This results in emerging void spaces due to displaced soil particles (Holtz 2008). As time passes, these void spaces get larger and result in a lack of support and bearing capacity failure for the upper pavement layer (Al-Qadi et al. 2004, Zuo et al. 2004, Diefenderfer 2005). On the other hand, the displaced particles move to the upper layer which initially had no fines and a higher permeability (Kermani et al. 2018a). Fines migration changes Grain Size Distribution of the upper layer, decreasing its permeability, increasing capillary height, and increasing soil water storage in unsaturated condition. The latter also results in a smaller modulus value for this layer. Eventually, this process causes cracks at the pavement surface resulting in more water infiltration and more damage. At extreme conditions, fine particles along with water are ejected through the cracks of the pavement surface. By this time, all of the pavement layers have been affected by the pumping and the overall performance of the pavement has significantly reduced.

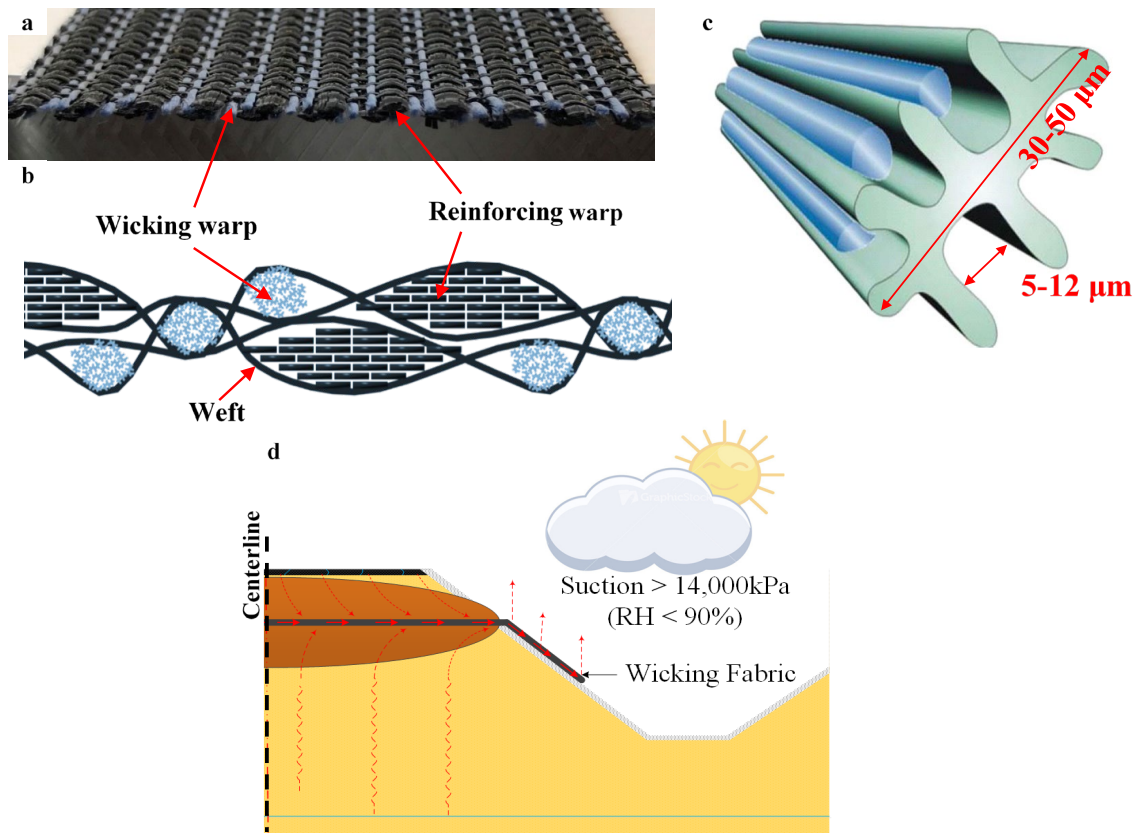
Figure 1.3 Wicking geotextile. a) geotextile photo, b) schematics of geotextile cross-section, c) schematics of a single wicking yarn, d) schematics of wicking geotextile working mechanism

In recent years, a new type of wicking geotextile has been developed that is able to remove both capillary water and gravitational (free) water out of the pavement structure in an effort to maintain good pavement performance and longevity. Figure 1.3a shows a picture of the new wicking geotextile. The schematic cross-section of the wicking geotextile is illustrated in Figure 1.3b. As depicted in Figures 1.3a and 1.3b, the wicking geotextile has two different warp yarns which are woven together by wefts of other geosynthetics material. The reinforcing warp yarn is made of polypropylene with high tensile strength. The wicking yarn consists of 144 wicking warps for drainage purposes. As can be seen, wicking yarns are weaved at the top, middle, and bottom of the geotextile cross-section allowing the wicking geotextile to absorb water from both the top and the bottom surface. The unique properties of the wicking geotextile come from the hydrophilic and hygroscopic nylon filaments with a unique multi-channel cross-section as shown in Figure 1c. Each wicking warp has an average diameter of 30-50 μm and an average groove width of 5-12 μm . The multichannel cross-section has a high shape factor and a great number of channels per fiber (specific surface area = 3650 cm^2/g), which give the wicking geotextile great potential for maximizing capillary action and water transport in an unsaturated condition. Figure 1.3d shows the mechanism of the wicking geotextile to drain water, which will be explained in the following section.

As mentioned above, the weaving pattern of the wicking yarns in the wicking geotextile (Figure 1.3b) allows it to absorb water from both sides of the surrounding soil (i.e., above and below). The unique design allows the wicking fiber to generate a higher capillary force. Thus, water from the adjacent soil is absorbed into the wicking fibers and can be easily transported along the deep grooved channels. Because the relative humidity of the air is usually less than 90% under most conditions, the suction caused by air at the surface of a pore is very high (>14MPa (>2 ksi)). If the end of the wicking geotextile is exposed to the atmosphere, there is a high suction gradient in the wicking geotextile from its buried end in the soil to the exposed end. The suction gradient is the driving force that continuously transports water from the buried end of the wicking geotextile yarns to the exposed end and water will be vaporized into the surrounding atmosphere at the exposed end. Theoretically, this process continues until the suction of the soil adjacent to the wicking geotextile is equal to the suction in the air. If time is long enough, all soils inside the pavement will be air-dried. Studies have shown that the wicking geotextile can effectively reduce the water content of adjacent soil corresponding to a suction value of 254 kPa (Lin et al. 2018b). At this point, even when repeated traffic load is applied on the pavement under undrained condition, the increase in pore water pressure will not be sufficient to build high positive pore water pressure and induce pumping.

Also, based on the air relative humidity and mean temperature, the air suction was calculated as shown in Figure 3.2f. The calculated air suction was always greater than 1 MPa (145 psi), and generally between 30-180 MPa (4350-26100 psi). Under such levels of suction, the soils on the slope of the road can be completely air-dried. Once the surface soils are air-dried, the water phase in the soils become discontinuous, which results in extremely low unsaturated permeability. It is therefore very difficult for water inside the pavement to come out even though the huge suction difference still exists between the soil inside and the surrounding atmosphere. However, as it is discussed before, with the help of multiple microchannels in the wicking geotextile, water can be easily transported from inside to the edge of the road shoulder and vaporized into the atmosphere. This suction is the driving force that drags the excess water out of the pavement through the channels in the wicking fibers as shown in Figure 1.3. This is the working mechanism of the wicking geotextile.

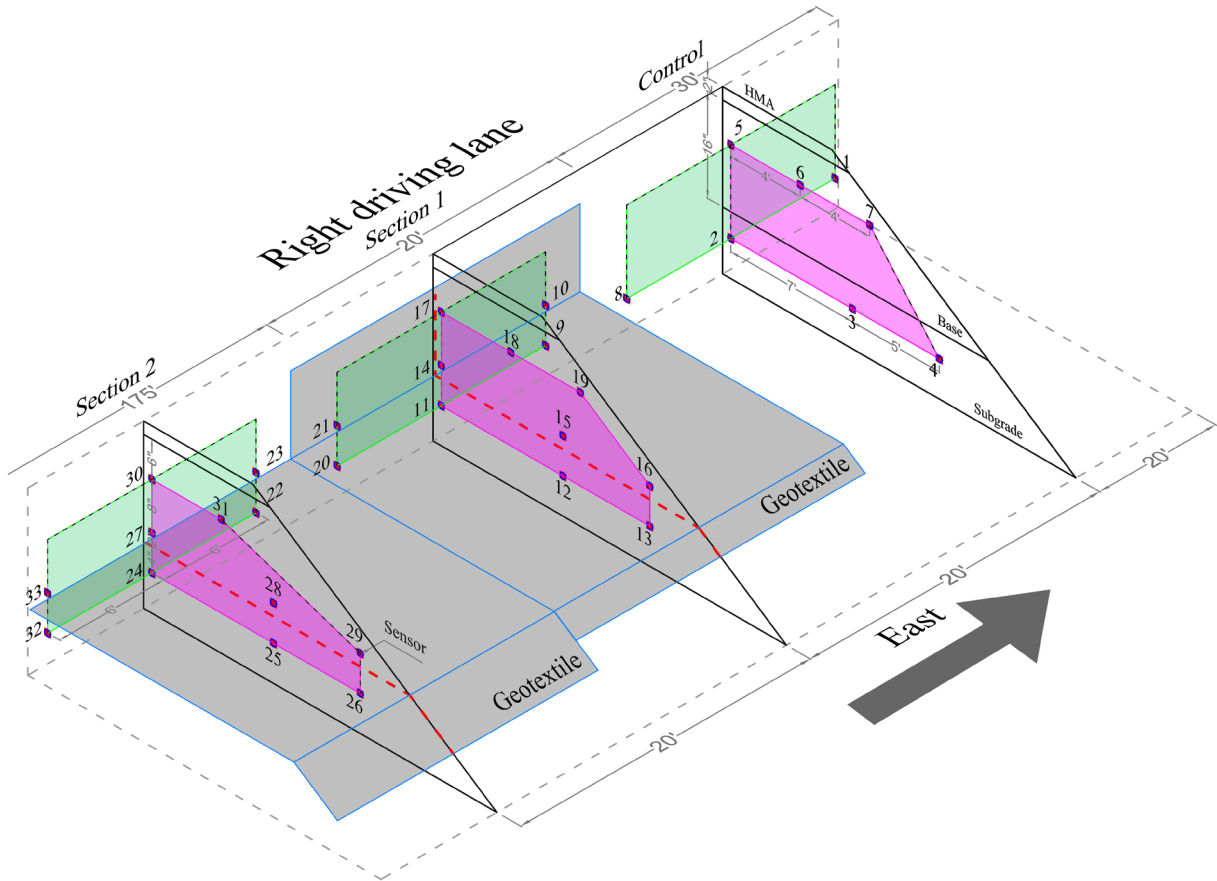
Figure 2.2 Schematic plot of test section design

Figure 2.2 shows the schematic plot of the test site design. The test site is 225 feet long. In order to study the effect of different placement methods on the drainage performance of wicking geotextile, the test site was divided into 3 sections as shown in Figure 2.2. From east to west, the three test sections were labeled as Control, Section 1, and Section 2 with lengths of 30 feet, 20 feet, and 175 feet respectively. The east section was left untreated without installation of wicking geotextile. It served as a control section and will be compared with the other two sections to evaluate the performance of the wicking geotextile on mitigating pumping. Section 1 was in the middle with installation of an L-shaped wicking geotextile. The red dotted line as shown in Figure 2.2 schematically shows the location of the installed wicking geotextile. As shown in Figure 2.2, the wicking geotextile was placed horizontally at the interface of the subgrade and base course layer with a depth approximately 18 in. below the road surface. At the interface between the driving lane and shoulder (inner edge of the shoulder), the wicking geotextile was folded up vertically to a height of approximately 12 in. This decision was made since the

pumping issue is mostly seen along the vertical interface of the driving lane and shoulder (inner edge of the shoulder) and cracks and potholes appear often in this region. Extending the geotextile to the location where damages are most likely to occur may facilitate the water drainage and have a beneficial effect on reducing the pumping issue over a longer period. Section 2 was at the west part of the test site and the wicking geotextile was placed horizontally at the interface of the subgrade and the base course layer with a depth approximately 18 in. below the road surface.

In order to evaluate the performance of different treatments, a total of 33 moisture sensors with temperature measurements were installed at different locations of the three test sections as represented by the red solid dots in Figure 2.2. As shown in Figure 2.2, 6 sensors (labeled as 2, 3, 4, 5, 6, and 7) were installed in a cross-section in the control section along the transverse direction of the road, which was 20 feet away from the east end of the test site. The sensors were installed at two different elevations, one was 8 in. below the designed road surface (sensors 5, 6, and 7) in the base course materials, and the other (sensors 2, 3, and 4) was about 2-4 in. into the subgrade and 22 in. below the designed road surface.

In addition, two other sensors (labeled as 1 and 8 in Figure 2.2) were installed in the control section along the vertical interface of the driving lane and shoulder, which were at the same elevation of sensors 2, 3, and 4, and 6 feet away from sensor 2 on both sides.

Sensor installations in sections 1 and 2 were similar to that in the control section, except that an additional layer of 5 sensors was installed 2 in. above the wicking geotextile. Specifically, in section 1, sensors 10, 14, 15, 16, and 21 were installed directly above the sensors at the lowest elevation of 9, 11, 12, 13, and 20, respectively. The middle layer of sensors was roughly 16 in. below the designed road surface. In section 2, the additional layer of sensors were 23, 27, 28, 29, and 33. The purpose of this installation was to more closely monitor the moisture migration near the wicking geotextile. Please see Figure 2.2 for the detailed layout of the sensors.

Figure 3.3 shows the volumetric water content (VWC) readings from sensors 4, 13, and 26, which are at the outer edge of the subgrade in the control section, section 1, and section 2 respectively (please refer to Figure 2.2). As can be seen in Figure 3.3, all the initial VWC readings were low, ranging from 19% to 28% with an averaged value of 23%.

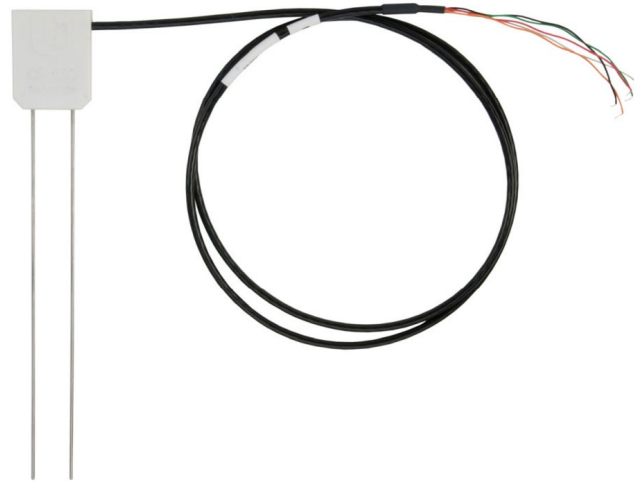
Figure 2.3 CS650 Water Content Reflectometer

The 33 sensors used in this project were the “CS650 Water Content Reflectometer” sensors from Campbell Scientific® as shown in Figure 2.3 . These sensors have a rod length of 300 mm (11.8 in.) and probe head dimensions of 85×63×18 mm (83.35×2.48×0.71 in.), and can measure volumetric water content and temperature of the soil. The volumetric water content measurement range is 0% to 100% ±3% and the temperature measurement range is -50 to +70 °C ±0.5 °C (-58 to +158 °F ±0.9 °F).

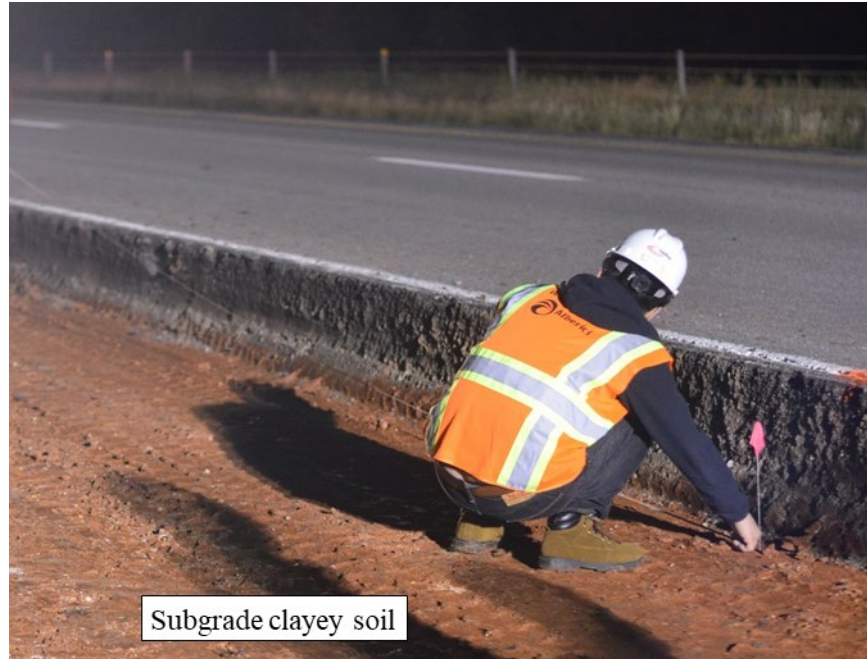
Figure 2.6 View of the shoulder after excavation

This work continued during the afternoon of September 26, 2018. During the following night, the contractor started the first phase of construction on the shoulder. The existing asphalt layer was removed and the road shoulder was excavated to a depth of 18 in. where subgrade soils were found as shown in Figure 2.6. The subgrade soils were found to be high plasticity clay with red color.

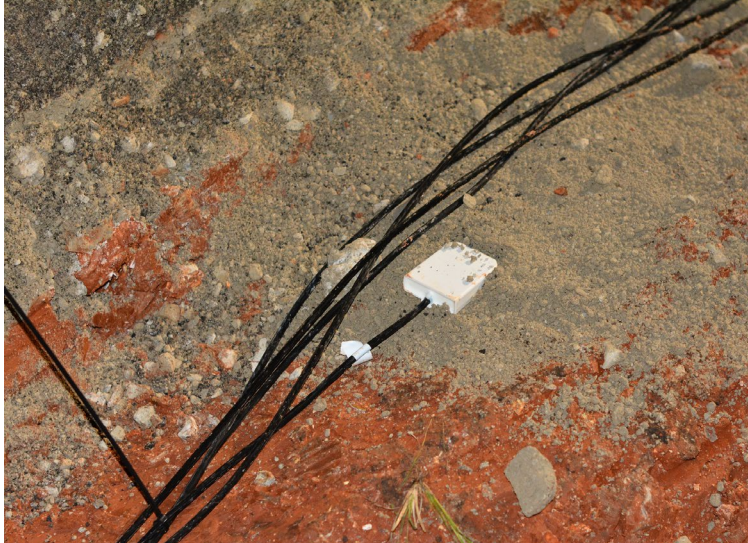
Figure 2.7 Sensor installation in the subgrade soil

The sensors were installed to monitor water content changes within the road shoulder in order to evaluate the performance of the wicking geotextile. Since the subgrade soils and the base course have different water storage capacity, the moisture contents in the two types of soils will be significantly different. More specifically, clayey subgrade soils can hold more water than the granular base course material. During rainfall events, water will migrate from base course soils, which have low moisture content, to subgrade soils, which has higher moisture content. In other words, water content is not the controlling factor for water to flow. Instead, water flows due to hydraulic head difference. In order to avoid the difficulties in future data analysis, it was decided that all sensors should be surrounded in the same type of soils during installation. In this way, we do not have to deal with the different water storage capacity associated with different soil types. For the same soils, water will flow from a location with high moisture content to another location with low moisture content if the elevation head is the same. In order to do so, in this study, the base course materials were firstly sieved using a 3/8 in. sieve and the soils passing the 3/8 in. sieve were used for sensor installation. For example, in order to install a moisture sensor in the subgrade soils as shown in Figure 2.7, a small hole was first made in the subgrade to a depth of 2-4 in. Then the hole was backfilled using the base course soils passing the 3/8 in. sieve. After that, the sensor was installed with its probes being horizontally placed in the fine base course soils.

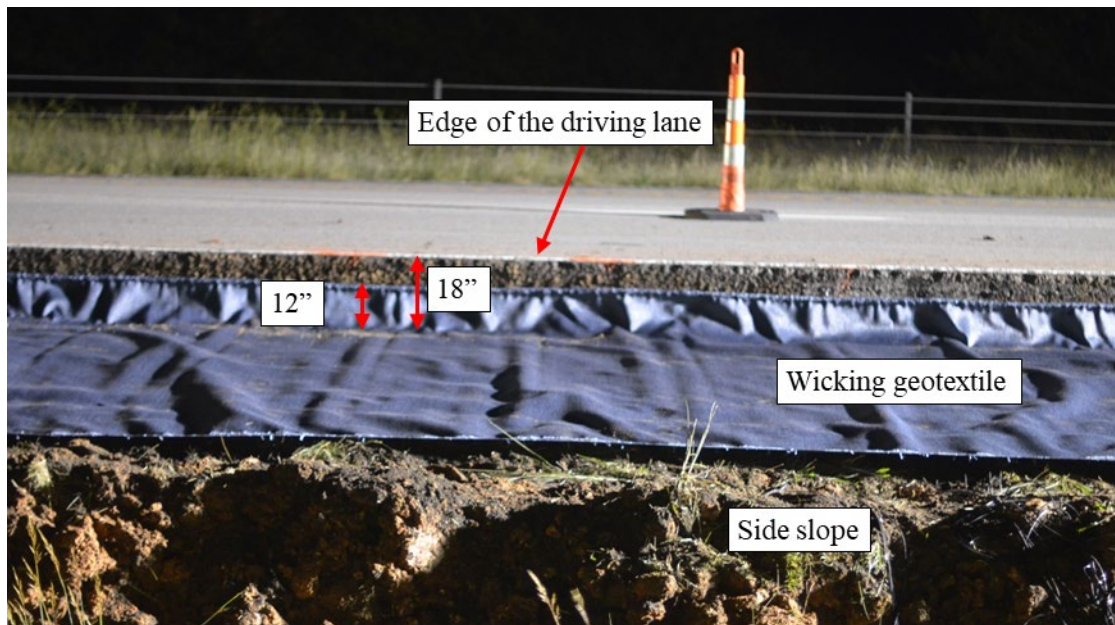
Figure 2.8 L-shaped placement of wicking geotextile in section 1

After the first layer of sensors were placed in the subgrade, the wicking geotextile was placed on top of the subgrade. Figure 2.8 shows the placement of the wicking geotextile in section 1. As mentioned previously, in section 1, the wicking geotextile was placed into a toppled L-shape by folding the wicking geotextile vertically along the edge of the driving lane as shown in Figure 2.8.

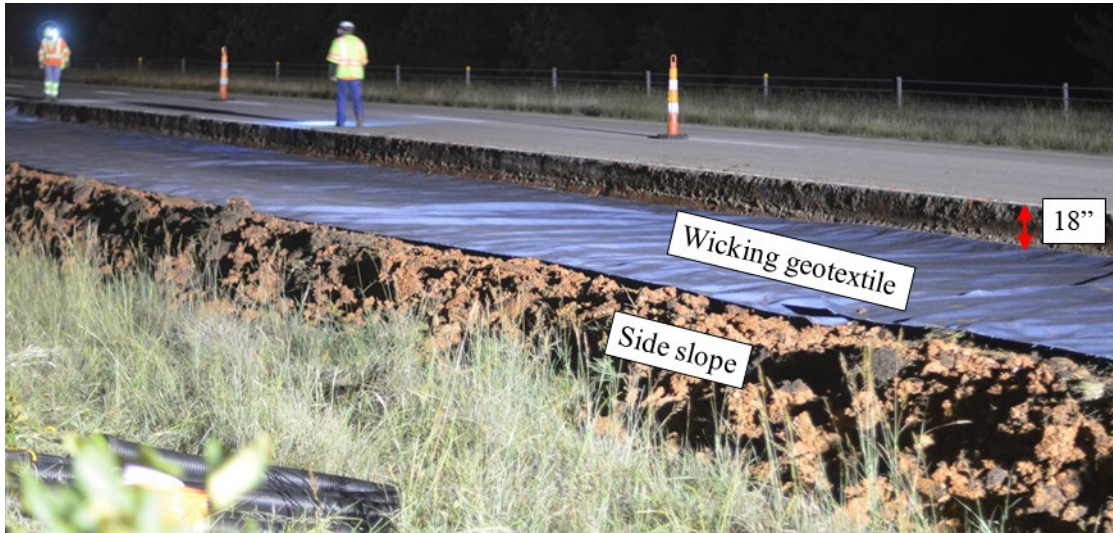
Figure 2.9 Horizontal placement of wicking geotextile in test section 2

Figure 2.9 shows how the wicking geotextile was placed in section 2. As can be seen in Figure 2.9, the wicking geotextile in section 2 was placed horizontally directly on top of the subgrade layer, starting from the edge of the driving lane to the other side which was on the side slope of

the shoulder. Between sections 1 and 2, an overlap of 12 in. was made to ensure that the subgrade was fully covered by the wicking geotextile.

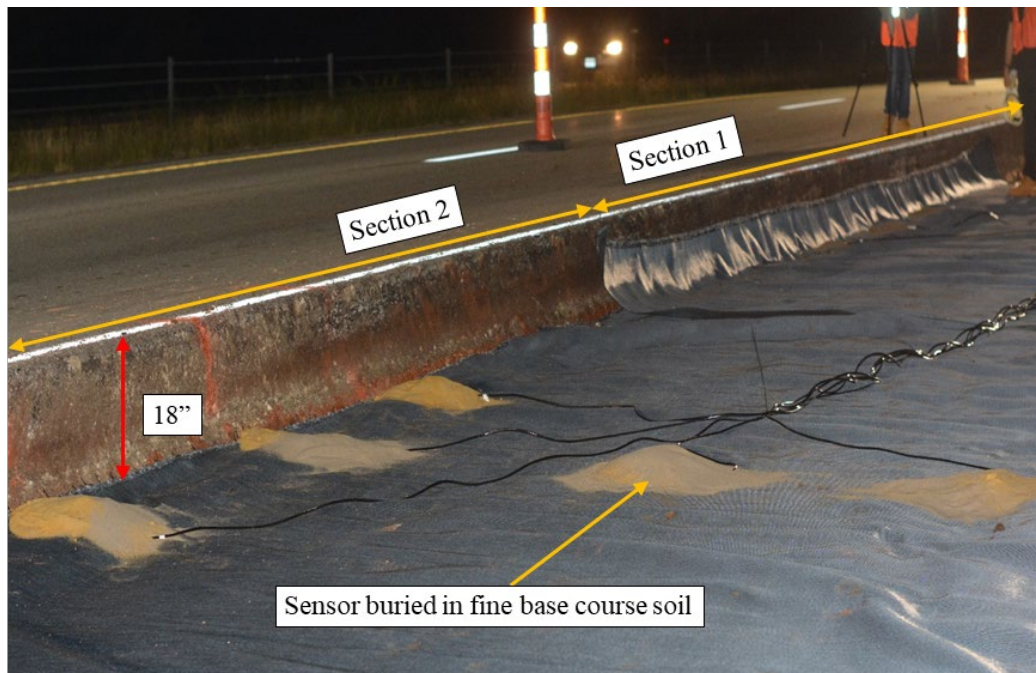
Figure 2.10 Sensor installation above the wicking geotextile in test section 2

Figure 2.10 shows how the sensors were installed above the wicking geotextile in section 2. The sensors were installed at approximately 2 in. above the geotextile in section 2. As discussed earlier, the sensors were installed in the sieved base course soils passing the 3/8 in. sieve. It would ensure the readings from all sensors were consistent within each other since the same soils were used. The finer base course soils also helped protect the sensors from being damaged by coarse aggregates during construction. The same procedures were adopted when sensors were installed above the wicking geotextile in section 1.

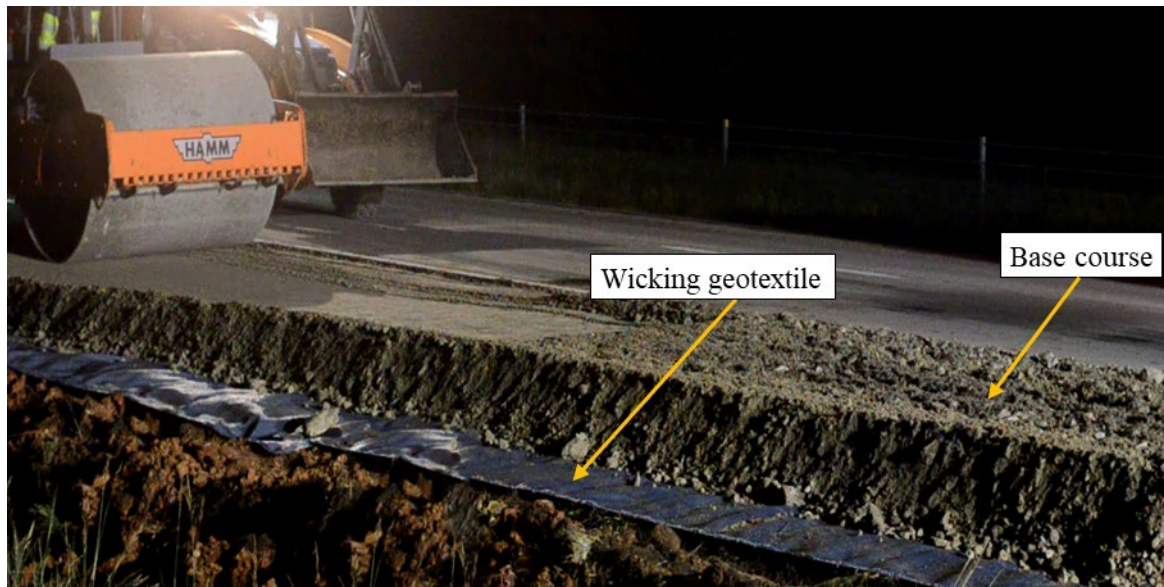
Figure 2.11 Compaction of the base course

After the second layer of sensors was installed, base course materials were directly dumped on the wicking geotextile and sensors and compacted to the designated elevation, which was the same as the existing road surface. Based on visual observation, the base course soil type was GP (Poorly graded gravel in the Unified soil classification system) with cobbles and occasional boulders. This backfill was then compacted using dynamic steel wheel rollers as shown in Figure 2.11.

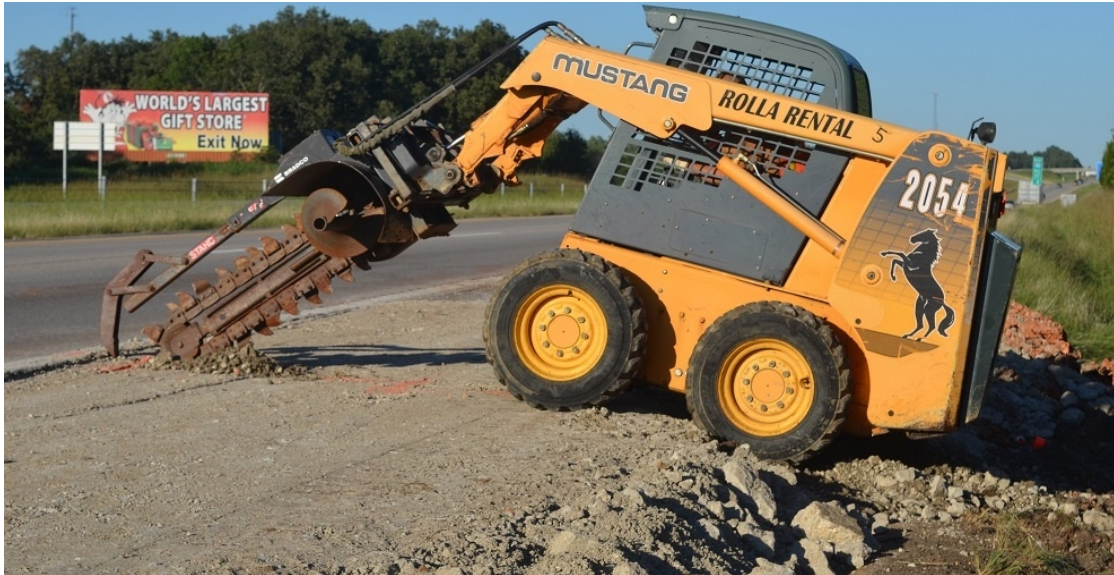
Figure 2.12 Preparing a trench for sensor installation using a trench-digger

After the compaction was completed, on September 27, 2019, as shown in Figure 2.12 a trench-digger was used to dig trenches in the compacted base course soils the installation of the remaining sensors on the top layer as shown in Figure 2.2. The trench was dug to a depth of about 8 in. below the road surface. The remaining sensors were also installed in the sieved base course soils passing the 3/8 in. sieve, similar to previously installed sensors. After that, all the sensors were connected to the data logger and all cables were buried underground in order to protect them from being damaged. All the installation work completed on September 27, 2018.

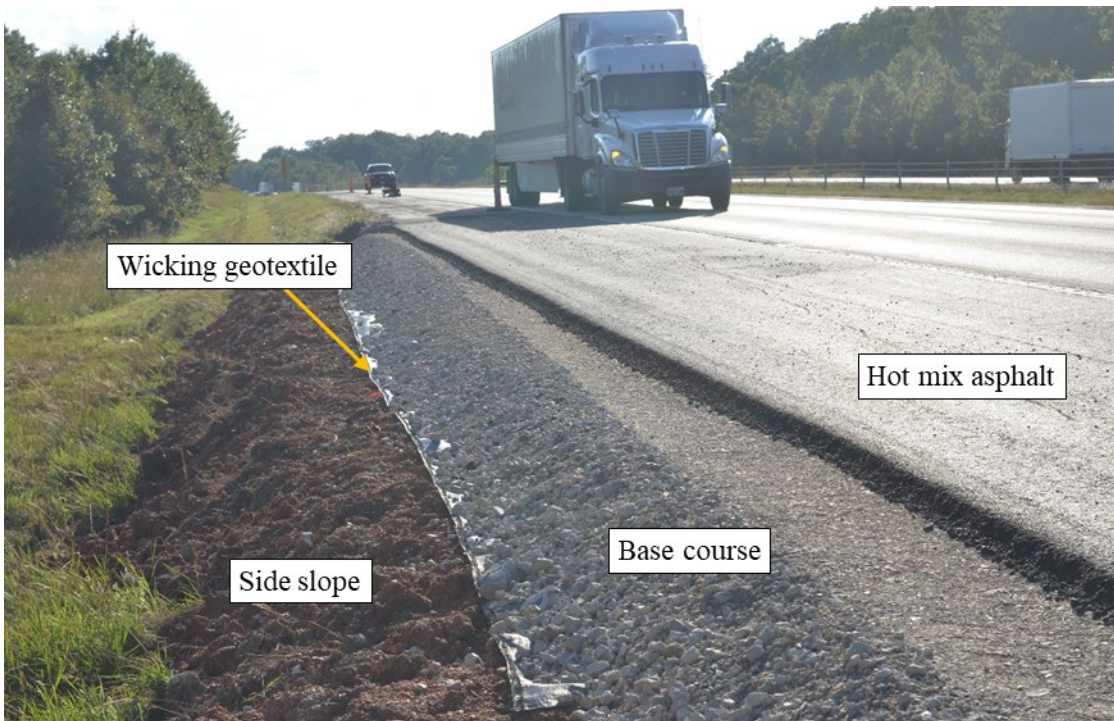
Figure 2.13 View of the test site after construction

After all the 33 sensors were installed, the contractor came back and excavated approximately 2 in. of the base course layer. Then the excavated base course layer was leveled and compacted. After that, asphalt materials were brought in and compacted to the elevation of the existing driving lane. Figure 2.13 shows the completed road shoulder. The photo was taken on October 5, 2018, during a revisit to the test site. It was noticed that the edge of the wicking geotextile was exposed to the atmosphere as designed.

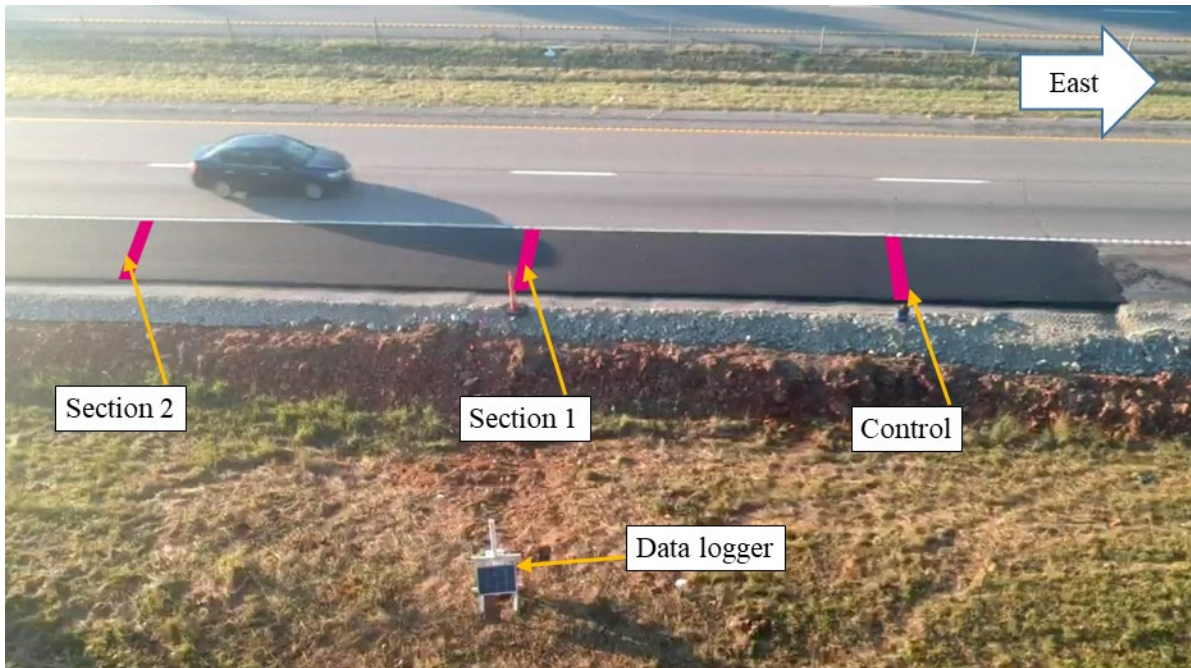
Figure 2.14 Location of the test sections after paving the road shoulder

In order to acquire preliminary results, the data logger readings were transferred to a portable computer. It was found that one of the sensors (sensor 13) was not transmitting data due to a connection problem. Although the connection was restored that day, the first week's data was not available for this sensor. Figure 2.14 shows the location of the designed sections after the construction was finished.

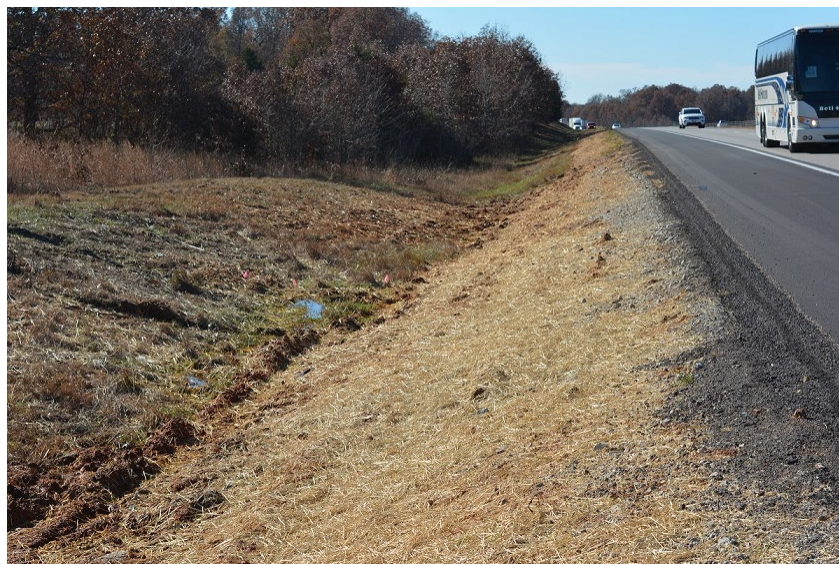
Figure 2.15 The final configuration of the test site

On November 18, 2018, another visit was made to the site in order to collect data. It was found that the unpaved part of the shoulder was graded. This work made the unpaved shoulder have a uniform slope, but the edge of the wicking geotextile was completely covered by base course soils. Figure 2.15 shows the final configuration of the test site.

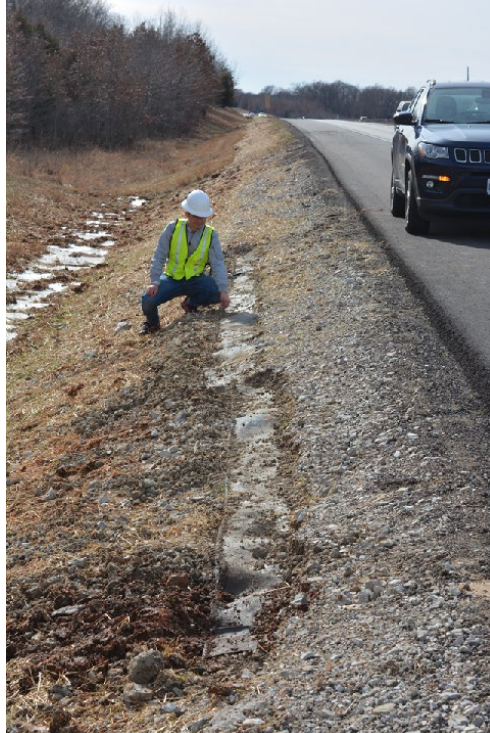
Figure 2.16 Exposing the outer end of the wicking geotextile on February 9, 2019

As previously mentioned, the drainage performance of the wicking geotextile could be improved by exposing the end of the wicking geotextile to the atmosphere. Thus, on February 9, 2019, about 1 foot of the edge of the wicking geotextile on the side slope was exposed along sections 1 and 2 by removing the base course as illustrated in Figure 2.16 .

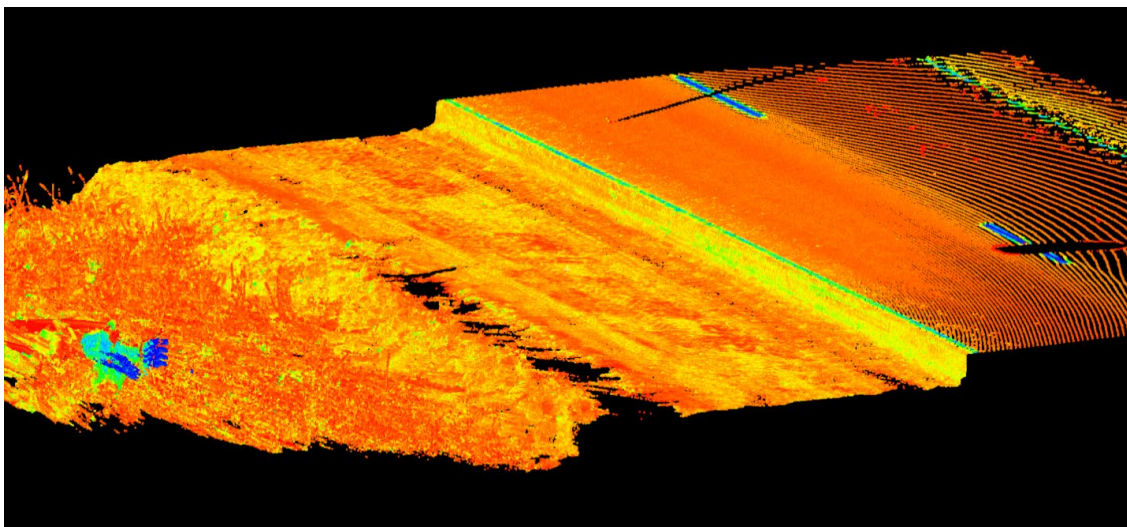
Figure 2.17 Scan data after excavation to the depth of 18in.

A number of laser scanings were performed to reconstruct the 3D geometry of the test site situation during different stages of the construction of the test site. For this purpose, Leica ScanStation P40 was used. This can be helpful to quickly get a 3D geometry of the test site which may be used in further analyses. Figure 2.17 through Figure 2.20 shows the reconstructed 3D geometry of the test site at different stages of construction. The 3D geometry can be used for future more comprehensive studies.

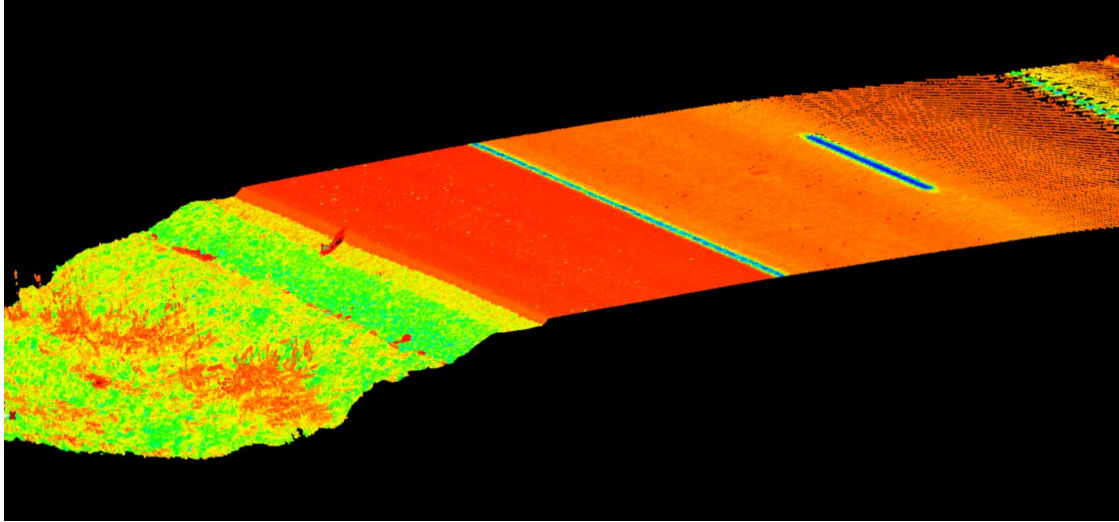
Figure 2.18 Scan data after paving the shoulder

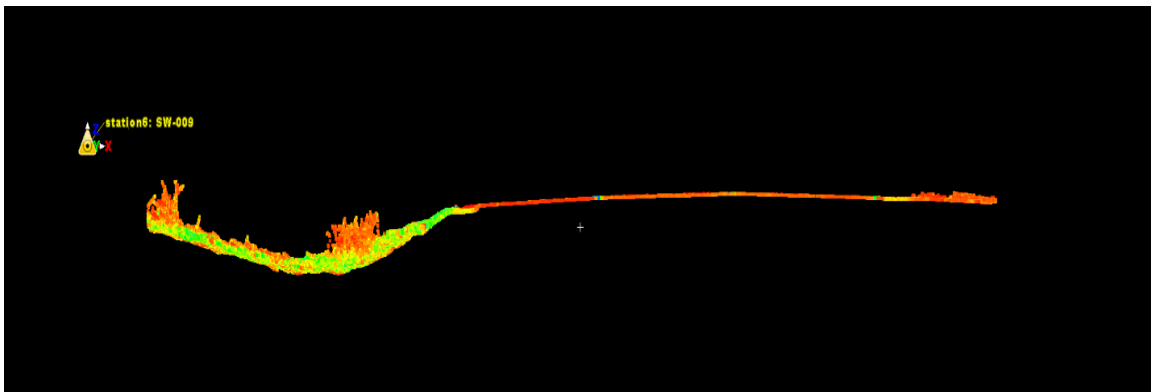
Figure 2.19 The final constructed cross-section

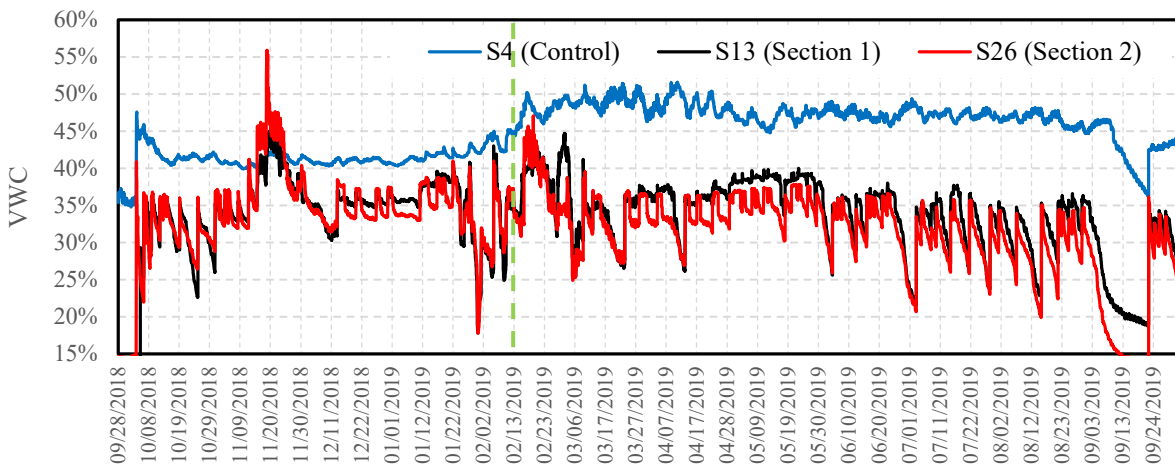
Figure 3.3 VWC at the outer edge of the subgrade

However, after the first rainfall on October 5, 2018, moisture contents at all three test sections of the pavement increased significantly. It can be seen in Figure 3.3 that VWC in the control section decreased to above 40% after the first rainfall was over, but never returned to the initial VWC which was observed right after construction of the test section. This implies that the performance of the pavement was always lower than that immediately after the construction due to rainfall infiltration. The VWC in winter 2018 was around 40%. However, in the spring of 2019, due to more frequent rainfall events, it increased to the range of 45-50%.

As shown in Figure 3.3, there were many sudden increases in VWC in the test sections. A reasonable assumption would be that these peaks were caused by rainfall events as shown in Figure 3.2e. Careful comparison between Figures 3.2e and 3.3, however, indicated that not all of the VWC peaks matched with the rainfall data. In fact, there were some peaks in the VWC in Figure 3.3 without any corresponding precipitation in Figure 3.2e. For example, on October 25, 2018, there was a VWC peak in Figure 3.3, but no rainfall event as indicated by Figure 3.2e. This might be attributed to the fact that some rainfall events only occurred in the small local

Figure 3.3 also shows that the overall VWC in the control section except for a short time was much higher than those in sections 1 and 2. As can be seen, the fluctuation magnitude in VWC of the control section, which was 8%, was much less than those for sections 1 and 2, which was 15%. The reason for this is due to the better drainage performance of the improved sections. During a rainfall, VWC in sections 1 and 2 increased more and quickly decreased to a much lower value after rainfall stopped. However, in the control section, due to an overall worse drainage performance, water accumulated by the recurring rainfalls leading to increased VWC. Since water could not drain as fast as the improved sections, the control section showed less fluctuation amplitude during each rainfall. This indicates that the overall permeability of the system was relatively lower in the control section. The low permeability delayed the increase in the water content during each rainfall. In the same way, it prevented quick water loss from the soil after the rainfall.

It can also be seen from Figure 3.3 that the VWC in sections 1 and 2 during late November was much higher compared with that in the control section. The increase in VWCs in the two sections was the result of recurring heavy rainfalls. Water may have started to flow back into the pavement through the wicking geotextile. At this time, the soil deep inside the pavement was still under unsaturated condition, while the outside slope was saturated. As a result, water flowed back into the pavement. However, once rainfalls stopped and the runoff water dissipated, the outside atmosphere was drier and water started to drain out of the pavement. It is also worth noting that the effect of water backflow is not significant for at least three reasons. First, as it was discussed before, on average rainfalls occurred only 1 out of every 3 days. Secondly, each rainfall event only lasted a few hours. Thus, this would increase runoff water and decrease the actual amount of water permeating the pavement. Lastly, the hydraulic gradients for backflow during rainfall events were much smaller than those during a sunny day with drainage.

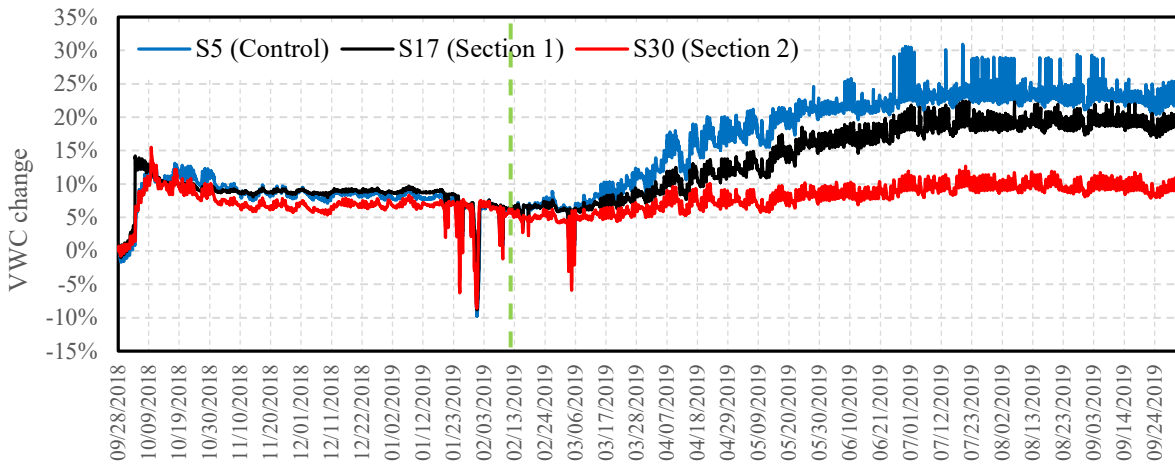
Figure 3.4 shows the changes in VWC at the inner edge of the base course at the shallowest sensor level in control section (sensor 5), section 1 (sensor 17) and section 2 (sensor 30) relative to their initial readings. It can be seen from Figure 3.4 that the relative VWC in section 2 was about 2-3% less than section 1 and control section until February 9, 2019, when the edge of the wicking geotextile was exposed to the atmosphere. It can also be seen that relative VWC in section 1 was occasionally slightly higher than the VWC in the control section before February 9, 2019. However, after the edge of the wicking geotextile in section 1 was exposed, VWC in section 1 started to deviate from the control section and section 1 started to perform better in terms of draining moisture out of the pavement. This is more obvious after March 2019. By the end of June in 2019, the VWC in section 1 and section 2 compared with the control section was approximately 5% and 10% lower, respectively.

Figure 3.4 Relative VWC in different test sections at the top of the base course and the inner edge of the base course

It can also be seen from Figure 3.4 that from mid-January to early April 2019, there are a number of sudden drops in VWC of all of the sensors. By comparing Figures 3.2 c and 3.4, it is found that these drops are likely to be the result of soil freezing during this period. The drops on air temperatures matched well with the sudden drops in VWC during the same period. The moisture sensors used in this study measure the unfrozen volumetric moisture content only. When prolonged durations of subzero temperatures caused subgrade soils and moisture contained within to freeze, the unfrozen moisture content in the soils decreased significantly.

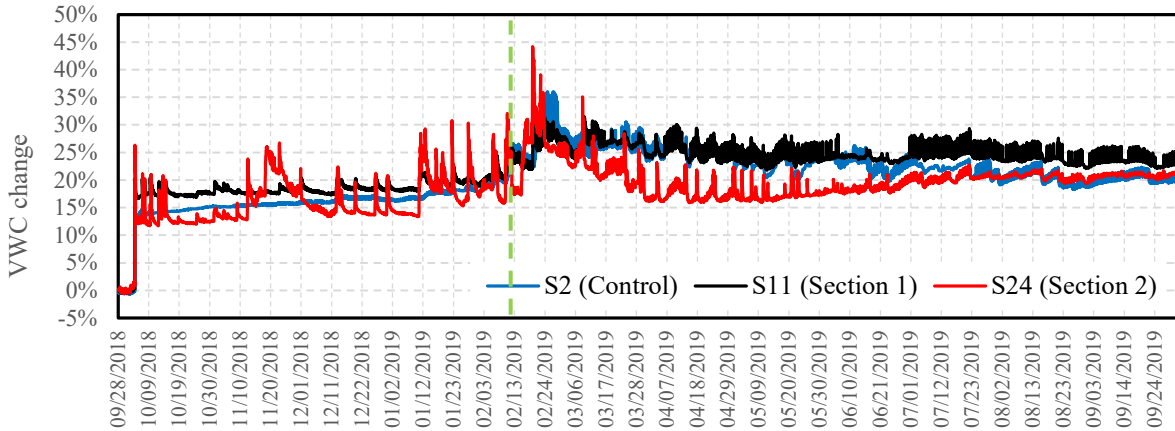
Figure 3.5 shows the relative VWC inside the subgrade in control section (sensor 2), section 1 (sensor 11), and section 2 (sensor 24) at the edge of the driving lane. It can be seen that relative VWCs in sections 1 and 2 increased significantly during each heavy rainfall, but only for a very short time.

Figure 3.5 Relative VWC in the subgrade at the edge of the driving lane.

As explained before, this happened because the exposed edge of the wicking geotextile became saturated and water started to move into the pavement through the wicking geotextile. However, after the rainfall stopped and the exposed edge of the wicking geotextile started to dry, the wicking geotextile started to drain moisture out of the pavement and VWC decreased quickly. It can be seen that relative VWC in section 2 was up to 6% less than those in the control section and section 1 between two successive rainfall events. This is attributed to the fact that in section 2, the wicking geotextile had the most exposure to the atmosphere, which resulted in more water loss.

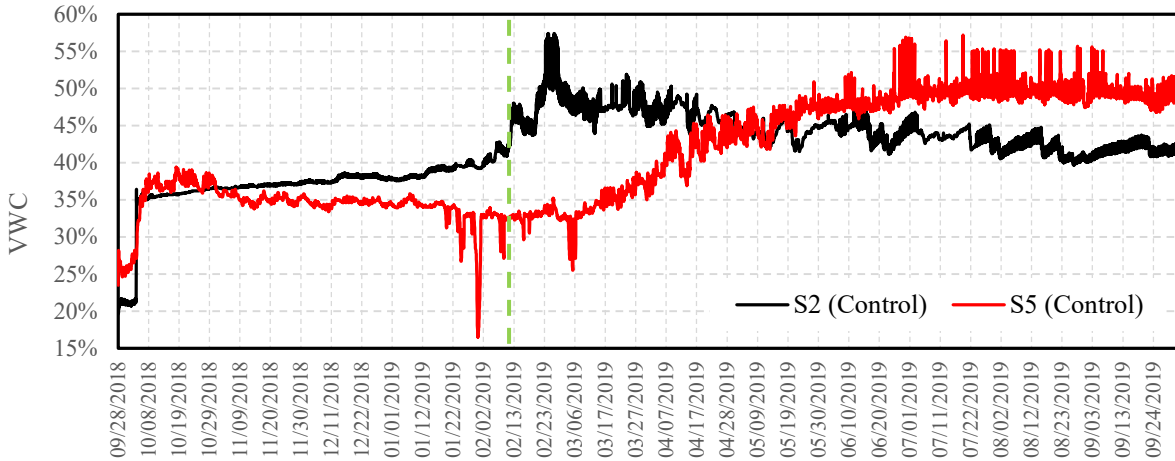
Figure 3.6 shows the variations of VWC at sensors 2 and 5, which are at the inner edge of the control section, respectively. As shown in Figure 2.2, sensors 2 and 5 are located at 8 in. and 22 in. below the final road surface respectively. The initial VWC at sensor 5 is around 23% corresponding to the initial moisture content of the base course during placement and compaction. All volumetric water content readings showed a significant jump on October 4, 2018, during the first rainfall after the construction of the test sections. As shown in Figure 3.1a, it is obvious that there was a rainfall event on October 4 with a total daily precipitation of 0.33 in. (8.3 mm). After the first rainfall, the VWC in the base course (sensor 5) continuously decreased until March 2019. This might be attributed to less frequent rainfall, gravity drainage of infiltrated water, and soil freezing during this period. In contrast, the VWC at the subgrade (senor 2) increased gradually over the same period due to the accumulation of infiltrated water.

Figure 3.6 Variation of VWC in the control section at different elevations at the inner edge of the shoulder

In early 2019, the VWC at sensor 5 experienced a few sudden drops due to soil freezing. In contrast, soils at sensor 2 did not experience such sudden drops. This is likely due to the fact that sensor 2 was buried deeper into the pavement, the freezing front didn't reach to the depth of sensor 2. In fact, when sensor 5 was not experiencing sub-zero temperature, the VWC in sensor 5 kept increasing consistently. At this time, there were several rainfall events in a short time as shown in Figure 3.2e. The increase in the VWC of sensor 2 is believed to be the result of water infiltration from these rainfall events.

After the winter was over in March 2019, the VWC in the base course layer (sensor 5) increased gradually starting from 32% for a period of around 2 months. By the end of June 2019, the average VWC in the base course reached 50% and remained constant. In the meantime, the average VWC in the subgrade decreased from around 50% in March to 42% in October 2019. The results seemed strange since the soil at higher elevations should have lower moisture content. This might be attributed to non-uniform soil distribution in the test section. If the soils at the top have more fines or smaller void due to better compactions, these soils can hold more water compared with the soils at the bottom with less fines content or lower density.

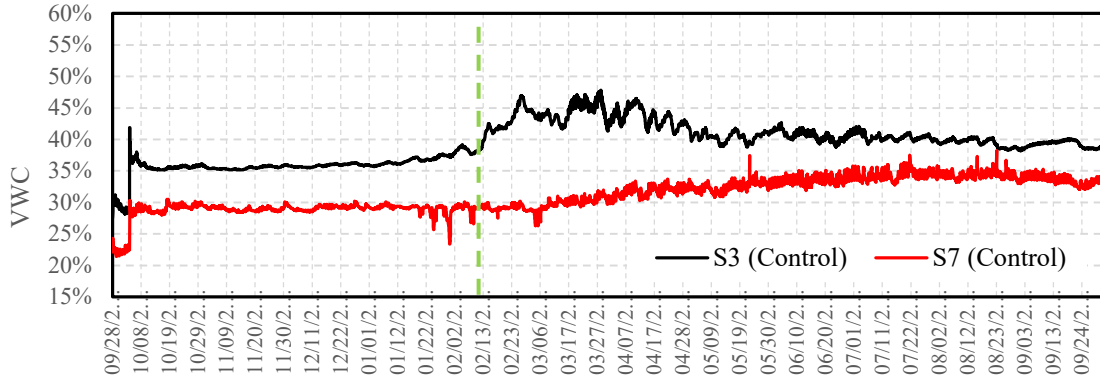
Similarly, Figure 3.7 shows the variation of VWC in the middle of the control section in the transverse direction at sensor 3 (22 in. below road surface) and sensor 7 (8 in. below the road surface). The trend of VWC is similar to those observed in Figure 3.6 at the inner edge of the control section. The VWCs at sensor 3 were always higher than those at sensor 7. The results seemed reasonable.

Figure 3.7 Variation of VWC in the control section at different elevations at the middle of the shoulder
