Performance of Wicking Geotextile on Mitigating Water Pumping Issue on I-44 Highway

March 2020
Final Report

Project number TR201905
MoDOT Research Report number cmr 20-003

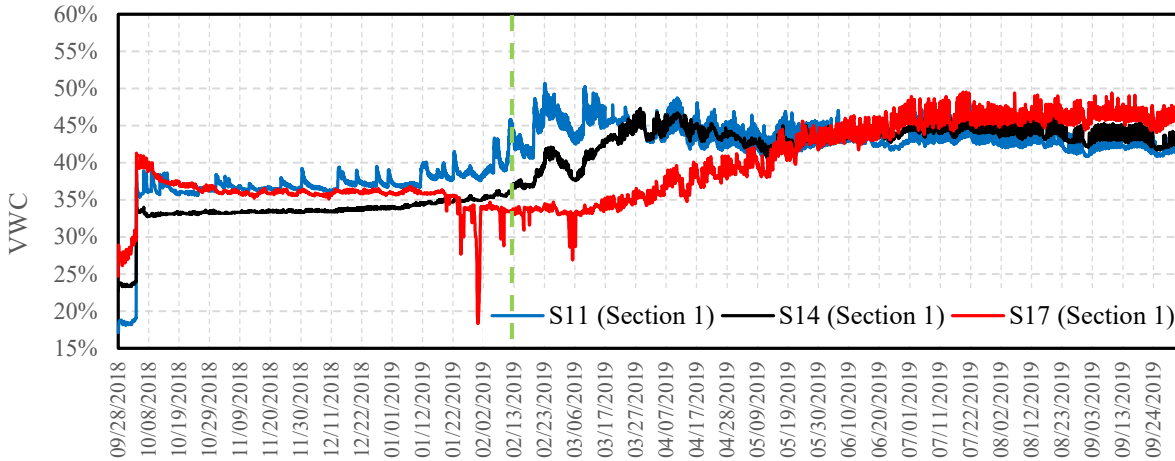
Figure 3.8 shows the variations of VWC at sensors 11, 14, and 17 in section 1 at the inner edge of the shoulder (from bottom to top as shown in Figure 2.2). As can be seen, prior to January 2019, except for some peaks due to rainfall, VWC at sensor 17 was similar to that in the subgrade (sensor 11) with a value of approximately 36%. However, from January to March 2019, the moisture content in sensor 17 reduced due to partial soil freezing. The sharp decrease in VWC readings in this period corresponds to the sudden freezing of the soils surrounding the sensor. On the other hand, the moisture content in sensor 11 generally increased with time if the peaks caused by the rainfall were not considered. The results were reasonable for two reasons. First, sensor 11 was located in the subgrade where the temperature was always higher than 0°C (32 °F). It means that the subgrade did not experience any freezing in winter. Secondly, the precipitation in early 2019 increased which increased the water infiltration into the pavement and results in an increase in moisture content. By June 2019, the VWC at different elevations of section 1 reached a constant value of approximately 45%. In general, VWC at sensor 14 located at the bottom of the base course layer was always between the VWC at sensor 11 and 17.

Figure 3.8 Variation of VWC in section 1 at different elevations at the inner edge of the shoulder

By comparing the VWCs at sensors 14 and 17 in Figure 3.8 with VWCs at sensors 15 and 19 in Figure 3.9, respectively, it was found that VWCs in Figure 3.8 were generally higher than those in Figure 3.9, even if the corresponding sensors were at the same elevations. This implies that rainfall infiltration was not uniform across the whole road shoulder. Instead, water infiltrated along the interfaces between the old pavement and the newly constructed road shoulder and

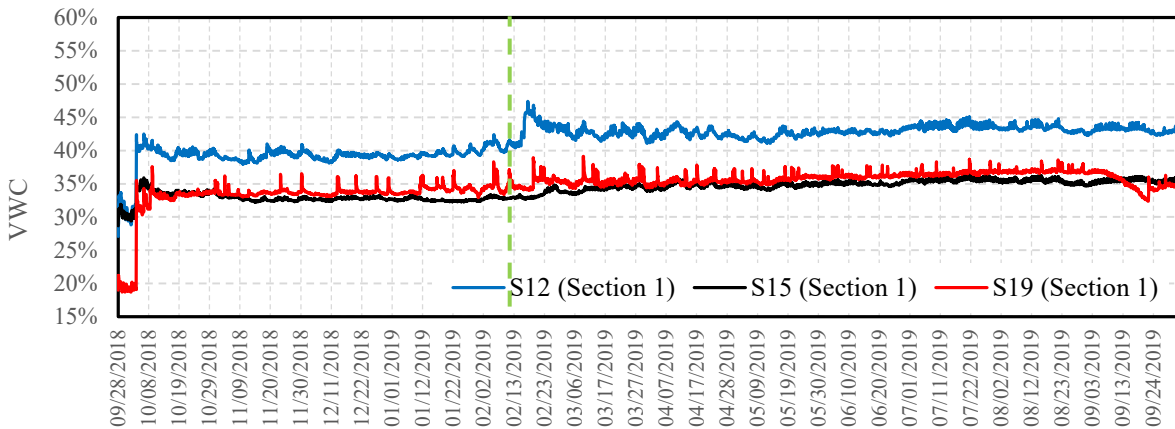
Figure 3.9 shows the variations of VWC at sensors 12, 15, and 19 in section 1 in the middle of the shoulder. VWC at sensor 12 (in the subgrade) was around 40% before February 2019. This value increased to 43% during the spring and summer of 2019 with increasing precipitation. The changes in VWC at sensors 19 and 15 were similar except that the VWC at sensor 19 had many peaks due to rainfall, which were not seen at sensor 15. The WVC values slightly increased from 33% in winter 2018 to 35% in spring and summer 2019 if the peaks caused by rainfall events were not considered.

Figure 3.9 Variations of VWC at sensors 12, 15, and 19 in section 1 in the middle of the shoulder

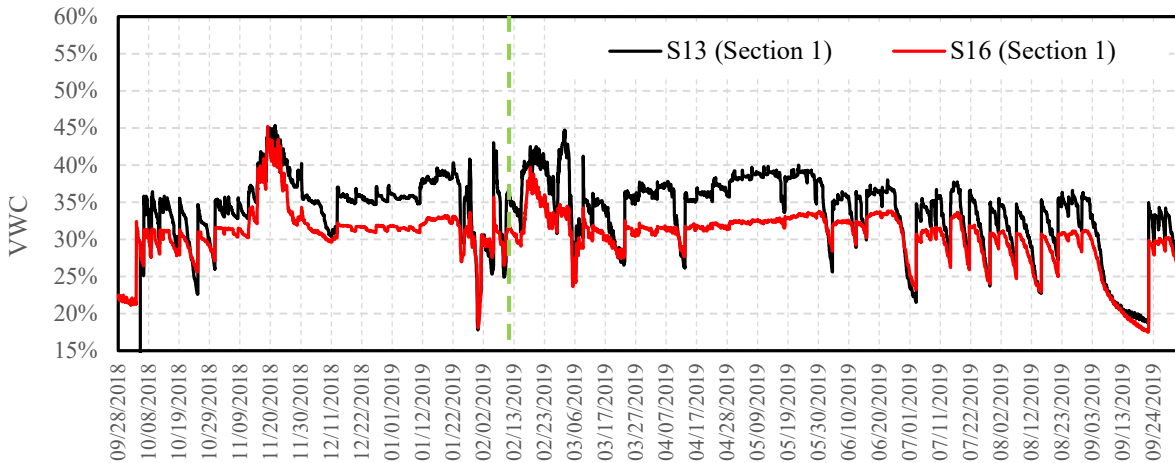
Figure 3.10 shows the variations of VWC at sensors 13 and 16, which is at the outer edge of section 1 during the monitoring period. In general, VWC at sensor 16 were 5%-8% lower than that at sensor 13 at the same time, although the trends of VWC changes were similar. This indicated that the base course layer on top of the wicking geotextile was much drier than the subgrade layer. However, during the heavy rainfalls on November 21, 2018, and February 19, 2019, the VWCs at the two sensors reached the same value.

Figure 3.10 Variation of VWC in section 1 at different elevations at the outer edge of the shoulder

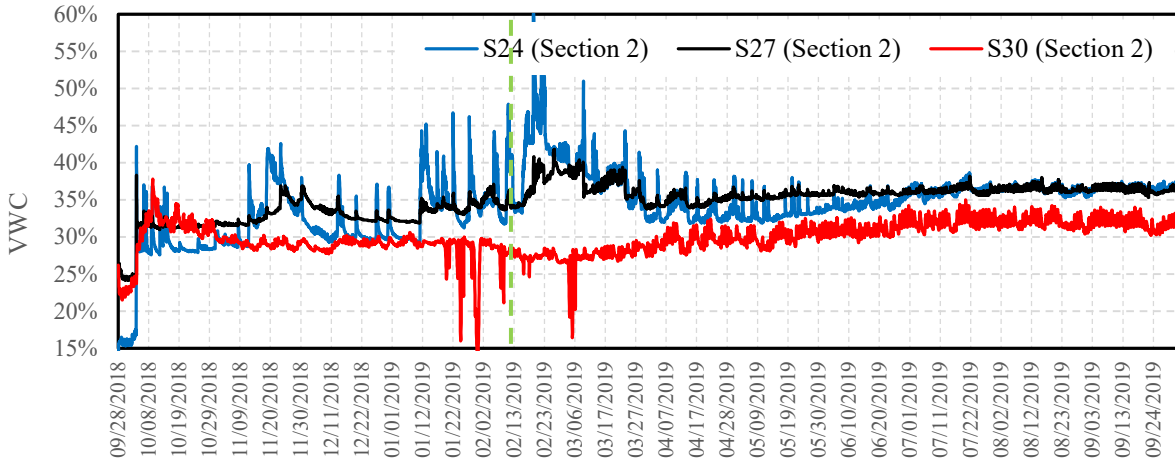
Figure 3.11 Variation of VWC in section 2 at different elevations at the inner edge of the shoulder

Figure 3.11 through 3.13 shows the variations of the VWC at different locations of section 2 for sensors at different elevations. In general, the trends in the VWC changes are similar to those in Figure 3.8 through 3.10 in section 1, thus the explanations for them will not be repeated again. More detailed comparisons between the control section, section 1 and section 2 will be made when the VWC contour plots are presented in the later sections.

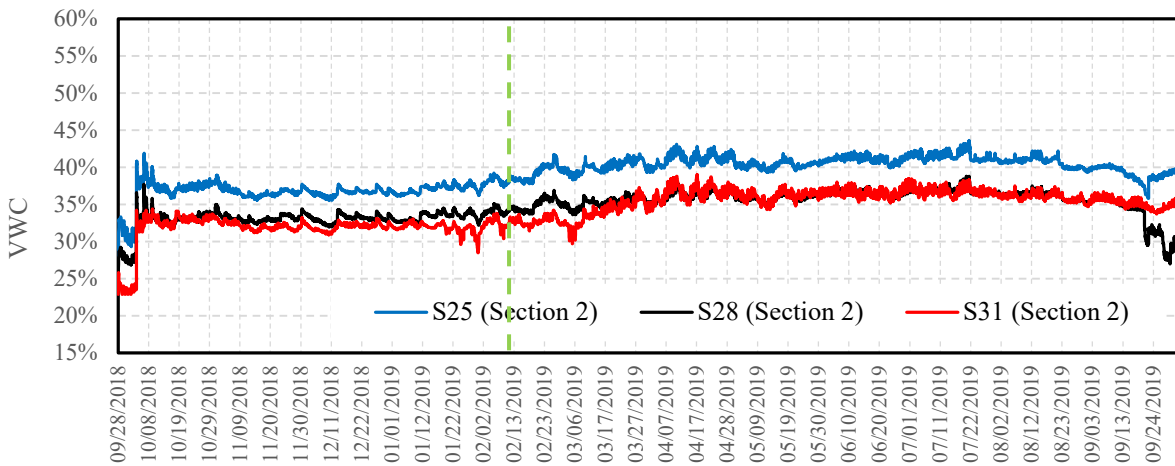
Figure 3.12 Variation of VWC in section 2 at different elevations at the middle of the shoulder

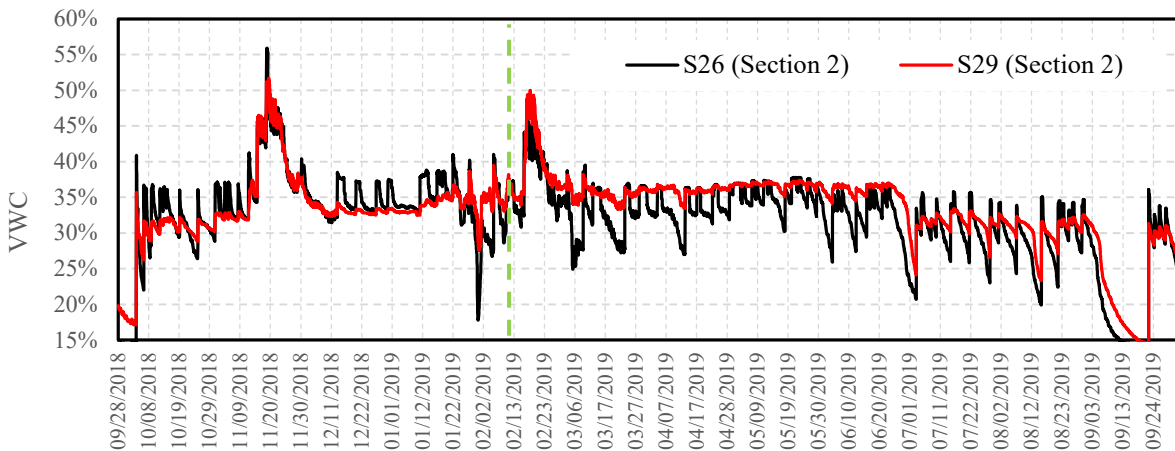
Figure 3.13 Variation of VWC in section 2 at different elevations at the outer edge of the shoulder

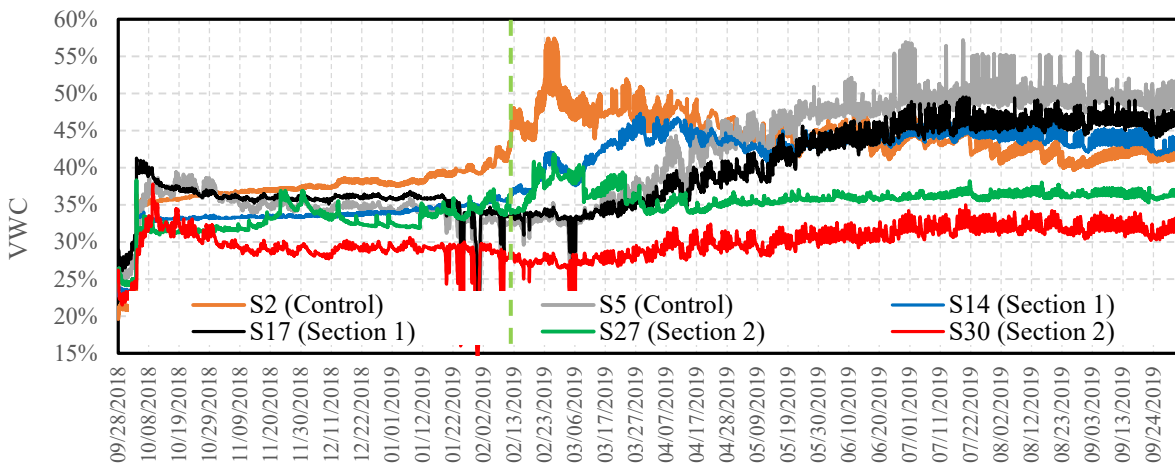
Figure 3.14 shows the variations of VWC at the interface between the driving lane and the shoulder in all three sections. The initial moisture content of all of the sensors was around 25%, indicating that the moisture content during the construction was controlled well. Sensors 14 and 17 are located immediately above the wicking geotextile in sections 1 and 2, while sensor 2 was installed at the interface between the subgrade and base course materials. These sensors were at similar locations in different sections.

As can be seen in Figure 3.14, throughout the whole monitoring period, the moisture contents at sensor 30 in section 2 was significantly lower than its counterpart sensors 5 and 17 in the control section and section 1 respectively. This is a clear evidence that the soils at the sensor location were always unsaturated and pumping was unlikely to occur. Similarly, at lower elevations near the interface between the subgrade and base course layer, sensor 27 in section 2 had the lowest VWC most of the time in all three test sections before February 9, 2019, when the wicking geotextile was completely buried. After the exit ends of the wicking geotextile were exposed after February 9, 2019, the VWC at sensor 27 was significantly lower than those at sensor 2 (control) and 14 (section 1), indicating much less likelihood of pumping issues.

Figure 3.14 Variations of VWC at different elevations at the inner edge of the shoulder

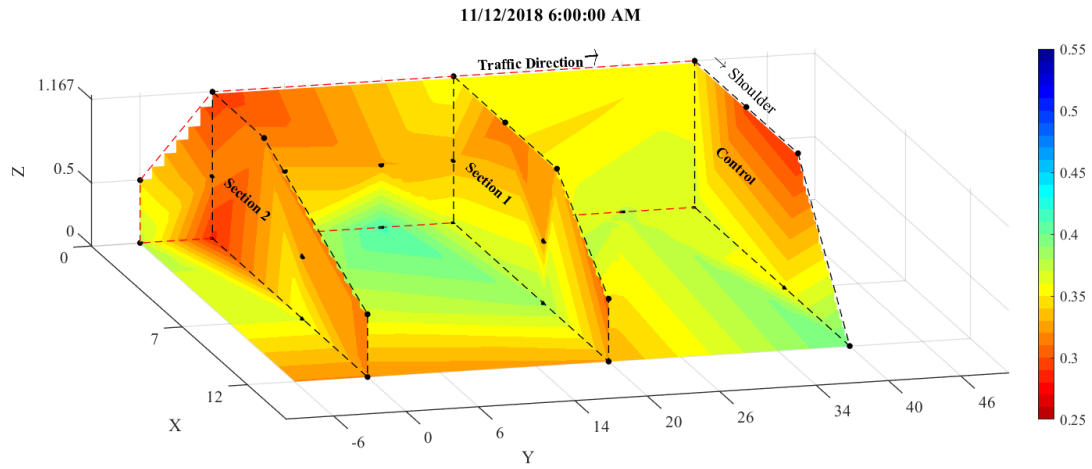
Figure 3.15a shows the spatial distribution of VWC at 6:00 A.M. on November 12, 2018, which is 7 days before the rainfall of November 19, 2018. At least one week had passed since the latest rainfall, and all of the three test sections were relatively dry. It can be seen from Figure 3.15a that section 2 was much drier compared with the other two sections, especially at the interface between the driving lane and the shoulder, where pumping damage was mostly observed. The driest location in section 2 is at the upper part of the interface between the driving lane and the shoulder, which indicated superior performance since if the soil at that point were dry, it is unlikely for the pumping to occur. The soils at the interfaces between the driving lane and the shoulder in section 1 and the control section were relatively dry compared with the soils at the interfaces between the subgrade and base course layer, but wetter than those in section 2 at the similar locations. Another observation was that soils near the surface were drier than soils inside the road shoulder.

(a) Before rainfall on 11/12/2018

Figure 3.15 VWC at different times before February 9, 2019

In order to better evaluate the performance of the three test sections, the VWC readings from all sensors at the same time were presented in a three-dimensional plot using the Matlab program, by generating VWC contours for all three test sections as shown in Figures 3.15 and 3.16. Since the sensors only provided VWC readings for discrete locations, linear interpolation techniques in

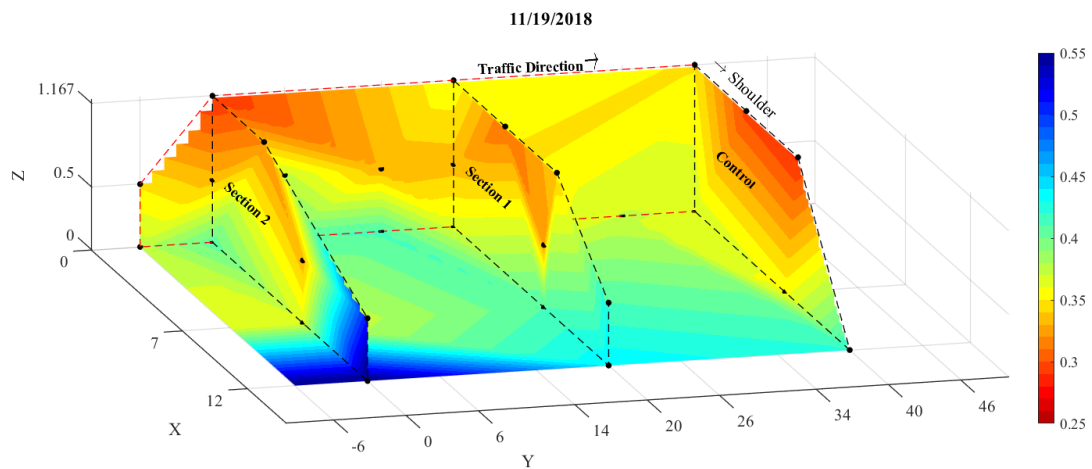
Figure 3.15b shows the spatial distribution of the VWC during a rainfall event of November 19, 2018, with accumulated precipitation of 0.12 in. (3 mm). The VWCs in all three sections increased in general, although the increases at the side slope portion were larger than that inside the shoulder. This is reasonable since it was much easier for the rainwater to infiltrate into soils at the side slope which was not covered by asphalt concrete. The largest increase in the VWC occurred at the side slope of section 2. The increases in the VWC in section 2 were clearly larger at the lower part of the interface between the driving lane and the shoulder than those at similar locations in the control section and section 1. This might be attributed to two reasons. First, water infiltrated preferably downward along the interface between the driving lane and the shoulder and ponded at the corner of subgrade and base course layer interface. In other words, there was a small horizontal distance between the sensor 30 and the vertical interface between the driving lane and the shoulder and water infiltrated more quickly along the vertical interface than flowed horizontally. As a result, sensor 30 recorded less increases in VWC than sensor 24. Secondly, the wicking geotextile in section 2 was wider in the horizontal direction than that in section 1. As a result, water can backflow into the road shoulder more easily during a rainfall event.

(b) During rainfall on 11/19/2018

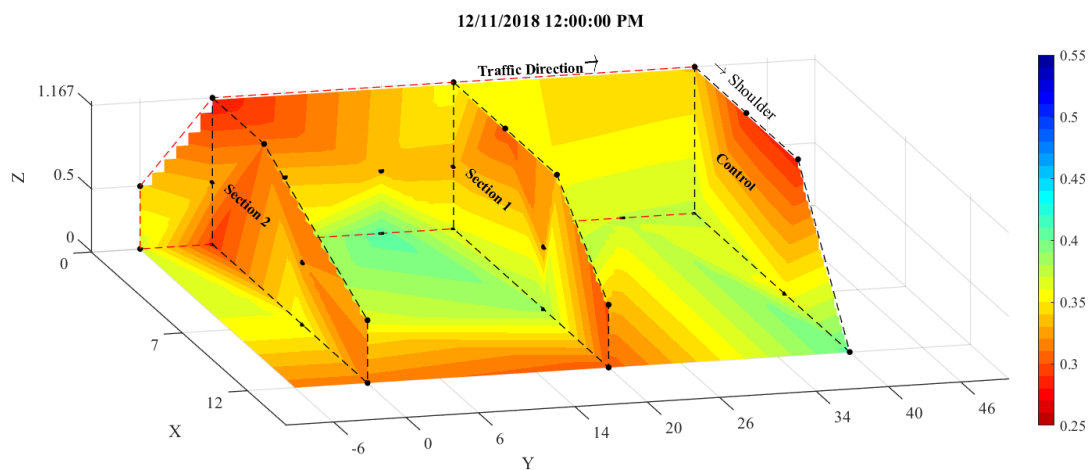
(c) After rainfall on 12/11/2018

Figure 3.15c shows the distributions of VWC in all three sections on December 11, 2018, which was more than two weeks after the main rainfall event on November 19, 2018. Compared with Figure 3.15b, soils at nearly all locations had lower VWCs in Figure 3.15c. It was found that larger changes in VWC occurred in soils near the surface than those inside the road shoulder, and the largest VWC changes occurred in section 2 at the lower part of the interface between the driving lane and the shoulder. At the similar locations in section 1, there was no visible changes in VWC, while in the control section, there was a slight increase in the VWC. It is therefore concluded that section 2 performed the best, section 1 was the second, and the control section performed the worst in terms of water drainage.

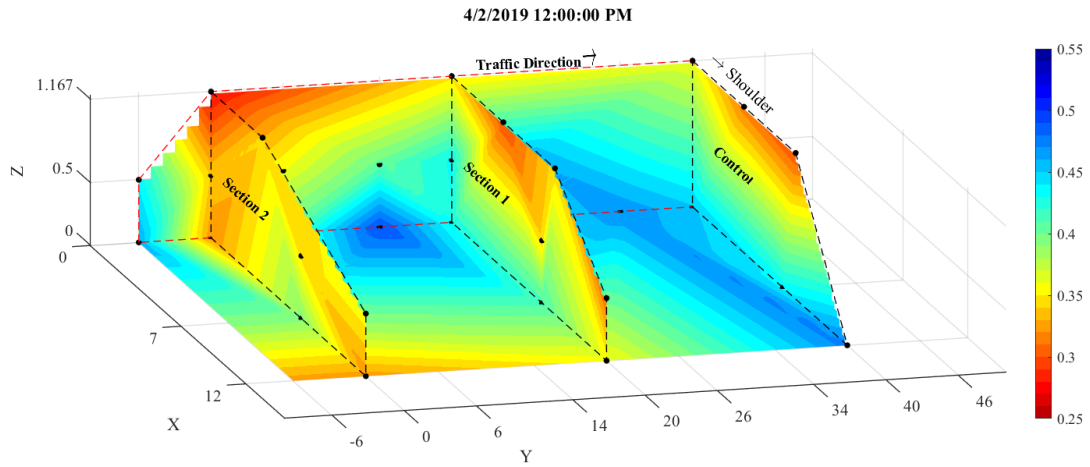
Figure 3.16a shows the distributions of VWC in all test sections on April 2, 2019, which was a few days after the last rainfall on March 30, 2019. In general, the VWCs in all test sections in Figure 3.16a were higher than those at the same locations as shown in Figure 3.15a, indicating that the VWC increased during the spring of 2019 due to some additional rainfall events. Similar to Figure 3.15a, all soils near the surface in Figure 3.16a were much drier than soil inside the road shoulder. In sections 1 and 2, the soils at the interface between the subgrade and the base course layer were drier than inside, especially at the exit side. In contrast, in section 1, the soils at the interface between the subgrade and the base course layer were still fairly wet. At the lower part of the interface between the driving lane and the shoulder, soils at section 2 were fairly dry, some soils at section 1 were fairly wet, and the soils at the whole control section were wet.

(a) Before rainfall on 4/2/2019

Figure 3.16 VWC at different times after February 9, 2019

Figure 3.16 shows the distribution of VWC before, during, and after a rainfall event on April 4, 2019, after the exit ends of wicking geotextiles in sections 1 and 2 were exposed on February 9, 2019.

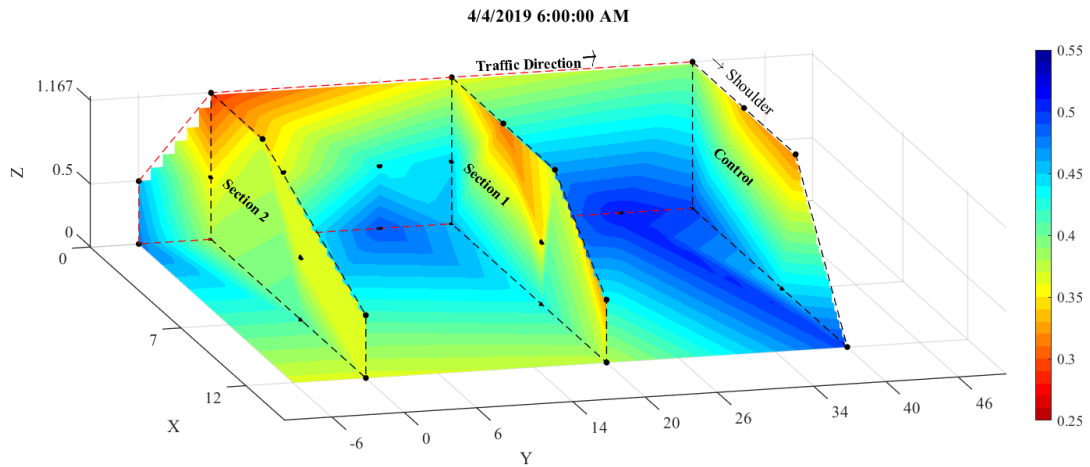
Figure 3.16b shows the distributions of VWC in all test sections on April 4, 2019, during a rainfall event with accumulated precipitation of 0.53 in. (13.4 mm). Comparing Figure 3.16b with Figure 3.16a, it can be seen that VWCs in all test sections increased. However, the increases in VWC in section 2 were not very obvious and the soils at all locations were fairly dry, especially at the interface between the driving lane and the shoulder. There were some visible increases in VWC in section 1, especially at the corner of the two interfaces. However, the whole road should body was still fairly dry. In contrast, there were clear increases in VWC in the control section, especially at the vertical interface between the driving lane and the shoulder and the horizontal interface between the subgrade and the base course layer. It is clear that the control section is more prone to pumping as a result of higher VWC compared with sections 1 and 2. This is another evidence that the wicking geotextile can effectively mitigate the pumping.

(b) During rainfall on 4/4/2019

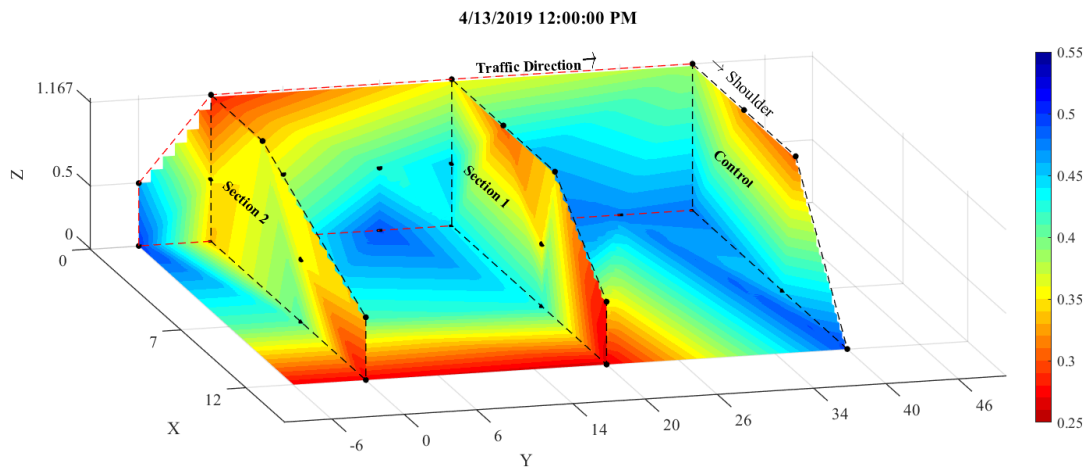
(c) After rainfall on 4/13/2019

Figure 3.16c shows the distributions of VWC in all test sections on April 13, 2019, 8 days after the rainfall. Comparing Figure 3.16c with Figure 3.16b, it can be seen that VWCs in all test sections clearly decreased. The decreases in VWC in sections 1 and 2 were significant at the side slope and at the interface between the subgrade and the base course layer near the side slope. There were some visible decreases in VWC in sections 1 and 2 along the vertical interface between the driving lane and the shoulder. However, it was more obvious in section 2 than in section 1. In contrast, in the control section, although there were some decreases in VWC at the edge of the road shoulder, the soils at the vertical interface between the driving lane and the shoulder and the horizontal interface between the subgrade and the base course layer were still fairly wet. Compared with sections 1 and 2, it is much easier for fined graded soils in the control section to migrate to the base course layer and be ejected out of the pavement structure along the vertical interface between the driving lane and the shoulder, which is pumping.

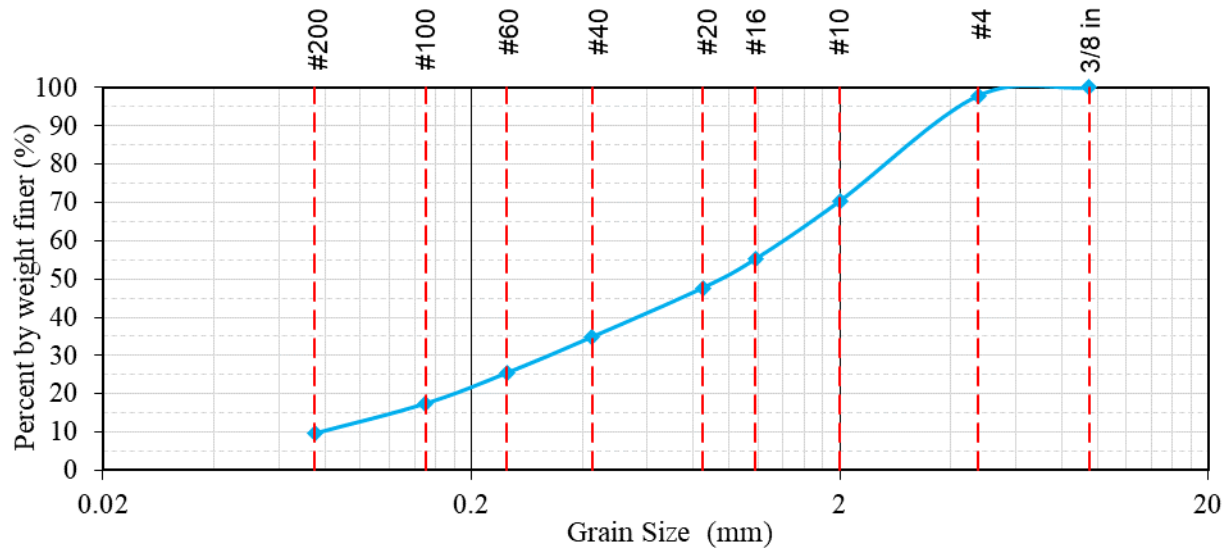
As a basic soil characterization, the base course material was graded using the sieve analysis method. The base course soil originally used for the construction of the test sections contained cobbles and large boulders. Since the permeability of the base course materials mainly depended on the finer particles, the larger soil particles were sieved out using 3/8 in. sieve. The remainder of the soil was used for the particle size distribution test. Figure 4.1 shows the gradation curve of the base course material passing 3/8 in. sieve. Based on the soil particle size distribution, the base course is characterized as poorly graded sand with silt (SP-SM) using the Unified Soil Classification System. The gravel, sand and fine contents were equal to 30%, 60%, and 10%, respectively.

Figure 4.1 Particle size distribution of the base course material passing 3/8 in. sieve

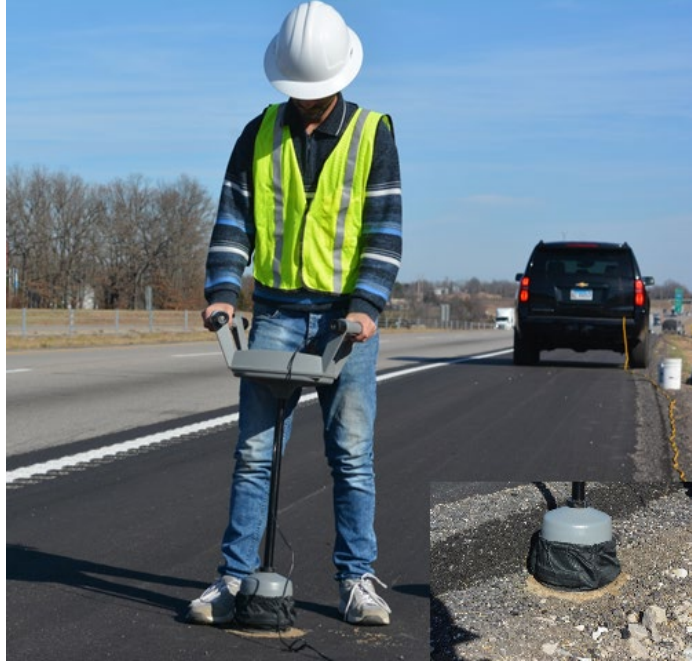
In order to quantify the base course hydraulic conductivity in the lab, firstly, its field density needed to be quantified. The field density of the base course was obtained by correlating the Briaud Compaction Device (BCD) modulus obtained in the lab and the test site. Figure 4.2 shows the application of the BCD test on the test site. Figure 4.3 shows the relation of the density with the BCD modulus, which was obtained by testing compacted soils in the lab. The measured field BCD modulus was used to calculate the dry density of the base course using the results of the laboratory BCD test.

Figure 4.2 BCD field test

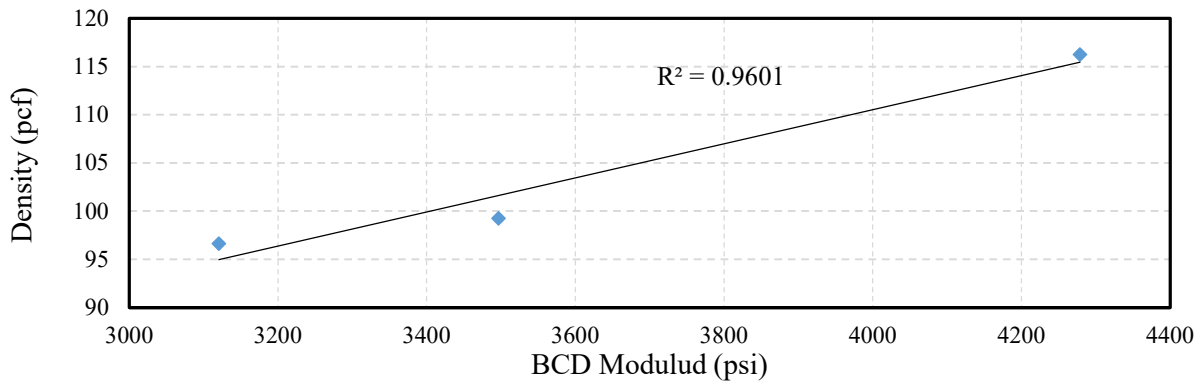
Figure 4.3 Correlation of BCD modulus with soil density for the base course material

Based on the results of the BCD tests, the average BCD modulus of the base course based on several measurements at different locations was approximately 3700 psi (25.5 MPa). The corresponding average density of the base course material in the field was calculated as 106 pcf (16.6 kN/m³). The calculated density was then used to construct the small scale box test in Chapter 5 as explained later.

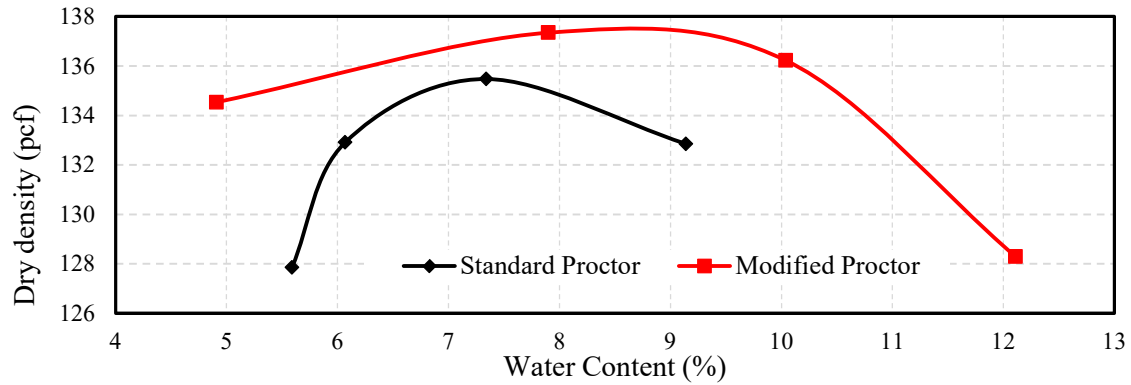
The sensitivity of the base course material with respect to its water content was investigated by the proctor compaction test. Figure 4.4 shows the results of standard and modified proctor tests. It can be seen that the maximum dry densities of the base course are 135 pcf (21.2 kN/m³) and 137 pcf (21.5 kN/m³) for standard and modified proctor tests, respectively. The corresponding optimum water contents were approximately 7.4% and 9%, respectively.

Figure 4.4 Compaction test results

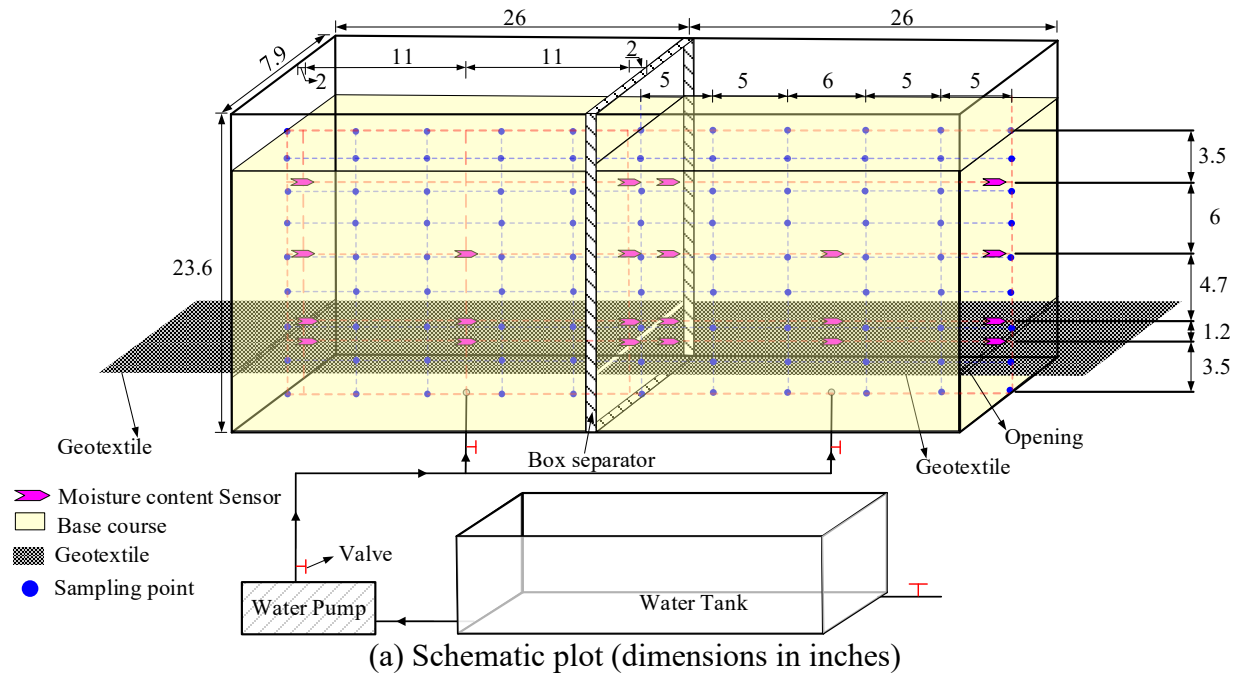
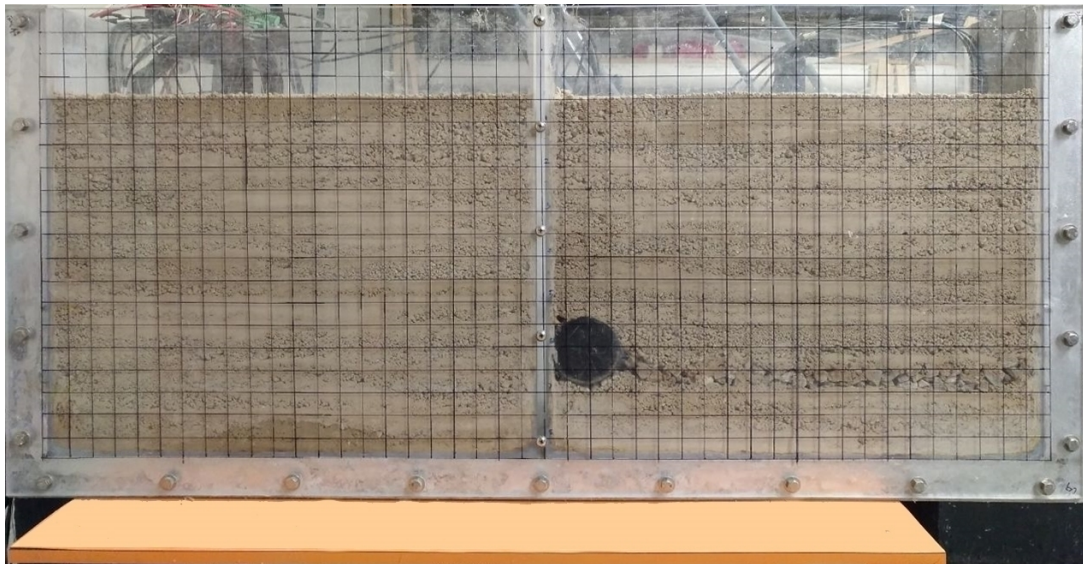
Figure 5.1 Test apparatus

Figure 5.1a and 5.1b show the configuration of the experimental testing box. The testing box frame was built with aluminum alloy to provide strong support for the testing materials. The sidewalls were made of transparent acrylic to facilitate the observation of the moisture migrations within the testing box. The dimensions of the testing box were 52 in. \times 23.6 in. \times 7.9 in. (132 cm \times 60 cm \times 20 cm) (Length \times Height \times Width). In order to compare drainage efficiency of different geosynthetics at the same time, the test box was divided into two sections, the dimensions for those two sections were 26 in. \times 23.6 in. \times 7.9 in. (66 cm \times 60 cm \times 20 cm) (Length \times Height \times Width), respectively, as shown in Figure 5.1a.

METER Environment® EC-5 Moisture sensors were installed in the testing box to monitor the drainage performance of different materials. In total four layers of soil moisture sensors were installed at depths of 3.5 in. (9 cm), 4.7 in. (12 cm), 9.4 in. (24 cm), and 15.4 in. (39 cm) from the bottom, respectively as shown in Figure 5.1a. The first layer of sensors (3.5 in. from the bottom) was installed at the level of opening and immediately below the wicking geotextile (if there is). In each test section, there were three sensors in the first three layers. In the fourth layer, only two sensors were installed as shown in Figure 5.1a. As a result, in total 11 sensors were installed in each test section as shown in Figure 5.1a. Within each layer, the spacing between two adjacent sensors was 11 in. (28 cm), and the sensors at the edges were 2 in. (5 cm) away from the sidewalls. Note that a $\pm 2\%$ accuracy of the sensor was provided by the manufacturer for non-uniform soils and general field conditions, which represent accuracy under disadvantageous field conditions. In this study, the sensors were used in a well-controlled and stable laboratory condition with nearly constant temperature, relative humidity, nearly zero vibration, and very short connection wires. In addition, the soils used were relatively uniform and were carefully prepared. Therefore, the sensors should be able to provide sufficient accuracy of the soil

(b) Filled test box

After all the three stages were completed, the testing system was disassembled and soils at different locations were carefully sampled to measure their gravimetric water contents using the oven method. The solid points in Figure 5.1a show the locations of the sampling. From the top to the bottom, a total of 9 layers of soils were sampled with an interval of 2.4 in. In each layer, six locations were selected for sampling and the sampling distance between two adjacent locations were 5, 5, 6, 5, and 5 in. (refer to Fig. 3a), respectively. As a result, a total of 54 samples were taken for each test section and a total of 108 gravimetric water contents were measured for the whole testing box for two test sections.

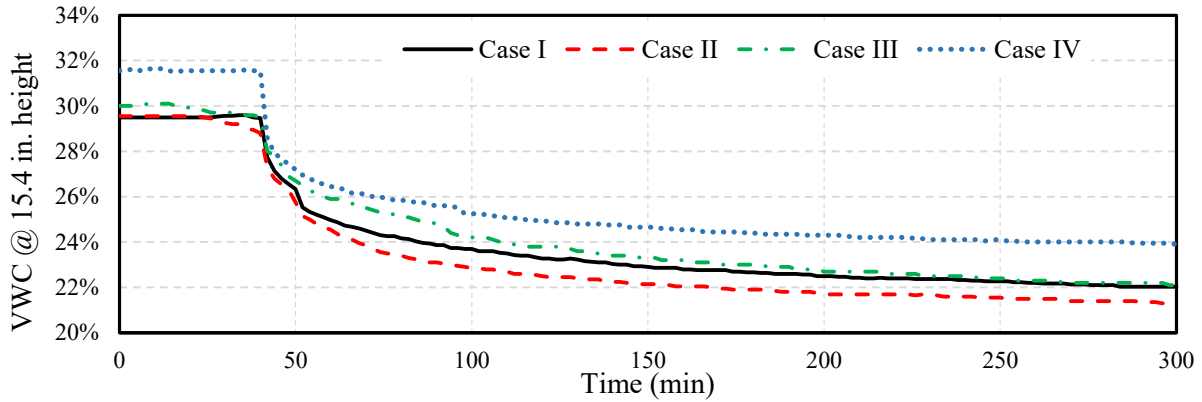
Figure 5.3 shows the average volumetric water content readings in the first 5 hours of the drainage tests for each case at heights 3.5, 9.4, and 15.4 in. from the bottom of the test box corresponding to first, third, and fourth layers of sensors, respectively. It is clear that the VWC changes in all of the cases have a similar trend. Initially, the soil was saturated and the sensor readings ranged from approximately 29% to 32%. The difference in the readings is due to the difference in compaction of the soil at different locations, even though a lot of effort was made to compact the soil uniformly. At the time of 20 minutes, the outlets were opened and water started to flow out of the system and the water table in the box started to drop. At the top-level sensors, a sudden drop in VWC was at the time of 40 minutes indicated that the water table reached the depth of 3.5 in. 20 minutes after the opening of the outlet. The average VWC at the top sensors in Case I and Case II started at the same value. However, shortly after 50 minutes, they clearly diverged and the VWC for Case II was always lower than that of Case I. It means that compared with the control case, more water was drained when a layer of wicking geotextile was installed horizontally. The distribution of VWC in Case III was very similar to Case II since in both cases the wicking geotextiles were installed as the drainage materials. VWC at the beginning of the Case IV started slightly below 32% and ended at approximately 24% with a similar trend as Case I. The drops in VWC readings in Cases I and IV were quicker than those in Cases II and III at the same time. The quicker drops in VWC in Cases I and IV indicate that water was drained faster in these two cases at the very beginning stages. This is reasonable since in Cases II and III, where a layer of wicking geotextile was used as drainage materials, part of the area of the outlet was occupied by the geotextile material which slowed down the water flow.

a) Fourth (top) layer of sensors (h = 15.4 in. from the bottom)

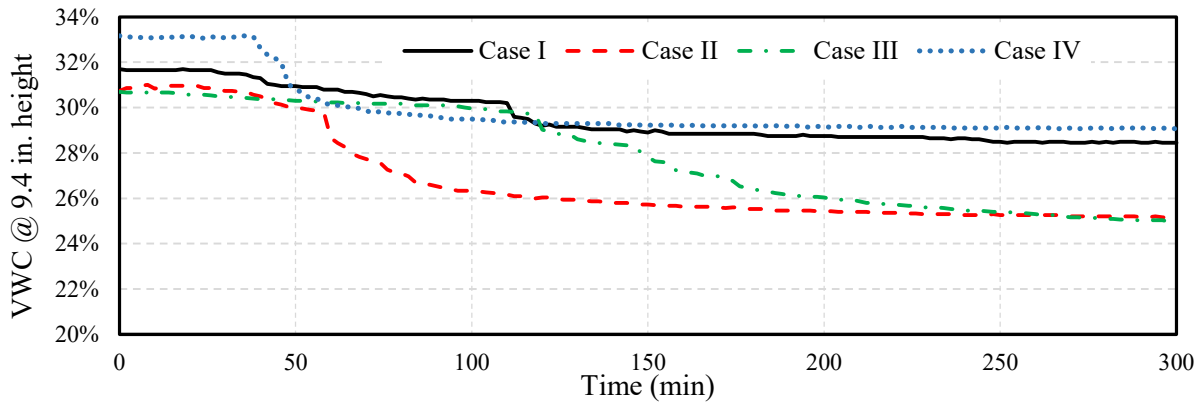
Figure 5.3b shows the average VWC of the third layer of sensors from the bottom. It can be seen that the VWC at the beginning of the test in both Cases II and III started at around 31% and ended at 25%. At the same height, the VWC in Cases I and IV started around 32% and 33% and ended around 30% and 31%, respectively. The difference in VWC at the beginning of the test compared to the end of the test in Cases II and III was 6%. While for Cases I and IV, the difference was about 2%. This clearly indicates that compared with the control case (Case I) and the case with French drain (Case IV), when wicking geotextile was used, more water can be drained out of the test box (representing the pavement structure).

b) Third layer of sensors (h = 9.4 in. from the bottom)

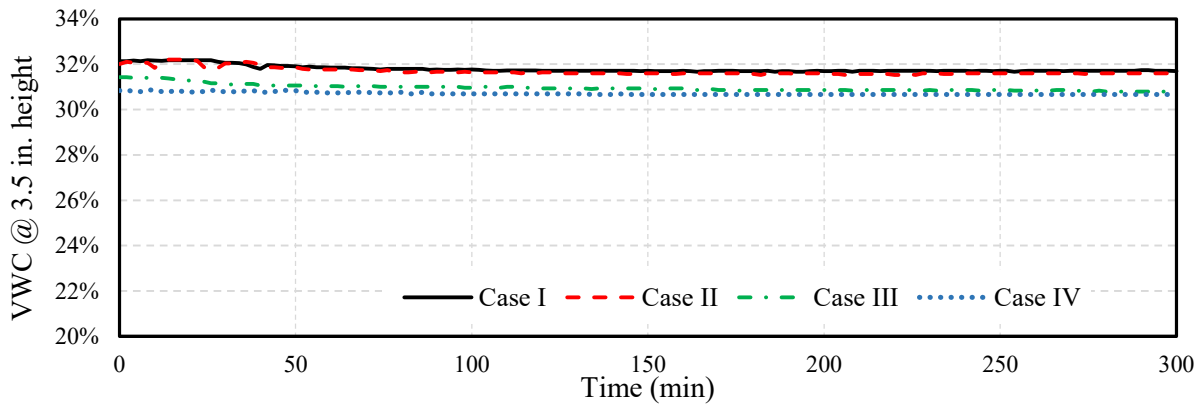
Figure 5.3c shows the average VWC at the first (lowest) layer of sensors in the four cases. As seen in Figure 5.3c, all of the sensors maintained a relative constant reading of 31-32%. It is clear that the soil in all cases was still in the saturated condition at the height of 3.5 in., which is below the elevation of the opening.

c) First layer of sensors (h = 3.5 in. from the bottom)

Figure 5.3 Average VWC for different cases

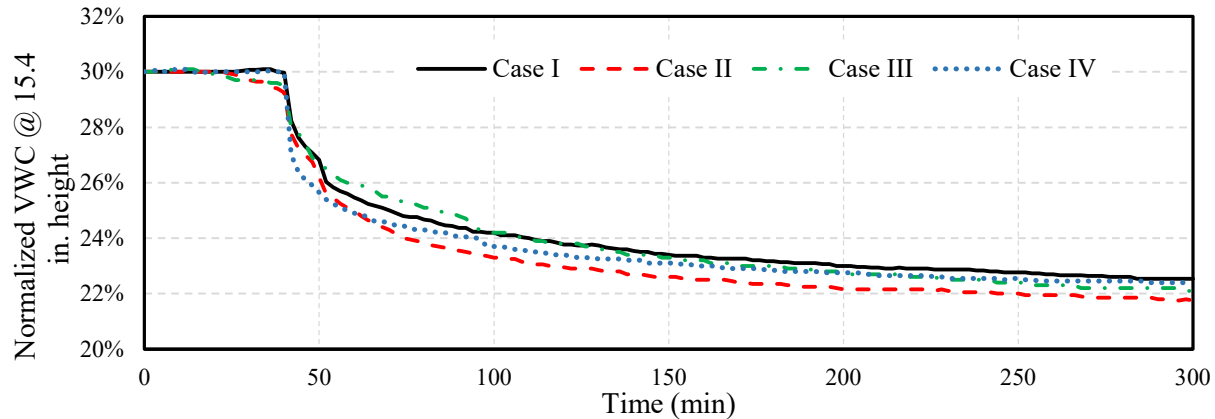
In order to eliminate the influences of possible nonuniform soil compaction, the VWC results were normalized by comparing the VWC changes relative to their corresponding initial VWC. This is helpful since the differences in the initial saturated VWC is mainly due to the difference in compaction of the soil at different locations. The results are illustrated in Figure 5.4. It is clear that Case II was the driest for the most part except at the beginning of the test. Case III had a similar trend to Case II. At the end of the fifth hour, Case I had the highest VWC. The difference

Figure 5.4 Normalized average VWC for different cases at top sensors ($h = 15.4$ in.)

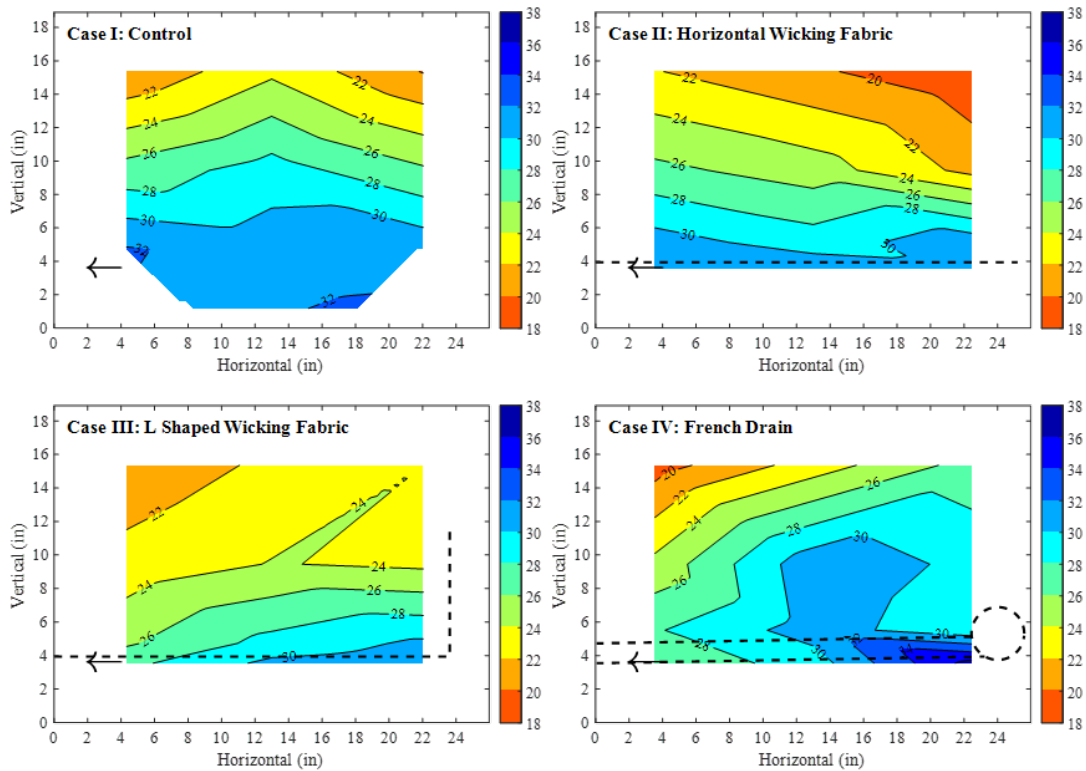
Figure 5.7 shows the contour plots for all cases 2 days after the beginning of the test. Although the tests were continued for 7 days, after 2 days, all the sensors measured no further change in VWC. The general trend of VWC lines was similar to Figure 5.6. However, the VWC distribution indicates that some water drained out even after all of the free water had been drained. This extra water drainage was considered mainly the capillary water. Comparing Figure 5.5b with 5.5c, it can be clearly seen that more water was drained in Cases II and III. On the other hand, the changes in VWC in Cases I and IV were trivial during the period. This clearly indicates that wicking geotextile was continuously draining the capillary water at a higher rate. As shown in Figure 5.3c, in terms of drainage performance, Cases II and III were clearly better than Cases I and IV. It can also be seen from Figure 5.3c that compared with the control case I, adding French drain to the soil slightly improved the drainage performance of the system, but was less significant compared with the cases with the wicking geotextile. These results verified that installing the wicking geotextile has a beneficial effect on draining extra capillary water out of the pavement structure.

Figure 5.7 Distributions of VWC in all four cases after 2 days (VWC in percentage)

Figures 5.5 through 5.7 show the contour plots of VWC at different times for each case. These contour plots were generated by linearly interpolating the VWC at different sensor locations to obtain a continuous spatial distribution of moisture content. In each figure, the arrow in the bottom left corner shows the location of the opening.

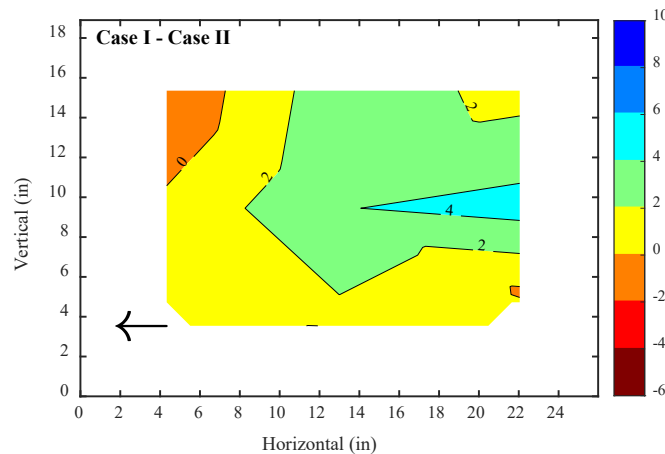
To better demonstrate the differences in drainage ability of different cases, Figure 5.8 shows the differences in VWC distributions between Cases I and II, and Cases IV and III after 2 days of draining. VWC in Case II was subtracted from the VWC in Case I and the results were shown in Figure 5.8a. As shown in Figure 5.8a, immediately above the location of the opening (3.9 in.), the differences in VWC between Cases I and II were negligible. The reason for this is that the soil at the elevation of the opening in all cases is nearly saturated, and the wicking geotextile did not improve the drainage when the soils are fully saturated. Since the soil used in this case has high saturated hydraulic conductivity, the beneficial effect of the wicking geotextile is shadowed. On the other hand, at the height of 9.4 in. (5.5 in. above the wicking geotextile), a reduction of VWC up to 4% more compared with the control case was observed. The relative contour values at the top of the soil are close to zero showing that no significant improvement observed at this elevation.

(a) Case I minus Case II

Figure 5.8 Relative VWC after 2 days.

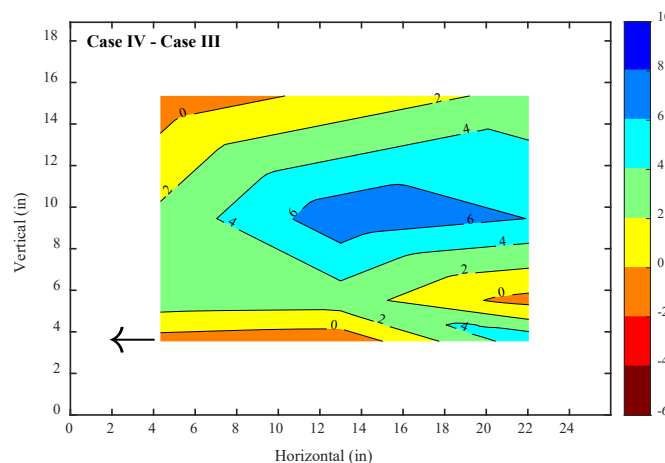
Similarly, VWC in Case IV was subtracted from the VWC in Case III and the results were shown in Figure 5.8b. At the elevation level that is close to the outlet, the two systems generally performed similarly as indicated by contour line with values close to zero. On the other hand, at the mid-height of the box, wicking geotextile reduced VWC up to 6% more than the French drain, indicating the efficiency of the wicking geotextile in draining water.

(b) Case IV minus Case III
