Report No. UT-19.17

## **PERFORMANCE EVALUATION OF TYPICAL UDOT SURFACE TREATMENTS**

Utah Department of Transportation  
Research & Innovation Division

University of Utah  
Department of Civil and Environmental  
Engineering

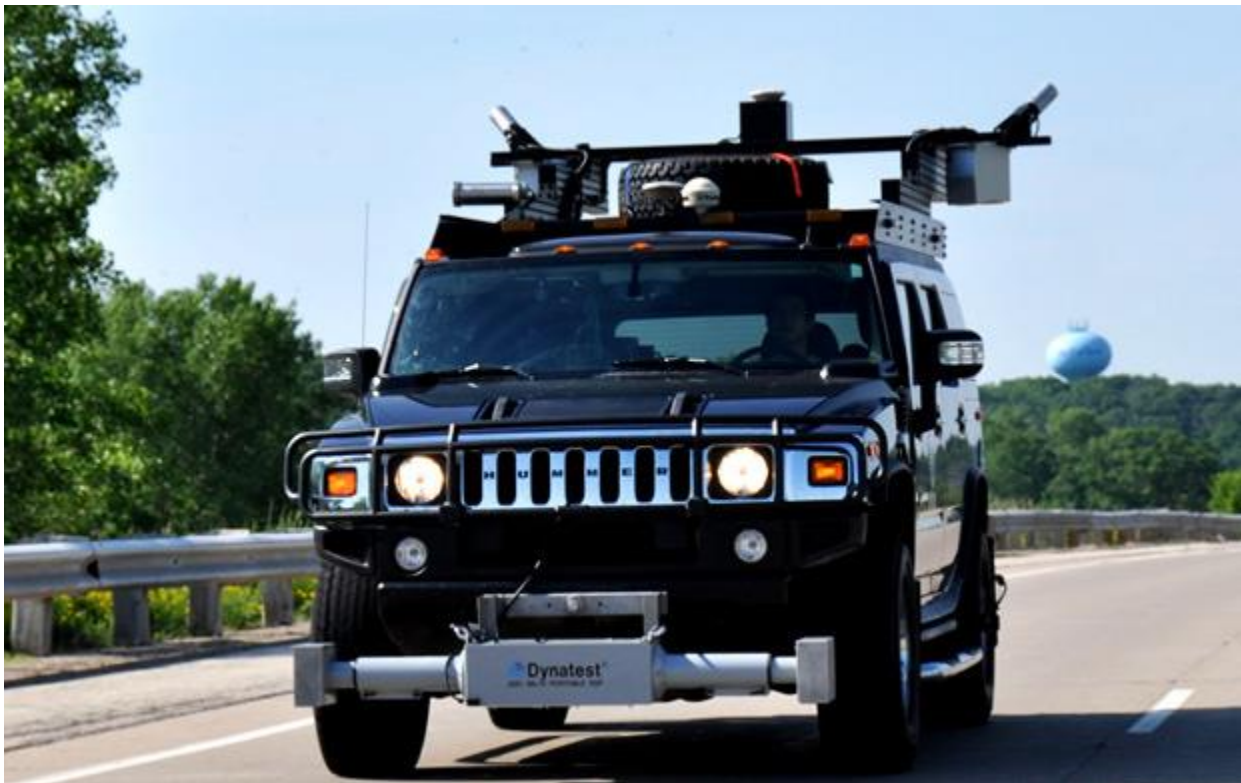
**Figure 2-1 Picture of data collection vehicle (from Mandli.com website)**

The manual data collection is done by a human who walks along a sample section and visually identifies and assesses pavement distresses. The automatic data collection is done using a modified survey vehicle with the mounted imaging equipment and the sensor driving down the road. The technology on these vehicles includes global positioning systems (GPS), sensory lasers to measure transverse and longitudinal profiles, and a set of high-resolution cameras. Data is captured with the vehicle moving at or near traffic speed (McGhee 2004), and then processed into a database manually. The reason why the data cannot be recorded directly into a database from the digital images is because the sensor and the camera only record the distress's physical measurement such as the width and length and then some interpretation is needed to identify the type and source of the distress. New, more sophisticated algorithms are constantly being developed. An example of the vehicle used is shown in Figure 2-1.

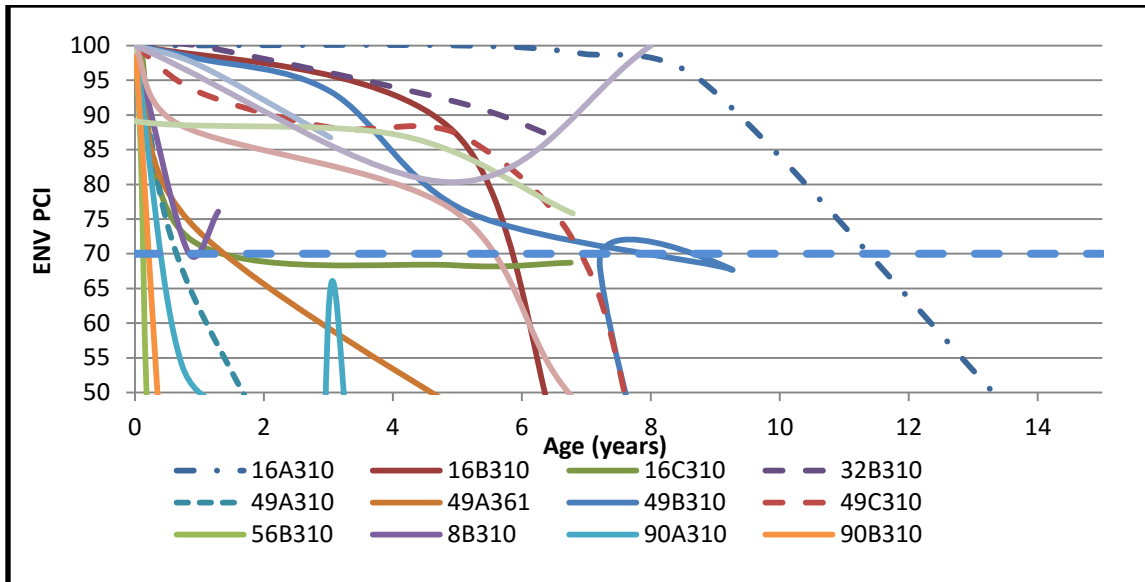
**Figure 6-2, Environmental pavement condition index with failure line.**

Two plots were made, one for WP and one for ENV distresses. These plots are shown in Figures 6-1 and 6-2, respectively. Out of the 16 sections, seven appear to be failing for WP cracking. Figure 6-2, ENV index versus age, shows some interesting behavior in the measurement of the ENV index for the sections. For instance, on section 8B310 the ENV index dips below 70 after one year and picks back up to 76 half a year later. Other sections that experienced this same behavior were 90A310, 8A310, and

49B310. This could possibly be attributed to self-healing of thermal distresses or it's possible the evaluator rated the distress types differently over the survey time period. Self-healing is the closure of cracks due to the liquid behavior of asphalt which increases at higher temperatures (Little and Bhasin 2007). Out of the 16 sections, ten appear to be failing for ENV distresses. This high number may be an indication of the Marshall Mix design method not considering temperature effects in binder selection.

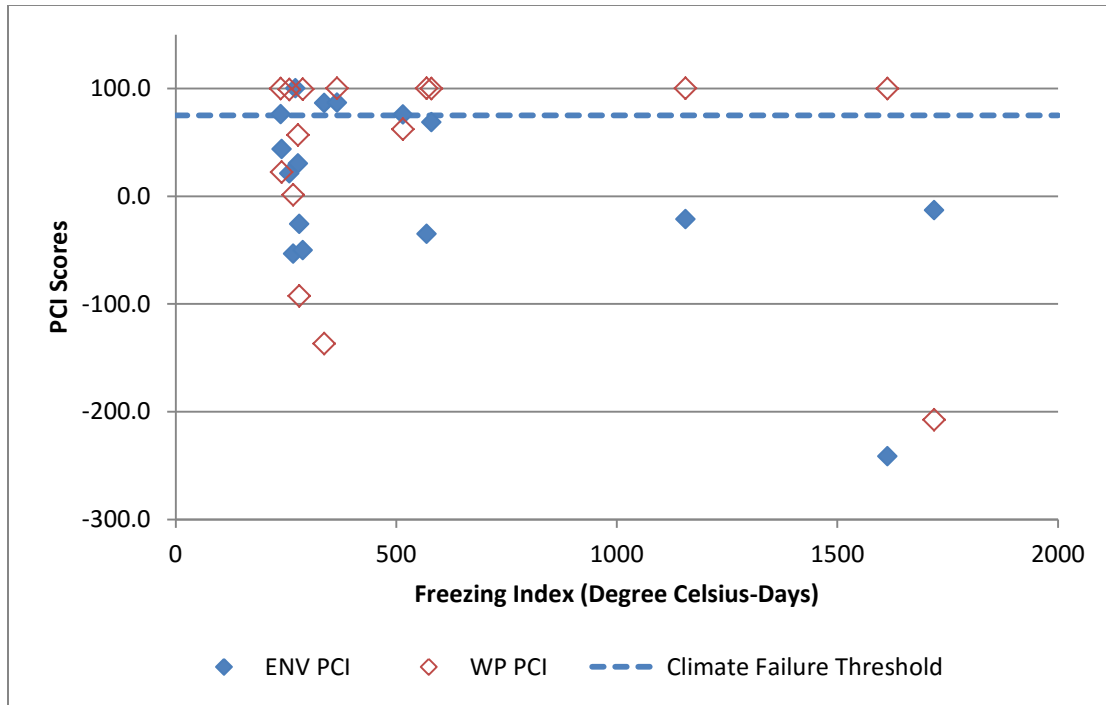
**Figure 6-3. LTPP pavement condition indices and freezing index.**

The effect that temperate and climate had on these overlay treatments was substantial. Obviously, colder climates will exacerbate distress formation. In order to show this, the ENV and WP indices for each route were plotted in Figure 6-3 against the annual freezing index for these sections. The freezing index, as defined by the National Snow & Ice Data Center, is the total annual number of degree-days when temperatures are below zero degrees Celsius. Noticeable from Figure 6-3 is the general downward trend in the ENV index scores with increasing freezing index. For the WP index, this trend is not noticeable as the data is more scattered. However, as ENV cracking increases it is expected for WP cracking to increase proportionately. This is primarily from increased water ingress into the pavement and subsequent structural damage to supporting layers.
