# **A Bio-Wicking System to Prevent Frost Heave in Alaskan Pavements: Phase II-Implementation**

**Department of Civil, Architectural, and Environmental  
Engineering  
Missouri University of Science and Technology**

**INE/CESTiCC 19.29**

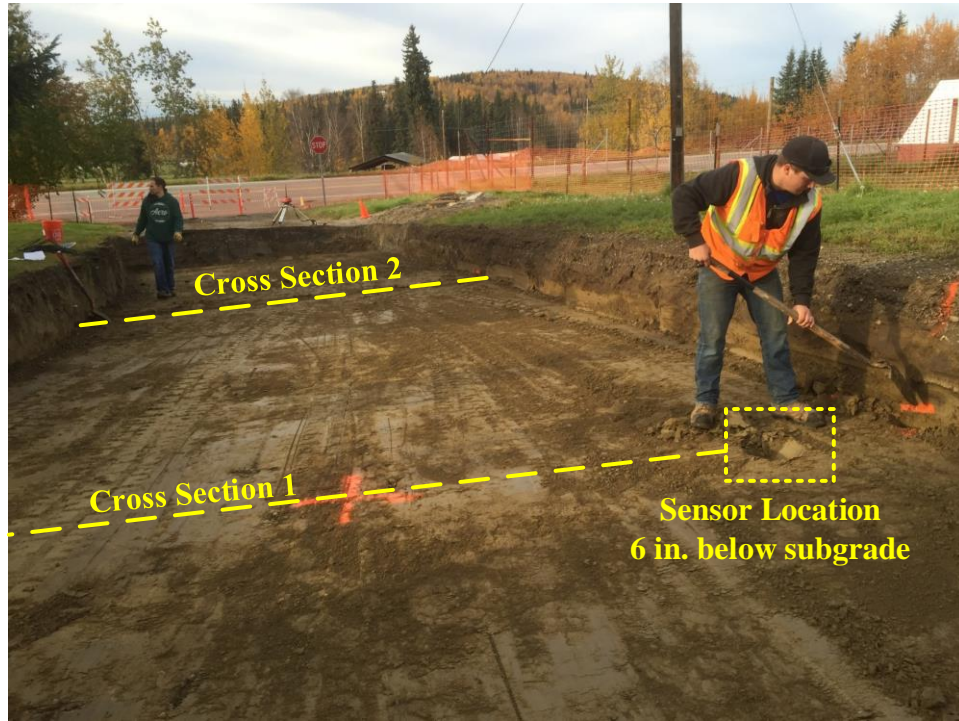
Figure 3.7(a) shows the determination of the cross sections 1 and 2. After the excavation had been completed, the Cross Section 2, which was 25 ft. north of the edge of west test area, was determined and marked. Then, the Cross Section 1, which was 25 ft. north of Cross Section 2, was also marked. After that, the locations of the first layer of sensors were determined. A shovel was used to dig a 6-in. deep hole into the subgrade soil and a GPS device was used to check the buried depth, as shown in Figure 3.7(b).

### Figure 3.7 Determination of Cross Sections 1 and 2

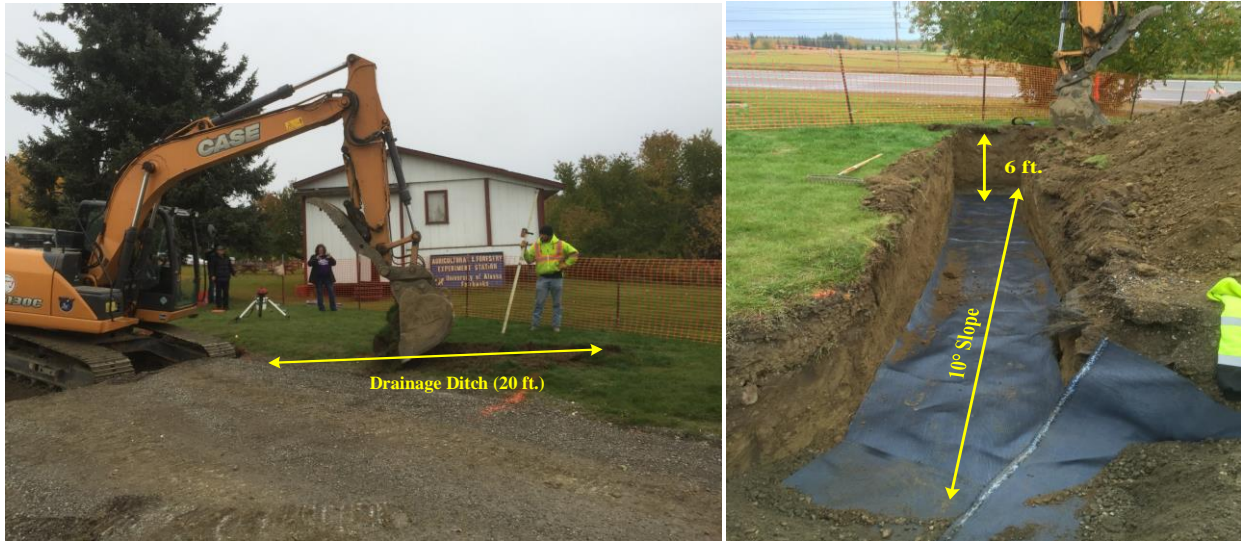
After completion of the installment of the H2Ri wicking fabric, a drainage ditch was excavated to direct the excess water to a dry well located on the southeast corner of the test section, as shown in Figure 3.10. The length and depth of the drainage ditch was 20 ft. and 6 ft., respectively. The drainage ditch was leveled to a 10° grade so that the excess water could be directed to the dry well. Then, the subgrade soil was backfilled to the drainage ditch. To direct the surface water to the dry well, a second layer of the H2Ri wicking fabric was installed. One soil moisture sensor was also installed within the backfill subgrade soil to monitor the water content variations within the dry well. Finally, the trench and the dry well were backfilled with Type A fill and compacted to the same grading of the roadway using a vibratory plate compactor.

**Figure 3.10 Excavation of drainage ditch**

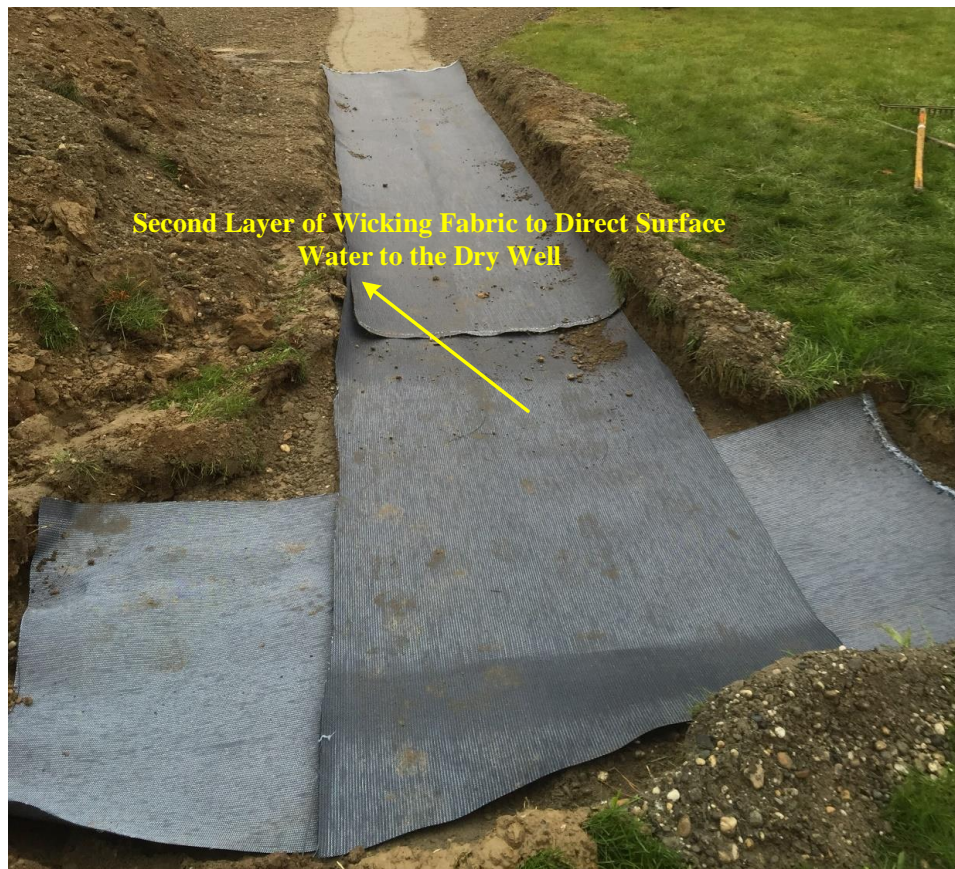
**Figure 3.11 Second layer of H2Ri wicking fabric**

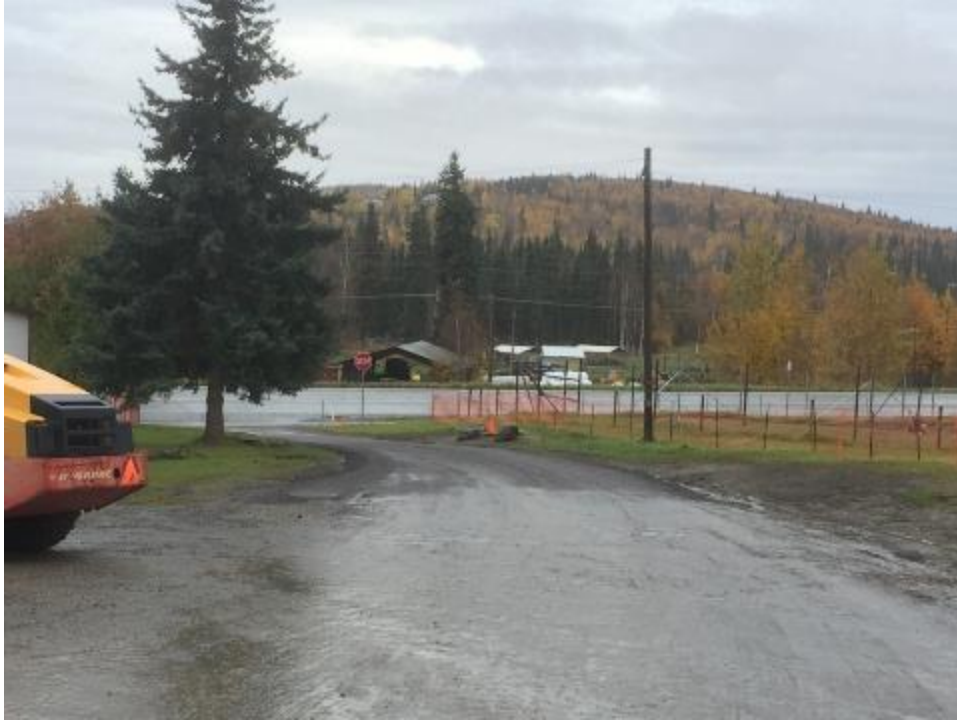
**Figure 3.13 Road condition after rehabilitation**

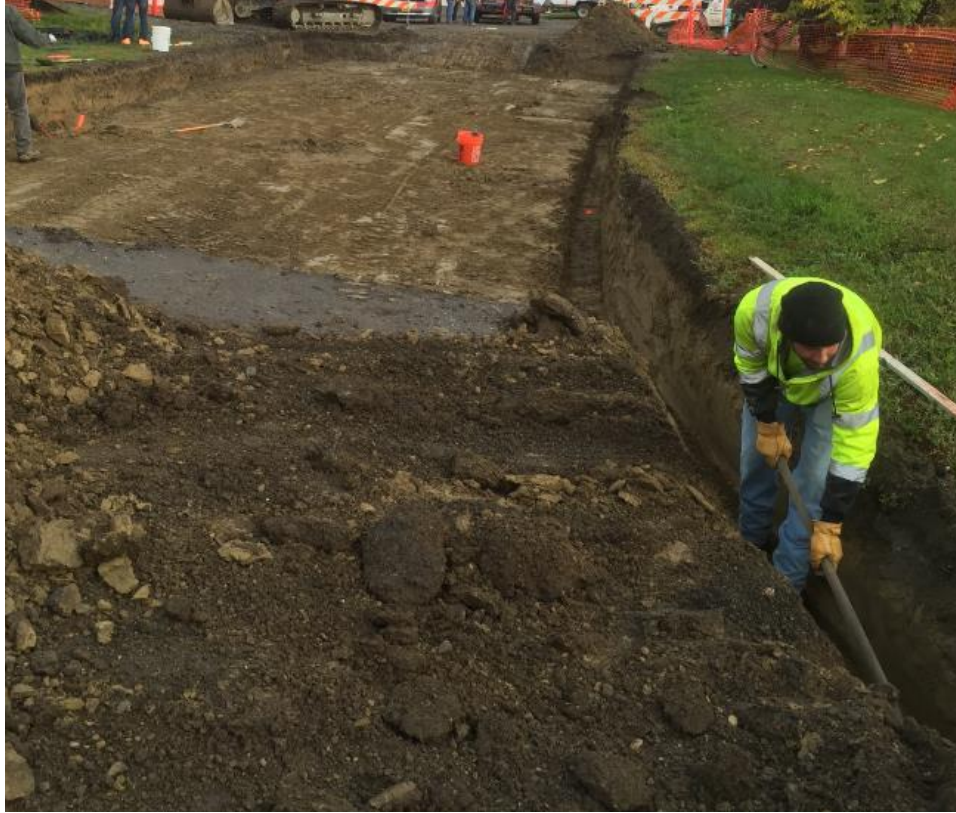
For the test section on the east side of the Yukon Drive, the excavation, sensor installation, and backfill procedures were the same as on the west test section. Therefore, the detailed information regarding the construction process will not be discussed again. However, according to the test design in Figure 3.3, the drainage design for Cross Section 4 is different compared with that on the west side test section. Therefore, this part mainly focuses on demonstrating the construction process of the drainage ditch on the east test area of the Yukon Drive. After excavation and leveling of the subgrade soils, the drainage trench was excavated on the east edge of the test area, as shown in Figure 3.14. The drainage trench extended to the ground surface 46 ft. away from the southeast corner of the test area.

**Figure 3.14 Excavation of drainage trench**

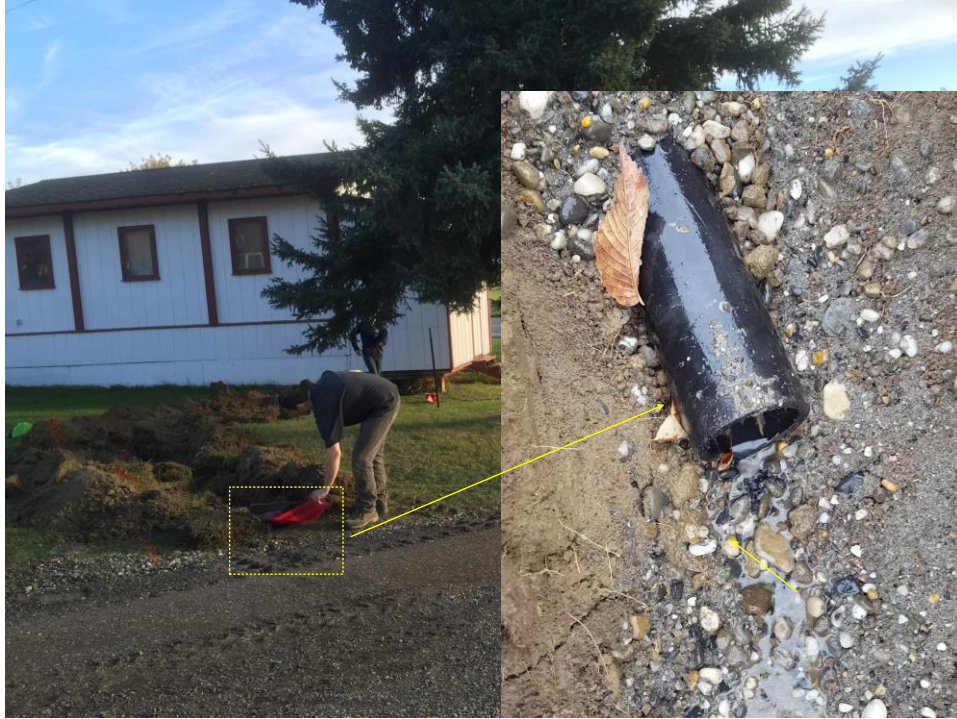
**Figure 3.16 Drainage pipe outlet**

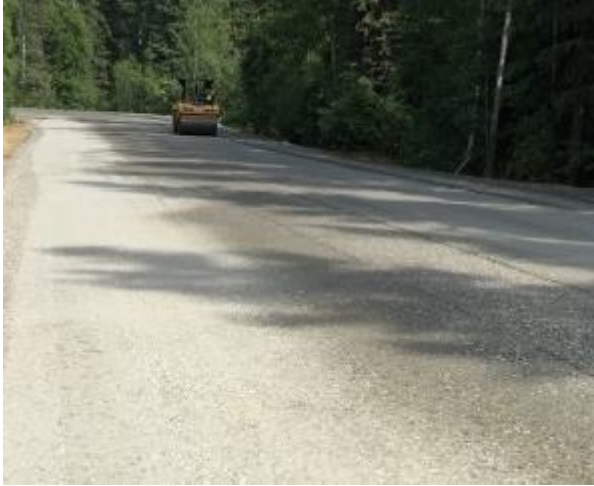
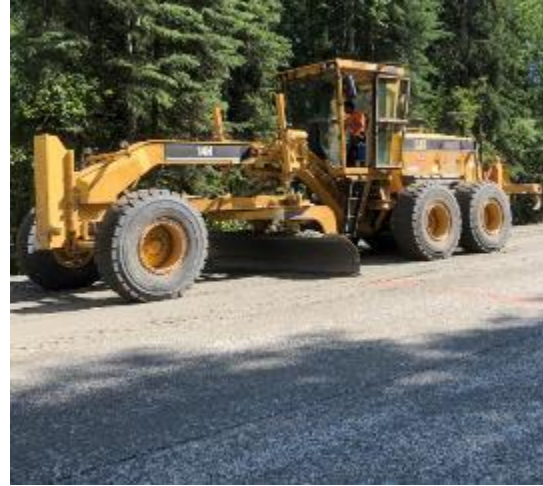
**Figure 3.24 Base course compaction and grading**

Figure 3.23 shows the installation of the 2<sup>nd</sup> layer of sensors. This layer of sensors was installed within the subbase layer that is a gravelly material. To ensure the consistency of sensor readings in gravelly material, uniform sand was used as a media. A 2 inch hole was first made and the sensor was put horizontally into the hole with the probes inserting into the sand layer. After that, the hole was backfilled with the subbase material and loosely compacted by hand. After the second layer of sensors were installed, the base course material was shipped on site and compacted with an intermediate roller, as shown in Figure 3.24(a). During the compaction process, water was continuously spread on the road and the surface of the base layer was graded with a 2<sup>o</sup> grading in the transverse direction, as shown in Figure 3.24(b). Finally, the 2-inch asphalt surface course was paved on July 1, 2019 and Figure 3.25 shows the road surface condition after the completion of rehabilitation.

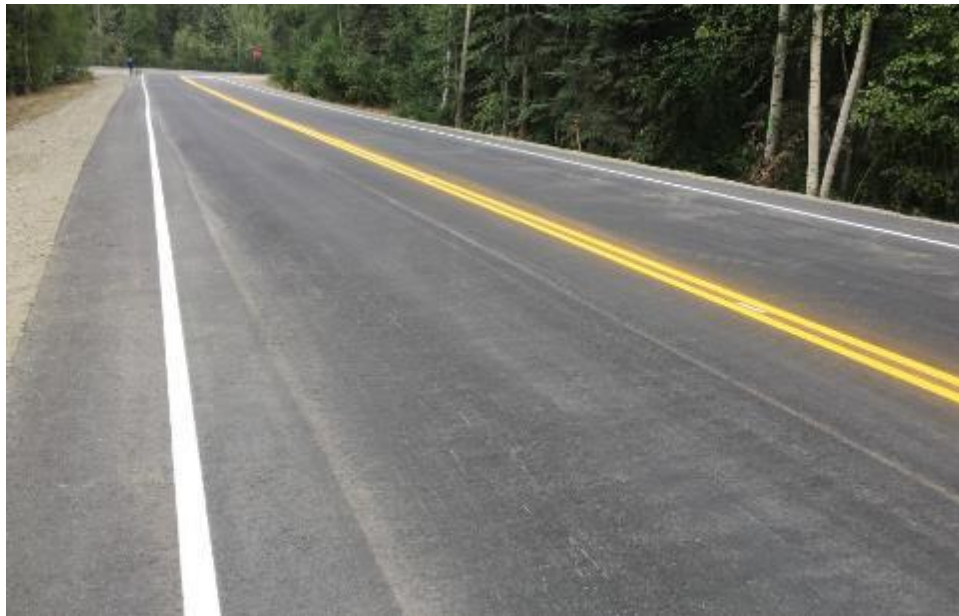
**Figure 3.25 Road condition after rehabilitation**

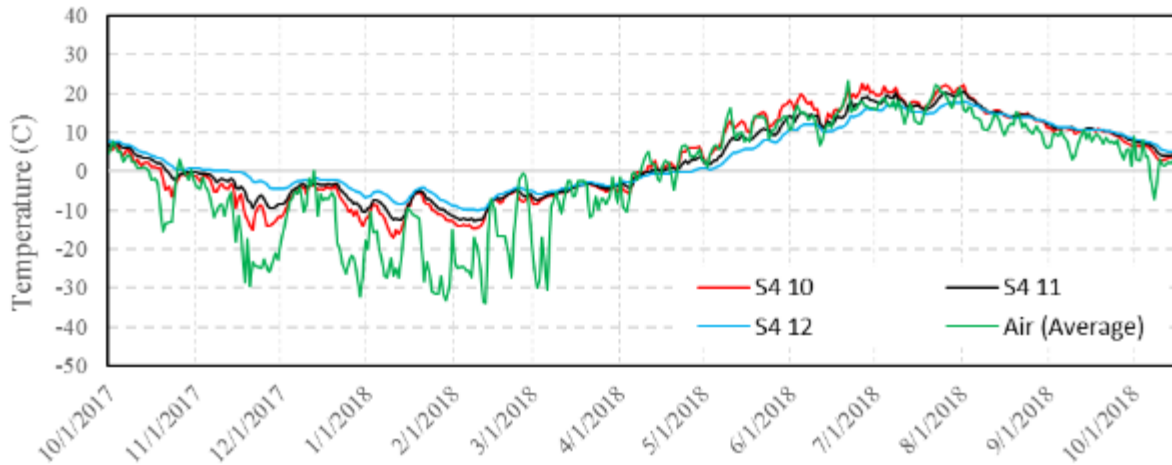
**Figure 4.3 Daily temperature at sensors 10 through 12 in section 4**

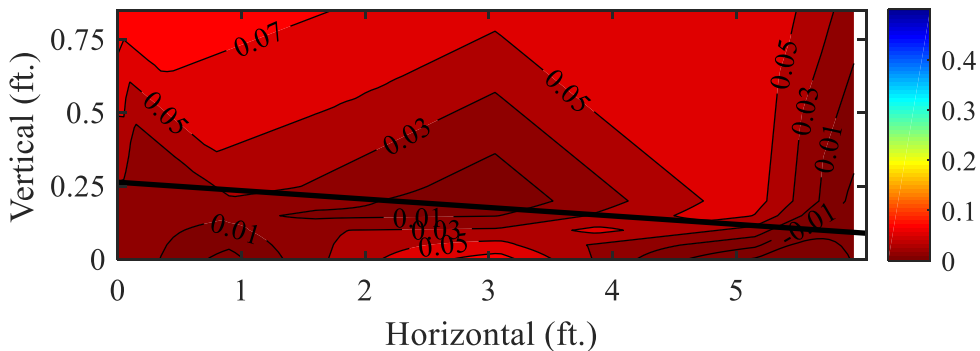
(a) VWC distribution at Section 1

(b) VWC distribution at Section 2

(c) VWC distribution at Section 3

(d) VWC distribution at Section 4

**Figure 4.5 VWC at different sections during thawing on February 1, 2018 at noon**

To further demonstrate the moisture migrations within each test section, the raw data for each sensor was used to generate soil volumetric water content and soil temperature contours. Figure 4.5 Figure 4.6 show the VWC and temperature variations in each test section on February 1, 2018. This day was selected because it was in the middle of the freezing period. In the temperature contours, the freezing front was below the location of the deepest sensors and all the base course material was frozen. Consistent observations were observed in the VWC contours in which the VWC values were lower than 8% in each test section. However, VWC values near the location of the H2Ri wicking fabric were significantly lower than the rest area and the average VWC value was approximately 2% in sections 1, 2, and 4. In contrast, the average VWC was 5% in section 3 where no H2Ri wicking fabric was installed.
