1. REPORT NO.	2. GOVERNMENT ACCESSION NO.	3. RECIPIENT'S CATALOG NO.	
4. TITLE AND SUBTITLE Alerts and Cues for Specific Conditions: Analysis and Application in Training		5. REPORT DATE March 20, 2015

6. PERFORMING ORGANIZATION CODE	
7. AUTHOR(S) Benjamin A. Berman, Janeen A. Kochan, Barbara K. Burian, Shawn Pruchnicki, Bonny Christopher, and Evan Silverman		8. PERFORMING ORGANIZATION REPORT NASA Ames Research Center

9. PERFORMING ORGANIZATION NAME AND ADDRESS NASA Ames Research Center Moffett Field, California		10. WORK UNIT NO.	
		11. CONTRACT OR GRANT NO. NASA-FAA IAA DTFWA-11-A-80004, Annex 7

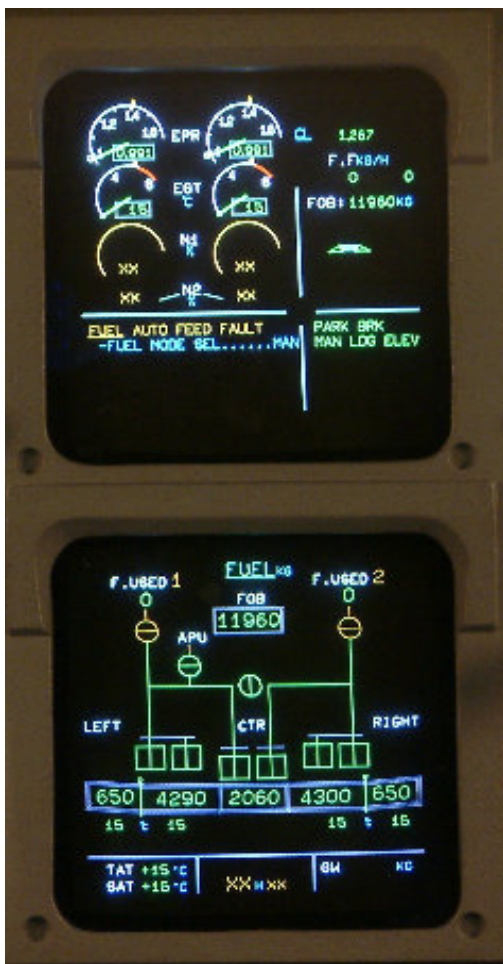
Figure A1. Airbus ECAM Displays

During emergency or abnormal conditions, the ECAM displays text alerts associated with the condition and corrective actions for the crews to take (i.e., checklist steps). For example, in

The A320 alerting system includes master caution and master warning visual and aural alerts, the Electronic Centralized Aircraft Monitoring (ECAM) system, a variety of other aural alerts (both synthesized speech and sounds), illuminated lights on overhead systems panels, and a variety of indications on the PFD, ND, and the flight management guidance computer multifunction control display unit (FMGC MCDU). As its name implies, the ECAM monitors aircraft systems and displays information about them through two primary cockpit displays, the Upper ECAM and the Lower ECAM (see Figure A1), which are located in the center of forward displays directly in front of the throttle quadrant.

Figure 2 the title of an abnormal condition (FUEL AUTO FEED FAULT) appears in amber in the lower left section of the upper ECAM display and is followed by one checklist item, in blue type, to be accomplished. The alerts and checklist actions are automatically displayed and prioritized so the most critical alerts and actions, based on algorithms developed by ECAM designers, are always presented first, when more than one emergency/abnormal condition exists. As checklist items are accomplished or the condition that triggered the item is resolved, they disappear from the display and remaining items move up.

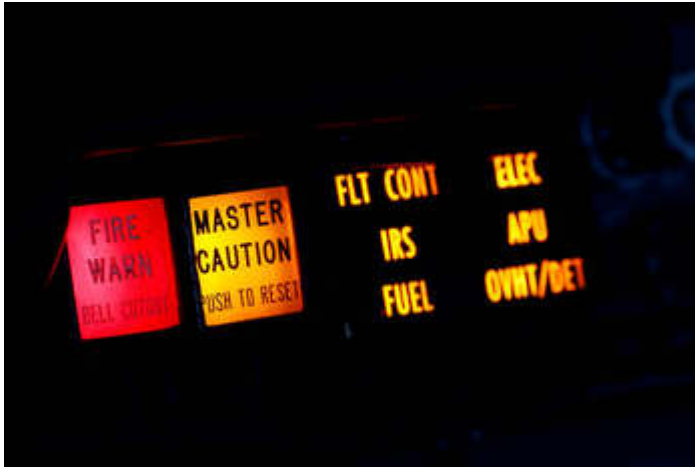
Figure A2. Boeing 737 Master Caution/Fire Warning and System Annunciator Lights

The master caution/fire warning lights are triggered by malfunctions affecting any of several systems; e.g., amber master caution lights for hydraulic failure and red master fire warning lights for cargo fire. For a subset of system failures, the system annunciator lights on the glareshield panels (see Figure 3) direct attention to the malfunctioning system whose controls and lights are located on the overhead panel or center console, outside of the pilots' normal field of view. For example, an illuminated "FLT CONT" light on the first officer's glareshield informs the pilots to look up at the flight control section of the overhead panel to find the illuminated amber light that pertains to the specific failure that has occurred.

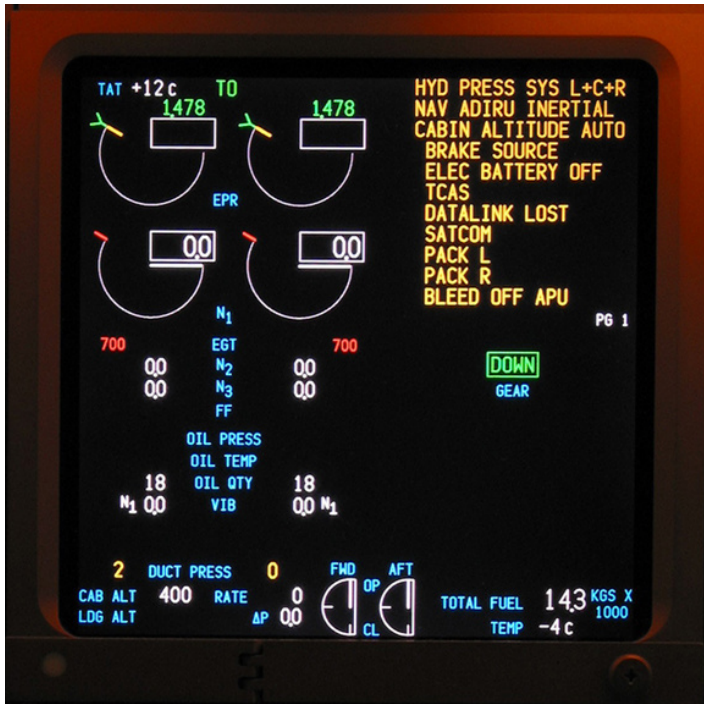
Figure A3. Boeing EICAS Display

The EICAS display is located in the center of the forward instrument panel, directly in front of the thrust levers. Text alerts are presented on the EICAS (see Figure A3) and, when multiple alerted conditions exist, their alerts are grouped by level of severity (warning, caution, advisory), and listed chronologically within each group (i.e., the most recent alerts appear at the top of its severity group list). Thus, as new messages are added existing messages are pushed physically lower on the display. Warning level alerts are colored red, caution level alerts are amber, and advisory level alerts are amber and indented. Additional status messages requiring no action by the pilots are presented in blue when manually recalled by the pilots. Any displayed message will remain presented on the EICAS until the condition that triggered it is resolved, if possible. Figure A3 depicts both caution and advisory level text alerts.

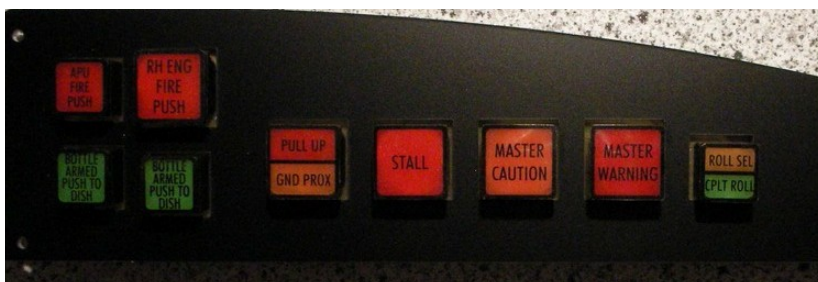
Figure A5. CRJ700 Glareshield Warning and Caution light switches (as seen on the right side of the cockpit)

When illuminated, the master warning and master caution push button is pressed which extinguishes the light and resets the system in the event that additional warning or caution alerts are needed. Pressing the master warning push buttons on the CRJ700 will silence some

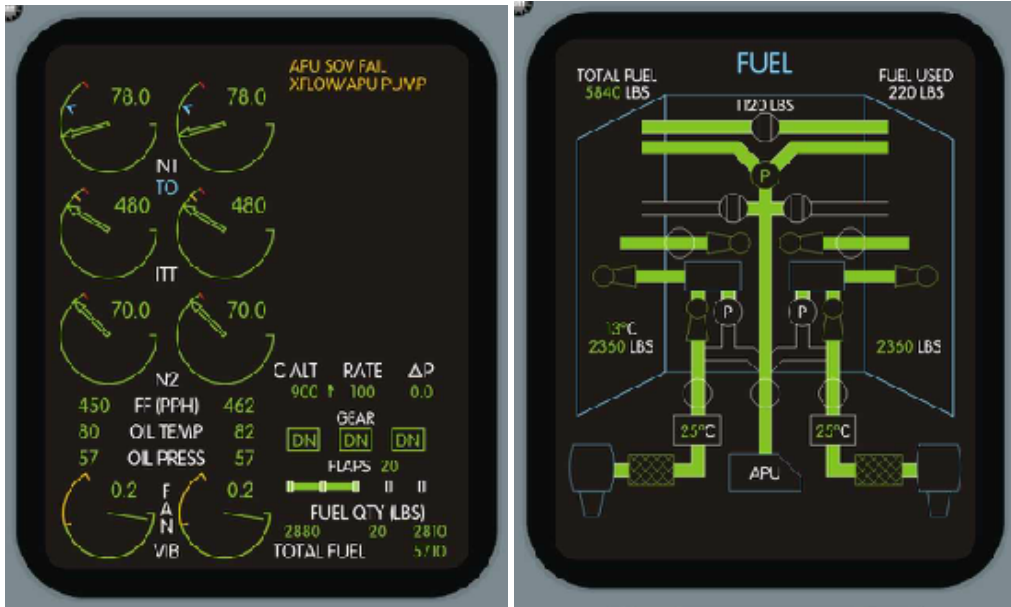
Figure A6. CRJ700 EICAS Displays 1 and 2

The EICAS displays show warning (red), caution (amber), advisory (green), and status (white) messages. ED1 usually displays the warning and caution messages and ED2 displays the advisory and status messages. In the case of a failure of one of the EICAS displays, all messages can be viewed on the remaining display (see Figure A6).

The CRJ700 alerting system includes master warning and master caution visual and aural alerts, two EICAS displays (ED1 and ED2), a variety of aural alerts including several synthesized speech advisories and sounds or tones, illuminated lights on overhead, forward, and center console panels, a variety of indications on the PFD, ND, and FMS CDU, and a tactile alert for stall warning. The master warning and master caution pushbuttons are located on the glareshield (both sides) within the primary field of view (see Figure A5) and the two EICAS displays (see Figure A6) are located in the center of the instrument panel in front of the thrust levers.

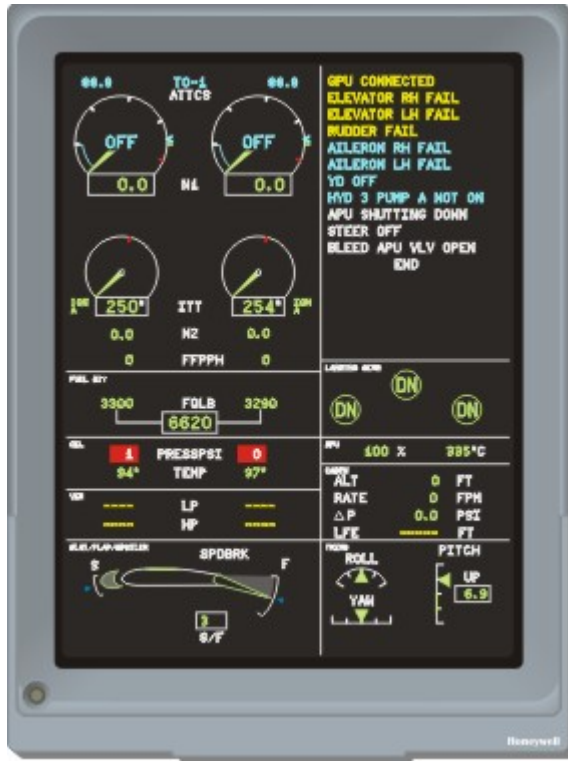
Figure A7. E190 EICAS Display

In addition to the use of colored text, the master caution/warning systems and the EICAS also incorporate blinking in their alerts. Warning and Caution alerts will cause the blinking of the associated Master Warning or Caution button. Steady illumination of these alerts will occur only after the pilots acknowledge the alert by pressing the associated Master Warning or Caution button. When new Warning, Caution, and Advisory EICAS alert messages are displayed, they also blink and appear in inverse video until crew acknowledgment. Advisory (cyan) messages automatically revert from blinking to steady illumination after five seconds. Status messages do not blink at all.

For redundancy, and as an additional attention-getting feature, aural warnings correspond with each alert category. Continuous chimes at three or five second intervals for Warning and Caution alert messages, respectively, are silenced after the associated button is pressed. Advisory and Information/Status alert messages are accompanied by a single chime.
