**Development of Quality Assurance and Quality Control
System for Post Tensioned Segmental Bridges in Florida:
Case of Ringling Bridge – Phase II**

**FDOT Contract No. BDV29-977-34
FINAL REPORT**

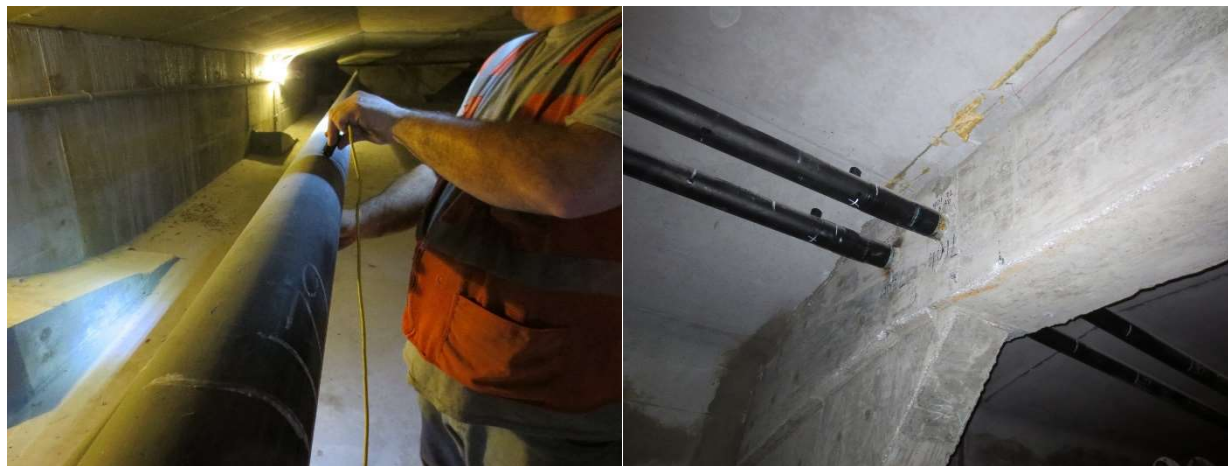
Figure 2-1: Measurements on tendon (left) and high elevation tendon spans (right).

The full length of each tendon (including sections along the floor of the precast segments, along the free span with vertical deviation, and high elevation tendon spans) were tested as shown in Figure 2-1. Before commencing of testing, the tendons were marked at every one feet. The marking procedure was standardized to allow easy

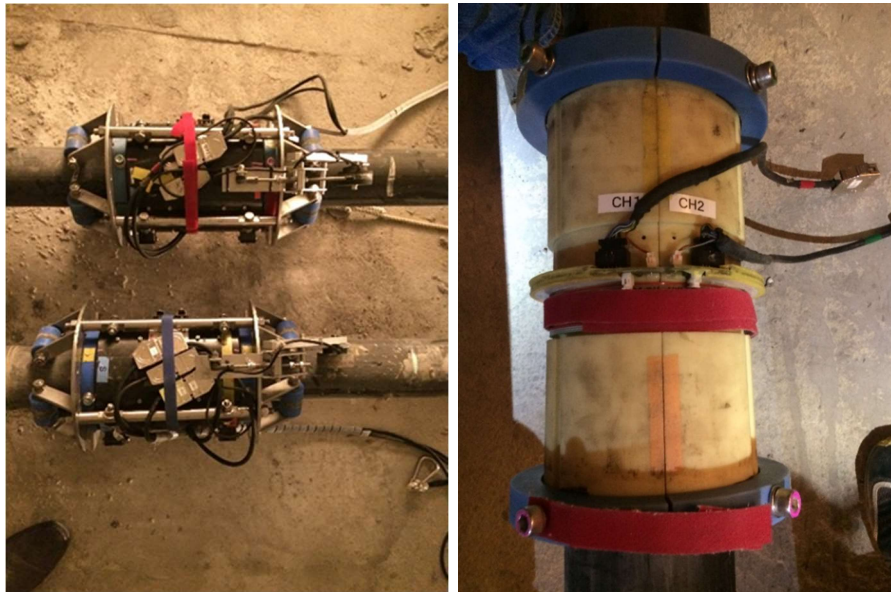
MTC has demonstrated field applicability of permanent magnet type MMFM. The equipment consists of a magnetizer, a controller and data acquisition system. This MMFM technology does not require external power sources making it a feasible choice when testing sites with no power access. The magnetizer assembly consisting of search coil and permanent magnet was wound over the external PT as shown in Figure 3-1. The installation of the magnetizer on the tendon was accomplished in a short period of time.

Figure 3-1: Installation of search coil and magnetizer on PT tendon.

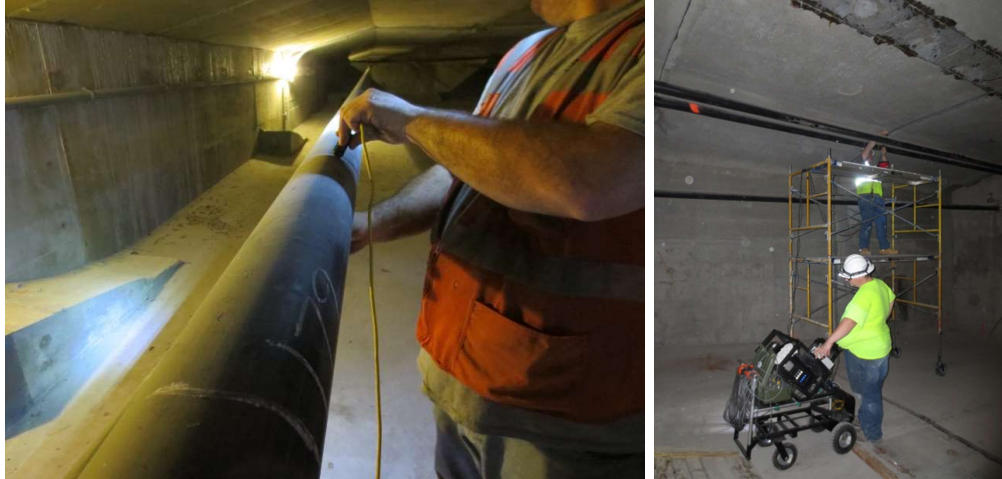
The full length of each tendon (including sections along the floor of the precast segments, along the free span with vertical deviation, and high elevation tendon spans) were tested. Measurements were typically made at 2-ft intervals for tendons along the precast segment floor and along the deviated free span. Shorter intervals were sometimes made especially when measurements indicated some form of tendon anomaly. Measurements were always made at 1-ft intervals for the high elevation tendon spans. Measurements typically were made in alternating sensor positions at 1-7 o'clock and 11-5 o'clock positions at the intervals described above for the deviated and high elevation tendon spans. 3-9 o'clock sensor positions were used for the floor tendon spans.

Figure 4-1: Ultrasonic/sonic testing on external PT tendons.

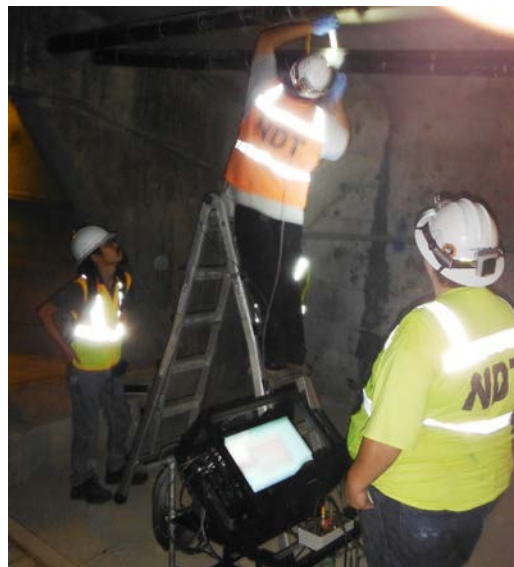
Photograph 1-Data acquisition

Sonic/ultrasonic and impact echo/resonant (multiple reflections) frequency measurements were obtained using a piezo electric "clicker" energy source, a hand-held sensor and a portable computer to archive and provide a quality control field display of data (Photograph 1). Sonic/ultrasonic data were obtained for each tendon by positioning the energy source on one side of the PT duct and a sensor on the opposite side and incrementing the readings at 1 or 2 foot intervals. Sonic/ultrasonic impact echo measurements were made at 1 foot intervals at tendon high points and 2 foot intervals in transition and low areas. Measurements were made by positioning the "clicker" energy source at 11:00 o'clock and the sensor at 5:00 o'clock or 1:00 and 7:00 o'clock positions depending on access, activating the energy sources and recording the resulting signal for 4 milliseconds. A discussion of the sonic/ultrasonic survey method is included in Appendix 1.

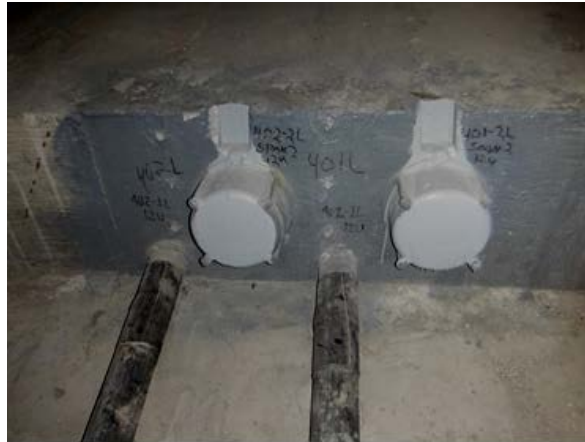
Photograph 2- Anchorage blocks at center of spans

Each duct was identified using the FDOT designations marked on anchorage, abutment, and diaphragms (see Photograph 2 below). PT ducts were stationed at 1 foot intervals from west to east using tape and measurements referenced to duct starting point at abutment and anchorage blocks and from the west face of diaphragm walls at piers. Spans 2 through 10 have anchoring blocks mid-span where the ducts are anchored (pictured below).

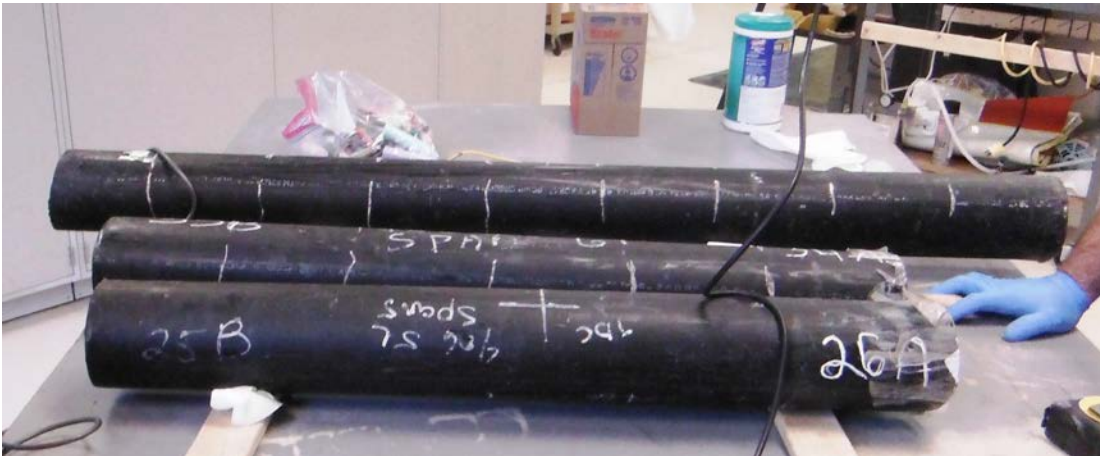
Photograph 4- Duct segments 25b, 33b and 36

Prior to initiating testing at the Ringling Bridge, sonic/ultrasonic testing was conducted at the Florida DOT's materials department in Gainesville on duct segments 25b, 33b and 36 (Photograph 4 below) removed from the Ringling Bridge during repairs.

Calibration sonic/ultrasonic testing was conducted at Florida DOT's Materials Department in Gainesville on duct segments 25b, 33b and 36 (FDOT designations) removed from the Ringling Bridge during repairs. This calibration determined that there is a full grout through thickness impact echo 20 kHz frequency indicative of "good" grout and when the 20 kHz was not present the ducts have weak segregated grout.

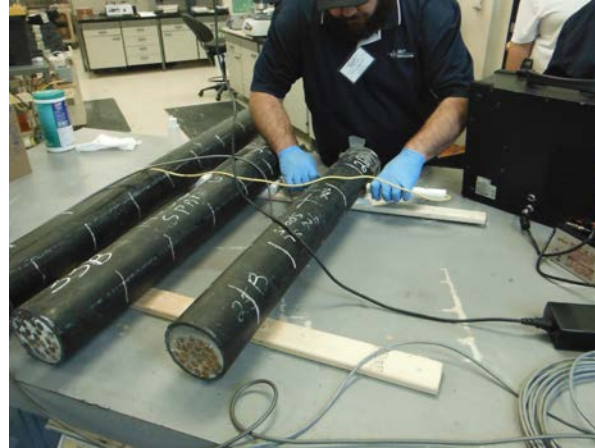
Photograph 5- Sonic/ultrasonic impact echo testing

The objective of the testing was to determine the difference in signal characteristics associated with ducts filled with hard “good” grout versus those with anomalous grout conditions (voided, soft or segregated, etc. grout). Sonic/ultrasonic impact echo and direct wave measurements were made at 6 inch intervals the length of all 3 sample duct sections. Measurements were made by positioning the “clicker” energy source at 9:00 o’clock and the sensor at 3:00 o’clock on the duct section (Photograph 5 next page) and recording the resulting signal for 4 milliseconds.

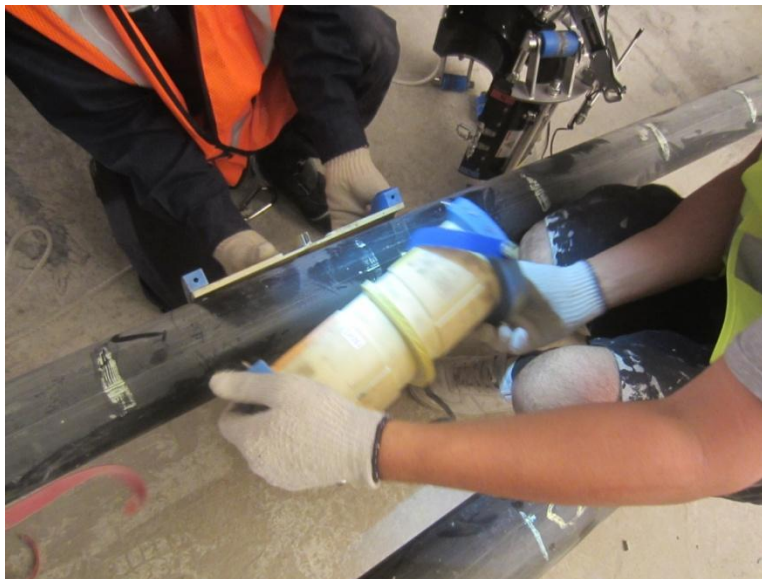
Two types of sensors are included in the magnetizer: search coils and Hall effect sensors. These sensors are accommodated in a sensor holder, which is placed inside the steel shell. The sensor holder consists of two half split pieces which allow quick installation around an external PT tendon. Figure 6 and Figure 7 show two sensor holder pieces being wrapped around a tendon and a close-up view of the assembled sensor holder, respectively.

Figure 6. Installing two half-split sensor holder pieces on a tendon.

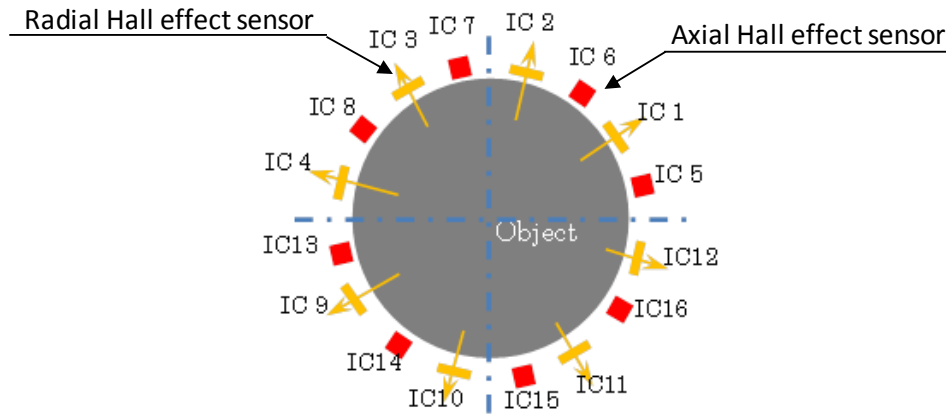
A Hall effect sensor produces the voltage proportional to the intensity of magnetic field (H, or magnetic flux density) which passes through the sensor. A gauss meter measures the changes in the magnetic field via the Hall effect sensor. In order to collect the induced voltages at various positions, a total of 16 Hall effect sensors are set around the metal object: eight radial sensors face the center of the object and eight axial sensors face in the longitudinal direction. Figure 8 shows the Hall effect sensor arrangement schematically. Actual Hall effect sensors are installed on the half split rings that are shown in Figure 7.

Figure 8. Arrangement of Hall effect sensors.

With such a sensor arrangement, no matter where a defect exists in the metal object, detecting a change of the magnetic flux can be ensured.

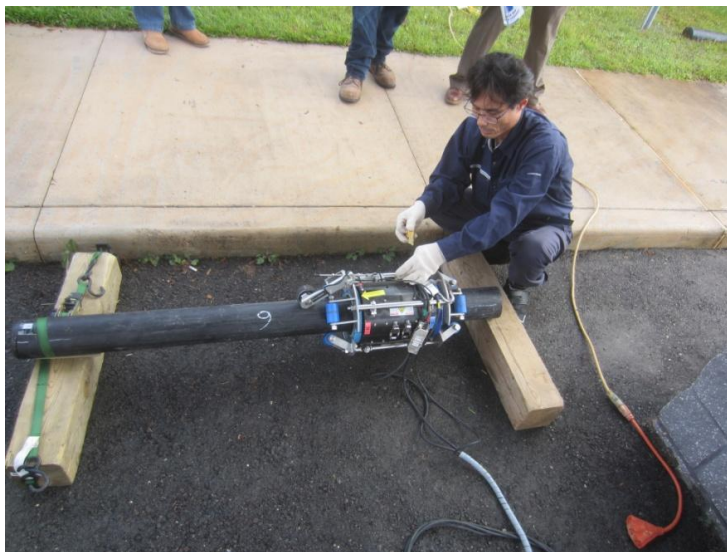
In order to ensure the accuracy and error-free condition of the MMFM systems, a half-day testing was performed for calibration and system check at the FDOT Manatee Operations Center in Bradenton, FL on February 5, 2018. For this testing, two 5-ft PT tendon samples retrieved from the Ringling Bridge were provided by FDOT. Since these tendon samples are identical to in-service tendons, they were considered the ideal specimens for calibration. Figure 11 shows the testing setup for tendon sample #1.

Figure 11. Calibration setup for tendon sample #1.

The calibration work was performed by introducing four levels of damage into 22 of 0.6-inch 7-wire strands (total 154 wires) in the tendon. The artificial damage simulating corrosion-induced section loss was created by removing 1, 7, 14, and 21 wire segments sequentially using an angle grinder. The average length of the removed wires was 6 inches. Although the center wire is slightly larger than the outer ones, a rough estimation was made by treating two wire types the same. From this, the removed wires were equivalent to 0.6, 4.5, 9.1, and 13.6 percent section loss, respectively.

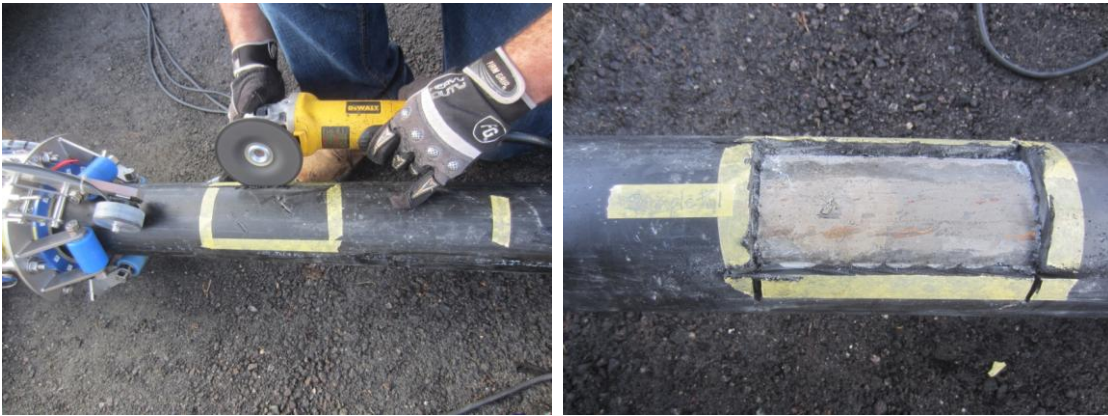
Figure 12 shows a 6 x 3 inches cut-out area in preparation of the artificial damage. Center of the cut-out area was 27 inches away from one end of the sample.

Figure 12. Making a 6 x 3 inches duct opening (left) and as-exposed grout condition (right).

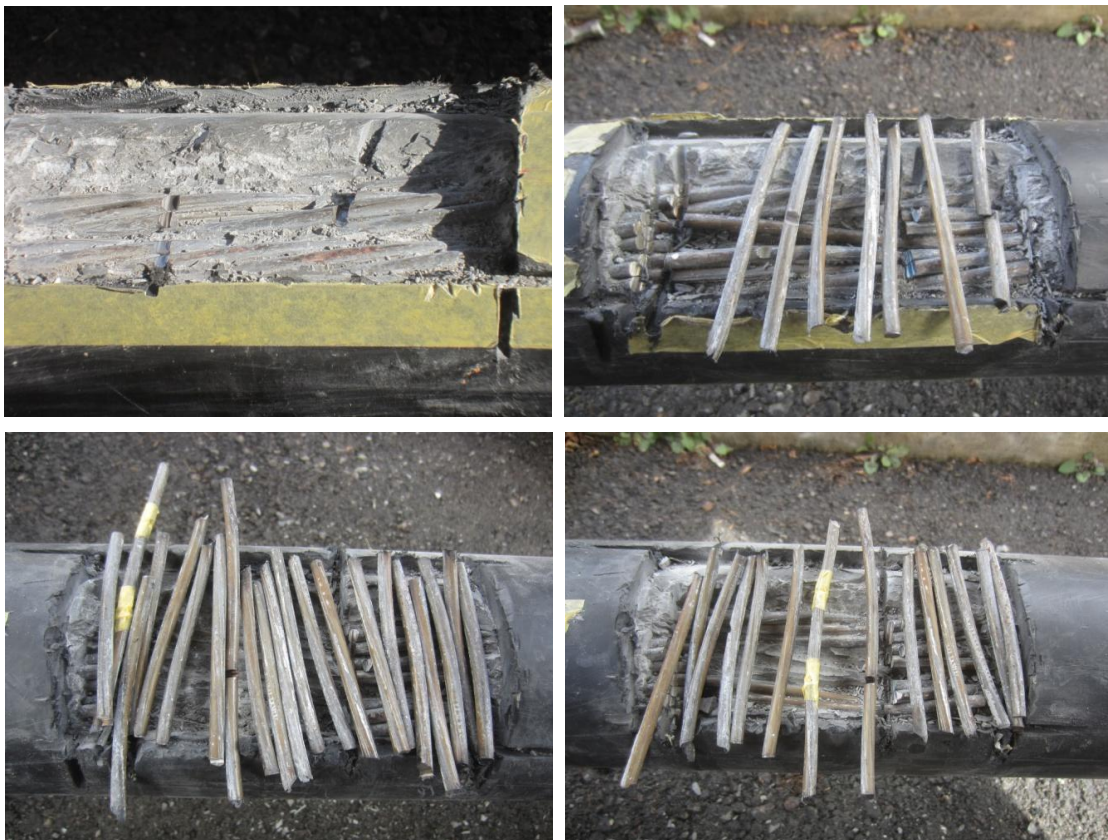
Figure 13 shows removed wires during the calibration work.

Figure 13. Removed wires for 0.6, 4.5, 9.1, and 13.6 percent section losses (clockwise from top left).

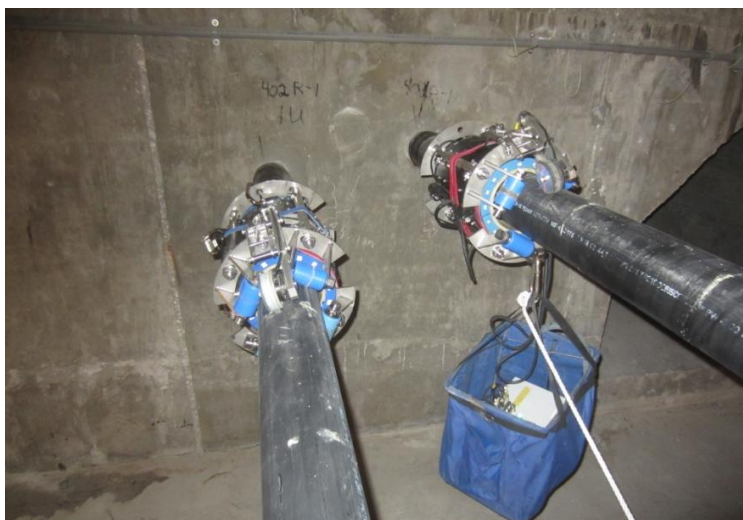
TRM prepared two MMFM systems to expedite the field testing. Figure 14 and Figure 15 show two complete MMFM systems and two magnetizers installed side by side on adjacent 4-inch external PT tendons on the bridge, respectively.

Figure 15. Two permanent magnet type MMFM magnetizers installed on PT tendons.

During the scan measurement, the controllers were carried in cloth baskets that were attached to the magnetizers. This arrangement is also shown in Figure 15.

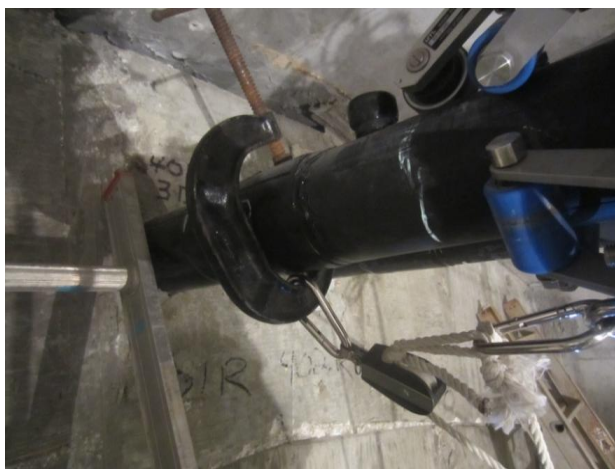
As shown in Figure 25, a steel clamp was attached to the highest point of an inclined section and a pulley was attached to the clamp. For every high elevation horizontal section, one more set of a clamp and a pulley was installed at the other end of the section.

Figure 25. Installing a steel clamp and a pulley.

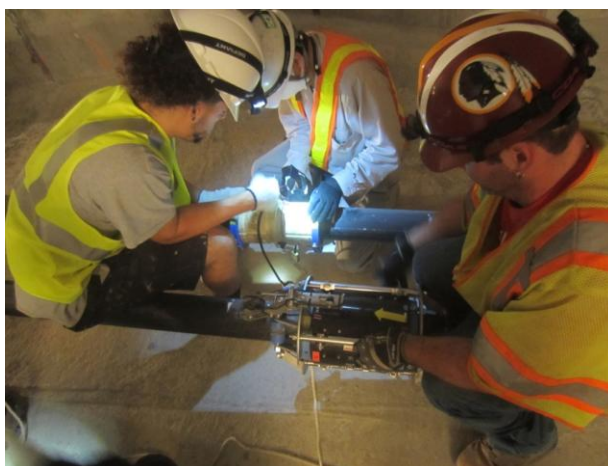
The sensor holder and the steel outer shell were installed on the tendon section. For the inclined section, this work was done at a low elevation for a better work environment. Figure 26 shows a sensor holder installation for the first magnetizer and a steel outer shell for the second magnetizer.

Figure 26. Installation of two magnetizers on the inclined sections at low elevation.

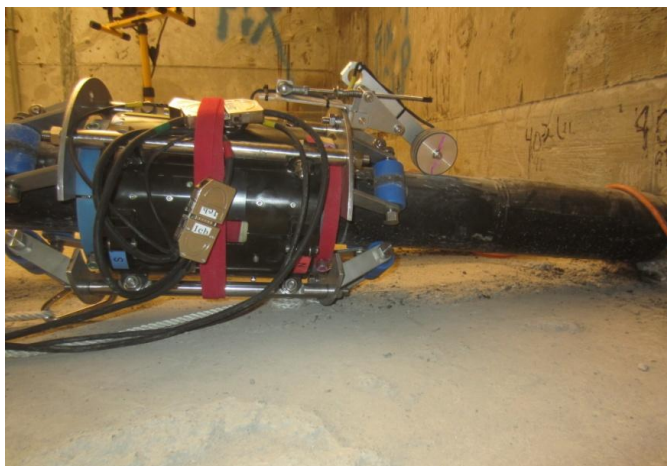
Two problems were encountered during the field testing. The first problem was related to the extended dead zone (untestable area) created by lack of clearance between the magnetizer and the inclined test section end. Figure 31 shows one of these situations.

Figure 31. A dead zone near the end of an inclined test section.

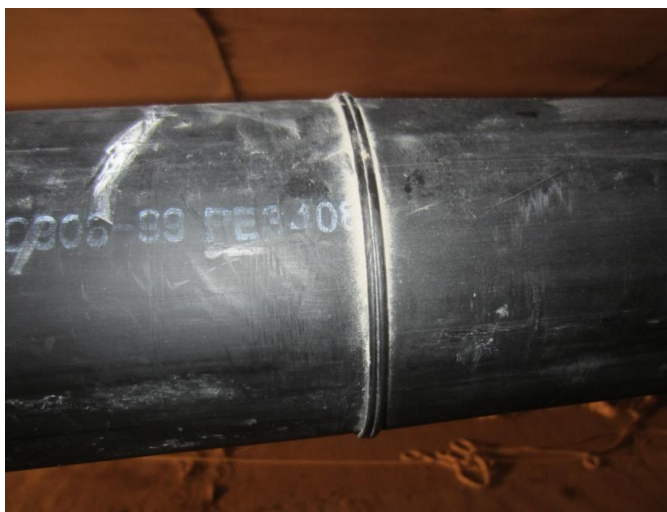
The second problem was extruded welding butt joints over the HDPE duct. One example is shown in Figure 32. Such a surface irregularity caused the magnetizer to jump and resulted in data disturbance in the waveforms.

Figure 32. Extruded HDPE welding joint.

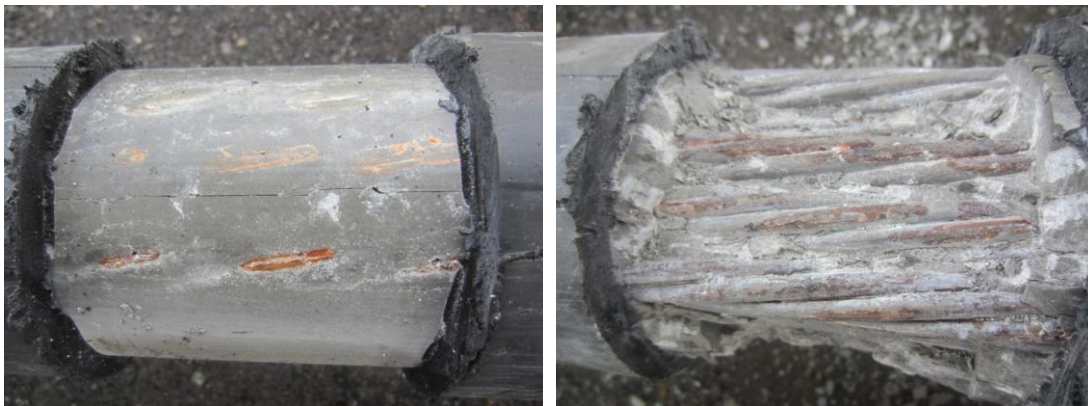
Upon reviewing the data, a 6-inch duct section was removed at the Manatee Operation Center to reveal the suspected area of damage. Figure 44 and Figure 45 show the exposed conditions soon after the duct was removed. When grout was partially removed, corrosion was apparent on the bottom side (Figure 45) compared to minor corrosion appeared on the top side (Figure 44). Even though 0.3 percent section loss is insignificant for naked eyes, none of the exposed strands appeared to contain the recognizable damage.

Figure 45. Back face of the suspected damage area as exposed (left) and after grout layer was partially removed (right).

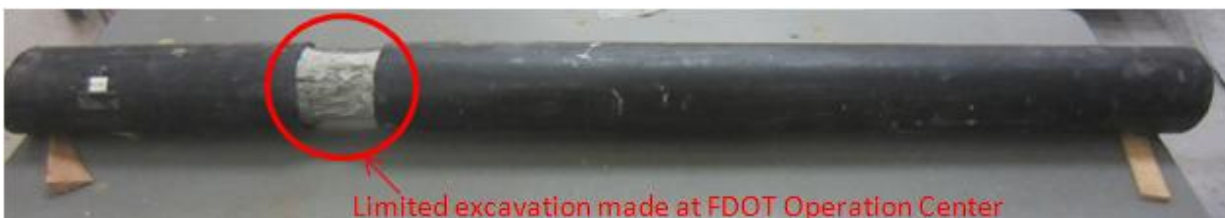
A further autopsy was performed in the laboratory to document strand condition after the entire sample #2 was dismantled. Figure 46 and Figure 47 show the sample condition before and after a full autopsy was performed, respectively.

Figure 46. Tendon sample #2 before full autopsy.

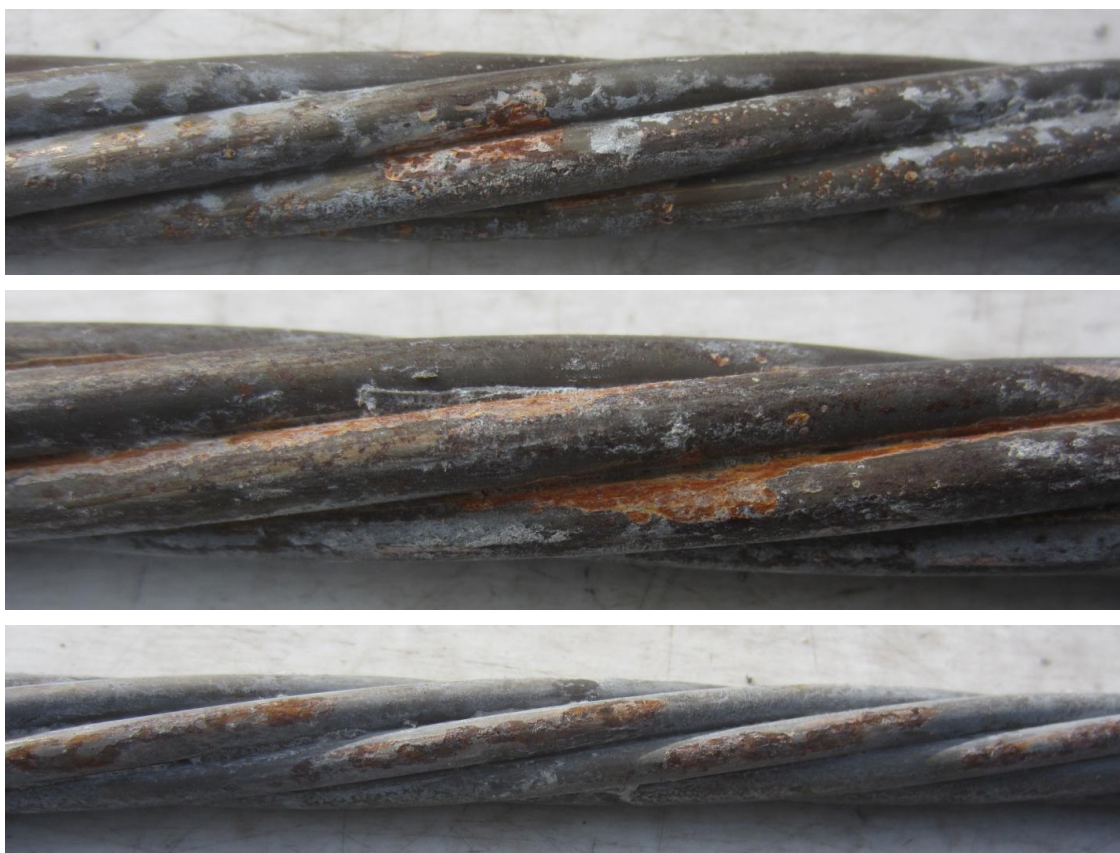
Figure 48 shows three strands that appeared to be in the worst condition. When they were cleaned with a scrubbing pad, superficial corrosion was revealed.

Figure 48. Representative conditions of rusted strands.

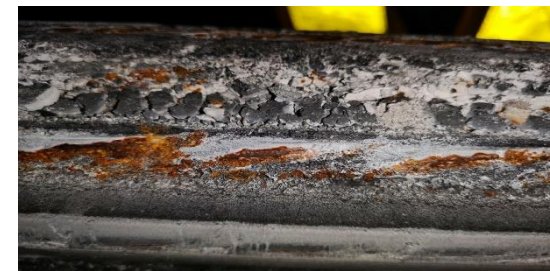
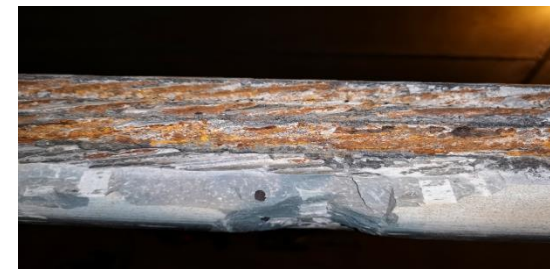
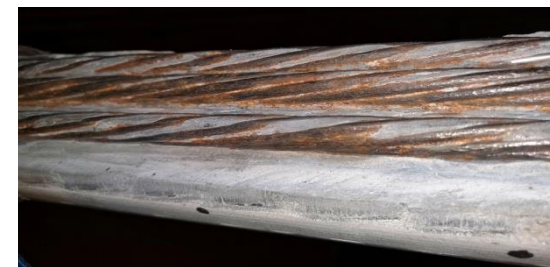
File Name 【Pier-Tendon-Section】	Section Total Length(m)	Scanned Length		Note			
		Starting Point(m)	Ending Point(m)				
P8-403R-H1	9.3	0.45	8.55	Starting point of damage1 : 2.68m			
Identified damage 1				Identified damage 2			
Max Loss Point(m)	Section Loss (%)	Damage Length(m)	Damage Orientation	Max Loss Point(m)	Section Loss (%)	Damage Length(m)	Damage Orientation
3.0	1.5	0.80	10~12 o'clock

- TR Test Result: Approx. 1.5% section loss signal
- Verification Result: Corrosion found

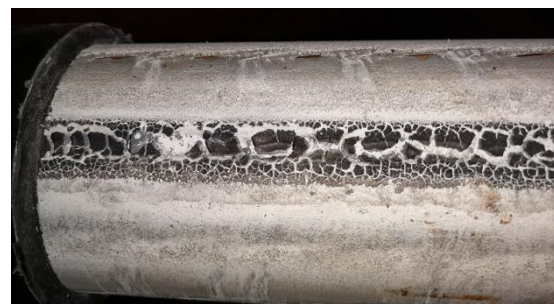
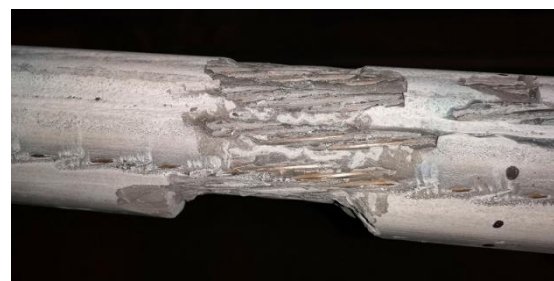
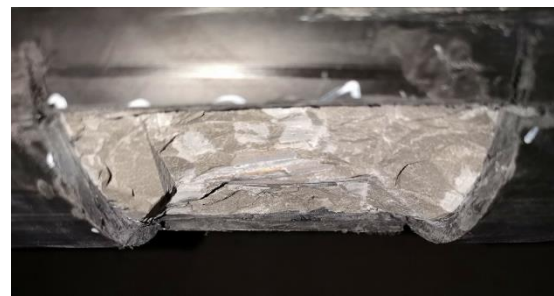
File Name 【Pier-Tendon-Section】	Section Total Length(m)	Scanned Length		Note			
		Starting Point(m)	Ending Point(m)				
P9-406L-II	21.5	0.45	20.77	Joint position : 12.2m Starting point of damage1 : 3.2m Starting point of damage2 : 15.9m			
Identified damage 1				Identified damage 2			
Max Loss Point(m)	Section Loss (%)	Damage Length(m)	Damage Orientation	Max Loss Point(m)	Section Loss (%)	Damage Length(m)	Damage Orientation
3.9	1.4	1.08	2~4 o'clock	16.5	1.2	0.71	12~3 o'clock

- TR Test Result: Approx. 1.4% section loss signal
- Verification Result: Irregular strand position observed but no corrosion found

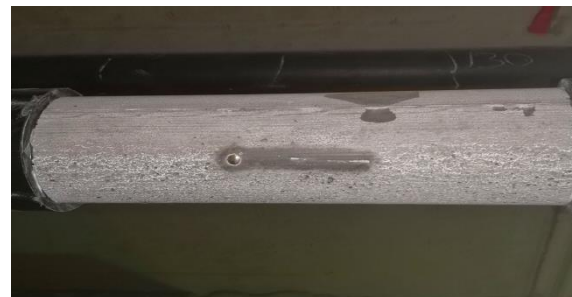
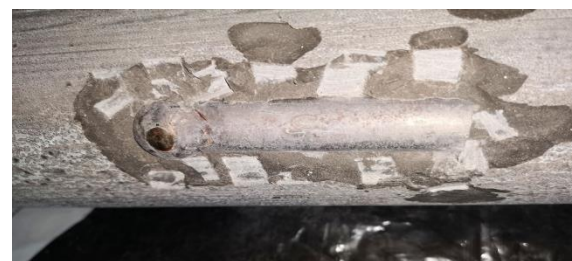
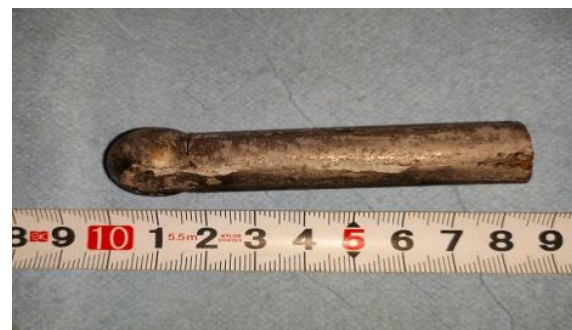
File Name 【Pier-Tendon-Section】	Section Total Length(m)	Scanned Length		Note			
		Starting Point(m)	Ending Point(m)				
P5-303L-I4	9.55	0.26	8.57	Identified damage 1 : Increase of change of magnetic flux Starting point of damage : 5.72m			
Identified damage 1				Identified damage 2			
Max Loss Point(m)	Section Loss (%)	Damage Length(m)	Damage Orientation	Max Loss Point(m)	Section Loss (%)	Damage Length(m)	Damage Orientation
5.8	-2.2	0.16	4~7 o'clock

Site 4 P5-303L-I4

- TR Test Result: Approx. 2.2% section increase signal
- Verification Result: Metal object found in the grout (see photos below)

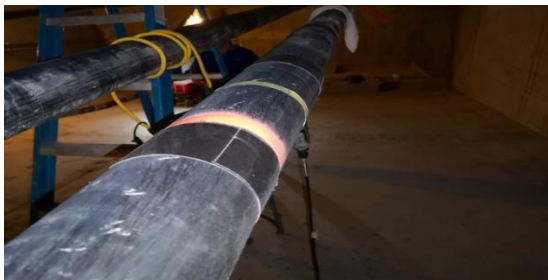
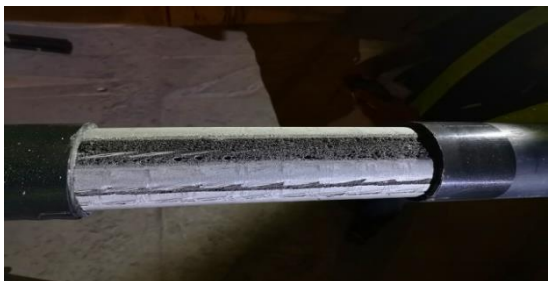
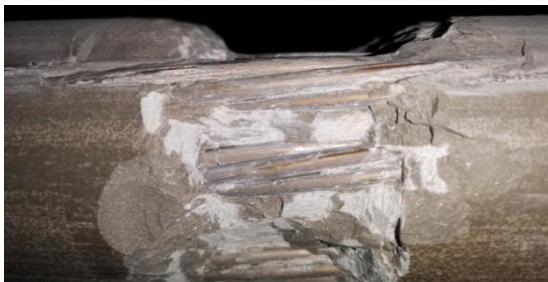
File Name 【Pier-Tendon-Section】	Section Total Length(m)	Scanned Length		Note			
		Starting Point(m)	Ending Point(m)				
P2-402L-II	21.37	0.59	20.68	Joint position : 12.3m Starting point of damage1 : 7.15m			
Identified damage 1				Identified damage 2			
Max Loss Point(m)	Section Loss (%)	Damage Length(m)	Damage Orientation	Max Loss Point(m)	Section Loss (%)	Damage Length(m)	Damage Orientation
8.2	2.4	1.78	6~8 o'clock

Site 5 P2-402L-I1

- TR Test Result: Approx. 2.4% section loss signal
 - Verification Result: No corrosion observed on the surface of the PC Strand
 - To analyze the result, we have compared with the signal of Site 1
- Comparison of the signals (Green line shows where opened 1ft for verification)

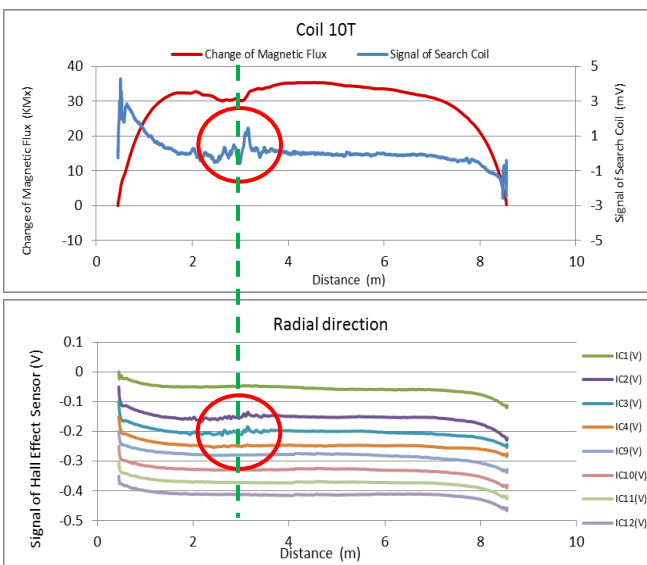
Site 1 P8-403R-H1 Signal

- Comparison of the signals (Green line shows where opened 1ft for verification)

- Comparing the 2 Signals of Site 1 and Site 2 (above), change of Magnet Flux (shown in red line) are similar, however short frequency wave on the signal of Search Coil (shown in blue line) is visible where the corrosion existed in Site 1, while there are no wave visible on the signal of Search Coil in Site 2.
- Also the Signals of Hall Effect Sensor showed wave in Site 1, while no wave were observed in the Signals of Hall Effect Sensor (V) on Site 2.
- From this observation, we can conclude that there is a possibility of corrosion loss when both Search Coil and the Hall Effect Sensor shows waves on the signals, however, Search Coil signals without the waves from the Hall Effect Sensor will likely be the other reason than corrosion.

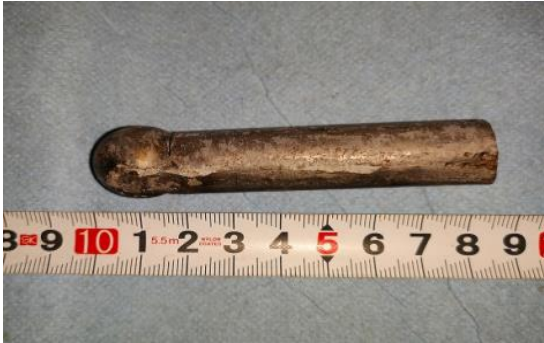
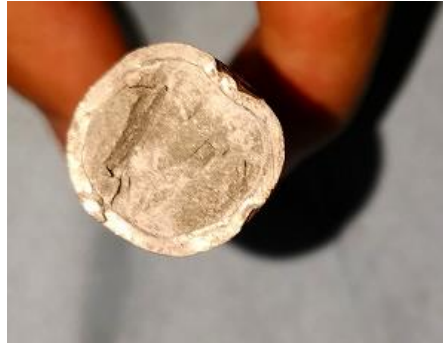
Metallic object found in grout

- Metal object was found and extracted from the grout as shown in the photos.
- The measurement of the object was equal to approx. 2.7% of the total area of PC Strands, which is close to the signal (2.2%) observed in the testing.
- We have observed 21 locations of similar section increase within 221 locations tested in February.

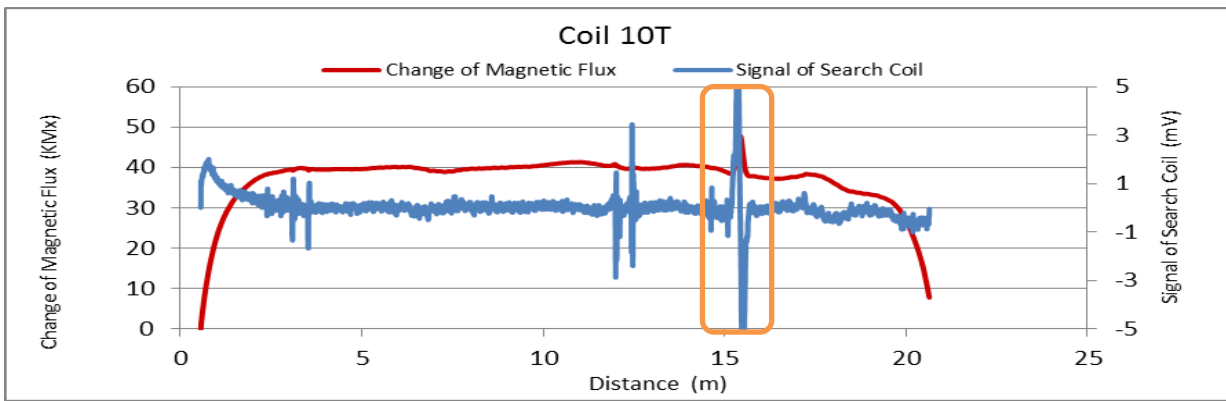
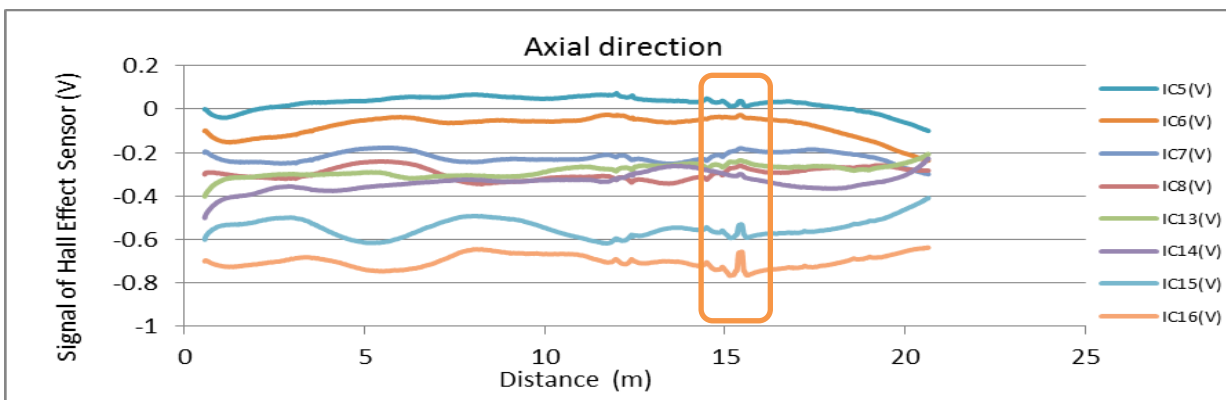
File Name 【Pier-Tendon-Section】	Section Total Length (m)	Scanned Length		Note			
		Starting Point (m)	Ending Point (m)				
P2-401R-II	21.43	0.56	20.64	Joint position : 12.2 m Identified damage 1 : Increase of magnetic flux Starting point of damage 1 : 15.33 m			
Identified Damage 1				Identified Damage 2			
Max Loss Point (m)	Loss (%)	Length (m)	Damage Orientation	Max Loss Point (m)	Loss (%)	Length (m)	Damage Orientation
15.4	-3.8	0.17	8~12 o'clock	—	—	—	—
