JOINT TRANSPORTATION RESEARCH PROGRAM

Pack Rust: Mitigation Strategy Effectiveness

Edgar Oscary Soriano Somarriba & Mark D. Bowman

17. Key Words pack rust, crevice corrosion, bridges, splice connections, repair methods, coatings, caulking, penetrating sealers		18. Distribution Statement No restrictions. This document is available through the National Technical Information Service, Springfield, VA 22161.

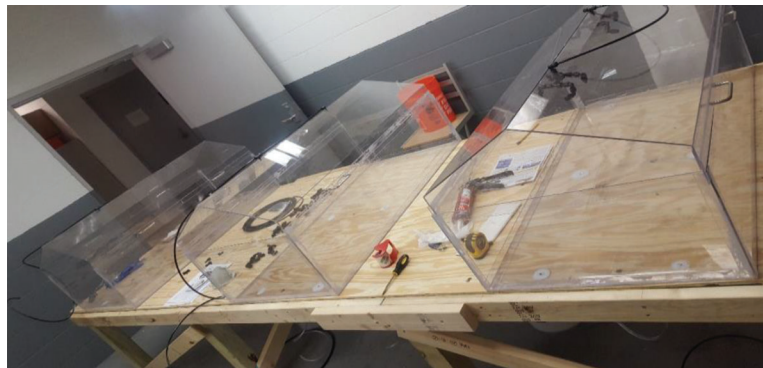
Figure 4.3 Lexan boxes.

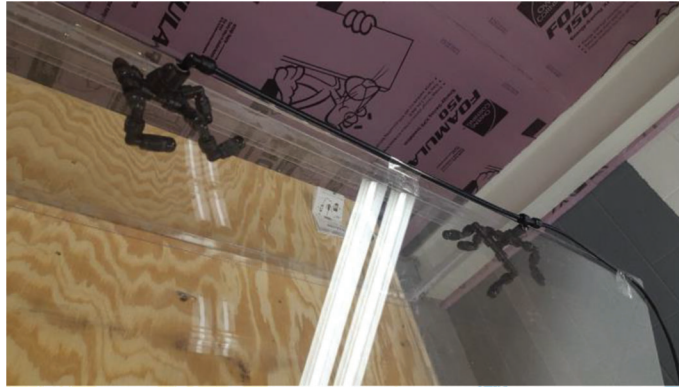
Figure 4.4 Roof of Lexan boxes holding the atomizers.

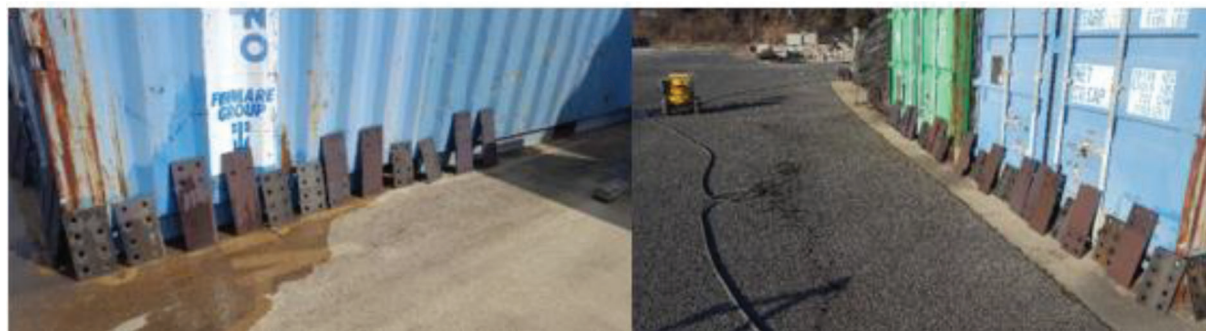
Figure 4.10 Plate's dirt removal with a 3,800-psi pressure washer.

1. In order to remove the dust and mill scale in a more time efficient way, the plates were pressured washed at 3,800 psi. They were placed in a vertical position to let the water run downwards and avoid puddles of water. Figure 4.10 shows a number of middle plates and splice plates being pressure washed. The pressure wand was at a distance of 6–12 inches from the plate and the angle of the nozzle was 15 degrees.
2. After the plates dried, Klean Strip Acetone was applied with rags to remove paint stains, remaining dirt, rust

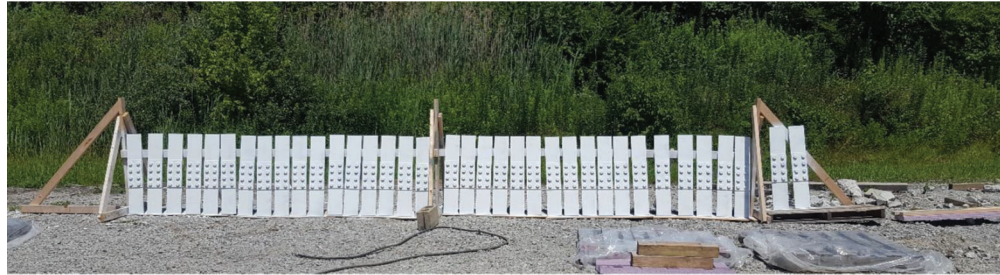
Figure 4.12 Application of epoxy layer.

2. After measuring the thicknesses, the plates were assembled, and the bolts were tightened using the Turn-of-Nut bolting method.
3. Approximately, 4 mils of epoxy were applied on the splice connections except on the areas covered with tape to avoid coating seeping into the gap. This coating was applied with a brush. Similar to the primer, this layer was allowed to cure and dry for 1 day before measuring the dry film thickness. A photograph of the specimens with the epoxy intermediate coat after application is shown in Figure 4.12.
4. Finally, approximately 3 mils of polyurethane were applied with a brush on the splice specimens except on the gap areas covered with tape. Similarly, dry film thicknesses were measured after the layer dried. A photograph of the specimens with the polyurethane topcoat layer after application is shown in Figure 4.13.

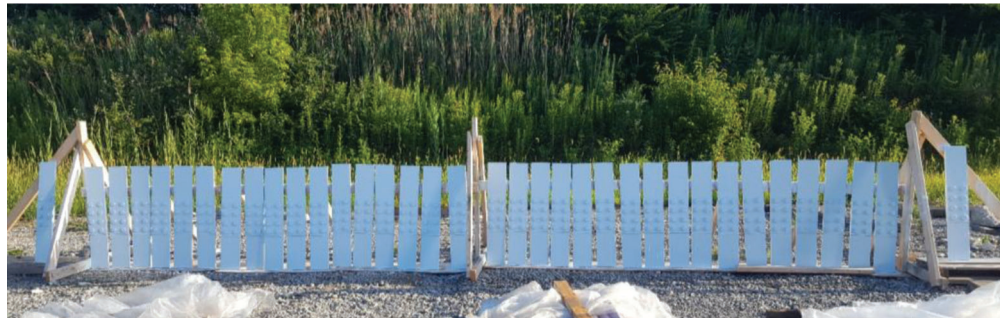
Figure 4.13 Application of polyurethane layer.

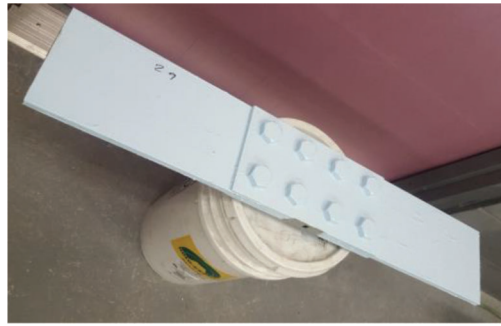
Figure 4.14 Final coated specimen.

Figure 4.14 shows the final product after the application of the coating system. Moreover, the area

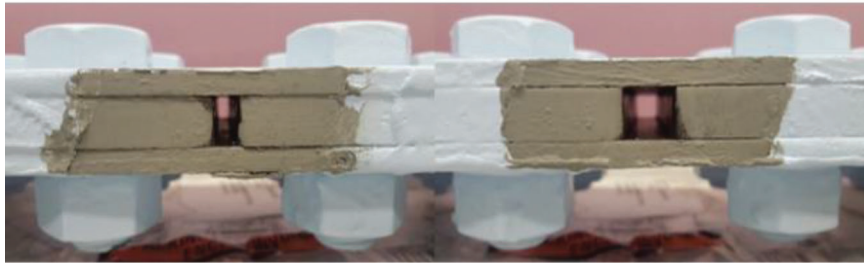
Figure 4.15 Close up image of the 1/4-inch gap specimen and 1/2-inch gap specimen.

outside the gap was only painted with zinc primer as shown in Figure 4.15. Removal of the tape, which was in place after specimen assembly to prevent any of the epoxy or polyurethane applications from coating the inside of the gap, resulted in some stripping off of the initial zinc primer coating. This region was touched up so that it only contained zinc primer. Table B.2 shows the coating thickness information for each one of the specimens.

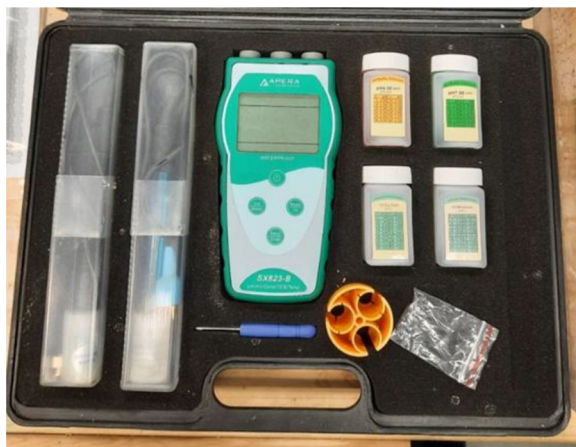
Figure 4.16 SX823-B portable multiparameter meter.

The standard specifies a pH range of 6.5 to 7.2 at a temperature of 95°F (35°C) for the salt solution collected after misting. The standards recommend checking the pH periodically with a maximum interval of 96 hours between measurements. In this project, pH levels were measured every 3 days with a SX823-B Portable Multiparameter meter from Apera Instruments (see Figure 4.16). This device is capable of measuring pH, electrical conductivity, total dissolved solids (TDS) and temperature.

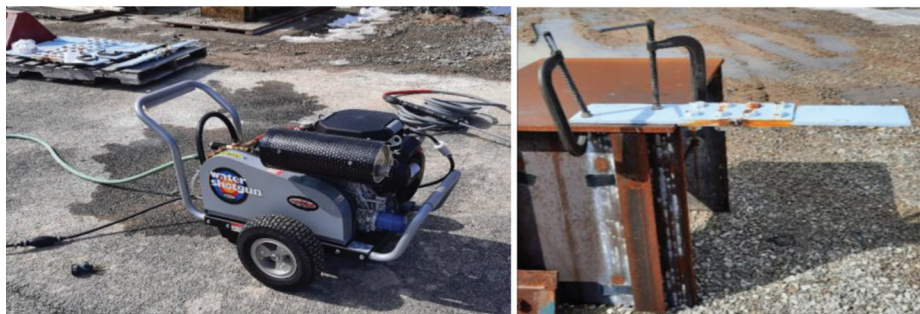
Figure 4.18 Pressure washer and pack rust removal set up.

The mitigating products were applied as *initial* on a specimen without corrosion or as *repair* on a specimen that had already reached a level of corrosion. Under the initial condition, no surface preparation was required prior to the application of the products. At the moment these specimens were treated, the surface of the plates was clean and free of any major contaminant. On the other hand, in order to repair the specimens with the mitigating products, removal of the pack rust, to the extent that is possible, was required. In accordance with Termarust Technologies, a minimum pressure of 5,000 psi using cold water is required to remove pack rust. A Simpson Water Shotgun professional pressure washer was used to remove the corrosion material at a standoff distance between 4 and 8 inches (see Figures 4.18 and 4.19). This procedure was also done for all the mitigation strategies. The only difference is that for Termarust, the specimens had to be pressure washed with a mix of water and Chlor*Rid at a ratio of 1:100.

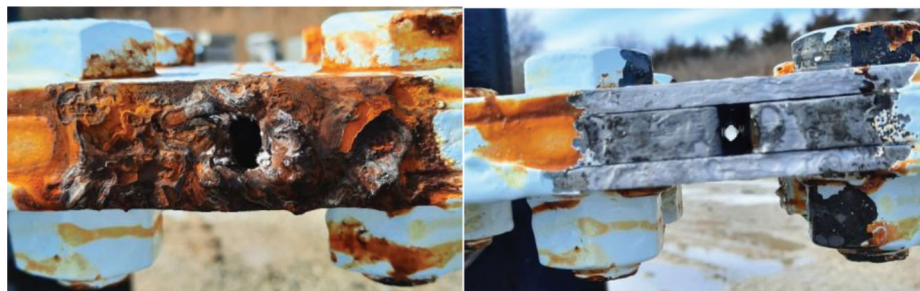
Figure 4.19 Surface and gap condition before and after pressure washing the connection.

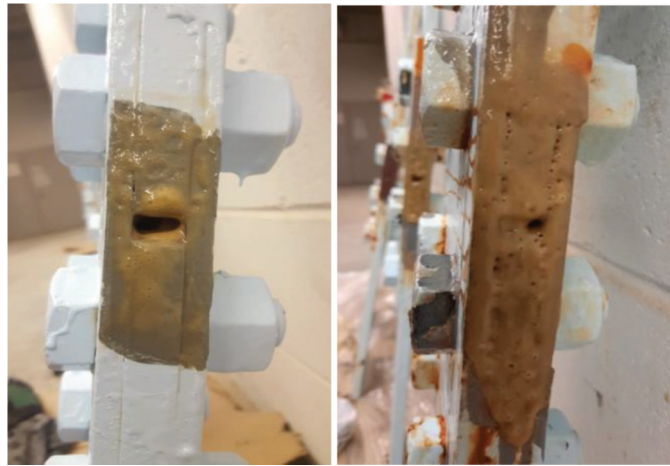
Figure 4.20 Fluid Film application for initial and repair condition.

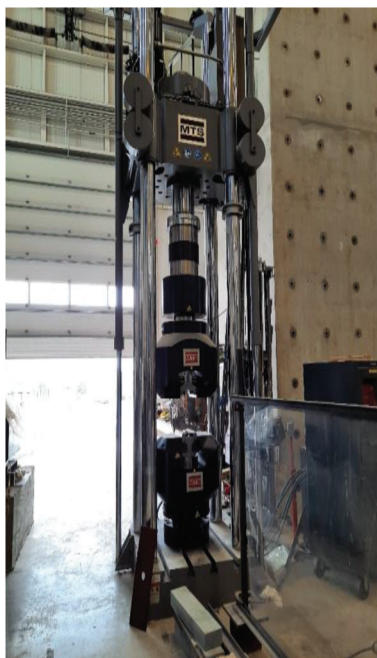
Figure 4.23 MTS machine used for strength testing.

tensile or pulling forces in the direction normal to the plates, which can lead to bolts coming off. For this test, a 700-kip MTS machine was used to pull the plates to failure (see Figure 4.23). The load rate for the load control portion of the test was 10 kip/min until a load of 80 kip was reached. After this, the test was switched to displacement control with a rate of 0.1 in/min. Two points of interest were obtained from the load vs. displacement plot: (1) load at slippage and (2) ultimate load. Load at slippage is the load at the early stages where significant displacement is observed at a nearly constant load (i.e., a continuous horizontal line in the plot). Finally, the ultimate load is the highest load reached by the structural element.

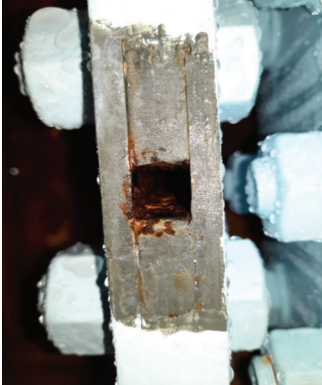
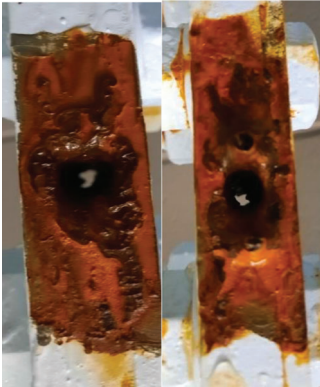
TABLE 5.4
Corrosion development for 1/2-inch gap specimens

Time of Exposure	Specimen 32
14 Days

1 Month

2 Months

Time of Exposure	Specimen 32
3 Months

4 Months

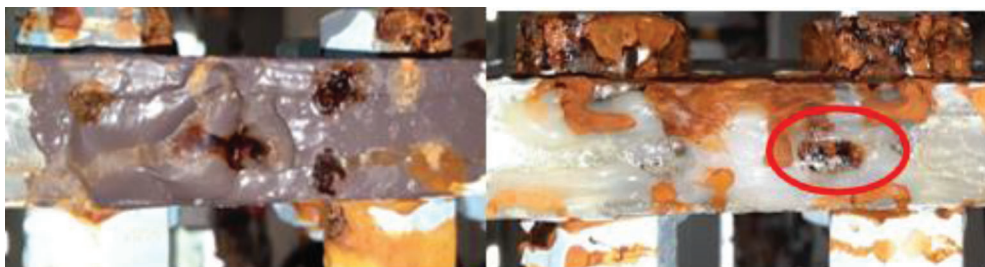
Figure 5.1 Black rust in Termarust (left) and caulked (right) specimens for Condition A.

For the first 30 days of Condition A repair, the Termarust topcoat was not affected by the corrosive environment while Fluid Film showed considerable surface corrosion. The caulked specimens showed surface corrosion around the caulk application area, but the caulk product itself did not show any signs of deterioration. At the end of the second repair cycle, Termarust specimens showed a few orangey spots near the plate interfaces. Also, black rust was leaking from the bottom end of the gap for one of the specimens (see Figure 5.1). This means that the topcoat was obstructing air from flowing through the gap. This problem is related to the viscosity of the topcoat and its difficulty to be applied in such a small space.

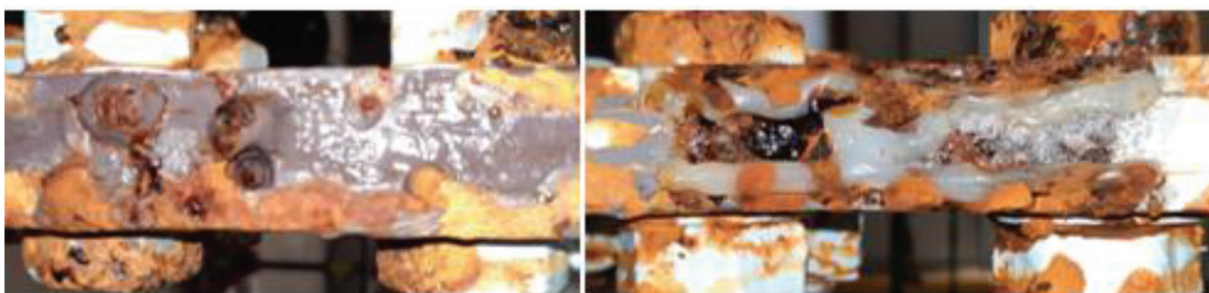
Figure 5.3 Black rust in Termarust (left) and caulked (right) specimens for Condition B.

The following paragraph provides some observations based on the cross-sectional photographs of the specimens. Table 5.8 shows the cross-section of the specimens that were repaired for Condition A and Condition B. Black rust staining is observed for the caulked specimens and the Termarust specimens (see Figure 5.3). For the caulked specimens, the formation of black rust is caused by sealing the gap at the ends. During repair, the corrosion products were removed by means of pressure washing. Nonetheless, 100% rust material removal is not guaranteed during this step. Consequently, the remaining rust plus the action of sealing the gap is not a recommended step towards mitigating corrosion. For the Termarust specimens, the topcoat did not flow smoothly in the small, confined gap. Additionally, it was observed that at the moment strength tests took place, the topcoat inside the specimens was still wet despite the specimens being allowed to cure for 3 days. The clogging of the gap with the topcoat did not allow air to flow and dry the surfaces. Clogging the gap also allows black rust to form by restricting the air flow in that space. For the Fluid Film specimens, the action of the sacrificial wax is observed again (similar to the initially treated specimens) but concerns regarding its capability to bear more aggressive conditions rose. Likewise, black rust developed in these specimens, but in a moderate degree.

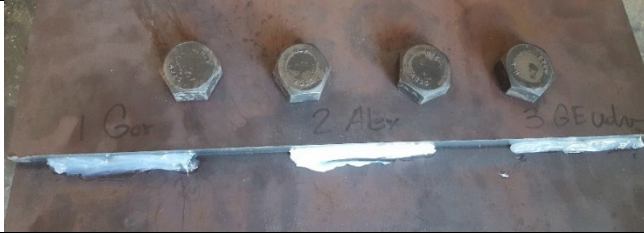
Caulking products are applied at the interface of the plate elements.
7 days

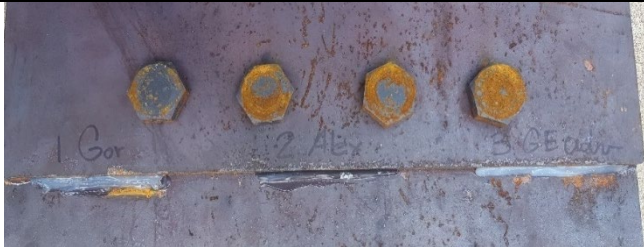
Gorilla and GE are in good shape. Alex Plus shrank a significant amount.
26 days

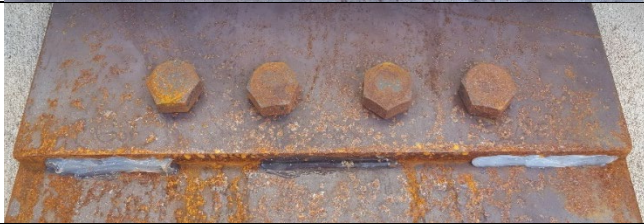
Gorilla and GE are in good shape. Alex Plus has vanished.
87 days

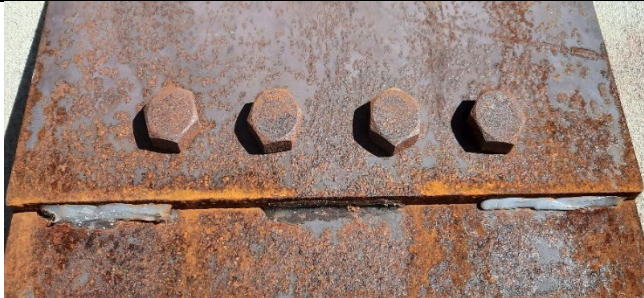
Gorilla showed some signs of discoloration, and lost adhesion in a corner. GE also lost adhesion in a corner.
