# JOINT TRANSPORTATION RESEARCH PROGRAM

## Synthesis Study: Repair and Durability of Fire-Damaged Prestressed Concrete Bridge Girders

**Tzu-Chun Tseng, Amit H. Varma**

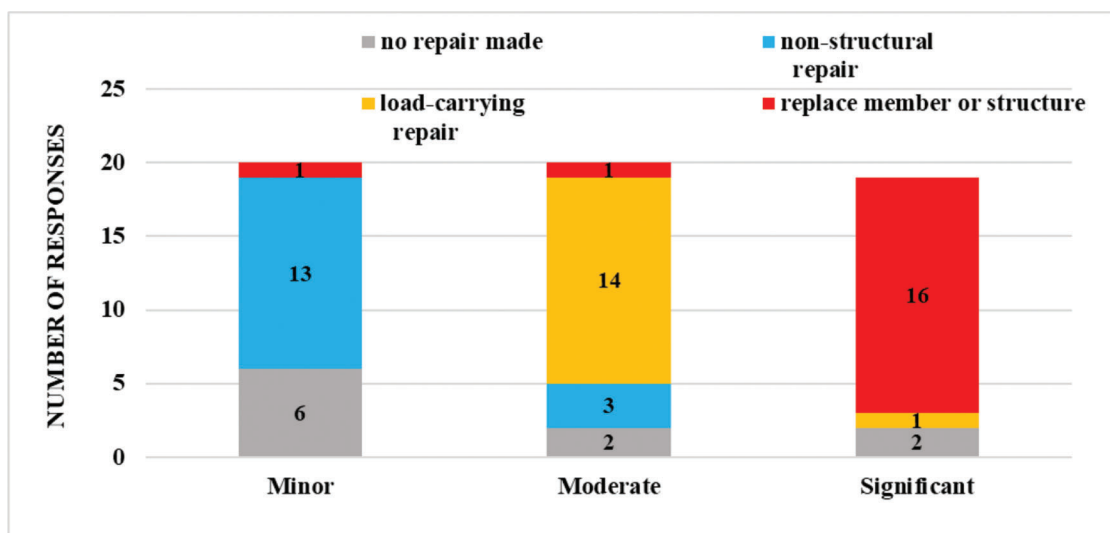
Figure 2.2 Results of Question 10.

In Q10 (Table 2.10), respondents reported their typical actions to repair/retrofit the prestressed concrete bridges subjected to various degrees of fire damage, and the results are presented in Figure 2.2. It is worth noting that respondents could select one or more answer choices in this question. It can be observed that 13 respondents (68%) stated that they would perform a non-structural repair to the concrete bridge with minor fire-caused damage. On the other hand, 14 respondents

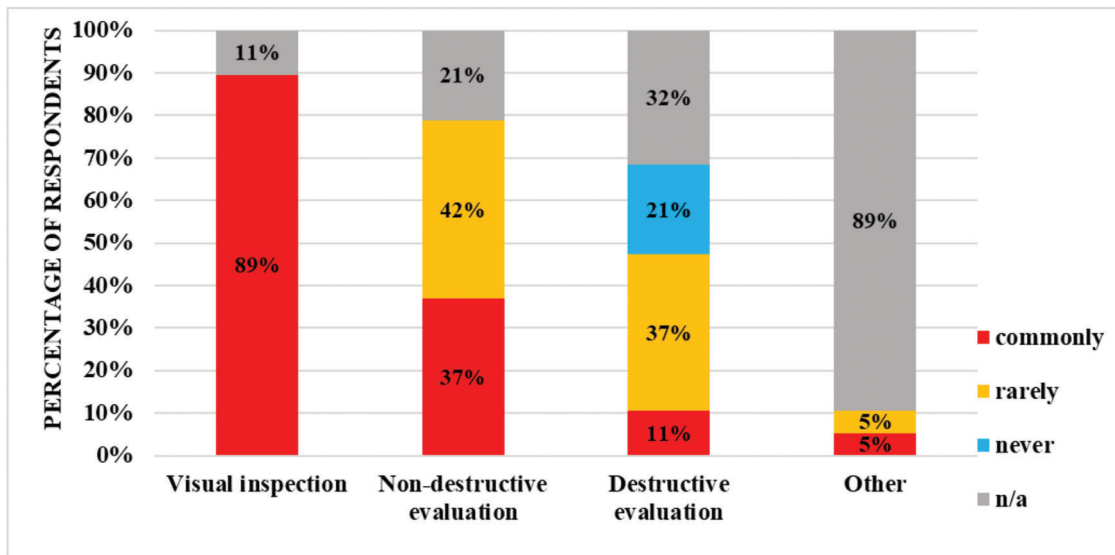
Figure 2.3 Results of Question 11.

In Q11 (Table 2.11), respondents were asked to indicate the typically adopted procedures for evaluating the extent of the damage if they determine to repair the fire-damaged concrete bridges. Moreover, respondents could provide their additional comments in Q12 (Table 2.12). Figure 2.3 summarizes the survey results for the Q11. Based on the survey result, most respondents selected visual inspection (89%) as their commonly used process to assess the damage condition. In contrast, non-destructive (37%) and destructive (11%) evaluation processes were checked by fewer respondents. In addition, based on the provided comments in Q12, concrete sounding seems to be a favored non-destructive technique to evaluate the extent of fire damage, which seven respondents suggested. However, respondents also stated that the sounding process might further damage the bridge element according to the area of fire damage.

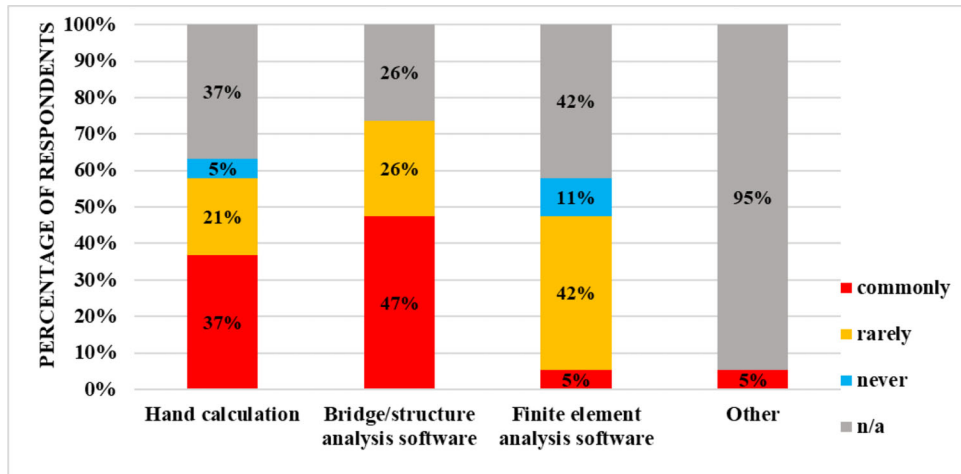
Figure 2.4 Results of Question 13.

In Q13 (Table 2.13), respondents were asked to answer the typically used analytical procedures to assess the fire-induced damage and the need to repair prestressed concrete bridges, and respondents could provide their additional comments in Q14 (Table 2.14). Figure 2.4 shows the survey results of this question. As shown, bridge/structure analysis software (47%) and hand calculation (37%) are two procedures commonly employed by the respondents. Moreover, the comments in Q14 demonstrate that different respondents typically use various types of analysis software (e.g., BrR, PGSuper, and Conspan). For the hand calculation, *AASHTO LRFD Bridge Design Specifications* and *ACI 440.2R-08* are two design specifications that respondents mentioned.

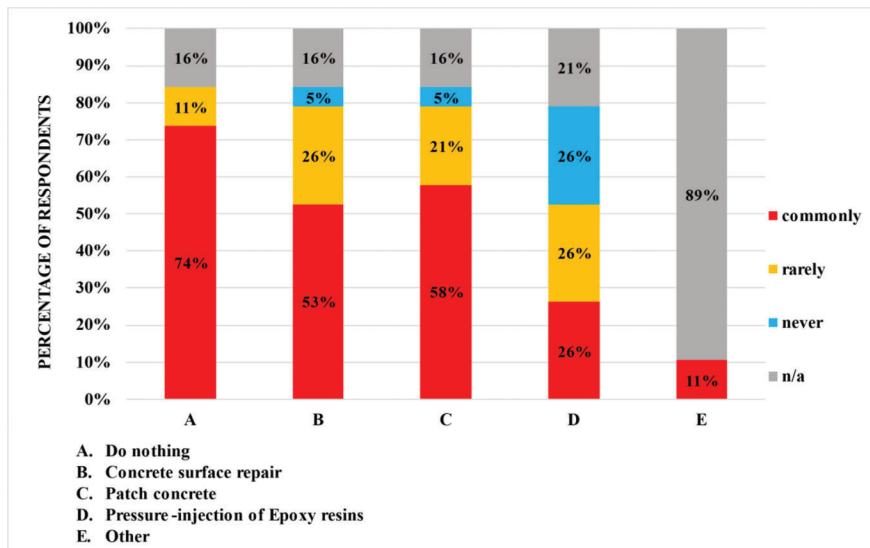
Figure 2.5 Results of Question 15.

Respondents provided their opinions/experiences regarding repairing prestressed concrete bridges with minor fire damage in Q15 (Table 2.15), and their additional comments are presented in Q16 (Table 2.16). The results are organized and shown in Figure 2.5. It is noticeable that the option “do nothing” is the most commonly used strategy in this case (74%). Moreover, more than half of respondents chose the patch concrete method (58%) and concrete surface repair method (53%) as preferred methods. On the other hand, pressure injection of epoxy resins is a relatively unpopular choice, and it was selected by 26% of respondents as a

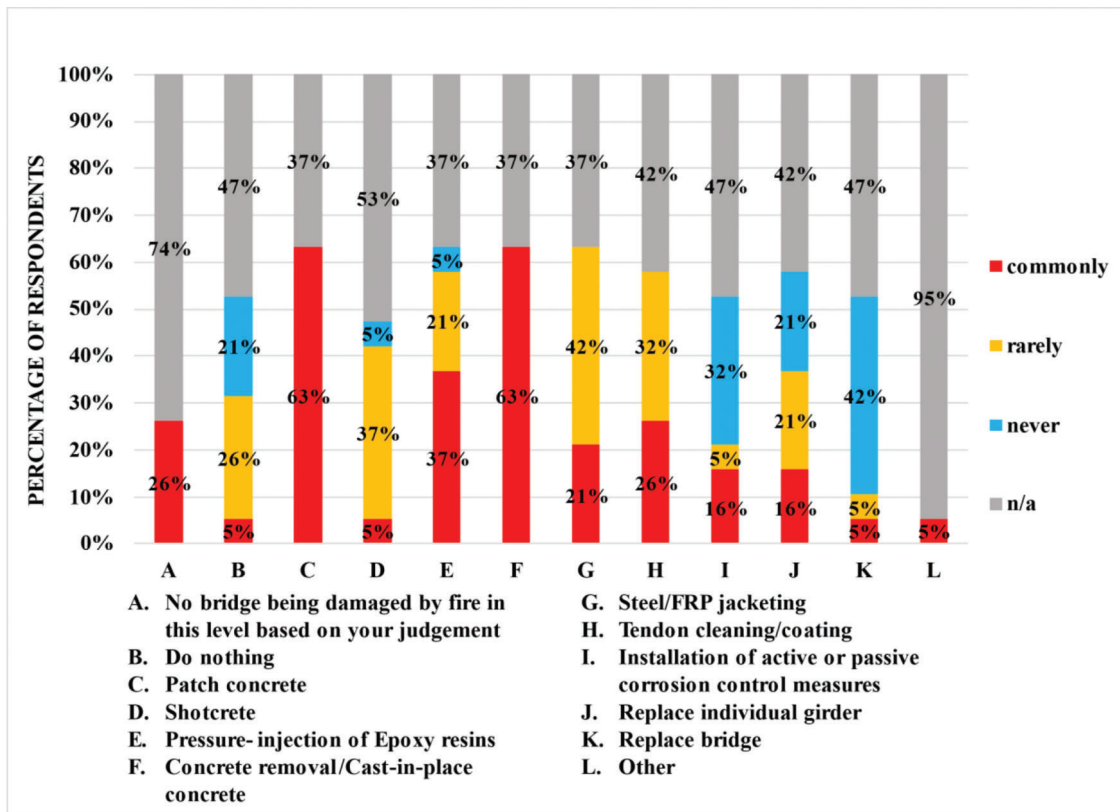
Figure 2.6 Results of Question 17.

of Q17 are displayed in Figure 2.6. Based on the received responses, the patch concrete method and concrete removal/cast-in-place concrete are suggested by most respondents (63%). Besides, pressure injection of epoxy resins (37%), tendon cleaning/coating (26%), and steel/FRP jacketing (21%) are three methods that were selected by more than 20% of respondents as their preferable repair methods in this scenario. It should be noted that, in this damage level, three respondents (Respondents 3, 10, and 17) claimed that they might replace the damaged bridge girders, and Respondent 3 indicated that the entire bridge might be replaced depending on the extent of the damage.

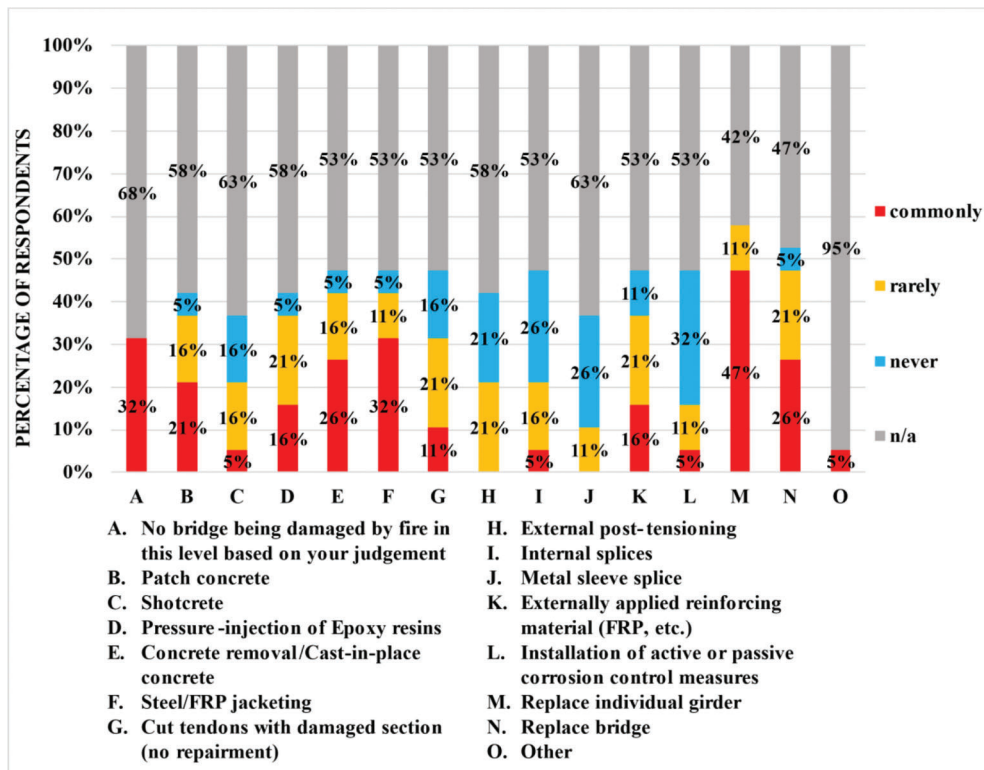
Figure 2.7 Results of Question 19.

In Q19 (Table 2.19), respondents indicated their decisions to deal with a prestressed concrete bridge sustained significant fire damage, and they could provide additional comments in Q20 (Table 2.20). The results of Q19 are demonstrated in Figure 2.7. In this case, 47% of respondents claimed that they would replace the fire-impacted bridge girder, and 26% of respondents pointed out that the whole bridge might need to be entirely reconstructed. Except for these two options, steel/FRP jacketing (32%), concrete removal/cast-in-place concrete (26%), and patch concrete method (21%)

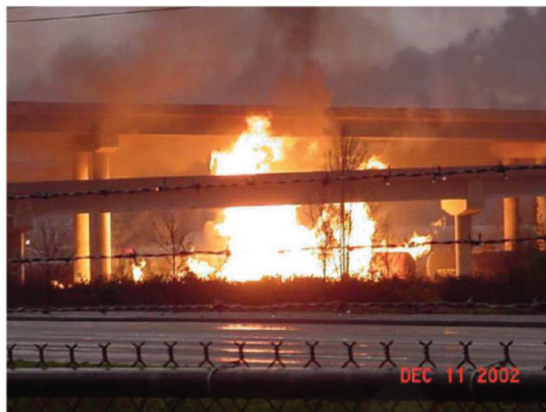
**Figure 3.1** Railroad tanker bridge fire in Washington State (Stoddard, 2004).

The first fire incident that was reviewed happened in 2002. A railroad tanker collision caused a fire under a prestressed concrete girder bridge. The incident was inspected by the Washington State Department of Transportation (WSDOT) and reported by Stoddard (2004). The bridge was constructed in 1997 with a span length of 146 ft. About 30,000 gallons of methanol was consumed during the fire. The fire engulfed one of the bridge spans for approximately 1 hour, as shown in Figure 3.1. After the fire, inspection and evaluation were performed to determine the damaged bridge's structural capacity. The author then investigated several potential repair strategies and provided a preferable solution for restoring the target bridge.

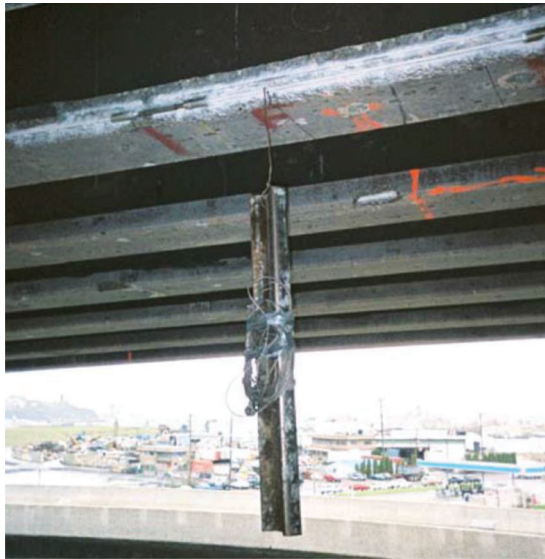
**Figure 3.5** Deflection test on exposed strand (Stoddard, 2004).

The test was performed before the exposed strands were cut off, a dead load was applied to the strand directly, and the deflection at the load point was measured to estimate the existing prestressing force. The setup of the deflection test is demonstrated in Figure 3.5. The calculated prestressing force suggests that the strands retained almost 100% of the original design force even surrounded by the hot concrete, indicating that the fire-induced reduction in the yield strength was not significant for the steel strands. After the deflection test, samples of steel strands in the burned region were removed to perform the material test in the laboratory. The samples were obtained from areas with different severities of the fire damage (the region away from the hot zone, the region directly above the fire, and the intermediate region). The tested samples' ultimate tensile strength and elastic modulus are greater than 280 ksi and 26,190 ksi, respectively. The results show that the steel strand's mechanical properties (strength and modulus of elasticity) were not affected significantly by the fire and can still meet the

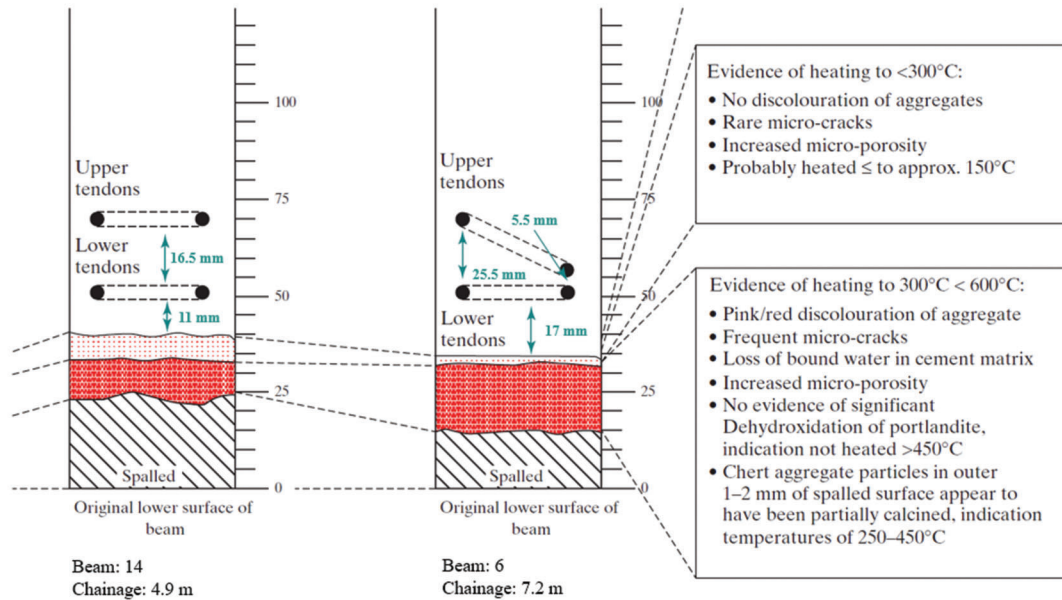
**Figure 3.10** Petrographic examination results (de Melo et al., 2014).

the damaged prestressed concrete girder. The material test results (petrographic examination) indicated that the maximum concrete surface temperature might have reached 1,112°F (600°C) and the internal concrete temperature near the exposed surfaces mostly ranged from 572°F to 1,112°F (300°C to 600°C). Figure 3.10 presents the result of the material tests from concrete samples taken from the two different fire-damaged girders. It can be observed that the severe concrete damages (experienced temperature higher than 572°F (300°C)) occurred from the exposed surfaces to the depth of approximately 1.26 inches (32 mm) for the prestressed girders. Furthermore, the material test results also stated that the experienced temperatures for most prestressing strands were not higher than 572°F (300°C) since the bottom strands were located at a depth of 1.97 inches (50 mm) from the bridge girder's bottom. Most of the steel components were still encased by concrete heated to less than 572°F (300°C) (although parts of the strands and reinforcements were exposed after the fire).

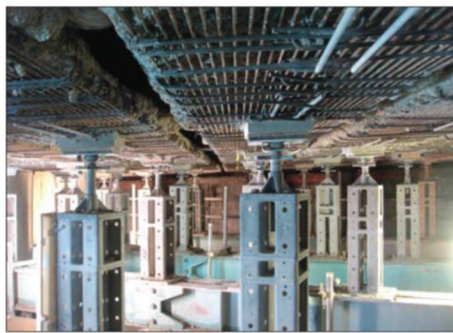
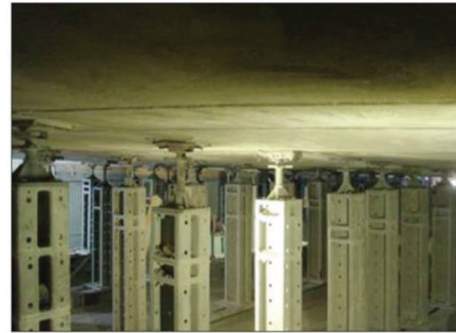
(a) Soffit before Repairing

(b) Soffit after Repairing

Figure 3.12 Restoration of bridge soffit (de Melo et al., 2014).

were used to restore the damaged area. In addition, extra steel reinforcements were also installed to tie the new steel meshes and old steel stirrups. Therefore, additional concrete covers were constructed to provide adequate protection to the extra steel refinements (the darker gray area in the plot). Figures 3.12(a) and (b) illustrate the bridge soffit before and after the restoration. It can be seen that, during the repair process, temporary supports are necessary to be used because the removal of the damaged concrete could decrease the bridge's structural capacity and lead to severe safety concerns.
