Strengthening of Existing Inverted-T Bent Caps— Volume 2: Experimental Test Program

Technical Report 0-6893-R1-Vol2

TEXAS A&M TRANSPORTATION INSTITUTE
COLLEGE STATION, TEXAS

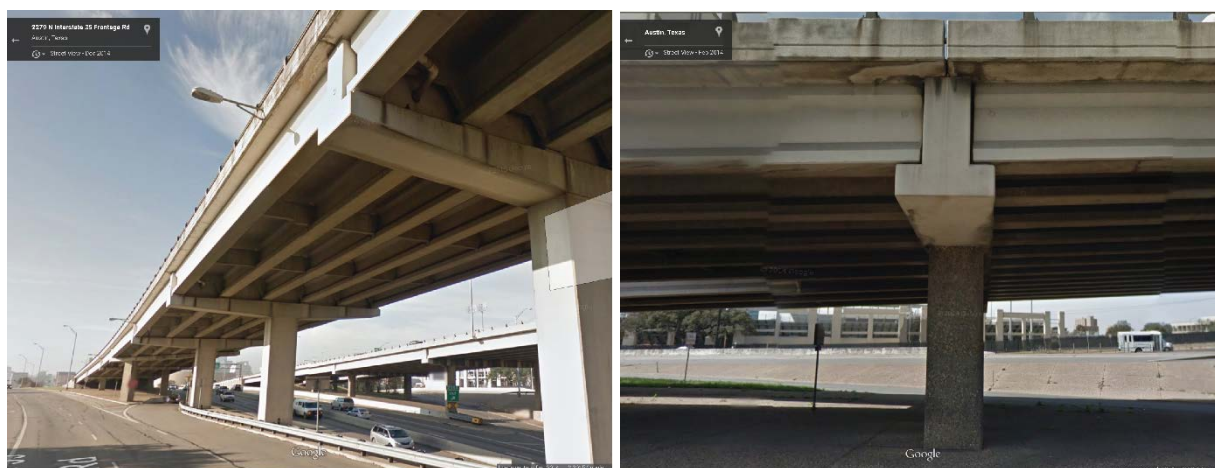
Inverted-T bent caps have been widely used in Texas to maximize the clearance beneath the bridge deck and to provide an aesthetically pleasing substructure alternative. Figure 1.1 shows inverted-T bent caps that are part of the substructure supporting the upper deck of IH 35 in downtown Austin. The loads from the girders are applied to the ledges at the bottom of the inverted-T section and transferred to the web through the stirrups that serve as hangers. The bottom flange (ledge) must have sufficient transverse and punching shear capacity to enable the transfer of applied loads to the web.

Figure 1.1. Inverted-T Bent Cap in Downtown Austin.

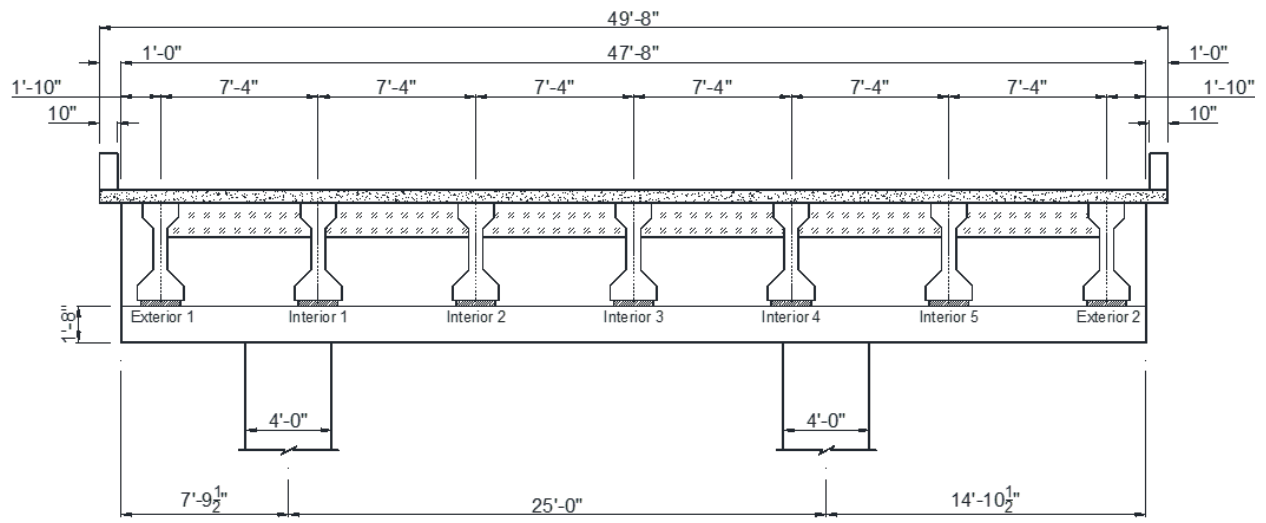
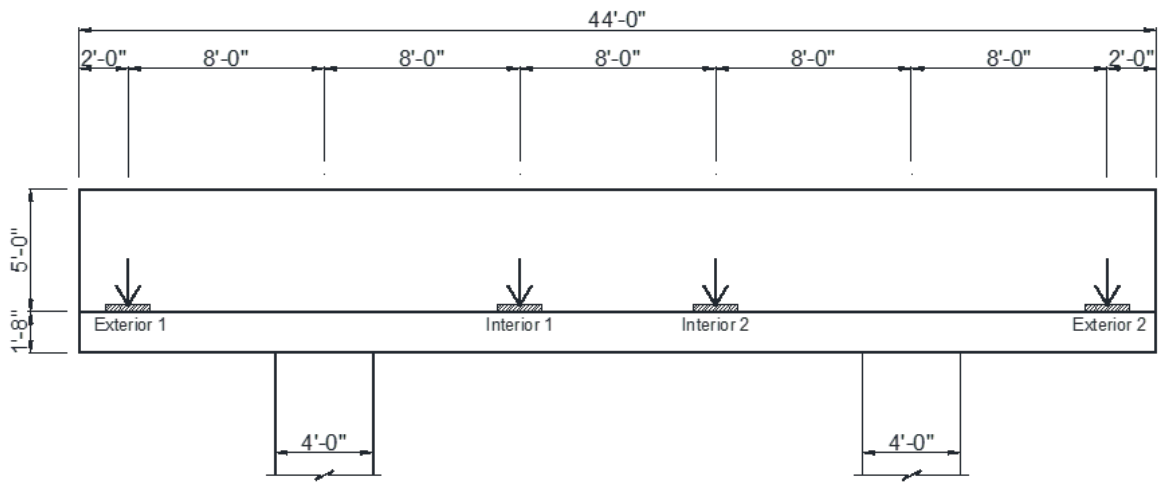
(a) Bent 13

(b) Full-scale prototype

Figure 2.1. Geometry of Inverted-T Bent Caps for Design of Specimens.

A full-scale prototype was adapted from Bent 13 with geometry altered slightly to account for laboratory constraints. Figure 2.1 provides a comparison of Bent 13 and the full-scale prototype structure geometry. Both structures have an average girder span of 115 ft.

The prototype structure included identical overhang lengths to provide consistency amongst test specimens. The overall prototype height was slightly reduced to accommodate clearance limits for the half-scale tests. Girders directly above the columns in Bent 13 were excluded from the prototype. Exterior girder locations were increased 2 in. from the edge of the bent cap, and interior girder spacing was increased 6 in. based on laboratory tie-down constraints. A consistent spacing of reinforcement was used in the prototype structure. A half-scale prototype was then defined with geometry equal to one-half that of the full-scale prototype. The bearing pad dimensions were 8 in. by 21 in. for the full-scale prototype and 5 in. by 12 in. for the half-scale prototype.

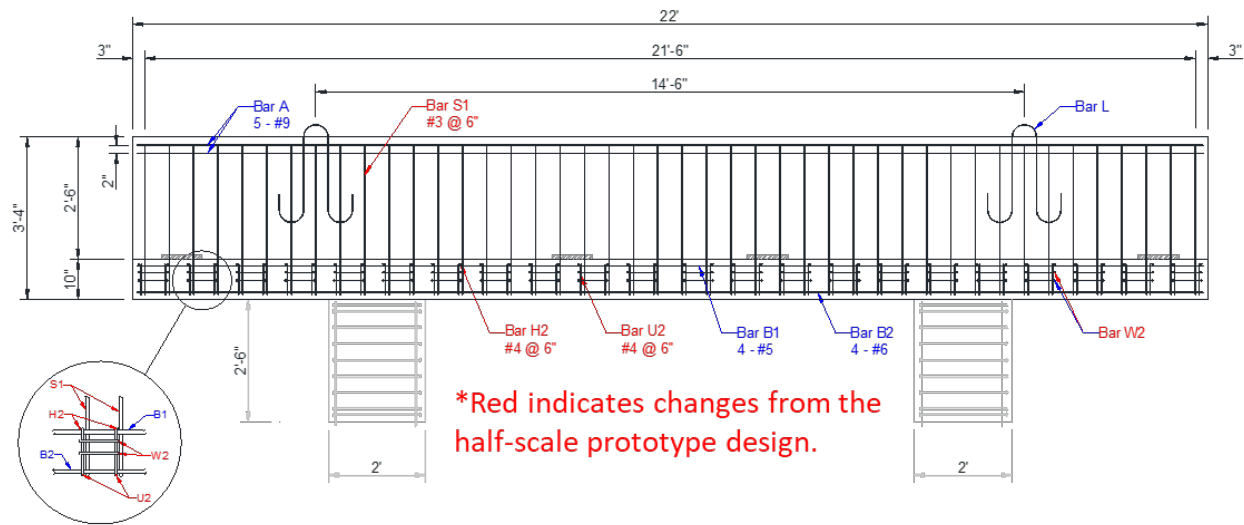
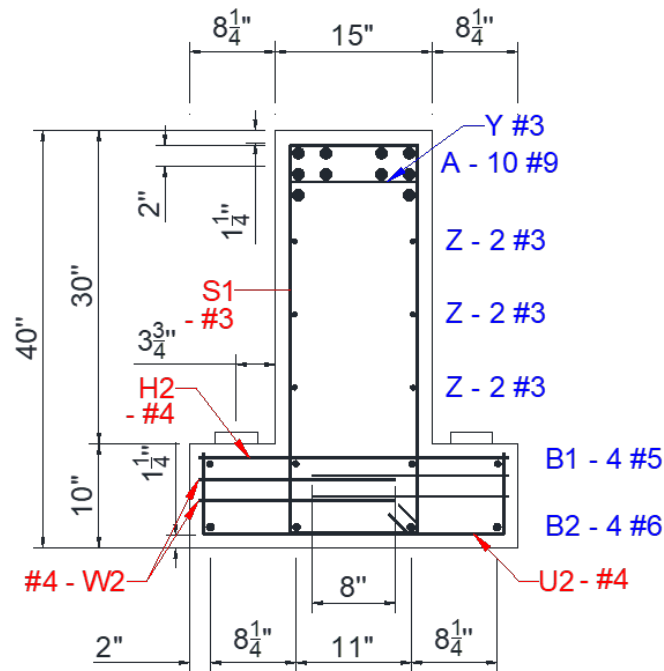
(a) Elevation

(b) Cross-section

Figure 2.3. Reinforcement Details of Hanger-Deficient Specimen.

In the experimental test program, the objective was to investigate the ability of retrofit solutions to strengthen specific deficiencies. To achieve this, the half-scale prototype was modified to provide two specimen designs with distinct deficiencies. For ease of construction, hanger and ledge reinforcement was specified to have the same spacing. Hanger-deficient specimens used an average spacing of 6 in. and increased the ledge reinforcement size from #3 to #4. Ledge-deficient specimens used an average spacing of 5.5 in. and increased the hanger reinforcement size from #3 to #4. Figure 2.3 and Figure 2.4 provide drawings of the hanger- and ledge-deficient specimens, respectively.

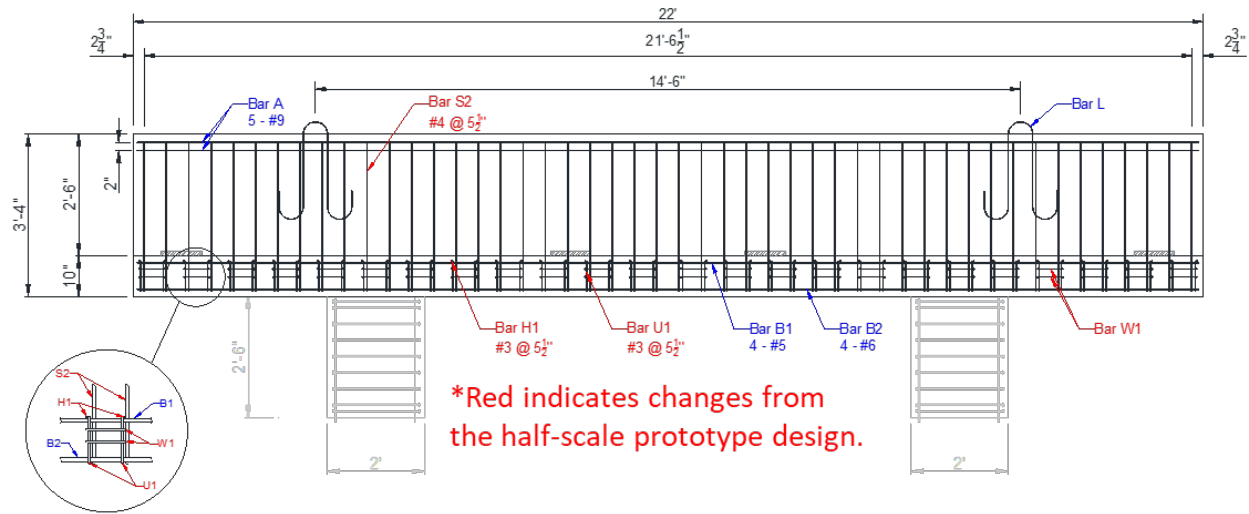
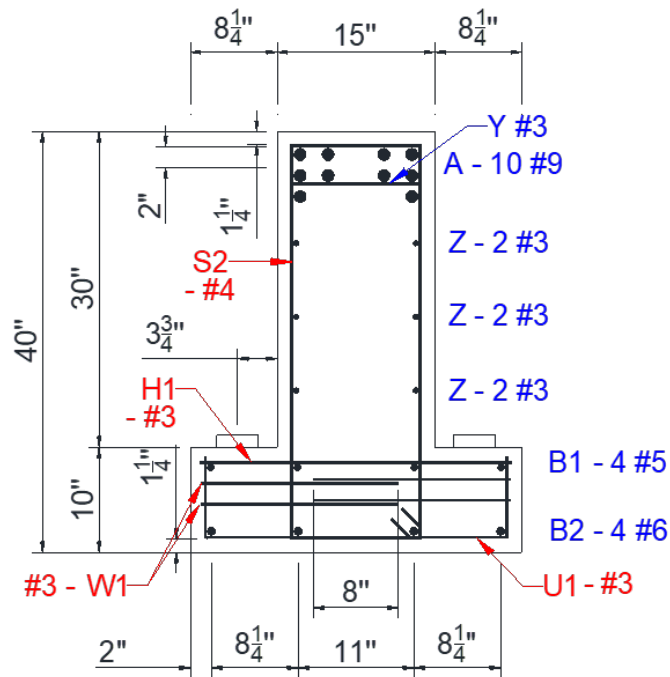
(a) Elevation

(b) Cross-section

Figure 2.4. Reinforcement Details of Ledge-Deficient Specimen.

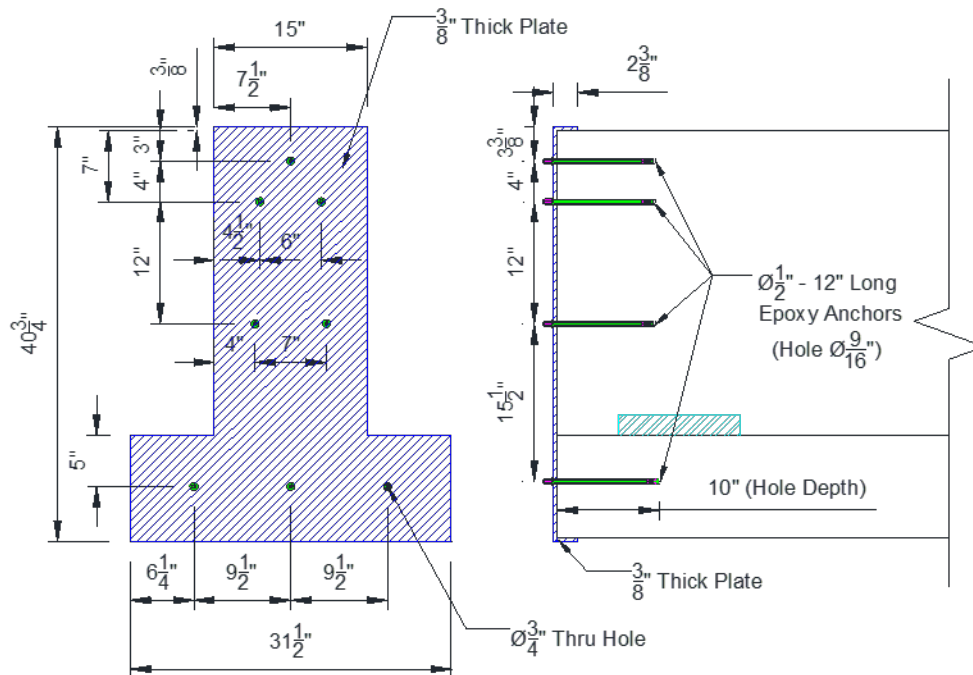
Eight 1/2 in. diameter Grade B7 epoxy anchors with an ultimate strength of 125 ksi were used. Layout of the anchors was modified from that in the Bent 13 retrofit designs to accommodate layout of the internal reinforcements. The steel plate was 3/8 in. thick, with 2-3/8 in. extensions on the top and bottom.

Figure 2.5. Solution 3—End-Region Stiffener.

The end-region stiffener solution provides an increase in the hanger, ledge flexure, and punching shear capacity of the end region of the bent cap. Figure 2.5 shows the geometric details and anchor hole configuration for the half-scale laboratory specimens.

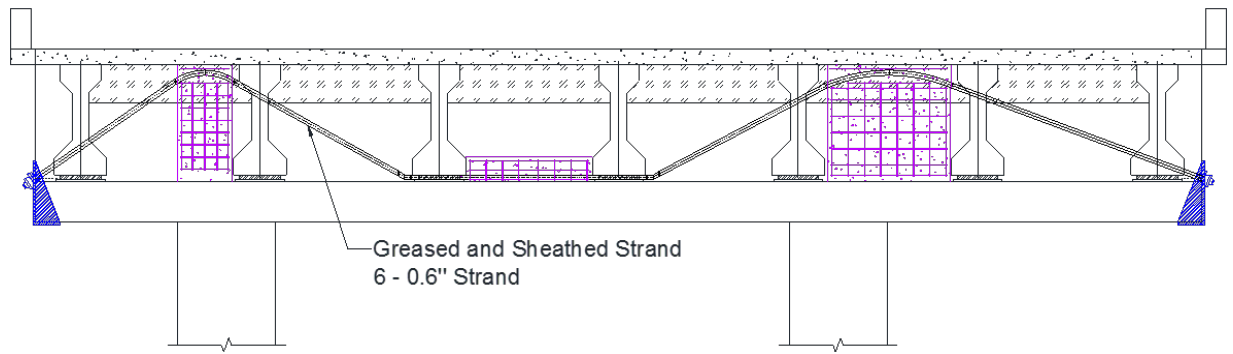
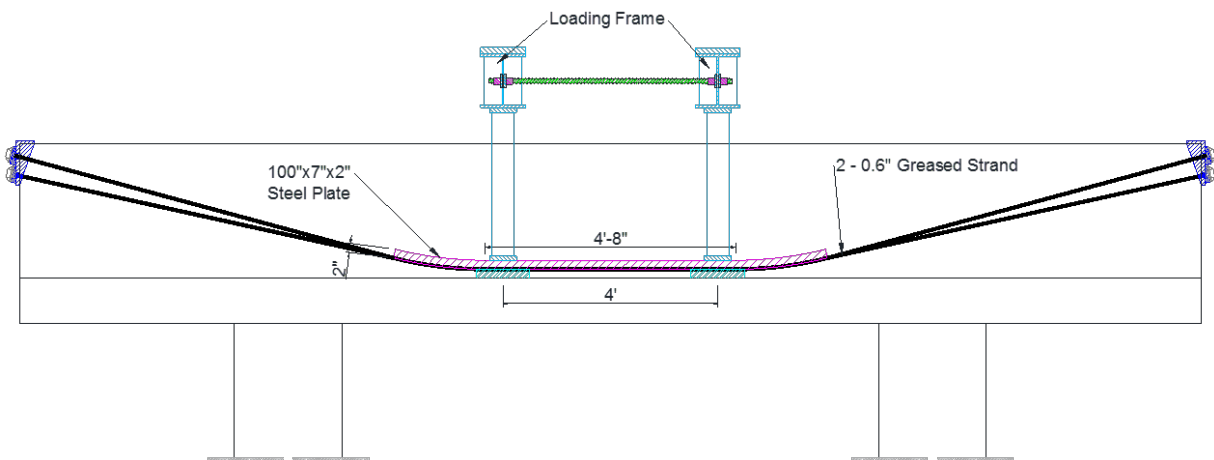
(a) Side elevation view for Bent 13

(b) Side elevation view for exterior part of specimen

(c) Side elevation view for interior part of specimen

Figure 2.7. Solution 14—Load-Balancing PT.

The load-balancing PT solution is applied to the full bent cap as shown in Figure 2.7(a) for Bent 13. The PT strands strengthen the hanger capacity of the bent cap by providing upward forces. By lifting the overhangs with the end-region anchor plate, the reaction forces to the PT are directly transferred into the columns. In the region between the two columns, the PT strands are placed beneath the girders.

Unlike the prototype bent, the experimental tests load the interior and exterior regions separately, resulting in the tests for each region having a different PT strand configuration, shown in Figure 2.7(b) and (c), respectively. For ease of construction and testing, the concrete infill above the columns are replaced by steel deviator plates (Figure 2.8), attached with four Hilti Stainless Steel Kwik 3 Expansion Anchors with 5/8 in. diameter and 5-1/2 in. embedded depth.

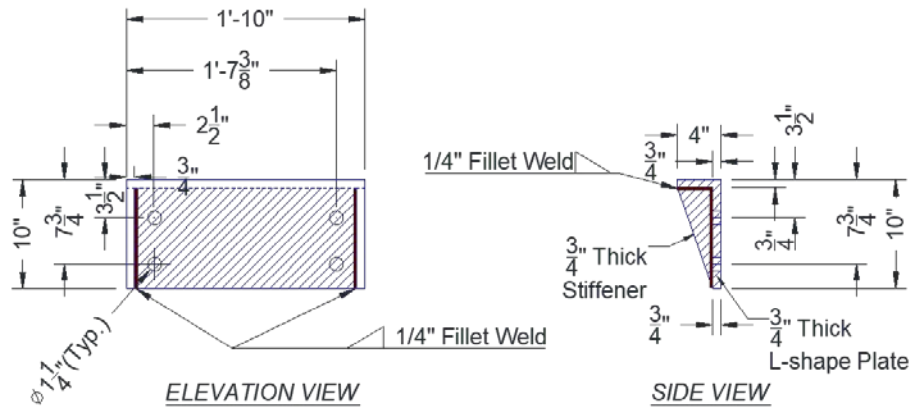
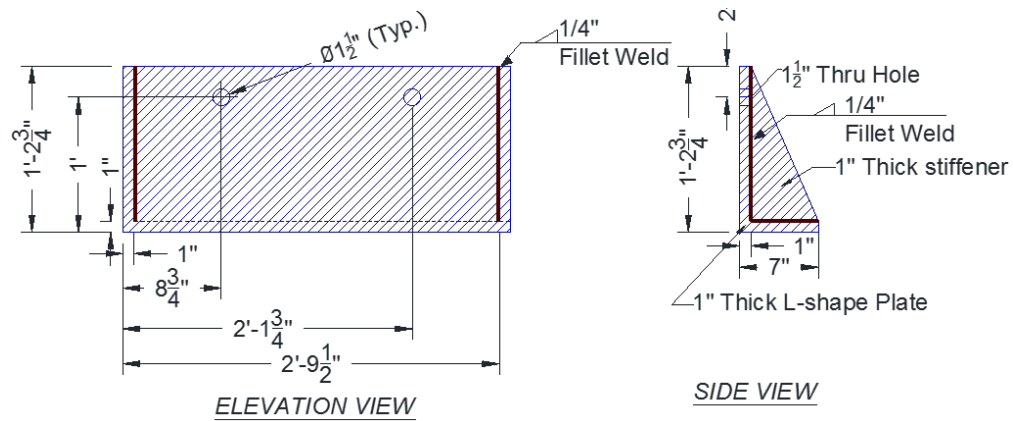
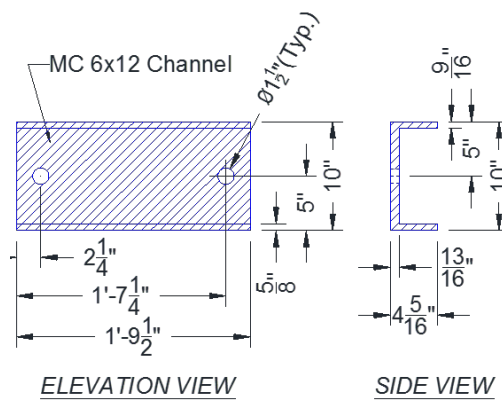
(a) Anchor plate for interior strengthening

(b) Bottom anchor plate for exterior strengthening

(c) Top anchor channel for exterior strengthening

Figure 2.9. Anchor Plates for PT Strand.

The angles for the interior and exterior tests are 14 degrees and 24 degrees, respectively. The post-tensioning force in each strand is 40 kips (70 percent of the ultimate strength of the strand), providing an uplift force of 19 kips and 16 kips for the interior and exterior portions, respectively. Anchor plates are designed based on bearing strength. Details of the anchor plates are shown in Figure 2.9.

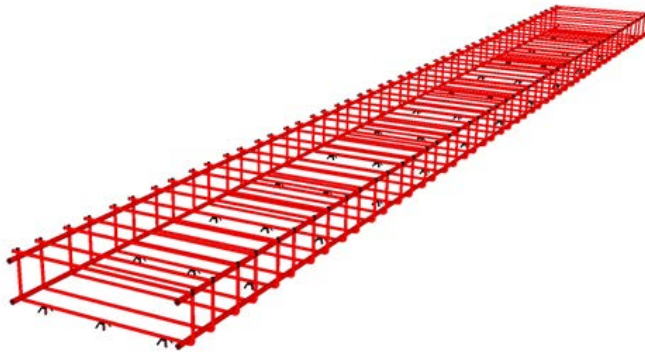
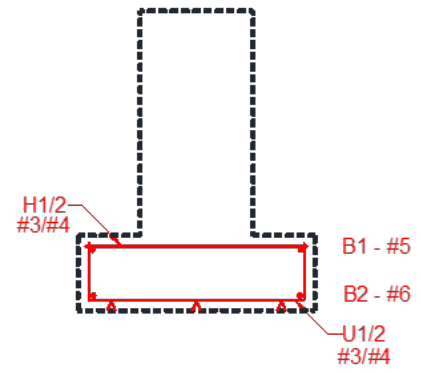
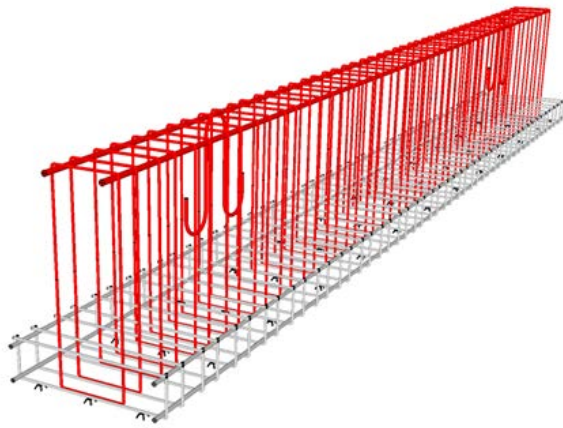
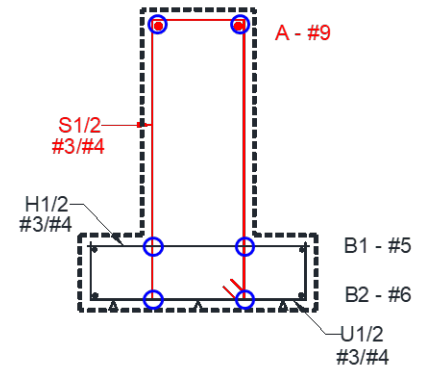
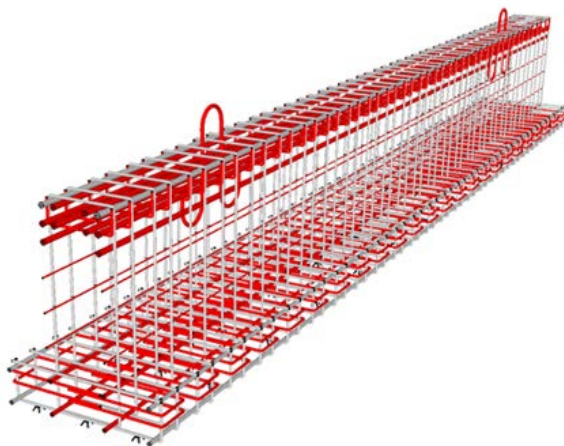
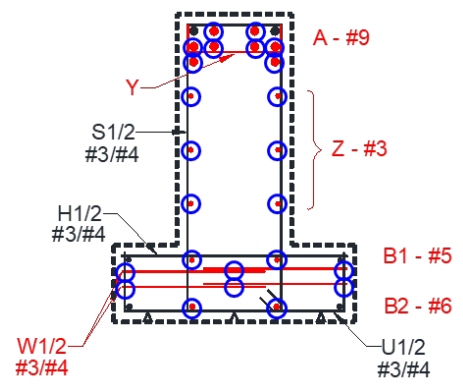
(a) Step 1

(b) Step 2

(c) Step 3

Figure 2.13. Inverted-T Rebar Cage Assembly Steps.

The rebar cages were tied prior to placement in the formwork. Figure 2.13 shows the assembly steps of the rebar cages; the rebar relevant to each step is shown in red, with blue circles indicating the rebar tying locations. Figure 2.14 shows the photos of each step after completion including a closer view of negative flexural and ledge shear friction reinforcement. The ledge reinforcement cage (U, H, B1, and B2 bars) was assembled first (Figure 2.13[a]).

Chairs were tied to the cage every 2 ft along the length to provide clear cover of 1-1/4 in. At each location, three chairs were used in one transverse plane. Next, the hanger reinforcement (S1/S2 bars) and the top longitudinal reinforcement (A bars) were added to the cage (Figure 2.13[b]). Lifting hooks were placed at the third points. Two 2x4 studs were provided at each end of the steel cage in the opposite angles to brace the steel cage against sway during assembly (Figure 2.14[b]). Finally, the remaining reinforcing bars (Z, Y, A, and W bars) were added to the cage. The A bars were arranged to allow room for holes for specimen tie down and installation of retrofit solutions (Figure 2.13[c]).

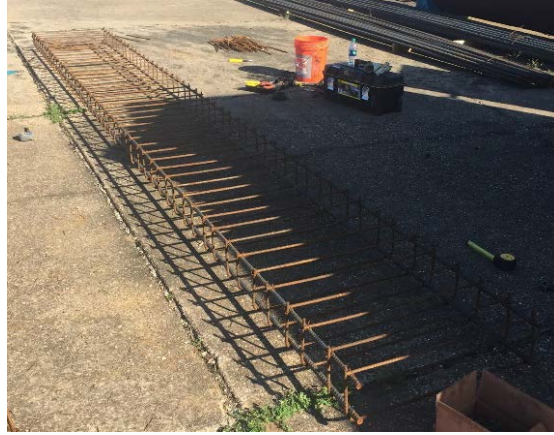
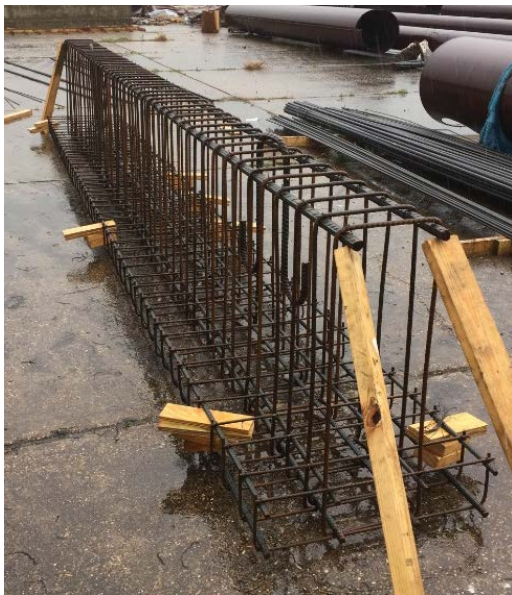
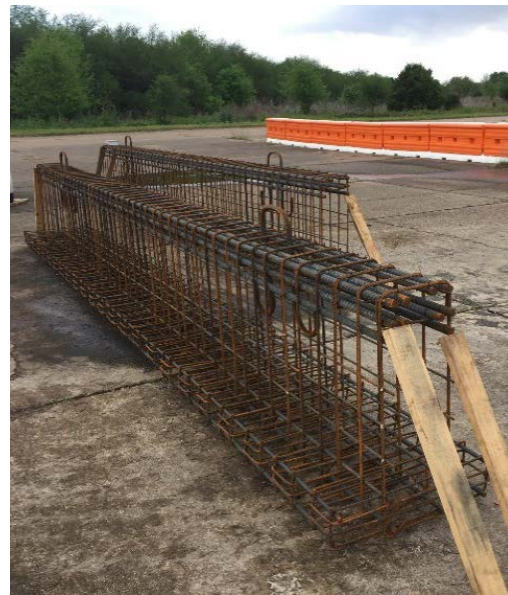
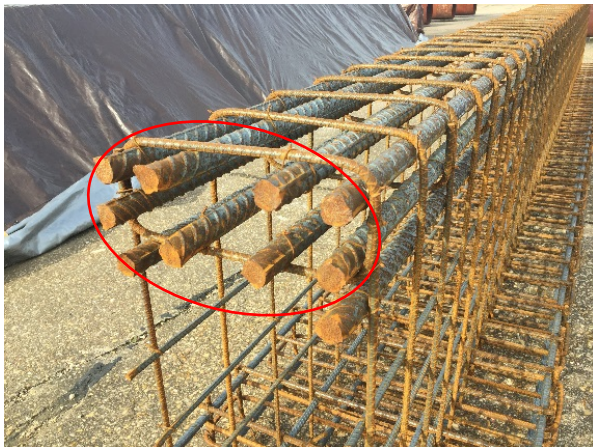
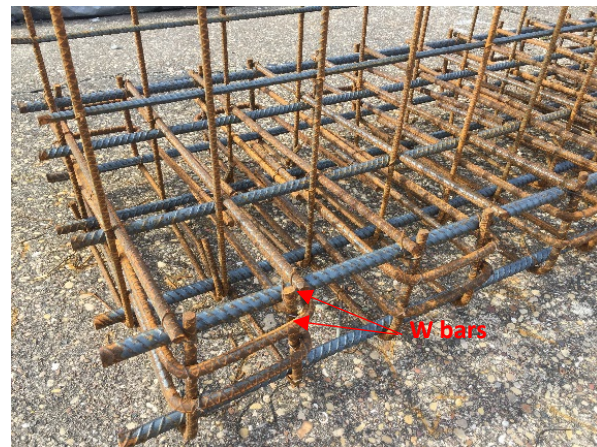
(a) Step 1

(b) Step 2

(c) Step 3

(d) Negative flexure reinforcement

(e) Shear friction reinforcement

Figure 2.14. Inverted-T Rebar Cage.

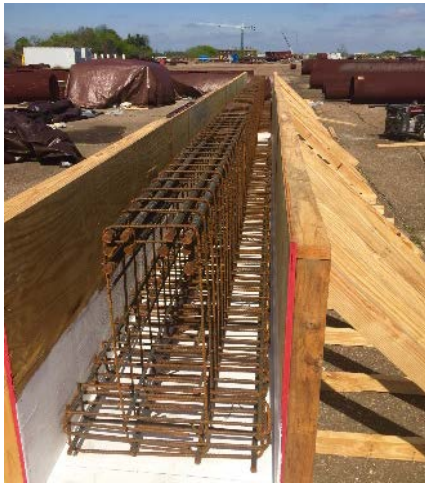
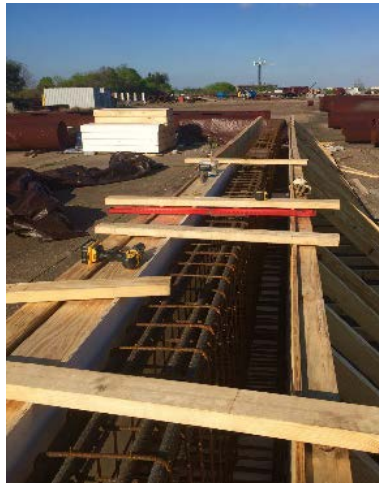
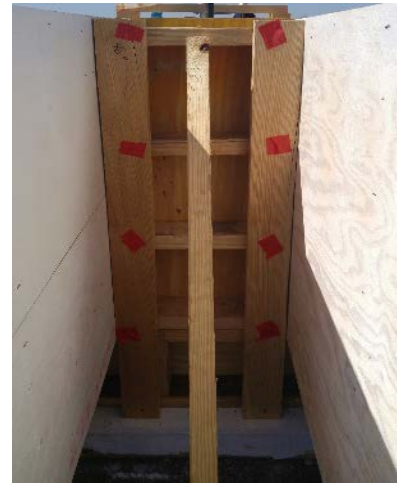
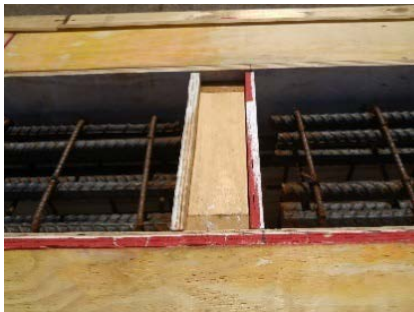
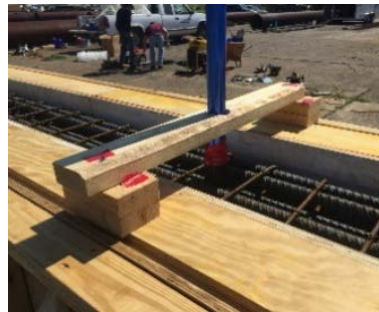
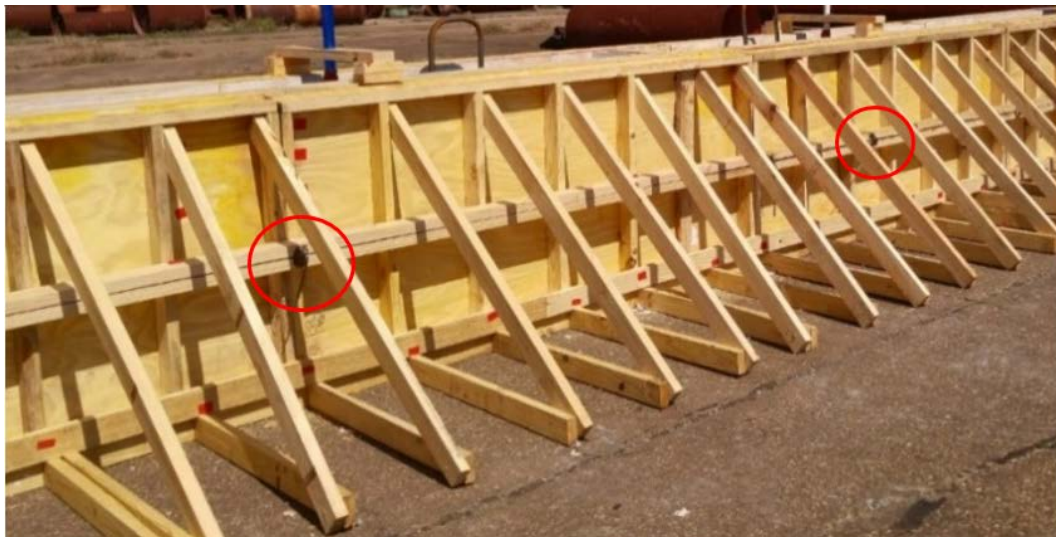
(a) Placing rebar cages

(b) Lowering inside panels

(c) End panels

(d) Middle panel

(e) Steel pipe holding frame

(f) Side chair

(g) Formwork tie

Figure 2.16. Formwork Assembly.

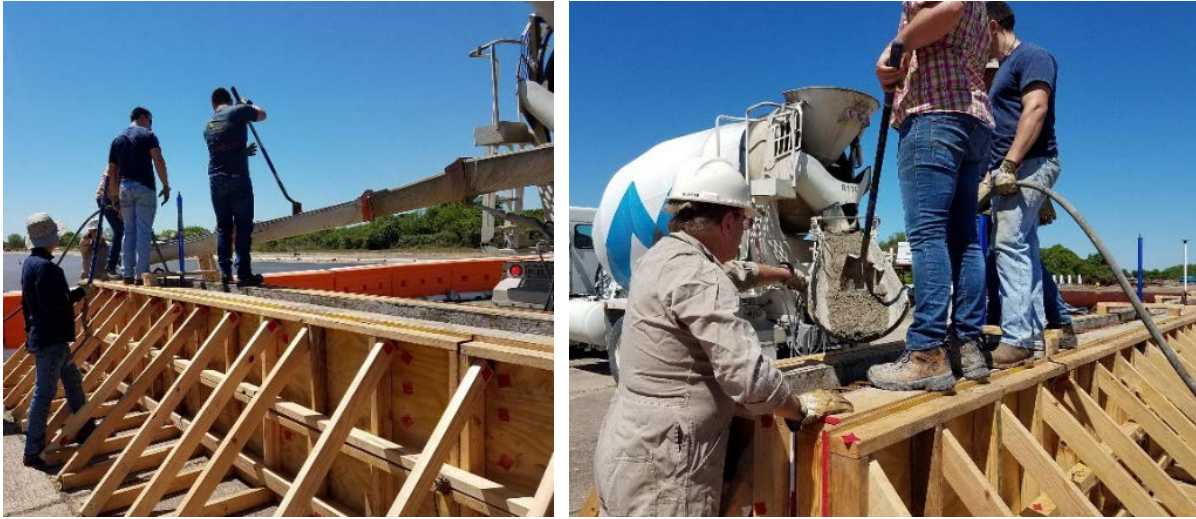
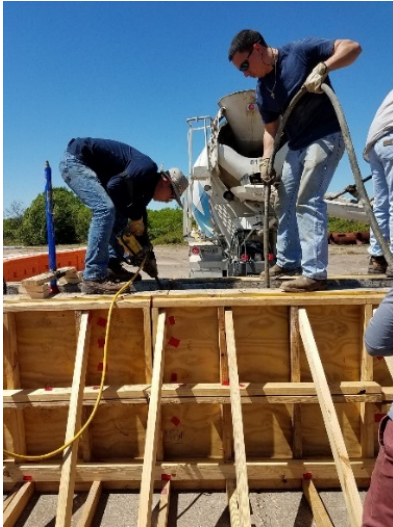
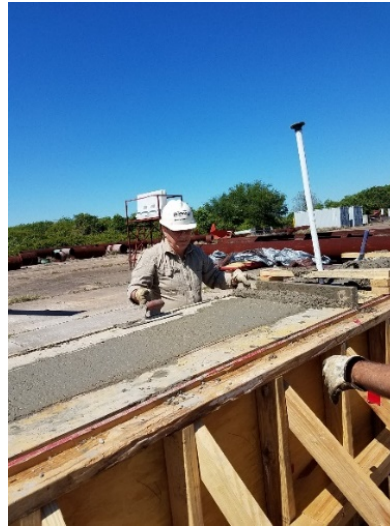
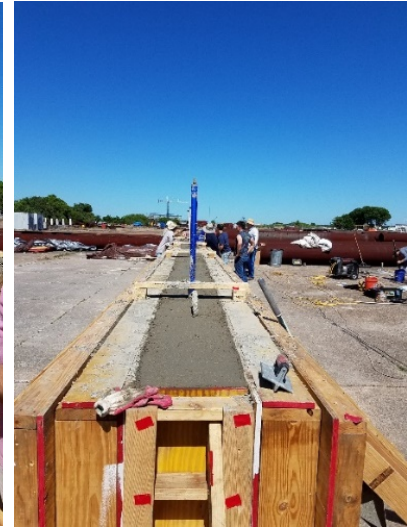
(a) Concrete placement

(b) Vibrating concrete

(c) Smoothing surface

(d) Finished surface

Figure 2.17. Casting of Inverted-T Specimens.

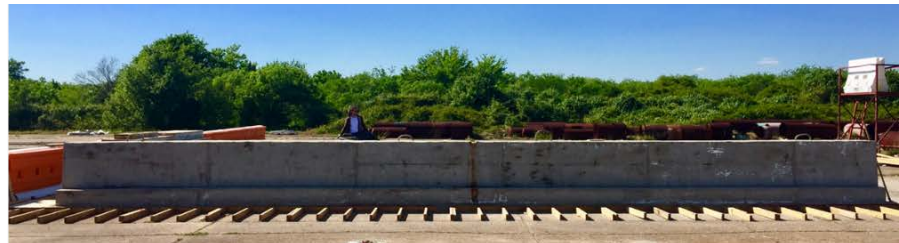
Figure 2.18. Uncovered Specimens.

Wooden formwork was constructed for fabrication of two specimens end to end. The formwork was reused for all four concrete pours. Figure 2.15 shows a three-dimensional (3D) view illustrating the fabrication of the formwork. The formwork consisted of six main components, as indicated in Figure 2.15(a) and (c): (1) bottom panel, (2) outside panel, (3) inside panel, (4) end panel, (5) diagonal braces, and (6) middle panel. Interior surfaces of the formwork were painted with semi-gloss latex paint. The formwork components were assembled using wood screws. Figure 2.16 shows photos of the formwork assembly process. The bottom panels were screwed together to form the floor of the formwork. The outside panels were then erected on the bottom panels and laterally supported by the diagonal braces. The steel cages were placed into the formwork using a forklift (Figure 2.16[a]). The inside panels were lowered into the formwork and fixed from the outside wall at their corresponding positions (Figure 2.16[b]). Then the end panels and mid-panel were placed in position to enclose and seal the formwork (Figure 2.16[c] and [d]). All the interior surfaces of the formwork were cleaned and oiled before closure. Wood holding frames were installed to keep the embedded steel pipe in position (Figure 2.16[e]). Chairs were provided on the sides of the steel cage to ensure the required clear side cover (Figure 2.16[f]). Figure 2.16(g) shows formwork ties provided every 8 ft to prevent lateral expansion. The concrete for the specimens was provided by local ready-mix concrete company Martin Marietta Materials. Slump tests were performed according to ASTM C143 (ASTM, 2012) for every pour. Figure 2.17 shows photos during a typical concrete pour. The concrete was directly placed into the formwork from the concrete truck (Figure 2.17[a]). Proper consolidation was achieved using rod vibrators (Figure 2.17[b]). The specimen surface was finished with smooth trowels (Figure 2.17[c]). Approximately one hour after concrete placement, filleted trowels were used to provide smooth round edges at the top surface of the specimen. Once the concrete hardened, the surface was watered and covered with soaked burlap mats and tarps for four days of moist curing. Formwork was removed after seven days. Figure 2.18 shows the specimens after removal of the formwork.

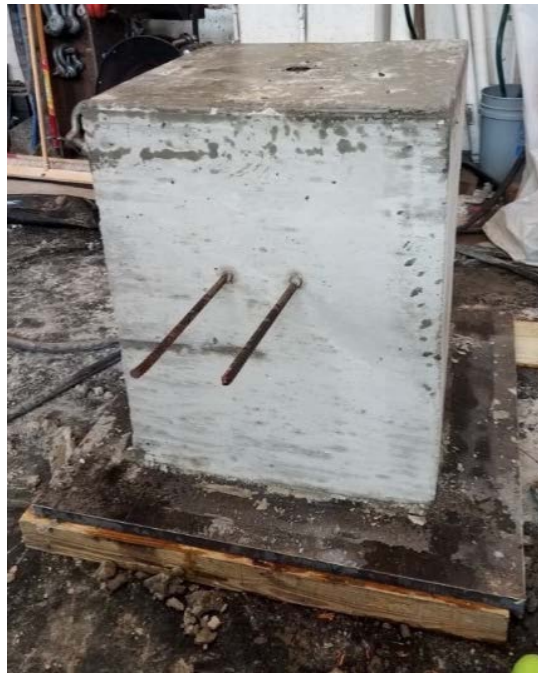
Figure 2.19. Support Column with Lifting Hooks.

The column cross-section dimensions were half-scaled from the prototype structure, with reinforcement designed to resist expected laboratory load demands. Figure 2.19 shows the column after the formwork was removed. The column concrete had a design strength of 10 ksi to ensure minimal, if any, damage, thereby enabling reuse of the columns. Column reinforcement details are shown in Figure 2.20. A steel plate formed the bottom of the columns, with longitudinal bars welded into predrilled holes. Flexural reinforcement consisted of 12-#8 bars. Nine rectangular and octagonal #3 hoops spaced at 4 in. provided confinement (Figure 2.20[b]). A 1-1/2 in. diameter steel pipe in the center of the column allowed for a Dywidag bar to clamp the specimen, a column, and the strong floor together. Rebar extending from the sides of the columns was provided for assistance with column placement during test setup.

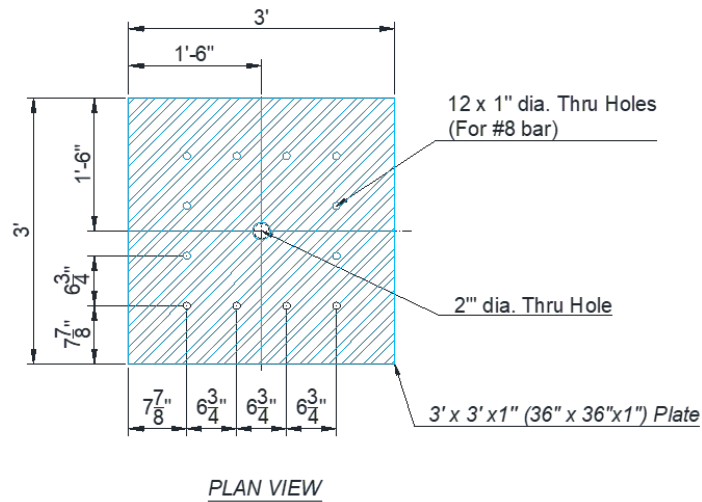
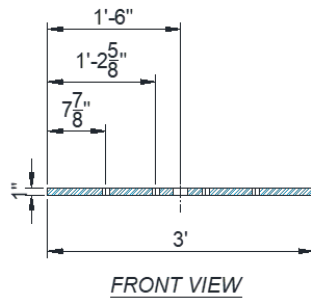
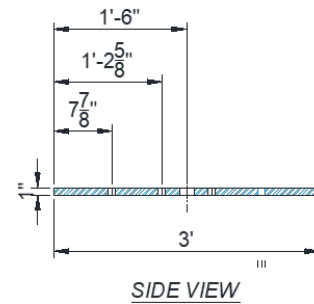
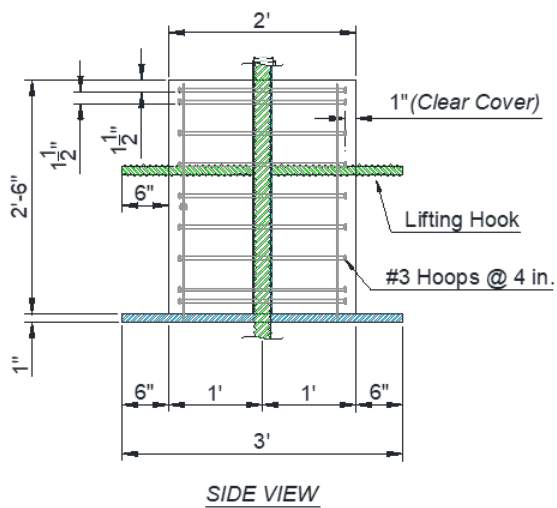
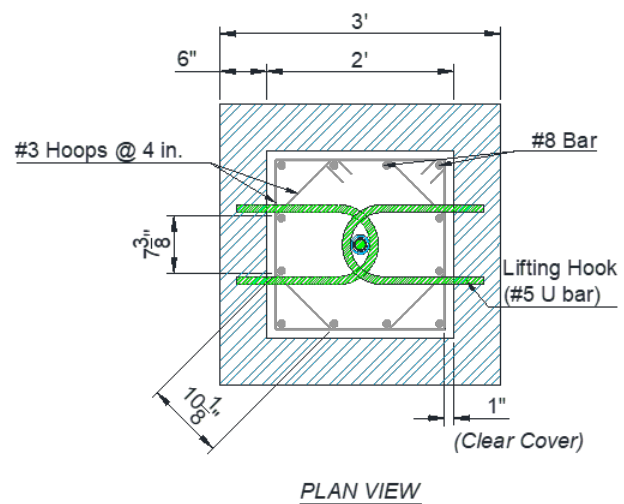
Figure 2.20. Column Details.

(a) Base plate design

(b) Column reinforcement

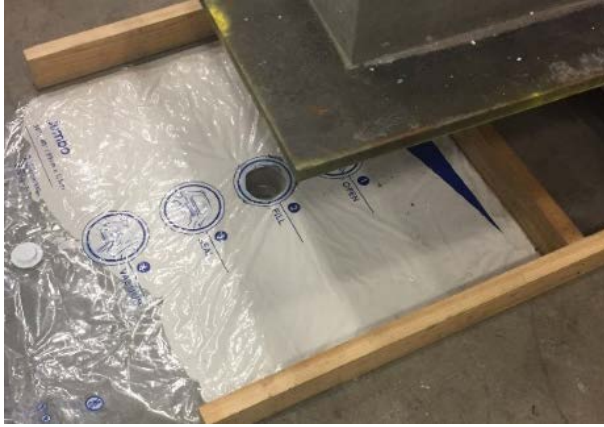
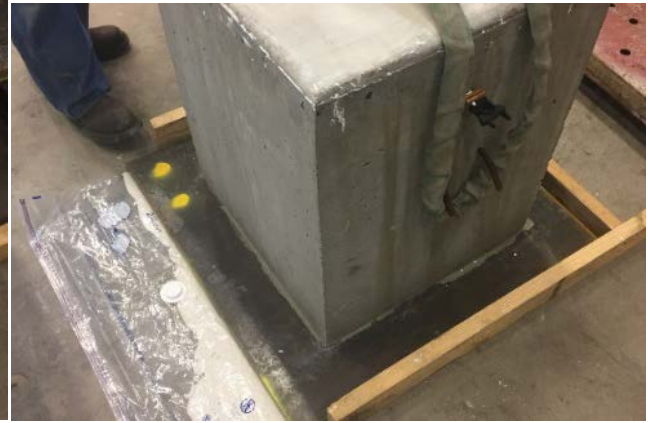
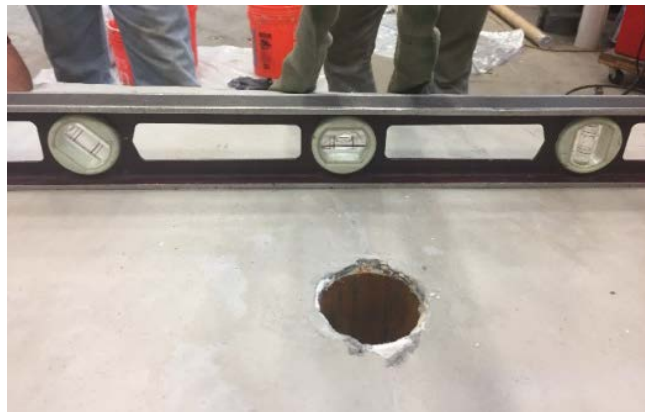
Figure 2.21. Leveling Column on Strong Floor.

(a) Place Ziploc bag with dental stone

(b) Place column on the dental stone

(c) Check level of the column

The column-base plate was leveled using dental stone, as shown in Figure 2.21. Once the columns were set on the floor, dental stone was placed on the top of the column to provide a level surface. Figure 2.22 shows the installation procedure of a specimen on the columns. A 1-3/8 in. Dywidag bar clamped the bent cap and a column together onto the strong floor. The bars were stressed with 75 kips force.

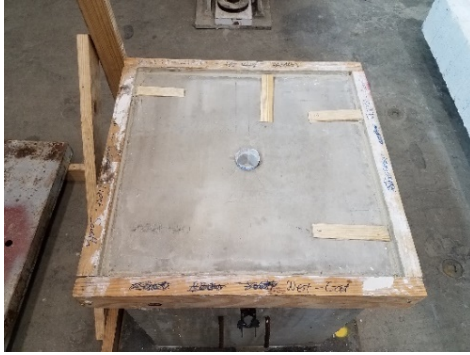
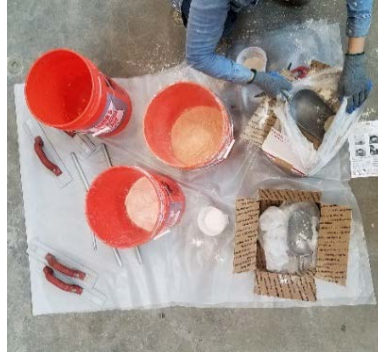
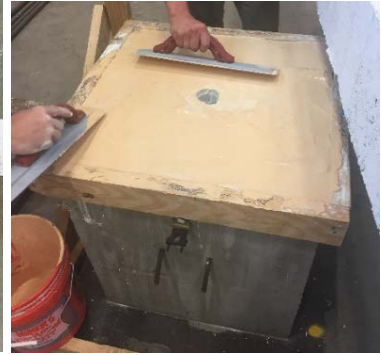
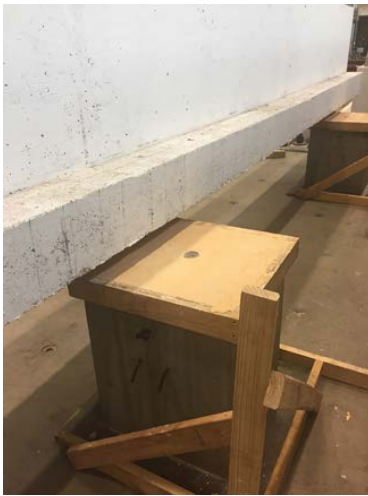
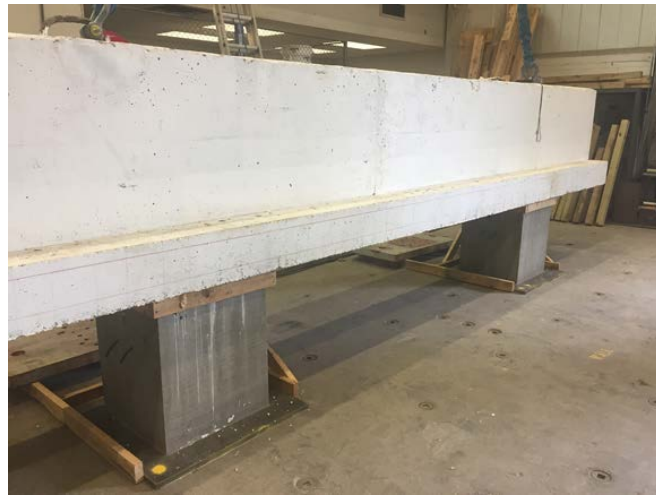
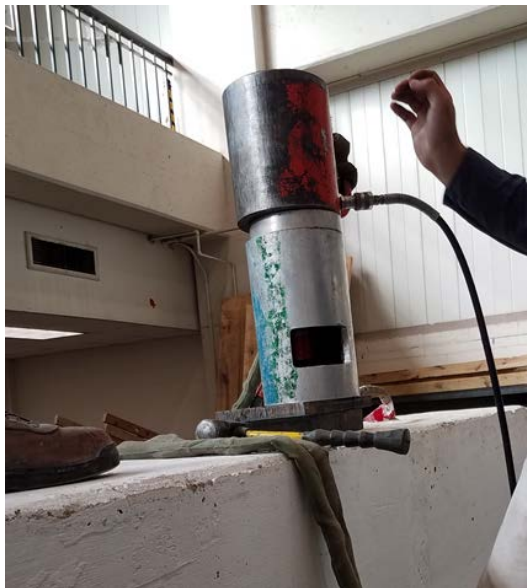
Figure 2.22. Installing a Specimen on the Columns.

(a) Shims to align column and specimen

(b) Mixing dental stone and filling on the top of column to level surface

(c) Placement of specimen on column

(d) Stressing Dywidag bar to clamp specimen to floor

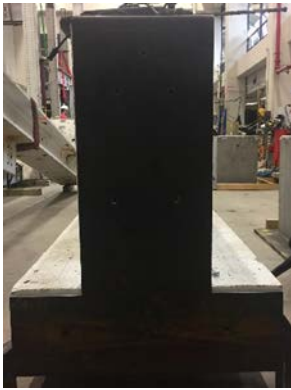
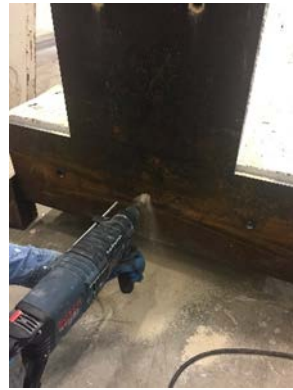
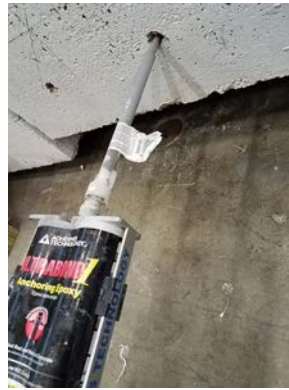
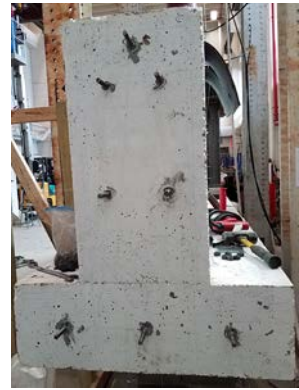
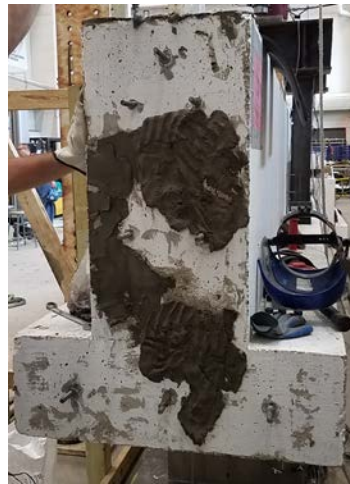
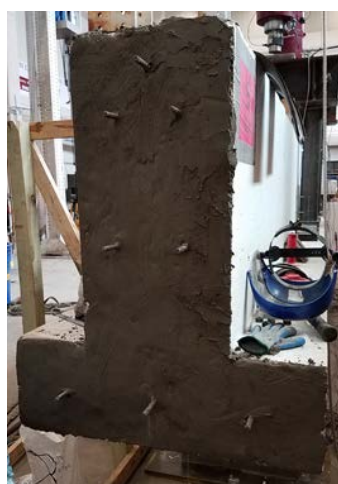
Figure 2.23. End-Region Stiffener Installation Procedures.

(a) Place steel plate, mark holes, and drill the holes with hammer drill

(b) Put epoxy in the holes and place anchors

(c) Grout the end face

(d) Place the end plate and hold from bottom

(e) Fasten the anchors

The end-region stiffener (Solution 3) consists of a steel plate and eight epoxy anchors. First, the steel plate was placed to mark and drill the holes for the anchors (Figure 2.23[a]). Holes were drilled with a hammer drill. A rebar cutter bit was used to cut through bottom W bars on three specimens (T2 east end, south anchor; T5 west end, north and south anchors; T7 west end, north anchor). Holes drilled with the rebar cutter required approximately one hour per a hole; all other holes required approximately one minute per a hole. Once all holes were drilled, the steel plate was removed and holes were cleaned using an air gun and 3/4 in. nylon brush. Epoxy was put into the holes using a standard caulking gun and mixing nozzle (Figure 2.23[b]). The anchors were placed immediately.

End plates were installed a minimum of four hours after placement of anchors. The contact surface of the specimen was covered with a 1/4 in. thick layer of rapid hardening concrete repair grout with a stiff gel-like consistency (no slump), as described in the manufacturer's guide, to allow application on a vertical surface (Figure 2.23[c]). The steel plate was placed immediately following application of grout. Installation of the plate required two people. The plate was held in place from the bottom by leveling jacks, as shown in Figure 2.23(d). Anchors were fastened using a wrench.

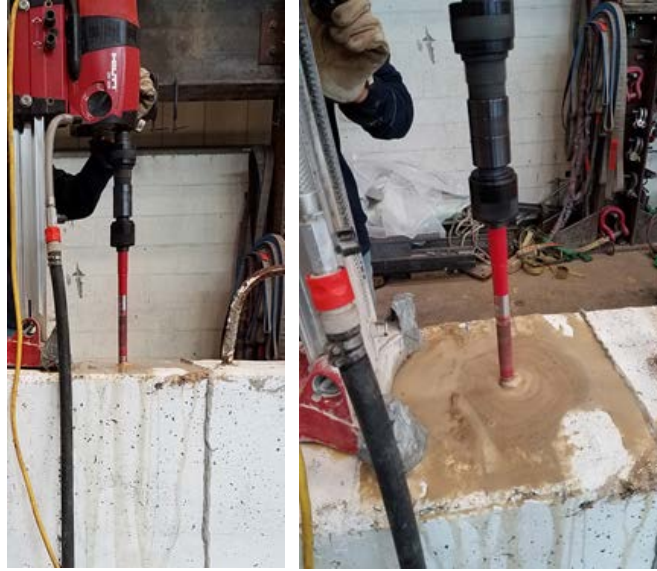
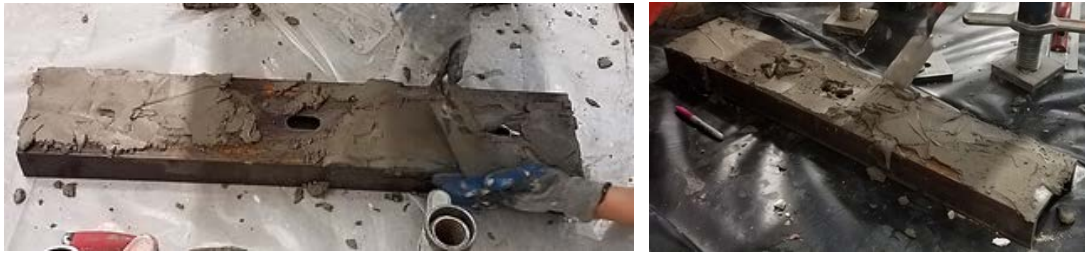
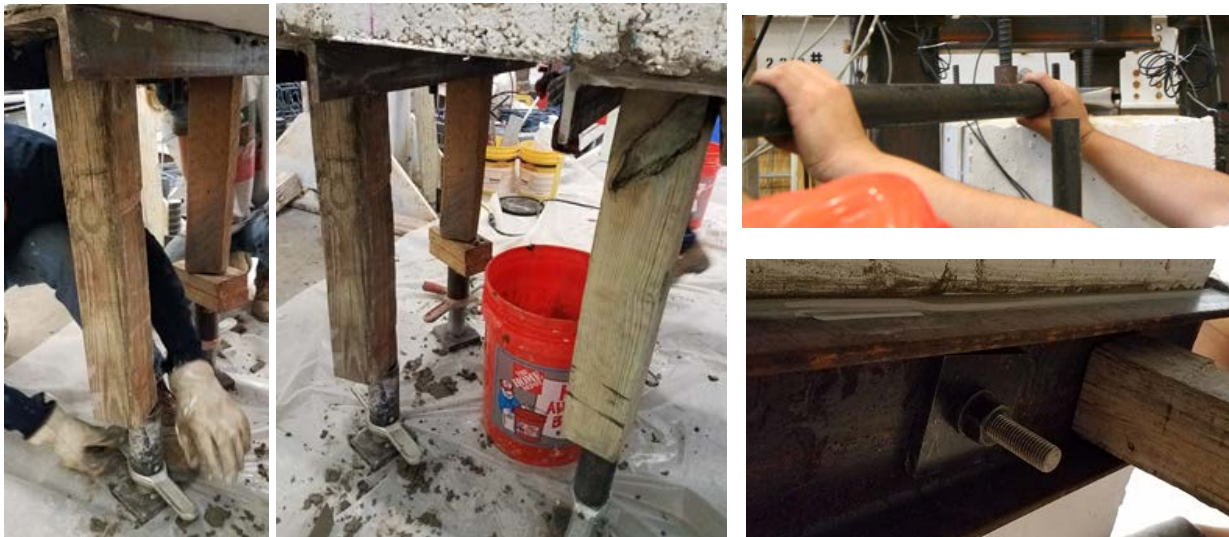
(a) Drill the holes using core dill

(b) Put grout on the channel

(c) Squeeze up and fix channel using leveling jack and wood support

(d) Place bearing plate, washer, and nut, and then fasten the threadbar using a wrench

Solution 8 consisted of a threadbar with channel. Holes for the threadbars were made using a core drill. A 12 in. long initial hole was drilled using a 14 in. long bit. The depth of the hole was increased using 24 in., 36 in., and 48 in. long bits. Each hole took approximately one hour. The threadbar was placed through the hole with the hex nut, washer, and bearing plate on the top of the bent cap. The channel (with predrilled hole) was secured to the bottom surface of the specimen with a rapid hardening grout, as shown in Figure 2.24(b). Leveling jacks and wood were used to hold the channel in place (Figure 2.24[c]). The threadbar was fastened within the 20-minute working time for the grout (Figure 2.24[d]). A minimum of four hours of curing time was allowed prior to testing.
