Strengthening of Existing Inverted-T Bent Caps— Volume 2: Experimental Test Program

Technical Report 0-6893-R1-Vol2

TEXAS A&M TRANSPORTATION INSTITUTE
COLLEGE STATION, TEXAS

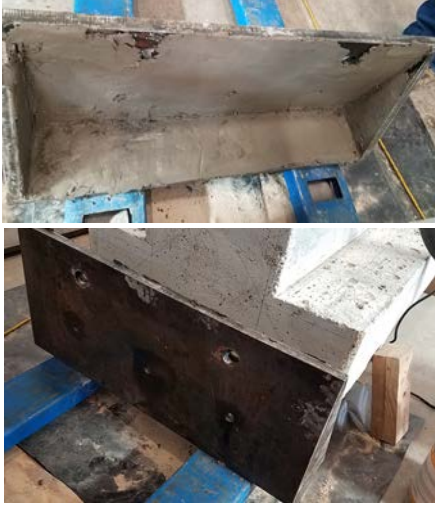
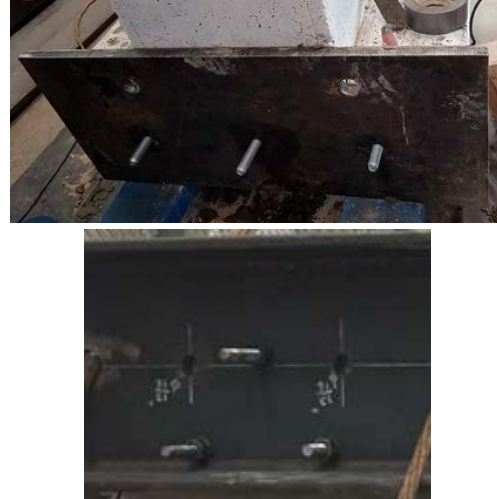
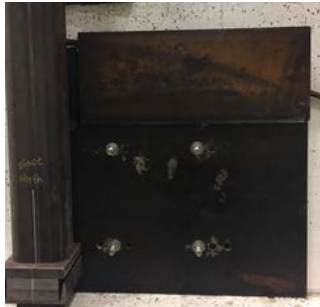
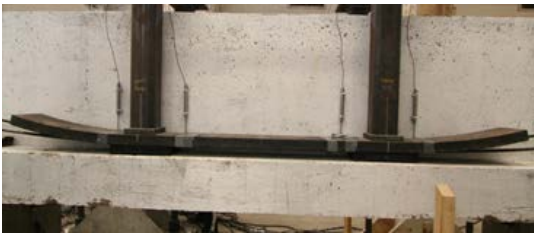
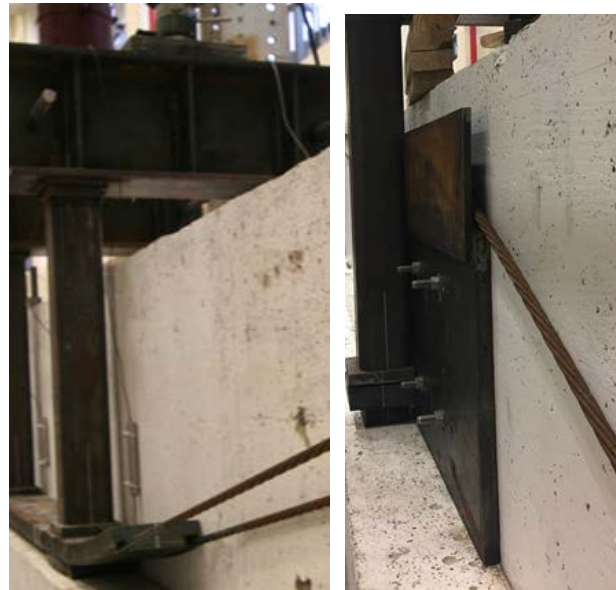
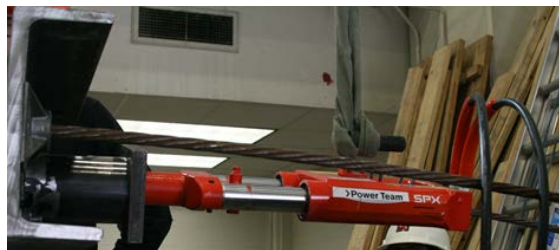
Figure 2.25. Installation Procedures for Load-Balancing PT.

(a) Put grout on the anchor plate or channel and place the anchor plate or channel

(b) Mark holes, drill the holes, and place mechanical anchors

(c) Place side plate for the exterior test, mark and drill the holes, and install anchors

(d) Place base plate on the bearing pads for the interior test

(e) Place strands

(f) Jack the strands to induce prestress

Load-balancing PT was installed separately for interior and exterior tests. For both solutions, the anchor plates/channels were installed first using a rapid hardening grout (Figure 2.25[a]). The holes for mechanical anchors were then drilled with a hammer drill and mechanical anchors were installed to anchor the plate/channel. Base plates for the interior test and side plates for the exterior test were properly placed as shown in Figure 2.25(c) and (d).

For the interior test, the stands were individually placed in each notch of the base plate (Figure 2.25[e]) and anchored at the east and west ends of the specimen. Before inducing prestressing force, the service load was applied on the base plate at all loading points. In both interior and exterior tests, a prestressing force of 45 kips was applied in each strand, with one-half applied at each end (east end stressed first). New strands were used for each test.

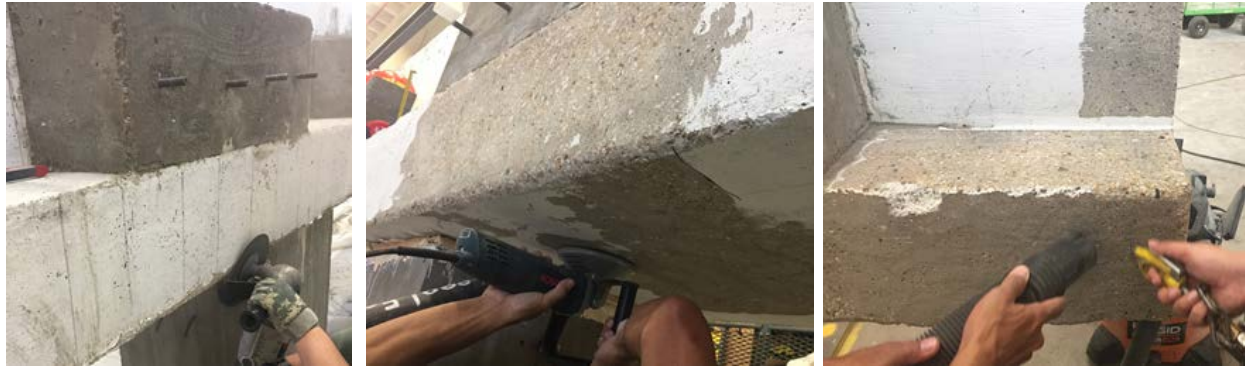
Figure 2.27. Surface Treatments Prior to FRP Application.

(a) Round sharp corner

(b) Remove coating

(c) Clean surface

Figure 2.27 shows the surface treatment prior to installation of the FRP. The bottom corners of the specimen were rounded with a minimum curvature of 1.5 in. to prevent sharp-corner-induced premature failure of the FRP, as shown in Figure 2.27(a). The removal of coatings, laitance, and all miscellaneous surface contaminates was performed subsequently performed, as shown in Figure 2.27(b). The surfaces were then smoothed with 80 grit sandpaper to meet the surface profile recommendation given by the manufacturer. Debris was removed with a vacuum and pressurized air (Figure 2.27[c]).

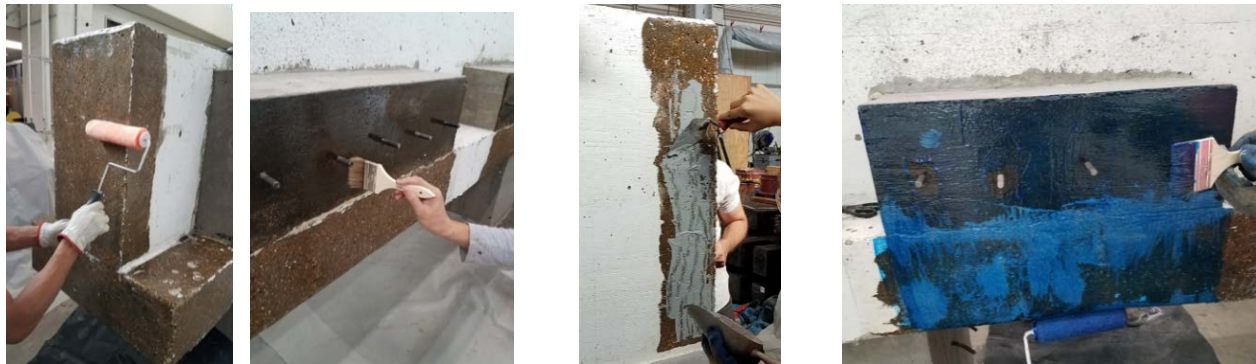
Figure 2.28. Application of Epoxy Components to Substrate.

(a) Applying epoxy primer

(b) Applying epoxy paste

Figure 2.28 shows the application of epoxy components to the substrate. First, the primer was uniformly applied to the substrate using 3/8 in. nap rollers and brushes, as shown in Figure 2.28(a). Two hours later, the paste was applied with a steel trowel to level small surface defects, as shown in Figure 2.28(b). The next day, the resin was applied using 3/8 in. nap rollers and brushes to a wet film thickness of 0.46 mm to 0.56 mm (Figure 2.28[c]).

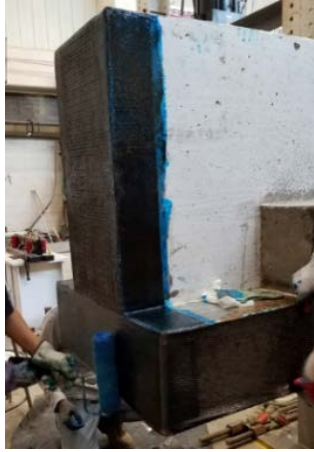
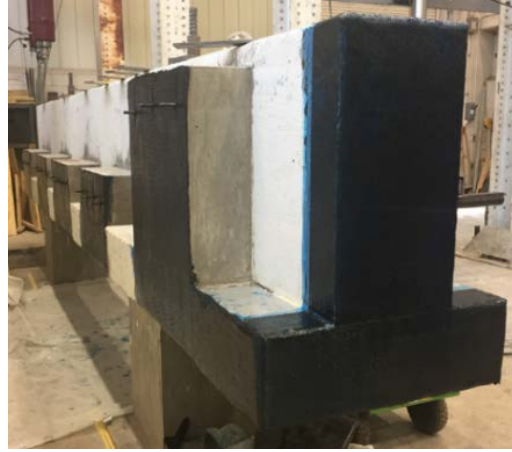
Figure 2.31. Application of Second Layer of Epoxy and Steel Waling.

(a) Applying second layer of epoxy

(b) After application

The second layer of epoxy encapsulation resin was applied over the fabric to a wet film thickness of 0.46 mm to 0.56 mm, as shown in Figure 2.31(a) and (b). The steel waling plates were installed on the specimen after the FRP application. As shown in Figure 2.31(c), the epoxy encapsulation resin was applied to the surface of the steel waling plate prior to placing it in position. The steel waling plates were positioned and tightened slightly to avoid damaging the fabric but to ensure uniform contact was achieved. Figure 2.31(d) shows the installed waling plates.

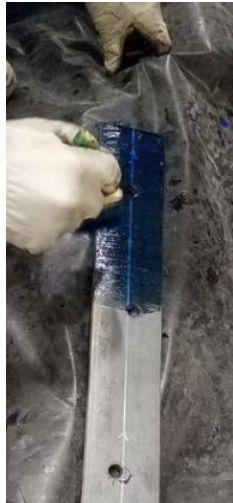
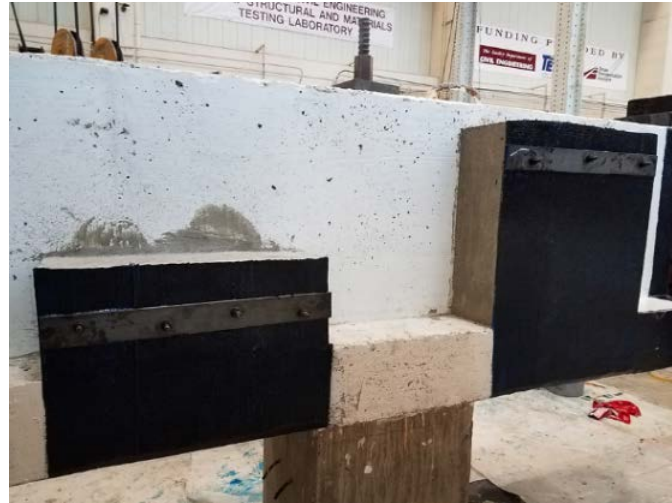
(c) Applying epoxy to waling plate

(d) Install waling plate

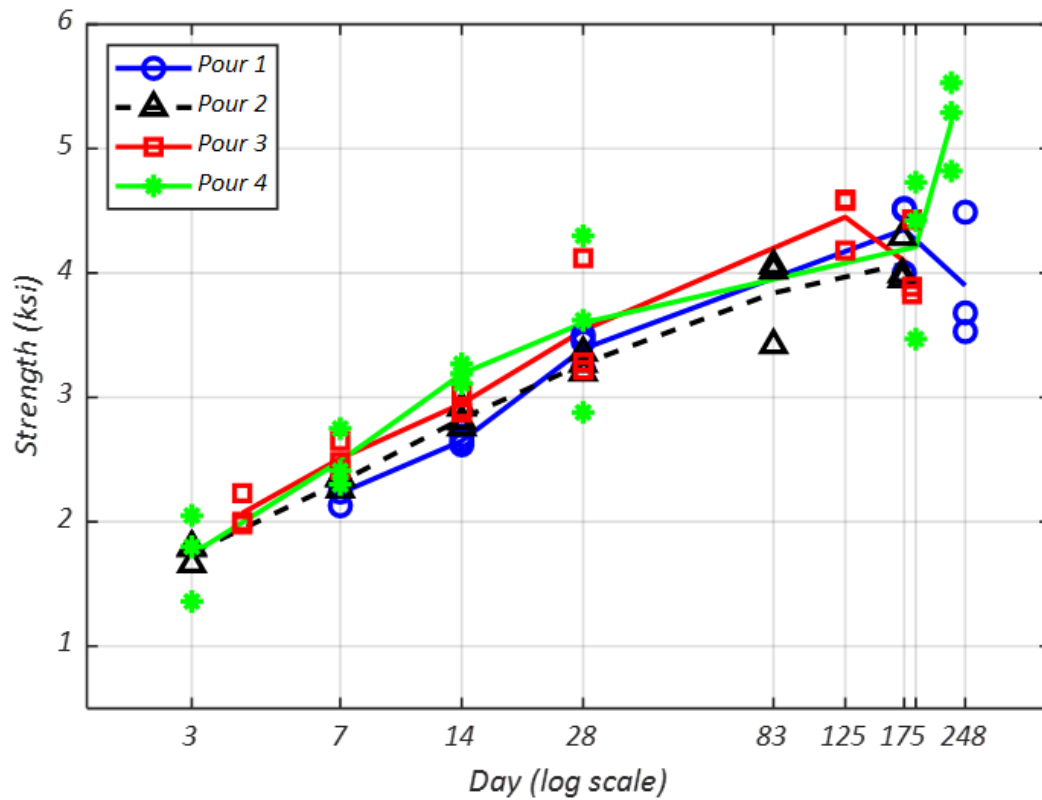
Figure 2.32. Compressive Strength Gain over Time.

For the bent caps, a 3.6 ksi 28-day strength modified Class C concrete with 3/8 in. aggregate was specified. Slump tests (following ASTM C143 [ASTM, 2012]) were conducted prior to each concrete pour. Standard 4 in. x 8 in. test cylinders were made in accordance with ASTM C31 (2015) and ASTM C192 (2016) specifications. The cylinders were transported to the lab, demolded, and placed in the curing room. Uniaxial compression testing following the guidelines provided in ASTM C39 (2017) was conducted at 3, 7, 14, and 28 days. Table 2.4 lists the measured material properties. Figure 2.32 shows strength gain over time in a log scale plot.

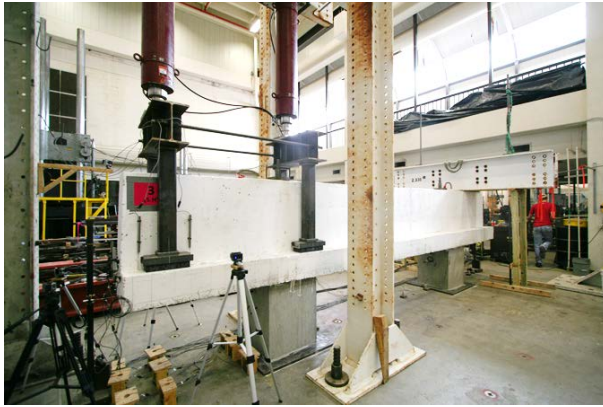
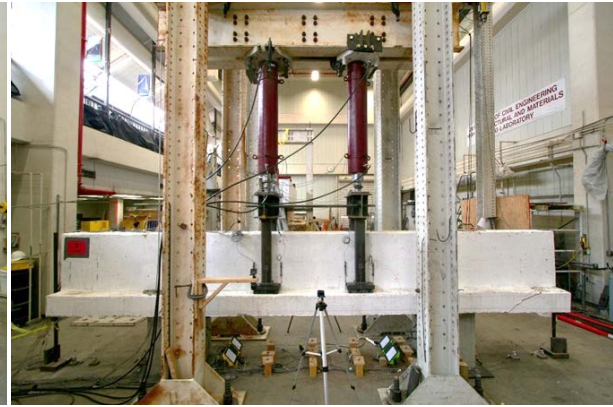
Figure 2.33. Test Setup in Laboratory.

Figure 2.33 shows overview photographs of the test setup in the Texas A&M High Bay Structural and Materials Testing Laboratory. The 22 ft long bent caps were centered on two 2 ft square columns spaced 12 ft on center.

(a) Exterior test setup

(b) Interior test setup

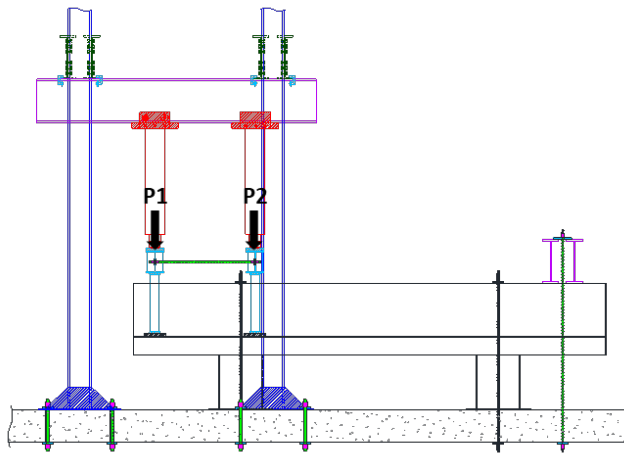
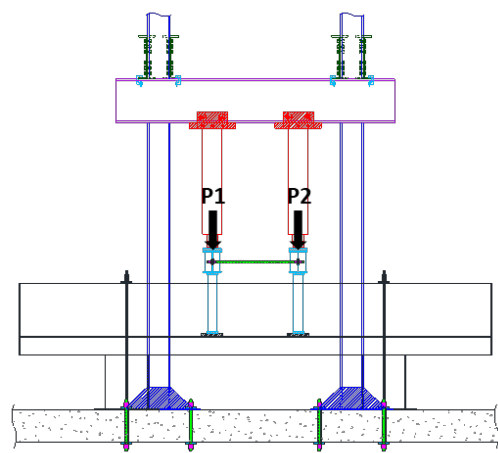
Figure 2.34. Overview of Experimental Test Setup Loading Locations.

Figure 2.34 shows the three test regions that were used for each specimen: two exteriors and one interior. Exterior tests (Figure 2.34[a]) simulated one girder line centered at 1 ft. Interior tests (Figure 2.34[b]) simulated two girder lines spaced at 4 ft, centered on the specimen, from the edge; an additional loading point was provided over the adjacent column. A plan view of the loading points is provided in Figure 2.34(c).

(a) Exterior test

(b) Interior test

(c) Plan view of loading points

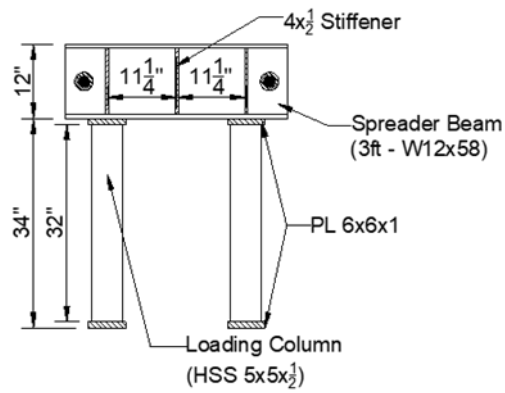
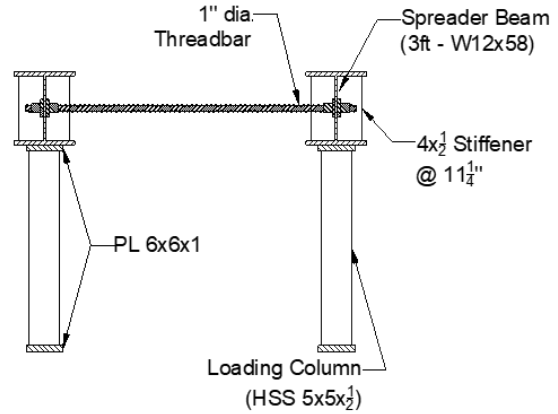
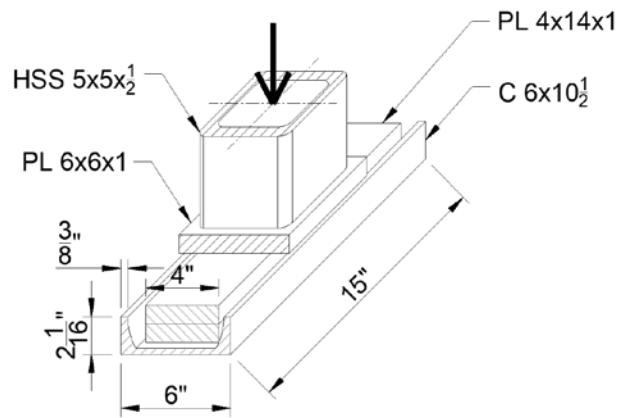
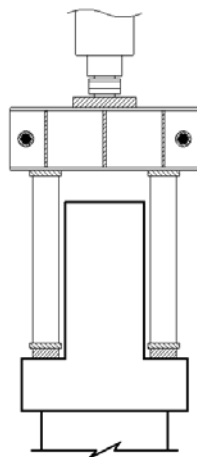
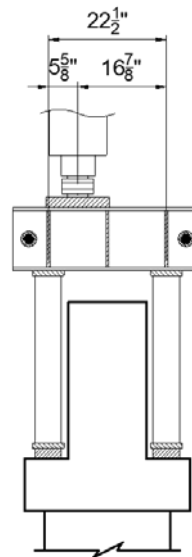
Figure 2.35. Details of Loading Frame and Side View of Actuator Location.

(a) Loading frame

(b) Connection of loading frames

(c) Built-up bearing steel parts

(d) Ledge and hanger tests

(e) Punching shear tests

For ledge and hanger tests, the jack was centered on the loading frame (Figure 2.35[d]) to provide equal loads on each ledge. Interior tests increased each jack equally. Exterior tests increased each jack equally up to dead load, at which point the load over the column was held constant. For punching shear tests, the actuator was placed 5-5/8 in. off center (Figure 2.35[e]) to allow for larger loading on one side. The off-center position was determined as that to provide dead load on the far side when the near side was at the design load. Both interior and exterior punching shear tests increased each jack equally up to dead load. After reaching dead load, only a single jack was increased in most tests. An exception occurred for tests T7I1 and T7I2, during both of which actuators were loaded equally to the ultimate load state. Once the ultimate load state was attained, the subsidiary jack was retracted to hold the dead load and the main jack was increased.

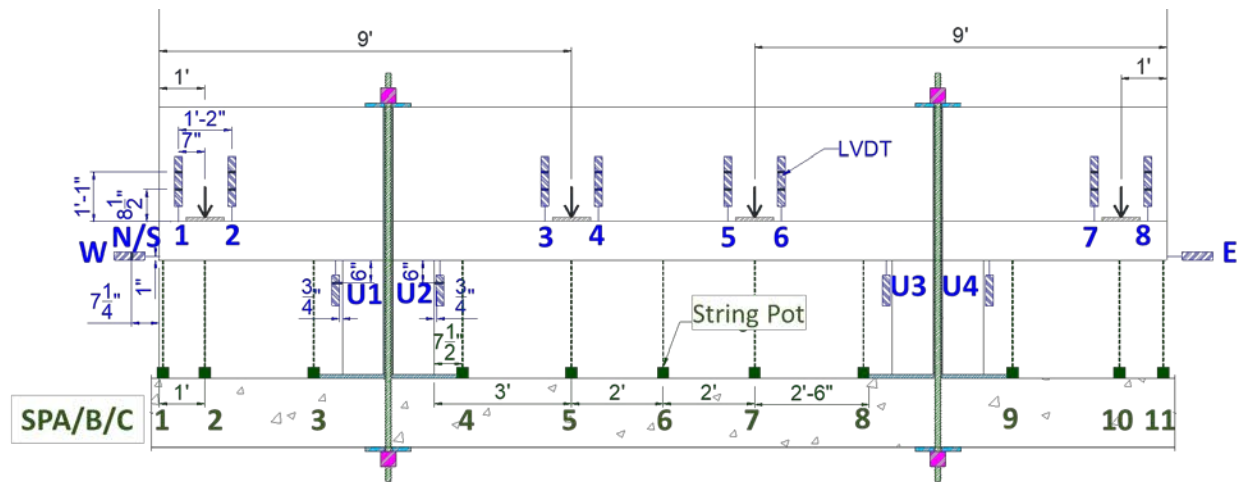
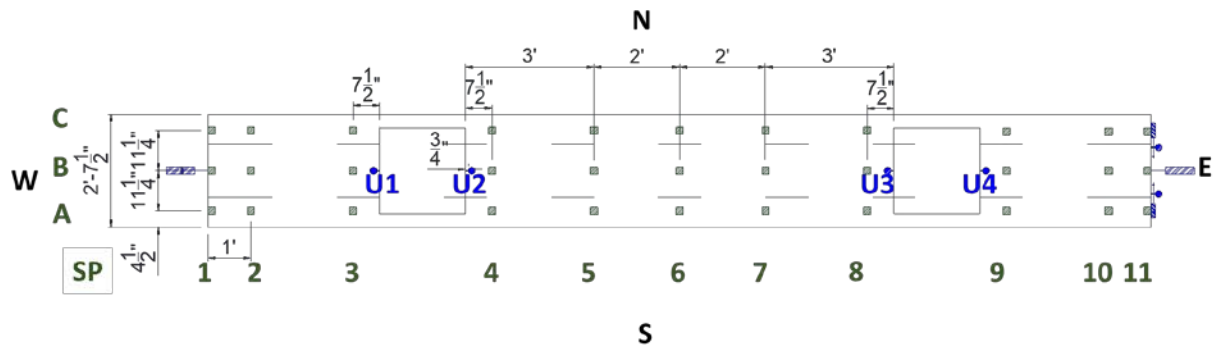
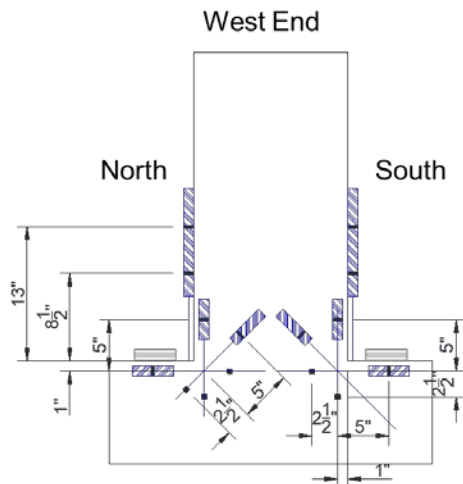
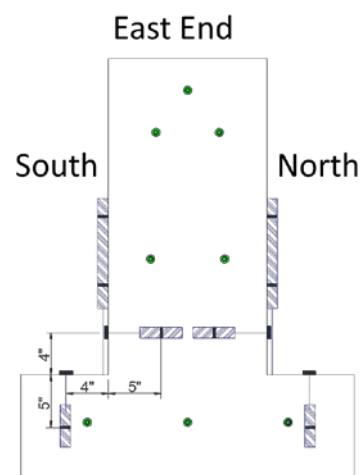
Figure 2.36. Overall LVDT and String Pot Installation Plan.

Figure 2.36 shows the instrument plan. Linear variable differential transducers (LVDTs) were used to measure differential displacement on each side of the loading point, at the edges or the columns, and on the end surfaces (exterior only). String potentiometers (string pots) were placed at 11 longitudinal stations to measure the vertical deflections. At each station, up to three string pots were placed in the transverse. String pots in Rows A and C (underneath ledge) were only used in the tested region.

(a) Side elevation view

(b) Bottom view

(c) South end surface

(d) End face plan for Solution 3

Table 2.9 lists string pot installation details, with label names corresponding with Figure 2.36.

For the tests with Solution 3 (end-region stiffener), the end face instrumentation plan moved the LVDTs to measure relative displacement between the end plate and specimen (Figure 2.36[d]). Table 2.10 lists LVDT installation details, with label names corresponding with Figure 2.36. For tests with Solution 3, LV5 and 6 were installed vertically, while LV7 and 8 were installed horizontally, as shown in Figure 2.36(d). LV9 and 10 were not used.

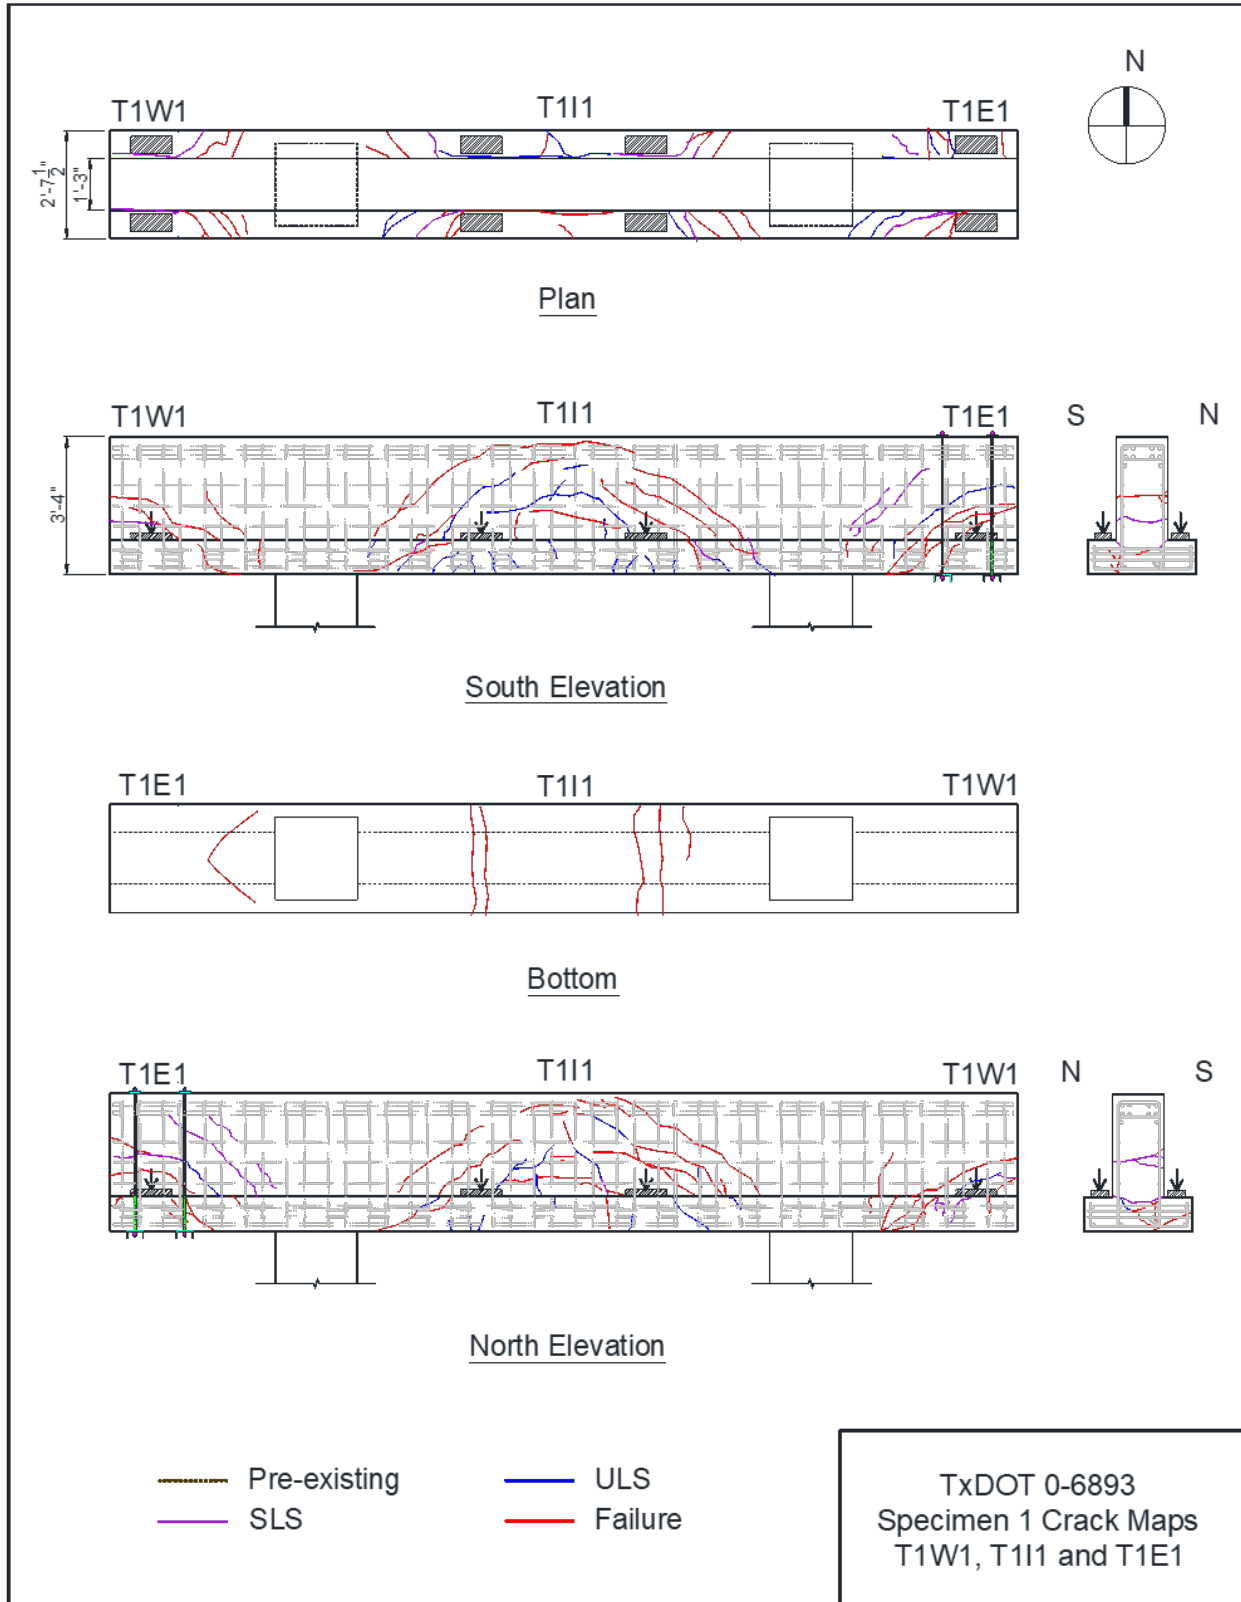
Figure 3.1. Crack Maps for Tests T1W1, T1I1, and T1E1.

Hanger-deficient Specimen 1 provided hanger reference tests on the exterior (T1W1) and interior (T1I1) and an exterior test of the clamped threadbar Solution 8(a) (T1E1). Figure 3.1 shows crack patterns at SLS, ULS, and failure.

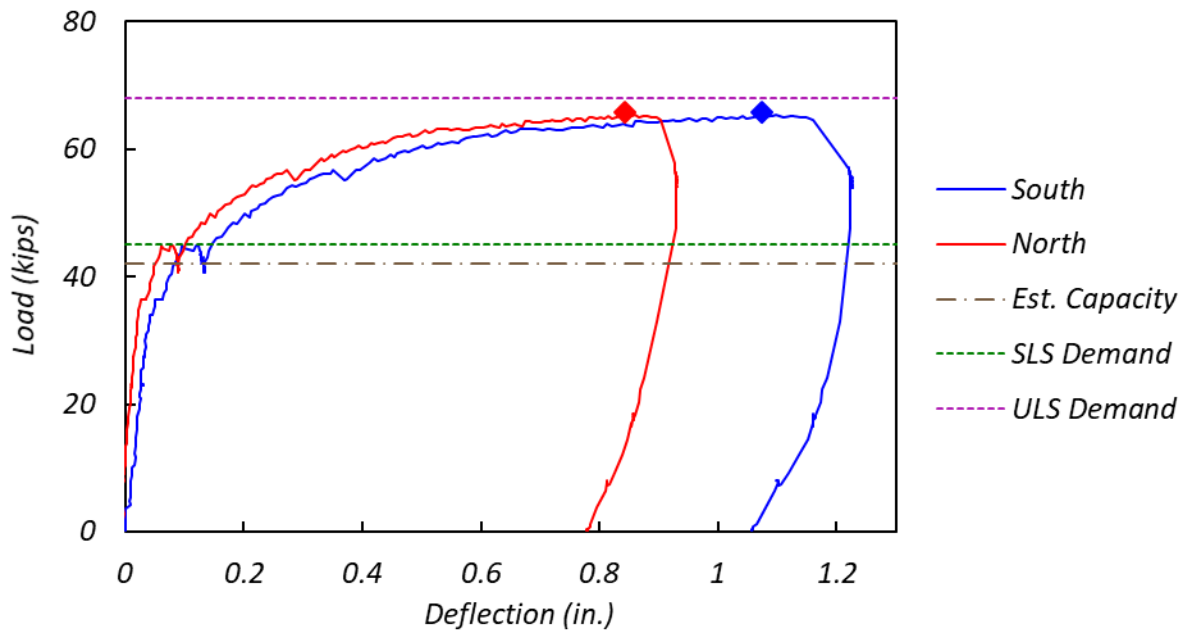
Figure 3.2. Load-Deflection Curve for T1W1.

T1W1 is the exterior reference test for hanger-deficient specimens. Figure 3.2 shows the load-deflection plots for the north and south load points, with horizontal lines indicating SLS, ULS, and estimated capacity, and diamonds indicating the measured ultimate load.

The measured ultimate load of 66 kips was 57 percent larger than the estimated capacity of 42 kips, but 2 kips less than ULS (68 kips). Loads were removed after documenting damage at the measured ultimate load. The controlling failure mechanism was hanger failure, as expected. Figure 3.3 shows the observed damage for test T1W1.

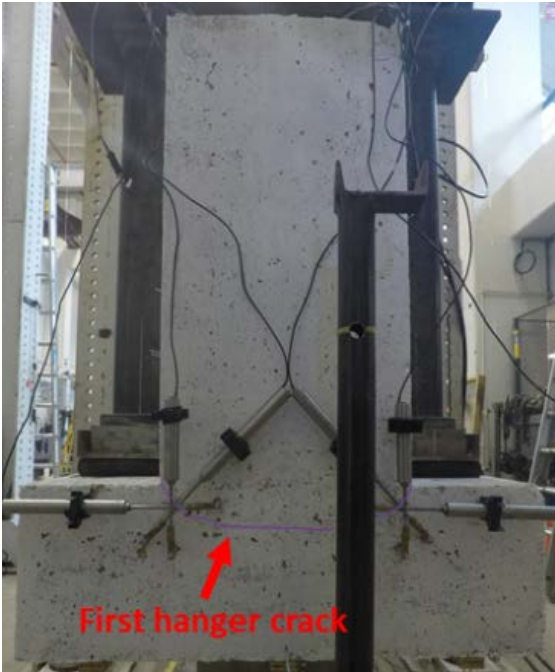
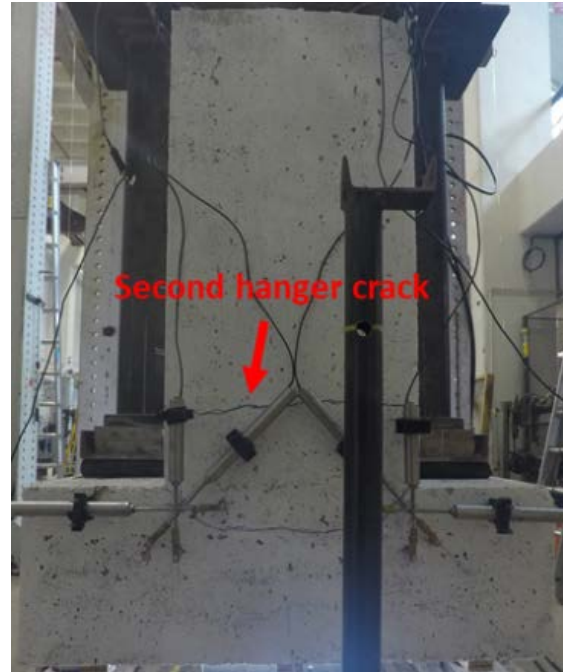
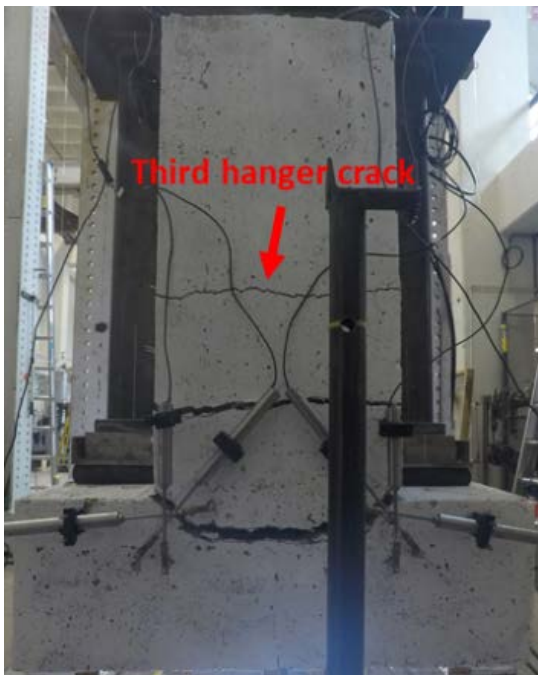
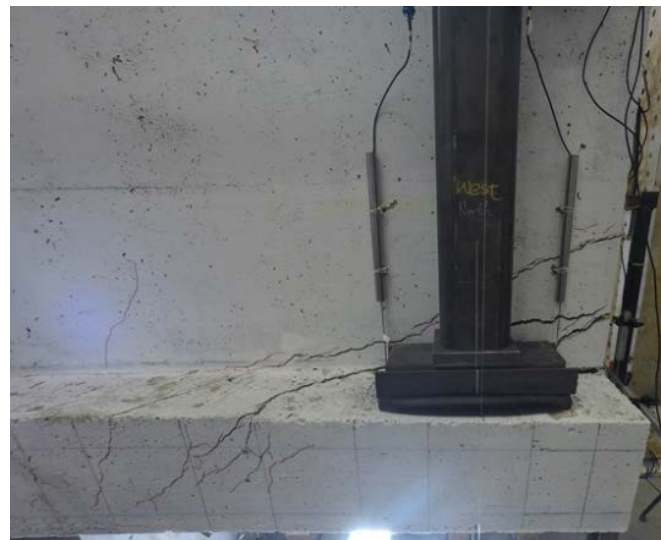
Figure 3.3. Observed Damage for T1W1 at Different Load Levels.

The initial crack, observed at 35.5 kips, was a hanger crack at the web-ledge interface, as shown in Figure 3.3(a). At SLS, an additional hanger crack formed near the neutral axis, as shown in Figure 3.3(b), with a width of 5 mm. The widths of the lower and upper hanger cracks were 3 mm and 5 mm, respectively. Cracks at the web-ledge interface extended behind the bearing pad, and on the north ledge turned diagonally from the inner edge of the bearing pad to the side face of the ledge. At loads beyond SLS, crack extensions and new crack formations were observed. At 57 kips, a third hanger crack formed on the end face 7 in. above the second hanger crack. Figure 3.3(c) and (d) show the damage on the end face and north side ledge at the measured ultimate load (66 kips), respectively. The widths of the first, second, and third hanger cracks were 15 mm, 1 mm, and 0.7 mm, respectively. Diagonal shear cracks were detected on both sides of the web, with an approximate angle of 30 degrees. New cracks also formed on the top and side face of the ledge, with more cracks on the north side than the south side.

(a) First crack at 35.5 kips

(b) SLS—end face

(c) Final load level—end face

(d) Final load level—north side

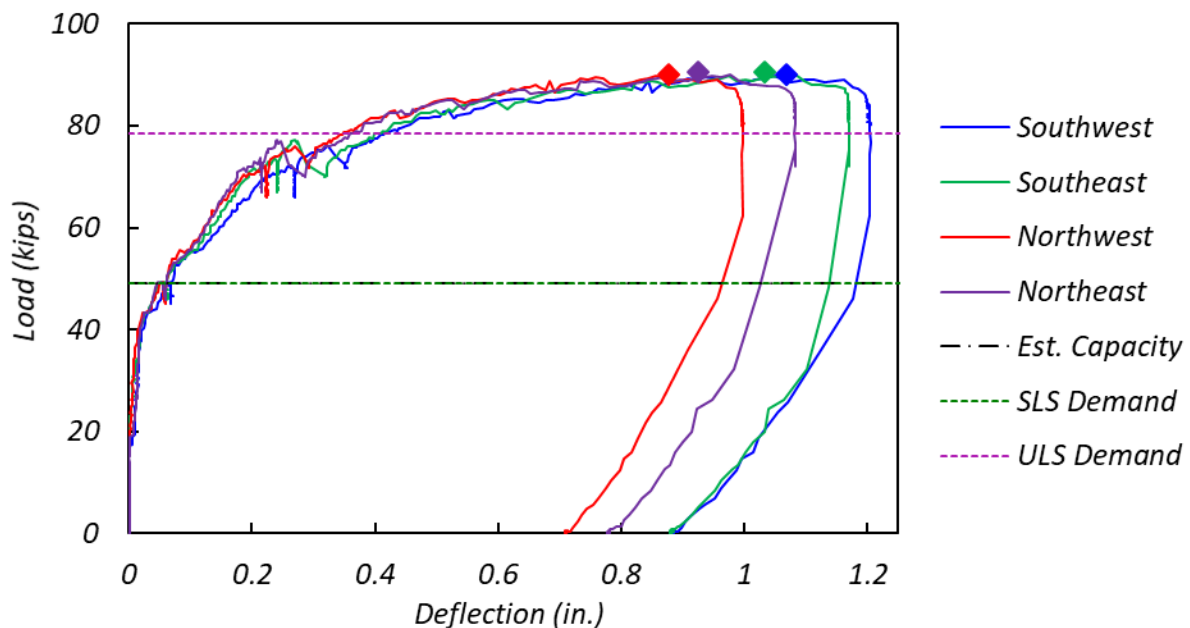
Figure 3.4. Load-Deflection Curve for T1I1.

T1I1 is the interior reference test for hanger-deficient specimens. Figure 3.4 shows the load-deflection plots for all load points.

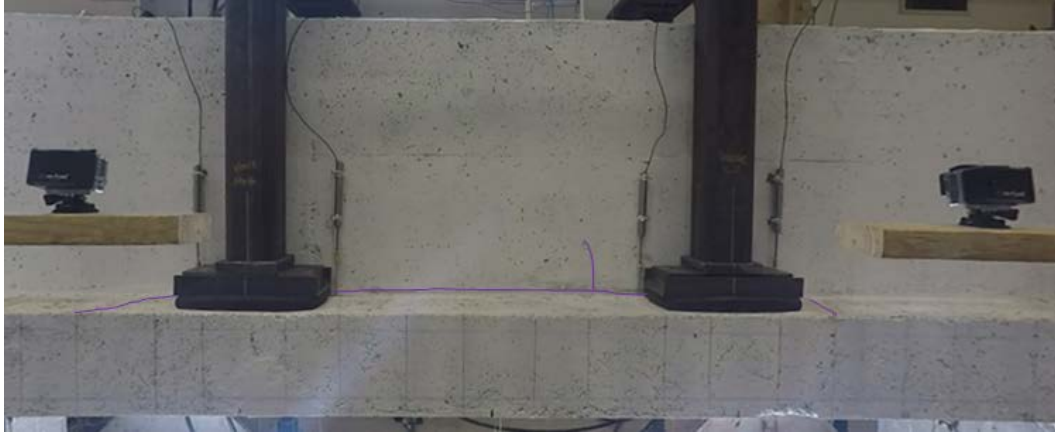
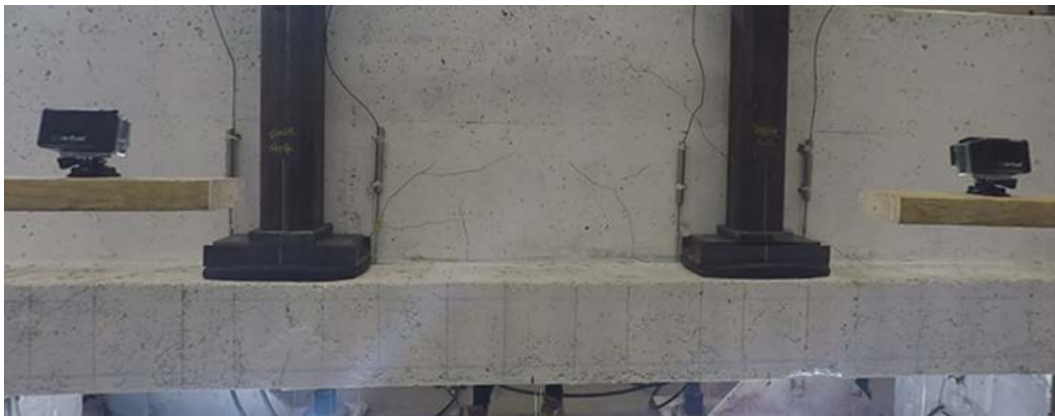
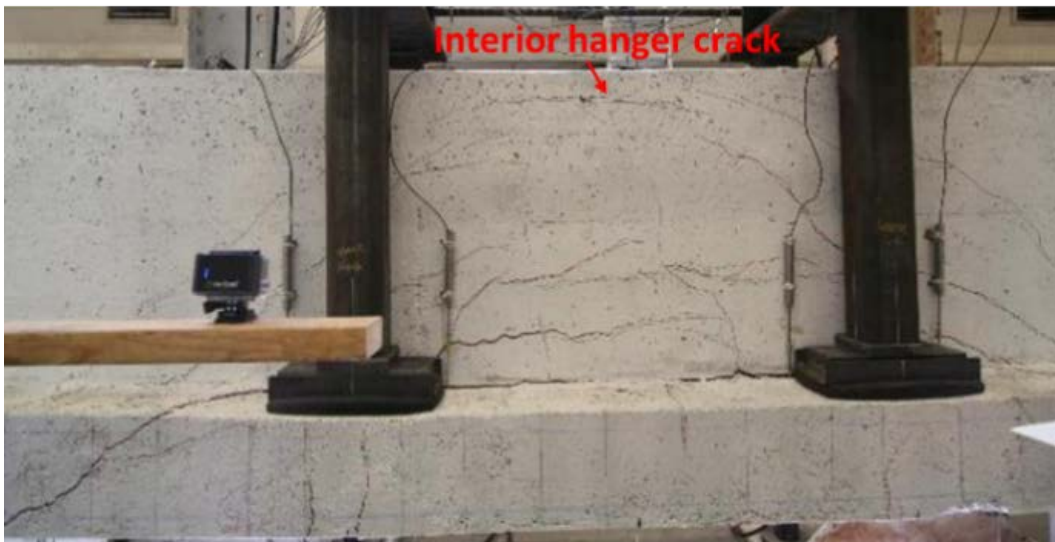
Figure 3.5. Observed Damage for T1I1 at Different Load Levels.

The initial cracks were observed at 49 kips. Figure 3.5(a) shows the cracks at SLS. The cracks formed at the web-ledge interface propagated between the two bearing pads. On the outside of the bearing pad, the cracks extended diagonally, starting at the outside edge of the bearing pads to the side face of the ledge. A 10 in. long vertical crack formed on the web about 18 in. away from the center of the west bearing pad. Crack extensions and new crack formations were observed as the load increased. Flexural cracks were found on the bottom of the bent cap at 56 kips. Web shear cracks started forming at 65 kips.

(a) SLS—north side

(b) ULS—north side

(c) Final load level—north side

At the ULS of 78.5 kips, web shear cracks at an approximate angle of 45 degrees were detected on both sides of the web. Figure 3.5(b) shows the cracks at ULS. The maximum width of the web shear cracks was 4.5 mm. The flexural cracks on the bottom extended to the side face of the ledge. On the outside of the bearing pads, diagonal cracks formed on the side of the ledge.

Crack length and width grew as the load increased while new web shear cracks were forming. Web shear cracks started to rotate and propagate horizontally as they extended toward the top of the web. At the measured ultimate load of 90 kips, web shear cracks initiated from the outside of the bearing pads that were connected and formed the interior hanger cracks, as shown in Figure 3.5(c). The maximum width of the web shear cracks was 2.5 mm.

The measured ultimate load of 90 kips was 84 percent larger than the estimated capacity of 49 kips. Loads were removed after documenting damage at the measured ultimate load. The controlling failure mechanism was hanger failure, as expected. Figure 3.5 shows the observed damage for test T1I1.

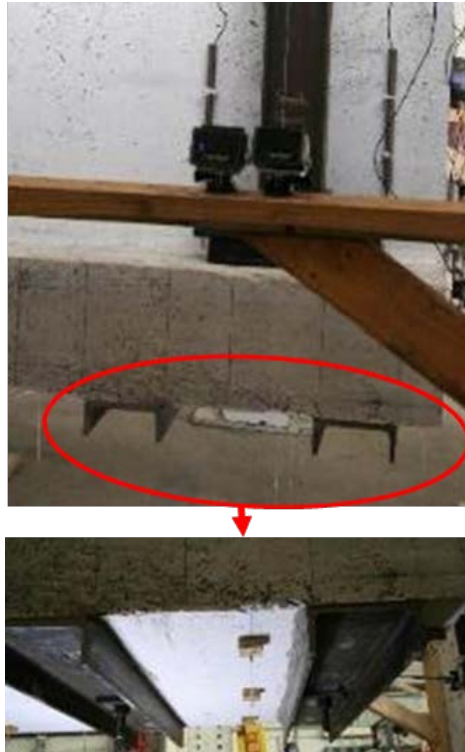
Figure 3.6. Retrofit Solution 8(a) Installed on East End of Hanger-Deficient Specimen 1.

T1E1 is an exterior test using two clamped threadbars (Solution 8[a]). Figure 3.6 shows the Solution 8(a) installed on the east end of the specimen. Figure 3.7 shows the load-deflection plots for the north and south load points.

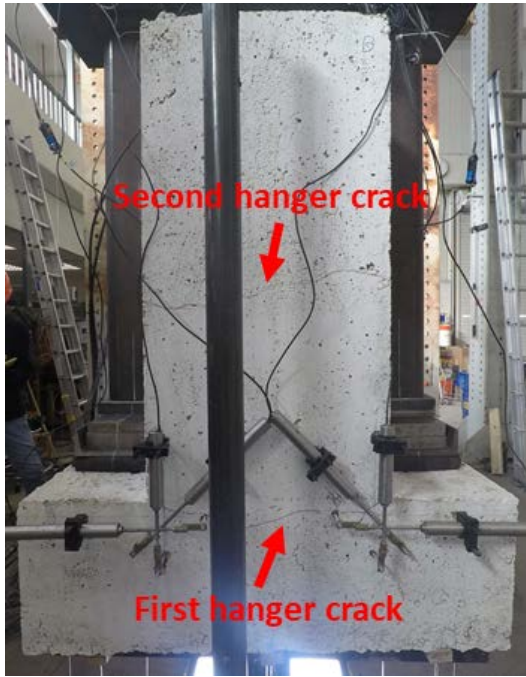
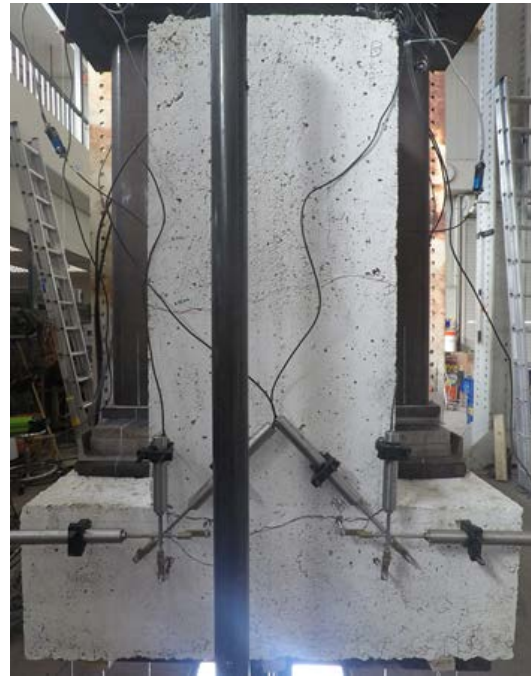
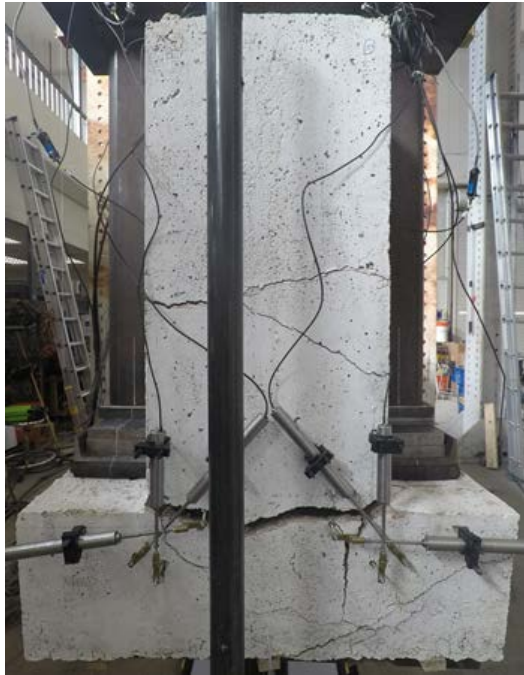
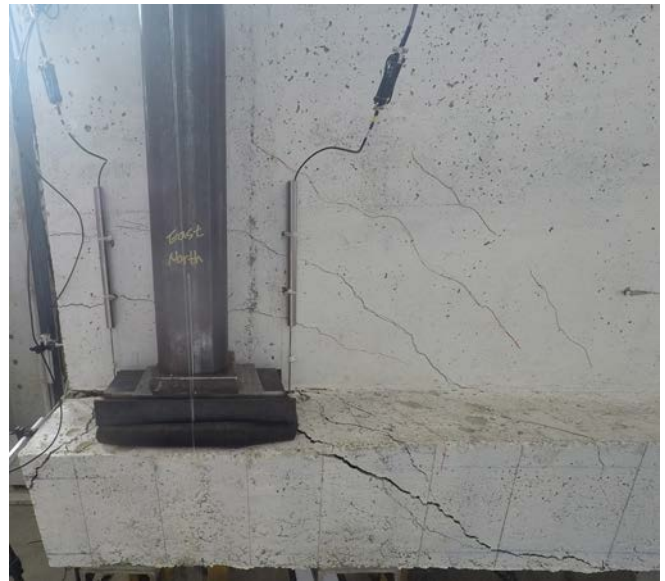
Figure 3.8. Observed Damage for T1E1 at Different Load Levels.

At the SLS of 45 kips, only a hairline crack was detected at the web-ledge interface behind the south bearing pad. The crack propagated 10 in. from the center of the bearing pad. The first hanger crack on the end face formed at the estimated capacity of 77 kips near the web-ledge interface, as shown in Figure 3.8(a). The second hanger crack formed near the neutral axis of the bent cap right after the first hanger crack. The crack widths of the first and second hanger cracks were 0.45 mm and 0.2 mm, respectively. On the top of the ledge, the cracks behind the bearing pad extended diagonally to the side face of the ledge. Web shear cracks were also detected on both sides of the web. Crack extension and new crack formation were observed as load increased.

At the ULS of 68 kips, more cracks were detected on the web and ledge. On the end face, the width of the first and second hanger cracks were increased to 0.45 mm and 1.5 mm, respectively. Figure 3.8(b) shows the end face of the bent cap at ULS. Significant extensions of existing cracks and new crack formations were detected while the load increased. At the measured ultimate load of 106 kips, more cracks formed on the web, ledge, and end face. The width of the first and second hanger cracks opened up to 2.5 mm and 10 mm, respectively.

(a) End face at estimated capacity

(b) End face at ULS

(c) End face at final load level

(d) North side at final load level

Solution 8(a) is expected to increase the hanger, ledge, and punching shear capacity of the bent cap. The measured ultimate load was 106 kips, which is 38 percent larger than the estimated capacity of 77 kips and 61 percent larger than the exterior hanger-deficient reference capacity. The test was ended after documenting damage at the measured ultimate load. Figure 3.8 shows the observed damage at different load levels and the hanger failure mode at the ultimate load level.

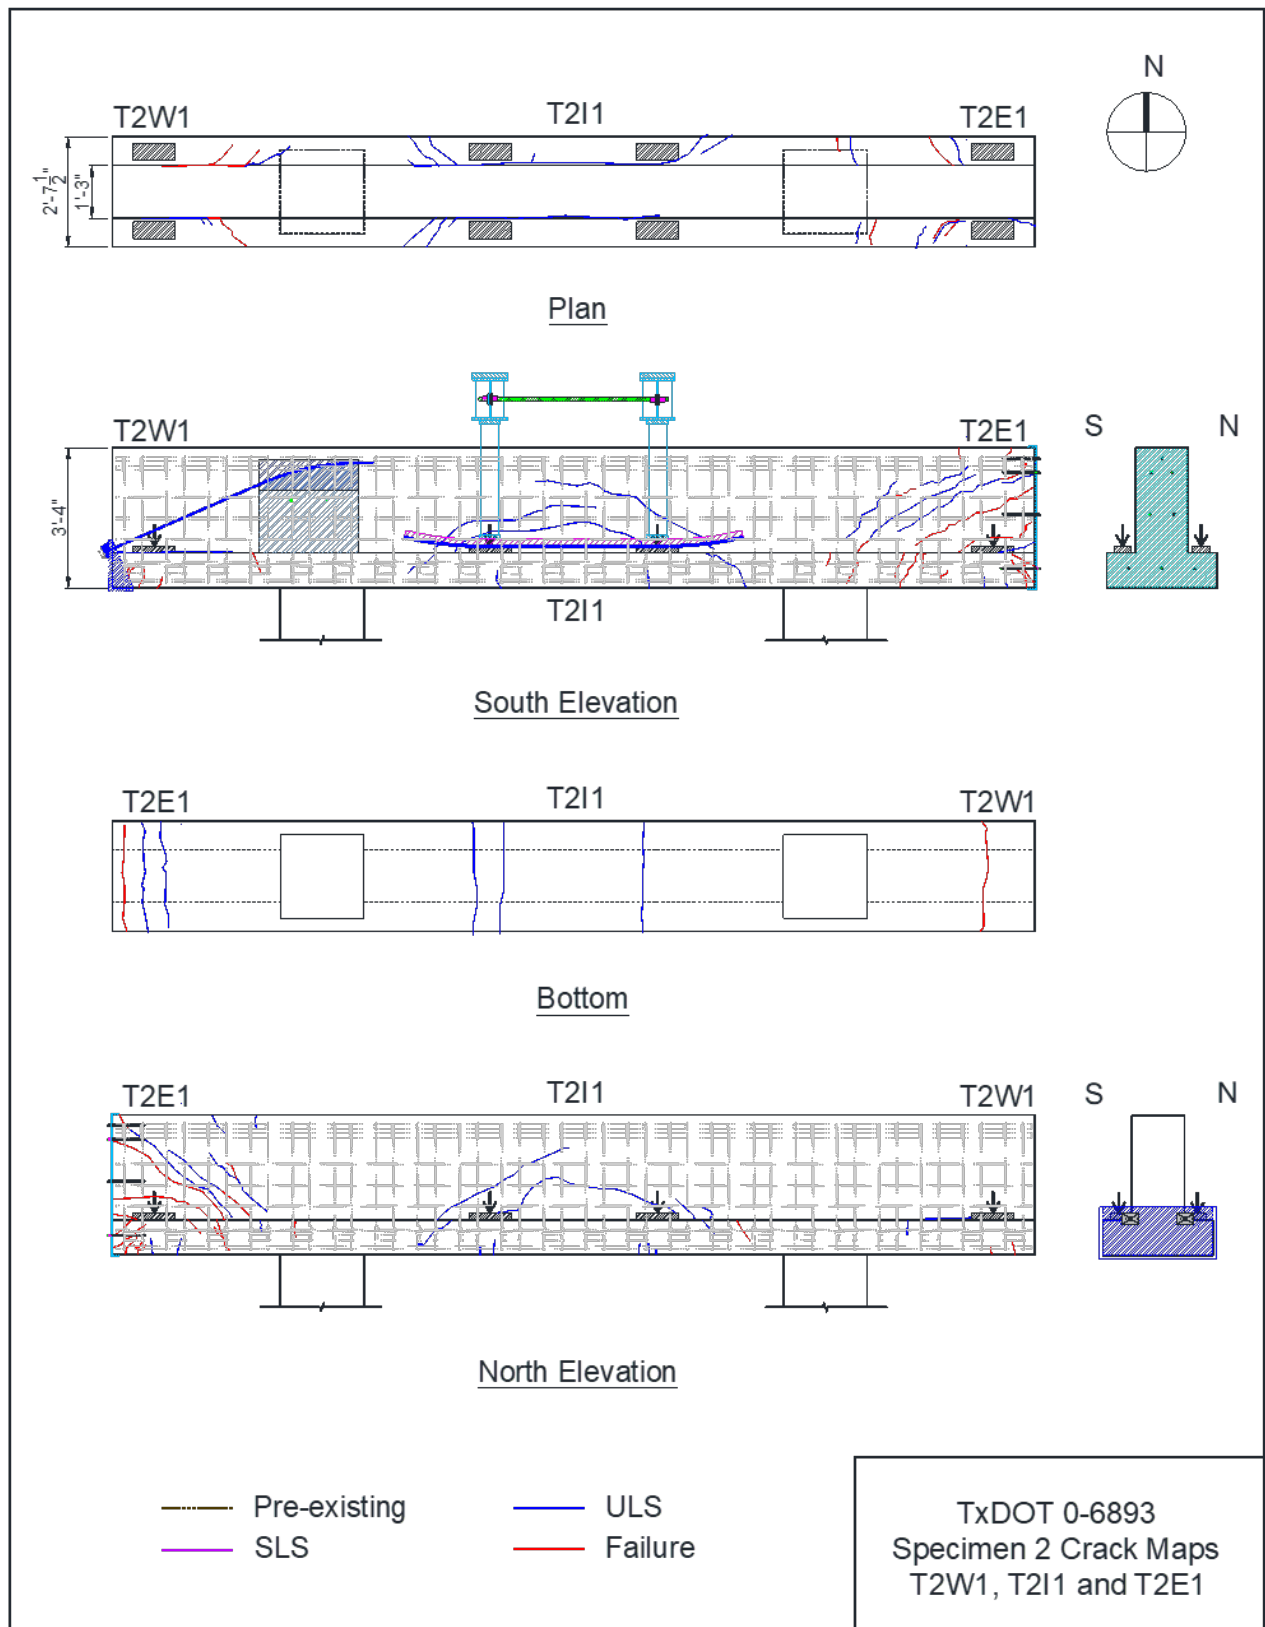
Figure 3.9. Crack Maps for Tests T2W1, T2I1, and T2E1.

Hanger-deficient Specimen 2 had three exterior tests (T2W1, T2E1, and T2W2) and two interior tests (T2I1 and T2I2). Test T2E1 tested the end-stiffener retrofit solution (Solution 3). Tests T2W1 and T2I1 tested the load-balancing PT solution (Solution 14) for the exterior and interior; both tests were stopped prior to failure. The retrofits were removed to test the full-depth FRP solution (Solution 17) for the exterior (T2W2) and interior (T2I2). Figure 3.9 shows crack patterns for tests T2W1, T2I1, and T2E1. Figure 3.10 shows crack patterns for tests T2W2 and T2I2, with cracks from previous tests marked by gray lines.

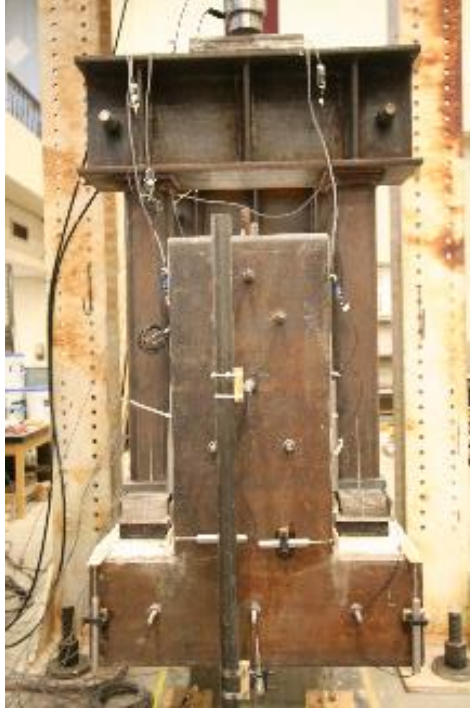
Figure 3.11. Retrofit Solution 3 Installed on East End of Hanger-Deficient Specimen 2.

T2E1 is an exterior test using an end stiffener (Solution 3). Figure 3.11 shows Solution 3 installed on the east end of the specimen. Figure 3.12 shows the load-deflection plots for the north and south load points, with horizontal lines indicating SLS, ULS, and estimated capacity, and diamonds indicating the measured ultimate load.
