Strengthening of Existing Inverted-T Bent Caps— Volume 2: Experimental Test Program

Technical Report 0-6893-R1-Vol2

TEXAS A&M TRANSPORTATION INSTITUTE
COLLEGE STATION, TEXAS

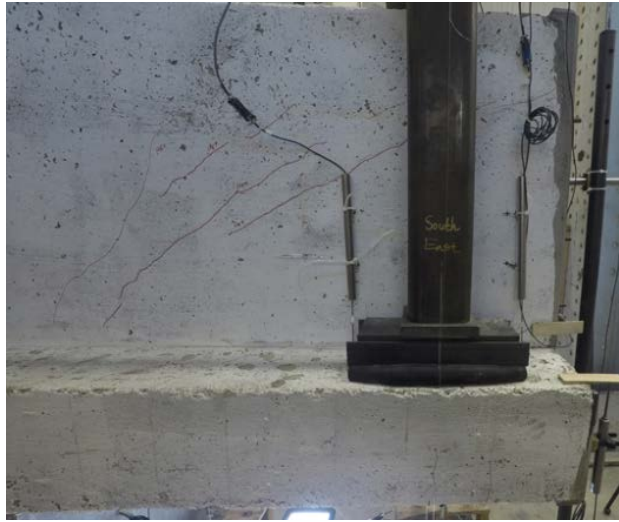
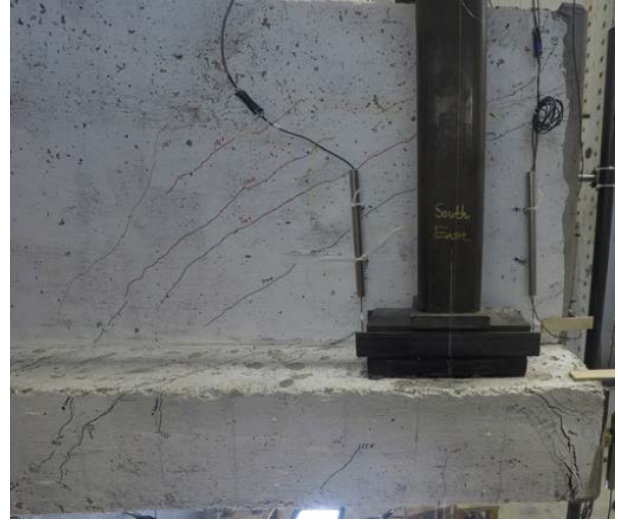
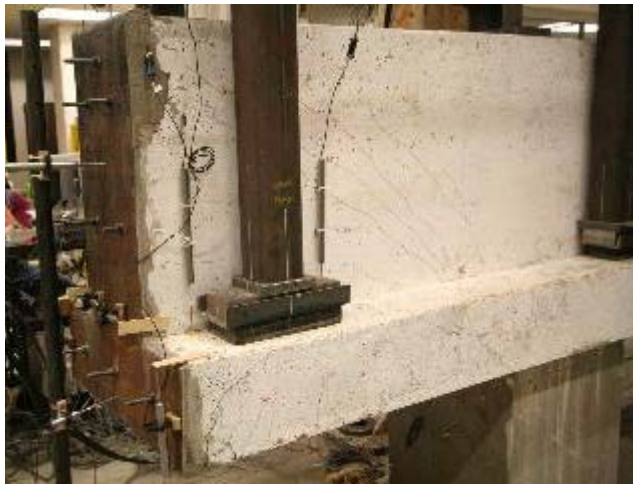
Figure 3.13. Observed Damage for T2E1 at Final Load Levels.

At ULS (68 kips), new cracks formed on the web and on the top and side face of the ledge. Diagonal ledge cracks on the side face of the ledge were observed under the bearing pads. Diagonal web cracks were also detected on both sides of the web. As the applied load increased to the measured ultimate load, crack extensions and new crack formations were observed on both the web and the ledge.

At the measured ultimate load of 78 kips, the end plate was bent at the bottom tip and in the stem near the neutral axis. New cracks had formed on the web and the side of the ledge. There were fewer cracks at the inside of the bearing pad compared to the reference test, which may have been due to the restraint provided by the end plate. The diagonal cracks on the outside of the bearing pad were steeper than the inside cracks.

(a) South side at ULS

(b) South side at final load level

(c) North side at final load level

Solution 3 is expected to increase the hanger, ledge, and punching shear capacity of the exterior portion of the bent cap. The measured ultimate load was 78 kips, which is 5 percent larger than the estimated capacity of 74 kips and 18 percent larger than exterior hanger-deficient reference capacity. The test was ended when the applied load dropped to about 90 percent of the measured ultimate load. Figure 3.13 shows the observed damage at different load levels. The bent cap experienced a ledge shear failure.

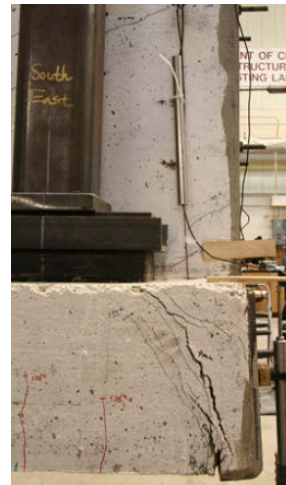
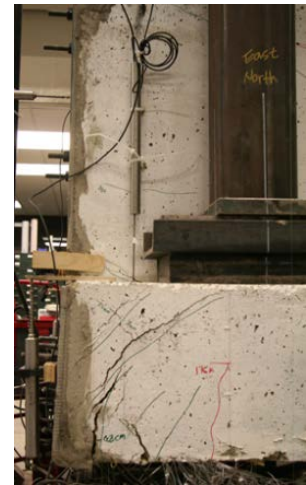
(d) South side bottom tip at final load level

(e) North side bottom tip at final load level

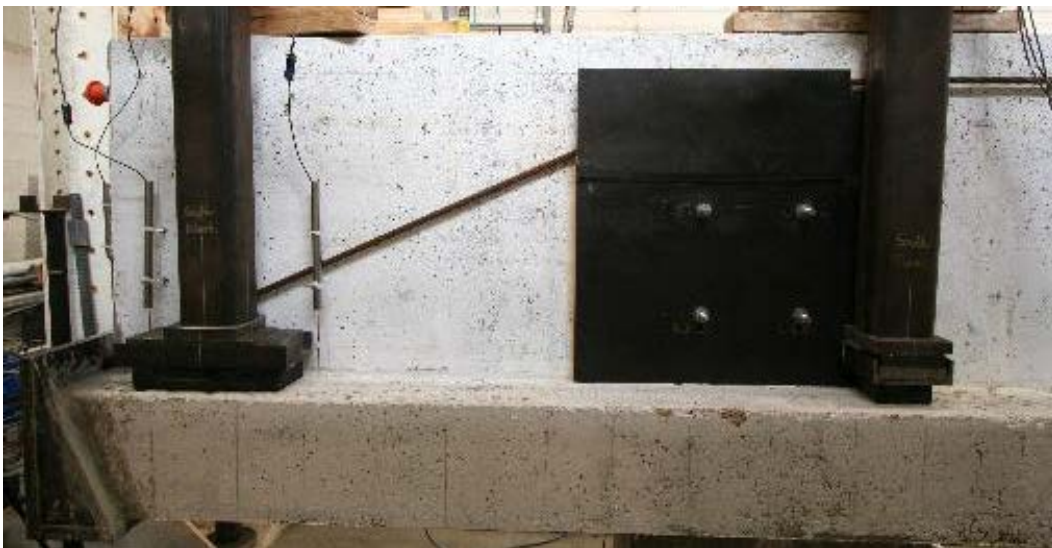
Figure 3.14. Retrofit Solution 14 Installed on West End of Hanger-Deficient Specimen 2.

T2W1 is an exterior test using the load-balancing PT retrofit solution (Solution 14). Figure 3.14 shows Solution 14 installed on the west end of the specimen. The test was terminated prior to failure or reaching a measured ultimate load. The test termination load (82 kips) was determined by adding the capacity contribution of the PT strands (16 kips) to the ultimate load capacity of the hanger-deficient exterior reference test (66 kips). Figure 3.15 shows the load-deflection plots for the north and south load points, with the diamond indicating the termination load.

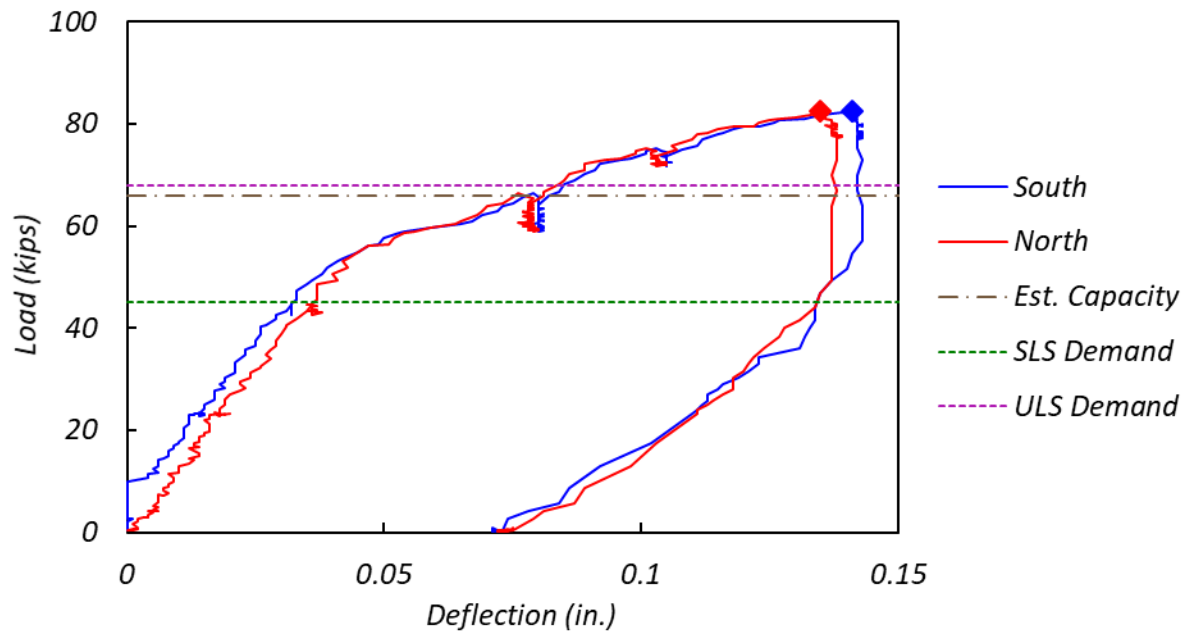
Figure 3.15. Load-Deflection Curve for T2W1 (Test Terminated Prior to Failure).

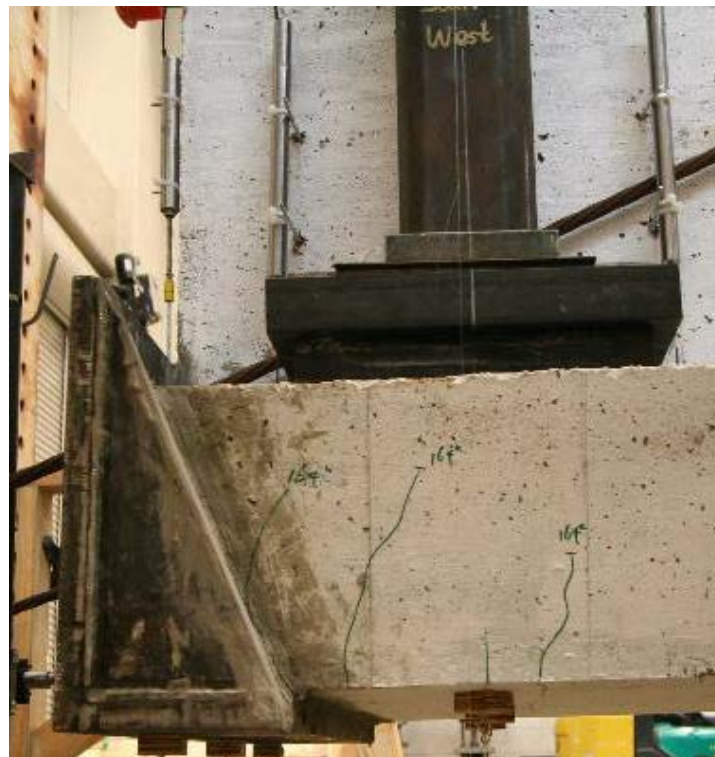
Figure 3.16. Observed Damage for T2W1 at Test Termination Load.

Solution 14 is expected to increase the hanger, ledge, and punching shear capacity. Figure 3.16 shows the observed damage at the test termination load. The specimen maintained a load carrying capacity with a moderate level of damage at an applied load 24 percent larger than the ultimate load capacity of the hanger-deficient exterior reference test.

At the test termination load, new cracks formed on the ledge and bottom of the specimen. Diagonal cracks on the side face of the ledge under the bearing pads were detected on both sides. The cracks that started at the bottom of the bent cap propagated about half the depth of the ledge toward the center of the bearing pad from the outside. Diagonal cracks on the side of the ledge were hairline cracks. The width of the cracks at the web-ledge interface increased to 1 mm. New diagonal cracks were also detected on top of the ledge. One more horizontal crack formed on the bottom and 3 in. from the end of the specimen. It was detected after removal of the retrofit parts.

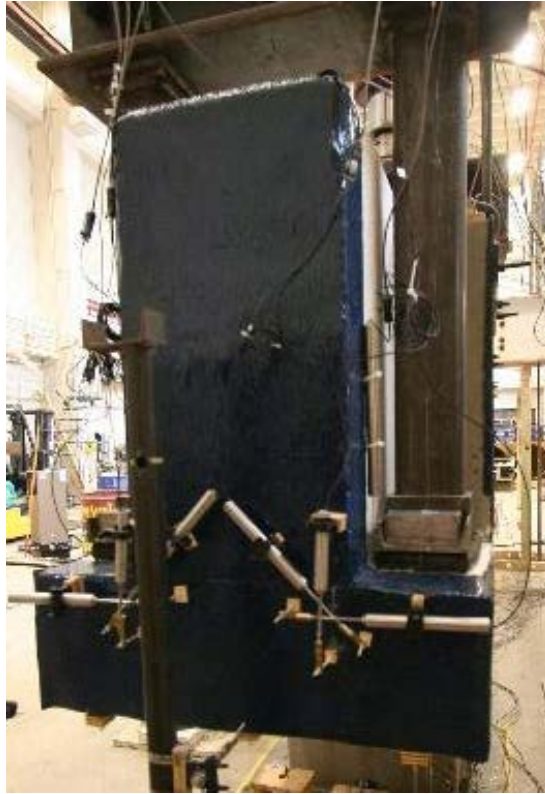
Figure 3.17. Retrofit Solution 17 Installed on West End of Hanger-Deficient Specimen 2.

T2W2 is an exterior test using the full-depth FRP retrofit solution (Solution 17) and was implemented with previous damage that occurred during test T2W1. Figure 3.17 shows the post-crack Solution 17 installed on the west end of the specimen. Figure 3.18 shows the load-deflection plots for the north and south load points.

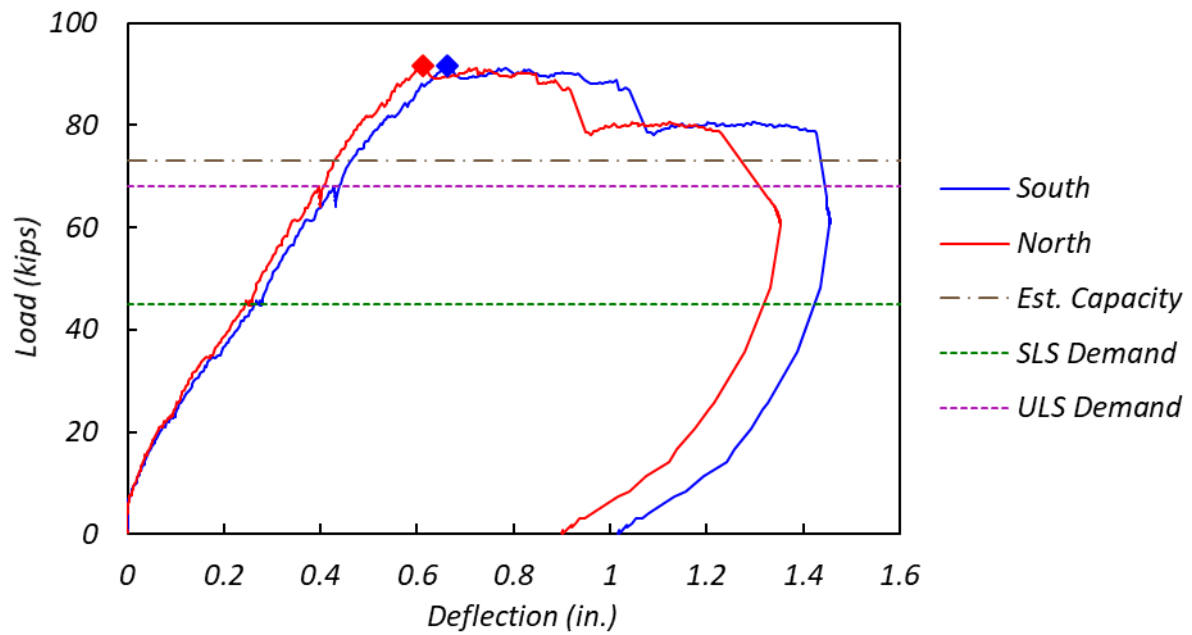
Figure 3.18. Load-Deflection Curve for T2W2.

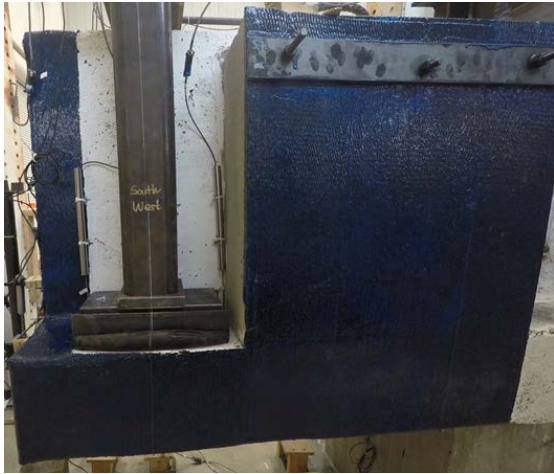
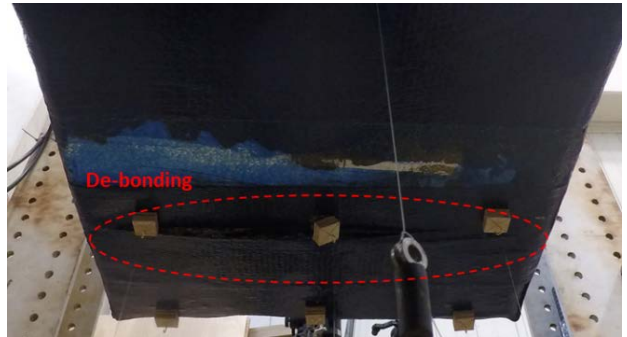
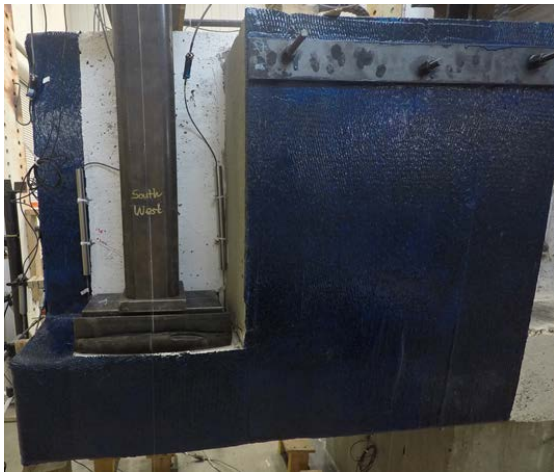
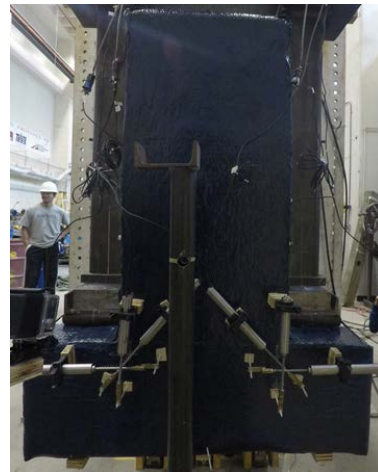
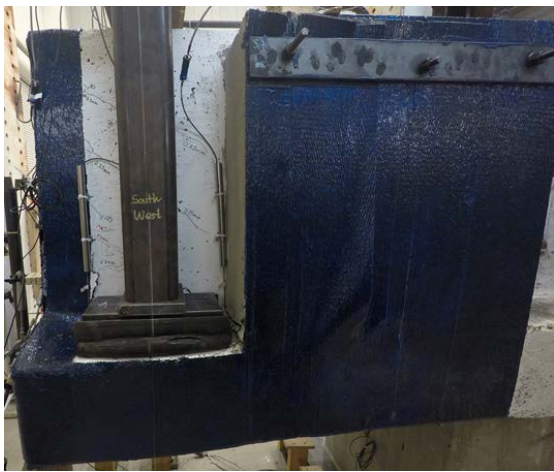
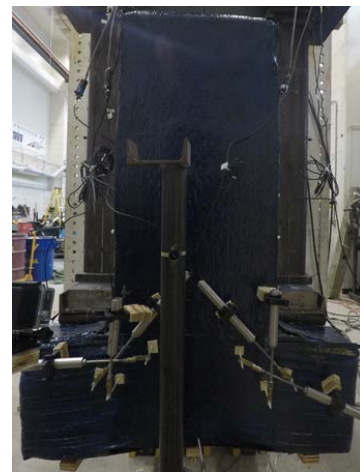
(a) North side at ULS

(b) Bottom at measured ultimate load

(c) North side at measured ultimate load

(d) End face at measured ultimate load

(e) North side at final load level

(f) End face at final load level

Figure 3.19. Observed Damage for T2W2 at Different Load Levels.

The measured ultimate load (92 kips) was 26 percent larger than the estimated capacity of 73 kips and 39 percent larger than the exterior hanger-deficient reference capacity. The test was ended when the applied load dropped to about 70 percent of the measured ultimate load. Figure 3.19 shows the observed damage at different load levels. The bent cap experienced a combined hanger and ledge flexure failure at the final load level.

At the ULS of 68 kips, cracks formed at the interface between the concrete block and the ledge beside the south side bearing pad. Figure 3.19(a) shows the observed damage on the north side ledge at current load level. Web shear cracks were detected on both sides of the web at the east side of the concrete block. More cracks were observed on the web as the load increased. Horizontal cracks on the flange of the end face started forming at 78.5 kips. Interface cracks between the north side concrete block and the ledge were detected at 81.5 kips.

At the measured ultimate load of 92 kips, the bottom tip of the web FRP de-bonded, as shown in Figure 3.19(b). On the south side concrete block, vertical cracks formed on the FRP wrap. Shear-cracking-induced debonding of the FRP was observed near the center of the south side concrete block. No notable damage was detected on the end face.

The specimen was further loaded after documenting the damage at the measured ultimate load. The applied load was sustained at 90 kips for about two minutes and then dropped to 80 kips. Figure 3.19(e) and (f) show the observed damage at the final load level. Additional cracks formed, and the FRP wrap de-bonded at the top of the south side concrete block. Vertical- and shear-crack-induced FRP debonding was also detected on the north side. FRP separation was observed at the web-ledge interface near the end of the bent cap. The damage increased significantly while the load was sustained at 80 kips for approximately three minutes. The test was ended when the load dropped to 65 kips which was 30 percent lower than the measured ultimate load.

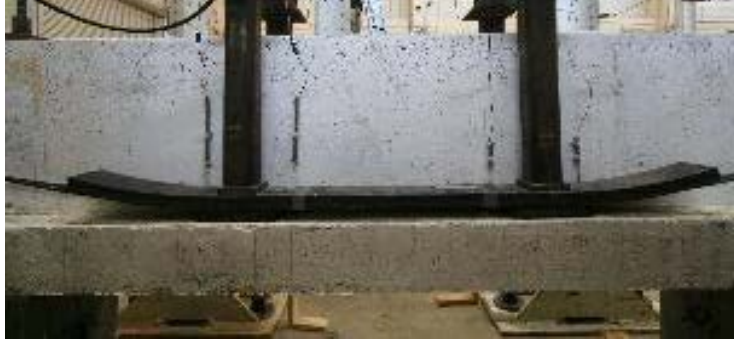
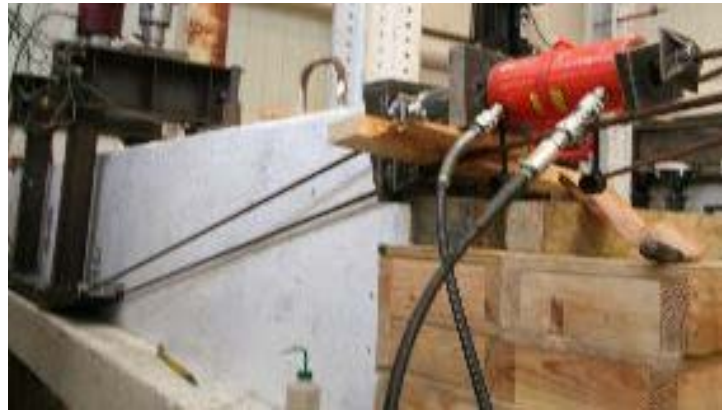
(a) Assemblies before testing

(b) Jacking of PT strands after dead load

Figure 3.20. Retrofit Solution 14 Installed on Interior of Hanger-Deficient Specimen 2.

T2I1 is an interior test using the load-balancing PT retrofit solution (Solution 14). In the interior region, the load balancing works by lifting the girders, thereby reducing the demands on the ledge. In order for the test to reflect conditions of field implementation, the specimen was loaded to dead load prior to stressing the strands. Implementation of the solution is shown in Figure 3.20. The strands were stressed one at a time using a mono strand jack, as shown in Figure 3.20(b). After the PT operation, the specimen was loaded to a test termination load of 105 kips which was determined by adding the capacity contribution of the PT strands (15 kips) to the ultimate load capacity of the hanger-deficient interior specimen (90 kips). Figure 3.21 shows the load-deflection plots for all load points, with diamond symbols indicating the test termination load.

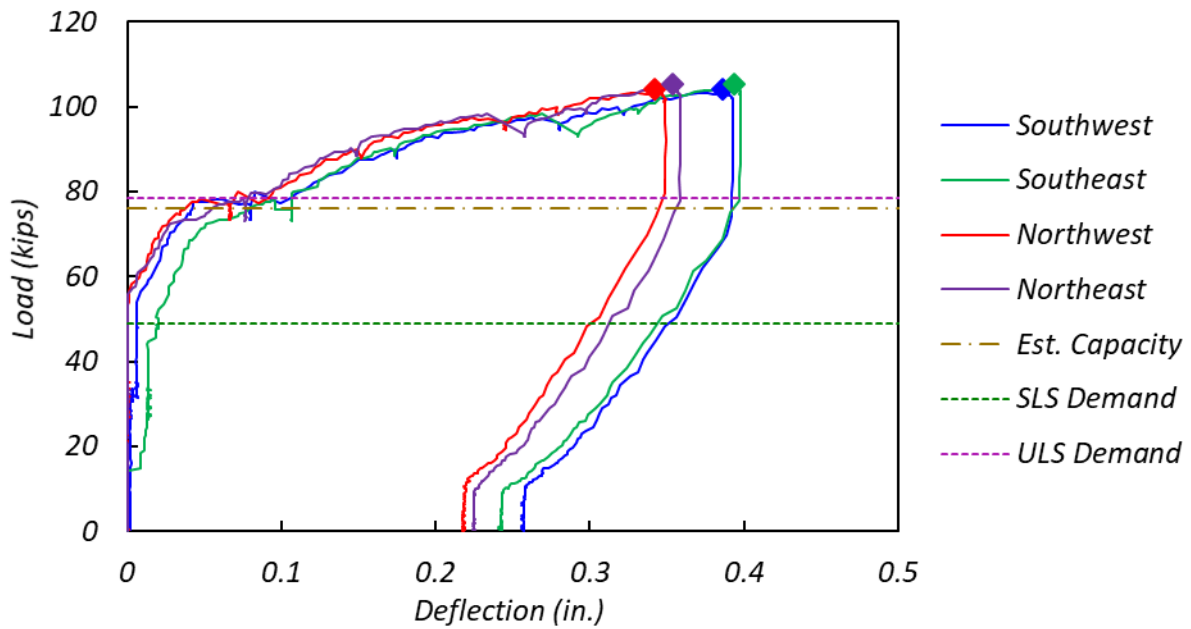
Figure 3.21. Load-Deflection Curve for T2I1.

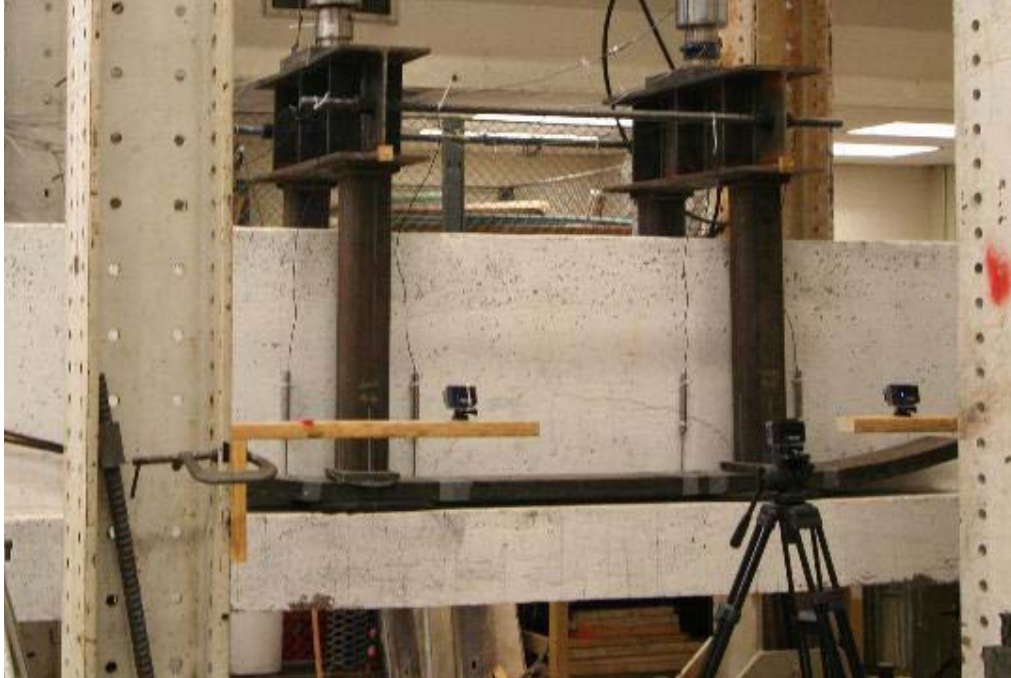
Figure 3.22. Observed Damage for Test T2I1 at Test Termination Load.

Figure 3.22 shows the observed damage at the test termination load. The specimen maintained a load carrying capacity with a moderate level of damage at the test termination load that was 17 percent larger than the ultimate load capacity of the hanger-deficient interior reference specimen.

No damage was observed until the ULS of 78.5 kips. At ULS, cracks formed at the web-ledge interface behind the bearing pads. The interface cracks propagated through the mid-span between the two bearing pads on both sides of the web. Diagonal shear cracks that initiated at the outside of the bearing pads and propagated toward the center of the specimen were formed on both sides of the web. The angle of the web shear cracks appeared to decrease as they got close to the center of the bent cap. Flexure cracks were detected on the bottom of the bent cap under the bearing pads. At the test termination load of 105 kips, the length and width of existing cracks increased, but no new cracks formed.

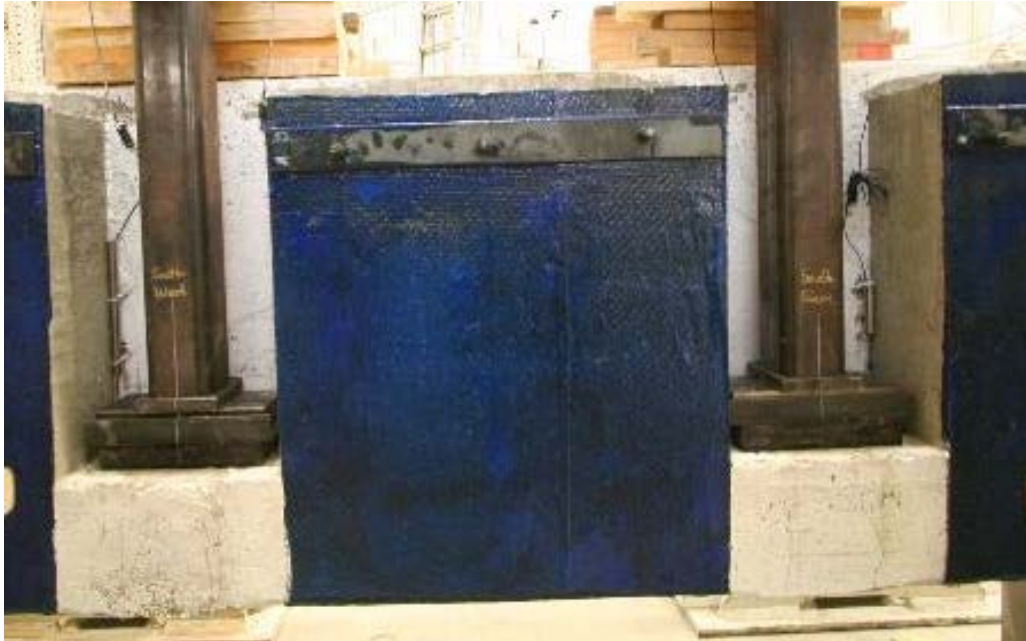
Figure 3.23. Retrofit Solution 17 Installed on Interior of Hanger-Deficient Specimen 2.

T2I2 is an interior test using the full-depth FRP retrofit (Solution 17) and was implemented with previous damage that occurred during test T2I1. Figure 3.23 shows Solution 17 installed on the interior of the specimen. Figure 3.24 shows the load-deflection plots for all load points.

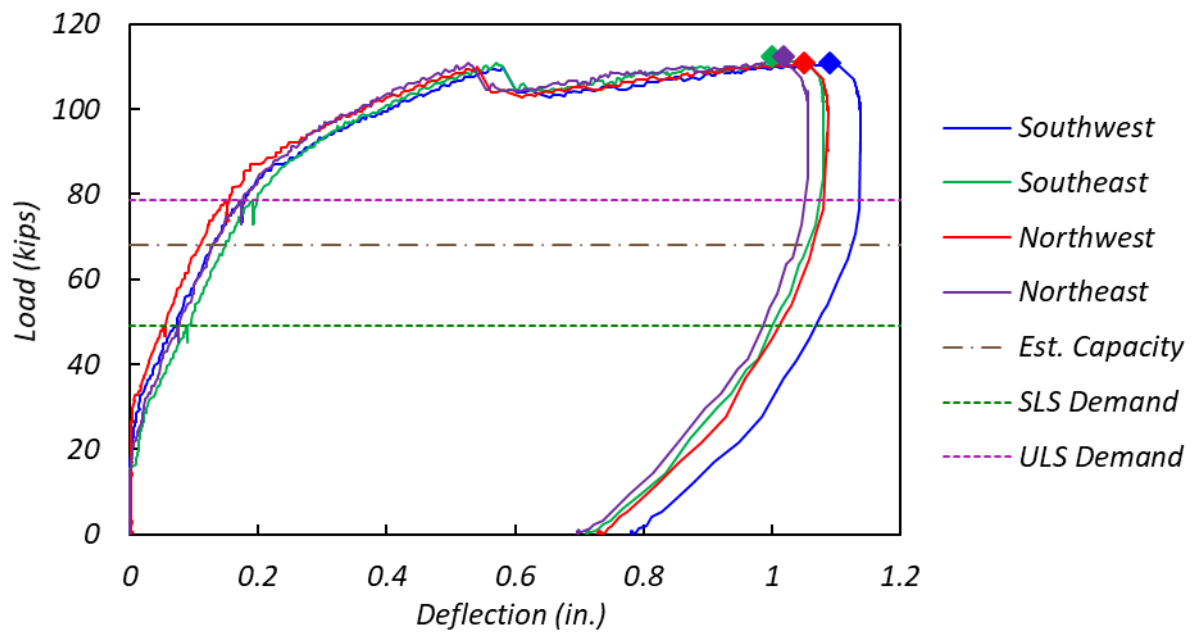
Figure 3.24. Load-Deflection Curve for T2I2.

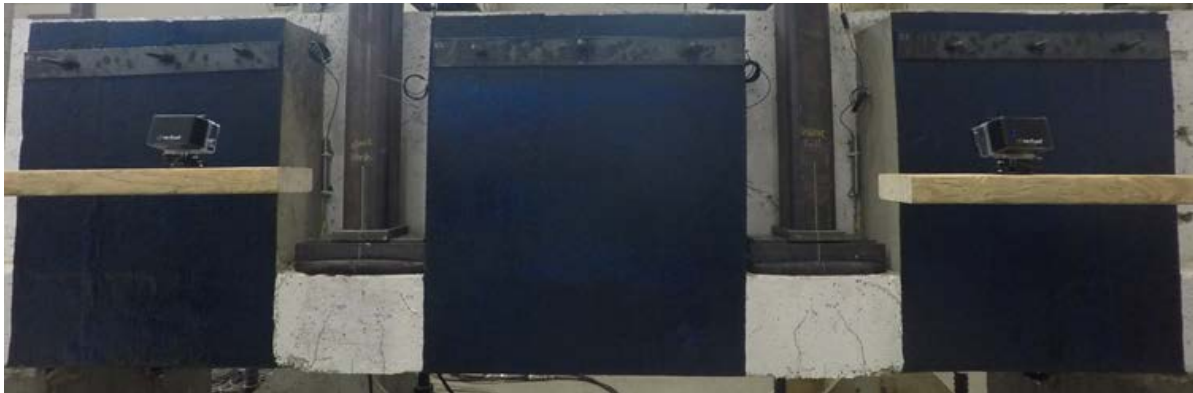
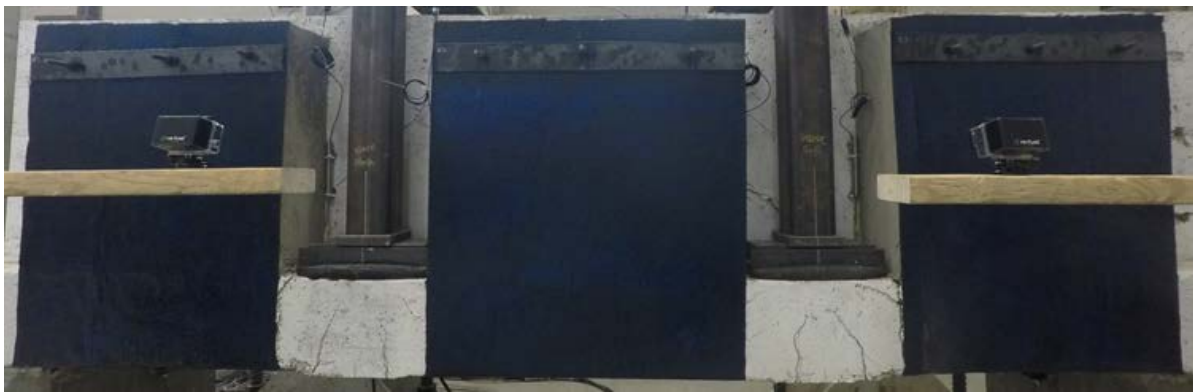
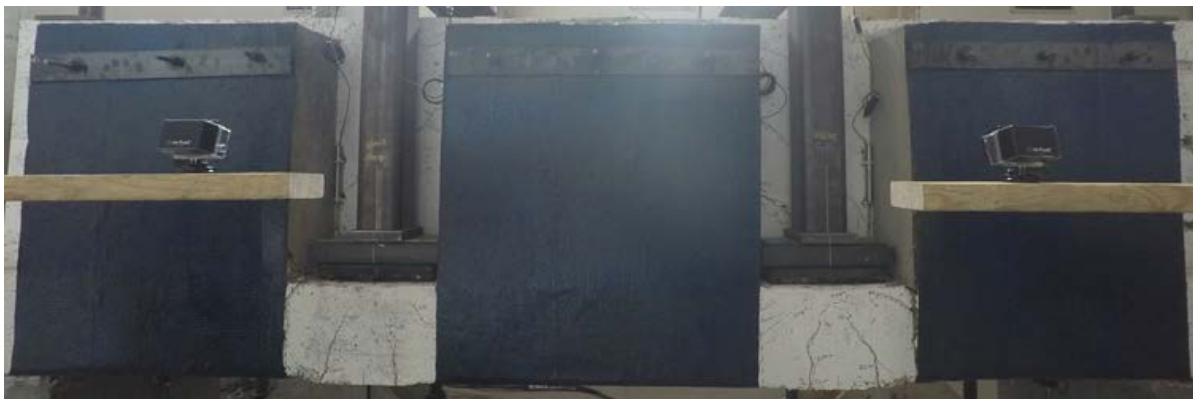
(a) North side at ULS

(b) North side at measured ultimate

(c) North side at final load level

Figure 3.25. Observed Damage for Test T2I2 at Different Load Levels.

The measured ultimate load of 111 kips was 63 percent larger than the estimated capacity of 68 kips and 23 percent larger than the interior hanger-deficient reference capacity. The test was ended after documenting damage at the measured ultimate load. Figure 3.25 shows the observed damage at different load levels. The bent cap experienced a combined hanger and ledge failure.

At the SLS of 49 kips, no new cracks formed. At a load of 74 kips, diagonal cracks formed on the side face of the ledge under the bearing pads. At the ULS of 78.5 kips, the cracks formed at the interface of the concrete blocks and the ledge. Flexure cracks were also detected on the bottom along the interface of the FRP strip and the bent cap. Crack extensions and new crack formations were observed as load increased. More diagonal shear cracks formed on the web behind the loading points. Near the top of the bent cap, the cracks on the web propagated horizontally.

End interfacial debonding of FRP was detected at the east end of the southwest concrete block at 109 kips. At the measured ultimate load of 111 kips, intermediate shear-crack-induced interfacial debonding of the FRP was observed at all inner ends of the concrete blocks.

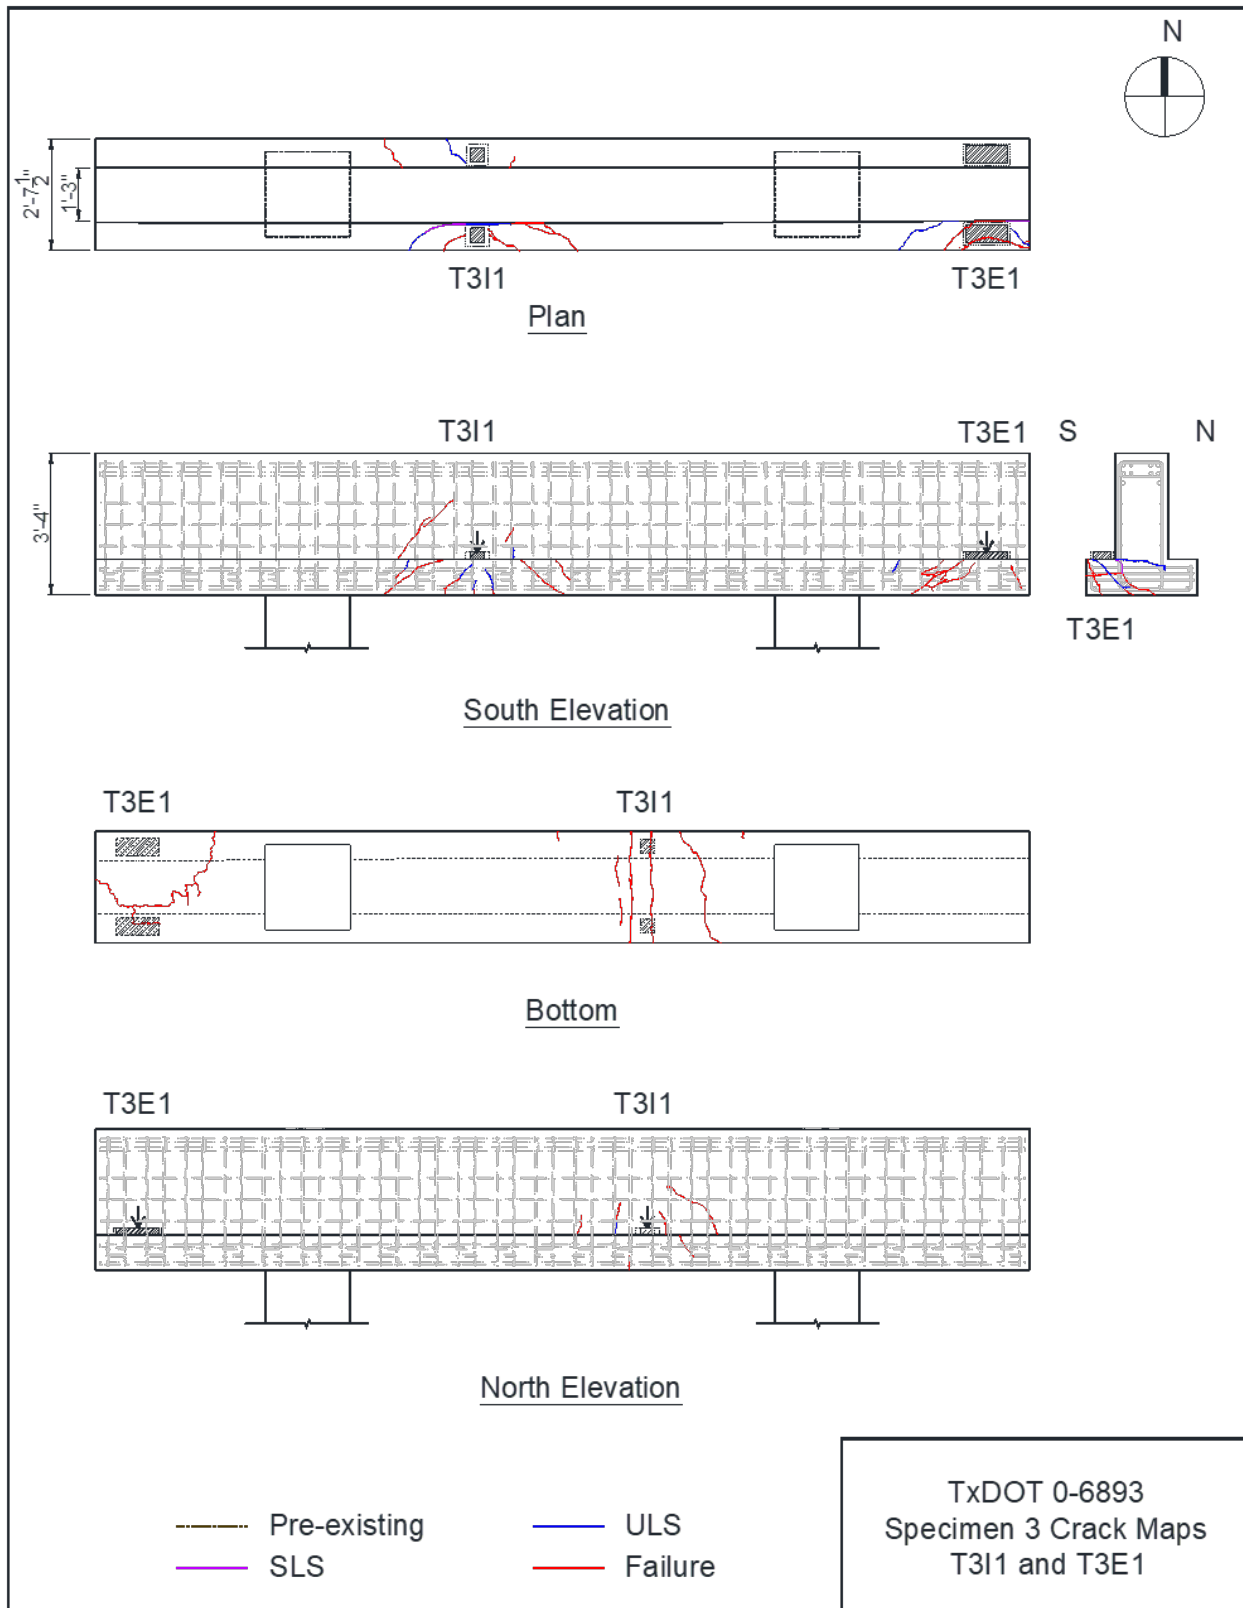
Figure 3.26. Crack Maps for Tests T3I1 and T3E1.

Ledge-deficient Specimen 3 provided punching shear tests with small bearing pads (4 in. by 4 in.) used as the reference capacity (T3W1 and T3I1) and larger bearing pads (12 in. by 5 in.) used as the retrofit solution (Solution 18). Figure 3.26 shows the crack patterns for test T3E1 and T3I1. Figure 3.27 shows the crack patterns for test T3W1, T3I2, and T3I3.

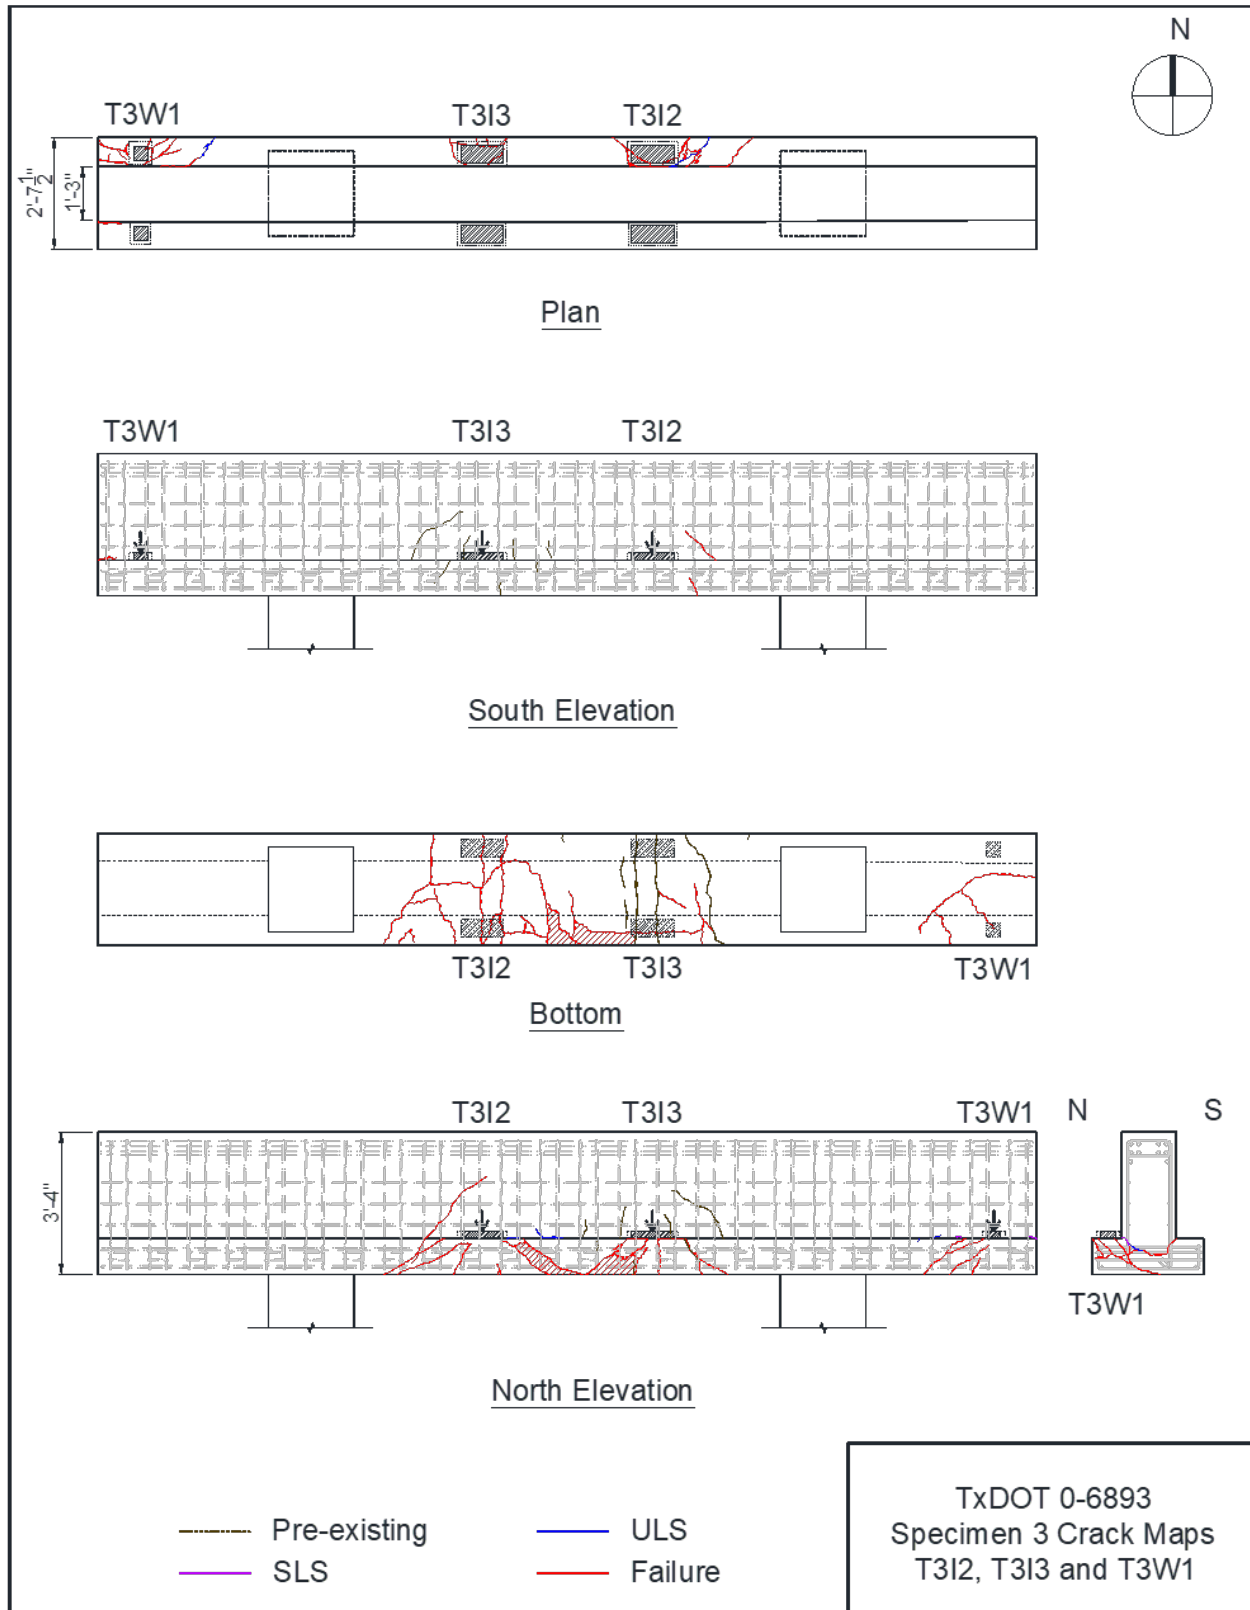
Figure 3.27. Crack Maps for Tests T3I2, T3I3, and T3W1.

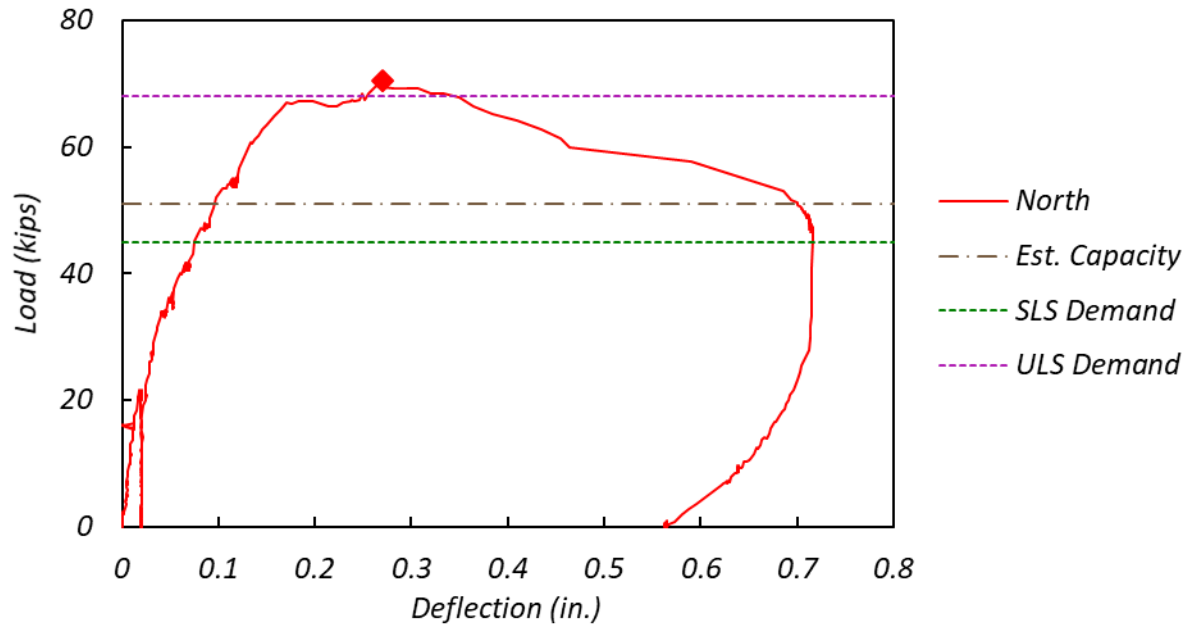
Figure 3.28. Load-Deflection Curve for T3W1.

T3W1 is the exterior reference test for punching shear capacity of ledge-deficient specimens. The small-size bearing pad (4 in. by 4 in.) was used. Figure 3.28 shows the load-deflection plot under the main load point, with horizontal lines indicating SLS, ULS, and estimated capacity, and a diamond indicating the measured ultimate load.

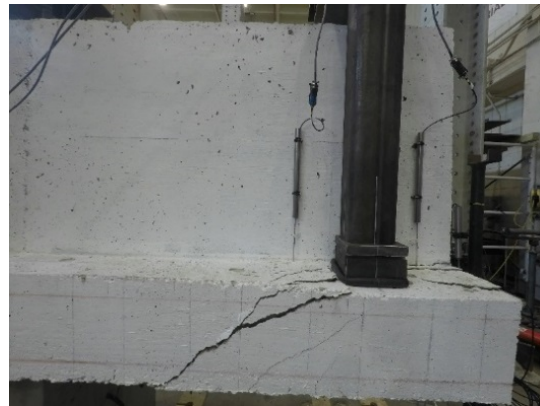
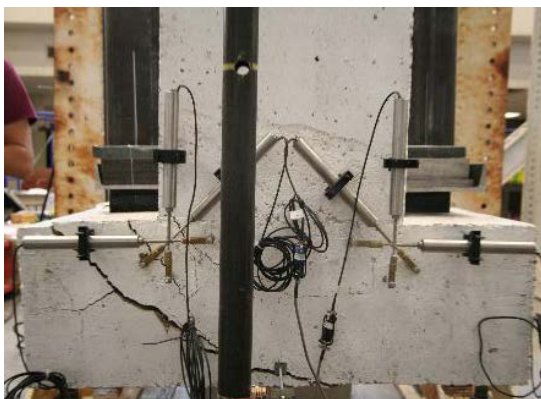
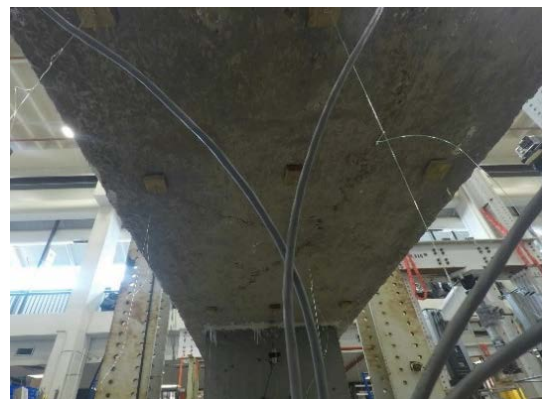
(a) North side

(b) End face

(c) Bottom

Figure 3.29. Observed Damage for T3W1 at Final Load Level.

The measured ultimate load (70 kips) was 37 percent larger than the estimated capacity (51 kips). The test was ended when the applied load dropped to about 70 percent of the measured ultimate load. Figure 3.29 shows the observed damage for test T3W1 at the final load level. The specimen showed a punching shear failure, evidenced by the concrete cone punched out from the ledge, as shown in Figure 3.29(a).

The specimen was loaded further after the measured peak, and significant damage progression was observed. The test was stopped when the load dropped to 52 kips. Final failure of the ledge was obtained as the cracks reached the bottom surface of the ledge either on the side surface of the ledge or the end surface of the bent cap. The maximum width of the cone crack was 7 mm at the final load level. The average angle of the main concrete cone was 32.5 degrees, which was shallower than the expected angle of 45 degrees.

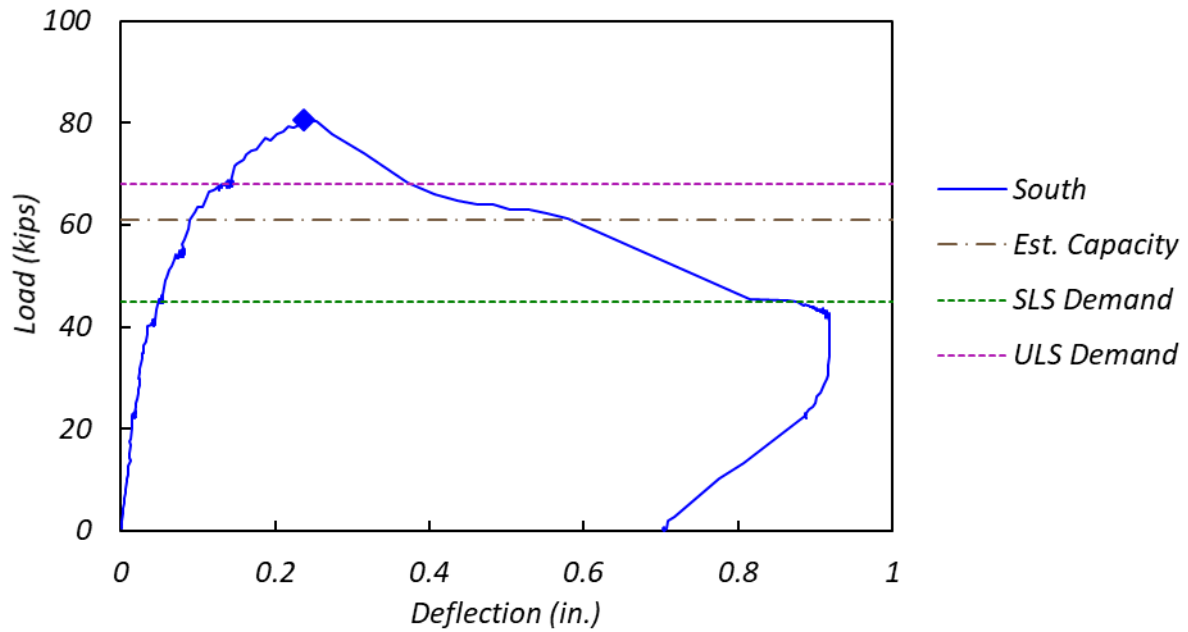
Figure 3.30. Load-Deflection Curve for T3E1.

T3E1 is an exterior test using a large (12 in. by 5 in.) bearing pad (Solution 18). Figure 3.30 shows the load-deflection plot under main loading point.

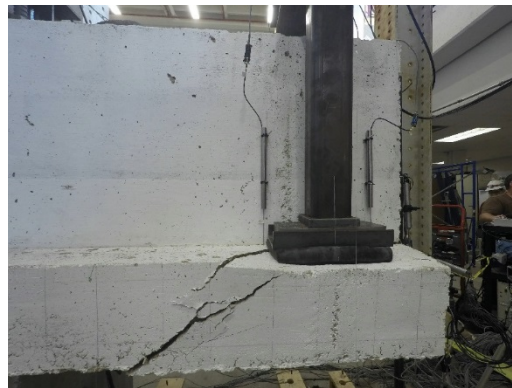
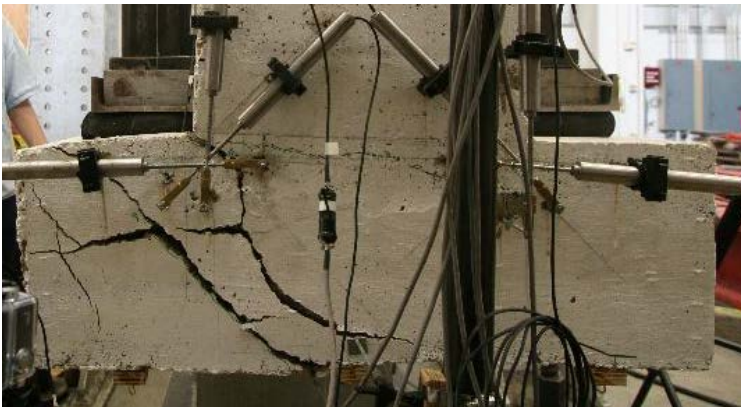
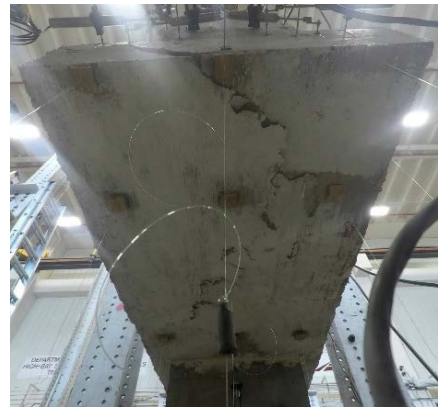
(a) Side

(b) End face

(c) Bottom

Figure 3.31. Observed Damage for T3E1 at Final Load Level.

The measured ultimate load (80 kips) was 31 percent larger than the estimated capacity of 61 kips and 14 percent larger than the measured ultimate load capacity of the exterior punching shear test with the small bearing pad. The test was ended when the applied load dropped to about 50 percent of the measured ultimate load. Figure 3.31 shows the observed damage for T3E1 at the final load level. The bent cap failed in punching shear when a clear concrete cone formed under the loading point.

The specimen was loaded further after the measured peak. More cracks formed and the width of the cone cracks were increased significantly. The test was ended when the load dropped to 43 kips. The width of the cone crack on the side of the ledge was 10 mm at the final load level. An average angle of 32.5 degrees was observed for T3E1, which was the same as T3W1.

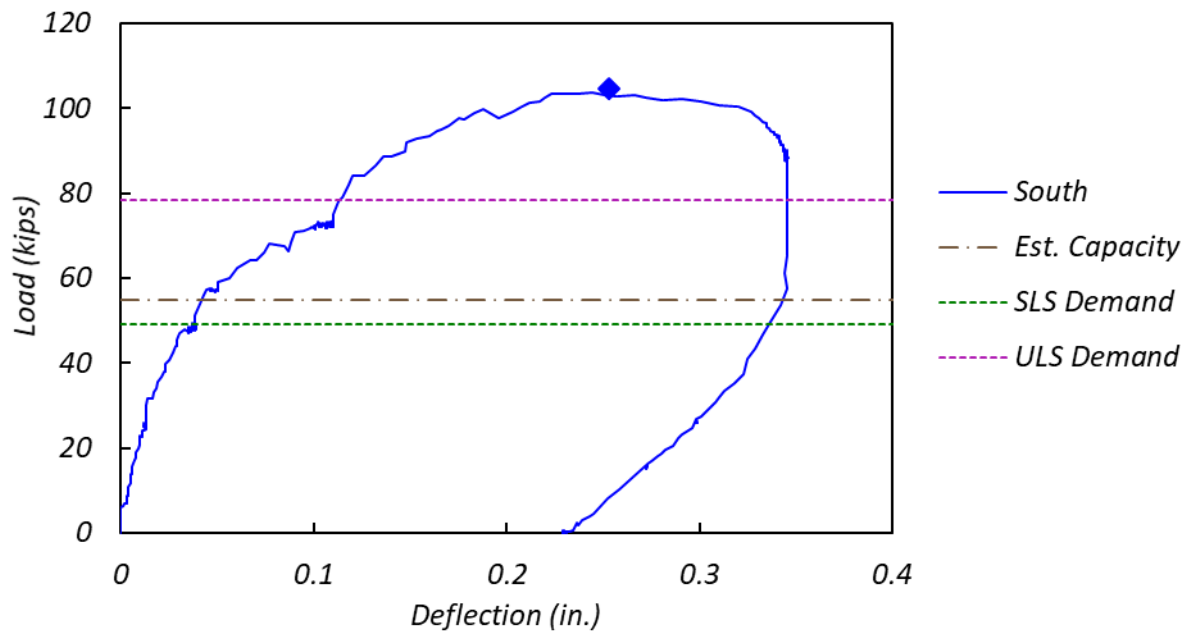
Figure 3.32. Load-Deflection Curve for T3I1.

T3I1 is the interior reference test for punching shear capacity of ledge-deficient specimens. The small-size bearing pad (4 in. by 4 in.) was used. Figure 3.32 shows the load-deflection plot under the main loading point.

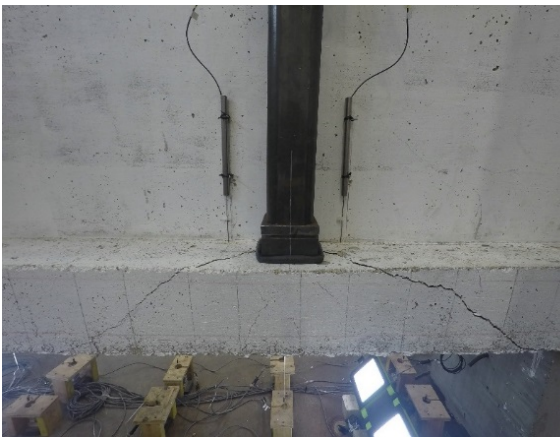
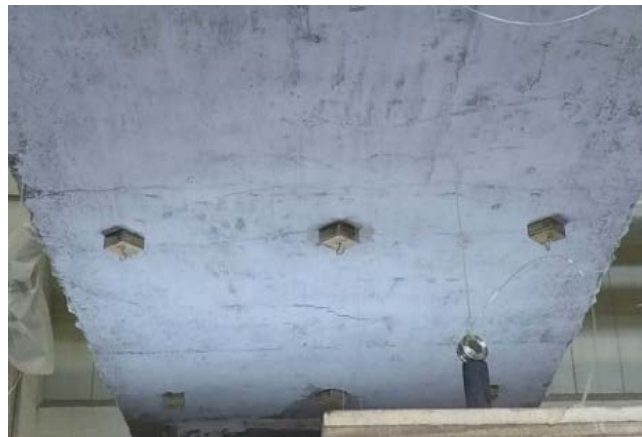
(a) Side

(b) Bottom

Figure 3.33. Observed Damage for T3I1 at Final Load Level.

The measured ultimate load (104 kips) was 89 percent larger than the estimated capacity of 55 kips. The test was ended when the applied load dropped to about 90 percent of the measured ultimate load. Figure 3.33 shows the damage for test T3I1 at the final load level. A clear punching shear failure was observed in which a truncated concrete pyramid punched out from the ledge.

The first cracks were observed at the service load. A crack began to form at the corner of the bent cap behind the bearing pad and extended 11 in. away from the pad. This crack extended to the side surface of the ledge as the loading reached the ultimate state. At the ultimate loading, different crack patterns formed compared to the previous tests. An almost vertical crack formed on the side surface of the stem that was 6 in. away from the south side of the bearing pad, and one more vertical crack formed on the other side surface of the stem. Moreover, cracks formed right underneath the bearing pad on the side surface of the ledge, extended to the bottom of the ledge, and went all the way through the flange of the bent cap on the bottom surface. The main concrete cone began to form at 92 percent of the failure load, and more cracks formed on the side surface of the stem. A notable difference in the crack pattern for test T3I1 was that the cracks on the stem and on the bottom went through the flange of the bent cap. The ledge failed as the main concrete cone cracks reached the bottom of the ledge. The formation of the concrete cone was obvious on the side surface of the ledge. However, there was no punching action on the bottom surface of the bent cap. Crack angles were 30 degrees on the west side and 35 degrees on the east side.
