Strengthening of Existing Inverted-T Bent Caps— Volume 2: Experimental Test Program

Technical Report 0-6893-R1-Vol2

TEXAS A&M TRANSPORTATION INSTITUTE
COLLEGE STATION, TEXAS

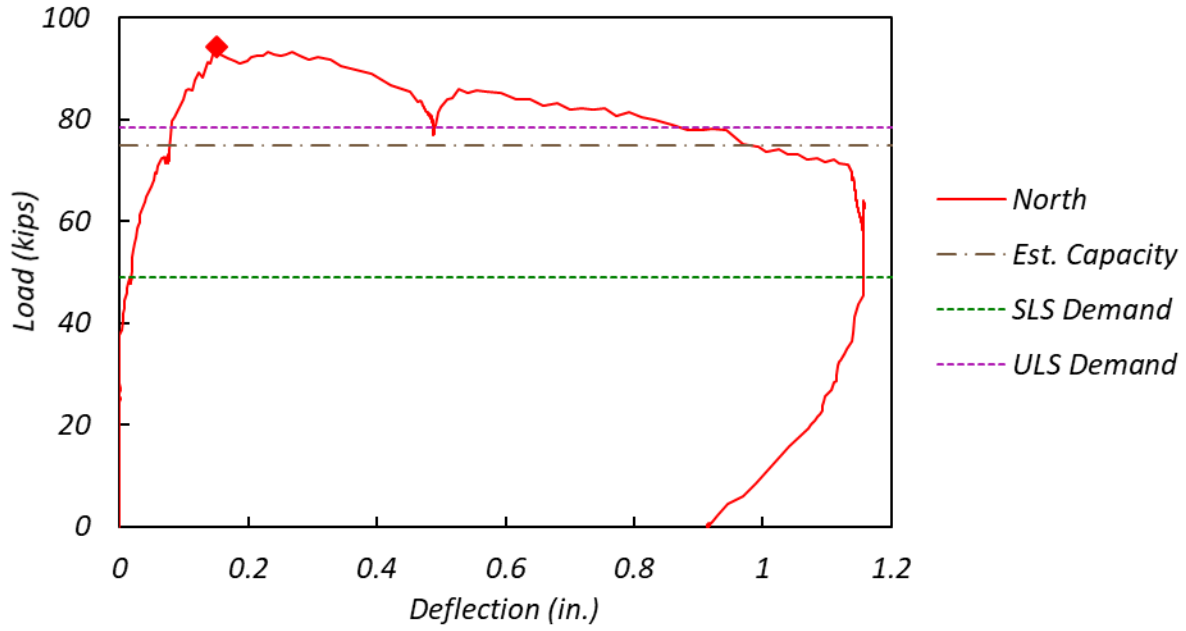
Figure 3.34. Load-Deflection Curve for T3I2.

The measured ultimate load for T3I2 and T3I3 (94 kips) was 25 percent larger than the estimated capacity of 75 kips but 10 percent smaller than the measured ultimate load capacity of the interior punching shear test with the small-size bearing pad. The test was ended when the applied load dropped to about 75 percent of the measured ultimate load. Figure 3.36 shows the observed damage for T3I2 and T3I3 at final load level. Both the tested regions experienced punching shear failure with truncated pyramid-shaped failure surfaces forming under the loading points.

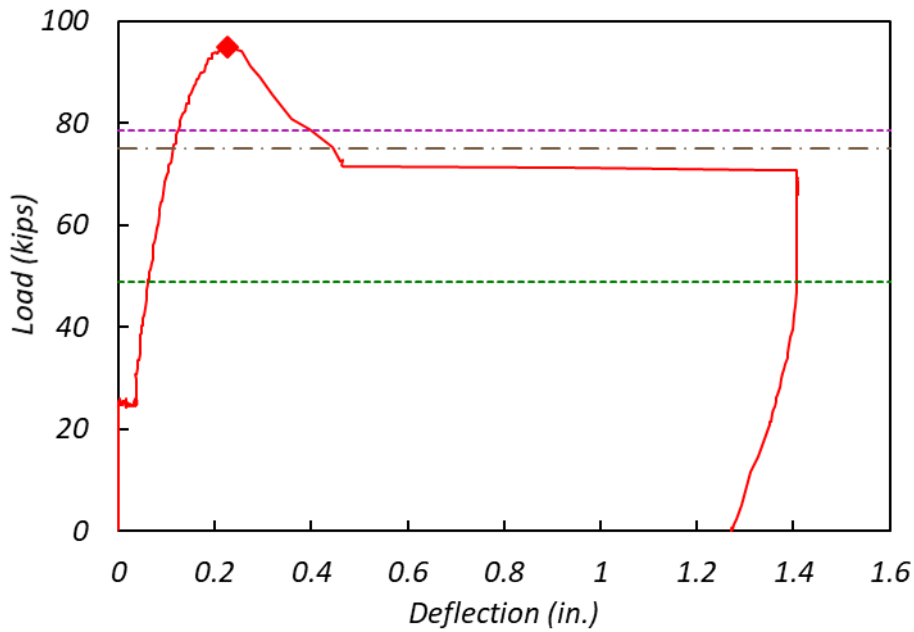
Figure 3.35. Load-Deflection Curve for T3I3.

The ledge failed as the concrete cone completely formed but with a relatively lower strength of 94 kips, even though it was loaded with the large bearing pad. Therefore, to have one more set of the data, T3I3 was conducted right beside the T3I2 location and loaded up to failure without stopping the load. A similar pattern was observed, and the ledge failed at the same load as T3I2 (94 kips), even though there were preexisting cracks at the location of T3I3 that were caused from T3I1. Moreover, the concrete cones from T3I2 and T3I3 intersected since the loading points were located closer to each other. The set of average crack angles for the concrete cone was 30 to 35 degrees and 40 to 45 degrees for T3I2 and T3I3, respectively.

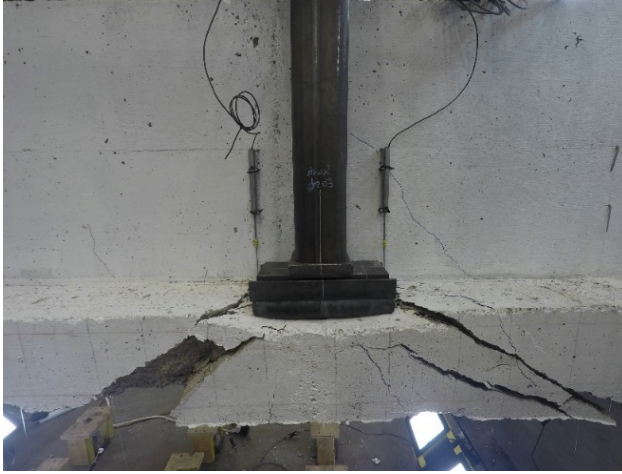
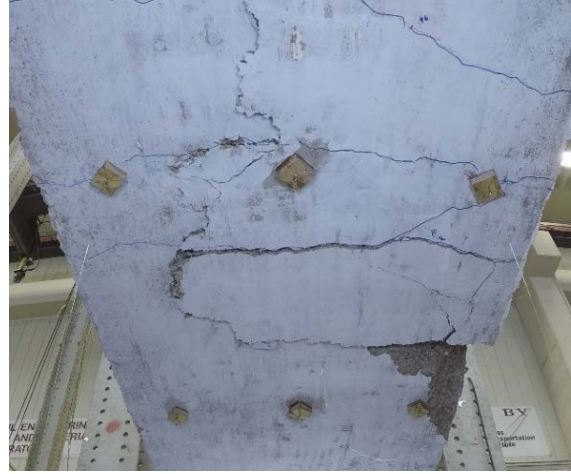
(a) T3I2

Figure 3.36. Observed Damage for T3I2 and T3I3 at Final Load Level.

The observed crack patterns and failure shapes for both tests were similar to the interior punching shear test with the small-size bearing pad. No cracks were found at SLS. Right after SLS, a crack formed in a similar way from the corner behind the bearing pad and extended diagonally about 11 in. away from the pad. The crack extended to the side surface of the ledge as the loading increased to the ultimate loading state. A small diagonal crack formed on the stem at the ultimate loading. Significant cracks formed when the load increased to 90 kips. A long 45-degree shear crack formed on the stem, and the main concrete cone also began to form at this loading stage. Similar crack patterns were formed on the bottom surface for test T3I2 as well.

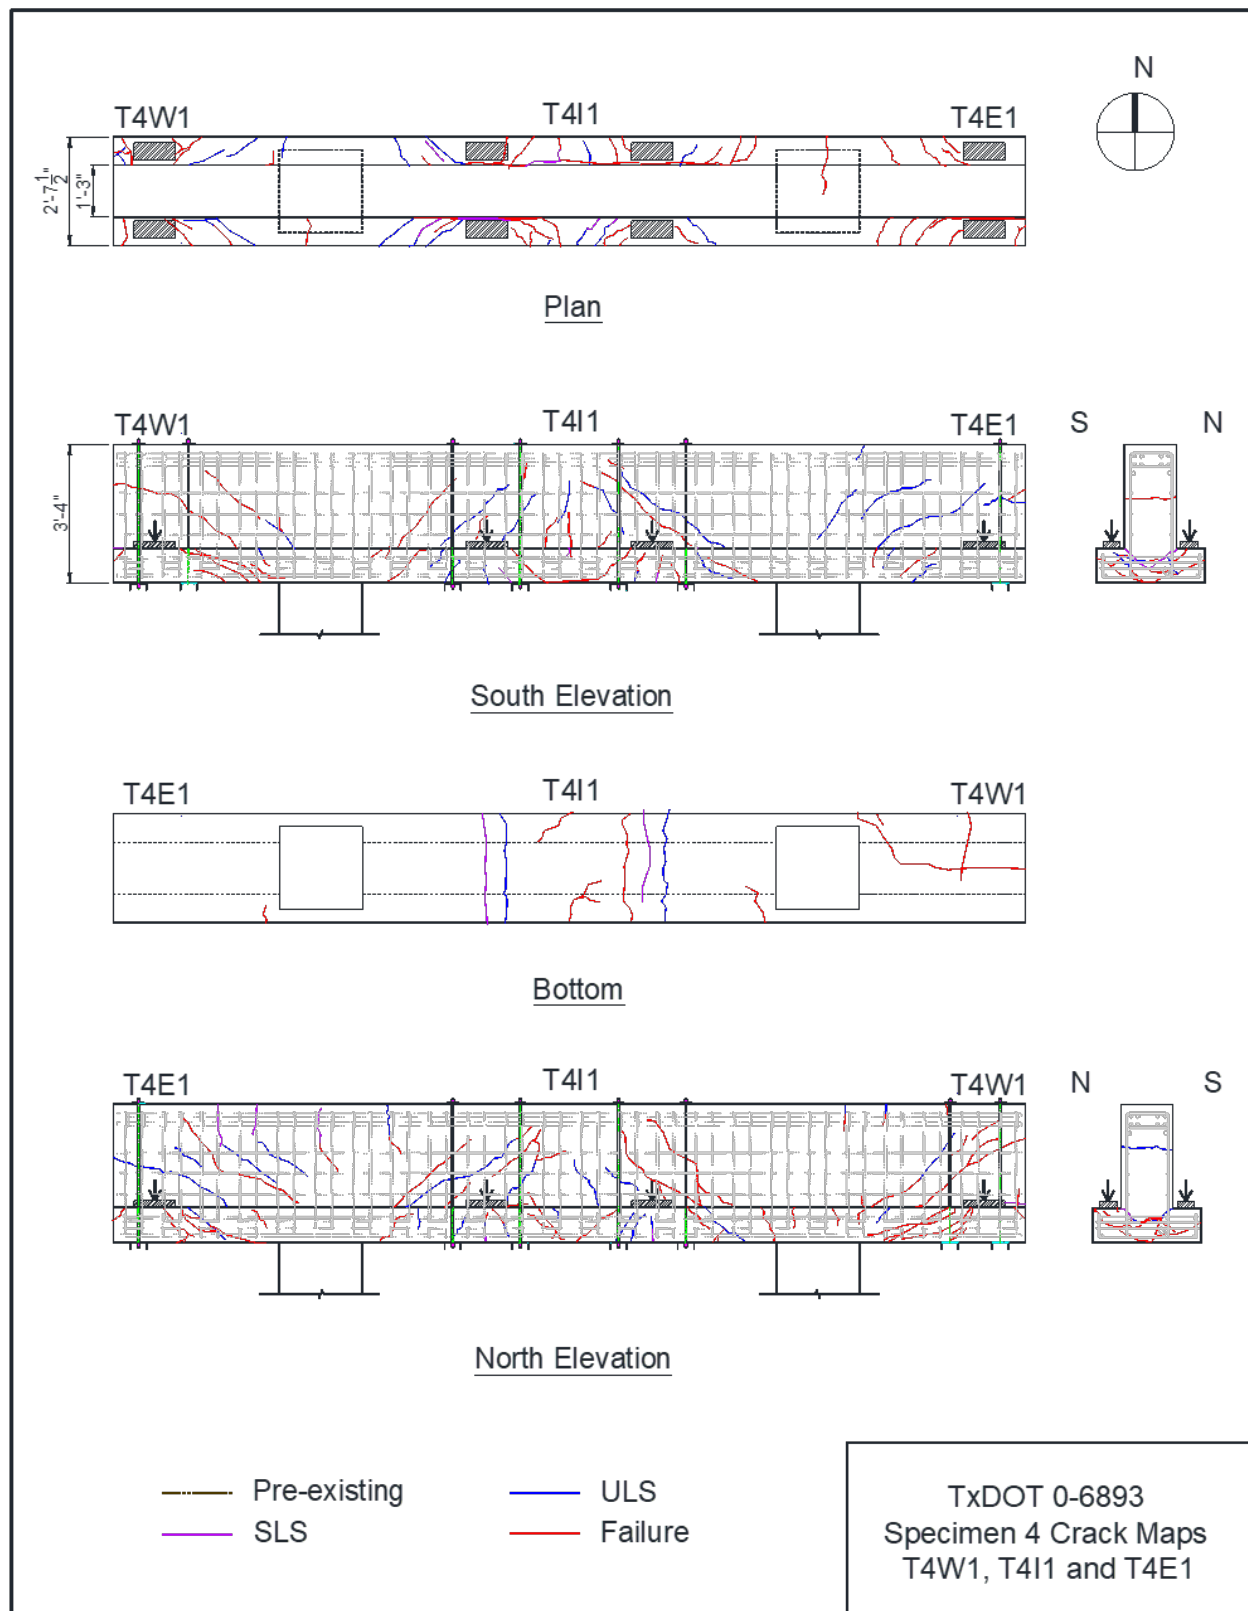
Figure 3.37. Crack Maps for Tests T4W1, T4I1, and T4E1.

Specimen 4 provided tests of all clamped threadbar solution variations (Solution 8) on a ledge-deficient specimen. Figure 3.37 shows crack patterns at SLS, ULS, and failure.

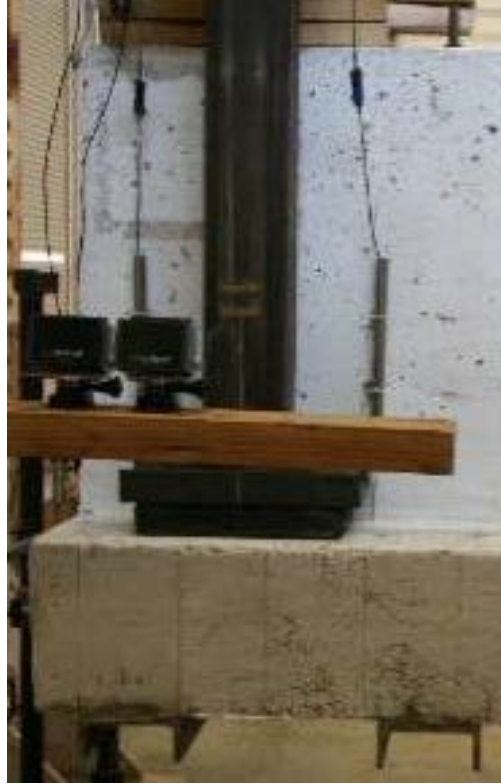
Figure 3.38. Retrofit Solution 8(a) Installed on West End of Ledge-Deficient Specimen 4.

T4W1 is an exterior test using a single clamped threadbar (Solution 8[a]). Figure 3.38 shows Solution 8(a) installed on the west end of the specimen. Figure 3.39 shows the load-deflection plots for the north and south load points, with horizontal lines indicating SLS, ULS, and estimated capacity, and diamonds indicating the measured ultimate load.

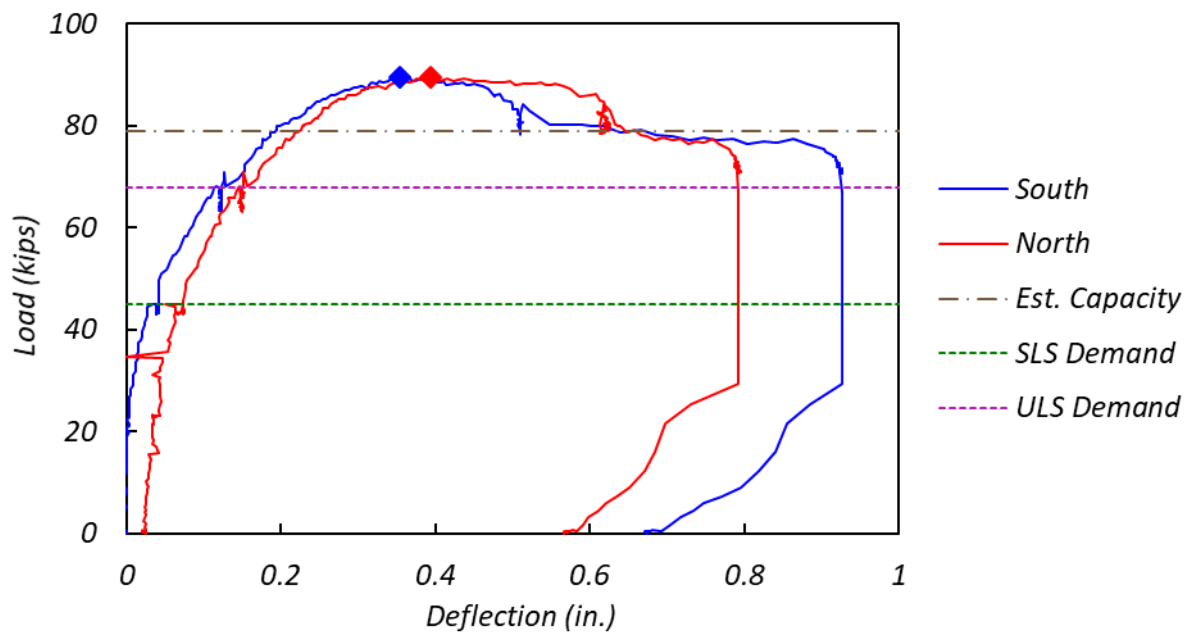
Figure 3.39. Load-Deflection Curve for T4W1.

The measured ultimate load (90 kips) was 14 percent larger than the estimated capacity (79 kips) and 36 percent larger than the exterior ledge-deficient reference capacity. The test was ended when the applied load dropped to about 80 percent of the measured ultimate load. Figure 3.40 shows the observed damage at the final load level. The specimen experienced a combined ledge flexure and punching shear failure, with more extensive damage occurring on the south side.

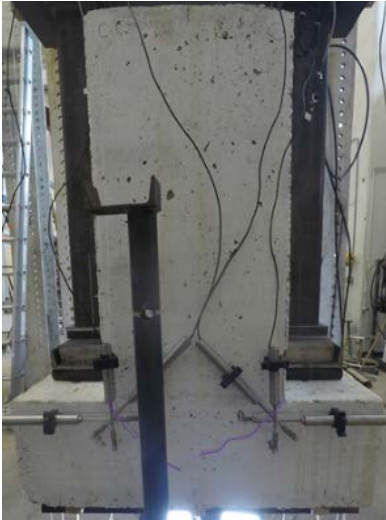
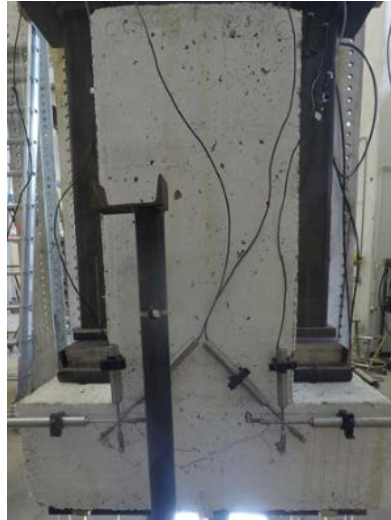
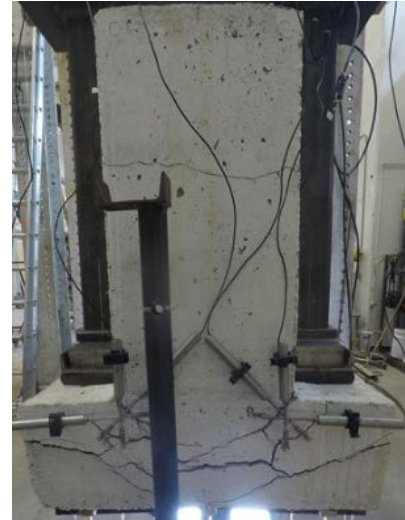
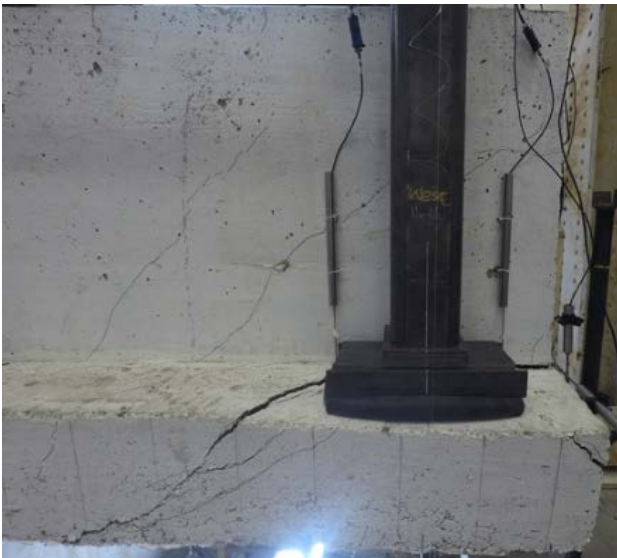
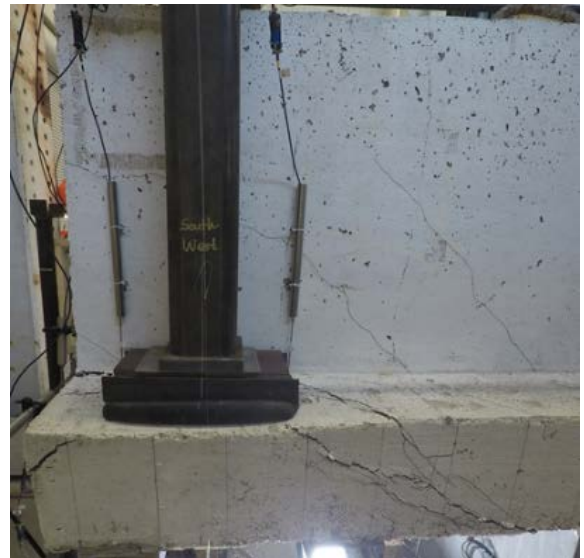
(a) End face at SLS

(b) End face at ULS

(c) End face at final load level

(d) North side at final load level

(e) South side at final load level

Figure 3.40. Observed Damage for Test T4W1 at Final Load Levels.

The initial crack formed at SLS (45 kips) at the web-ledge interface behind the south side bearing pad. It propagated to the end of the specimen along the web-ledge interface. On the end face, the crack extended diagonally at an approximate angle of 30 degrees.

Under the ULS demand of 68 kips, crack extensions and new crack formations were observed. The cracks at the web-ledge interface propagated toward the column. On the top of the ledge, the cracks at the web-ledge interface extended diagonally to the side face of the ledge. Diagonal shear cracks were also detected on both sides of the web. On the end face, another diagonal crack formed at the north corner. The two diagonal cracks on the end face started at the reentrant corner, propagated horizontally, and connected. A hanger crack formed on the end face 26 in. above the bottom of the bent cap.

Significant extension of existing cracks and new crack formations on the entire tested region were observed as the load went higher than ULS. More diagonal cracks formed on the top of the ledge and further extended to the side face. On the web, new diagonal shear cracks were also presented. New cracks were only formed on the ledge part of the bent cap on the end face. The cracks at the web-ledge interface behind the south bearing pad had a maximum crack width of 8 mm. The maximum crack width observed on the end face was 7 mm. The deflection of the outside channel under the bent cap was visible to the naked eye at the measured ultimate load.

After marking the cracks at the measured ultimate load, the bent cap was loaded further. Crack widths increased except on the hanger crack, with wider cracks on the south side ledge. The bent cap lost its load carrying capacity gradually. The test was ended when the load dropped to 71 kips, which was 20 percent lower than the measured ultimate load.

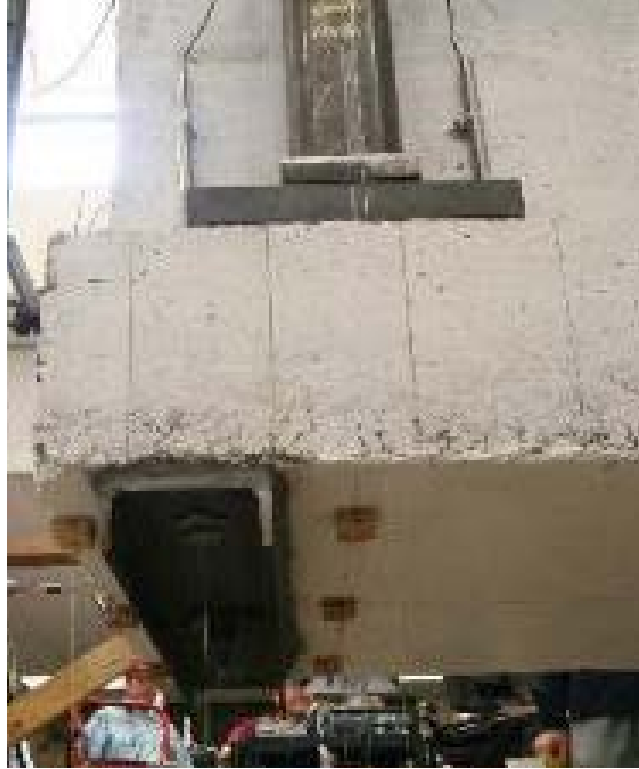
Figure 3.41. Retrofit Solution 8(b) Installed on East End of Ledge-Deficient Specimen 4.

T4E1 is an exterior test using a single clamped threadbar (Solution 8[b]). Figure 3.41 shows Solution 8(b) installed on the east end of the specimen. Figure 3.42 shows the load-deflection plots for the north and south load points.

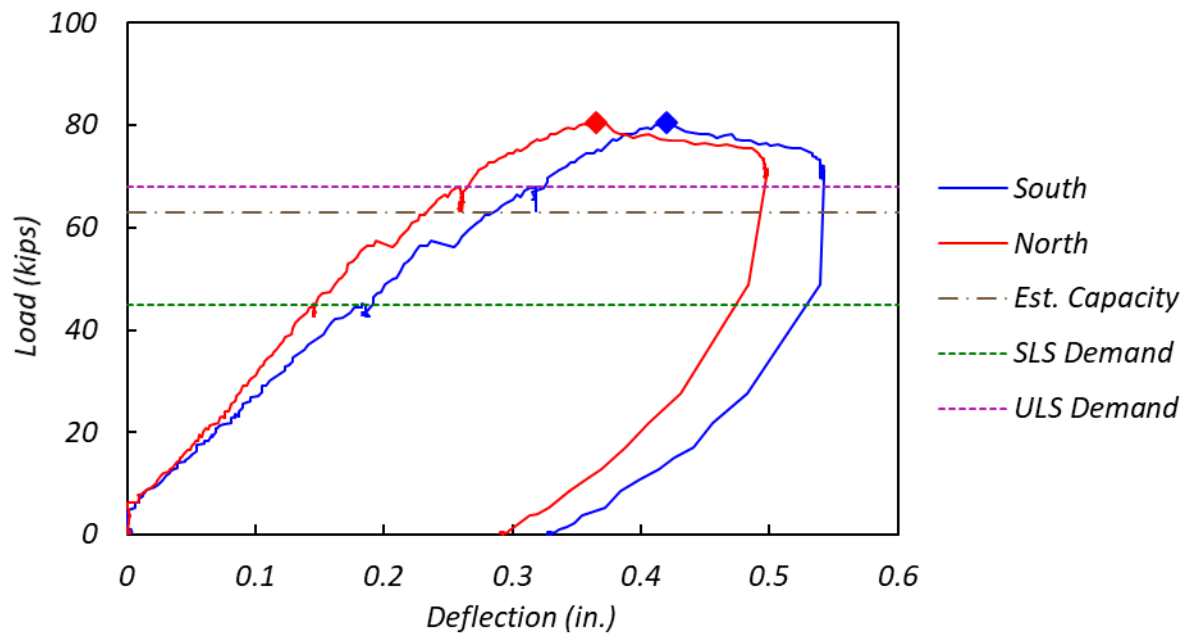
Figure 3.42. Load-Deflection Curve for T4E1.

The measured ultimate load (80 kips) was about 27 percent larger than the estimated capacity (63 kips) and 21 percent larger than the interior ledge-deficient specimen reference capacity. The test was ended when the applied load dropped to about 90 percent of the measured ultimate load. Figure 3.43 shows the observed damage at final load level. A combined ledge and punching shear failure occurred, with greater damage on the north side.

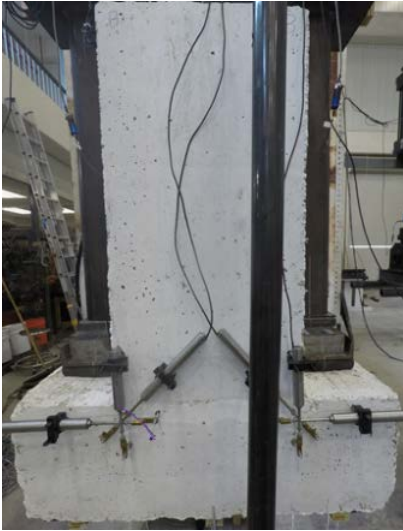
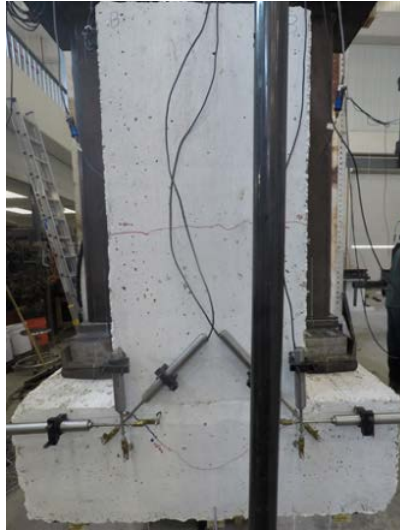
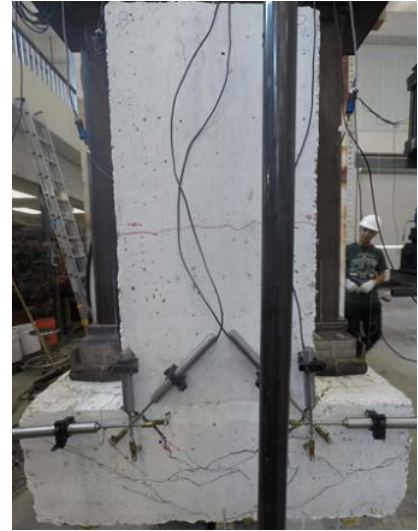
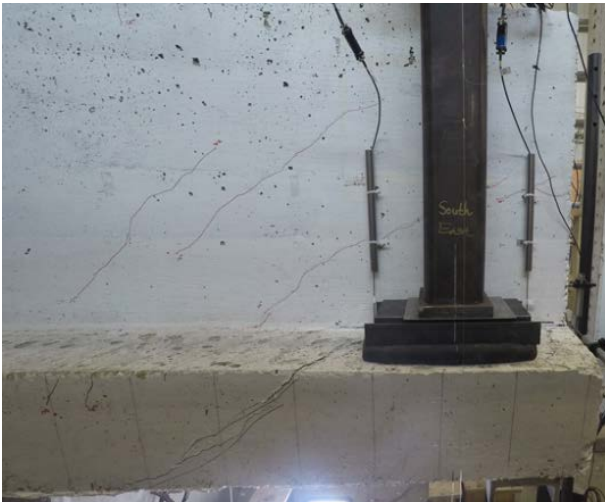
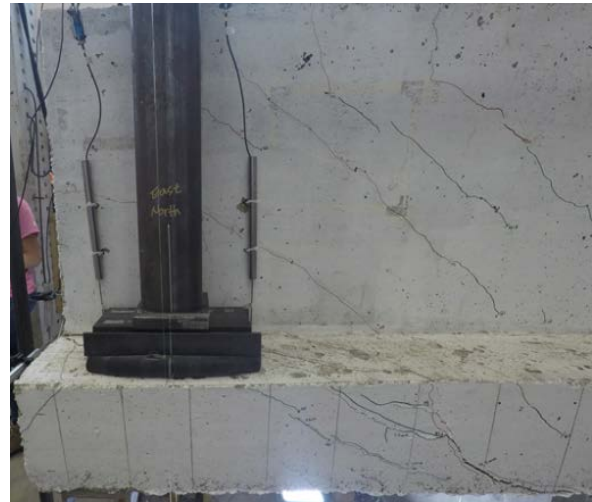
(a) End face at SLS

(b) End face at ULS

(c) End face at final load level

(d) South side at final load level

(e) North side at final load level

Figure 3.43. Observed Damage for Test T4E1 at Different Load Levels.

The initial cracks formed at 40 kips at the web-ledge interface behind the south bearing pad. Negative flexure cracks were detected on the north side of the web. At the SLS of 45 kips, interface cracks behind the bearing pads were found at both sides of the ledge. On the end face, cracks propagated diagonally at an angle of 32° toward the center of the bent cap.

At a load of 57 kips, initiation of diagonal shear cracks was observed on both sides of the web. A hanger crack formed 24.5 in. above the bottom of the bent cap on the end face. At the ULS of 68 kips, more web cracks appeared. On the top of the ledge, the cracks behind the bearing pad extended diagonally, starting at the inner edge of the bearing pad and going to the side face of the ledge. More ledge cracks formed near the web-ledge interface on the end face. The maximum width of the ledge cracks on the end face was 0.9 mm, and the width of the hanger crack was 0.5 mm.

As the load exceeded ULS, the bent cap showed significant crack length and width extensions and new cracks formed. Most of the new cracks formed on the ledge. More cracks formed on the north side of the ledge than on the south side. At the measured ultimate load of 80 kips, diagonal cracks formed on the top of the ledge on both sides. On the side of the ledge, new cracks mainly formed on the north side ledge, with a maximum width of 4.5 mm. One more web shear crack formed on the north side, while no new crack formations were observed on the south side of the web. The negative cracks on the north side of the web extended farther. On the end face, new ledge cracks were detected. As shown in Figure 3.43(d) and (e), more cracks formed on the north part. The maximum crack width on the end face was 6 mm. The width of the hanger cracks remained the same.

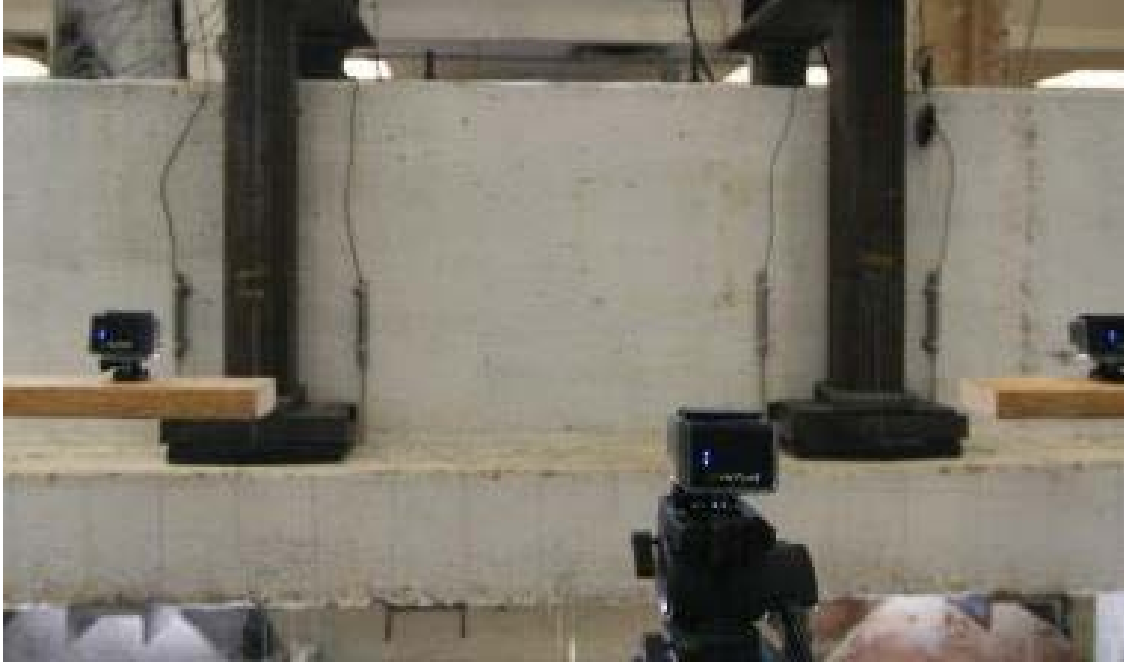
Figure 3.44. Retrofit Solution 8 Installed on Interior of Ledge-Deficient Specimen 4.

T4I1 is an interior test retrofitted with clamped threadbars (Solution 8). Figure 3.44 shows Solution 8 installed on the mid-span of the specimen. Figure 3.45 shows the load-deflection plots for all load points.

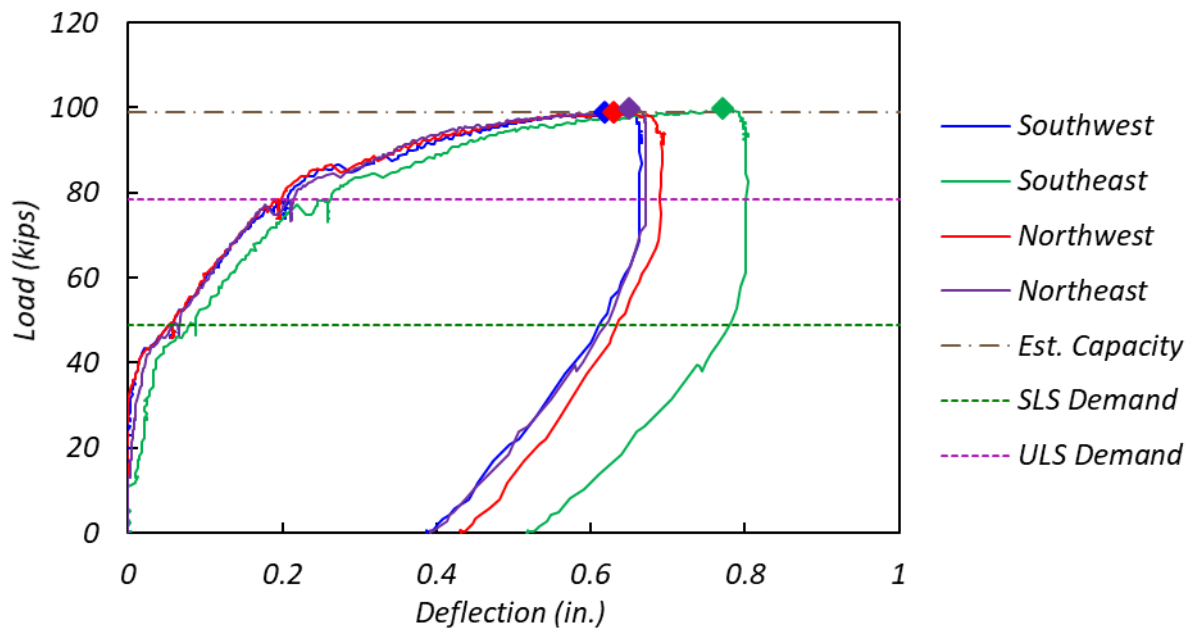
Figure 3.45. Load-Deflection Curve for T4I1.

The measured ultimate load (99 kips) was 6 percent smaller than the estimated capacity of 105 kips and 16 percent larger than the interior ledge-deficient reference test measured ultimate load. The test was ended after documenting the damages at the measured ultimate load. Figure 3.46 shows the observed damage. The bent cap failed in a combined ledge flexure and punching shear.

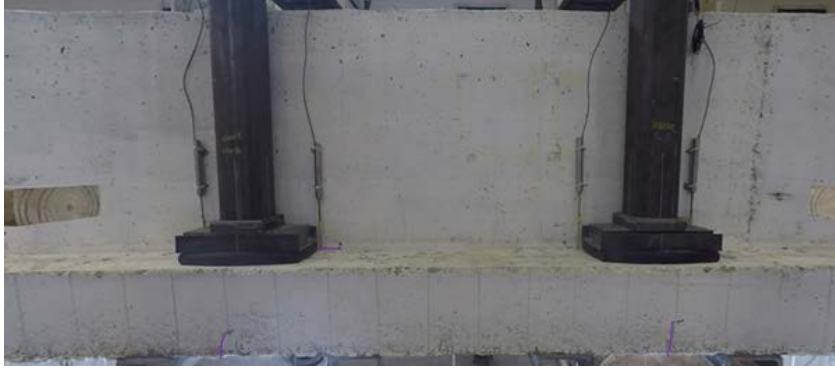
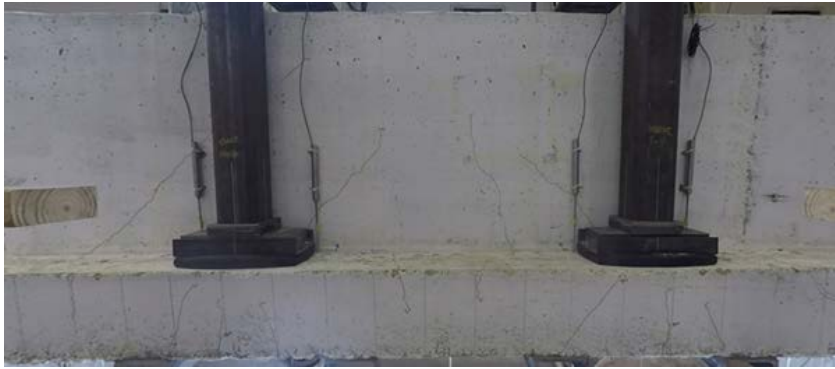
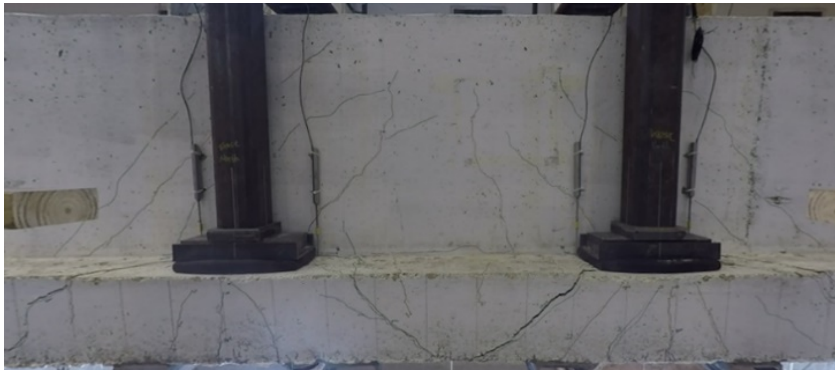
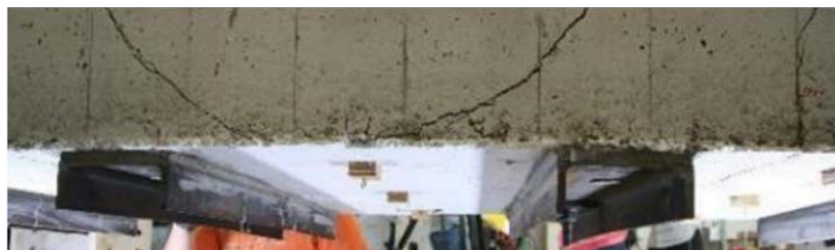
(a) North side at SLS

(b) North side at ULS

(c) North side at final load level

(d) Channels at final load level

Figure 3.46. Observed Damage for Test T4I1 at Different Load Levels.

The initial cracks were found at the SLS of 49 kips at the web-ledge interface behind the bearing pads. The cracks at the interface propagated about 10 in. toward both sides of the bearing pad, and diagonally extended to the top of the ledge. Flexure cracks were detected on the bottom of the bent cap under the loading points.

Crack extensions and new crack formations were observed as the load increased. Initiation of shear cracks on both sides of the web were detected at a load of 64.5 kips. The web shear cracks on this state were formed at the outside of the bearing pads toward the center of the bent cap.

At the ULS of 78.5 kips, more diagonal shear cracks were formed on both sides of the web. The shear cracks close to the center of the bent cap had steeper angles than the cracks near the columns. More diagonal cracks formed at the top of the ledge. Diagonal cracks were detected on the side face of the ledge at the outside of the bearing pads with the exception of the northwest bearing pad. Cracks formed on the inside as well as around the northwest bearing pad. The maximum crack width of the diagonal cracks on the side face of the ledge was 2 mm. On the bottom of the bent cap, two more flexure cracks were detected.

A significant crack width increase of ledge cracks was observed as the load was increased above the ULS demand. New crack formations were observed on the entire test region. At the measured ultimate load of 99 kips, the deflection of the two outside channels was visible. Diagonal cracks on the side face of the ledge had a maximum width of 5 mm. A clear pyramid-shaped cone formed under all the bearing pads. The outside diagonal cracks on the ledge were wider than the inside cracks.

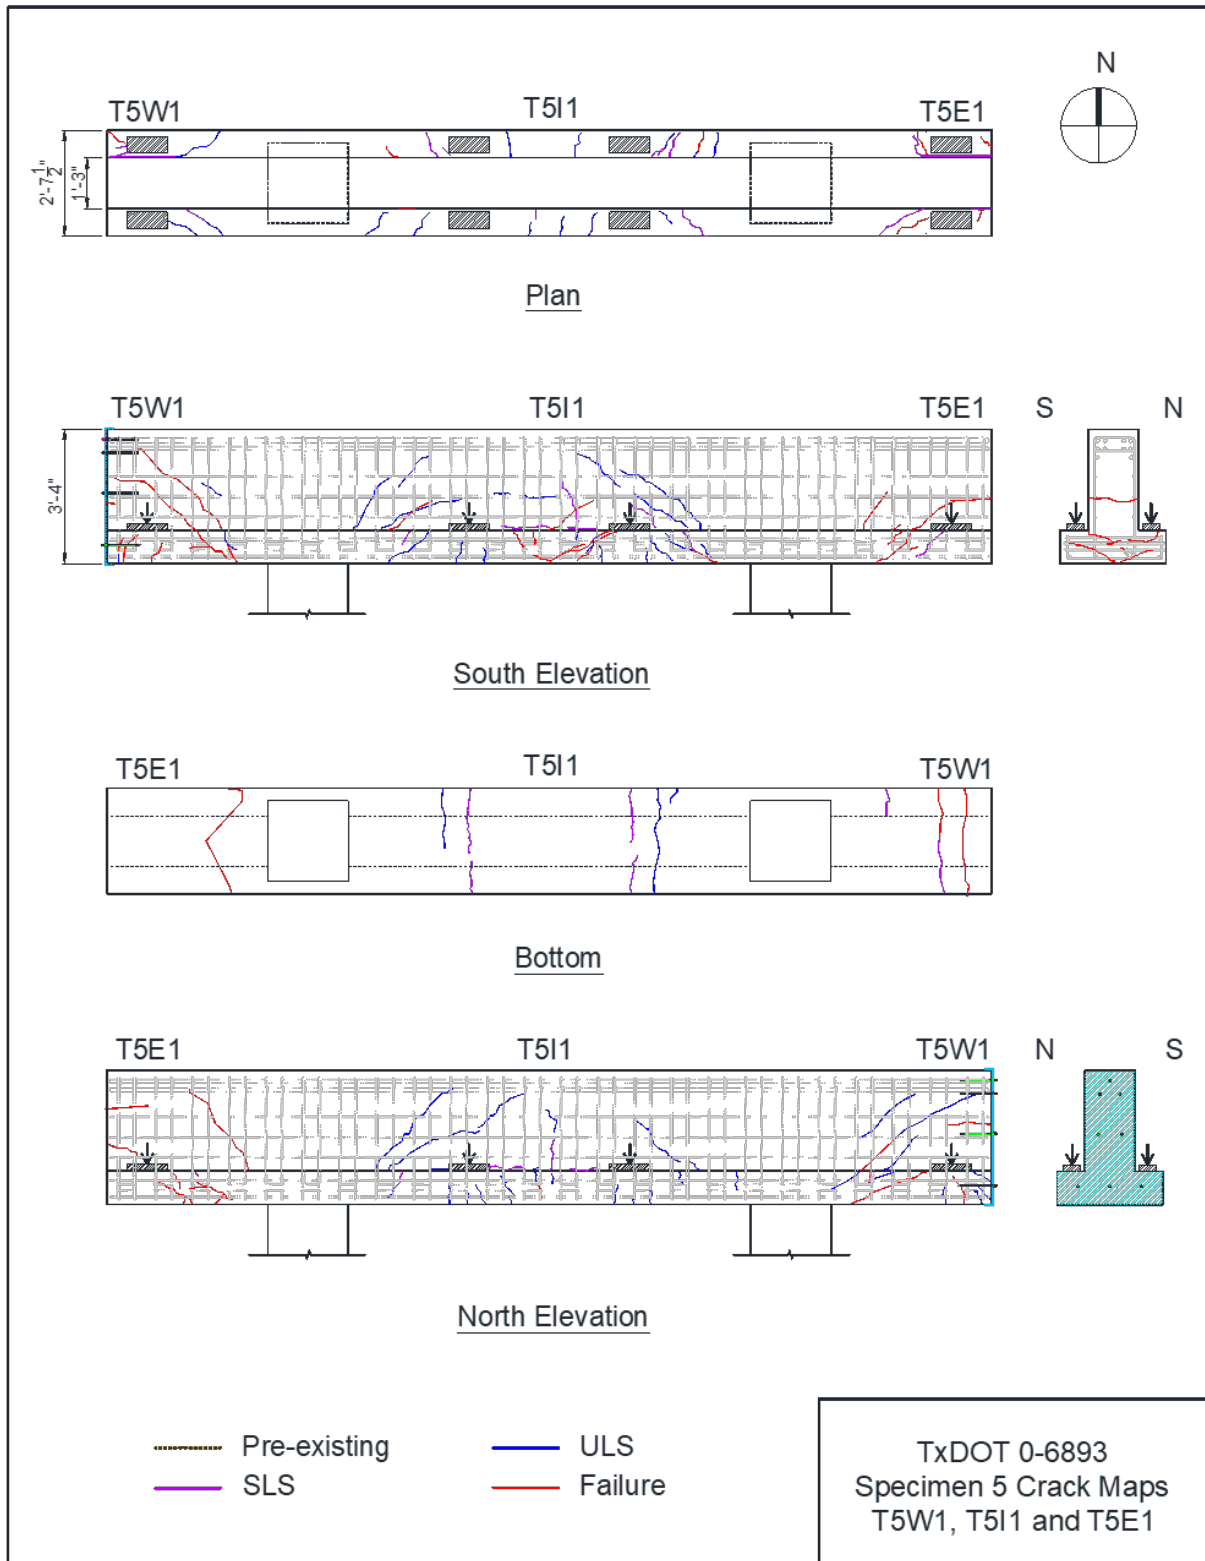
Figure 3.47. Crack Maps for Tests T5W1, T5I1, and T5E1.

Ledge-deficient Specimen 5 provided ledge reference tests on the exterior (T5E1) and interior (T5I1) and an exterior test of the end-stiffener retrofit solution (Solution 3). Figure 3.47 shows crack patterns at SLS, ULS, and failure.

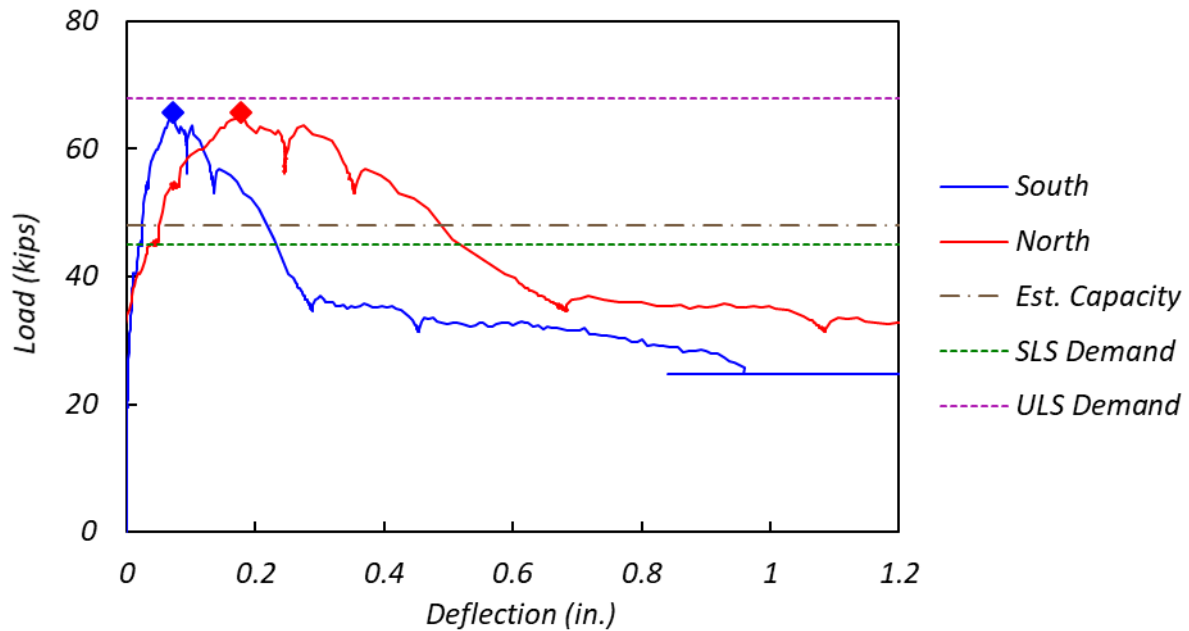
Figure 3.48. Load-Deflection Curve for T5E1.

T5E1 is the exterior reference test for ledge-deficient specimens. Figure 3.48 shows the load-deflection plots for the north and south load points, with horizontal lines indicating SLS, ULS, and estimated capacity, and diamonds indicating the measured ultimate load.

The measured ultimate load (66 kips) was 37 percent larger than the estimated capacity (48 kips). Loading continued after the measured ultimate load until the applied load dropped to about 45 percent of the measured peak load. Figure 3.49 shows the observed damage for test T5E1 at different load levels. The failure started as a ledge flexure failure and finally formed a combined ledge flexure and punching shear failure.

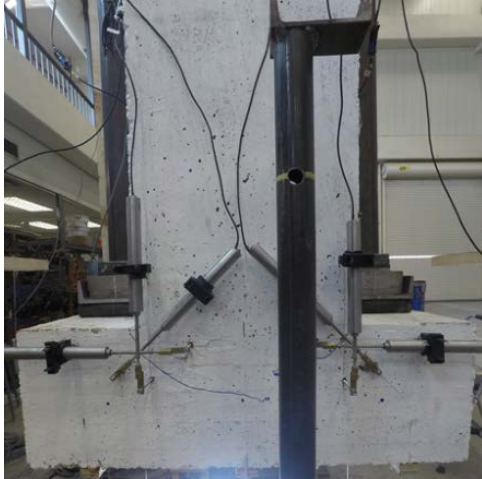
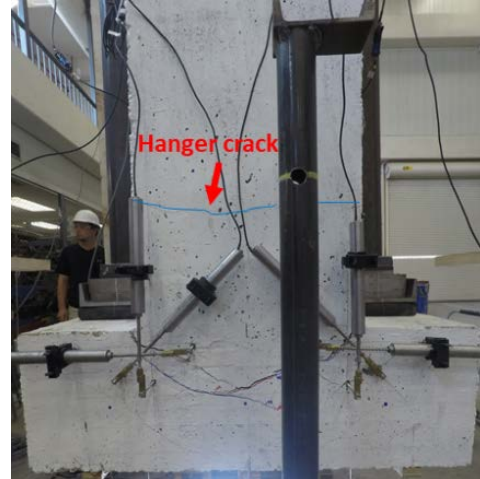
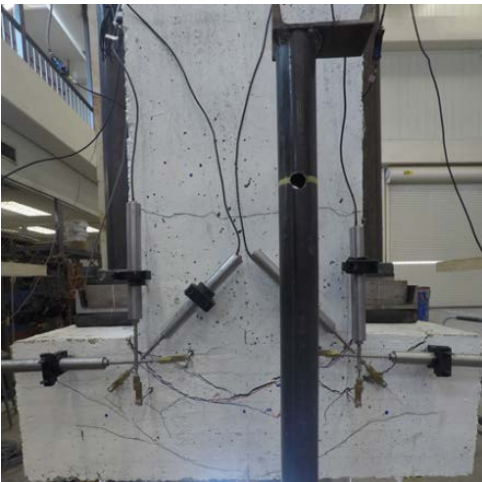
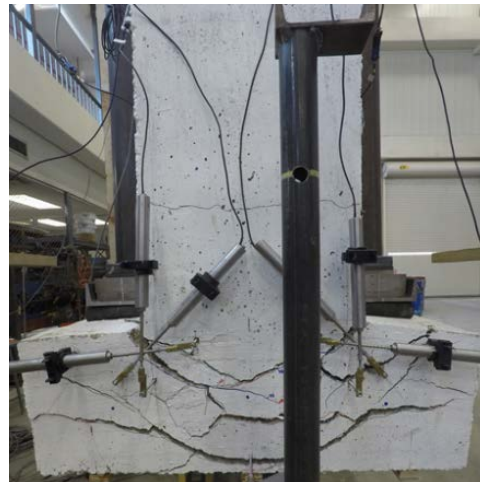
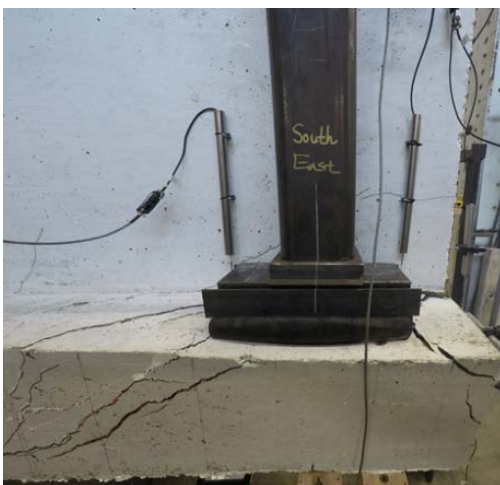
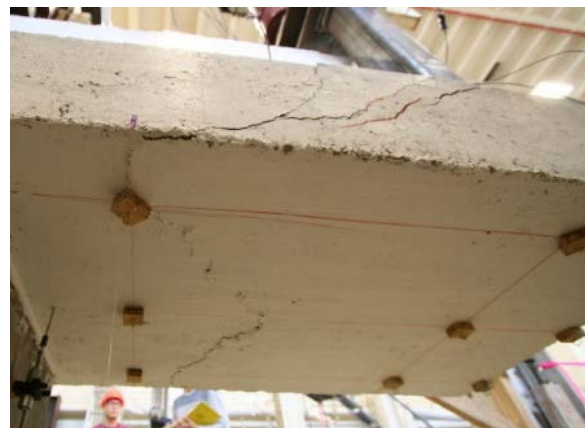
(a) End face at SLS

(b) End face at estimated capacity

(c) End face at measured ultimate load

(d) End face after peak—37.5 kips

(e) South side after peak—37.5 kips

(f) Bottom after peak—37.5 kips

Figure 3.49. Observed Damage for T5E1 at Different Load Levels.

The initial crack formed at 41 kips at the web-ledge interface behind the south bearing pad. At SLS, similar cracks formed behind the northern bearing pad. The cracks behind the bearing pad propagated along the web-ledge interface to the end face. On the end face, cracks extended diagonally at an angle of approximately 30 degrees, as shown in Figure 3.49(a). On the top of the ledge, the cracks behind the bearing pad extended diagonally, starting at the inner edge of the bearing pad and going to the side face of the ledge. The cracks that formed at SLS were all hairline cracks.

At the estimated capacity of 54 kips, the diagonal cracks from two reentrant corners on the end face connected horizontally with a width of 1 mm, as shown in Figure 3.49(b). Crack extensions and new crack formations were observed as the load increased.

The load reached the measured ultimate load of 66 kips, which was less than the ULS demand of 68 kips, and then dropped to 55 kips. Figure 3.49(c) shows the damage on the end face at the measured ultimate load. A hanger crack—horizontal crack through the web on the end face, as shown in Figure 3.49(c)—formed near the neutral axis of the bent cap. More ledge cracks formed on the flange on the end face. The crack near the web-ledge interface on the end face opened up to 2.5 mm. Diagonal shear cracks were present on both sides of the web about 20 in. from the edge of the bearing pad. More cracks also formed at the top and side faces of the ledge.

After marking cracks at the measured ultimate load, the specimen was further loaded by adding the same amount of pressure to the actuator. The load was then increased to 62.5 kips and then dropped to 37.5 kips. Crack length and width growth of existing cracks except the hanger crack was observed. The maximum width of the ledge cracks on the end face increased to 4 mm, while the width of the hanger cracks remained the same. New crack formations on the side and bottom of the ledge were also detected. The cracks on the side of both ledges extended to form a cone shape. The cone started from each side of the ledge and connected on the bottom of the bent cap, as shown in Figure 3.49(f). The load was sustained at about 32 kips while it was loaded again and then dropped to 23 kips at the final stage.

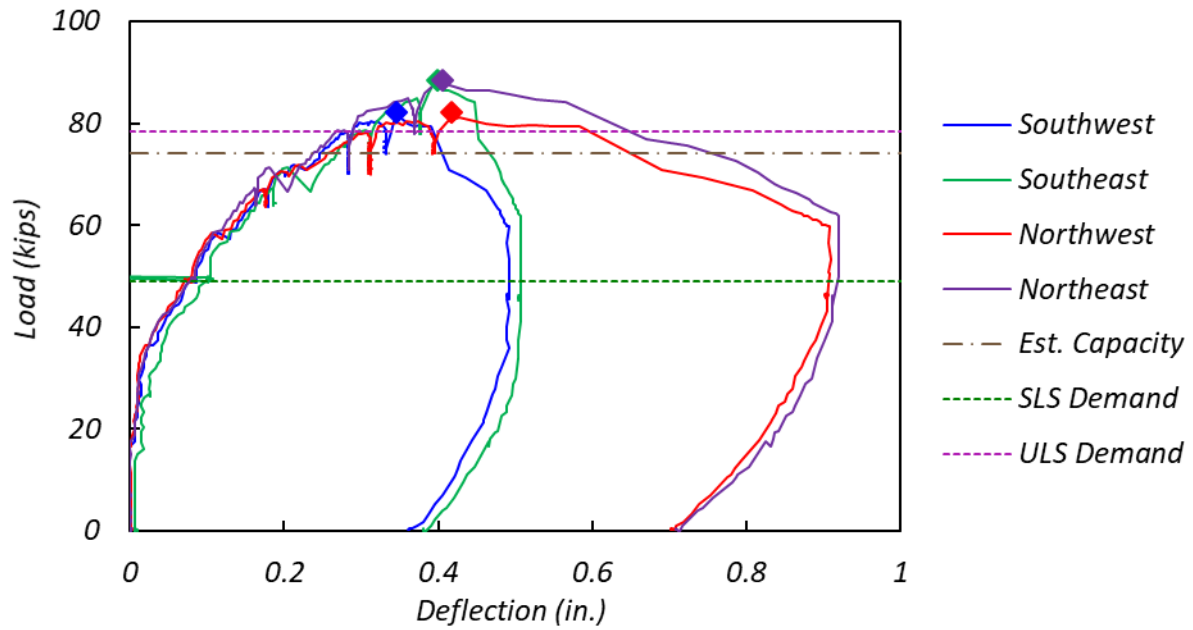
Figure 3.50. Load-Deflection Curve for T5I1.

T5I1 is the interior reference test for ledge-deficient specimens. Figure 3.50 shows the load-deflection plots for all load points.

The measured ultimate load (85 kips) was 15 percent larger than the estimated capacity (74 kips). The test was ended when the applied load dropped to about 70 percent of the measured ultimate load. Figure 3.51 shows the observed damage at different load levels. The tested region experienced a ledge shear failure, with more extensive damage on the north side.

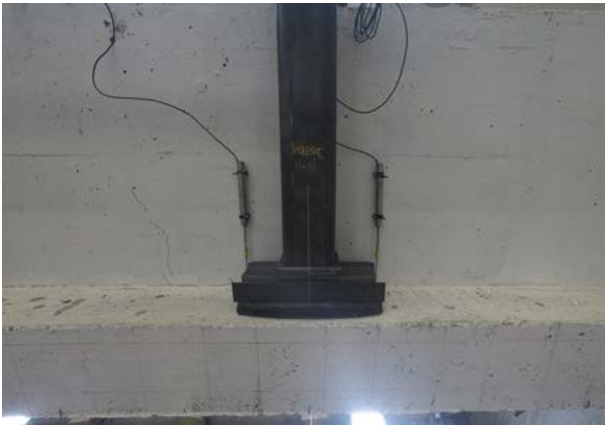
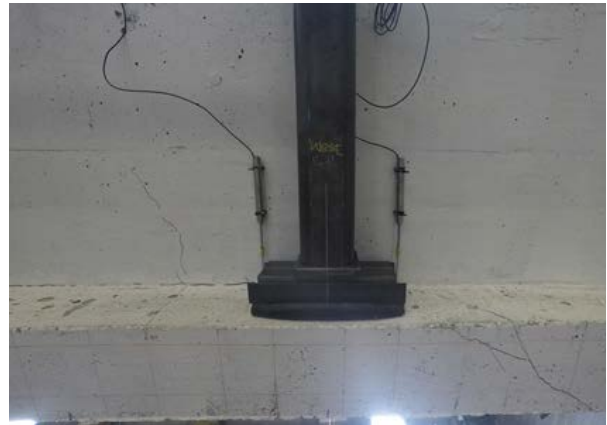
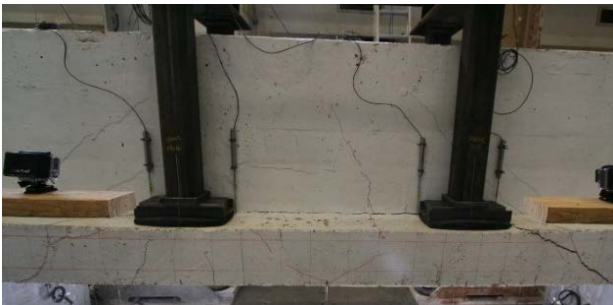
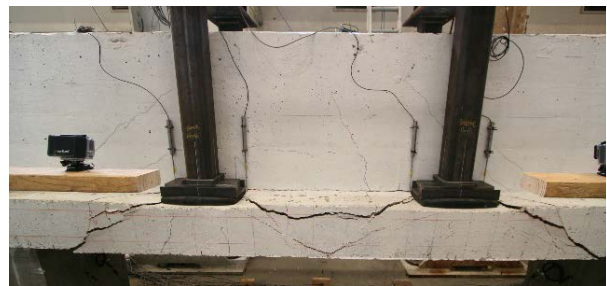
(a) SLS—northwest loading point

(b) ULS—northwest loading point

(c) Measured ultimate load—north side

(d) After peak—north side

Figure 3.51. Observed Damage for T5I1 at Different Load Levels.

The initial cracks were observed at SLS on the web-ledge interface behind the bearing pads. Figure 3.51(a) shows the observed damage at SLS around the northwest loading points. The cracks at the interface extended about 10 in. from the center of the load points toward the center of the bent cap. On the outside of the bearing pads, the web-ledge interface cracks started from the edge and propagated diagonally to the side face of the ledge. A 75-degree-angle web shear crack and an 85-degree-angle web shear crack were observed near the center of the bent cap on the north and south sides, respectively. Flexural cracks were also detected on the bottom of the bent cap. The cracks observed at SLS were all hairline cracks.

Under the ULS demand, crack extension and new crack formation were observed. Figure 3.51(b) shows the observed damage at ULS around the northwest loading point. Diagonal cracks on the top face of the ledge started at the web-ledge interface and propagated all the way to the side face of the ledge. Web shear cracks on the web that initiated from the web-ledge interface were formed on the outside of the bearing pad. More flexural cracks were observed on the bottom of the bent cap. The maximum width of the web-ledge interface cracks and ledge shear cracks was 2.5 mm and 0.8 mm, respectively.

Under the measured ultimate load, width extension of existing cracks and new crack formations around the northwest bearing pad were detected. Figure 3.51(c) shows the observed damage on the north side. It is evident in the figures that more damage occurred on the north side than on the south side. New cracks mainly formed on the side face of the ledge. The width of the diagonal ledge shear crack on the outside of the northwest bearing pad was 3.5 mm. Web-ledge interface cracks on the north side increased to 3.5 mm.

The bent cap was further loaded after the measured ultimate load by pumping the same amount of pressure to both actuators. The east and west actuator loads were sustained at around 73 kips and 75 kips, respectively. Figure 3.51(d) shows the extent of damage at a post-failure load of 45 kips, when the cracks further opened and the north side ledge region deformed outward and downward from the web.

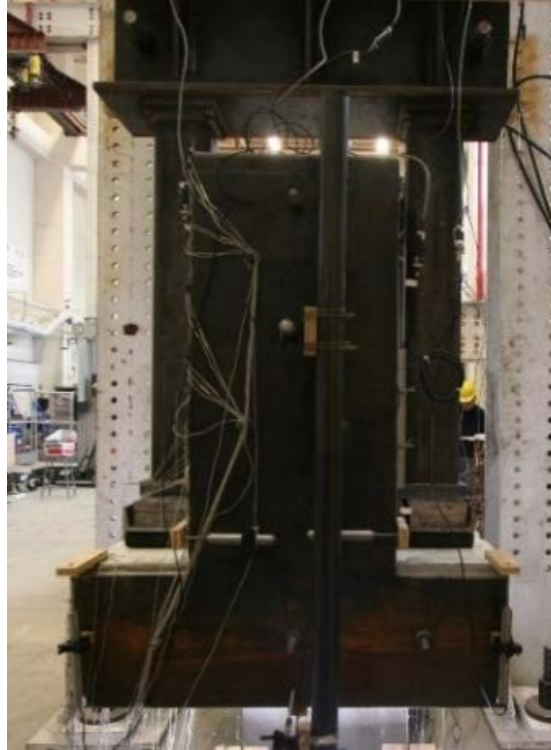
Figure 3.52. Retrofit Solution 3 Installed on West End of Ledge-Deficient Specimen 5.
