Strengthening of Existing Inverted-T Bent Caps— Volume 2: Experimental Test Program

Technical Report 0-6893-R1-Vol2

TEXAS A&M TRANSPORTATION INSTITUTE
COLLEGE STATION, TEXAS

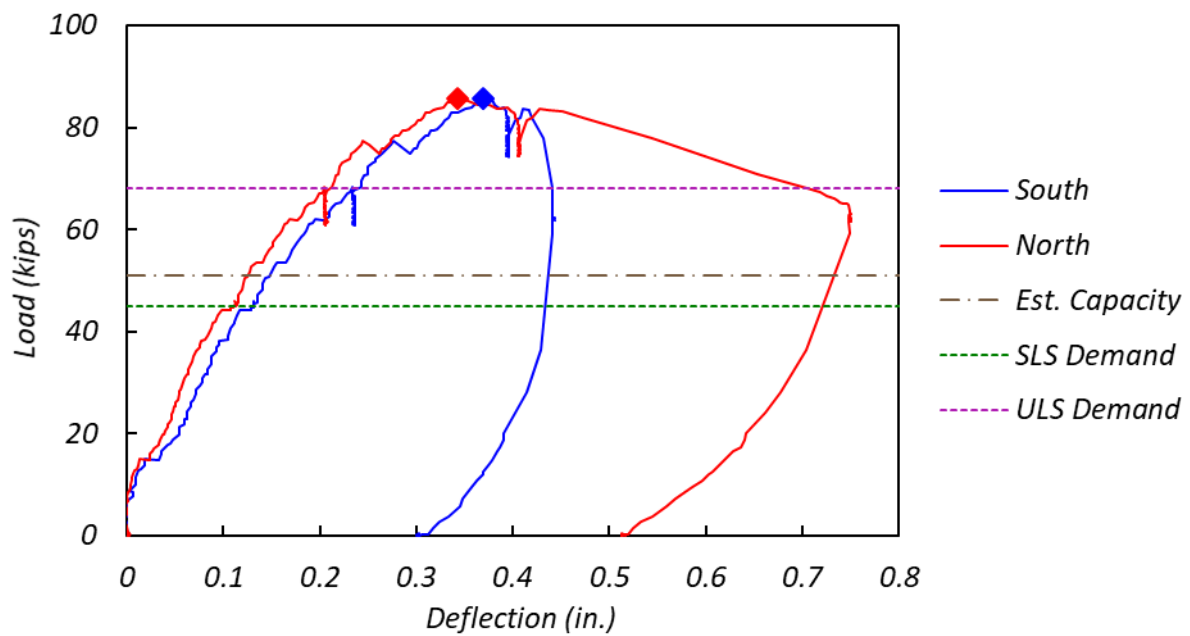
Figure 3.53. Load-Deflection Curve for T5W1.

The measured ultimate load (86 kips) was 69 percent larger than the estimated capacity of 51 kips and 30 percent larger than the exterior ledge-deficient reference capacity. The test was ended when the applied load dropped to about 80 percent of the measured ultimate load. Figure 3.54 shows the observed damage at the final load level. The specimen failed in punching shear on the north side.

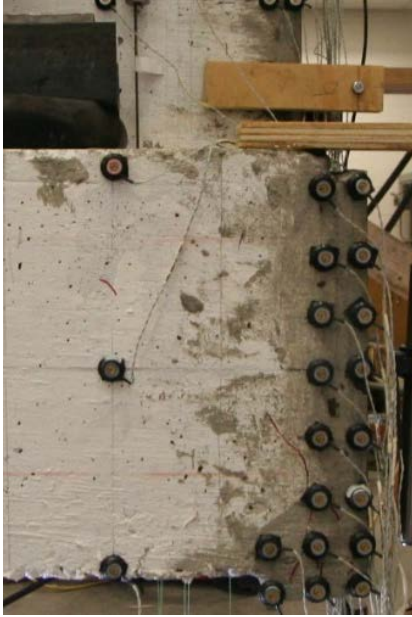
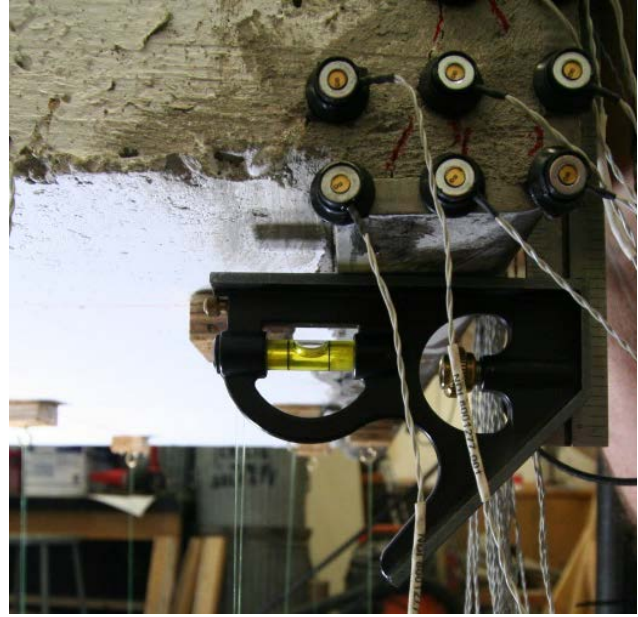
(a) Concrete cracks at corner

(b) Deformation of end plate

Figure 3.54. Observed Damage for T5W1 at Final Load Level.

The initial cracks formed at the web-ledge interface behind the bearing pads at SLS. The cracks extended about 20 in. along the interface. On the south side ledge, the interface crack propagated diagonally to the top face of the ledge about 7 in. with an angle of 35 degrees. Overall, light levels of damage were detected at SLS compared to the reference test. Crack extensions and new crack formations were observed as the load increased. Web shear cracks initiated at a load of 54 kips.

Under the ULS of 68 kips, new cracks formed on the web and on the top and side face of the ledge. Diagonal ledge cracks were observed around the bottom corner of the ledge side face. Diagonal web cracks were also detected on the web.

During loading to the measured ultimate load, crack extensions and new crack formations were observed on both the web and ledge. The grout cracks between the end plate and the bent cap formed at 80 kips. Under the measured ultimate load of 86 kips, the bottom tip of the end plate deformed outward, as shown in Figure 3.54(b). More damage occurred on the north side than on the south side. Significant extensions of existing cracks and new crack formations on the north side ledge are seen in Figure 3.54(d). A hanger crack was detected near the neutral axis of the bent cap. There were fewer cracks at the inside of the bearing pad compared to the reference test, which may have been due to the restraint provided by the end plate. The diagonal cracks outside of the bearing pad showed a steeper angle than the inside cracks. The bottom of the end plate deformed outward and downward about 0.5 in. at the end of the test.

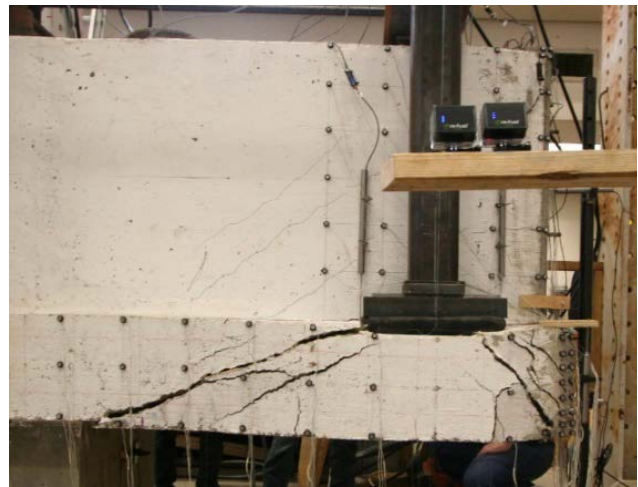
(c) South side

(d) North side

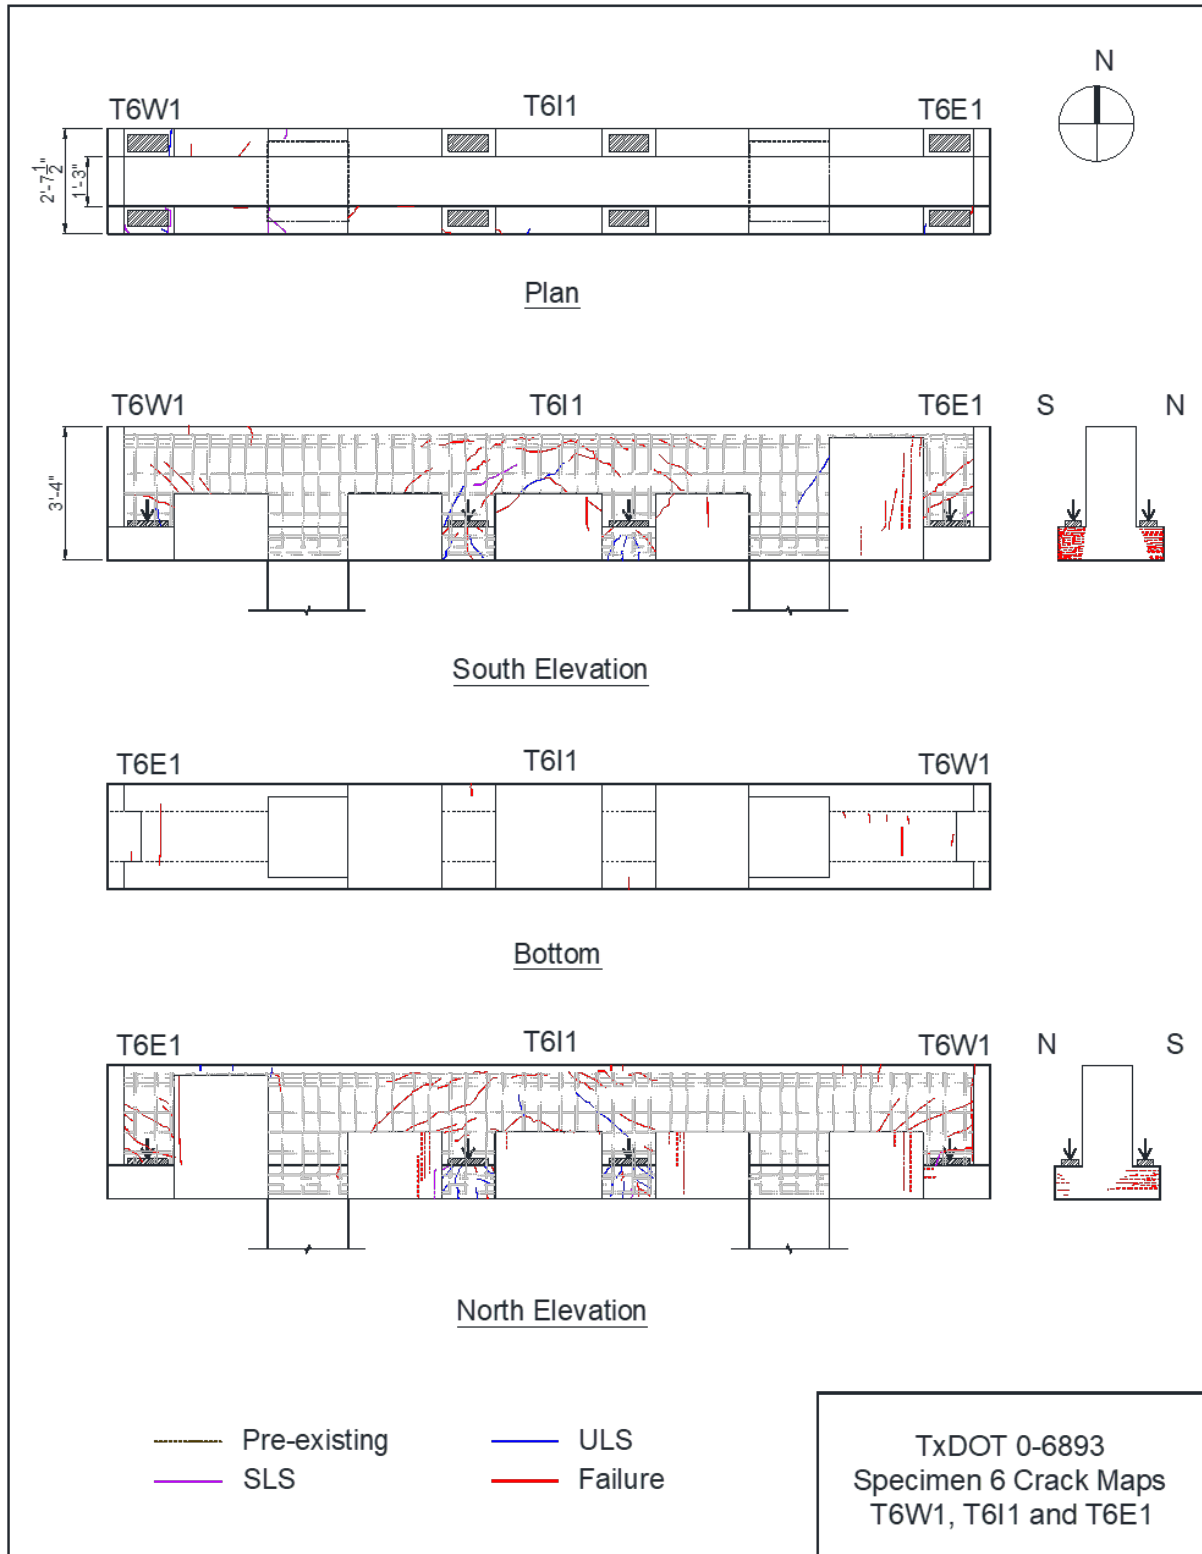
Figure 3.55. Crack Maps for Tests T6W1, T6I1, and T6E1.

Ledge-deficient Specimen 6 provided exterior (T6W1) and interior (T6I1) of the partial-depth FRP retrofit solution (Solution 16) and an exterior test (T6E1) of the full-depth FRP retrofit solution (Solution 17). Figure 3.55 shows crack patterns for all three tests at SLS, ULS, and failure.

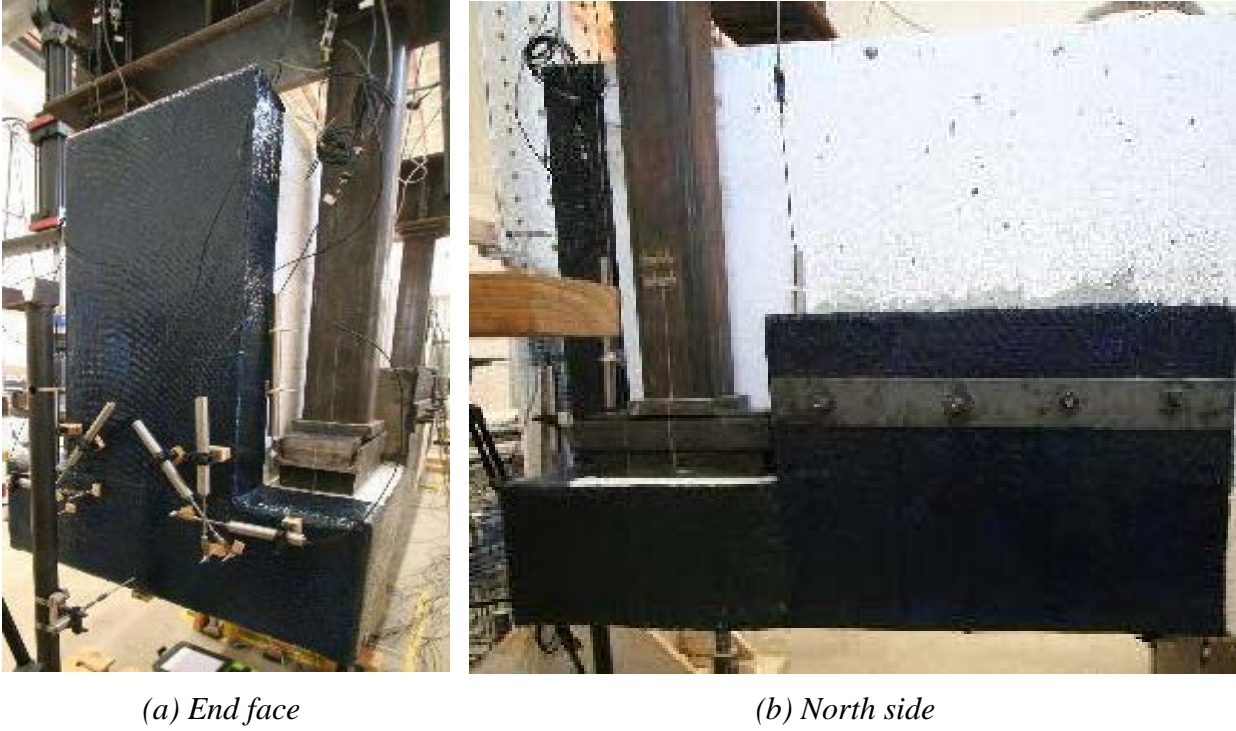
Figure 3.56. Retrofit Solution 16 Installed on West End of Ledge-Deficient Specimen 6.

T6W1 is an exterior test using the partial-depth FRP retrofit (Solution 16). Figure 3.56 shows Solution 16 installed on the west end of the specimen. The FRP strip wrapping the stem of the specimen is expected to contribute strength to hanger capacity. The remaining FRP is expected to strengthen the ledge and punching shear capacity. Figure 3.57 shows the load-deflection plots for the north and south load points, with horizontal lines indicating SLS, ULS, and estimated capacity, and diamonds indicating the measured ultimate load.

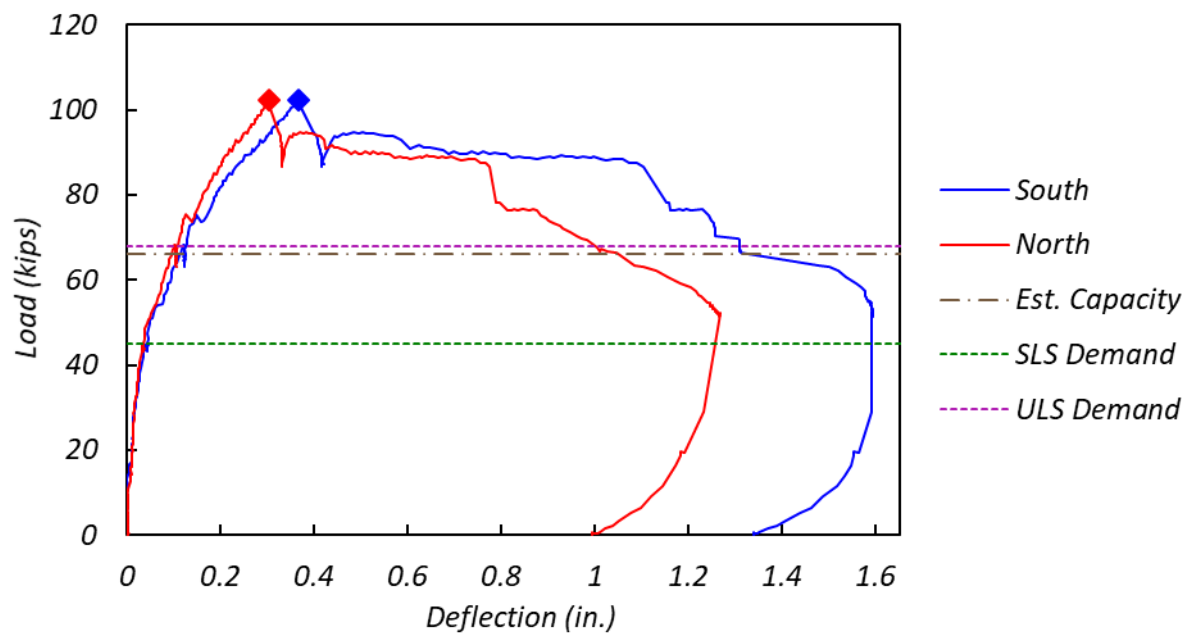
Figure 3.57. Load-Deflection Curve for T6W1.

The measured ultimate load (102 kips) was 46 percent larger than the estimated capacity (66 kips) and 55 percent larger than the exterior ledge-deficient reference capacity. The test was ended when the applied load dropped to about 55 percent of the measured ultimate load. Figure 3.58 shows the observed damage. The specimen showed a significant increase in ductility compared to the exterior ledge-deficient reference test. The tested region experienced a ledge flexure failure, with more extensive damage on the south side.

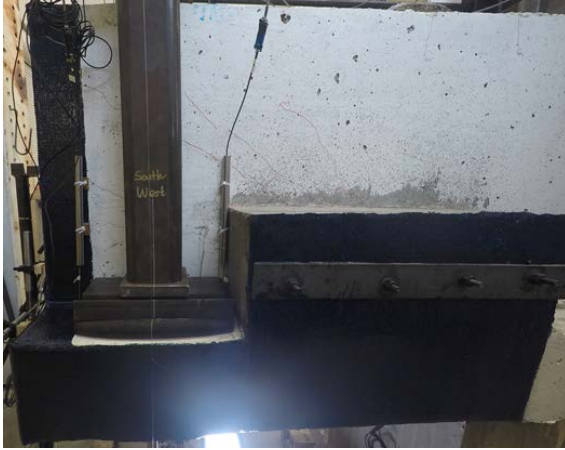
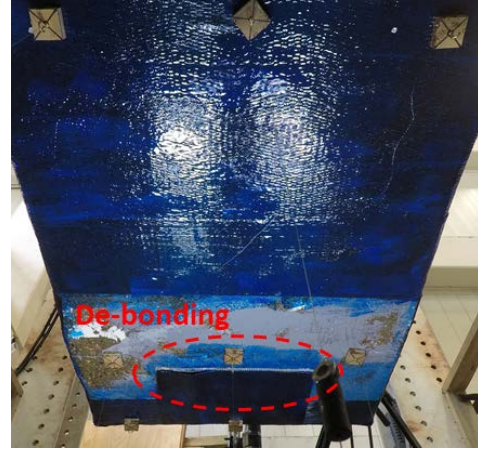
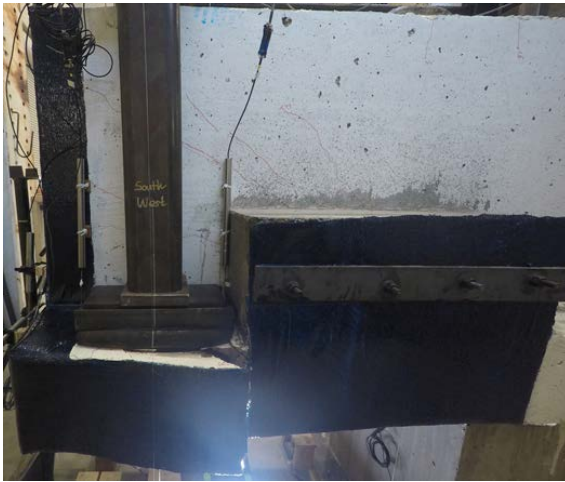
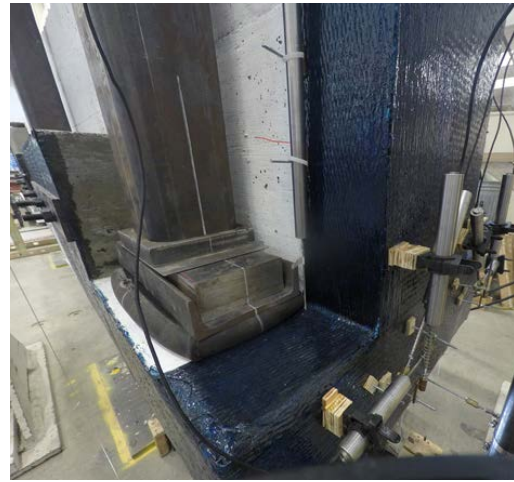
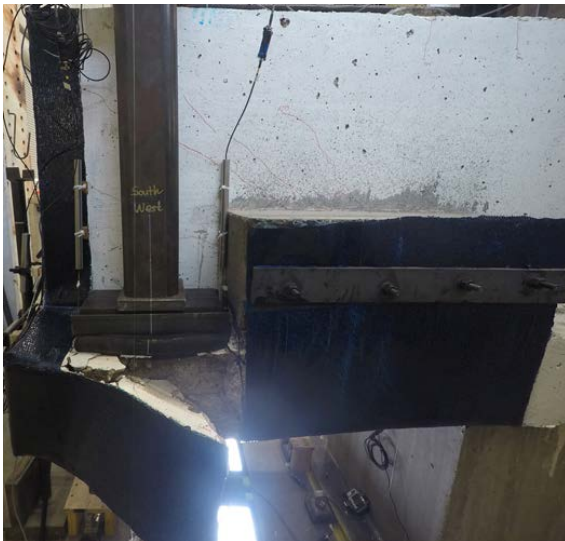
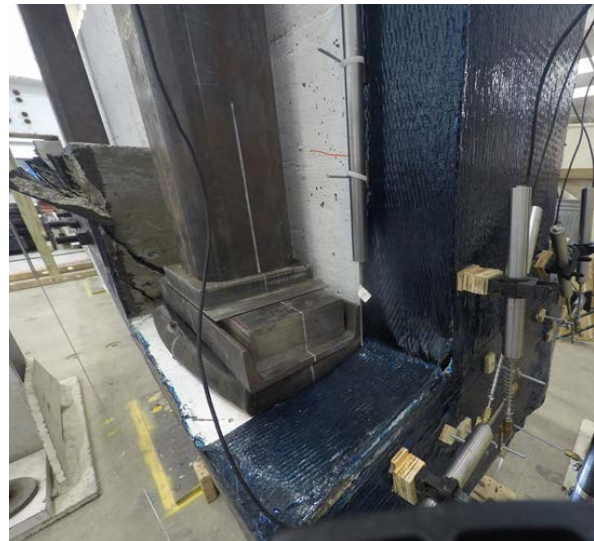
(a) South side at measured ultimate load

(b) Bottom at measured ultimate load

(c) South side at post-peak 75 kips

(d) North corner at post-peak 75 kips

(e) South side at final load level

(f) North corner at final load level

Figure 3.58. Observed Damage for Test T6W1 at Different Load Levels.

No damage was found before the load reached the ULS demand. At the ULS of 68 kips, end interfacial debonding of the FRP occurred at the west end of the concrete block along with vertical shear cracks. Cracks were also detected at the interface of the concrete block and the ledge. A vertical crack formed on the south side web behind the bearing pad. Web shear cracks formed starting at 90 kips.

The load reached the measured ultimate load of 102 kips and then dropped to 90 kips. At the measured ultimate load, intermediate shear-crack-induced interfacial debonding of the FRP was detected at the end of the concrete block on both sides. The same crack patterns were observed on the web at the end of the side FRP strip. On the bottom of the bent cap, an end interfacial debonding of the stem FRP strip was observed. On the end face, horizontal cracks formed over the FRP strip on the flange due to the shear cracks.

After the described damage, the bent cap was loaded again from the load of 90 kips. The load reached a post-peak 90 kips and then gradually decreased. Significant extensions of existing cracks and new crack formations were detected. More horizontal cracks formed on the flange of the end face while the load decreased to 90 kips. Side FRP strip separation was observed at the web-ledge interface. Concrete cover separation was observed on the end of the concrete block and on the side face of the north side ledge. The south side ledge experienced more deflection than the north side. The test was ended when the load dropped to 60 kips, which was 40 percent lower than the measured ultimate load.

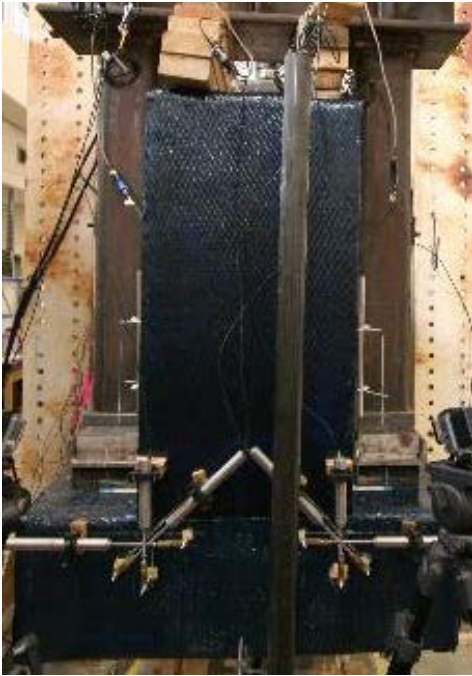
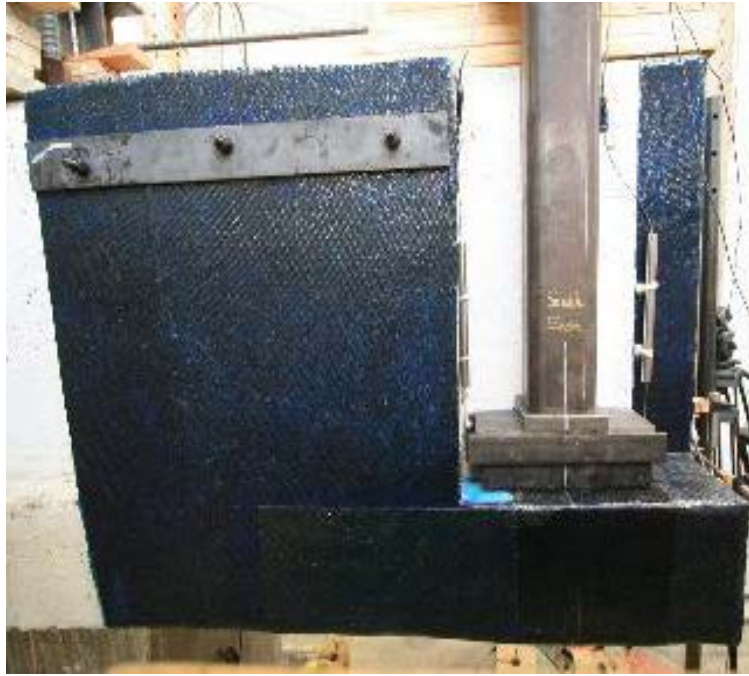
(a) End face

(b) South side

Figure 3.59. Retrofit Solution 17 Installed on East End of Ledge-Deficient Specimen 6.

T6E1 is an exterior test using the full-depth FRP retrofit solution (Solution 17). Figure 3.59 shows Solution 17 installed on the east end of the specimen. Solution 17 is aimed at strengthening the hanger, ledge, and punching shear capacity of the bent cap.

Additional bandages were applied to provide anchorage to the bottom termination region of the FRP strip, which was applied on the end face to vertically wrap the stem of the specimen and connect the horizontal FRP strip on the end face and the vertical FRP strip attached on the concrete block. Figure 3.60 shows the load-deflection plots for the north and south load points.

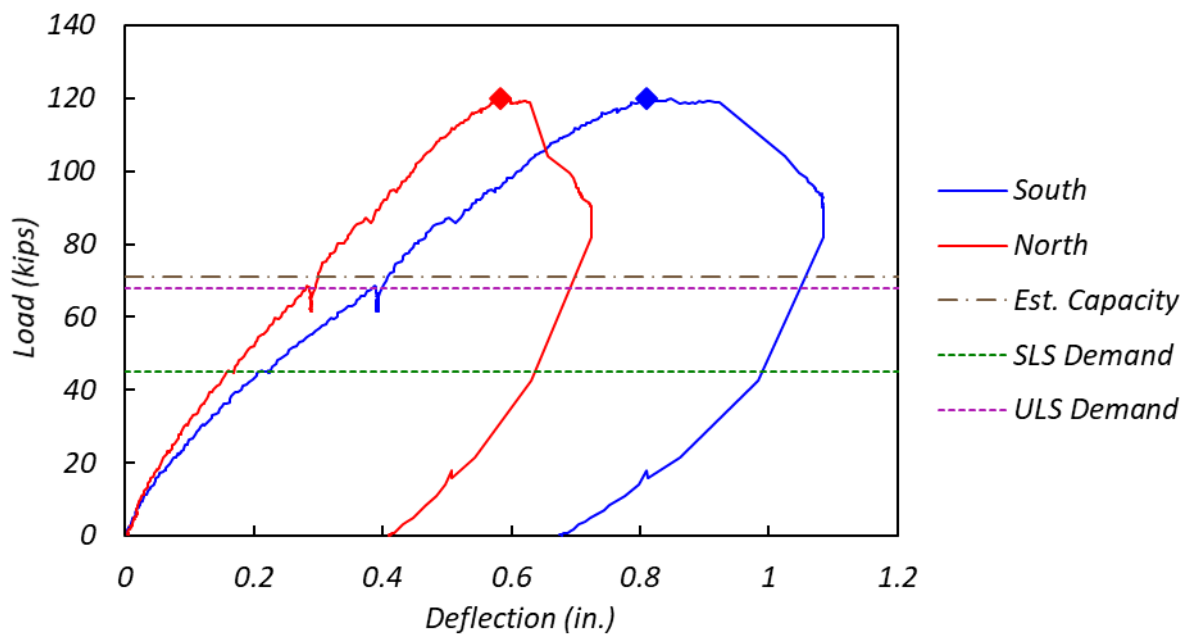
Figure 3.60. Load-Deflection Curve for T6E1.

The measured ultimate load (120 kips) was 69 percent larger than the estimated capacity (71 kips) and 82 percent larger than the exterior ledge-deficient reference capacity. The test was ended when the applied load dropped to about 75 percent of the measured ultimate load. Figure 3.61 shows the observed damage. The specimen at final load level showed a combined ledge flexure and punching shear failure.

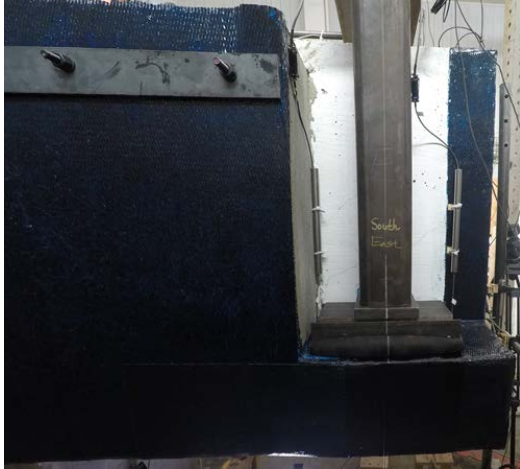
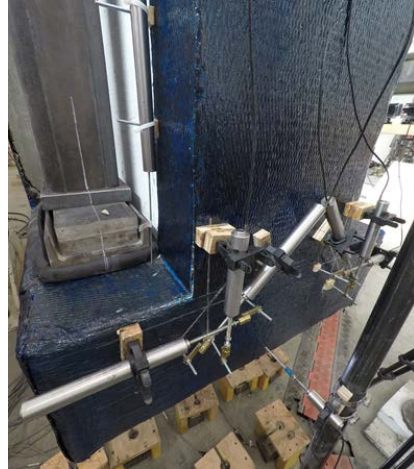
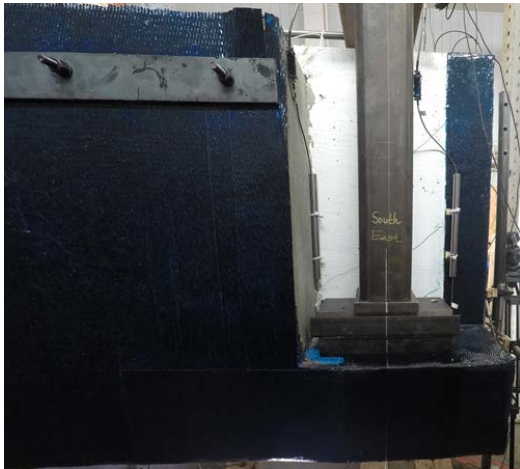
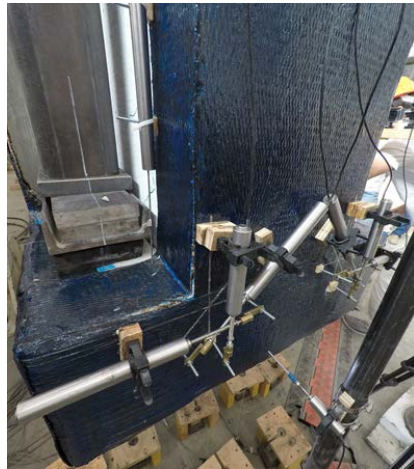
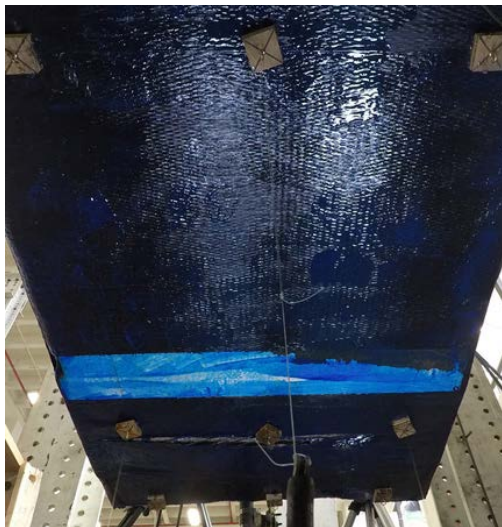
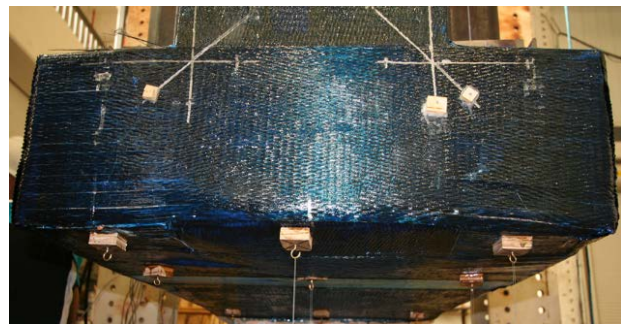
(a) North side at measured ultimate load

(b) North corner at measured ultimate load

(c) North side at final load level

(d) North corner at final load level

(e) Bottom at final load level

(f) Ledge after removal of load

Figure 3.61. Observed Damage for Test T6E1 at Different Load Levels.

No damage was visible until the ULS demand of 68 kips. At ULS, cracks formed at the interface between the concrete block and the ledge beside the south side bearing pad. A web shear crack was detected on the south side web at the inner side of the concrete block. Negative flexure cracks formed on the north side of the web.

More cracks on the web were observed as the load increased. A hanger crack formed at 88 kips. At a load of 102.5 kips, horizontal cracks started to form on the flange at the end face. Intermediate shear-crack-induced debonding of the FRP occurred at the end of the concrete block on the bearing pad side. More separations of the FRP strip were observed at the end of the concrete block as the load went higher. At a load of 112.5 kips, a separation of the FRP was observed at the web-ledge interface near the end of the bent cap. At the measured ultimate load of 120 kips, end interfacial debonding of the FRP was observed at the end of the south side concrete block. The load dropped to 100 kips, accompanied by a loud sound, due to shear rupture of the FRP at the end region of the concrete block.

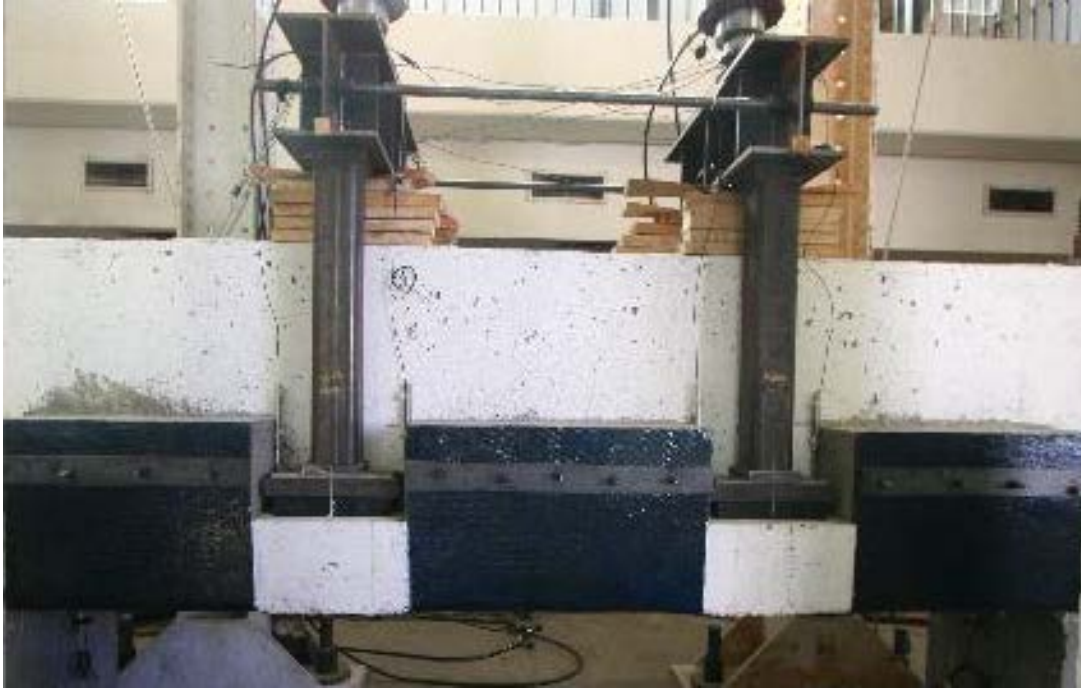
Figure 3.62. Retrofit Solution 16 Installed on Interior of Ledge-Deficient Specimen 6.

T6I1 is an interior test using the partial-depth FRP retrofit solution (Solution 16). Figure 3.62 shows Solution 16 installed on the interior of the specimen. Solution 16 for interiors is aimed at improving the ledge and punching shear capacity. Figure 3.63 shows the load-deflection plots for all load points.

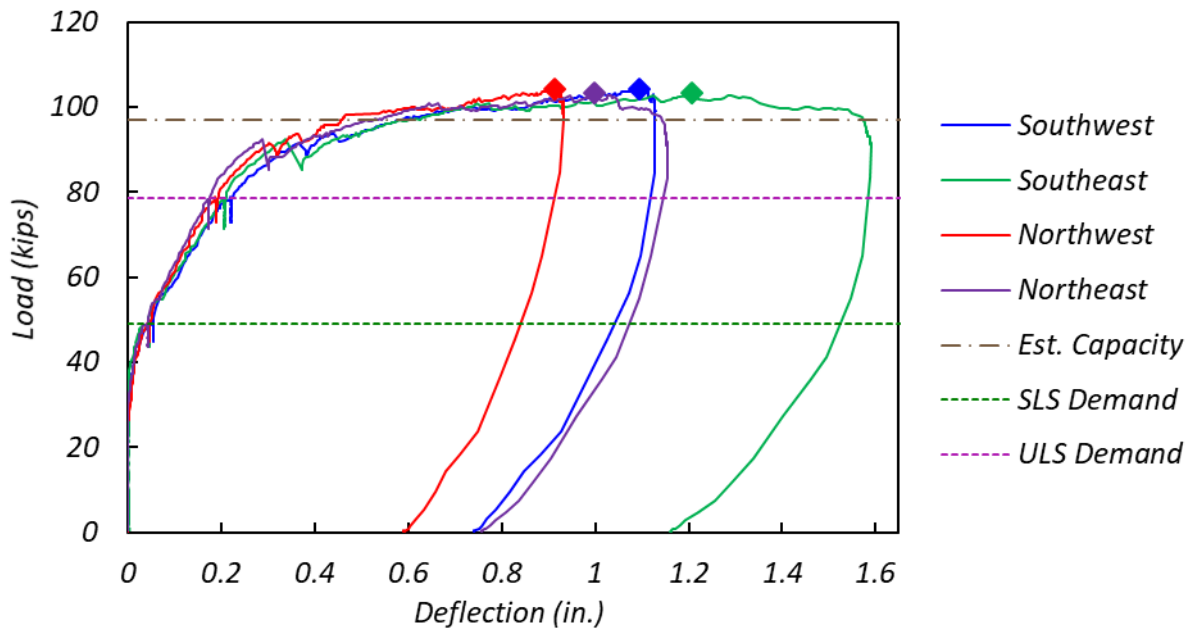
Figure 3.63. Load-Deflection Curve for T6I1.

The measured ultimate load (103 kips) was 6 percent larger than the estimated capacity (97 kips) and 21 percent larger than the interior ledge-deficient reference capacity. The test was ended when the applied load dropped to about 90 percent of the measured ultimate load. Figure 3.64 shows the observed damage at the final load level. The specimen at the final load level showed a combined hanger and punching shear failure.

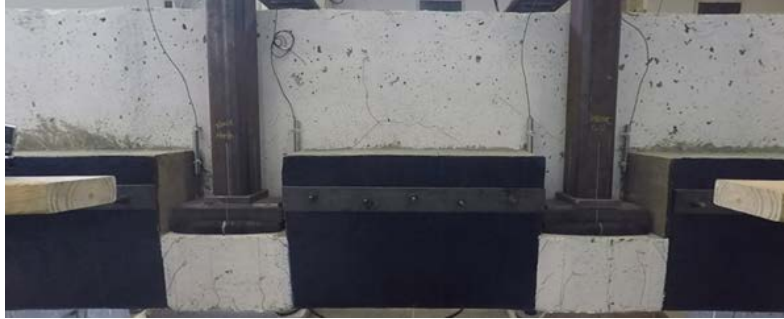
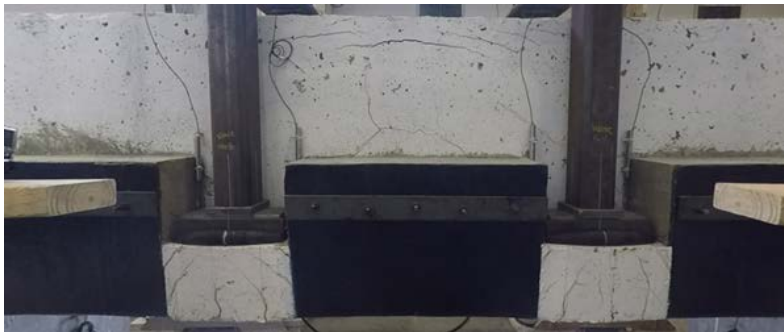
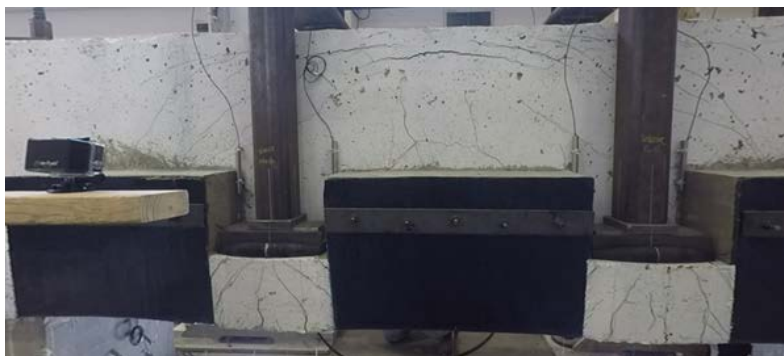
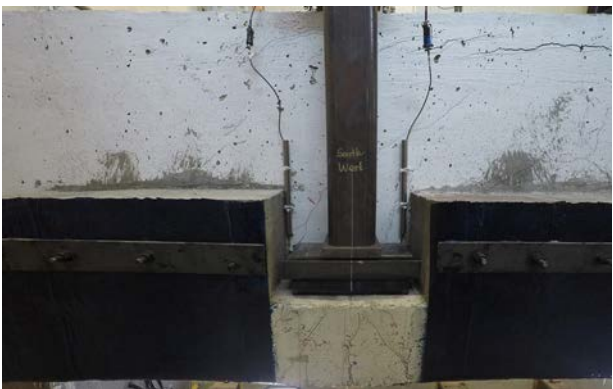
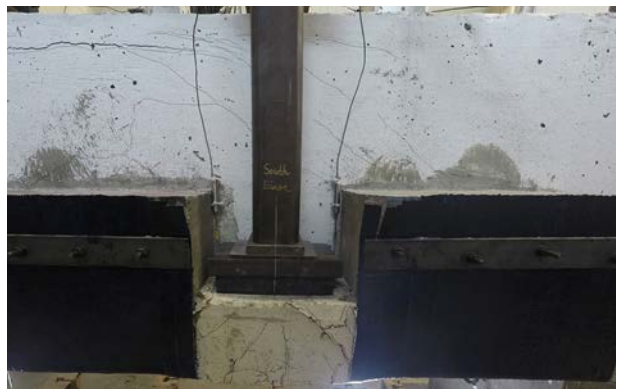
(a) North side at ULS

(b) North side at measured ultimate

(c) North side at final load level

(d) Southwest at final load level

(e) Southeast at final load level

Figure 3.64. Observed Damage for Test T6I1.

At the SLS of 49 kips, the initial cracks formed at the interface of the northwest concrete block and the ledge. Flexure cracks were detected on the bottom along the interface of the FRP strip and the bent cap. More cracks formed on the side face of the north side ledge at the interface of the FRP strip and bent cap. At a load of 75 kips, the first diagonal shear cracks were detected on the web behind the southwest load point.

At the ULS of 78.5 kips, more cracks had formed at the interface between the FRP and bent cap. Diagonal shear cracks were detected on both sides of the web. On the side face of the ledge, diagonal cracks formed under the bearing pad between the concrete blocks. Crack extensions and new crack formations were observed as the load increased.

End interfacial debonding of the FRP was detected at the east end of the southwest concrete block at 84 kips. More cracks formed on the web. As the load increased, the web shear crack angles appeared to decrease, tending more toward horizontal angles between the loading points. More end interfacial debonding of the FRP occurred at the end of the concrete blocks. At a load of 99 kips, intermediate shear-crack-induced interfacial debonding was observed at the end of the southeast concrete block. The web shear cracks from the outside of the bearing pads connected horizontally near the top of the bent cap formed interior hanger cracks. At the measured ultimate load of 103 kips, intermediate shear-crack-induced interfacial debonding of the FRP was observed at all inner ends of the concrete blocks. The maximum crack width of the interior hanger cracks was 5.5 mm.

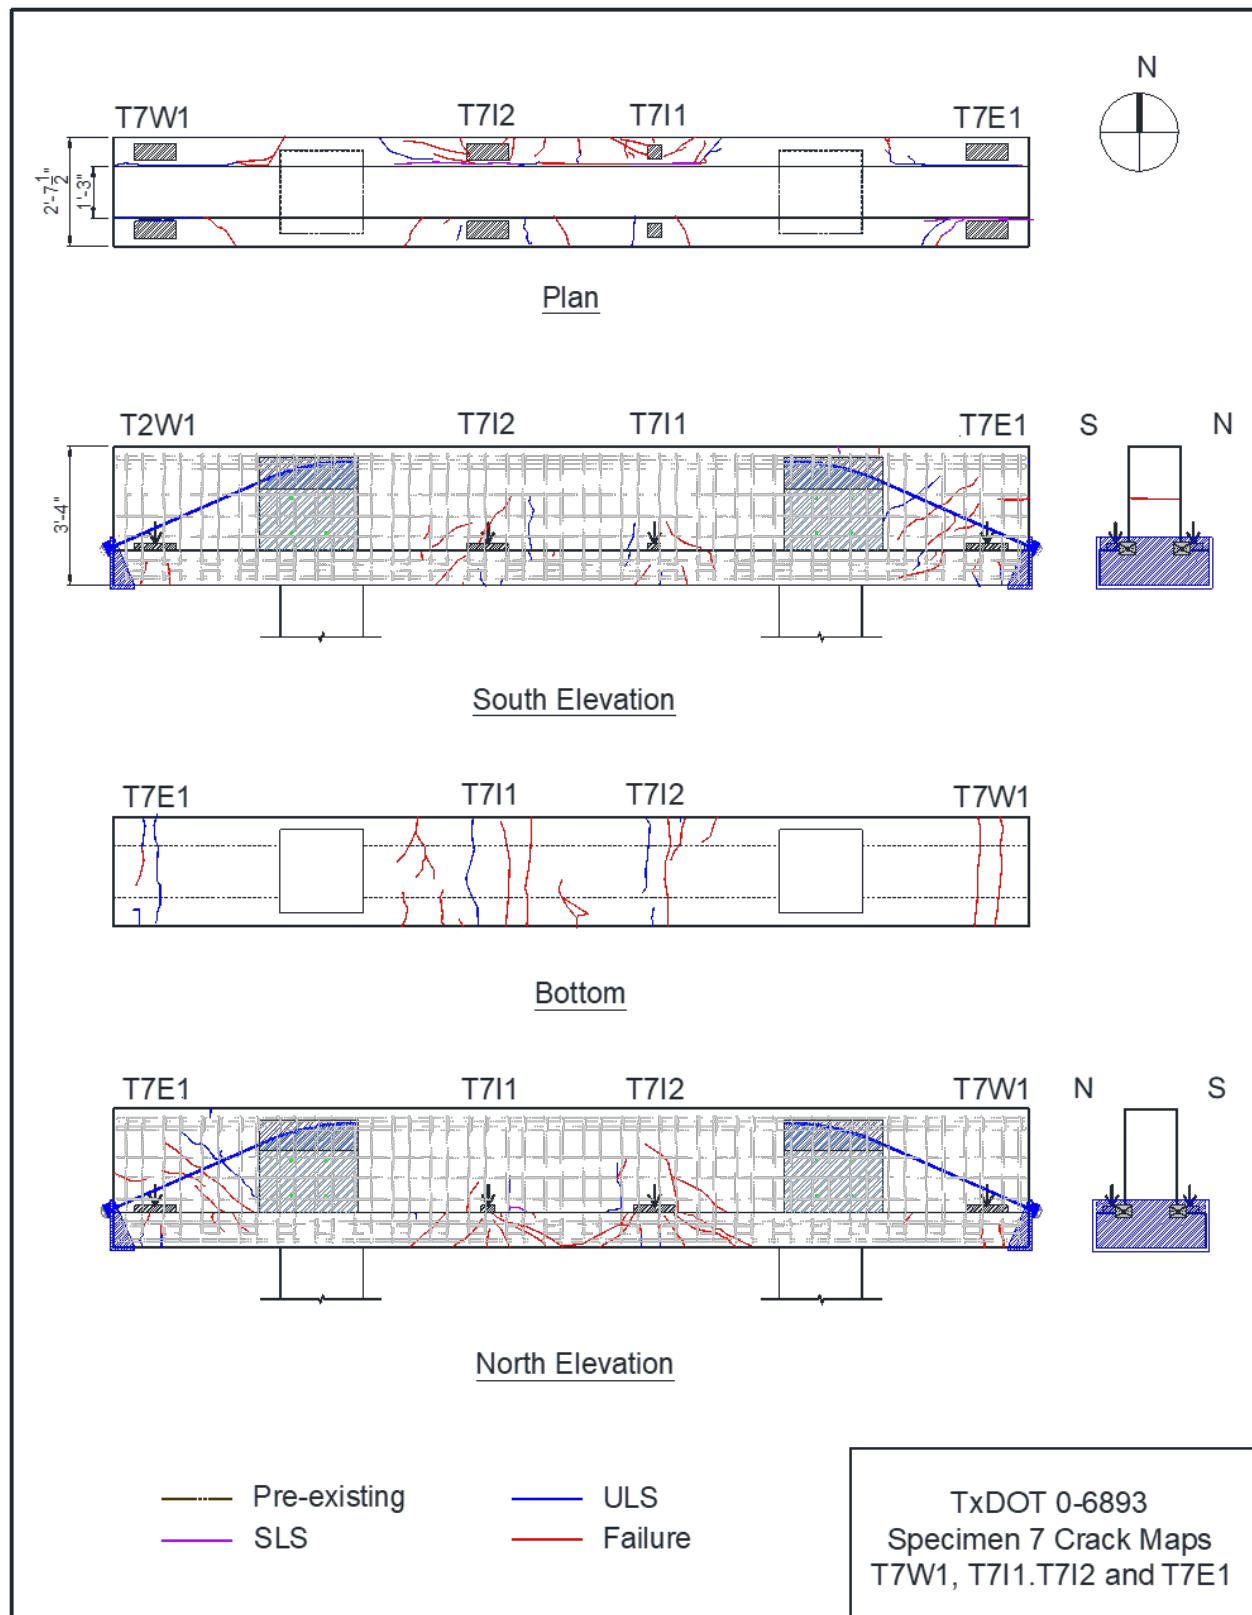
Figure 3.65. Crack Maps for Tests T7W1, T7I1, T7I2, and T7E1.

Ledge-deficient Specimen 7 had four exterior tests and four interior tests. Exterior tests with post-tensioning (Solution 14) were tested first, with one end pre-cracked (T7E1). The post-tensioning was then removed to allow the end-stiffener (Solution 3) and clamped threadbar (Solution 8[a]) solutions to be tested. All interior tests were punching shear tests. T7I1 and T7I2 used small (4 in. by 4 in.) and large (12 in. by 5 in.) pads, respectively, on the north side ledge. T7I3 and T7I4 used small and large bearing pads, respectively, on the south side ledge. Figure 3.65 shows crack patterns for tests T7W1, T7I1, T7I2, and T7E1. Figure 3.66 shows crack patterns for tests T7W2, T7I3, T7I4, and T7E2.

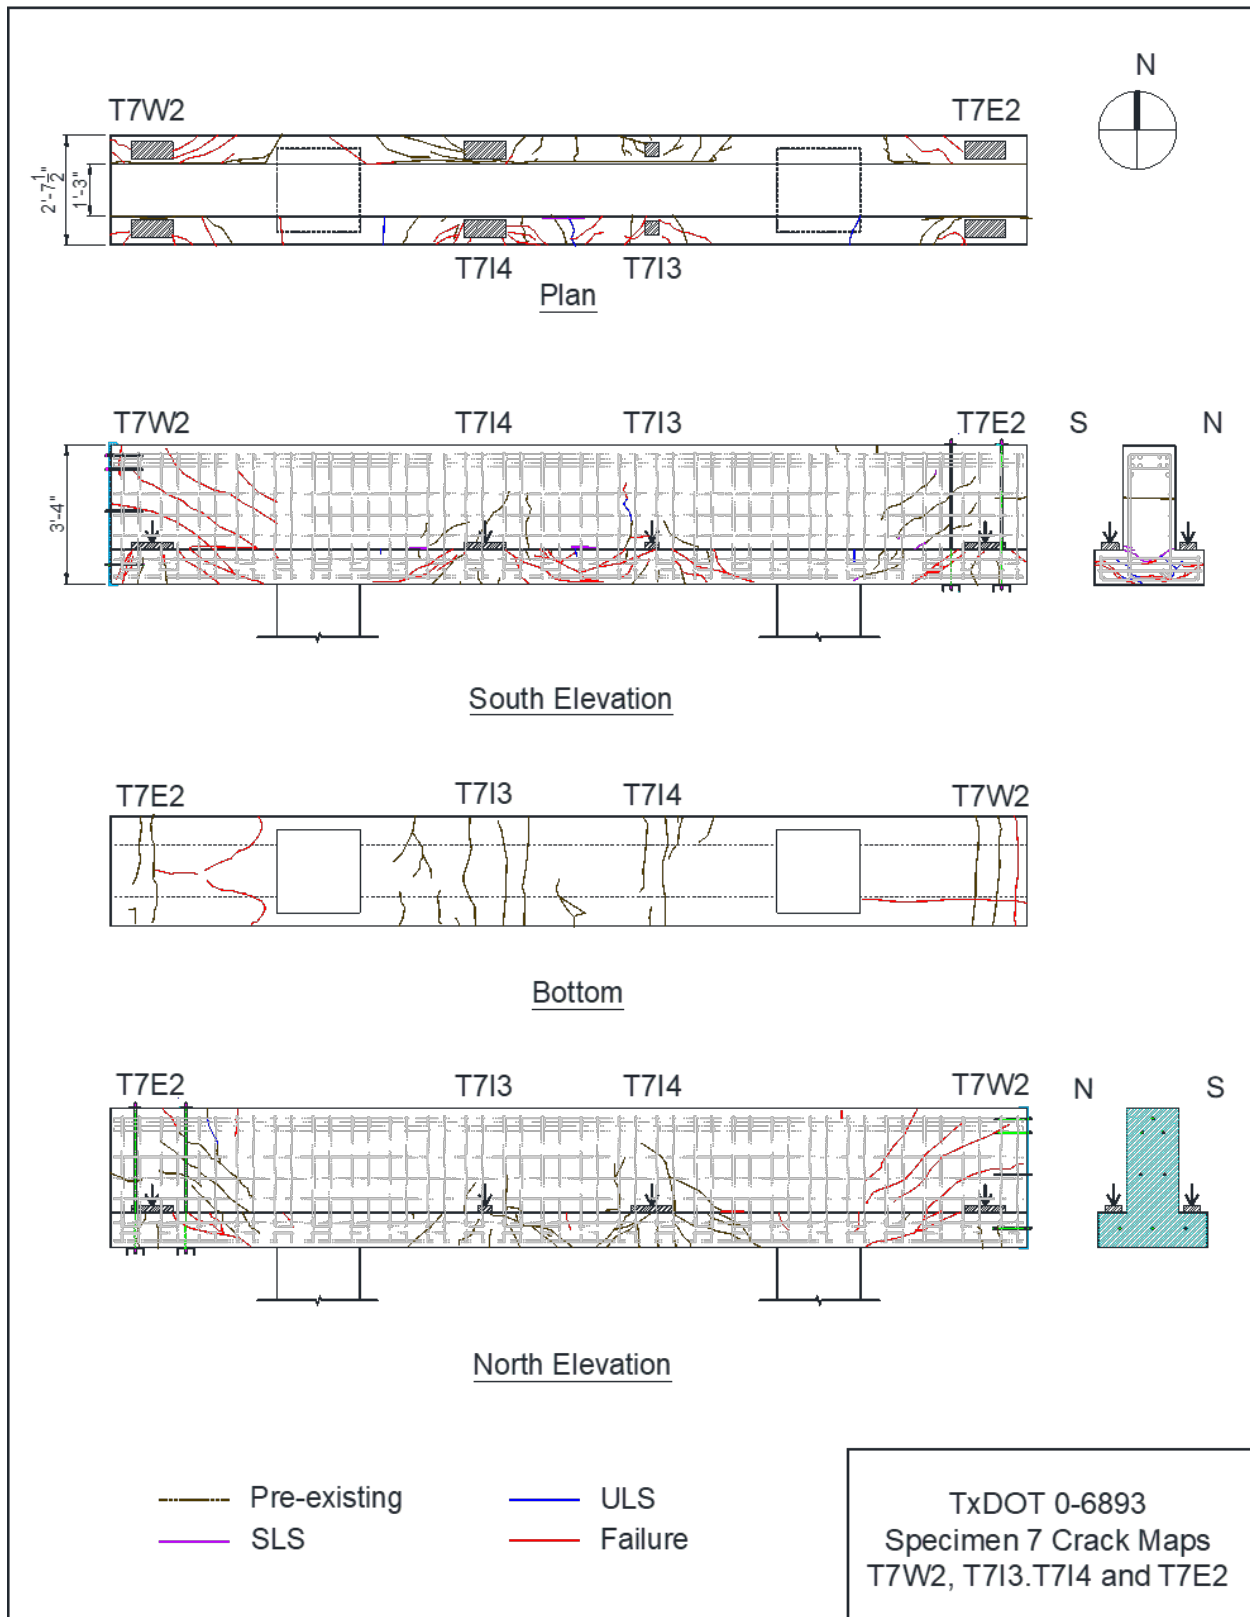
Figure 3.66. Crack Maps for Tests T7W2, T7I3, T7I4, and T7E2.

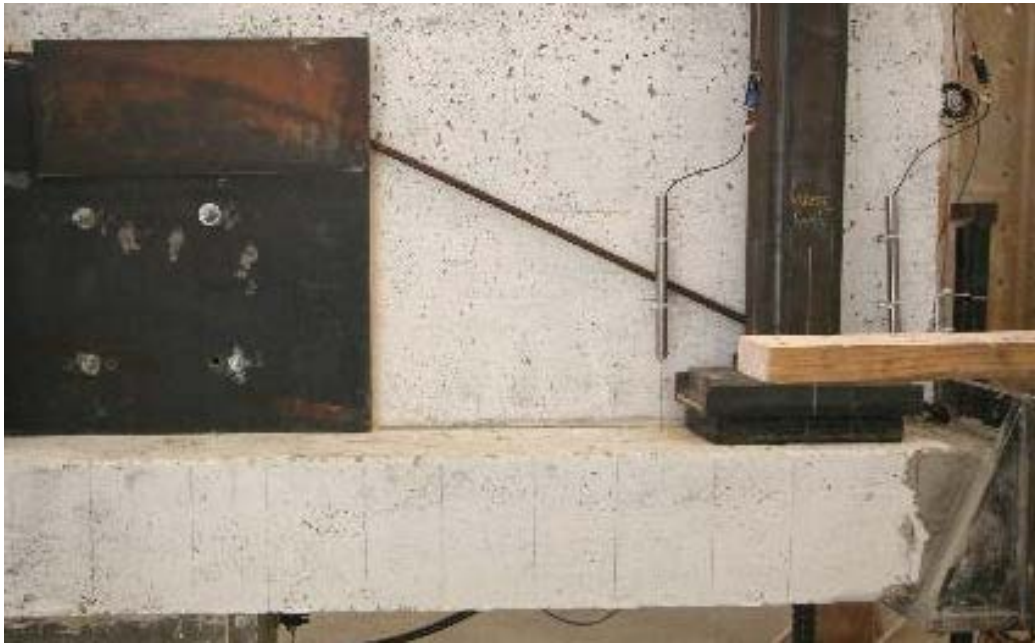
Figure 3.67. Retrofit Solution 14 Installed on West End of Ledge-Deficient Specimen 7.

T7W1 is an exterior test using the load-balancing PT retrofit solution (Solution 14). Figure 3.67 shows Solution 14 installed on the west end of the specimen. The test was terminated prior to failure or reaching a measured ultimate load. The test termination load (82 kips) was determined by adding the capacity contribution of the PT strands (16 kips) to the ultimate load capacity of the ledge-deficient exterior reference specimen (66 kips). Figure 3.68 shows the load-deflection plots for the north and south load points, with horizontal lines indicating SLS, ULS, and estimated capacity, and diamonds indicating the test termination load.

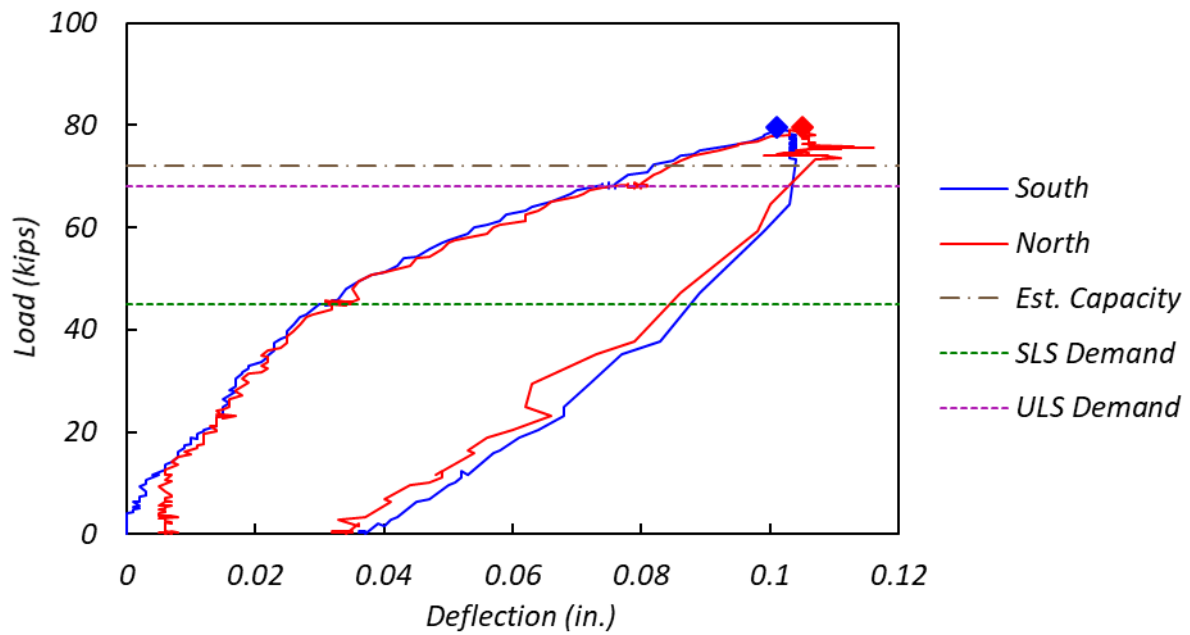
Figure 3.68. Load-Deflection Curve for T7W1.

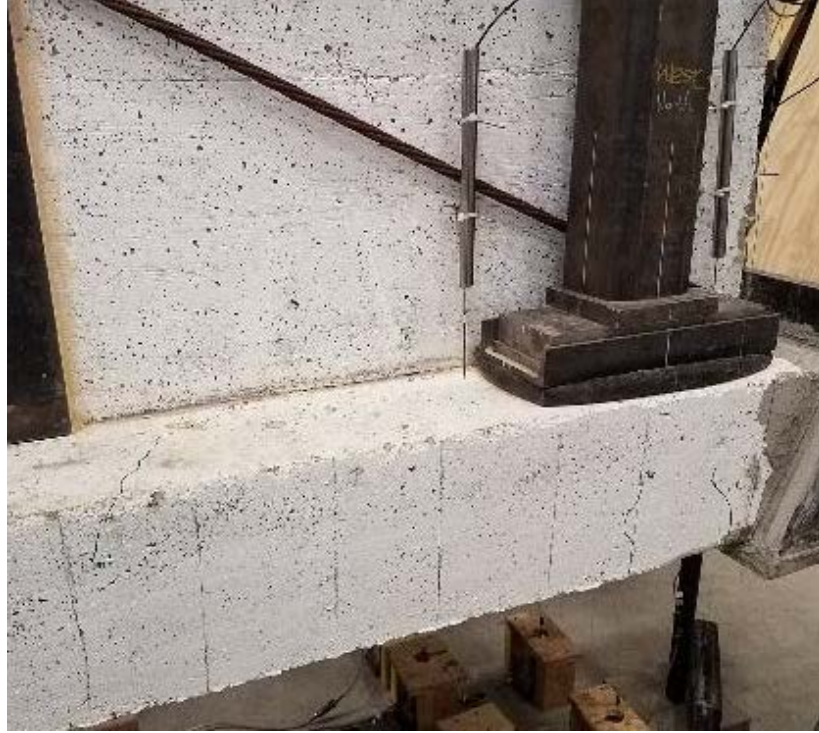
Figure 3.69. Observed Damage for Test T7W1 at Test Termination Load.

Solution 14 is expected to increase the hanger, ledge, and punching shear capacity. Figure 3.69 shows the observed damage at the test termination load. The specimen maintained its load carrying capacity with a moderate level of damage at a load 21 percent larger than the ultimate load capacity of the ledge-deficient exterior reference test.

No damage was detected at the SLS demand. The first crack occurred at a load of 64 kips at the web-ledge interface behind the bearing pads on the north side of the ledge. At the ULS demand of 68 kips, cracks formed at the web-ledge interface behind the bearing pad on both sides. On the top of the north side ledge, the cracks behind the bearing pad propagated along the web-ledge interface toward the column. Horizontal cracks formed on the bottom of the bent cap beneath the bearing pad. All the cracks detected at ULS were hairline cracks.

At the test termination load of 82 kips, the cracks at the web-ledge interface propagated diagonally to the side face of the ledge on both sides of the bent cap. Diagonal cracks on the side face of the ledge under the bearing pads were detected on both sides. Cracks at the bottom of the bent cap propagated at about two-thirds of the ledge toward the center of the bearing pad from the outside. The maximum widths of the interface and ledge cracks were 0.25 mm and 0.1 mm, respectively.
