Strengthening of Existing Inverted-T Bent Caps— Volume 2: Experimental Test Program

Technical Report 0-6893-R1-Vol2

TEXAS A&M TRANSPORTATION INSTITUTE
COLLEGE STATION, TEXAS

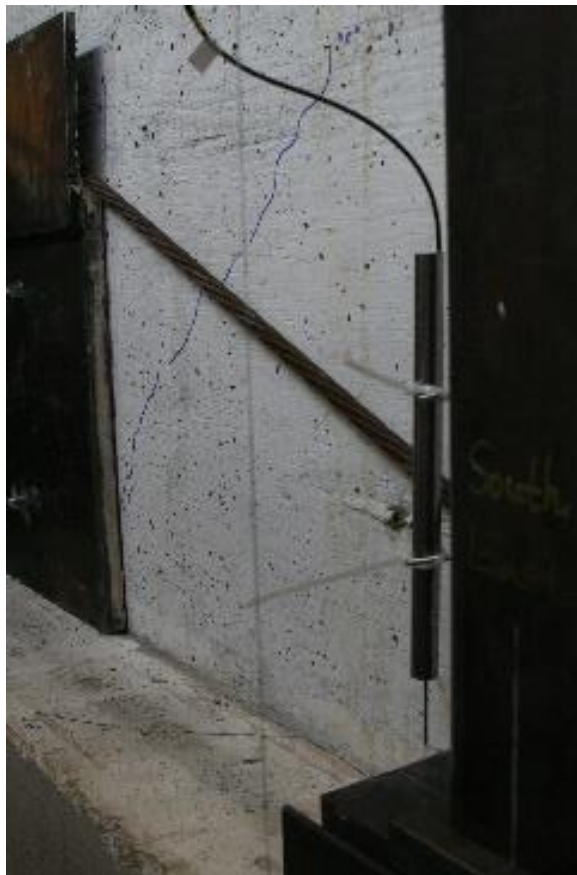
Figure 3.70. Observed Damage Before PT Jacking Operation.

T7E1 is an exterior test using the load-balancing PT retrofit solution (Solution 14) implemented with existing cracks. The assemblies for Solution 14 were preinstalled on the specimen, but the PT strands were not prestressed until cracking was induced by loading the specimen to 63 kips. Figure 3.70 shows the damage prior to prestressing. Unlike in the reference test, there were no cracks at the service load state, possibly as a result of increased capacity provided by the preinstalled steel assemblies. The PT strands were tensioned after the load reached 63 kips. Then the specimen was loaded gradually to the test termination load of 100 kips, determined based on the observation of the damage level. Figure 3.71 shows the load-deflection plots for the north and south load points.

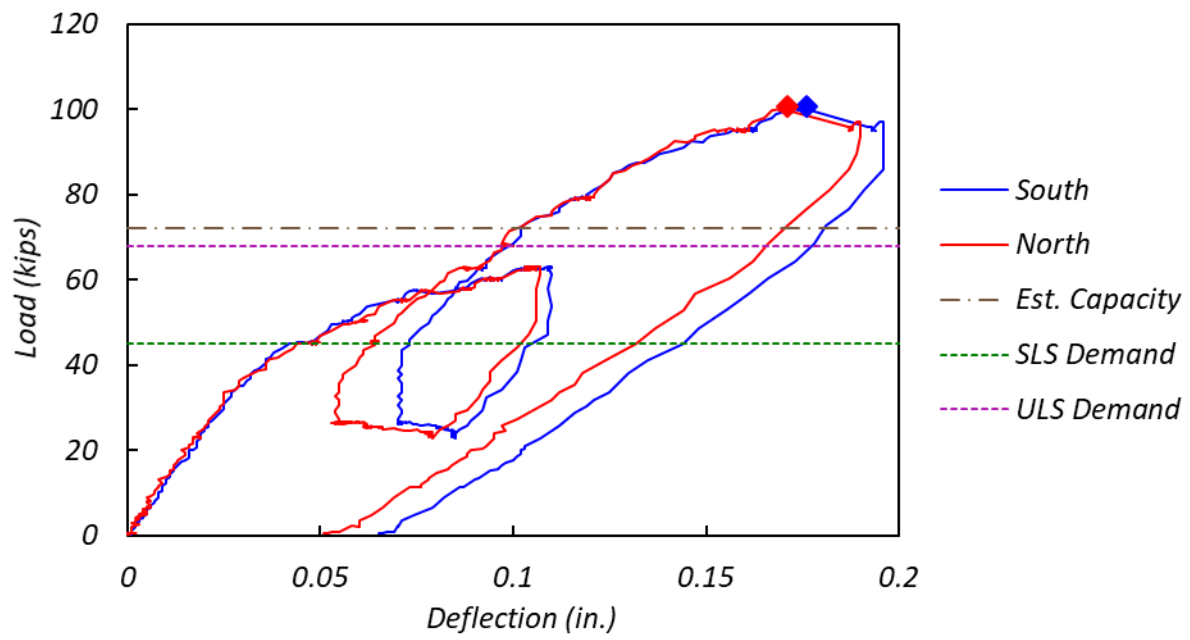
Figure 3.71. Load-Deflection Curve for T7E1.

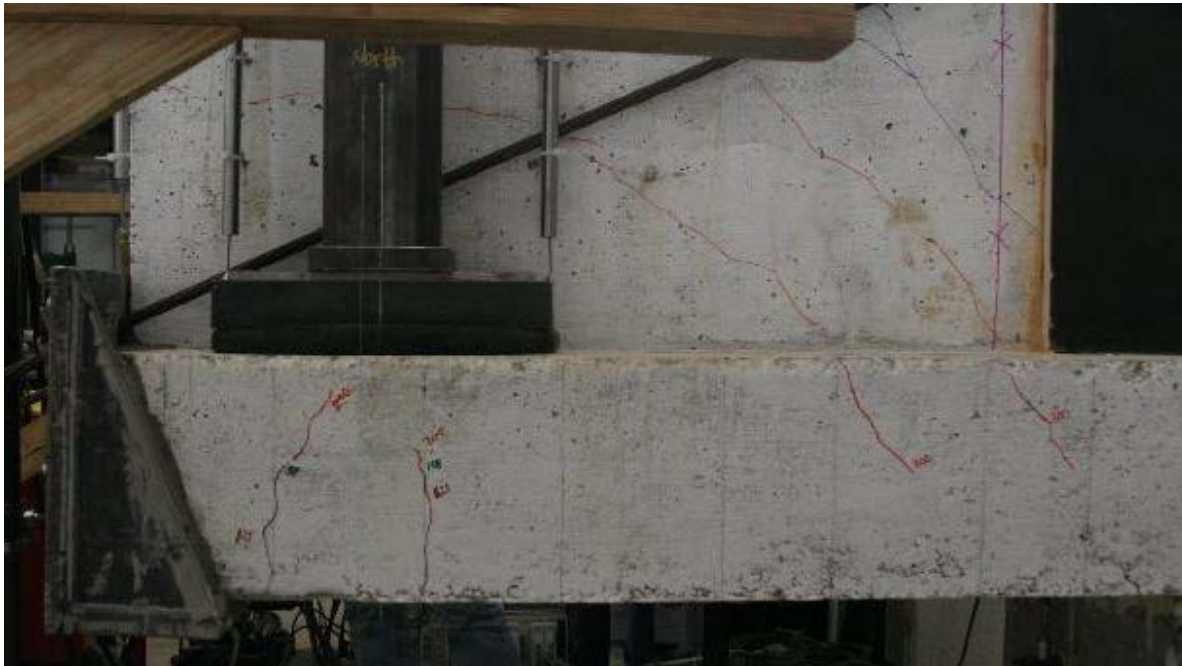
Figure 3.72. Observed Damage for Test T7E1 at Test Termination Load.

Figure 3.72 shows the observed damage at the test termination load. The specimen maintained a load carrying capacity with a moderate level of damage at the test termination load that was 50 percent larger than the ultimate load capacity of the ledge-deficient exterior reference specimen.

New cracks were observed on the south side ledge at the SLS demand after the PT strands were tensioned. More cracks on the ledge and web were detected at the ULS demand of 68 kips.

Diagonal shear cracks were formed on both sides of the web. The web-ledge interface cracks were propagated diagonally to the top of the ledge. Cracks on the side face of the ledge under the bearing pad were observed on both sides. The maximum width of the cracks on the side face of the ledge was 0.5 mm. Crack extensions and new crack formations were observed as the load increased.

At the test termination load of 100 kips, more cracks were observed on the web and ledge on both sides of the bent cap. The maximum width of the ledge cracks was increased to 0.7 mm. A hanger crack formed on the end face 26 in. above the bottom of the bent cap.

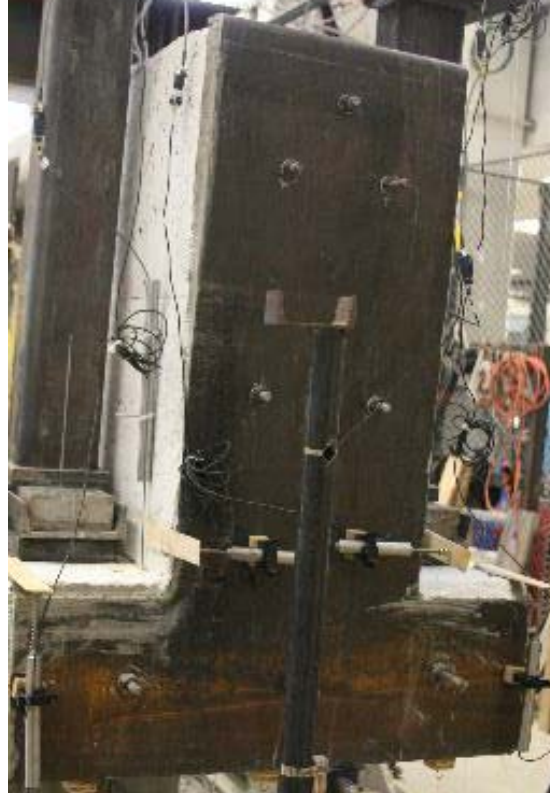
Figure 3.73. Post-Crack Retrofit Solution 3 Installed on West End of Ledge-Deficient Specimen 7.

T7W2 is an exterior test using an end stiffener (Solution 3) installed with existing cracks from the T7W1 test. Figure 3.73 shows the post-crack Solution 3 installed on the west end of the specimen. Figure 3.74 shows the load-deflection plots for the north and south load points.

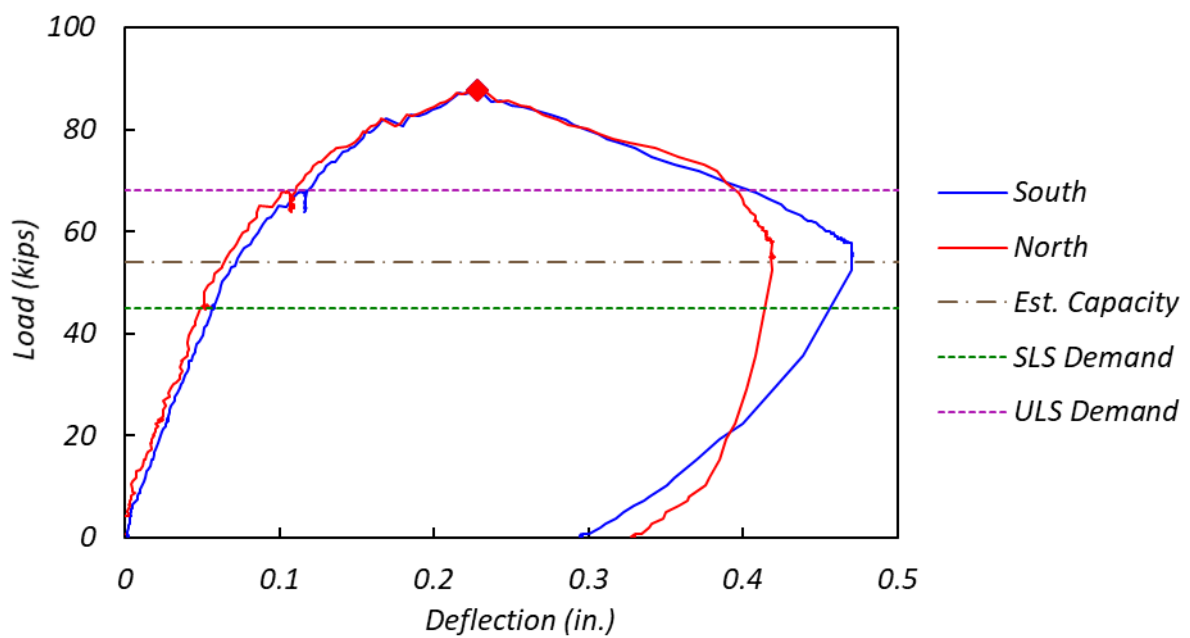
Figure 3.74. Load-Deflection Curve for T7W2.

The measured ultimate load (88 kips) was 63 percent larger than the estimated capacity of 54 kips and 33 percent larger than the ultimate load capacity of the exterior ledge-deficient reference capacity. The test was ended when the applied load dropped to about 60 percent of the measured ultimate load. Figure 3.75 shows the observed damage at the final load level. The bent cap experienced a punching shear failure on the north side. Damage was more extensive on the north side of the bent cap.

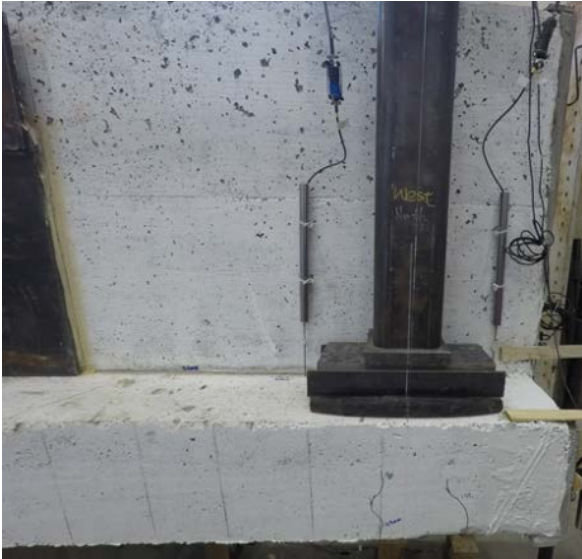
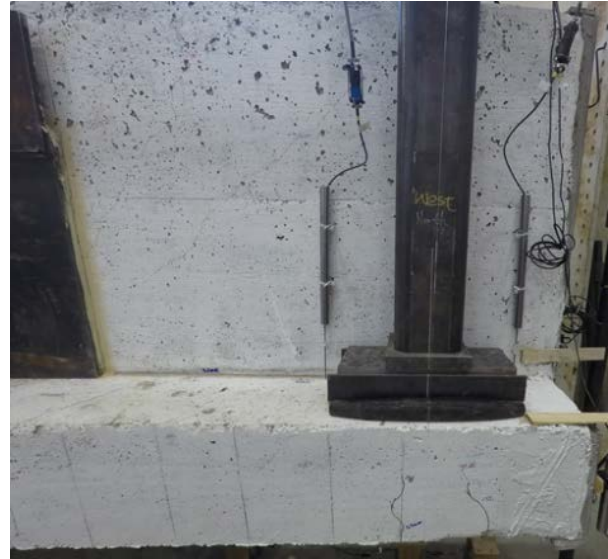
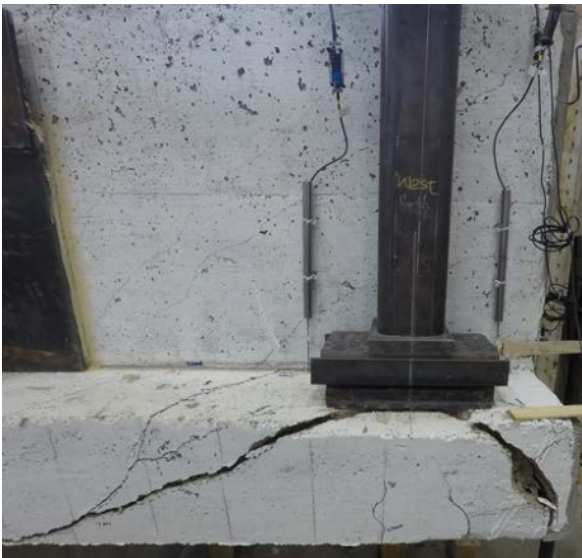
(a) North side at SLS

(b) North side at ULS

(c) North side at final load level

Figure 3.75. Observed Damage for Test T7W2 at Different Load Levels.

Existing cracks opened during loading, with the first new cracks observed at SLS demand. The maximum crack width of the web-ledge interface cracks behind the bearing pads increased to 0.3 mm from 0.25 mm, and the maximum width of the cracks on the side face of the ledge increased to 0.15 mm from 0.1 mm.

Under the ULS of 68 kips, diagonal shear cracks on both sides of the web were detected. The web-ledge interface cracks extended diagonally to the top of the ledge. More diagonal cracks formed on the side face of the ledge on both sides. A negative flexure crack was detected on the north side web.

During loading to the measured ultimate load, crack extensions and new crack formations were observed on both the web and ledge. The bottom corner of the end plate started to open as the load reached 77 kips. At a load of 82.5 kips, vertical cracks formed on both sides of the web at the top of the end plate. At the measured ultimate load of 88 kips, more cracks were observed on both sides of the web and ledge. The north side of the ledge had more severe damage than the south side. A clear pyramid-shaped cone formed under the north side bearing pad.

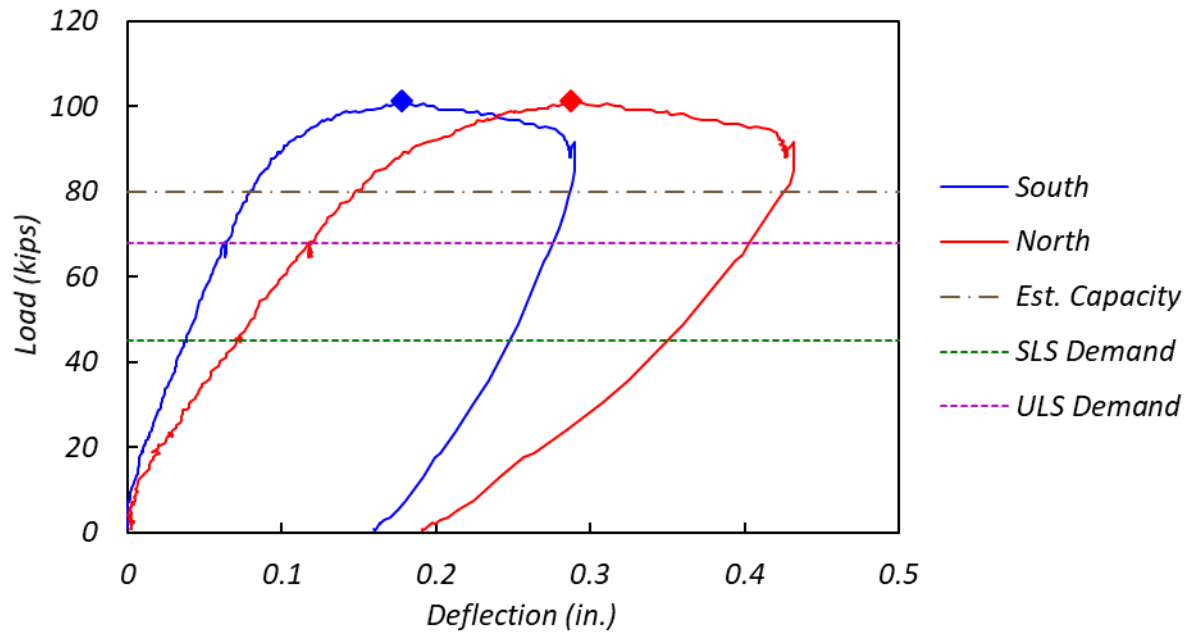
Figure 3.76. Load-Deflection Curve for T7E2.

T7E2 is an exterior test using two clamped threadbars (Solution 8[a]) installed with existing cracks from test T7E1. Figure 3.76 shows the load-deflection plots for the north and south load points.

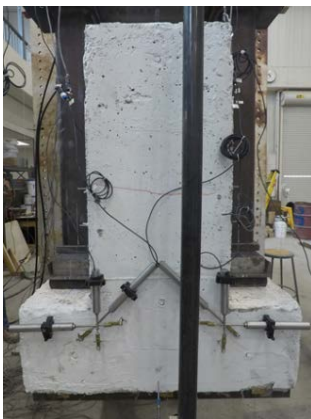
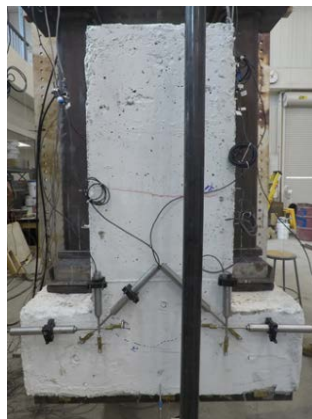
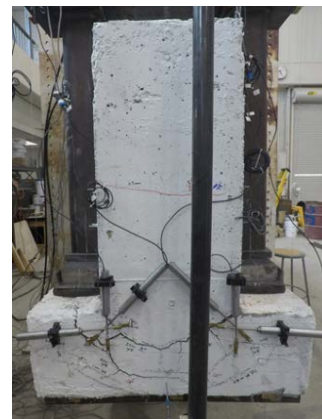
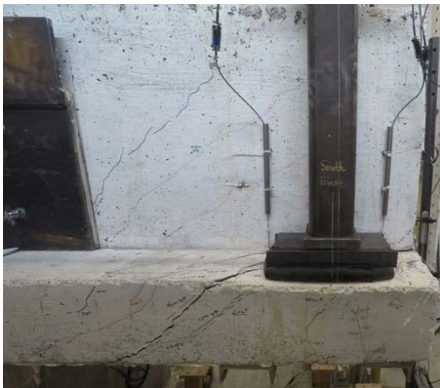
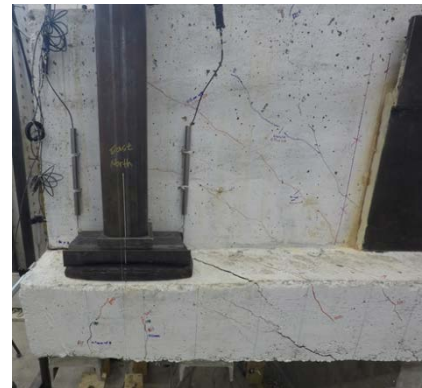
Figure 3.77. Observed Damage for Test T7E2 at Different Load Levels.

The measured ultimate load (101 kips) was 26 percent larger than the estimated capacity of 80 kips and 53 percent larger than the ledge-deficient exterior reference capacity. The test was ended when the applied load dropped to about 90 percent of the measured ultimate load. Figure 3.77(a) shows the observed damage on the end face before the test. Figure 3.77(b) shows the observed damage on the end face at SLS, and Figure 3.77(c), (d), and (e) show the observed damage at the final load level.

The width of the existing cracks increased a bit while the load increased to the SLS of 45 kips. A new hanger crack near the web-ledge interface on the end face was observed at SLS. It was a parabolic-shaped crack that connected the two corners of the end face, as shown in Figure 3.77(b). The old hanger crack on the end face above the neutral axis was the widest crack at SLS, with a width of 0.2 mm.

At the ULS of 68 kips, more diagonal cracks formed on the end face. A flexure crack was detected on the north side web. The width of the old hanger crack on the end increased to 0.4 mm, and the width of the new hanger crack that formed at SLS near the web-ledge interface was 0.5 mm at ULS.

Crack extensions and new crack formations were observed as the load went above ULS. A pyramid-shaped cone started to form under the bearing pad on both sides of the specimen when the load exceeded 90 kips, accompanied by a slope change in load-deflection curve. Significant damage progression was observed after 90 kips. The measured ultimate load of 101 kips was observed in 90 seconds. The width of the cone cracks on the side ledge, and of the hanger crack near the web-ledge interface on the end face, increased extensively during this stage. The width of the old hanger crack on the end face above the neutral axis did not increase. The maximum width of the cone cracks and hanger crack at the measured ultimate load were both 2.5 mm. The test was stopped when the load dropped to 93 kips. More damage on the south side than the north side was observed after the measured ultimate load. The maximum widths of the cone cracks on the south side and north side were 4 mm and 2.5 mm at the final load level, respectively. The widths of the new and old hanger cracks on the end face were 3.5 mm and 0.5 mm at the final load level, respectively.

(a) End face before test

(b) End face at SLS

(c) End face at final load level

(d) South side at final load level

(e) North side at final load level

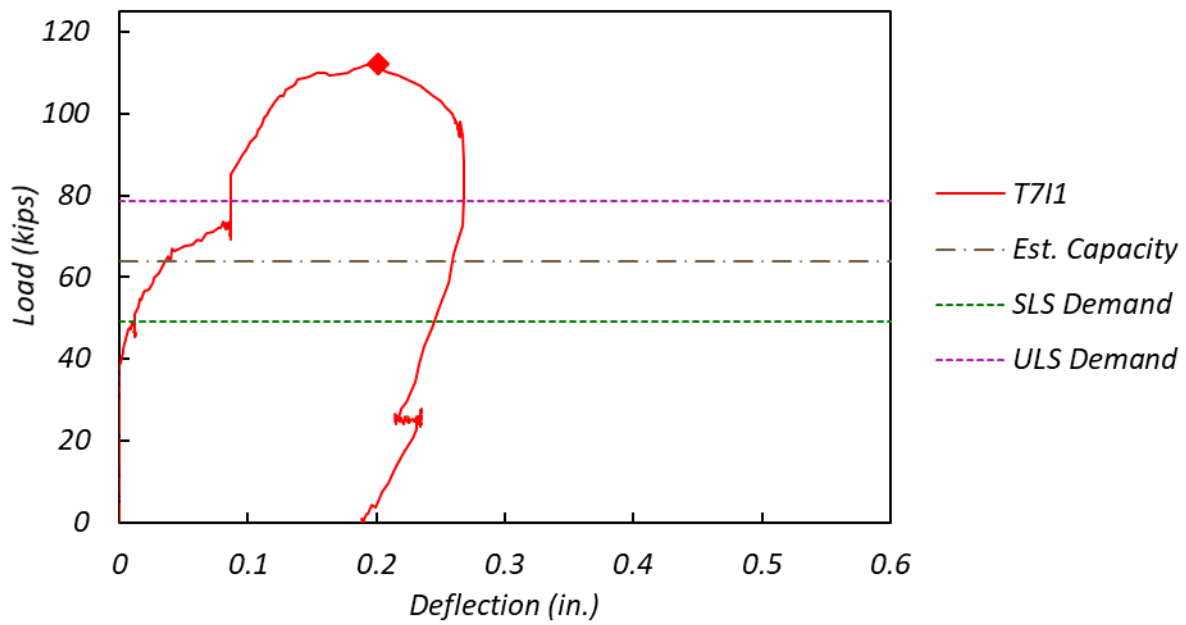
Figure 3.78. Load-Deflection Curve for T7I1.

T7I1 and T7I2 are interior punching shear tests with small (4 in. by 4 in.) and large (12 in. by 5 in.) bearing pads, respectively. Both tests were conducted on the north side of the bent cap and loaded simultaneously until the ultimate load state. After the load reached ULS, the test region of T7I1 was loaded to ultimate failure, while the load was kept at the dead load for the test region of T7I2. After T7I1 failed, the applied load for T7I1 was retracted to the dead load. T7I2 was then loaded to failure. Figure 3.78 and Figure 3.79 show the load-deflection plots for T7I1 and T7I2, respectively, with horizontal lines indicating SLS, ULS, and estimated capacity.

The measured ultimate load for test T7I1 (112 kips) was 75 percent larger than the estimated capacity (64 kips). The measured ultimate load for test T7I2 (119 kips) was 37 percent larger than the estimated capacity (87 kips) and 6 percent larger than the measured ultimate load capacity of T7I1. Both tests were ended when the applied load dropped to about 85 percent of the measured ultimate load. Figure 3.80 shows the observed damage for tests T7I1 and T7I2. Both tested regions showed punching shear failure with truncated pyramids forming under the loading areas.

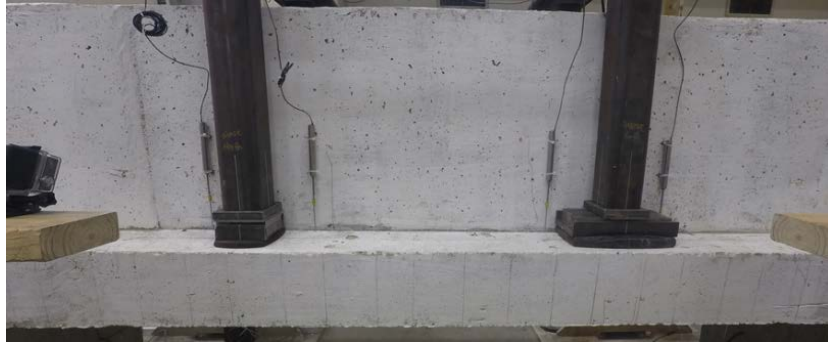
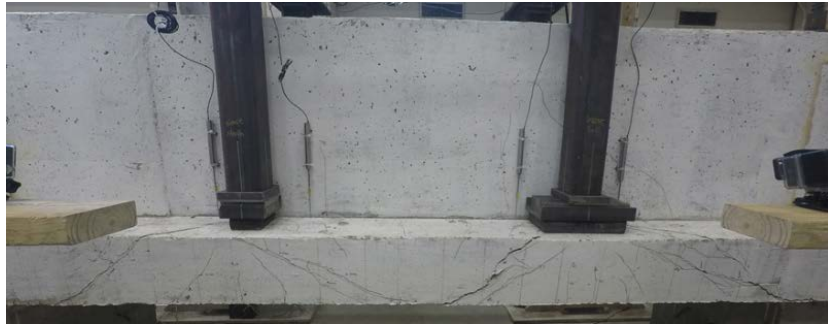
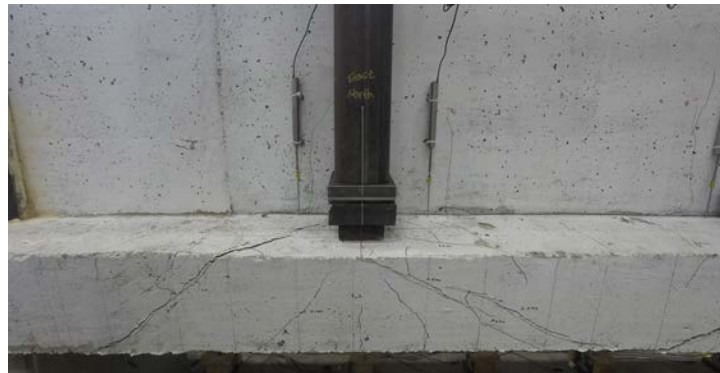
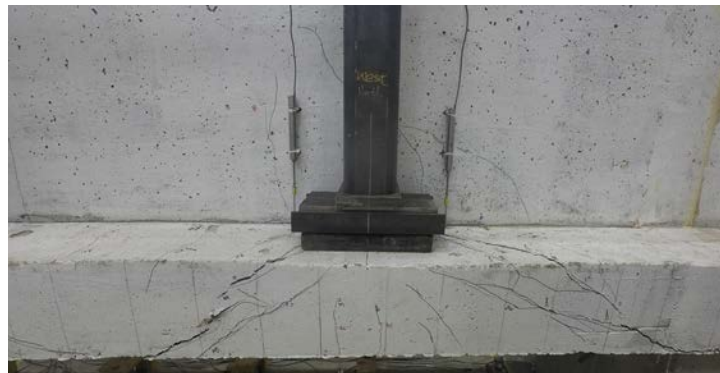
Figure 3.80. Observed Damage for Test T7I1 and T7I2 at Different Load Levels.

The initial cracks formed at the web-ledge interface behind both bearing pads at 45 kips before reaching SLS. At the SLS of 49 kips, the cracks behind the two bearing pads extended toward the center of the specimen along the web-ledge interface and connected. The cracks also extended toward the support columns along the interface about 12 in. and 22 in. away from the center of the west and east bearing pads, respectively. More cracks formed on the ledge and web as the load increased.

At 90 kips, diagonal cracks formed on top of the ledge 15 in. from the center of the bearing pads. The cracks initiated from the web-ledge interface and propagated to the side face of the ledge toward the support columns. At the ULS of 78.5 kips, flexure cracks were found on the bottom of the specimen beneath the two bearing pads. The cracks propagated through the bent cap in the transverse direction and further extended to the side face of the ledges on both sides. Nearly vertical cracks formed on both sides of the web at the inner sides of the T7I1 and T7I2 bearing pads, which were 6 in. and 12 in. away from the center and raised 6 in. and 14 in., respectively.

No intersection of the failure planes for T7I1 and T7I2 was observed at final load level.

(a) North side at ULS (loaded simultaneously)

(b) North side at final load level

(c) T7I1 at final load level

(d) T7I2 at final load level

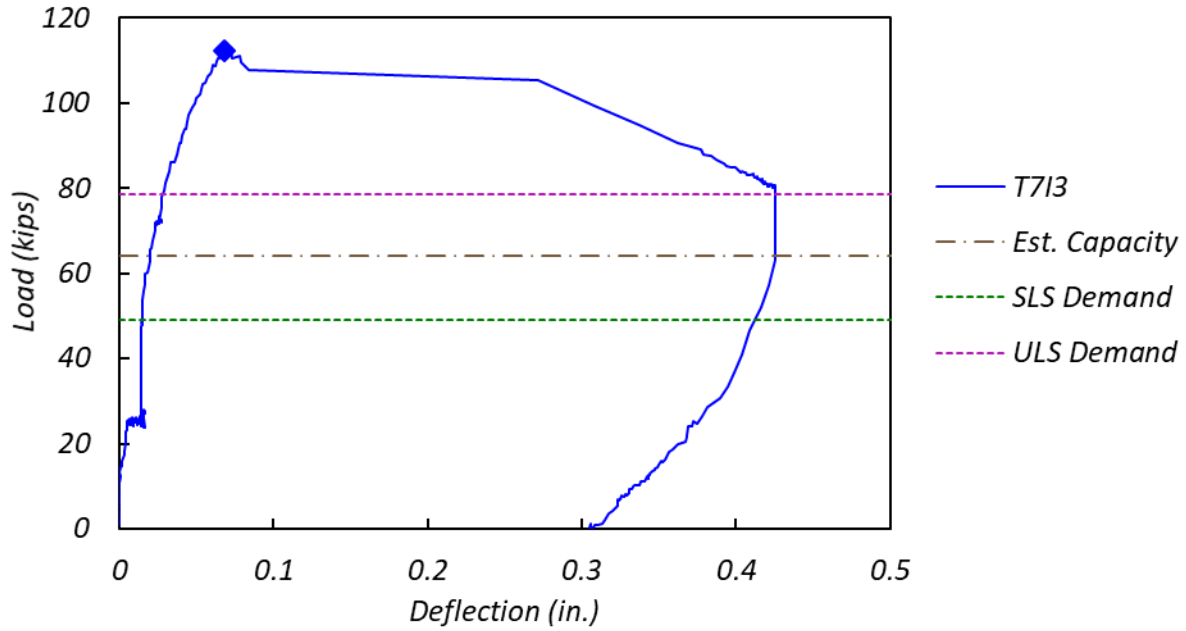
Figure 3.81. Load-Deflection Curve for T7I3.

T7I3 and T7I4 are interior punching shear tests with small (4 in. by 4 in.) and large (12 in. by 5 in.) bearing pads, respectively. Both tests were conducted on the south side of the bent cap. The tested regions were cracked slightly during the T7I1 and T7I2 tests on the north side of the specimen. The two tests were loaded simultaneously until the dead load. T7I4 (large pad) was loaded to ultimate failure, while the load for T7I3 was held at the dead load. After the ultimate failure of T7I4, the load for T7I4 was retracted to the dead load and T7I3 (small pad) was loaded to the ultimate failure. Figure 3.81 and Figure 3.82 show the load-deflection plots for T7I3 and T7I4, respectively.

The measured ultimate load for test T7I3 was 112 kips, which was 75 percent larger than the estimated capacity (64 kips). The measured ultimate load for test T7I4 was 113 kips, which was 30 percent larger than the estimated capacity (87 kips) and 1 percent larger than the measured ultimate capacity of T7I3. Tests T7I3 and T7I4 were stopped when the applied load dropped to about 70 percent and 85 percent of the corresponding measured ultimate load, respectively. Figure 3.83 shows the observed damage for tests T7I3 and T7I4. Both tested regions experienced punching shear failure.

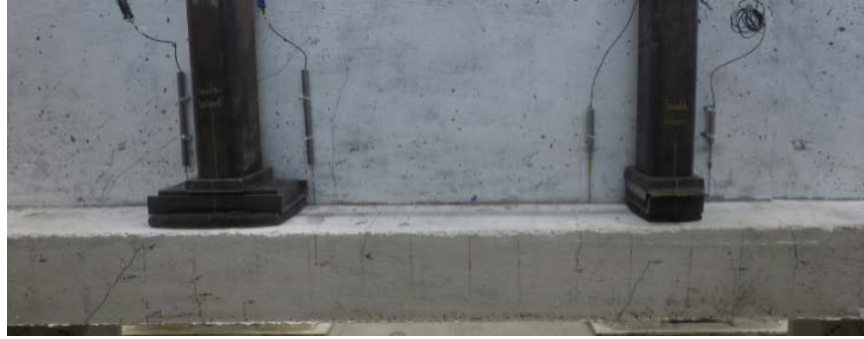
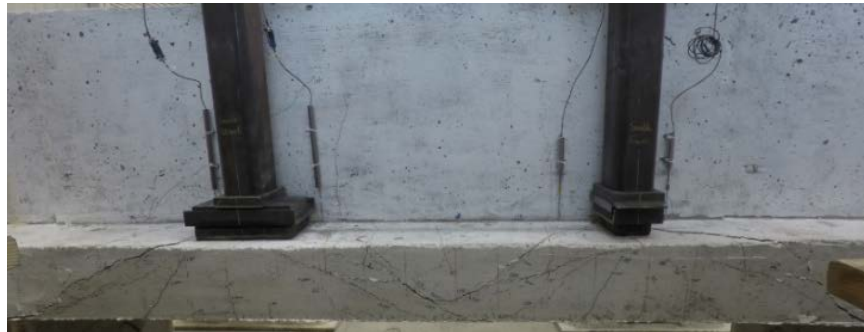
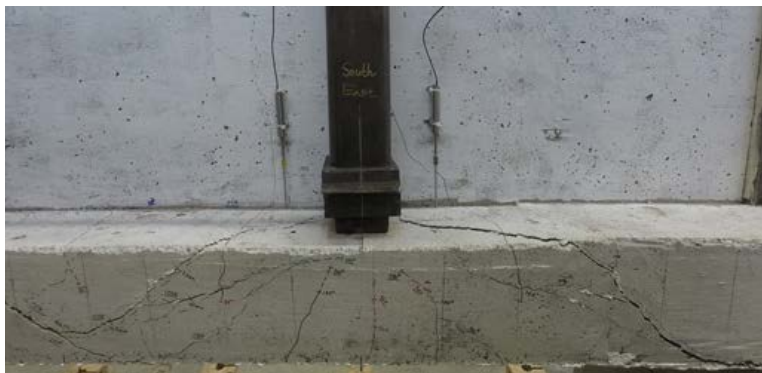
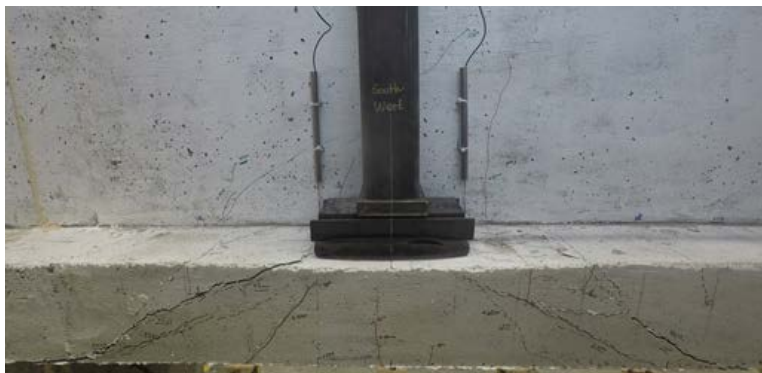
Figure 3.83. Observed Damage for Test T7I3 and T7I4 at Different Load Levels.

The west side of the failure plane for T7I3 intersected with the one for T7I4 that was conducted before T7I3 (Figure 3.83[b]).

(a) South side at dead load (loaded simultaneously)

(b) South side at final load level

(c) T7I3 at final load level

(d) T7I4 at final load level

All the existing cracks were hairline cracks before the test. At the dead load, no new cracks had formed. The load for T7I4 was then increased to ultimate failure, while for T7I3, it was held at the dead load level. At the SLS of 49 kips, the width of the existing cracks increased a bit and a new crack formed at the web-ledge interface between the two bearing pads. The interface crack was the widest crack at SLS, with a width of 0.2 mm.

The load for T7I3 increased to ultimate failure after the load for T7I4 was retracted to the dead load level. Extension of the existing cracks was observed at the SLS of 49 kips. At the ULS of 78.5 kips, new diagonal cracks formed on top of the ledge. The diagonal cracks on the side of the ledge beneath the bearing pad extended about 2 in. The main cone cracks started to form at 105 kips. The east side of the cone crack formed first, resulting in a slope change in the load-deflection curve. The west side of the cone formed at 112 kips. The applied load reached the measured ultimate load (113 kips) shortly after both sides of the cone crack formed. The widths of the west and east sides of the cone cracks were 1.5 mm and 2 mm, respectively, at the measured ultimate load. The starting points for the west and east side of the cone cracks on the side of the ledge were 12 in. and 14 in. away from the west and east tip of the bearing pad, respectively. More diagonal cracks on the side of the ledge that had shallower angles than the main cone cracks were formed at the measured ultimate load. These cracks started at the tip of the bearing pads and connected to the main cone cracks at about half the depth of the ledge on both sides. More cracks formed on top of the ledge, and the cracks on the web extended. The load dropped gradually after reaching the measured ultimate load. The test was stopped when the applied load dropped to 80 kips. The widths of the west and east side of the cone cracks were 3.5 mm and 4 mm at the final load level, respectively.

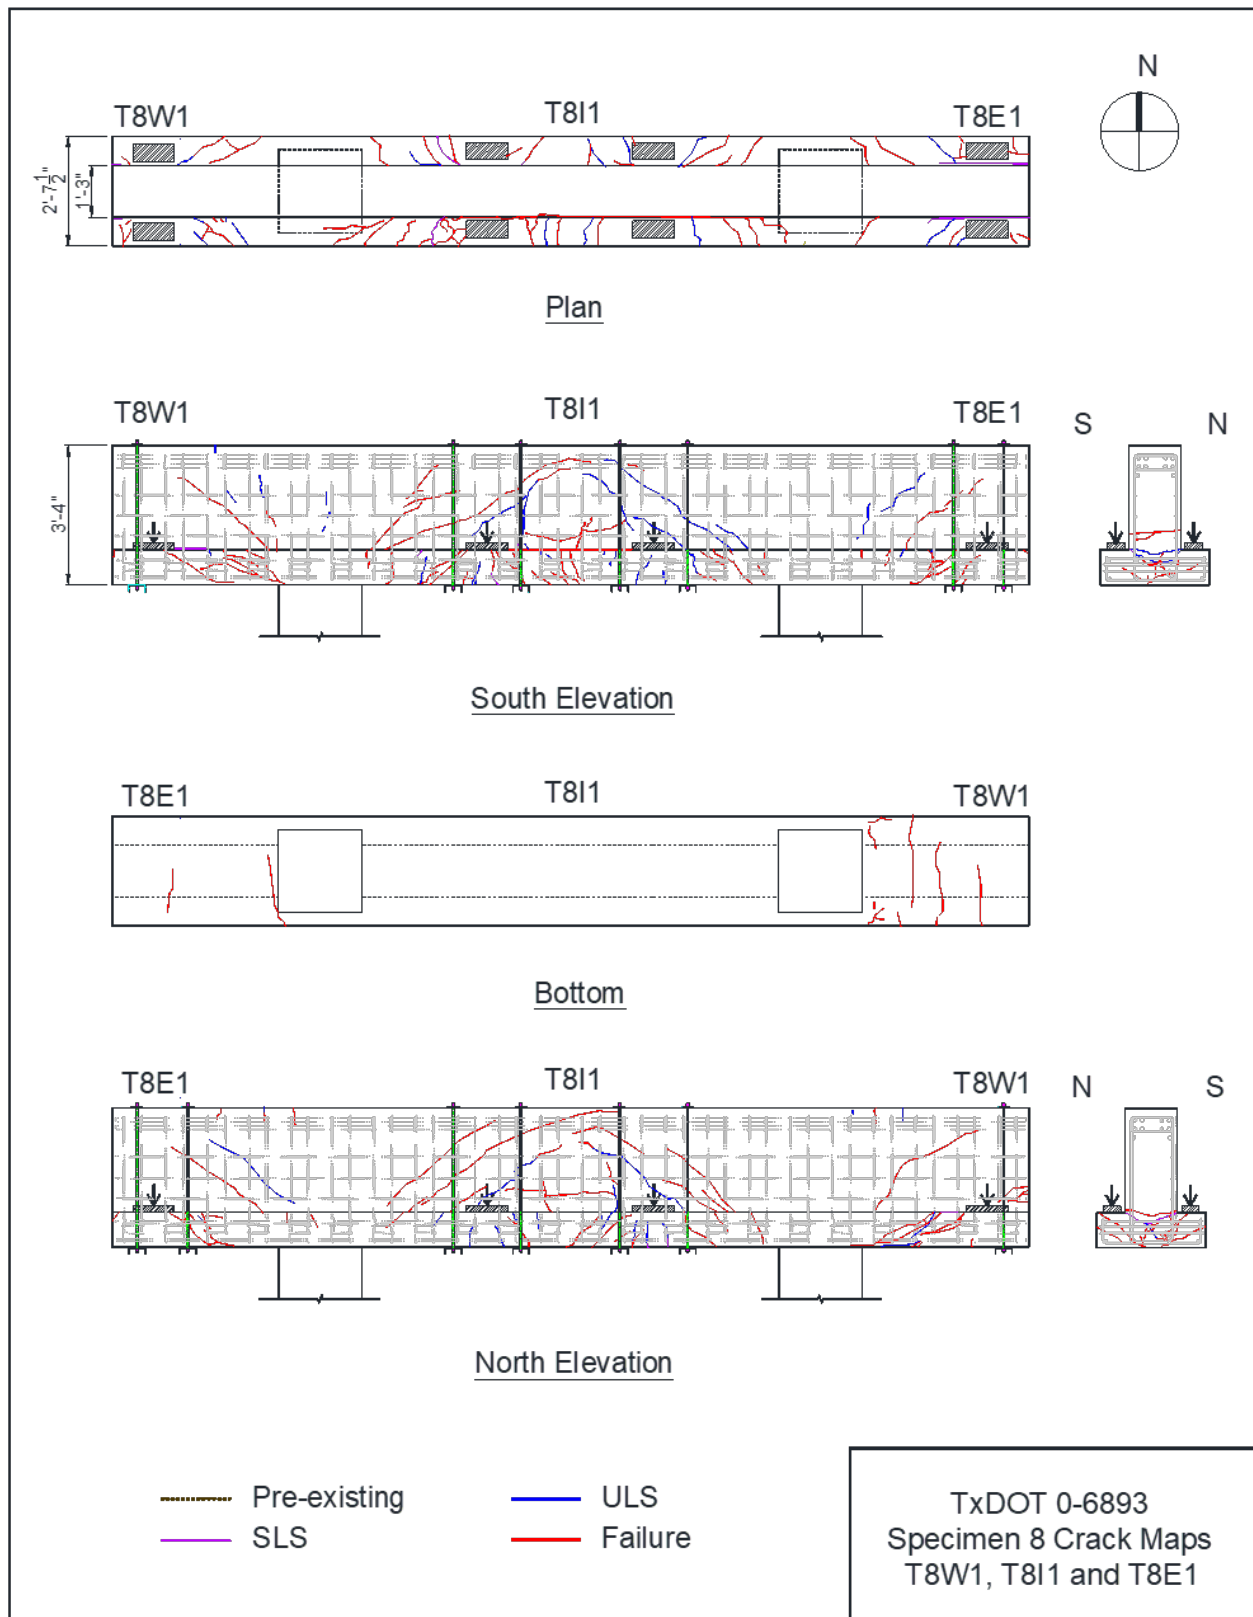
Figure 3.84. Crack Maps for Tests T8W1, T8I1, and T8E1.

Specimen 8 provided tests of all clamped threadbar solution variations (Solution 8) on a hanger-deficient specimen. Test T8E1 was a post-crack exterior test with two clamped threadbars (Solution 8[a]). Test T8I1 was an interior test with clamped threadbars (Solution 8). Figure 3.84 shows crack patterns at SLS, ULS, and failure.

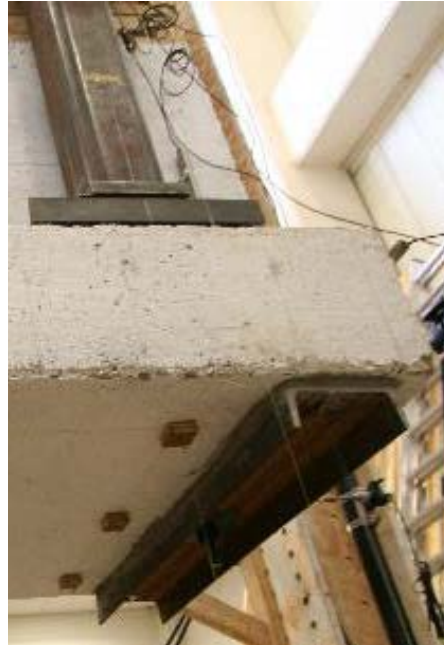
Figure 3.85. Retrofit Solution 8(b) Installed on West End of Hanger-Deficient Specimen 8.

T8W1 is an exterior test using a single clamped threadbar (Solution 8[b]). Figure 3.85 shows Solution 8(b) installed on the west end of the specimen. Figure 3.86 shows the load-deflection plots for the north and south load points, with horizontal lines indicating SLS, ULS, and estimated capacity, and diamonds indicating the measured ultimate load.

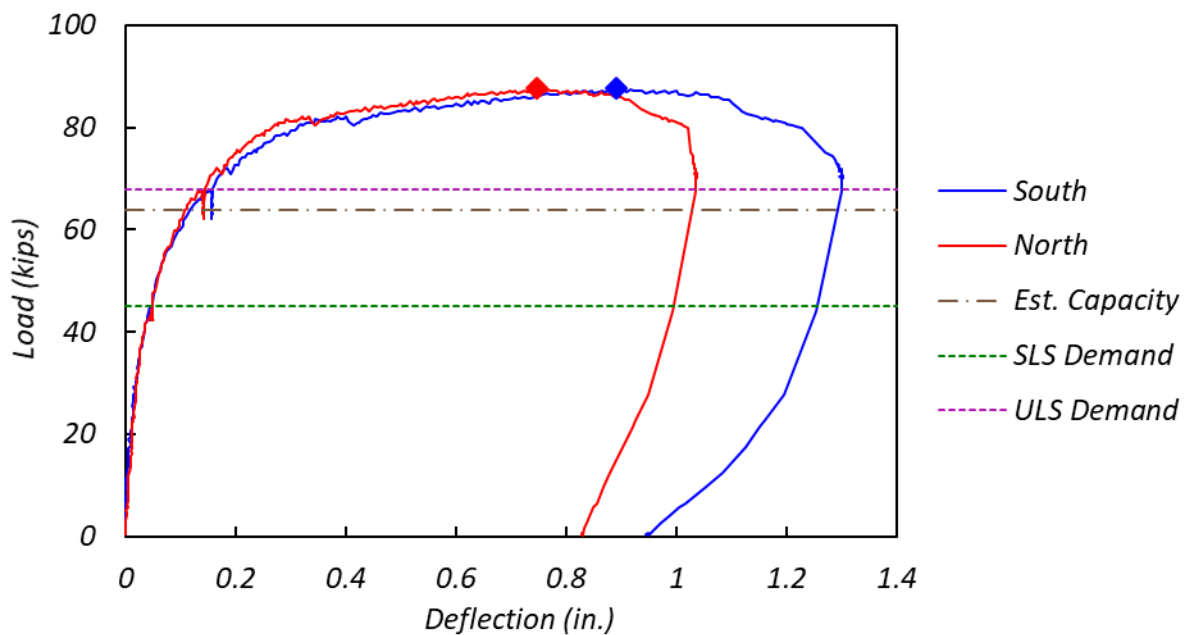
Figure 3.86. Load-Deflection Curve for T8W1.

The measured ultimate load (88 kips) was 37 percent larger than the estimated capacity (64 kips) and 33 percent larger than the exterior hanger-deficient reference capacity. The test was ended when the applied load dropped to about 70 percent of the measured ultimate load. Figure 3.87 shows the observed damage at the final load level. The bent cap experienced a hanger failure.

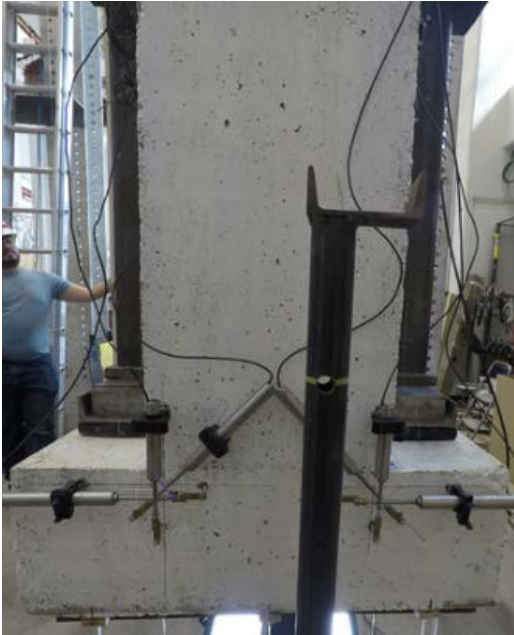
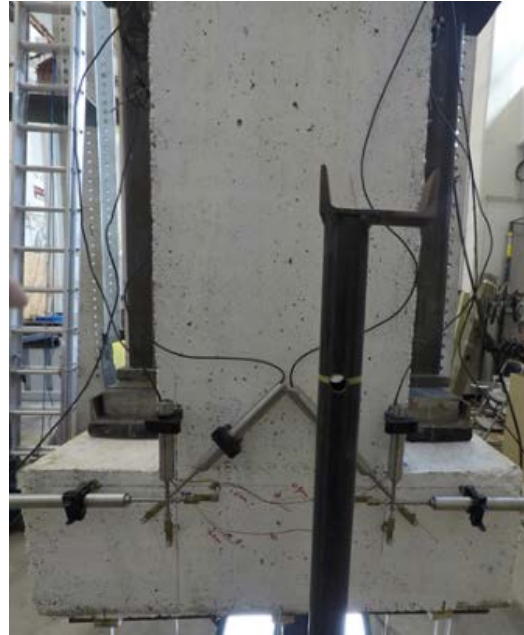
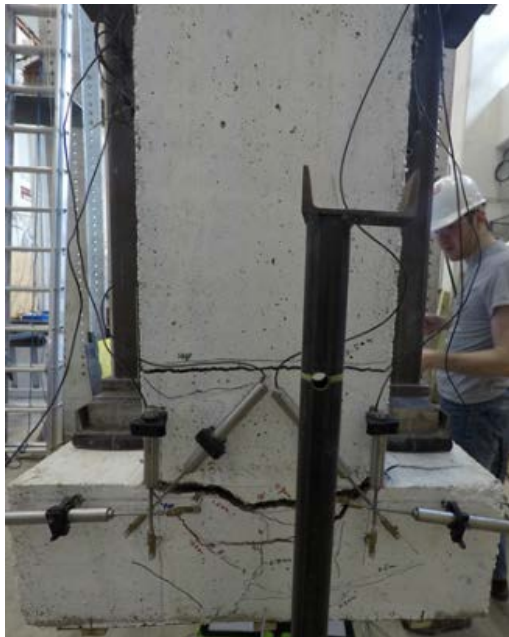
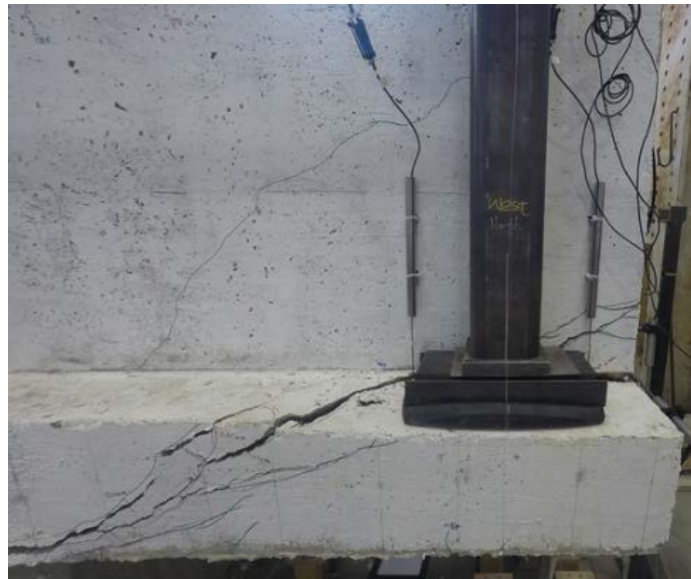
Figure 3.87. Observed Damage of Test T8W1 at Different Load Levels.

At the measured ultimate load of 88 kips, new ledge shear cracks had formed on the end face. The horizontal crack on the end face near the web-ledge interface opened up to 7 mm. The second hanger formed near the neutral axis and had a width of 5 mm. More diagonal cracks were detected on the side face of the ledge with a maximum width of 11 mm. The deflection of the outside channel under the bent cap was visible at the measured ultimate load.

(a) End face at SLS

(b) End face at ULS

(c) End face at final load level

(d) End face at SLS

Under the ULS of 68 kips, crack extensions and new crack formations were observed. The cracks at the web-ledge interface propagated toward the column of the bent cap. On the top of the ledge, the cracks at the web-ledge interface extended diagonally to the side face of the ledge. Diagonal shear cracks were detected on the south side of the web. Negative flexure cracks were detected on the north side of the web. The crack near the web-ledge interface on the end face had a maximum crack width of 0.9 mm.

Significant extensions of existing cracks and new crack formations on the entire tested region were observed as the load went higher than ULS. Web shear cracks formed on the north side at 73 kips. More diagonal cracks formed on the top of the ledge and further extended to the side face. A hanger crack formed on the end face near the neutral axis of the bent cap at 82 kips. The hanger cracks were propagated to the web at 84 kips.

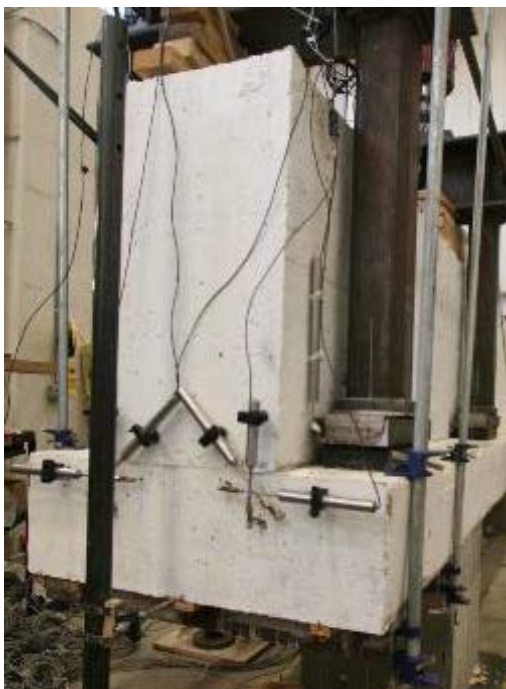
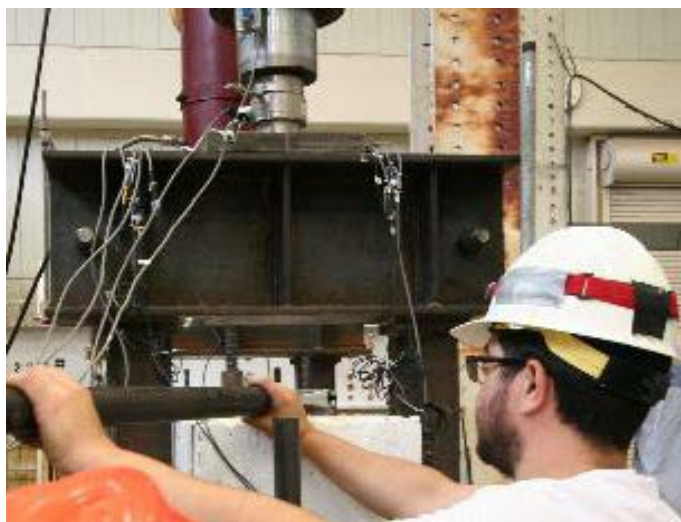
Figure 3.88. Post-Crack Retrofit Solution 8(a) Installed on East End of Hanger-Deficient Specimen 8.

T8E1 is an exterior test using two clamped threadbars (Solution 8[a]) installed with existing cracks. As shown in Figure 3.88(a), the two clamped threadbars and channels were preinstalled before loading the specimen, but threadbars were not fastened. The specimen was then loaded to the SLS of 45 kips to simulate the demands of in-service bridges. Cracks were marked at SLS and two threadbars were fastened, as shown in Figure 3.88(b). The specimen was then loaded to ultimate failure. Figure 3.89 shows the load-deflection plots for the north and south load points.

(a) Threadbar through the web before fastening

(b) Fastening of threadbars after service load

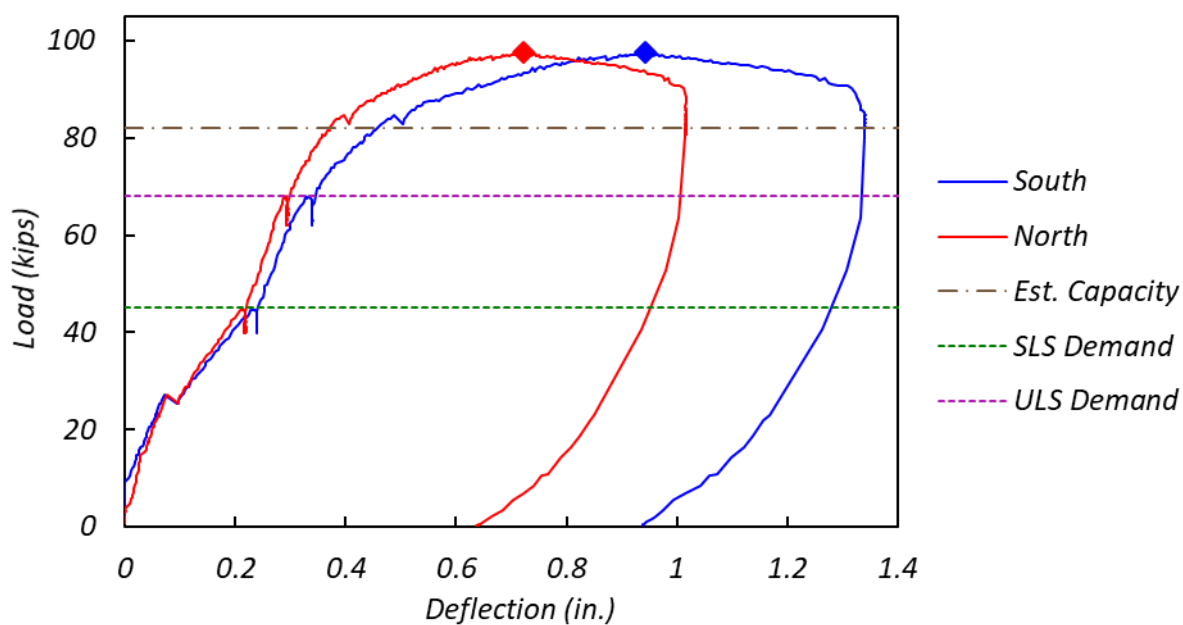
Figure 3.89. Load-Deflection Curve for T8E1.

The measured ultimate load (98 kips) was 19 percent larger than the estimated capacity (82 kips) and 48 percent larger than the exterior hanger-deficient reference capacity. The test was ended when the applied load dropped to about 90 percent of the measured ultimate load. Figure 3.90 shows the observed damage. The damage was more extensive on the south side.

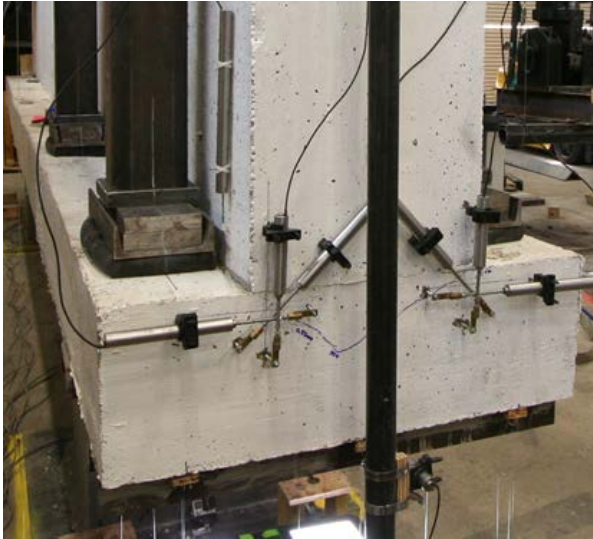
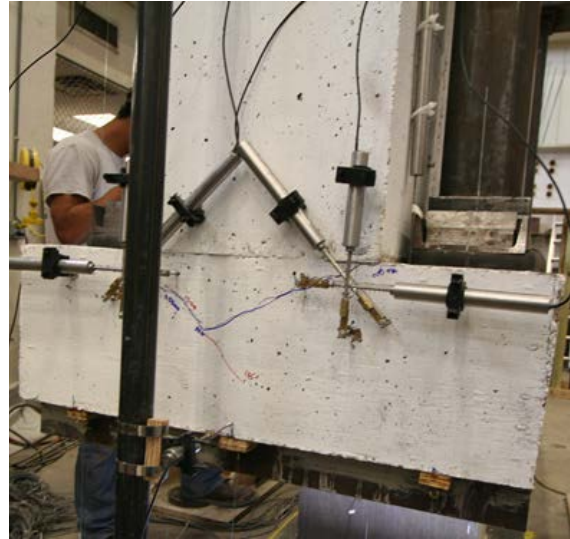
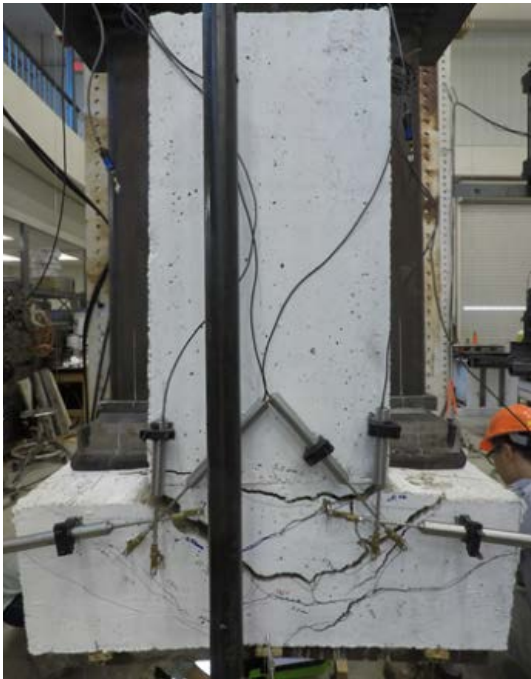
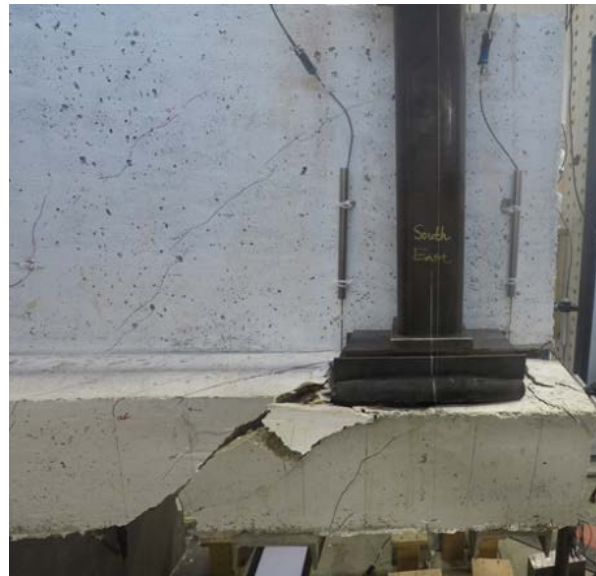
Figure 3.90. Observed Damage for Test T8E1 at Different Load Levels.

(a) End face at SLS (after fastened threadbars)

(b) End face at ULS

(c) End face at final

(d) South side at final

At the ULS of 68 kips, shear cracks were detected on both sides of the web. The diagonal cracks that started at the two reentrant corners on the end face were propagated horizontally and connected to each other. The width of the crack was 1 mm. At the top of the ledge, the cracks behind the bearing pad extended diagonally, starting at the inner edge of the bearing pad and going to the side face of the ledge.

As the load exceeded ULS, the bent cap showed significant crack length and width extensions with the formation of new cracks. Most of the new cracks formed on the ledge. At a load of 75 kips, a hanger crack formed on the end face near the neutral axis of the bent cap. At the measured ultimate load of 98 kips, more diagonal cracks had formed on the top and side face of the ledge on both sides. New shear cracks were also detected on both sides of the web. On the end face, new ledge cracks were detected. The width of the crack near the web-ledge interface on the end face increased to 5.5 mm.
