Strengthening of Existing Inverted-T Bent Caps— Volume 2: Experimental Test Program

Technical Report 0-6893-R1-Vol2

TEXAS A&M TRANSPORTATION INSTITUTE
COLLEGE STATION, TEXAS

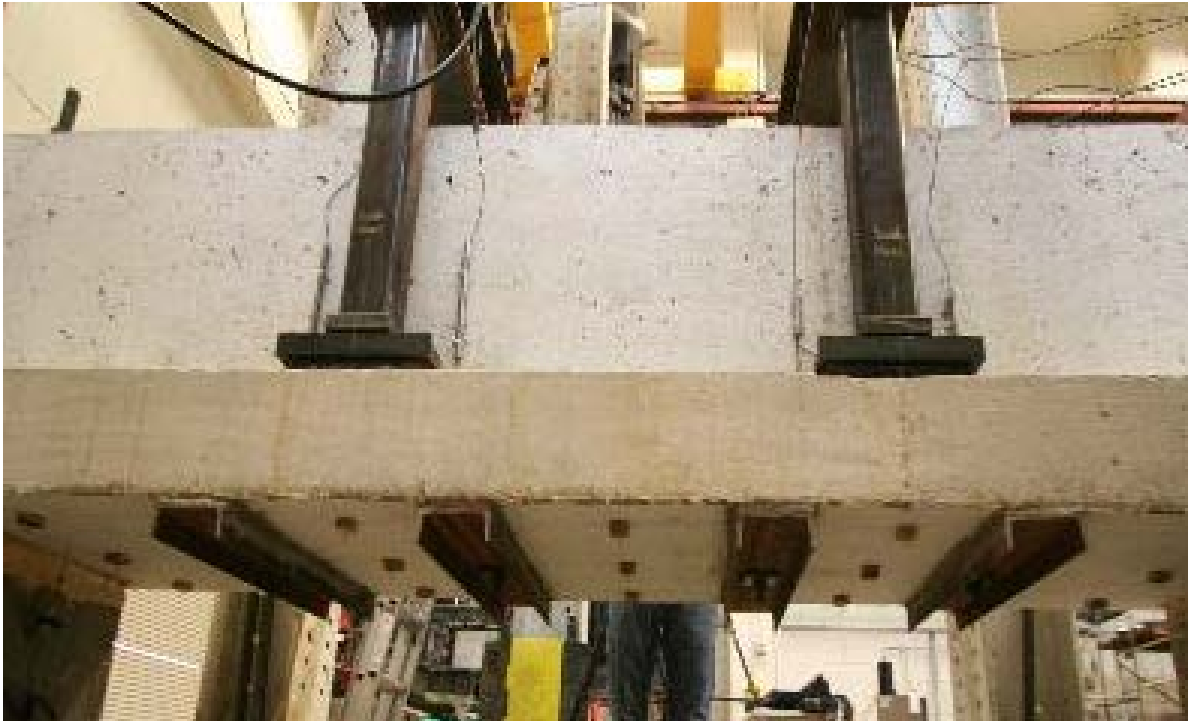
Figure 3.91. Retrofit Solution 8 Installed on Interior of Hanger-Deficient Specimen 8.

T8I1 is an interior test with clamped threadbars (Solution 8). Figure 3.91 shows Solution 8 installed on the interior of the specimen. Figure 3.92 shows the load-deflection plots for all load points.

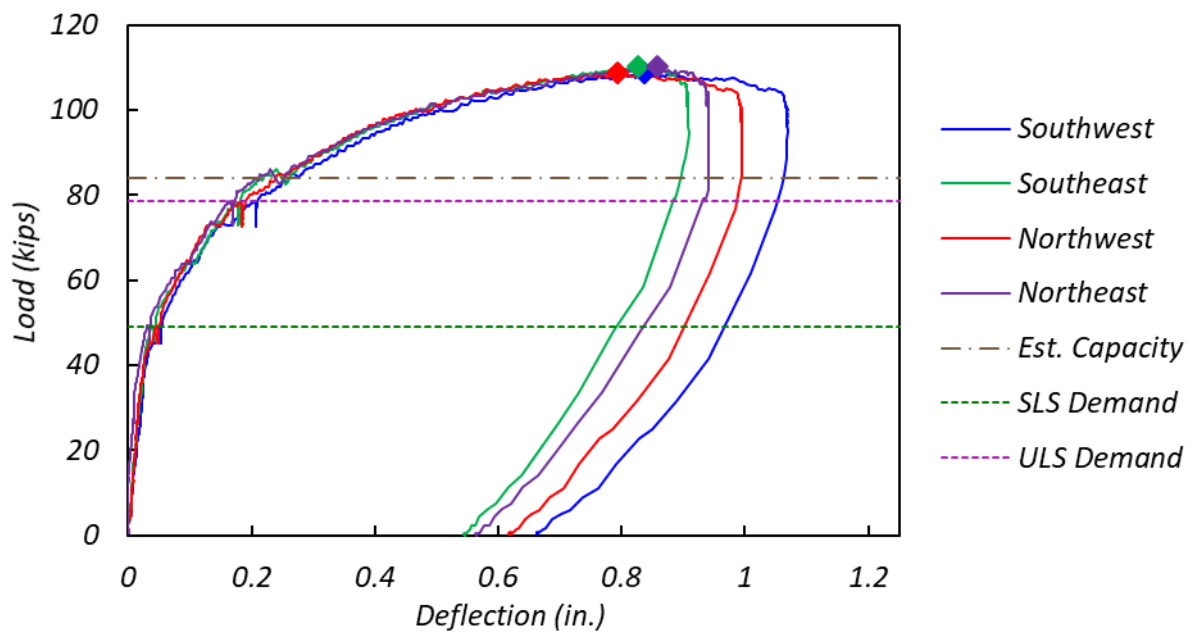
Figure 3.92. Load-Deflection Curve for T8I1.

The measured ultimate load (109 kips) was 30 percent larger than the estimated capacity (84 kips) and 21 percent larger than the interior hanger-deficient reference test measured ultimate load. The test was ended when the applied load dropped to about 90 percent of the measured ultimate load. Figure 3.93 shows the observed damage. The specimen failed in hanger.

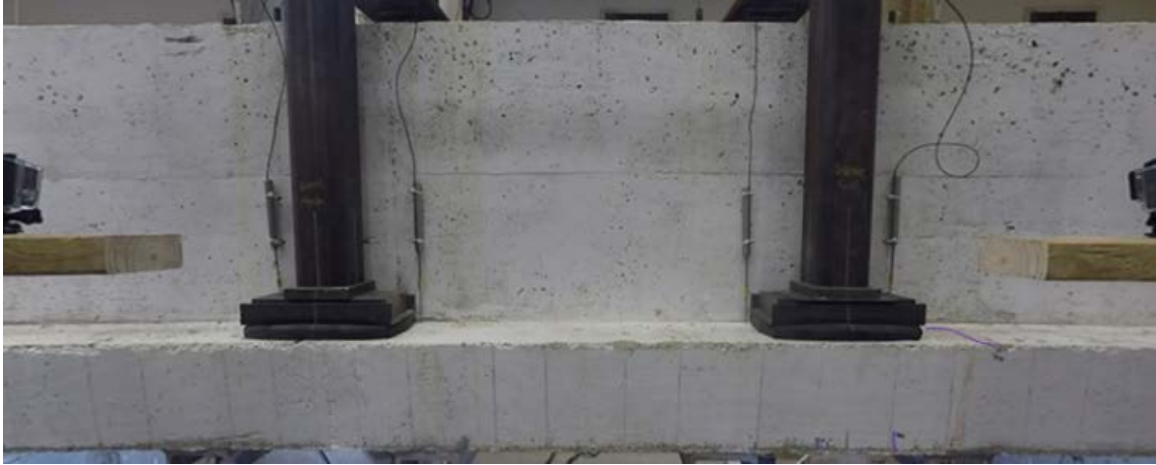
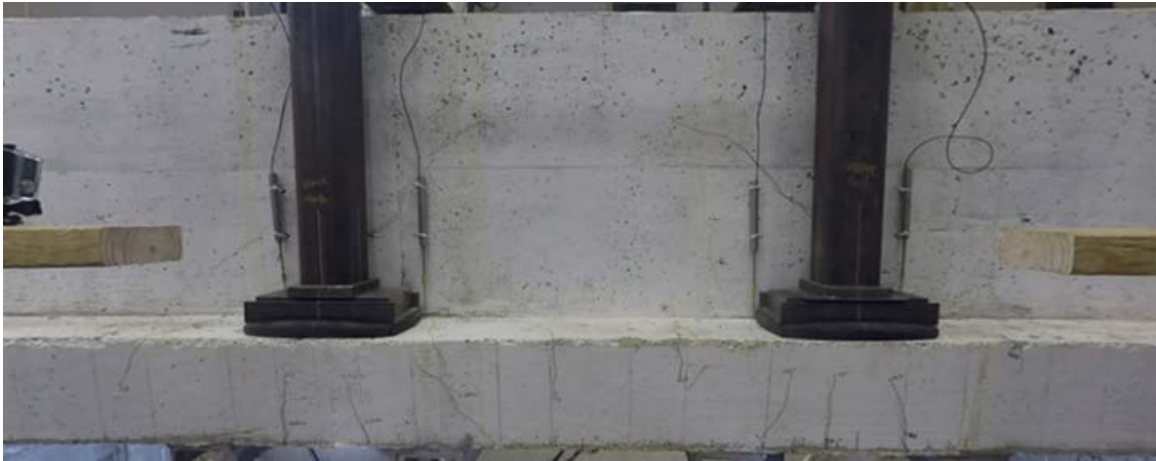
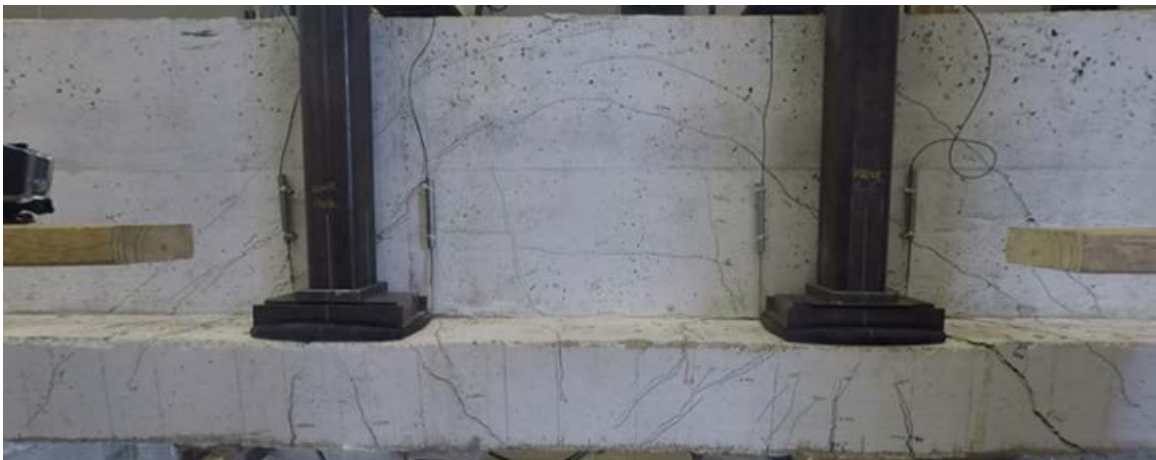
Figure 3.93. Observed Damage for Test T8I1 at Different Load Levels.

(a) North side at SLS

(b) North side at ULS

(c) North side at final load level

At the ULS of 78.5 kips, diagonal shear cracks were formed on both sides of the web. The web shear cracks at this state were formed on the outside of the bearing pads, going toward the center of the bent cap. More diagonal cracks were formed on top of the ledge. Diagonal cracks were also detected on the side face of the ledge near the bearing pads. The maximum crack widths of the diagonal cracks on the side face of the ledge and the web shear cracks were 1 mm and 0.3 mm, respectively.

New cracks formed throughout the specimen, and ledge crack widths increased significantly. At the measured ultimate load of 109 kips, deflections of the two outside channels were visible. More diagonal shear cracks formed on both sides of the web. The angles of the shear cracks decreased as they propagated toward the center of the bent cap. The maximum width of the web shear cracks was 0.9 mm.

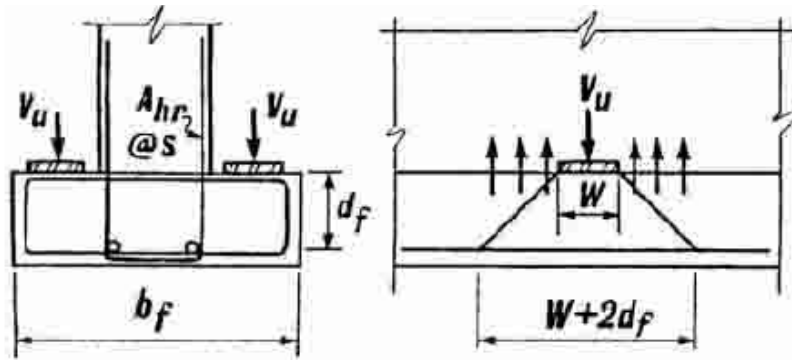
Figure 4.2. Notation for Interior Girder Hanger Capacity at the Strength Limit State (AASHTO, 2014).

$$V_n = 0.063\sqrt{f'_c}b_f d_f + \frac{A_{hr}f_y}{s} \left(\frac{W + 2d_f}{2} + c \right) \quad (4.4)$$

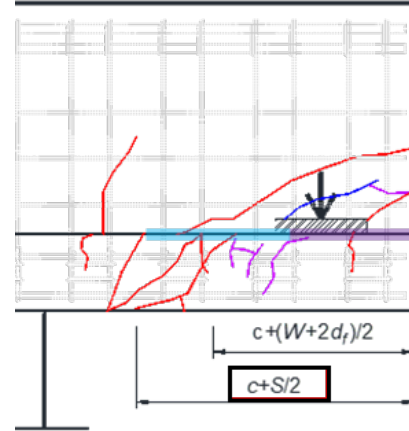
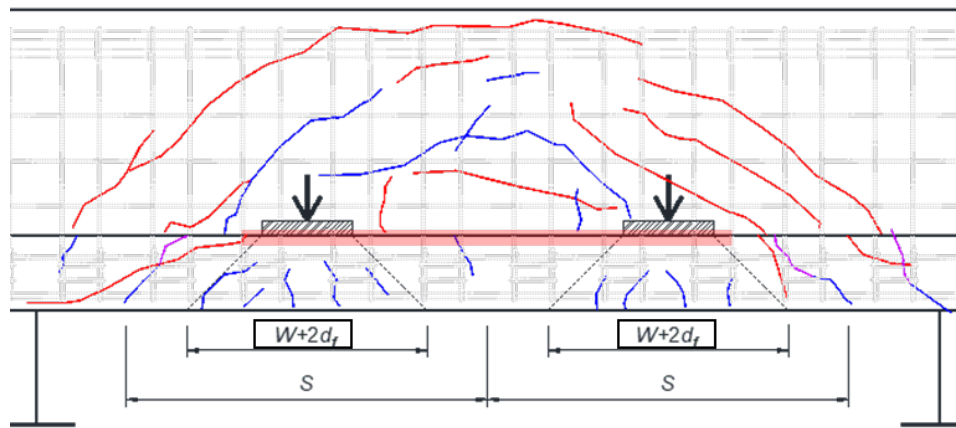
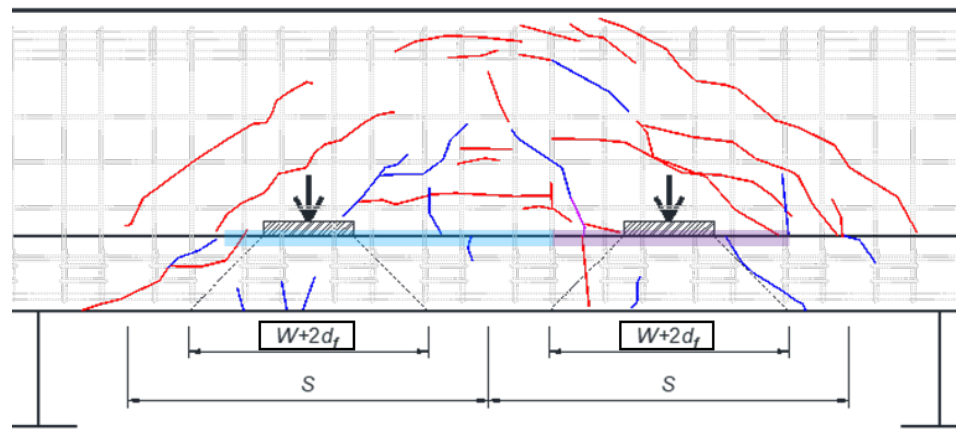
Figure 4.3. Observed Damages and AASHTO Distribution Widths for Hanger-Deficient Reference Tests.

(a) South side of T1W1

(b) North side of T1W1

(c) South side of T1I1

(d) North side of T1I1

Note: W = bearing pad width, d_f = distance from ledge top to the center of bottom flexural reinforcement, S = spacing between bearing pads, and c = distance from the center of bearing pad to the end face of specimen.

For the exterior girder, damage beyond the initial crack (horizontal at the web-ledge interface) first occurred at 45 kips, which is approximately the estimated capacity calculated by Equation (4.4). At this load, a second horizontal crack formed, accompanied by a small drop in load. Although this is not the ultimate capacity of the specimen, it should be interpreted as the hanger capacity for comparison to design equations since the behavior beyond this point is beyond an acceptable level for in-service structures. The increase in specimen capacity beyond the initial hanger capacity is a result of (a) post-yield strength of reinforcement, and (b) extension of the hanger crack along the bent cap length. An estimate of strain based on measured widths suggests the outermost hanger reinforcement is well beyond the strain hardening plateau, with stresses as large as $0.7 f_u$. The interface cracks at 45 kips and observed ultimate load are highlighted in purple and blue, respectively, in Figure 4.3(a) and (b).

The behavior for the interior tests was similar to that of the exterior tests, with secondary hanger cracks forming in the web at a load of 65 kips. An initial hanger failure could not be as clearly defined as it was for the exterior. This is largely due to a greater ability of the response mechanism to change in the interior region, evidenced by the formation of flexure and shear cracks, as documented in Section 3.1.2. The length of the interface hanger cracks, highlighted in Figure 4.3(c) and (d), indicate the distribution width used is reasonable.

The ratio of the estimated hanger to observed hanger capacities, as established by the initial hanger failure, is 0.93 for exterior and 1.02 for interior. From this, along with a comparison of hanger crack lengths to the labeled distribution widths in Figure 4.3, it can be concluded that the AASHTO design equations are appropriate for assessing the capacity of in-service inverted-T bent caps.

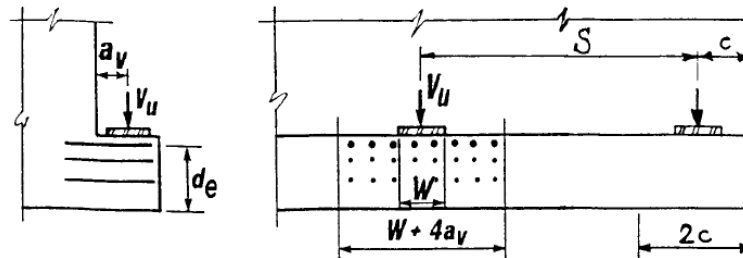
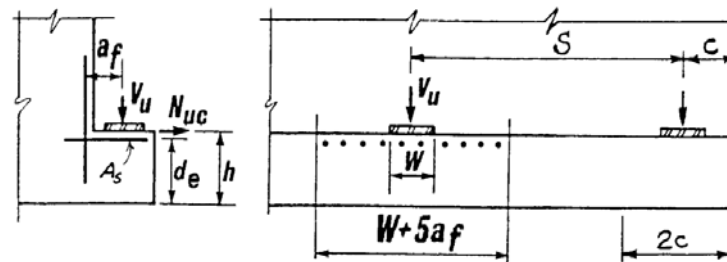
Figure 4.4. Notation and Distribution Width for Capacity Analysis (AASHTO, 2014).

(a) Ledge shear friction

(b) Ledge flexure and axial tension

where V_n = nominal shear friction; f'_c = specified compressive strength of concrete in ksi; d_e = depth to the center of gravity of negative flexural reinforcements as noted in Figure 4.1; $b_w = W + 4a_v$ (interior) or c (exterior) = distribution width for shear friction, as shown in Figure 4.4(a); and a_v = distance from the center of the bearing pad to the face of the web.

The ledge flexure capacity accounts for the flexure and horizontal resistance of the ledge. The nominal flexure capacity for the specimen is calculated with the nominal flexure resistance specified in Article 5.7.3.2.2 with the specified distribution width for ledge flexure as shown in Figure 4.4(b). Therefore, the ledge flexure capacity is obtained by:

where A_s = area of ledge flexure reinforcement indicated in Figure 4.4; f_y = yield stress of ledge flexure reinforcement; and a = depth of the equivalent stress block with axial tension.

where $b_m = W + 5a_f$ (interior) or $2c$ (exterior) = distribution width for ledge flexure and axial tension for interior and exterior, respectively; and a_f = distance from the center of the bearing pad to the center of the nearest stirrup, as shown in Figure 4.4(b).

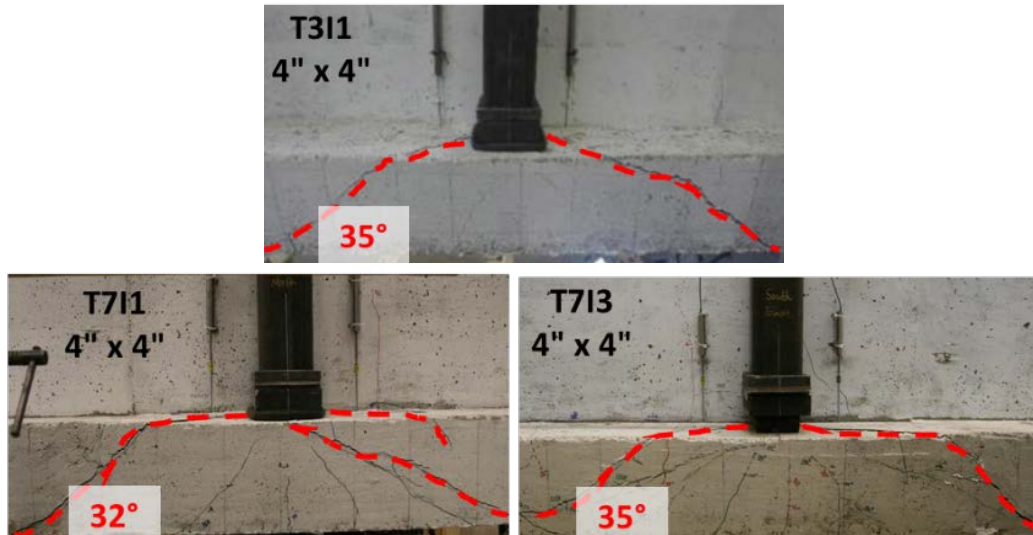
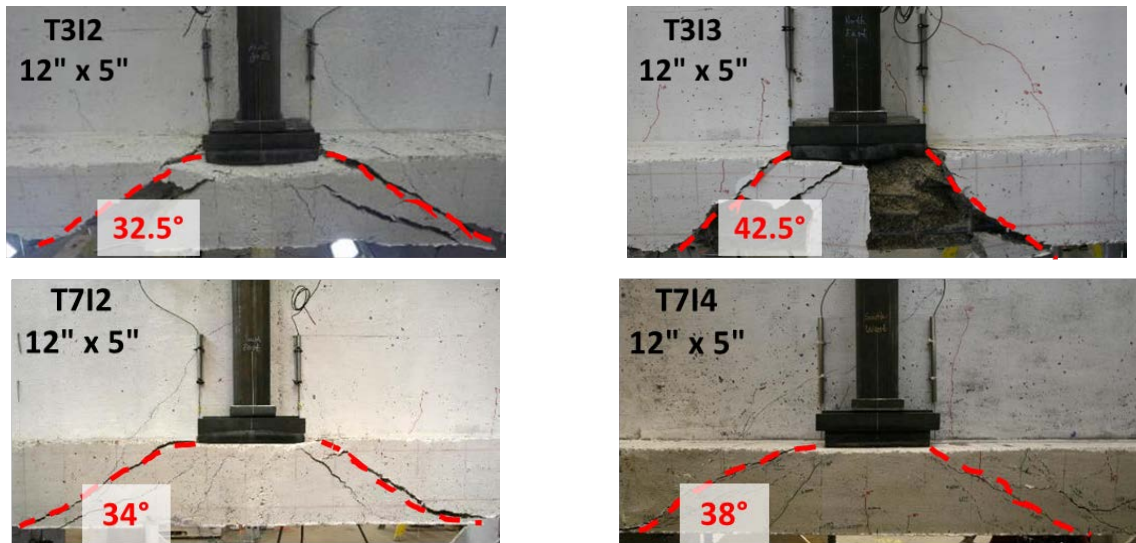
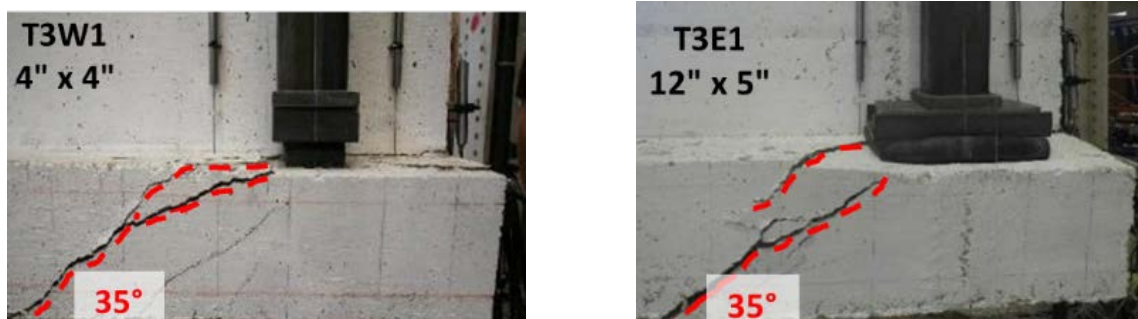
Figure 4.8. Observed Crack Angle for Punching Shear Tests.

(a) Interior ledge with small bearing pad

(b) Interior ledge with large bearing pad

(c) Exterior ledge with small bearing pad

(d) Exterior ledge with large bearing pad

To address the first question, the observed damage can be considered. Figure 4.8 shows the observed punching shear damage, with the angle of the primary cracks indicated. On average, cracks have a 35-degree angle, shallower than the 45-degree assumed in the AASHTO LRFD (2014) calculations. Based on this observation, a rational modification of the equations for punching shear capacity calculation is proposed in Section 4.4.3. With regards to the second question, the observed damage and instrumentation readings are unable to provide a rational explanation; however, a number of hypotheses can be made. These include (a) influence of adjacent loading points (interior tests have two load points per ledge, while the exterior tests have a single point); and (b) ledges on the tension chord of the bent cap (interior) rather than on the compression chord (exterior). Further investigation is needed to explore these hypotheses.

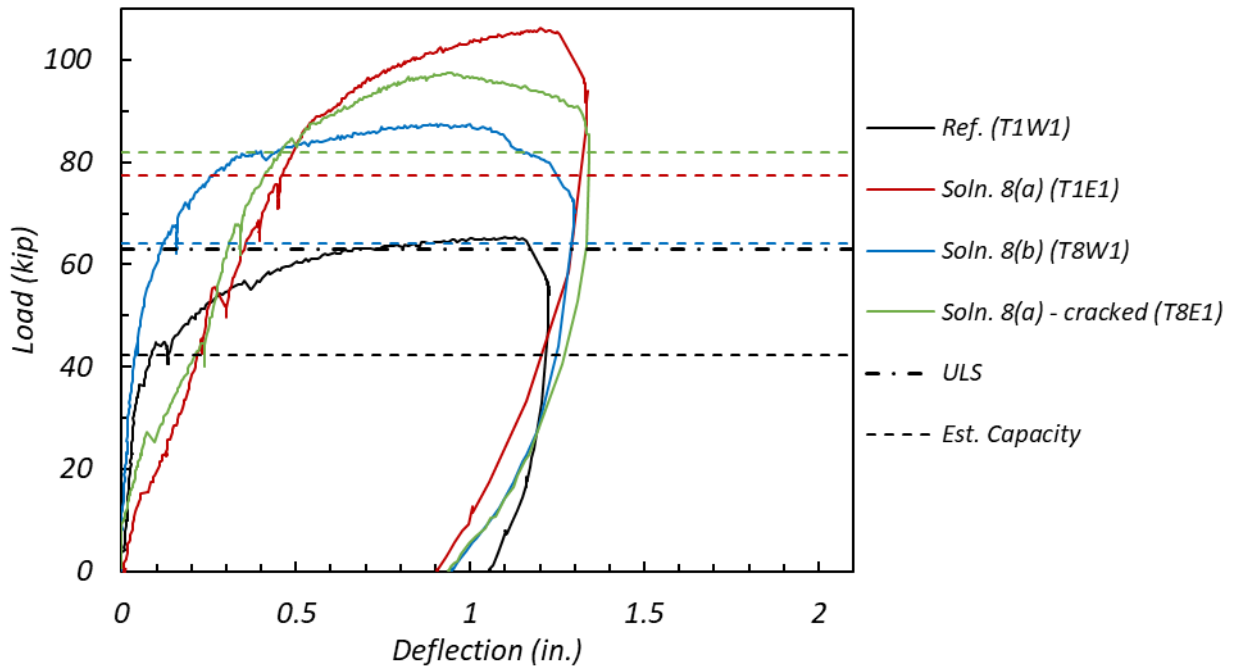
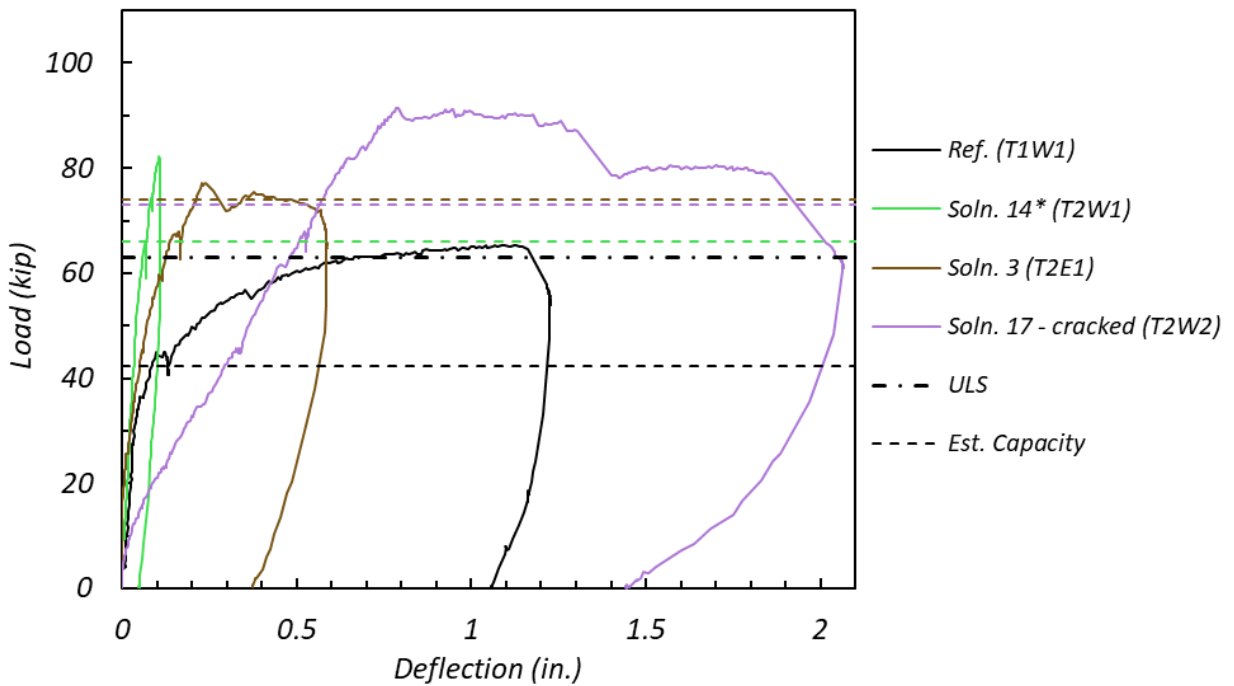
(a) Solution 8

(b) Solutions 3, 14, and 17

Note: Solid lines: experimentally measured capacities; dashed lines: estimated capacities using empirical AASHTO (2014) LRFD procedures; dash-dot line: ultimate factored load demand (ULS) = V_u .

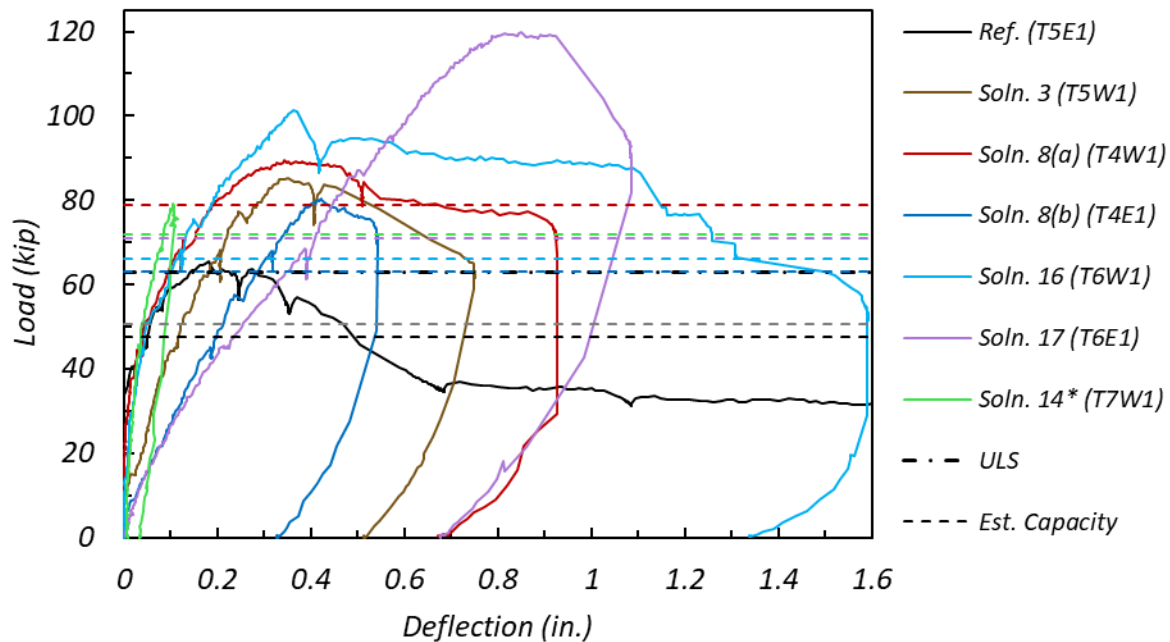
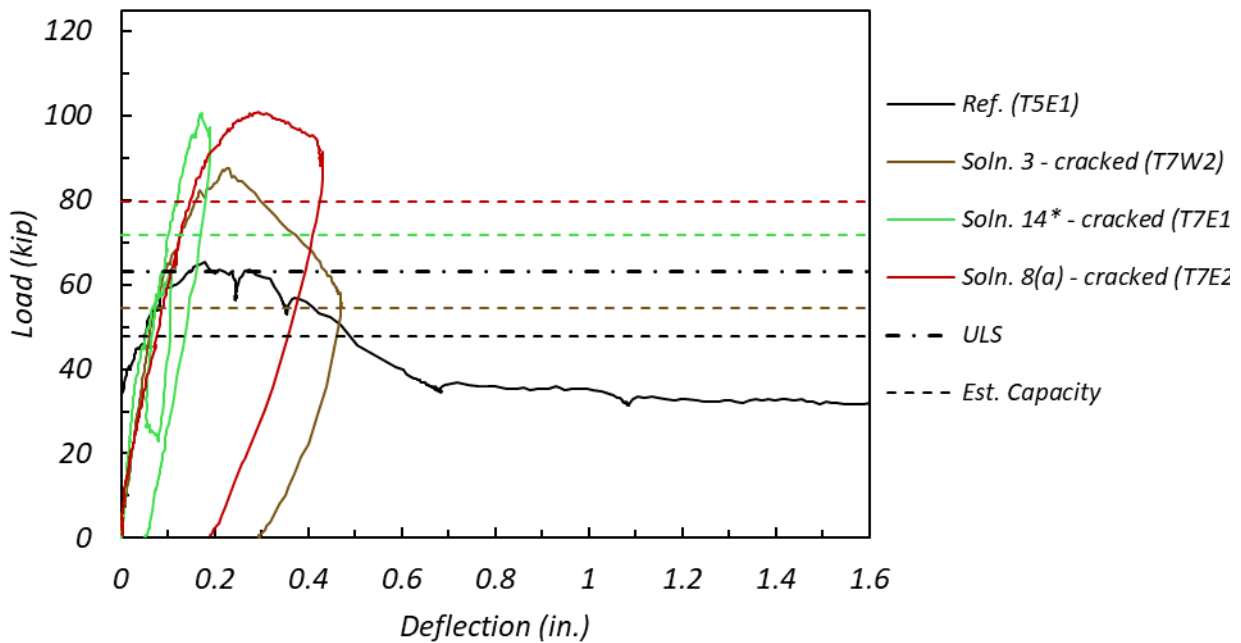
(a) Uncracked specimen

(b) Pre-cracked specimen

Note: Solid lines: experimentally measured capacities; dashed lines: estimated capacities using empirical AASHTO LRFD (2014) procedures; dash-dot line: ultimate factored load demand (ULS) = V_u .

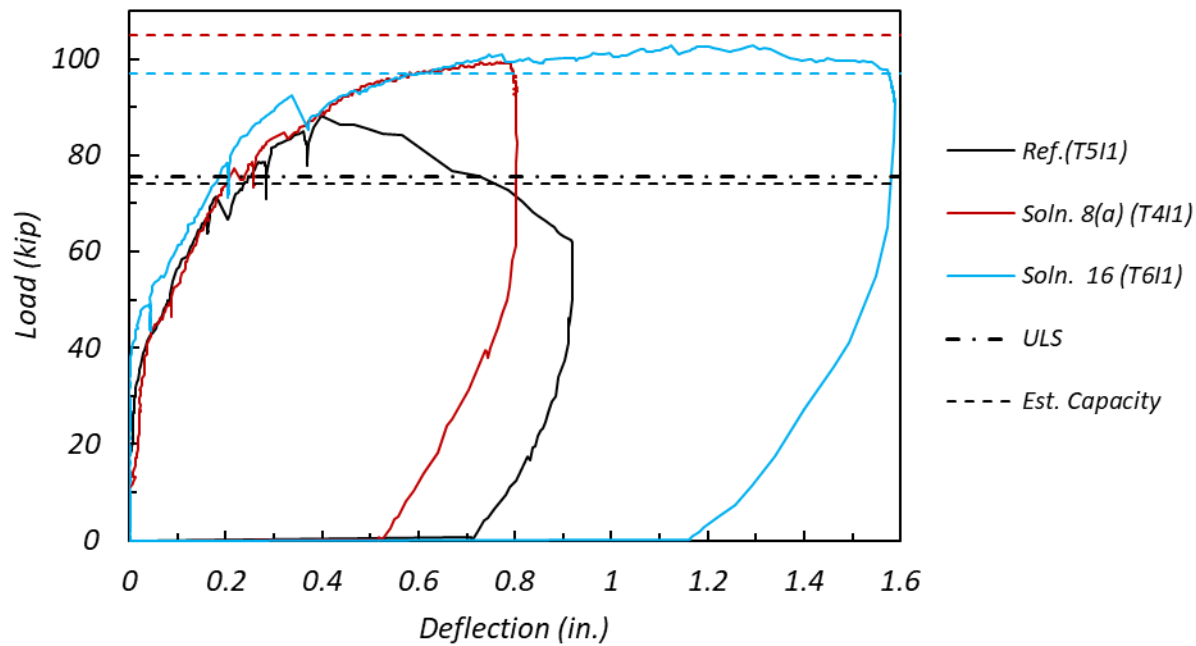
Figure 5.4. Load-Deflection Curves for Ledge-Deficient Interior Tests.

Note: Solid lines: experimentally measured capacities; dashed lines: estimated capacities using empirical AASHTO LRFD (2014) procedures; dash-dot line: ultimate factored load demand (ULS) = V_u .

The interior portions of the ledge-deficient specimens were strengthened with two clamped threadbars (Solution 8[a]) and partial-depth FRP (Solution 16). Table 5.6 summarizes the estimated capacity and measured ultimate load for each test. Retrofit values are normalized by the values for the reference test (T5I1). Load-deflection curves are provided in Figure 5.4.
