# Evaluation of Four Bridge Rail Systems for Compliance with the 2016 Edition of Manual for Assessing Safety Hardware (MASH)

**NCDOT Project 2019-23**  
**FHWA/NC/2019-23**  
**August 20, 2021**

Howie Fang, Ph.D. et al.  
Department of Mechanical Engineering &  
Engineering Science  
University of North Carolina at Charlotte

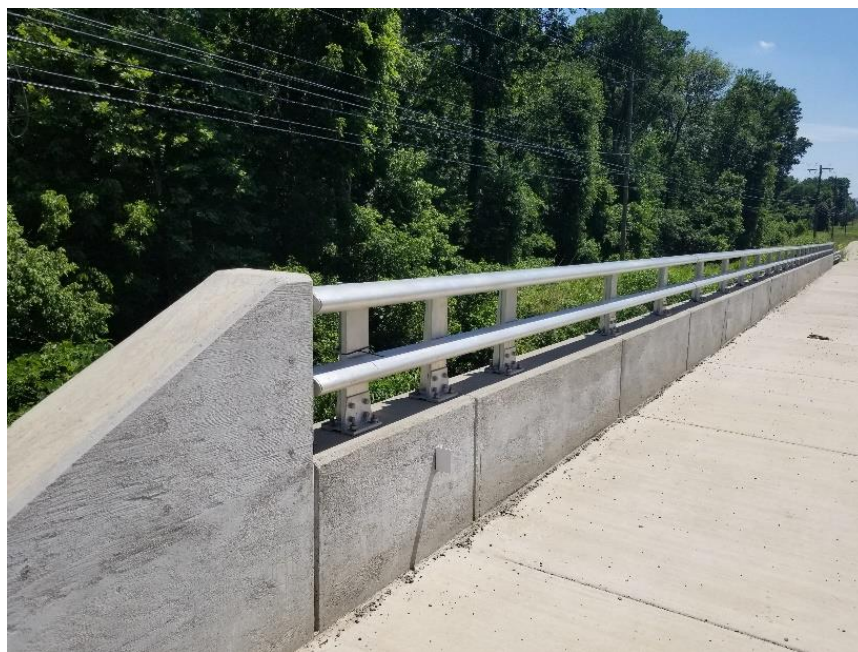
Figure 1.1: An NC two-bar metal rail.

Longitudinal barriers are generally categorized into flexible, semi-rigid and rigid barriers. Semi-rigid barriers such as the two-bar metal rail are more forgiving in severe crashes than rigid barriers and are relatively easy to maintain. Figure 1.1 shows the two-bar metal rail (2BMR) developed by the North Carolina Department of Transportation (NCDOT). It is a commonly used bridge rail in North Carolina and is recognized for its performance and aesthetics. This bridge rail consists of aluminum or steel posts, elliptical rails, and base plates mounted on a concrete parapet.

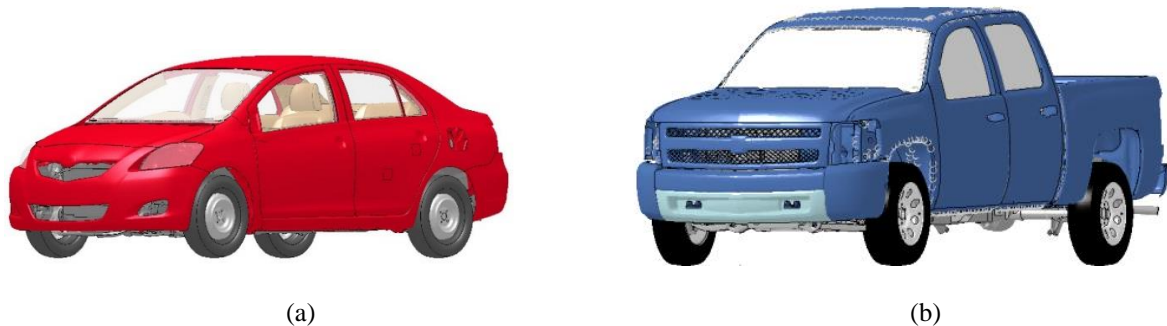
Figure 1.2: Finite element models of two MASH-compliant test vehicles.  
(a) 2010 Toyota Yaris; and (b) 2007 Chevy Silverado quad cab.

The test vehicles required for MASH TL-3 are a small passenger car (1100C) and a pickup truck (2270P) with masses of 2,420 lb (1,100 kg) and 5,000 lb (2,270 kg), respectively. Figure 1.2 shows the FE models of two MASH-compliant vehicles, a 2010 Toyota Yaris and a 2007 Chevy Silverado pickup truck, that were available for this project. Although it would be ideal to use the exact same vehicles (years and makes) in the crash tests as the FE vehicle models, the research team could not obtain the same vehicles for crash tests. The two vehicles for the crash tests in this project were a 2010 Hyundai Accent passenger car (1100C) and a 2015 Chevy Silverado quad cab pickup truck (2270P), both were MASH-compliant and similar/comparable in sizes and shapes to the respective FE vehicle models. During the project, the research team obtained the FE model of a 2014 Chevy Silverado quad cap that was also used in the simulations and compared to the 2007 Chevy

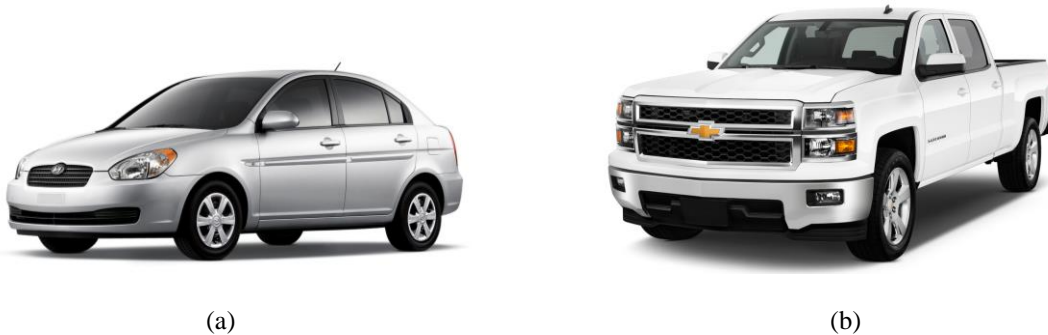
Figure 1.3: MASH-compliant test vehicles for this project.  
(a) 2010 Hyundai Accent; and (b) 2015 Chevy Silverado quad cab.

In this task, a 90-ft test section of the 2BMR was constructed at MwRSF and tested under MASH TL-3 conditions. Figure 1.3 shows the stock pictures of two MASH-compliant test vehicles obtained for this project, a 2010 Hyundai Accent (1100C) and a 2015 Chevy Silverado quad cab (2270P). Detailed information about the 2BMR test section and test vehicles are included in the Appendix of this report.

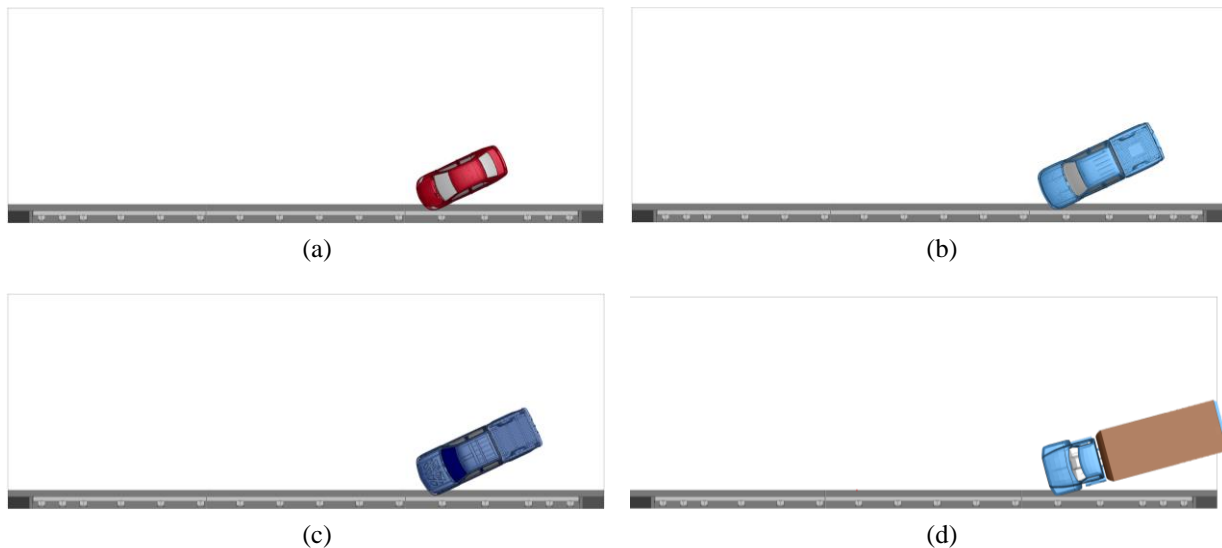
Figure 3.22: Full simulation models for the Oregon Rail using expansion joints as the reference points. (a) 2010 Toyota Yaris; (b) 2007 Chevy Silverado; (c) 2014 Chevy Silverado; and (d) 1996 Ford F800.

The safety performance of the Oregon Rail was evaluated under MASH TL-4 conditions, which involved four test vehicles: a 2010 Toyota Yaris, a 2007 Chevy Silverado, a 2014 Chevy Silverado, and a 1996 Ford F800. Two reference points were used to determine the CIPs: the expansion joint and a post closest to the expansion joint, as shown in Figure 3.21. A total of eight crash simulations were required for the Oregon Rail and the simulation matrix is given in Table 3.3. Figure 3.22 shows the full simulation models of the four impact cases using the expansion joint as the reference point.

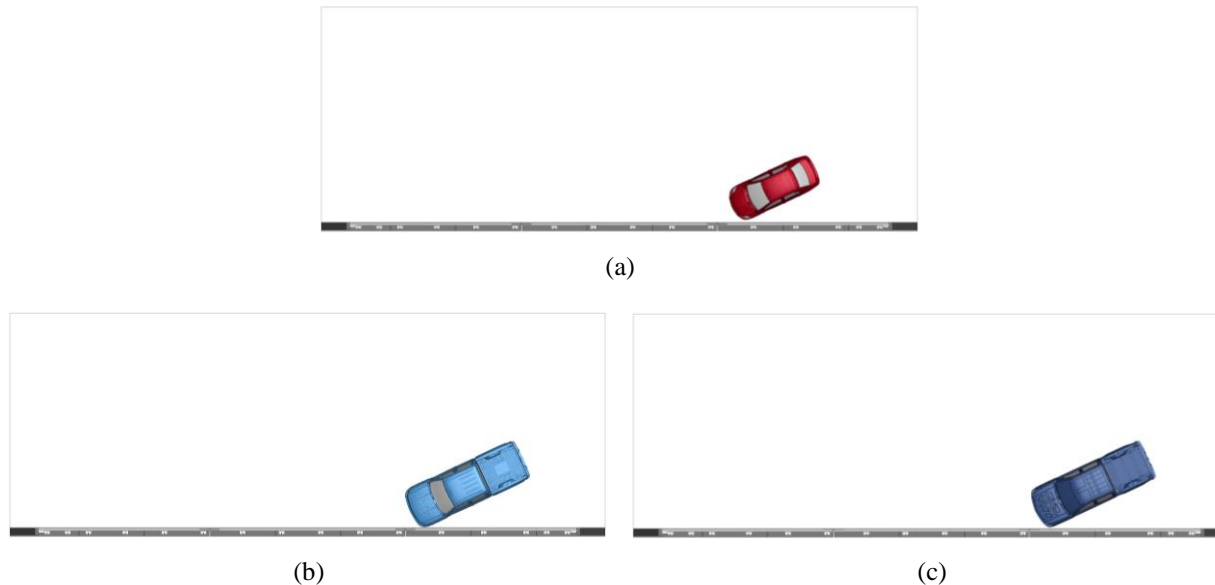
Figure 3.24: Full simulation models for Group 1 simulations using expansion joint as reference point. (a) 2010 Toyota Yaris; (b) 2007 Chevy Silverado; and (c) 2014 Chevy Silverado.

Each group consisted of six simulation cases and the simulation conditions were summarized in Tables 3.4, 3.5, and 3.6. Figure 3.24 shows the model setups for the three cases of Group 1 using expansion joint as the reference point. All other cases were similar to the cases of Group 1 except for the impact velocities and/or reference points and CIPs.

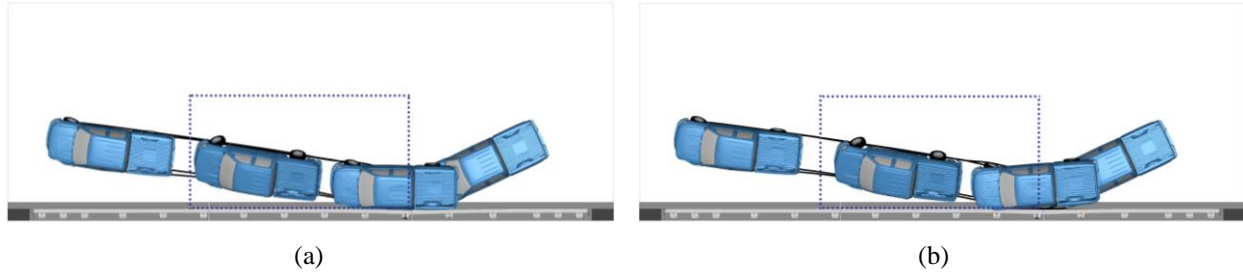
Figure 4.23 shows the top-view vehicle trajectories of the 2007 Chevy Silverado impacting the Oregon Rail at 62 mph (100 km/h) and a 25° impact angle. Tire tracks of the vehicle and the exit box were also shown in the figure. For both impact cases, the vehicle was redirected by the bridge rail with small exit angles and passed MASH exit box criterion. The post-impact trajectories of the vehicle in both cases were considered as safe redirections.

Figure 4.23: Vehicle trajectories of 2007 Chevy Silverado impacting the Oregon Rail.  
(a) With expansion joint as reference; and (b) with the post as reference.

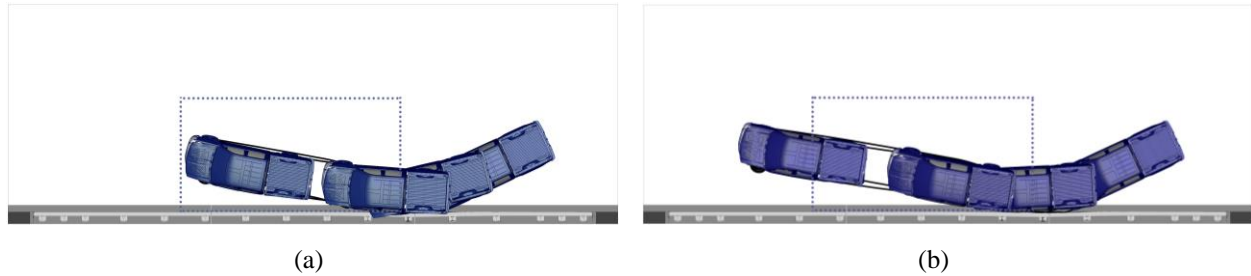
Figure 4.26 shows the top-view vehicle trajectories of the 2014 Chevy Silverado impacting the Oregon Rail at 62 mph (100 km/h) and a 25° impact angle. Tire tracks of the vehicle and the exit box were also shown in the figure. For both impact cases, the vehicle was redirected by the bridge rail with small exit angles and passed MASH exit box criterion. The post-impact trajectories of the vehicle in both cases were considered as safe redirections.

Figure 4.26: Vehicle trajectories of 2014 Chevy Silverado impacting the Oregon Rail. (a) With expansion joint as reference; and (b) with the post as reference.

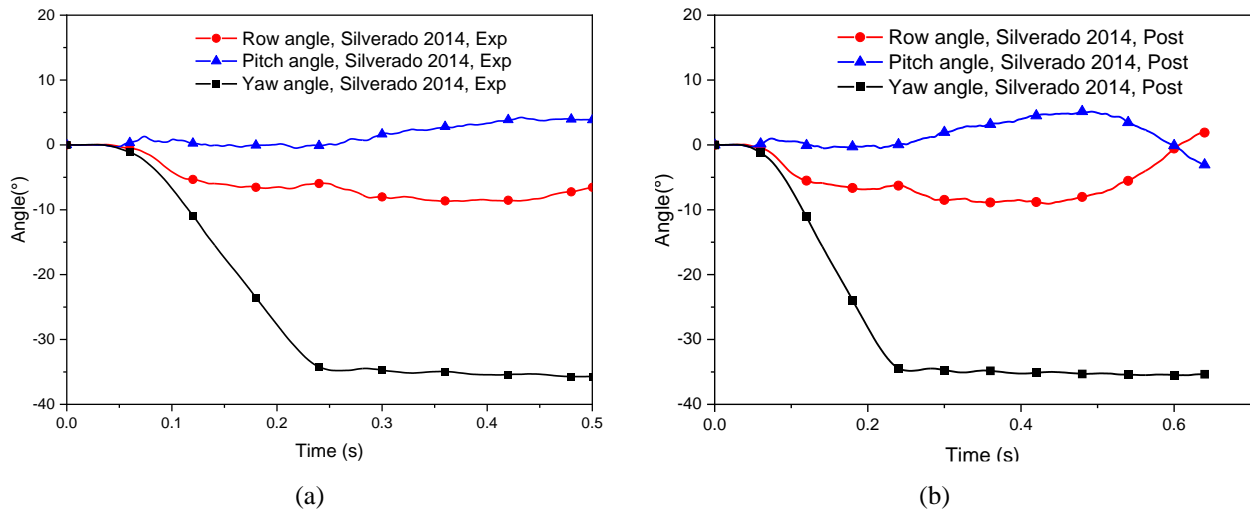
Figure 4.28 shows the time history of the vehicle's roll, pitch, and yaw angles. The maximum roll angles for the two impact cases were 8.7° and 9.1°, respectively, and the maximum pitch angles were 4.2° and 5.1°, respectively, for the two cases. These values were much smaller than those of the 2007 Chevy Silverado, indicating a more robust suspension system (model) of the 2014 Chevy Silverado. In both cases, the Oregon Rail passed the MASH evaluation criterion  $F$ .

Figure 4.28: Time histories of angular motions of 2014 Chevy Silverado impacting the Oregon Rail. (a) With expansion joint as reference; and (b) with the post as reference.

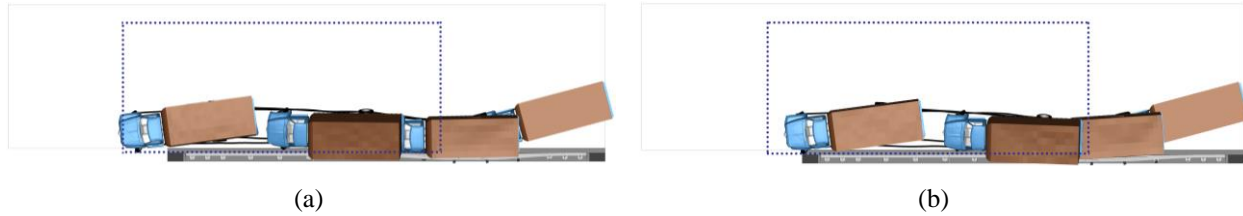
Figure 4.29 shows the top-view vehicle trajectories of the 1996 Ford F800 single-unit truck impacting the Oregon Rail at 56 mph (90 km/h) with a 25° impact angle. Tire tracks of the vehicle and the exit box were also shown in the figure. For both impact cases, the vehicle was redirected by the bridge rail with small exit angles and passed MASH exit box criterion. Due to the small exit angle, the vehicle maintained an upright position during the entire course of impact, though this was not required by MASH for single-unit trucks. The post-impact trajectories of the vehicle in both cases were considered as safe redirections.

Figure 4.29: Vehicle trajectories of 1996 Ford F800 impacting the Oregon Rail.  
(a) With expansion joint as reference; and (b) with the post as reference.

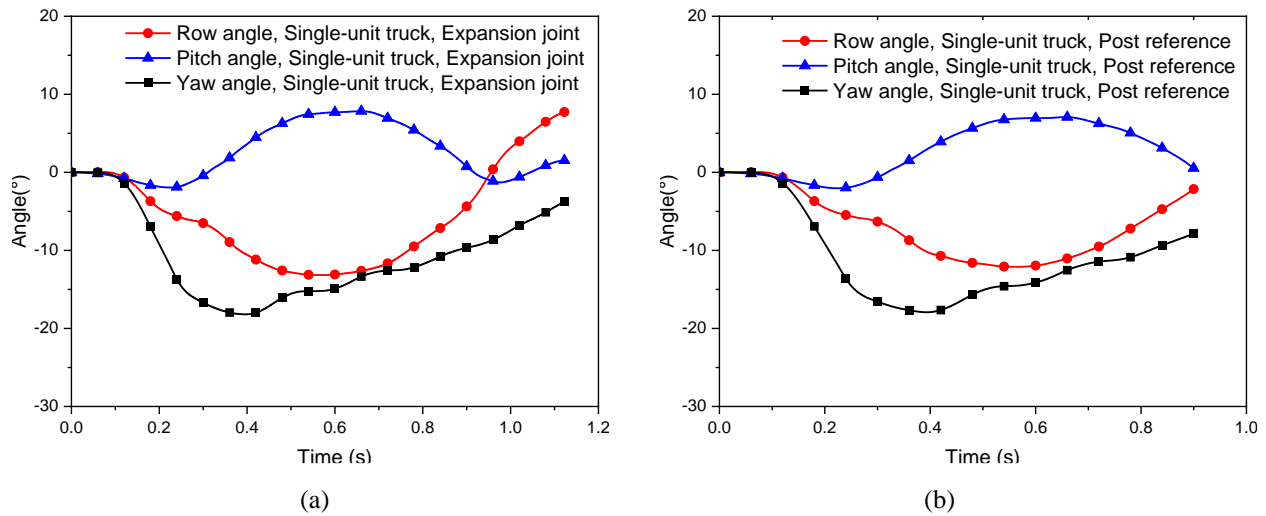
Figure 4.31 shows the time history of the vehicle's roll, pitch, and yaw angles. The maximum roll angles for the two impact cases were 13.2° and 12.1°, respectively, and the maximum pitch angles were 7.8° and 7.1°, respectively. These results showed that the Oregon Rail passed the MASH evaluation criterion  $F$  in both cases under impacts by the 1996 Ford F800.

Figure 4.31: Time histories of angular motions of 1996 Ford F800 impacting the Oregon Rail. (a) With expansion joint as reference; and (b) with the post as reference.

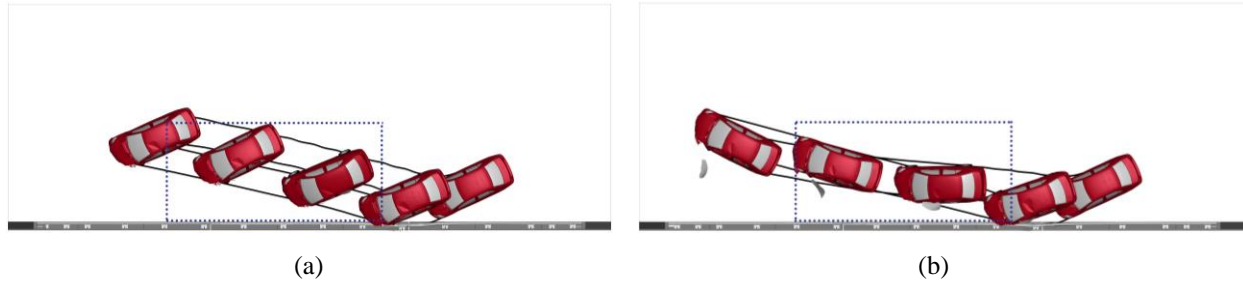
Figure 4.42 shows the top-view vehicle trajectories of the 2010 Toyota Yaris impacting the 3BMR-1 at 62 mph (100 km/h) and a 25° impact angle. Tire tracks of the vehicle and the exit box were also shown in the figure. Under TL-3 conditions, the post-impact vehicular responses were different in the two impact cases. For impact with the expansion joint as the reference point, as shown in Figure 4.42(a), the vehicle was bounced back without being redirected. In this case, the

MASH exit box criterion was not met because the vehicle left the rectangular box with wheel tracks on both the left side (i.e., the short side) and the top side (i.e., the long side) of the rectangular box. To pass the exit box criterion, the vehicle must leave the rectangular box from the left side with wheel tracks not going over the top, long side. For the case with the post as reference point, the vehicle was redirected and passed the MASH exit box criterion, because the vehicle's wheel tracks were below the top side before leaving the rectangular box from the left side. Based on the post-impact trajectories of the vehicle, only the case with the post as reference point was considered as a safe redirection.

Figure 4.42: Vehicle trajectories of 2010 Toyota Yaris impacting 3BMR-1 under TL-3 conditions. (a) With expansion joint as reference; and (b) with the post as reference.

Figure 4.51 shows the top-view vehicle trajectories of the 2010 Toyota Yaris impacting the 3BMR-2 at 62 mph (100 km/h) and a 25° impact angle. The post-impact vehicular responses for the two impact cases were similar to those using the 3BMR-1 model (see Figure 4.42). These responses were expected, since no significant failure was found in the concrete foundation under impacts of the 2010 Toyota Yaris using the 3BMR-1 model. Only in the case with the post as reference point, the vehicle was redirected and passed the MASH exit box criterion.

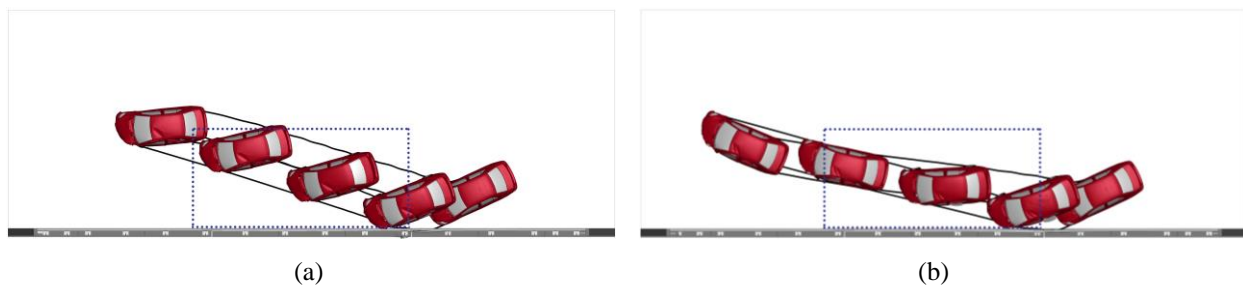
Figure 4.51: Vehicle trajectories of 2010 Toyota Yaris impacting 3BMR-2 under TL-3 conditions. (a) With expansion joint as reference; and (b) with the post as reference.

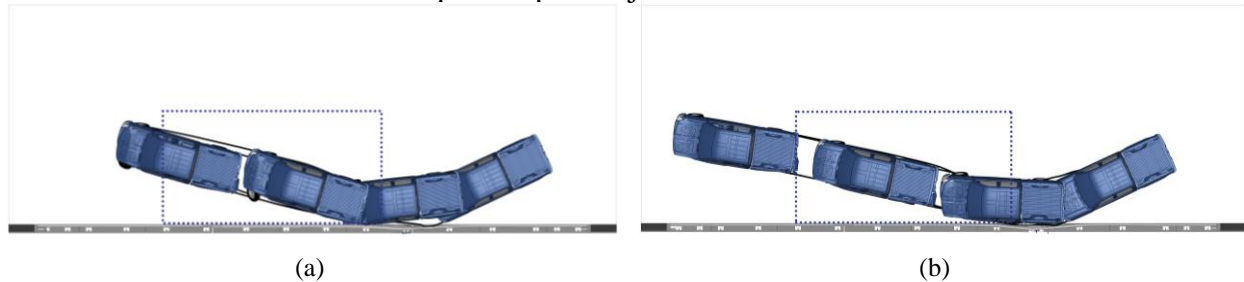
Figure 4.57 shows the top-view vehicle trajectories of the 2014 Chevy Silverado impacting the 3BMR-2 at 62 mph (100 km/h) and a 25° impact angle. For both impact cases, the vehicle passed MASH exit box criterion and the post-impact trajectories were considered as safe redirections.

Figure 4.57: Vehicle trajectories of 2014 Chevy Silverado impacting 3BMR-2 under TL-3 conditions. (a) With expansion joint as reference; and (b) with the post as reference.

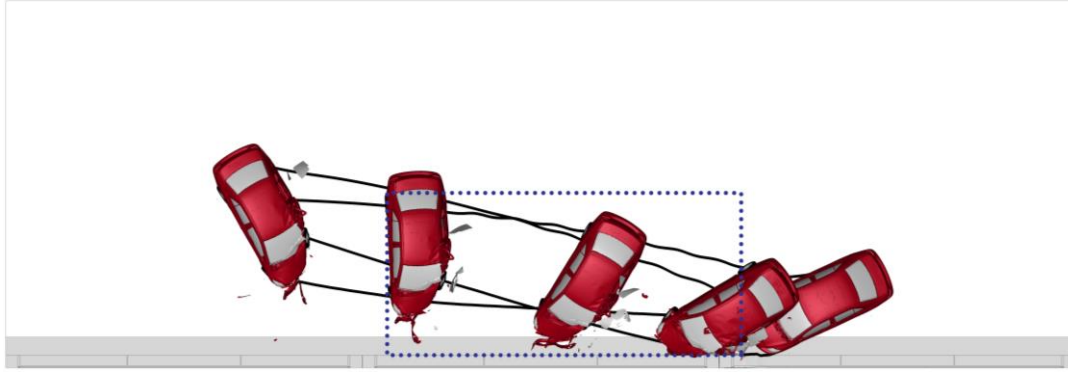
Figure 4.72 shows the top-view vehicle trajectories of the 2010 Toyota Yaris impacting the Classic Rail at 62 mph (100 km/h) and a 25° impact angle. In this case, the vehicle was stuck on the barrier before it was bounced back; therefore, the vehicle was not redirected and failed to pass the MASH exit box criterion. The damage on the bridge rail was localized around the initial impact location (see Figure 4.73), and it was much more severe than the case by 2010 Toyota Yaris under TL-2 conditions.

Figure 4.72: Vehicle trajectories of 2010 Toyota Yaris impacting Classic Rail under TL-3 conditions.

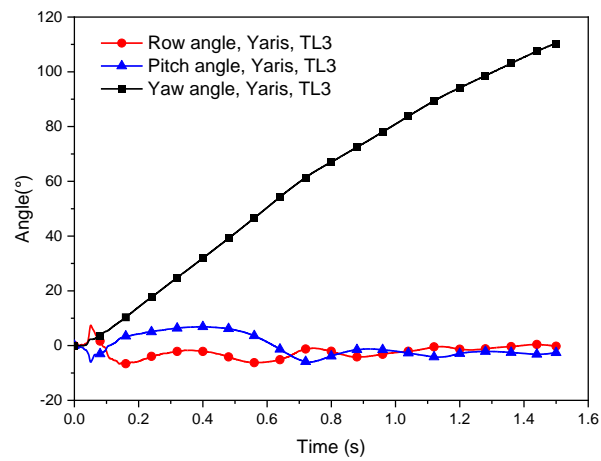
Figure 4.74 shows the time history of the vehicle's roll, pitch, and yaw angles. With a maximum roll angle of 7.4° and a maximum pitch angle of 6.9°, the Classic Rail passed the MASH evaluation criterion *F*, which specified a maximum 75° roll and pitch angles.

Figure 4.74: Time histories of angular motions of 2010 Toyota Yaris impacting Classic Rail under TL-3 conditions.

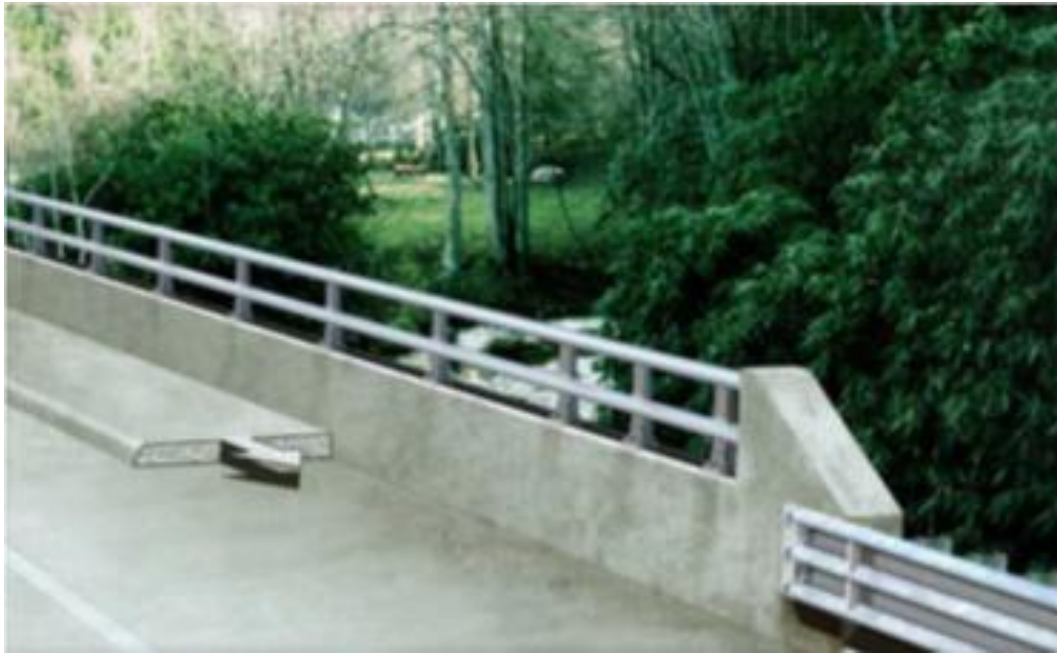
Figure 1. NCDOT Two-Bar Metal Bridge Rail Installation

The North Carolina Department of Transportation's (NCDOT) two-bar metal bridge rail was developed for use on scenic bridges to allow for enhanced viewing of the surroundings. An example of an installed configuration is shown in Figure 1. NCDOT's standard drawings of the two-bar metal bridge rail are shown in Appendix A.

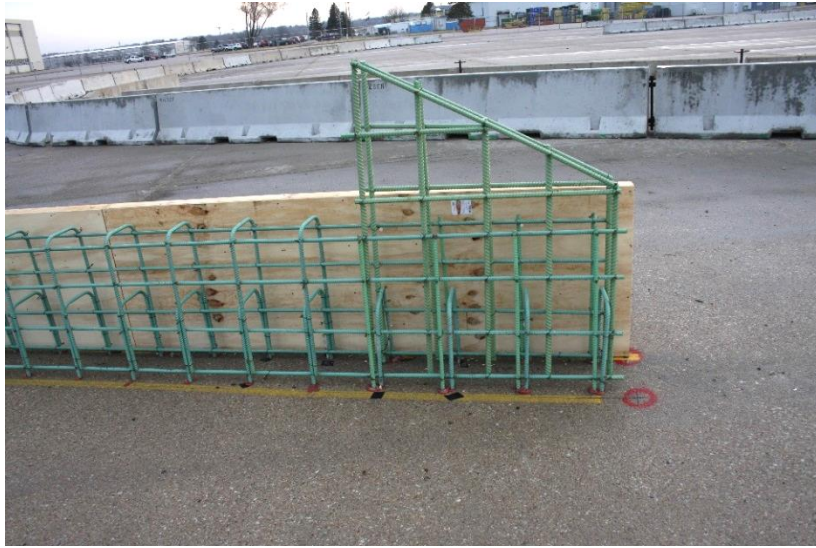
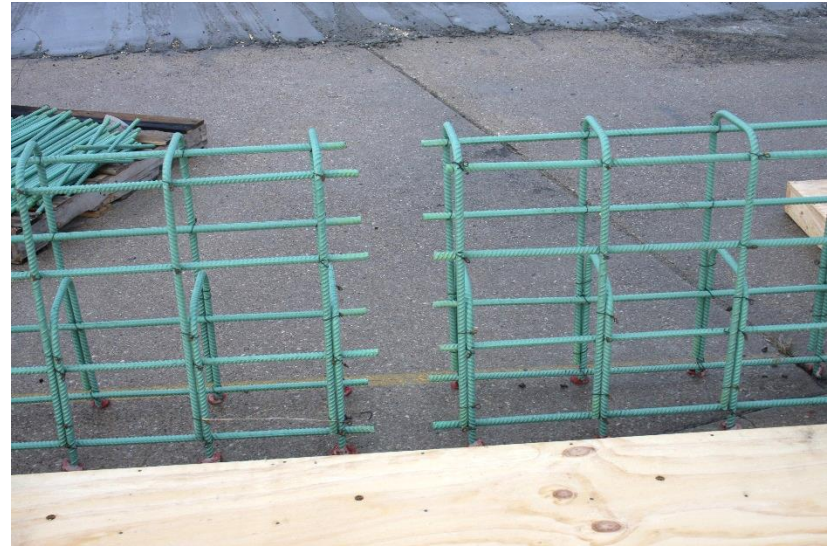
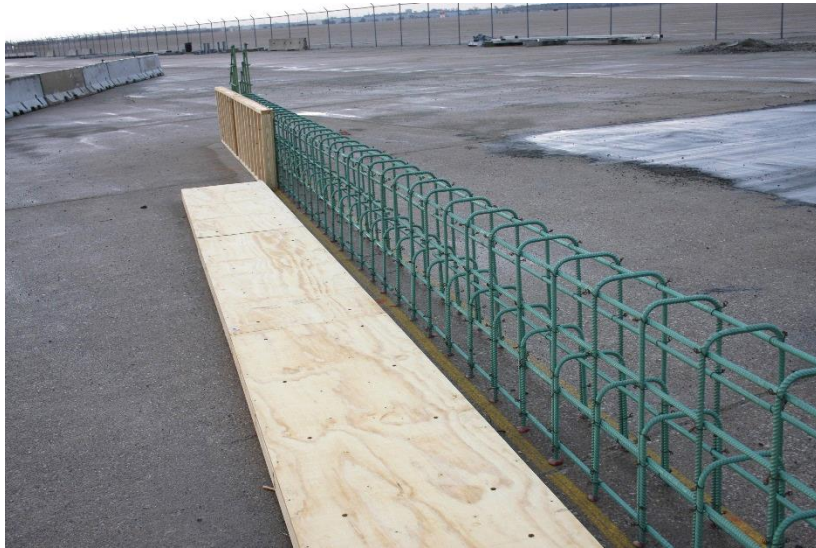
Figure 29. Construction Photographs, Test Nos. NCBR-1 and NCBR-2

The concrete parapet consisted of three 30-ft long concrete barrier segments with 1-in. long, unfilled gaps to replicate bridge expansion joints in between segments. NCDOT typically installs a joint filler between expansion joints, but this material erodes over time. Thus, this material was omitted in construction to ensure a “worst practical case” impact scenario, maximizing the risk that snag could occur. The overall length and width of the concrete parapet were 90 ft and 14 in., respectively. The concrete parapets consisted of tapered buttress ends at the upstream and downstream end of the system, and 30-in. tall prismatic concrete parapet segments. The concrete end buttresses were 56 in. tall and were vertically tapered to 32¾ in. above the roadway at the outer faces over a longitudinal distance of 39 in. All edges of the concrete faces had ½-in. x ½-in. chamfers. Construction joints, consisting of ½-in. wide, saw-cut grooves extending on the front, back, and top faces, were installed in equally-spaced, 10-ft increments and at the interior faces of the concrete buttresses. Photos of the rail parapet construction are shown in Figure 29, and the parapet is shown in Figure 30.

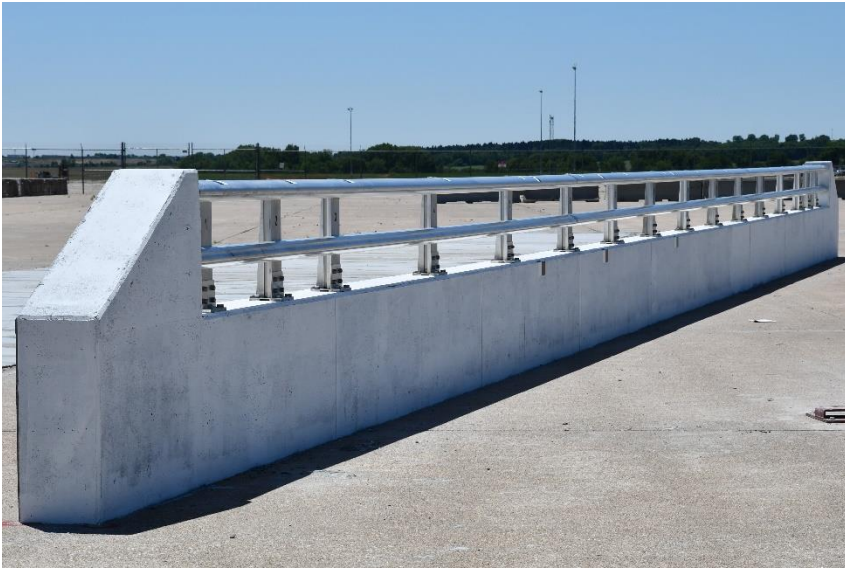
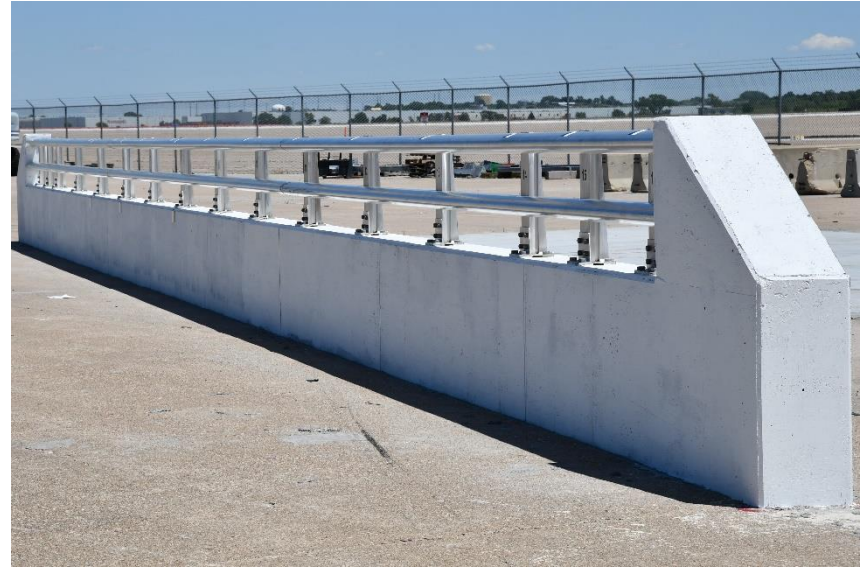
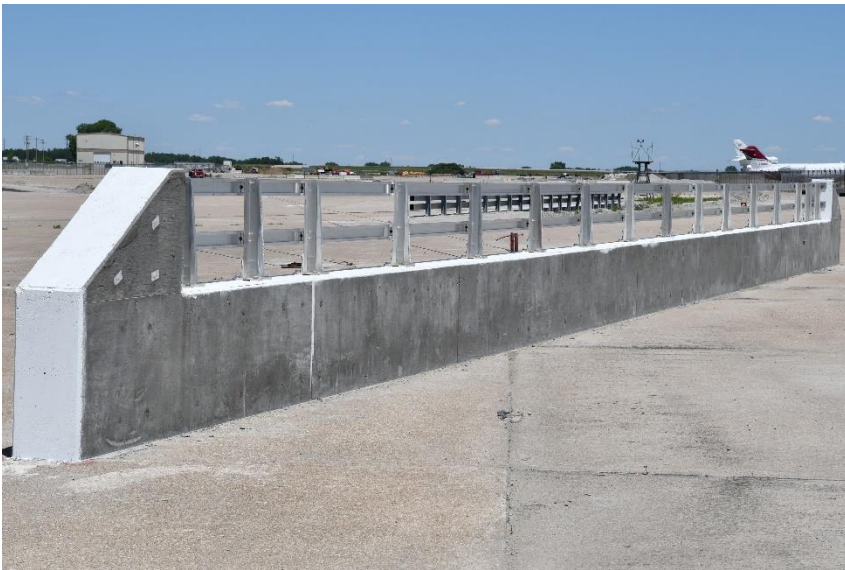
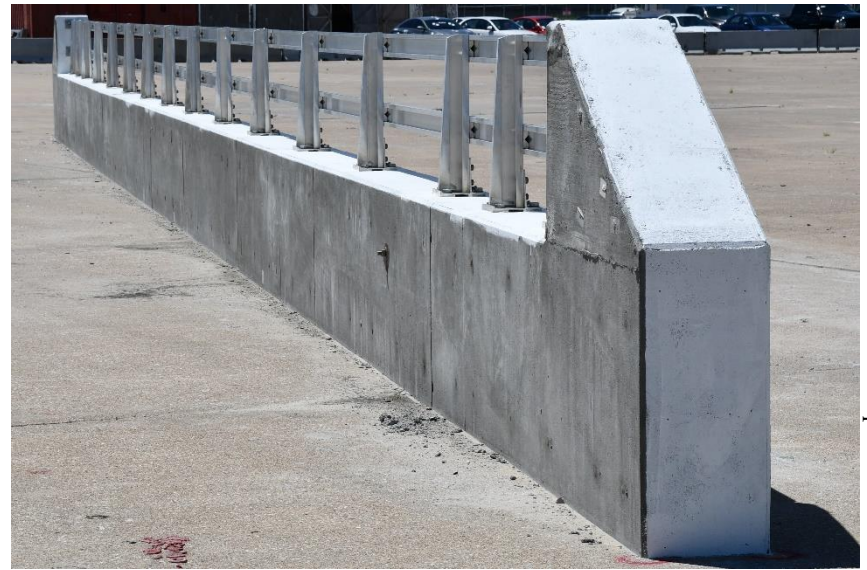
Figure 30. System Installation Photographs, Test Nos. NCBR-1 and NCBR-2

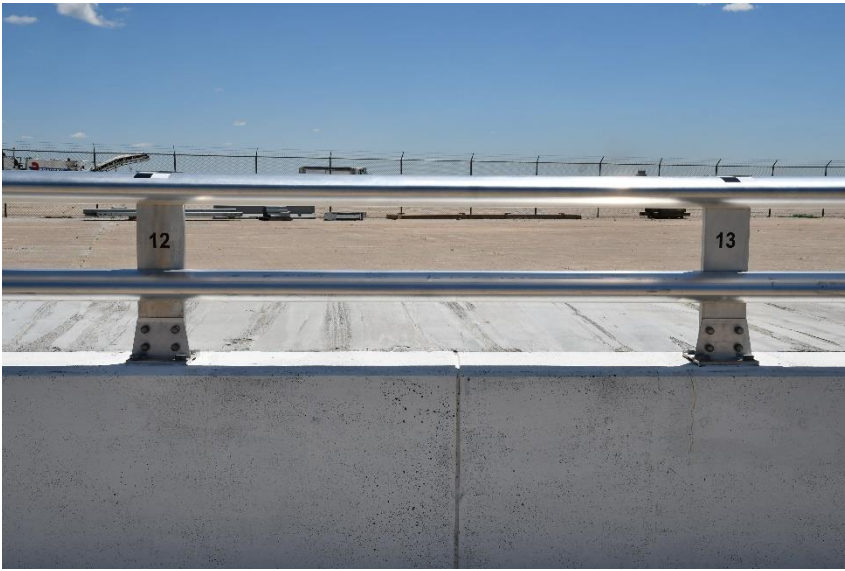
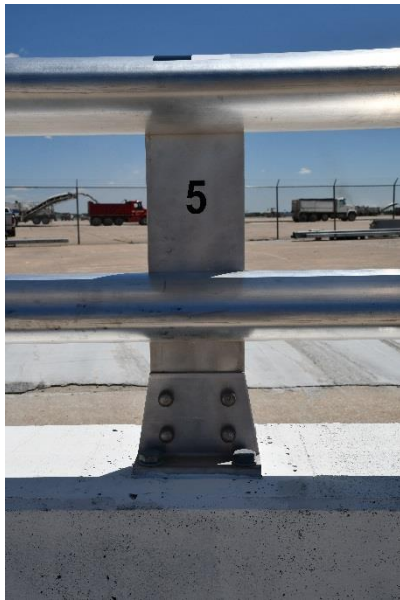
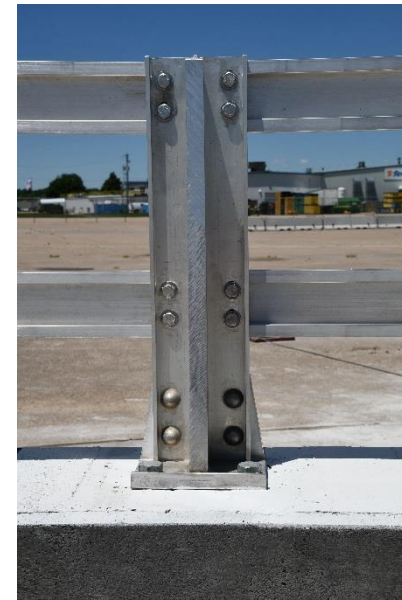
Figure 31. Post and Rail Assembly, Test Nos. NCBR-1 and NCBR-2

Two elliptical rail segments were mounted on the front side of each aluminum post, as shown in Figures 3, 4, and 31. The elliptical rails were  $4\frac{3}{4}$  in. wide and 4 in. tall, with a grooved back slot, as shown in Figure 12. At each post location, clamp bars and shim plates (as needed for alignment) were bolted to the posts with  $\frac{1}{2}$ -in.-13 UNC, 1-in. long, ASTM F593 stainless steel cap screws, as shown in Figures 3, 9, and 10. Shaped splice bars measuring 36 in. long with dimpled back plates were inserted into the elliptical rails at every expansion joint, which provided rail shear and bending connectivity. Post-to-rail attachment details are shown in Figure 32.

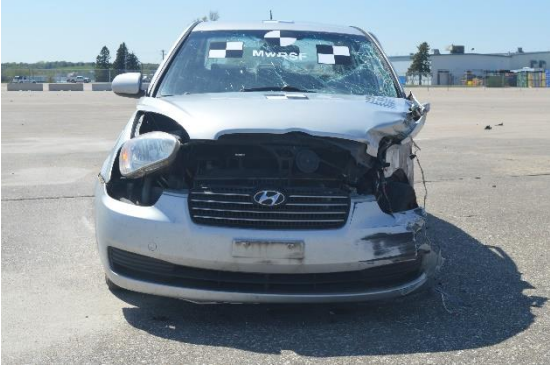
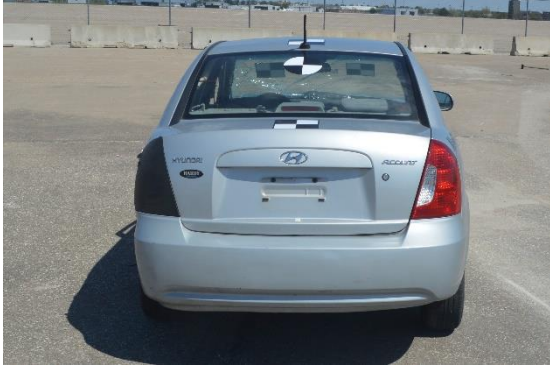
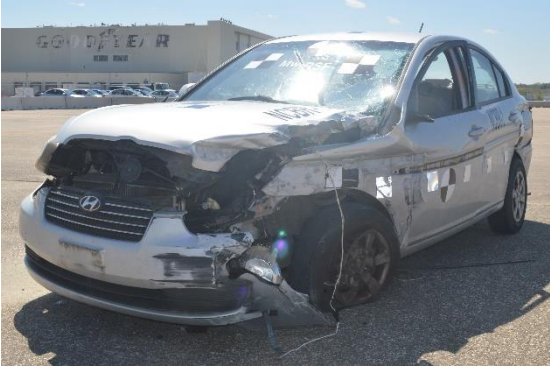
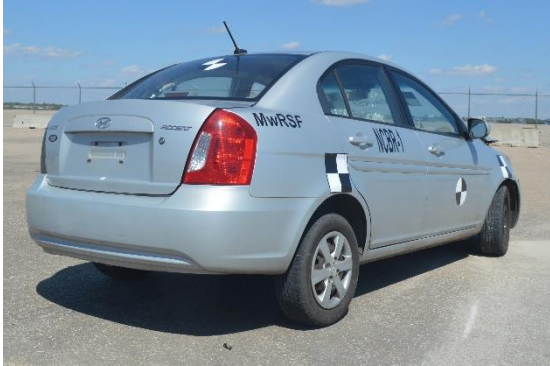
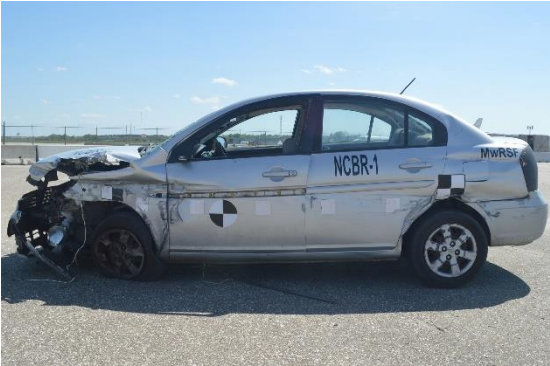
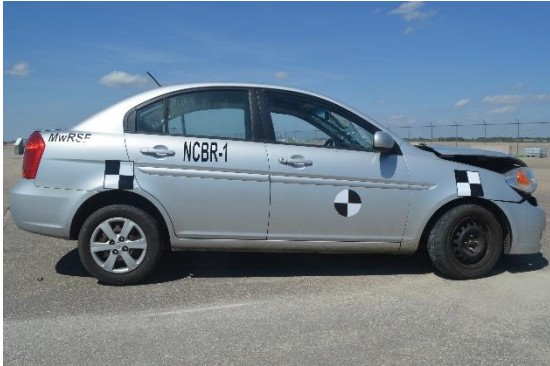
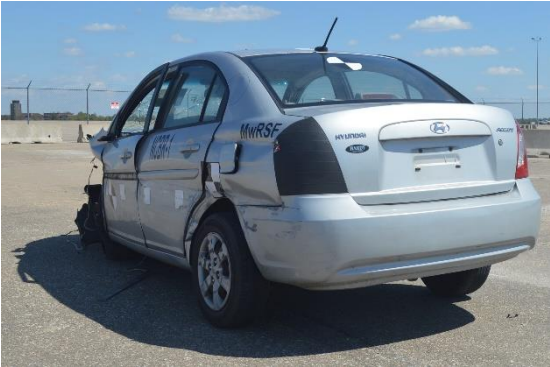
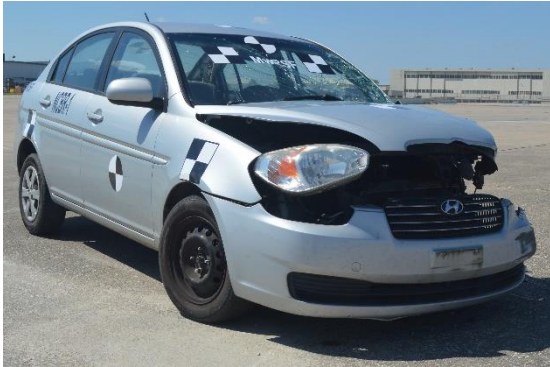
Figure 59. Vehicle Damage, Test No. NCBR-1

Damage to the vehicle was moderate, as shown in Figures 59 through 63. The majority of the damage was concentrated on the left-front corner and left side of the vehicle where impact had occurred. The left side of the bumper was deformed and torn in front of the wheel. The left-front fender was pushed inward near the door panel and torn around the left-front wheel. The left-front steel rim was deformed with tears and crushing. The left-front tire was torn and deformed. The left-side headlight and fog light were disengaged from the vehicle. The left side of the radiator was pushed backward. Denting and scraping were observed across the entire left side. The top of the left-front door was slightly ajar and the bottom was pushed inward. The bottom of the left-rear door was dented and scuffed. The fuel hatch was ajar. The left-rear wheel assembly was deformed inward. The left-rear steel rim and tire were scuffed. The left side of the rear bumper was dented and scuffed. The hood was crushed inward, separated from the bumper entirely, and the left edge was torn. The right side of the bumper was pushed downward. The left side of the windshield was cracked and deformed, and the upper-right side had minor cracking. The left-front side window

disengaged from the vehicle after contact with the dummy's head. The remaining window glass was undamaged. The spring perch on the left side was cracked. The left-side control arm was bent backward. The transmission mounts shifted toward the right side. The left-side frame rail compressed and bent upward. The rear cross member bent inward on both ends. The front cross member was bent and crushed upward. The frame horn was bent upward on the left side. The floor pan was opened at the seam across the whole left side. The front exhaust mount folded inward.

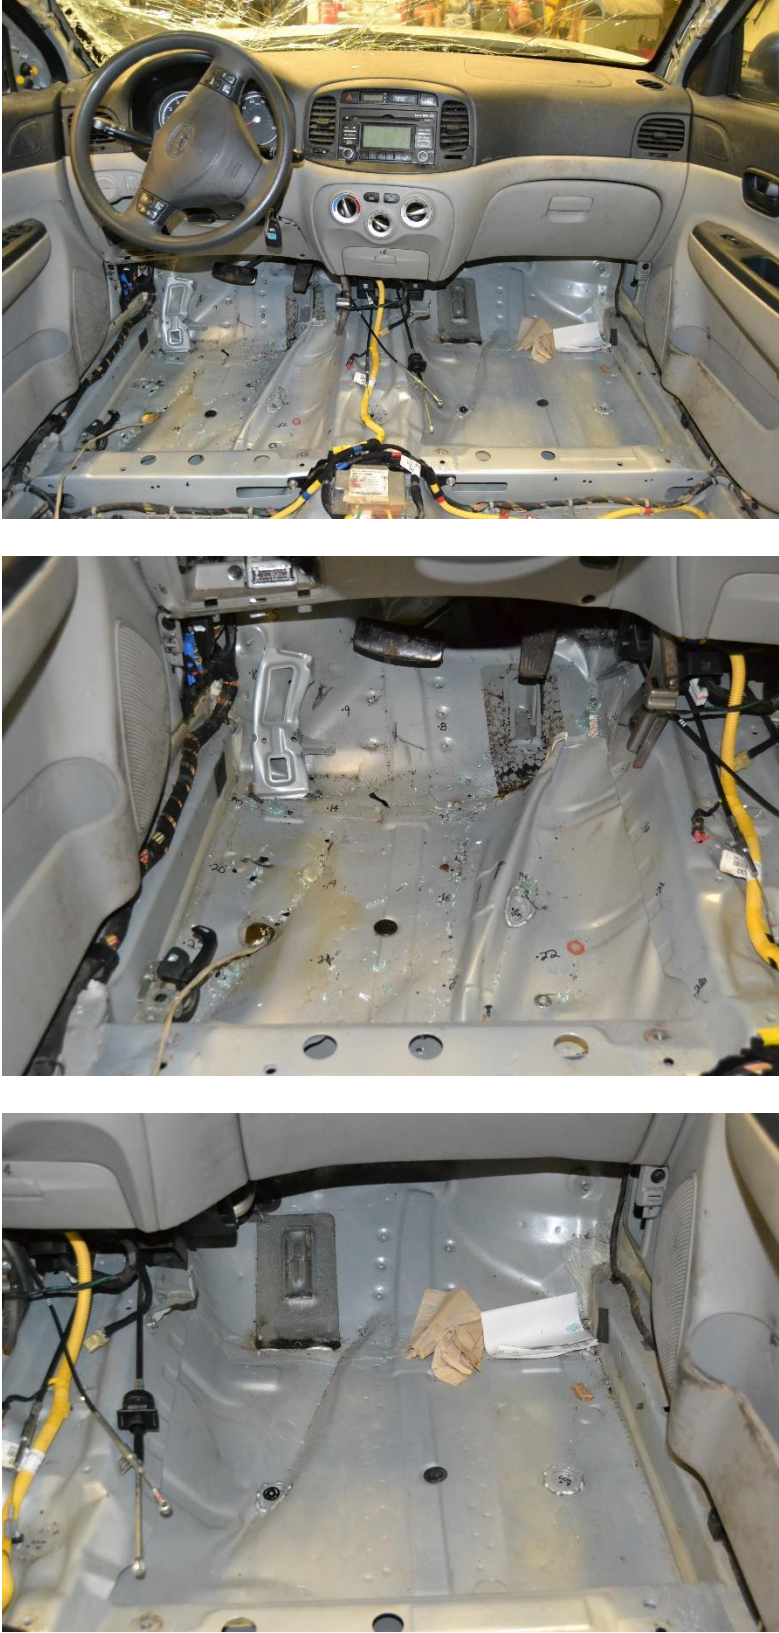
Figure 61. Occupant Compartment Damage, Test No. NCBR-1

The maximum occupant compartment intrusions are listed in Table 5, along with the intrusion limits established in MASH 2016 for various areas of the occupant compartment. MASH 2016 defines intrusion or deformation as the occupant compartment being deformed and reduced in size with no observed penetration. There were no penetrations into the occupant compartment and none of the established MASH 2016 deformation limits were violated. Complete occupant compartment and vehicle deformations and the corresponding locations are provided in Appendix D. It should be noted that a large tear was visible in the vehicle windshield. Review of the high-speed video revealed that tearing of the windshield was formed due to crushing of the back left corner of the hood, resulting in a vertical crack which propagated through the windshield to the roof. Neither the barrier nor any vehicle component contacted the windshield except at the bottom left corner. The displacement of the vehicle's "A"-pillar and hood were minimal. No deformations occurred to the roof panel. After the test, the windshield displacements were measured and compared against an exemplary vehicle. However, windshield deformations were artificially high due to settling that occurred in between testing and measurement. Therefore, windshield displacements were deemed acceptable according to MASH, and none of the MASH criteria for windshield contact, protrusion, or deformation were violated.

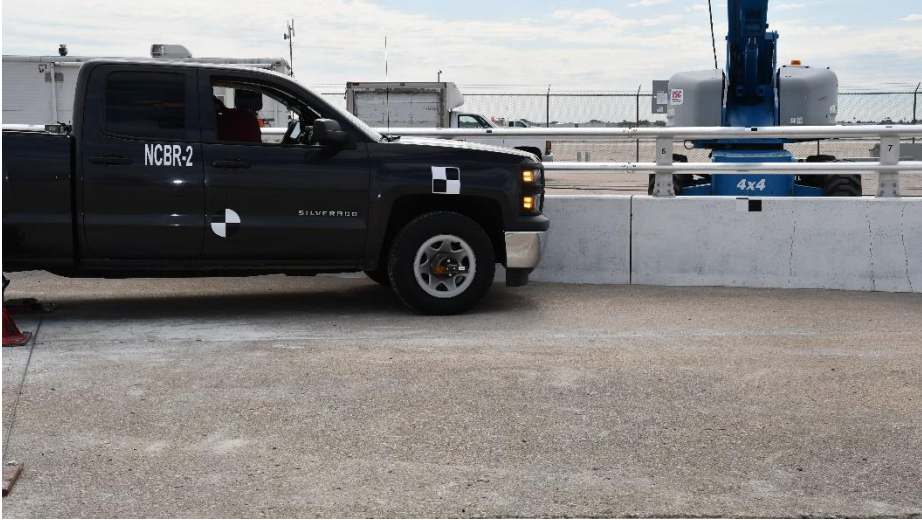
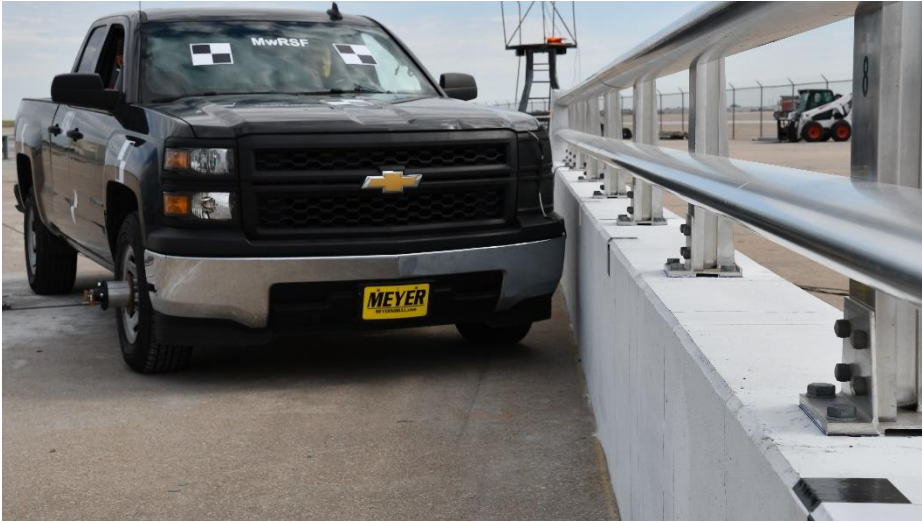
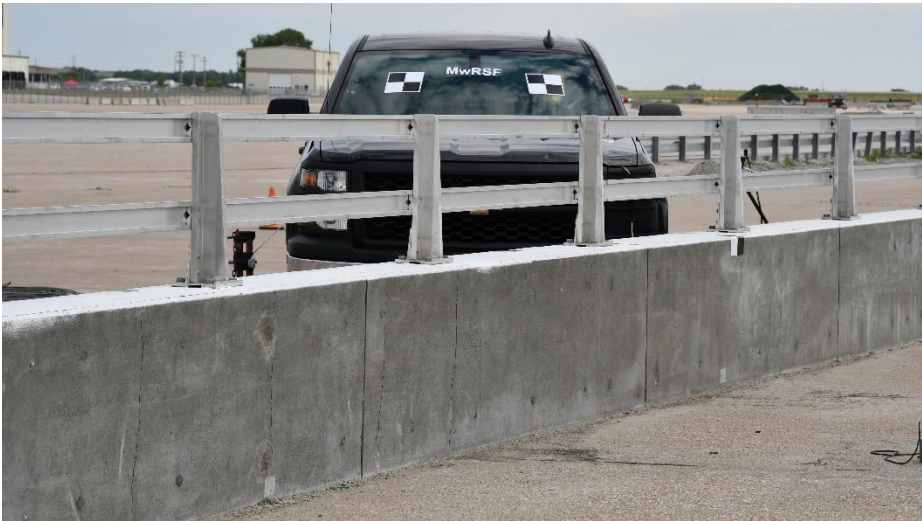
Figure 66. Impact Location, Test No. NCBR-2

Initial vehicle impact was to occur  $61^{15}/_{16}$  in. upstream from post no. 6, as shown in Figure 66, which was selected by UNCC from simulation results and verified by NCDOT as the point that maximized loading on the rail splices. The 5,018-lb quad cab pickup truck impacted the NCDOT two-bar metal bridge rail at a speed of 61.9 mph and an angle of 24.9 deg. The actual point of impact was  $61^{7}/_{8}$  in. upstream from post no. 6. The vehicle came to rest 200 ft – 2 in. downstream and 25 ft – 10 in. laterally in front of the traffic side of the barrier after the brakes were applied.

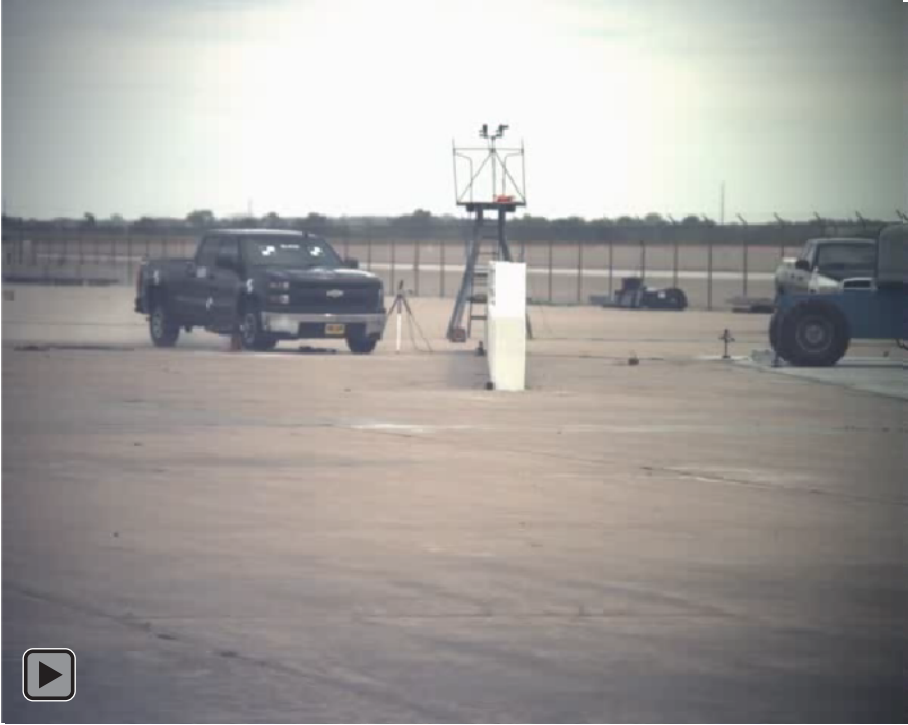
Figure 67. Downstream High-Speed Footage, Test No. NCBR-2

A detailed description of the sequential impact events is contained in Table 8. High-speed footage of the test is shown in Figure 67. Sequential photographs are shown in Figures 69 and 70. Documentary photographs of the crash test are shown in Figures 71 through 73. The vehicle trajectory and final position are shown in Figure 74.
