# Evaluation of Four Bridge Rail Systems for Compliance with the 2016 Edition of Manual for Assessing Safety Hardware (MASH)

**NCDOT Project 2019-23**  
**FHWA/NC/2019-23**  
**August 20, 2021**

Howie Fang, Ph.D. et al.  
Department of Mechanical Engineering &  
Engineering Science  
University of North Carolina at Charlotte

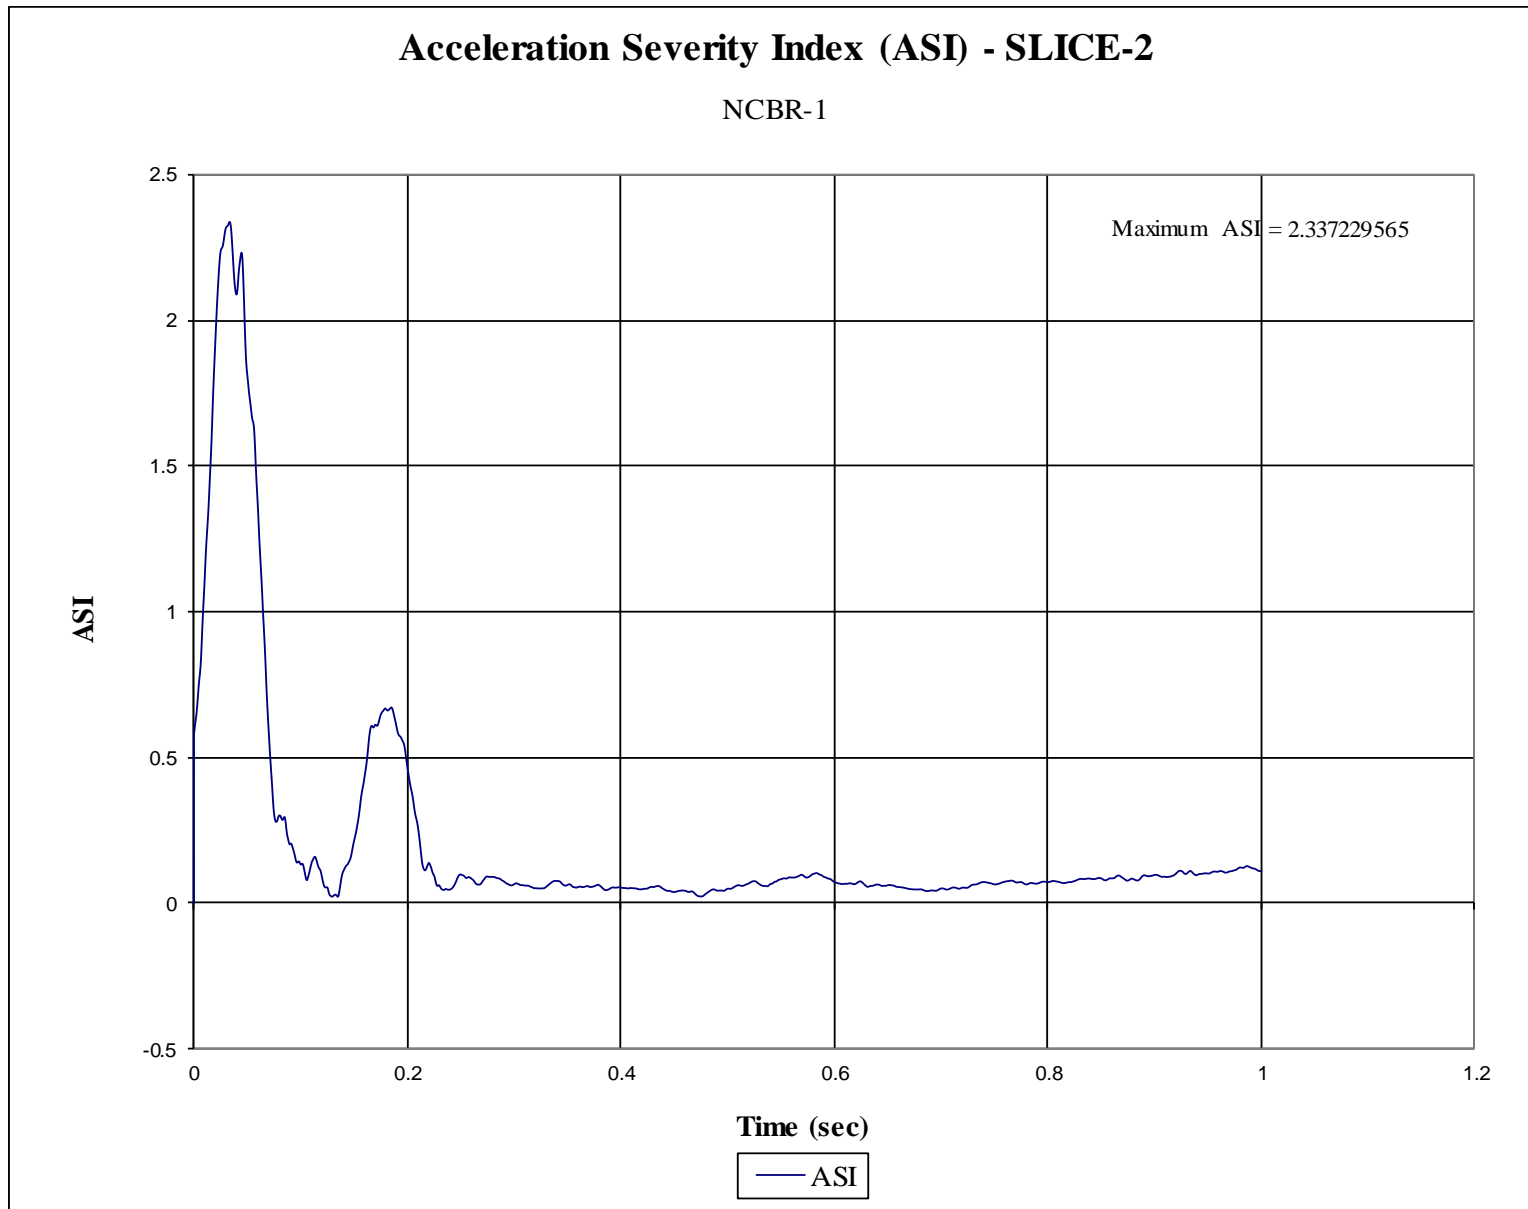
Figure E-16. Acceleration Severity Index (SLICE-2), Test No. NCBR-1
