Evaluation of Galvanized and Painted Galvanized Steel Piling

**Interim Report
September 2022**

Sponsored by
Iowa Highway Research Board
(IHRB Project TR-766)
Iowa Department of Transportation
(InTrans Project 18-678)

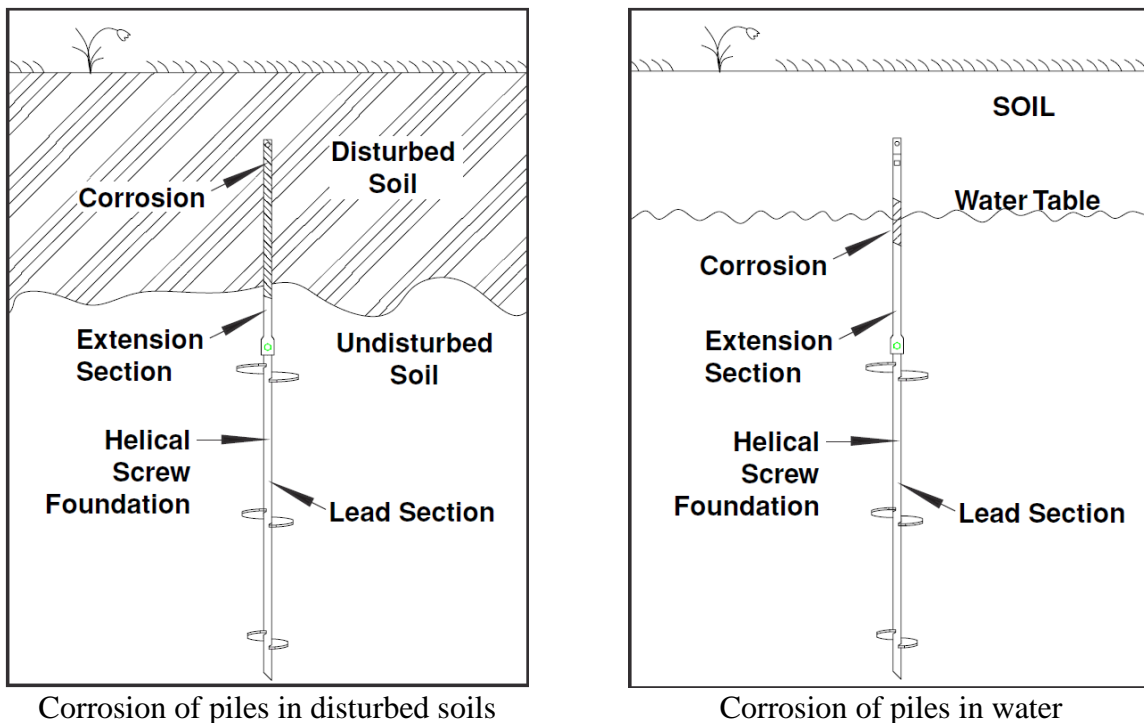
Figure 1 (left) illustrates the region prone to corrosion for piles immersed in disturbed soil.

Figure 1. Corrosion of piles in disturbed soils and water

Protective measures such as zinc coatings should be used on piles when corrosion may be a potential problem at a site. In the case of piles driven through disturbed soils, the protection should be applied to the critical region, which extends from the bottom of the pile cap down to about 3.28 ft (1 m) below the water table, as shown in the previous Figure 1 (right).

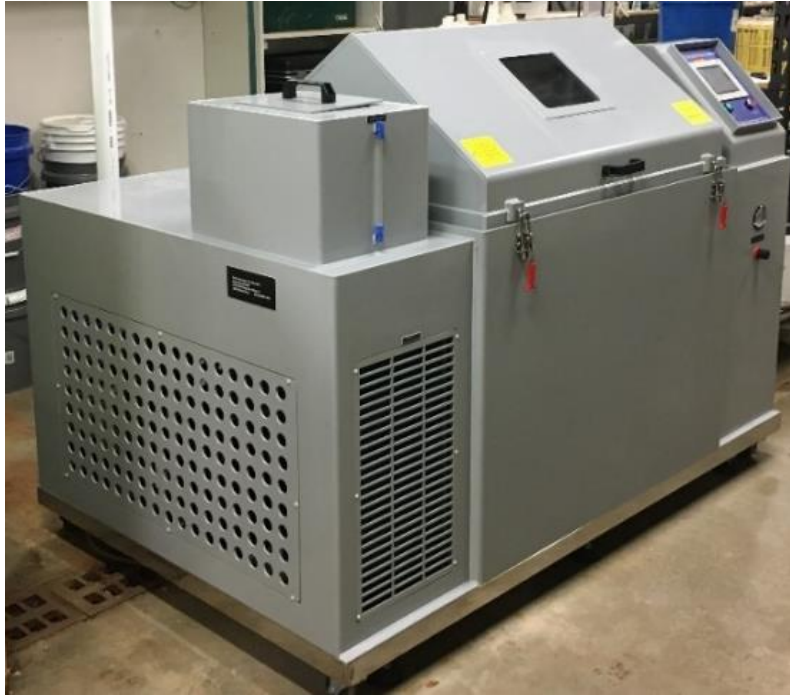
To perform the proposed laboratory testing, a chamber with sufficient internal space was utilized. Figure 2 shows the CCT chamber.

Figure 2. Cyclic corrosion test chamber

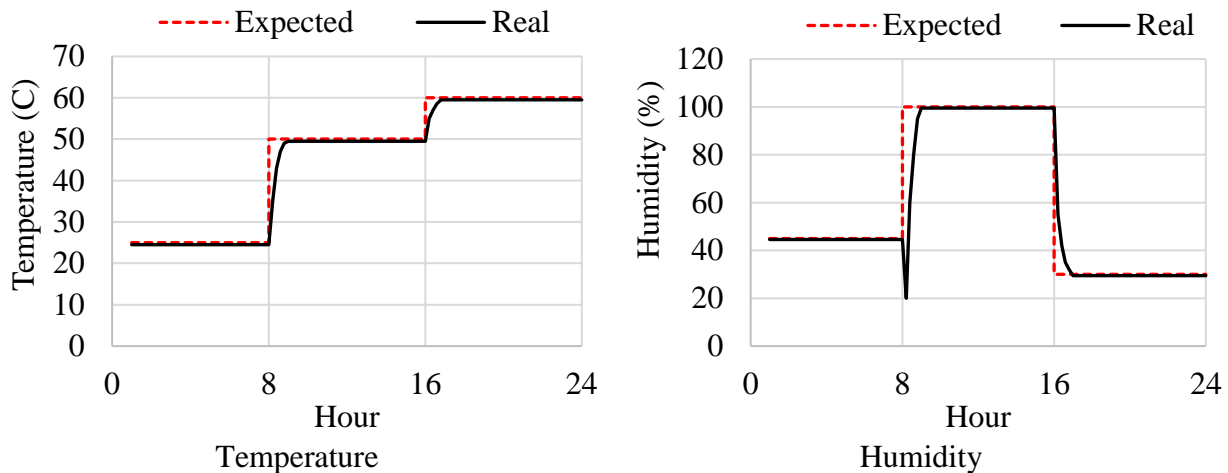
Figure 3. Temperature and humidity variation during each cycle

During the first 8-hr period, called the ambient stage, the temperature was 77°F (25°C), and the relative humidity was about 45%. In the second period, called the humid stage, the temperature rose to 122°F (50°C), and the relative humidity rose to nearly 100%. In this period, a salt solution fog was produced and uniformly enveloped the samples. The last 8-hr period is called the dry-off stage, and the temperature was increased to 140°F (60°C), while the relative humidity dropped to 30%.

As shown in Figure 3, changing the humidity and temperature inside the chamber between the stages took about 30 minutes, after which the measured temperature and relative humidity were maintained.

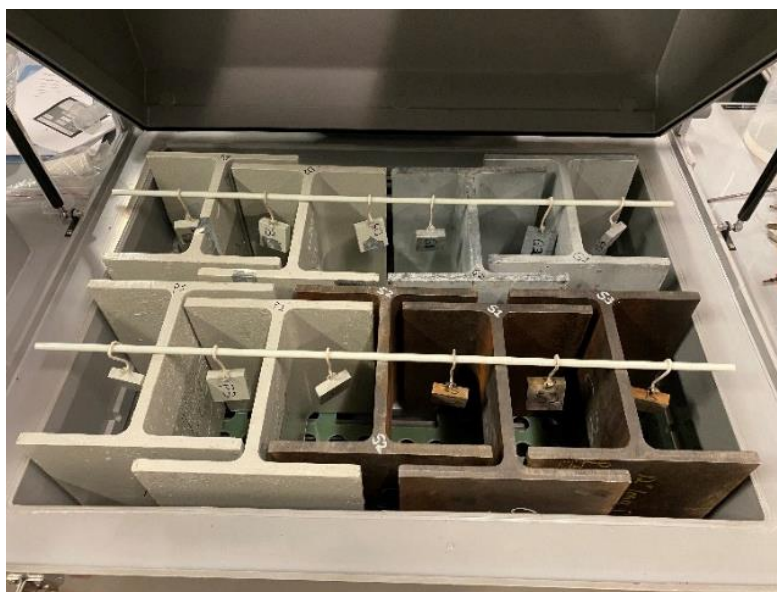
Five variations of coupon specimens were included: bare steel, galvanized, painted galvanized, painted galvanized with simulated paint layer damage, and galvanized with the galvanizing layer damaged. For the 1-ft pile specimens, four variations were included: bare steel, galvanized, painted galvanized, and painted galvanized with simulated paint layer damage. Figure 4 shows the samples inside the cyclic corrosion chamber.

Figure 4. Samples inside the cyclic corrosion chamber

To obtain a direct visualization of the corrosion process on the pile structures, nine 1-ft long HP 10×57 sections (three bare steel, two galvanized, two galvanized with painted coating, and two galvanized and painted with painting layer damaged) were prepared and placed into the chamber, as shown in the previous Figure 4. Appendix A.2.1 through A.2.4 show the condition of the S, G, P, and D pile samples, respectively, during the CCT process.

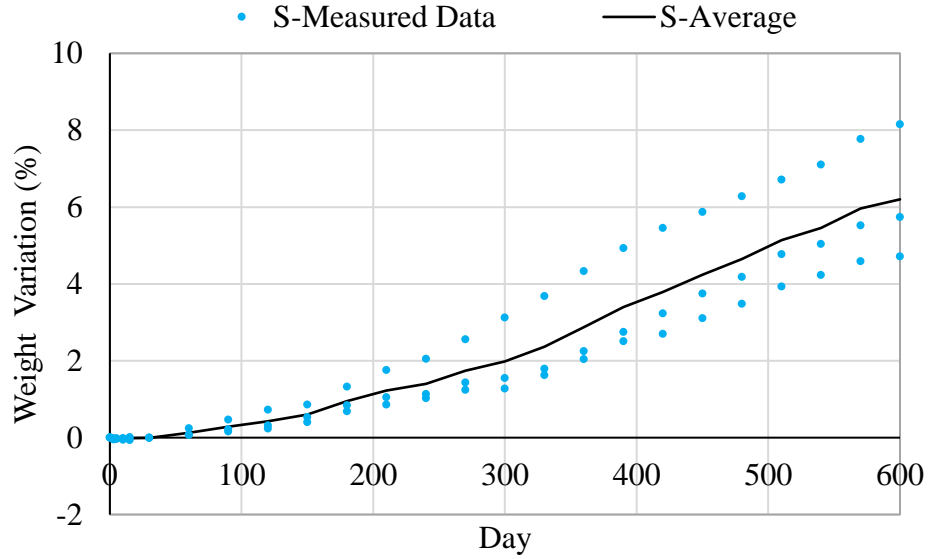
The S samples were bare steel samples without any coating. Figure 5 shows the weight variations for each of the S samples and their average during the 600 days.

Figure 5. Weight variation (%) of samples without coating

Figure 5 shows that the weight of the samples continually increased through the duration of the CCT process. This weight variation occurred as a result of a series of chemical reactions that take place during the oxidizing process of steel. These chemical reactions can be expressed as equation (2) (McCafferty 2010, Gräfen et al. 2000).

The plot shows that the weight of the samples decreased significantly during the first 100 days, which could be caused by the loss of the galvanized layer during brush cleaning. Although the metal brush was used through 600 days, the weight after nearly 120 days (20 years), started to increase until the end of the period. This is because a patina layer (zinc carbonate) formed on the surface of the coupons after 120 days, which is harder than the fresh galvanizing layer. Hence the hand brush induced less effect on the weight of the coupons. Nevertheless, comparing to the weight change (about 6%) of the S samples in the previous Figure 5 at 600 days, the weight variation of G samples was small (within $\pm 0.3\%$).

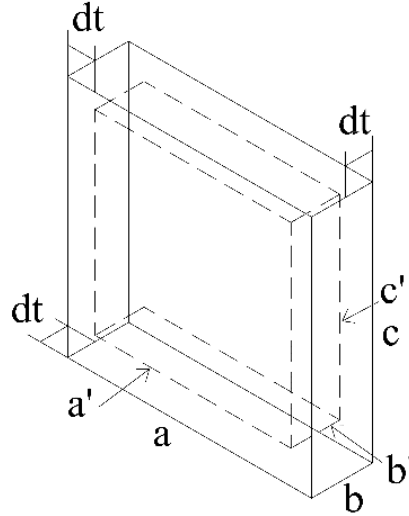
Figure 6 shows a view of the coupon with initial dimensions (a , b , and c) and final dimension (a' , b' , and c') after a thickness loss of dt of each face in all directions.

Figure 6. Coupon sample dimensions before and after corrosion

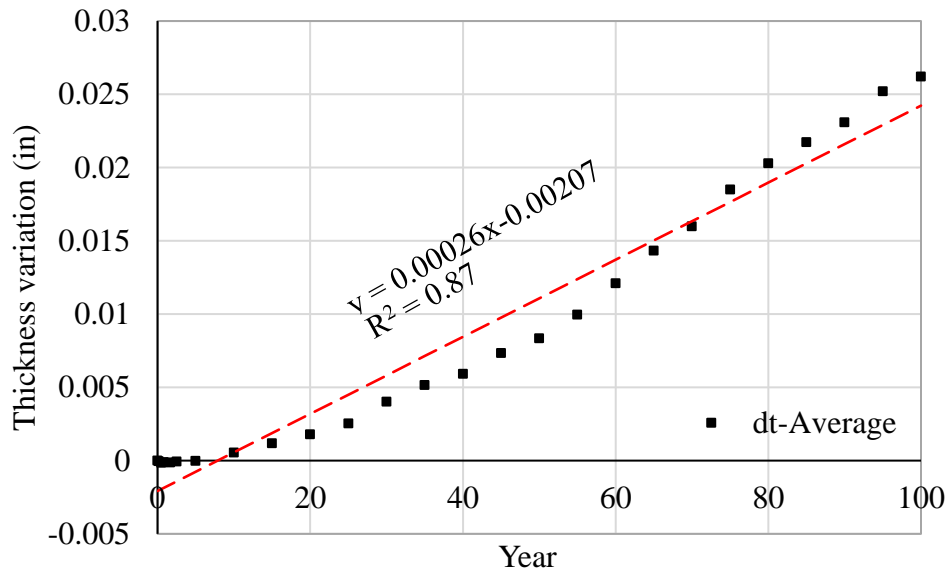
Figure 7 shows the resulting thickness variation (solid squares) fitted by the linear regression (dashed line).

Figure 7. Estimated thickness loss of the bare steel in each year

The slope of the dashed line (0.00026 in/yr) shows the thickness loss per year on one side of the coupon. This value is close to the suggested value of 0.000235 in/yr (0.00047 in/yr for two sides) in various references (EN 1993/Eurocode 3, Gaythwaite 1981, Ohsaki 1982).

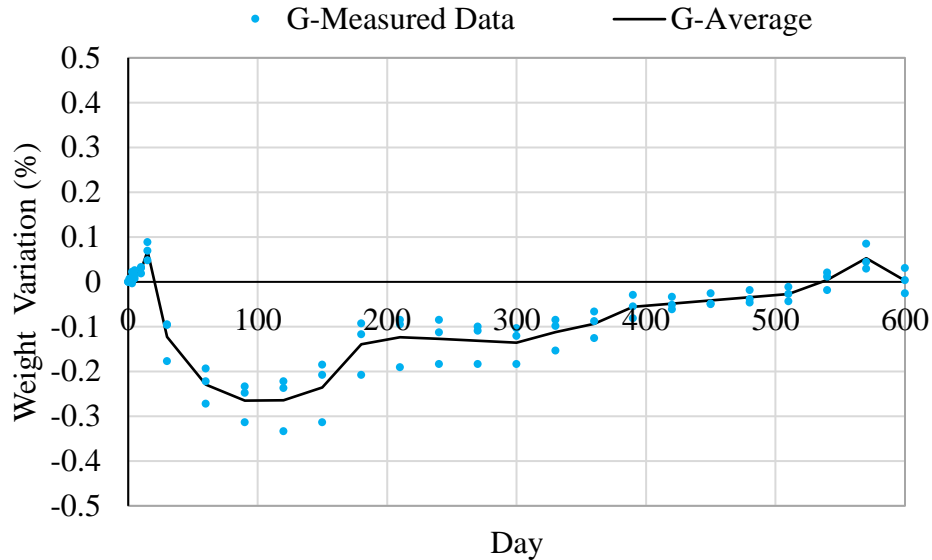
Figure 8 shows the weight variations for the G coupon samples and their average during the 600 days of CCT cycles.

Figure 8. Weight variation (%) of samples with galvanized coating

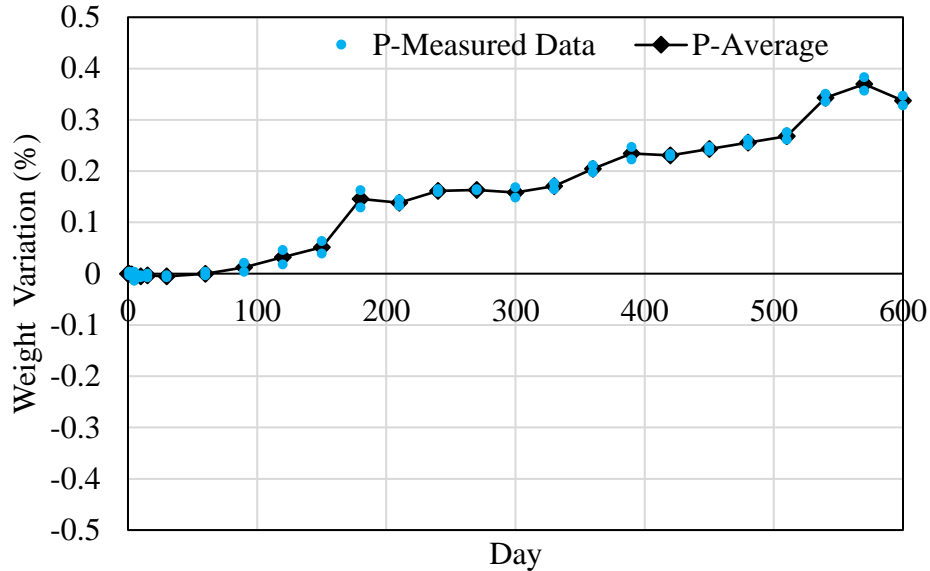
Figure 9 shows the weight variations for the P coupon samples and their average during the tests.

Figure 9, Weight variation (%) of samples with painted galvanized coating

Appendix A.1.3 includes images of the corrosion process for one of the P coupon samples. The data indicate that, in the first 60 days (10 years), the paint is completely intact and the variation in the weight of the samples is not significant. However, after 60 days, the weight of the samples started to increase, which coincides with the observed cracking of the paint layer.

The data for the P2 samples included two sudden weight drops, which occurred after 210 days and 270 days. These occurred because of the rapid deterioration of the paint layer (peeling and separation) from the sample. (Appendix A.1.3 includes images of a P2 sample.) Because of the significant change in the weight, the data from the P2 samples were not presented or used in the experimental result analysis. The previous Figure 9 includes the weight variations of the P1 and P3 samples and their average values in 600 days.

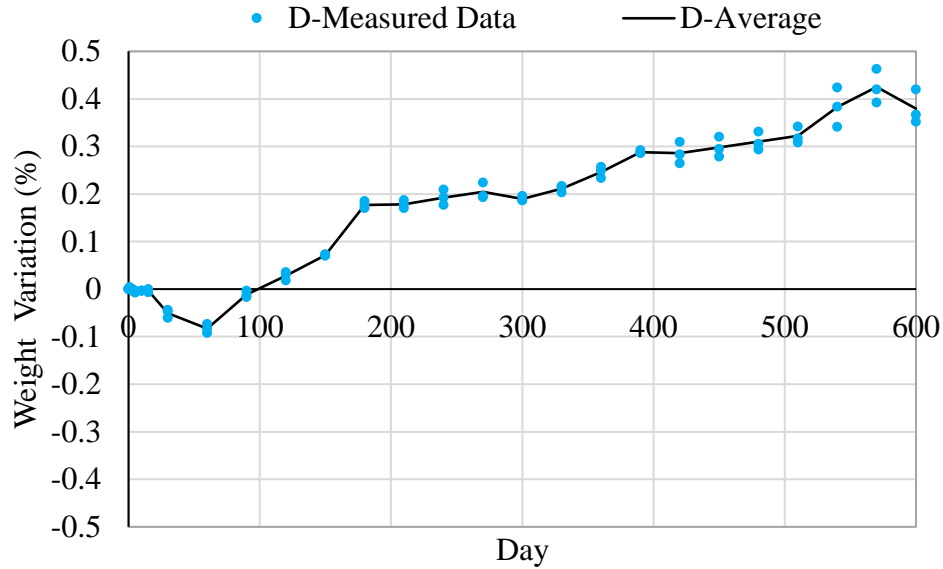
Figure 10 shows the weight variations for the D coupon samples and their average during the 600 days of testing.

Figure 10. Weight variation (%) of samples with damaged painted galvanized coating

In general, the weight changes of the D samples showed a similar trend and magnitude as that for the P samples. This result indicated that the damage on the paint layer does not impose significant weight change on the samples.

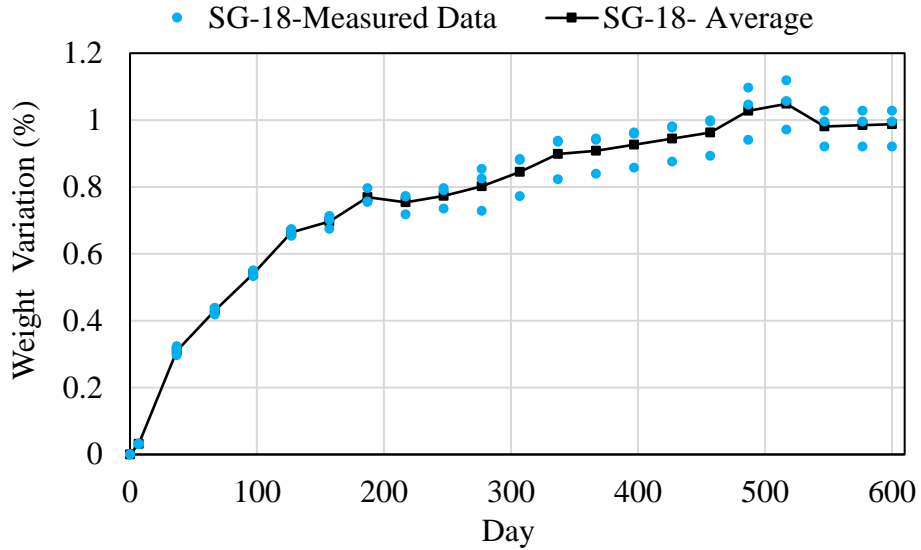
Figure 11, Figure 12, and Figure 13 show the weight variations for the SG-18, SG-28, and SG-38 samples, respectively, and their averages.

Figure 11. Weight variation (%) of SG-18 samples

The data indicated that, on all of these samples, the weight significantly increased during the first 120 days (20 years), regardless of the width of the scratches. These weight variations are induced by the steel oxidation process where the galvanizing layers are damaged, and the bare steel is exposed. After this period, the rates of the weight changes are reduced. In general, the samples with wider scratches resulted in higher weight variations.

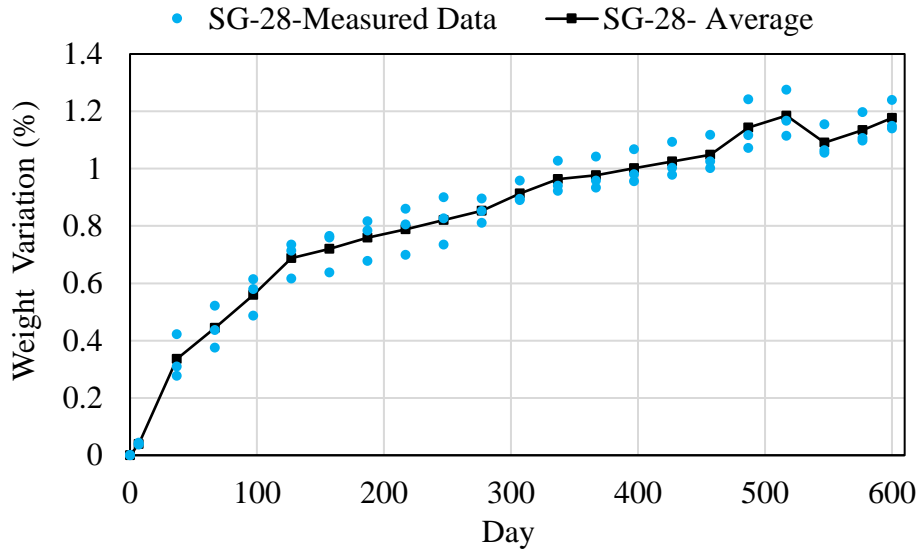
Figure 12. Weight variation (%) of SG-28 samples

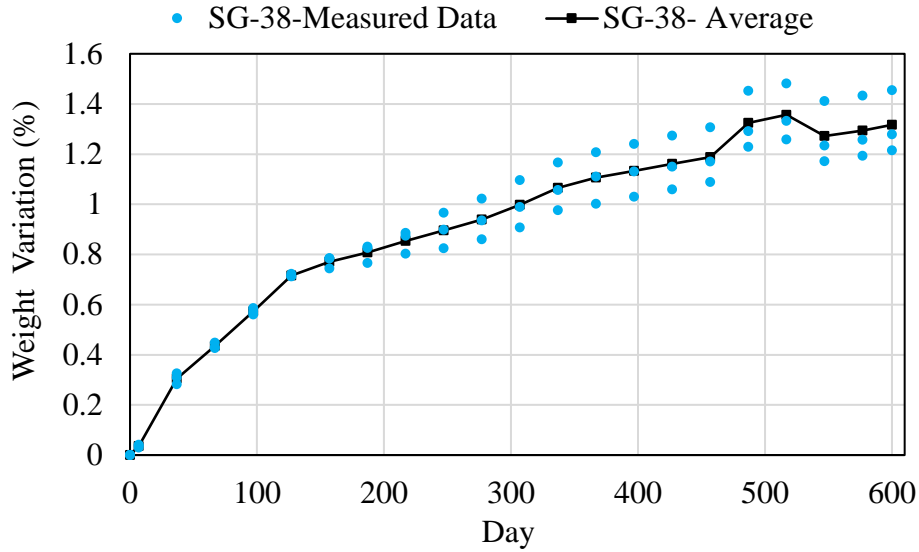
Figure 13. Weight variation (%) of SG-38 samples

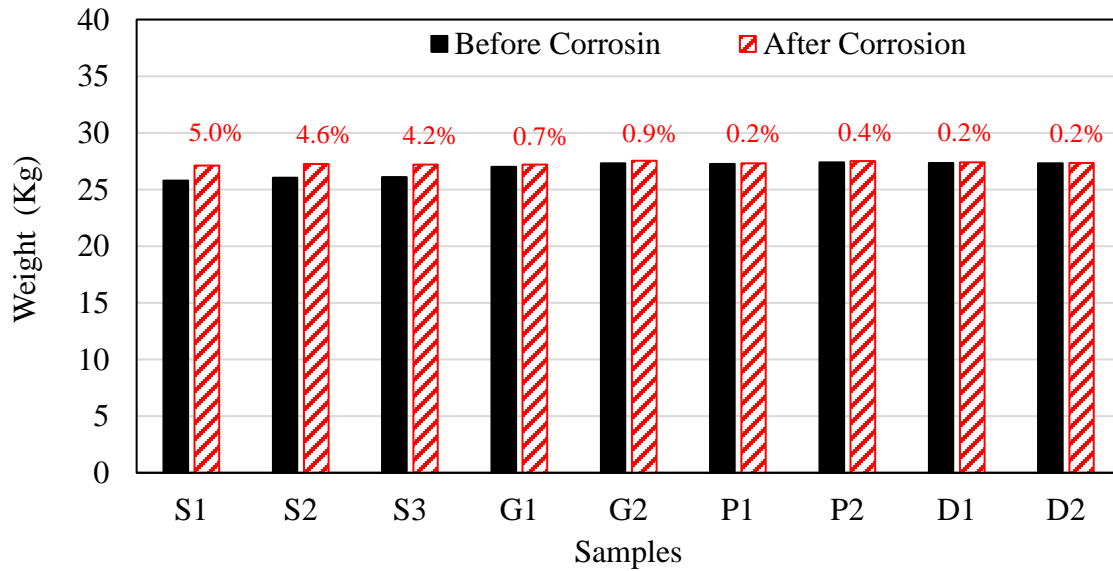
Figure 14 compares the weight measurements before and after the 600 days of testing for all the pile samples.

Figure 14. Weight variation in one-foot pile sections

The results indicated that, for the S samples, the weight of each pile increased by 4.2% to 5.0%. For the three types of coating samples, the weight of each increased by 0.2% to 0.9%.

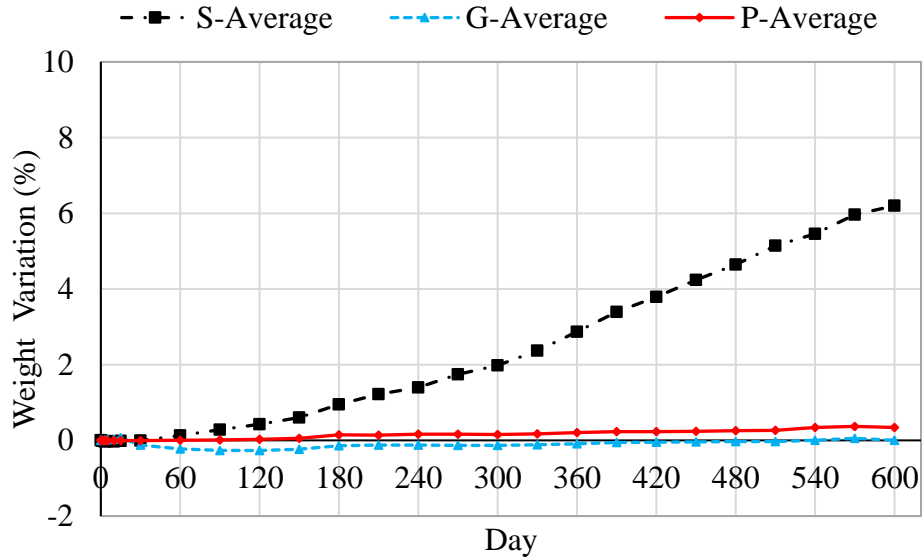
Figure 15 shows the average weight variations for the S, G, and P coupon samples.

Figure 15. Comparison of average weight variation (%) for S, G, and P samples

The results indicate that the S samples, without any protective measures, gain weight (and lose cross-sections) at a higher rate compared to the G and P samples with galvanized and/or paint layers. This figure also shows that the weight variation magnitude for the P and G samples are very similar.

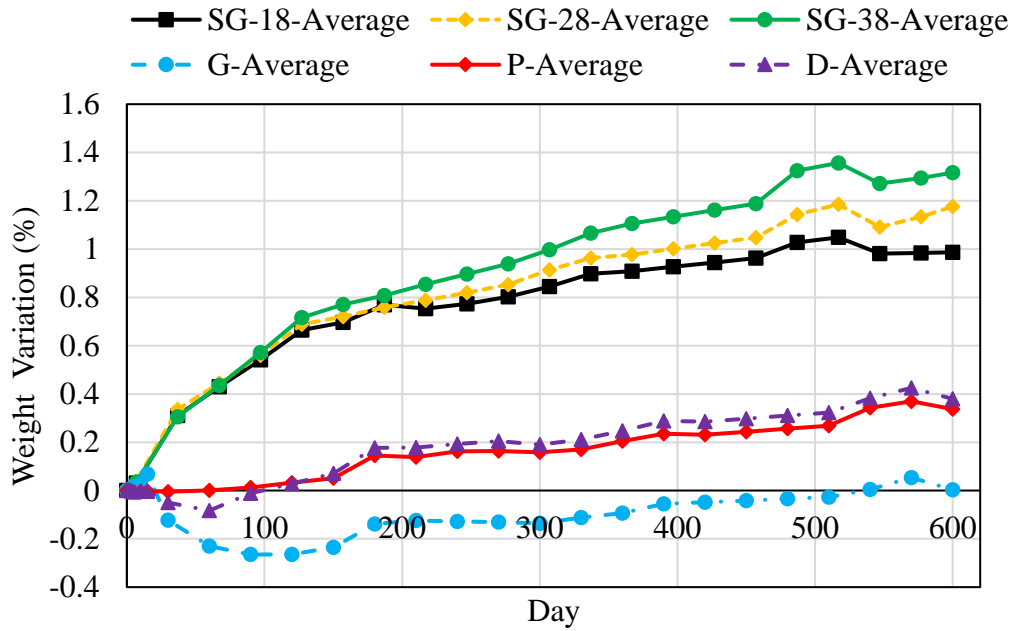
Figure 16 compares the average of the weight variations for the G, P, D, and SG samples.

Figure 16. Comparison of average weight variation (%) for G, P, D, and SG samples

The results indicate that, with a portion of steel exposed to the air, the SG samples experienced a much higher weight increase than the other three sample types. This is induced by the oxidation process of the bare steel. The results indicate that the oxidation process of the steel is the main source of the weight increase. This also demonstrates that damage of the galvanized surface can result in greater weight increases when compared to the damage of only the paint on painted galvanized samples.

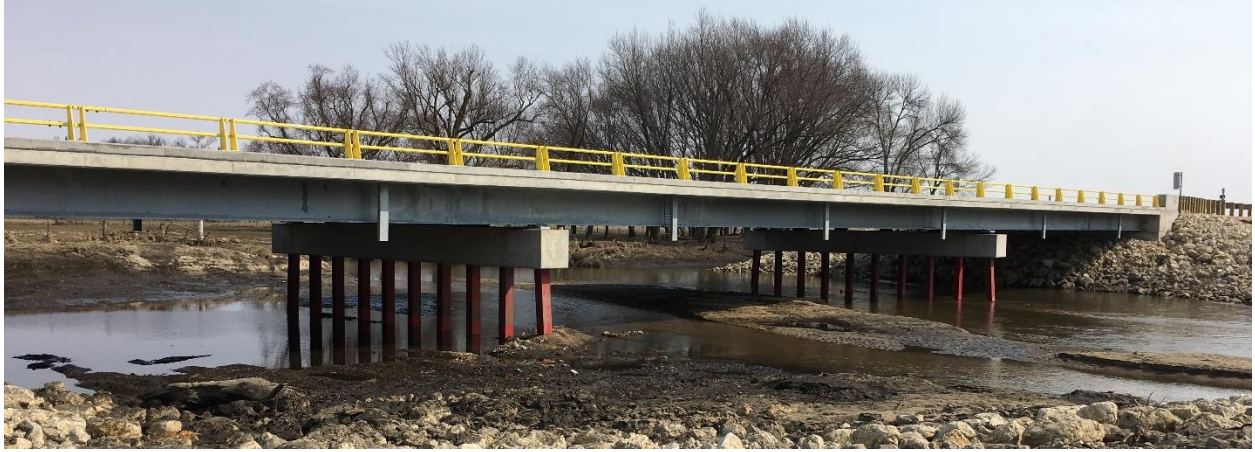
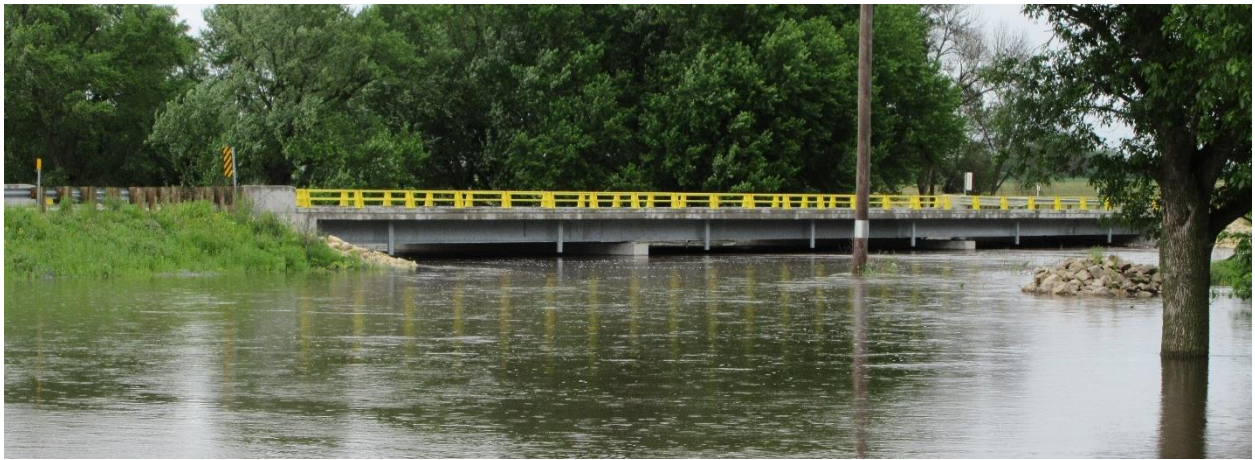
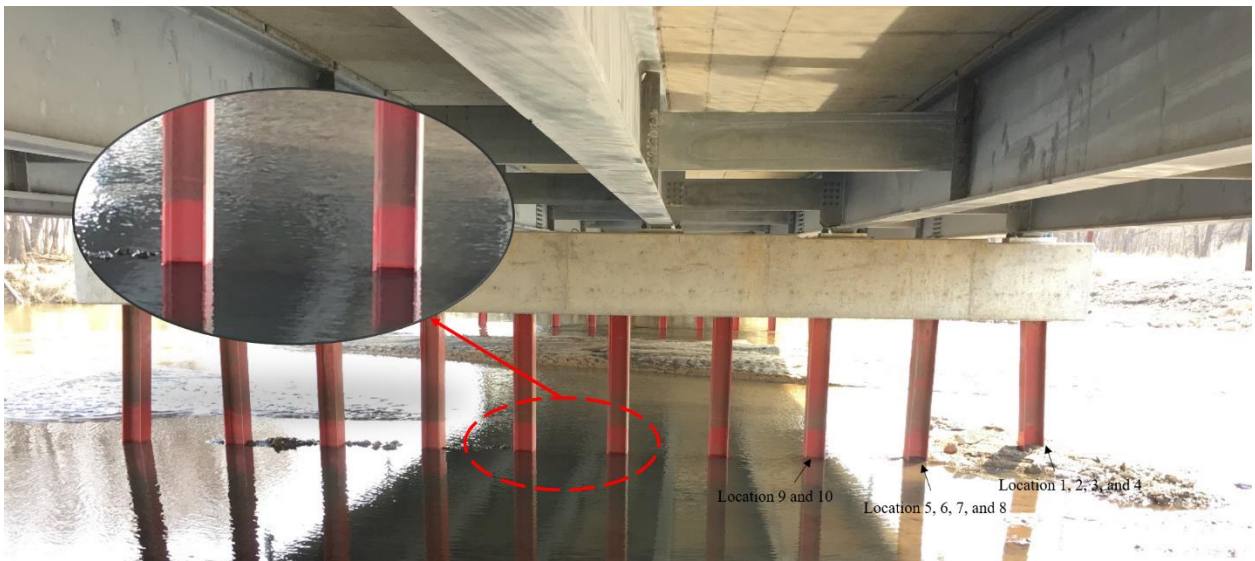
The bridge is located on Buchanan County Road (CR) D-22 over Buffalo Creek. The bridge has three spans totaling 200 ft in length, and the bridge is 40 ft wide. The bridge superstructure consists of steel girders and a concrete deck. The superstructure bears on concrete abutments supported by painted galvanized piles at each end and two piers comprised of painted galvanized piles and concrete pile caps. The pile size used in each location is HP 10×57. Figure 17 shows the bridge side view with specific focus on the pier structures.

a) Bridge side view (with water level low)

b) Bridge side view (with water level high)

c) Galvanized and painted piles

Figure 17. Field evaluated bridge

Buffalo Creek is especially sensitive to high-total rain events. A significant amount of rain can quickly raise the water levels; thus, the piles are differently exposed to air, water, and river debris throughout its service life. Generally, the water level remains low as shown in Figure 17-a. However, it is not unusual to see increased water levels like that shown in Figure 17-b. When precipitation ceases, the water levels drop relatively quickly.

The bridge is oriented in the east-west direction. Piles on the west pier were selected for the thickness measurements as shown in the previous Figure 17-b. Figure 18 compares the images of 10 measurement locations over three years from March 28, 2019 through May 3, 2021.

For the 2020 site visit, the water level was high (as shown in Figure 17), and no thickness data were collected.

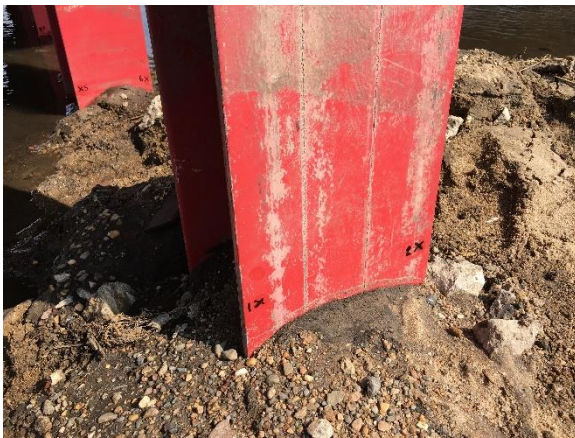
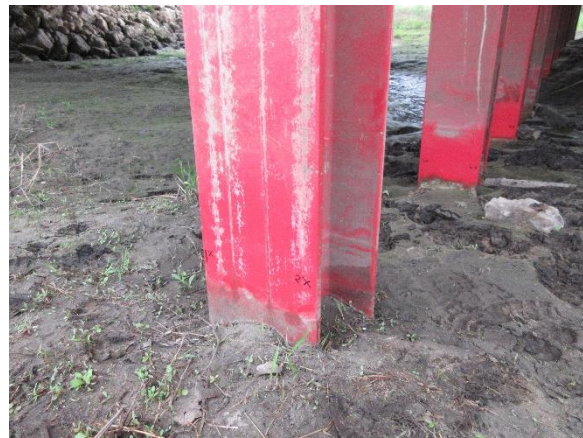
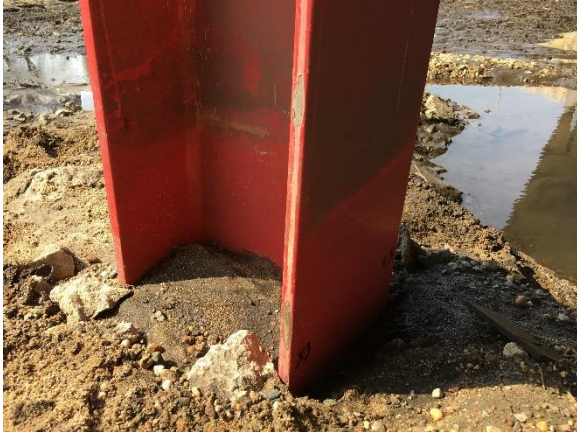
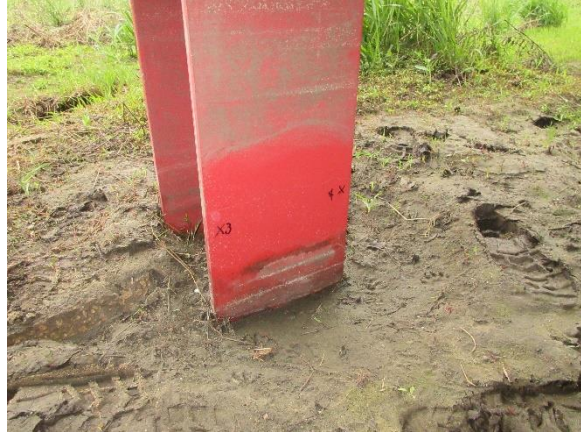
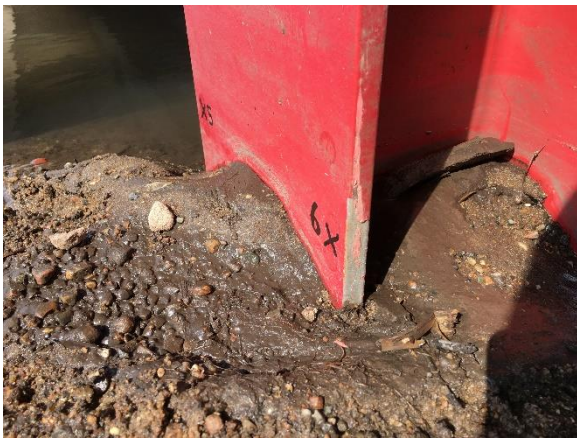
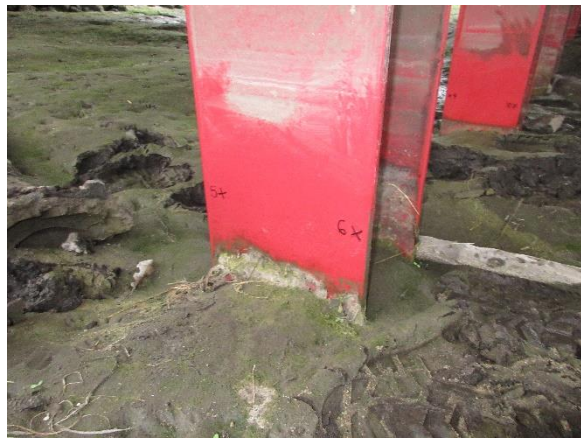
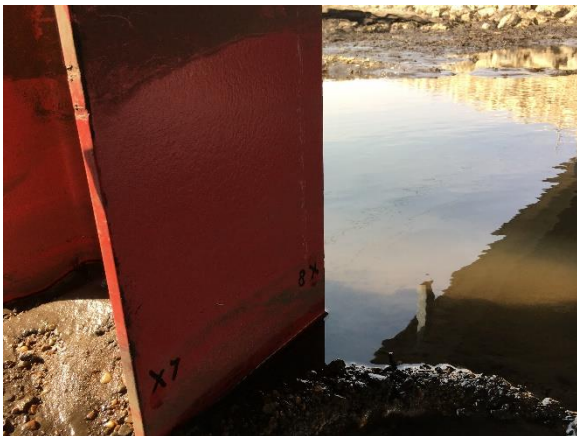
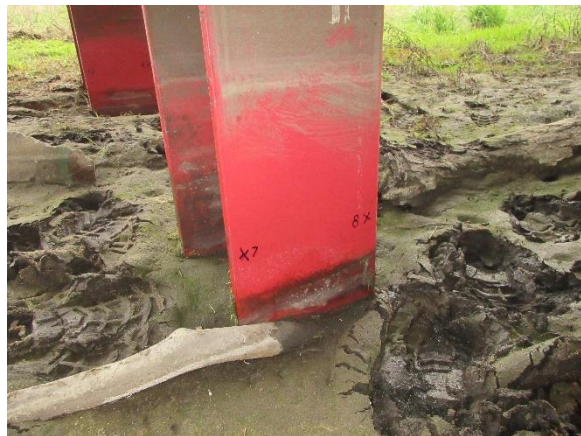
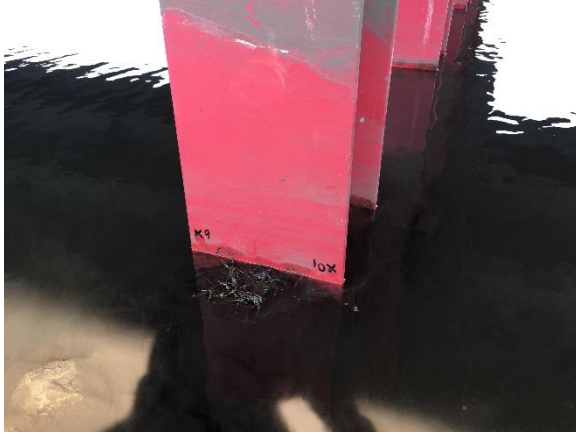
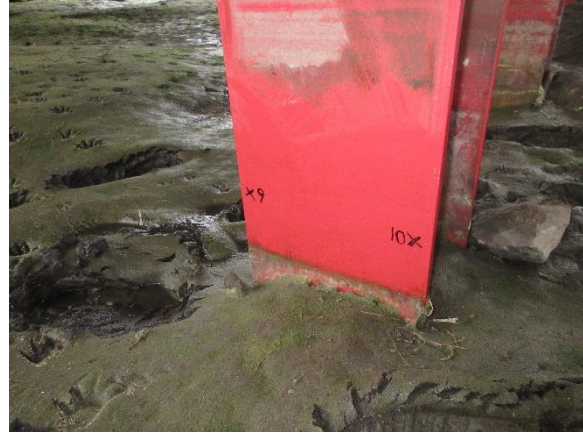
Figure 18. Measurement locations on March 28, 2019 and May 3, 2021

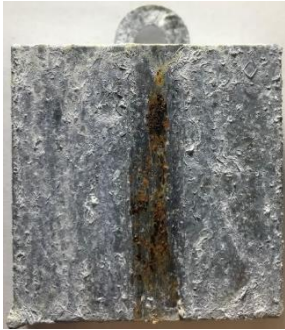
Day 7

A.1.7 SG-38 Coupon Sample Images

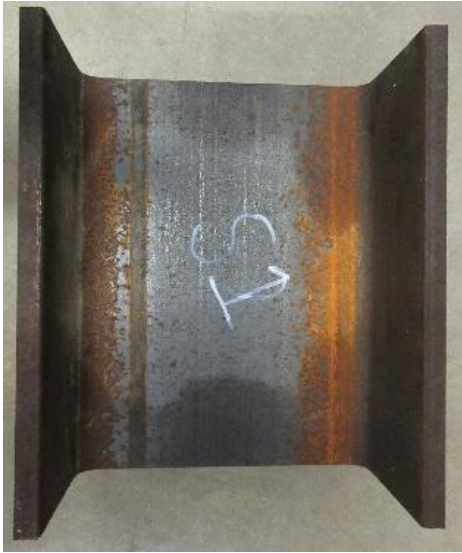
Day 0

A.2.1 S Pile Sample Images

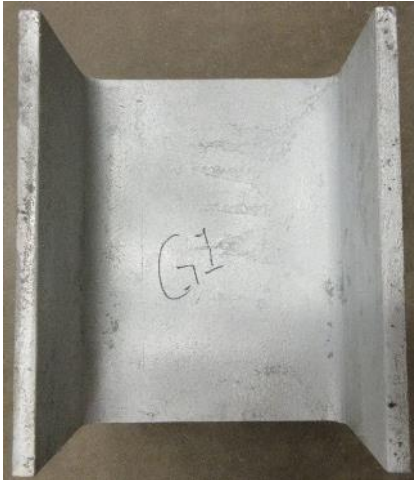
Day 0

A.2.2 G Pile Sample Images

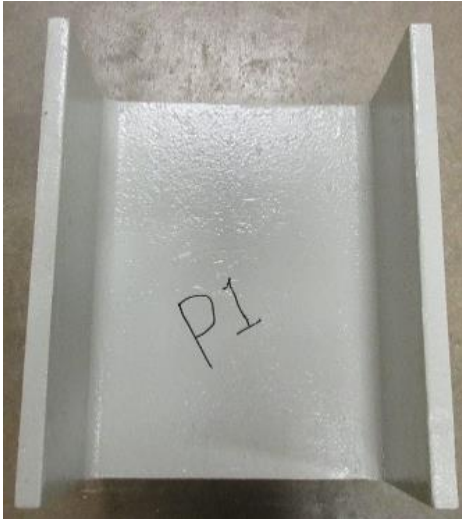
Day 0

A.2.3 P Pile Sample Images

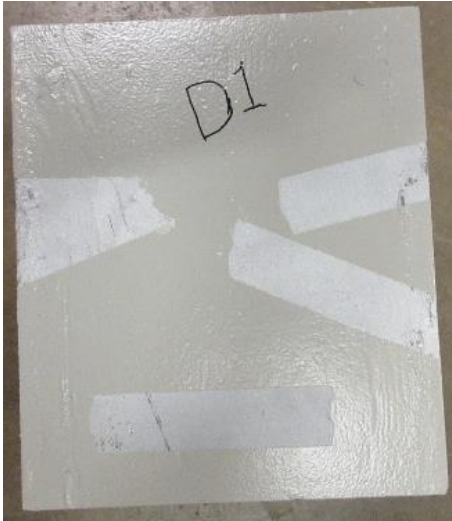
Day 0

A.2.4 D Pile Sample Images
