Publication No. FHWA-RD-88-071
July 1989

Rehabilitation of Concrete Pavements

Volume I: Repair Rehabilitation Techniques

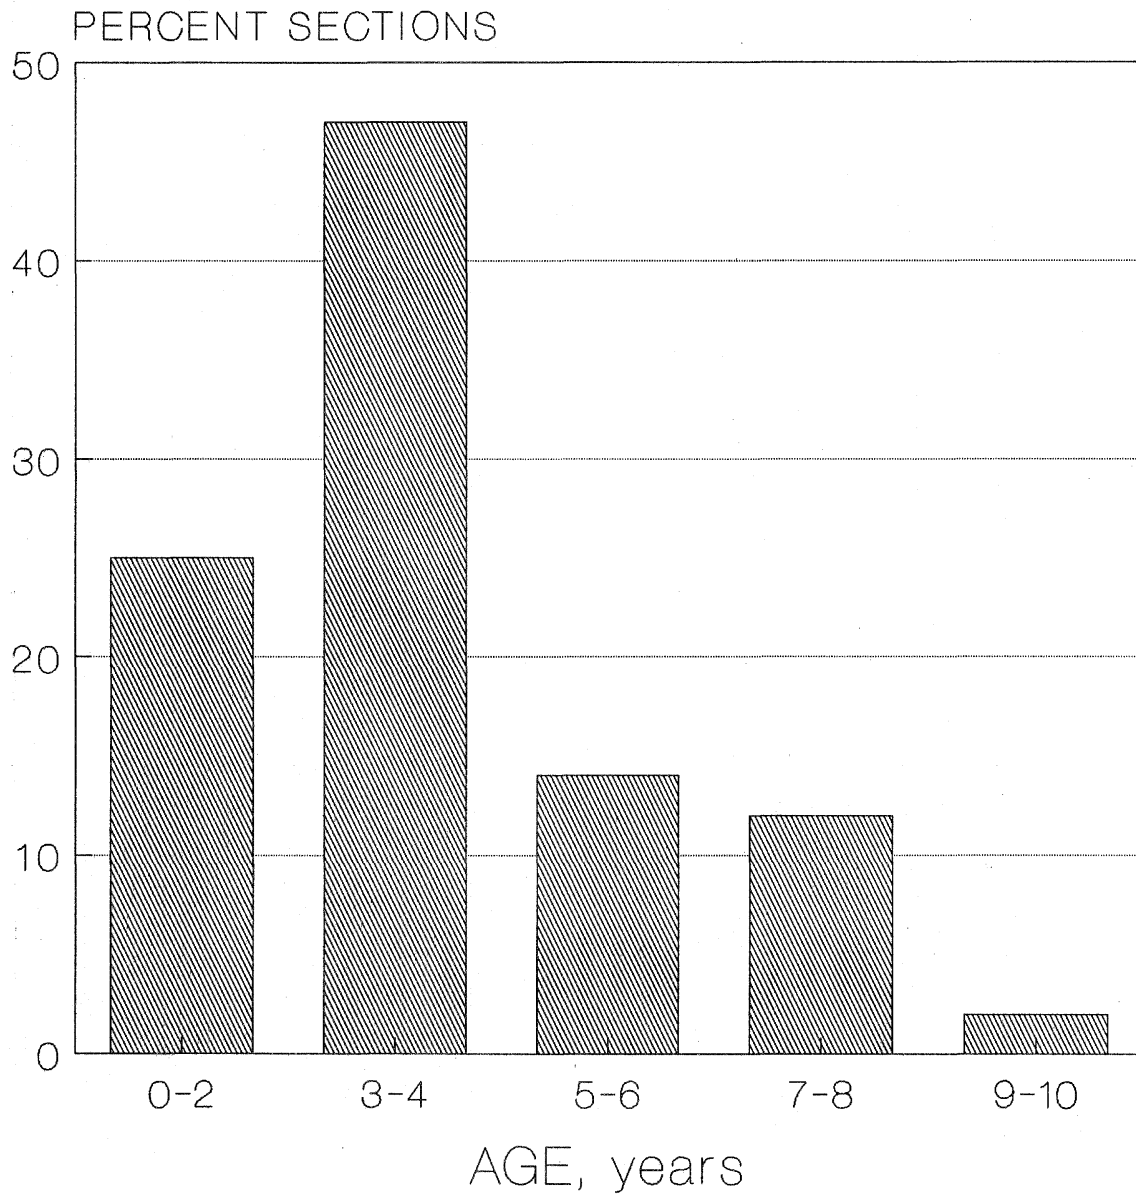
Figure 3. Age distribution for diamond grinding sections.

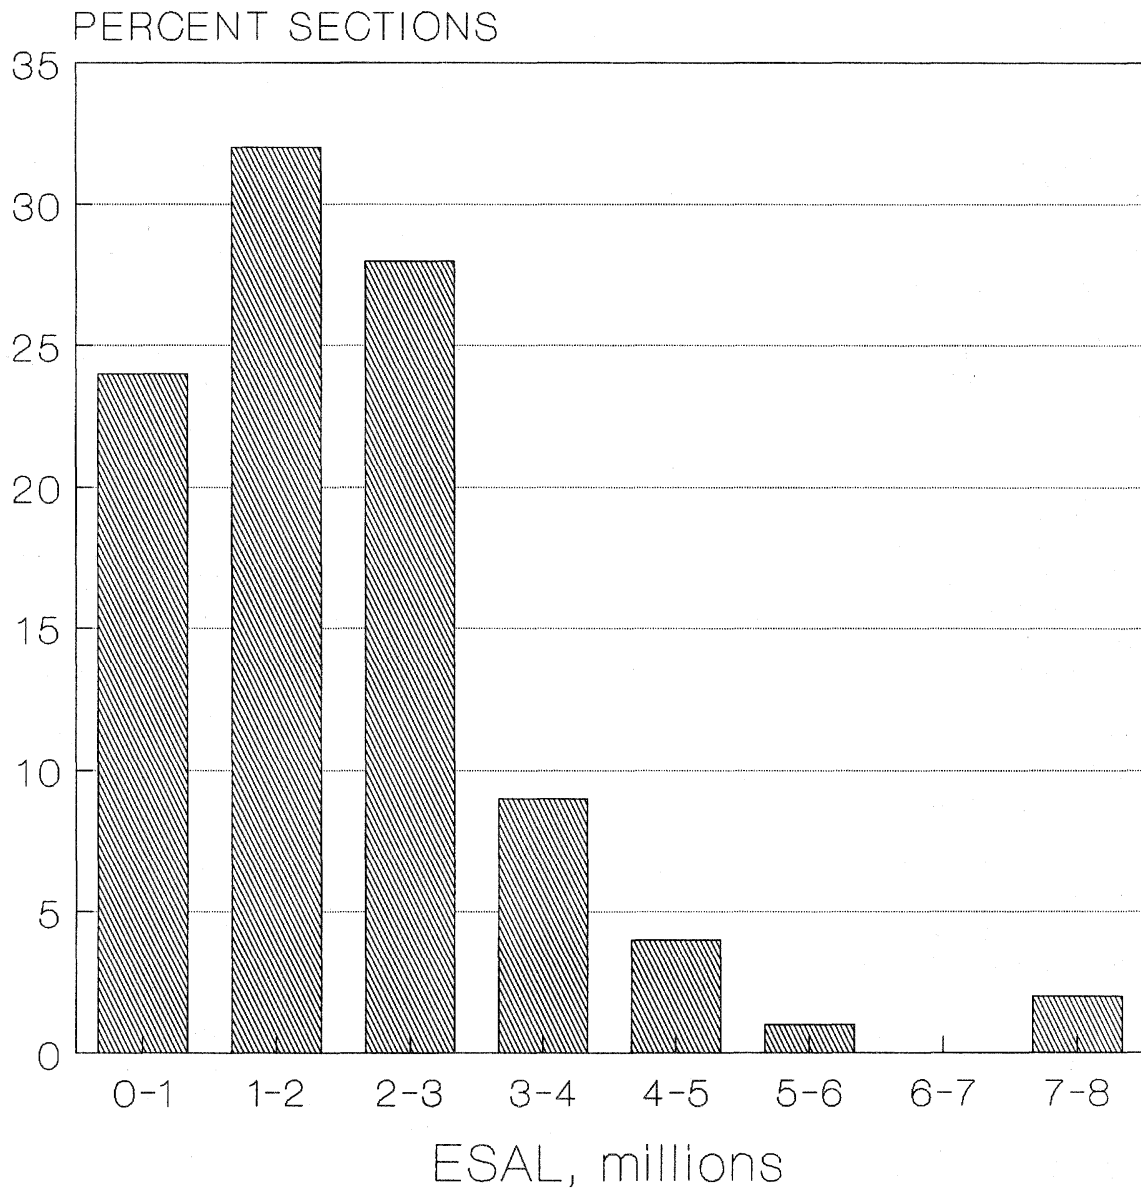
Figure 4. ESAL distribution for diamond grinding sections.

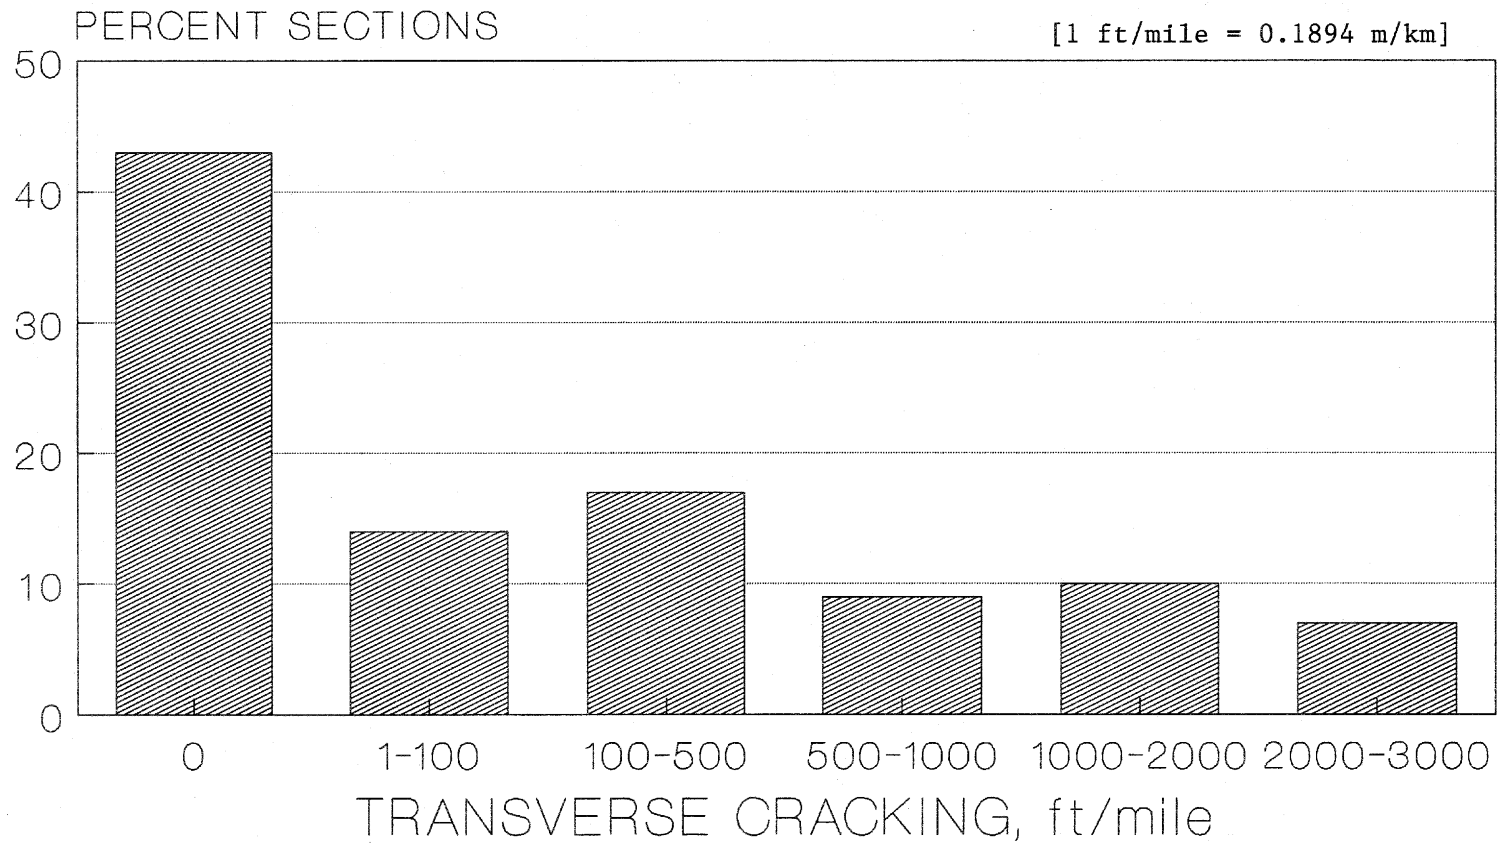
TRANSVERSE CRACKING DISTRIBUTION

Deteriorated Cracks
Diamond Grinding Sections

Figure 5. Transverse cracking distribution for diamond grinding sections.

Transverse deteriorated cracks on jointed concrete pavements are largely caused by a combination of traffic loading fatigue damage and thermal curling stresses. In addition for JRCP, a contributing factor may be a lock up of transverse joints from corrosion or misalignment of dowels. The distribution of deteriorated transverse cracks (medium and high severity) in the truck lane for ground pavements is shown in figure 5. Forty-three percent of all uniform sections contained no deteriorated transverse cracking, while 21 percent contained over 825 ft per mile [156 m per km] of deteriorated cracks. A serious level of cracking, where pavement rehabilitation is needed, is approximately 825 ft per mile [156 m per km] (this value was determined as the average of all projects in the NCHRP 1-19 database that had a present serviceability index less than 3.0). This amount can be conceived as a working crack every 77 ft [23.5 m] for JRCP that is spalled and faulted (or a working cracking in about 50 percent of the slabs if joint spacing was 40 ft [12.2 m]) and about 12 percent cracked slabs for JPCP.

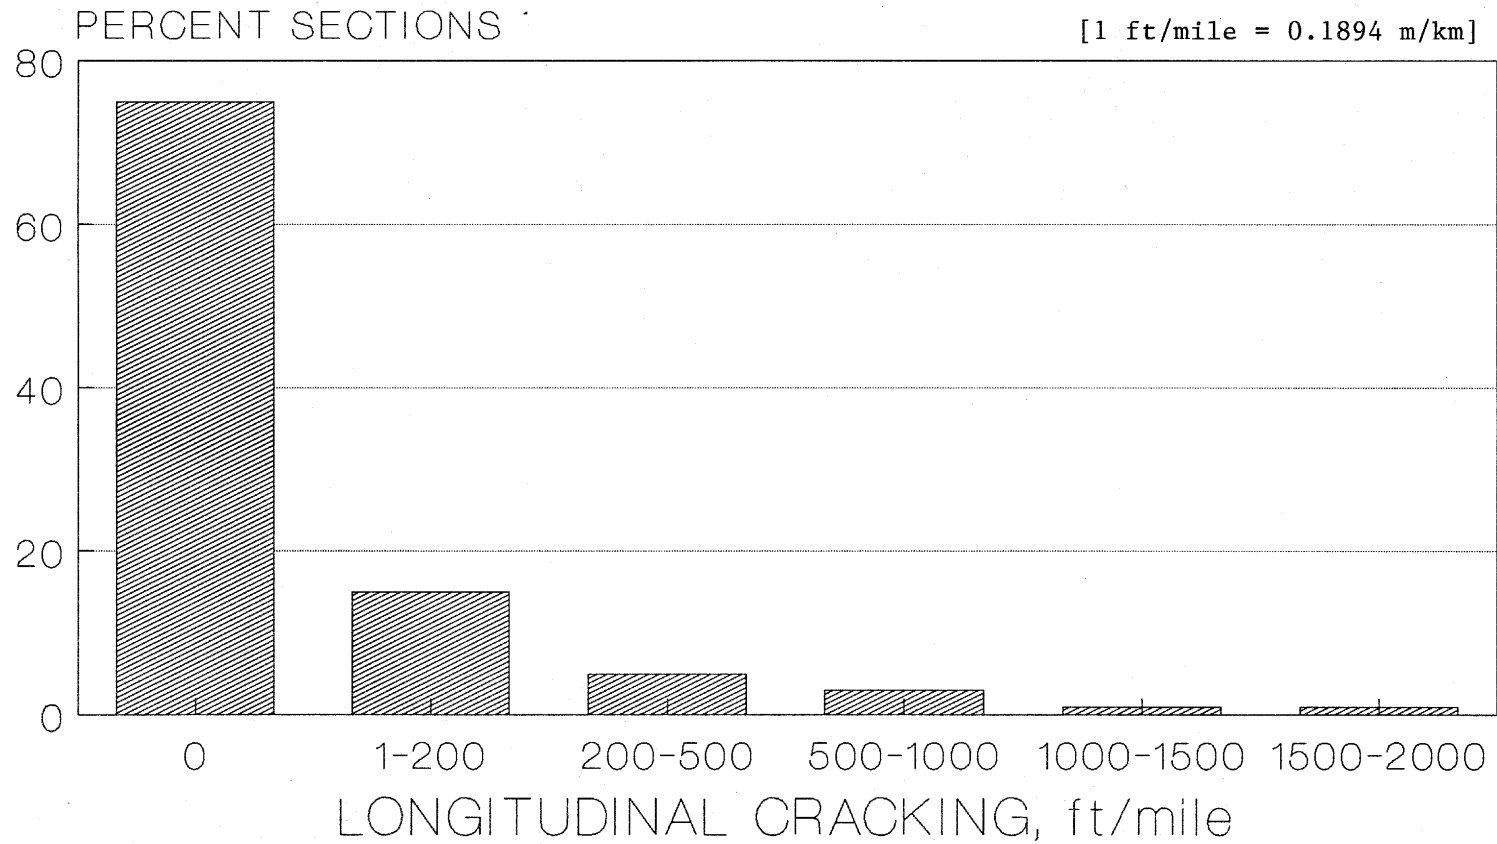
Figure 6. Longitudinal cracking distribution for diamond grinding sections.

Longitudinal cracking is generally caused by late sawing, shallow saw cuts, or the use of plastic inserts that do not create an adequate weakened plane for the longitudinal joint. Figure 6 is a histogram of the longitudinal medium to high severity cracking on the diamond ground sections. Seventy-five percent had no deteriorated longitudinal cracking. Only 5 percent had more than 500 ft [152 m] of deteriorated longitudinal cracking per mile.

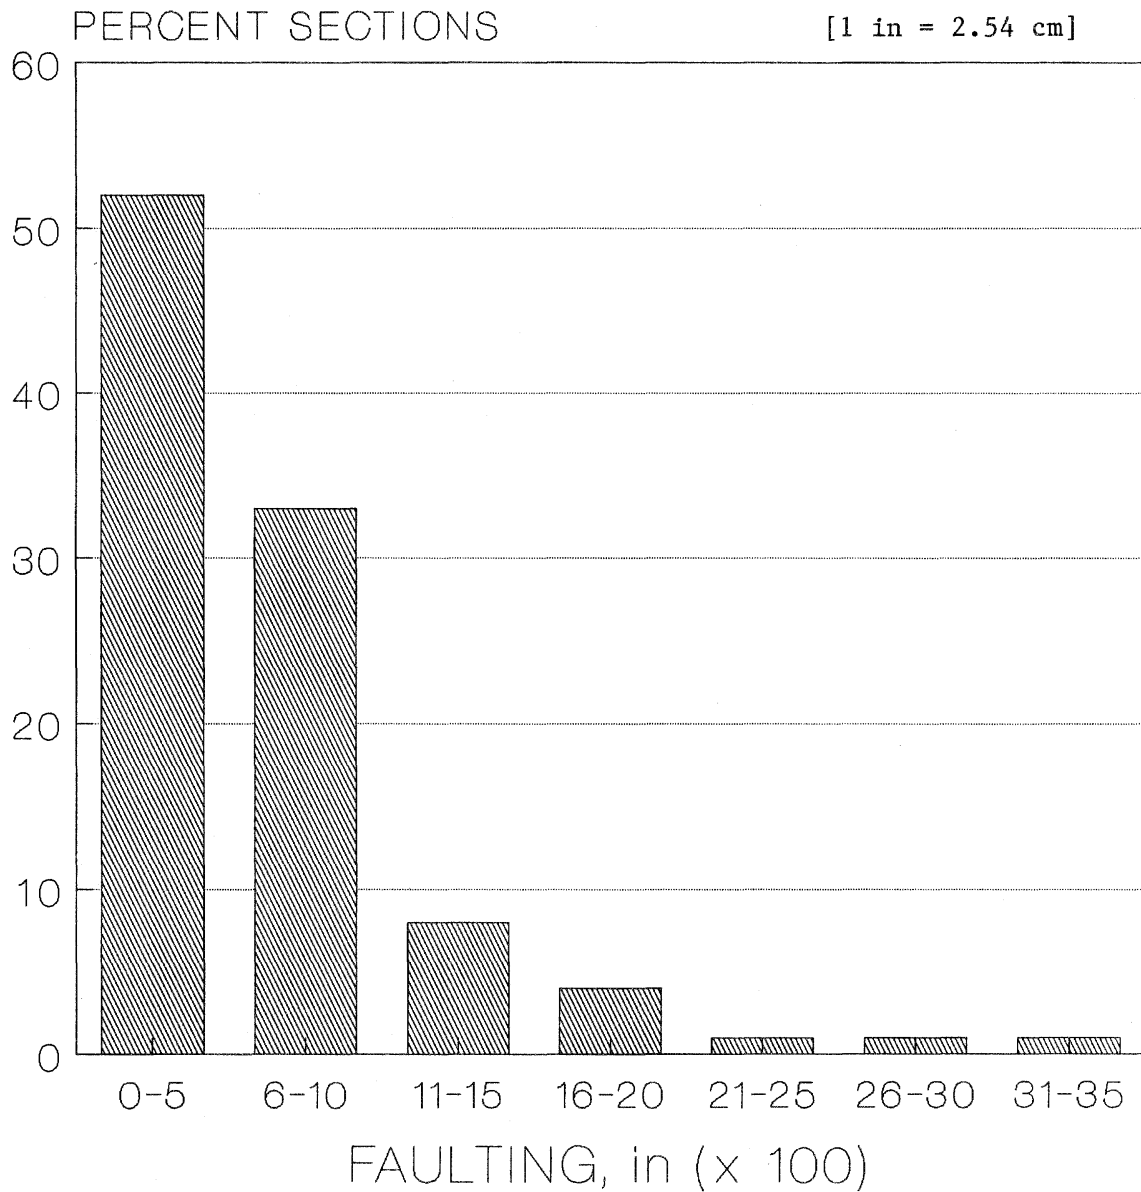
Figure 7. Faulting distribution for diamond grinding sections.

The distribution of transverse joint faulting for the diamond grinding sections is shown in figure 7. The average faulting in the drive lane was 0.065 in [0.165 cm], with individual sections ranging from 0.01 to 0.33 in [0.025 to 0.838 cm]. Faulting becomes detrimental for JPCP when it exceeds about 0.13 in [0.38 cm], which occurred on 7 percent of the sections.(52)

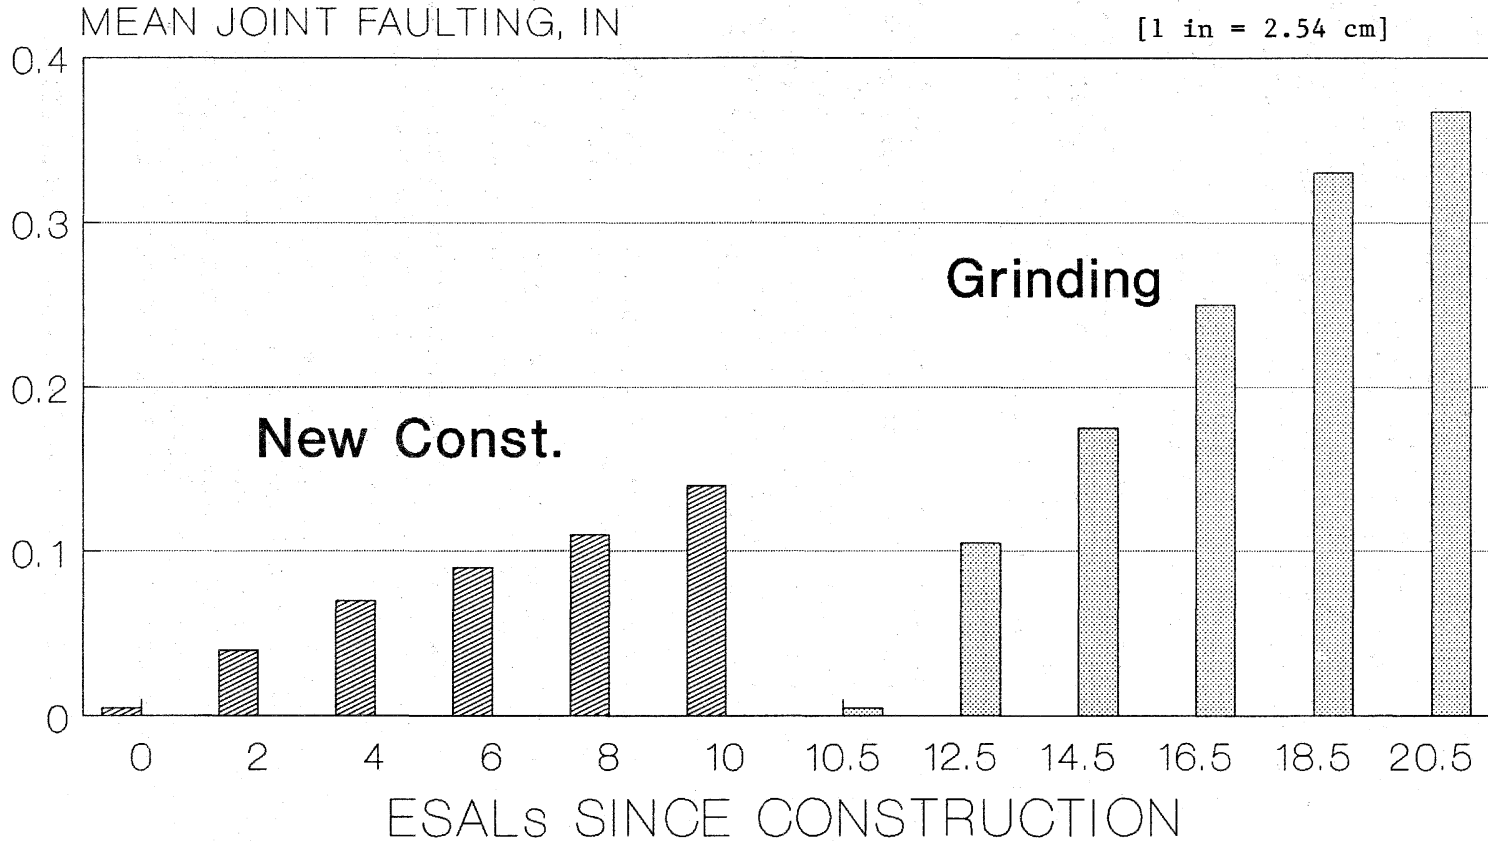
Figure 8. Estimated project faulting history for standard JRCP section for new construction and after restoration with diamond grinding.

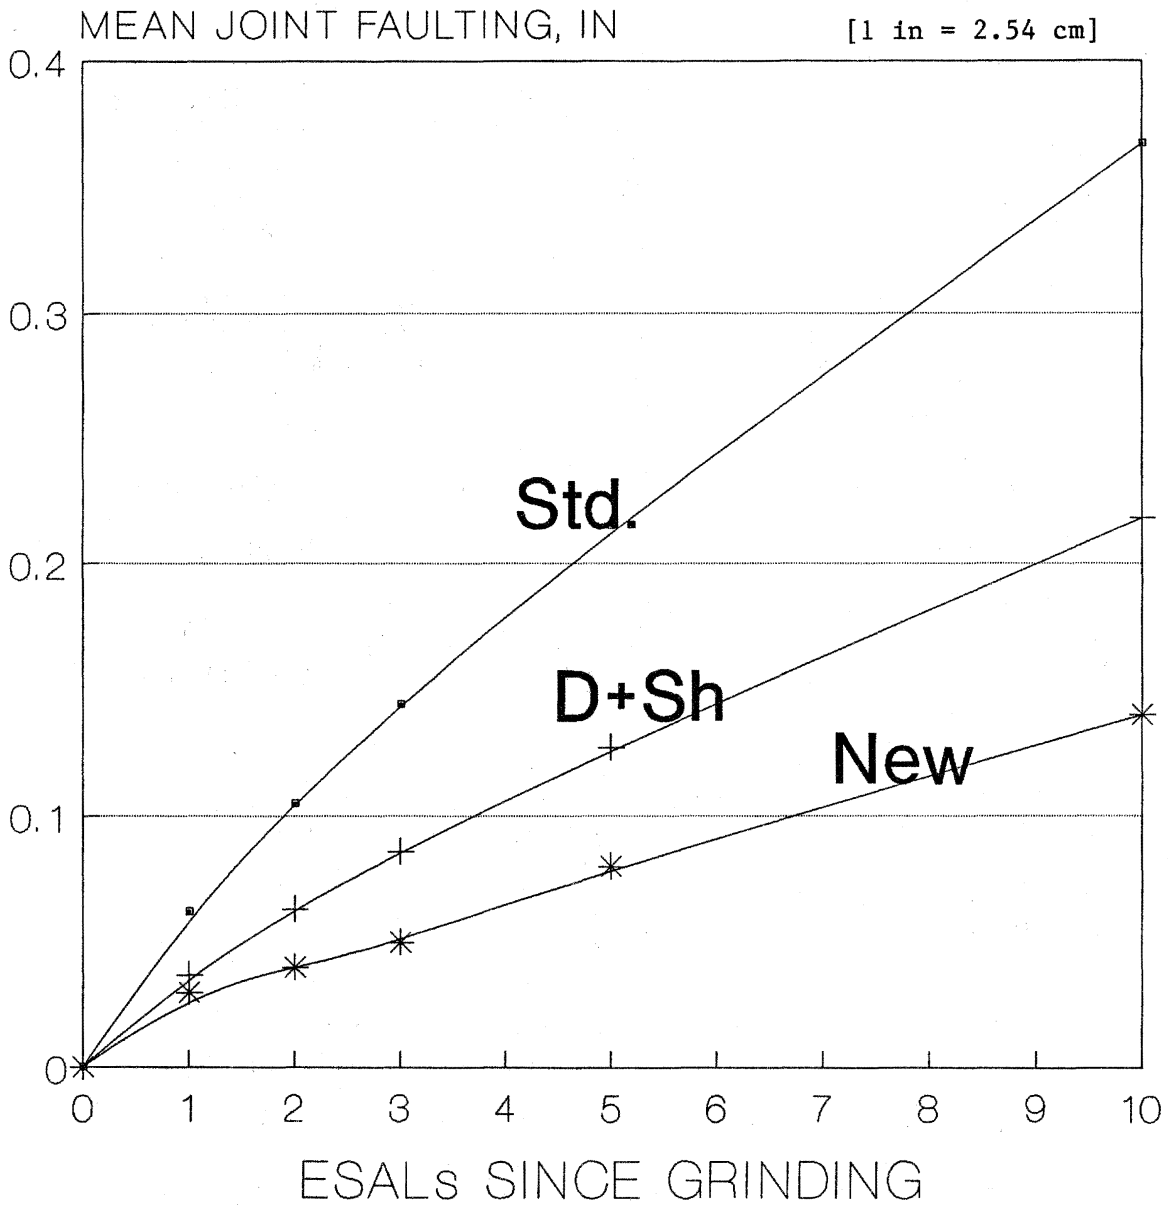
Figure 9. Faulting projections for standard JRCP and standard plus drains and PCC shoulders (Estimated faulting for new section also shown for comparison).

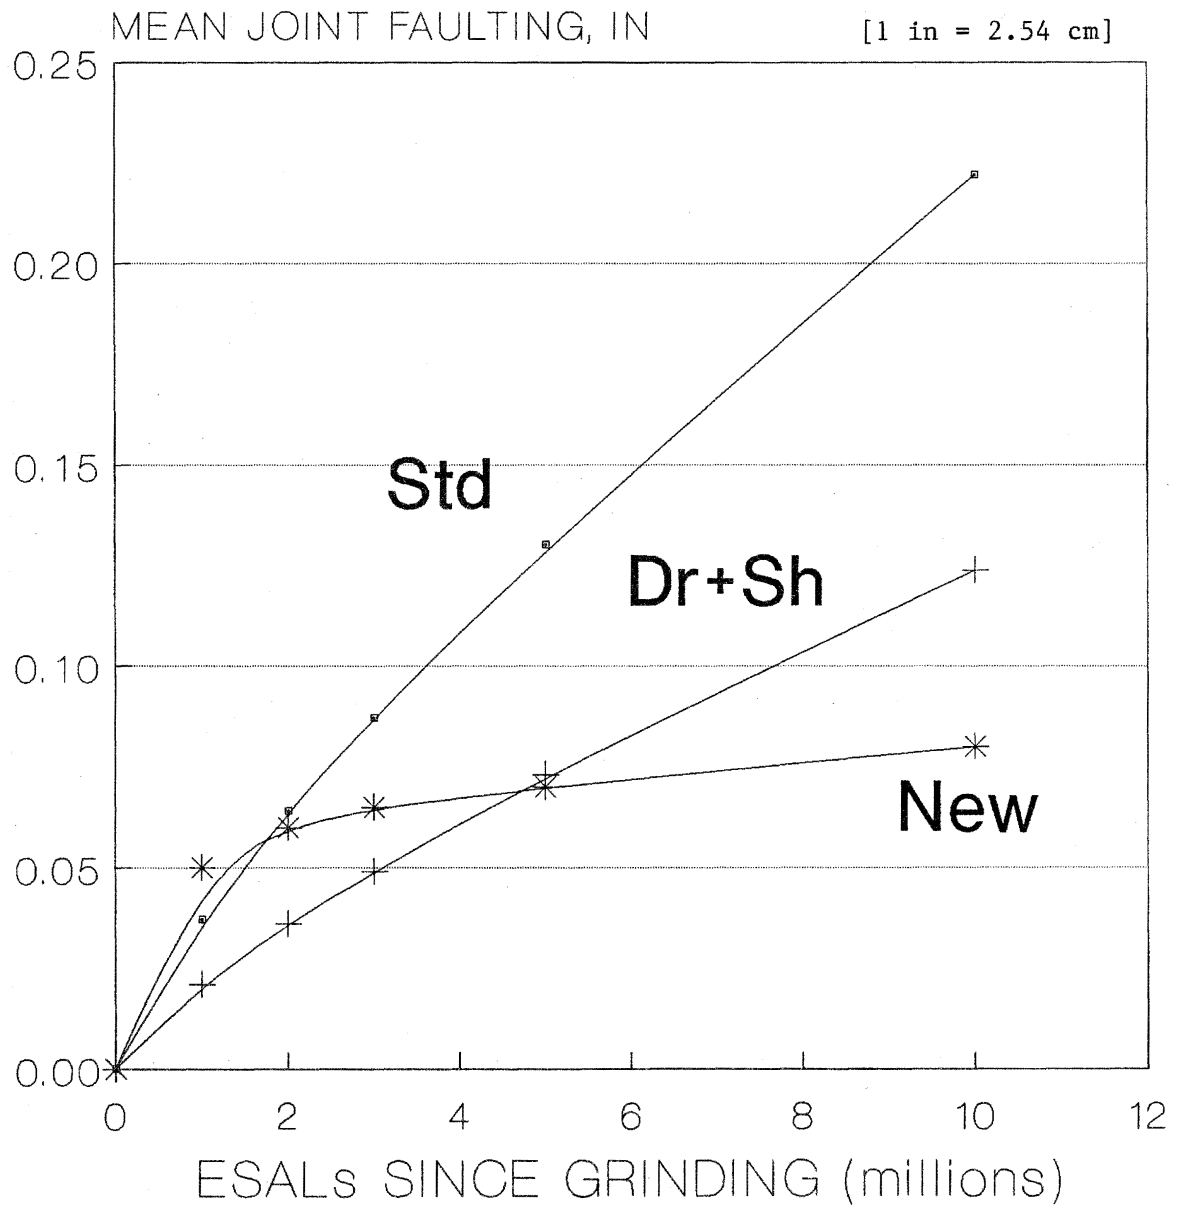
Figure 10. Faulting projections for standard JPCP and standard plus drains and PCC shoulders (Estimated faulting for new section also shown for comparison).

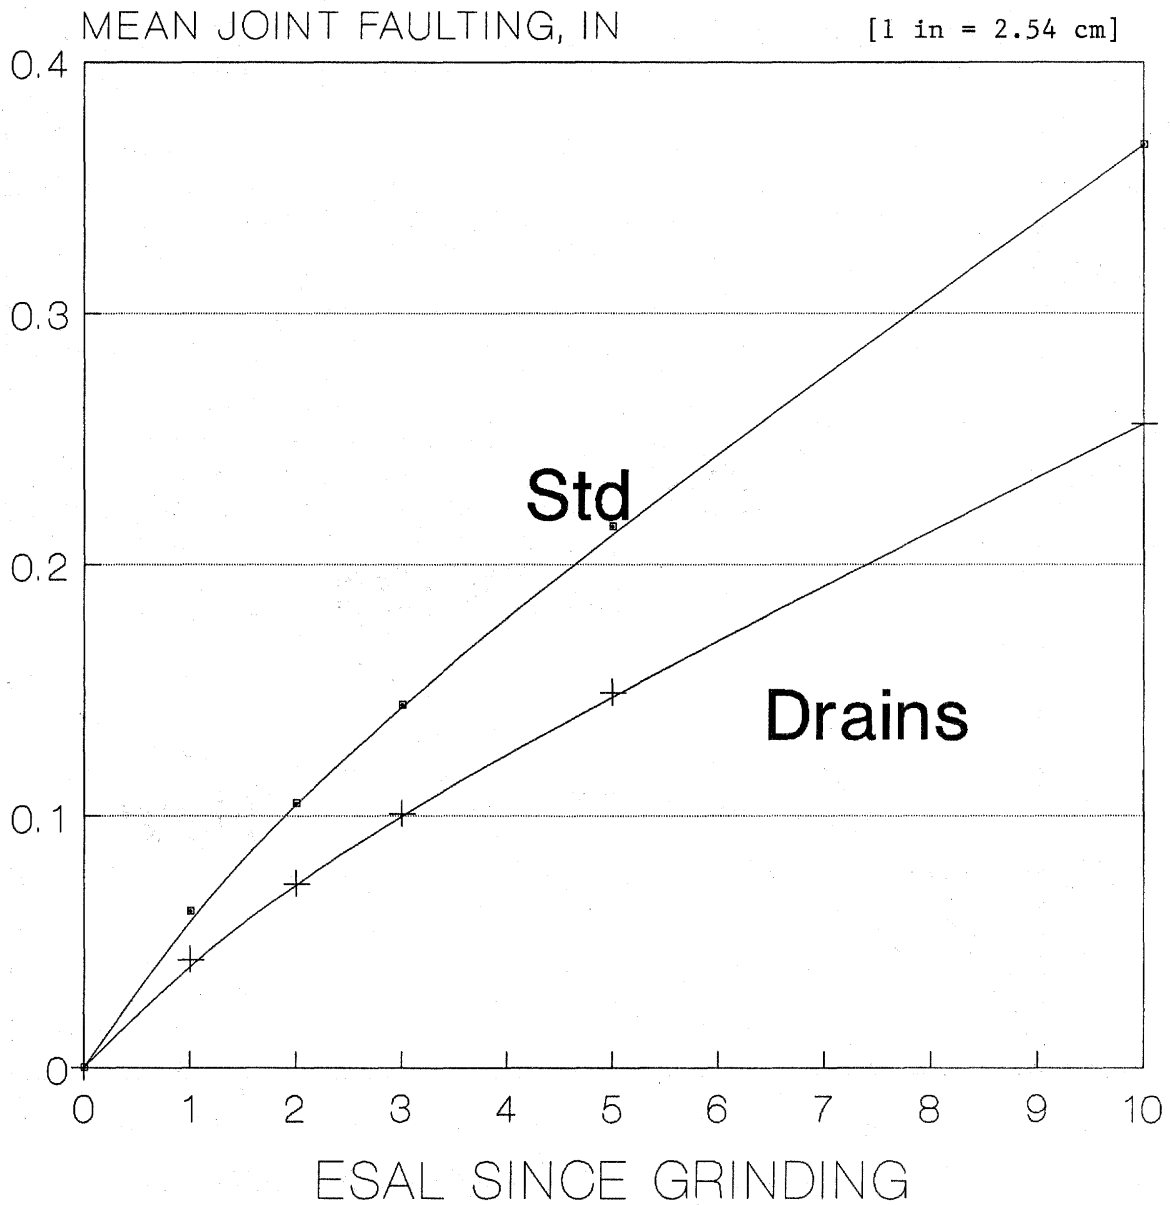
Figure 11. Faulting projections for standard JRCP and standard plus drains and PCC shoulders.

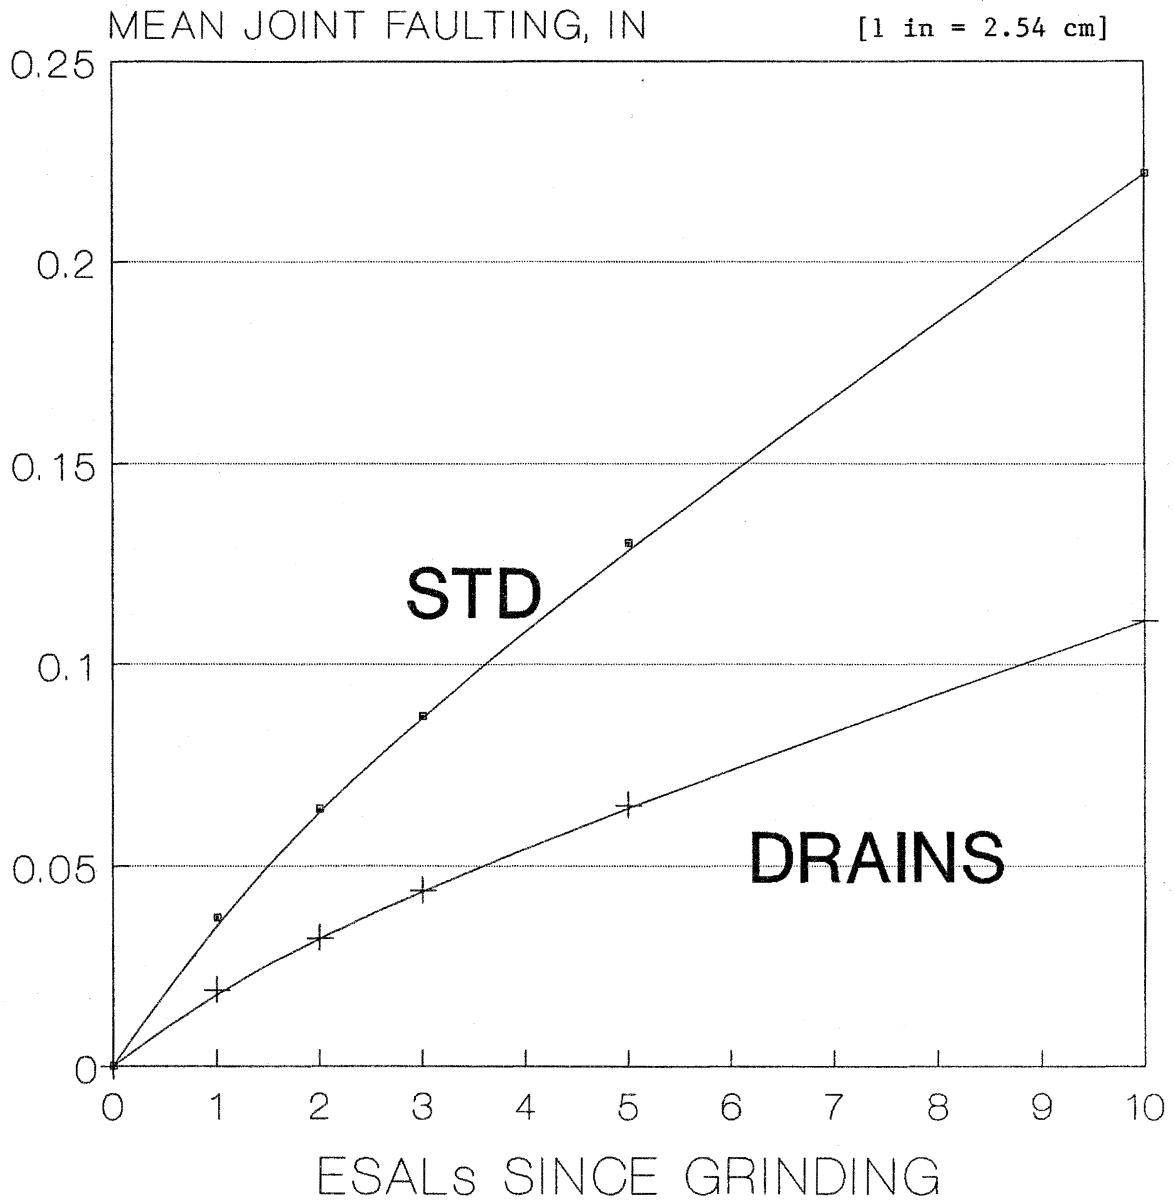
Figure 12. Faulting projections for standard JPCP and standard plus drains and PCC shoulders.

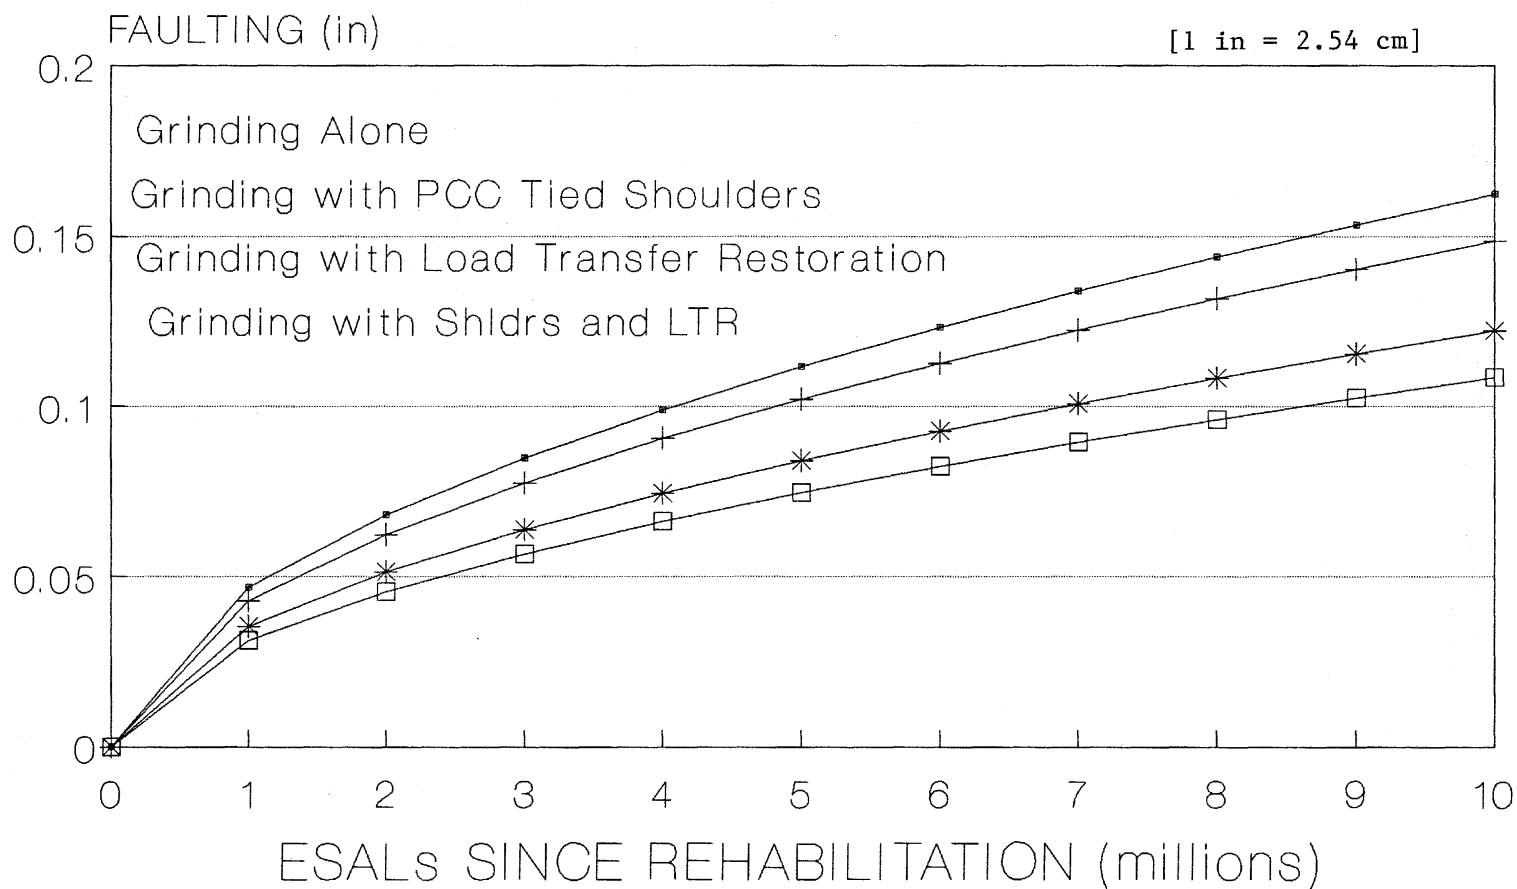
Figure 13. Illustration of predicted faulting for various restoration techniques for JPCP.

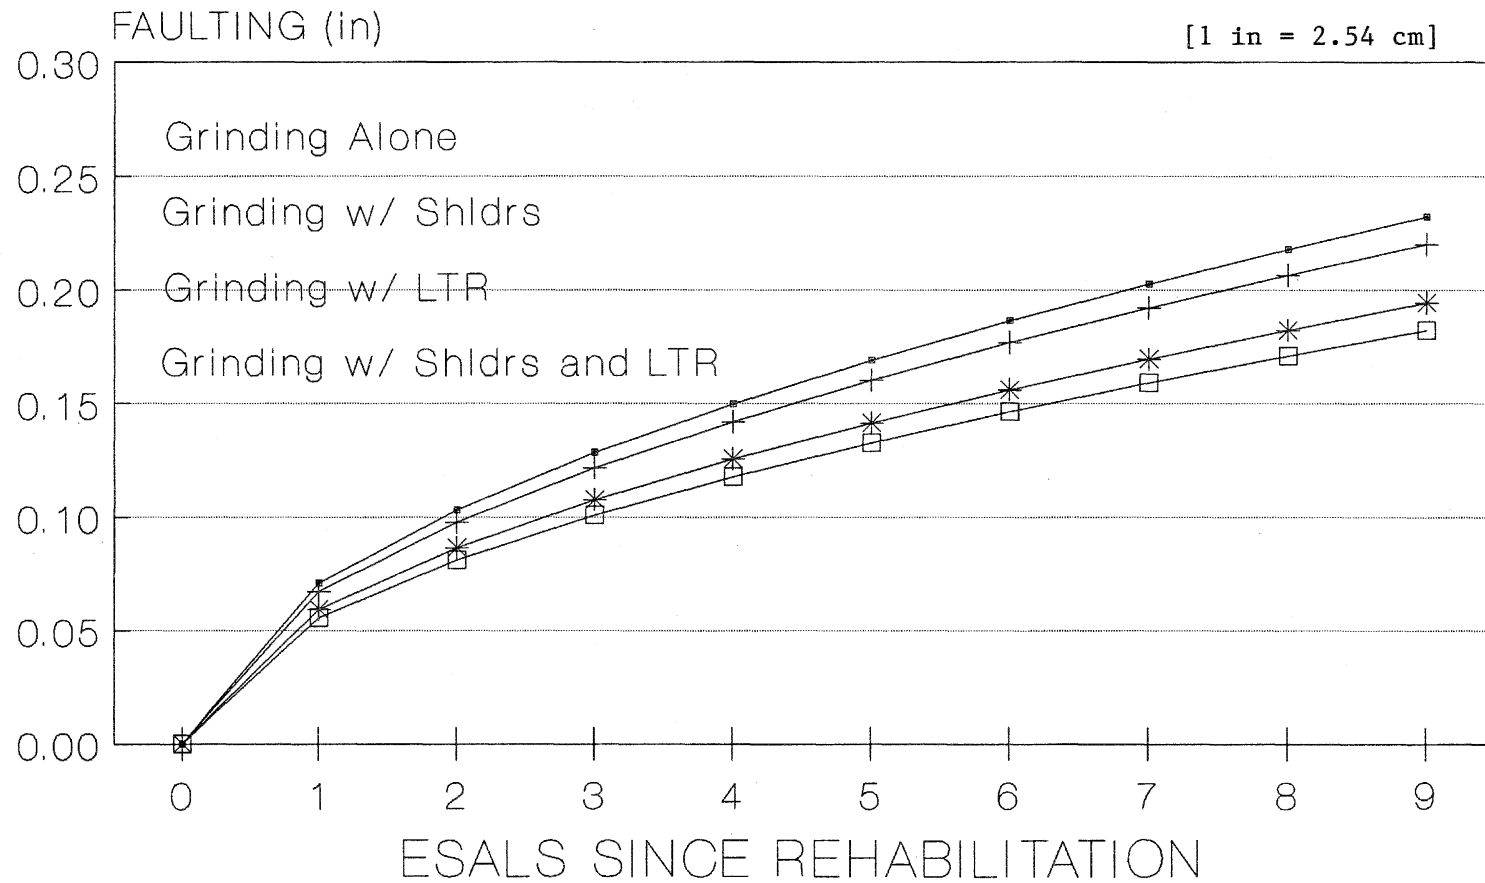
Figure 14. Illustration of predicted faulting for various restoration techniques for JRCP.

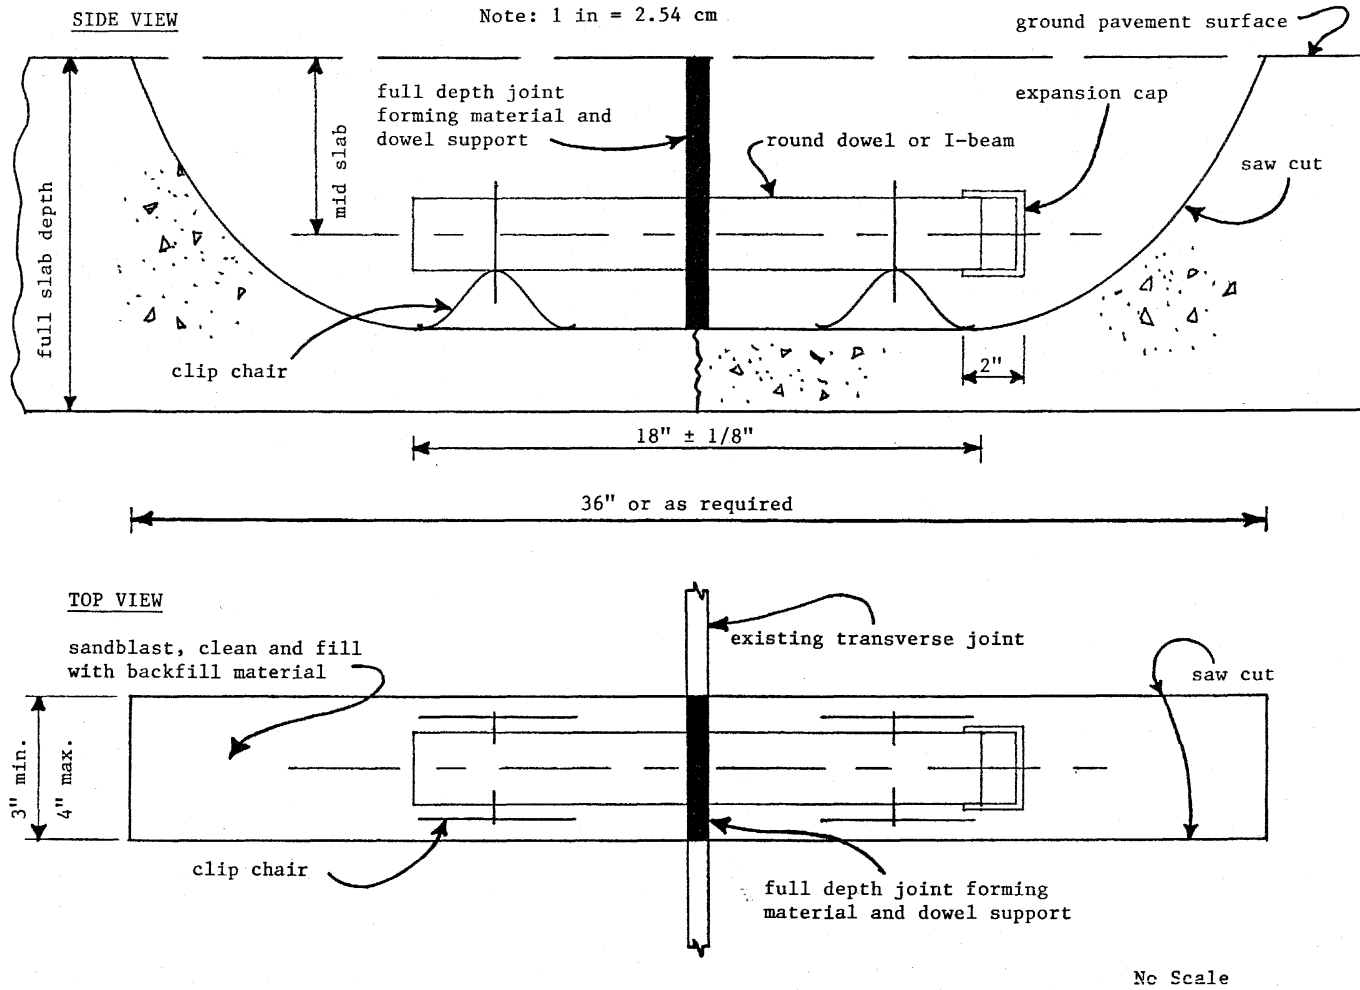
Figure 17. Diagram of retrofit dowel or I-beam device and installation.

The performance of the miniature I-beam devices, as shown in figure 17, was measured in terms of two criteria:

Plans should include details and sketches of the load transfer device itself. Details of the dowel device and supporting chair are shown in figure 17.

Dowels must be provided with filler board or styrofoam material at mid-length to prevent the intrusion of patch material into the existing joint/crack, and to form the joint in the kerf. To account for varying joint/crack widths over the project, multiple thin sheets of filler can be used. To keep joints/cracks free of material it is important to have a tight fitting filler which matches the existing contraction joint width. Details of the dowel placement are shown in figure 17.

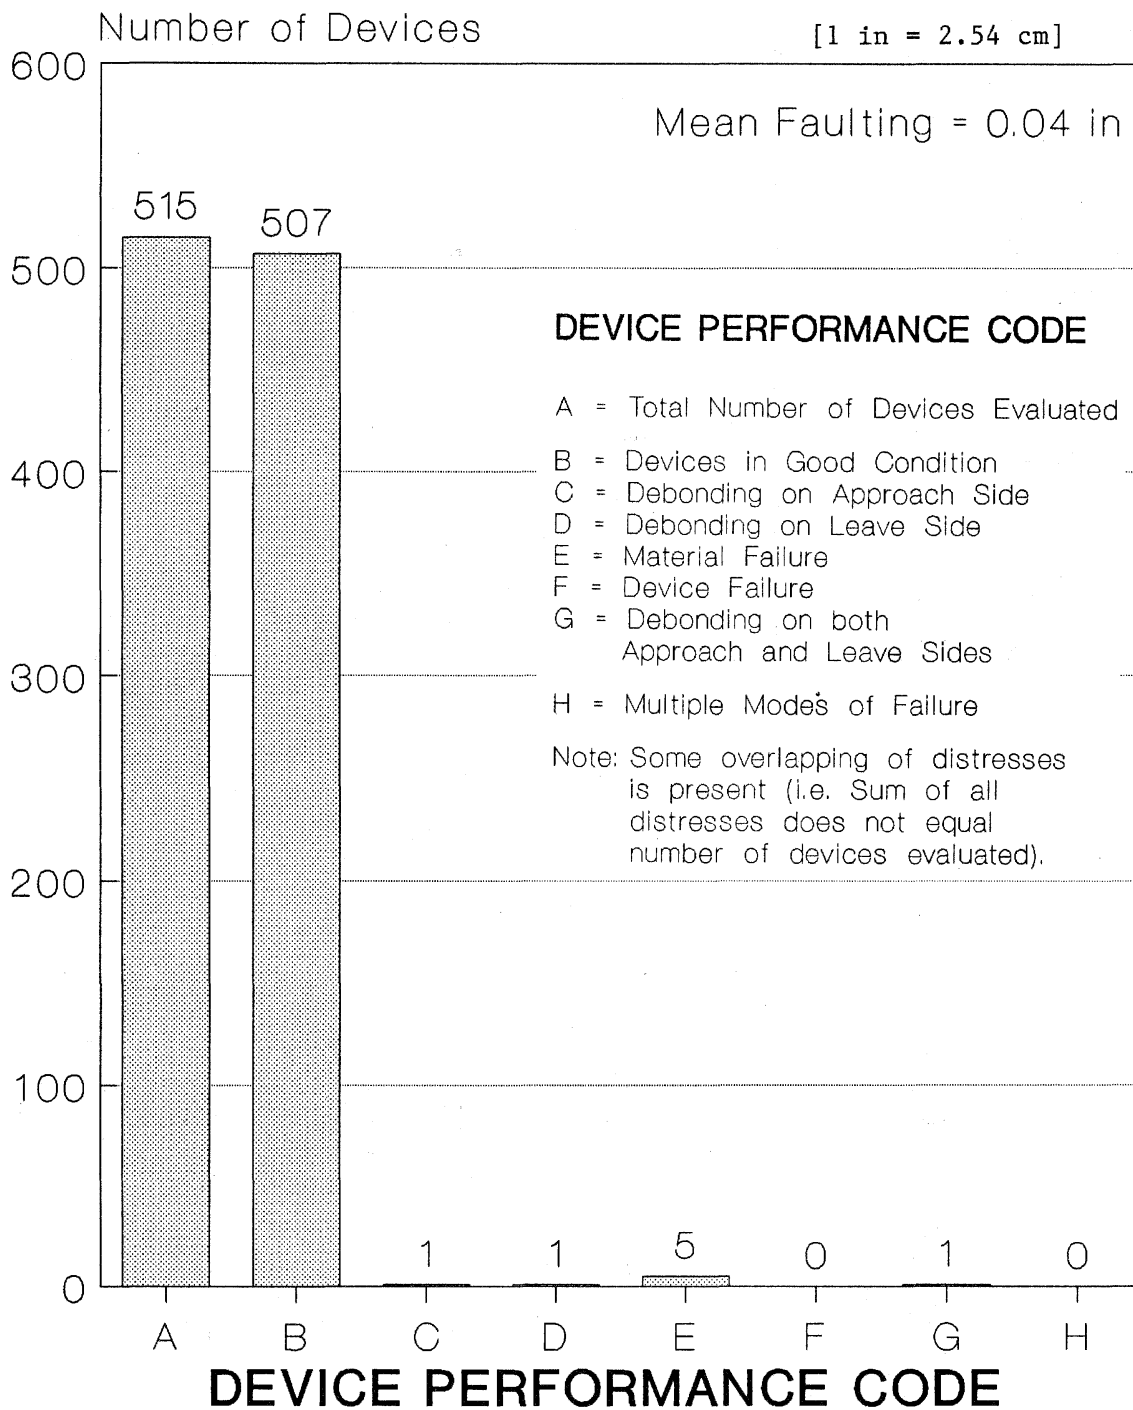
Figure 18. Distribution of retrofit dowel performance.

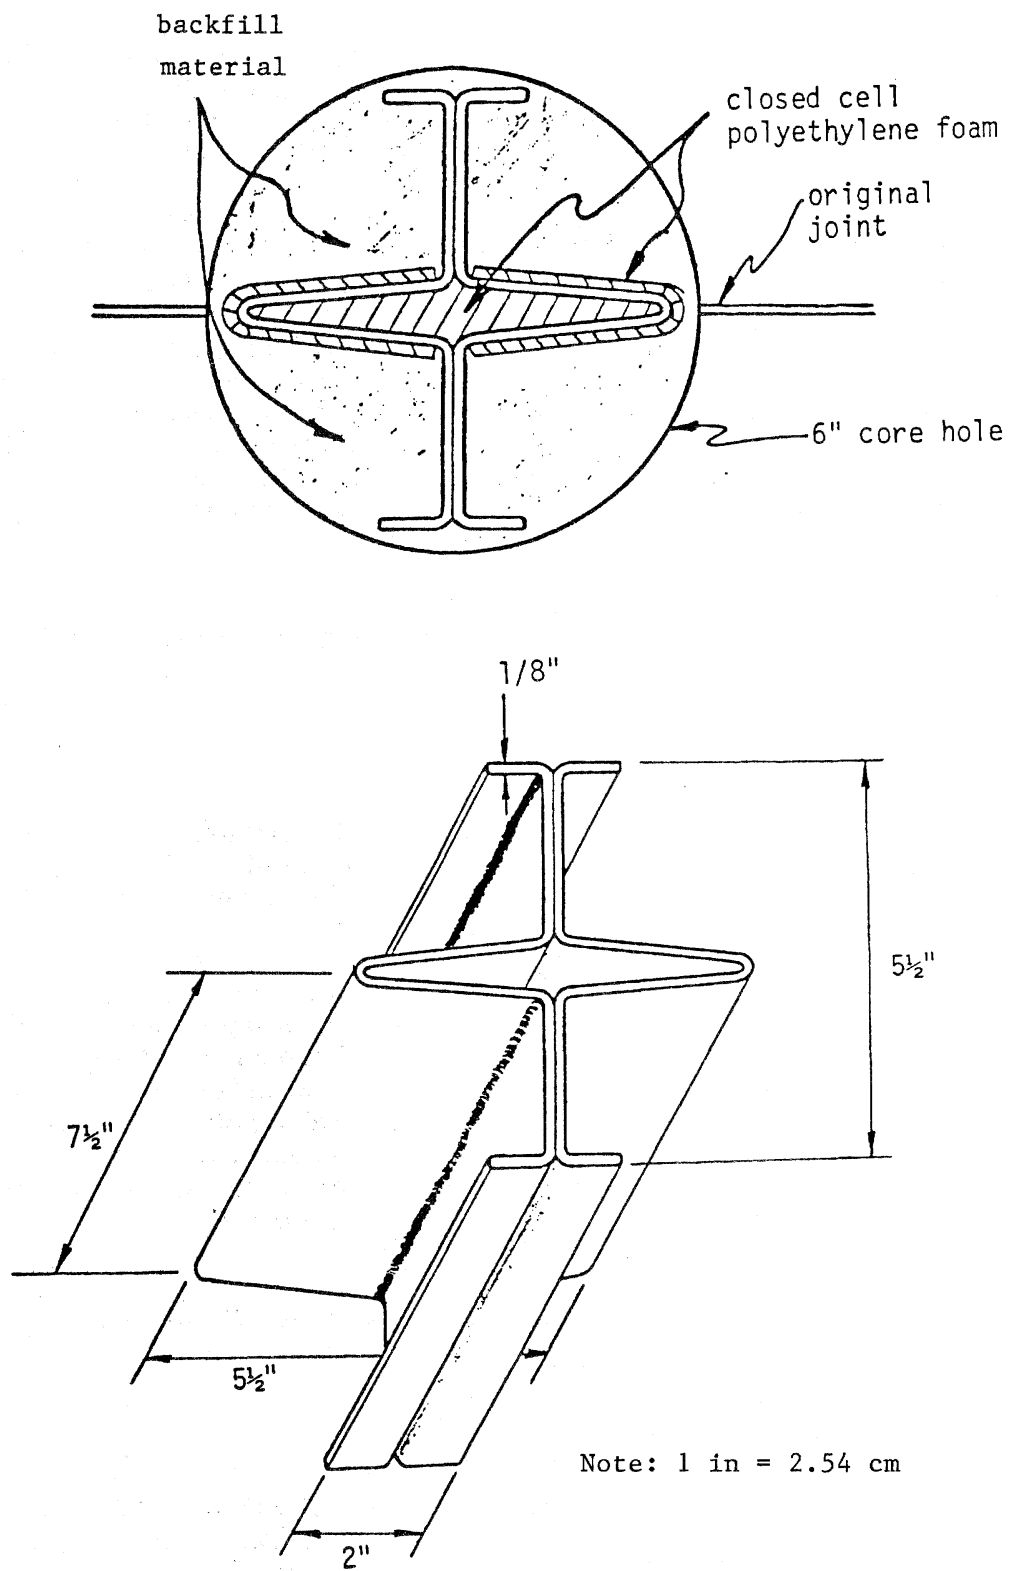
Figure 19. Diagram of double-vee shear device and installation.

The performance of the Double-vee shear devices (see figure 19) was measured in terms of two criteria:
