Publication No. FHWA-RD-88-071
July 1989

Rehabilitation of Concrete Pavements

Volume I: Repair Rehabilitation Techniques

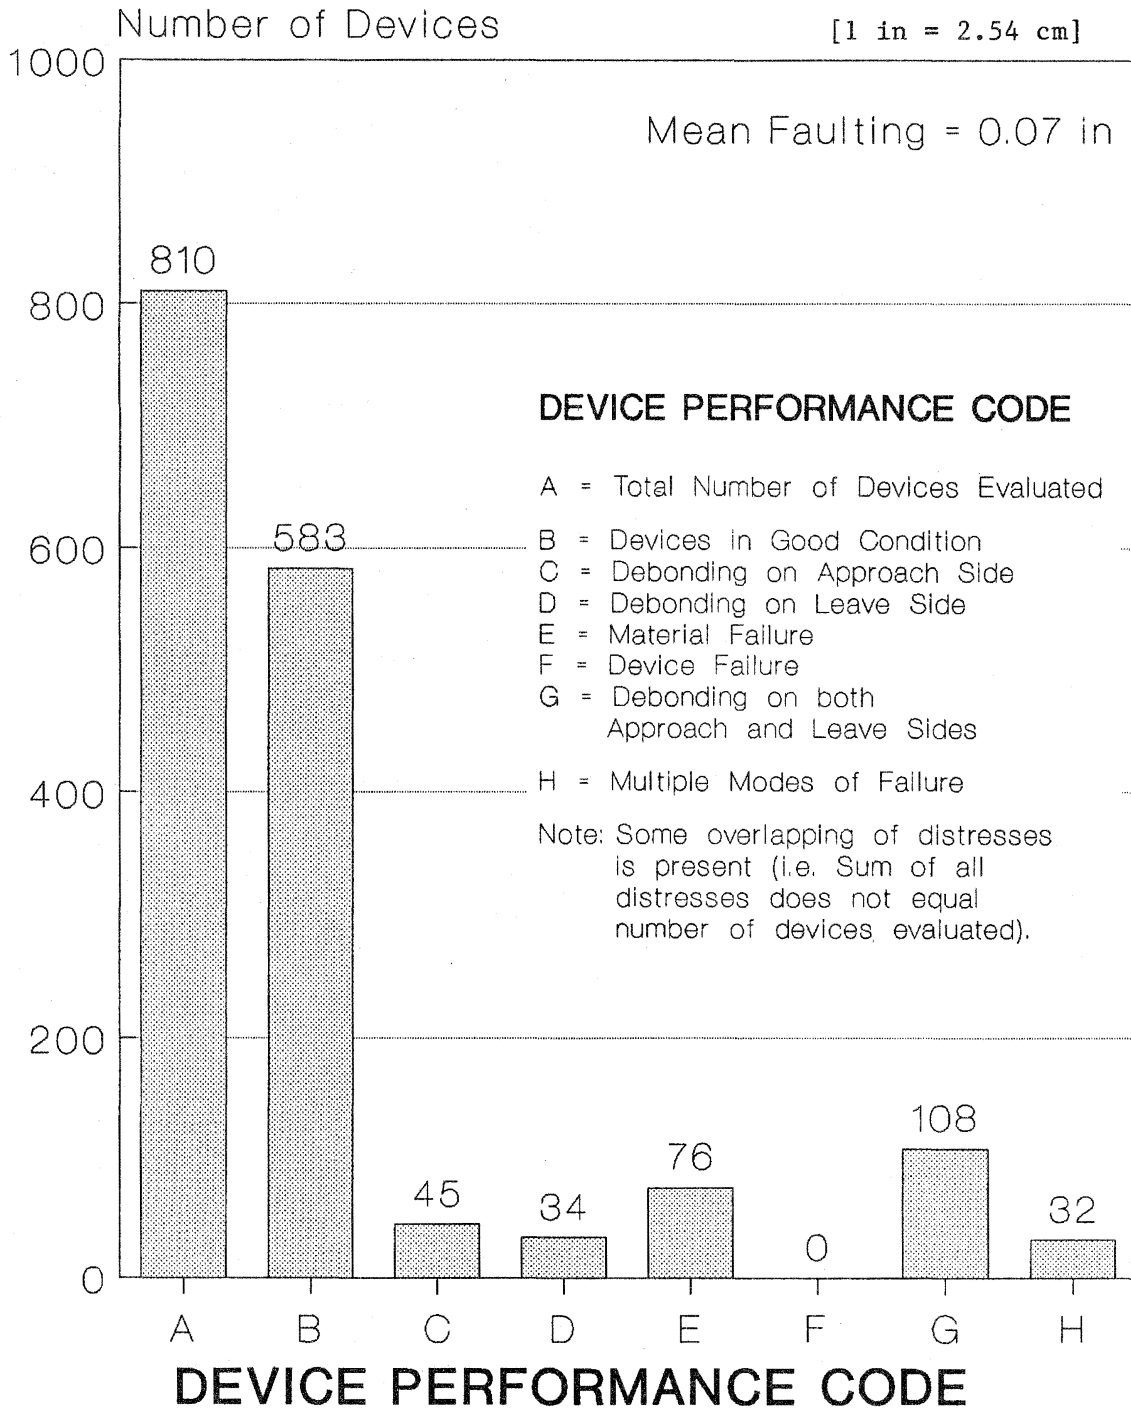
Figure 20. Distribution of double-vee shear device performance.

Of the 810 uncompressed, ungrooved shear load transfer devices inspected, 583, or 72 percent, of the devices were in good condition (see figure 20). The most prominent mode of failure identified was debonding on both the approach and leave sides of the same device which was found at 108, or 13 percent, of the devices. As stated previously under the discussion of retrofit dowel bars, this failure mode was recorded separately from the individual modes of debonding failure. Again, the Florida study is evaluating the use of device precompression and core wall grooving as remedies to this debonding mode of failure. None of the joints restored with shear devices exhibited device failure. Multiple modes of failure were identified at 4 percent of the devices. Multiple modes of failure refers to the existence of two or more of the failure mechanisms listed in table 8 at any one device.

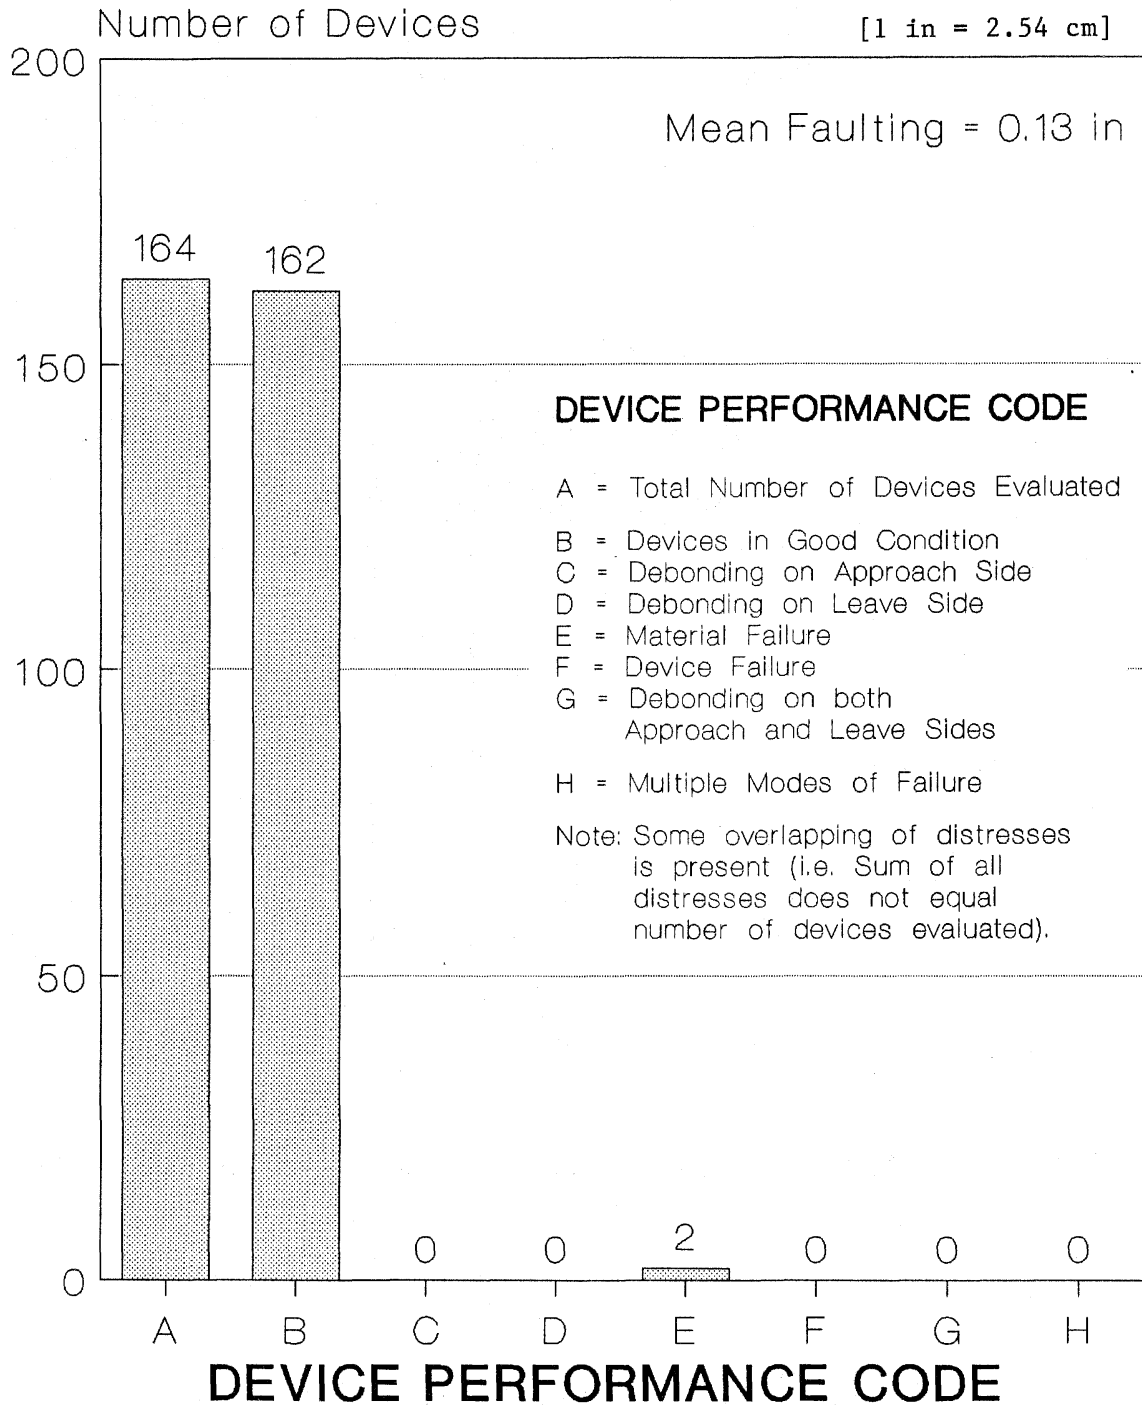
Figure 21. Distribution of I-beam device performance.

Of the 164 I-beam load transfer devices inspected, 162, or better than 98 percent, of the devices were in good condition (see figure 21). The most prominent mode of failure identified was material failure (located at about 1 percent or 2 devices), where the backfill matrix had been cracked or become loose and dislodged by traffic. None of the devices were debonded on the approach, leave or both approach and leave sides. Also, none of the joints restored with I-beams exhibited device failure or multiple modes of failure. Multiple modes of failure refers to the existence of two or more of the failure mechanisms listed in table 8 at any one device.

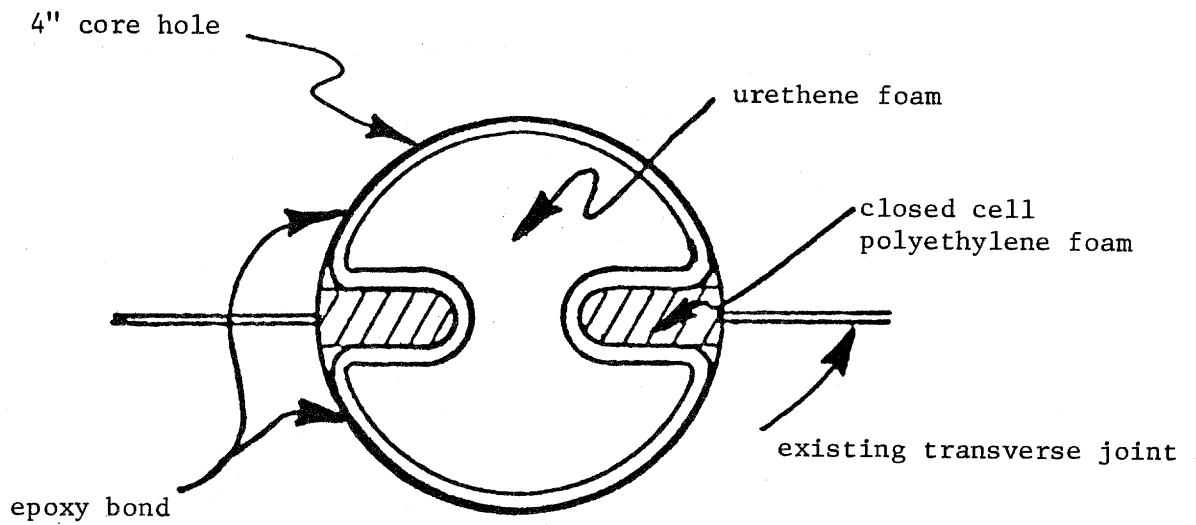
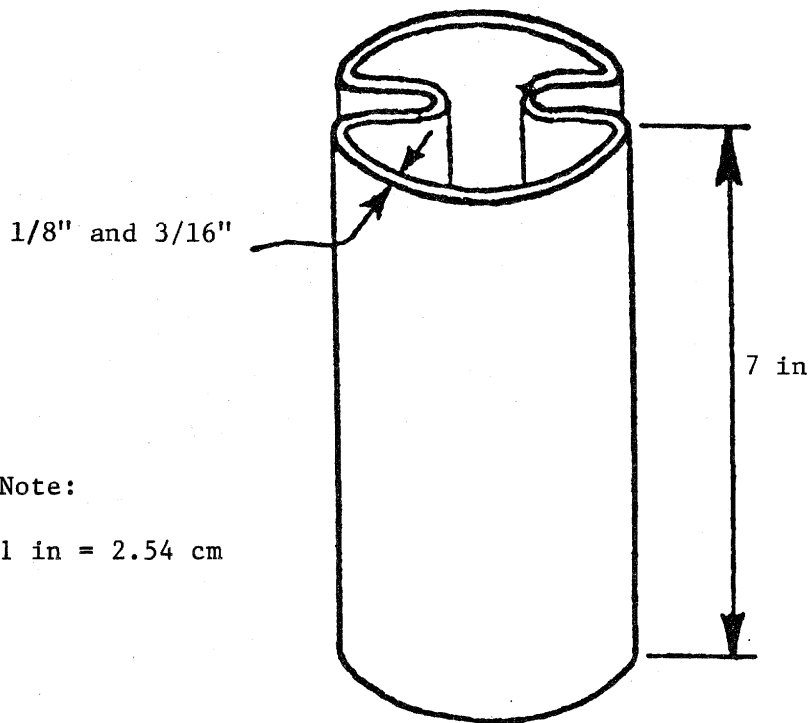
Figure 22. Diagram of figure-eight device and installation.

The performance of the Figure-eight devices (see figure 22) was measured in terms of two criteria:

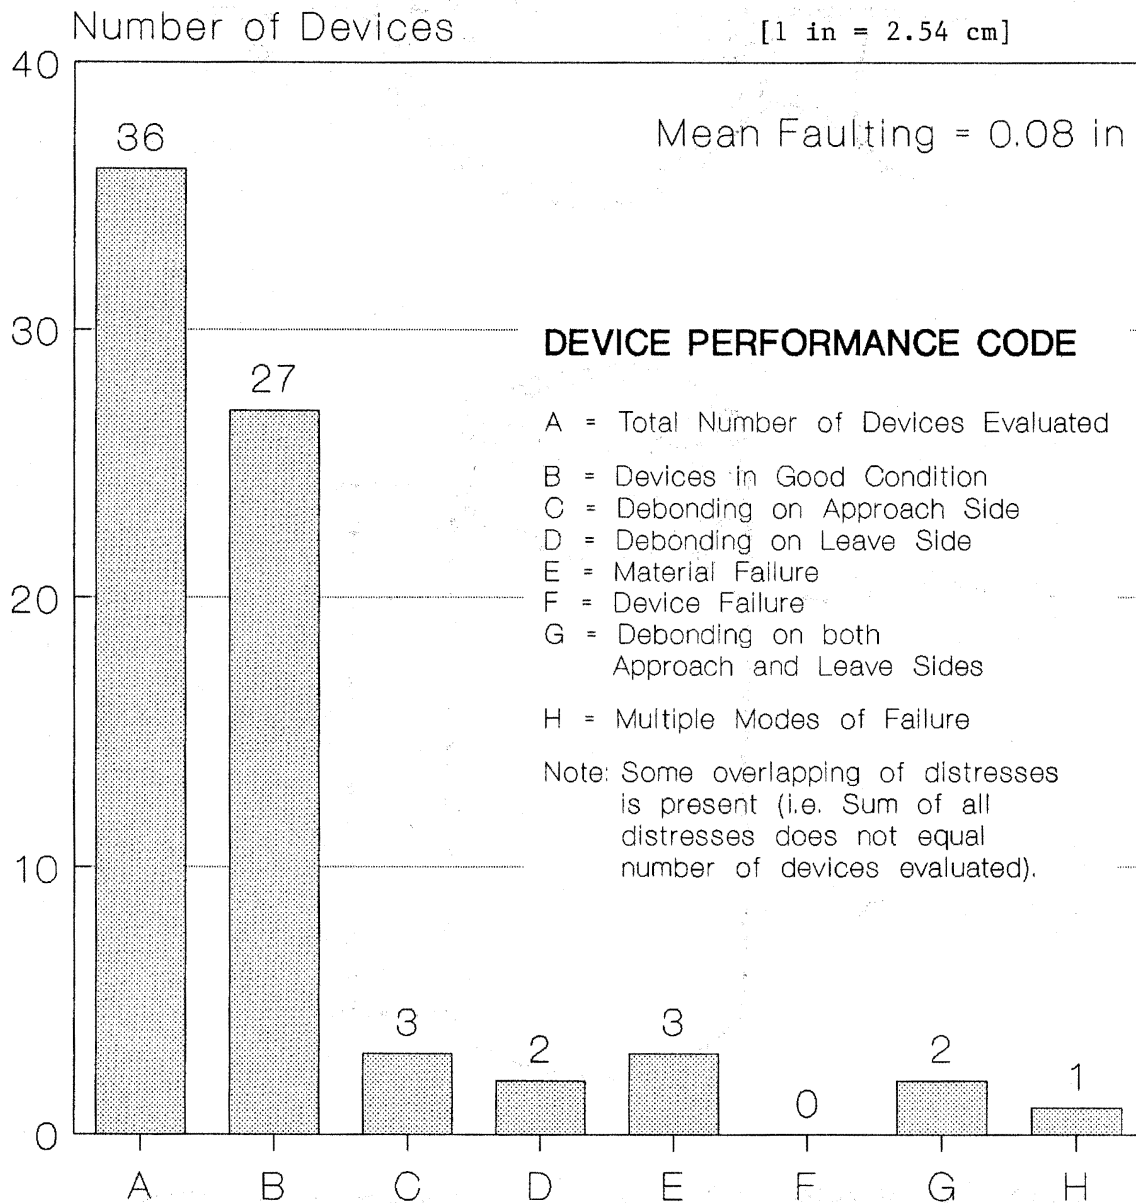
Figure 23. Distribution of figure-eight device performance.

Of the 36 Figure-eight load transfer devices inspected, 27, or 75 percent, of the devices were in good condition (see figure 23). The most prominent failure modes identified were debonding on the device approach side and material failure. Both of

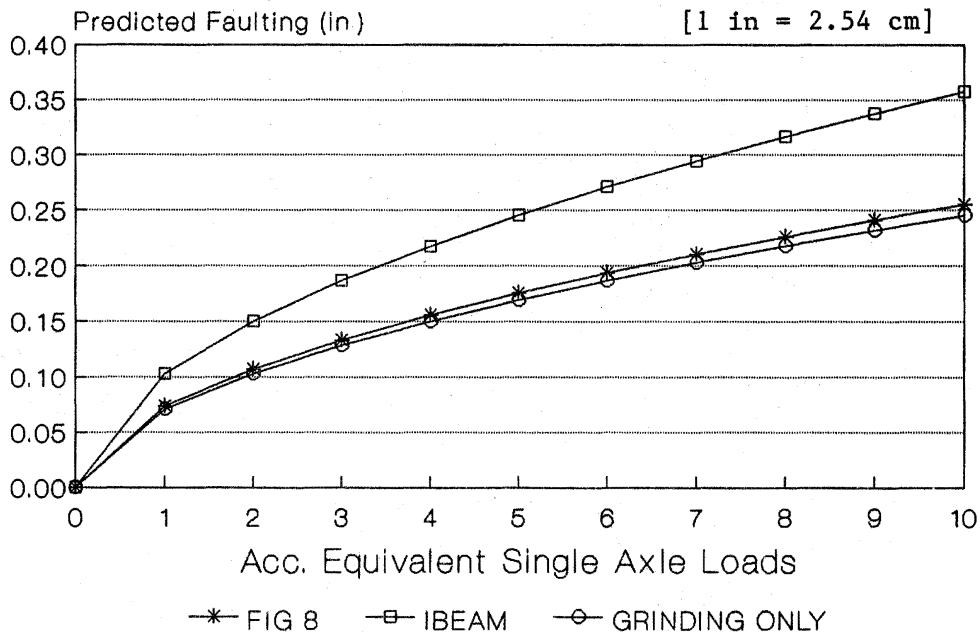
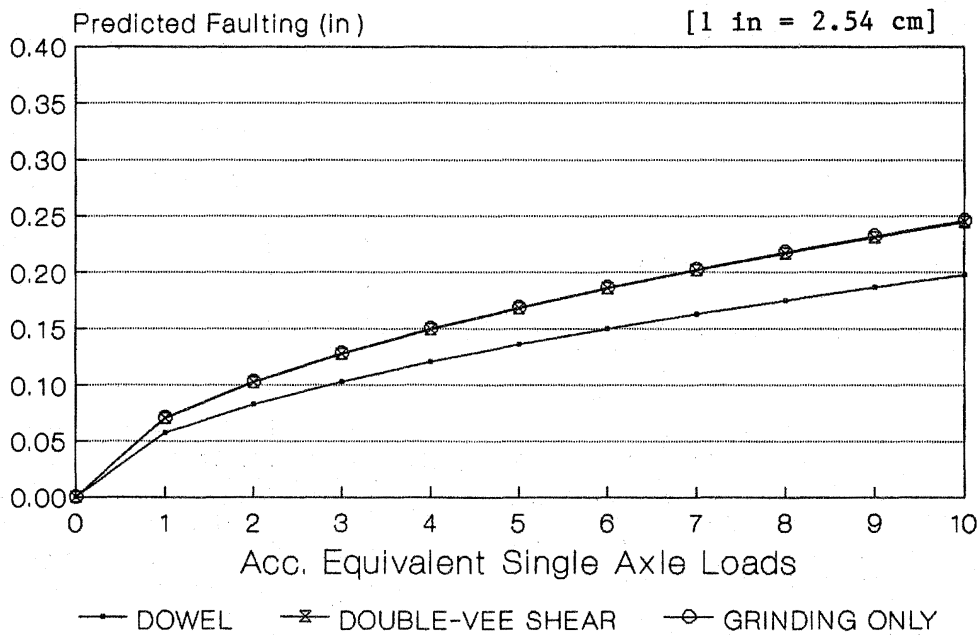
Figure 24. Sensitivity plot depicting model-predicted faulting vs. accumulated 18-kip [80kN] ESALs for JRCP.

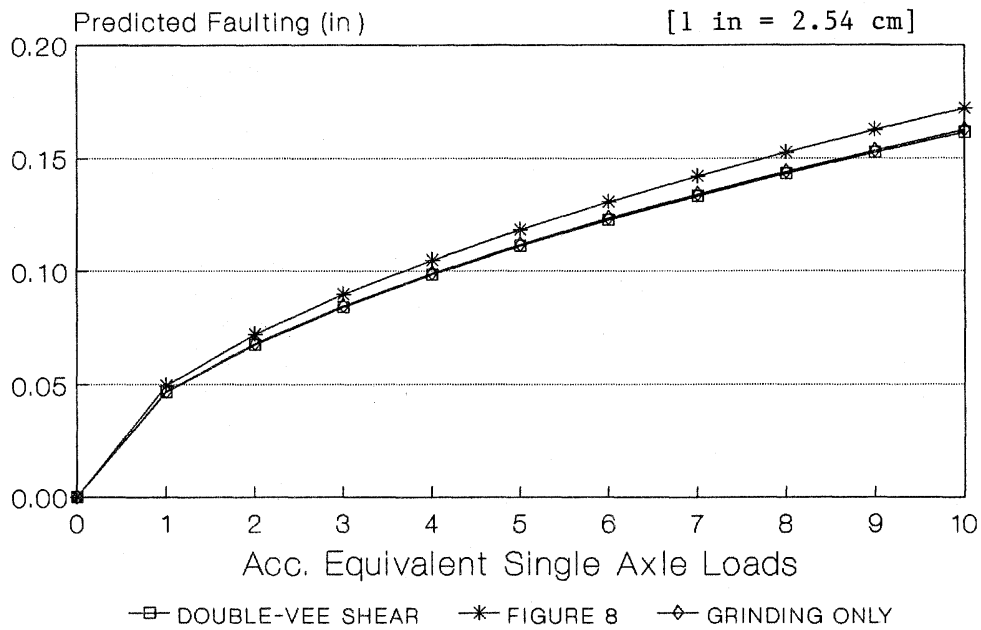
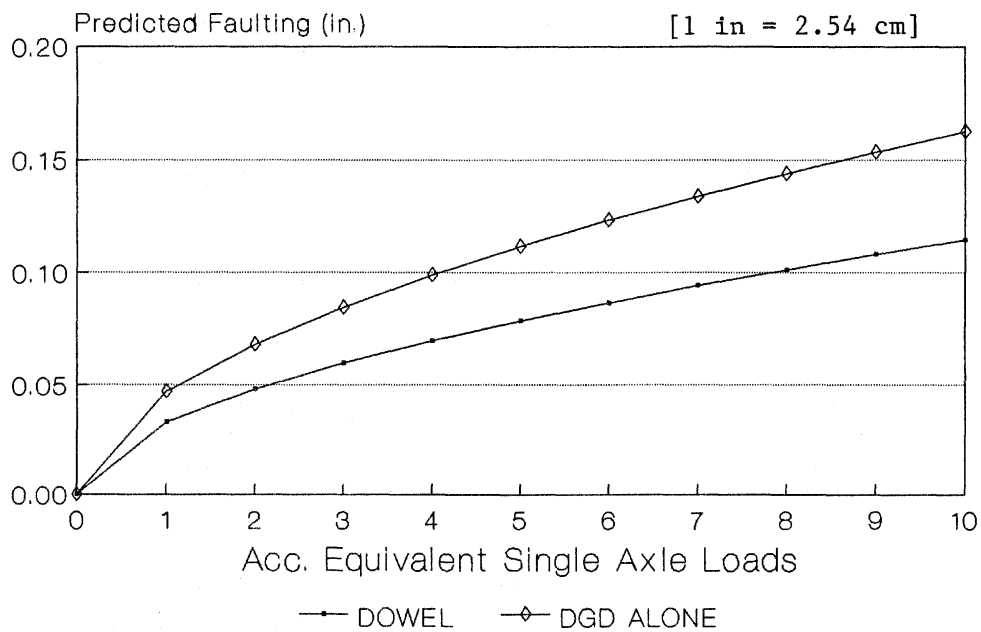
Figure 25. Sensitivity plot depicting model-predicted faulting vs. accumulated 18-kip [80 kN] ESALs for JPCP.

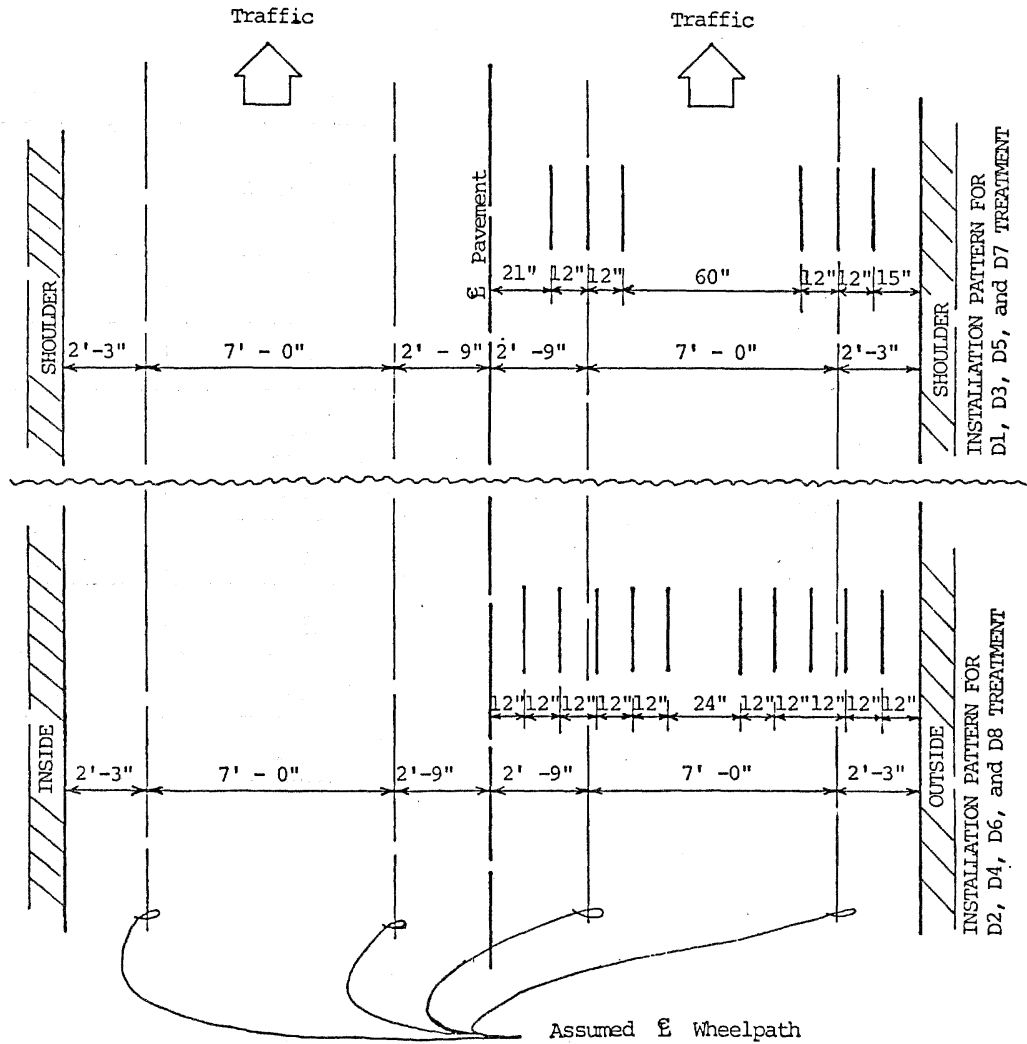
INSTALLATION PATTERN
FOR
RETROFIT DOWEL LOAD TRANSFER DEVICES

- (1) \bar{E} of dual wheel average 27 in from outside pavement edge.
- (2) 8 ft-6 in out to out dual wheel distance (7 ft-0 in center to center).
- (3) 12-in dowel spacing is desirable.

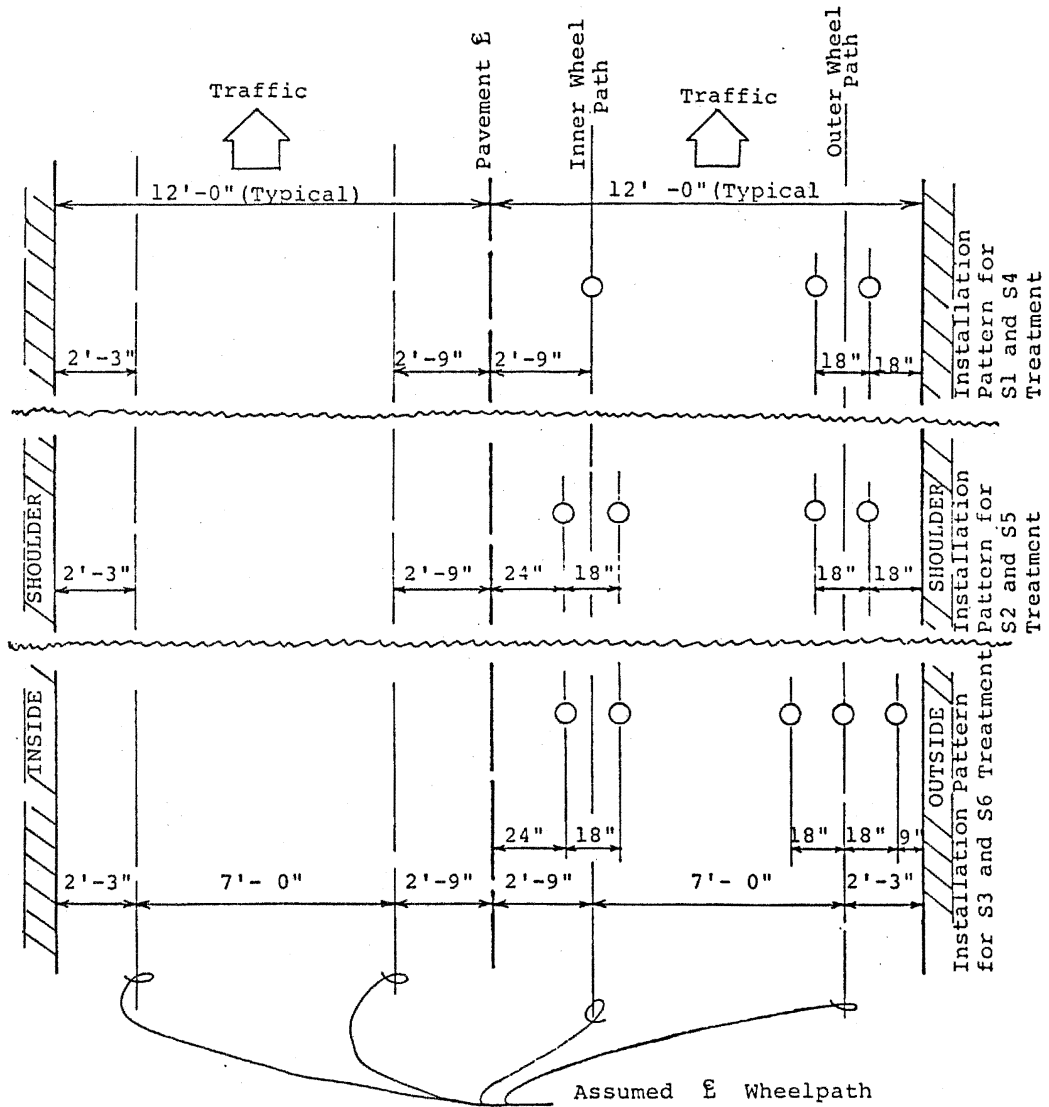
Installation Pattern For Retrofit Load Transfer Shear Devices

- (1) \bar{E} of dual wheel average 27 in from outside pavement edge.
- (2) 8 ft-6 in out to out dual wheel distance (7 ft-0 in center to center).

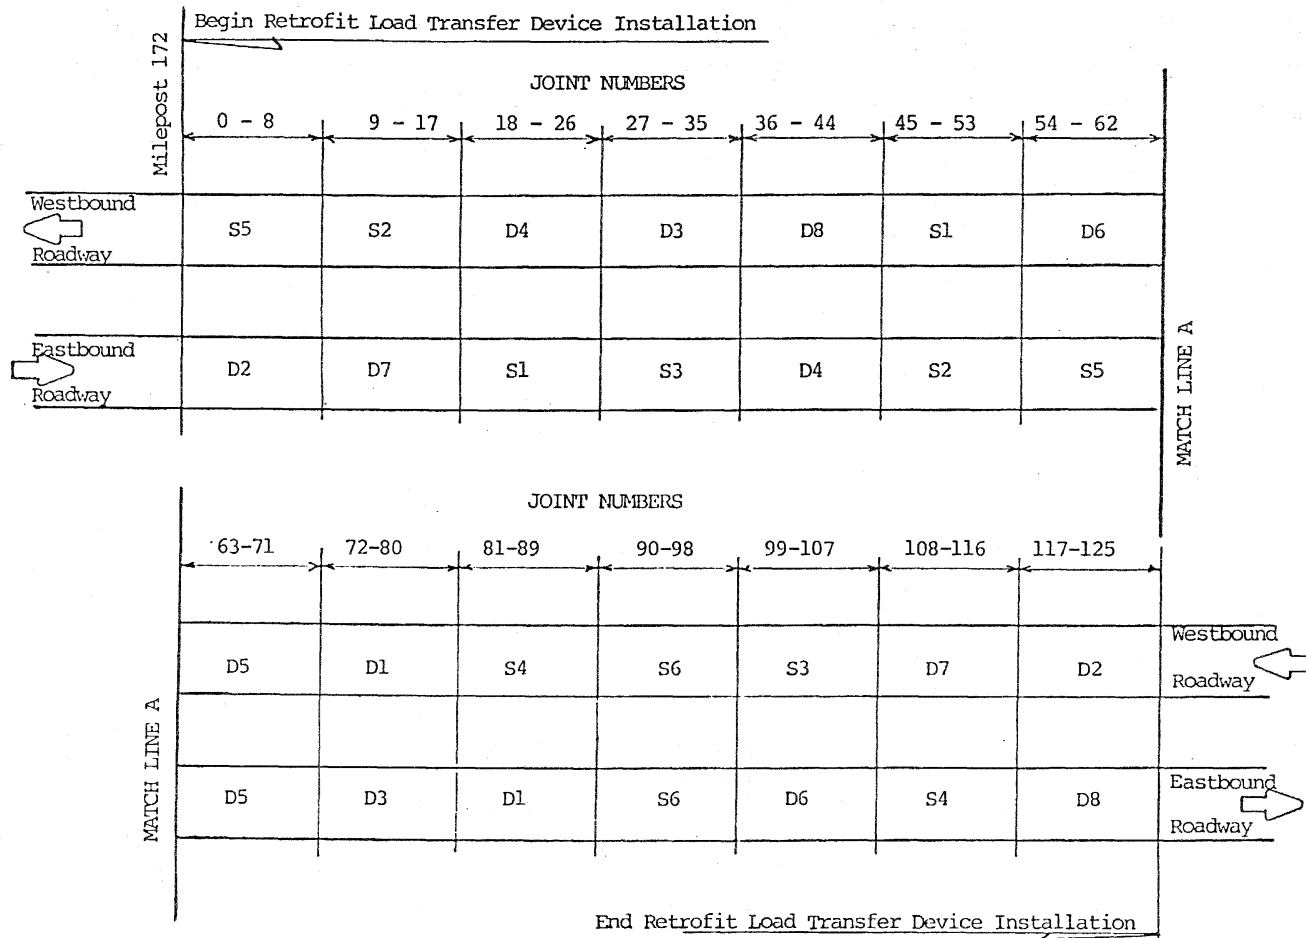
Figure 28. Layout plan of treatment configurations and locations by joint number in Florida project.

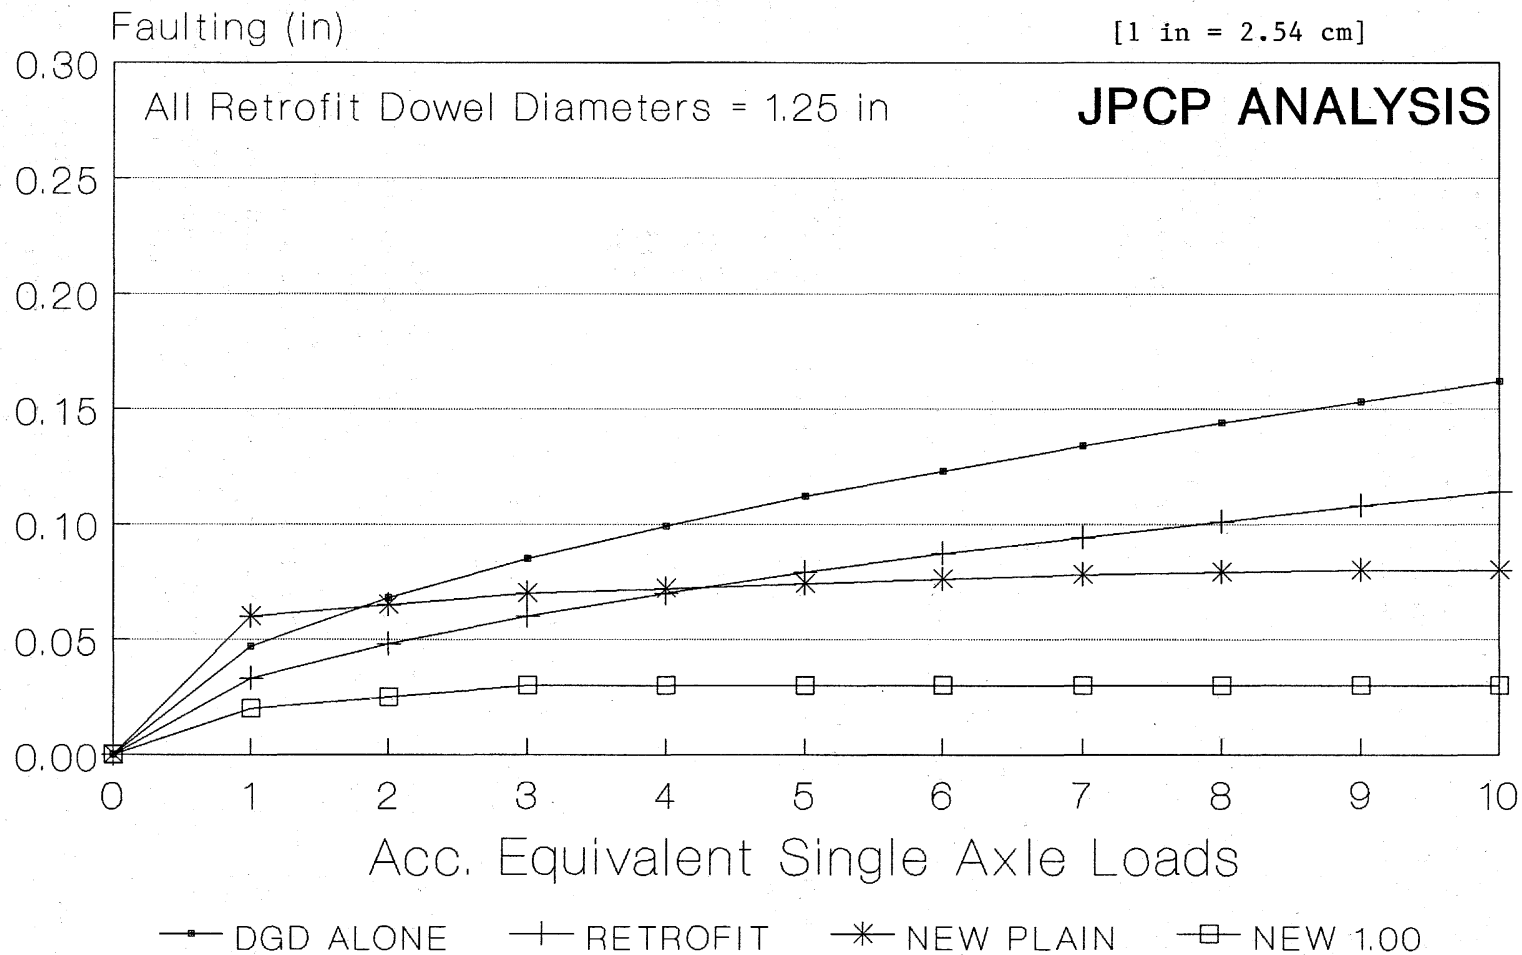
Figure 29. Comparison of JPCP joint faulting: new pavement vs. rehabilitated pavement.

Results from NCHRP Project 1-19 showed the significant impact dowel diameter has on faulting. Larger diameter dowels slow down the development of faulting in new pavements. The larger dowels also showed less loss of load transfer in the Illinois Interstate 70 full-depth repair study (see chapter 5). Figures 29 and 30 compare joint faulting of new JPC and JRC pavements of various dowel diameters with similar rehabilitated pavements (either diamond grinding alone or diamond grinding along with retrofit dowel load transfer restoration). These figures show that retrofit dowels reduce faulting; however, not to the same level as new construction dowelled pavements. This probably occurs because the aggregate interlock is much less for an older pavement than for new construction.

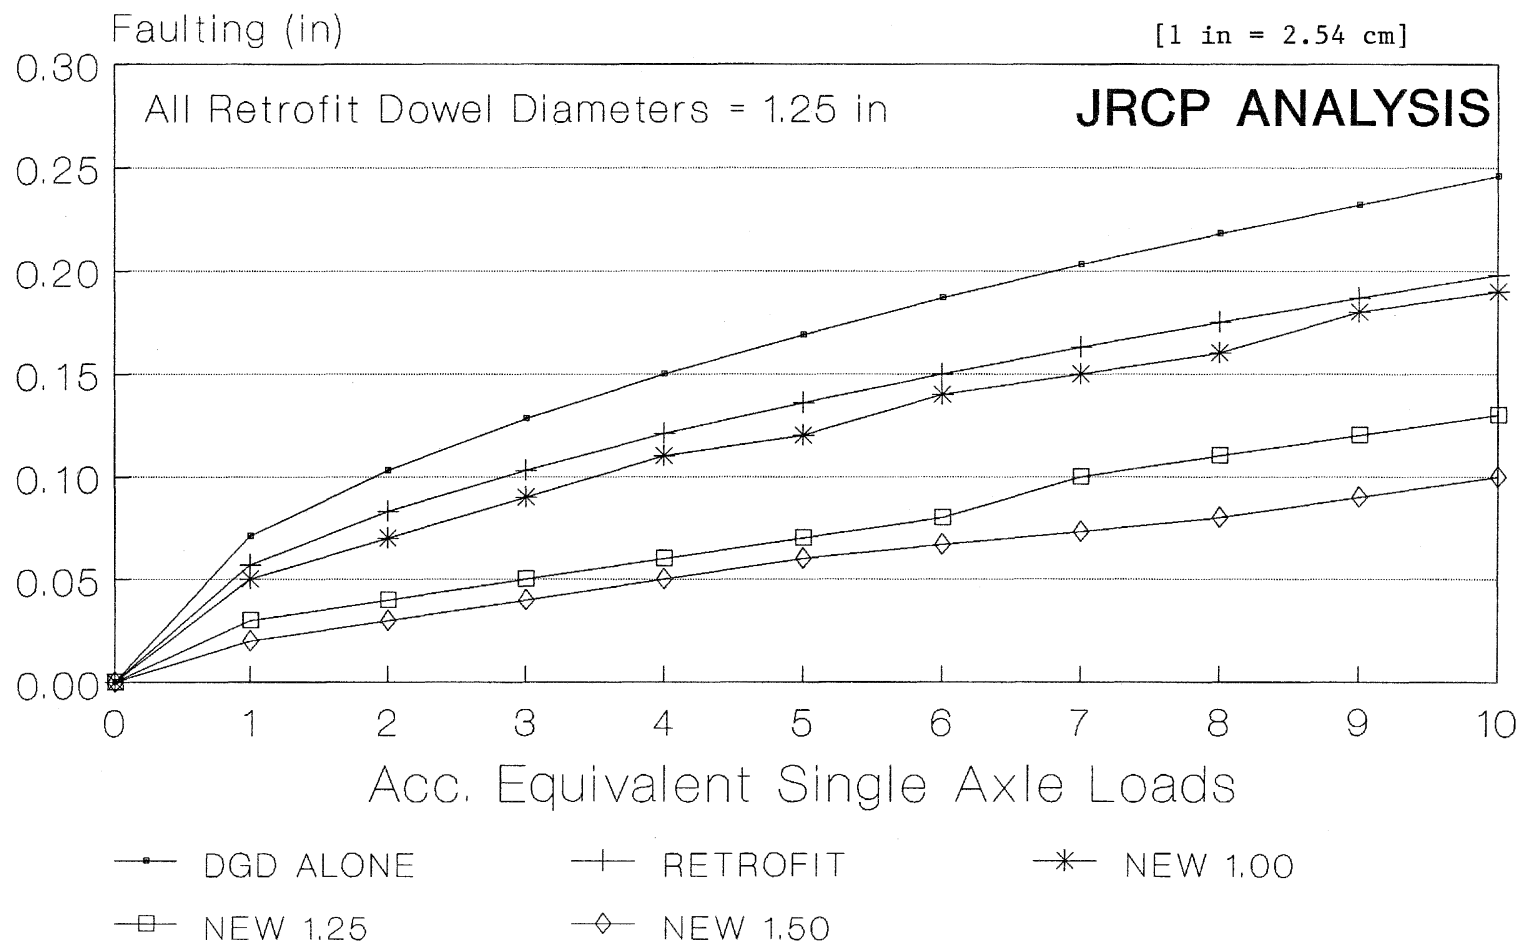
Figure 30. Comparison of JRCP joint faulting: new pavement vs. rehabilitated pavement.

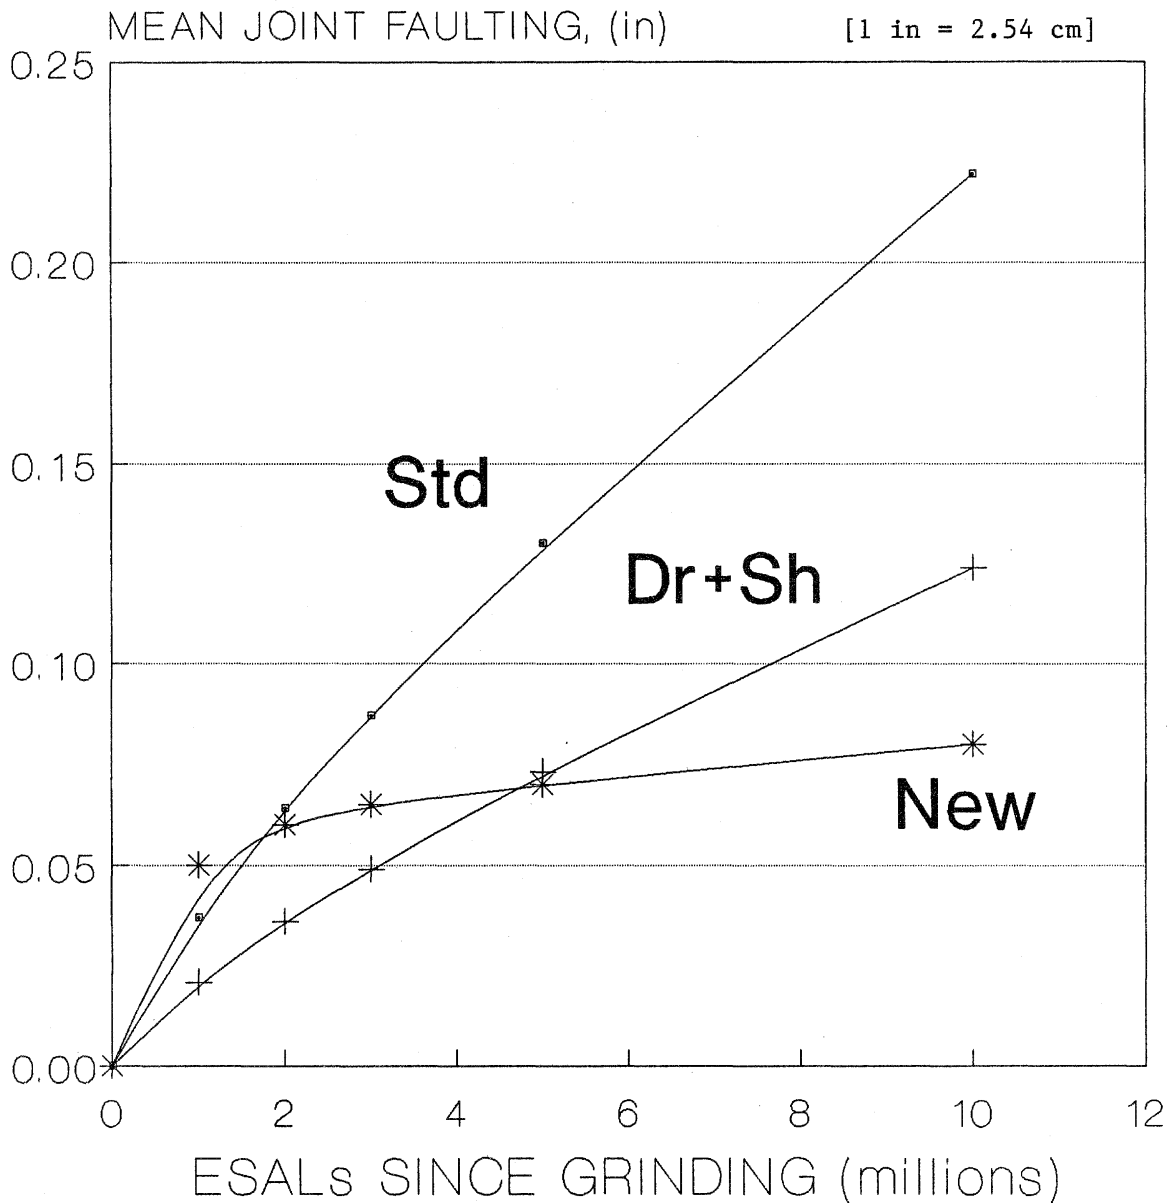
Figure 34. Faulting projections for standard JPCP and standard plus drains and PCC shoulders (Estimated faulting for new section also shown for comparison).

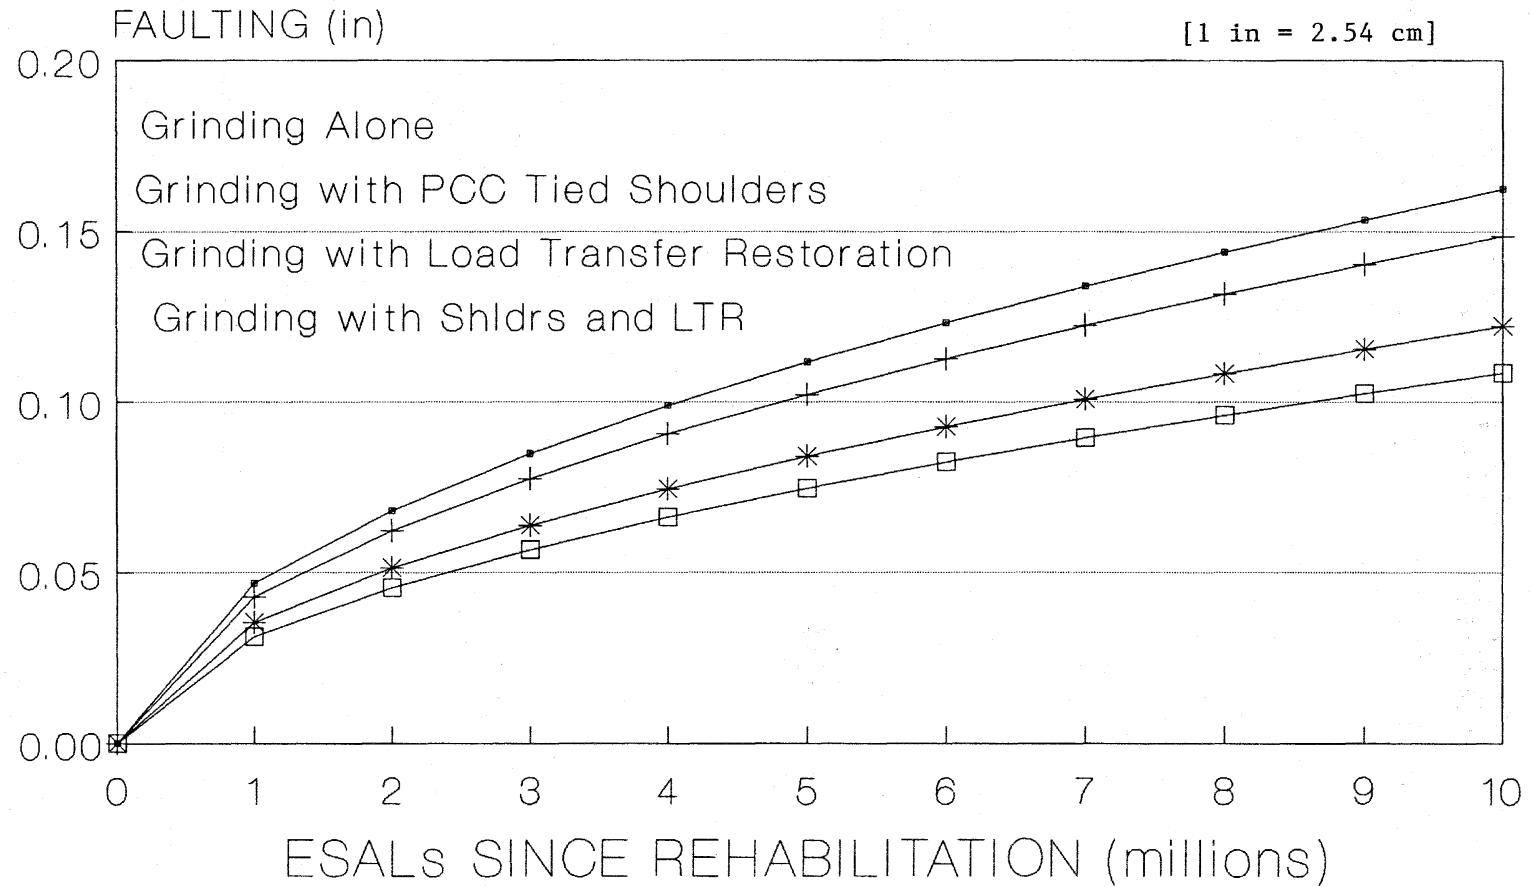
Figure 35. Illustration of predicted faulting for various restoration techniques for JPCP.

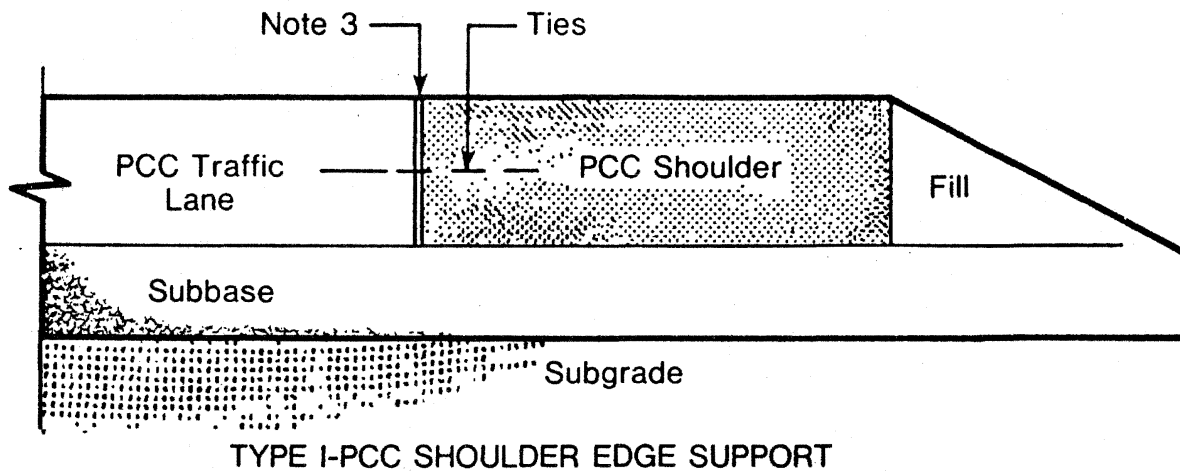
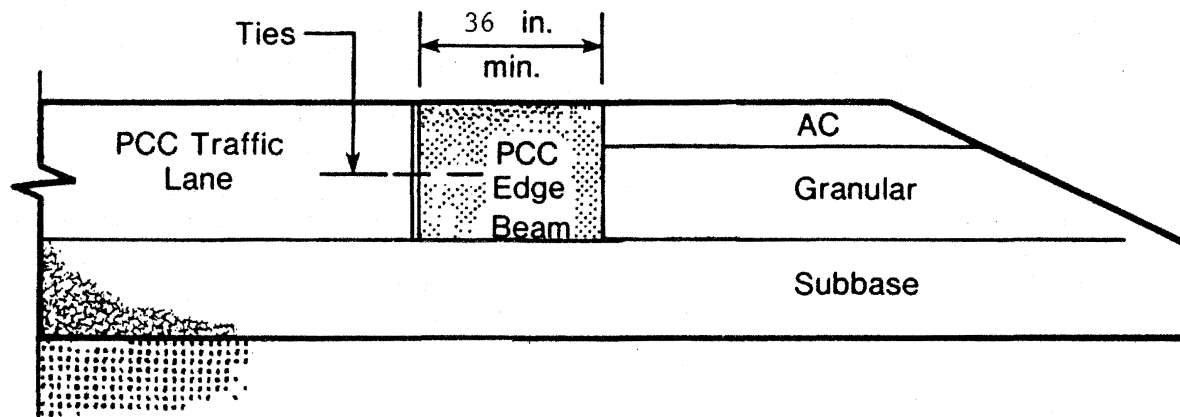
- (1) Ties should be No. 5 deformed rebar or equivalent at middepth of slab.
- (2) Existing shoulder to be removed to the extent required.
- (3) Joint between traffic lane and shoulder should be either edged, or a reservoir that is formed or sawed and then sealed.
- (4) 1 in = 2.54 cm

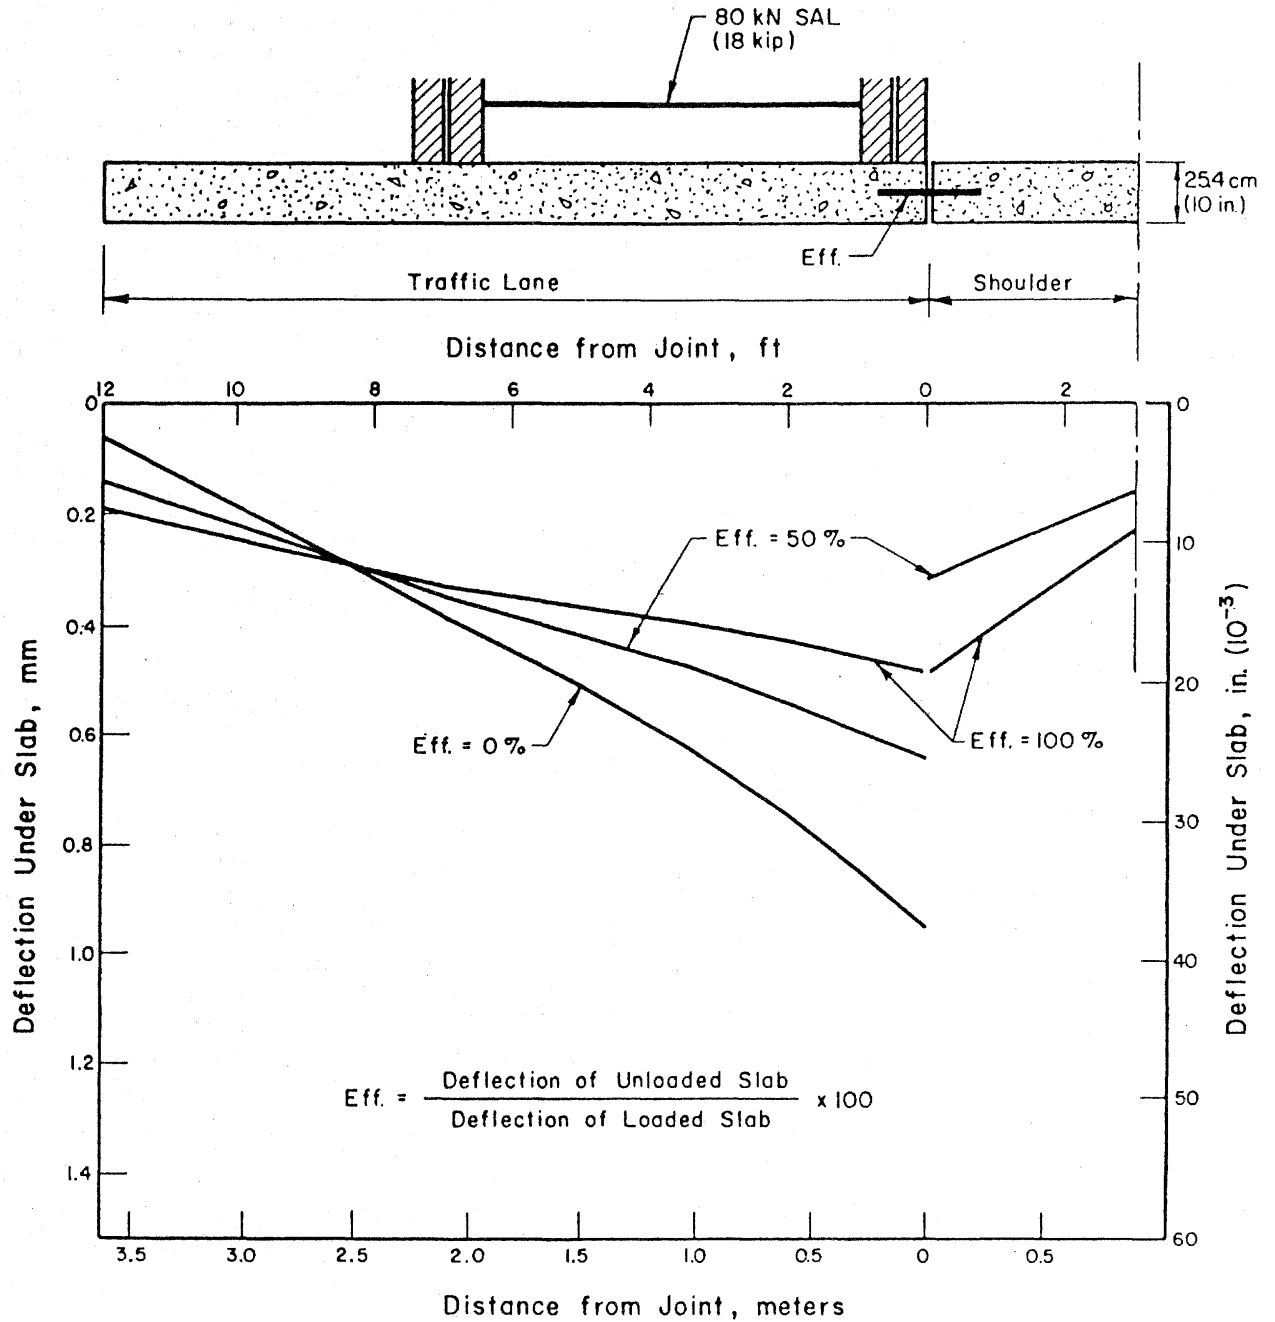
Figure 37. Effect of lane/shoulder tie on deflection of PCC traffic lane.(6)

Figure 37 shows the effect of edge support on edge deflection. A concrete shoulder with a strong tie that provides 100 percent deflection load transfer efficiency reduces the deflection by one-half as shown. Figure 38 shows the effect of both the joint load transfer efficiency and the width of the shoulder. Again, good load transfer reduces the stress by one-half. The width of the support beam/shoulder has a major effect from 1 to 3 ft [0.3 to 0.9 m].
