Publication No. FHWA-RD-88-071
July 1989

Rehabilitation of Concrete Pavements

Volume I: Repair Rehabilitation Techniques

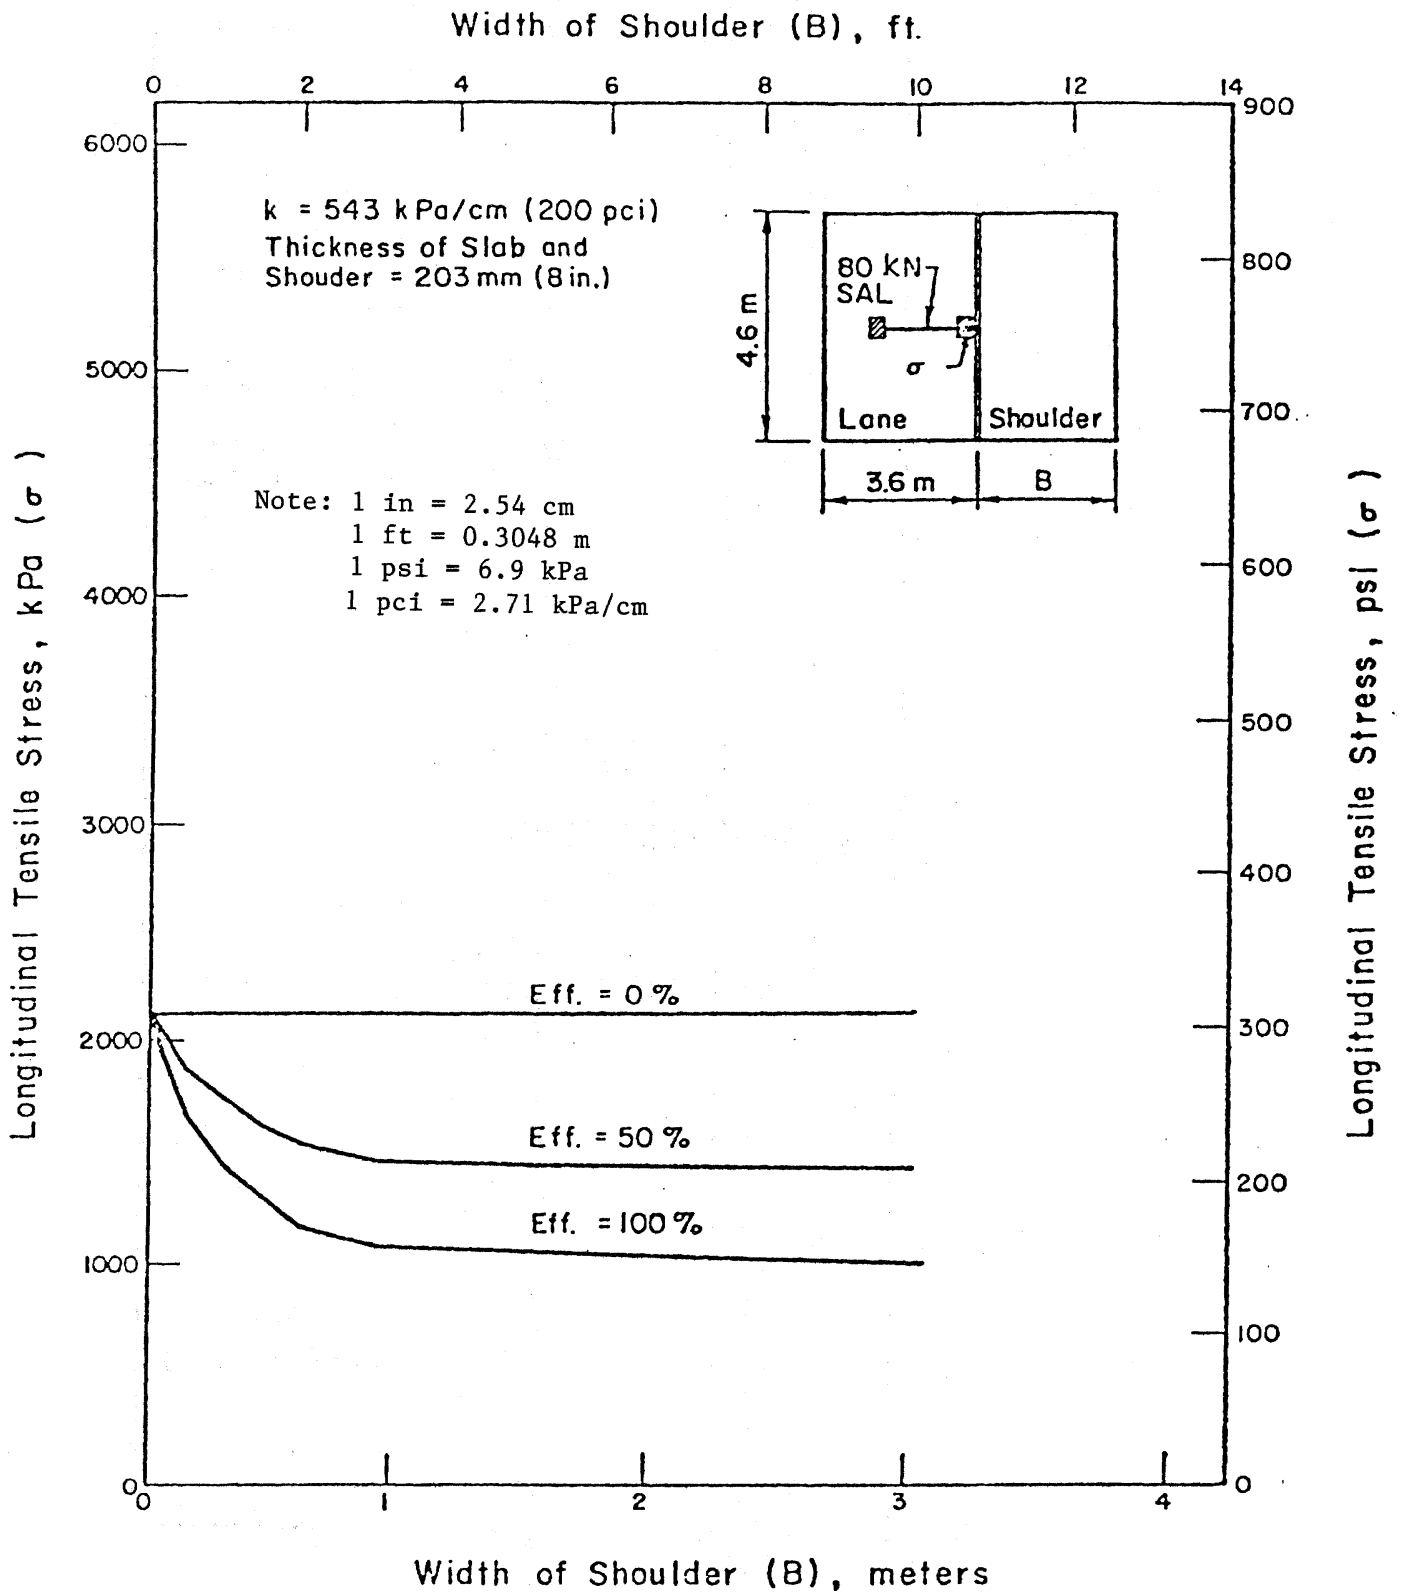
Figure 38. The effect of lane/shoulder tie and width of PCC shoulder on tensile stress of traffic lane.(6)

Figure 37 shows the effect of edge support on edge deflection. A concrete shoulder with a strong tie that provides 100 percent deflection load transfer efficiency reduces the deflection by one-half as shown. Figure 38 shows the effect of both the joint load transfer efficiency and the width of the shoulder. Again, good load transfer reduces the stress by one-half. The width of the support beam/shoulder has a major effect from 1 to 3 ft [0.3 to 0.9 m].

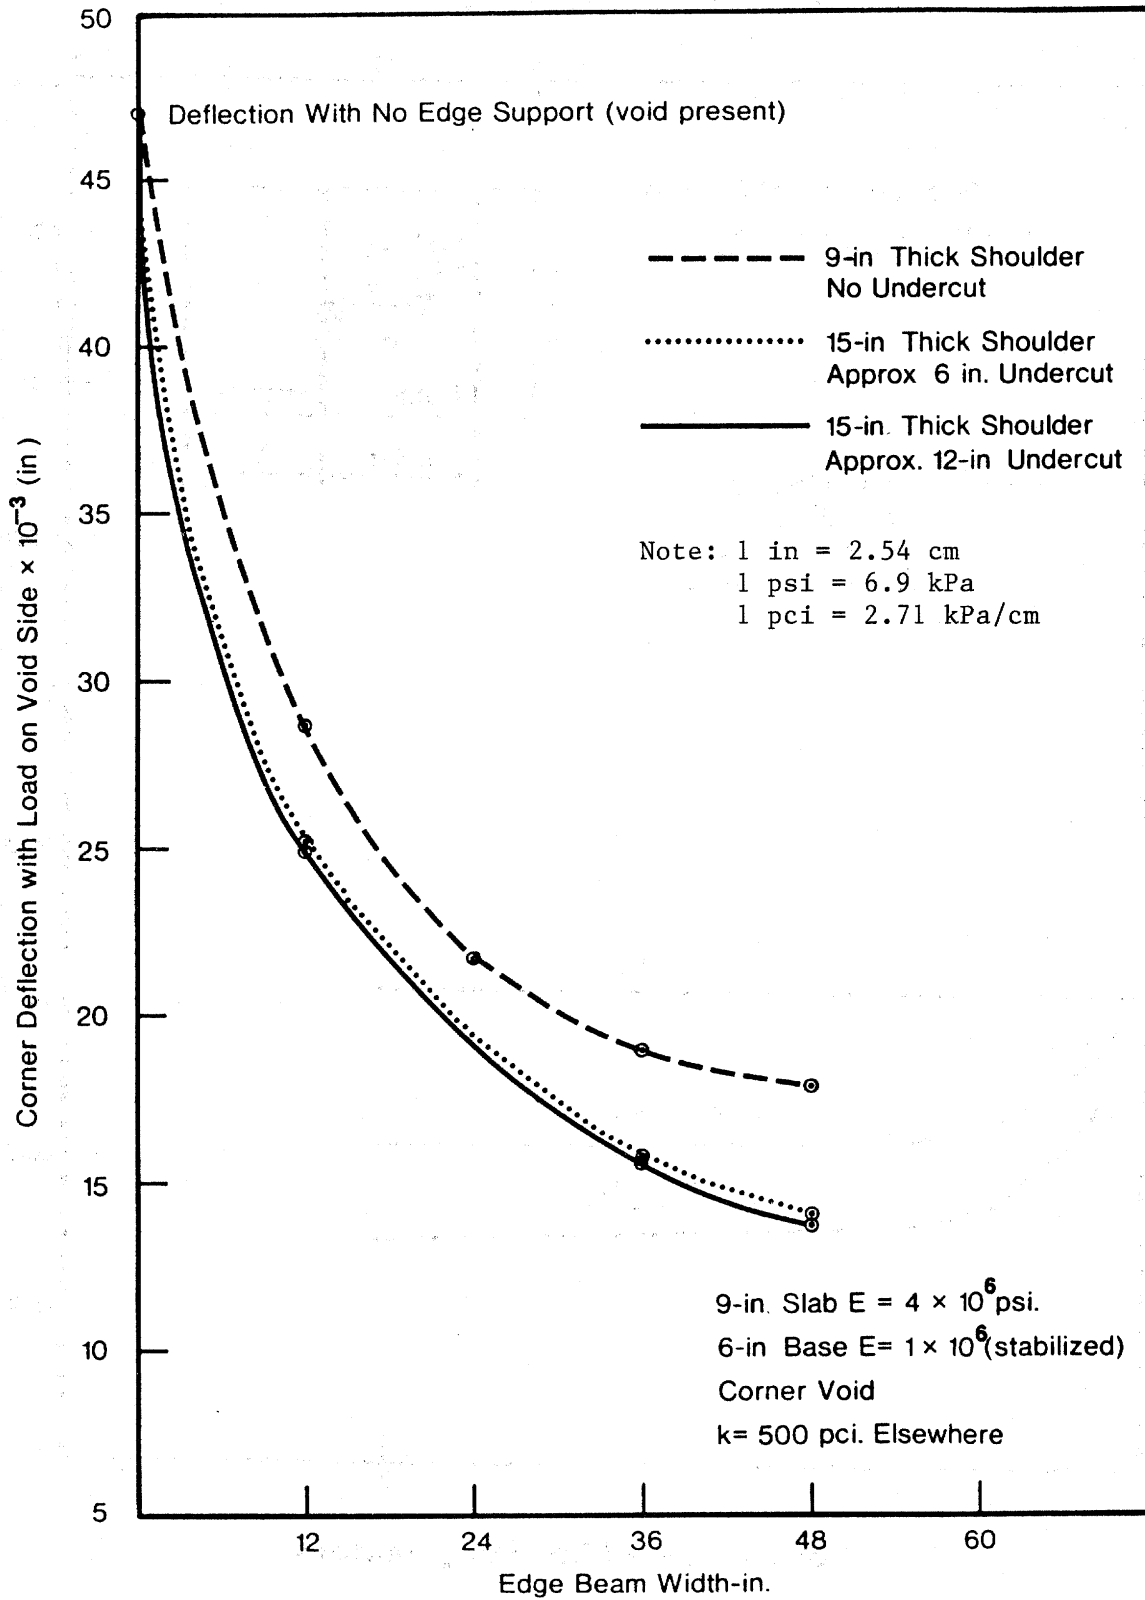
Figure 39. Effect of edge support on slab corner deflection with a stabilized subbase.(6)

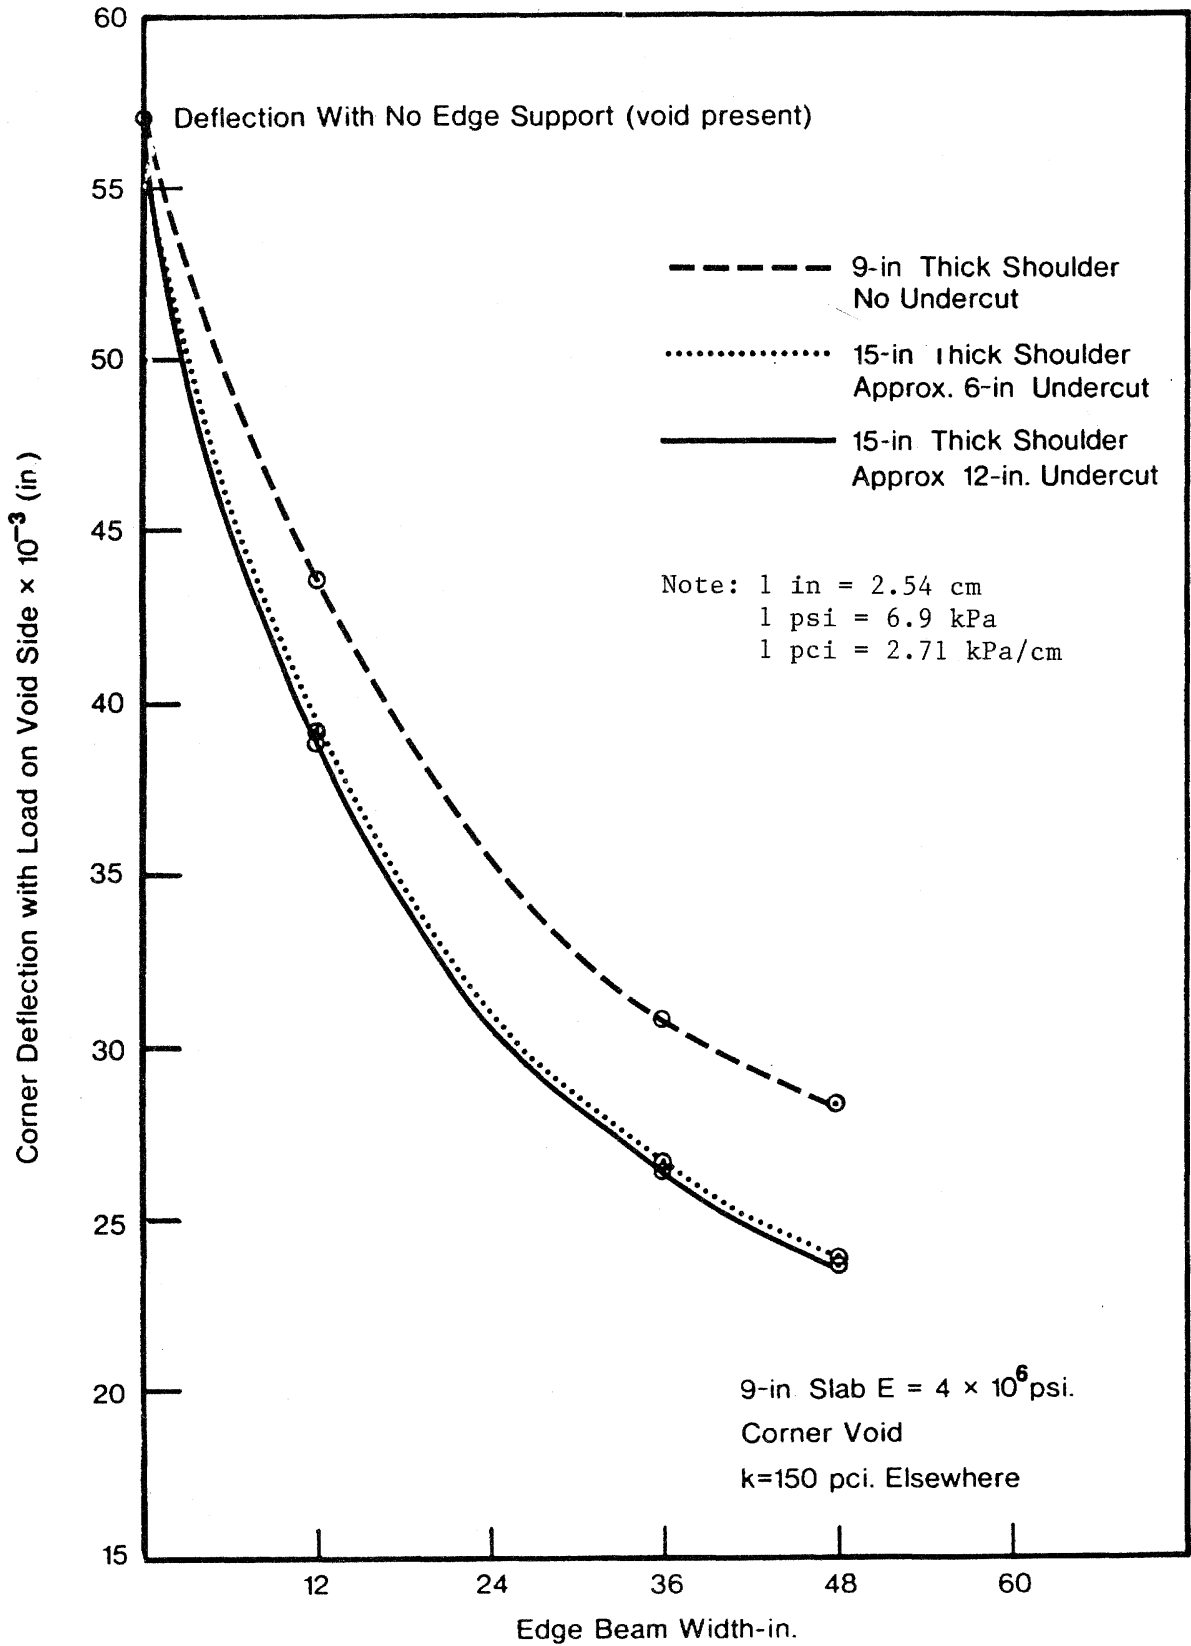
Figure 40. Effect of edge beam on slab corner deflection with a granular subbase. (6)

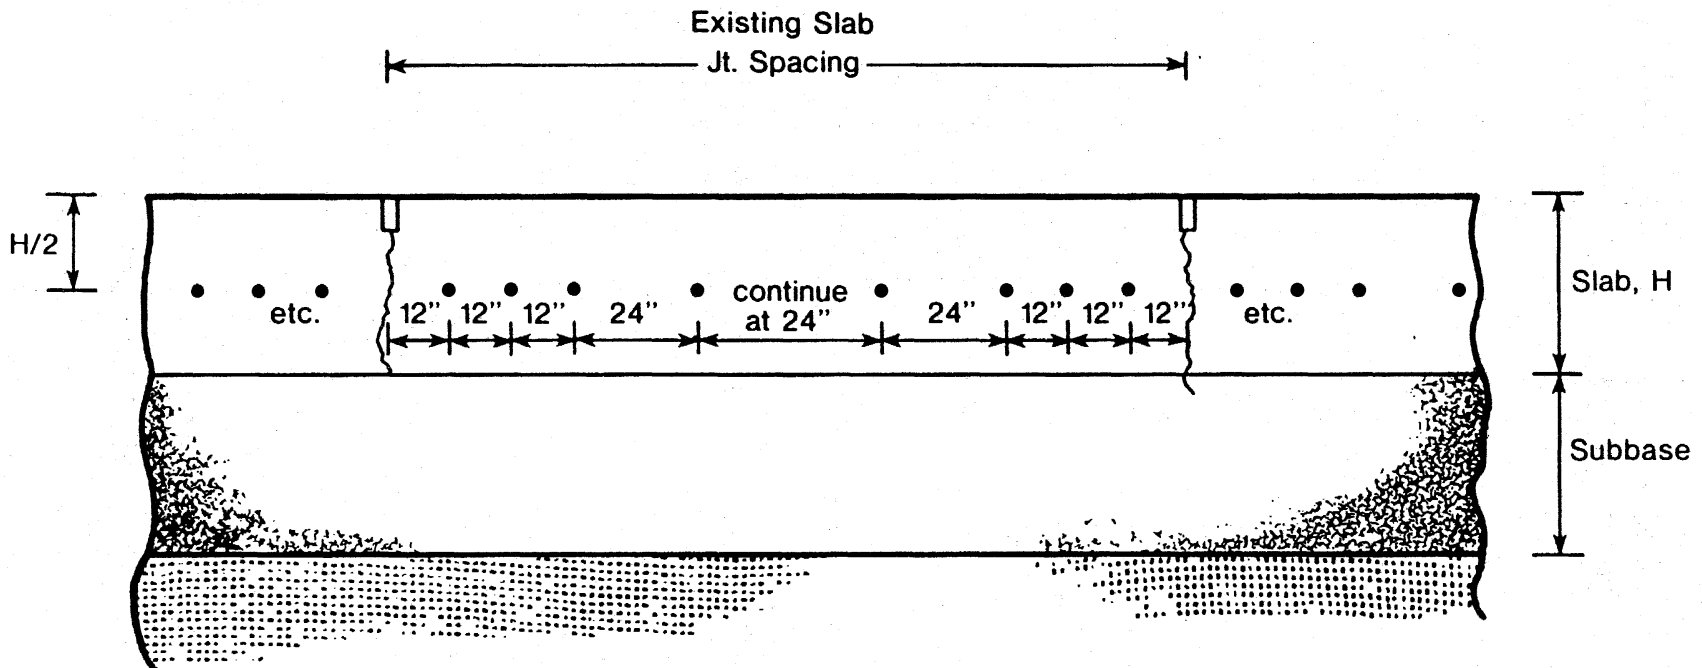
Figure 41. Recommended tie bar spacing (No. 5 deformed rebar or equivalent).(6)

Malleable tie bars of small diameter (No. 4 or 5) spaced 12-24 in [30.5-61.0 cm] at midslab depth are preferable as shown in figure 41. In areas where deicing salts are used, the bars should be coated with a corrosion resistant coating. Other means of tying the shoulder to the traffic lane (such as a 5/8-in [1.6 cm] round tie bolt with a hook) should be fully tested to ensure full bar yield strength development.

The depth of the beam should be at least the thickness of the slab. The edge beam should be jointed to prevent thermal curling stresses and to match the existing pavement. Weakened-plane contraction joints, perhaps with dowels for structural stability, should be formed as soon as possible after placement. Figure 41 illustrates the joints and tie bar design recommended by NCHRP 1-21 to provide improved corner load transfer.(32)

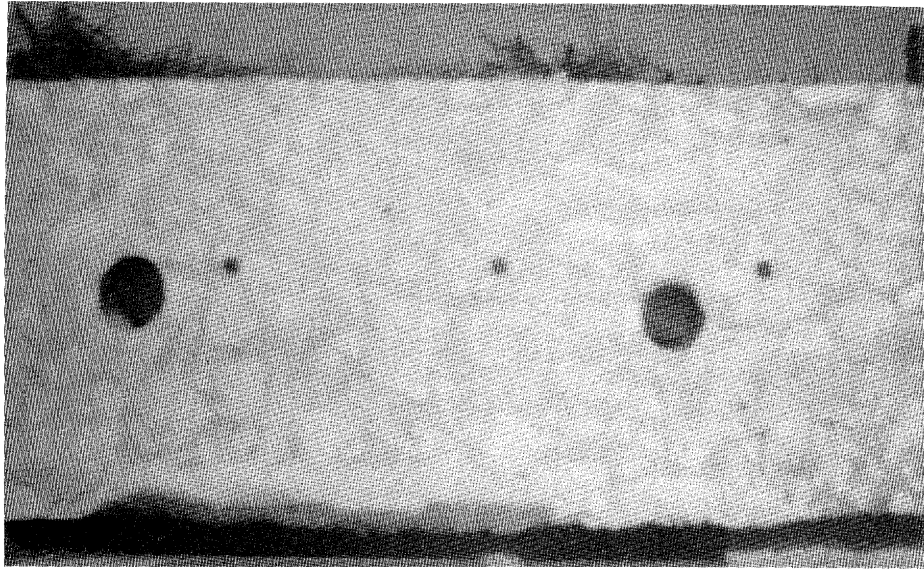
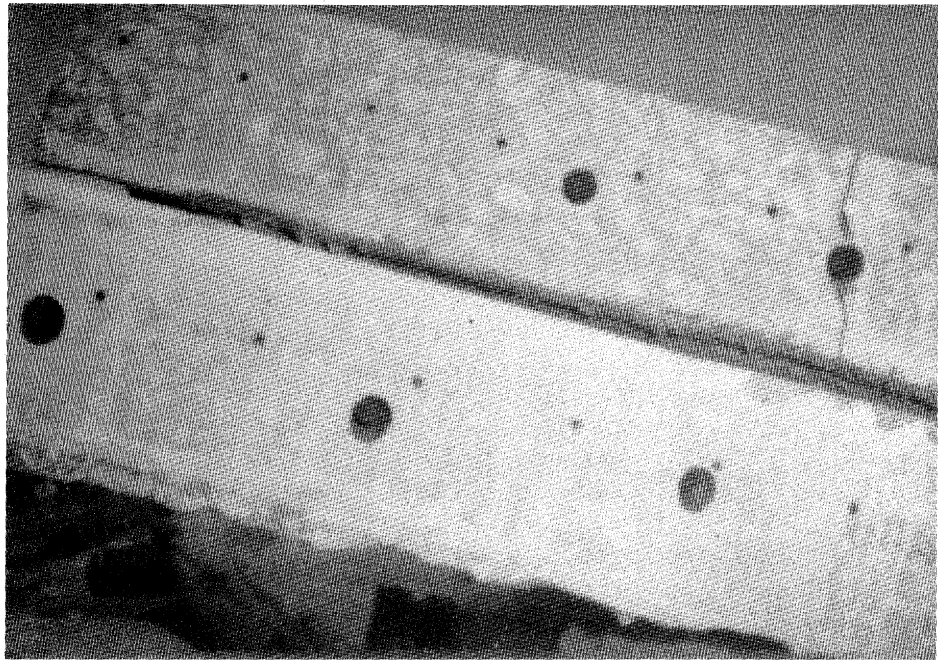
Figure 42. Elongation of transverse repair joint dowel holes after one year of heavy traffic.

When these same devices are installed in full-depth repair joints, loss of load transfer is often accelerated due to built-in defects, such as weak, damaged or missing grout or epoxy material in the immediate vicinity of the device, inadequate structural design of the device, and improper installation or construction.(35) Figure 42 illustrates the elongation of transverse repair joint dowel holes due to poor dowel bar grouting and erosion of the supporting concrete that was observed after only 1 year of service on a heavily trafficked pavement.

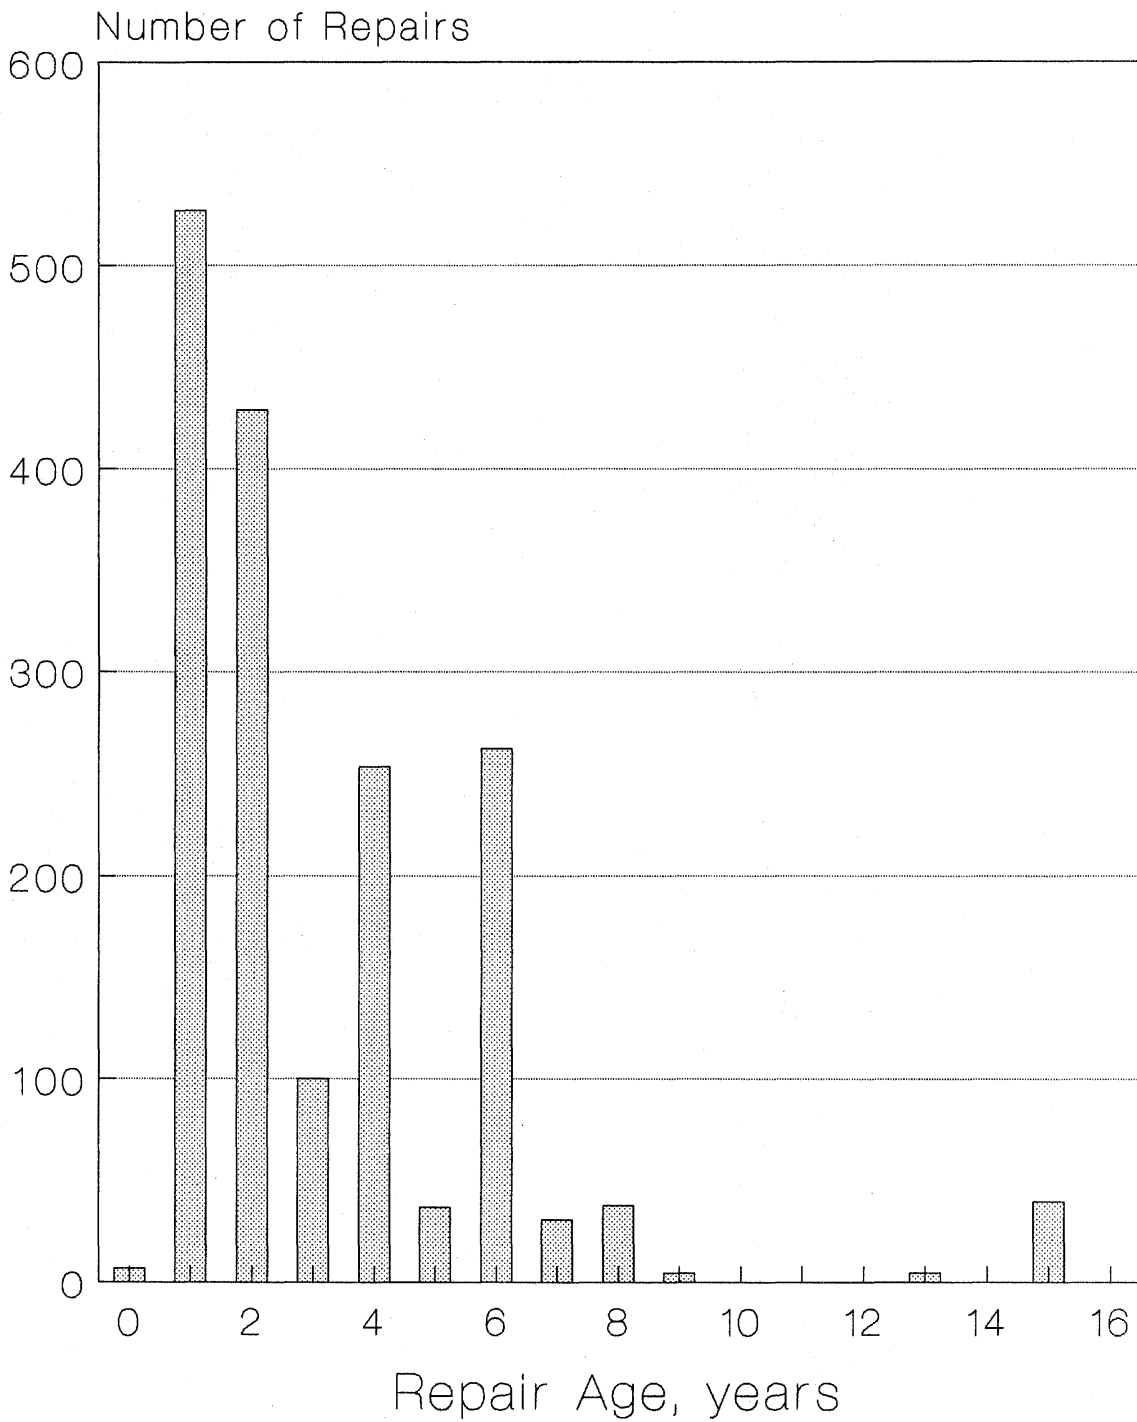
Figure 44. Distribution of full-depth repair ages.

Figure 43 shows the distribution of repairs across the United States. Figure 44 presents the age distribution of the surveyed repairs and table 19 presents the distribution of cumulative 18-kip [80-kN] equivalent single-axle loads and load transfer system designs for these repairs.

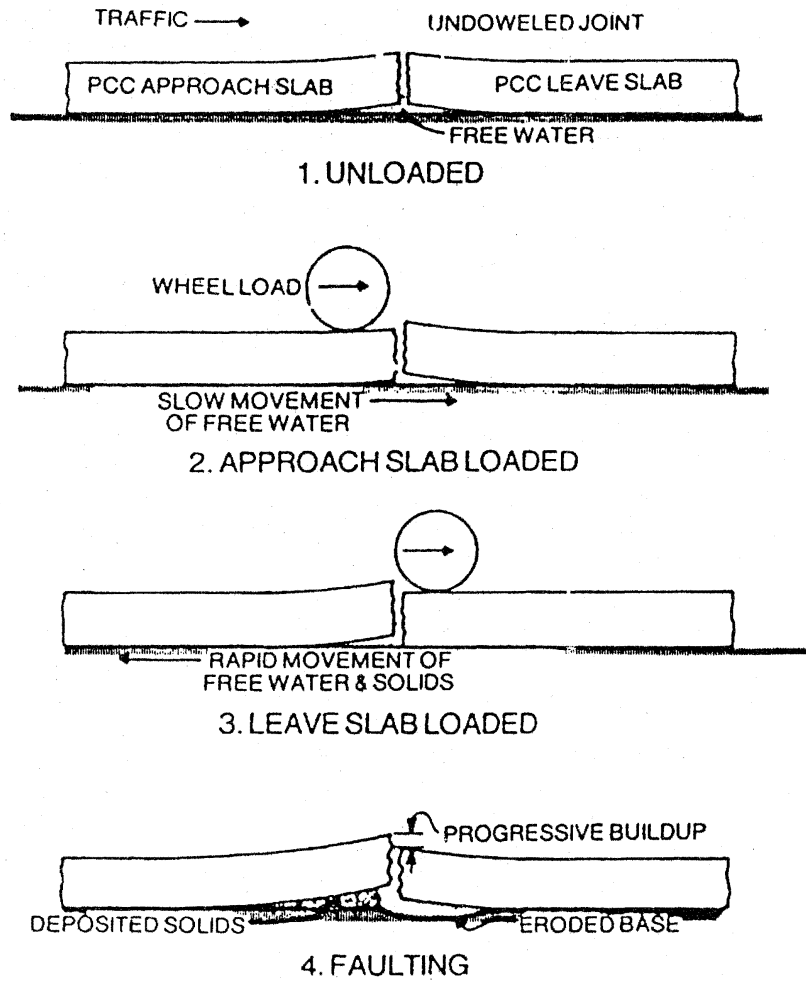
Figure 45. Illustration of the development of faulting at transverse joints.(7)

Possible explanations for this finding were sought in the accepted mechanisms for faulting at pavement contraction joints, which are illustrated in figure 45. Where excess moisture, heavy traffic and erodible pavement layers are present, the

moisture under the slab can be moved (relatively slowly) across the joint by approaching traffic and ejected (rapidly) as the traffic crosses the joint, carrying eroded material back to the approach side of the joint, where it is deposited. A buildup of this material will lift the approach slab while a void develops beneath the leave slab. This mechanism also depends on the independent vertical movement of the two slabs at the joint. Faulting is reduced by nearly one-half where good load transfer capacity exists.

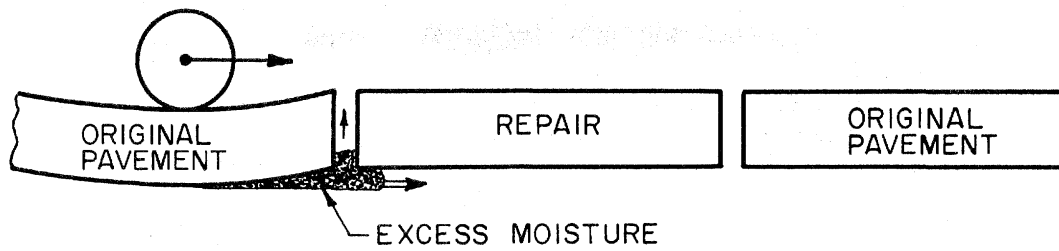
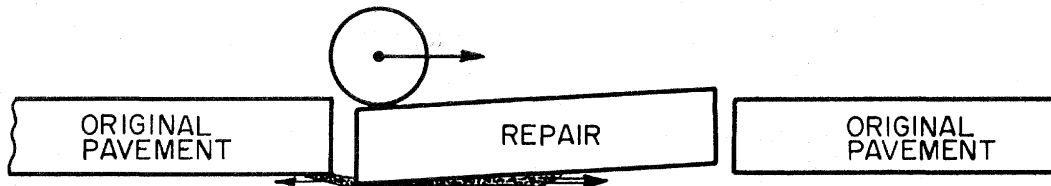
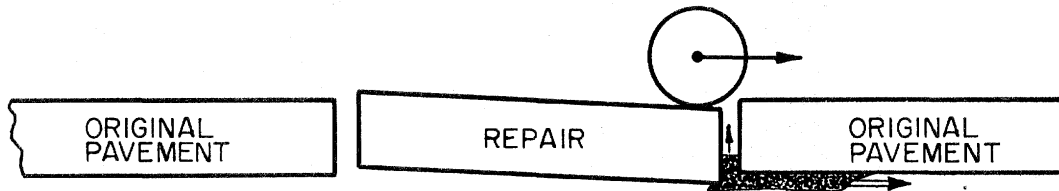
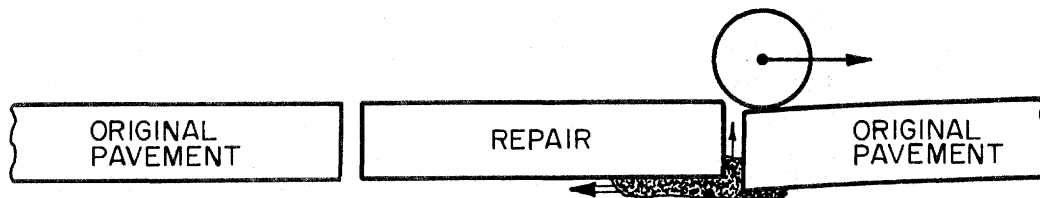
a) Moisture is Squeezed Forward by Approaching Wheel Load

b) Wheel Crosses Repair Joint and Repair Tilts Slightly, Allowing Some Moisture to Eject Backwards (Causing Some Approach Joint Faulting) But Forcing Most Moisture Forward

c) Wheel Approaches Repair Leave Joint, Pushing Excess Moisture Ahead

d) Wheel Crosses Leave Joint and Most Moisture is Ejected Backward, Carrying Erodible Foundation Materials and Causing Leave Joint Faulting

Figure 46. Illustration of possible mechanism for repair faulting where leave joint faulting exceeds approach joint faulting.

These different types of behavior would result in different moisture movements than were described above. A rocking motion of the repair would allow the moisture (or a substantial portion of it) to continue to be pushed forward as the traffic crosses the repair approach joint. As the traffic crosses the repair leave joint, the water would be ejected from beneath the original slab and deposited under the repair leave joint, resulting in a larger repair leave joint fault. This process is illustrated in figure 46.

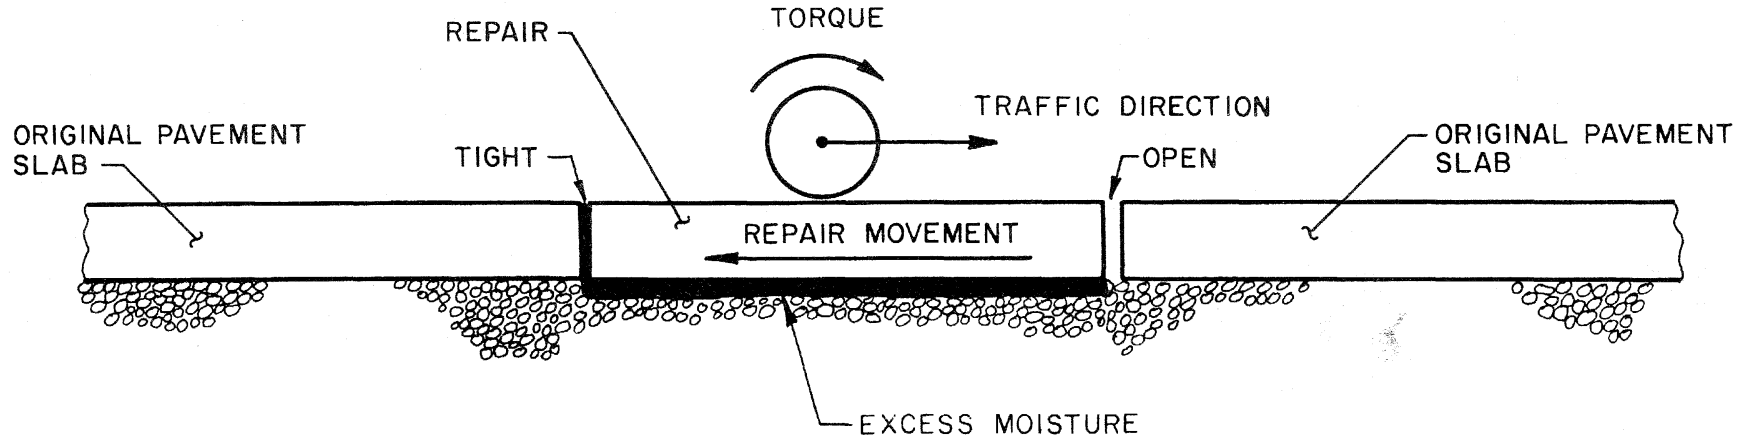
Figure 47. Full-depth repair loading and faulting mechanism.

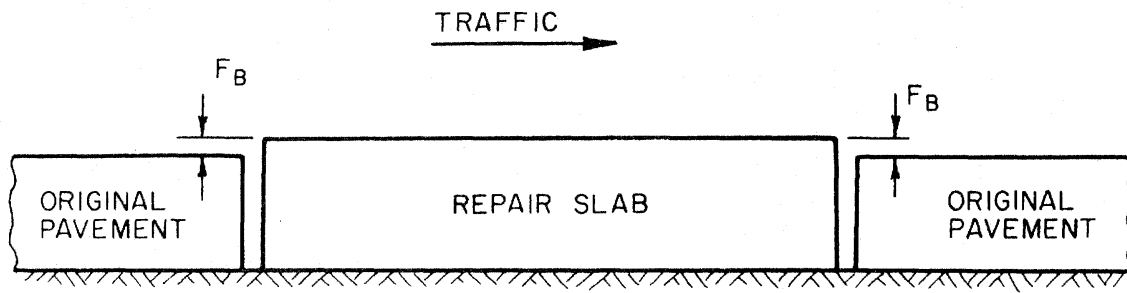
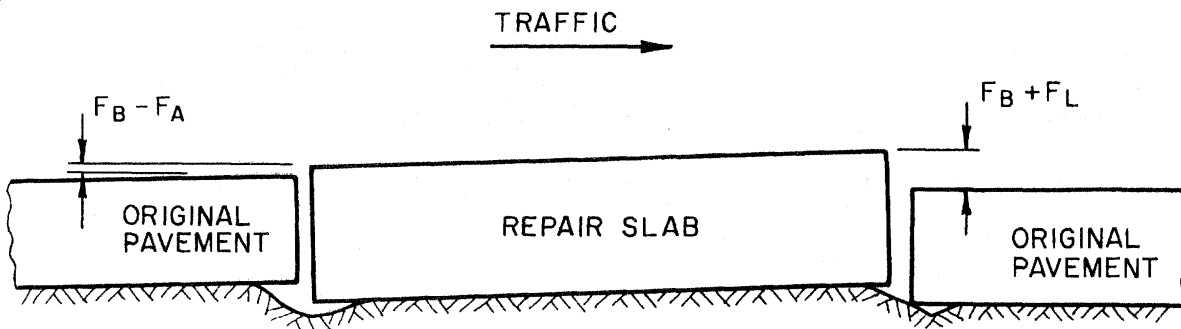
a) Overfilled Repair Immediately After Construction (Built-In Approach Joint Fault = $-F_B$, Built-In Leave Joint Fault = F_B)

b) Overfilled Repair After Development of Faulting

F_B = "Built-In" Faulting Due to Overfilling of Repairs

Finally, the overfilling of many repairs results in a "built-in" negative approach joint fault (leave slab higher than approach) and a positive leave joint fault (leave slab lower than approach). If accepted pumping and faulting mechanisms are active at both repair joints, the approach slab will be raised relative to the leave slab at each joint, causing the magnitude of approach joint faulting to decrease until it changes from negative to positive. The magnitude of faulting at the repair leave joint will increase from its initial value. This process is illustrated in figure 48.

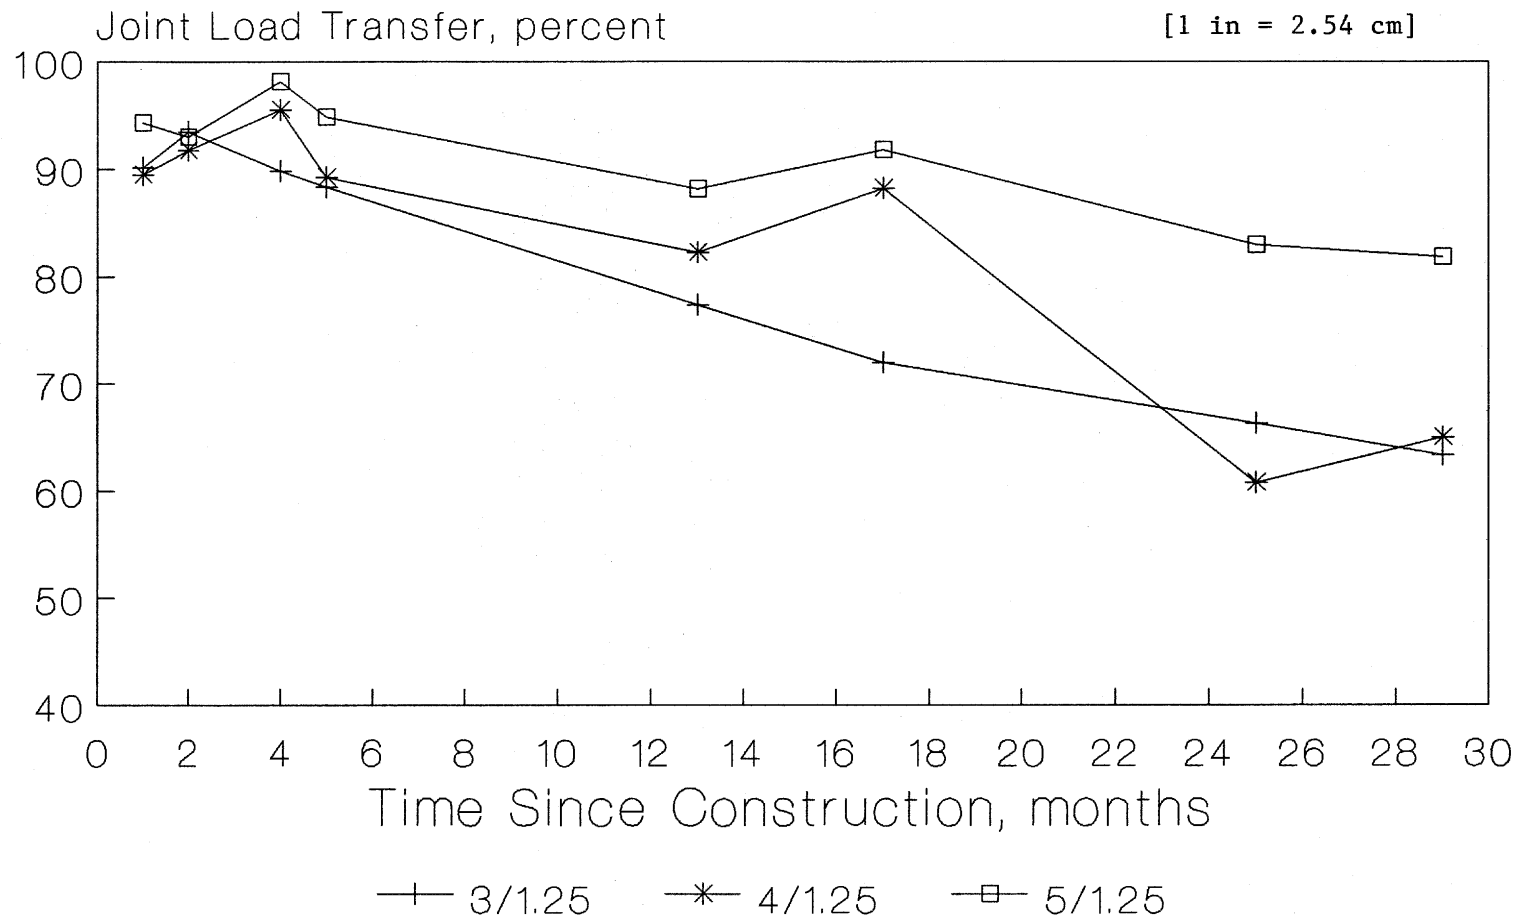
Leave Joint Load Transfer vs. Time

Figure 49. Plot of leave joint load transfer vs. time for varying numbers of 1.25-in [3.2-cm] dowels per wheelpath.

data were collected by Illinois DOT personnel. The load transfer data were collected using a Dynatest Model 8000 Falling Weight Deflectometer. These data represent relatively short-term performance, but they come from one of the few well-designed experimental repair projects that have been constructed in the United States to date and provide a good indication of general performance trends. Figures 49 through 53 contain graphical presentations of some of the collected data and illustrate several key conclusions.

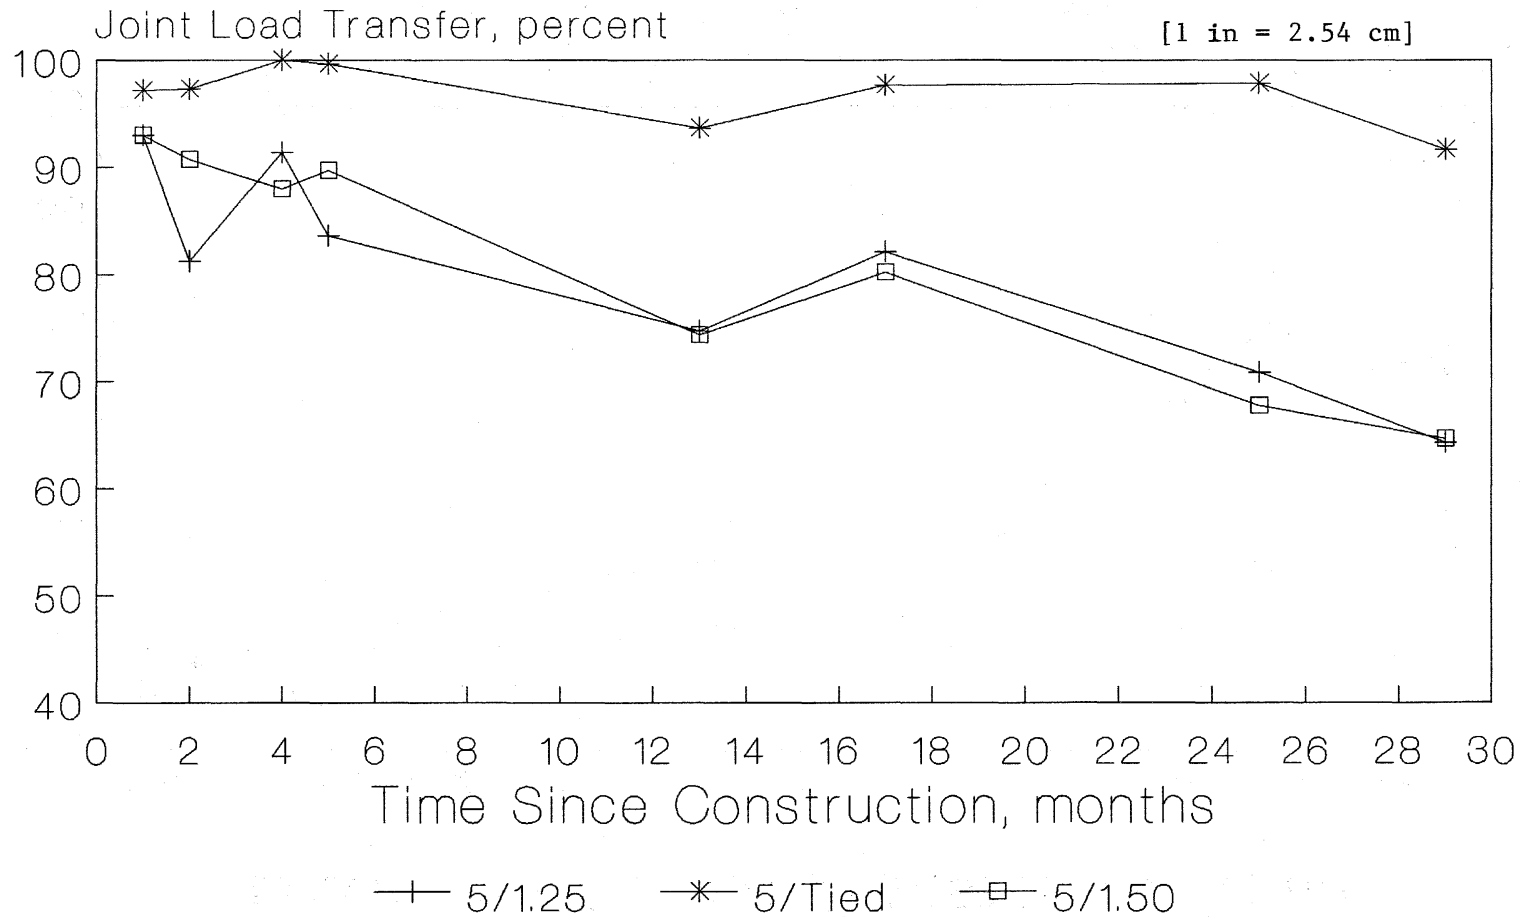
Illinois I-70 Experimental Project Approach JLT vs. Time (EB and WB)

Figure 50. Plot of approach joint load transfer vs. time for tied and dowelled joints.

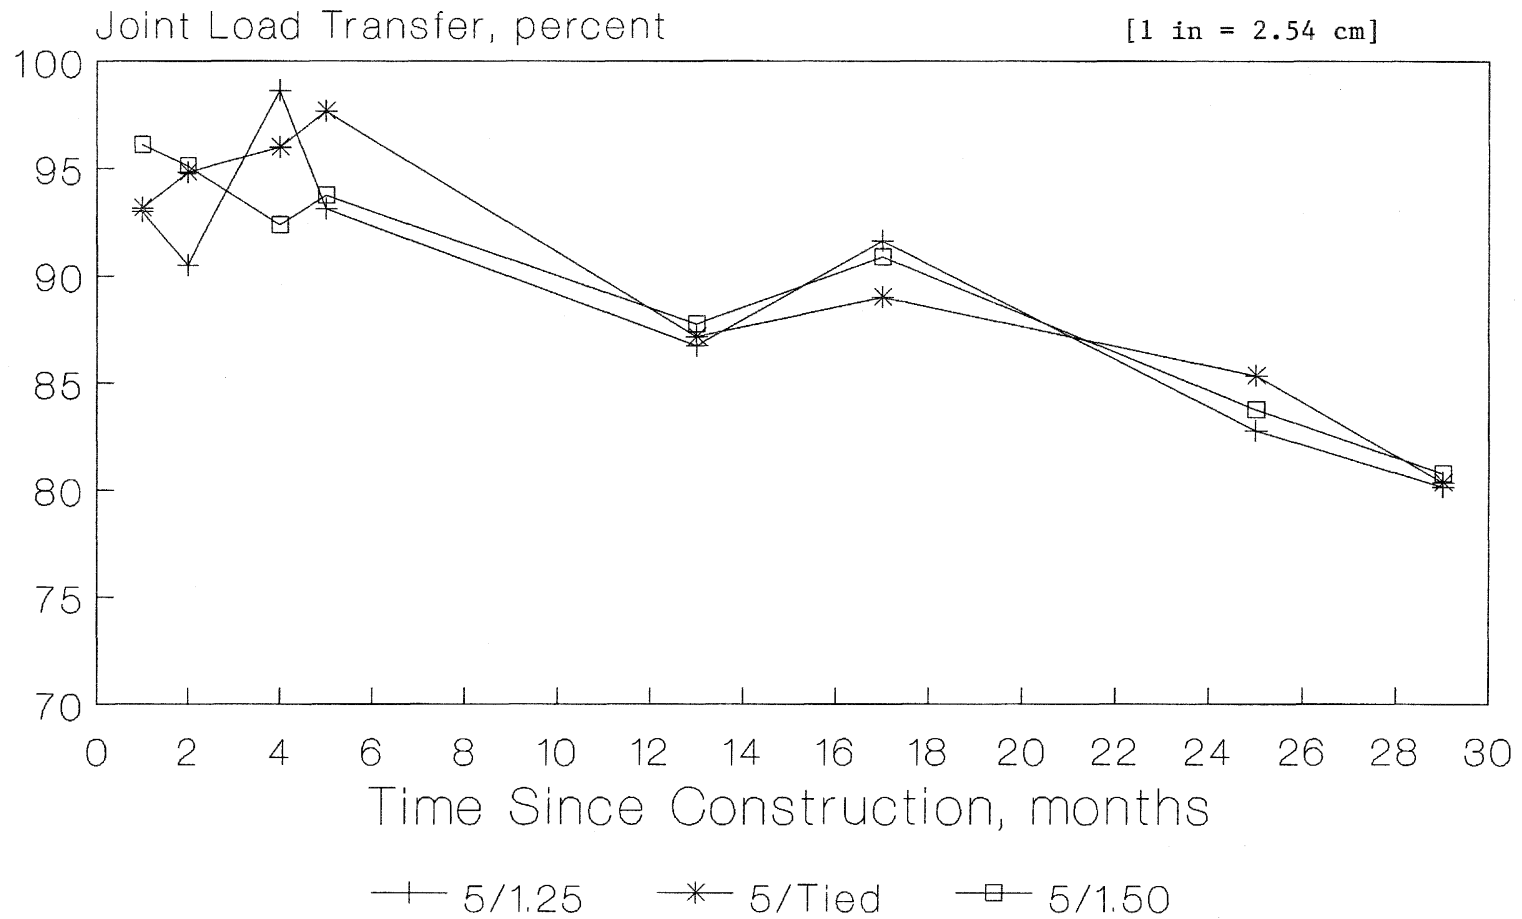
Illinois I-70 Experimental Project Leave JLT vs. Time (EB and WB)

Figure 51. Effect of tied and dowelled approach joints on leave joint load transfer.

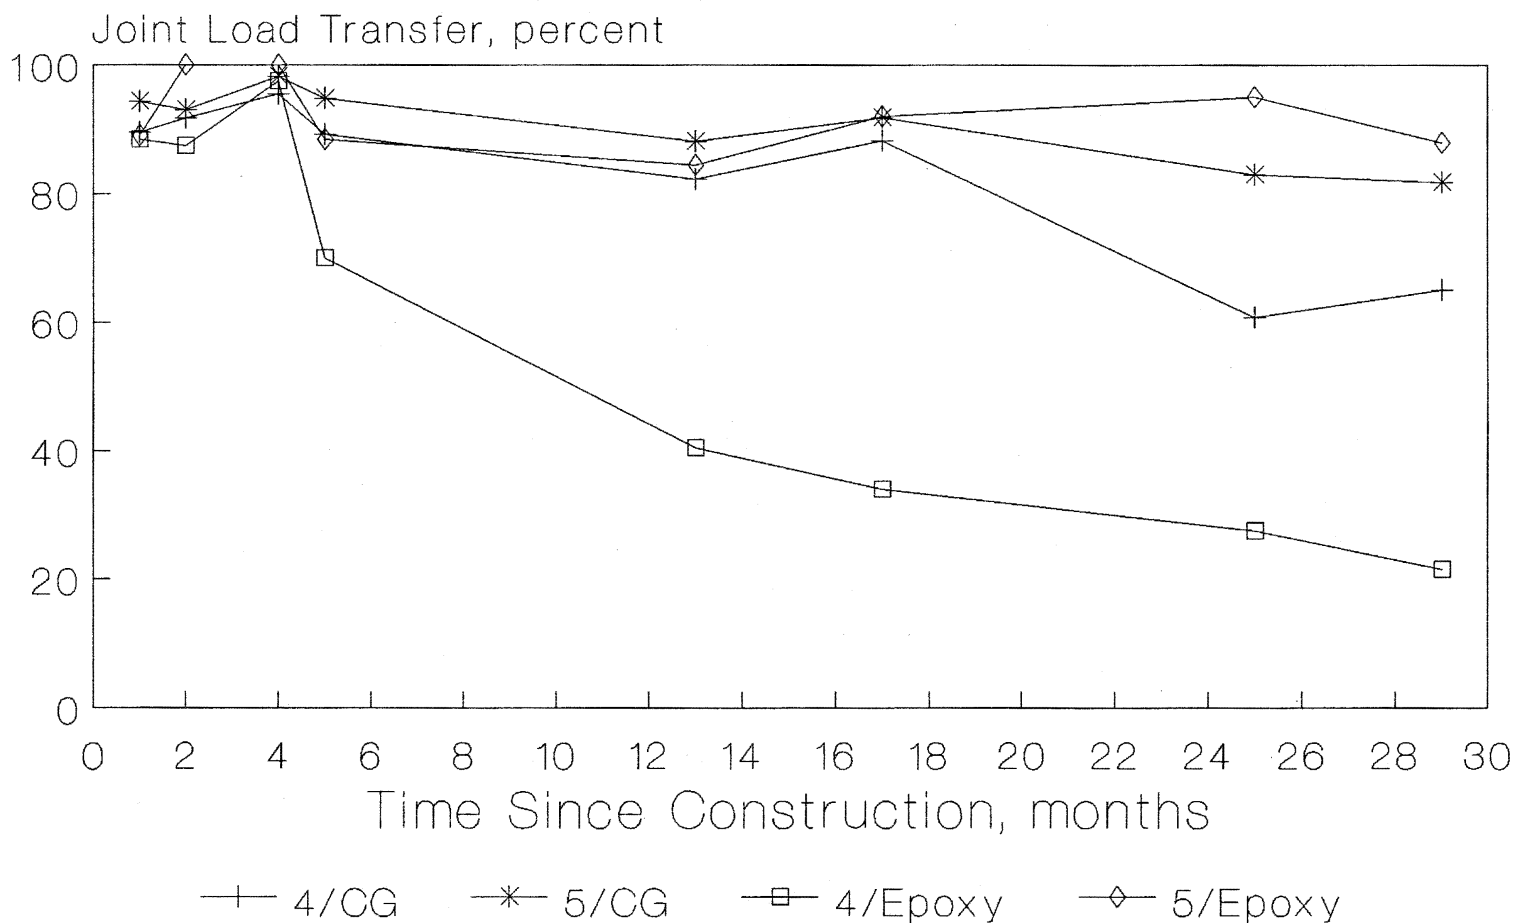
Illinois I-70 Experimental Project Leave Joint Load Transfer vs. Time

Figure 52. Effect of varying anchor materials and number of dowels per wheelpath on repair leave joint load transfer.

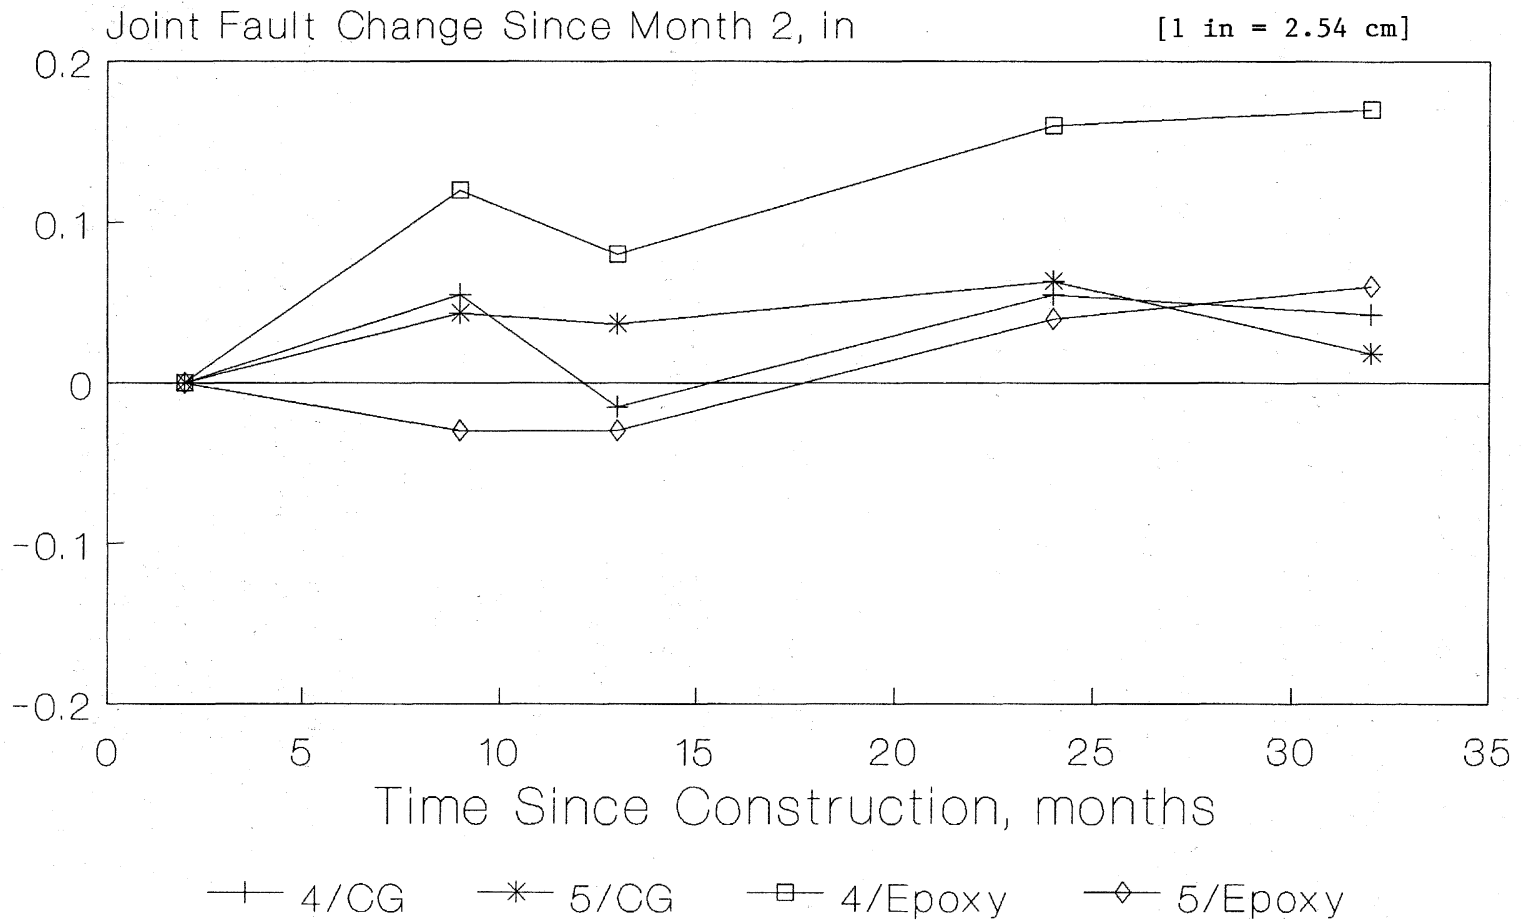
Lv. Joint Faulting vs. Time (EB)

Figure 53. Effects of varying anchor materials and number of dowels per wheelpath on repair leave joint faulting.

faults were measured on the repair with four dowels per wheel path and epoxy mortar anchor material, which also exhibited the poorest load transfer. The repair with the best load transfer (five dowels per wheel path, epoxy mortar) developed very little faulting (less than 0.05 in [0.13 cm]) over 32 months. The other repair types covered in this figure also exhibited very little faulting, which indicates that large dowels (1.25-in [3.2 cm] diameter or greater) and good construction practices can produce good results with either cement grout or epoxy mortar.
