Publication No. FHWA-RD-88-071
July 1989

Rehabilitation of Concrete Pavements

Volume I: Repair Rehabilitation Techniques

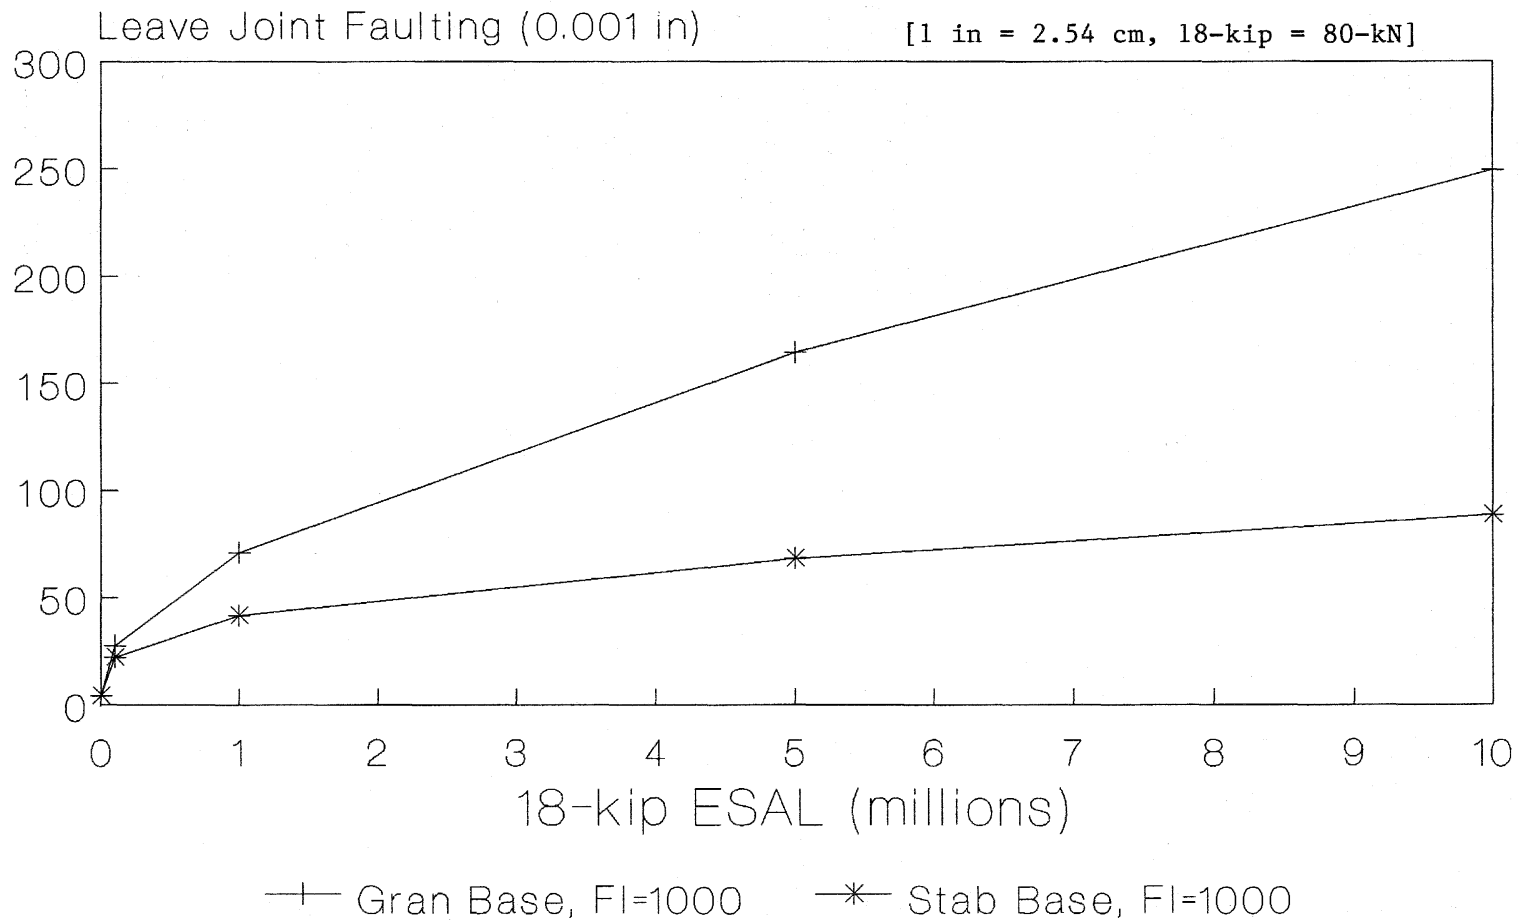
Predicted Repair Leave Joint Faulting 500,000 18-kip ESAL/yr

Figure 54. Sensitivity of repair leave joint faulting model to traffic and base support.

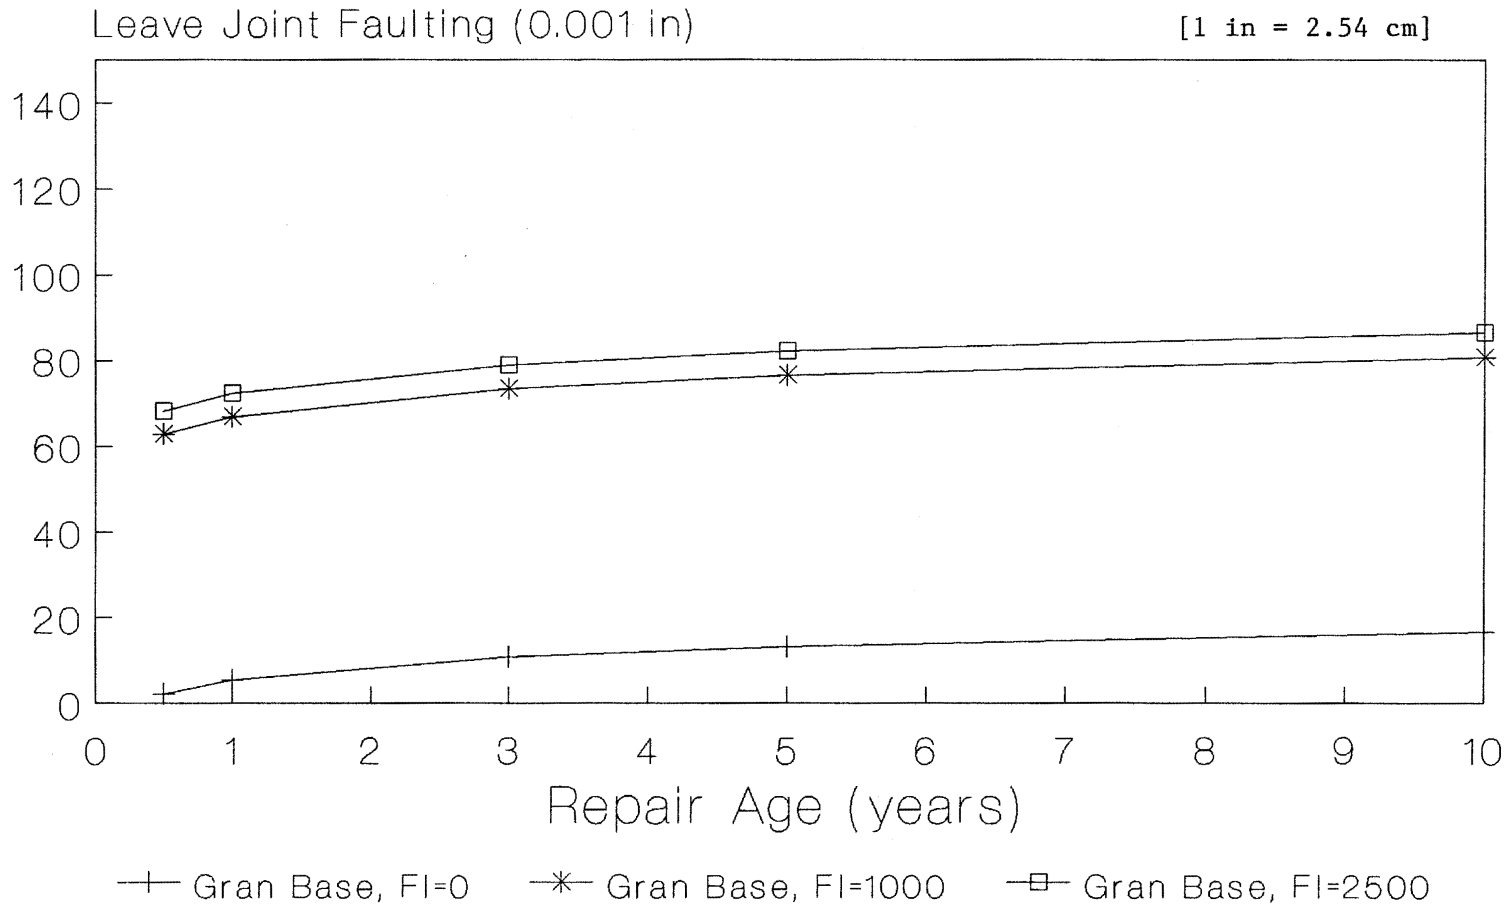
Predicted Repair Leave Joint Faulting Varying Repair Age and FI, 1E6 ESAL

Figure 55. Sensitivity of repair leave joint faulting model to climatic factors (Freezing Index and age).

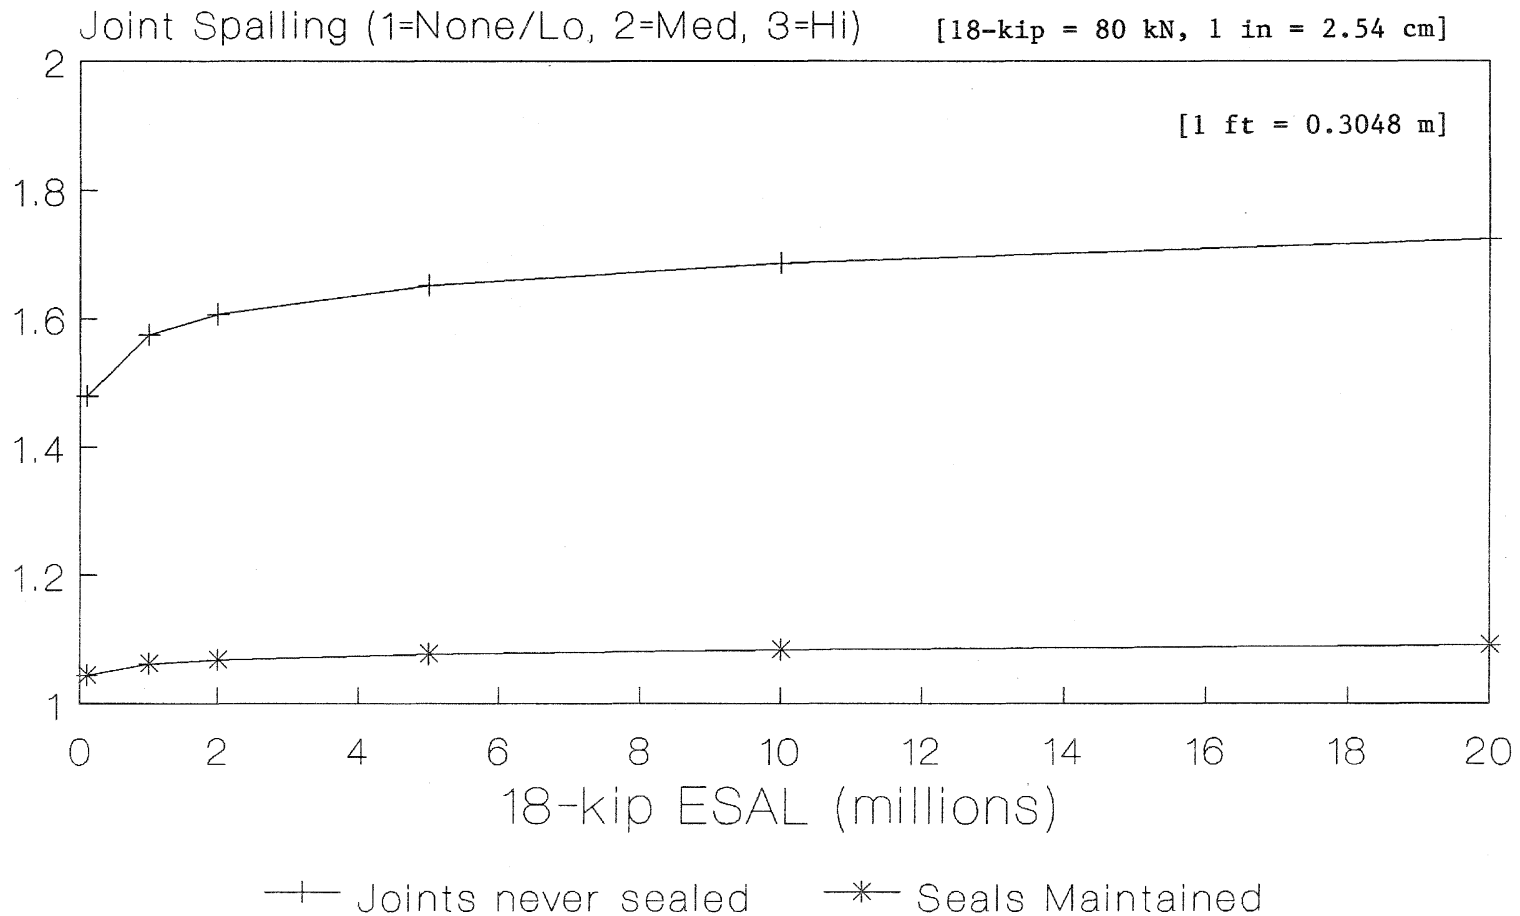
30 ft Jts, No Agg Problems, Jt Wd=0.3 in

Figure 56. Sensitivity of repair approach joint spalling model to traffic and the use and maintenance of repair joint seals.

The sensitivity of the repair approach joint spalling model is presented in figures 56 and 57. Figure 56 illustrates the tremendous effect of using and maintaining repair joint seals. Even after many years of heavy truck traffic, repairs may resist joint spalling if the transverse joint seals are maintained. The exclusion of joint seals, however, is predicted to result in immediate moderate or greater spalling of the joints.

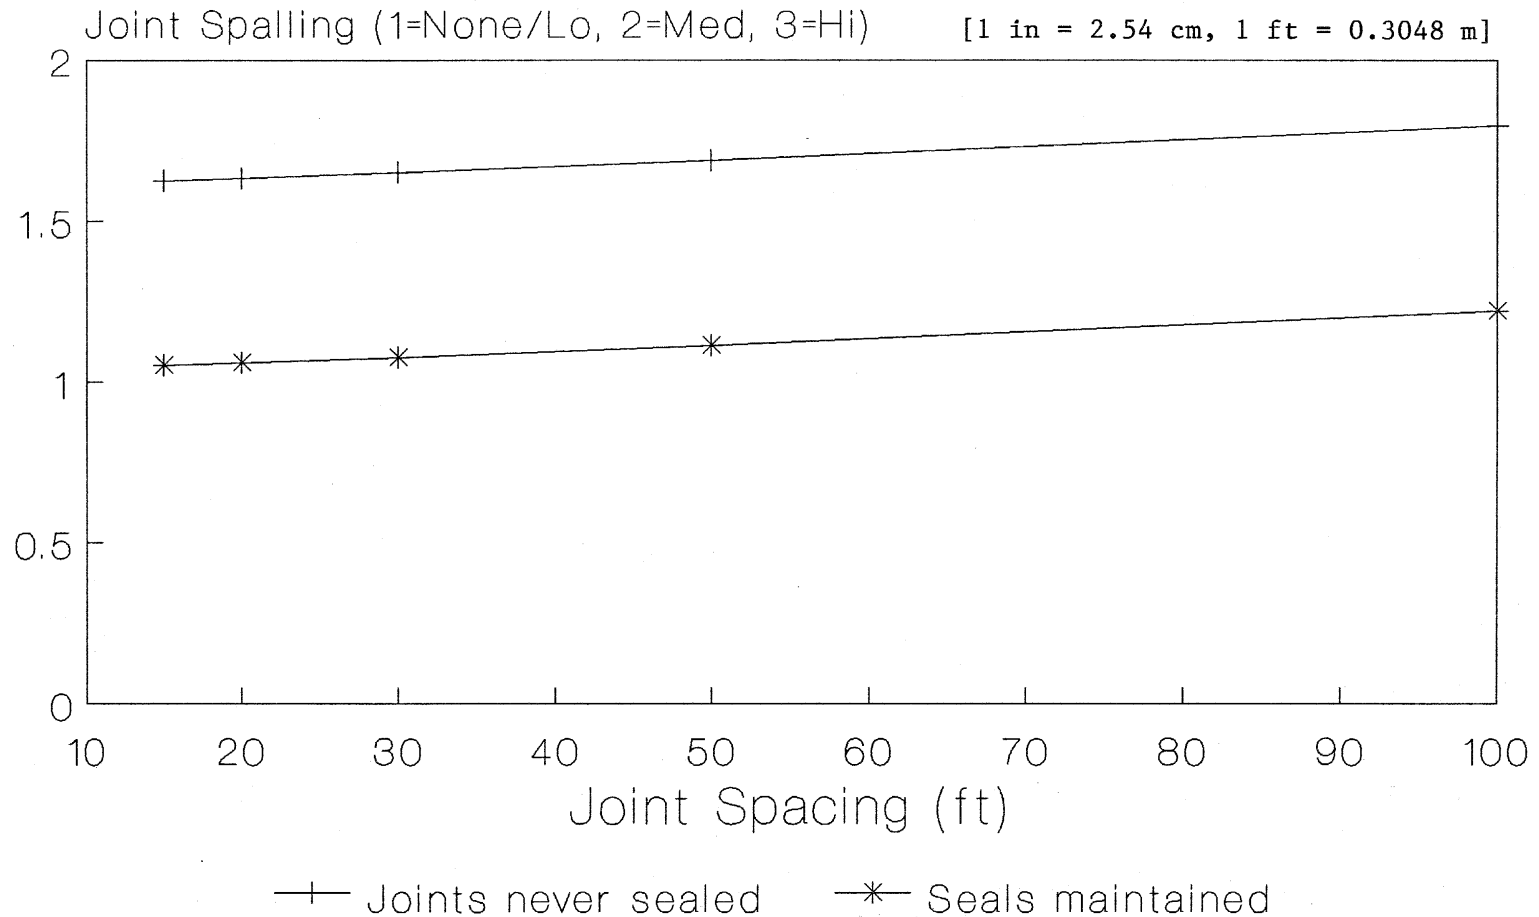
5E6 ESAL, Jt Width = 0.3 in

Figure 57. Sensitivity of repair approach joint spalling model to contraction joint spacing and the use and maintenance of repair joint seals.

Figure 57 reiterates the effect of good joint sealant construction and maintenance practices and also illustrates the predicted increase in repair spalling that might accompany longer joint spacings.

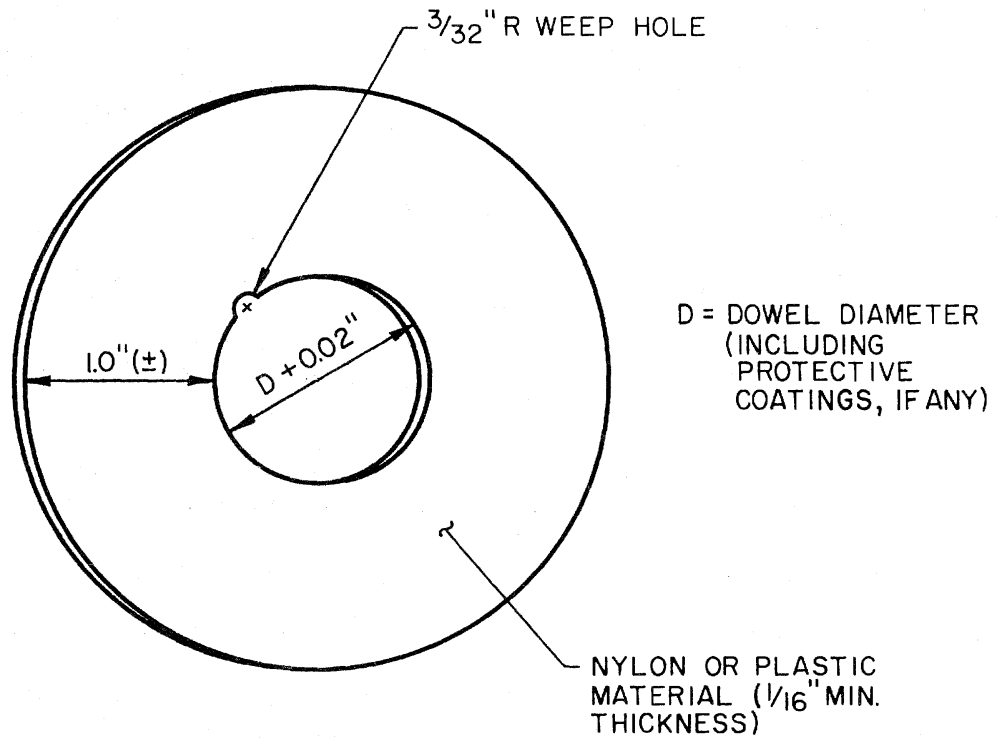
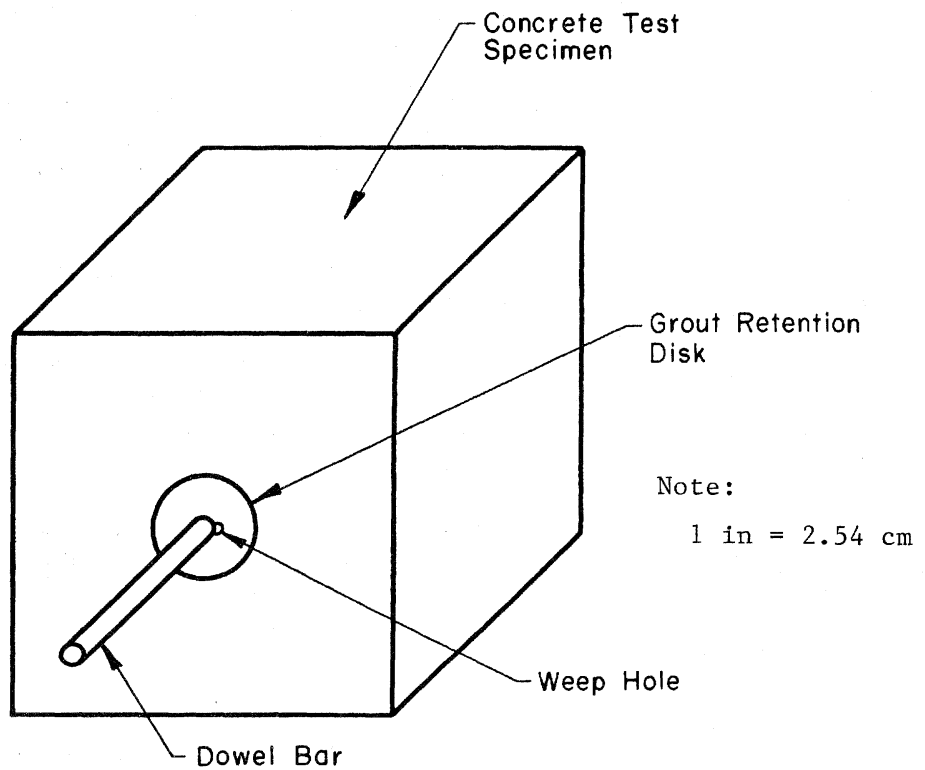
Figure 58. Illustration of grout retention disk used in lab experiment.

The dowels were installed horizontally by injecting sufficient anchor material into the backs of the drilled holes to cause material extrusion when the dowels were inserted. The dowels were allowed to settle or tip in the holes as the anchor material cured. A tight-fitting nylon disk, 2 in [5.1 cm] larger in diameter than the dowel and approximately $\frac{3}{32}$ in [0.24 cm] thick was fixed on each dowel at a distance equal to the embedment length from one end of the dowel (see figure 58). These disks were used to prevent the anchor material from flowing out of the holes and creating voids around the dowels. They also forced the anchor material to fill spalls near the dowel hole on the concrete face caused by the drill.

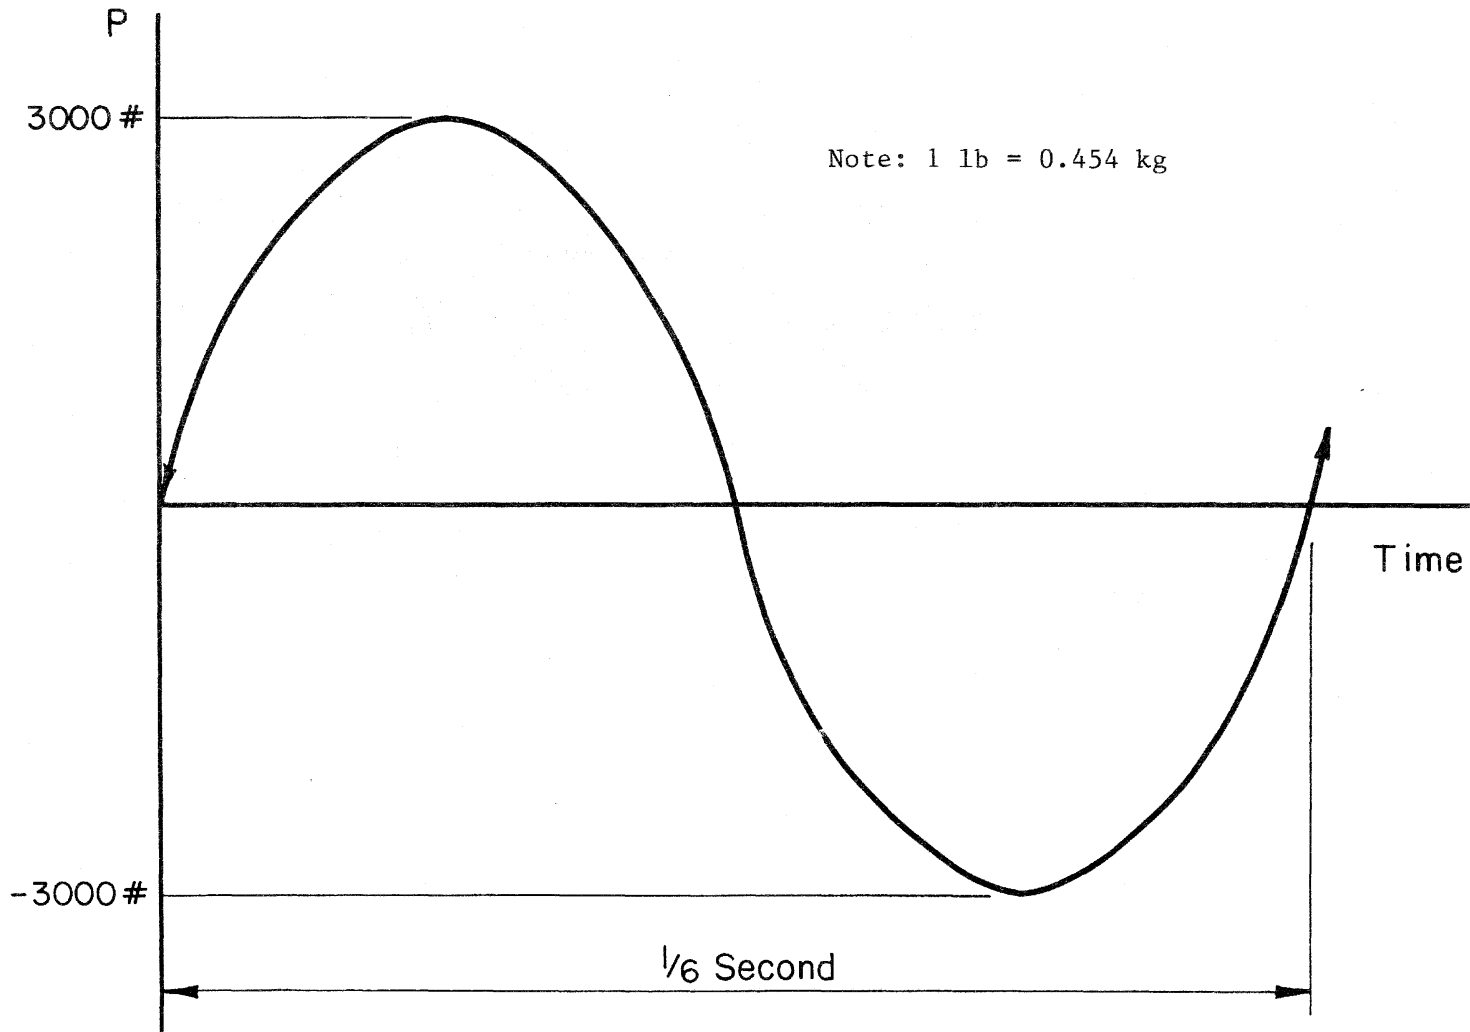
Figure 59. Illustration of load function used for lab testing.

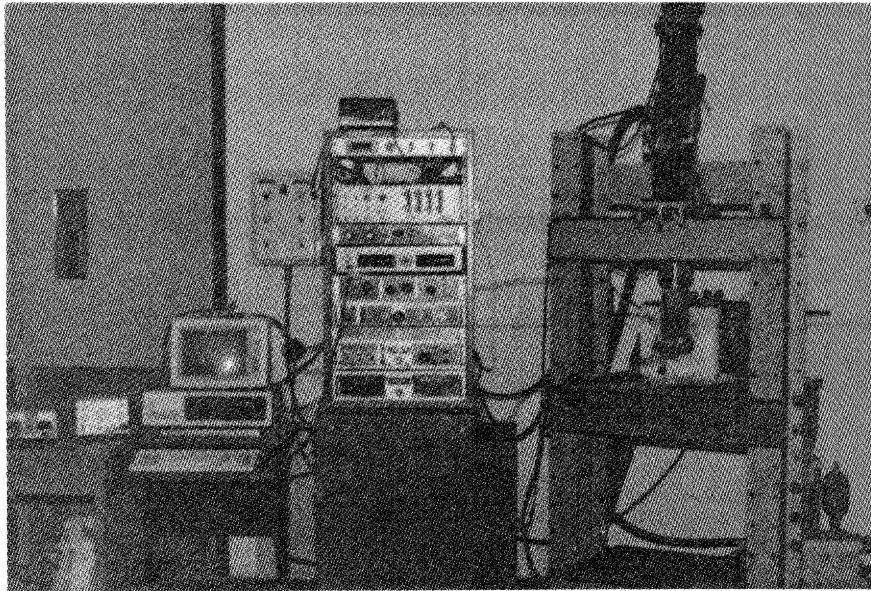
Figure 60. Repeated dowel load test assembly.

The entire test operation was controlled by an IBM Personal Computer using a Data Translations DT-2801A Analog/Digital (A/D) board and a controlling program written in BASIC using the PCLAB library of A/D board control subroutines.(38) Figure 60 shows the entire test assembly arrangement.

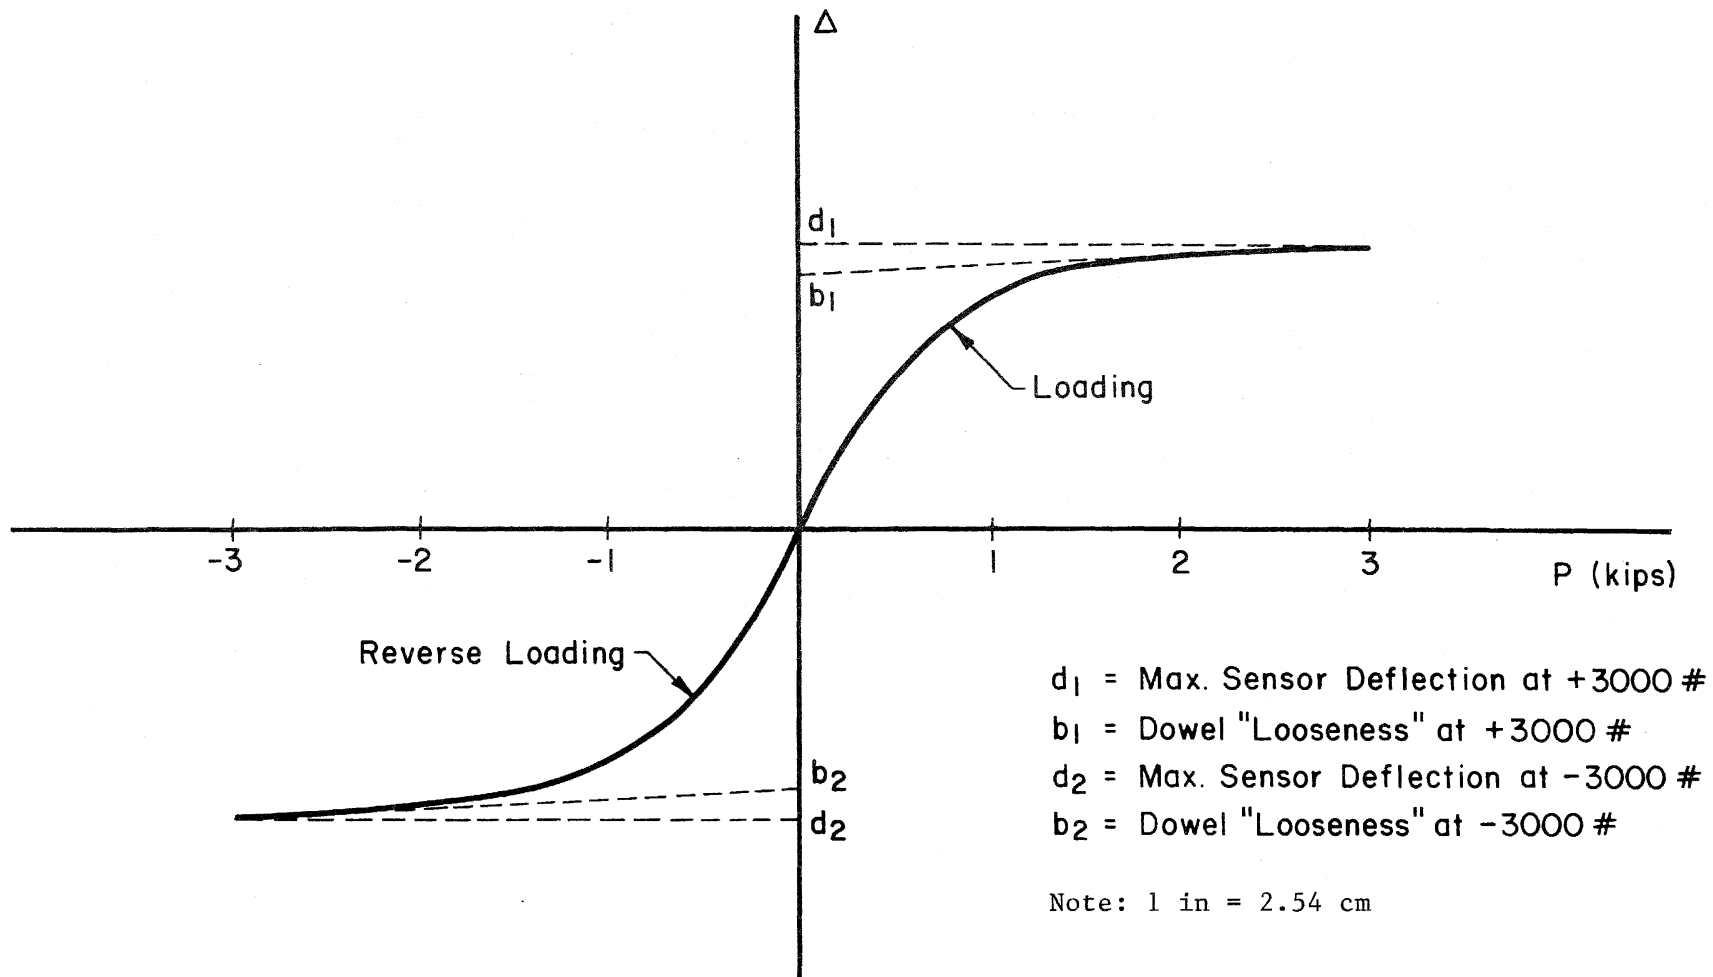
Figure 61. Illustration of estimation of dowel looseness from load deflection curve.(47)

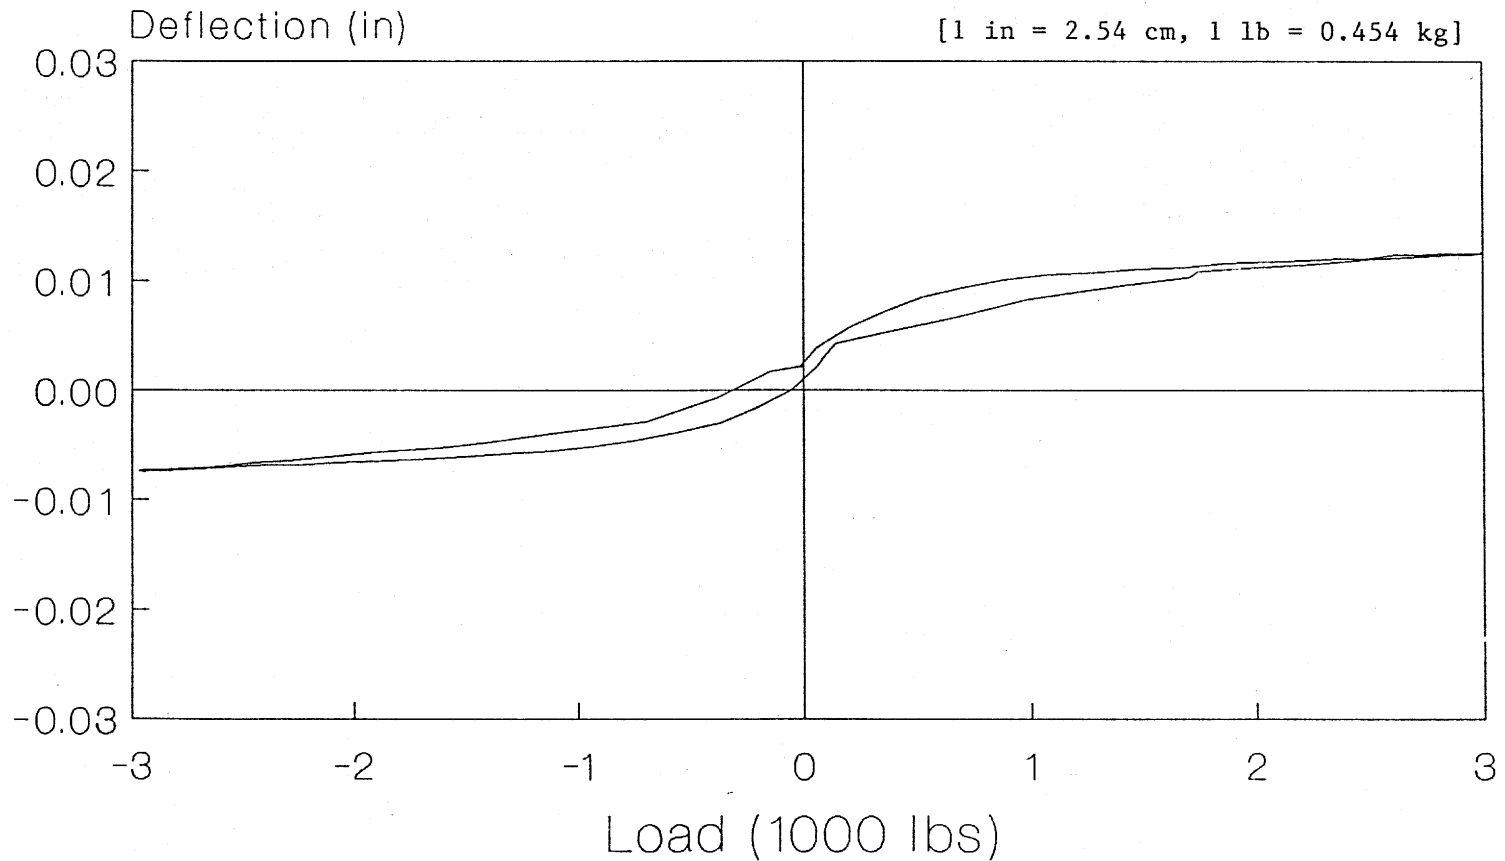
Specimen D10R, 27 E9 C10, 300000 Cycles Sensor Deflection vs. Load

Figure 62. Measured load-deflection profile after 300,000 load cycles for specimen D10R (1-in [2.5 cm] dowel, 1/32-in [0.08 cm] annular gap, 9-in [23 cm] embedment, low-energy drill, epoxy mortar).

The results of the lab study can be further illustrated by looking at the deflection profiles and "looseness" envelopes (such as those presented in figures 62 and 63) for various specimens. Each deflection profile consists of four response curves -- loading (lower curve, right side), load relaxation (upper curve, right side), reverse loading (upper curve, left side) and reverse load relaxation (lower curve, left side). Each "looseness" envelope illustrates the development of dowel looseness over time for a given specimen. "Upstroke looseness" is the component of total looseness computed from the reverse loading curve, "downstroke looseness" is the component of total looseness computed from the normal loading curve, and "total looseness" is the distance between the other two curves and corresponds to $B_{\max\min}$ in the regression models.

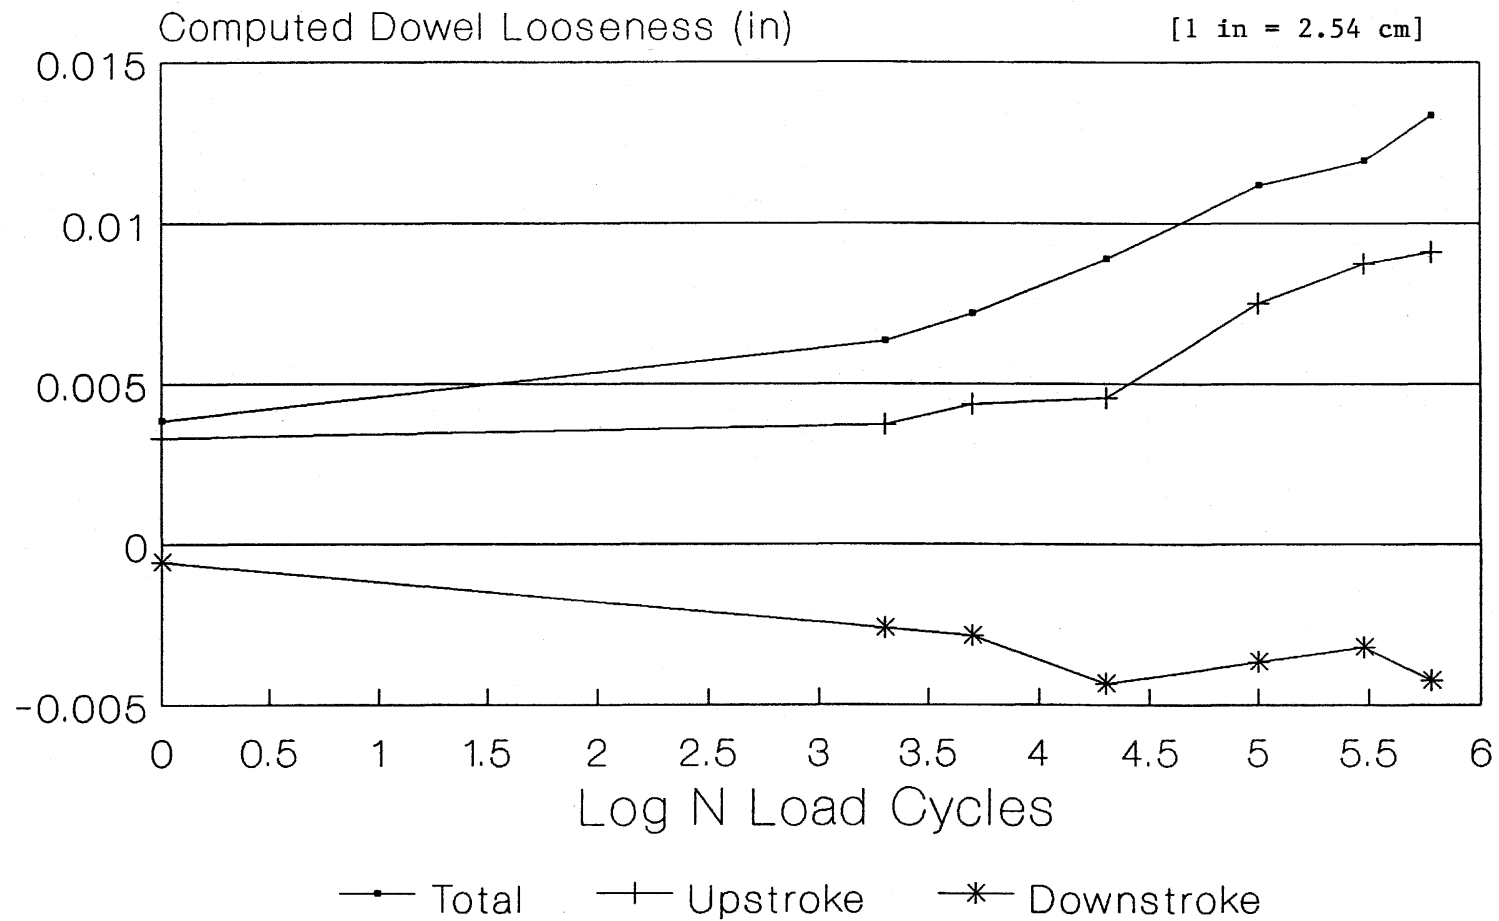
Specimen D10R, 27, E9, Epoxy

Figure 63. Computed dowel looseness vs. log load cycles for specimen D10R (1 in [2.5-cm] dowel, 1/32-in [0.08 cm] annular gap, 9-in [23 cm] embedment, low-energy drill, epoxy mortar).

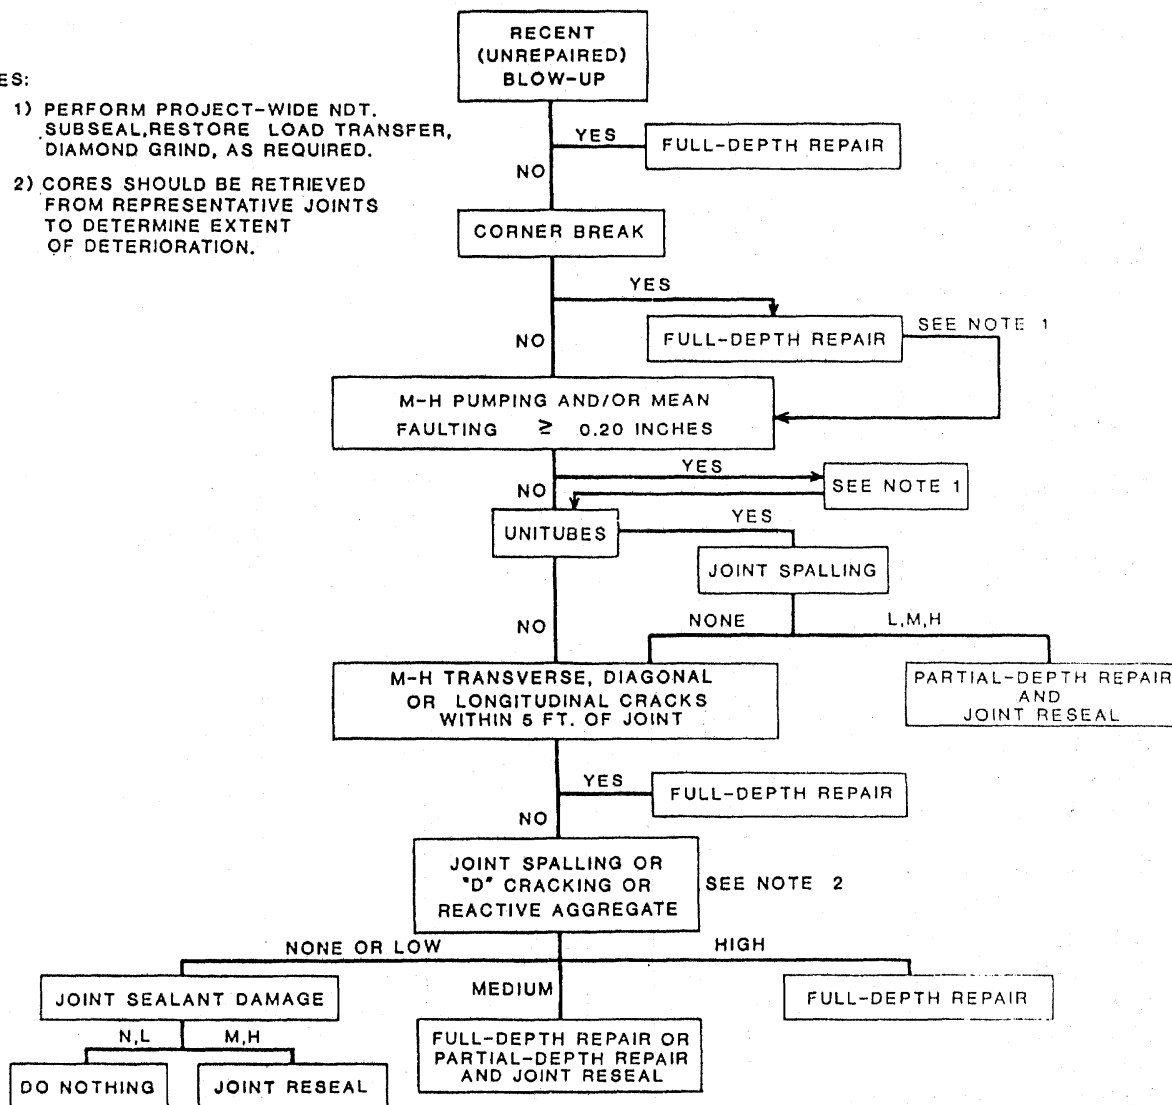
Figure 64. Transverse joint evaluation and rehabilitation selection for jointed concrete pavements.(34)

The need for full-depth repair at individual joints can be assessed using the decision chart shown in figure 64. Specific guidelines for repairing individual joints are provided in the section on design.

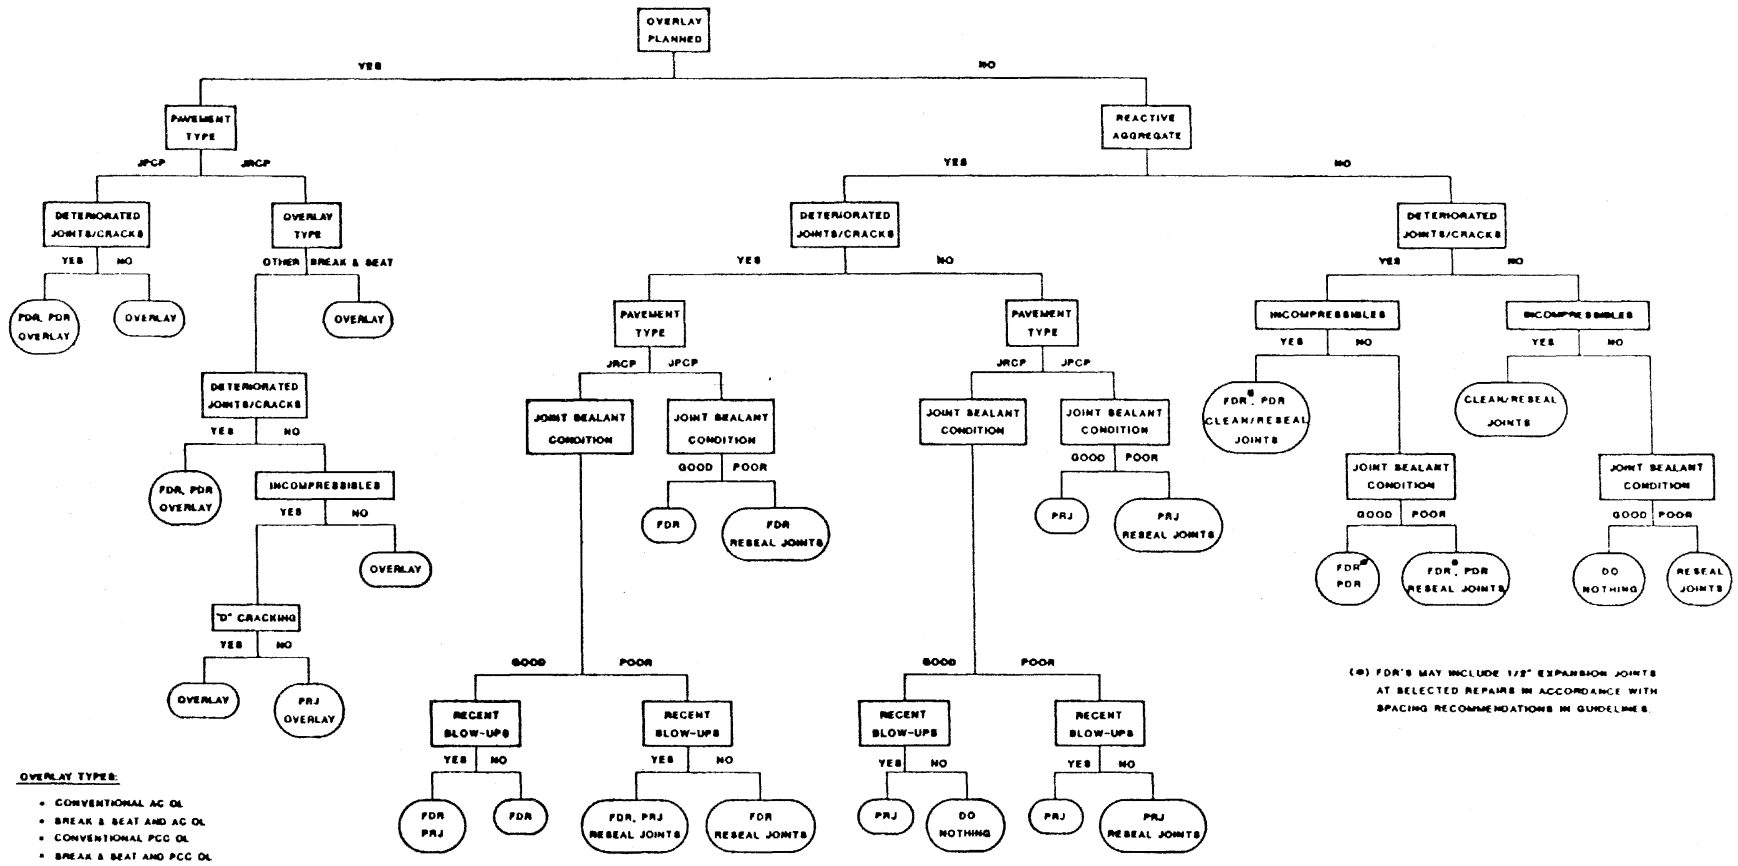
Figure 65. General flow chart for determining joint rehabilitation needs.(34)

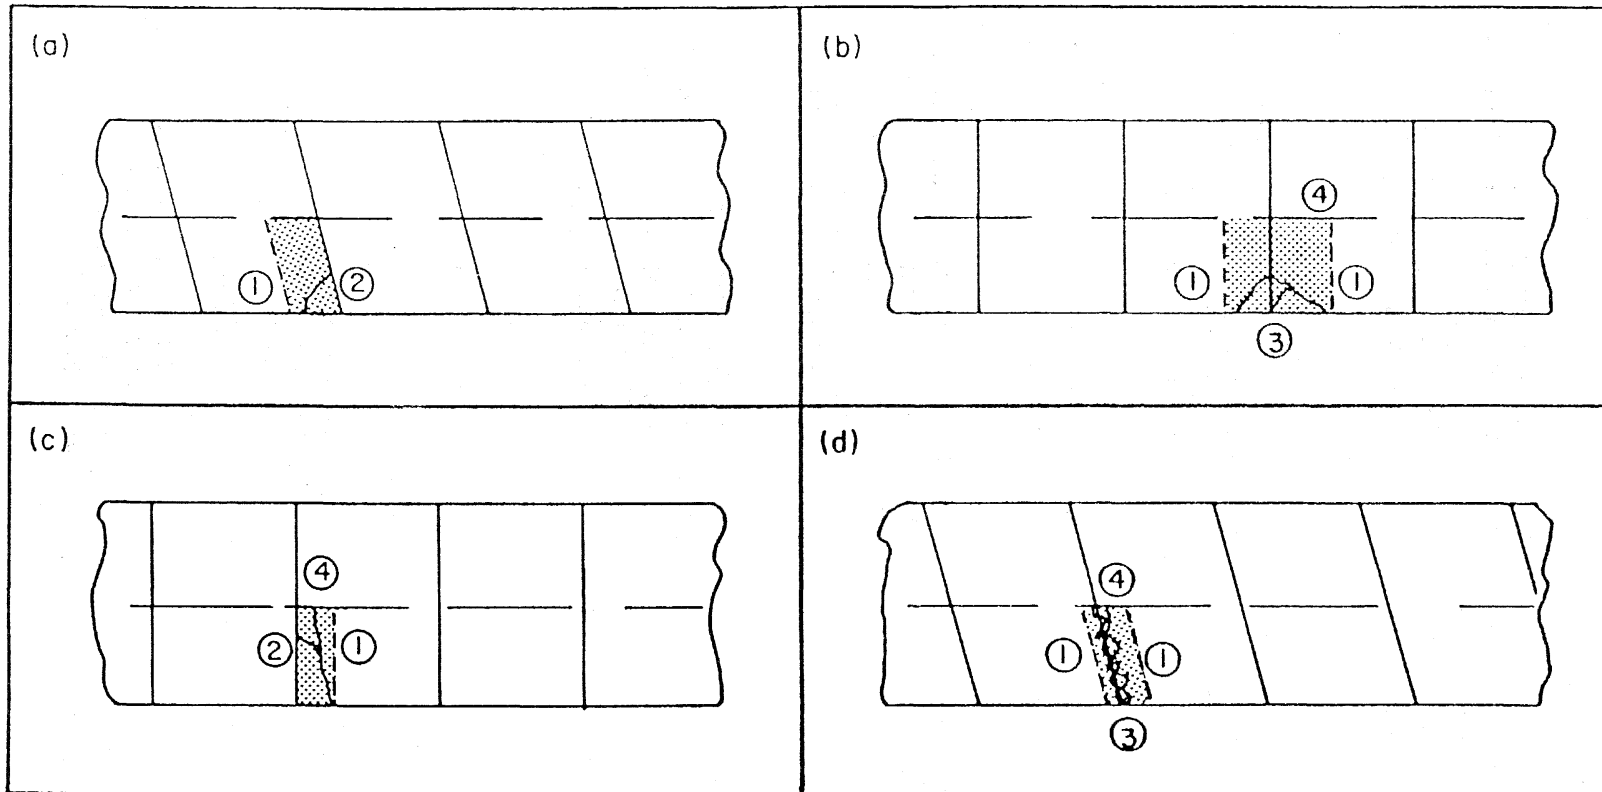
① Full Depth Saw Cut With Deformed Tie Bars or Dowels

③ Transverse Joint not Required at This Point Unless Tie Bars/Epoxy are Used at ① Joints, or if Length is > 12 Ft. [1 ft = 0.3048 m]

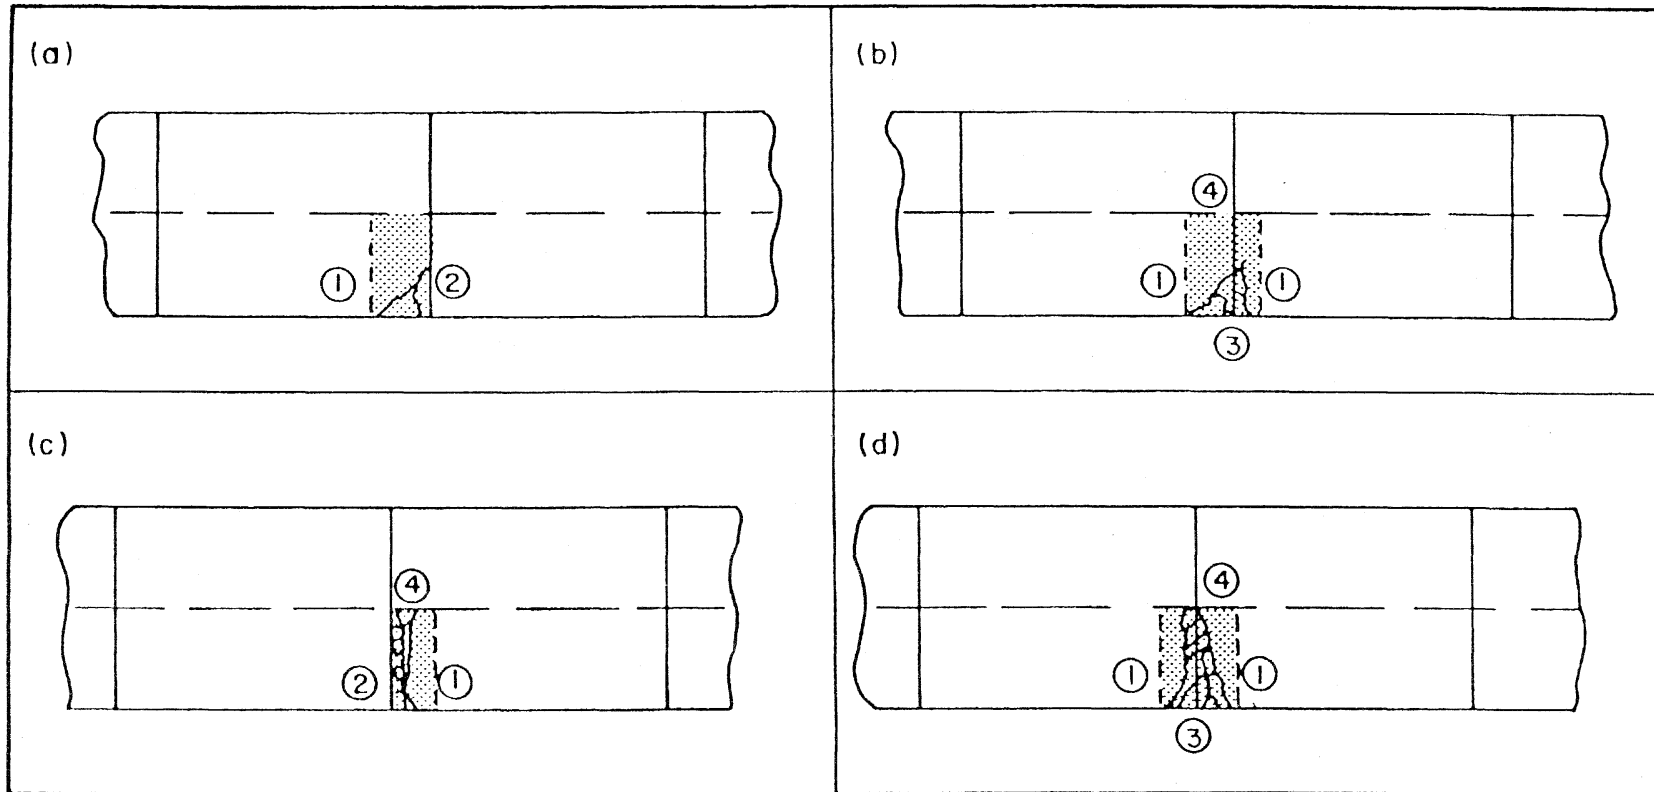
① Full Depth Saw Cut With Smooth Dowel Bars

② Butt Type Joint-Dowels Left in Place or as Shown in Figure (b) if Concrete Deteriorated

③ Transverse Joint not Required at Point Unless Repair > 12 Ft. Long [1 ft = 0.3048 m]

④ Sawing of Joint May be Required to Cut Tie Bars and Key-Way. Tie Bars not Required. Bond Breaker Material Must be Placed Along Longitudinal Joint.

Figure 67. Full-depth repair recommendations for jointed reinforced concrete pavements under heavy traffic.(6)

The recommended full-depth repair designs that will provide adequate horizontal movement and load transfer for the indicated situations are shown in figure 66 (for jointed plain concrete pavement) and figure 67 (for jointed reinforced concrete pavement). A detailed layout of the dowels or rebars is shown in figure 68, which shows the load transfer devices located in the wheel paths, where they are needed the most.(6,22)

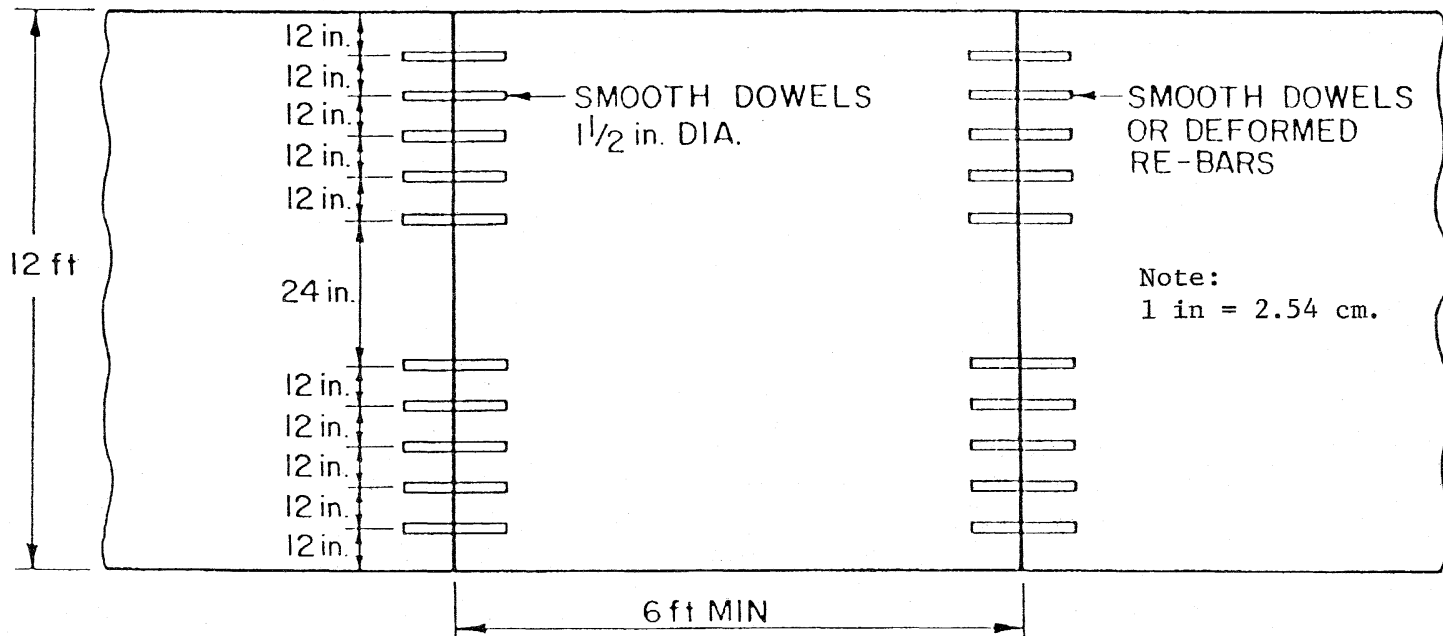
Figure 68. Recommended dowel bar layout for heavy traffic loadings.(6)

The dowels should be located to provide the most benefit. Placing the bars in and near the wheel paths and the outer edges of the slab is believed to be the most effective. This minimizes the number of bars, yet provides load transfer in the wheel paths. Figure 68 suggests a recommended design spacing for bars.

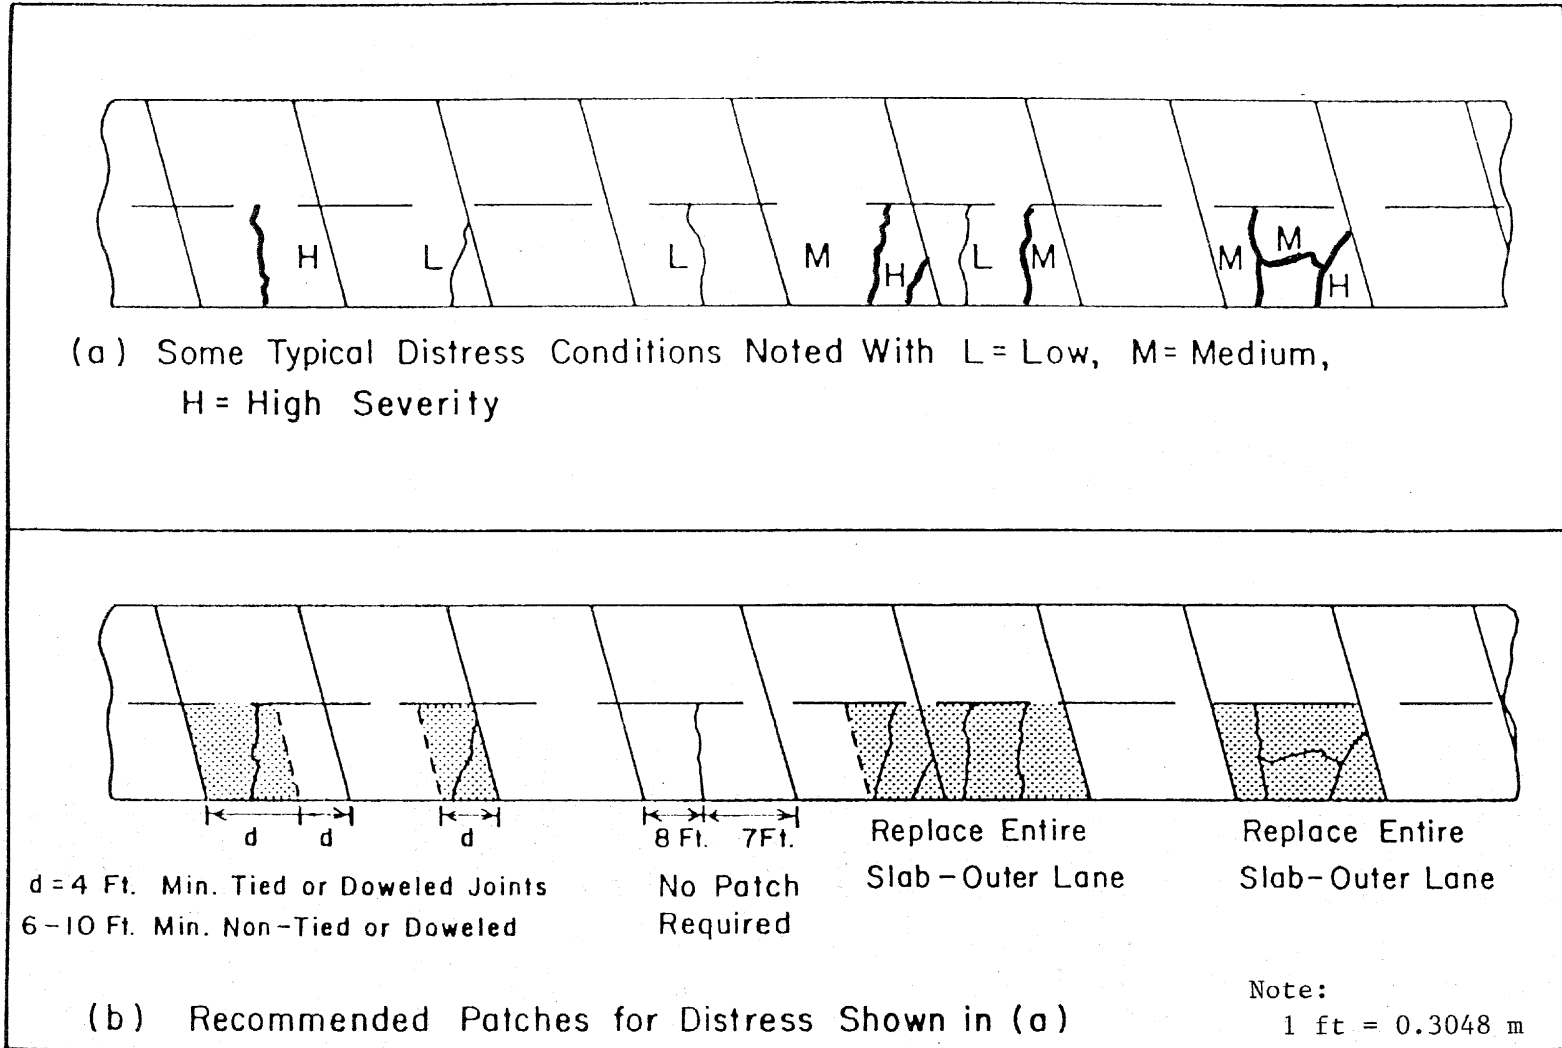
Figure 69. Recommended designs for full-depth repairs for jointed plain concrete pavements.(6)

Example repair layouts are shown in figure 69 for jointed plain concrete pavements (JPCP) and figure 70 for jointed reinforced concrete pavements (JRCP).
