Publication No. FHWA-RD-88-071
July 1989

Rehabilitation of Concrete Pavements

Volume I: Repair Rehabilitation Techniques

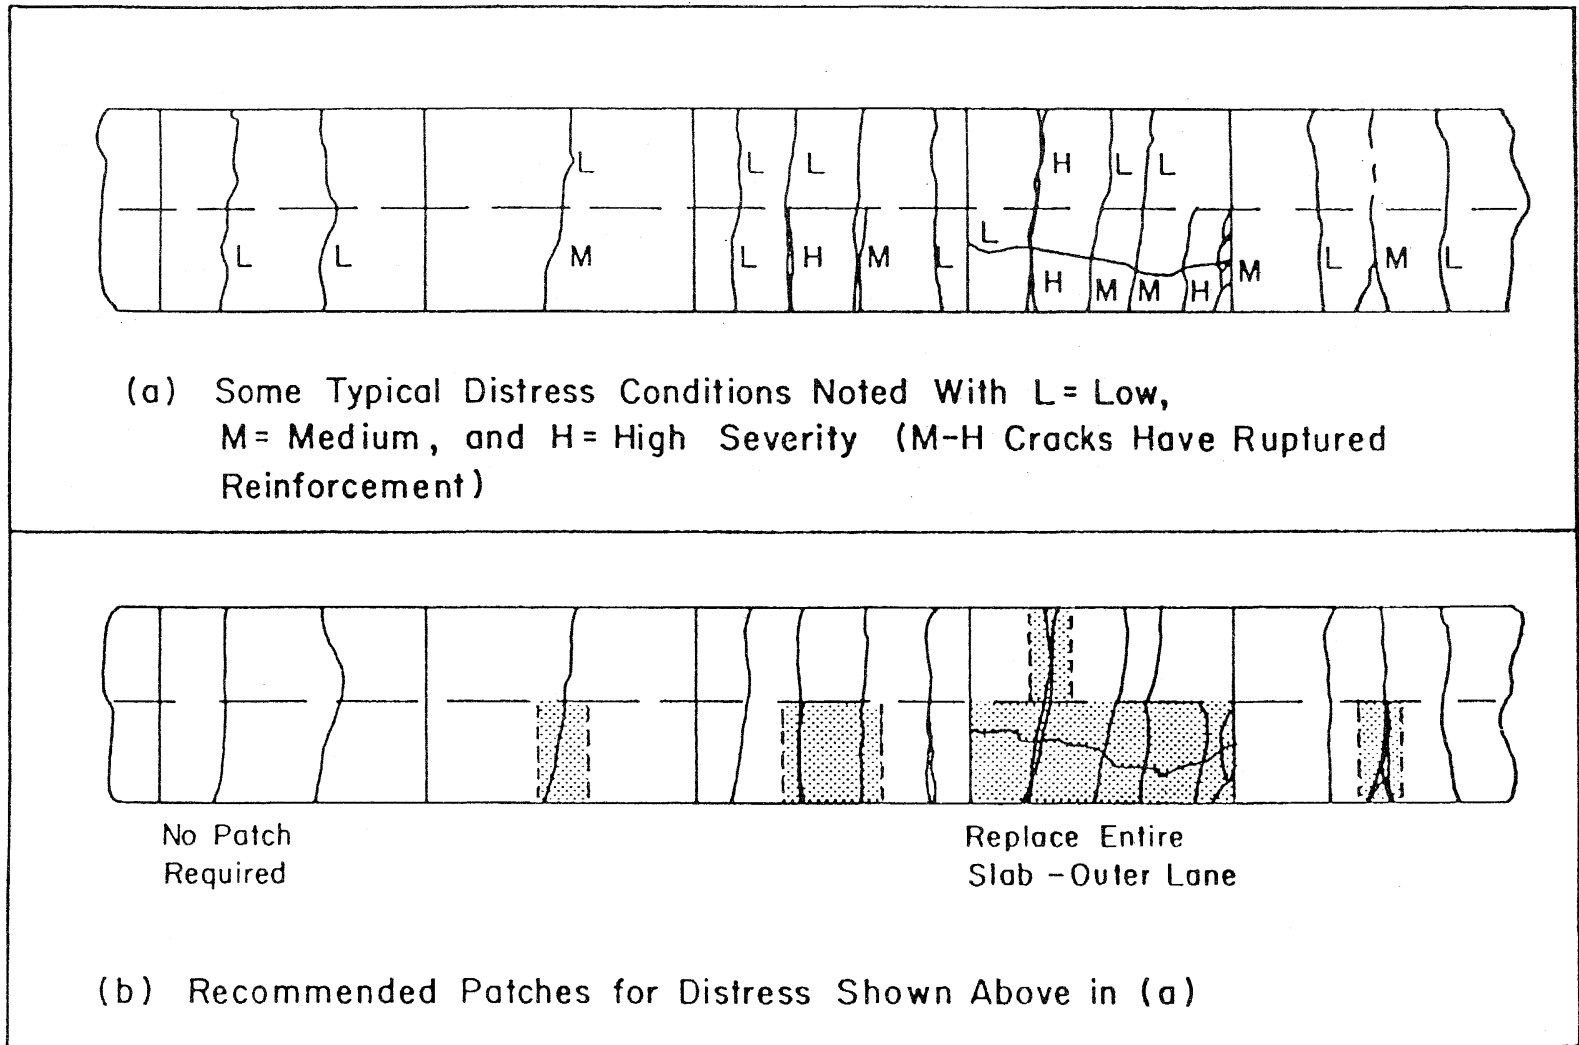
Figure 70. Recommended designs for full-depth repairs for jointed reinforced concrete pavements. (6)

Example repair layouts are shown in figure 69 for jointed plain concrete pavements (JPCP) and figure 70 for jointed reinforced concrete pavements (JRCP).

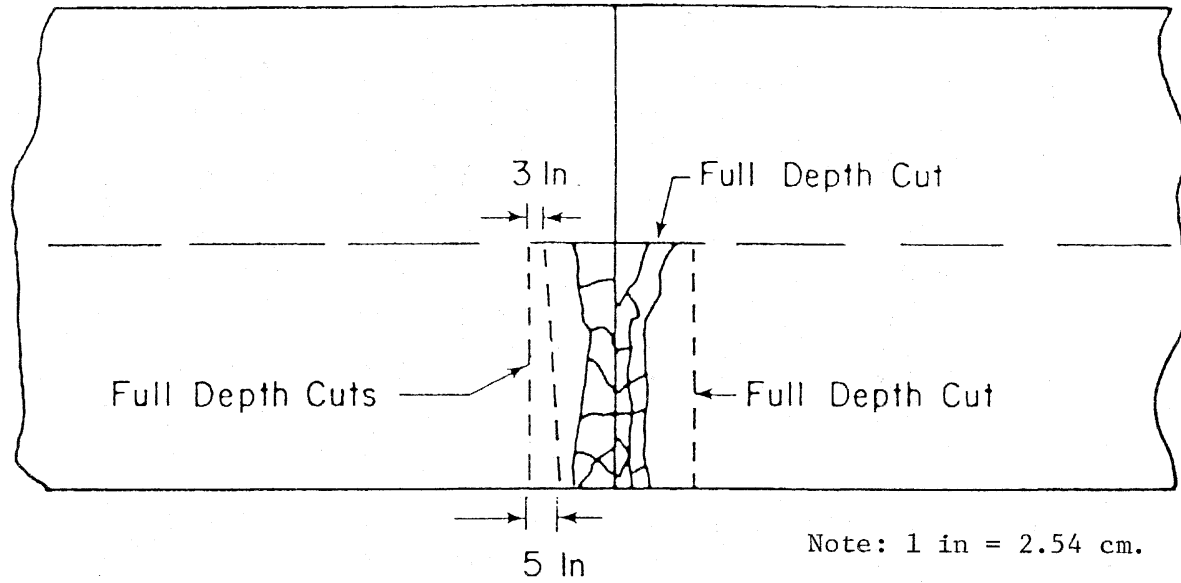
Saw Cuts for Lift out Method

- Heavy drop hammers should not be allowed on the job.
- Hydro hammers (large automated jackhammers) must not be allowed near a sawed joint.
- Whenever the temperature is such that the sawed joint closes up, saw cuts can be made to relieve pressure and spalling when the existing slab is broken up or lifted out. A relief cut pattern that will eliminate spalling is shown in figure 71.

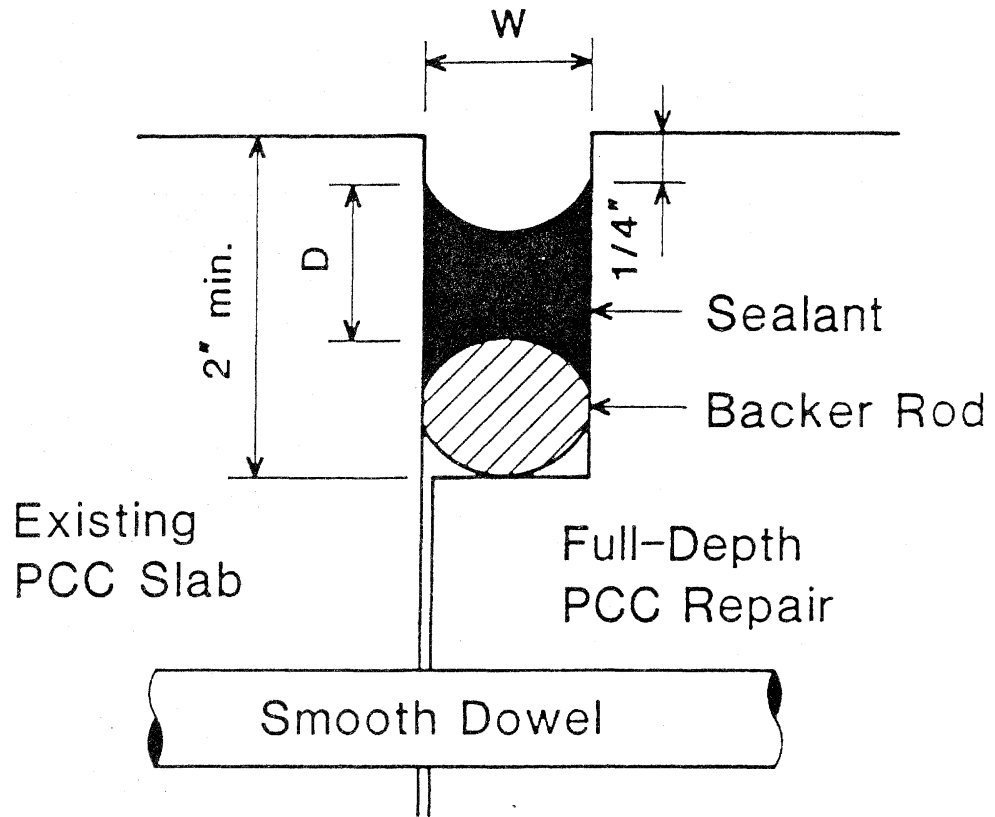
(a) Transverse Joint Design
(W) to be Determined
From Joint Opening and
Sealant Properties

Figure 72. Transverse and longitudinal joint reservoir designs.(34)

Figure 72 shows a typical diagram for transverse and longitudinal joints that could be placed in the project plans with appropriate dimensions.

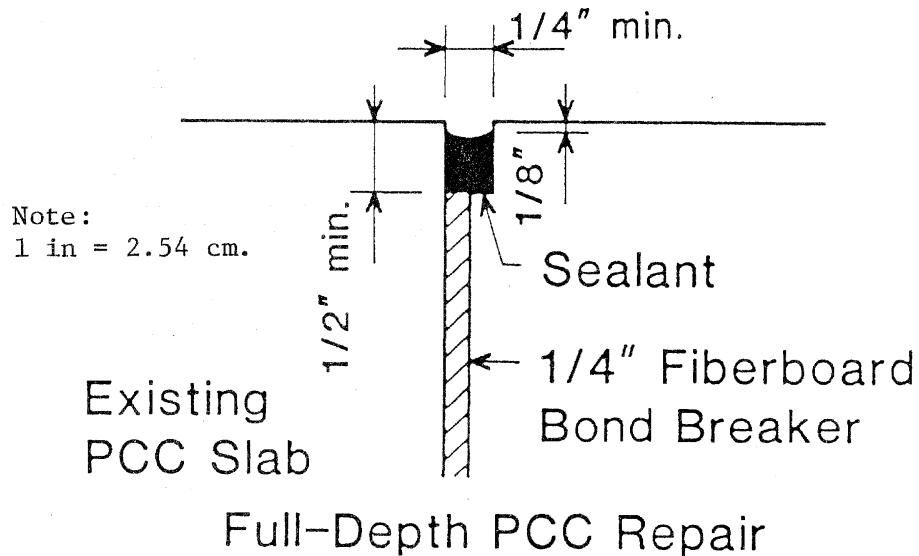
(b) Longitudinal Joint Between Lanes

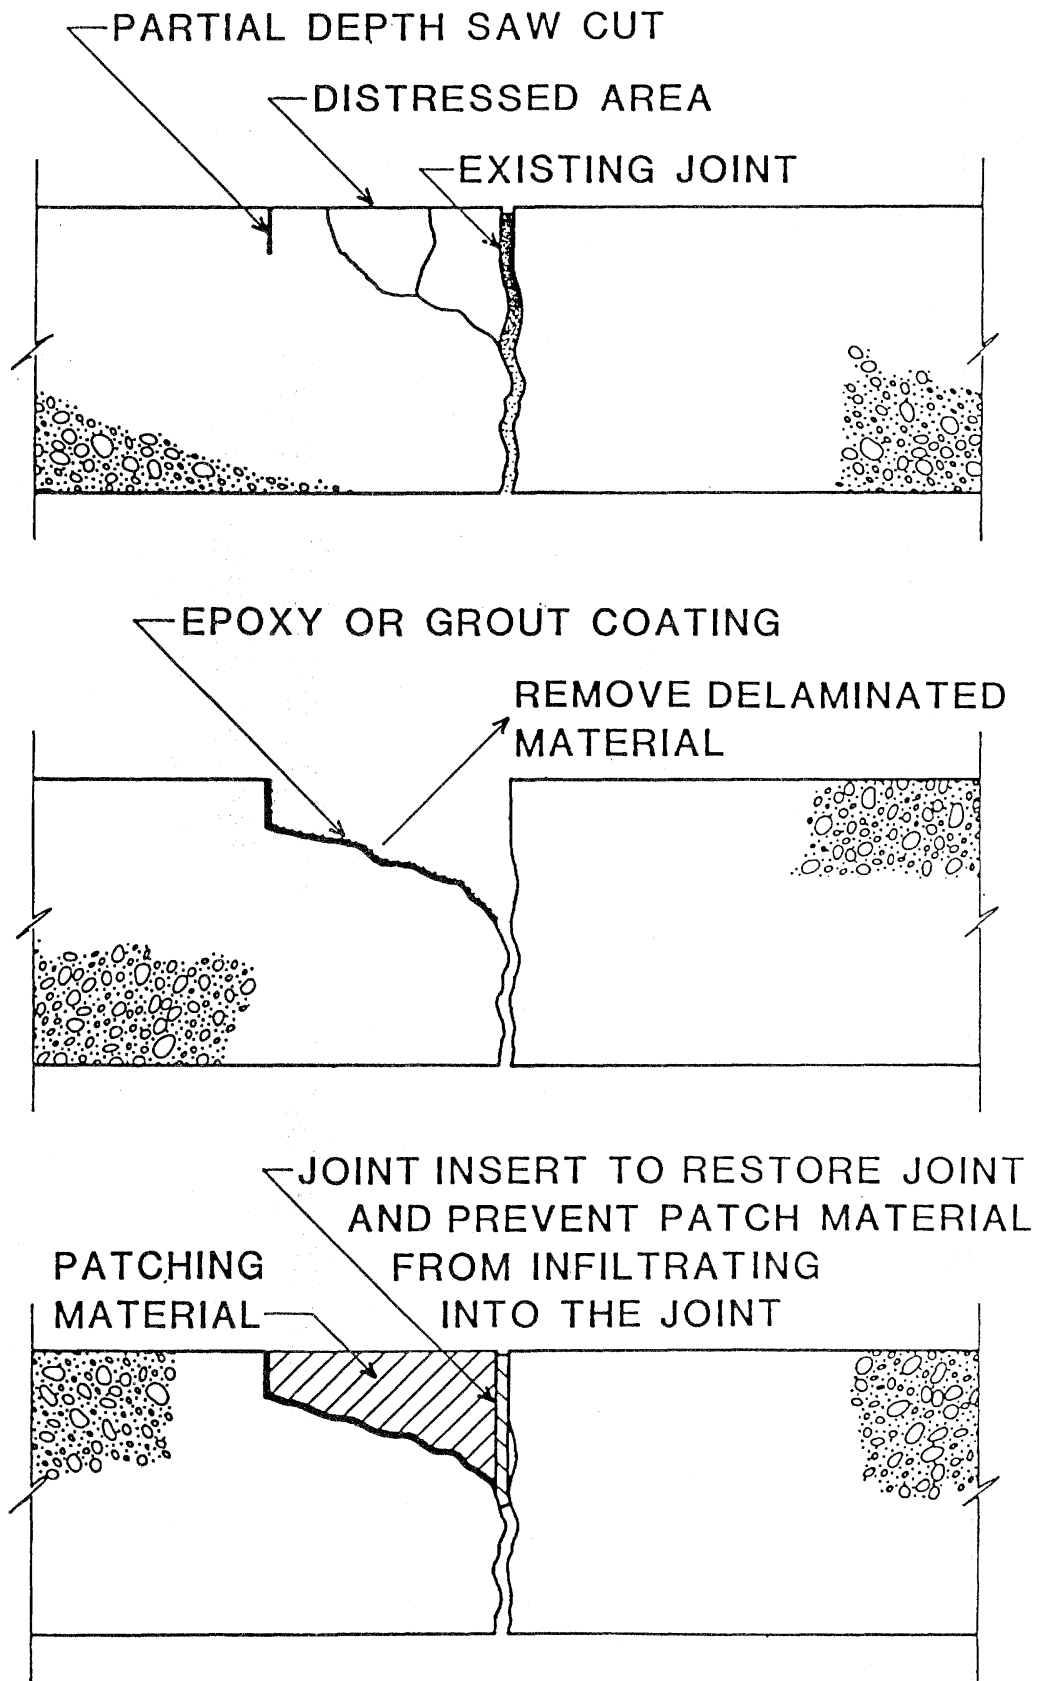
Figure 74. Steps in partial-depth repair operation.(6)

A vertical saw cut 1 to 2 in [2.5 to 5.1 cm] deep should be made beyond the boundary of the unsound area to be removed (see figure 74). The cut boundary should be straight and vertical to provide a vertical face and square corners. Cutting repair boundaries with jackhammers results in "scalloped" boundaries into which repair materials must be "feathered." Vertical boundaries reduce the spalling associated with thin or "feathered" concrete along the repair perimeter.

After the surface of the existing concrete has been prepared, and just prior to placement of the repair material, it should be coated with a bonding agent to ensure complete bonding of the repair material to the surrounding concrete (figure 74). A saturated, surface-dry condition is desirable for application of cement grouts. When epoxies or other manufactured grouts are being used, the manufacturer's directions must be followed closely.

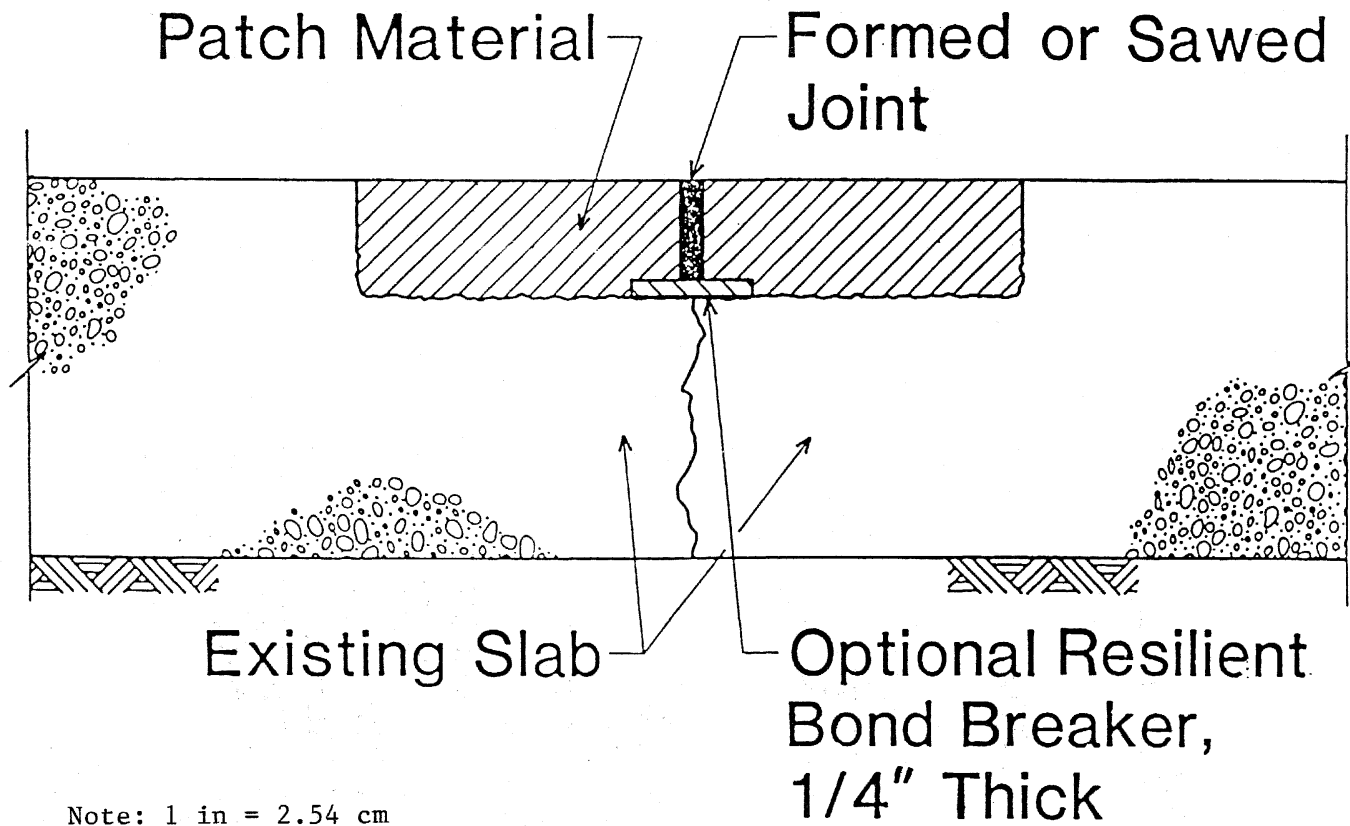
Figure 75. Placement of partial-depth repair over a joint or crack.(6)

The most frequent cause of failure of partial-depth repairs placed directly across transverse joints or cracks is crushing by the compressive forces created when the slabs expand. This must be prevented by placing a strip of Styrofoam or asphalt-impregnated fiberboard between the new concrete and the adjoining slab (see figures 74 and 75). This material must be placed so as to prevent intrusion of the repair material into the opening. Failure to do so can result in compressive
