BDV31-977-58

Florida Department of Transportation Research**Evaluation of Techniques to Remove Defective Grout from Post-Tensioning Tendons**

March 2020

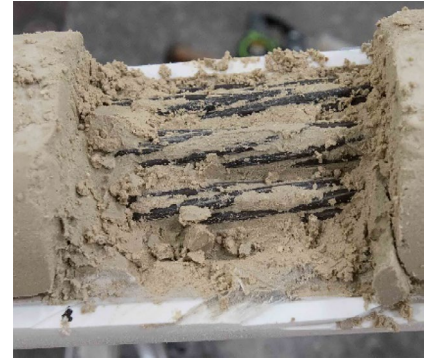
Removing the top of the PVC duct and chiseling away the soft grout exposes the steel strands of a post-tensioning tendon.
