Field Monitoring of Wicking Geotextile for Moisture Reduction in Pavements

Jie Han, Ph.D., P.E.
Hao Liu, Ph.D.
Mahdi Al-Naddaf, Ph.D.
Robert L. Parsons, Ph.D., P.E.
Jamal Ismail Kakrasul, Ph.D.

The University of Kansas

| 4 Title and Subtitle Field Monitoring of Wicking Geotextile for Moisture Reduction in Pavements | | 5 Report Date March 2023 | |

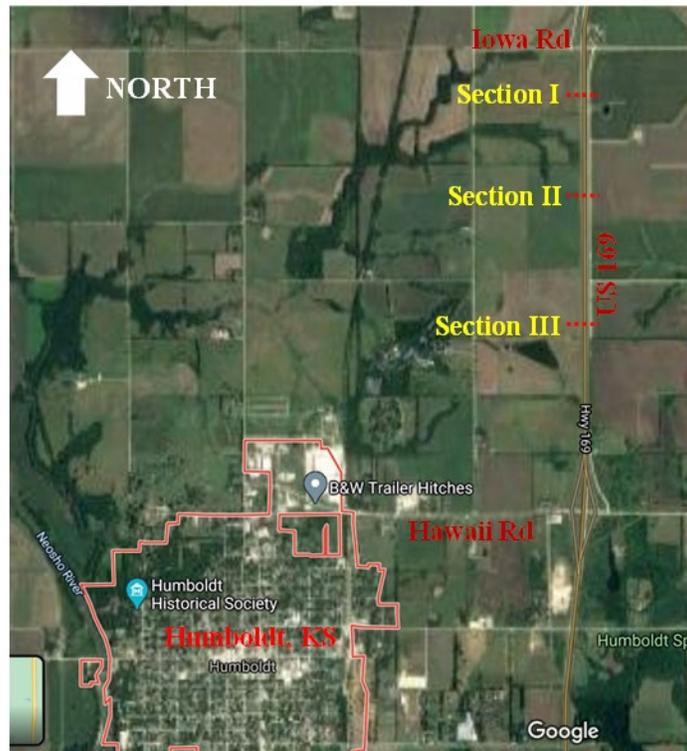
Figure 3.1: Test Sections on the US-169, Allen County, KS

Figure 3.1 shows the locations of the three test sections (Section I, Section II, and Section III from north to south), which are located between the interchange of the US-169 and Iowa road and the interchange of US-169 and Hawaii Road, near Humboldt, KS. Section II served as the control section with a non-woven geotextile placed between the subgrade and the base course, which was the pavement section used for the reconstruction of the road. Section I and Section III had the wicking geotextile at the interface between the subgrade and the base course. Aggregate base course Class 1 (AB-1) was used as the base material in Section I and Section II while aggregate base course Class 3 (AB-3) was used as the base material in Section III. It should be pointed out that the cross section of Section II was different from that of Section I and Section II.

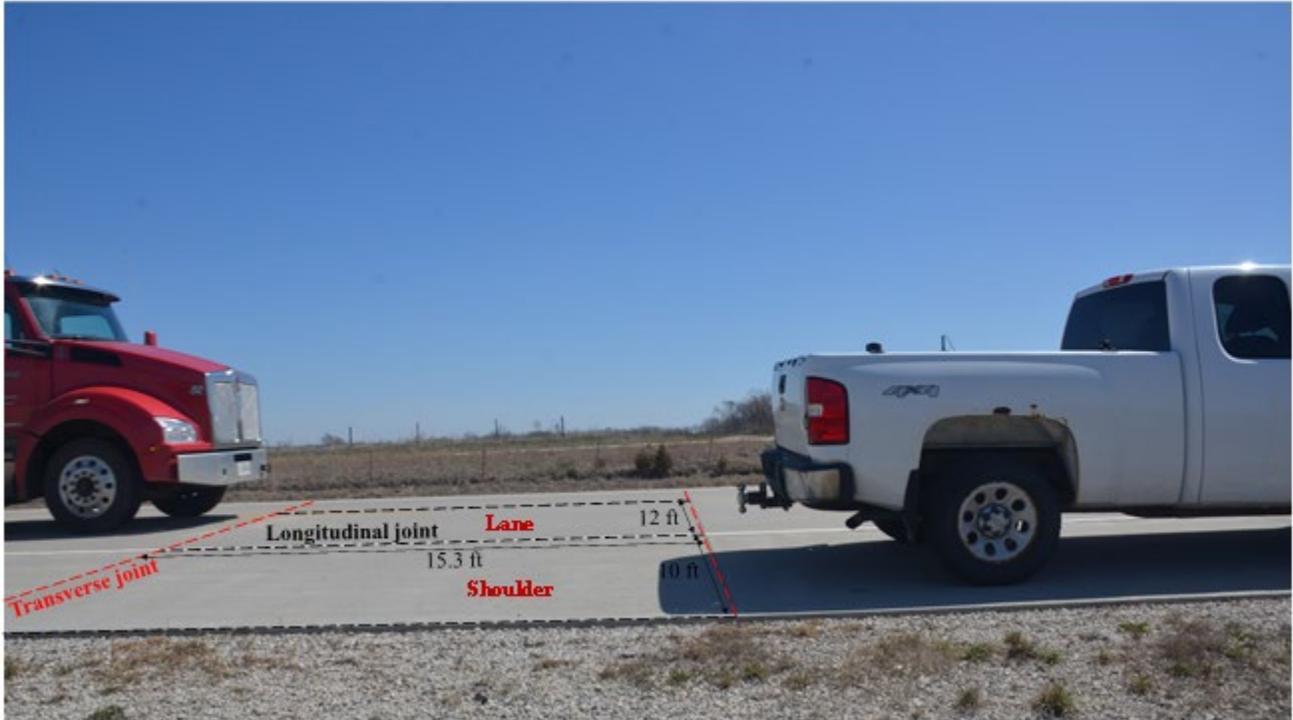
Figure 3.2: Joints of the Pavement Section

The test sections had a jointed concrete pavement, jointed concrete shoulders, and gravel slopes with a rock stone cover. Water infiltration is expected to occur at joints and gravel slopes. Figure 3.2 shows the photo of one of the test sections on the US-169 after opening to traffic for approximately two years. Each direction of the road had one 12-ft (3.6-m) wide traffic lane and one 10-ft (3.0-m) wide shoulder. This highway had five longitudinal joints including one joint between the left lane and the right lane, one joint between the lane and the shoulder in each direction, and another joint between the shoulder and the gravel slope in each direction. In addition, there were transverse joints that crossed the two traffic lanes and the two shoulders, and their spacing of transverse joints was 15.3 ft (4.6 m).

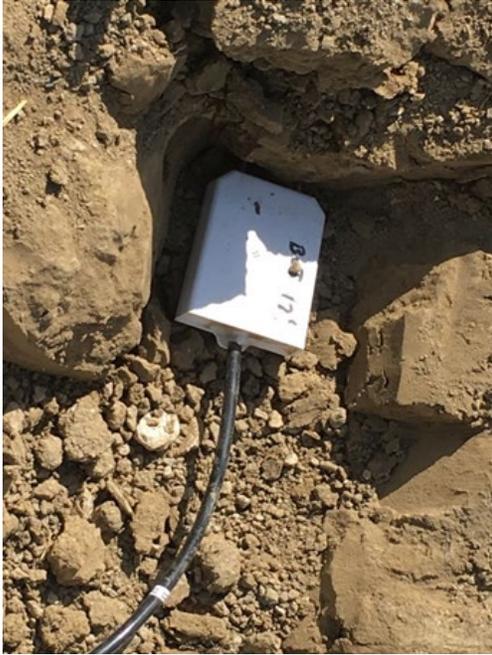
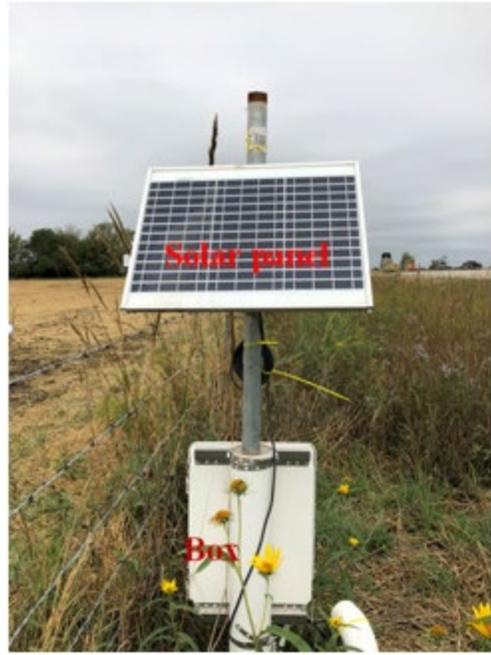
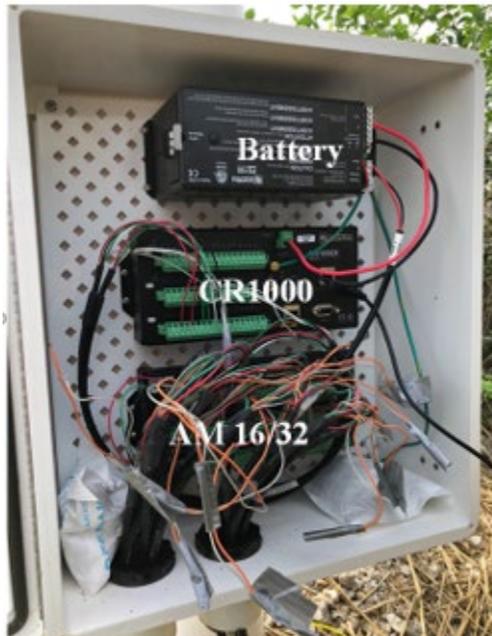
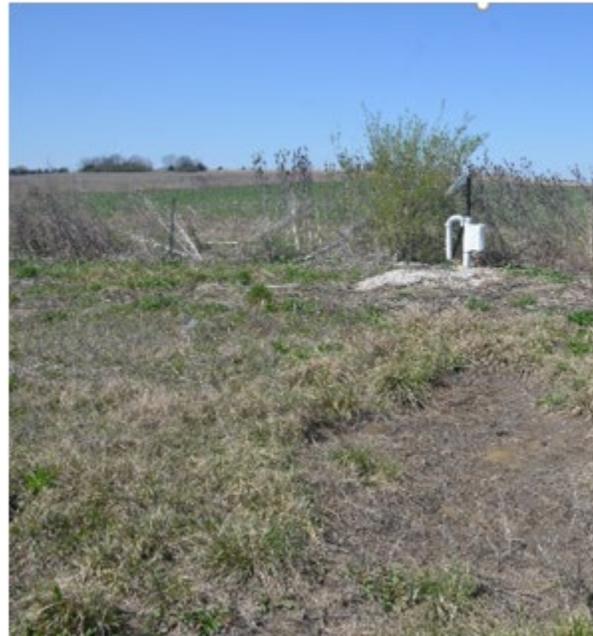
(a) Installed Sensor

(b) Solar Panel

(c) Datalogger and Battery

(d) Data Collection System in Section I

Figure 3.5: Sensor and Data Collection System

To install a moisture sensor, a small hole was dug in the soil and then two needles of the sensor were carefully pushed into the soil horizontally to ensure good contact between the sensor and the soil. After the installation of the sensor, the hole was backfilled with the same soil and some compaction was applied. Figure 3.5(a) shows a moisture sensor was installed in the subgrade at the depth of 6 in. (0.15 m) below the designed elevation of the wicking geotextile. After installation of all the sensors in one section, they were connected to a multiplexer (AM 16/32) and the data were automatically collected and stored in a CR1000 or CR1000X datalogger. The datalogger was powered by a 12 V battery, which was charged by a solar panel at daytime. Each section had one data collection system in the box to protect the battery, the multiplexer, and the datalogger from adverse weather conditions (e.g., rainfall) as shown in Figure 3.5.

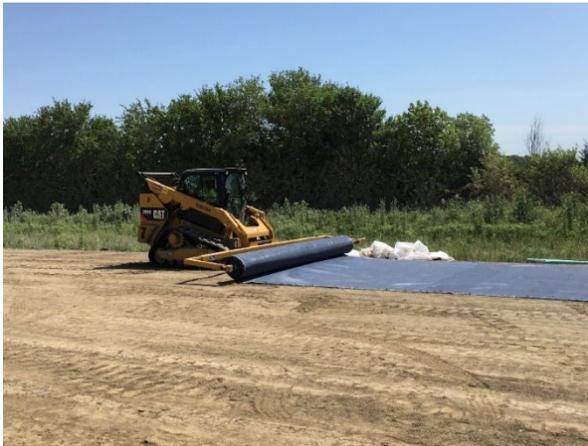
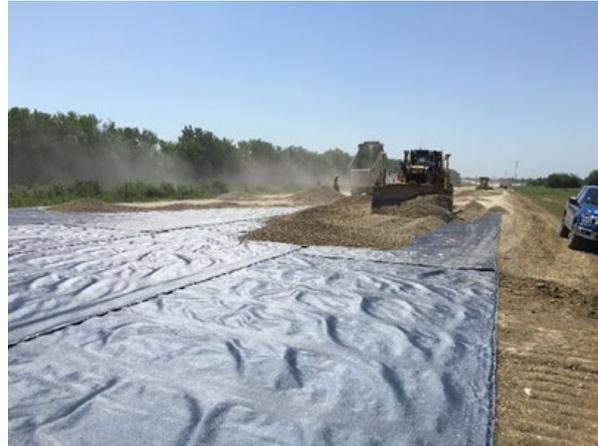
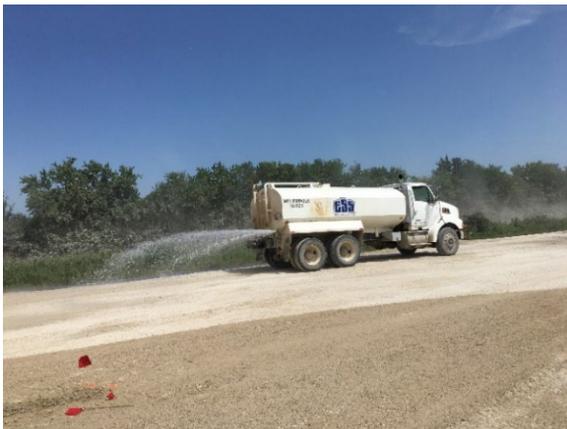
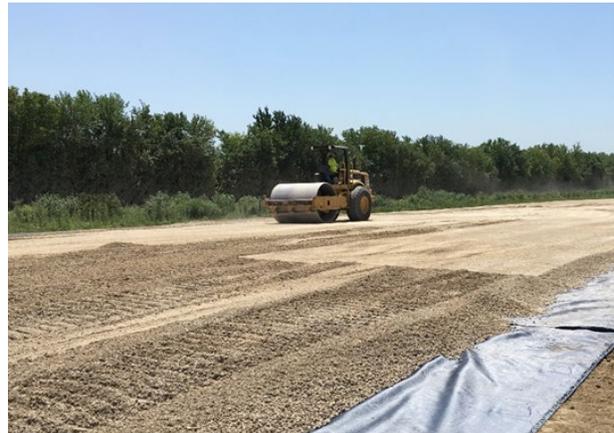
(a) Placement of the Wicking Geotextile

(b) Placement of the Aggregate

(c) Adding Water for Easy Compaction

(d) Compaction

Figure 3.6: Construction of the Test Section

After all the sensors in the subgrade were installed, the wicking geotextile was placed, followed by the placement of aggregate, watering, and compaction as shown in Figure 3.6.

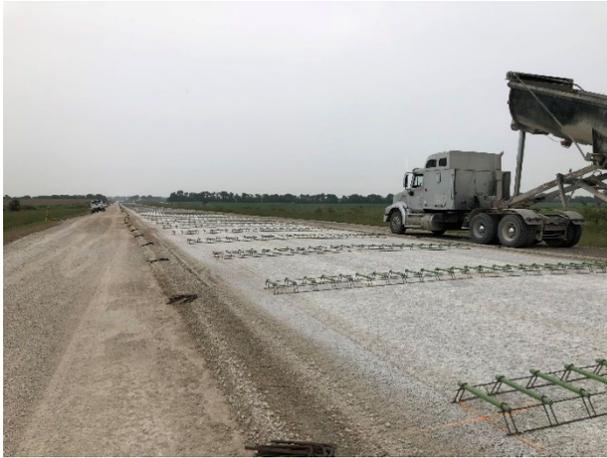
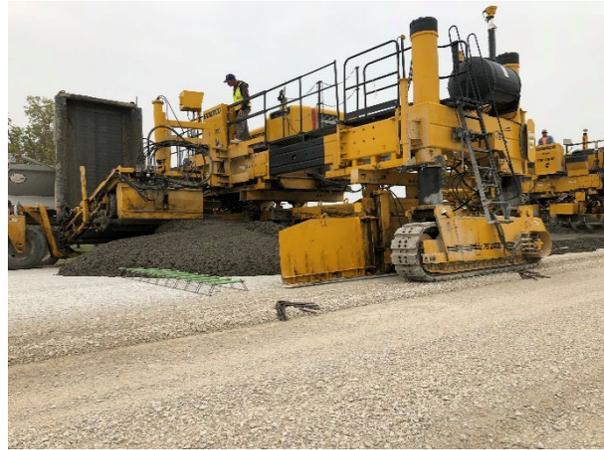
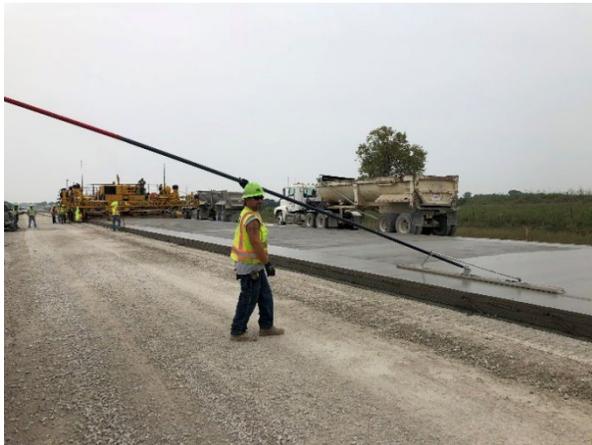
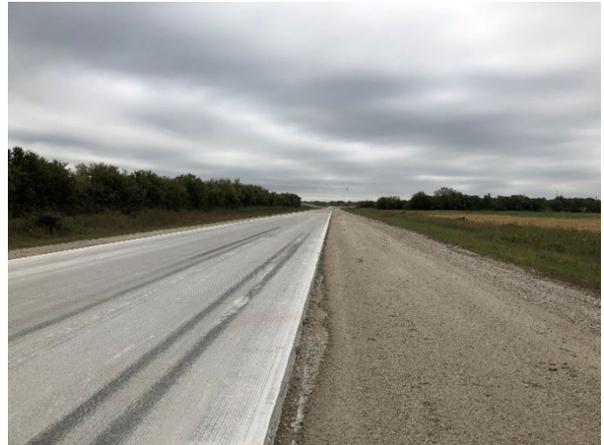
(a) Placement of Dowel Bars

(b) Concrete Casting

(c) Concrete Surface Smoothing

(d) Concrete Pavement Curing

Figure 3.7: Construction of the Concrete Pavement

Figure 3.7 shows the construction process of the concrete pavement including placement of dowel bars, concrete casting, concrete surface smoothing, and concrete curing.

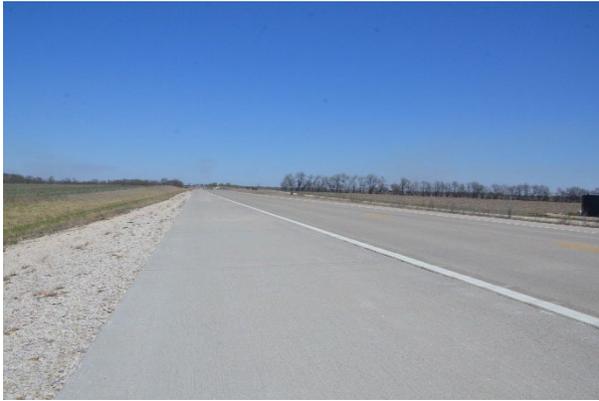
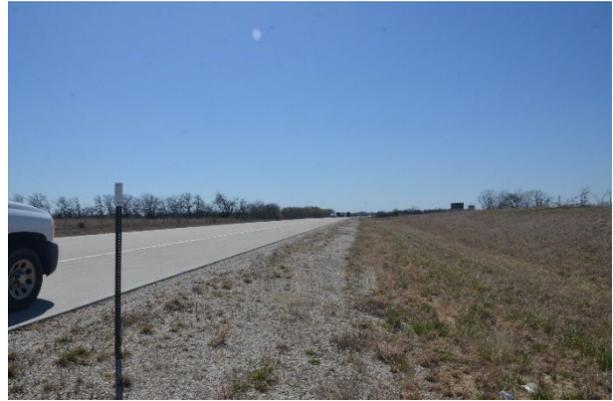
(a) Road Condition Looking North

(b) Road Condition Looking South

Figure 3.8: Road Condition on April 1st, 2021 (after approximately two years of being open to traffic)

Figure 3.8 shows the road condition on April 1st, 2021.
