**National Highway  
Traffic Safety  
Administration**

DOT HS 813 416

# **Status of NHTSA's Roof Ejection Mitigation Research**

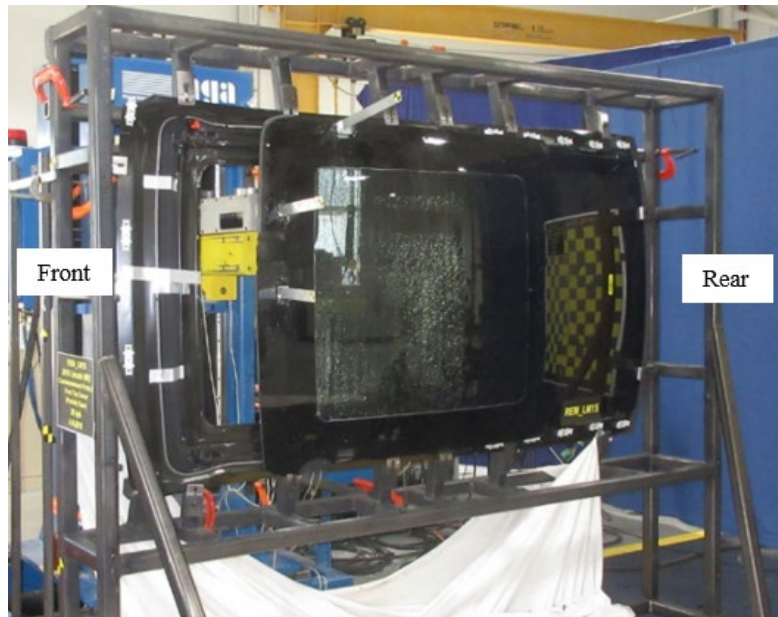
The 2018 Lincoln MKZ is a large outer slider panoramic sunroof module obtained from Webasto Roof Systems, Inc. A large panoramic outer slider type sunroof is one where the sliding panel moves outside of the vehicle and rearward during operation. The MKZ module consisted of a single large movable panel that slid rearward outside of the rear window glass (Figure 1).

*Figure 1. Lincoln MKZ Outer Slider Sunroof*

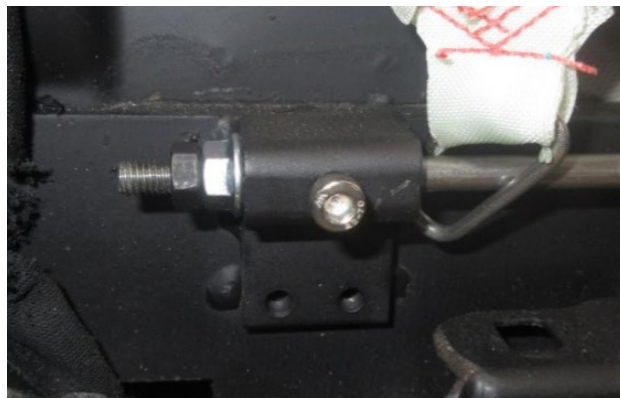
A new air bag and new guide rods were installed for each test. The guide rod was slid through the six guide rings on the lateral edge of the air bag and inserted into the attachments on the roof module (Figure 6). The guide rod was attached to the roof structure at the front and rear using four nuts, two at each end and a bolt at each end to keep the rod from turning. This process was done for both sides of the air bag. Guide rods and attachments were oriented as in Figures 6 and 7. The air bag and inflator were attached to the interior rear of the roof module at six locations. Four locations held the air bag, while the other two held the inflator.

*Figure 6. Bolt Attachment of Bottom Guide Rod to Module*

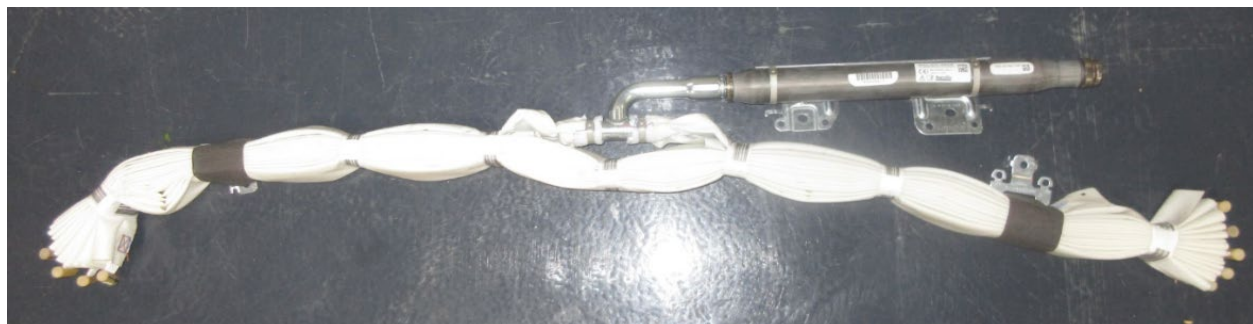
Autoliv’s prototype air bags were made of OPW material. Each air bag was installed following directions provided by Autoliv. The bag had five bullets sewn to each of the longitudinal sides (Figures 10 and 11). The bullets were slid into the hollow rail mounted on each side of the roof opening. At the end of each rail was a locking mechanism that allowed the bullet to slide past in one direction during deployment but would not allow the bullet to move in the other direction. An image of the locking mechanism is shown in Figure 12.

*Figure 10. Autoliv Air Curtain*

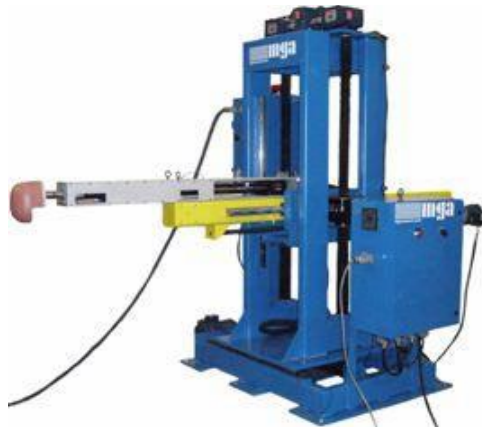
A 40 lb (18 kg) linear impactor with a featureless headform (NHTSA, 2011) meeting the requirements specified in FMVSS No. 226 was used for impacts (Figure 14). Speed and displacement of the ram were collected from the linear pot (LVDT) on the impactor. An accelerometer on the headform measured headform accelerations. Displacement from the LVDT was used to measure ram excursion, which was the maximum distance from the zero plane that the headform reached. Photogrammetry (i.e., TEMA) was used for the Lincoln MKZ to measure edge excursions, which are reported as the maximum distance the edge of the panel moved from its original position during the impact. The performance of each sunroof or roof curtain was evaluated by analyzing ram excursion, edge excursion, observations of failures, and high-speed video.

*Figure 14. FMVSS No. 226 Linear Impactor*

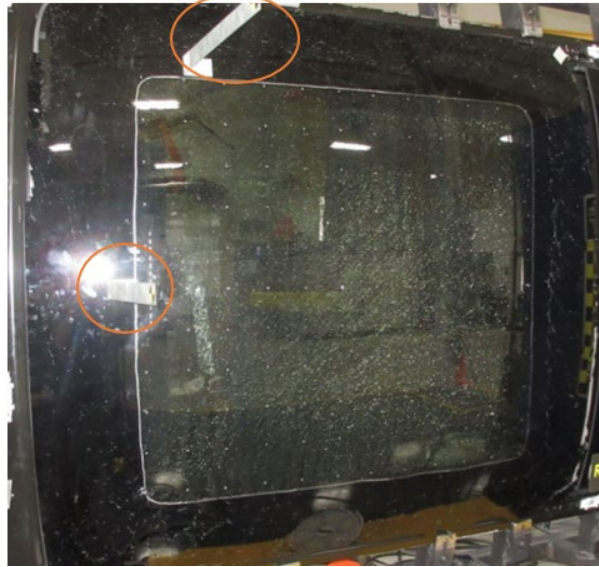
The 2018 Lincoln MKZ Protec II glass was pre-broken using a centerpunch, following the FMVSS No. 226 test procedure. However, instead of the 75 mm offset pattern, the glass was punched once on the exterior side in the forwardmost lower (driver side) corner of the daylight opening. The tempered glazing fractured all the way across the sunroof and therefore did not need to be punched additional times (Figure 16). The same phenomenon occurred for both the production and countermeasure panels.

*Figure 16. 2018 Lincoln MKZ Pre-broken Protec II Glazing*

Targets for photogrammetry were placed on the exterior surface of the glass using brackets at the edges of the daylight opening along the same planes as the impact location (circled in Figure 16). These targets were tracked using TEMA software to measure edge excursion.

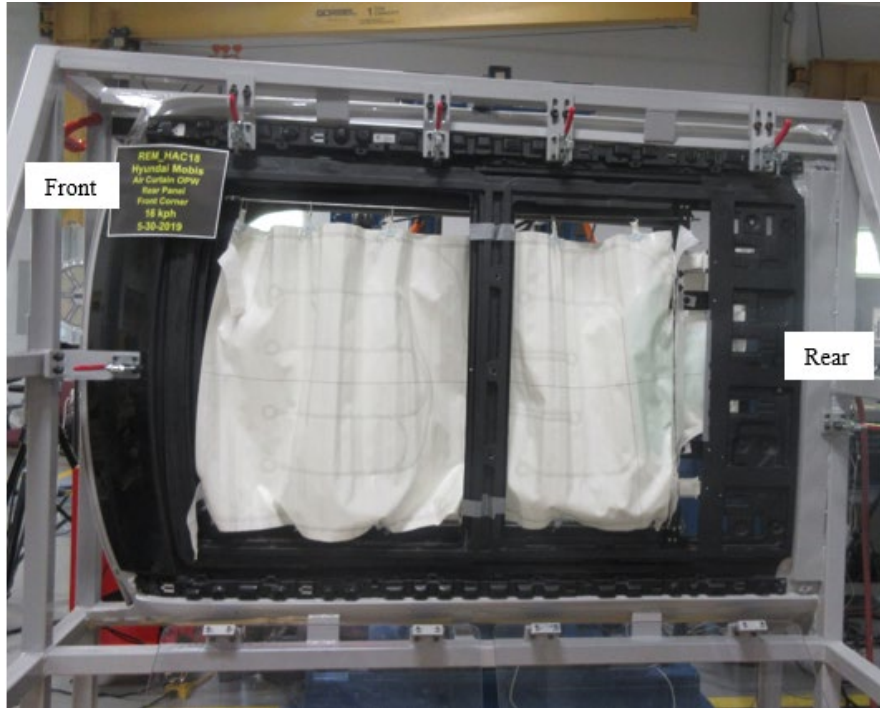
A new air curtain and guide rods were installed for each test. Initial trials were done with the air bag unfolding on its own across the opening using the propellant from the inflator. During one of these trials the air curtain did not successfully unfold across the openings. Per discussions with Hyundai-Mobis, based on their experience, it was suggested to manually open the bag across the opening prior to inflation. Therefore, in order to test consistently, it was assumed that the air bag would deploy across the portals successfully each time, so for all the Hyundai-Mobis tests the air curtain was manually opened and unfolded across both openings to ensure successful inflation (Figure 17). Prior to the test, the bag was unfolded, and the seams were marked with black marker to aid in observing the reaction of the bag when the headform impacted it. Once unfolded, the bag was inflated using the propellant from the inflator. The 6-second delay was measured from the time the inflator was triggered.

*Figure 17. Curtain Manually Opened Across Both Openings Prior to Test*

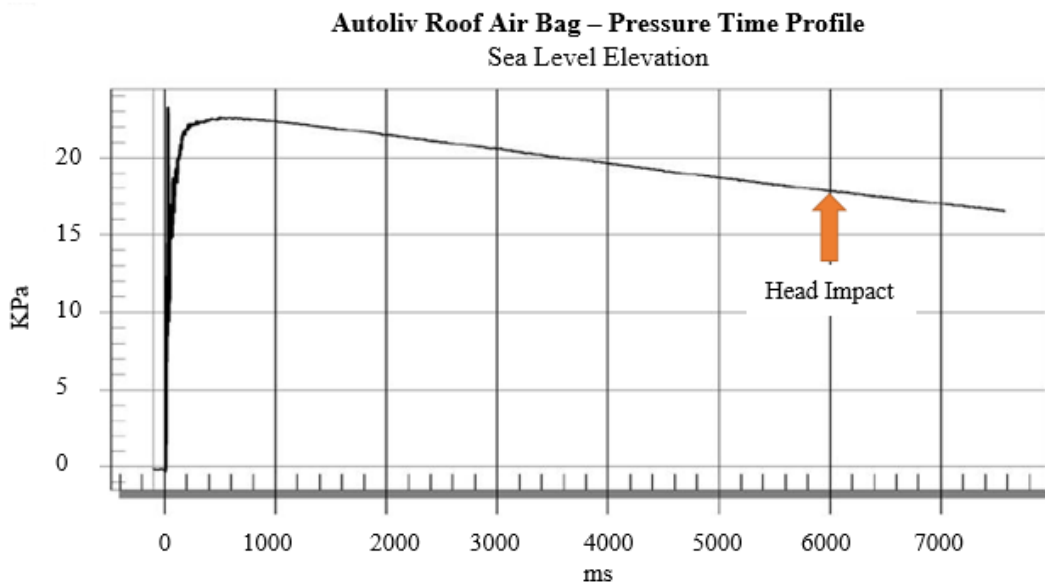
When there was an acceptable deployment for the Autoliv bag, it took approximately 50 milliseconds for the air bag to deploy across the opening. Figure 19 shows the pressure time profile of the air bag. Head impact occurred at 6 seconds (6,000 ms) after triggering of the inflator of the air bag (orange arrow, Figure 19). It was not expected that hand opening the bag would influence the pressure at impact.

Figure 19. Pressure Retention in Autoliv Bag

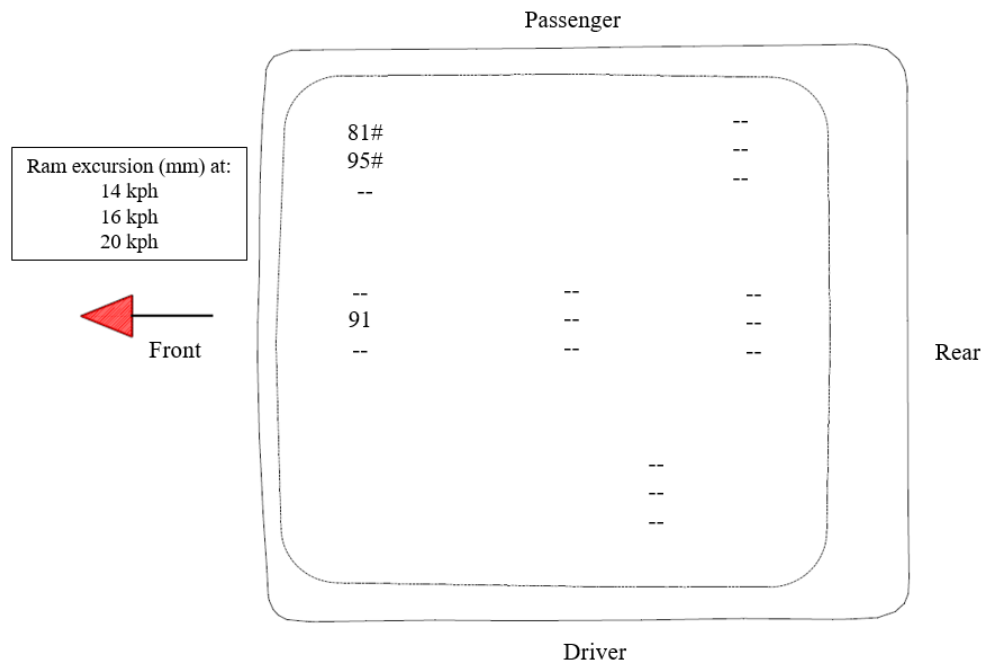
Ram excursion from impacts on the 2018 Lincoln MKZ production panel are shown in Figure 20. The excursions, in millimeters, are placed at the impact locations on the figure. The pound sign (#) indicates ripping of the film layer.

Figure 20. Lincoln MKZ Production Protec II Results

All impacts resulted in excursion values less than 100 mm. However, looking at failure modes, the rips occurred along the glue line, where there were holes cut into the film (Figure 21). These holes were thought to aid in adhesion of the glass to the metal frame because the metal frame was glued directly to the glass surface and film layer, not just to the film layer. However, these holes caused the film to rip easier when impacted by the headform. Edge excursions were also measured and can be seen in Appendix B.

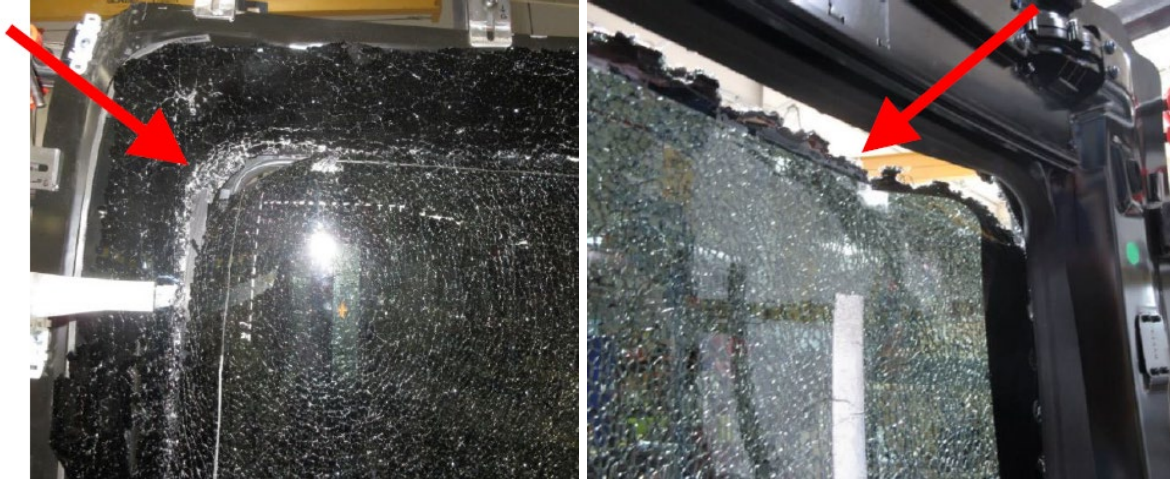
*Figure 21. Lincoln MKZ Production Film Layer Rip*

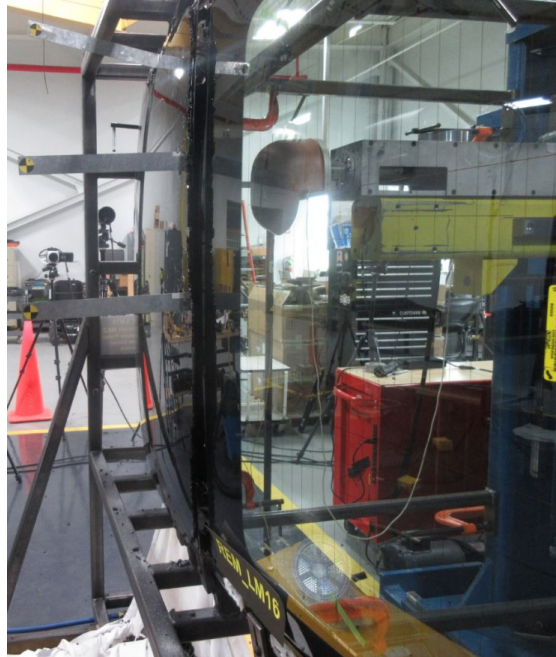
Additionally, this sunroof had the capability of being vented, which results in the rear edge raising up approximately 15 mm, so an impact was also done on the rear corner. The front edge moved rearward approximately 20 mm, putting the front pin in the center of the front cam (Figure 23).

Figure 23. Vented Configuration

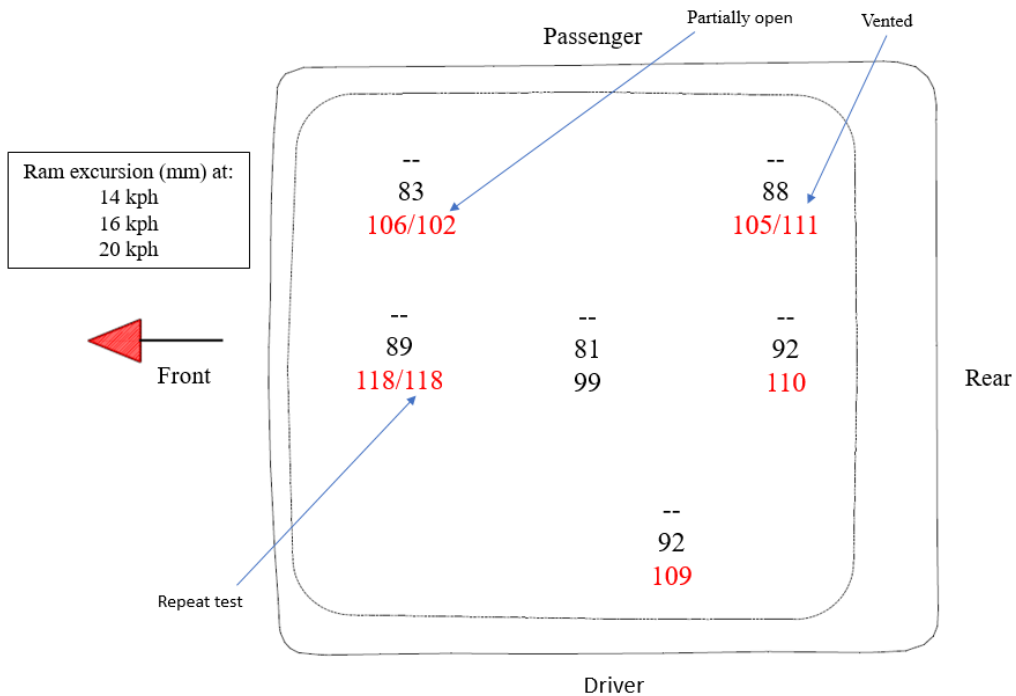
For the Lincoln MKZ countermeasure panels, ram excursion results are shown in Figure 24. Edge excursions can be seen in Appendix B1. All locations were impacted following the order of tests outlined in section 3.0.

Excursion results of these configurations are shown in Figure 24 below and are labeled as “repeat test,” “partially open,” and “vented.” All of the excursions from the countermeasure tests, in millimeters, are placed at the impact locations on the figure. Test speeds were 16 km/h and 20 km/h. No 14 km/h tests were conducted due to good results (<100 mm excursions) in the 16 km/h tests. Results in red indicate the ram excursion exceeded 100 mm.

Figure 24. Lincoln MKZ Countermeasure Protec II Results

Testing of the countermeasure panel resulted in eight excursion values over 100 mm and seven tests with excursion under 100 mm. The highest excursion was 118 mm at the front edge mid location. All excursions at the 16 km/h speed were below 100 mm. However, it should be noted that at the highest impact speed (20 km/h), all but one test had excursions over the 100 mm criteria. There were no rips or tears in the PET layer of the Protec II glass. This shows that removing the holes from the production panel improved the performance of the platform in both excursion (95 mm in production versus 83 in countermeasure) and attachment. No gross failure was seen at the mounting or attachment brackets. All mounting and attachment brackets were made of metal components that aided in the strength of the design. The 2018 Lincoln MKZ sunroof module, with the countermeasure, represents a good containment design for a large panoramic sunroof, when the sunroof is closed sufficiently to avoid ejection. For roof ejection mitigation platforms to meet an excursion requirement all components in load path will need to be considered.

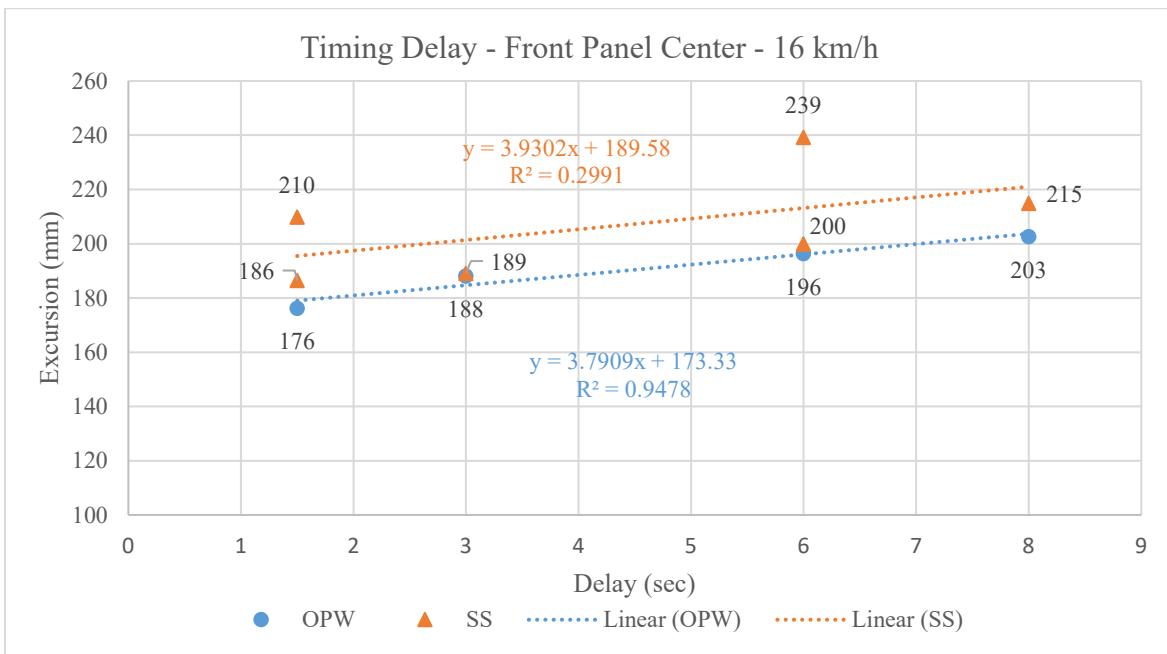
Figure 29. OPW (Blue Circle) and Seam Sealing (Orange Triangle) Timing Delay Results

Results of the timing delay series are also plotted in Figure 29 to show the excursion changes over time comparison between the two types of bags. In the plot, the OPW results are shown with blue circles and the SS results shown with orange triangles.

For the pressure retention tests in the OPW and seam sealed bags, excursions were higher with the SS bags than the OPW for the same time delays. It was assumed that higher excursion results would indicate lower pressure in the bag. Therefore, assuming that the same inflator was used for both bags, the results show that the SS bags do not retain as much pressure as the OPW bag. However, both lose pressure at a similar rate, as shown by the consistent slopes of the regression lines in Figure 29.

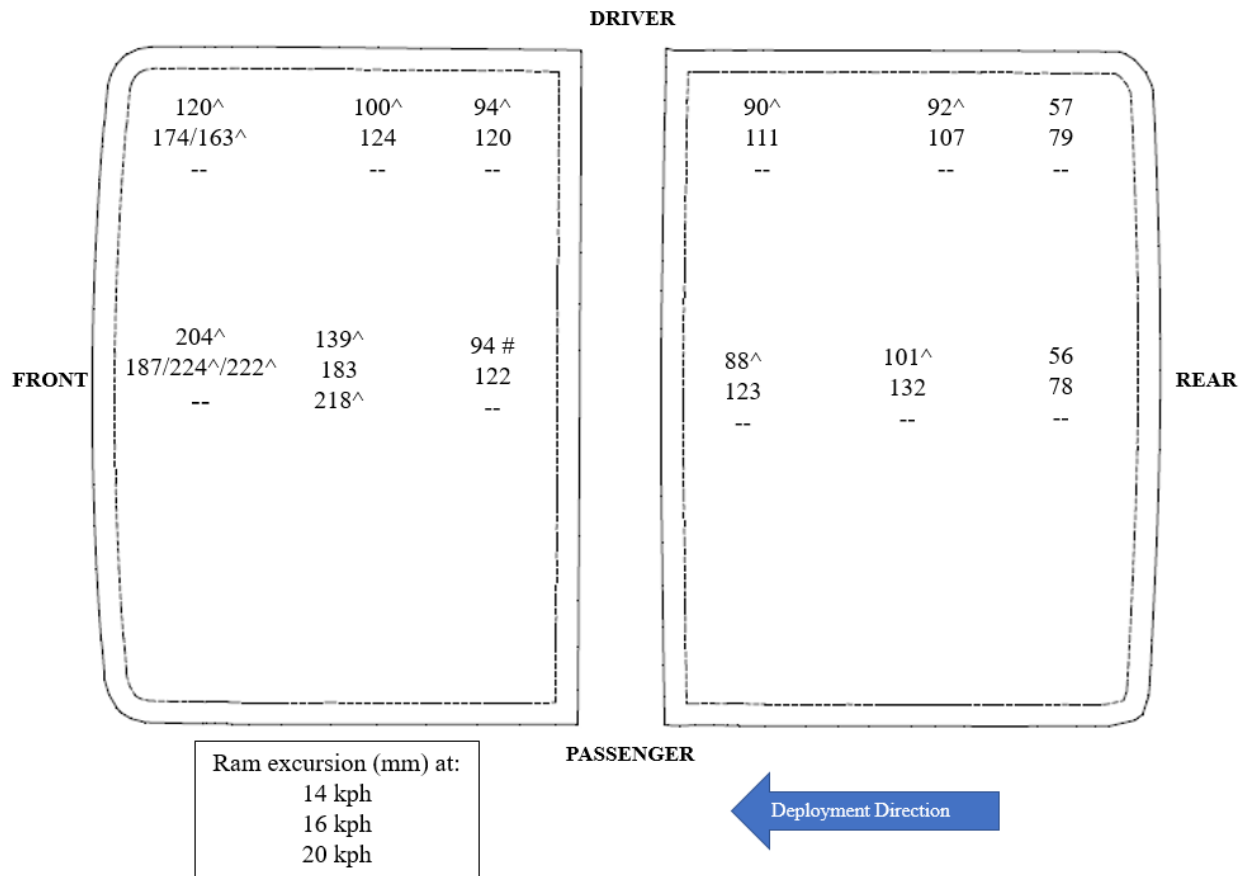
Figure 30. Autoliv Prototype Air Curtain Results

Results of the Autoliv Prototype Roof Air Curtain system are shown in Figure 30. Impact speeds were 14, 16, and 20 km/h. All results shown are from a 6-second delay between the inflation of the air bag and the impact from the headform. All results presented below were from tests with successful deployments. A caret (^) indicates the bag was hand opened. All others were deployed from the closed state. Any repeat tests are separated by a slash. For example, on the front panel, front corner location at 16 km/h, two repeat tests were completed.

Overall, the air bag contained the headform, with no failure modes identified. Out of 28 tests, 10 had excursions at 100 mm or below. The excursions ranged from 56 to 224 mm. The rear panel, closer to the inflator, had lower excursions than the locations further away from the inflator. The front edge and center location both of which have limited support, were the most challenging for meeting the excursion limits.

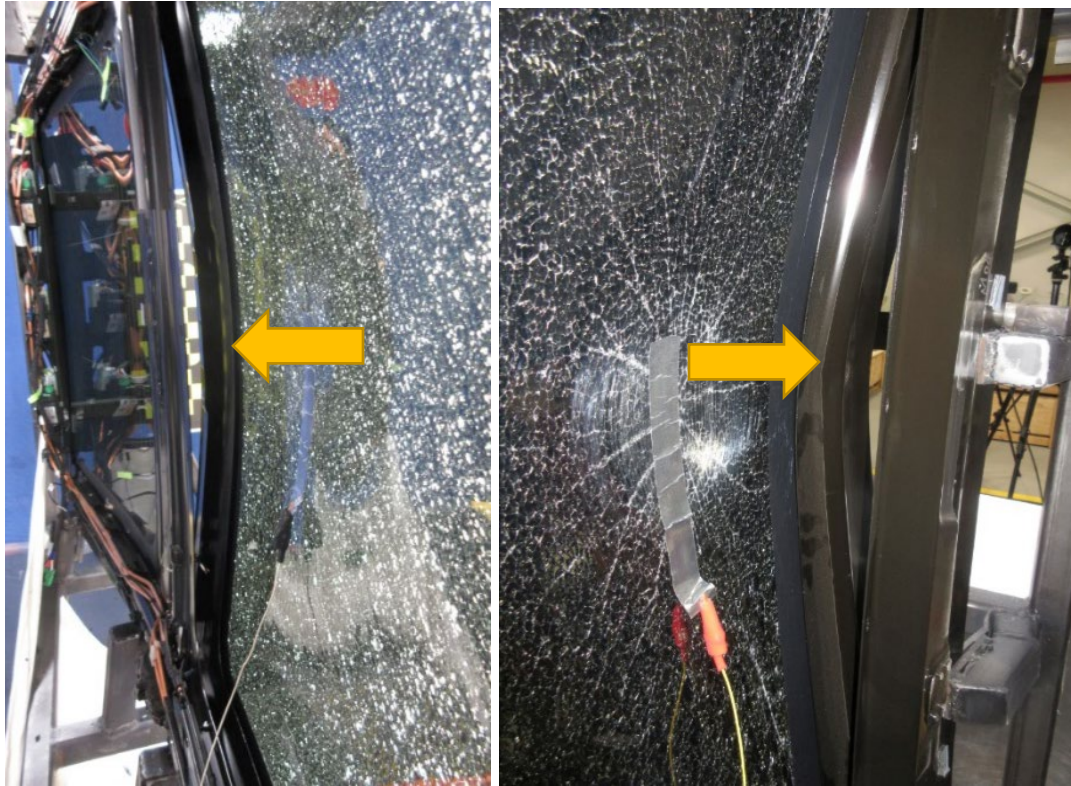
*Figure 31. Bending of Metal Frame Holding Glass (Yellow Arrows)*

Ram excursion values for the Lincoln MKZ panel were 100 mm or less from the 16 km/h impacts and just over 100 mm from the 20 km/h impacts. There was no gross failure of the attachments or film layer, even at the higher impact speed. However, it was observed that there was some bending of metal frame that holds the glass (Figure 31). The openings created from this bending were less than 100 mm in width and were not considered to be an indicator of performance or ejection concerns.

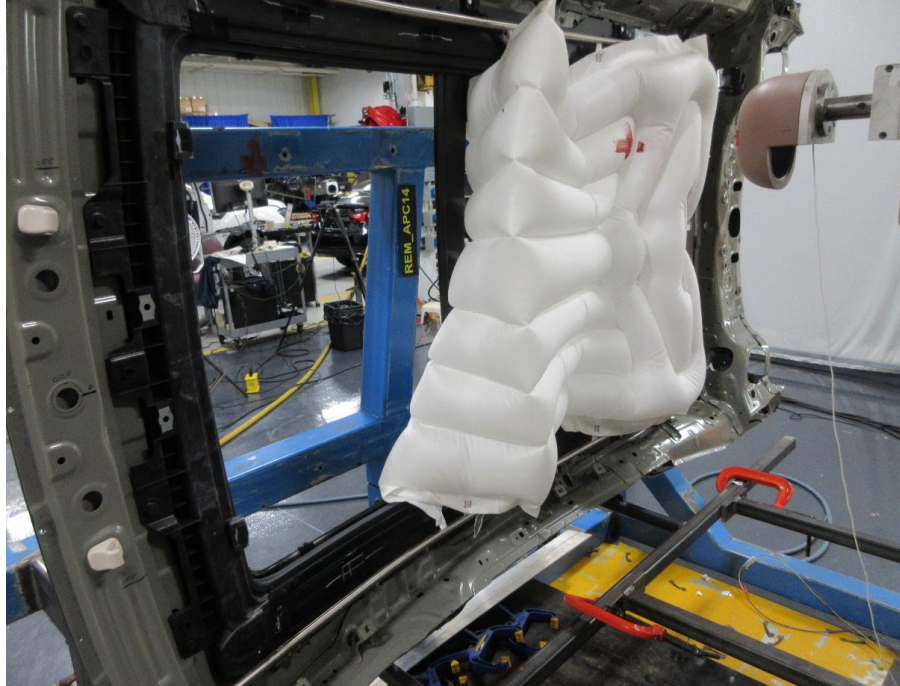
*Figure 33. Example of Bag Caught on Middle Support Member*

Tests with the Autoliv prototype air bag were first completed by deploying the bag across the opening prior to impact. During this section of testing (21 tests), there were seven tests that did not deploy correctly, usually because they got caught on the middle support member (Figure 33). Several troubleshooting actions were taken to try to get the bag to deploy, including verifying installations and orientation of the bag in the folded position prior to deploying, lubricating the rails, and replacing the center support. None of these efforts solved the issue and the remaining 15 tests were hand opened prior to inflation and impact.

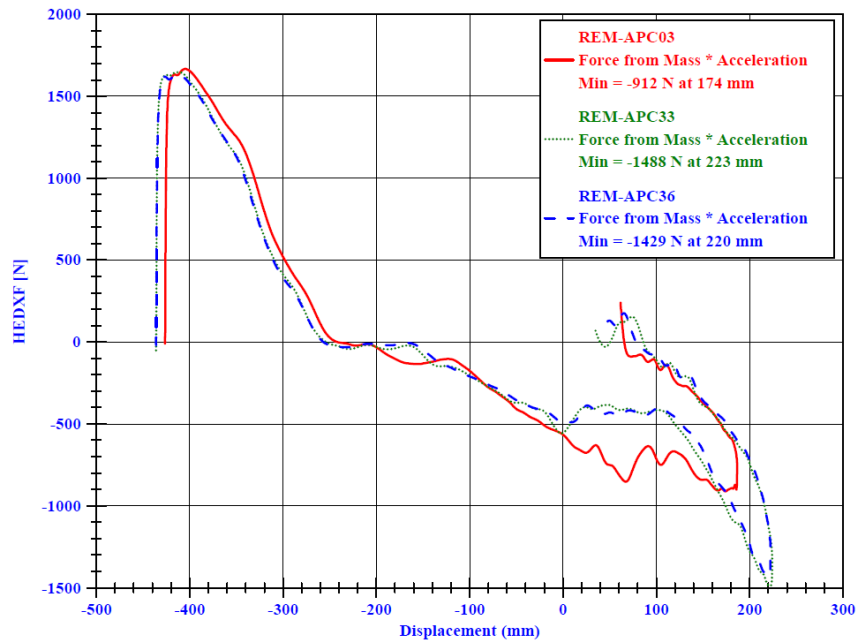
Figure 35. Force-Displacement of Autoliv Repeat Tests

As part of the test series, three repeat tests were performed at the front panel front edge location. One test was with the bag deploying, and the other two were with hand opening the bag. The deployed bag result had slightly less excursion (187 mm), which was approximately 37 mm different than the hand opened results (224 and 222 mm). The hand opened test excursion results were similar to each other. Figure 35 shows the force-displacement plot for the three tests. The red line was the deployed test, and the blue and green lines were the hand-opened tests.

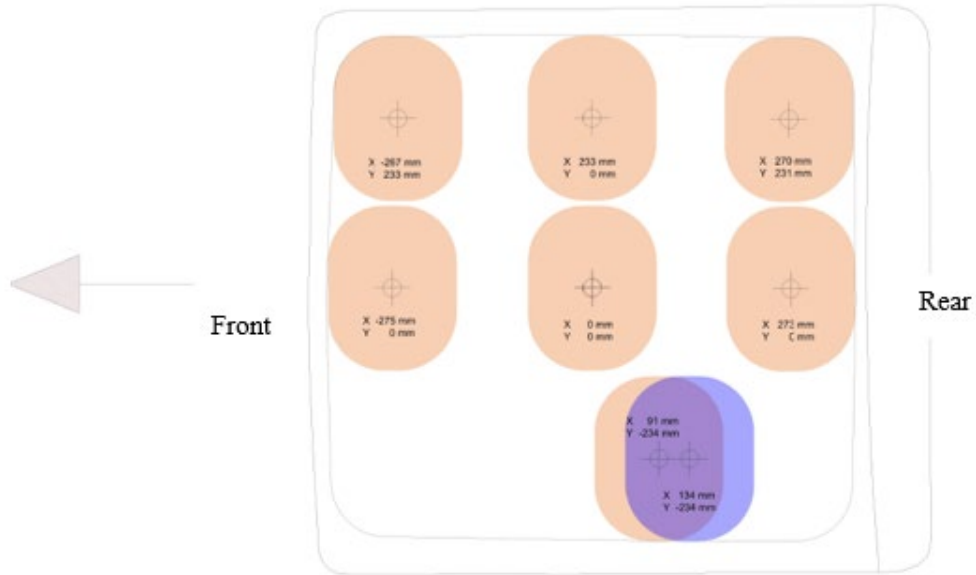
Figure 39. 2018 Lincoln MKZ Impact Locations. Purple Location Was Impacted, Correct Locations Shown in Peach

During post processing of the test data it was discovered that the 2/3 lateral edge location was not aligned correctly during test setup for both the Lincoln MKZ and Hyundai-Mobis Roof Air Curtain setups. All other impact points were targeted as intended. The below diagrams show the tested impact location (purple) along with the correct impact location (peach) (Figures 39 and 40). The tested impact location on the Hyundai-Mobis Roof Air Curtain was found by taking 2/3 of the length of the full daylight opening. The intended method is to take 2/3 the length between the centers of the corner impact points. In the Lincoln MKZ setup, the tested impact point was 43 mm rearward of the correct impact point. In the Hyundai-Mobis Roof Air Curtain the tested impact point on the front panel was 6 mm forward of the intended impact point and the tested impact point on the rear panel was 34 mm rearward of the intended impact point. It is not known what the effect of this difference in impact location would make on the performance of the designs.

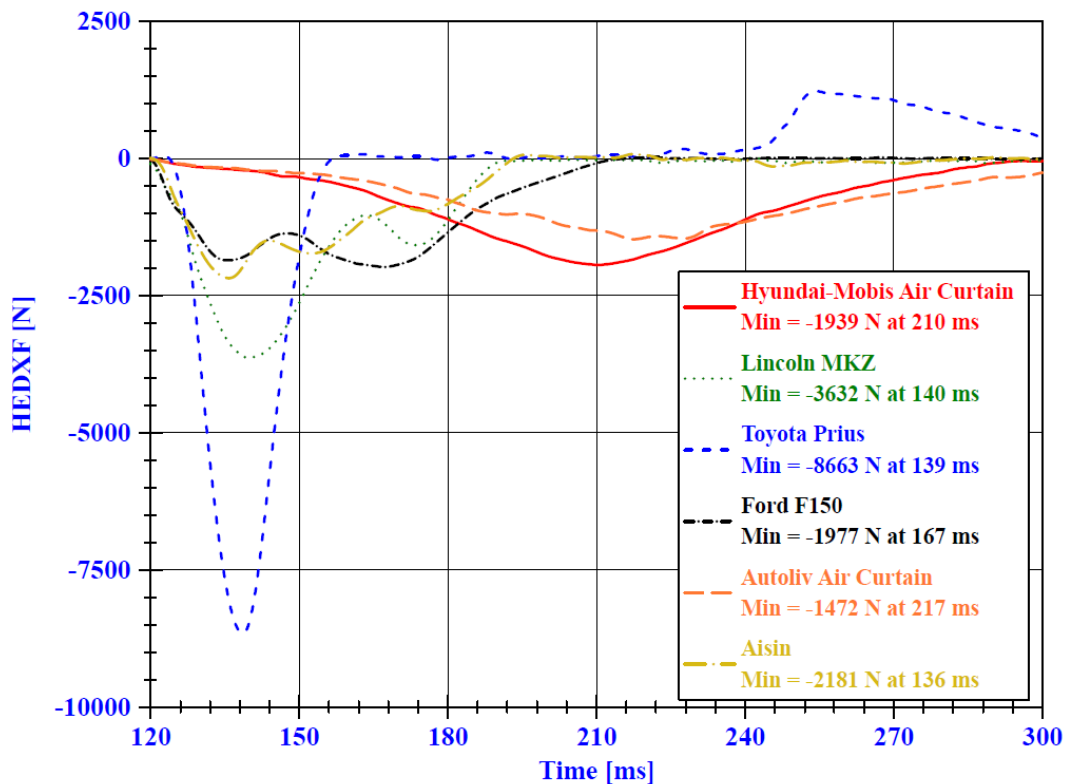
Figure 41. Head Impact Force Comparison Curves

Using the accelerometer in the headform, the force on the headform can be calculated as the product of the ram acceleration and headform mass (18 kg) to estimate the maximum forces that may be expected from interaction with the sunroof or other ejection mitigation surface. Figure 41 shows a comparison of the force-time curves of platforms tested previously along with the platforms discussed in this report. The curves represent the forces on the headform over time when impacting at 16 km/h at the center of the front daylight opening. The plot starts near 120 ms at the first interaction of the headform with the sunroof or ejection mitigation surface. As seen in the figure, the greatest force on the headform (8663 N) was from the Toyota Prius (blue curve), which was a fixed polycarbonate sunroof. The next highest force was the Lincoln MKZ, shown in green at 3632 N. The Hyundai-Mobis air curtain, Ford F150 and Aisin panoramic had similar forces of around 2000 N. The Autoliv air curtain (orange curve) had the lowest force at 1472 N.

Impulse is the change in momentum of an object. The headform in each of these tests had the same momentum ( $p=m*v$ ) prior to impacting the sunroof or other ejection mitigation surface, since the mass of the headform and impact velocity of 16 km/h was consistent. However, the impulse in each of these tests was different once it impacts the mitigation surface. Impulse, shown in Table 4, was calculated as the area under each force-time curve in Figure 41.
