Rehabilitation and Load Rating of Deteriorated Timber Bridges in Colorado: Parametric Investigations and Implementation

1. Report No. CDOT-2023-06		2. Government Accession No.		3. Recipient's Catalog No.	
4. Title and Subtitle Rehabilitation and Load Rating of Deteriorated Timber Bridges in Colorado: Parametric Investigations and Implementation				5. Report Date May 2023

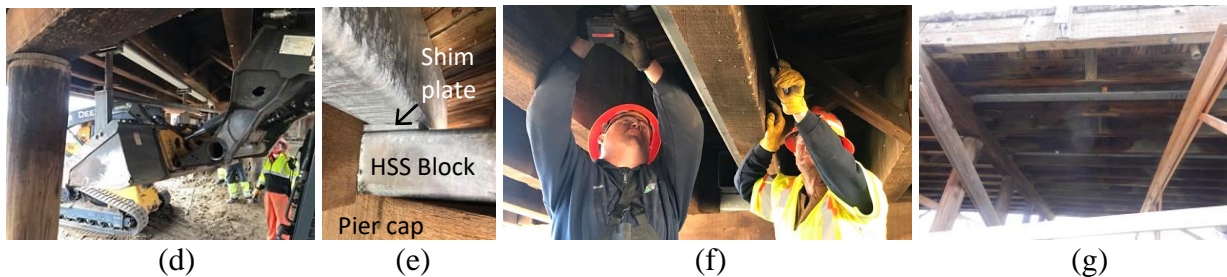
Fig. III.2. Repair with hollow structural sections (HSS): (a) schematic view; (b) HSS installation locations of F-22-V; (c) HSS installation locations of H-20-T; (d) lifting of HSS; (e) assembled HSS system; (f) drilling for connection; (g) completion

- Step 1: end diaphragms and cross bracings were removed
- Step 2: one HSS beam was located next to a target timber girder (Fig. III.2(d)). In addition, at least 2 steel members were allocated per travel lane

- Step 3: steel bearing blocks (HSS $9 \times 7 \times 5/16$, 9 in. deep \times 7 in. wide \times 0.29 in. thick) were placed above pier caps (Fig. III.2(e)). Steel shim plates with a thickness of 3 mm were inserted between the longitudinal HSS beam and the bearing blocks until the beam was snug tight.
- Step 4: a 0.7 mm diameter hole was drilled through the girder at midspan and an all threaded rod (0.63 in. in diameter) was inserted through the HSS beam and the girder (Fig. III.2(f)). Nuts were snug-tightened with plate washers (2 in. \times 2 in.).
- Step 5: the diaphragms and cross bracings were replaced and field-fitted to avoid a gap. These secondary structural members were then connected to the girder (Fig. III.2(g)).

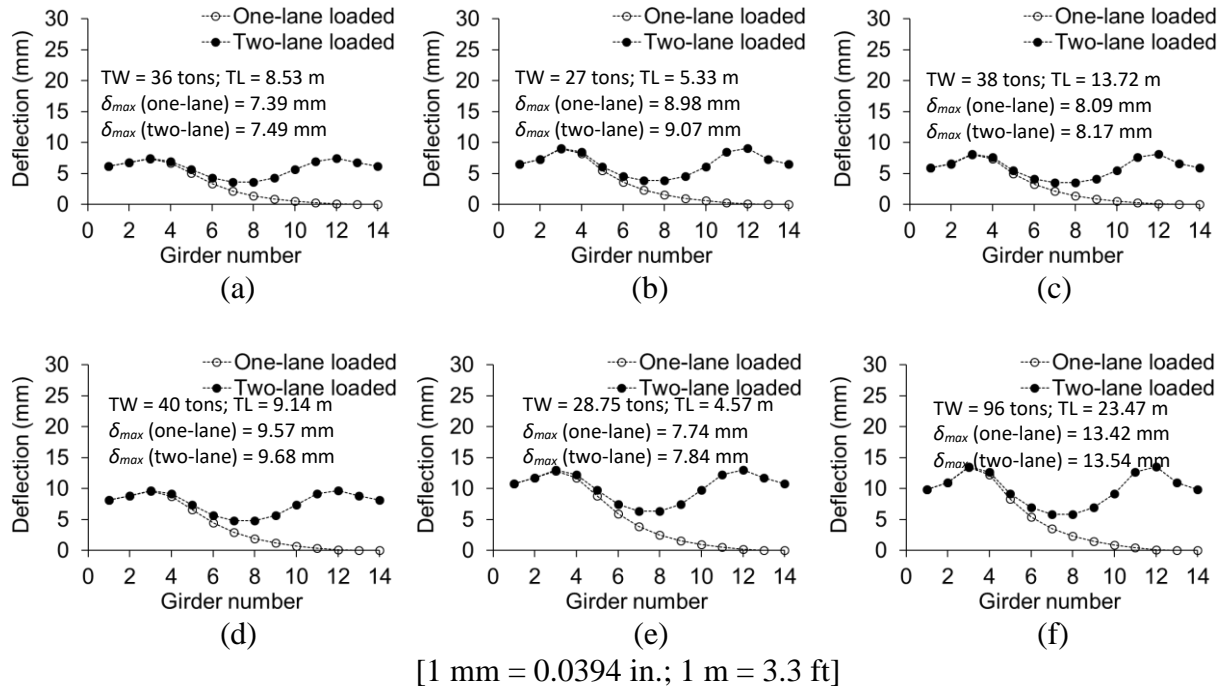
Fig. III.5. Deflection profiles of unrepaired F-22-V under selected truck loads (TW = truck weight in total; TL = truck length from front to rear axles): (a) HS20; (b) Colorado Legal Type 3; (c) Interstate Type 3S2; (d) Hauling Vehicle A; (e) Emergency Vehicle 2; (f) Colorado Permit

Figure III.5 exhibits the deflection profiles of the unrepaired F-22-V bridge under selected live loads. The HS20 truck generated the maximum deflections of 7.39 mm (0.291 in.) and 7.49 mm (0.295 in.) for the one- and two-lane loaded cases, respectively (Fig. III.5(a)), and the individual configurations were dependent upon the position of the truck. Although the total weight of Colorado Legal Type 3 (27 tons) was less than that of HS20 (36 tons), the deflections increased by 21.5% and 21.1% for the one- and two-lane loaded cases, respectively (Fig. III.5(b)). This is due to the reduced distance between the front and rear axles (5.33 m (17.6 ft) for Colorado Legal Type 3 vs. 8.53 m (28 ft) for HS20), which resulted in the so-called concentrated load effect. A similar tendency was found between Interstate Type 3S2 and Hauling Vehicle A in Figs. III.5(c)

and (d), where a reduction of 33.4% in the axle-to-axle distance was responsible for the increased deflections of 18.3% and 18.5% belonging to the one- and two-lane loads, respectively. Such observations, however, are not always valid as can be seen in Figs. III.5(e) and (f). Even if the axle-to-axle distance of Emergency Vehicle 2 (4.57 m (15 ft)) was much shorter than the distance of Colorado Permit (23.47 m (77 ft)), the deflection under Colorado Permit was 173.4% higher than the instance of Emergency Vehicle 2 (13.42 mm (0.528 in.) vs. 7.74 mm (0.305 in.)) owing to a significant difference in the total weights (96 tons vs. 28.75 tons). It is, thus, recommended that sophisticated modeling be carried out when the ramifications of nonconforming features (other than the customary design loads of HS20 and HL93) are examined. The flexural responses of H-20-T with the steel beams are plotted in Fig. III.6. For facilitating discussions on the effectiveness of the repair, the predicted results were normalized to show a ratio between deflections with and without the steel beams. The responses before and after the repair entailed inappreciable variations without regard to the types of the live loads and the number of the loaded lanes. This signifies that a single methodology can be used to generate consistent evaluation outcomes for timber bridges repaired with steel sections.

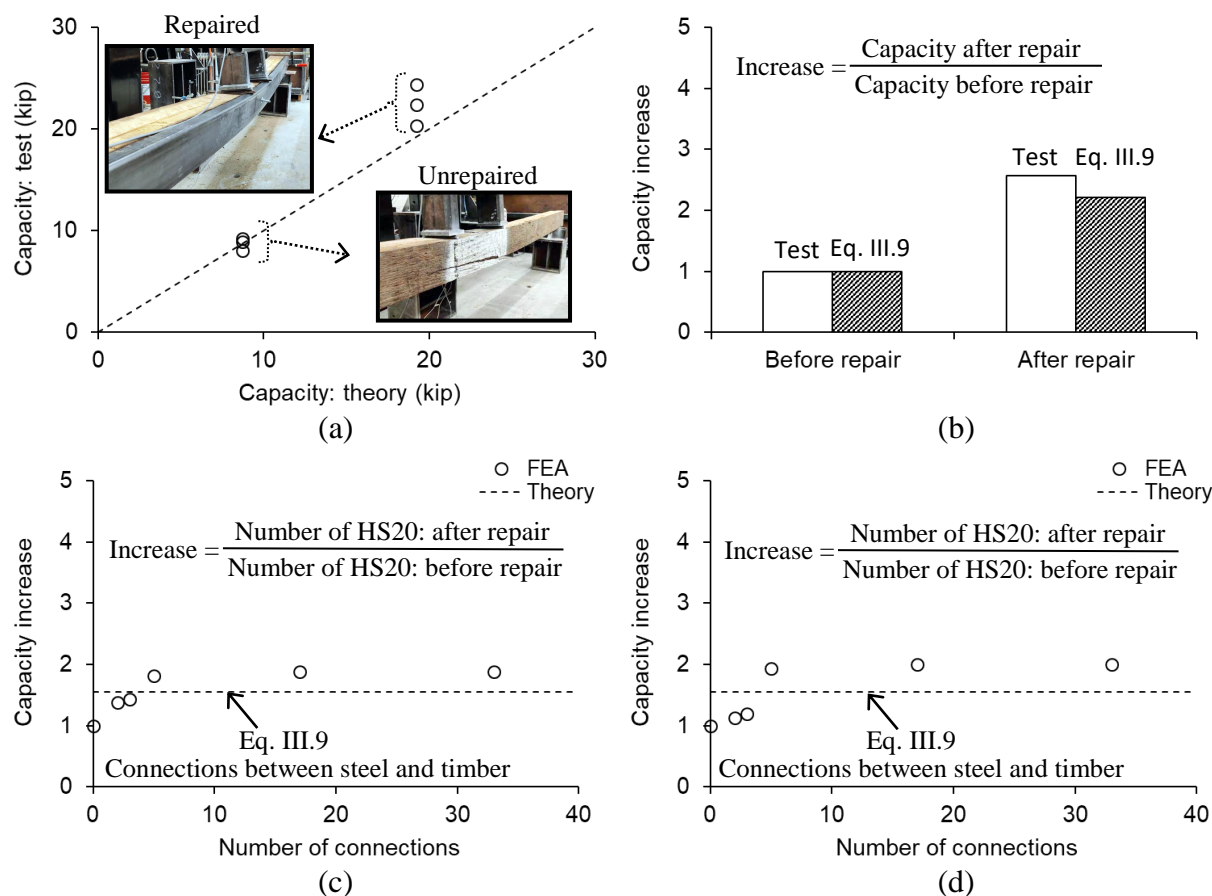
Fig. III.7. Flexural capacity of timber girders before and after repair (FEA = finite element analysis): (a) comparison with tests; (b) assessment with test data; (c) F-22-V; (d) H-20-T

Prior to executing the capacity adjustment approach, its relevance was appraised. Figure III.7(a) displays test data excerpted from Part I, which loaded Douglas Fir beams with and without repair (inset pictures in Fig. III.7(a)), and predicted results from the proposed approach. For the unrepaired case, the average ultimate loads of the experimental and theoretical beams were 8.72 kips and 8.70 kips, respectively; in contrast, the calculated capacity of the repaired beam was lower than the measured capacities by 14.1%, on average. This discrepancy can be ascribed to the fact that the actual modular ratio n in Eqs. III.7 and III.8 might be higher than the nominal value and that the applied load might not be uniformly distributed to the timber and steel during the test. The increased capacities of the experimental and theoretical beams after the repair were 2.56 and 2.21 times the capacities of the unrepaired beams, respectively (Fig. III.7(b)).

The efficacy of the repair for the F-22-V and H-20-T bridges is charted in Figs. III.7(c) and (d), respectively. To determine the capacity of the bridges, the weight of the HS20 truck (Fig. III.3(a)) was incrementally raised in the finite element analysis (FEA) until the maximum tensile stress of the timber girders reached the modulus of rupture. Subsequently, the number of the trucks was counted before and after the repair to attain a capacity increase ratio, as indicated in Figs. III.7(c) and (d). The ratio was contingent upon the number of connections between the timber and steel at uniform spacings (i.e., the number of the link elements delineated in Sec. III.4.1). When the number of the connections was more than five, increases in the capacity were alike between the FEA and theory (Eq. III.9), which means that full composite action took place. On the site application with three connections at both ends and midspan (Fig. III.2), the average capacity increase was 1.32 (41.9% lower than that of the five connection cases). It is hence stated that the capacity increase after the repair with at least three connections varied from 1.32 to 1.94 and, for practical ratings in the field, the capacity increase is suggested to be 10% lower than the capacity increase estimated by Eq. III.9, stemming from the difference between the theory and the lower bound value of 1.32. Therefore, including the capacity reduction factor (κ) given in Table III.3 to reflect in-situ degradation over time (MDT 2019), the adjusted nominal capacities of the repaired timber girder for rating become (F_r is in MPa for Eq. III.13):

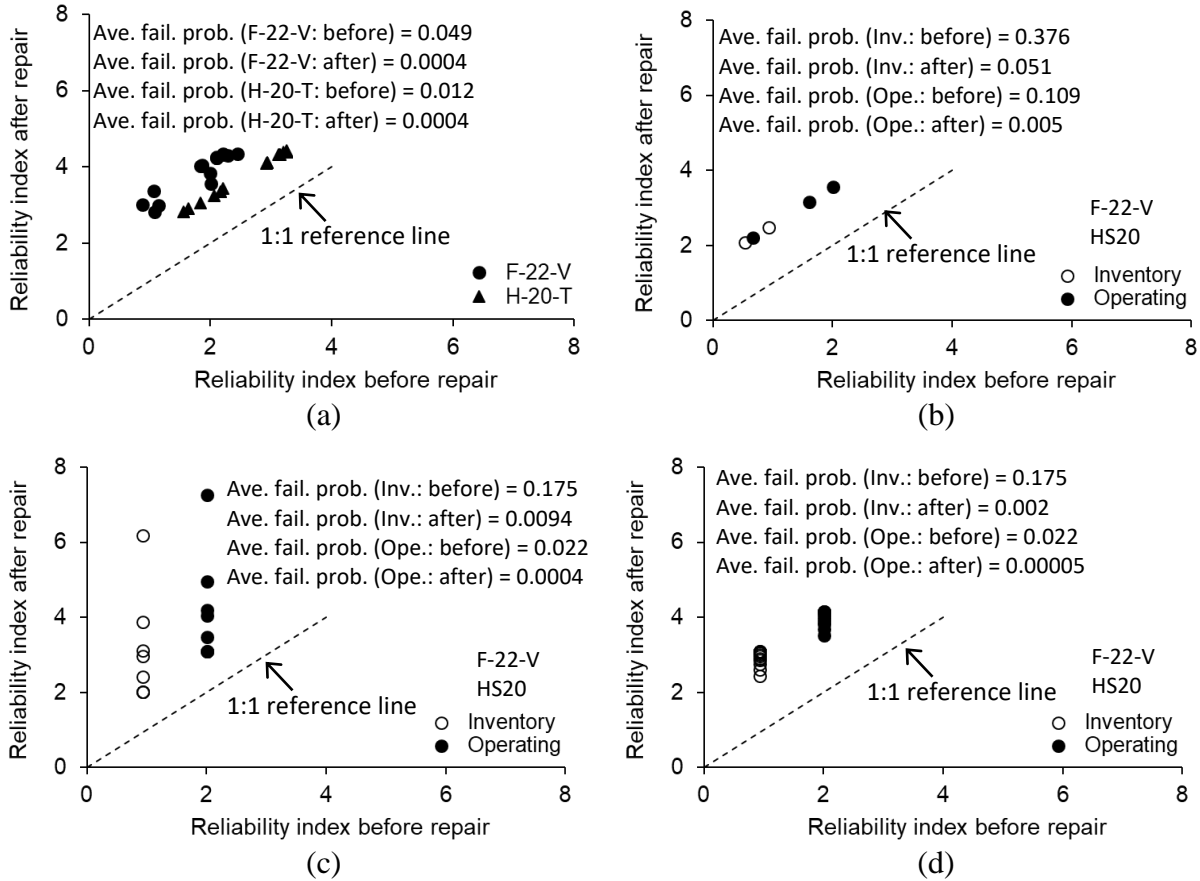
Fig. III.11. Safety analysis: (a) Operating level under 17 rating live loads; (b) deterioration level; (c) steel section size; (d) steel section arrangement

where $\Phi(\cdot)$ is the standard normal cumulative distribution. Figure III.11(a) demonstrates the reliability indexes of F-22-V and H-20-T (the Operating levels in flexure are shown, controlling traffic restrictions in most agencies, Wang et al. 2011). The degree of reliability rose owing to the steel beam repair and the probability of failure remarkably diminished by 99.2% and 96.7% for F-22-V and H-20-T, respectively. The reliability indexes and corresponding failure probabilities associated with the parametric studies are given in Figs. III.11(b) to (d). On all occasions, the use of the steel beams was more effective for the Operating levels than the Inventory levels in terms of reducing the failure probability; in other words, the repair method is expected to preclude the catastrophic collapse of decrepit timber bridges.
