# IMPROVED METHODS AND EQUIPMENT TO CONDUCT PAVEMENT DISTRESS SURVEYS

Report No.  
FHWA-TS-87-213

Final Report  
April 1987

<b>16. Abstract</b> <p>This report documents the second phase of an FHWA study, entitled "Pavement Condition Monitoring Methods and Equipment". In this phase selected distress survey methods and devices, representing a range in automation, were tested from July to September 1986. The following methods and devices were included in the testing: manual mapping, detailed visual surveys using manual recording and automatic data logging, PASCO ROADRECON survey vehicle, the GERPHO survey vehicle, the ARAN survey vehicle, and the Laser RST survey vehicle. The field tests were conducted on flexible, rigid, and composite pavements exhibiting a range of pavement distresses.</p> <p>The survey devices were evaluated using performance, capability, efficiency, and cost-effectiveness criteria. The study concluded that, at present, the GERPHO and PASCO ROADRECON are best suited for pavement performance research studies due to factors such as the permanent film record, cost-effectiveness, and data quality. The GERPHO and PASCO ROADRECON are also judged to be suitable for net

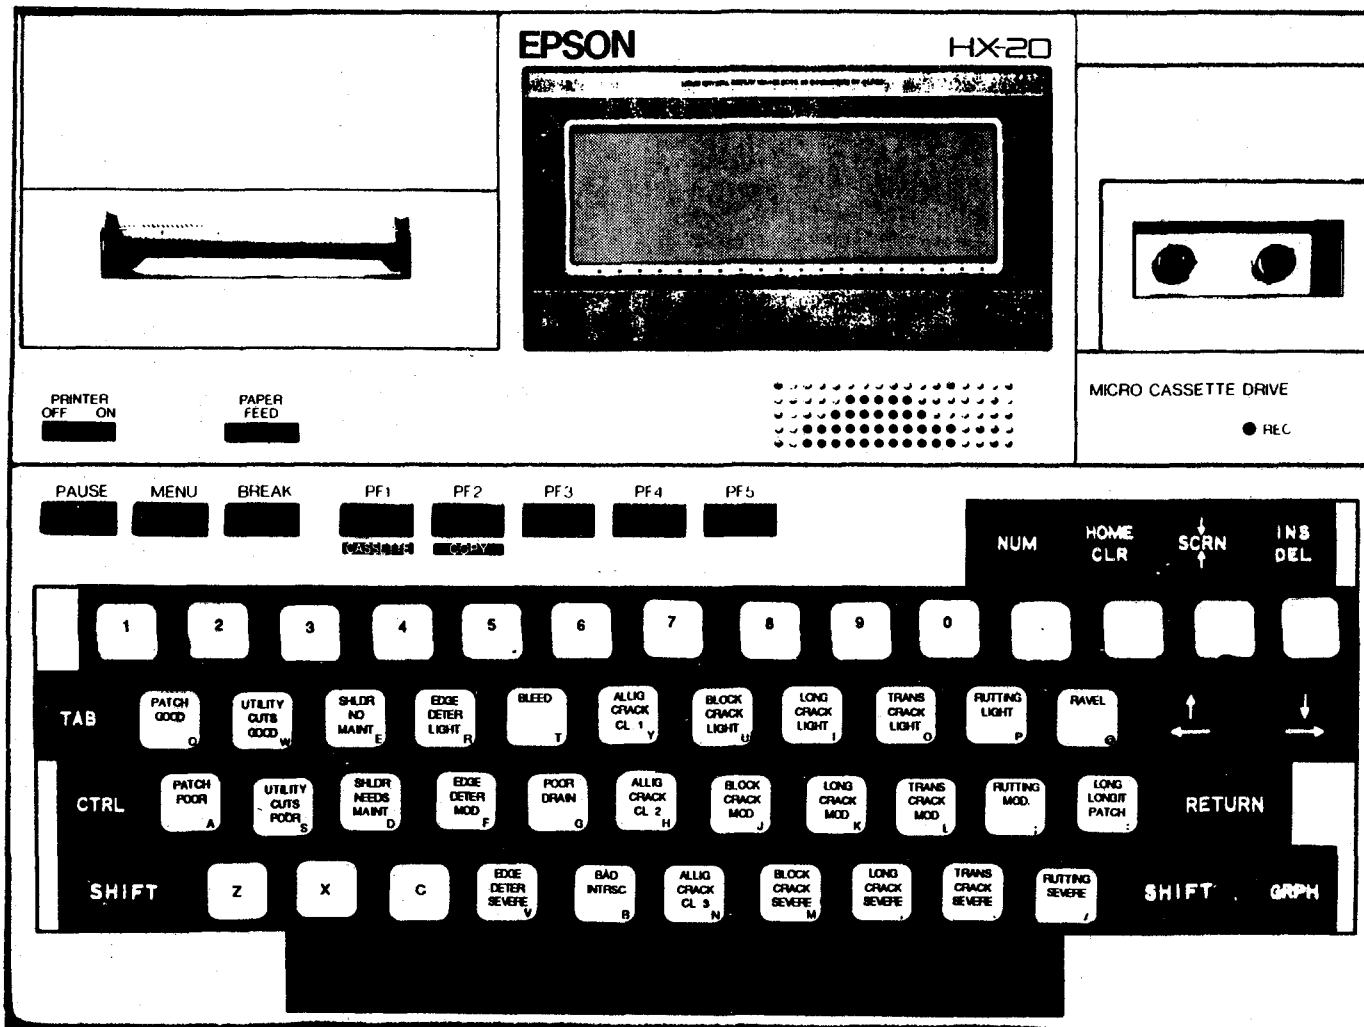
Figure 4. EPSON HX-20 keyboard used for automatic distress data logging.

The detailed distress survey using a field data logger was performed using a battery operated Epson HX-20 portable computer programmed by ARE Inc to record distress and section information. The interactive program prompts the rater for input of the severity and extent of each previously defined distress category. The information is stored on a computer encoded microcassette. This allows the information to be downloaded in the office using hardwired connections between computers and a communications program. Paper tapes are also produced in the field as the information is recorded to serve as backup. The automatic data logging keyboard is shown in Figure 4.

An EPSON HX-20 portable computer was used in the field to record section identification information as well as distresses. The EPSON keyboard, used for automatic data logging was shown in Chapter 2 (Figure 4). A 10-foot (3.05 m) straightedge was also utilized in the field to make an estimate of rut depth. The severity level of rutting was based on this estimated depth. No other equipment was used in the field.

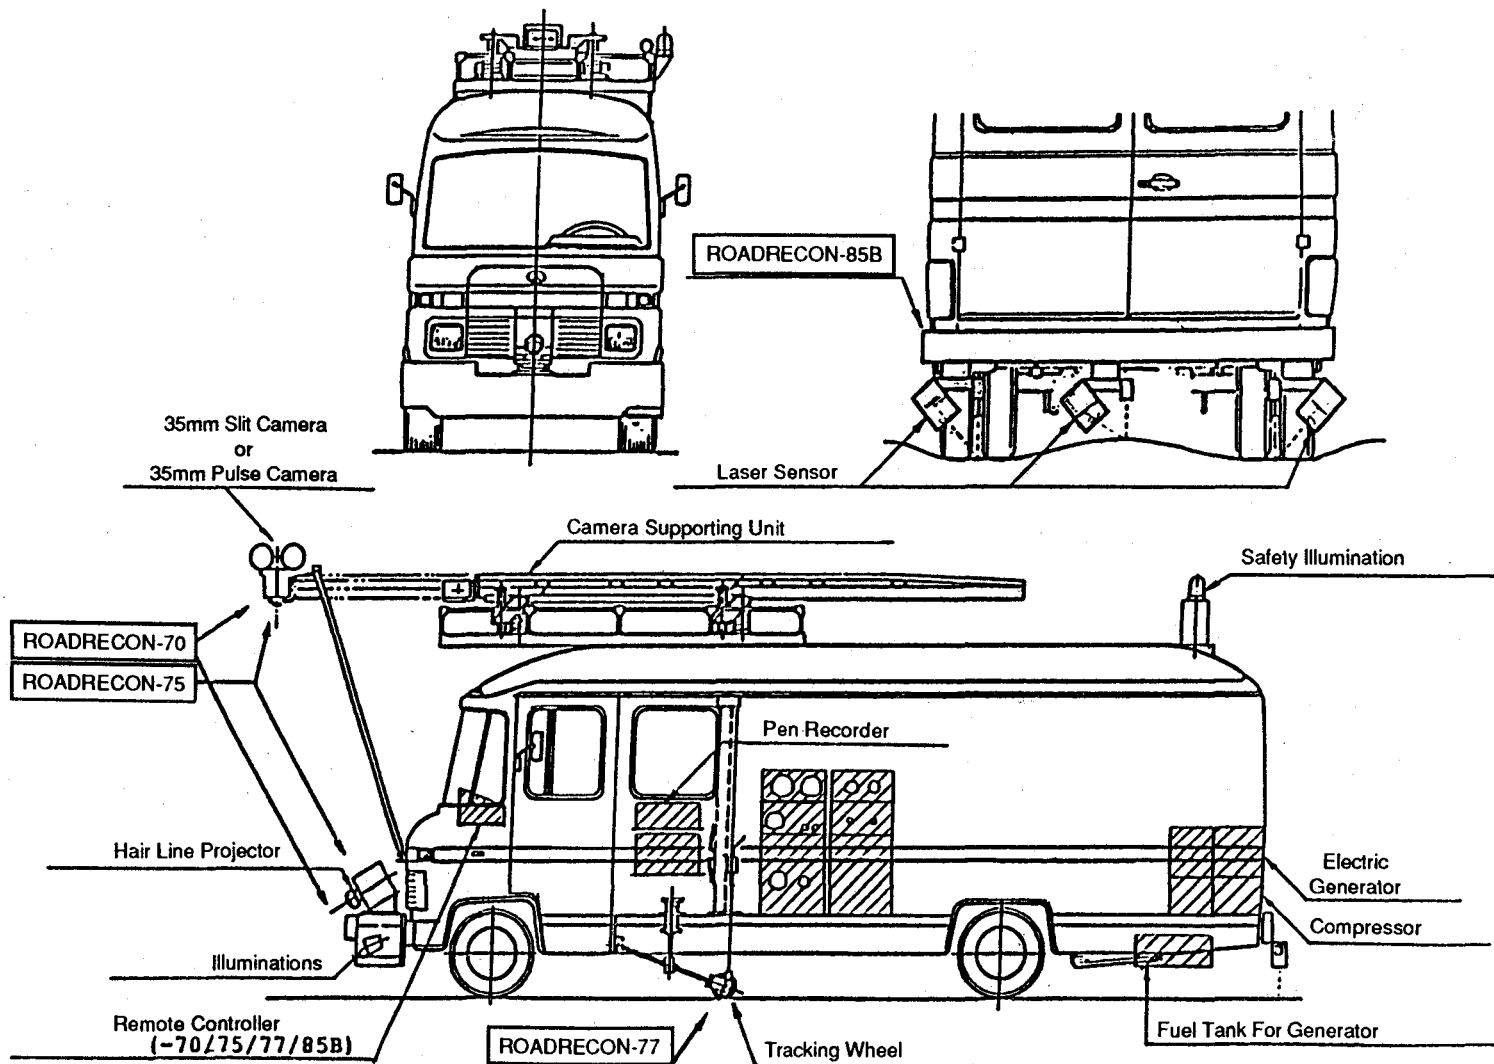
Figure 5. PASCO ROADRECON system featuring automated photographic equipment and laser sensors (Ref 8).

an approximation of rut depth since each wheel path is measured. The measurements with the ROADRECON-85B is not a true profile since the movement of the vehicle body is not subtracted from the height measurements. The PASCO survey vehicle also has other devices for measuring pavement surface characteristics as described below and in Appendix A. This study concentrated on the continuous photograph made with the ROADRECON-70 and the rut depth measurements performed with the ROADRECON-75 device. The ROADRECON survey vehicle and systems used for this study are illustrated in Figure 5.

Cracking, patching, and other distresses are recorded using a continuous road surface photographic recorder, called the ROADRECON-70 system (Ref 7). The vehicle travels at speeds between 3 and 53 mph (5 and 85 kmph). A continuous photographic record of the pavement surface is made using a 35-mm slit camera. The system synchronizes film feed speed and camera aperture with the speed of the vehicle in order to equalize image density and photographic reduction. A continuous film record of approximately 37 miles (60 km) of road can be created with 1000 feet (305 m) of film. Road width up to 16 feet (5 m) can be filmed. Photographing is performed at night using on-board lights. The lights are set at an angle to the road surface so that shadows are produced at cracks and other defects in the surface, making interpretation easier. Interpretations of the distresses present on the road are made by a technician viewing the developed 35-mm film enlarged ten times on the ROADRECON Film Digitizer. A grid pattern is overlaid on the film to aid in quantification of the distress for input into a computer data base.

Rut depth surveys can be carried out at speeds up to 50 mph (80 kmph) using the ROADRECON-75 system (Ref 8). A pulse camera mounted on the vehicle photographs hairline optical bars projected onto the road. The camera shutter and hairline projector are synchronized according to the distance covered by the projection vehicle, so the system is able to create a photographic record of rutting over a given distance. The film is projected onto a digitizing table and traced with a computer "mouse", enabling the wave patterns to be processed into a transverse profile of

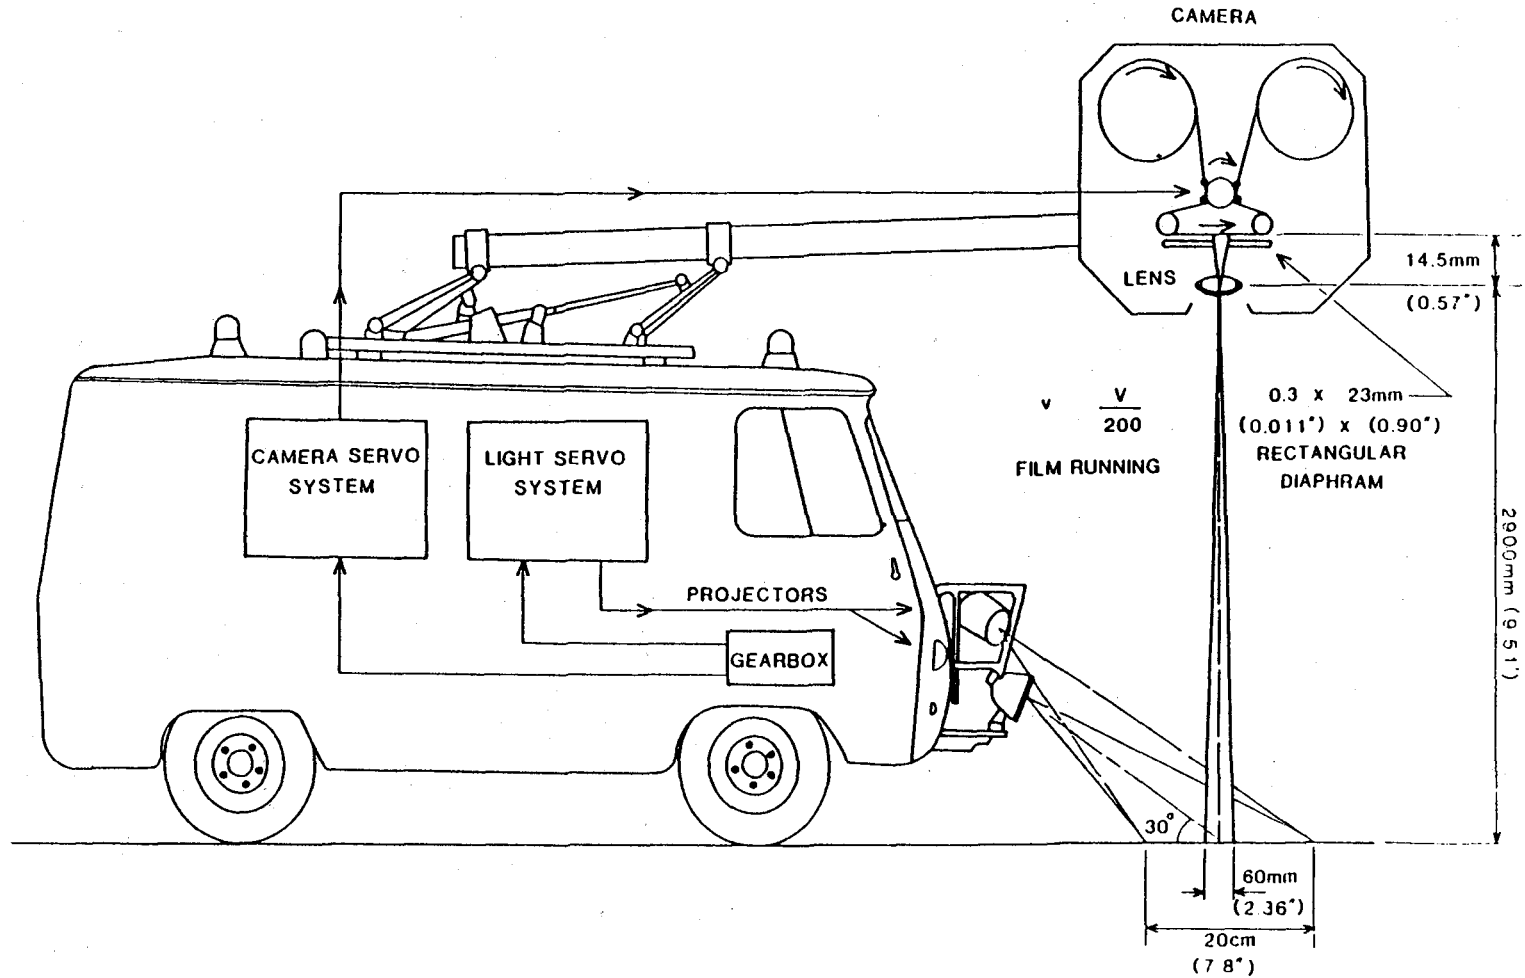
Figure 6. Schematic illustrating principles of GERPHO's automated photographic system (Ref 9).

The GERPHO system consists of a 35-mm continuously-running (strip film) camera, mounted on a van with a light source that illuminates the pavement as illustrated in Figure 6. The pavement surveys are conducted at night to allow for uniform lighting conditions. The boom mount allows the height of the camera to be varied for easy loading of the film. The camera is fitted with a 14.5-mm lens with an aperture of F-3.5. Automatic cartridges hold 394 feet (120 meters) of film and can

photograph 15 miles (24 km) of pavement. The scale used is 1/200 (the film useful width divided by width of filmed pavement) which means that the camera lens should be placed at 9.5 feet (2.90 m) above the pavement (focal length/height = 1/200). The picture covers a width of pavement up to 15 feet (4.6 m). Thus, the picture covers the entire traffic lane along which the van moves, together with part of the adjacent lane and/or part of the shoulder (Ref 9). The film and light source are controlled as a function of vehicle speed. The GERPHO system takes a continuous image of the pavement surface at speeds up to 40 mph (60 kmph). Between 63 to 125 lane miles (100 to 200 km) can be photographed per working night. Two operators, who do not have to be highly skilled, are required.

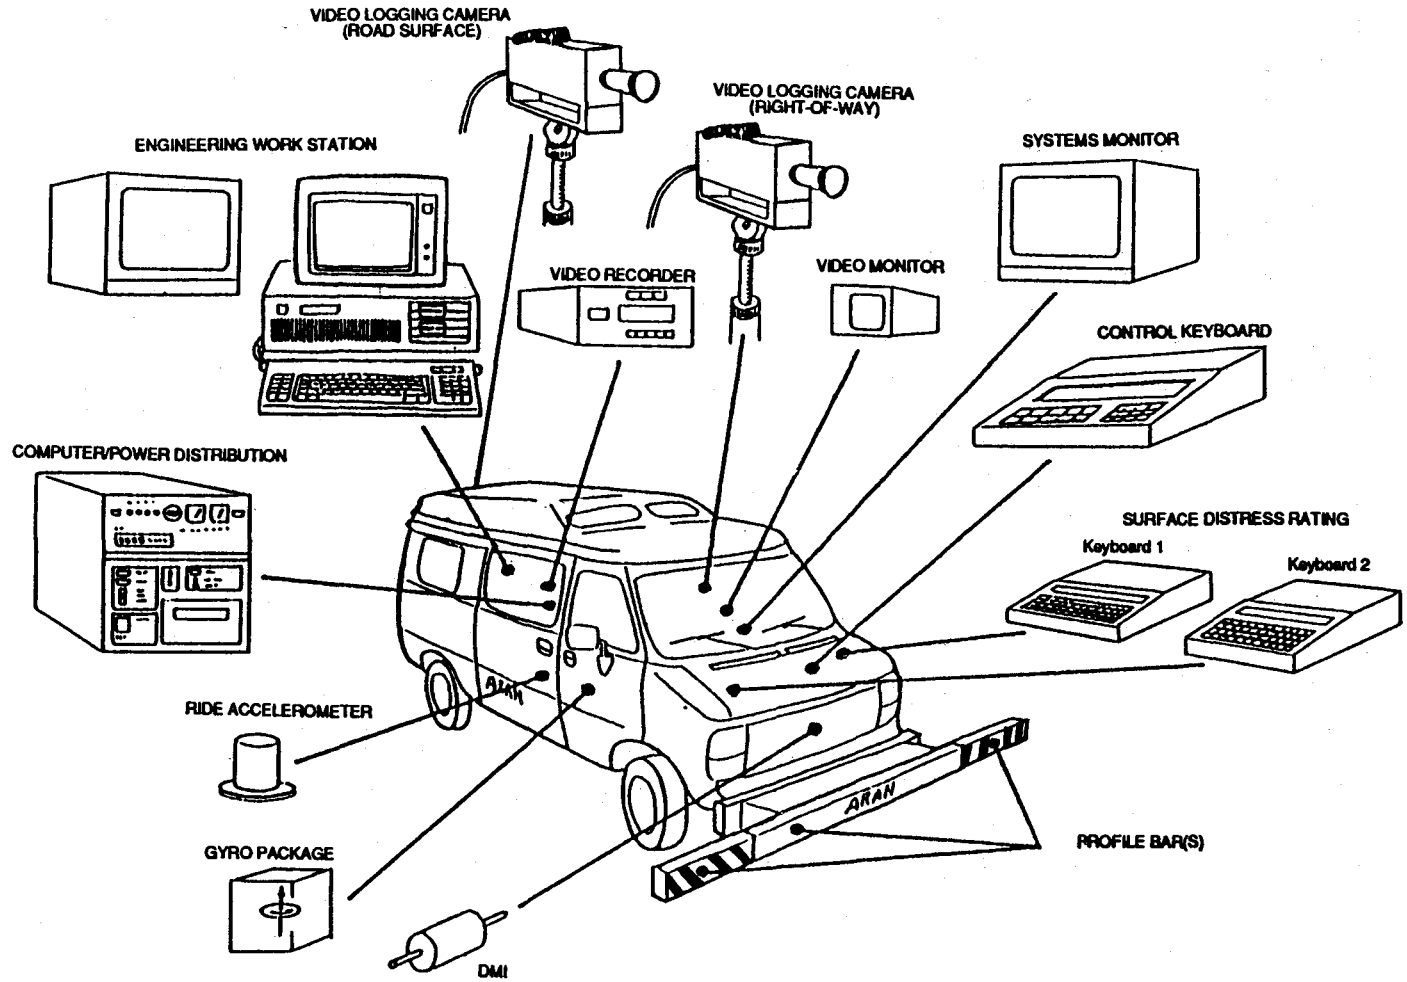
Figure 7. Schematic illustrating various components of HPI's automatic road analyzer (ARAN) (Ref 11).

The Automatic Road Analyzer (ARAN) vehicle is produced by Highway Products International, Inc. of Paris, Ontario, Canada. An ARAN Model III unit was used in the field tests of this project (Figure 7). It measures rut depth and transverse profile with ultrasonic sensors, ride/roughness quality with an accelerometer on the rear axle, takes a video picture of the road right-of-way through the windshield, takes a video picture of the pavement surface with a shuttered video camera behind the vehicle, and uses an on-board microprocessor to record distress data (Ref 11). Seven ultrasonic sensors on 12-inch (30.5 mm) centers, mounted in a front-bumper rut bar, are reported by the manufacturer to measure the distance to the pavement surface with 1-mm precision at operating speeds up to 55 mph (90 kmph). Additional sensors and bar extensions can be used to extend the

rut bar to a width of 10, 11, or 12 feet (3.1, 3.4, or 3.7 m). A calibration sensor is used to compensate for changes in air density due to temperature variation. Microprocessor-controlled, plug-in optional keyboards, with built-in liquid crystal displays, automate the collection and recording process. Dual keyboards have the capacity to handle up to 20 distress categories in three severity categories and five degrees of areal extent. Landmarks, such as bridges and railway crossings, can be recorded using eight special-event keys. The video equipment operates from a 12-volt power supply.

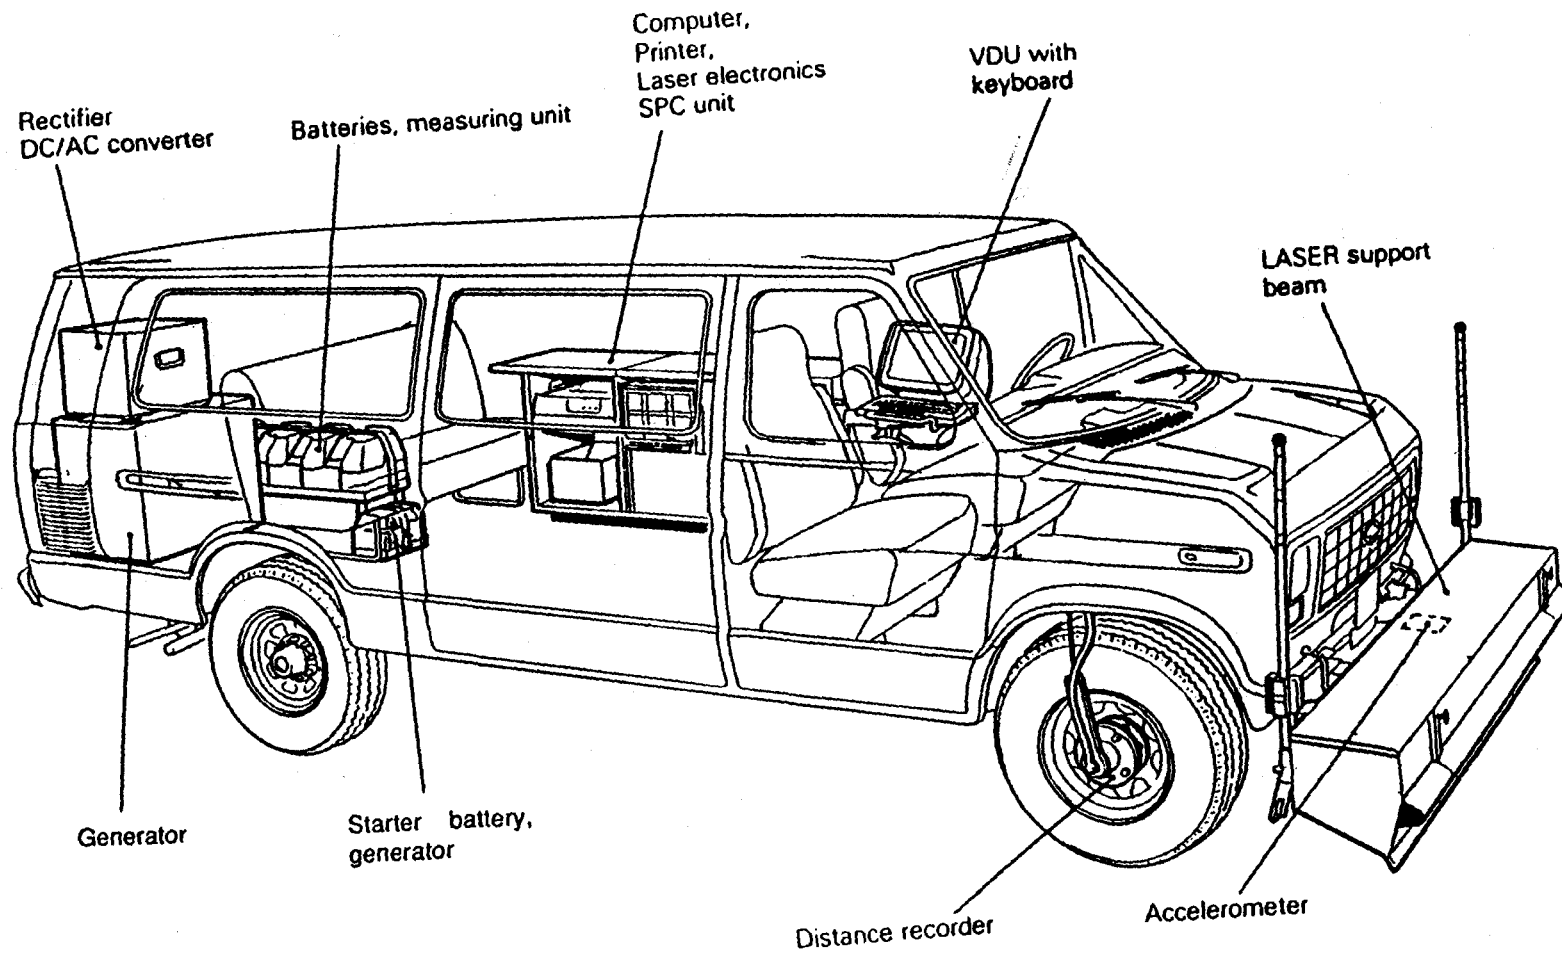
Figure 8. Schematic illustrating various components of IMS' Laser Road Surface Tester (RST) (Ref 13).

The Laser Road Surface Tester (RST) was developed by the Swedish Road and Traffic Research Institute and has been used in Sweden for about three years (Ref 12). The Laser RST can reportedly measure crack depths and widths, rut depths, longitudinal profile from which roughness is computed, macrotexture, cross profile, and distance. A "windshield" condition survey can also be performed by one of the operators to identify types of cracking and other distresses. The device tested on this project uses eleven bumper-mounted laser range finders and an accelerometer to measure the transverse road profile and detect cracks while traveling at speeds of 18 to 55 mph (30 to 80 kmph) (Ref 13). A pulse transducer, mounted on the wheel hub, measures the distance traveled by the unit. Seven of the lasers pulse at 16 kHz and are used for the rut depth measurements. Four of the lasers pulse at 32 kHz and are used for measurement of rut depth and cracking. Two of these lasers are used for macrotexture and longitudinal profile measurements. These lasers have a reported accuracy of 0.01 inches (0.26 mm). An on-board microcomputer integrates the sensor signals with the accelerometer and distance transducer, averages the data into manageable sections, and provides the processed data in real time. A set of eight three-position toggle switches are used to rate types of cracking and other distresses. An illustration of the Laser RST is shown in Figure 8. The Laser RST is available in the United States only under a lease agreement with Infrastructure Management Services. Three operators are required for normal operations with one operator well-trained in setup and use of the equipment.

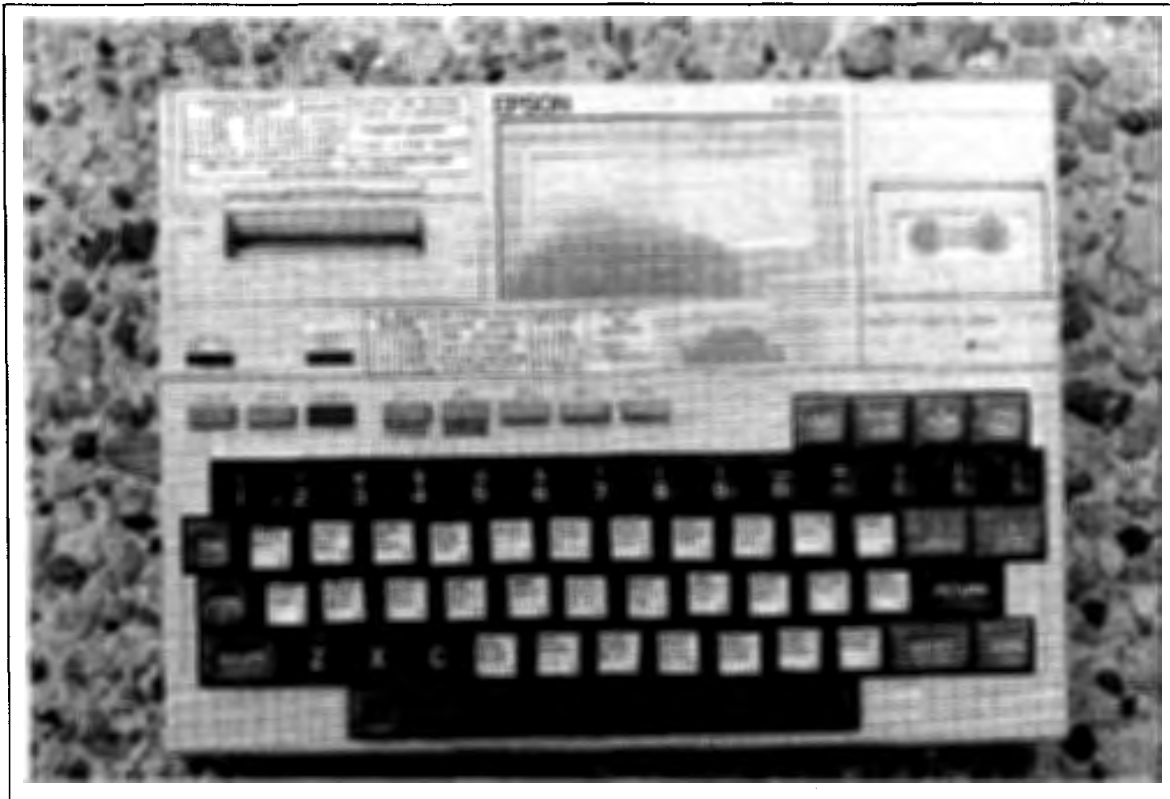
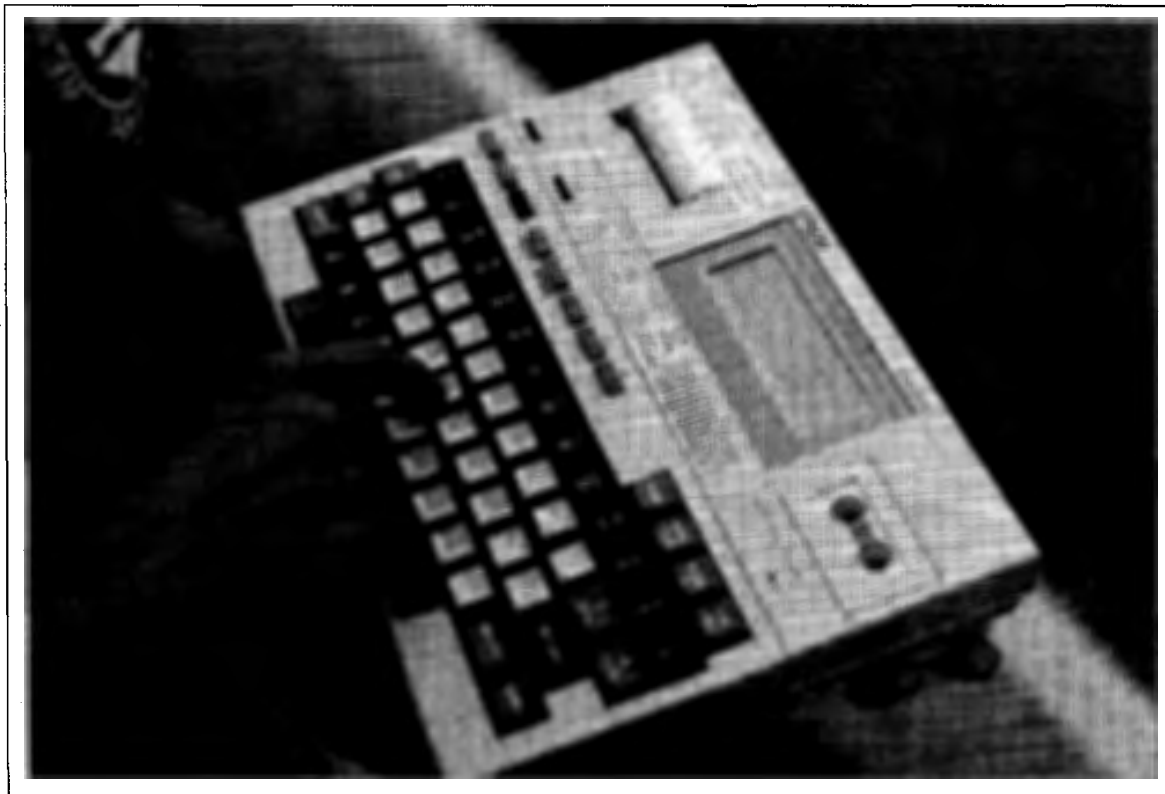
Figure 12. Two views of the EPSON HX-20 portable computer used for automatic data logging.

The automated data logging system used for the distress survey tests (Figure 12) was based on a pavement evaluation and management system developed for the Rhode Island Department of Transportation by ARE Inc (Ref 6). The system allowed data to be input directly into a field data

recorder, and to be transferred to a microcomputer for further processing in the office.

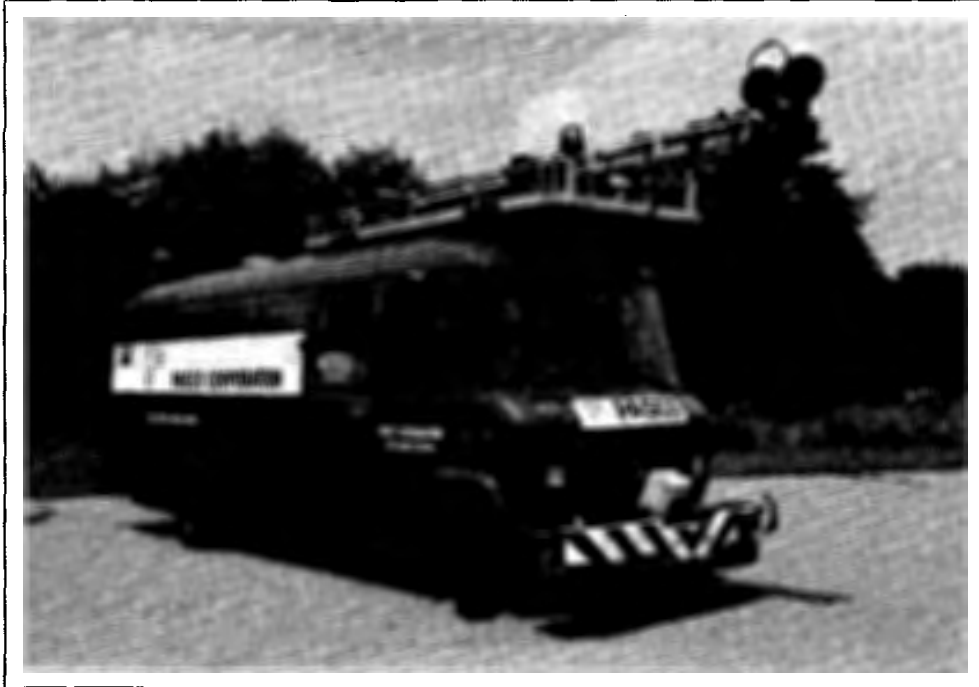
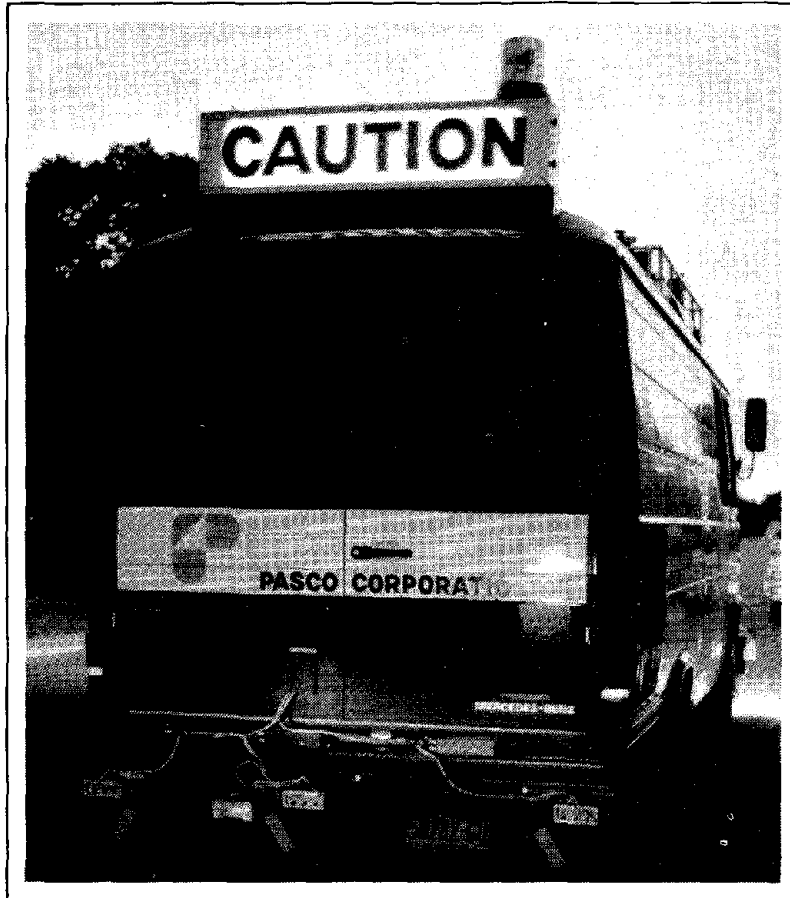
Figure 14. Side view (top) and rear view (bottom) of PASCO ROADRECON systems.

Figure 14 illustrates the PASCO Road Survey Vehicle (called PASCO ROADRECON equipment in this study) used in the field tests. This unit was built in 1983 and has traveled over 190,000 miles (306,000 km), according to the Japanese team who also mentioned that five units are in service in Japan with an annual survey of about 6200 miles (10,000 km) per unit. Four different ROADRECON instruments were installed in that unit. These were: ROADRECON-70 (35-mm continuous strip film photography), ROADRECON-75 (hairline projector and 35-mm photography for rut depth), ROADRECON-77 (longitudinal roughness using a fifth tracking wheel), and ROADRECON-85B (laser sensors for faulting and rut depth). Table 29 summarizes the historical background of the PASCO's Road Surface (PRS) Condition Survey System. Principles of operations and equipment description (based on Ref 8) for ROADRECON-70, ROADRECON-75, and ROADRECON-85B, pertinent to the objectives of this study, are presented below.

Various configurations of the ROADRECON survey vehicle can be designed according to PASCO (Ref 8). A combination of ROADRECON-70, ROADRECON-75, ROADRECON-77, and ROADRECON-85B was used in the field tests. The survey vehicle shown in Figure 14 is comprised of:

- o A full-size diesel van (Mercedes Benz) fitted with a rotating yellow light on the roof.
- o Engine-driven generator and power controlling panel.
- o Instruments used for the four ROADRECON series.

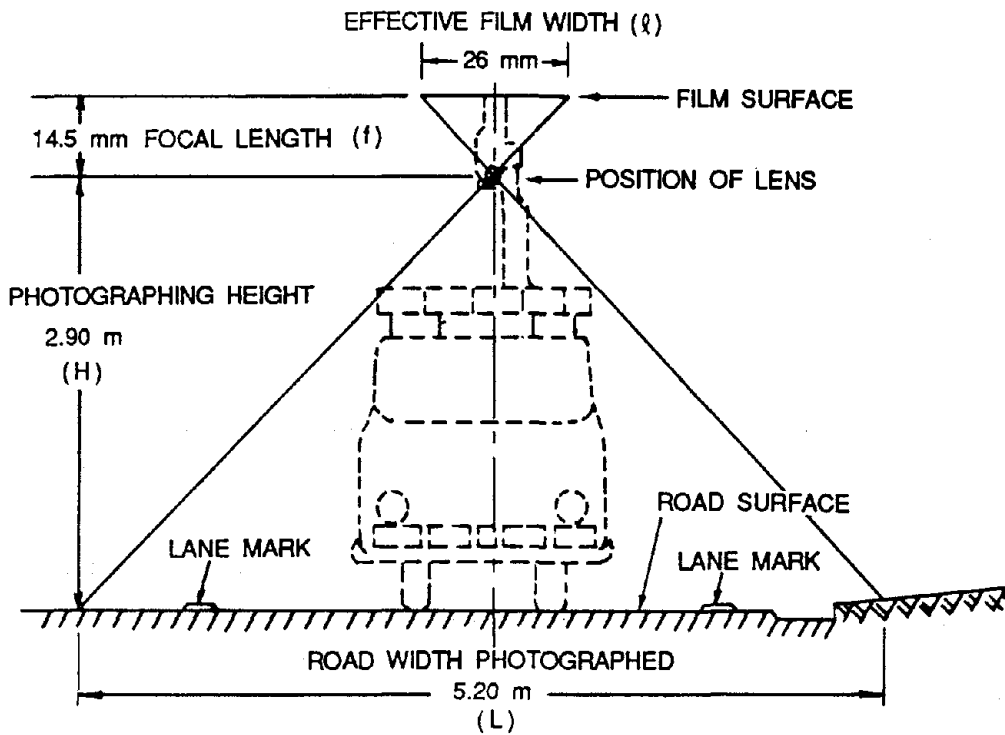
Figure 15. Photographing scale of PASCO'S ROADRECON-70.

$$\text{PHOTOGRAPHIC REDUCTION RATIO} = \frac{f}{H} = \frac{l}{L} = \frac{1}{200}$$

mm) is held at 2.9 m vertically from the road surface. Therefore, photographic reduction can be expressed by 14.5 mm/2.9 m or 1/200 as illustrated in Figure 15.

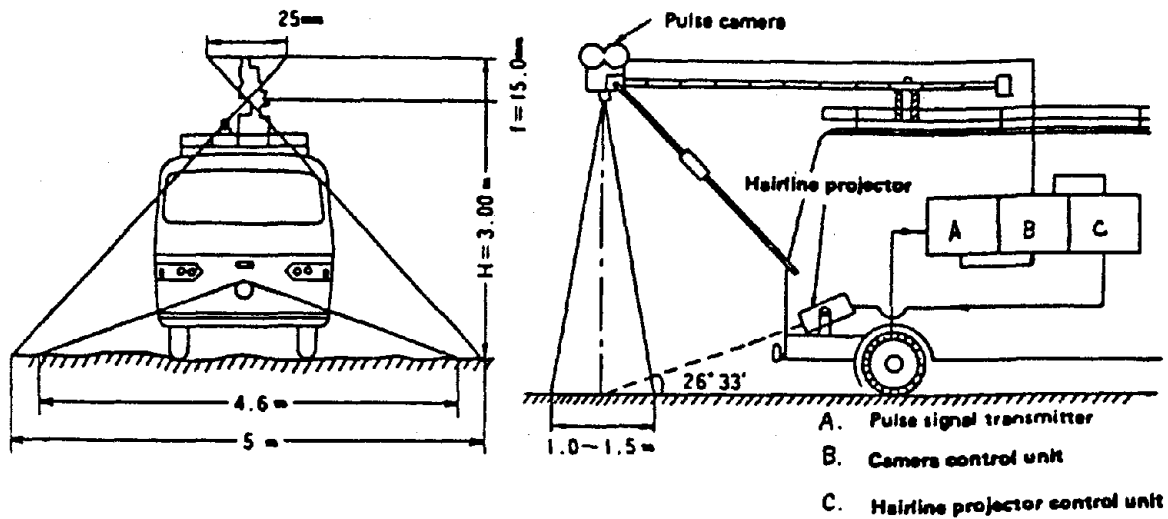
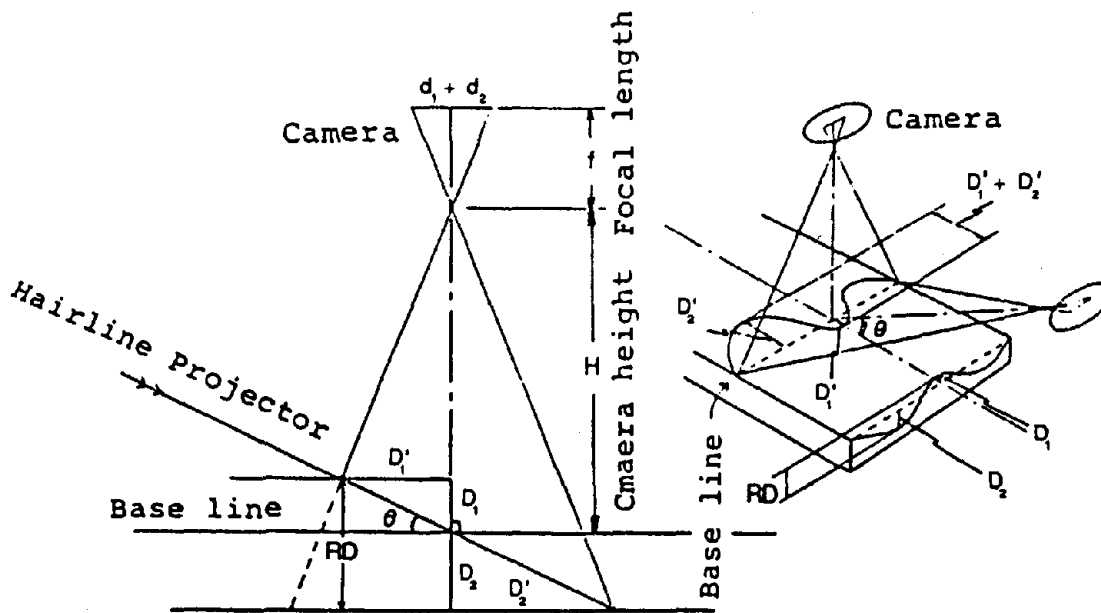
Figure 16. Principle of the ROADRECON-75.

(a) ROADRECON - 75 System mounted in vehicle.

RD : Rut depth

$d_1 + d_2$  : Rut depth as observed in photo (rd)

(b) Geometric relations between Optical Bar and Camera.

The ROADRECON-75 photographs an optical bar projected on the road surface as illustrated in Figure 16. If the projector angle is set at  $26^{\circ}33'$  and a pulse camera is set perpendicular to the road surface, then the rut depth (RD) can be obtained using the following equation.

$\text{Cot}\theta = \text{Cot}(26^{\circ}33') = 2.0$ , other terms as defined in Figure 16(b).

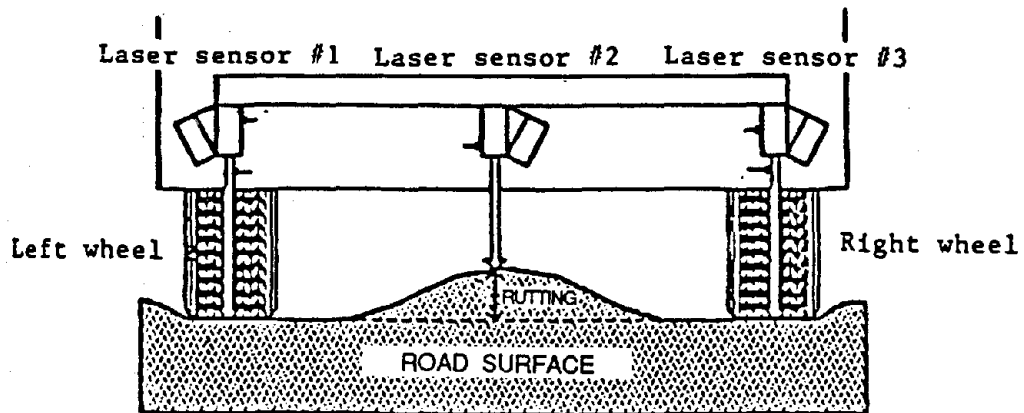
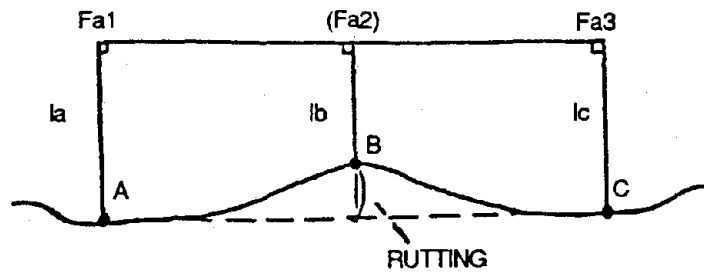
Longitudinal profile  
 Right wheel path:  $Fa3 = la$   
 Left wheel path:  $Fa1 = lc$

$$\text{Rutting: } RD = \frac{la + lc}{2} - lb$$

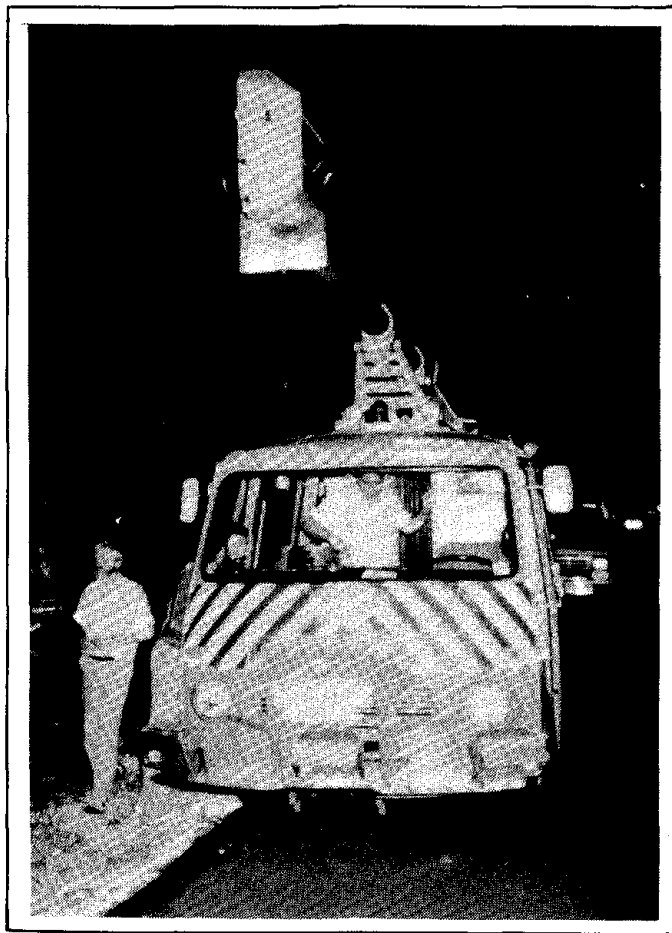
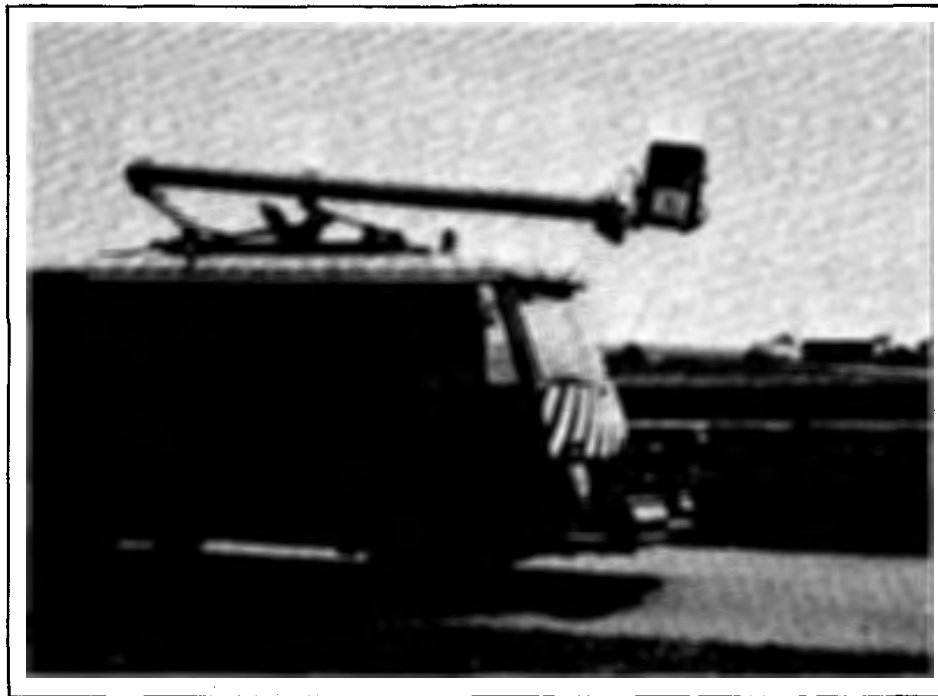
Figure 18. Night (top) and day (bottom) views of GERPHO.

Figure 18 illustrates two views of the GERPHO equipment. The equipment is set up aboard a mid-size Peugeot J7 van. It comprises:

Camera. Three units comprise the camera: lens, mechanisms, and associated electronic elements. The camera box is custom made in France. It is fitted with a 14.5-mm Angenieux lens with an aperture of F3.5 and a mask having a slit 0.3-mm wide by 23-cm long, which makes it possible to check 15.2 inches (0.4 m) x 15.6 feet (4.8 m) of roadway. The mechanical unit includes a continuous running drive which is geared to the vehicle speed. Distance and timing marks are recorded on the film by two marker tubes. The magazines hold 400 ft (120 m) of 35-mm film which will film 15 miles (24 km) of pavement. The ASA200 film is Kodak Double X negative #5222 (black and white). The mechanical and optical units are contained in a housing with a protective cover. There is an end-of-film indicator and a meter that shows the length of the film exposed.

The film is driven by an impulse motor actuated by the Rhythm-O-Start and by a source of impulses. The impulse unit is coupled to the gear box of the van. This system ensures synchronization between the advance of the film and the movement of the vehicle, in the ratio of 1/200. There

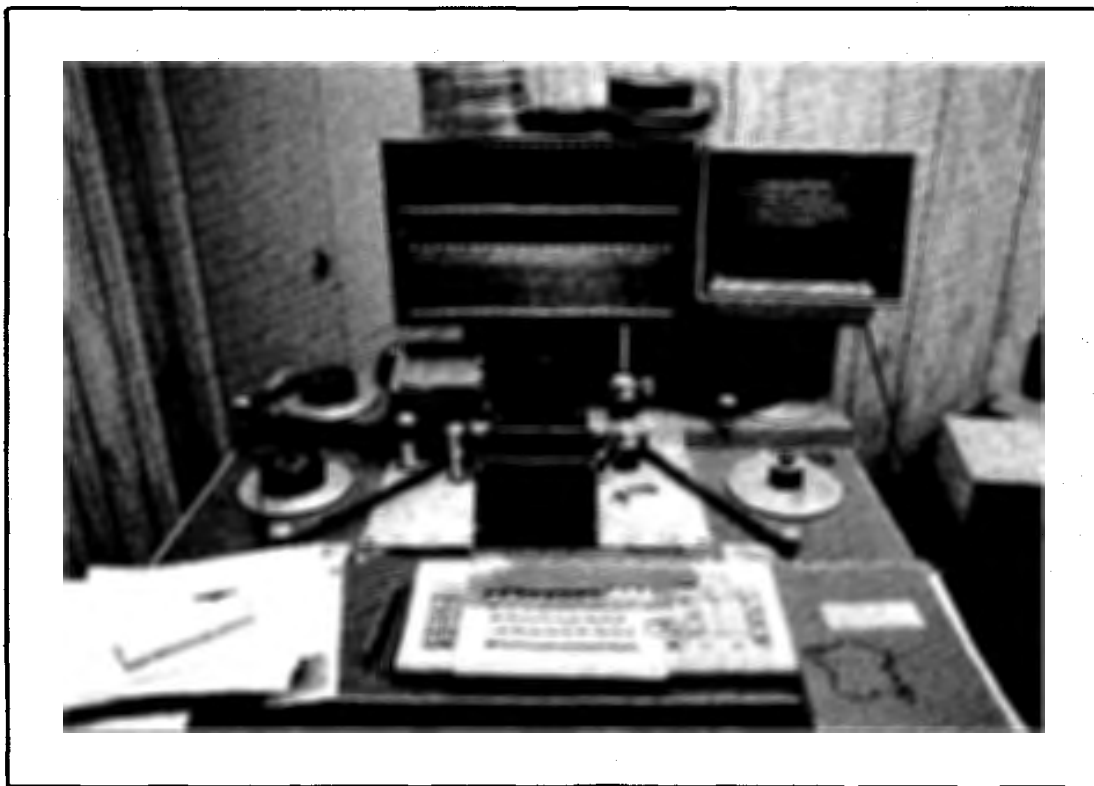
Figure 19. Viewing table and operating station used for office visual analysis of films and data reduction.

As illustrated in Figure 19, the processed negative films are placed on a viewing table. A screen 12 inches by 19 inches (0.3 m by 0.5 m) shows two films simultaneously, representing the equivalent of 65 feet (20 m)

with a magnification of four. The analysis of the GERPHO films in terms of the nature of distress goes through a process of human interpretation. In the case where two films are operated simultaneously, the information is collected at a rate of 10 to 12 miles per day for roads with relatively large degradations, according to the French delegation (Ref 9). The system allows for simultaneous reading of two films representing two different road lanes. These lanes could be:

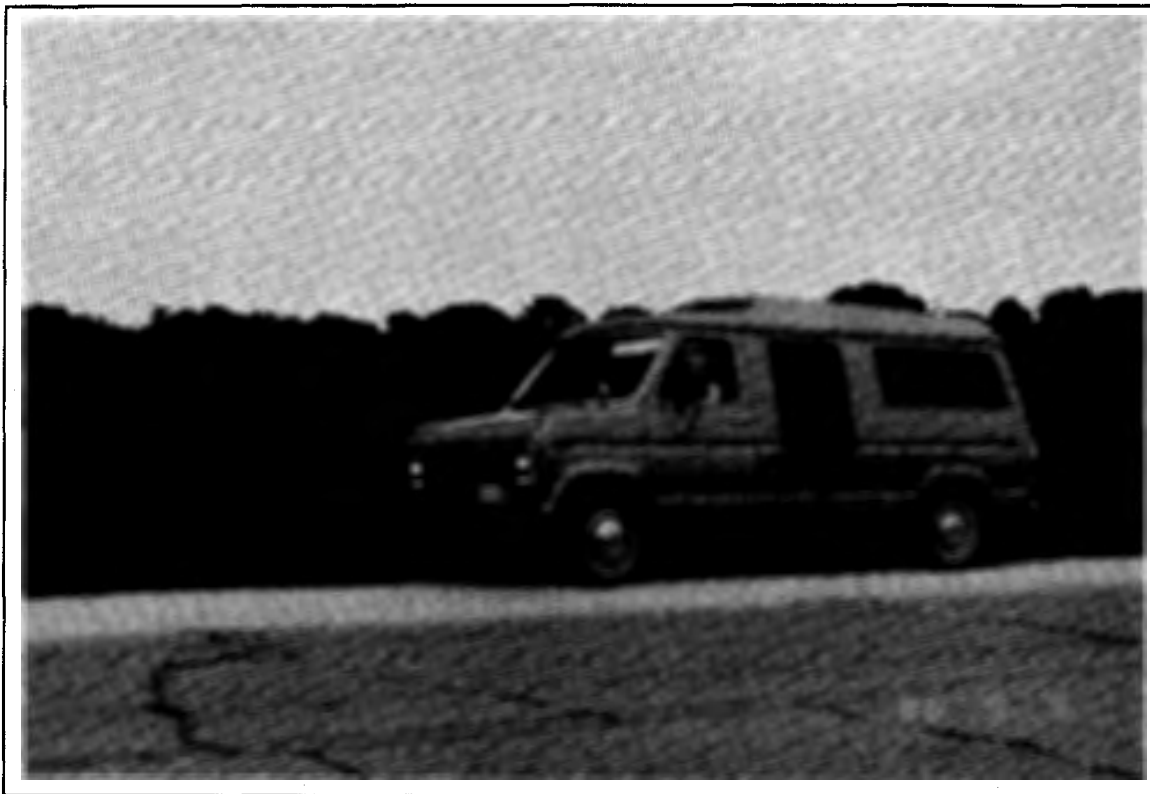
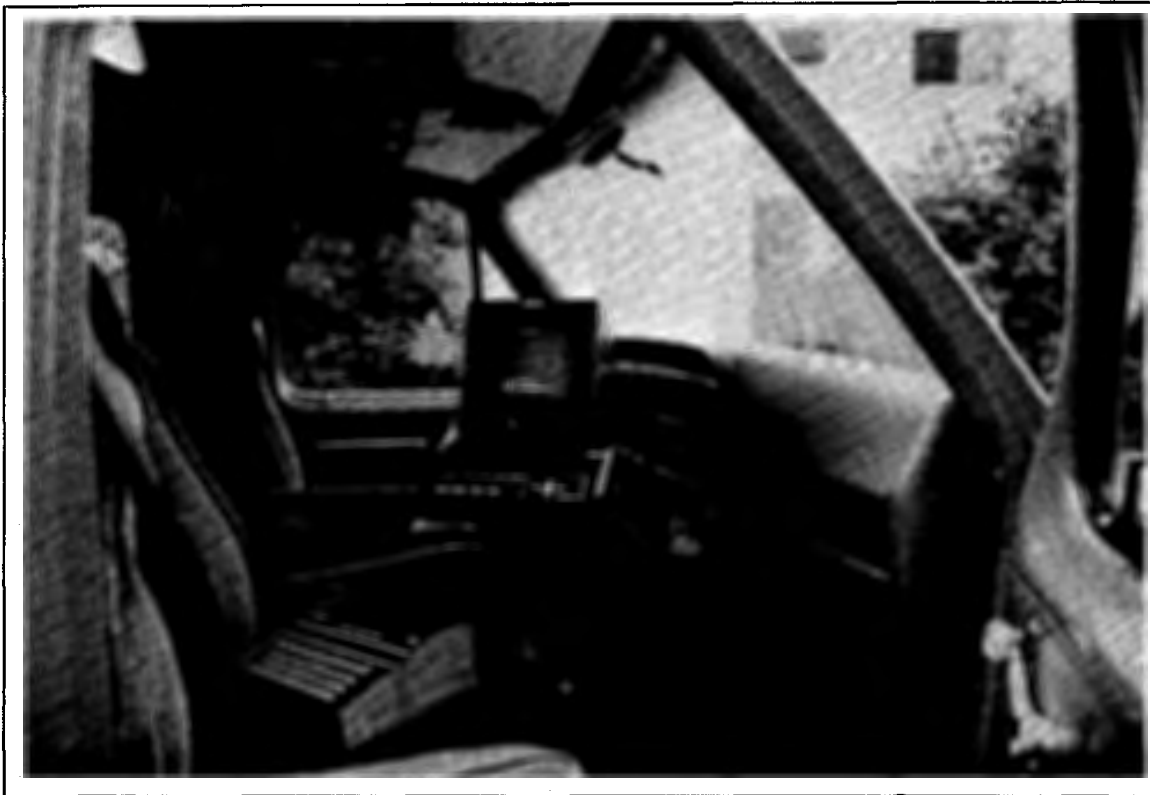
Figure 20. A side view of the ARAN van (top) and systems monitor and control keyboard (bottom).

The Automatic Road Analyzer (ARAN) is produced by Highway Products International, Inc. Eight ARAN orders have been completed or are in process (Ref 14). The ARAN Model III, used for the field tests, is shown in Figure 20. Field tests for the ARAN were conducted during the day on September 4 to 8, 1986. The information presented here is based on References 14 and 11 and discussions with the ARAN team.

consists of two batteries and alternators. A transmission driven Distance Measuring Instrument (DMI) is used. Other hardware included is a video system, microcomputer, accelerometer, surface distress rating keyboards, gyroscope, and ultrasonic sensor profile bar, all of which are described below.
